Beckett Bridge

Project Development & Environment (PD&E) Study

January 2016

Preliminary Engineering Report Volume 2: Appendices

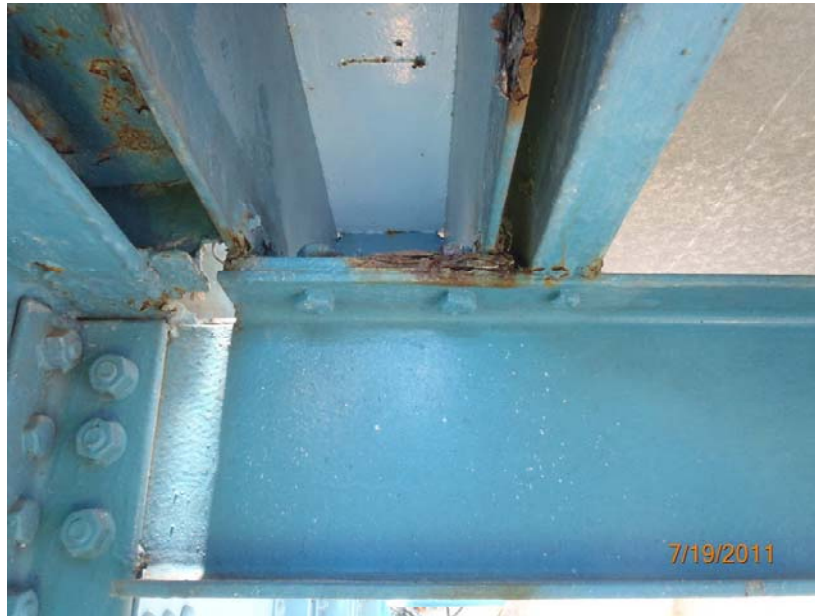
PHOTO 2: 28/4 Steel Deck/Open Grid

The open steel grating and cantilevered sidewalk supports exhibit widespread areas of peeling paint and moderate to heavy corrosion.

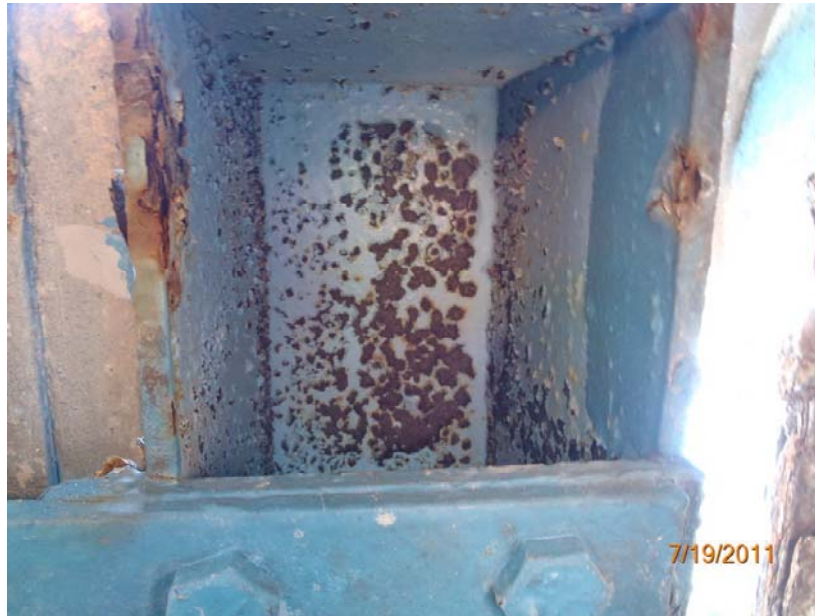
PHOTO 4: 28/4 Steel Deck/Open Grid

The inside of the steel box curbs exhibits areas of blistered paint and moderate to heavy active corrosion.

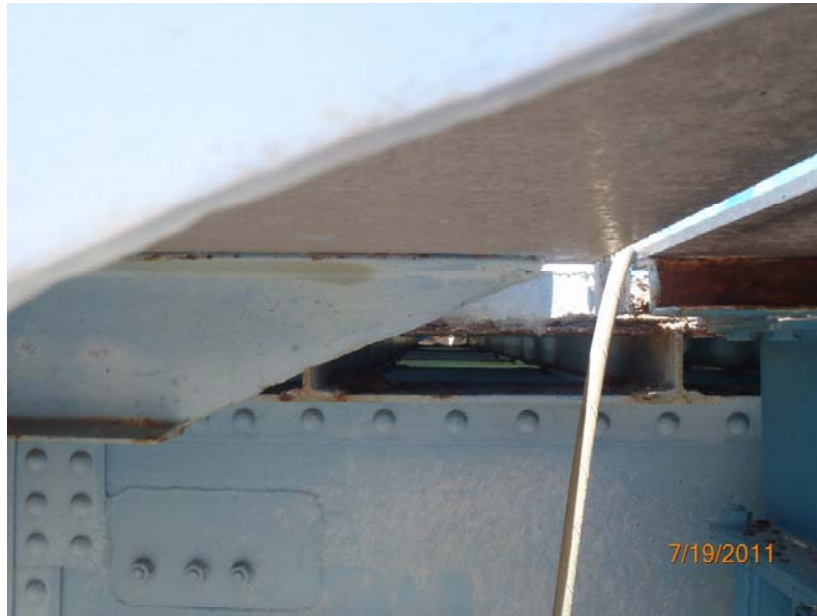
PHOTO 6: 29/4 Steel Deck/Conc Grid

The underside of the concrete filled steel grid deck exhibits areas of moderate active corrosion.

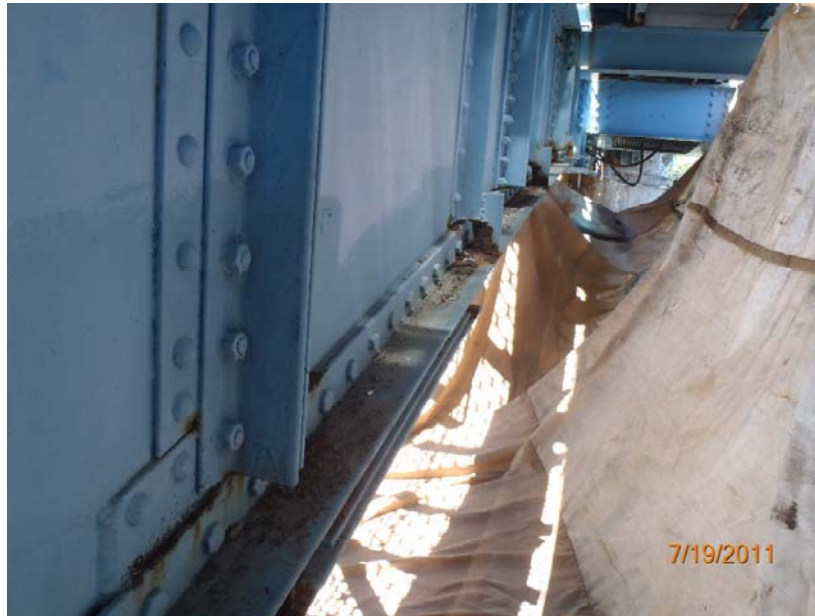
PHOTO 8: 107/4 Paint Stl Opn Girder

Both main girders exhibit areas of active corrosion at the floor beams, vertical stiffeners and at the curve tracks.

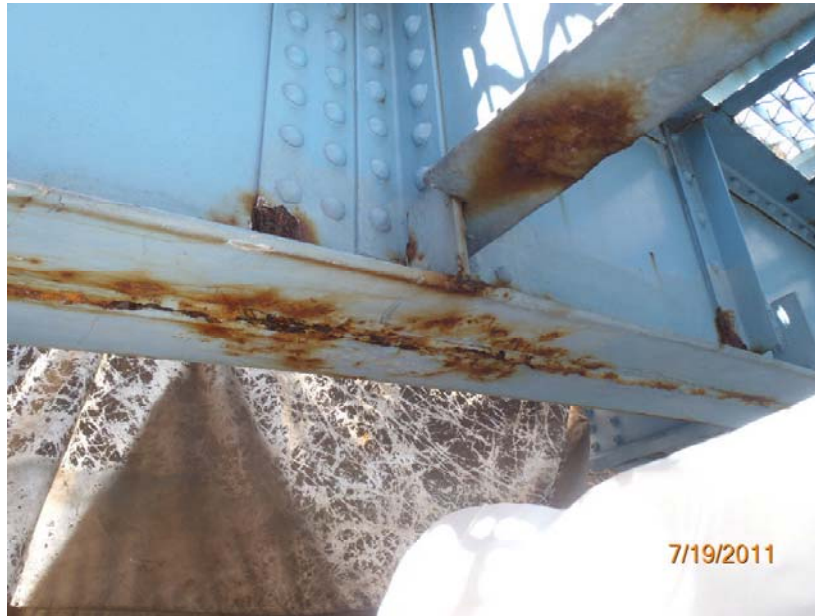
PHOTO 9: 152/4 Paint Stl Floor Beam

Floor Beam 6-2 exhibits a 1 ft. long area of moderate corrosion in the bottom flange at Main Girder 6-2.

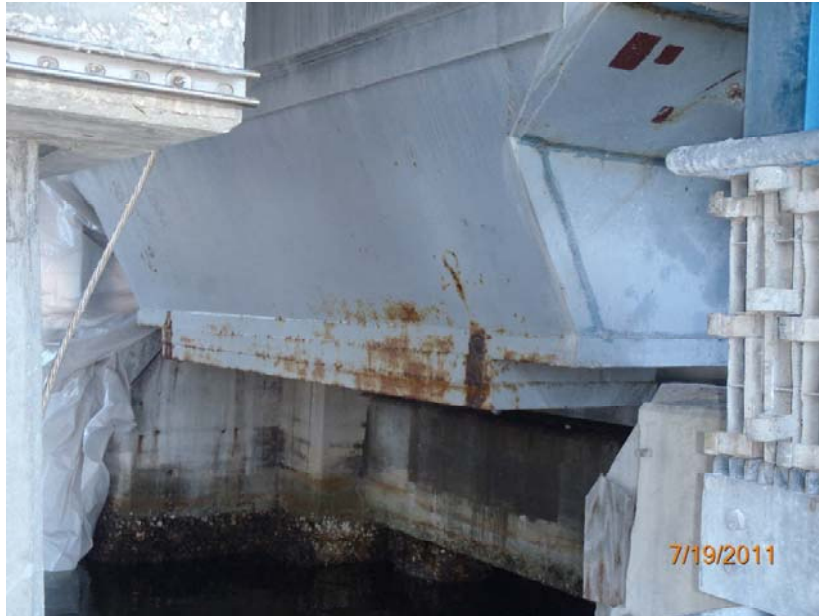
PHOTO 13: 562/4 Counterweight Support

The lower east edge of the counterweight support exhibits, moderate surface corrosion.

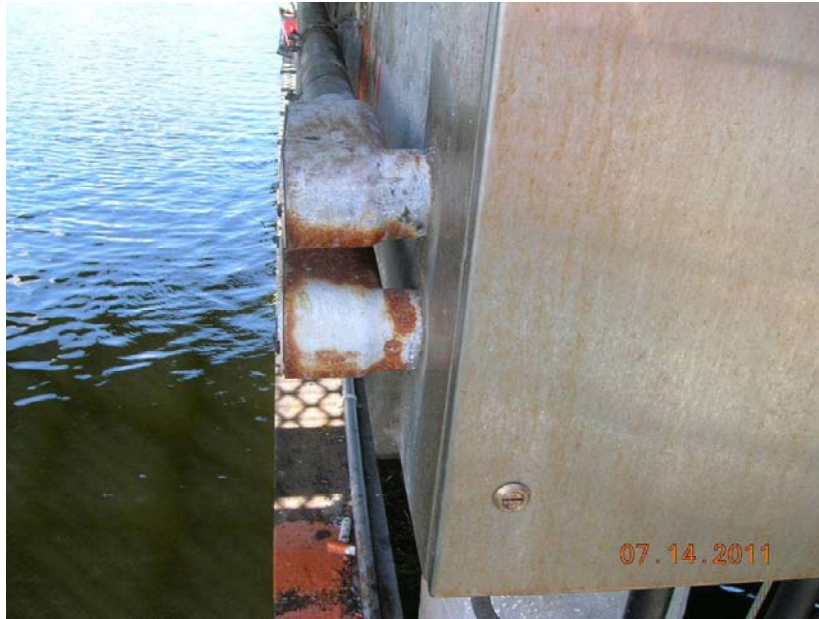
PHOTO 16: 572/4 Conduit & Junc. Box

Typical view of corrosion in conduit bodies and junction boxes.

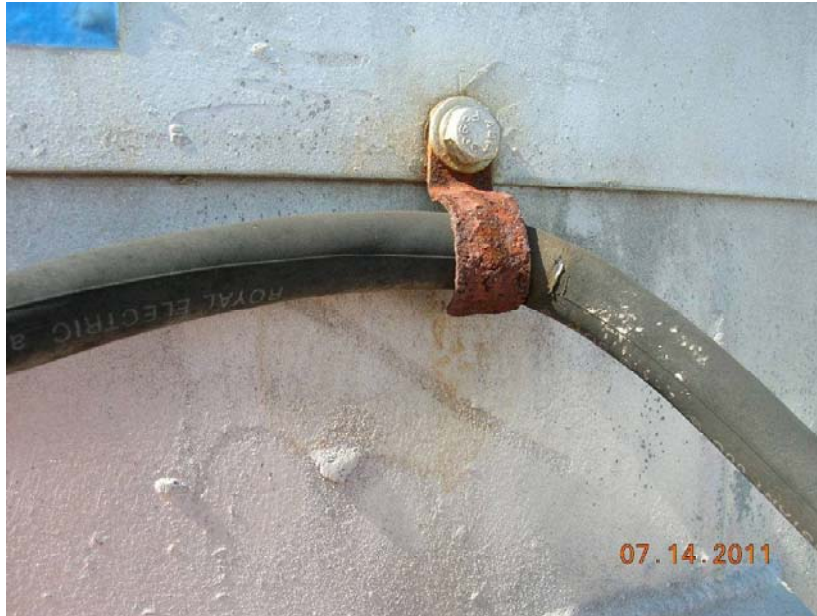
PHOTO 17: 572/4 Conduit & Junc. Box

Typical view of heavy corrosion in several conduit cable clamps throughout bridge.

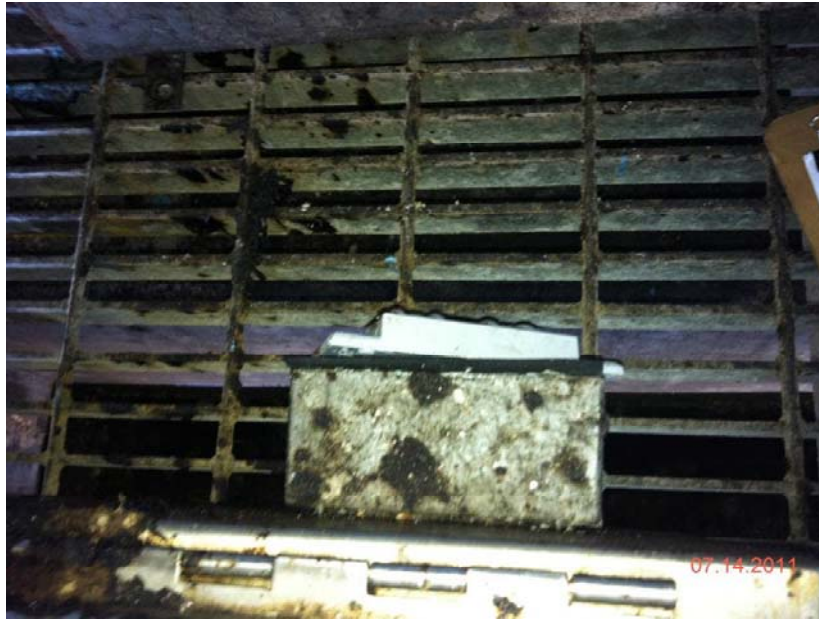
PHOTO 18: 572/4 Conduit & Junc. Box

Receptacle enclosure improperly sealed on near side of machinery level.

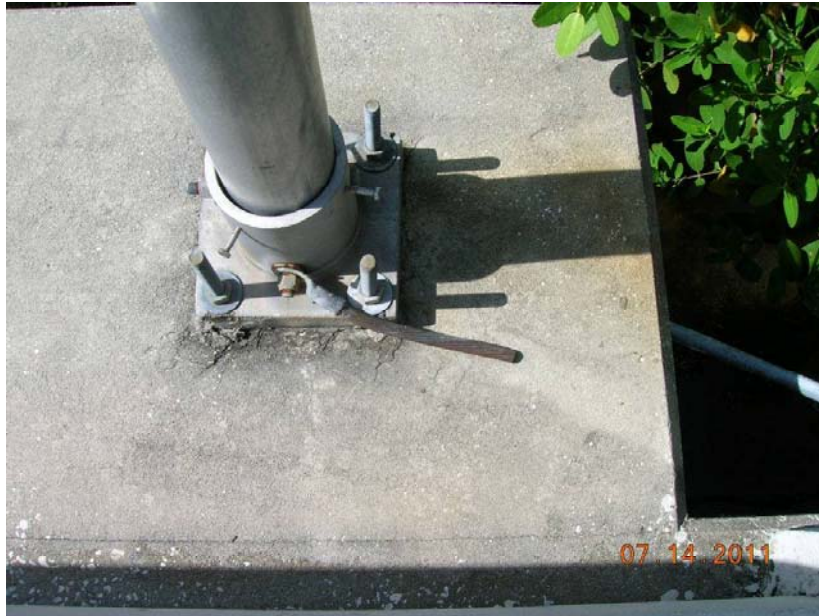
PHOTO 19: 572/4 Conduit & Junc. Box

The lightning protection conductors were missing in several locations on the far approach spans.

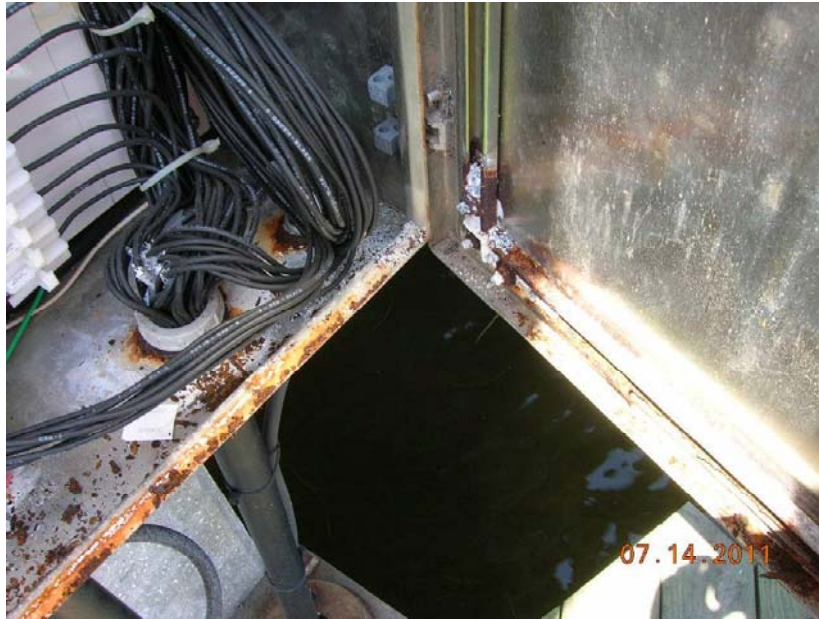
PHOTO 20: 572/4 Conduit & Junc. Box

West submarine termination cabinet exhibits moderate to heavy corrosion.

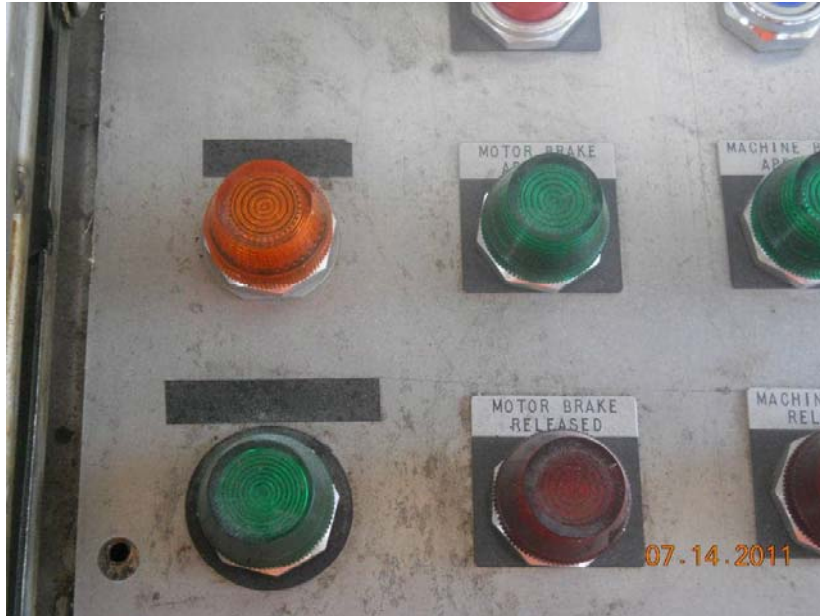
PHOTO 21: 574/4 Control Console

There are missing nameplates for indicator lights and switches on the control console.

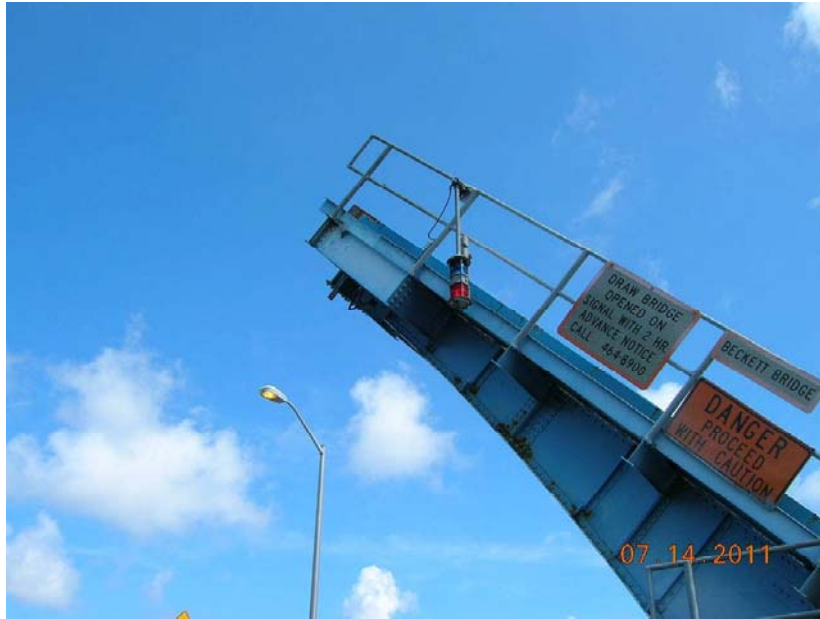
PHOTO 22: 580/4 Navigational Lights

South side tip swing light with cracked bottom and chain is missing.

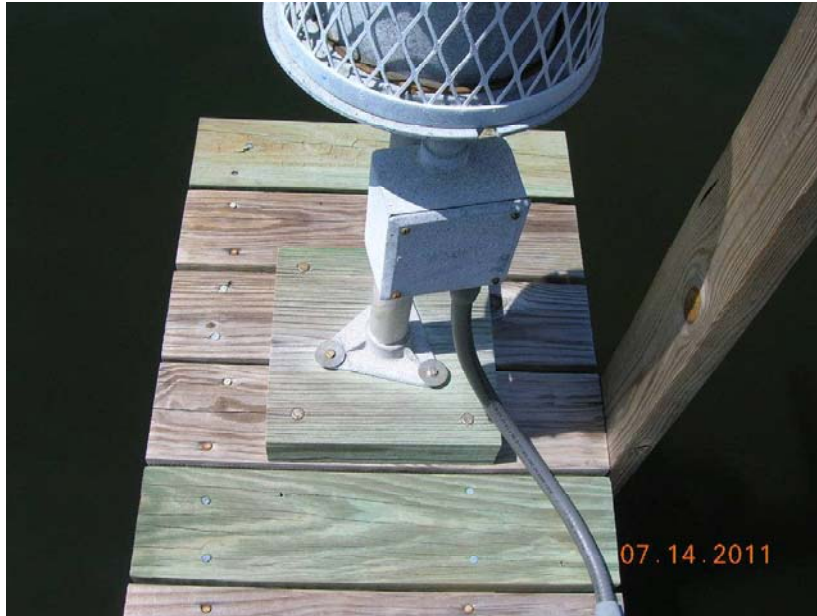
PHOTO 23: 580/4 Navigational Lights

Broken base on southwest fender light.

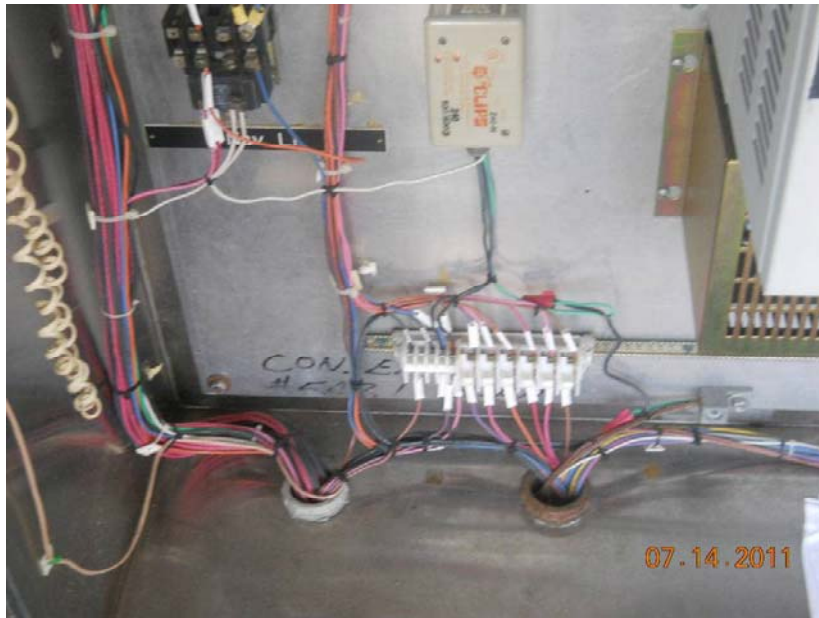
PHOTO 24: 580/4 Navigational Lights

Navigational Light UPS is missing.

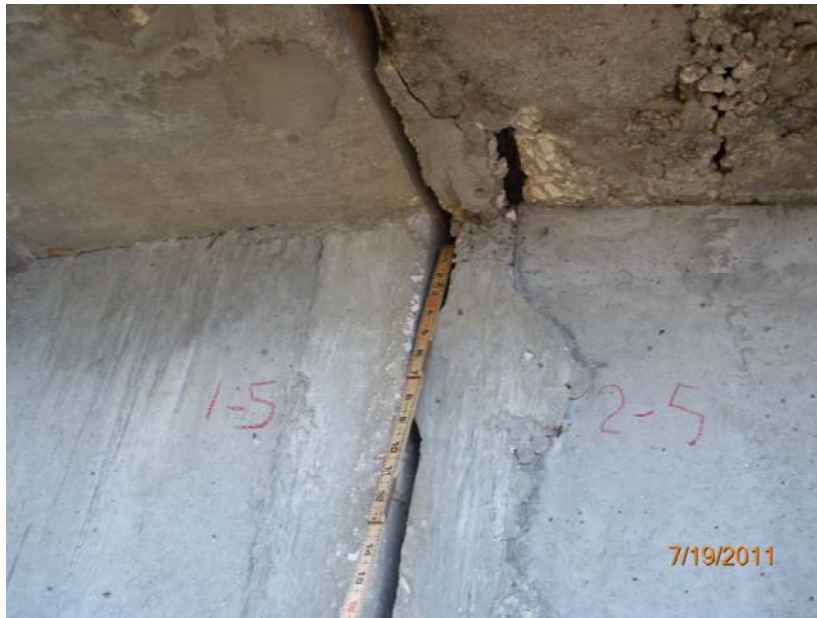
PHOTO 32: 12/4 Bare Concrete Deck

The right deck soffit exhibits an 8 in. x 1 ft. x 1-1/2 in. delamination/spall with exposed, corroded reinforcing steel in Span 2 at Bent 2.

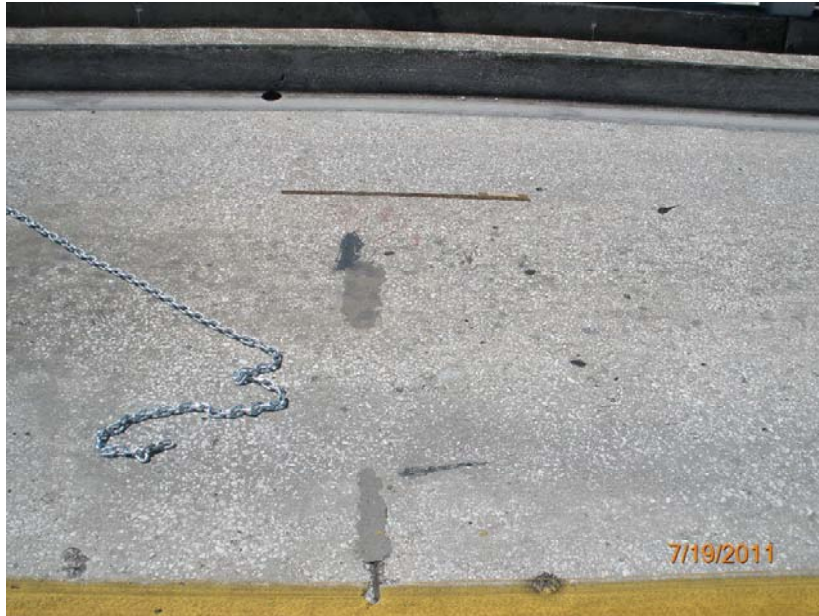
PHOTO 33: 12/4 Bare Concrete Deck

The 3/4 point in the middle of Lane 2 of Span 2 exhibits (3) delaminations/spalls with exposed steel up to 5 in. x 3 in. x 1/2 in.

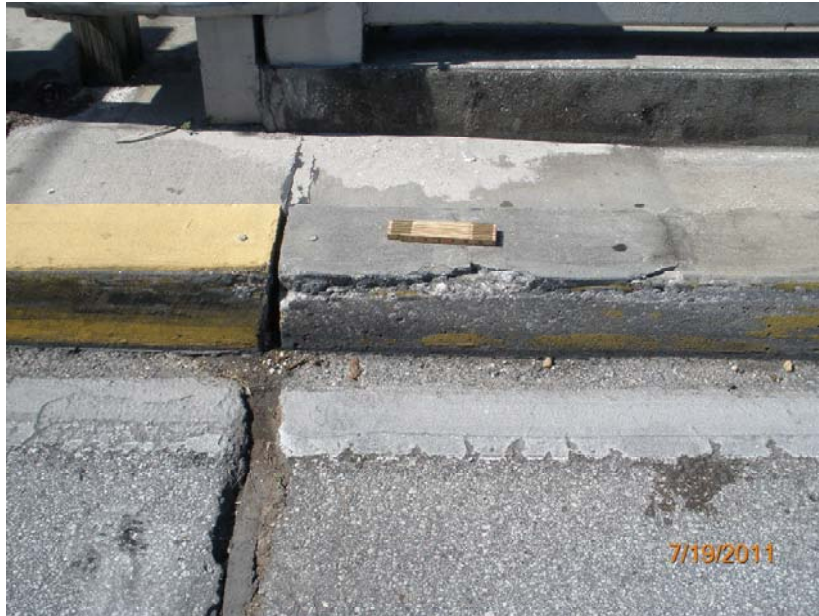
PHOTO 34: 12/4 Bare Concrete Deck

The top of the right curb adjacent to the joint at Abutment 11 exhibits a 30 in. x full width delaminated repair.

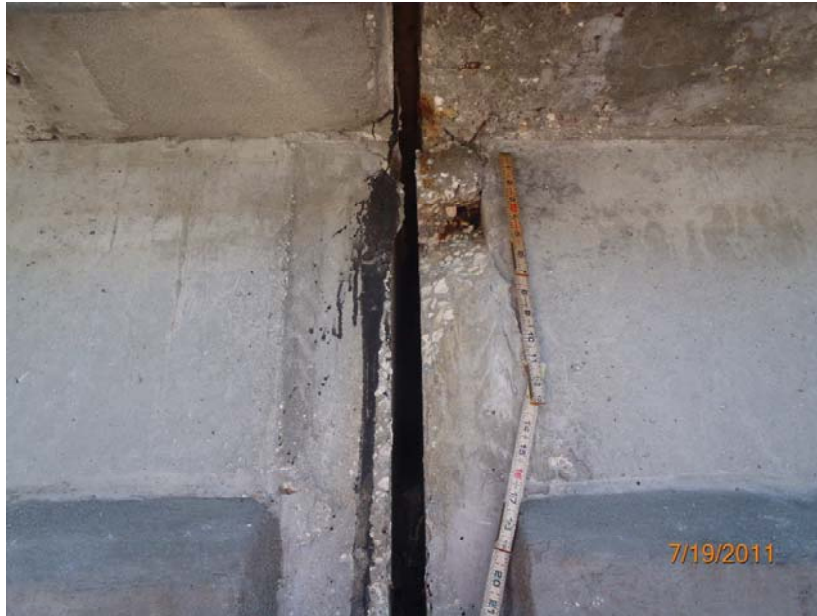
PHOTO 36: 109/4 P/S Conc Open Girder

The beam end of Beam 4-5 at Bent 4 exhibits a 3 in. x 10 in. x 2 in spall with exposed, corroded reinforcing steel.

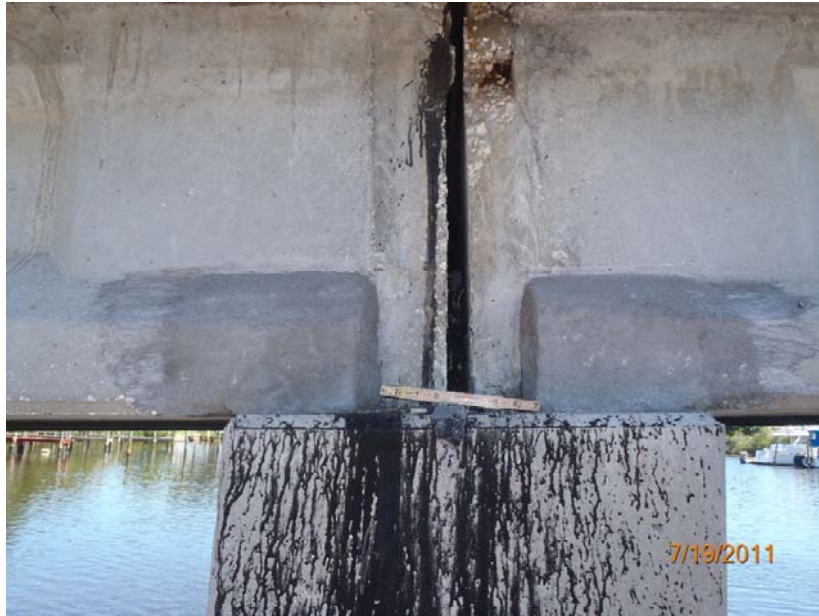
PHOTO 37: 109/4 P/S Conc Open Girder

Beams 3-5 and 4-5, south faces, exhibit delaminated repairs up to 4 in. x 8 in. over Bent 4.

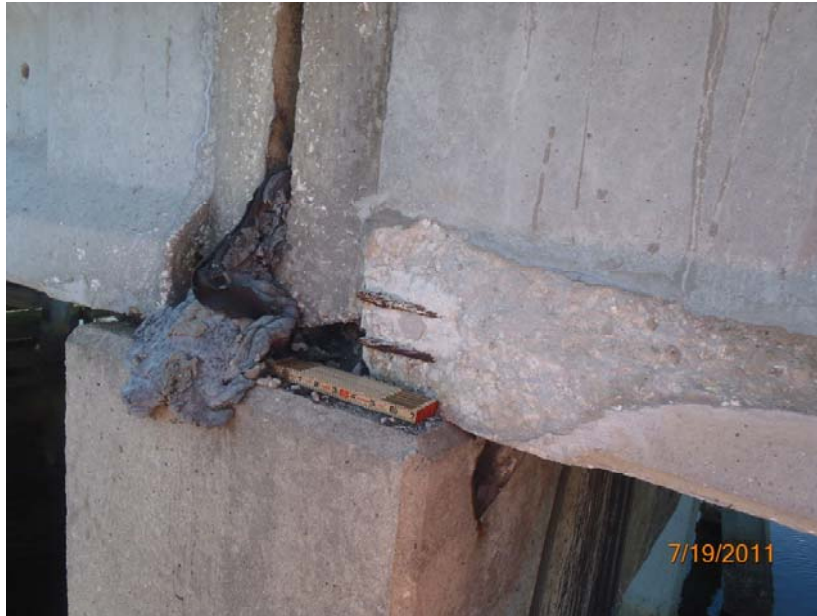
PHOTO 38: 109/4 P/S Conc Open Girder

Beam 4-1, north face, exhibits a 30 in. x 8 in. x 2 in spall with two exposed, corroded pre-stressing strands at Bent 5.

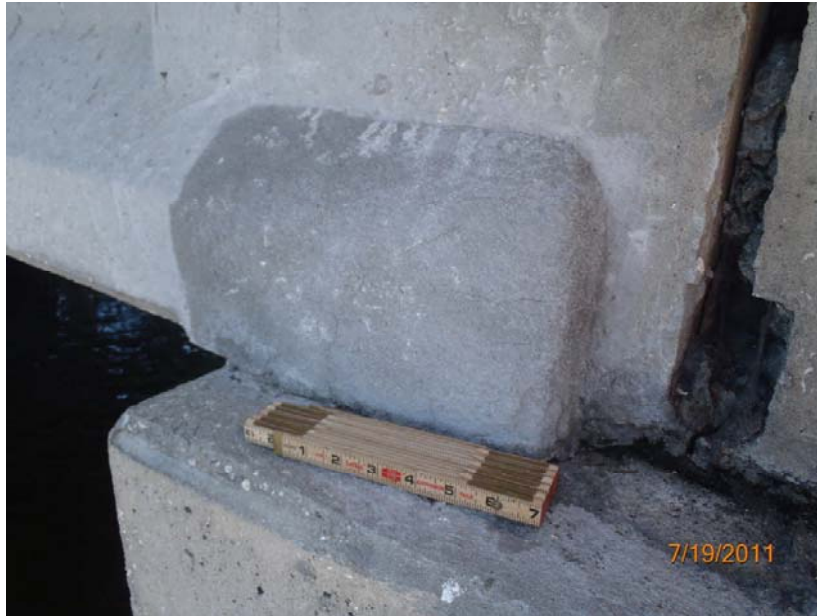
PHOTO 39: 109/4 P/S Conc Open Girder

Beam 7-5, previously reported as 7-1, exhibits a 12 in. x 8 in. delaminated repair at Bent 8.

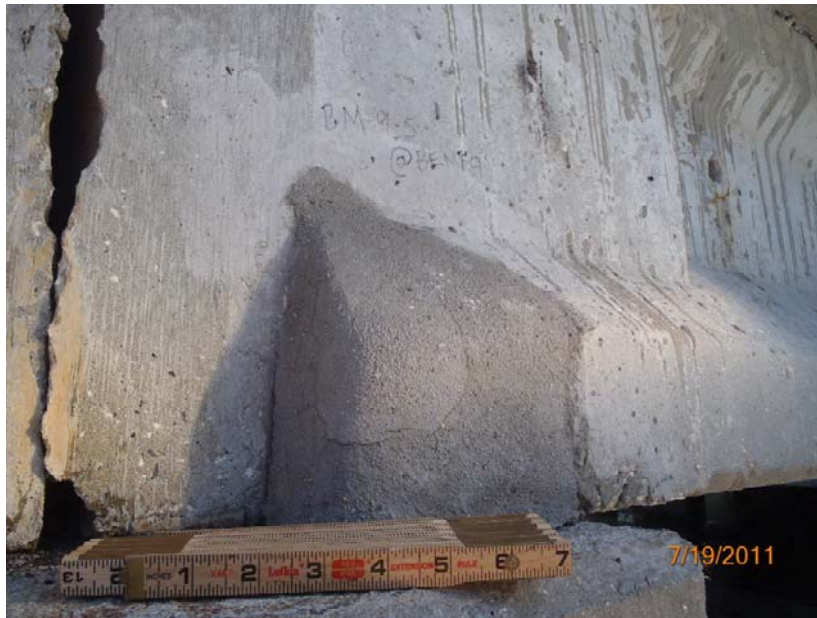
PHOTO 40: 109/4 P/S Conc Open Girder

Beam 9-5, south face, exhibits a 6 in. x 8 in delaminated repair at Bent 9.

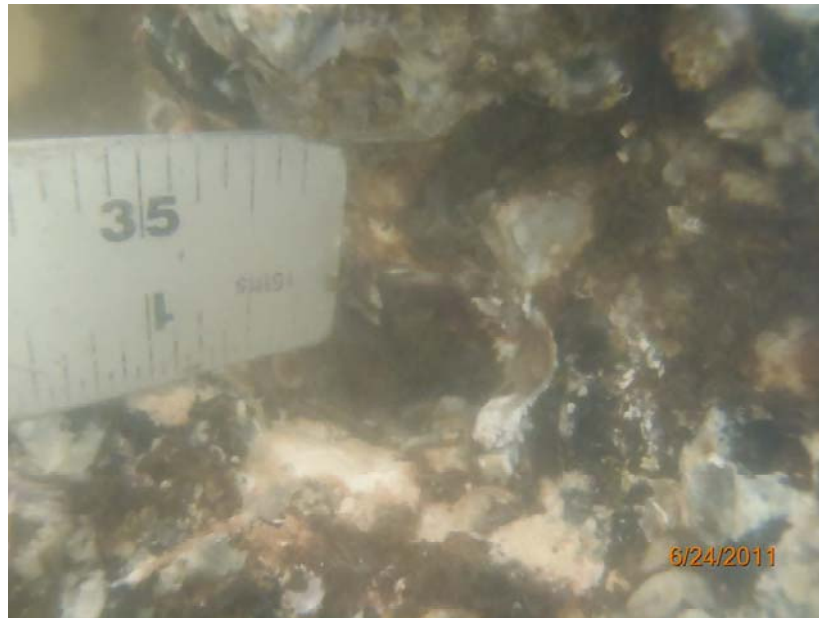
PHOTO 44: 204/4 P/S Conc Column

Pile 8-4 exhibits minor spalls around the splice between the pile and the build-up, 3 ft. 3 in. below the top of the marine growth. This spall is located in the southwest edge and measures 4 in. H x 4 in. W x 3 in. D with 100% deteriorated exposed steel.

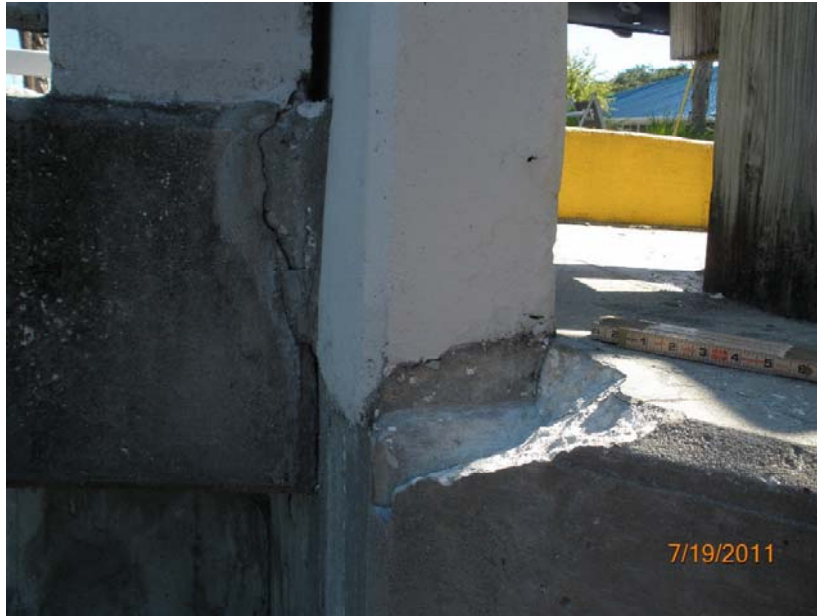
PHOTO 48: 474/4 Wall Uncoated

There is a 1 ft. x 6 in. x 3 in. spall with no exposed steel in the NW edge of the SE wing wall cap.

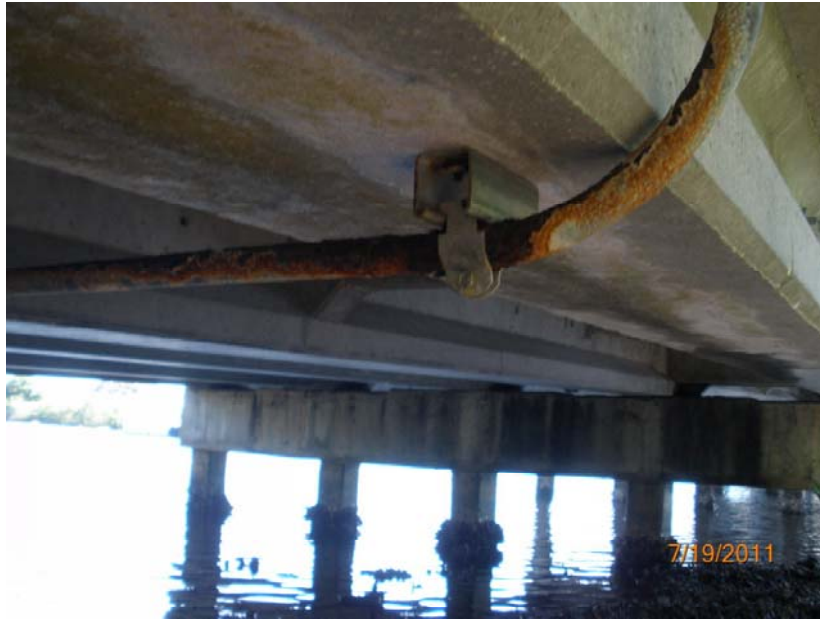
PHOTO 49: Inspection Notes

There is a heavily corroded conduit under Span 1.

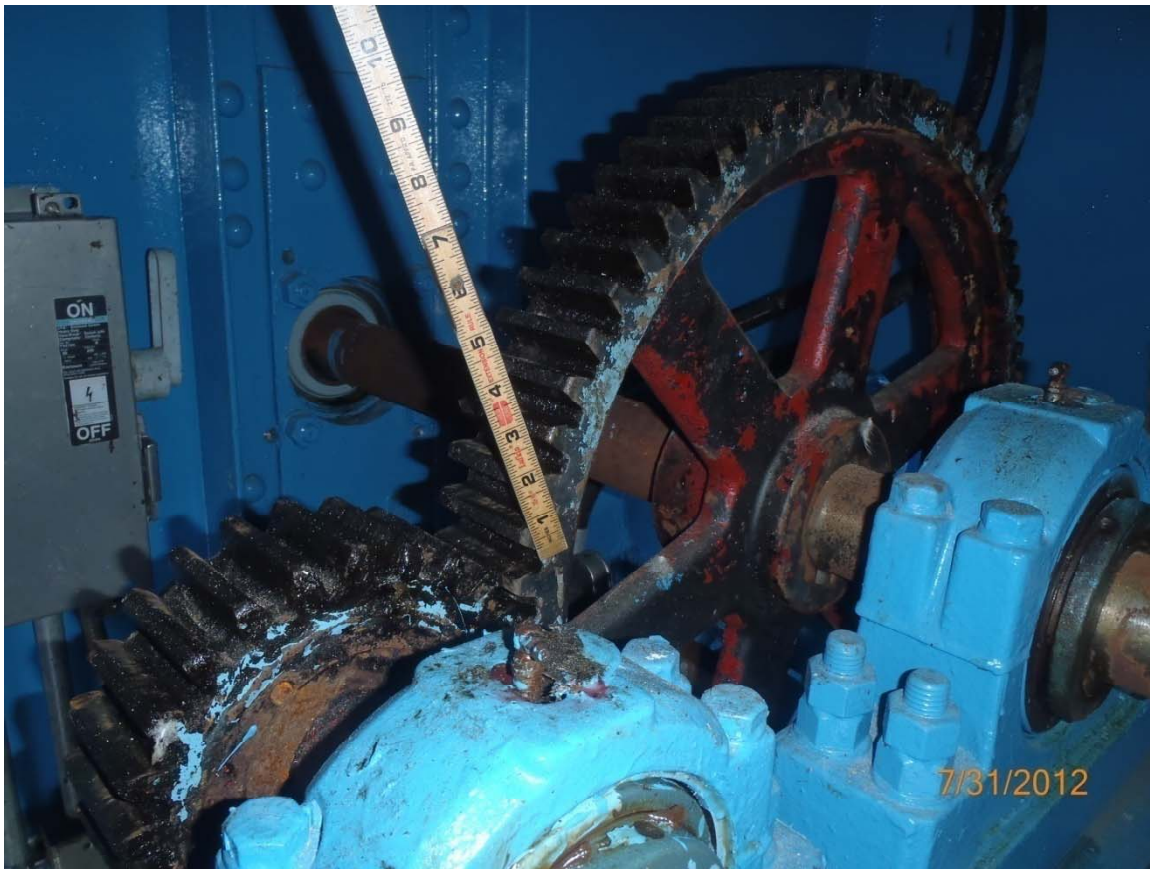
PHOTO 1: 540/4 - Open Gearing

Typical corrosion on gear sets (P/G-4N shown).

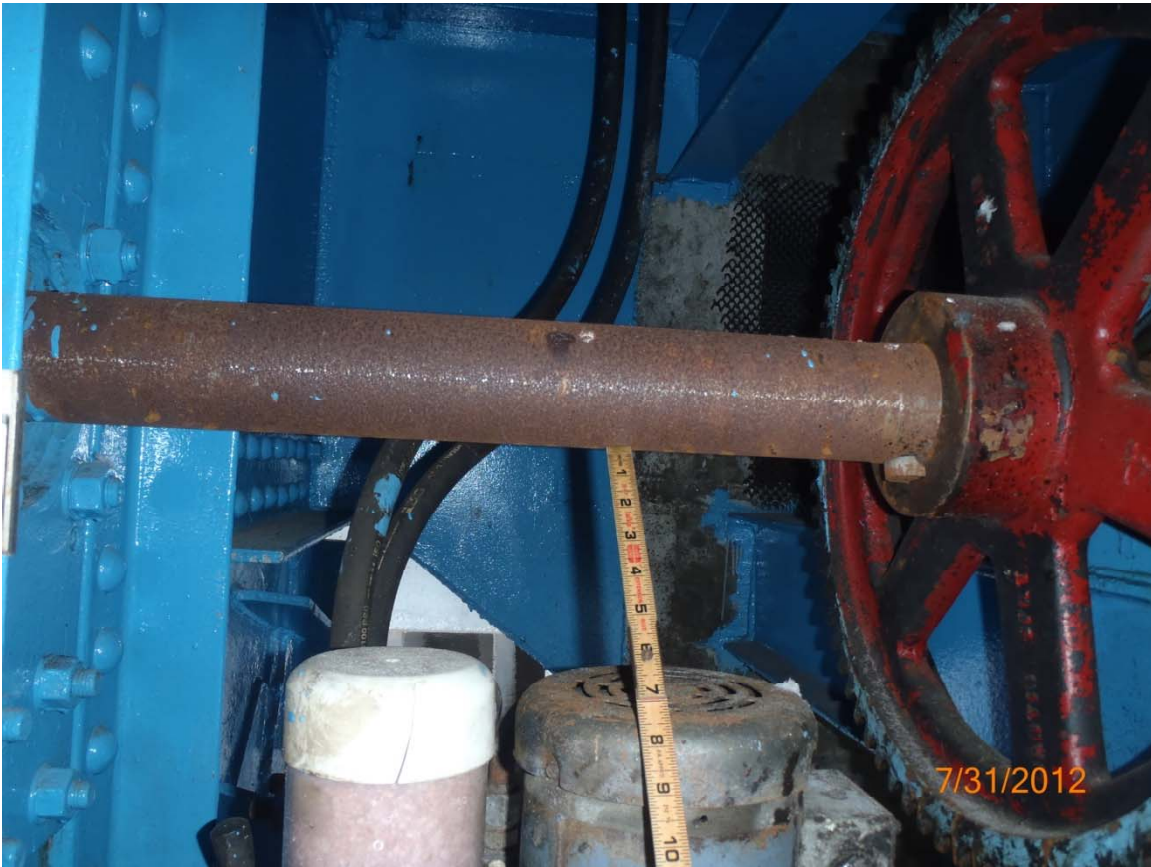
PHOTO 2: 542/4 - Shafts

Typical corrosion in shafts (S-5N shown).

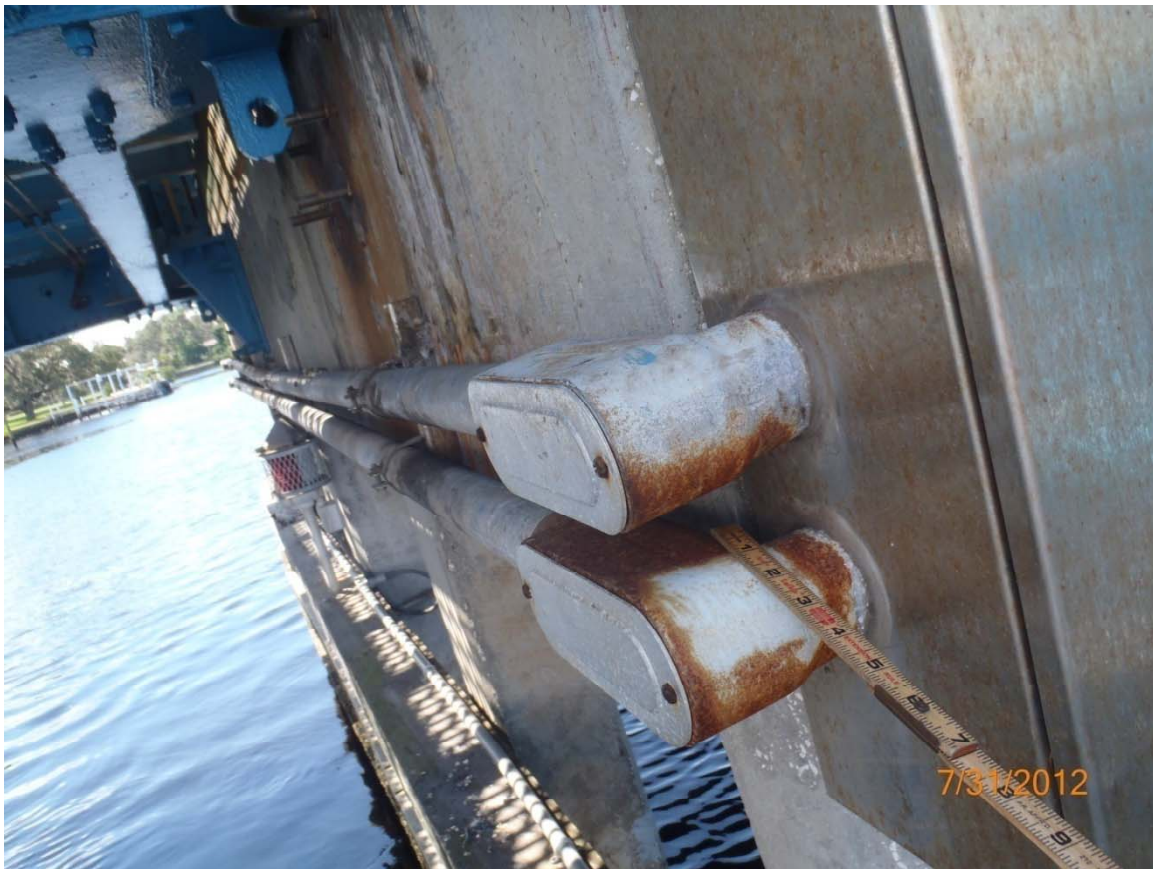
PHOTO 5: 572/4 - Conduit & Junc. Box

Typical corrosion in conduit bodies and junction boxes (at Rest Pier 6 shown).

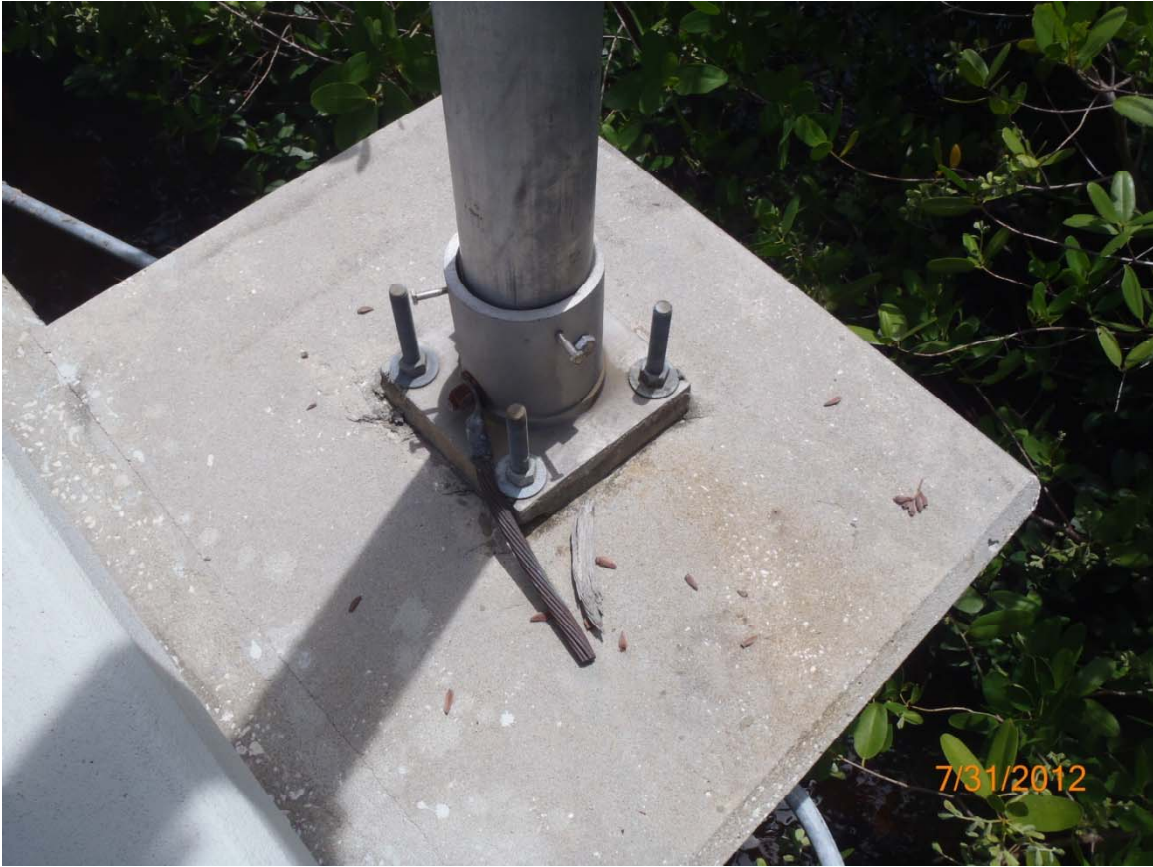
PHOTO 6: 572/4 - Conduit & Junc. Box

Typical missing grounding cable (at southwest traffic signal shown).

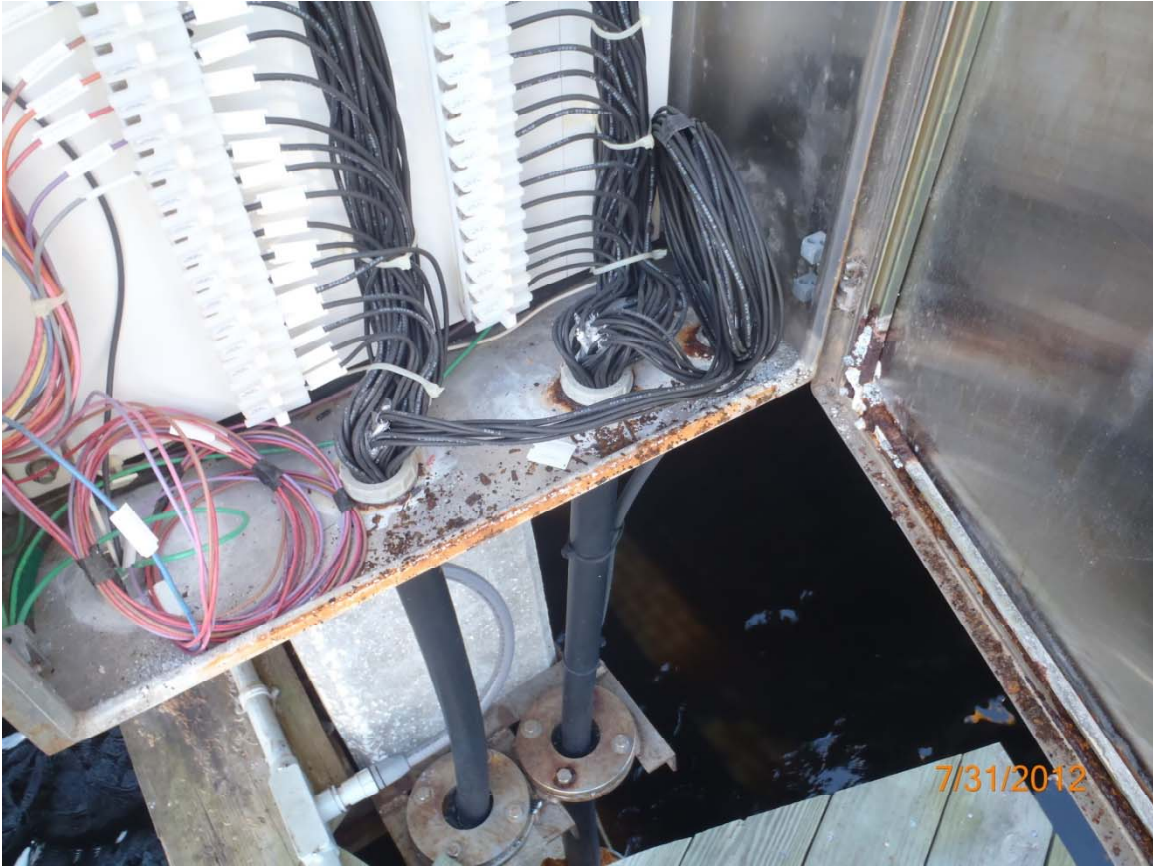
PHOTO 7: 572/4 - Conduit & Junc. Box

View of corrosion in submarine cable termination cabinet at Rest Pier 6.

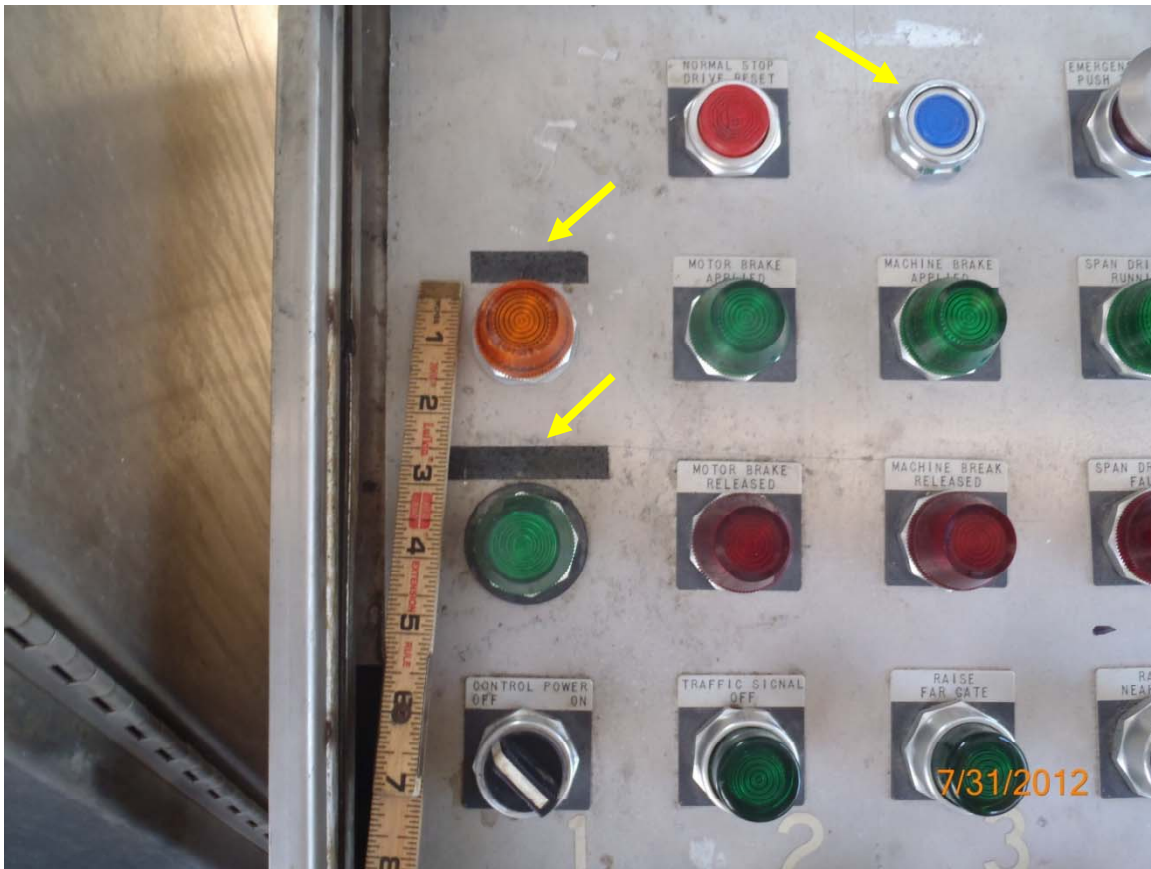
PHOTO 8: 574/4 – Control Console

View of missing nameplates for switches and indicator lights in control console.

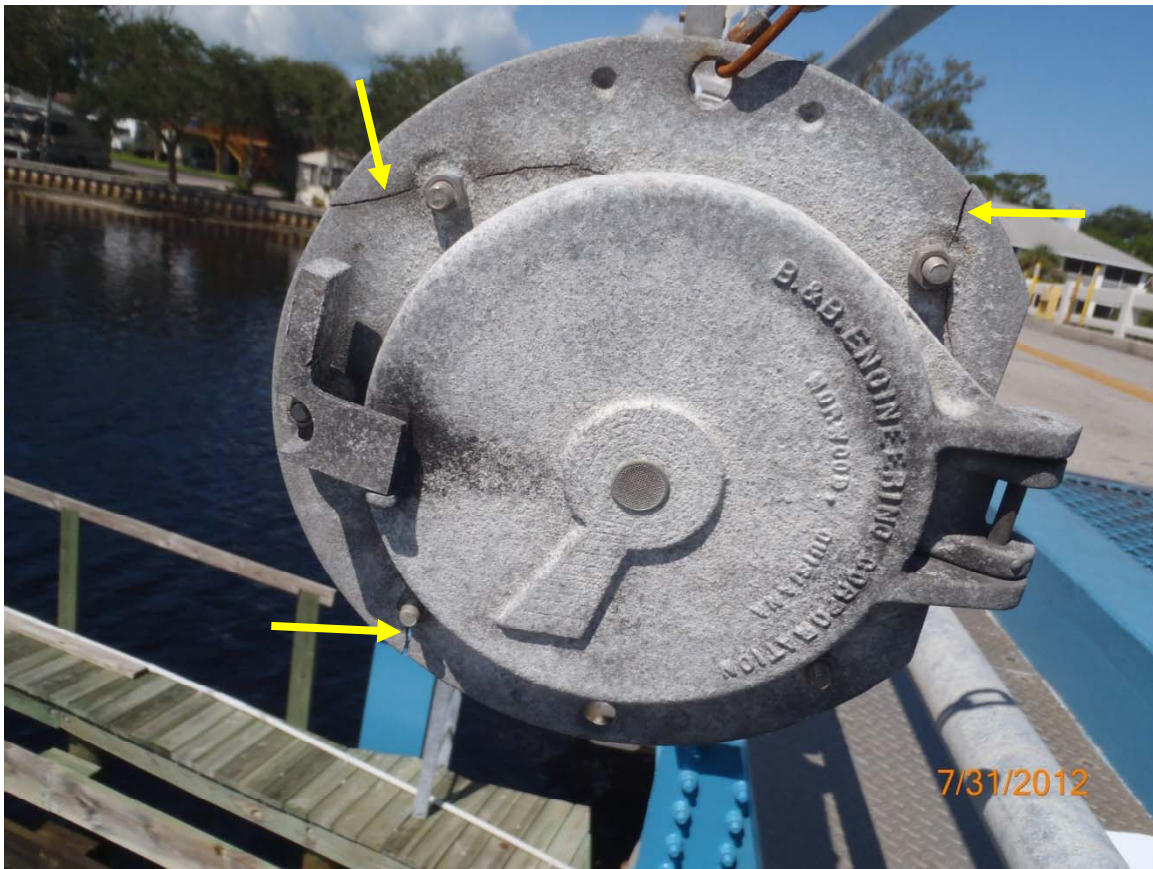
PHOTO 9: 580/4 - Navigational Lights

View of cracked bottom of south tip swing light.

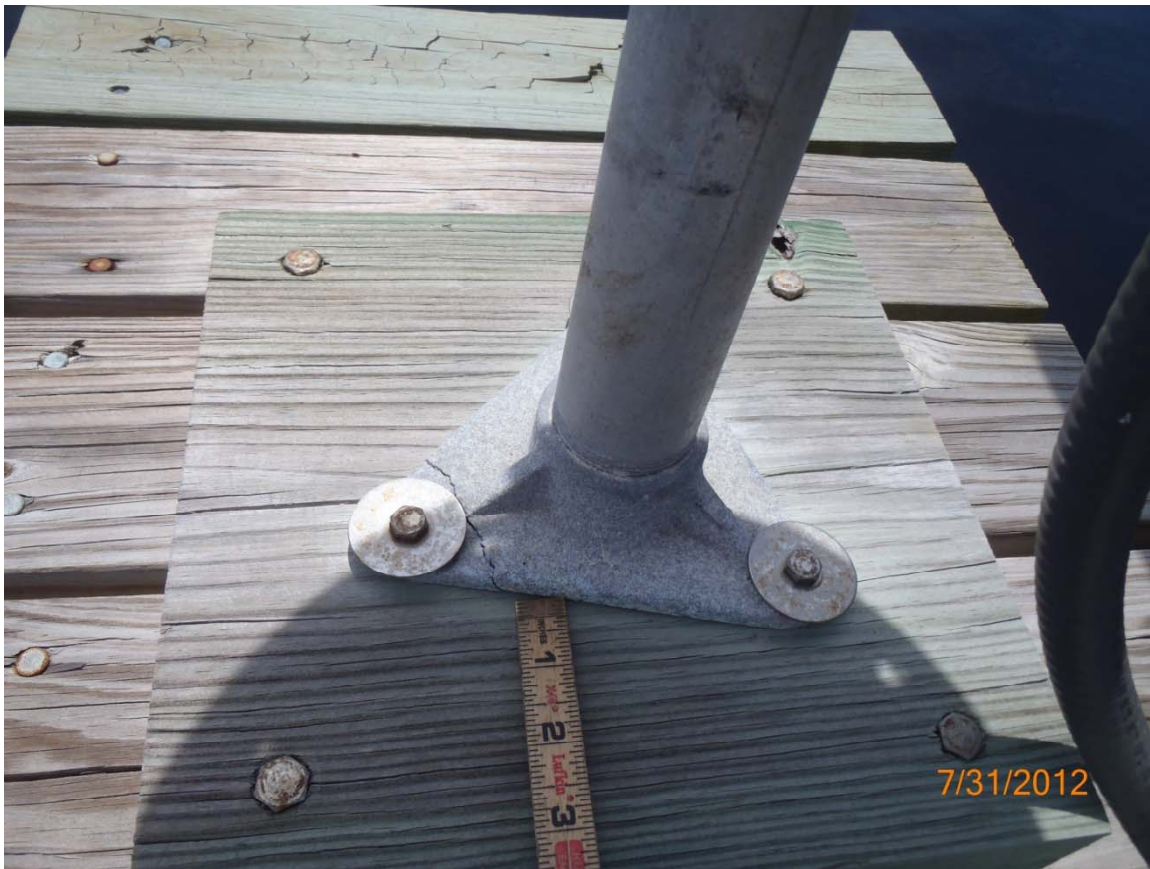
PHOTO 10: 580/4 - Navigational Lights

View of broken base of southwest fender light.
