APPENDIX B
Site Specific Data and Photographs

**SR. 694 (GANDY BLVD) PDE STUDY
FROM U.S. 19 TO EAST OF 4TH STREET
PINELLAS COUNTY, FLORIDA**

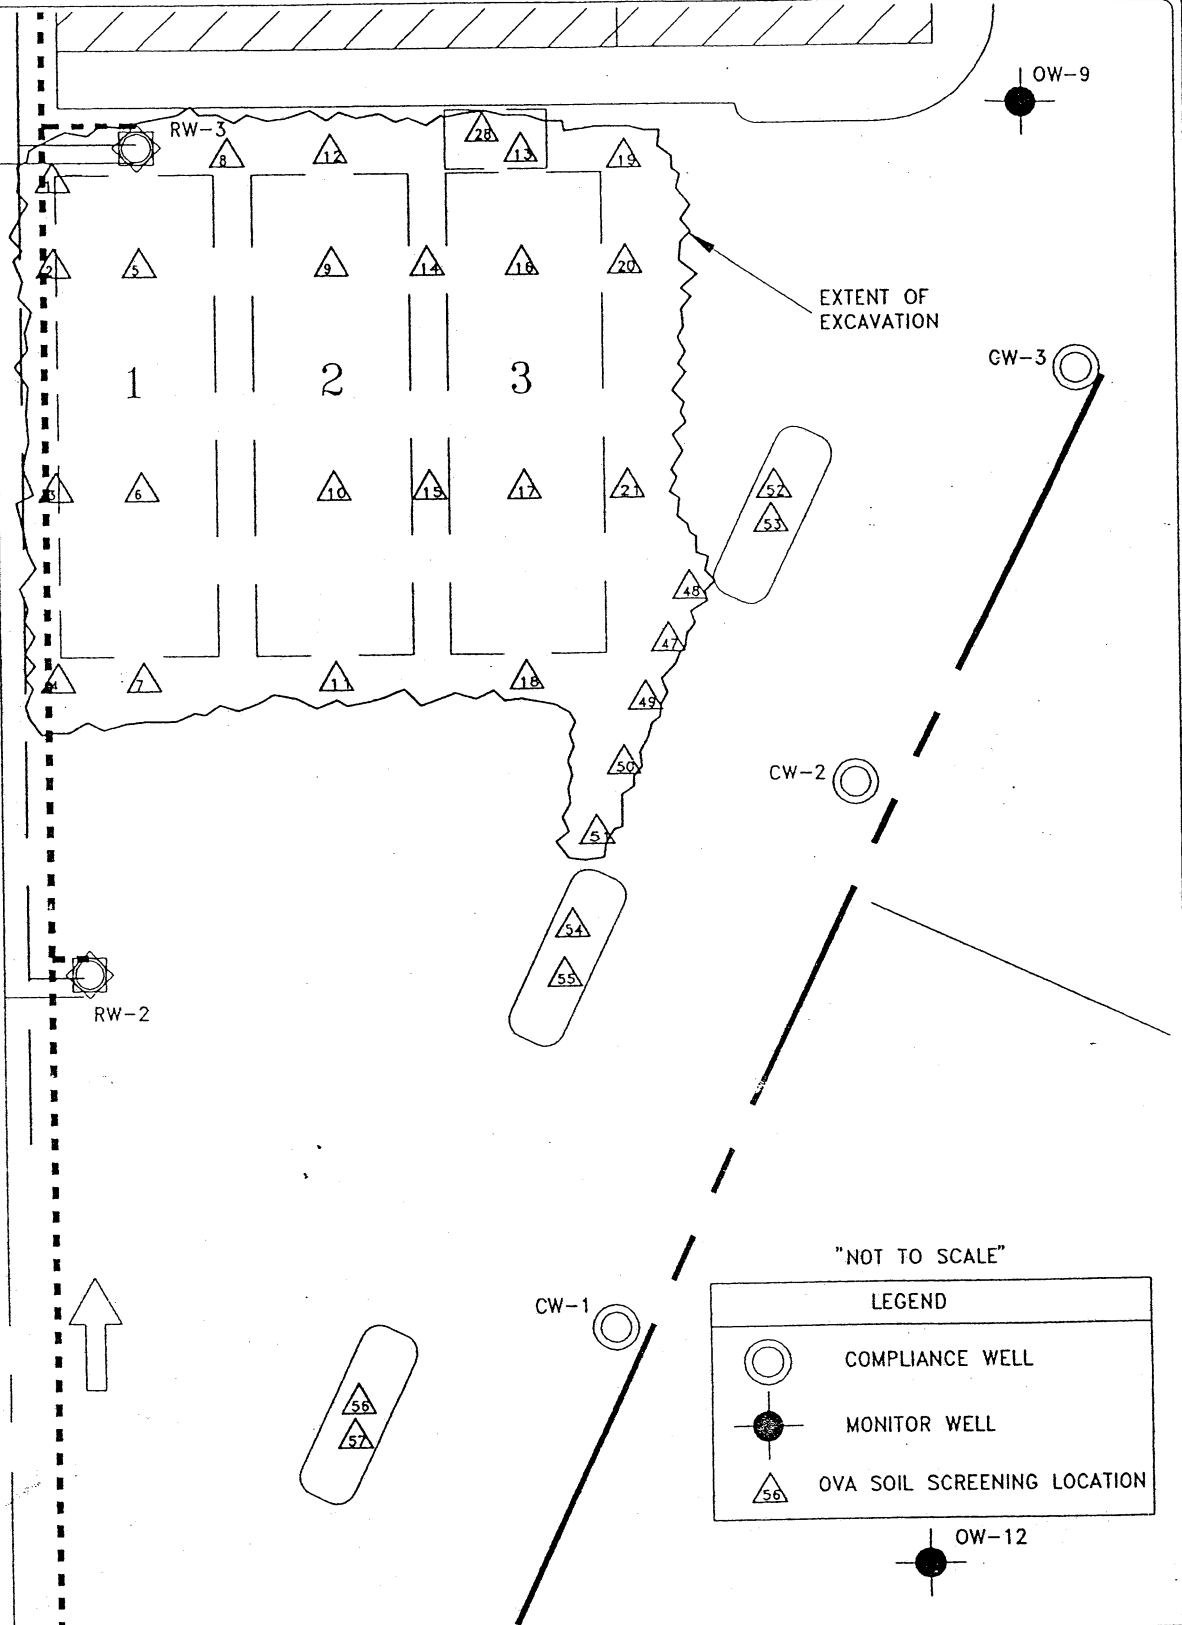
FIGURE 2

OVA SOIL SCREENING LOCATIONS
TANK PIT AREA
 AMOCO STATION NO. 1463
 AMOCO OIL COMPANY
 9901 4th STREET NORTH
 ST. PETERSBURG, FLORIDA
