**ASBESTOS SURVEY REPORT FOR RENOVATION**

***Bridge No. 150049***

***SR 679 – Pinellas Bayway Structure E Bridge  
over Boca Ciega Bay  
St. Petersburg, Pinellas County, Florida***

***February 2009***

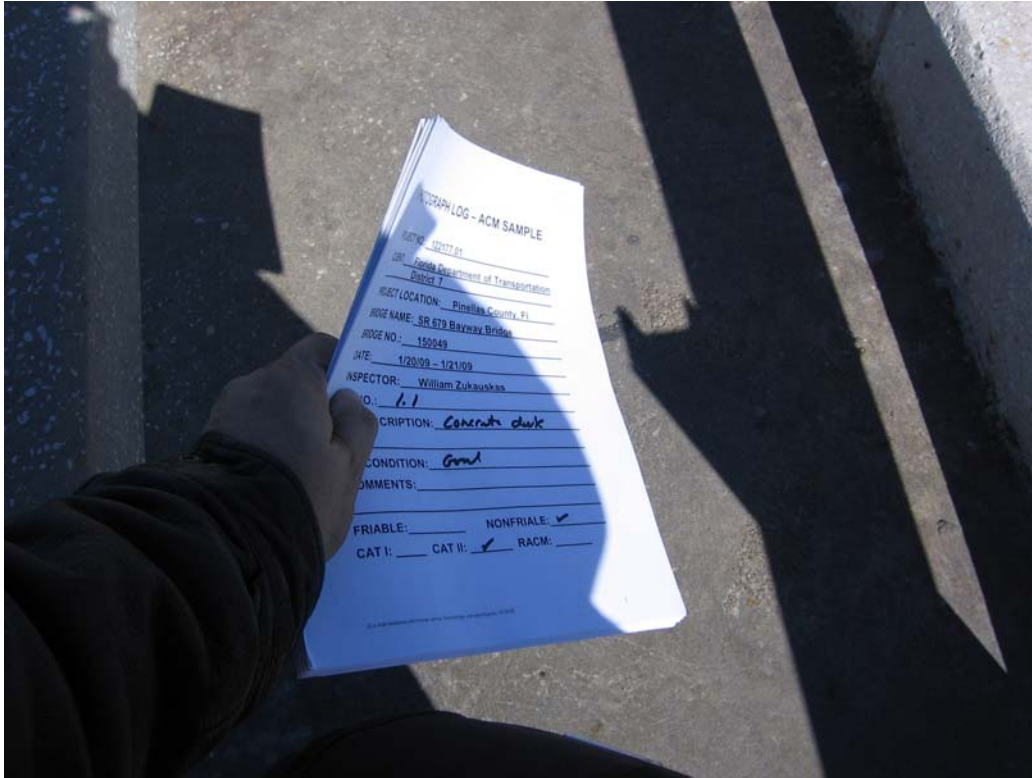
**PHOTO 3 – 01/21/09 – SAMPLE 1.1 – HA 1**  
**CONCRETE**  
**BRIDGE DECK AND COLUMNS**

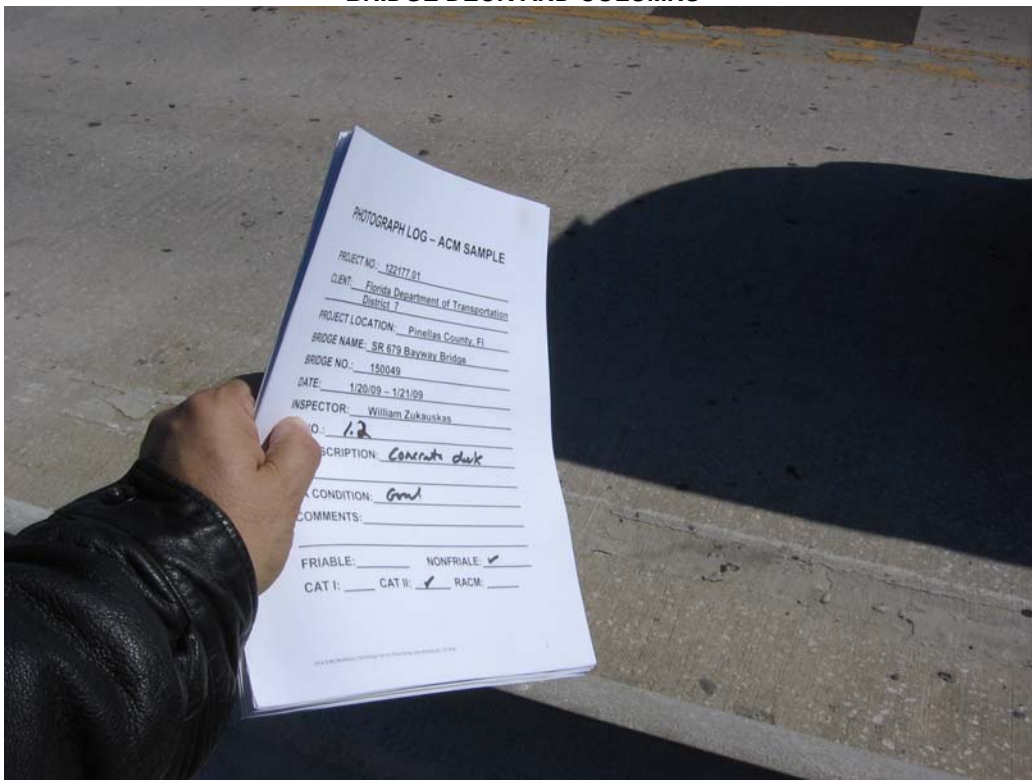
**PHOTO 4 – 01/21/09 – SAMPLE 1.2 – HA 1**  
**CONCRETE**  
**BRIDGE DECK AND COLUMNS**

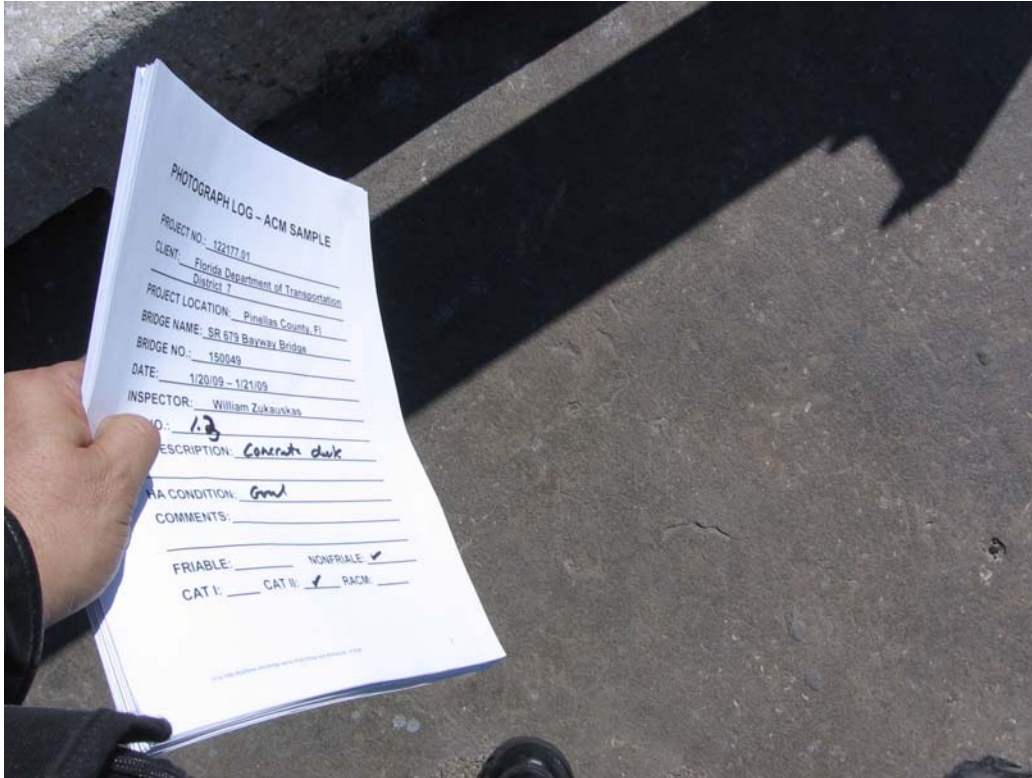
**PHOTO 5 - 01/21/09 - SAMPLE 1.3 - HA 1**  
**CONCRETE**  
**BRIDGE DECK AND COLUMNS**

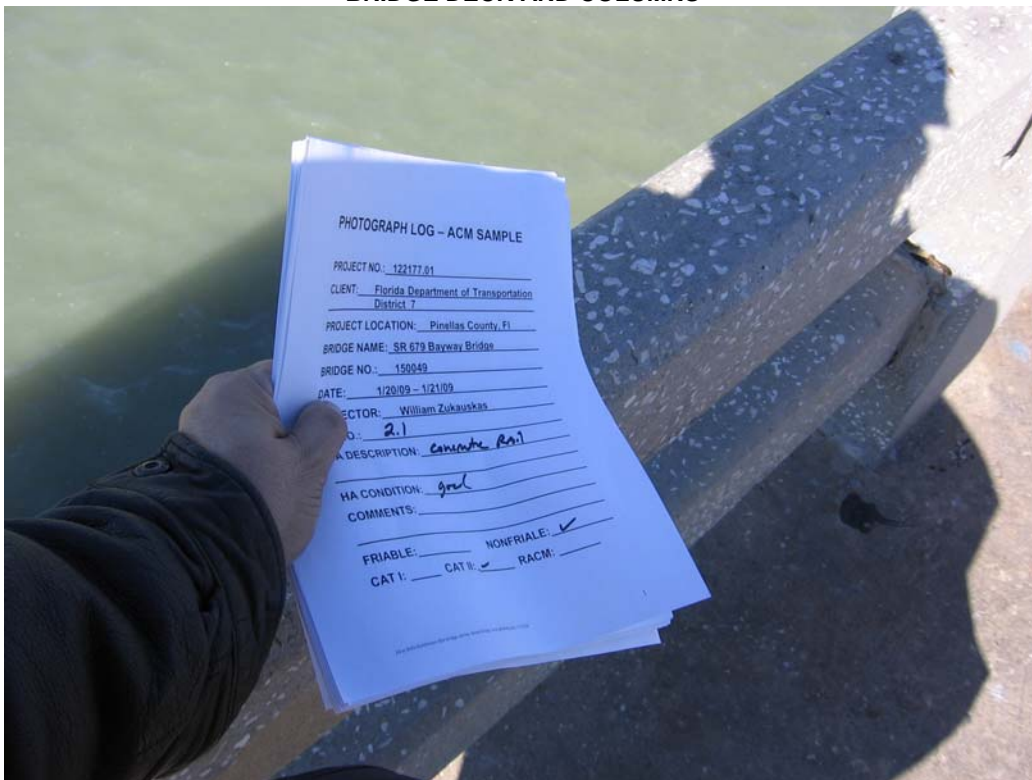
**PHOTO 6 - 01/21/09 - SAMPLE 2.1 - HA 2**  
**CONCRETE**  
**RAILS AND BEAMS**

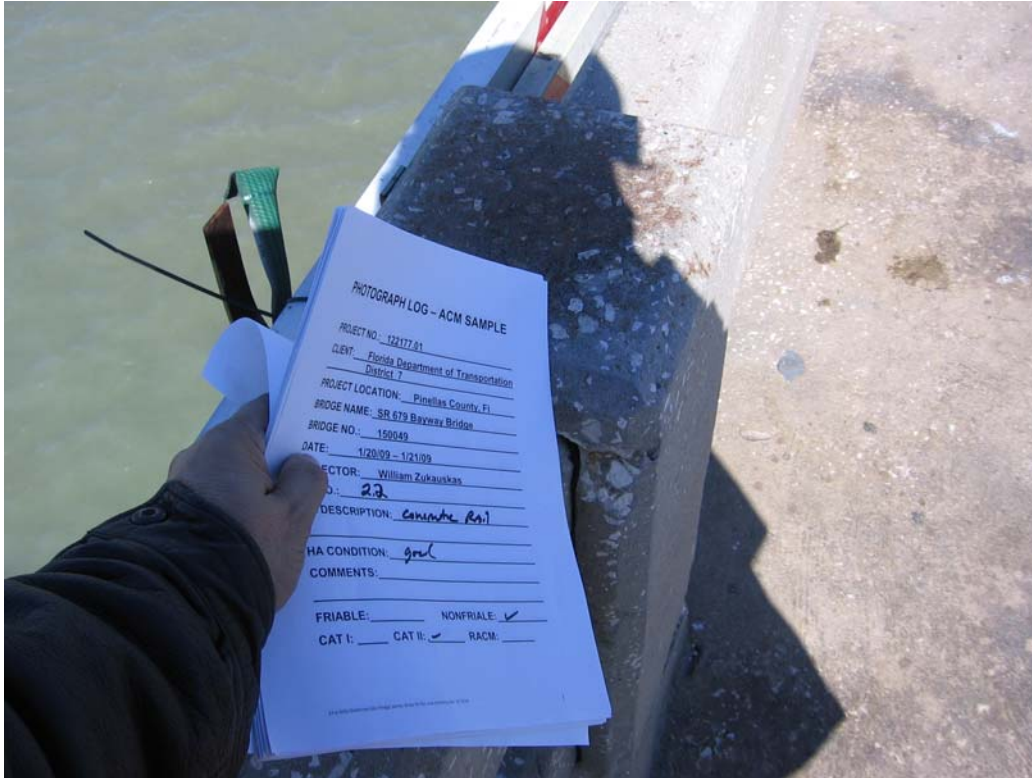
**PHOTO 7 - 01/21/09 - SAMPLE 2.2 - HA 2**  
**CONCRETE**  
**RAILS AND BEAMS**

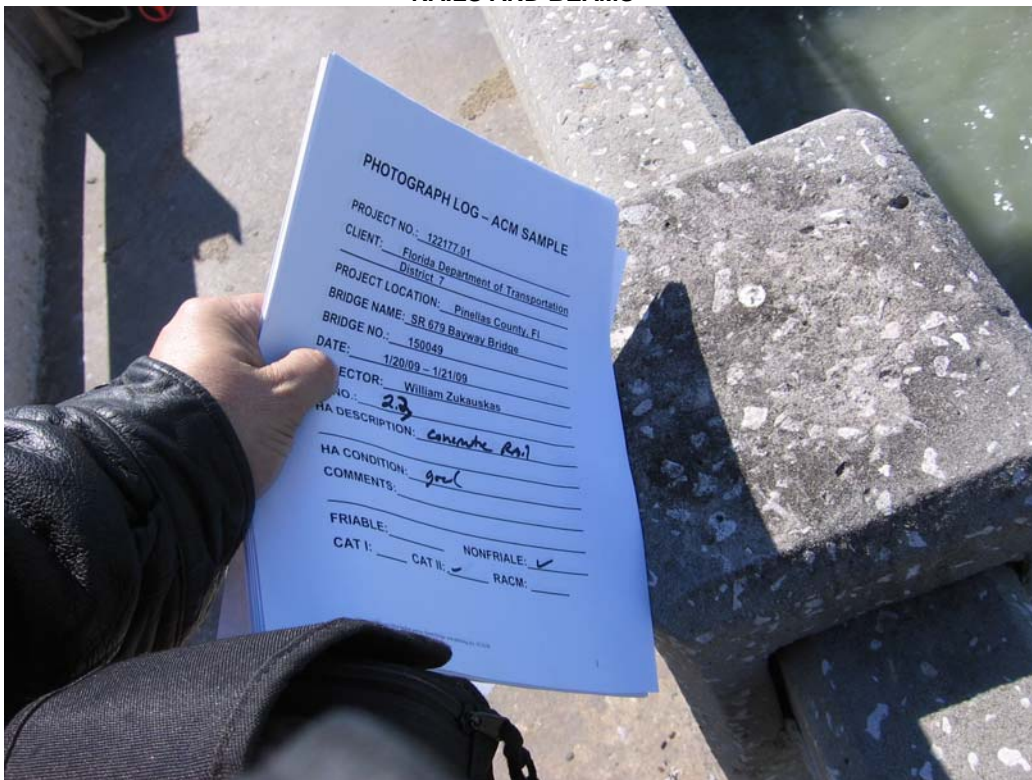
**PHOTO 8 - 01/21/09 - SAMPLE 2.3 - HA 2**  
**CONCRETE**  
**RAILS AND BEAMS**

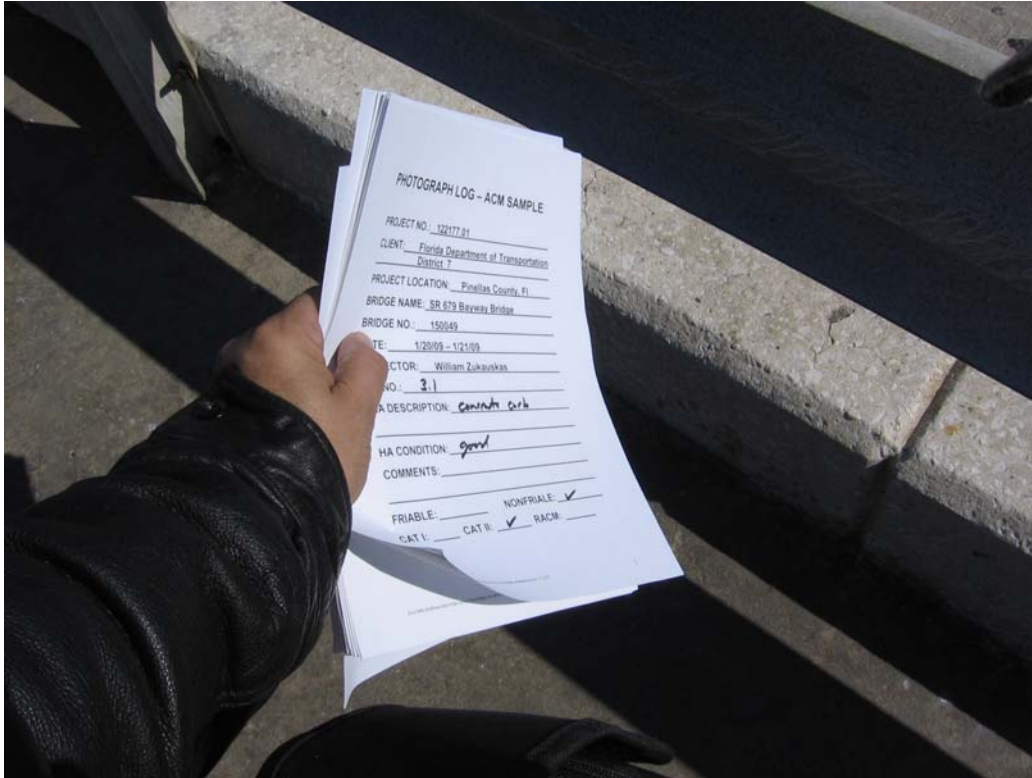
**PHOTO 9 – 01/21/09 – SAMPLE 3.1 – HA 3**  
**CONCRETE**  
**CURB**

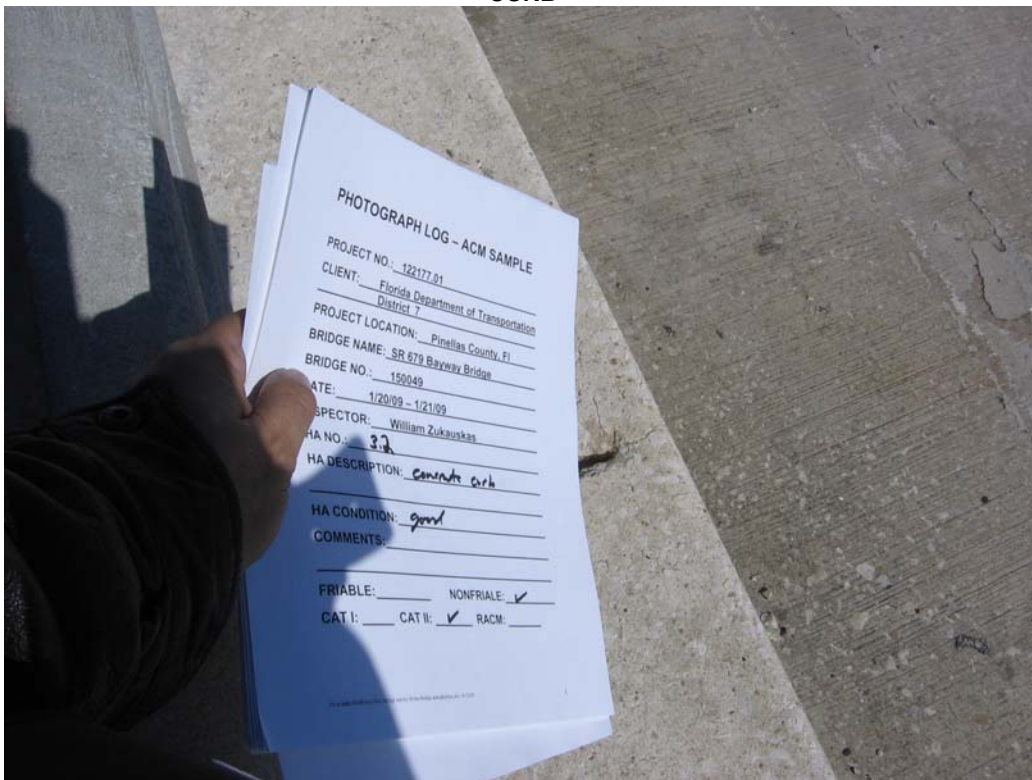
**PHOTO 10 – 01/21/09 – SAMPLE 3.2 – HA 3**  
**CONCRETE**  
**CURB**

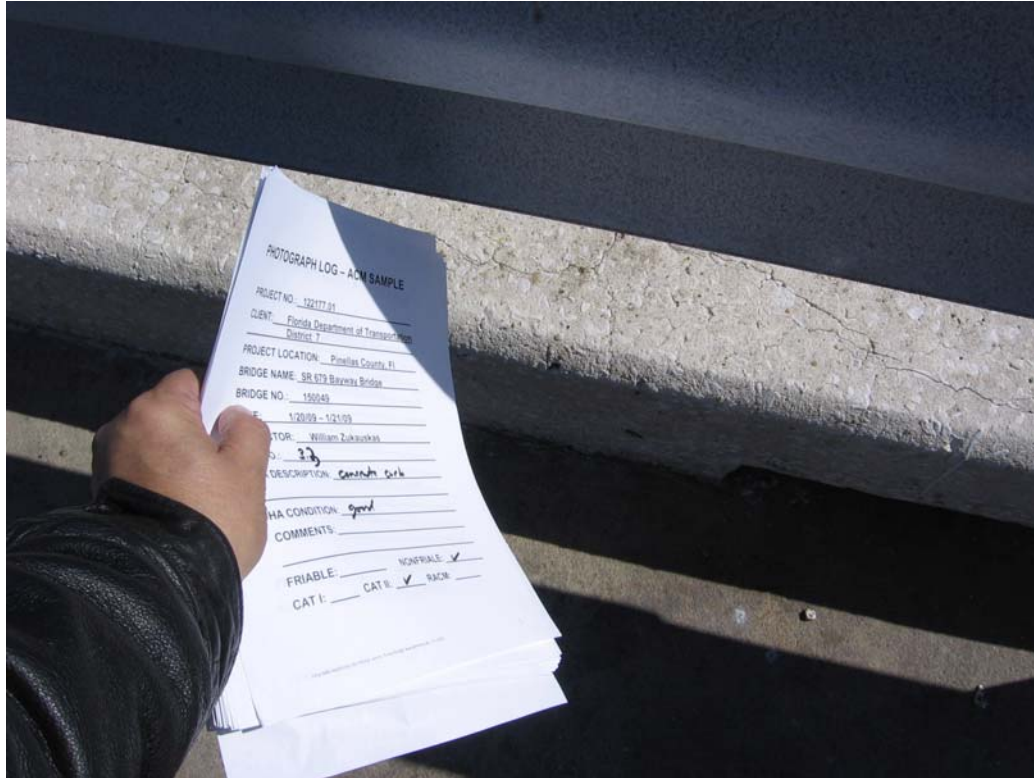
**PHOTO 11 – 01/21/09 – SAMPLE 3.3 – HA 3**  
**CONCRETE**  
**CURB**

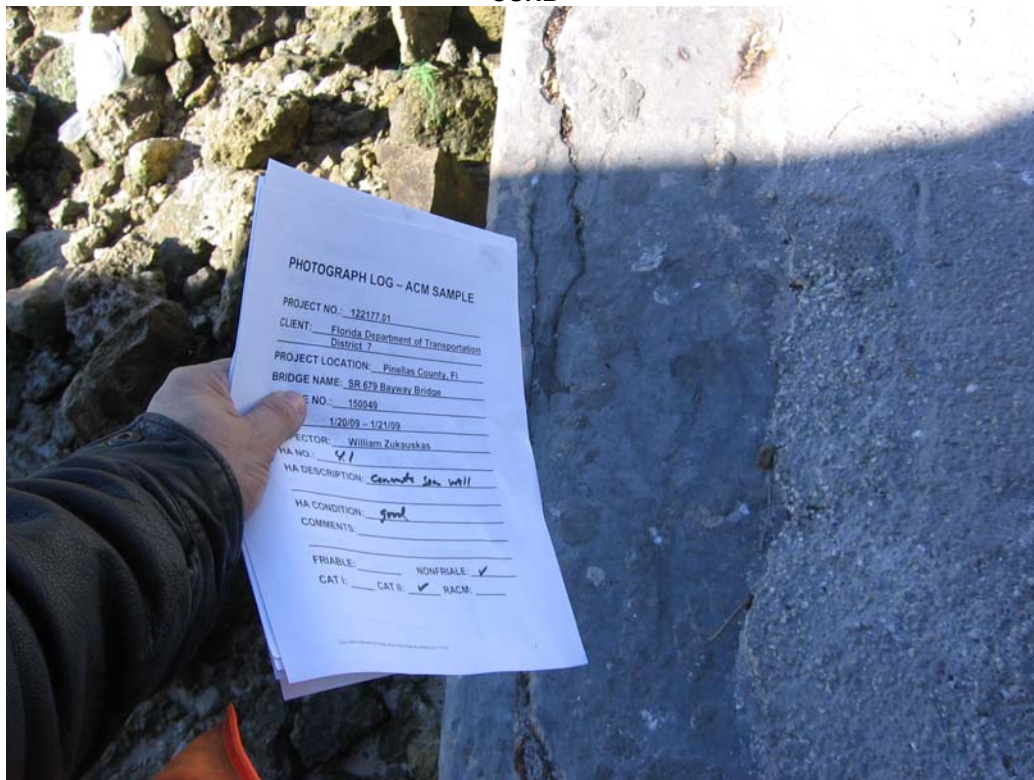
**PHOTO 12 – 01/21/09 – SAMPLE 4.1 – HA 4**  
**CONCRETE**  
**SEAWALL**

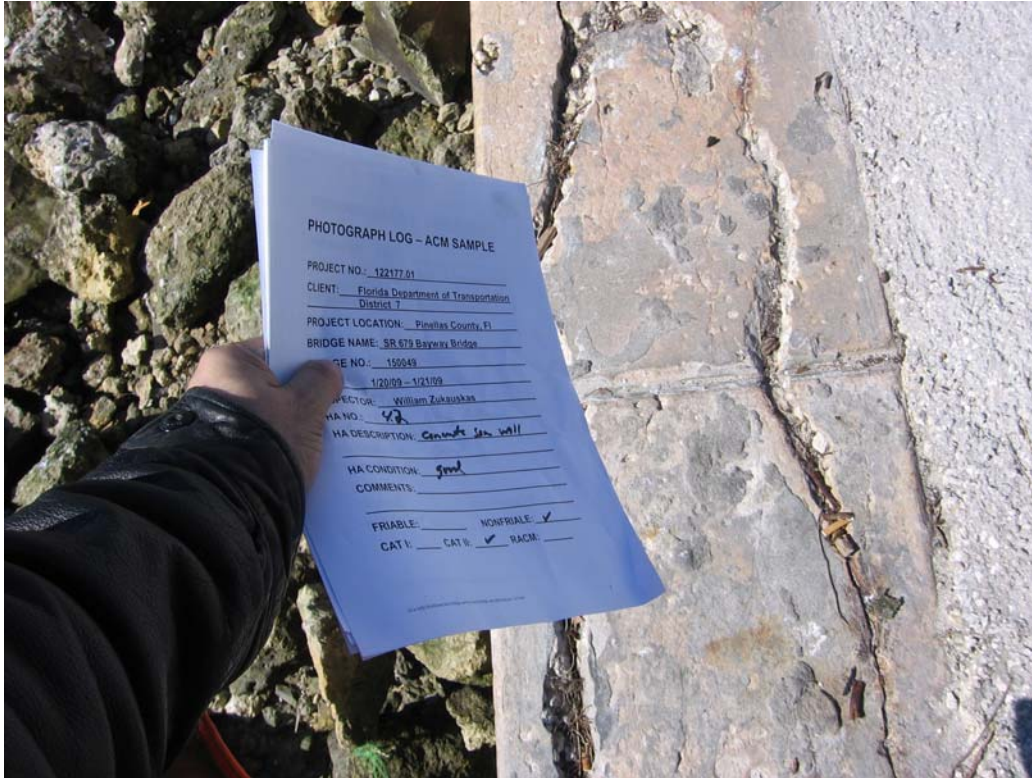
**PHOTO 13 – 01/21/09 – SAMPLE 4.2 – HA 4**  
**CONCRETE**  
**SEAWALL**

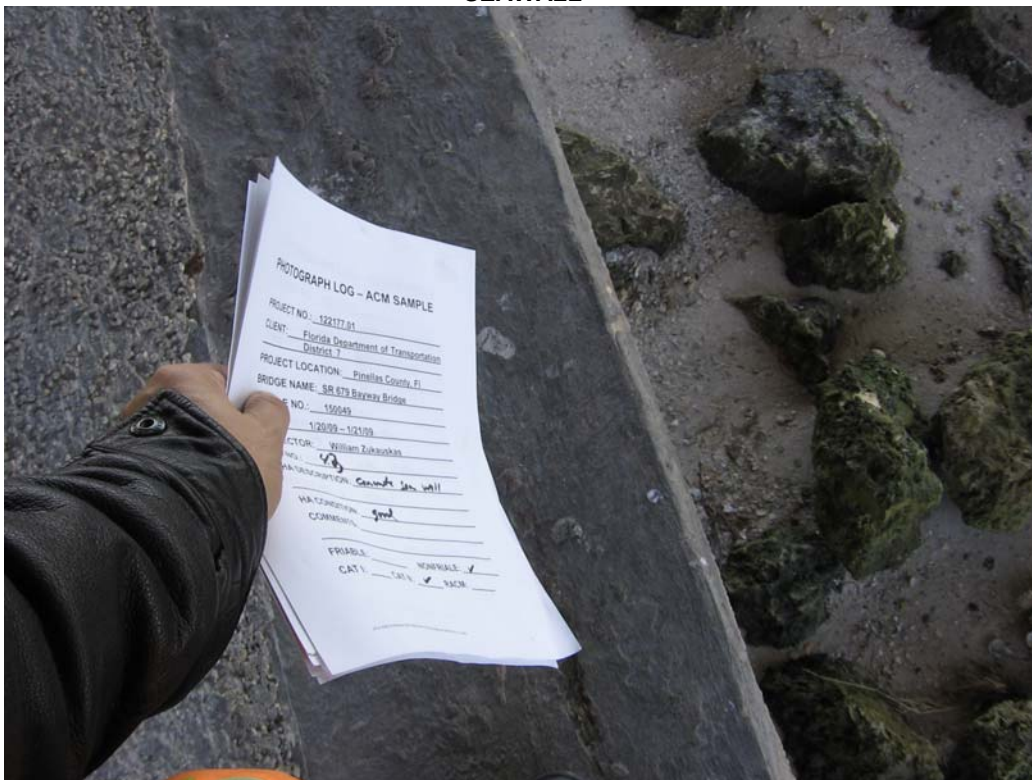
**PHOTO 14 – 01/21/09 – SAMPLE 4.3 – HA 4**  
**CONCRETE**  
**SEAWALL**

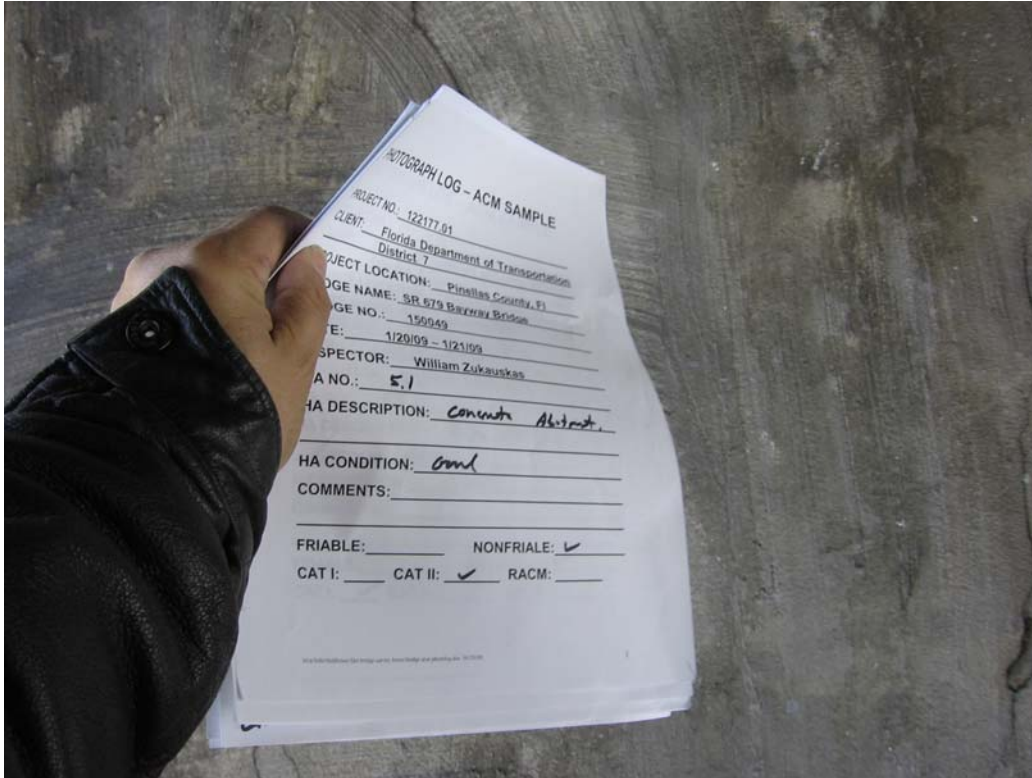
**PHOTO 15 – 01/21/09 – SAMPLE 5.1 – HA 5**  
**CONCRETE**  
**ABUTMENT WALLS**

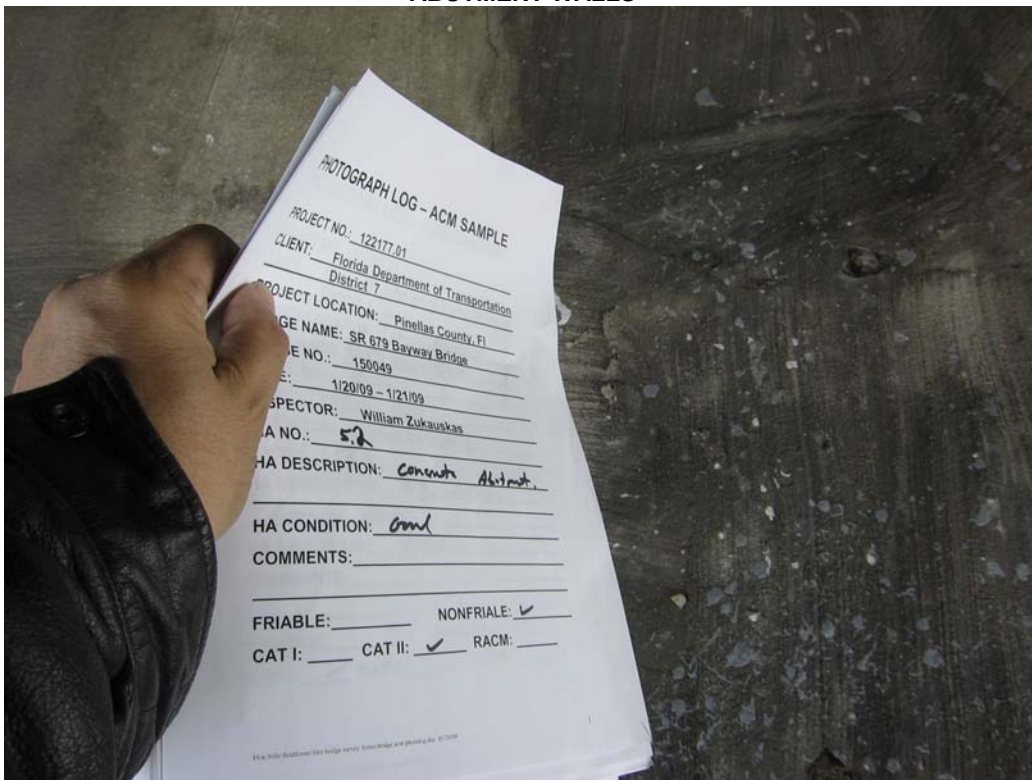
**PHOTO 16 – 01/21/09 – SAMPLE 5.2 – HA 5**  
**CONCRETE**  
**ABUTMENT WALLS**

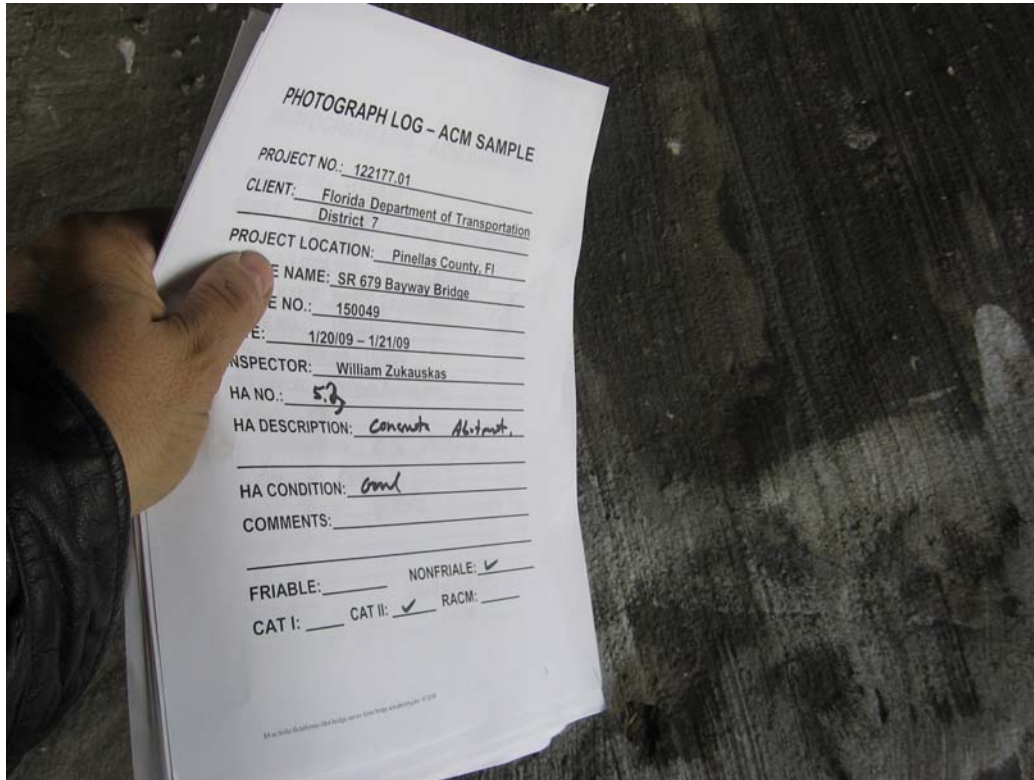
**PHOTO 17 - 01/21/09 - SAMPLE 5.3 - HA 5**  
**CONCRETE**  
**ABUTMENT WALLS**

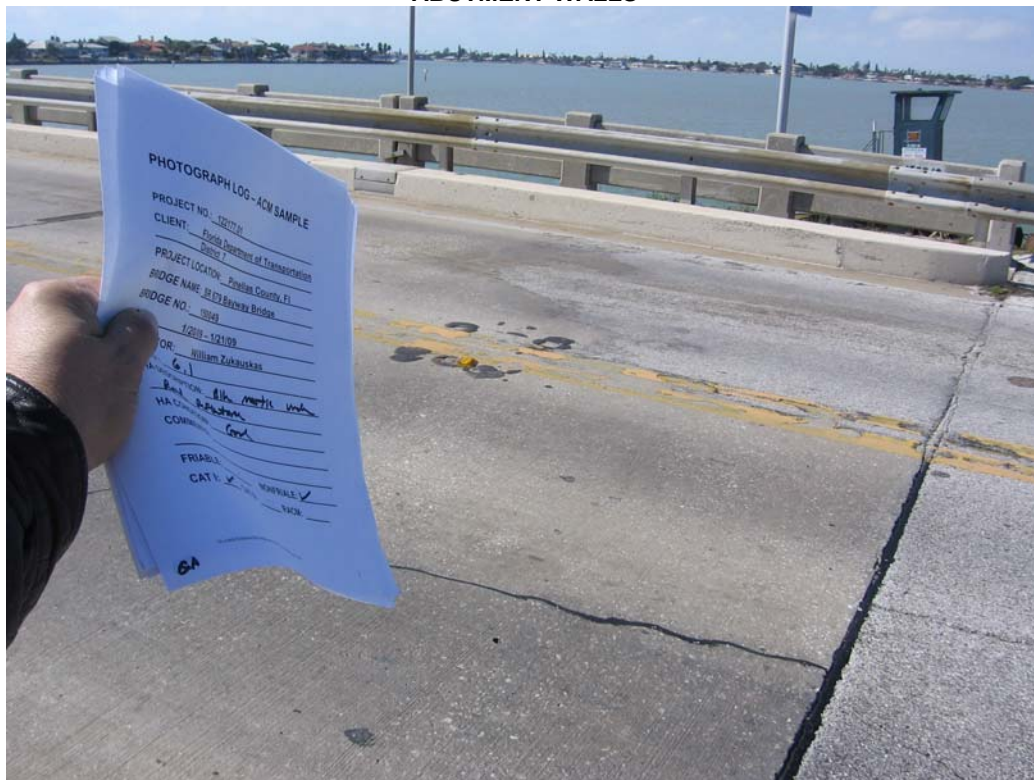
**PHOTO 18 - 01/21/09 - SAMPLE 6.1 - HA 6**  
**BLACK MASTIC**  
**UNDER ROAD REFLECTORS**

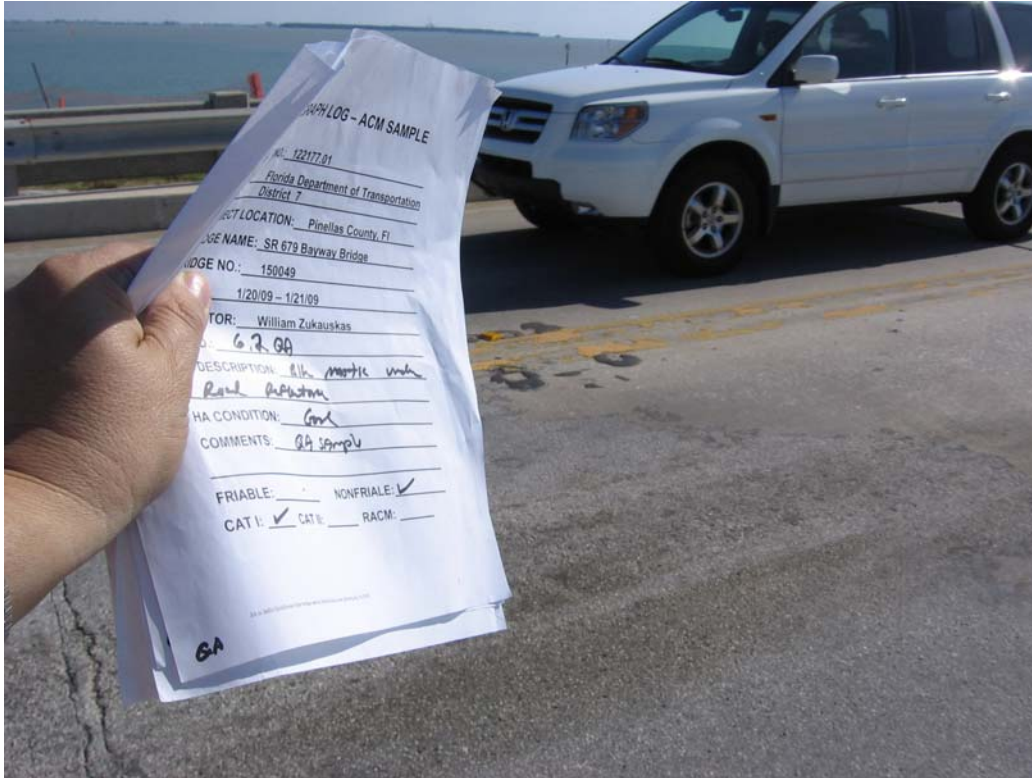
PHOTO 19 - 01/21/09 - SAMPLE 6.2 QA/QC - HA 6  
BLACK MASTIC  
UNDER ROAD REFLECTORS

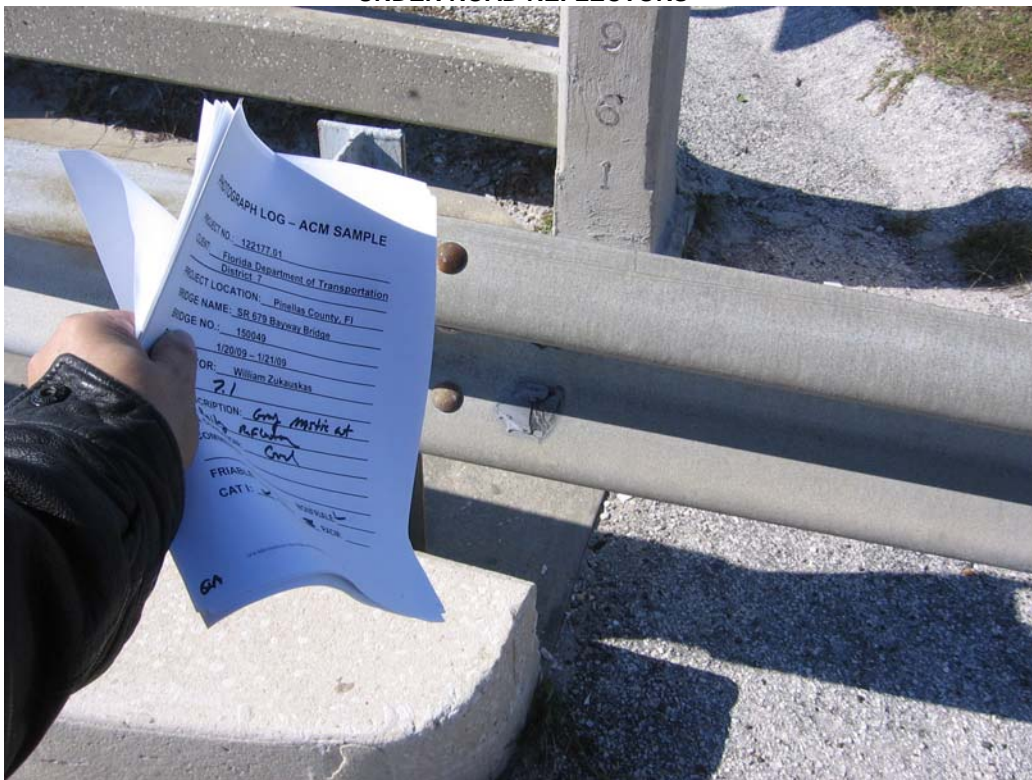
PHOTO 20 - 01/21/09 - SAMPLE 7.1 - HA 7  
GRAY MASTIC  
UNDER RAILING REFLECTORS

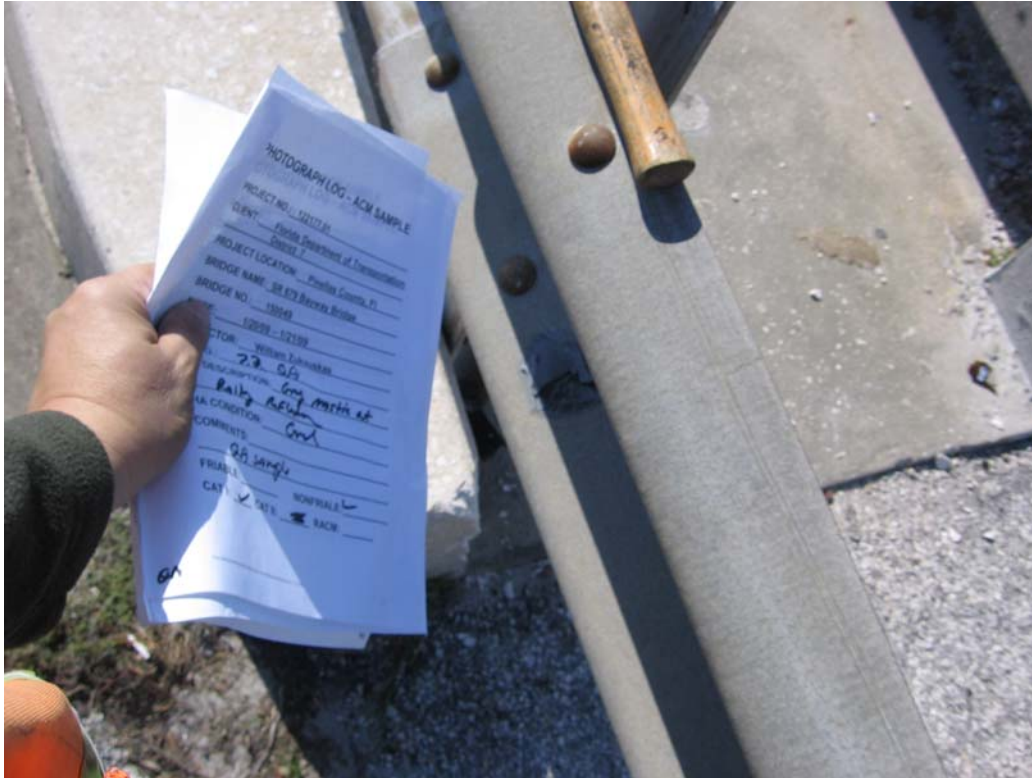
PHOTO 21 – 01/21/09 – SAMPLE 7.2 QA/QC – HA 7  
GRAY MASTIC  
UNDER RAILING REFLECTORS

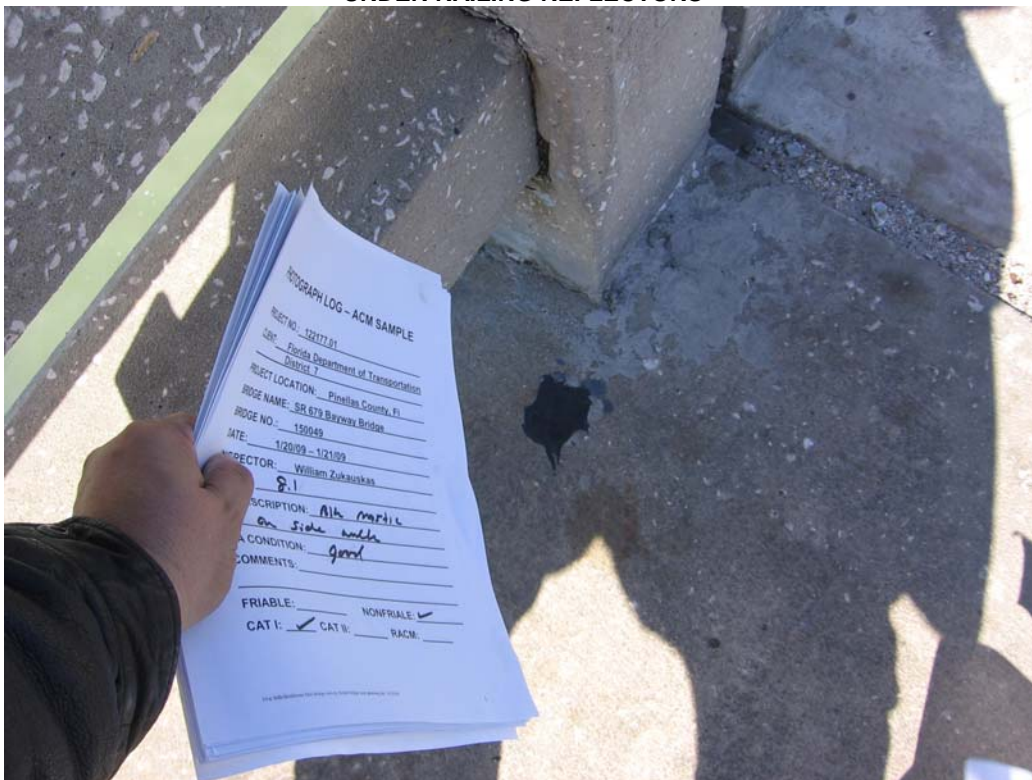
PHOTO 22 – 01/21/09 – SAMPLE 8.1 – HA 8  
BLACK MASTIC  
PATCHES ON WEST SIDEWALK

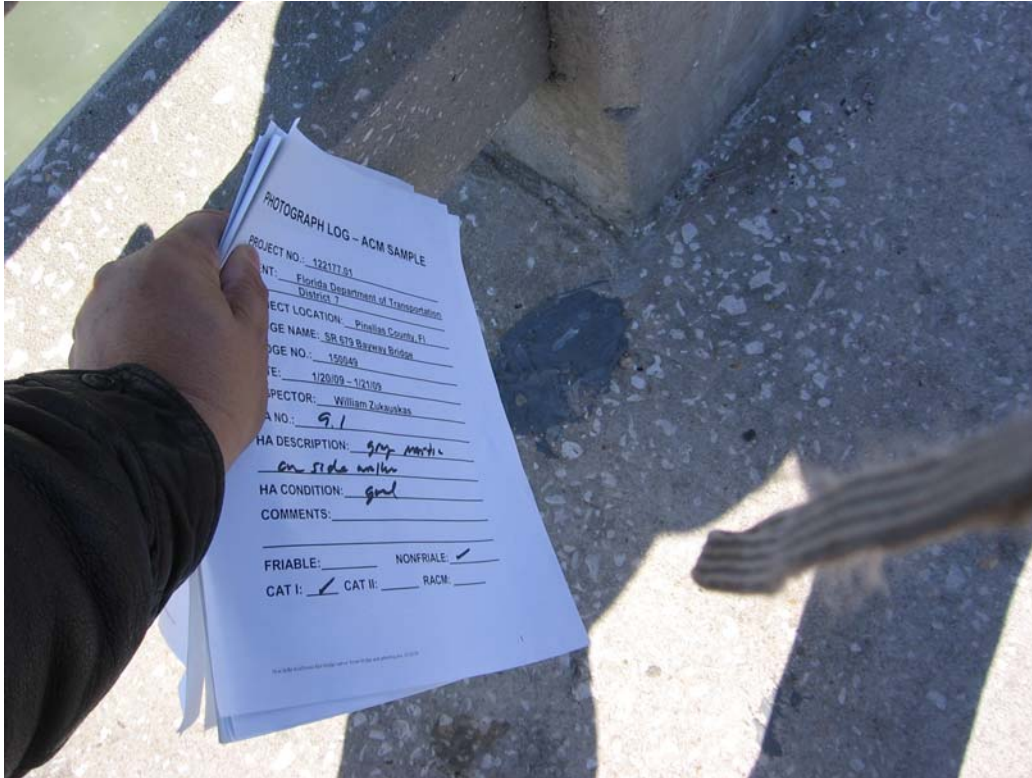
**PHOTO 23 – 01/21/09 – SAMPLE 9.1 – HA 9**  
**GRAY MASTIC**  
**PATCHES ON WEST SIDEWALK**

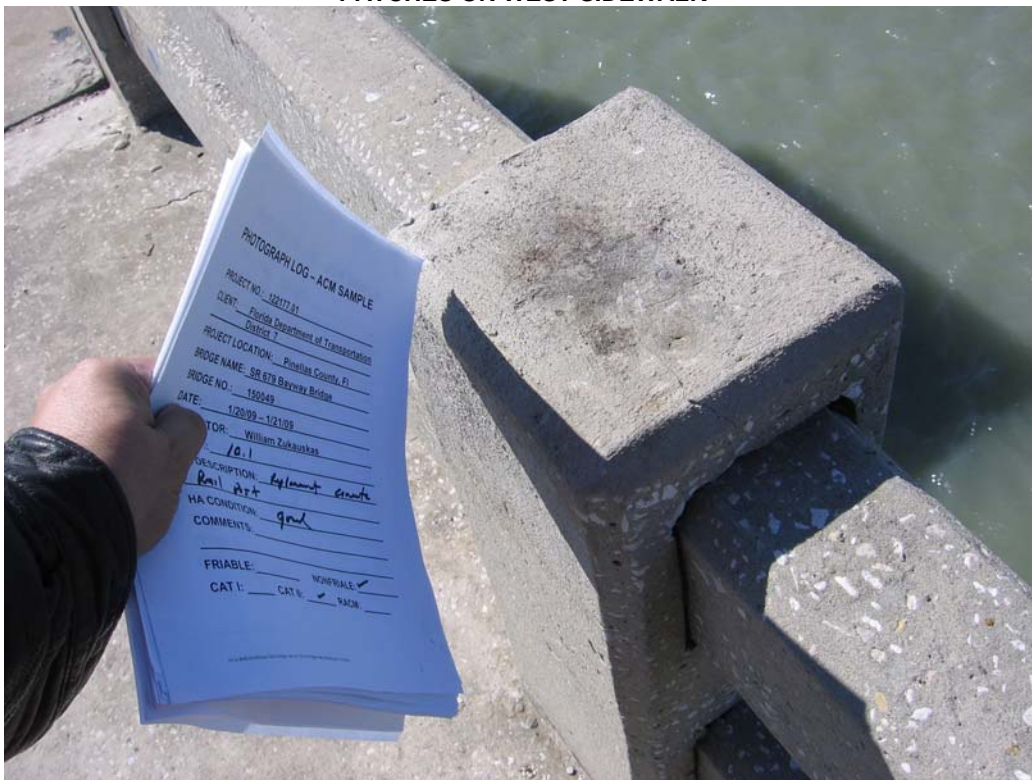
**PHOTO 24 – 01/21/09 – SAMPLE 10.1 – HA 10**  
**CONCRETE**  
**REPLACEMENT RAIL POSTS**

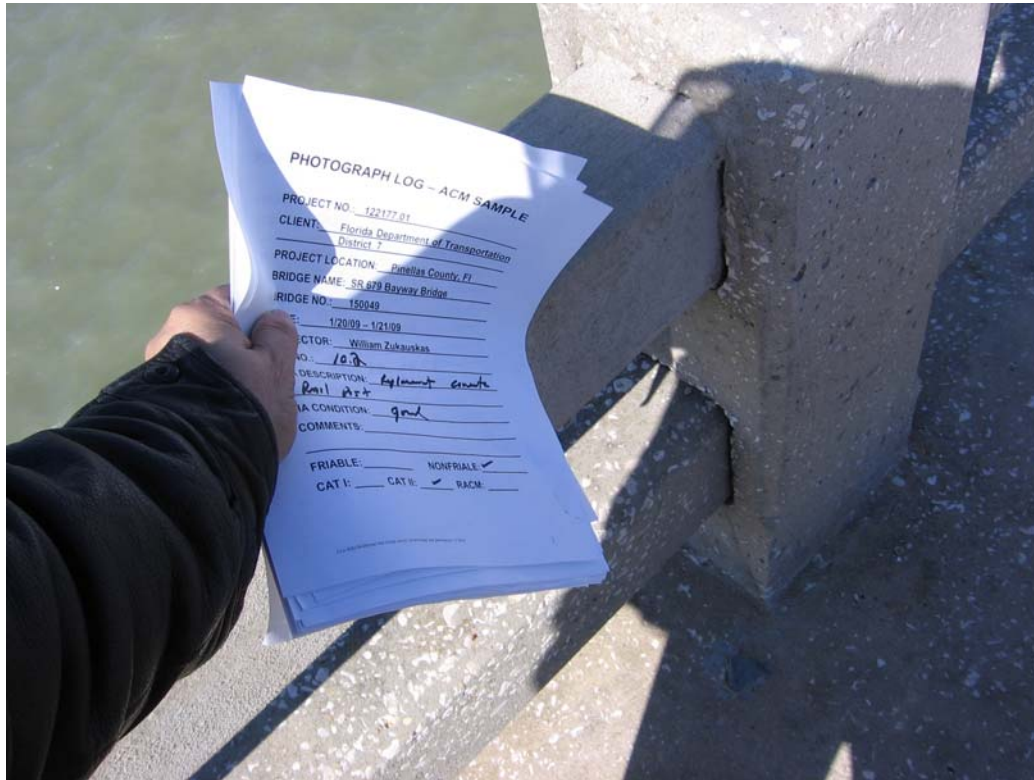
**PHOTO 25 – 01/21/09 – SAMPLE 10.2 – HA 10**  
**CONCRETE**  
**REPLACEMENT RAIL POSTS**

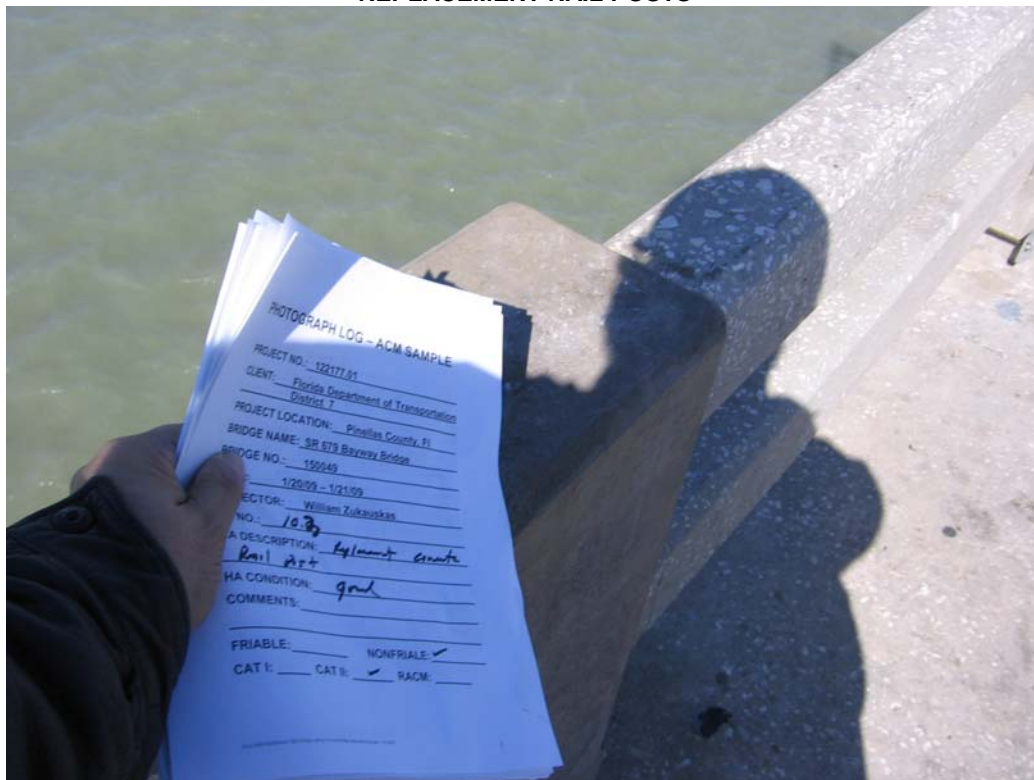
**PHOTO 26 – 01/21/09 – SAMPLE 10.3 – HA 10**  
**CONCRETE**  
**REPLACEMENT RAIL POSTS**

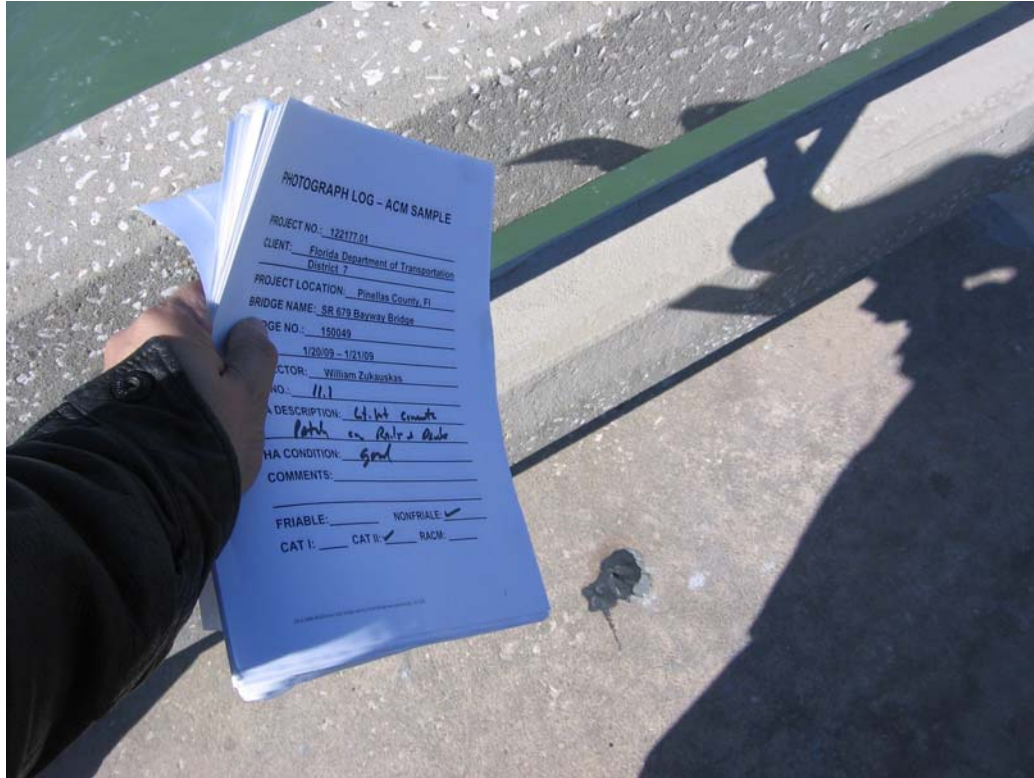
**PHOTO 27 – 01/21/09 – SAMPLE 11.1 – HA 11**  
**LIGHTWEIGHT CONCRETE PATCHING**  
**ON RAILS AND BRIDGE DECK**

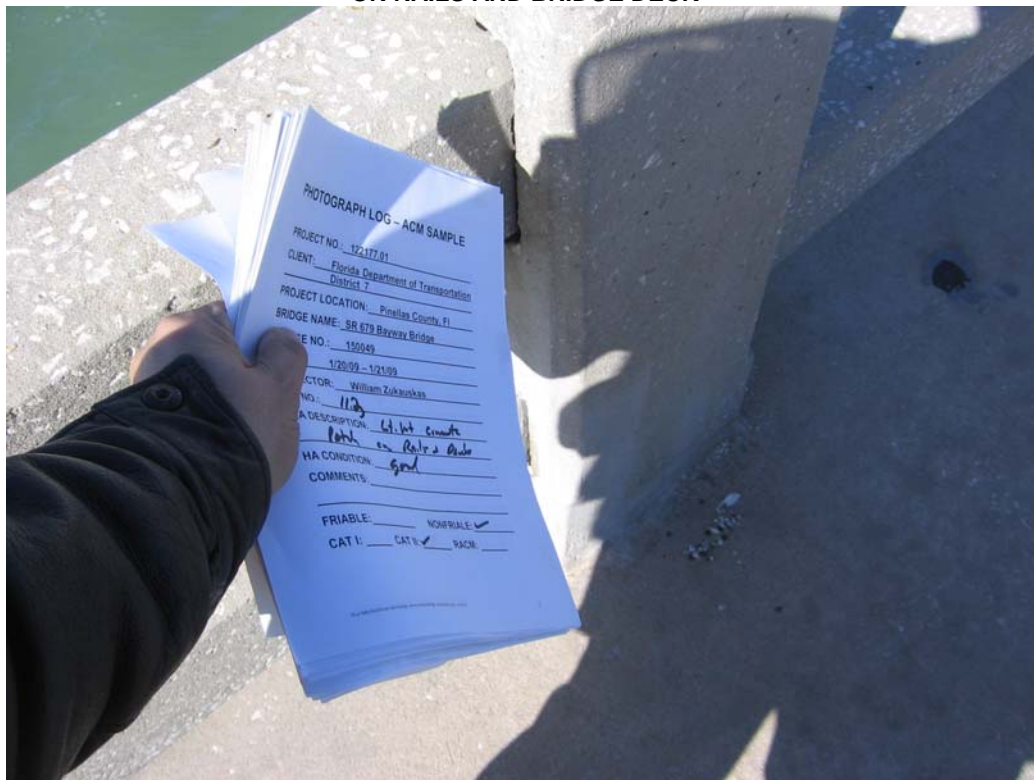
**PHOTO 28 – 01/21/09 – SAMPLE 11.2 – HA 11**  
**LIGHTWEIGHT CONCRETE PATCHING**  
**ON RAILS AND BRIDGE DECK**

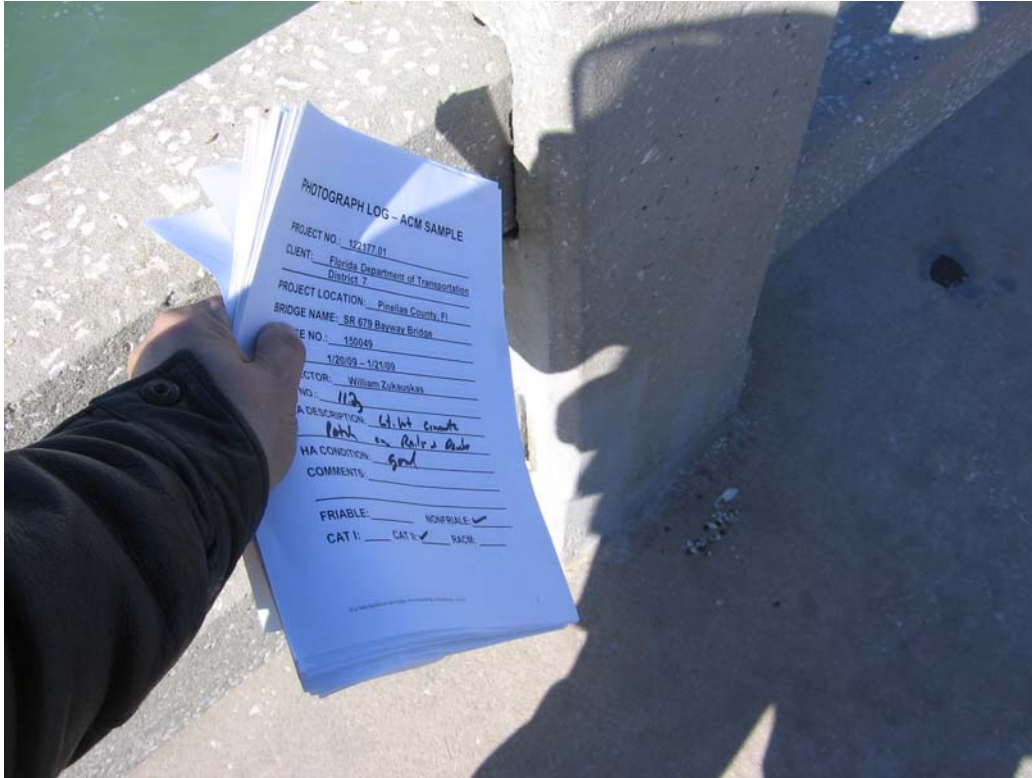
PHOTO 29 – 01/21/09 – SAMPLE 11.3 – HA 11  
LIGHTWEIGHT CONCRETE PATCHING  
ON RAILS AND BRIDGE DECK

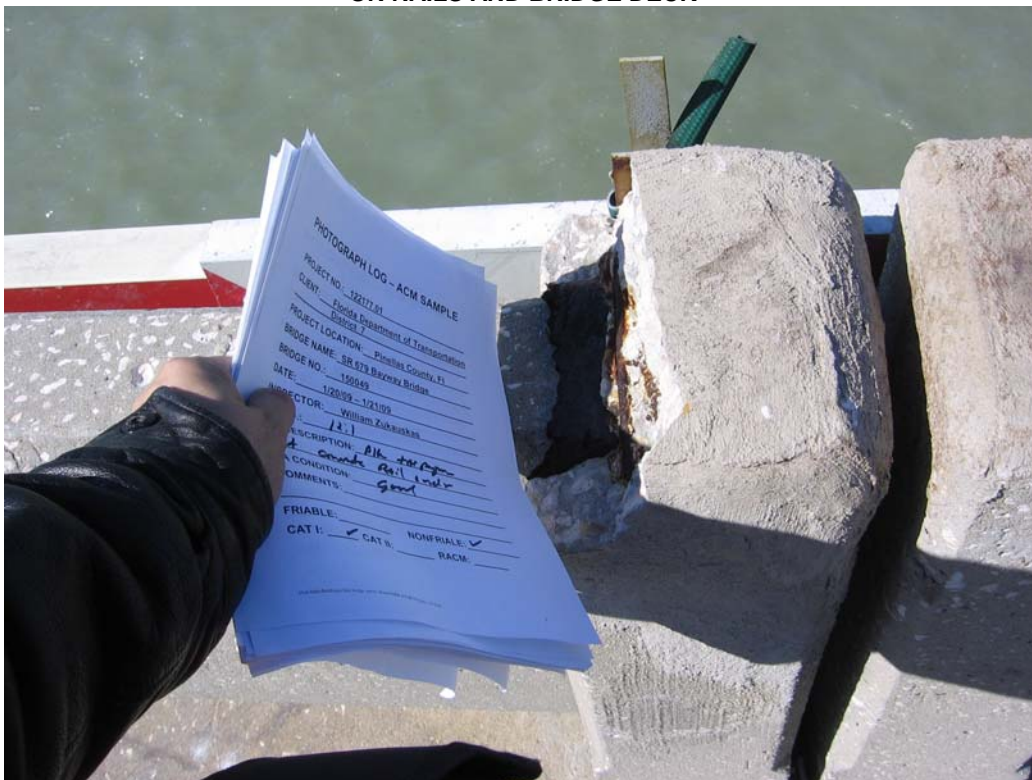
PHOTO 30 – 01/21/09 – SAMPLE 12.1 – HA 12  
BLACK TARPAPER  
AT RAIL POSTS
