**ASBESTOS SURVEY REPORT FOR RENOVATION**

***Bridge No. 150049***

***SR 679 – Pinellas Bayway Structure E Bridge  
over Boca Ciega Bay  
St. Petersburg, Pinellas County, Florida***

***February 2009***

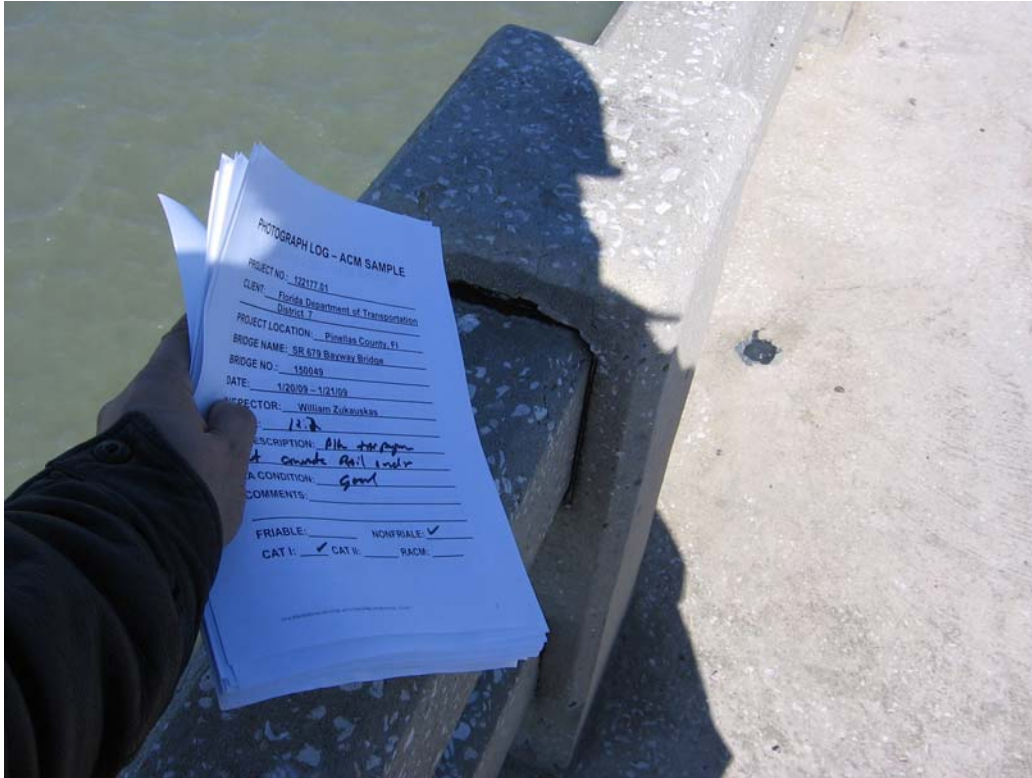
**PHOTO 31 – 01/21/09 – SAMPLE 12.2 – HA 12**  
**BLACK TARPAPER**  
**AT RAIL POSTS**

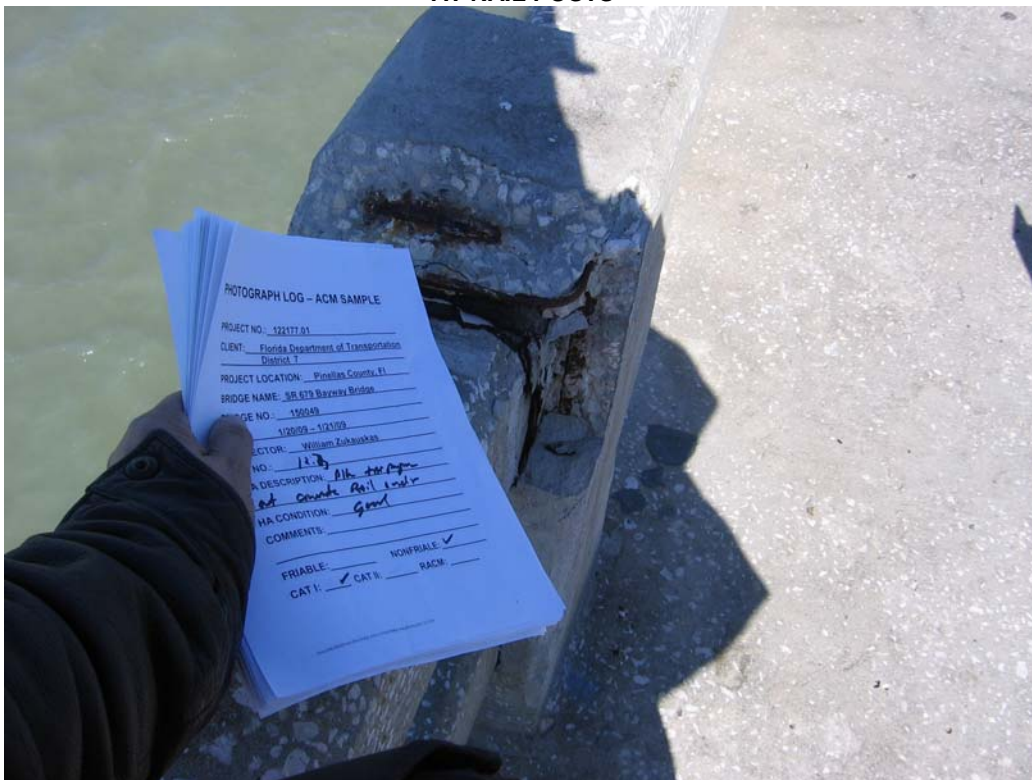
**PHOTO 32 – 01/21/09 – SAMPLE 12.3 – HA 12**  
**BLACK TARPAPER**  
**AT RAIL POSTS**

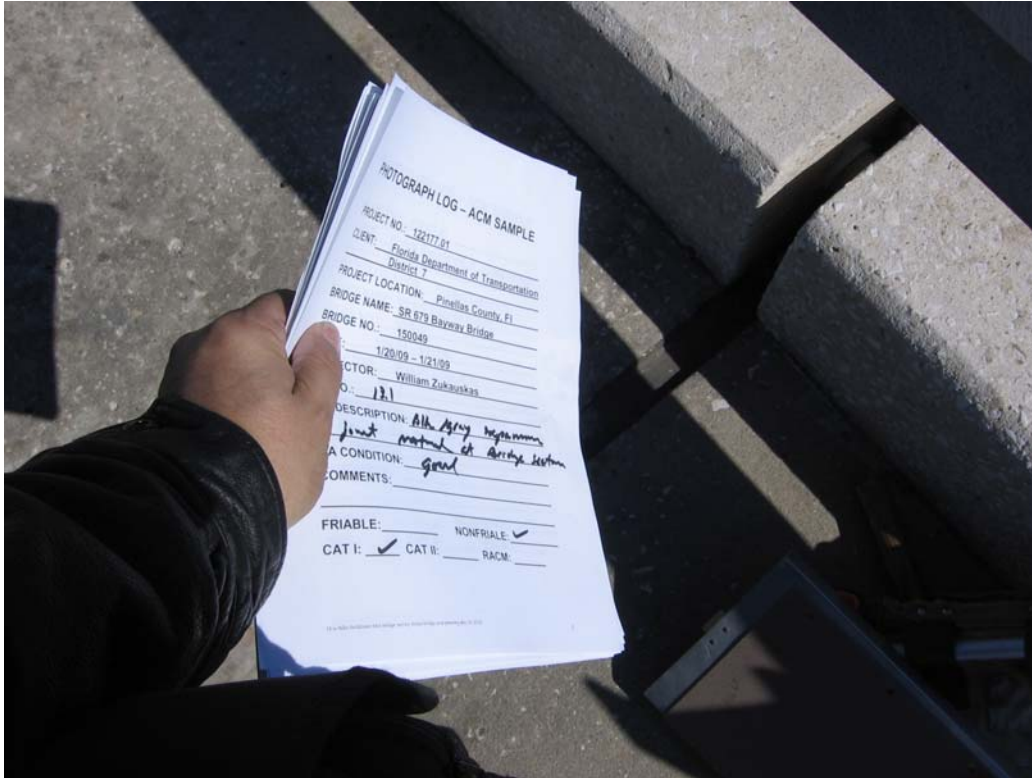
**PHOTO 33 – 01/21/09 – SAMPLE 13.1 – HA 13**  
**BLACK AND GRAY EXPANSION JOINT MATERIAL**  
**BETWEEN DECK SECTIONS**

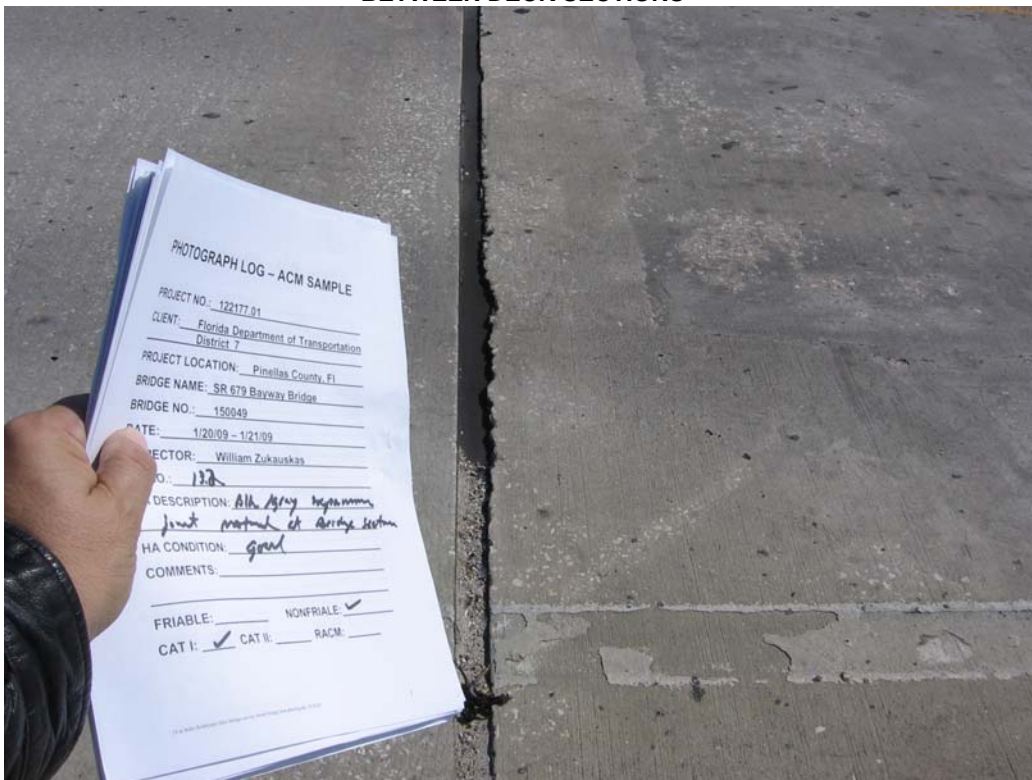
**PHOTO 34 – 01/21/09 – SAMPLE 13.2 – HA 13**  
**BLACK AND GRAY EXPANSION JOINT MATERIAL**  
**BETWEEN DECK SECTIONS**

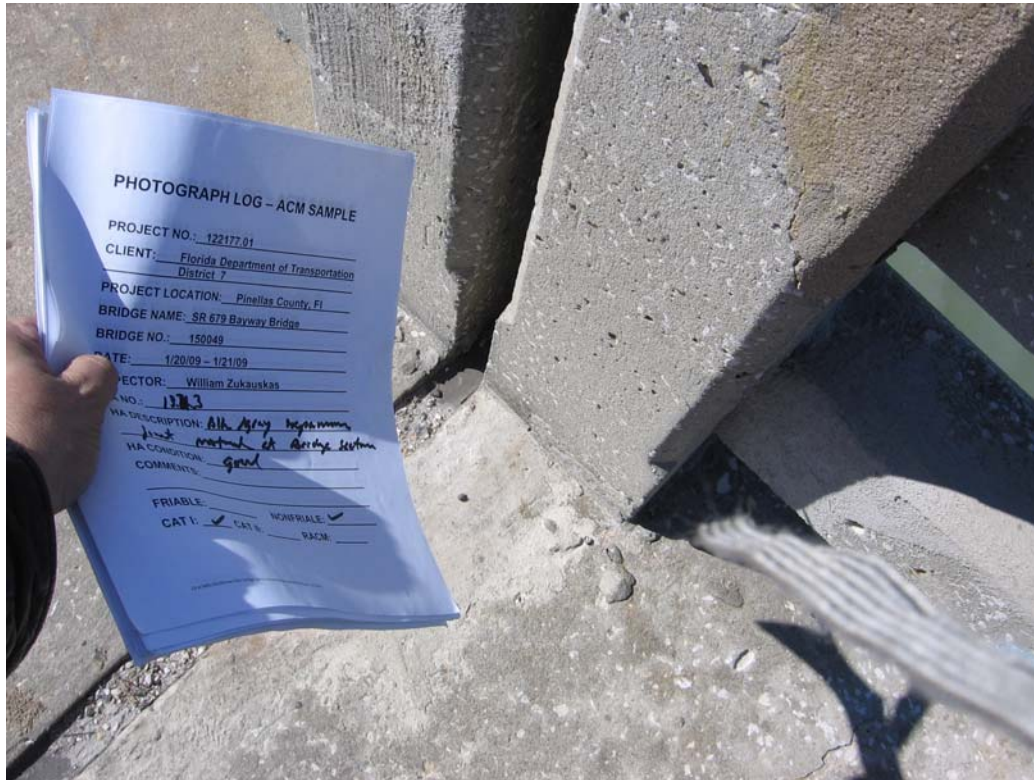
**PHOTO 35 - 01/21/09 - SAMPLE 13.3 - HA 13**  
**BLACK AND GRAY EXPANSION JOINT MATERIAL**  
**BETWEEN DECK SECTIONS**

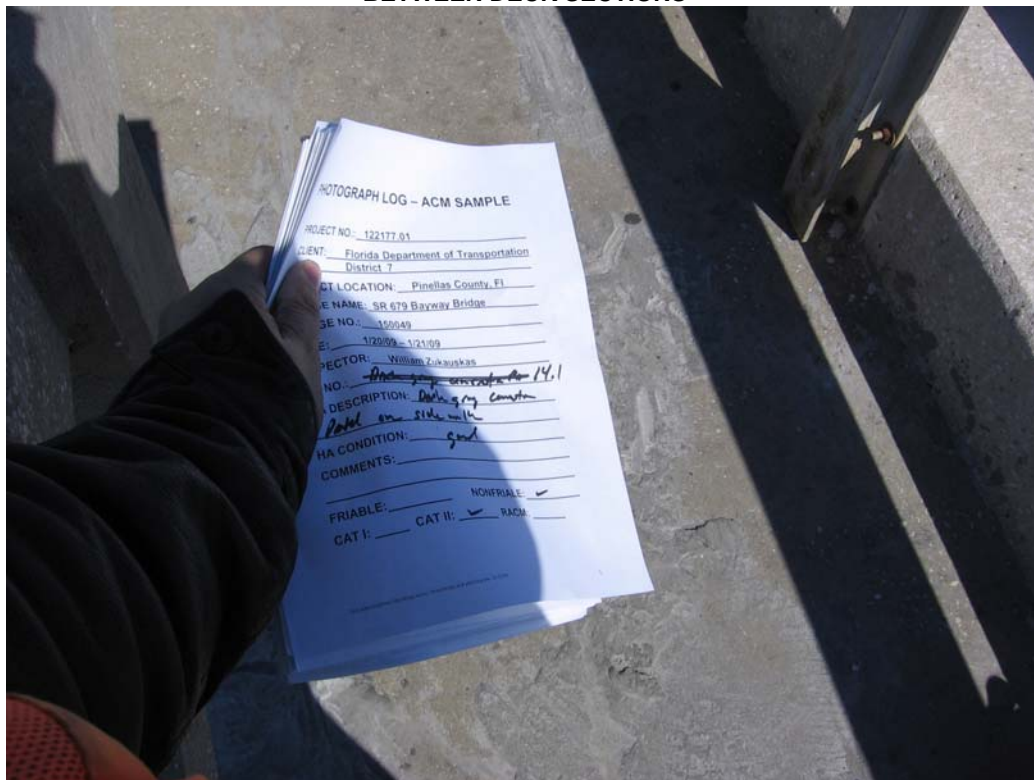
**PHOTO 36 - 01/21/09 - SAMPLE 14.1 - HA 14**  
**DARK GRAY CONCRETE PATCH**  
**ON WEST SIDEWALK**

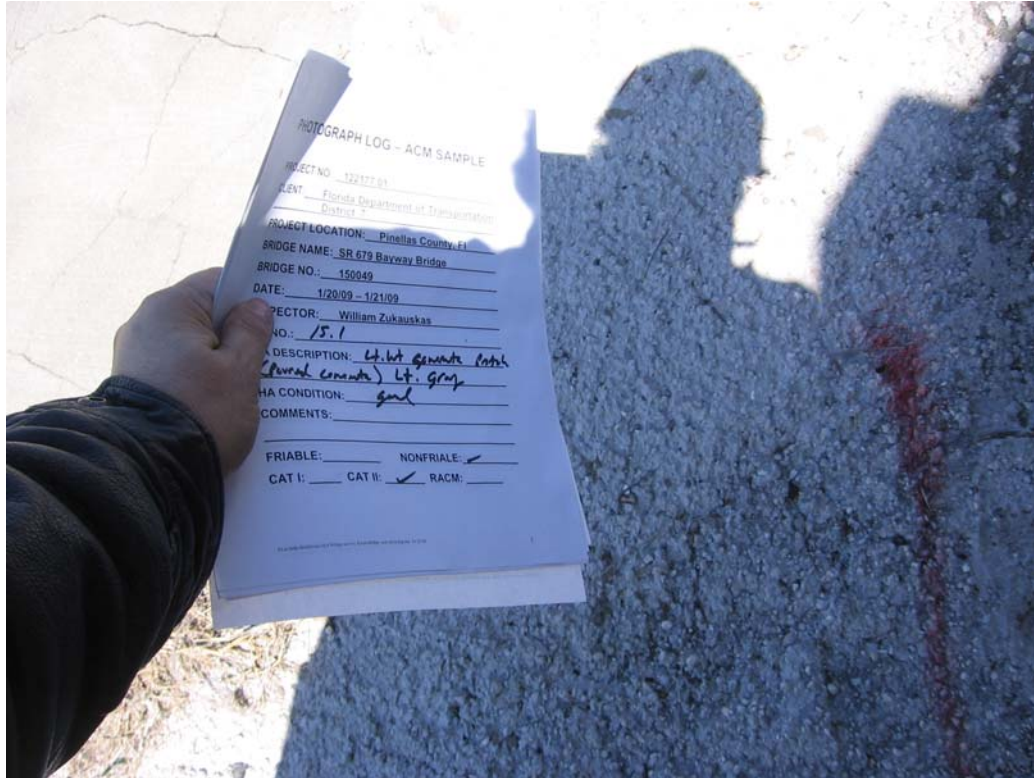
PHOTO 37 - 01/21/09 - SAMPLE 15.1 - HA 15  
LIGHT GRAY CONCRETE  
POURED ON ABUTMENT WALL NORTH END

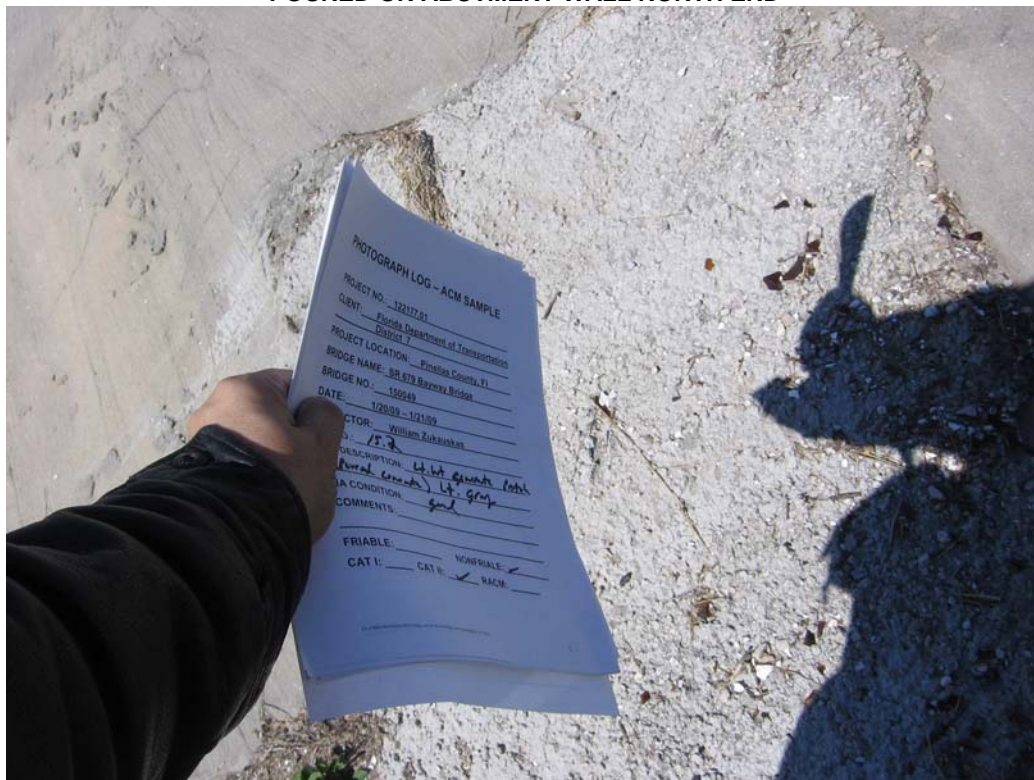
PHOTO 38 - 01/21/09 - SAMPLE 15.2 - HA 15  
LIGHT GRAY CONCRETE  
POURED ON ABUTMENT WALL NORTH END

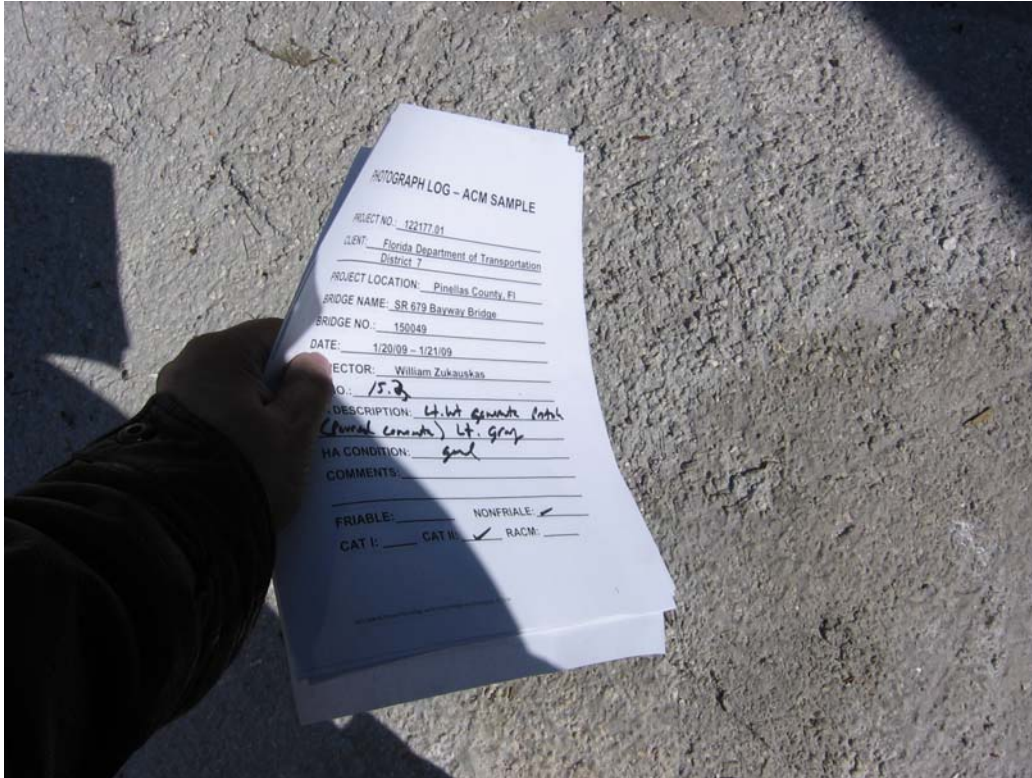
**PHOTO 39 – 01/21/09 – SAMPLE 15.3 – HA 15**  
**LIGHT GRAY CONCRETE**  
**POURED ON ABUTMENT WALL NORTH END**

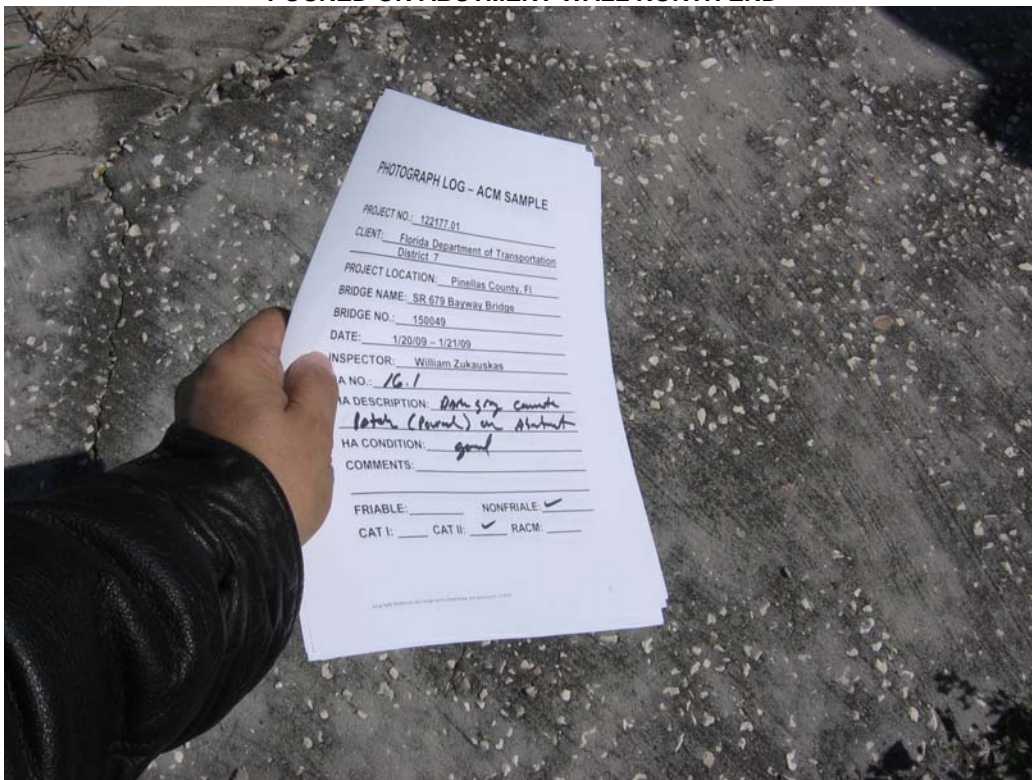
**PHOTO 40 – 01/21/09 – SAMPLE 16.1 – HA 16**  
**DARK GRAY CONCRETE**  
**POURED ON ABUTMENT WALL NORTH END**

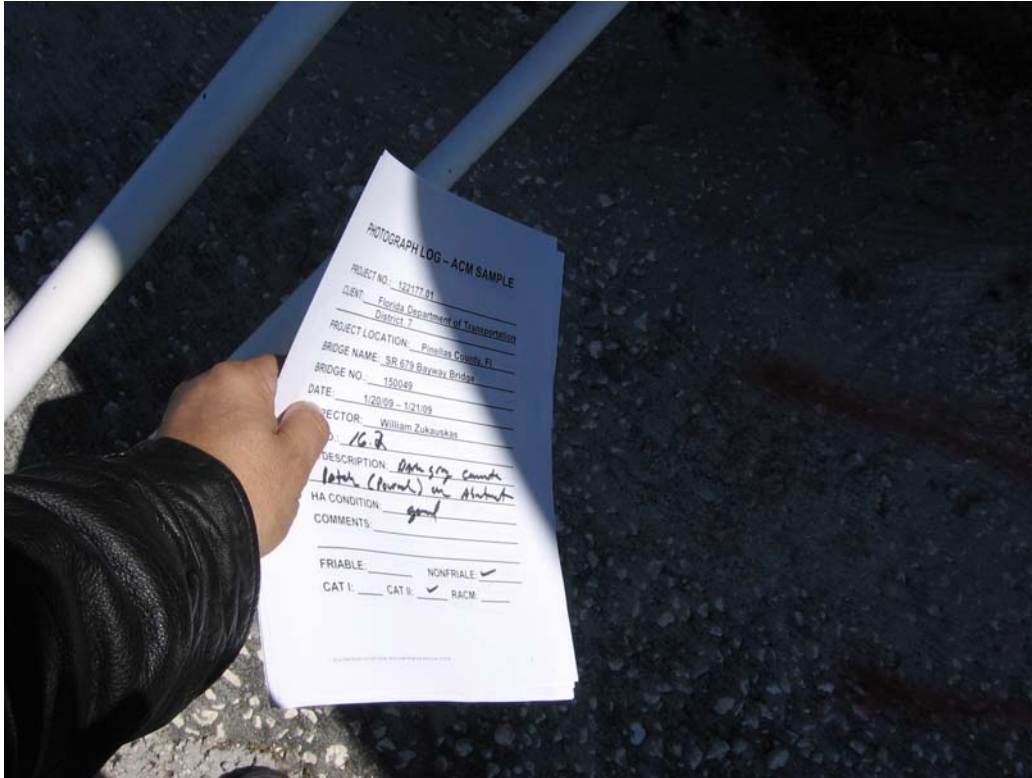
**PHOTO 41 – 01/21/09 – SAMPLE 16.2 – HA 16**  
**DARK GRAY CONCRETE**  
**POURED ON ABUTMENT WALL NORTH END**

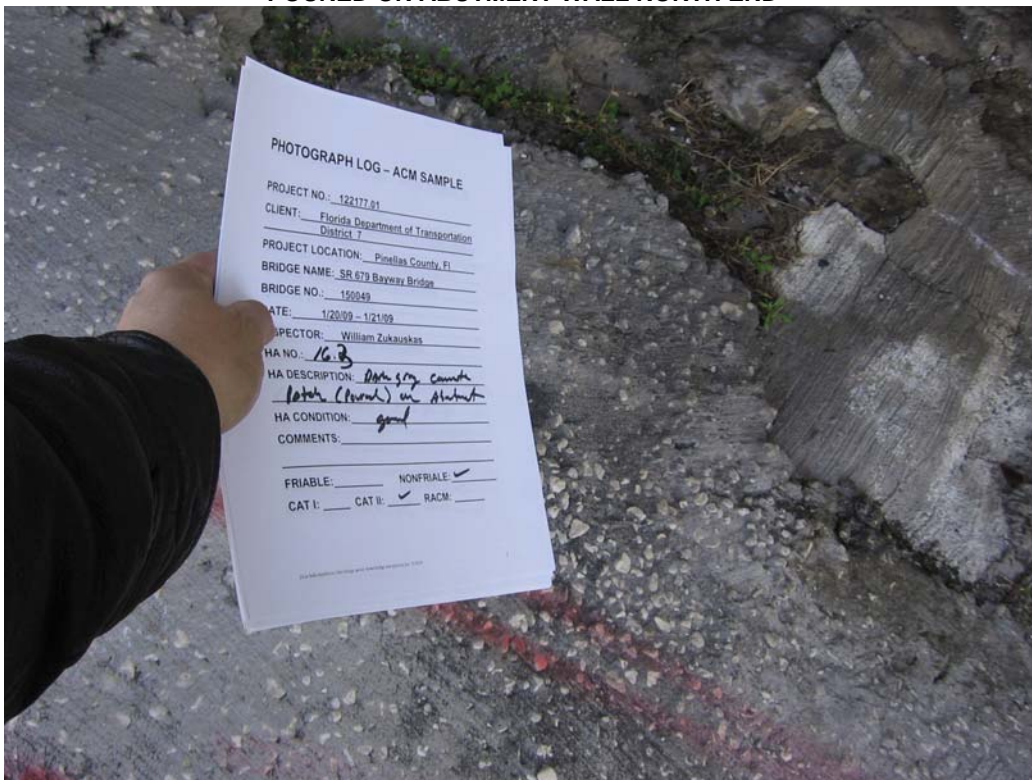
**PHOTO 42 – 01/21/09 – SAMPLE 16.3 – HA 16**  
**DARK GRAY CONCRETE**  
**POURED ON ABUTMENT WALL NORTH END**

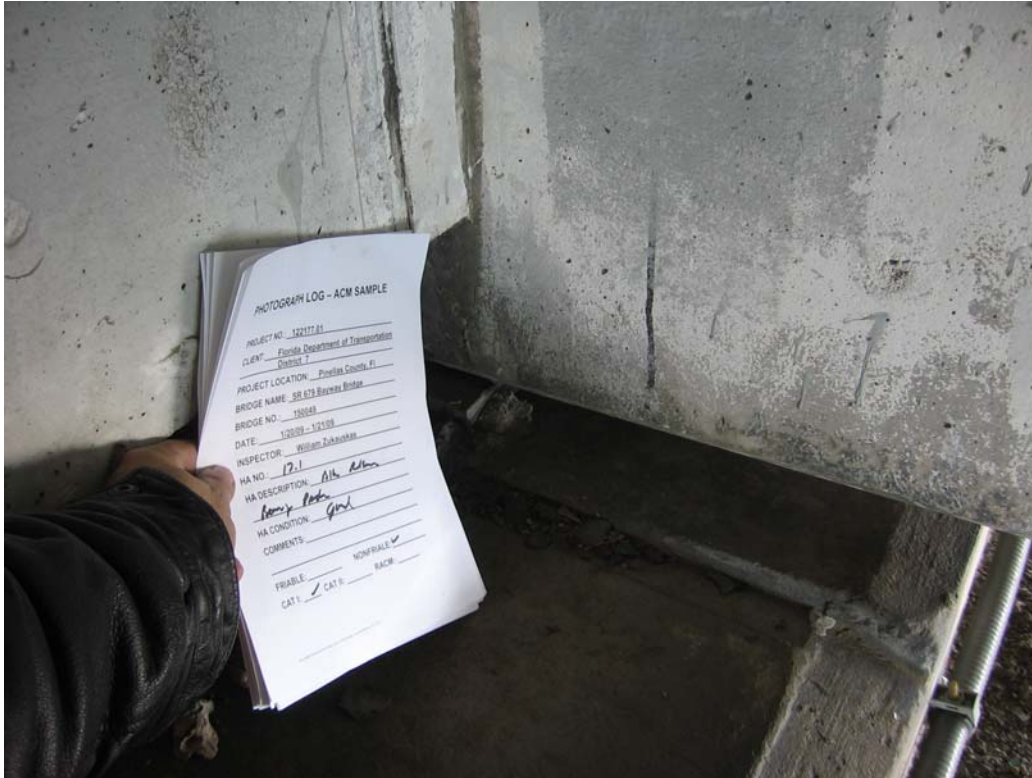
**PHOTO 43 – 01/21/09 – SAMPLE 17.1 – HA 17**  
**BLACK RUBBER BEARING PADS**  
**UNDER SUPPORT POSTS AND AT BRIDGE ENDS**

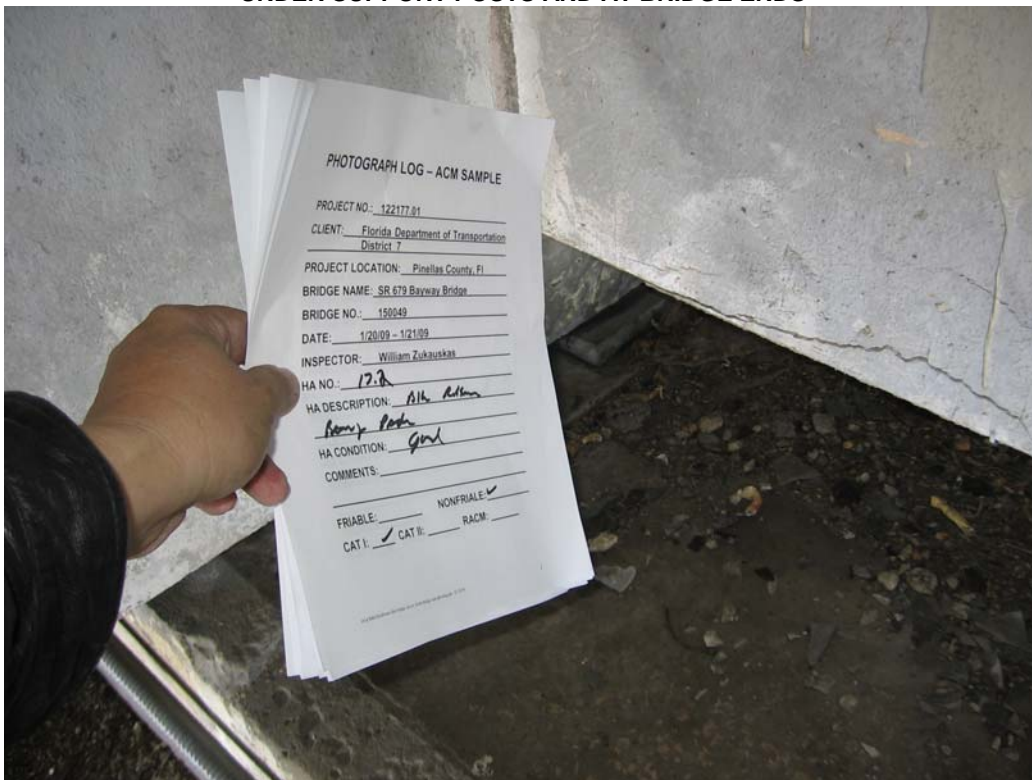
**PHOTO 44 – 01/21/09 – SAMPLE 17.2 – HA 17**  
**BLACK RUBBER BEARING PADS**  
**UNDER SUPPORT POSTS AND AT BRIDGE ENDS**

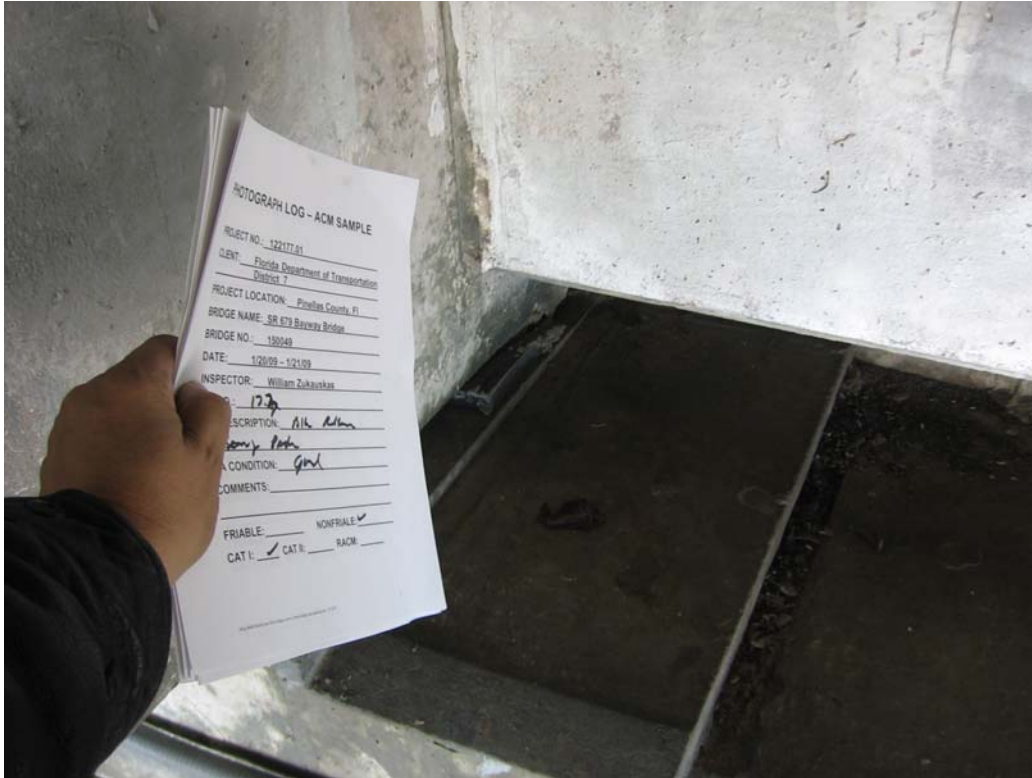
**PHOTO 45 – 01/21/09 – SAMPLE 17.3 – HA 17**  
**BLACK RUBBER BEARING PADS**  
**UNDER SUPPORT POSTS AND AT BRIDGE ENDS**

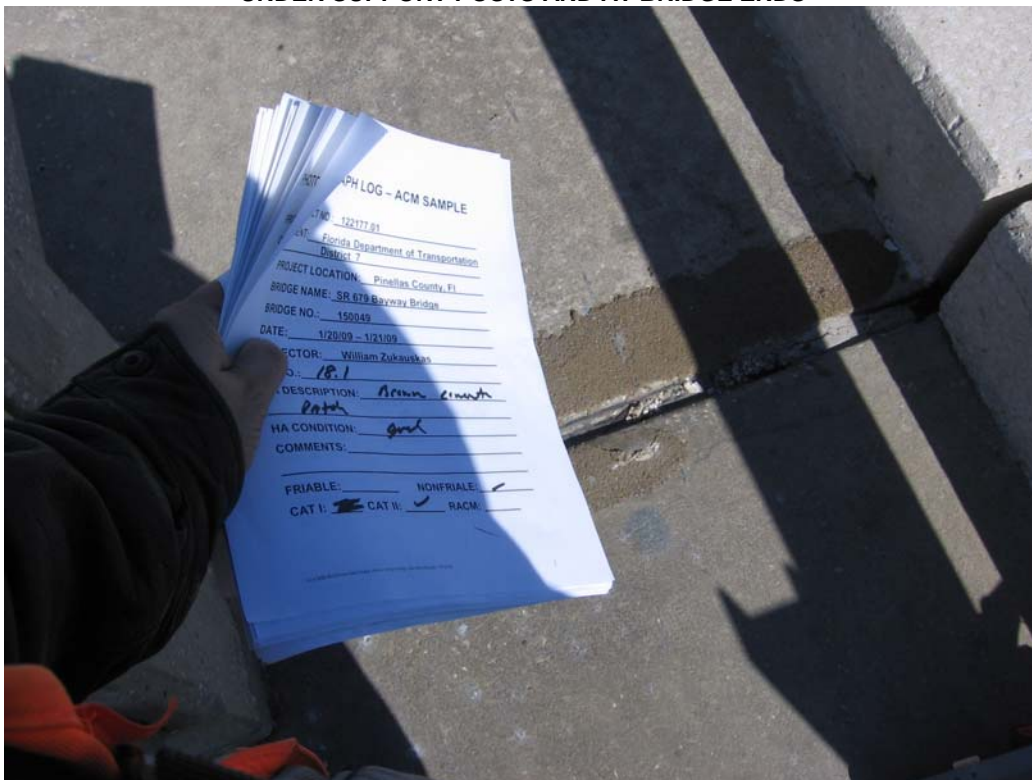
**PHOTO 46 – 01/21/09 – SAMPLE 18.1 – HA 18**  
**BROWN CONCRETE**  
**PATCH ON SIDEWALKS NW AND SE SIDES**

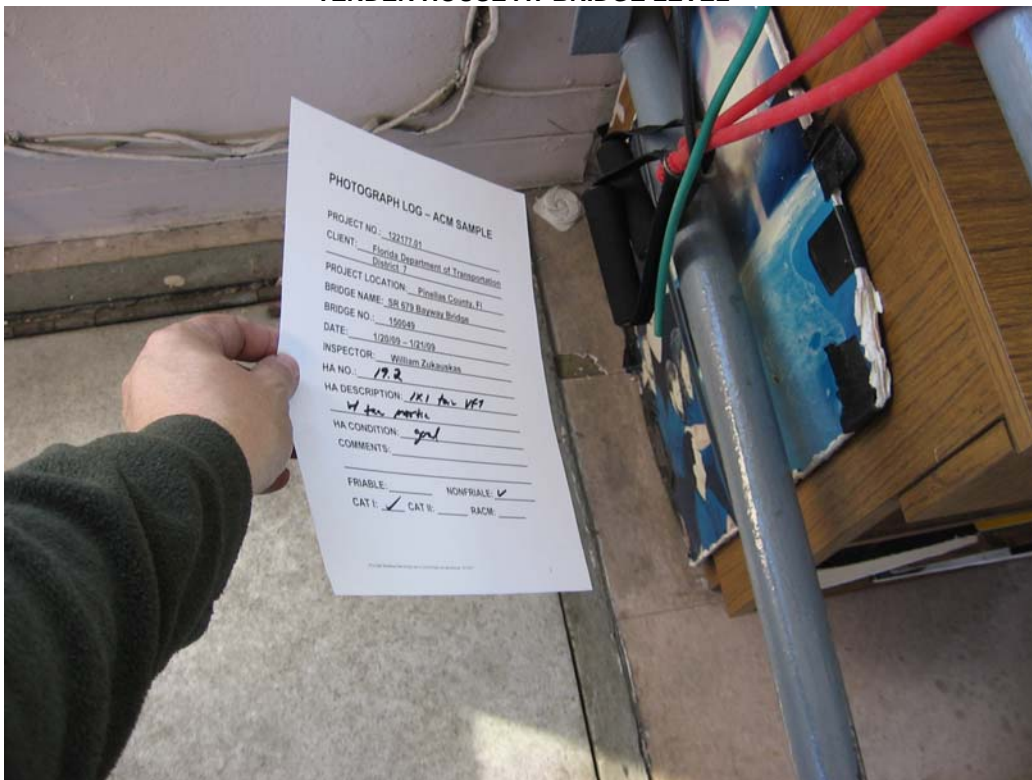
**PHOTO 48 – 01/21/09 – SAMPLE 19.2 – HA 19**  
**1'X 1' TAN VINYL FLOOR TILE WITH TAN MASTIC**  
**TENDER HOUSE AT BRIDGE LEVEL**

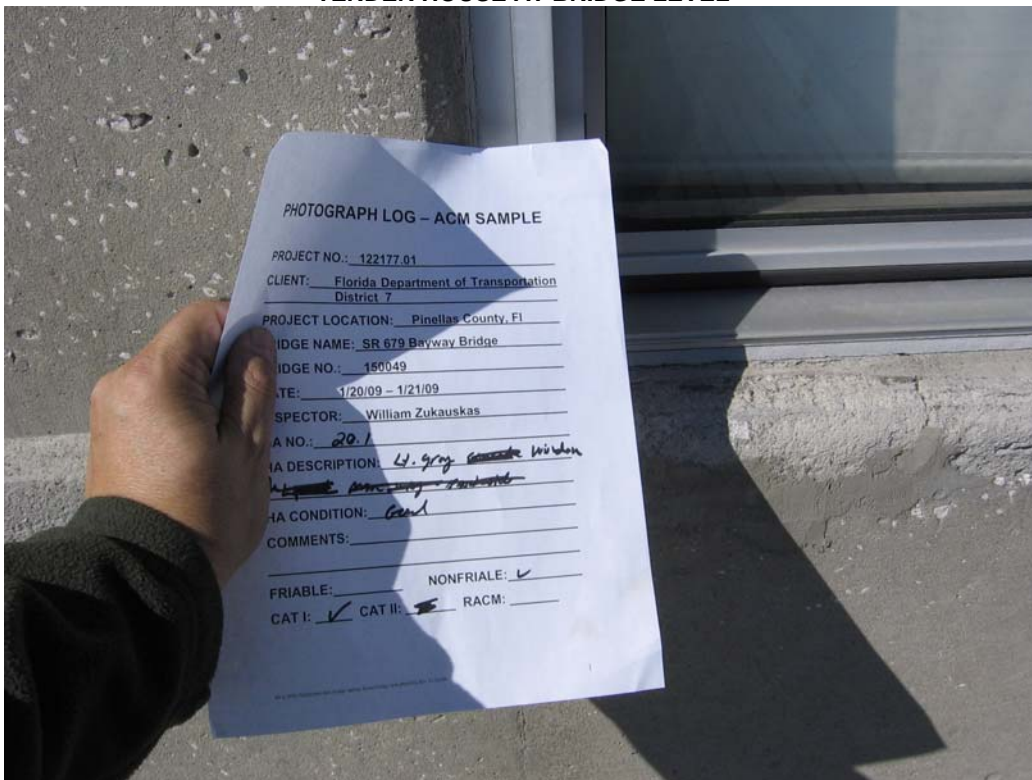
**PHOTO 50 – 01/21/09 – SAMPLE 20.1 – HA 20**  
**GRAY CAULK**  
**TENDER HOUSE EXTERIOR AND INTERIOR OF METAL WINDOW FRAMES**

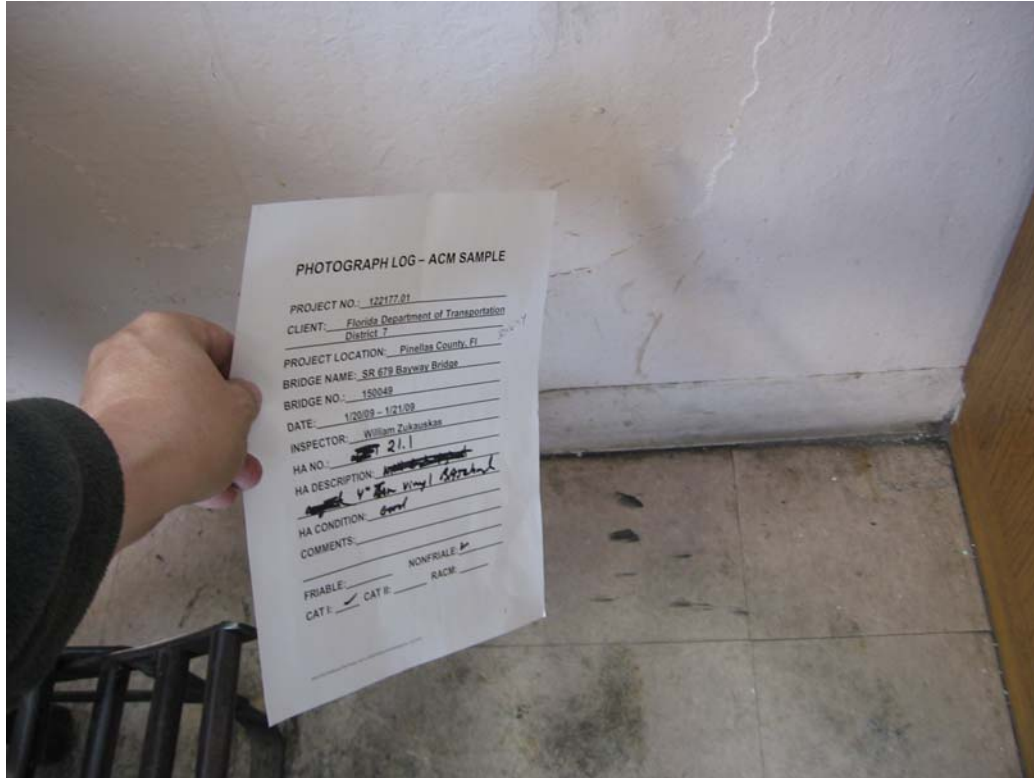
**PHOTO 51 – 01/21/09 – SAMPLE 21.1 – HA 21**  
**4" TAN VINYL BASEBOARD WITH TAN MASTIC**  
**TENDER HOUSE BRIDGE LEVEL**

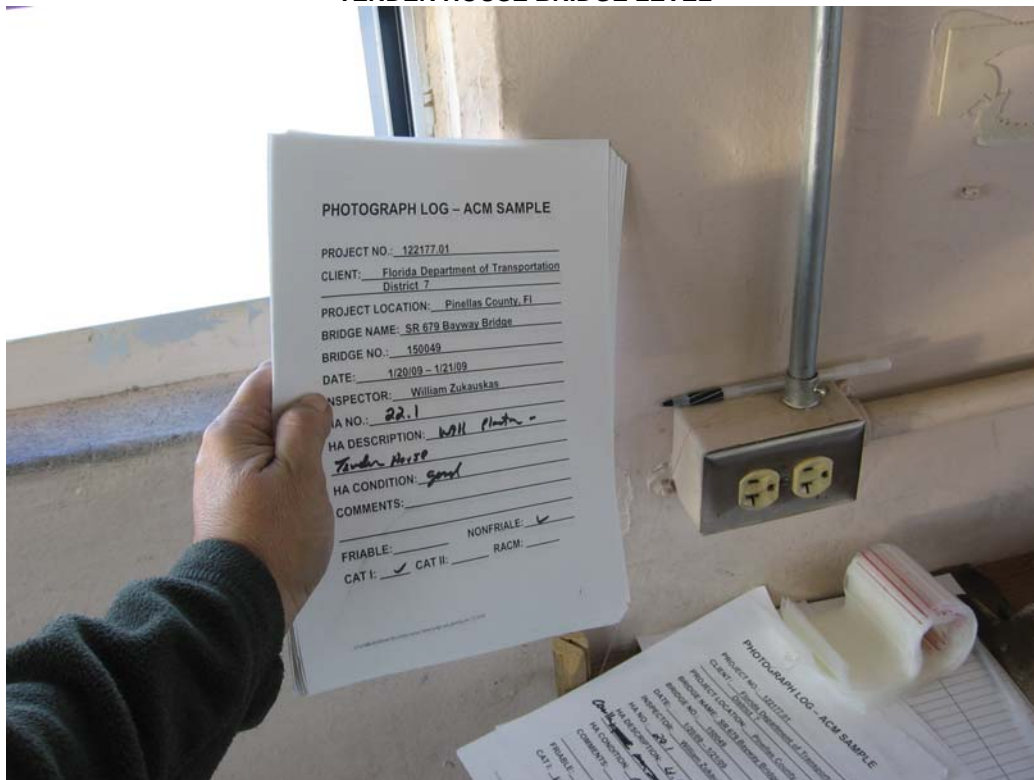
**PHOTO 52 – 01/21/09 – SAMPLE 22.1 – HA 22**  
**PLASTER**  
**TENDER HOUSE INTERIOR WALLS AND CEILINGS**

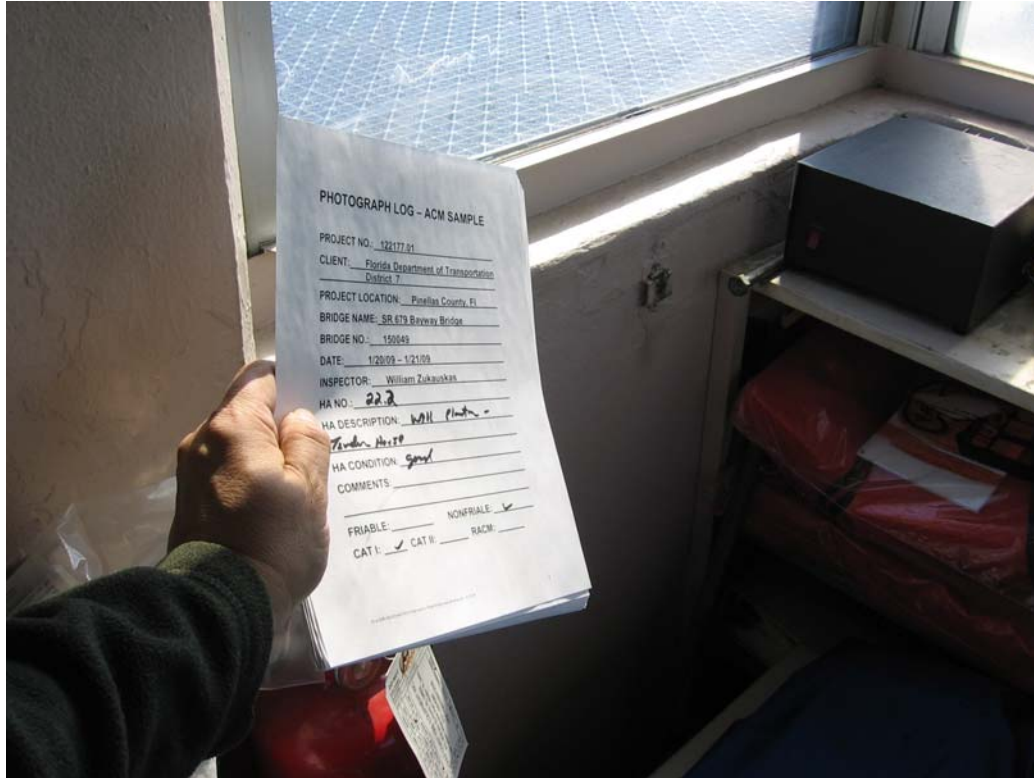
**PHOTO 53 – 01/21/09 – SAMPLE 22.2 – HA 22**  
**PLASTER**  
**TENDER HOUSE INTERIOR WALLS AND CEILINGS**

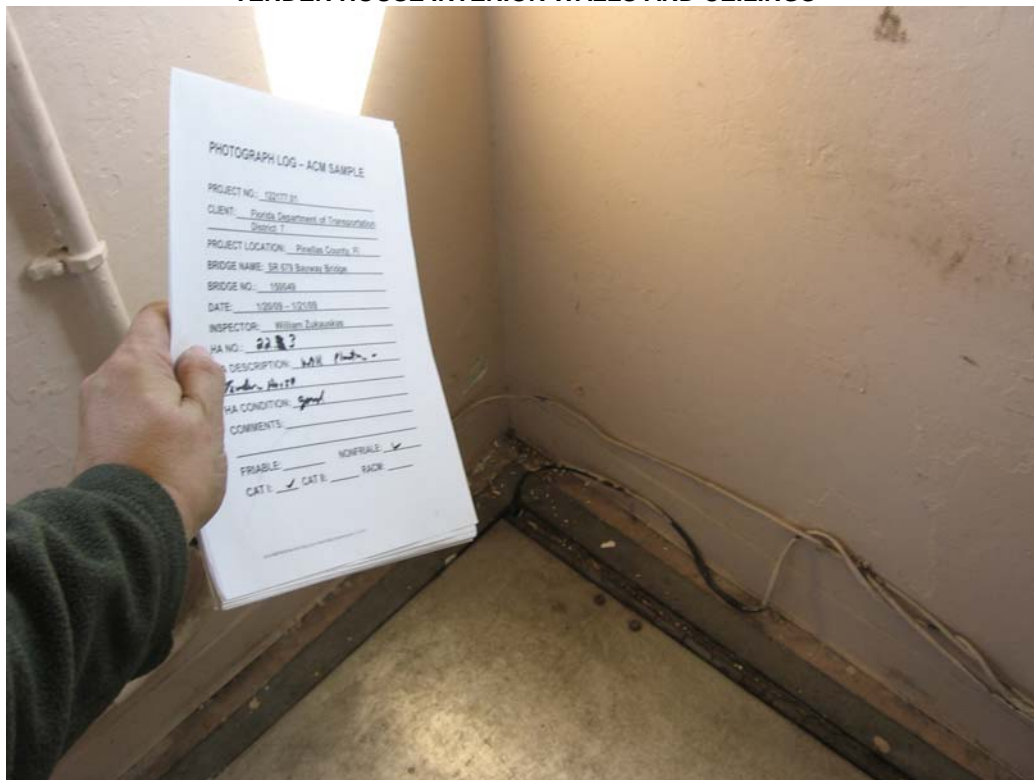
**PHOTO 54 – 01/21/09 – SAMPLE 22.3 – HA 22**  
**PLASTER**  
**TENDER HOUSE INTERIOR WALLS AND CEILINGS**

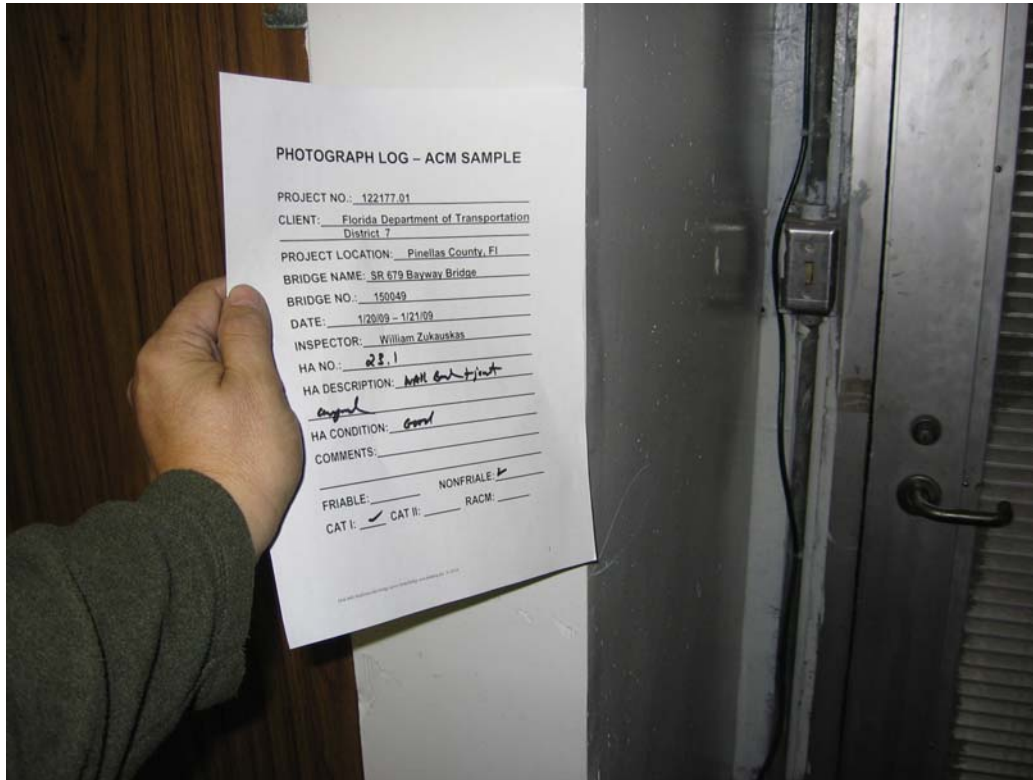
**PHOTO 55 - 01/21/09 - SAMPLE 23.1 - HA 23**  
**WALLBOARD AND JOINT COMPOUND**  
**TENDER HOUSE 2ND LEVEL RESTROOM**

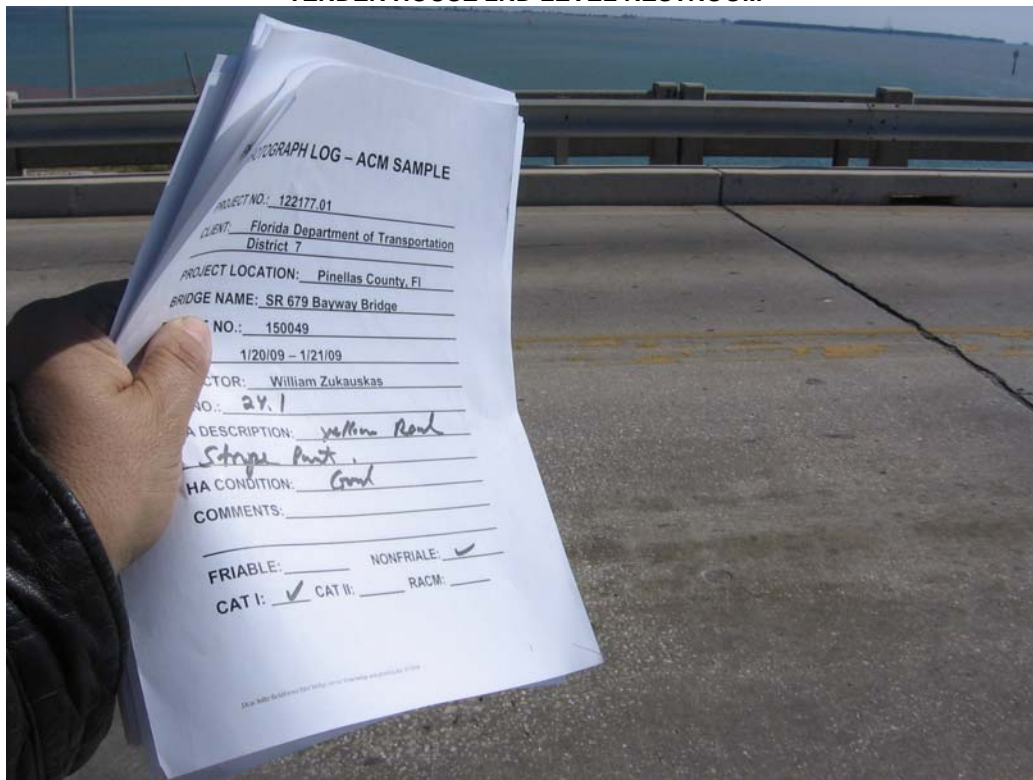
**PHOTO 56 - 01/21/09 - SAMPLE 24.1 - HA 24**  
**YELLOW PAINT**  
**ROAD STRIPES**

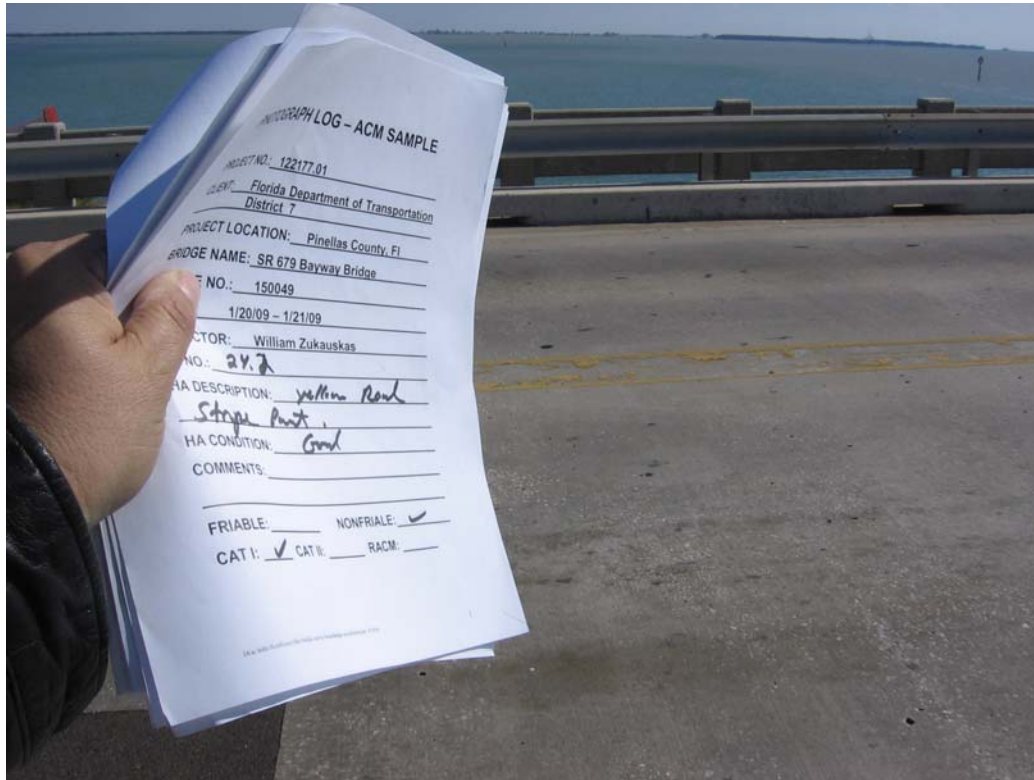
**PHOTO 57 – 01/21/09 – SAMPLE 24.2 – HA 24**  
**YELLOW PAINT**  
**ROAD STRIPES**

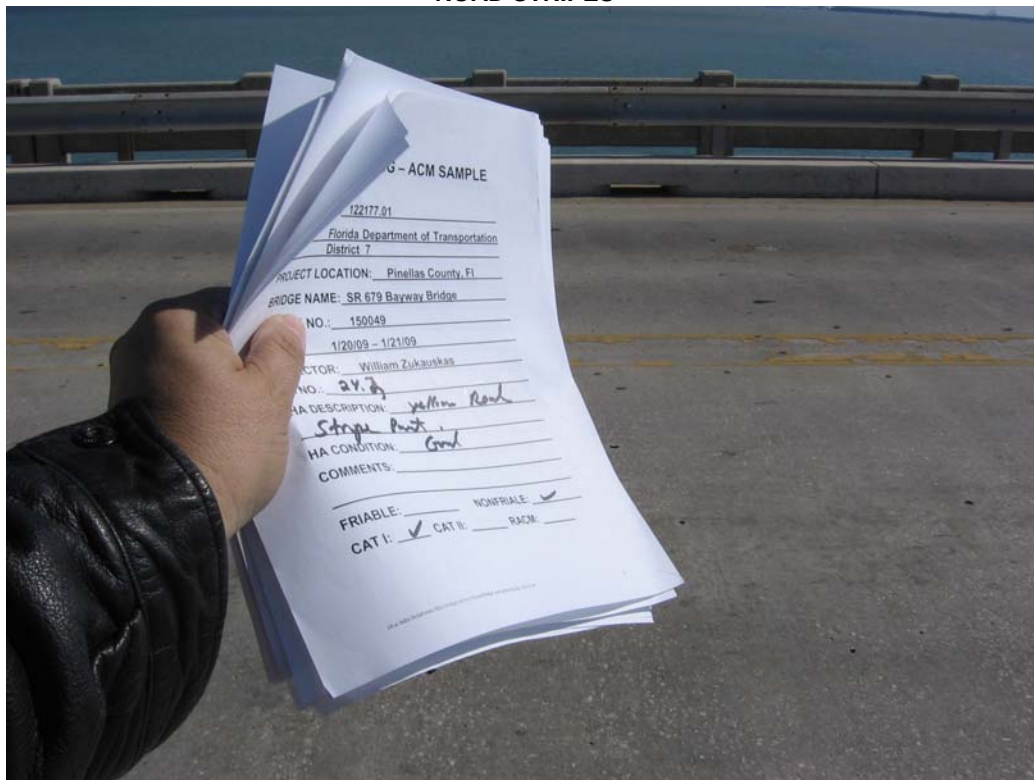
**PHOTO 58 – 01/21/09 – SAMPLE 24.3 – HA 24**  
**YELLOW PAINT**  
**ROAD STRIPES**

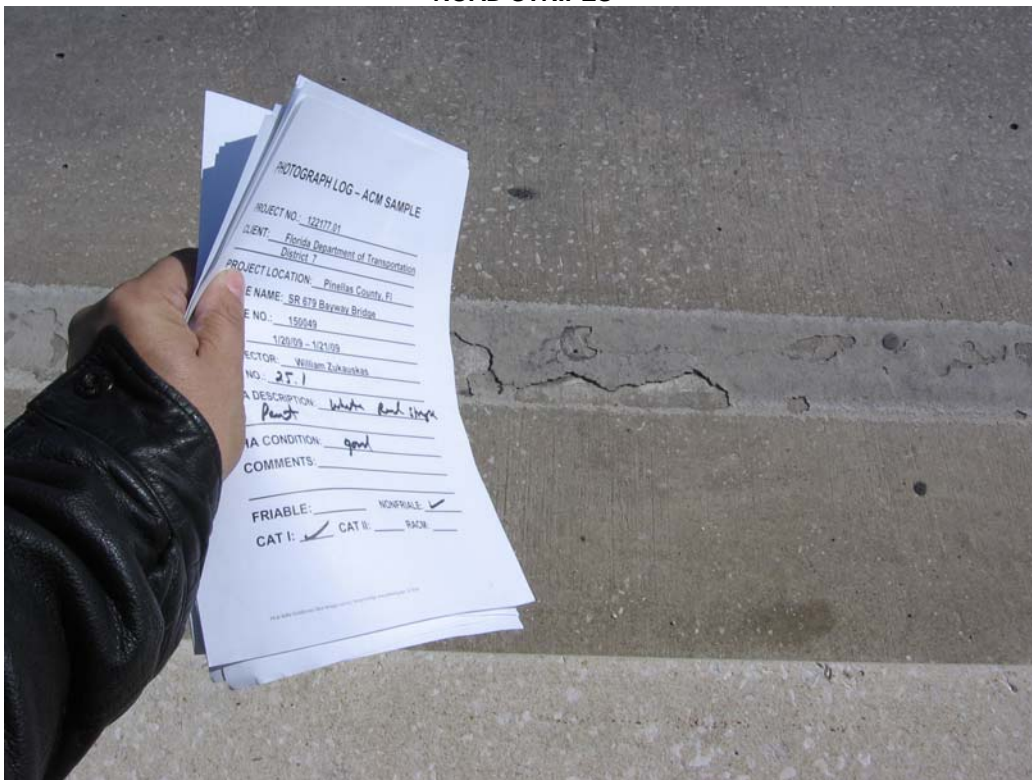
PHOTO 60 – 01/21/09 – SAMPLE 25.1 – HA 25  
WHITE PAINT  
ROAD STRIPES
