**ASBESTOS SURVEY REPORT FOR RENOVATION**

***Bridge No. 150049***

***SR 679 – Pinellas Bayway Structure E Bridge  
over Boca Ciega Bay  
St. Petersburg, Pinellas County, Florida***

***February 2009***

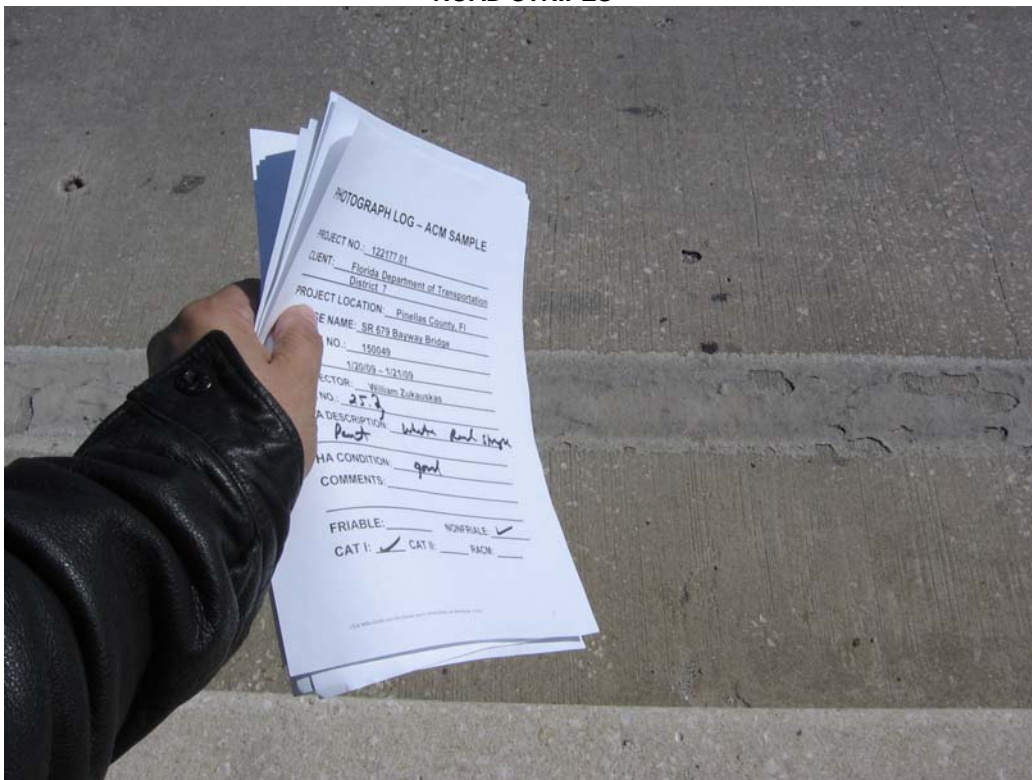
**PHOTO 62 – 01/21/09 – SAMPLE 25.3 – HA 25**  
**WHITE PAINT**  
**ROAD STRIPES**

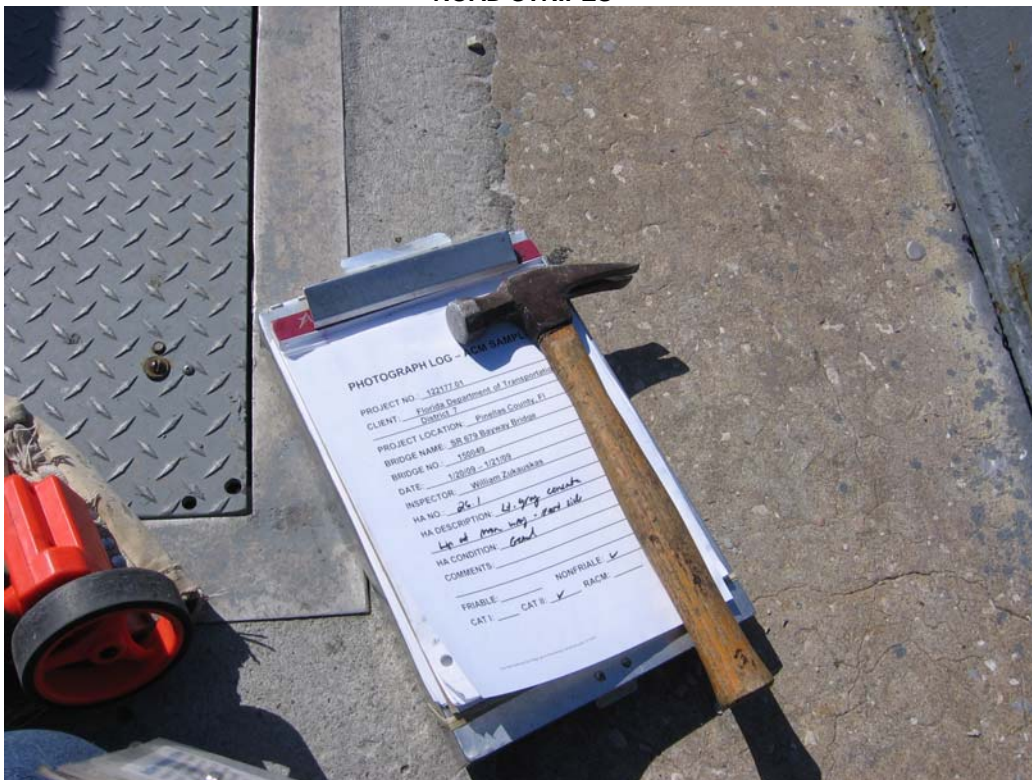
PHOTO 64 - 01/21/09 - SAMPLE 26.1 - HA 26  
LIGHT GRAY CONCRETE  
LIP AROUND MAN WAY ON SE SIDE OF BRIDGE

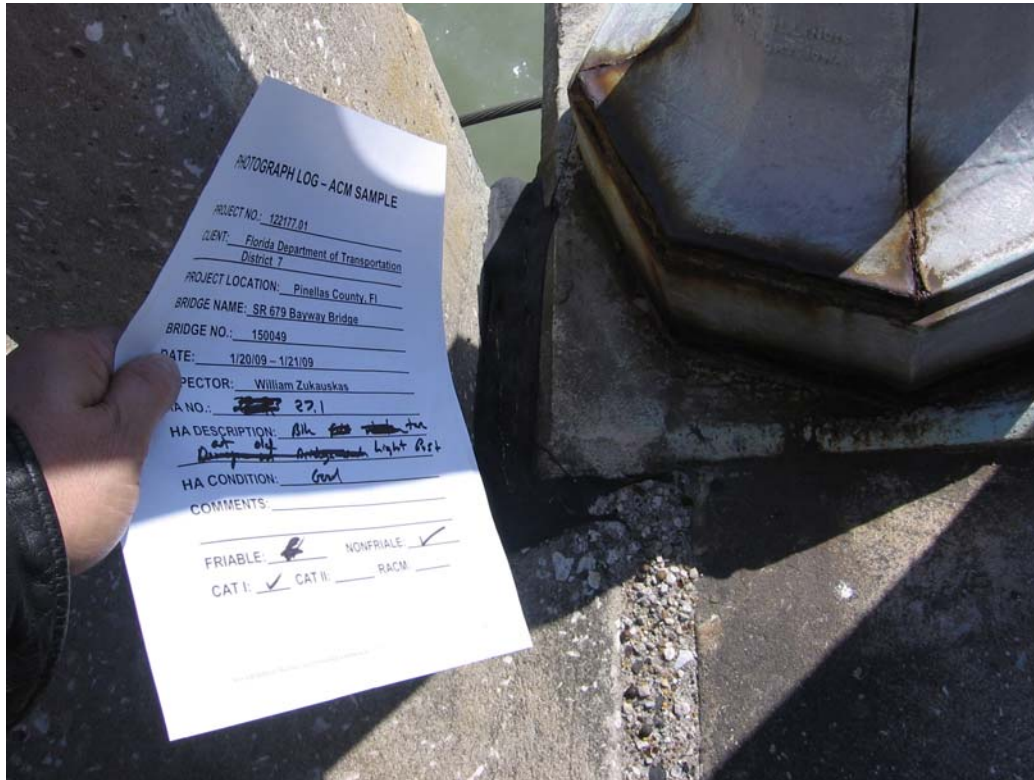
**PHOTO 65 - 01/21/09 - SAMPLE 27.1 - HA 27**  
**BLACK TAR**  
**AT LIGHT POST BY SIDEWALK ON SE SIDE**

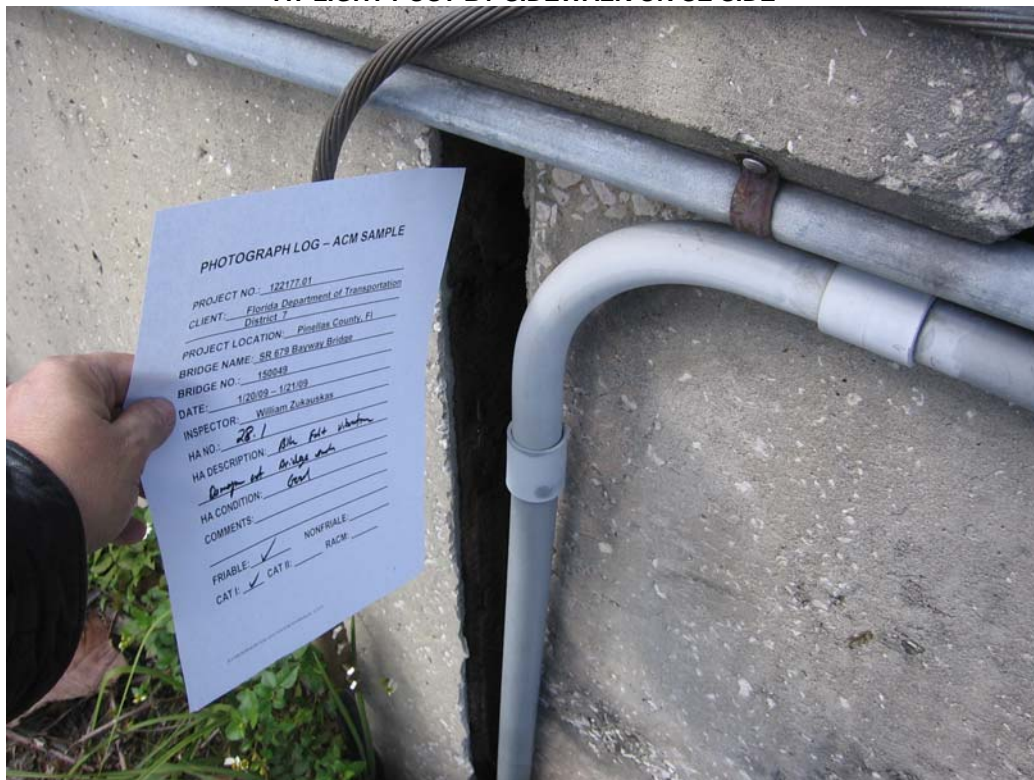
**PHOTO 66 - 01/21/09 - SAMPLE 28.1 - HA 28**  
**BLACK VIBRATION DAMPERS**  
**AT NORTH AND SOUTH BRIDGE ENDS**

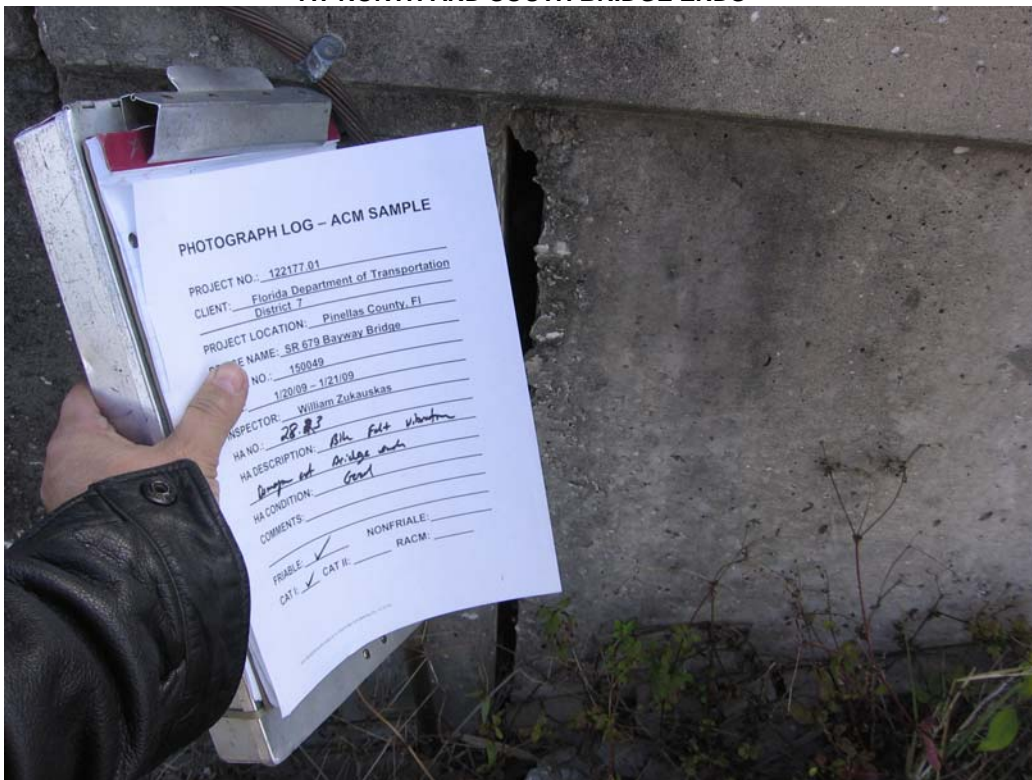
**PHOTO 68 – 01/21/09 – SAMPLE 28.3 – HA 28**  
**BLACK VIBRATION DAMPERS**  
**AT NORTH AND SOUTH BRIDGE ENDS**

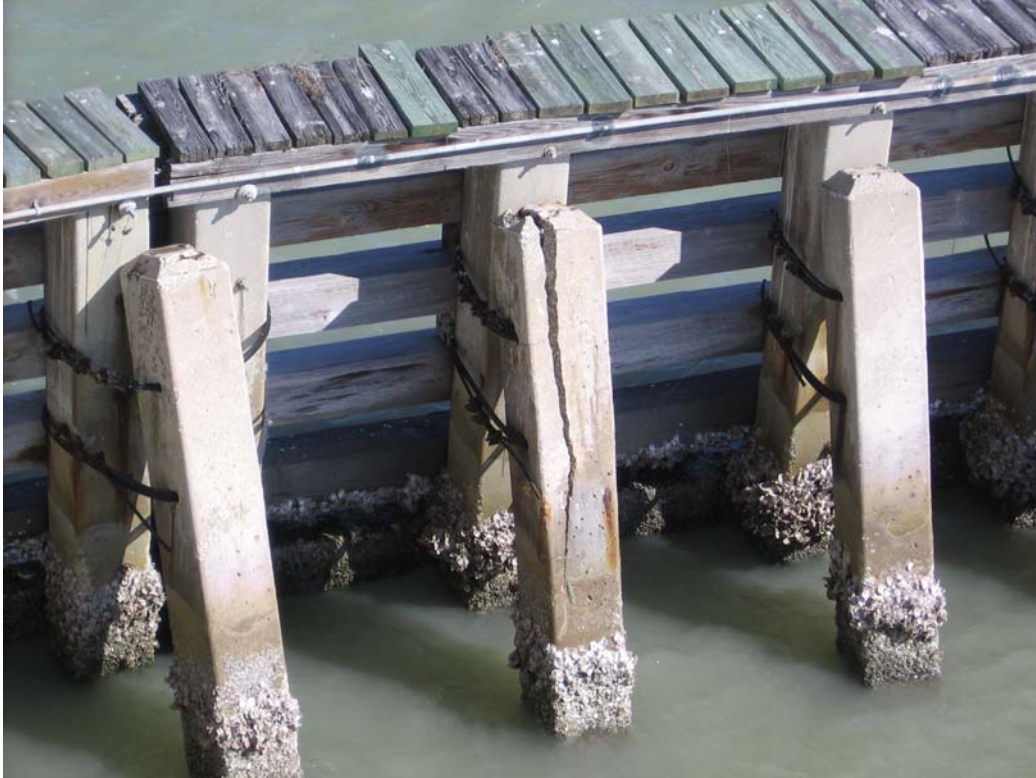
**PHOTO 69 – 01/21/09 – SAMPLE 29.1 – HA 29**  
**CONCRETE**  
**PILINGS/PIERS AT WOOD FENDERS**

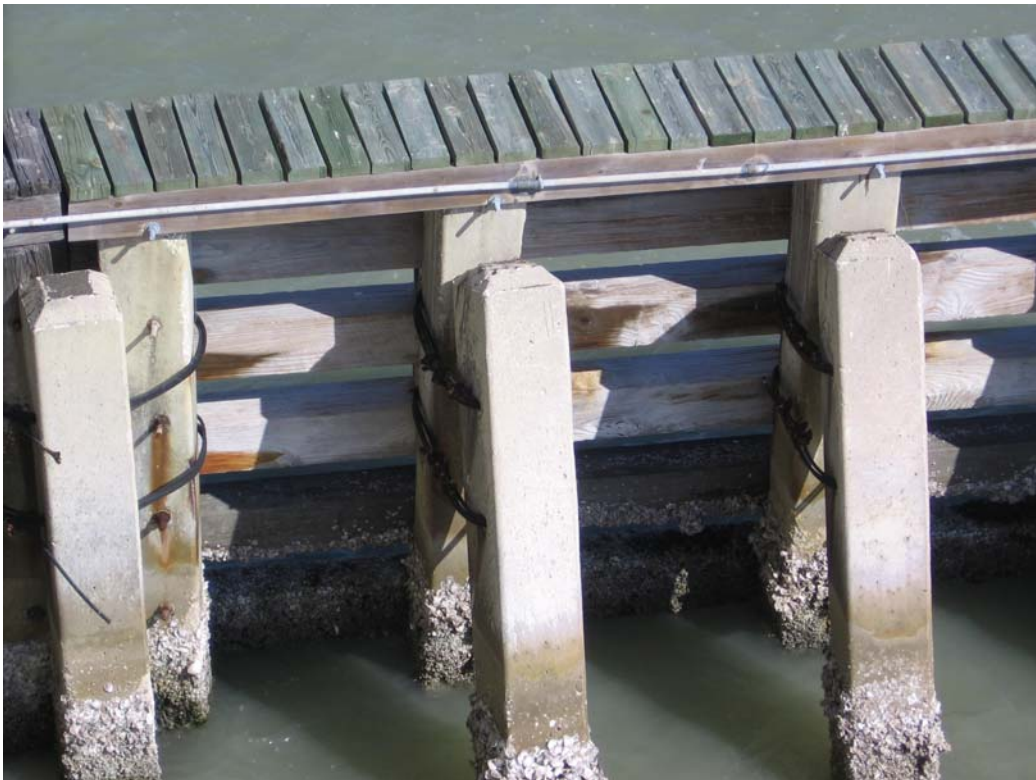
**PHOTO 70 – 01/21/09 – SAMPLE 29.2 – HA 29**  
**CONCRETE**  
**PILINGS/PIERS AT WOOD FENDERS**

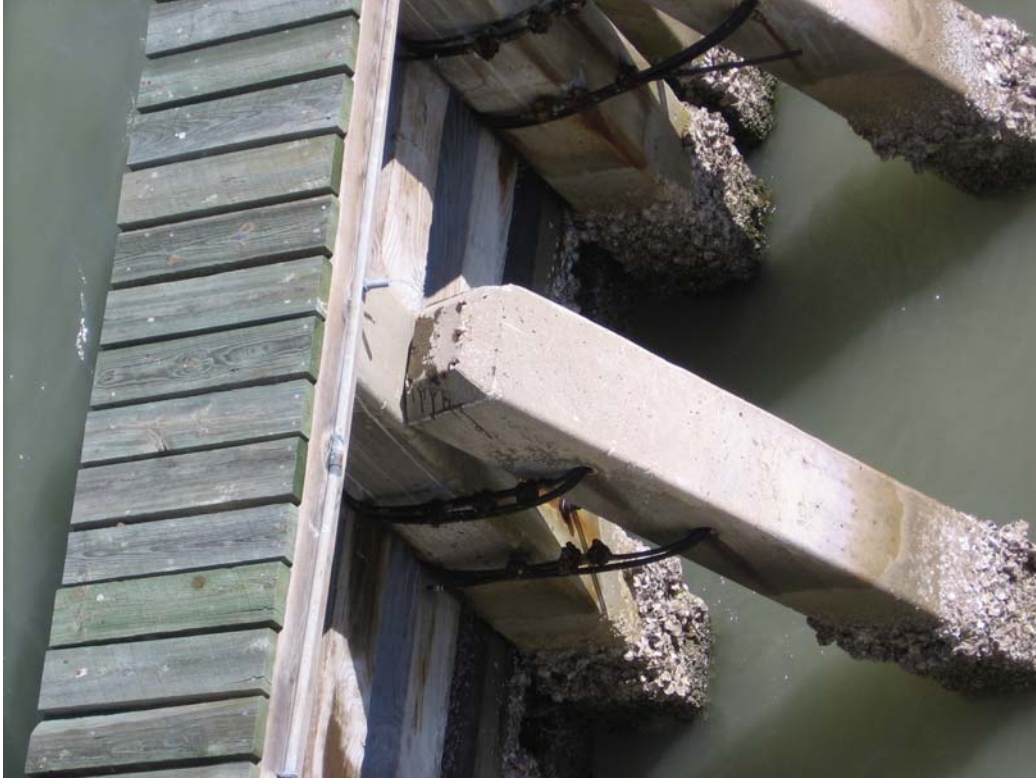
**PHOTO 71 – 01/21/09 – SAMPLE 29.3 – HA 29**  
**CONCRETE**  
**PILINGS/PIERS AT WOOD FENDERS**

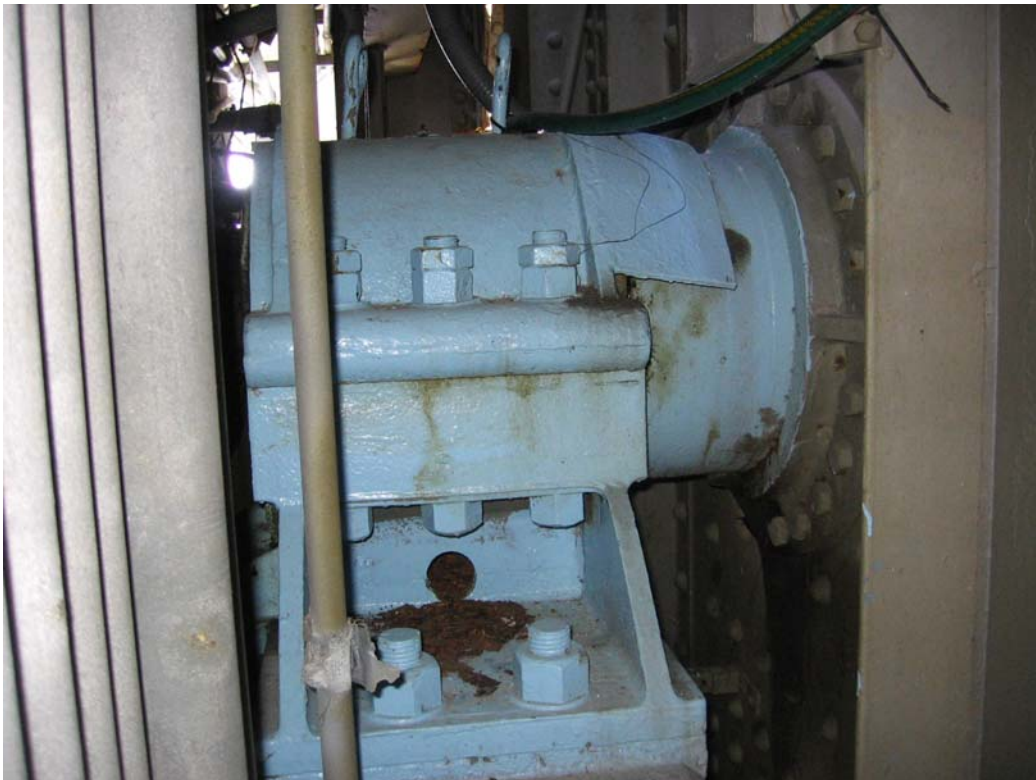
Homogeneous area HA 30 (brake shoes on lift equipment) was assumed to be ACM because of its inaccessibility. Since this material is Category I nonfriable, it is not considered to be regulated asbestos-containing material (RACM). However, during demolition or renovation activities that will impact the brake unit, the brake shoes should be removed intact, using wet methods to minimize the potential for fiber release.

**PHOTO 72 – 01/21/09 – SAMPLE ASSUMED – HA 30**  
**BRAKE SHOES**  
**ON BRIDGE LIFT EQUIPMENT**
