RE: NESHAP Asbestos and Protective Coatings Survey Report  
**Beckett Bridge over Whitcomb Bayou (Bridge No. 154000)**  
Beckett Bridge Project Development & Environment (PD&E) Study  
From Chesapeake Drive to Forest Avenue  
Pinellas County, Florida  
PID 2161; ETDM #: 13040; FPN: 424385-1-28-01  
Tierra Project No.: 6511-11-265

# NESHAP ASBESTOS AND PROTECTIVE COATINGS SURVEY REPORT

**Beckett Bridge over Whitcomb Bayou  
Bridge No. 154000**

**Beckett Bridge Project Development & Environment (PD&E) Study  
From Chesapeake Drive to Forest Avenue  
Pinellas County, Florida**

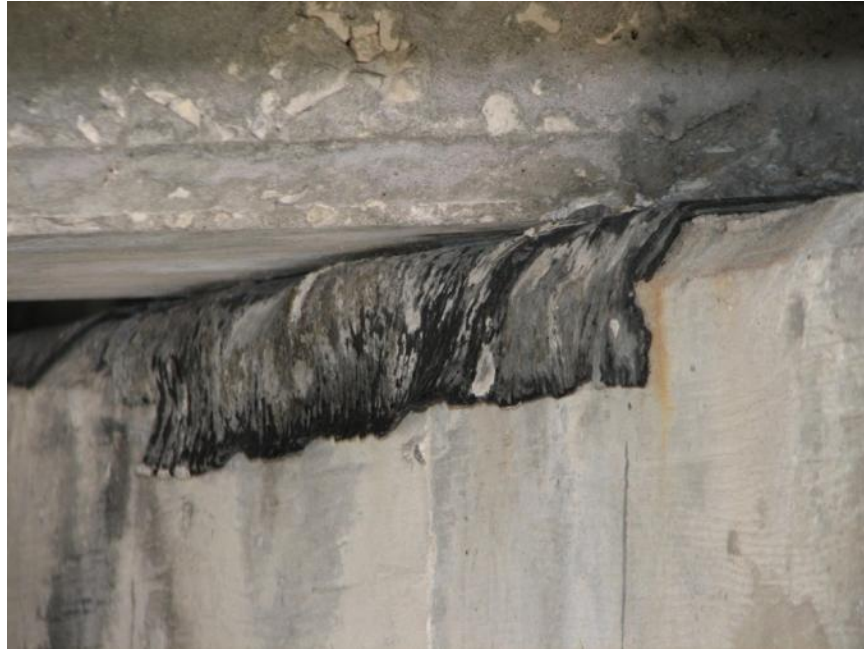
| Homo. No. | Sample No. | Material Description | Approx. Quantity | Lab Results % Asbestos | NESHAP Category |
|---|---|---|---|---|---|
| 1 | 1 | Tar paper on all bent caps | 600 ft <sup>2</sup> | Not Detected | N/A |

None of the thirteen samples tested positive for the presence of asbestos.

Homogeneous Material 1 – Black tar paper on all bent caps

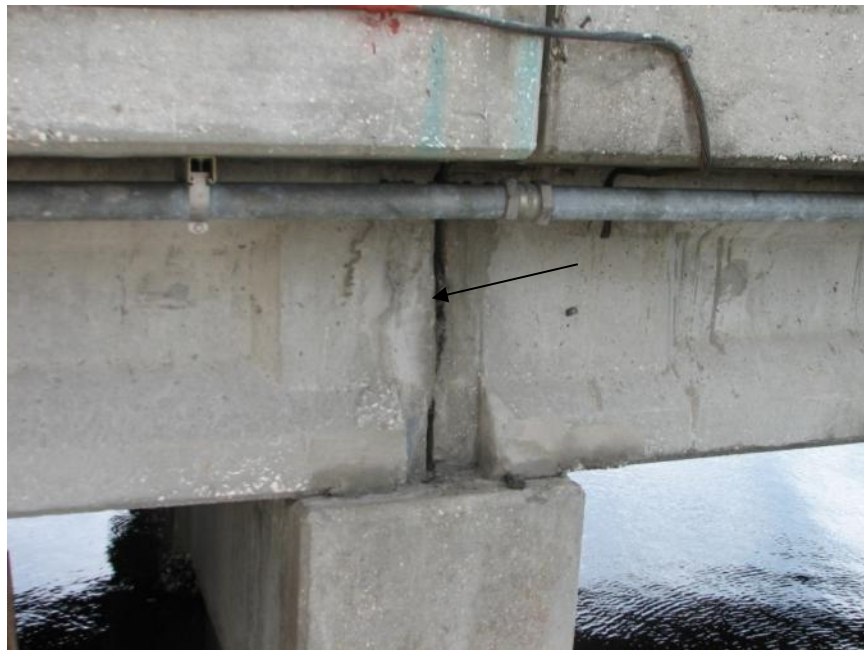
| Homo. No. | Sample No. | Material Description | Approx. Quantity | Lab Results % Asbestos | NESHAP Category |
|---|---|---|---|---|---|
| 2 | 1 | Black expansion joint board between beam ends | 100 ft <sup>2</sup> | Not Detected | N/A |

Homogeneous Material 2 – Expansion joint board between beams

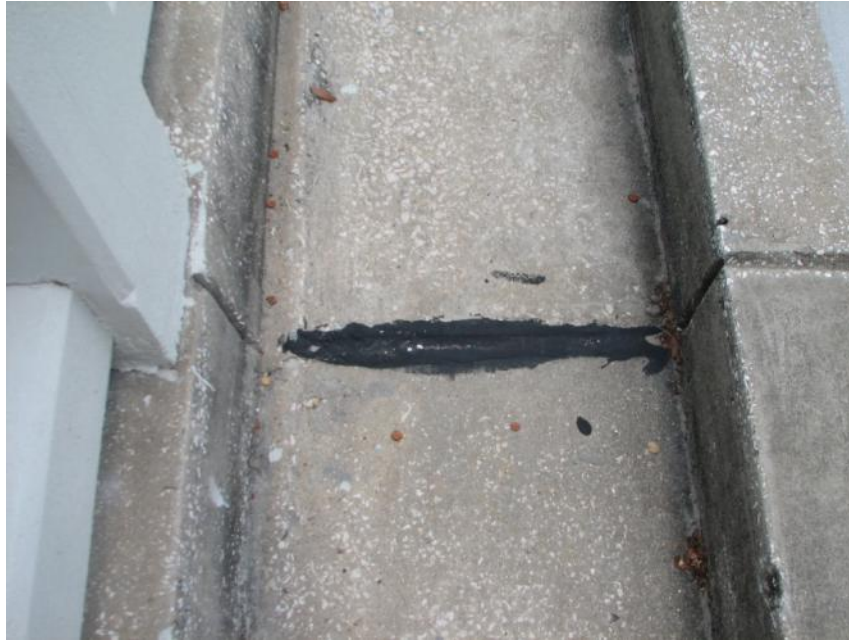
| Homo. No. | Sample No. | Material Description | Approx. Quantity | Lab Results % Asbestos | NESHAP Category |
|---|---|---|---|---|---|
| 3 | 1 | Rubber joint filler on decking | 20 ft <sup>2</sup> | Not Detected | N/A |

Homogenous Material 3 – Joint filler

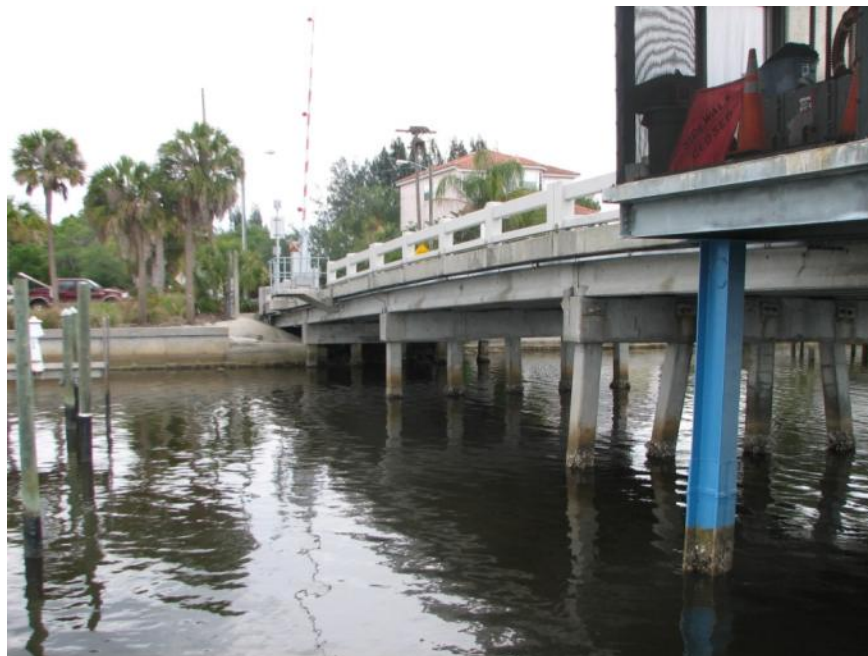
| Homo. No. | Sample No. | Material Description | Approx. Quantity | Lab Results % Asbestos | NESHAP Category |
|---|---|---|---|---|---|
| 4 | 1 | Concrete decking, piles, beams and guardrail | Not Measured | Not Detected | N/A |

Homogeneous Material 4 – Various concrete elements (bents, decking, piles and guardrail)

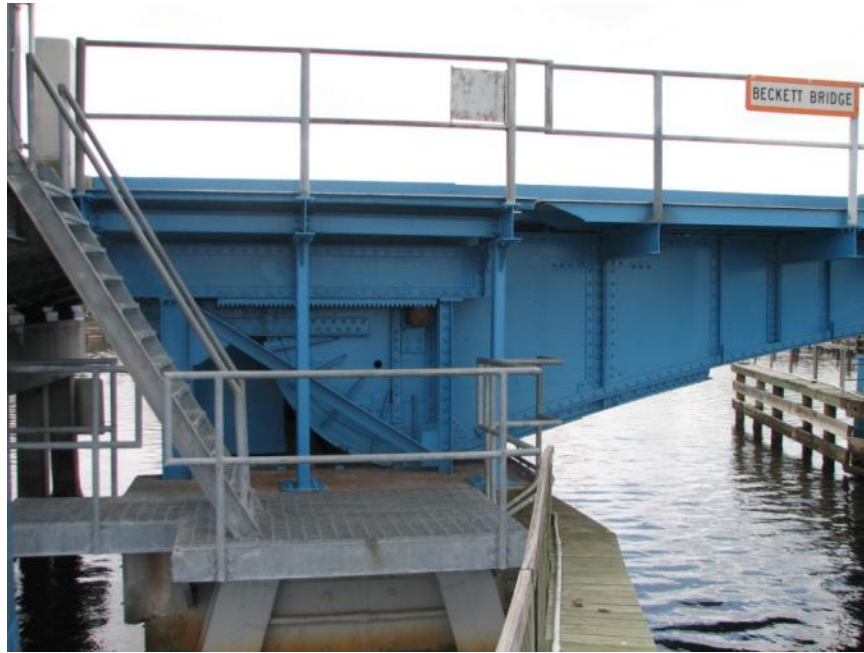
| Sample No. | Location | Lead (mg/kg) | Cadmium (mg/kg) | Zinc (mg/kg) | Chromium (mg/kg) |
|---|--|---|---|---|---|
| 1 | Blue paint on structural steel of bascule bridge | 4.6 | 0.1781 | 2820 | 4.91 |

The lab results indicate the painted surfaces present at the bridge do not meet the definition of Lead Based Paint. Additionally based on the results for the total concentration of the metals, it does not appear that the coating materials would be classified as a hazardous waste per 40 CFR 261. However, prior to disposal of any waste materials containing coating, a TCLP analysis of the waste should be performed to make a final determination.

Blue painted structural steel and bascule bridge structure

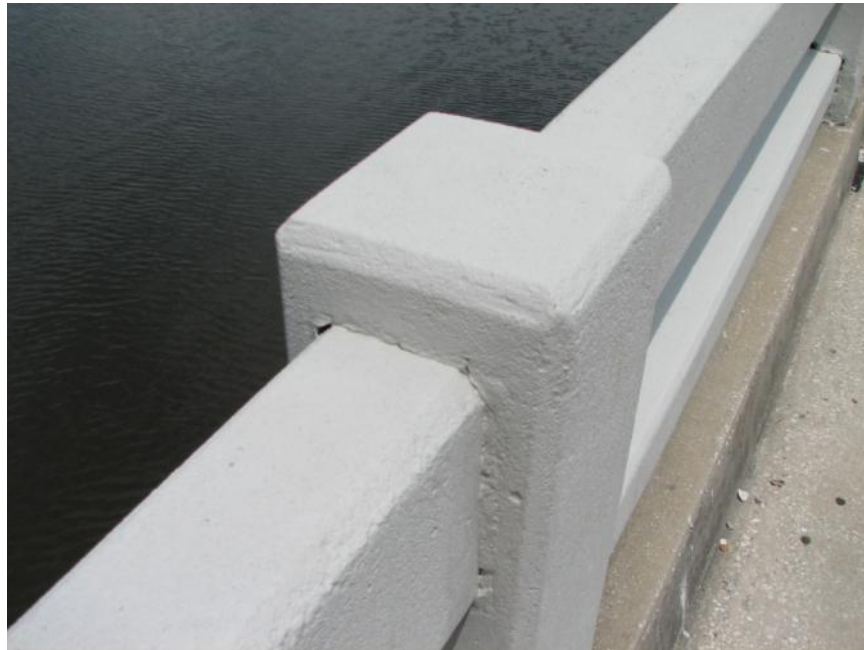
| Sample No. | Location | Lead (mg/kg) | Cadmium (mg/kg) | Zinc (mg/kg) | Chromium (mg/kg) |
|---|--|---|---|---|---|
| 3 | Light gray paint on guardrails | 4.0 | 0.0928 l | 89 | 7.52 |

Light gray painted concrete guardrail

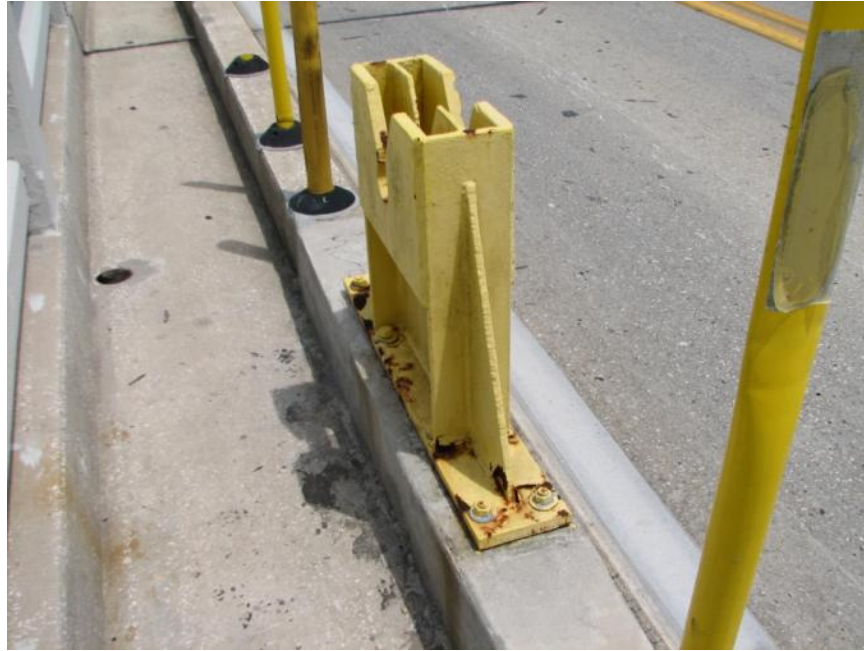
| Sample No. | Location | Lead (mg/kg) | Cadmium (mg/kg) | Zinc (mg/kg) | Chromium (mg/kg) |
|---|--|---|---|---|---|
| 2 | Yellow paint on west barricade support | 36.9 | 1.71 | 1260 | 34.8 |

Yellow paint on barricade support

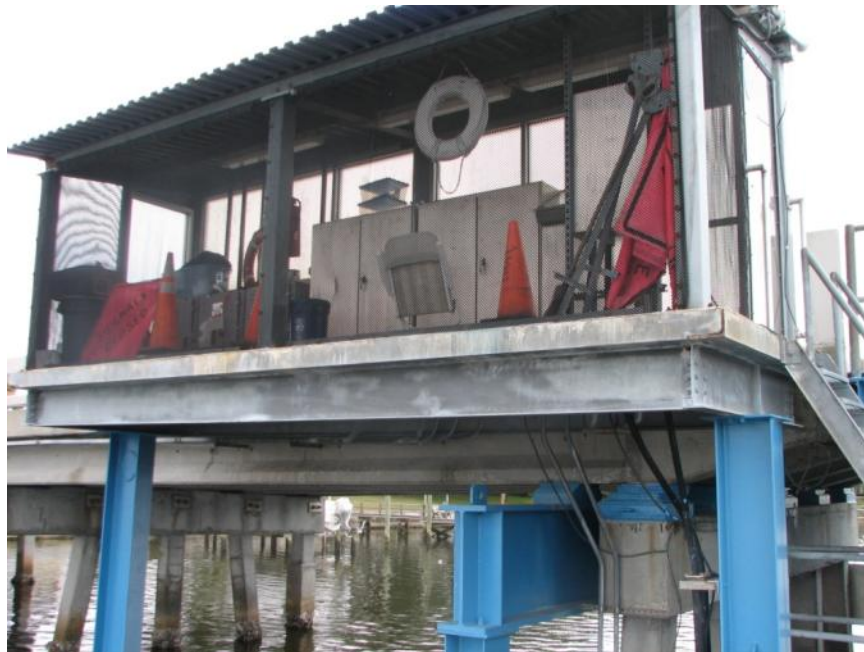
The existing bascule bridge was originally constructed in 1924 as a timber structure with a steel movable span. The fixed timber approach spans were replaced with concrete approach spans in 1956. The current bridge provides two lanes servicing both east and west bound traffic which span Whitcomb Bayou. The bridge is approximately 360 feet long and has a total of ten spans including nine concrete approach spans and a steel single-leaf rolling-lift bascule span over the main navigation channel. It is constructed on driven concrete piles with concrete bent caps supporting concrete I beams with a cast in place concrete bridge deck. Asphalt pavement has been placed over the concrete decking. Major repairs were performed on the bridge in 1979, 1998 and in 2011. There is a small bridge tender house on the north side of the bridge. The tender house is constructed of concrete and galvanized steel beams and columns with a metal roof. Walls are open chain link and aluminum framed Plexiglas. No interior finishes were observed in the tender house.

View of bridge tender house
