Beckett Bridge

Project Development & Environment (PD&E) Study

from Chesapeake Drive to Forest Avenue
Tarpon Springs, Pinellas County, FL

Geotechnical Technical Memorandum

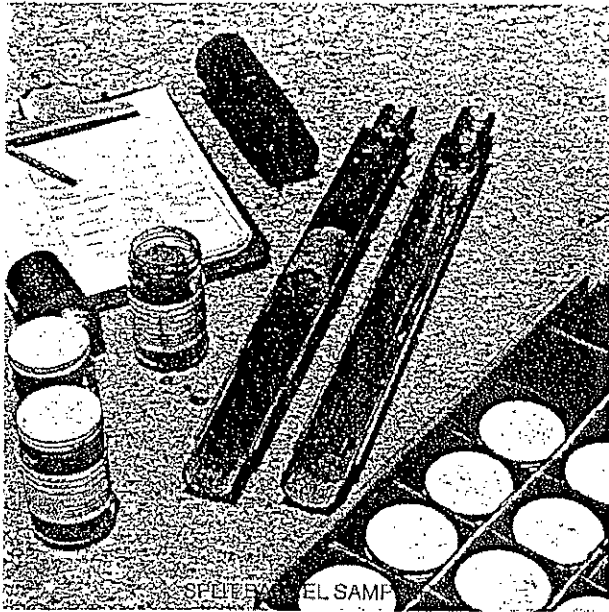
SPLIT BARREL SAMPLER

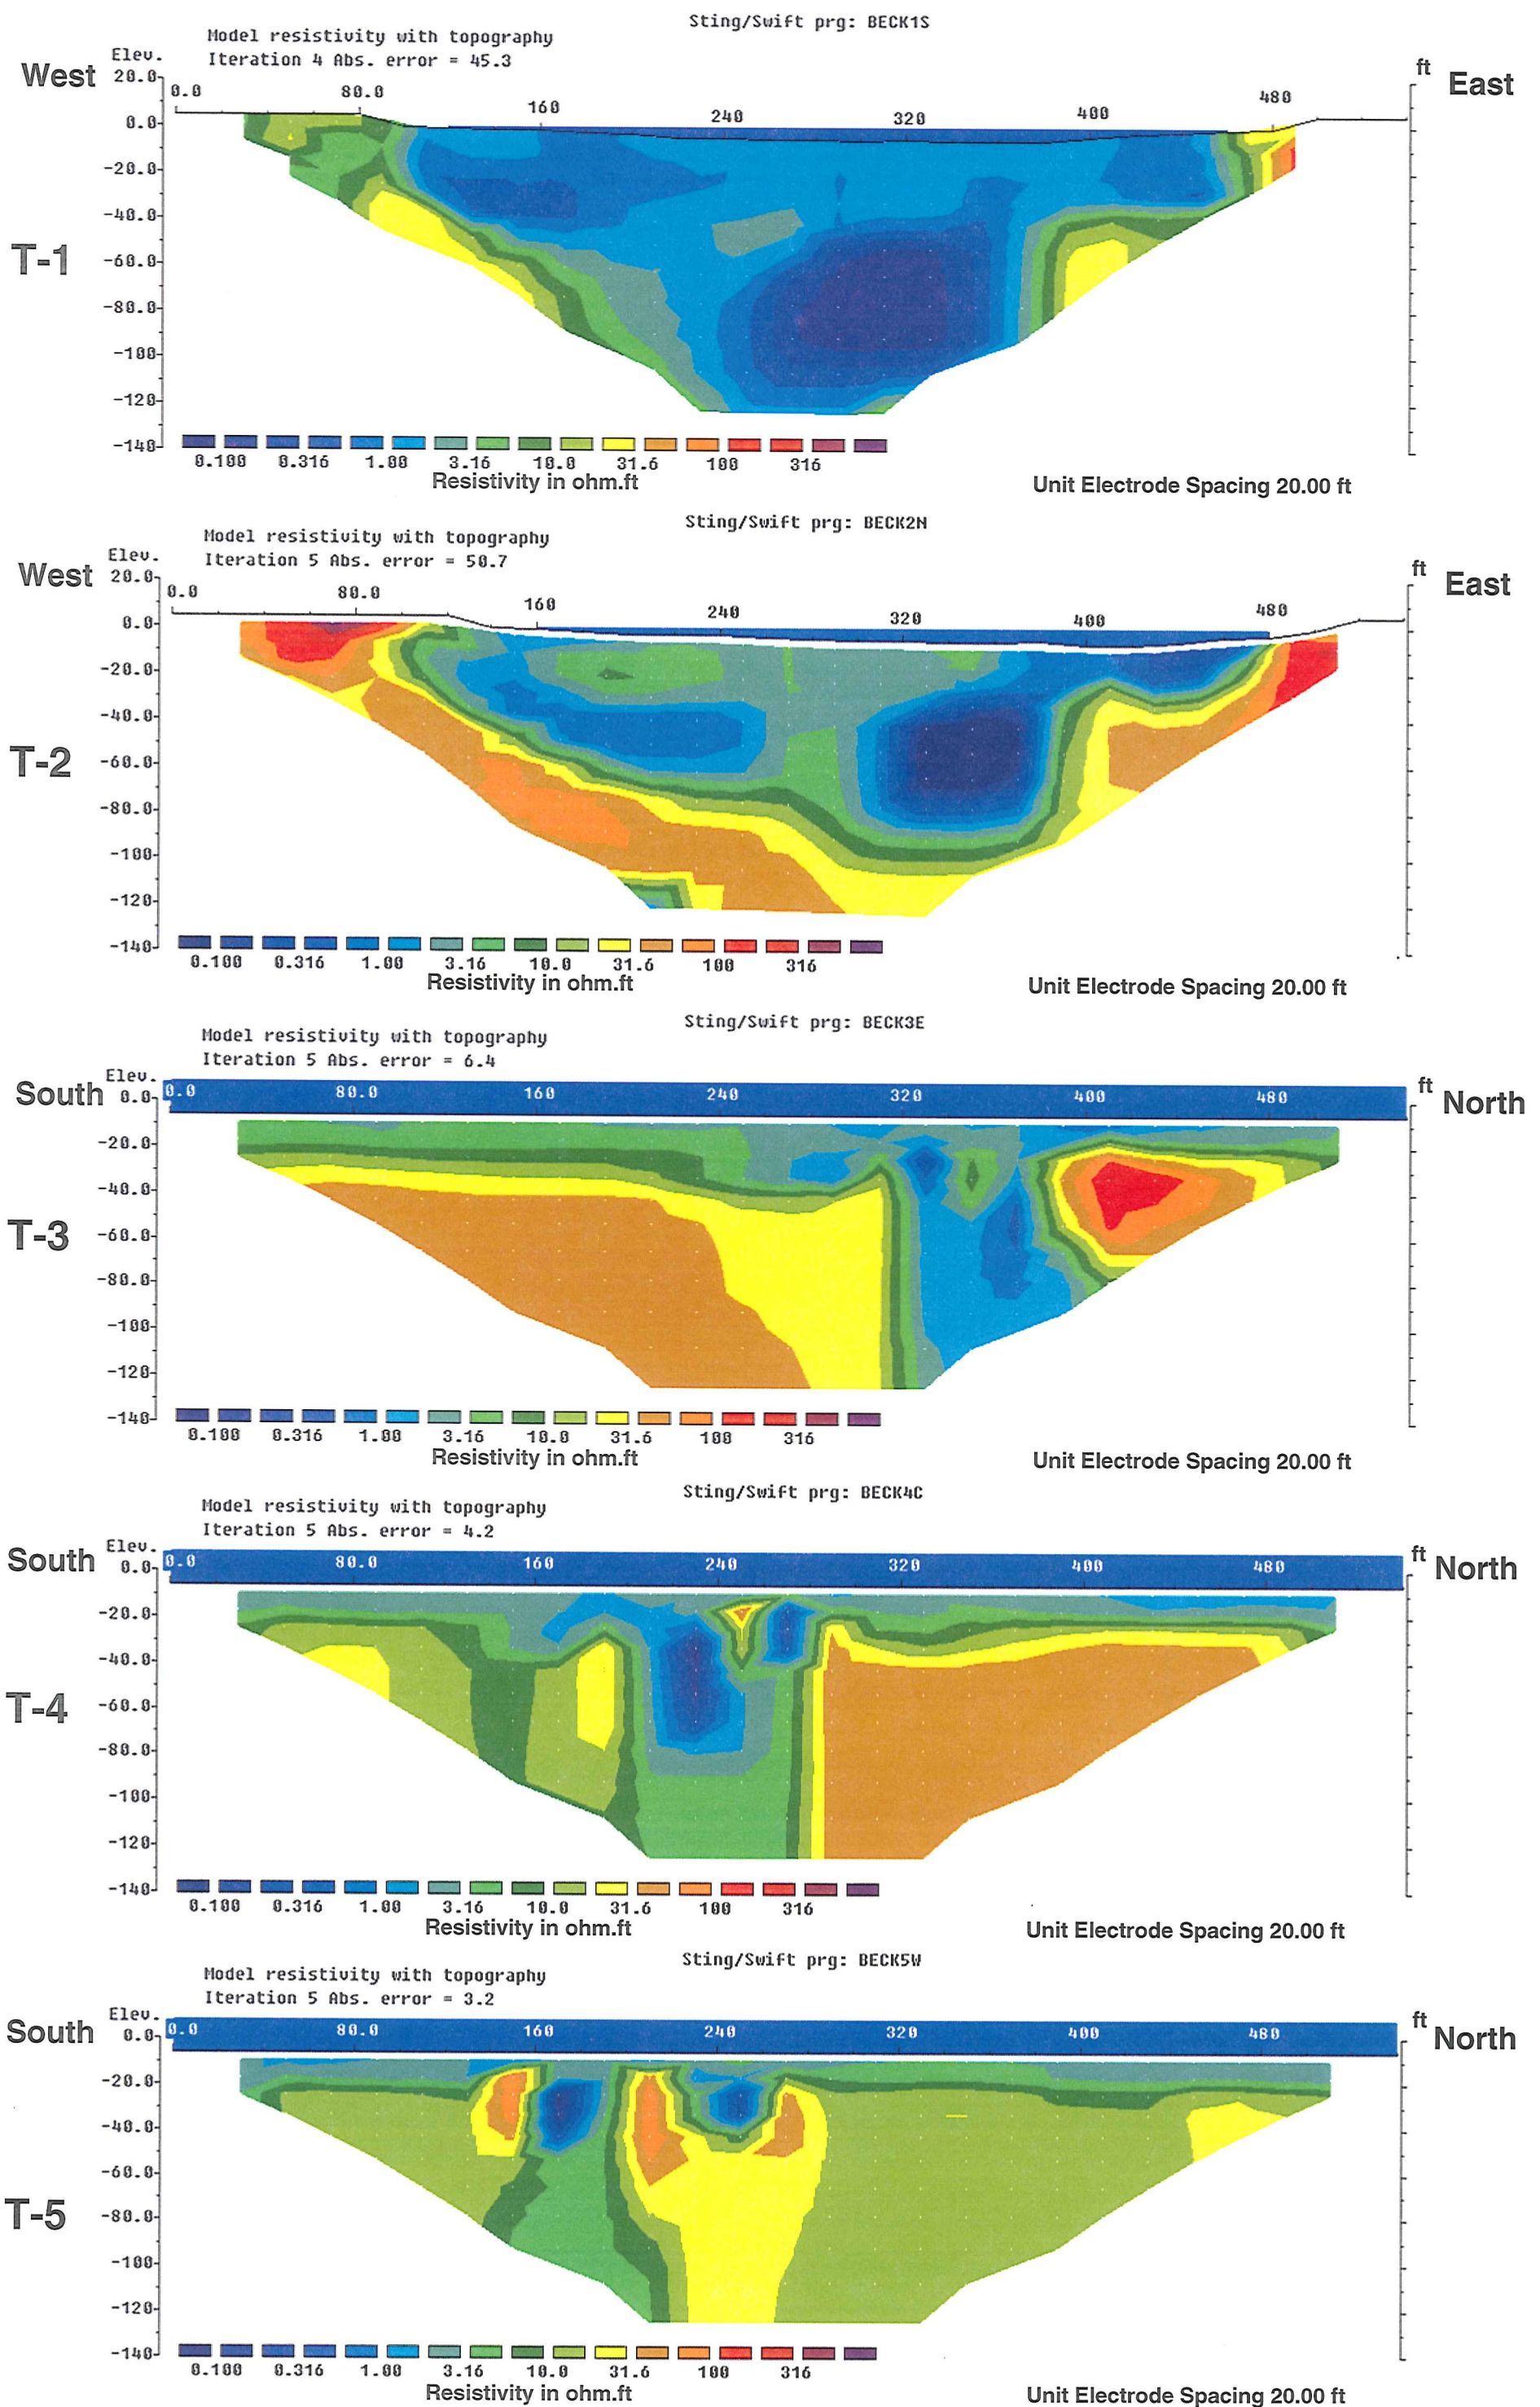
**Fig 2: Electrical Resistivity Imaging Pseudosections T1-T5
Beckett Bridge, Tarpon Springs, Florida**

During the 2009 study, Electrical Resistivity Imaging (ERI) was conducted. The purpose of the ERI testing was to determine the vertical extent and lateral continuity of soil layers and to identify possible karst hazards within the river along the sides of the bridge. The ERI testing was performed by “Subsurface Evaluations, Inc.” (SEI) and their report, dated April 28, 2009, is included in Appendix B.
