Branch Forbes Road South of US 92 to North of I-4 Project Development & Environment (PD&E) Study

Cultural Resource Assessment Survey

Work Program Item Segment No. 447159-1 Federal Project No. D721 009 B ETDM Project No. 14470 Hillsborough County, Florida

Florida Department of Transportation District 7

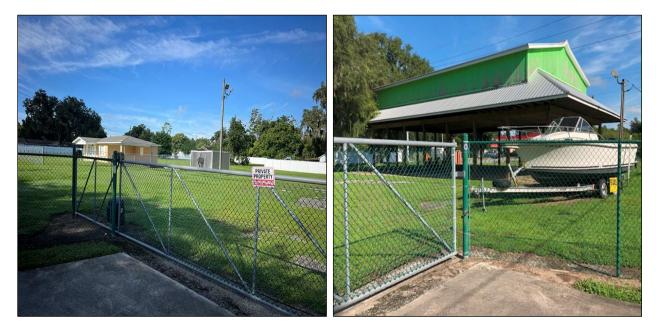
Figure 9. Existing conditions within Pond SMF 3C. Left: environmental overview of the pond area, view southwest. Right: environmental overview of the pond area, view northwest.

not possible due to lack of parcel access. If Pond SMF 3C is selected for construction, archaeological survey, including shovel testing, is recommended.

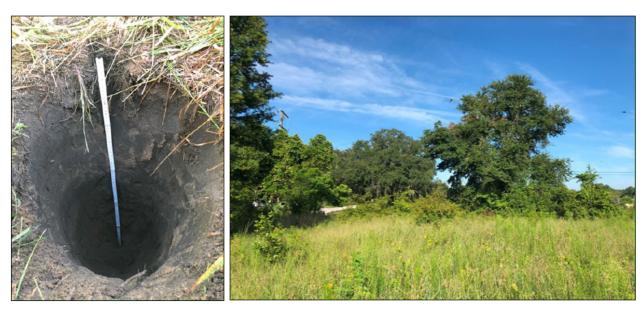
Figure 10. Existing conditions within Pond SMF 7B. Left: typical soil profile within the pond area. Right: environmental overview within Pond SMF 7B, view west.
