**Gibsonton Drive
From Fern Hill Drive to US 301
Project Development & Environment (PD&E) Study**

***Cultural Resource Assessment Survey,
Gibsonton Drive from Fern Hill Drive to US 301 PD&E Study,
Hillsborough County, Florida***

Work Program Item Segment No. 450438-1
ETDM Project No. 14493
Hillsborough County, Florida

PaleoWest, Technical Report Number 23-492

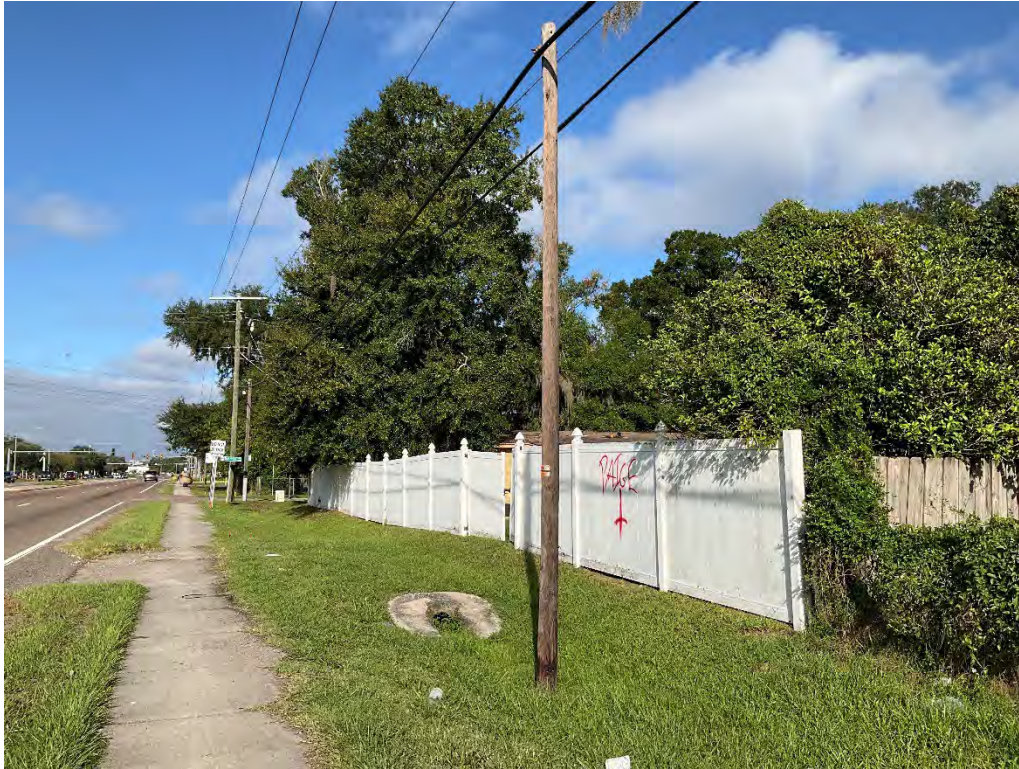
Figure 4. Overview of the APE at STP 28 facing west showing adjacent residential properties. Note visible and marked subsurface and overhead utilities.

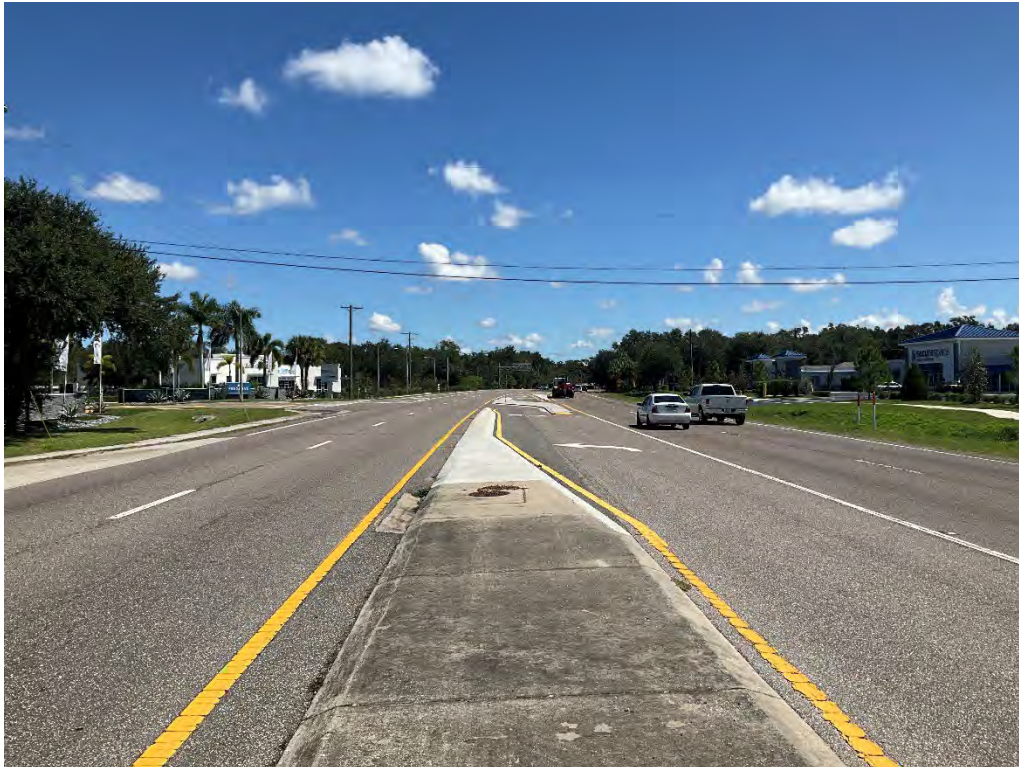
Figure 5. Overview from the western end of the APE facing northeast along Gibsonton Drive.

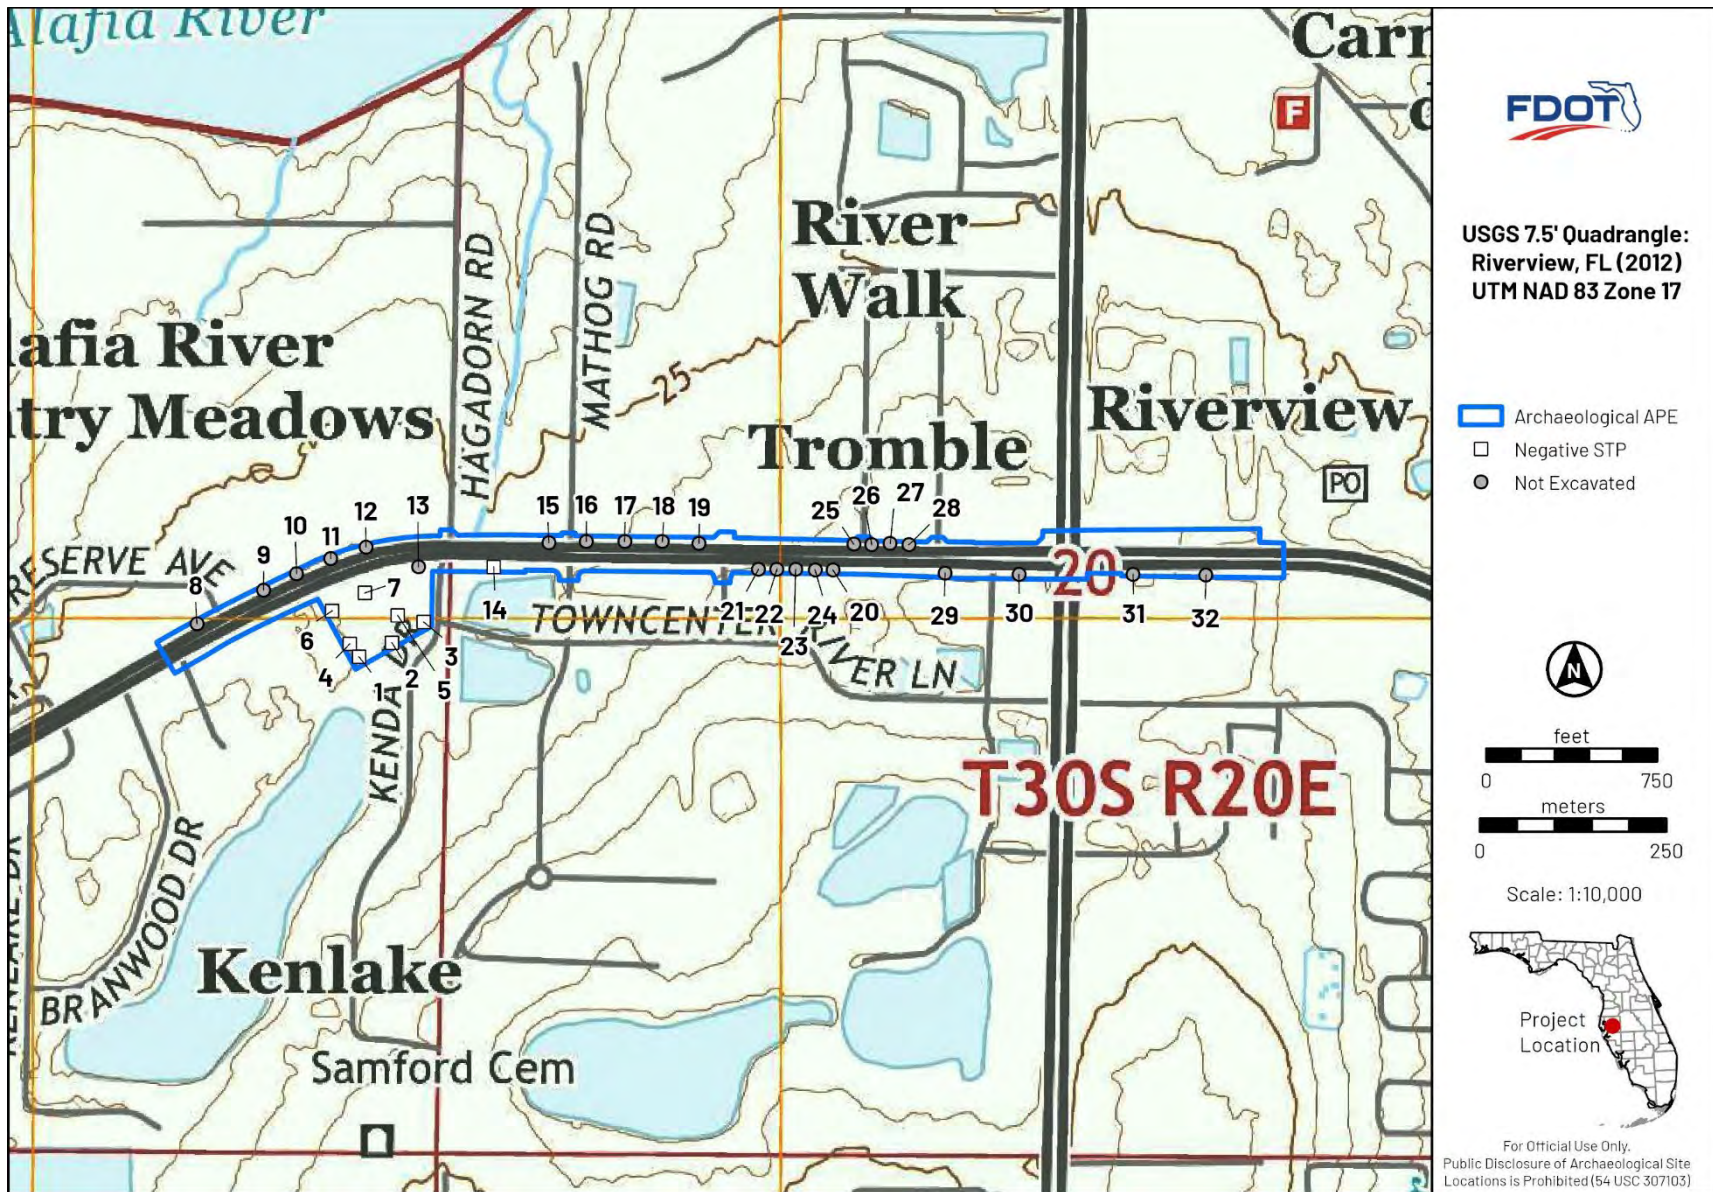
Figure 17. Results of the survey of the archaeological APE shown on the Riverview, Florida 7.5-minute topographic quadrangle (USGS 2012).

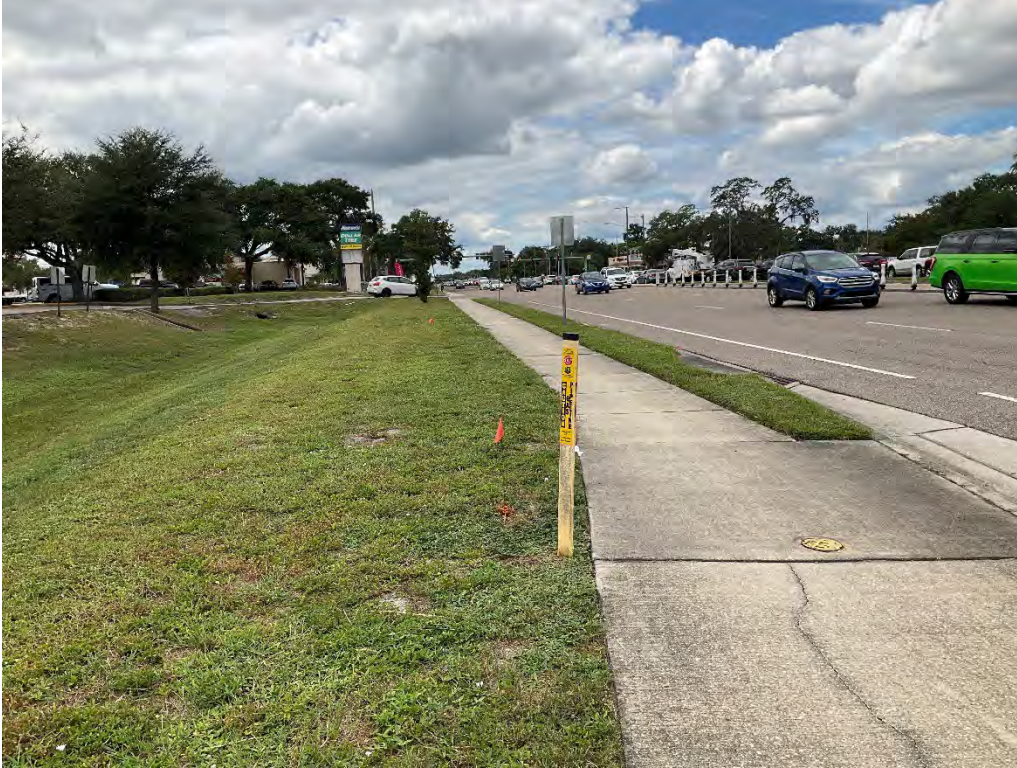
Figure 18. Overview of the eastern end of the APE at STP 32 facing west showing commercial properties marked subsurface utilities that prevented STP excavation.

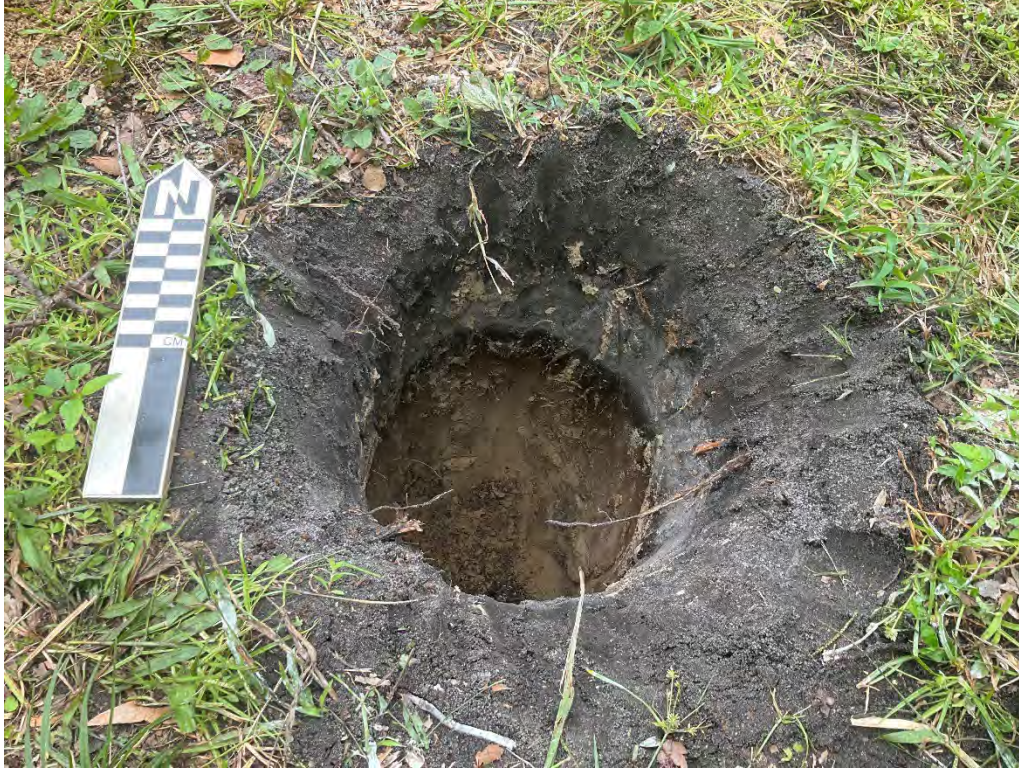
Figure 20. Detail of the soil profile observed in STP 5.

The proposed pond location is a residential area bordered by commercial properties. Vegetation in this area consists of scattered hardwoods with an understory of some natural vegetation and cultivated landscape plants (Figure 19). Seven of the 8 pre-plotted STPs within the pond were safely excavated to an average depth of 73 cmbs. The typical soil profile within the proposed pond consisted of dark gray (10YR 4/1) sand from 0-15 cmbs, light gray (10YR 7/1) sand from 15-40 cmbs, brown (10YR 4/3) sand from 40-50 cmbs, and light yellowish brown (10YR 6/4) sand from 50-100 cmbs (Figure 20).

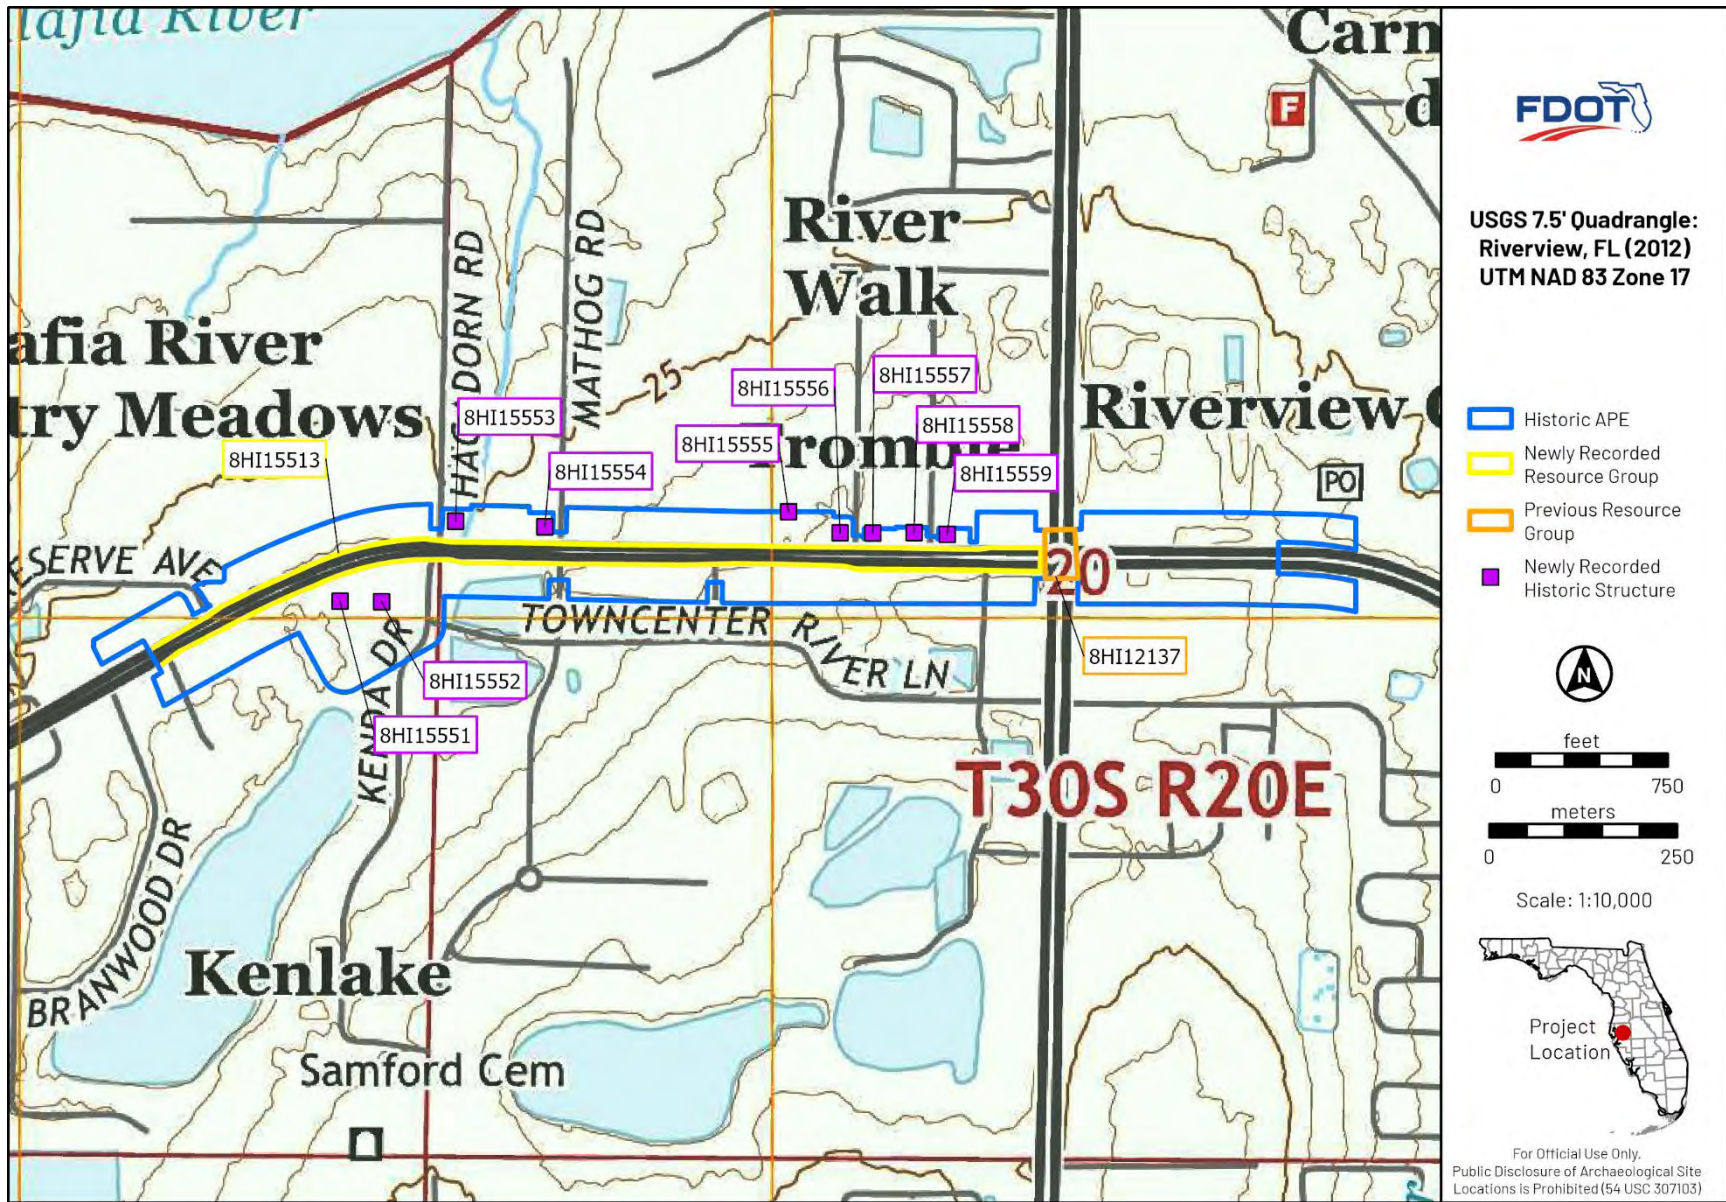
Figure 22. Results of the survey of the historic APE shown on the Riverview, Florida 7.5-minute topographic quadrangle (USGS 2012).

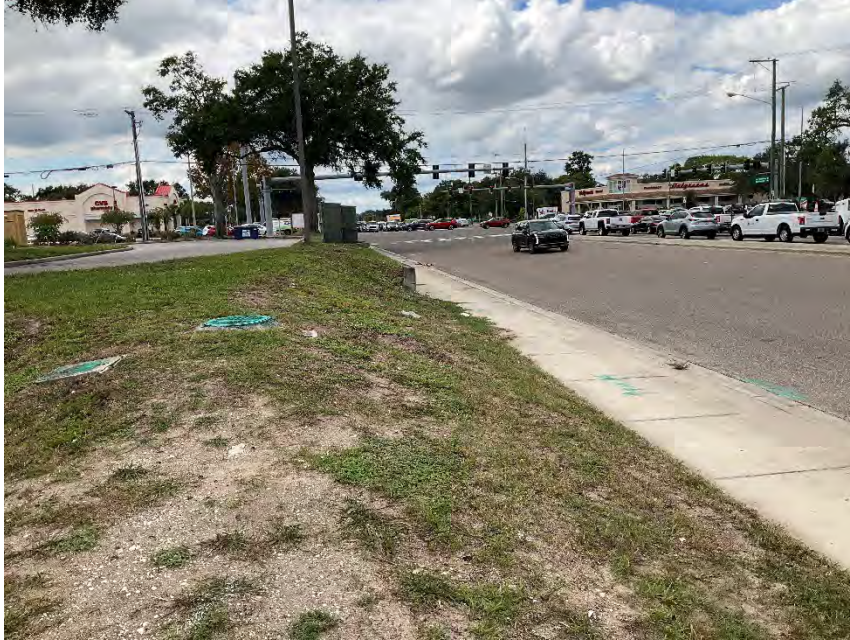
Resource Description: 8HI12137 (US 301) is a previously recorded approximately 211-ft (64-m) segment of a linear resource in Hillsborough County, also known as US 41 and SR 43. Within the APE, the roadway is paved and oriented north–south with a six-lane typical section divided by medians and bounded by sidewalks, multi-use trails, a grassy shoulder, and overhead utilities (Figure 23). The roadway has sustained routine maintenance activities so as to remain viable for use.

Figure 23. Photograph of 8HI12137- 1, at Gibsonton Drive intersection, facing southwest.

Recommendation: 8HI12137 within the APE was recently recorded and the SHPO determined there was insufficient information to evaluate the resource for listing in the NRHP (PaleoWest 2023; FDHR 2023-04183). As the resource cannot be fully documented outside of the APE, the District maintains that there is **insufficient information to evaluate 8HI12137 for listing in the NRHP**. 8HI12137 does not appear eligible under Criteria A or B, as no significant historical associations are known; however, more research would be required to determine any associations. Additionally, it does not appear eligible under Criterion C, as the resource is not an exemplary or unique sample of its style, design or construction methods, the roadway no longer retains historic materials, and it has been widened from two to six lanes. 8HI12137 does not appear eligible under Criterion D, as it does not possess the potential to provide further information of historical importance. Proposed project activities within the boundary of 8HI12137 include widening to accommodate additional through and right-turn lanes, construction of traffic islands and concrete curb and gutter and sidewalks, and providing additional bicycle and pedestrian facilities. The road has been previously widened and modernized. These activities will not alter the character-defining qualities that may qualify this linear resource for inclusion in the NRHP. As such, the District recommends the proposed undertaking will have **no adverse effect** on 8HI12137, and **no additional investigation** within the APE is necessary.

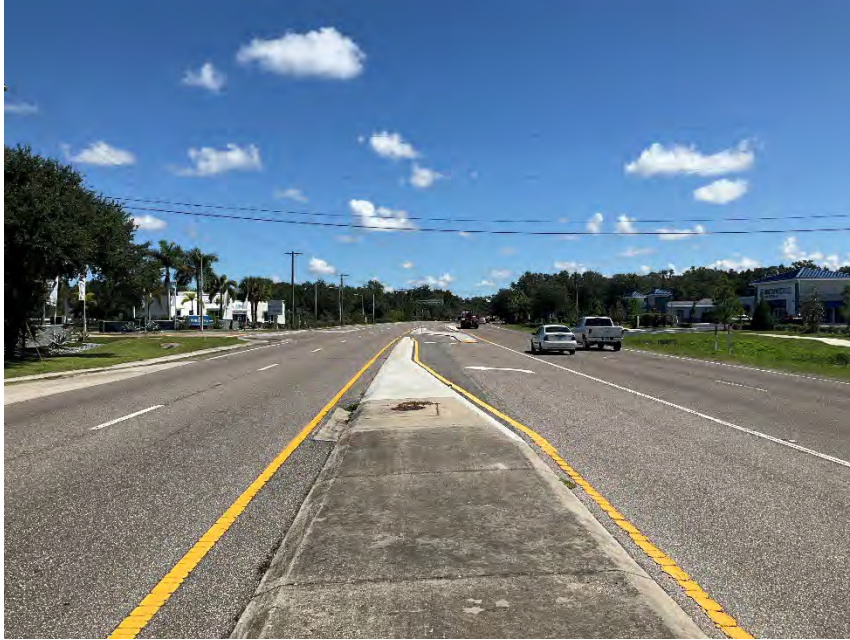
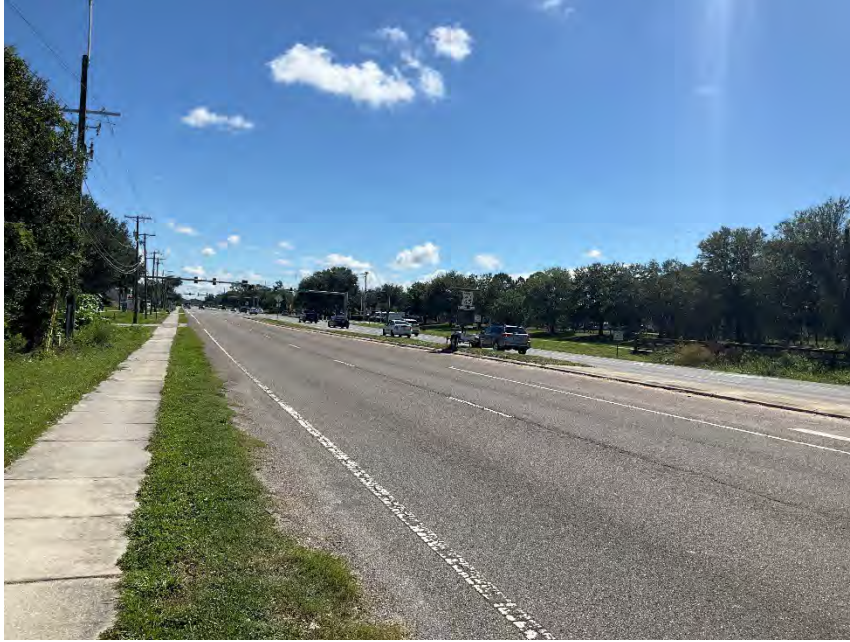
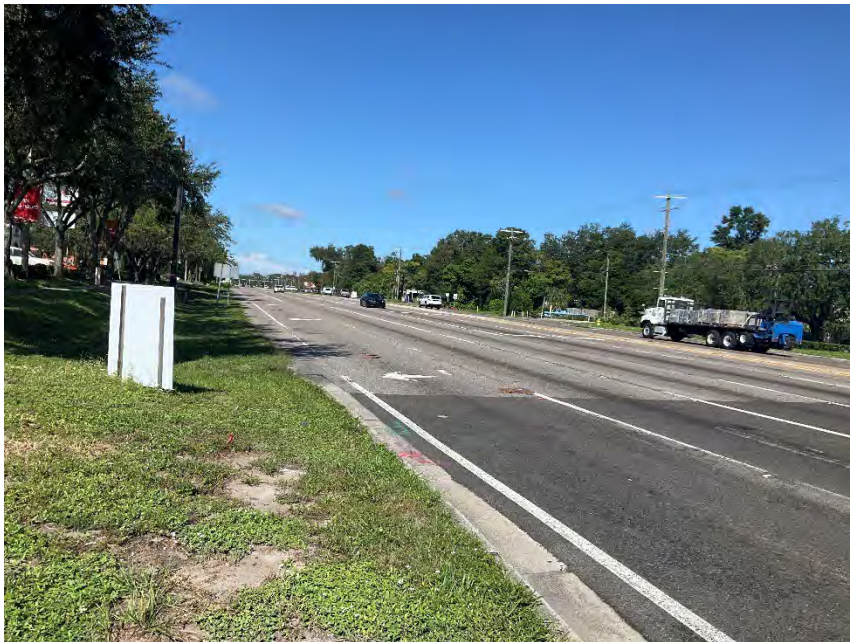
concrete medians with modern intersections and intermittent turn lanes and bounded by buffered sidewalks and overhead utilities (Figure 24–Figure 26).

Figure 24. Photograph of 8HI15513- 1, at Water Works Lane, facing northeast.

Figure 25. Photograph of 8HI15513- 2, towards Mathog Road, facing east.

Figure 26. Photograph of 8HI15513- 3, from US 301, facing west.

Recommendation: Because the resource extends beyond the APE, the District possesses **insufficient information to evaluate 8HI15513 for listing in the NRHP**. 8HI15513 does not appear eligible under Criteria A or B, as no significant historical associations are known; however, more research would be required to determine any associations. Additionally, it is does not appear eligible under Criterion C, as the resource is not an exemplary or unique sample of its style, design or construction methods, the roadway no longer retains is historic materials, and has been widened from two to four lanes. 8HI15513 does not appear eligible under Criterion D, as it does not possess the potential to provide further information of historical importance, the roadway no longer retains is historic materials, and has been widened from two

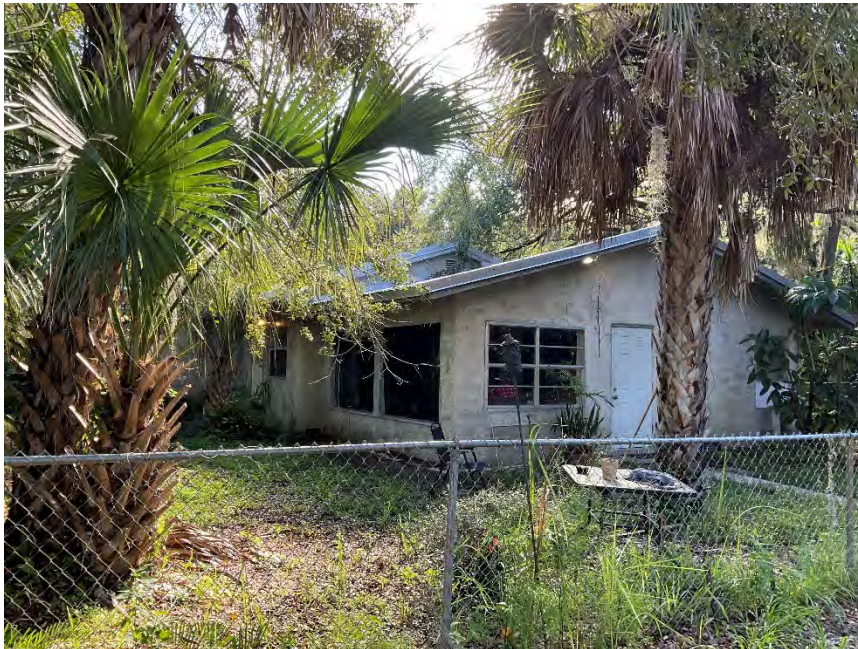
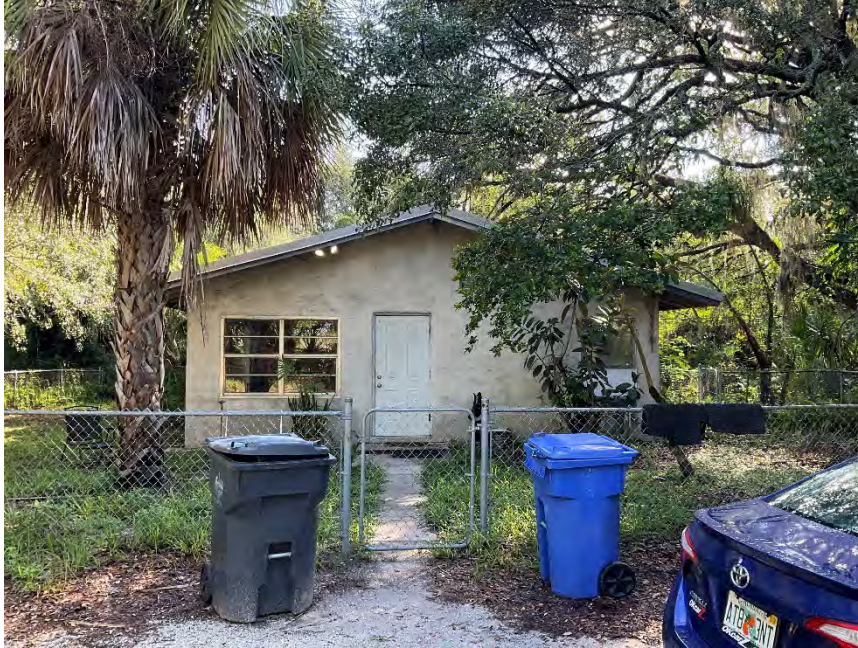
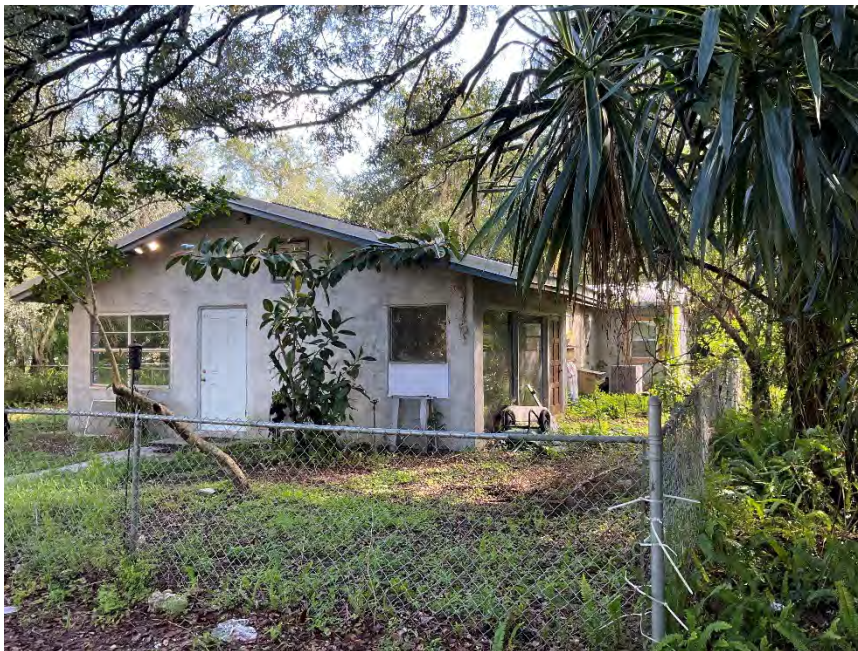
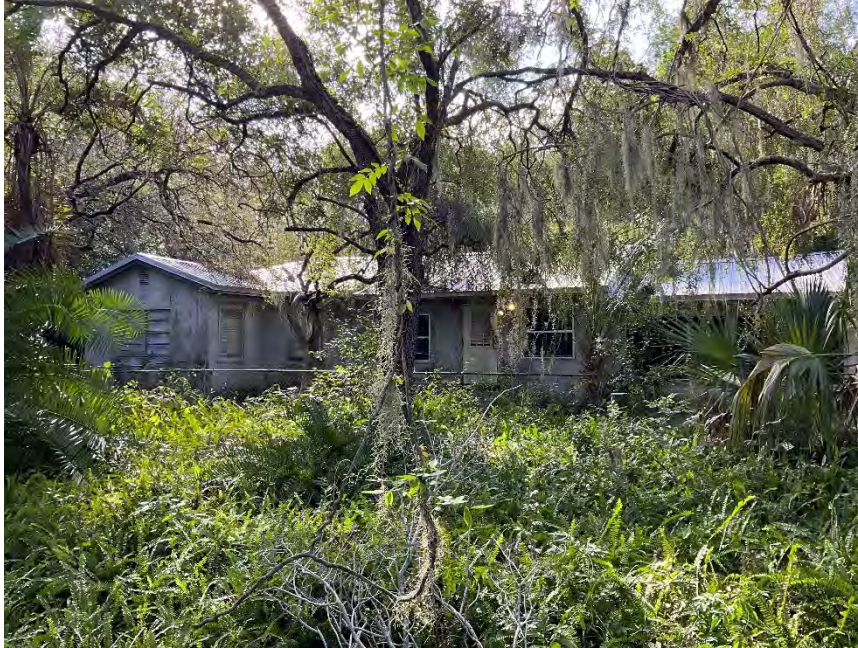
Figure 27. Photograph of 8HI15551–1, facing southeast.

Figure 28. Photograph of 8HI15551-2, facing east.

Figure 29. Photograph of 8HI15551-3, facing northeast.

Figure 30. Photograph of 8HI15551-4, facing south.

Resource Description: 8HI15551 (10119 Gibsonton Drive) is a newly recorded historic structure with Masonry Vernacular style. Built in 1956, 8HI15551 is a one-story, rectangular-shaped plan residence set on a concrete slab foundation. The side-gable roof is clad in 5V crimp metal, and the walls are clad in stucco. The main entry is on the west façade through a hollow core panel door. Fenestration includes individual and paired metal-framed single-hung-sash windows with a two-over-two configuration and paired metal-framed picture windows. Distinguishing features include attic vents in the gable ends and additional entrances on the north and south elevations. Select windows have been replaced and others are obscured by hurricane shutters. The siding does not appear to be original. A chain link fence encloses the overgrown parcel. A concrete sidewalk leads to the entryway (Figure 27–Figure 30).

Eligibility Recommendation: The District recommends the resource is **ineligible for listing in the NRHP**. 8HI15551 is not eligible under Criterion A because it is not indicative of a particular era and is not associated with any significant period, event, or theme. The resource is not eligible under Criterion B because it lacks association with any person significant in history. The resource is not eligible under Criterion C due to its lack of architectural distinction and

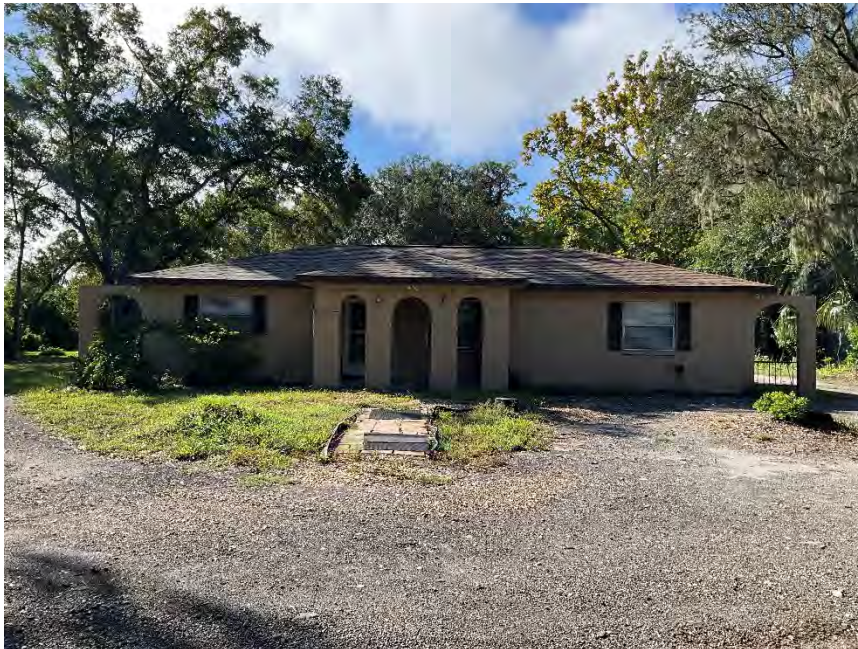
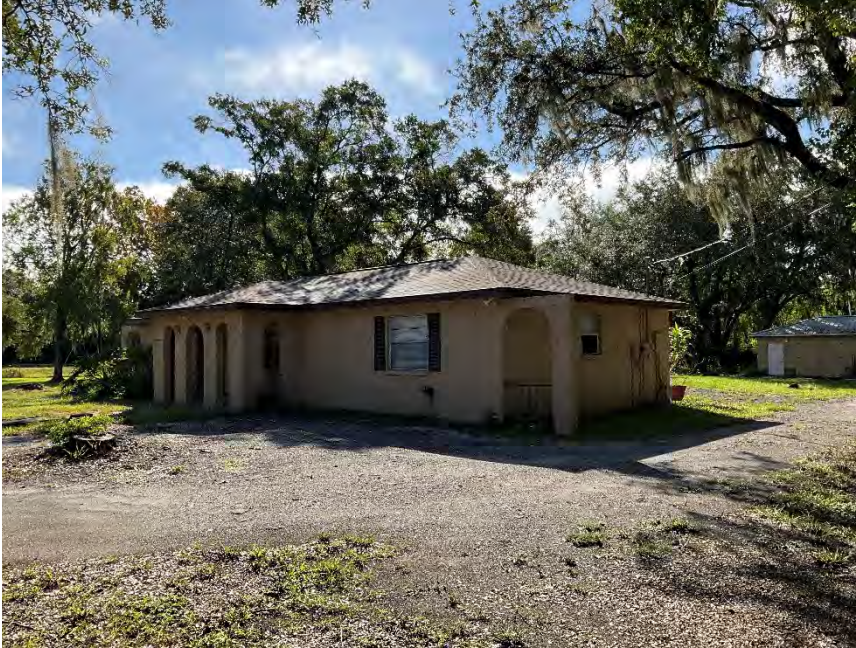
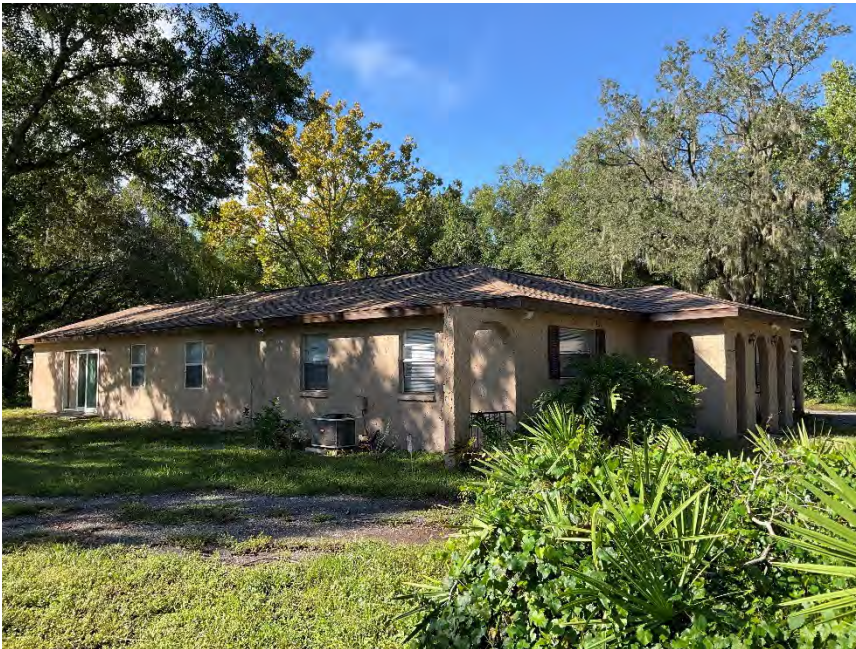
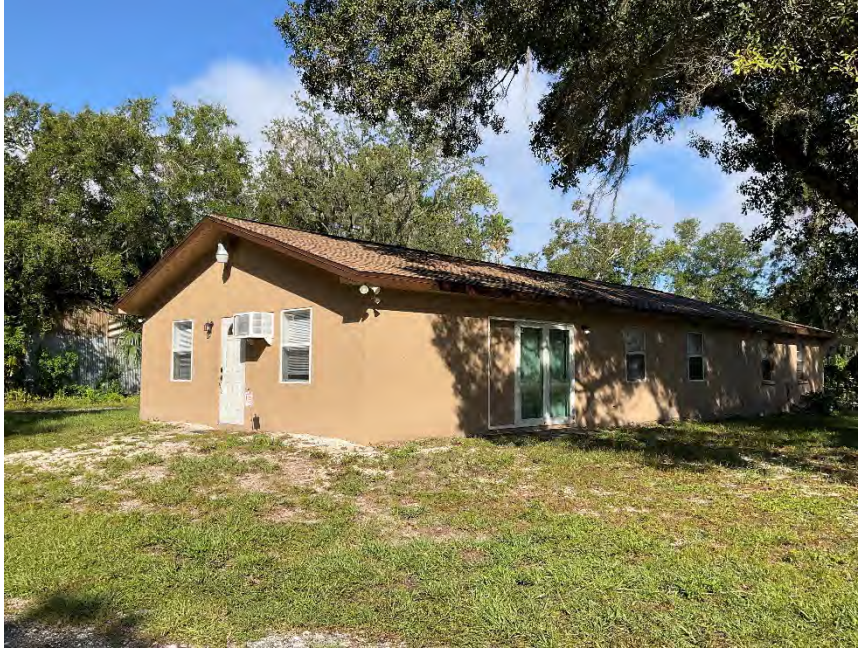
Resource Description: 8HI15552 (10209 Gibsonton Drive) is a newly recorded historic structure with Masonry Vernacular style. Built in 1979, 8HI15552 is a one-story, L-shaped plan residence set on a concrete slab foundation. The hip roof is clad in asphalt shingles, and the masonry walls are clad in stucco. The main entry is centrally located on the north façade through a door obscured by a glazed storm door and is within an attached partial width hip porch with an arcade. Fenestration includes individual metal-framed single-hung-sash windows with two-over-two and one-over-one configuration and individual vinyl-framed single-hung-sash windows with one-over-one configuration. Distinguishing features include inoperable shutters, a concrete block wall with an archway attached to the east and west elevations, turned eaves, and a rear entry on the south elevation. A gravel driveway is west of the building, and a concrete block outbuilding is south of the residence (Figure 32–Figure 35).

Figure 32. Photograph of 8HI15552–1, facing south.

Figure 33. Photograph of 8HI15552-2, facing southeast.

Figure 34. Photograph of 8HI15552-3, facing southwest.

Figure 35. Photograph of 8HI15552-4, facing northwest.

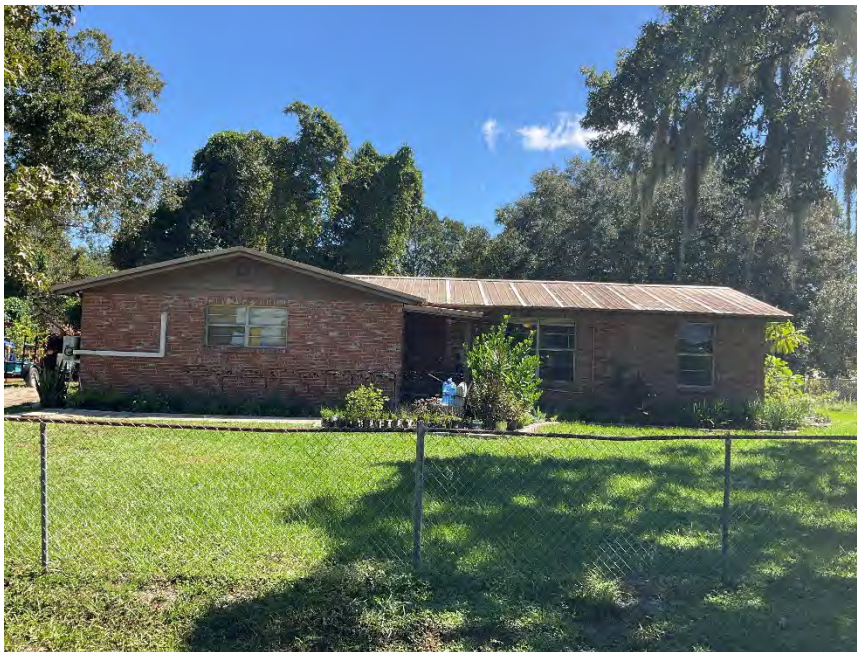
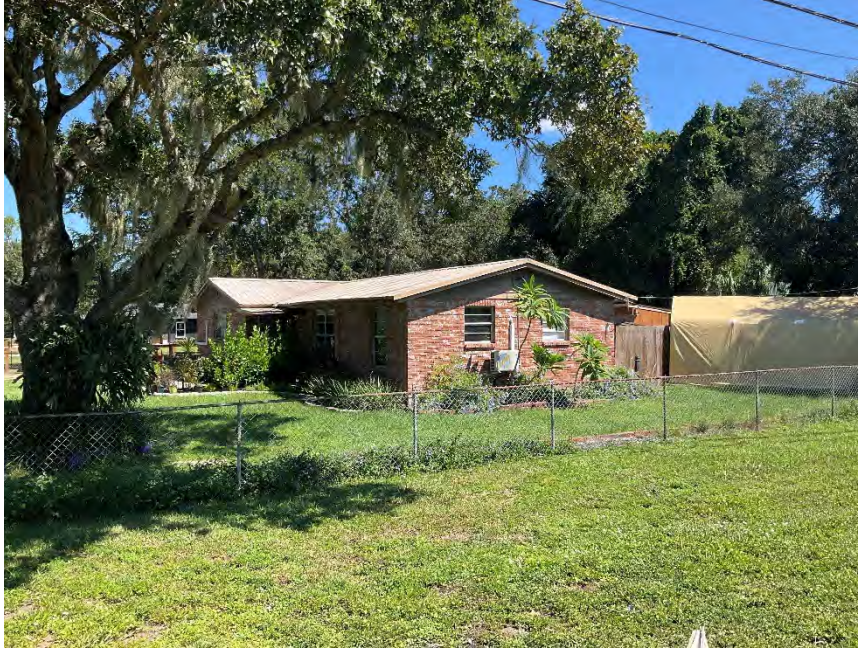
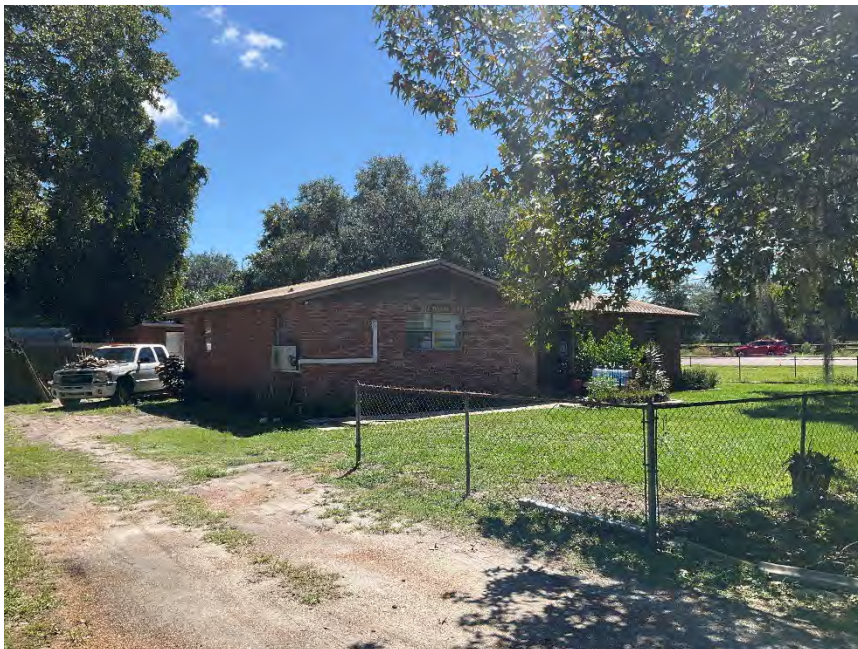
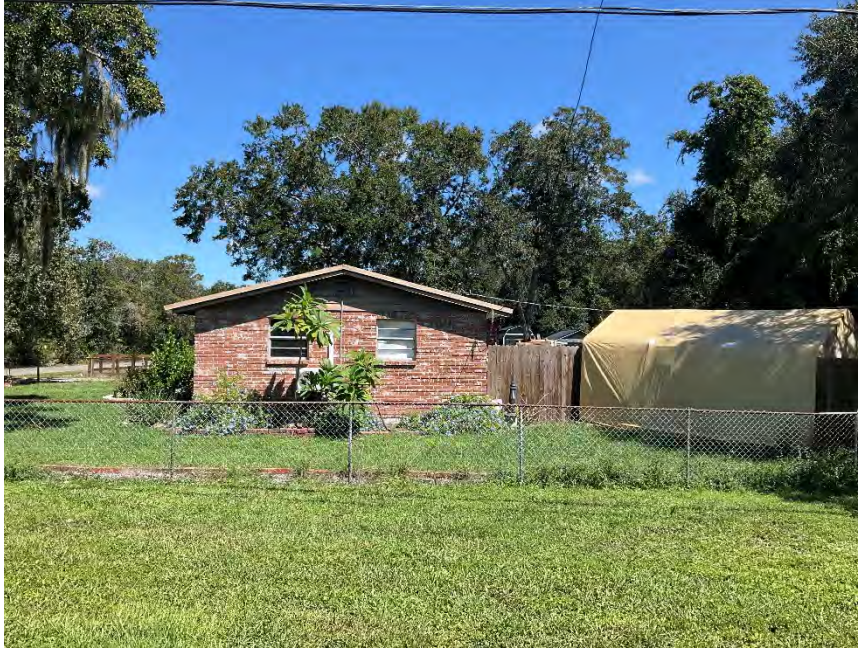
Resource Description: 8HI15553 (9622 Hagadorn Drive) is a newly recorded historic structure with Masonry Vernacular style. Built in 1976, 8HI15553 is a one-story, L-shaped plan residence set on a concrete slab foundation. The intersecting-gable roof is clad in 5V crimp metal, and the masonry walls are clad in brick veneer. The main entry is on the west façade through a hollow core panel door within an attached partial width shed porch supported by wood posts. Fenestration includes individual and paired metal-framed single-hung-sash windows with two-over-two configuration. Distinguishing features include wood siding in the gable ends and circular attic vents. A gravel driveway is north of the building, and a metal chain link fence encloses the lot (Figure 37–Figure 40).

Figure 37. Photograph of 8HI15553–1, facing east.

Figure 38. Photograph of 8HI15553-2, facing northeast.

Figure 39. Photograph of 8HI15553-3, facing southeast.

Figure 40. Photograph of 8HI15553-4, facing north.

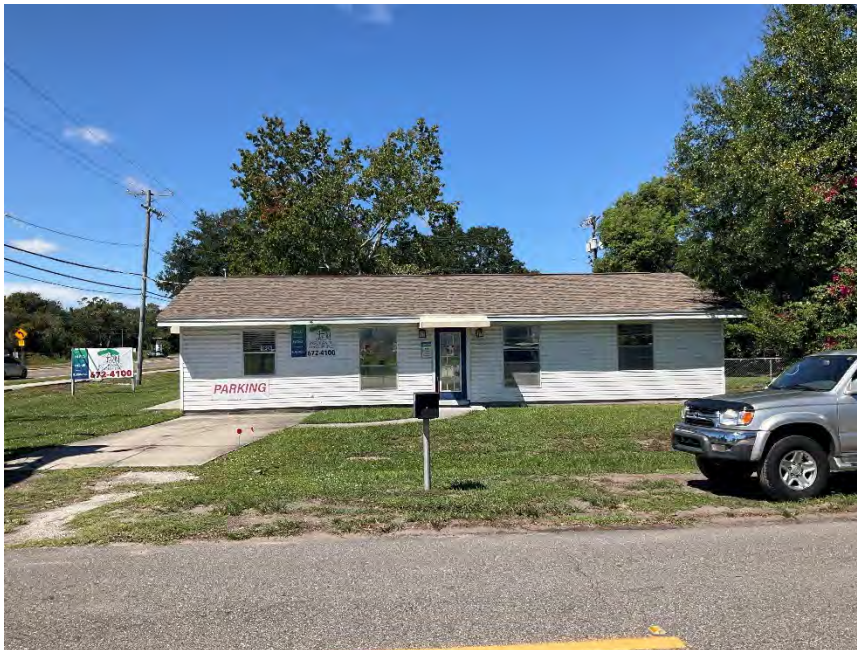
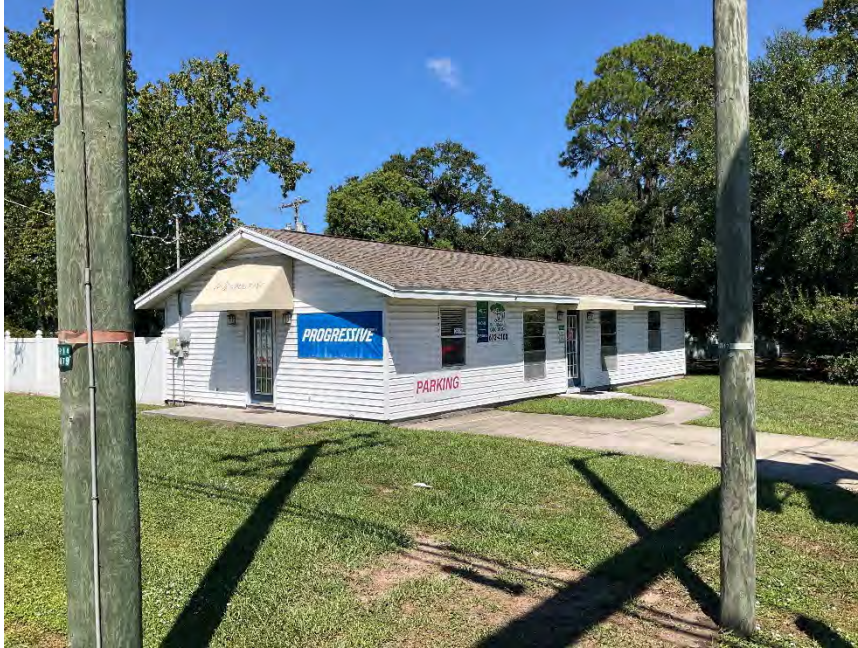
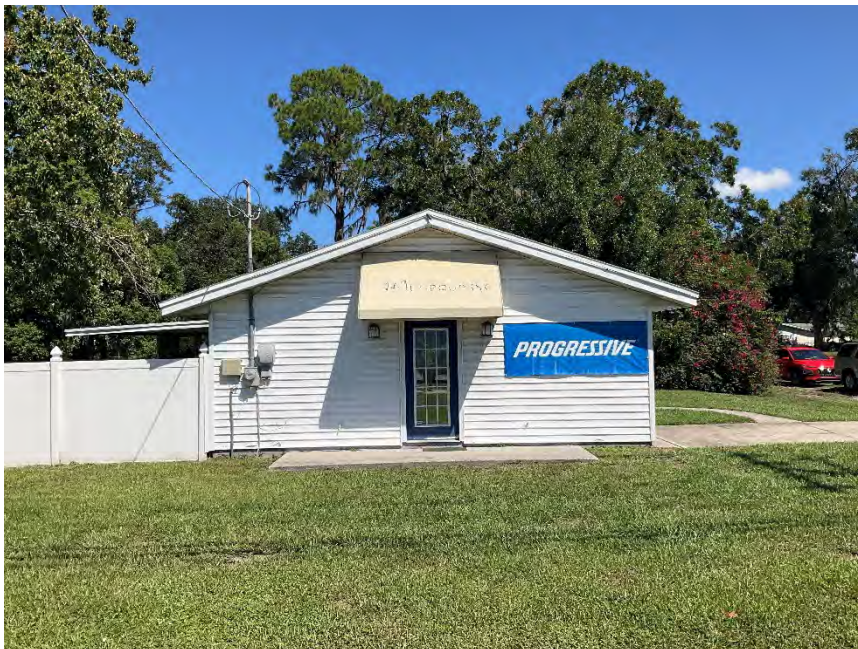
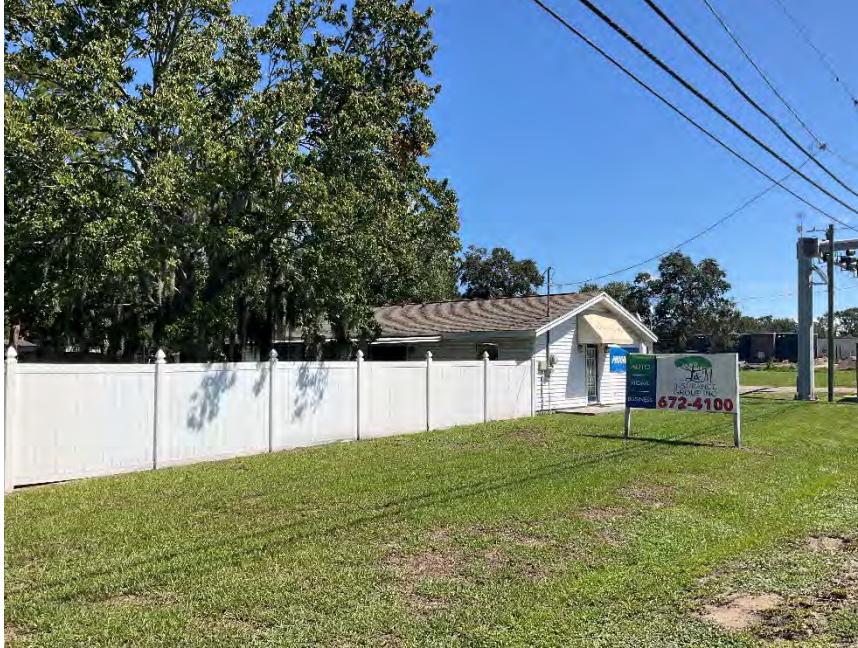
Resource Description: 8HI15554 (9623 Mathog Road) is a newly recorded historic structure with Frame Vernacular style. Built in 1975, 8HI15554 is a one-story, rectangular-shaped plan former residence (current office) set on a concrete slab foundation. The side-gable roof is clad in asphalt shingles, and the walls are clad in replacement vinyl siding. The main entry is on the east façade through a wood frame door with divided light. The main entry door is beneath a cloth awning. Fenestration includes individual metal-framed single-hung-sash windows with two-over-two configuration and individual vinyl-framed single-hung-sash windows with one-over-one configuration. Distinguishing features include an enclosed garage and an additional entry on the south elevation. A concrete driveway is east of the building, and a wood panel fence encloses a portion of the lot (Figure 42–Figure 45).

Figure 42. Photograph of 8HI15554–1, facing west.

Figure 43. Photograph of 8HI15554-2, facing northwest.

Figure 44. Photograph of 8HI15554-3, facing north.

Figure 45. Photograph of 8HI15554-4, facing northeast.

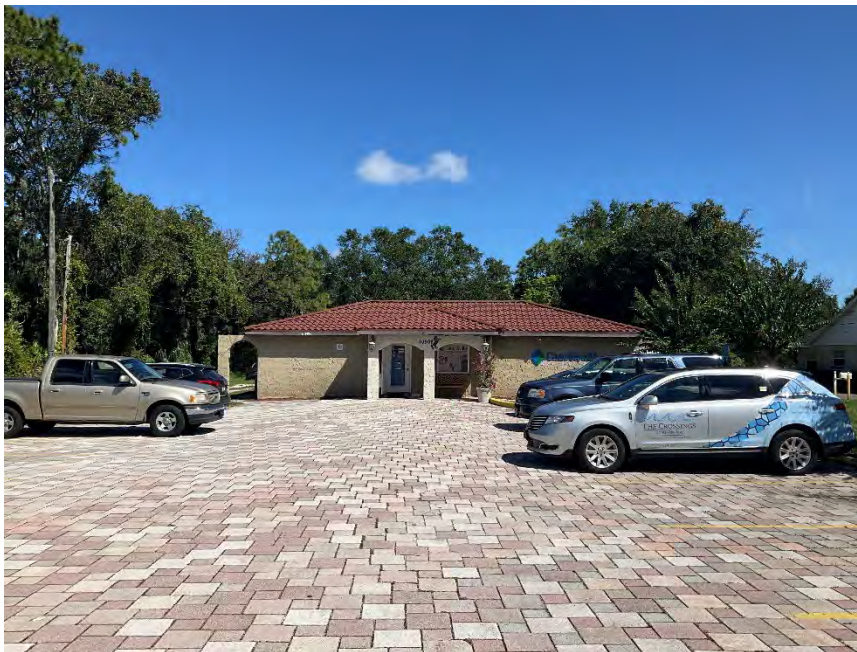
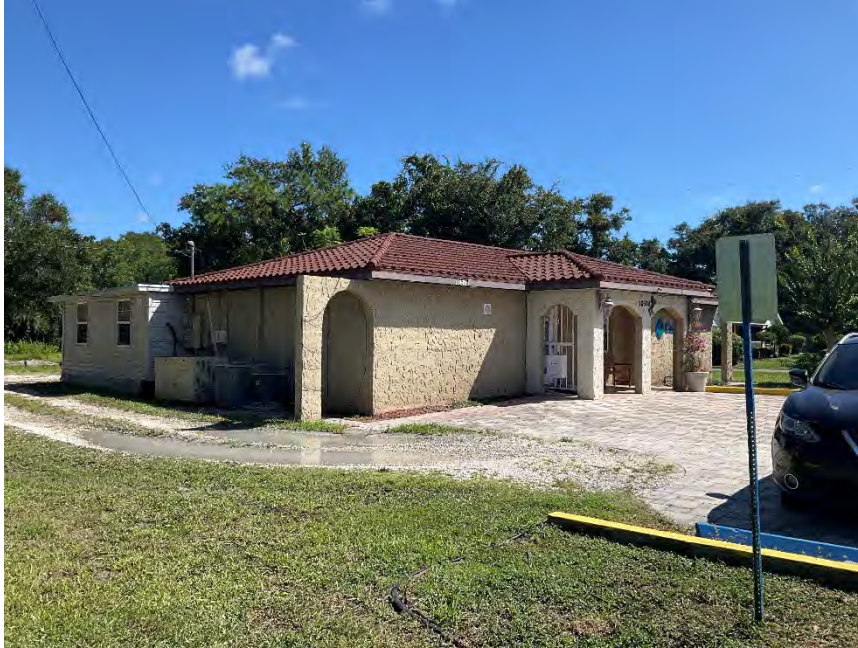
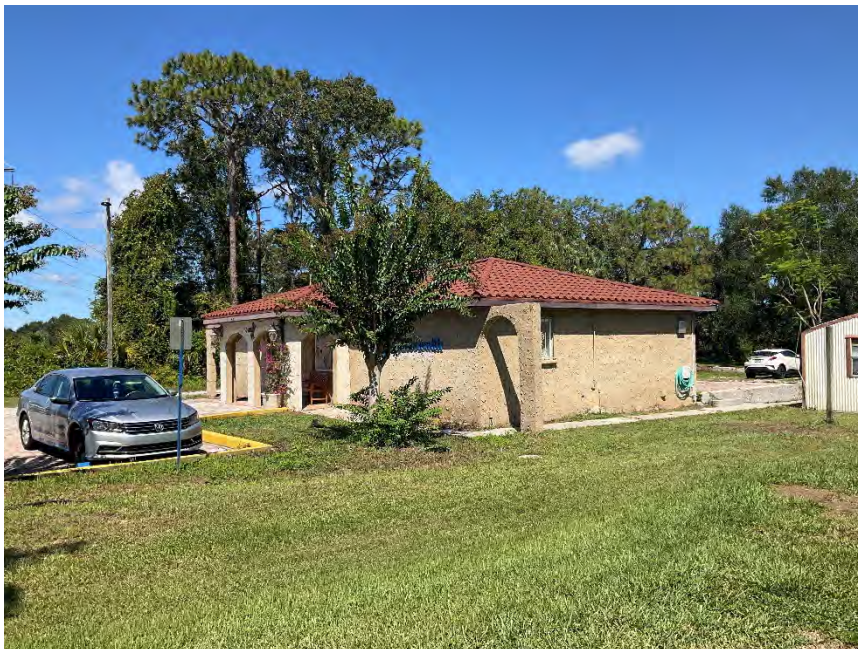
Resource Description: 8HI15555 (10508 Gibsonton Drive) is a newly recorded historic structure with Masonry Vernacular style. Built in 1979, 8HI15555 is a one-story, L-shaped plan former residence (current medical office) set on a concrete slab foundation. The hip roof is clad in clay barrel tiles, and the masonry walls are clad in stucco. The main entry is centrally located on the south façade through a wood frame door with a large light that is within an attached partial width hip porch with an arcade. Fenestration includes individual metal-framed fixed windows. Distinguishing features include a circa 2007 flat addition clad in vinyl on the north elevation and a concrete block wall with an archway attached to the east and west elevations. A brick paver driveway and parking area is south of the building (Figure 47–Figure 49).

Figure 47. Photograph of 8HI15555–1, facing north.

Figure 48. Photograph of 8HI15555-2, facing northeast.

Figure 49. Photograph of 8HI15555-3, facing northwest.
