**Gibsonton Drive
From Fern Hill Drive to US 301
Project Development & Environment (PD&E) Study**

***Cultural Resource Assessment Survey,
Gibsonton Drive from Fern Hill Drive to US 301 PD&E Study,
Hillsborough County, Florida***

Work Program Item Segment No. 450438-1
ETDM Project No. 14493
Hillsborough County, Florida

PaleoWest, Technical Report Number 23-492

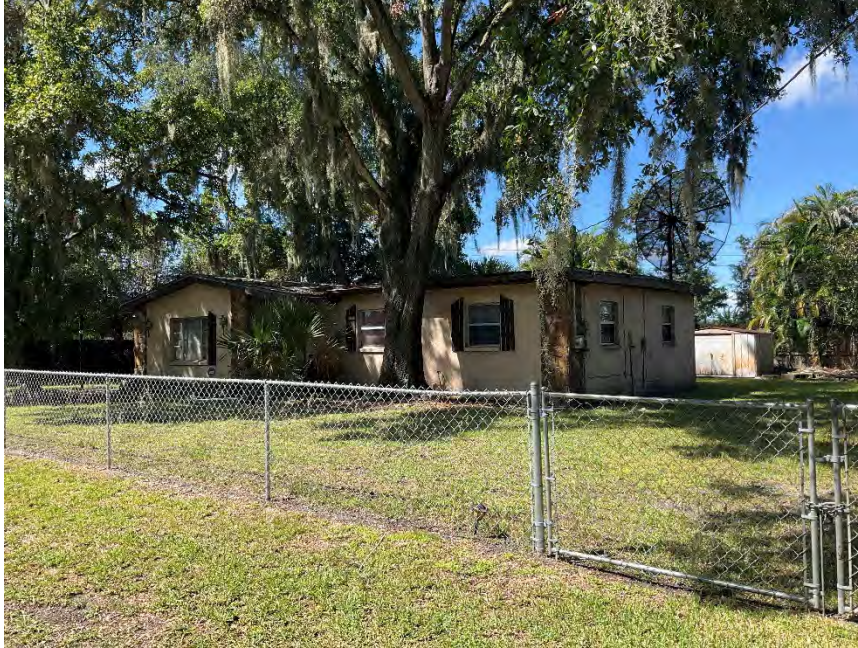
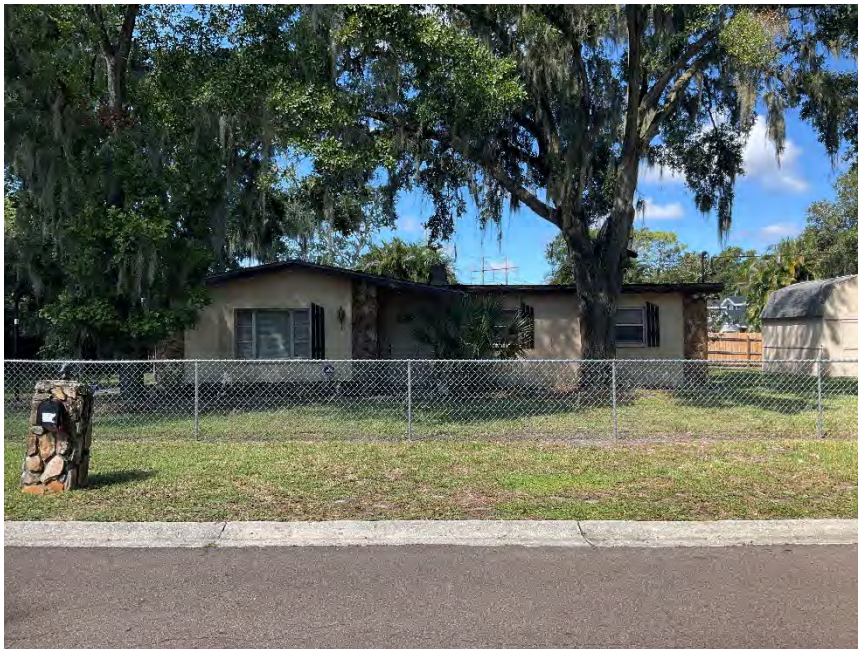
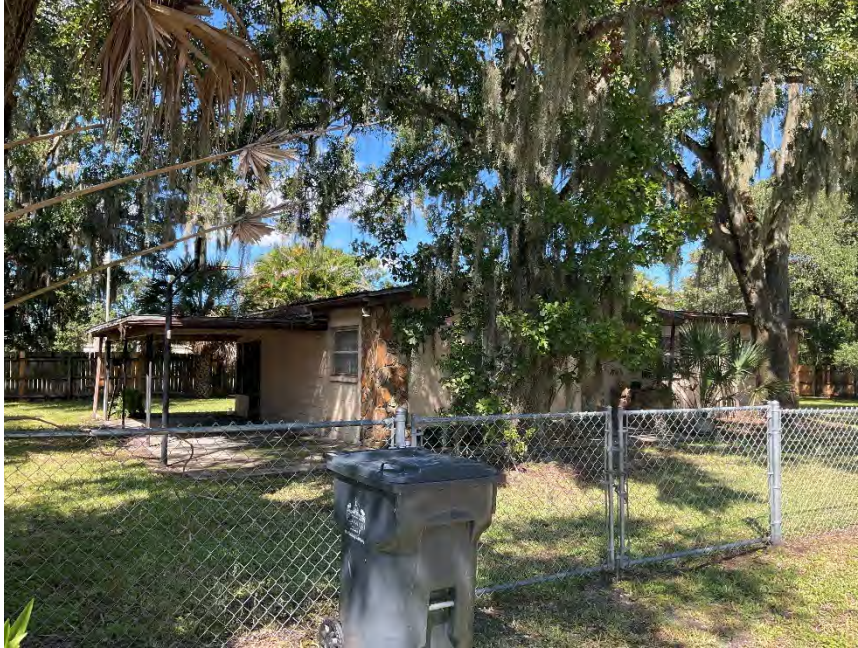
Resource Description: 8HI15556 (9617 Oak Ridge Avenue) is a newly recorded historic structure with Masonry Vernacular style. Built in 1962, 8HI15556 is a one-story, irregular-shaped plan residence set on a concrete slab foundation. The intersecting-gable roof is clad in asphalt shingles, and the masonry walls are clad in stucco. The main entry is on the east façade through a hollow core panel door with a divided fanlight that is within an incised partial width shed porch supported by wood posts. Fenestration includes individual vinyl-framed single-hung-sash windows with one-over-one configuration and a metal-framed tripartite window. Distinguishing features include inoperable shutters, stone veneer accents on corners, and an interior masonry chimney. An open carport is attached to the south elevation. A metal chain link fence encloses the lot (Figure 51–Figure 53).

Figure 51. Photograph of 8HI15556-1, facing southwest.

Figure 52. Photograph of 8HI15556-2, facing west.

Figure 53. Photograph of 8HI15556-3, facing northwest.

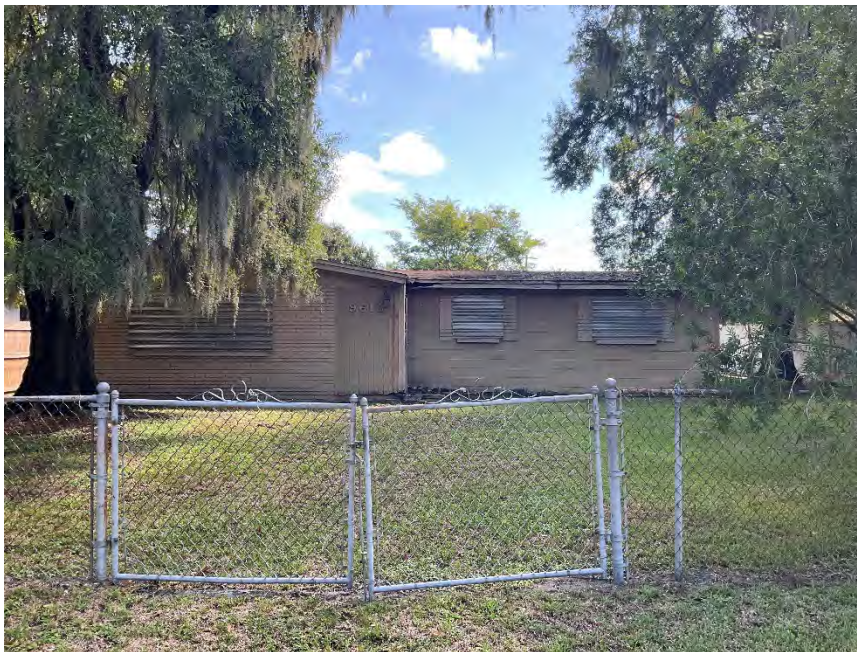
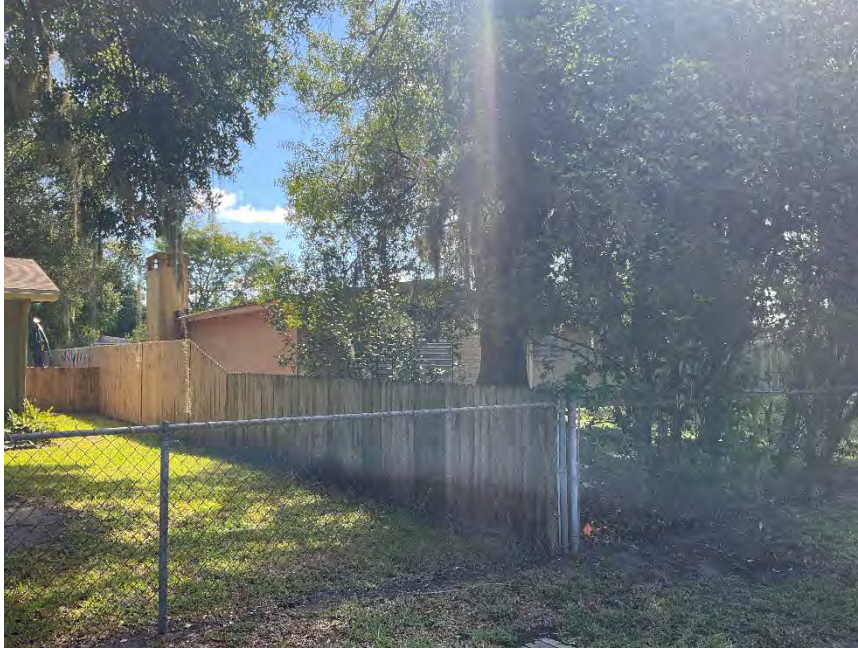
Resource Description: 8HI15557 (9618 Oak Ridge Avenue) is a newly recorded historic structure with Masonry Vernacular style. Built in 1962, 8HI15557 is a one-story, irregular-shaped plan residence set on a concrete slab foundation. The intersecting-gable roof is clad in asphalt shingles, and the masonry walls are clad in brick veneer and board and vertical wood siding. The main entry is on the west façade within an incised partial width shed porch supported by wood posts. The main entry door is obscured from the ROW. Fenestration is obscured by metal hurricane shutters. Distinguishing features include brick faux shutters, vertical wood siding in the porch, and an exterior masonry chimney on the north elevation. A metal chain link fence encloses the lot (Figure 55–Figure 56).

Figure 55. Photograph of 8HI15557–1, facing east.

Figure 56. Photograph of 8HI15557-2, facing southeast.

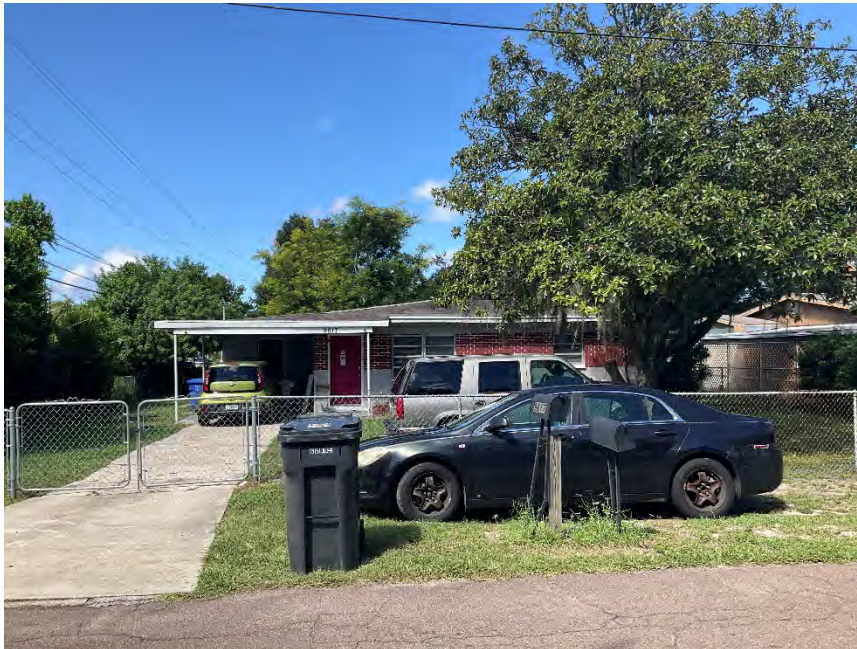
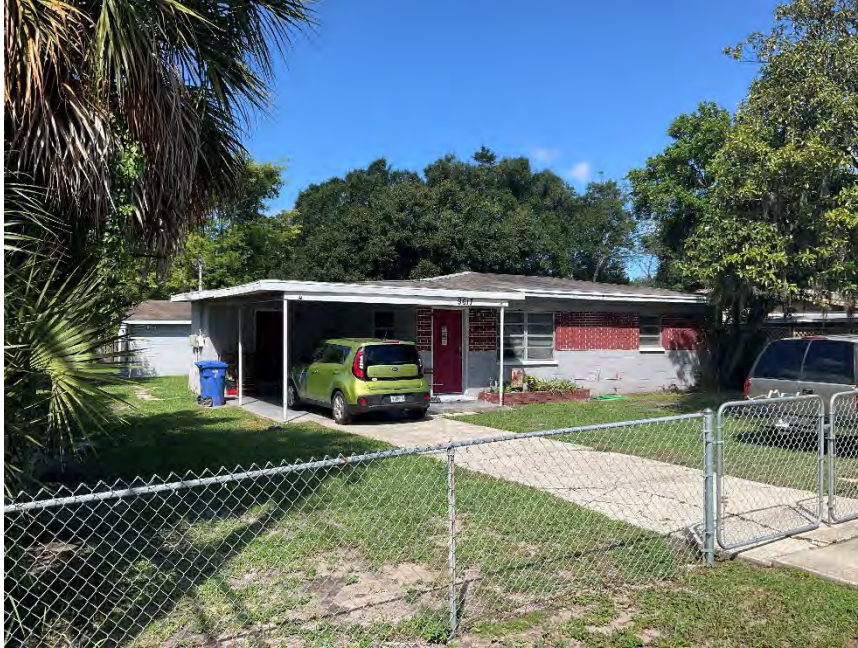
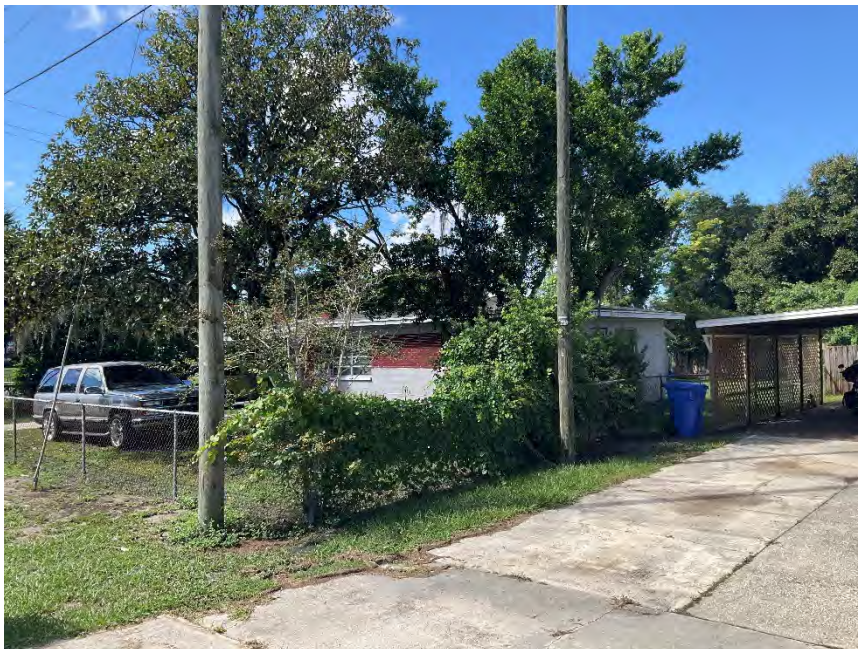
Resource Description: 8HI15558 (9617 Pine Ridge Avenue) is a newly recorded historic structure with Masonry Vernacular style. Built in 1962, 8HI15558 is a one-story, rectangular-shaped plan residence set on a concrete slab foundation. The hip roof is clad in asphalt shingles, and the masonry walls are painted and clad in brick veneer. The main entry is on the east façade through a hollow core panel door within an incised partial width shed porch with a concrete stoop. Fenestration includes individual and paired metal-framed awning windows. Distinguishing features brick veneer along the upper portion of the façade and a brick planter. An open carport is attached to the south elevation. A metal chain link fence encloses the lot (Figure 58–Figure 60).

Figure 58. Photograph of 8HI15558–1, facing west.

Figure 59. Photograph of 8HI15558-2, facing northwest.

Figure 60. Photograph of 8HI15558-3, facing southwest.

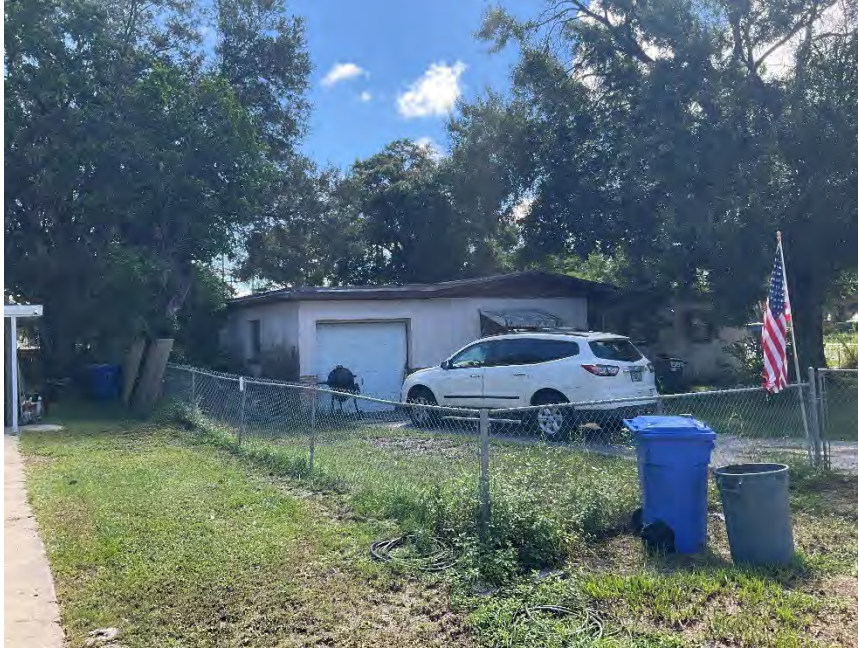
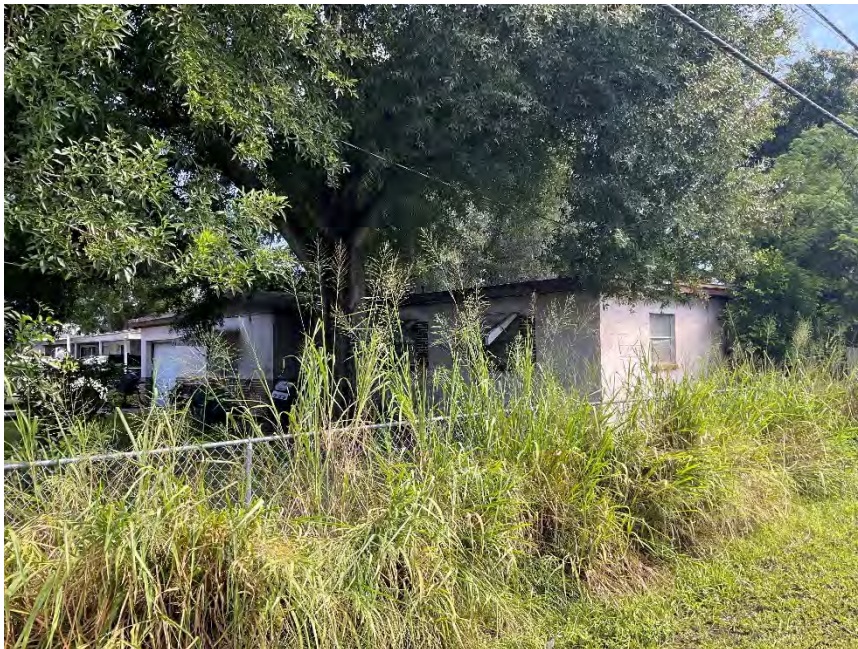
Resource Description: 8HI15559 (9618 Pine Ridge Avenue) is a newly recorded historic structure with Masonry Vernacular style. Built in 1961, 8HI15559 is a one-story, irregular-shaped plan residence set on a concrete slab foundation. The combination roof is clad in asphalt shingles, and the masonry walls are painted and clad in brick veneer. The main entry is on the west façade through a wood panel door within an incised partial width shed porch with a concrete stoop. Fenestration includes individual and paired metal-framed single-hung-sash windows two-over-two and one-over-one configuration. Distinguishing features brick veneer along the lower portion of the façade, brick faux shutters, and metal clam shell awnings. A garage with metal roll door is on the west façade. A concrete driveway leads to the garage. A metal chain link fence encloses the lot (Figure 62–Figure 64).

Figure 62. Photograph of 8HI15559-1, facing southeast.

Figure 63. Photograph of 8HI15559-2, facing northeast.
