Hillsborough Avenue (US 92/SR 600)

**Project Development and Environment (PD&E) Study
From 50th Street to Interstate 4 (I-4),
Hillsborough County, Florida**

Cultural Resource Assessment Survey (CRAS) Report

WPI Segment No.: 430054-1
FAP Number: Not Applicable
ETDM Project No.: 13312

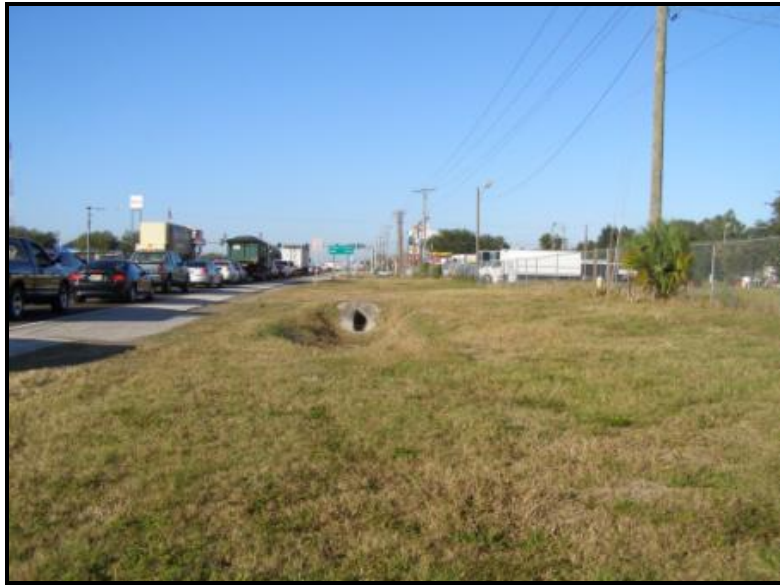
Photo 2.1. General view of Hillsborough Avenue, looking west.

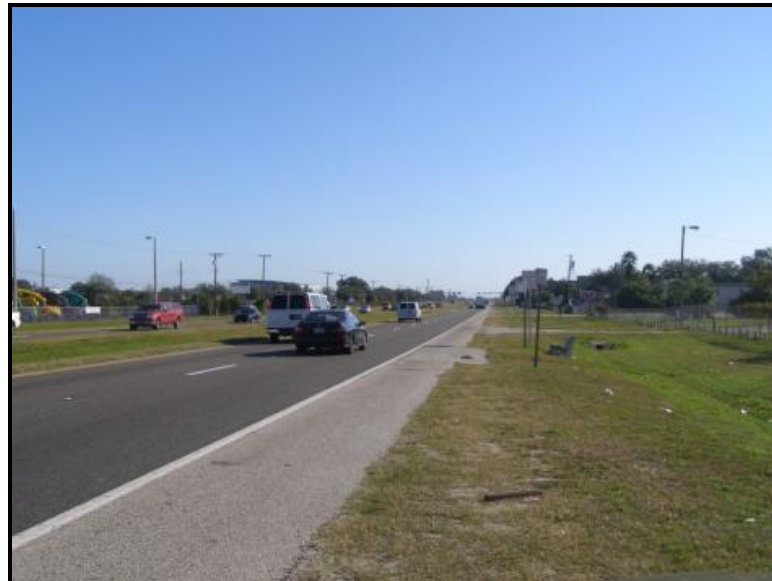
Photo 2.2. Hillsborough Avenue near its intersection with Harney Road, looking east.

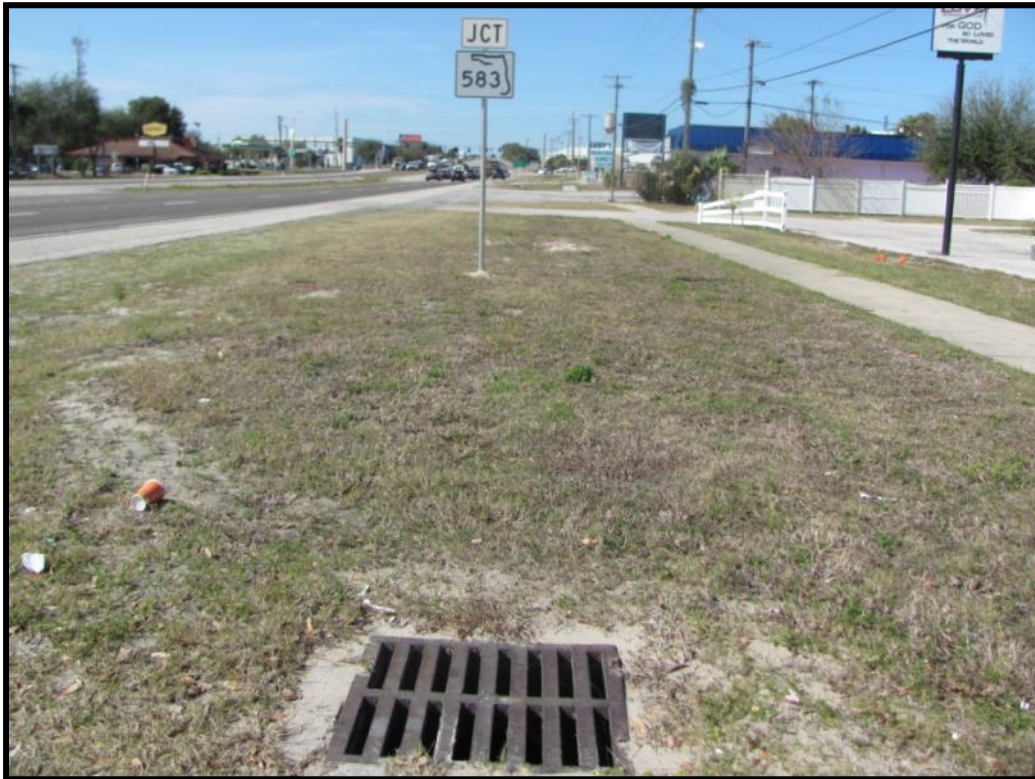
Photo 5.1. Existing conditions along the south side of Hillsborough Avenue.
Note sidewalk, driveways, and drainage improvements.

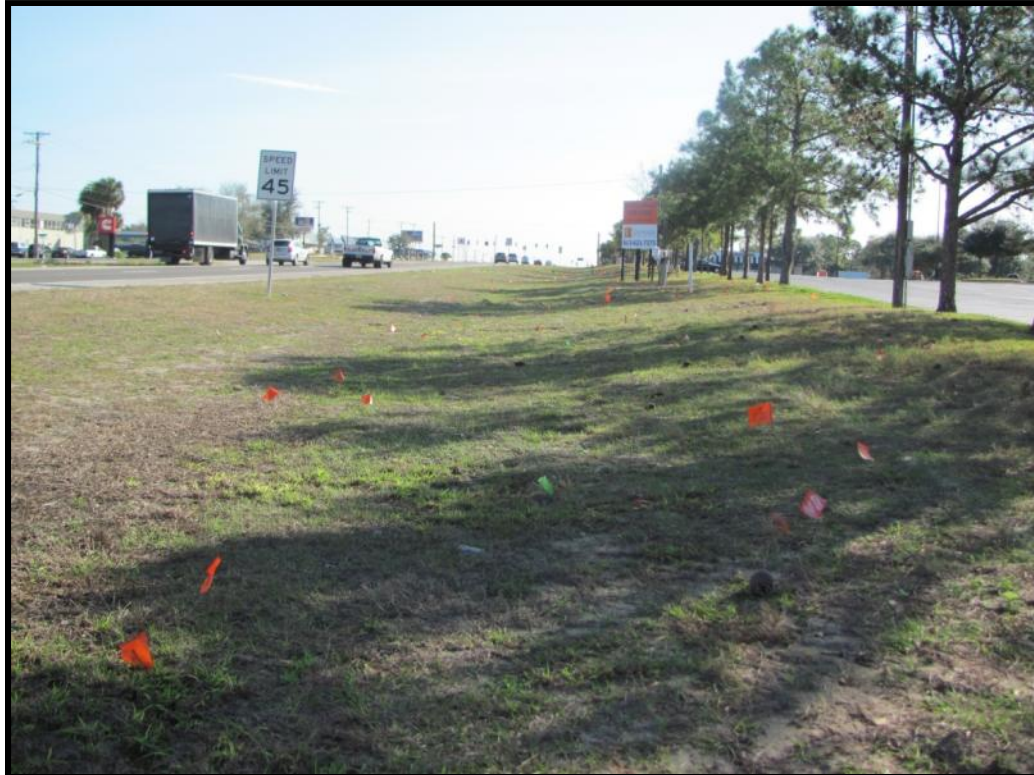
Photo 5.2. Existing conditions along the north side of Hillsborough Avenue.
Note placement of utility lines.

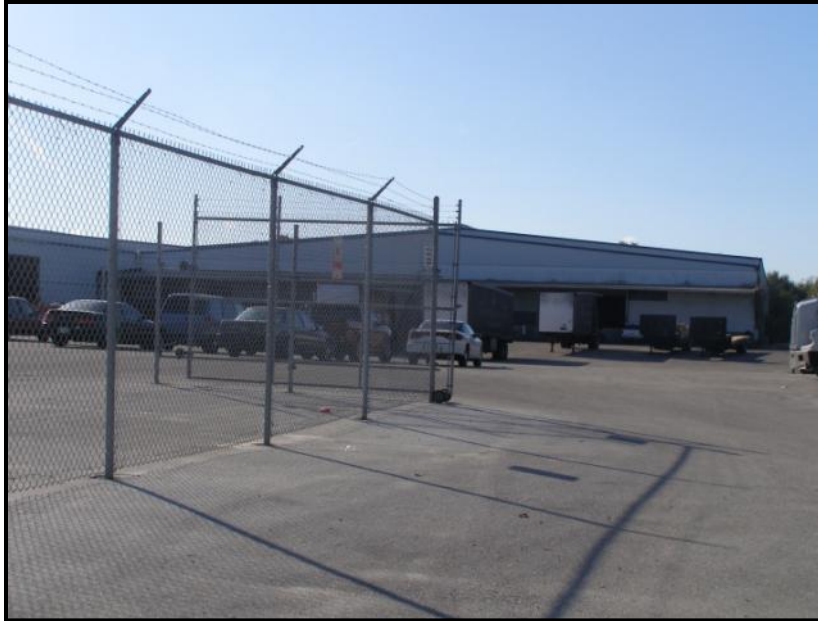
Photo 5.3. West half of south elevation of 5015 East Hillsborough Avenue, 8HI11668.

8HI11668: The large Industrial Vernacular style building at 5015 East Hillsborough Avenue was constructed ca. 1962 (**Photos 5.3 and 5.4**). The slab foundation supports the steel frame walls that are clad in sheet metal. The gable roof is covered with corrugated metal and the windows are one-light fixed. A loading bay and an office area are situated on the north elevation, and multiple garage bays are located on the north and west elevations. This is a typical example of the Industrial Vernacular style found throughout Hillsborough County, and research did not reveal any significant historical associations. Therefore, 8HI11668 is not considered potentially eligible for listing in the NRHP.

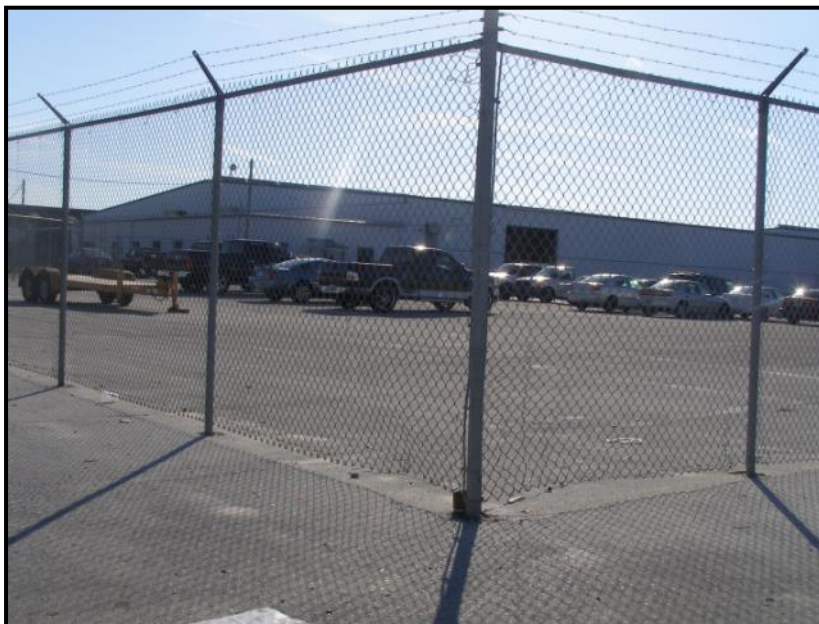
Photo 5.4. East half of the south elevation of 5015 East Hillsborough Avenue, 8HI11668.

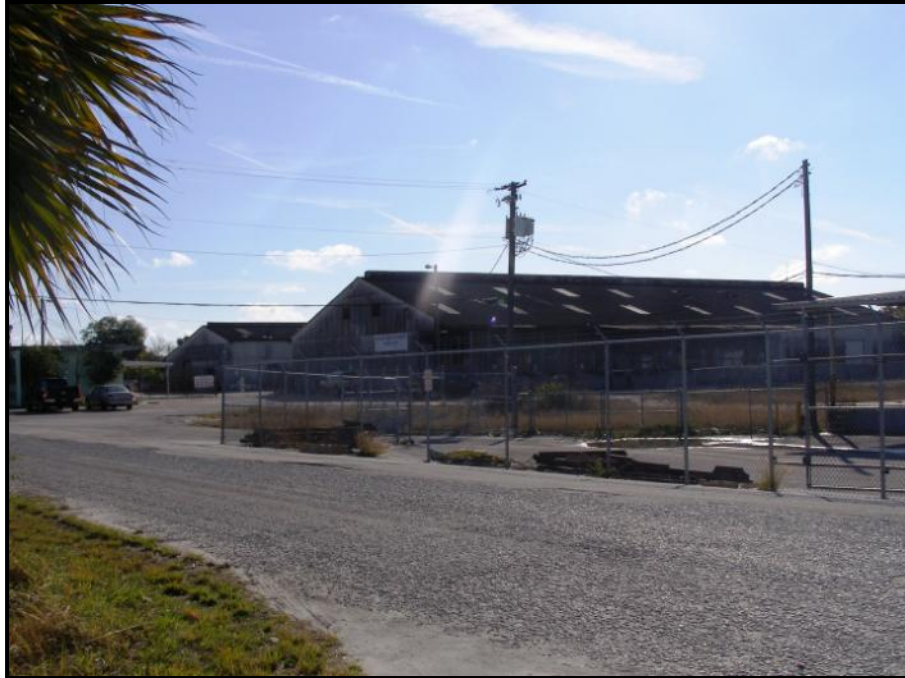
Photo 5.5. General view of the Steward-Mellon Company Resource Group, 8HI11684, at 5101 East Hillsborough Avenue, looking southwest.

8HI11684: The Steward-Mellon Company Resource Group, at 5101 East Hillsborough Avenue (**Photo 5.5**), is comprised of four buildings constructed ca. 1953 in the Industrial Vernacular and Modern styles. The four buildings which occupy the approximate three-acre site include three steel frame and corrugated metal warehouses and one concrete block office. The Steward-Mellon Company, which specializes in terrazzo and stone, began in 1919 as a partnership between A.E. Mellon and E.G Steward. The original company warehouse was located in downtown Tampa on Morgan Street, where the Crosstown Expressway now stands. In 1945, the Naugle family gained an equity claim in the company, and currently is in its third generation of ownership. The company moved to its present location in 1953 because of its proximity to neighboring cities and for the increased space (Naugle 2012a). Among Steward-Mellon's notable projects are the terrazzo floor in the Central Security Checkpoint at Jacksonville International Airport, the terrazzo floor in the Baggage Claim at Tampa International Airport, and the restoration efforts of the Antonio Maceo monument in Ybor City (Naugle 2012b; Bay News 9 2009). While the Steward-Mellon Company has a long association with the industry of Tampa and Hillsborough County, the buildings within the resource group generally are undistinguished examples of their respective types and styles. Therefore, 8HI11684 does not appear to meet the criteria of eligibility for listing in the NRHP. A description of each historic building within the resource group follows.

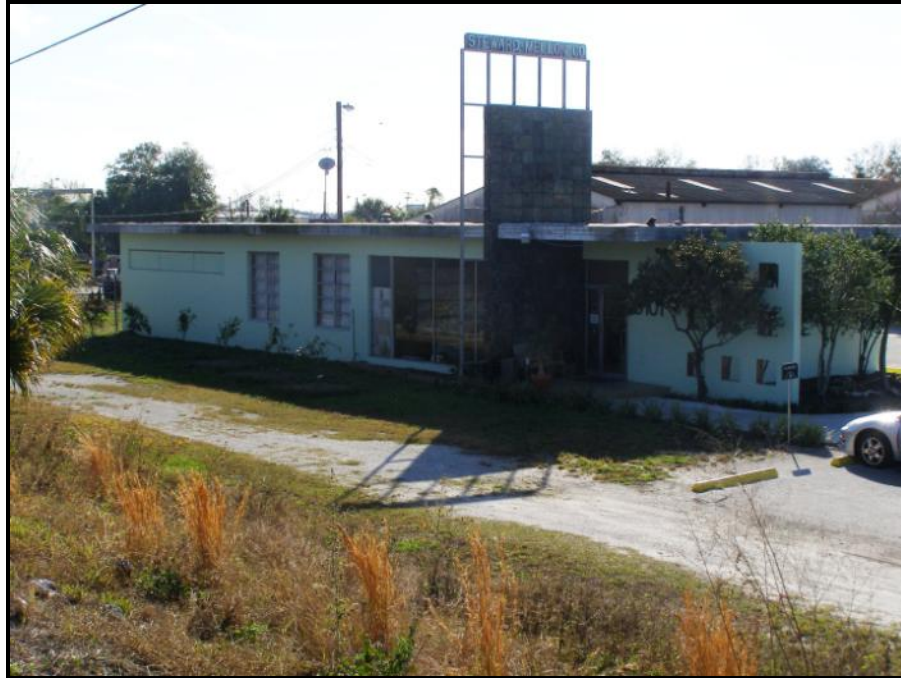
Photo 5.6. North and west elevations of Building 1 (8HI11669) of the Steward-Mellon Company Resource Group (8HI11684) at 5101 East Hillsborough Avenue.

8HI11669: Building 1 (**Photo 5.6**) of the Steward-Mellon Company Resource Group (8HI11684) at 5101 East Hillsborough Avenue was constructed ca. 1953 as a Modern style office. According to Mark Naugle, it was designed by William Watson, who later helped design the Howard Frankland Bridge (Naugle 2012a). The slab foundation supports the concrete block walls that are topped with a flat roof covered in built-up materials. A concrete block “tower” clad in marble tile is on the north elevation. A concrete block screen is on the west elevation. Some of the windows are painted over; visible windows are five-light awning and one-light fixed. Three associated warehouse buildings (8HI11670 to 8HI11672) are located to the south and west. This Modern style commercial building does not appear potentially eligible for listing in the NRHP, either individually or as part of a potential historic district. It is not distinguished by its association with events or persons significant to local history, nor is it among the best examples of a Modern style commercial building found in Hillsborough County.

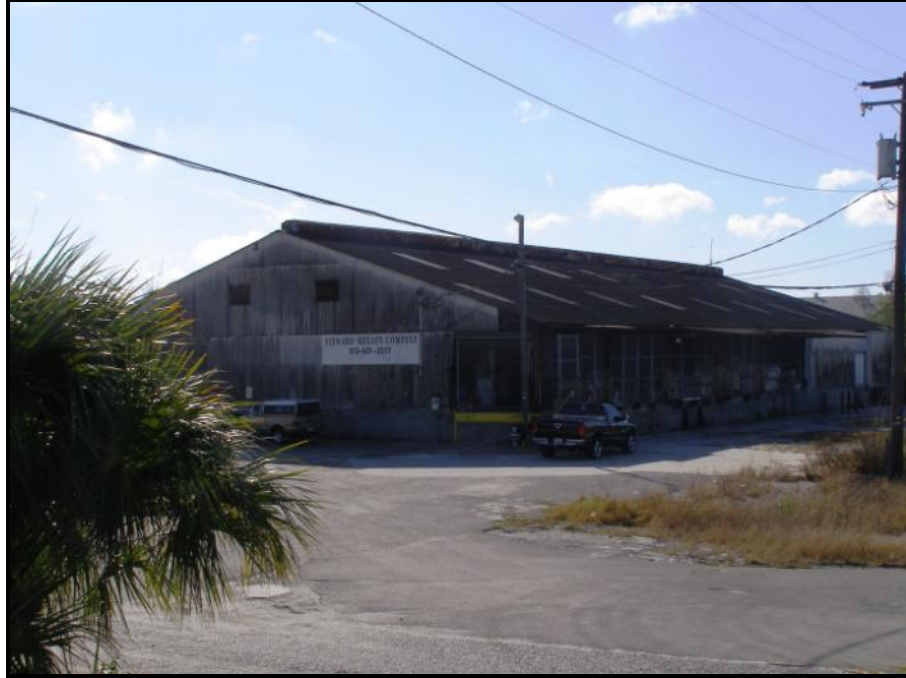
Photo 5.7. North and west elevations of Building 2 (8HI11670) of the Steward-Mellon Company Resource Group (8HI11684) at 5101 East Hillsborough Avenue.

8HI11670: Building 2 (**Photo 5.7**) of the Steward-Mellon Company Resource Group (8HI11684) at 5101 East Hillsborough Avenue was constructed ca. 1953 as an Industrial Vernacular style warehouse. The corrugated metal clad steel frame walls are supported by a continuous concrete block and slab foundation. The gable roof is covered with 5-V metal crimp and has a small clerestory with skylights throughout the roof slopes. The windows are one-light fixed. A loading bay is on the west elevation. This is a typical example of a 1950s Industrial Vernacular style warehouse found throughout Hillsborough County, with no significant historical associations. Therefore 8HI11670 is not considered potentially eligible for listing in the NRHP, either individually or as part of a potential historic district.

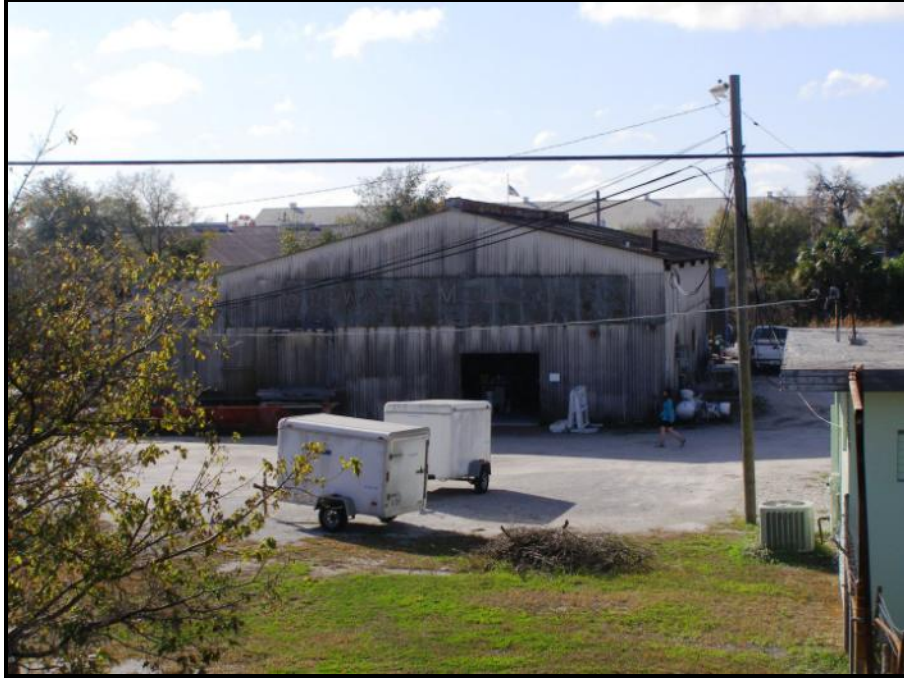
Photo 5.8. North and west elevations of Building 3 (8HI11671) of the Steward-Mellon Company Resource Group (8HI11684) at 5101 East Hillsborough Avenue.

8HI11671: Building 3 (**Photo 5.8**) of the Steward-Mellon Company Resource Group (8HI11684) at 5101 East Hillsborough Avenue was constructed ca. 1953 as an Industrial Vernacular style warehouse. The continuous concrete block and slab foundation supports the steel frame walls that are clad with corrugated metal. The gable roof, covered with 5-V metal crimp, has a small clerestory. The windows are jalousie and one-light fixed. A garage bay is on the north elevation and above it is a faded company sign. This is a typical example of a 1950s Industrial Vernacular style warehouse found throughout Hillsborough County, with no significant historical associations. Therefore 8HI11671 is not considered potentially eligible for listing in the NRHP, either individually or as part of a potential historic district.

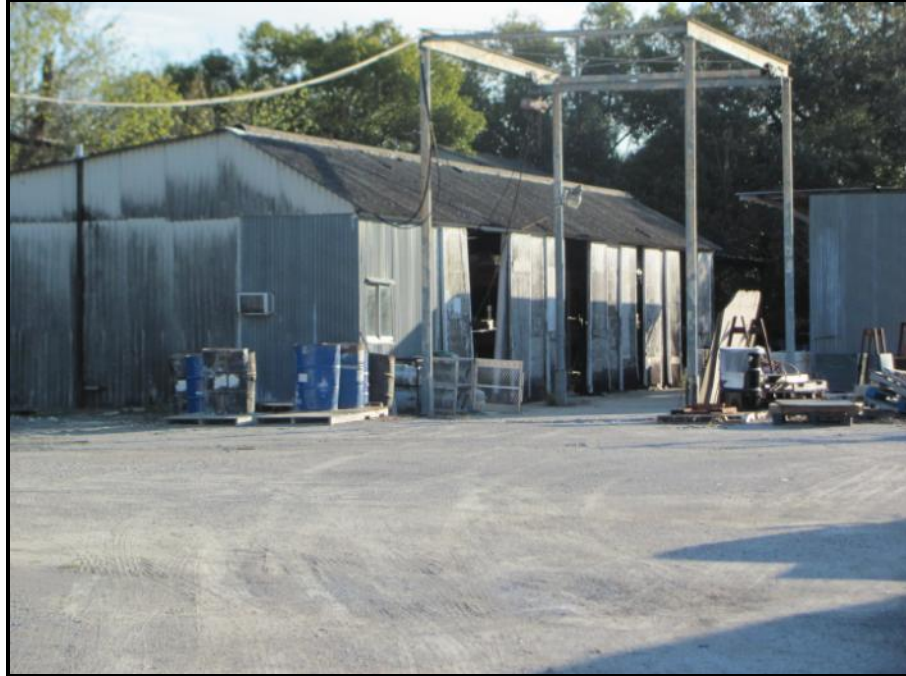
Photo 5.9. South and west elevations of Building 4 (8HI11672) of the Steward-Mellon Company (8HI11684) at 5101 East Hillsborough Avenue.

8HI11672: Building 4 (**Photo 5.9**) of the Steward-Mellon Company Resource Group (8HI11684) at 5101 East Hillsborough Avenue was constructed ca. 1953 as an Industrial Vernacular style warehouse. The steel frame walls are clad in corrugated metal and supported by a slab foundation. The saltbox roof is covered with 5-V metal crimp. Some windows are obscured by plywood covering; visible windows are two-light sliding. There are garage bays on the north elevation. This is a typical example of a 1950s Industrial Vernacular style warehouse found throughout Hillsborough County, with no significant historical associations. Therefore 8HI11672 is not considered potentially eligible for listing in the NRHP, either individually or as part of a potential historic district.

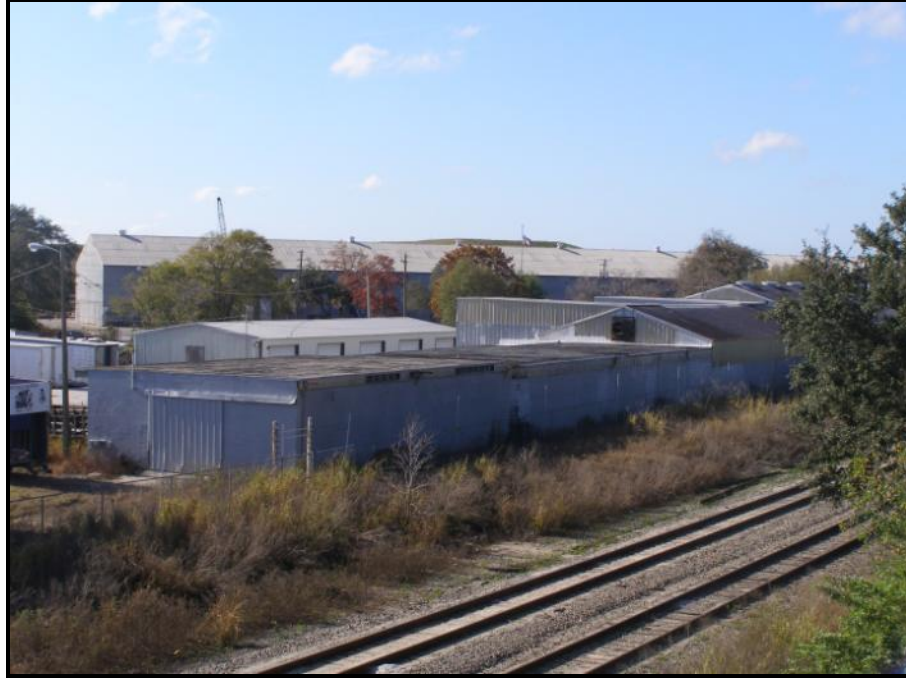
Photo 5.10. North and west elevations of 8HI11673 at 5116 Shadow Lane.

8HI11673: The Industrial Vernacular style warehouse at 5116 Shadow Lane (**Photo 5.10**) was constructed ca. 1947. According to informant Mark Naugle, this warehouse was once used for building caskets. The current function is unknown (Naugle 2012a). The concrete block walls are supported by a slab foundation, and the building is topped with a flat roof covered with built-up materials. A garage bay is on the north elevation, and a decorative concrete frieze is near the roofline. A ca. 1965 addition is located on the south elevation. It features a gable roof covered with composition roll, a gable vent, and corrugated metal. A non-historic warehouse is to the south. This is a typical example of an Industrial Vernacular style commercial building found throughout Hillsborough County, and research did not reveal any significant historical associations. Therefore, 8HI11673 is not considered potentially eligible for listing in the NRHP.

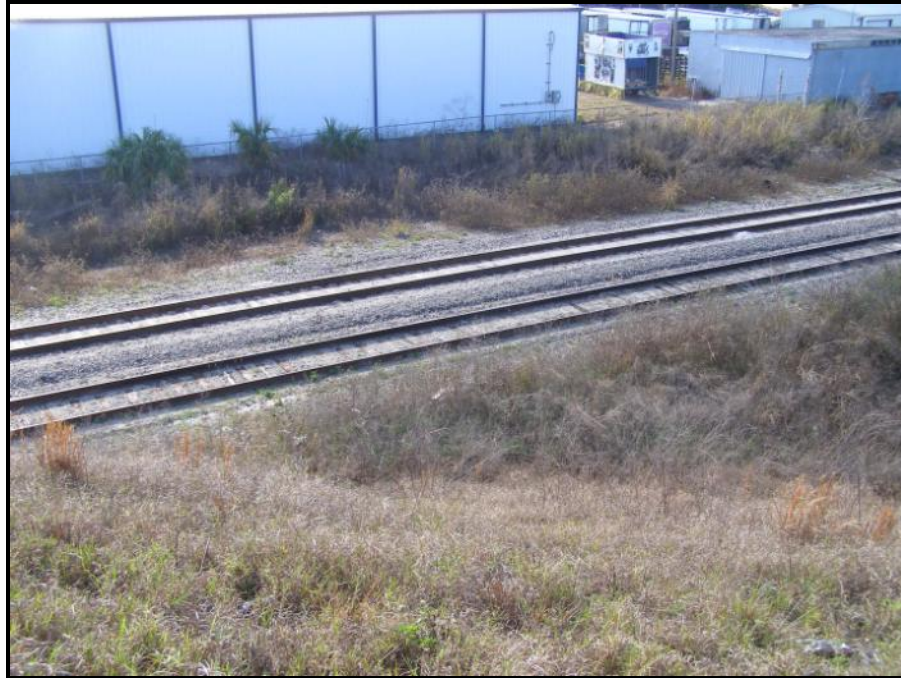
Photo 5.11. General view of the CSX Railroad (8HI11686), looking south.

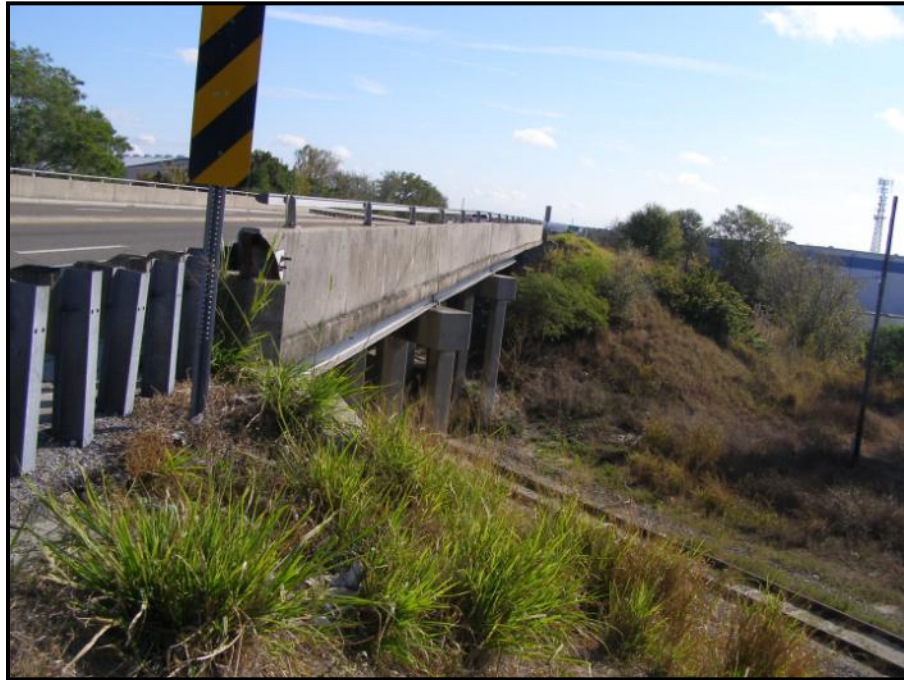
Photo 5.12. South elevation of the SR 600/US 92/Hillsborough Avenue over CSX Railroad Bridge (FDOT No. 100021), 8HI11687.

8HI11687: The four-lane Hillsborough Avenue over CSX Railroad Bridge (FDOT No. 100021) is a beam and girder type bridge originally constructed in 1936 and reconstructed in 1955 (**Photo 5.12**). It is likely that the bridge was widened to four lanes at the time of reconstruction. The bridge is approximately 167 feet in length and has three spans of varying lengths. The substructure consists of concrete retaining wall abutments and a pair of supports with six piers and a cap. This is a common beam and girder style bridge with no unique engineering or architectural features or significant historical associations. Thus, 8HI11687 is not considered potentially eligible for listing in the NRHP.

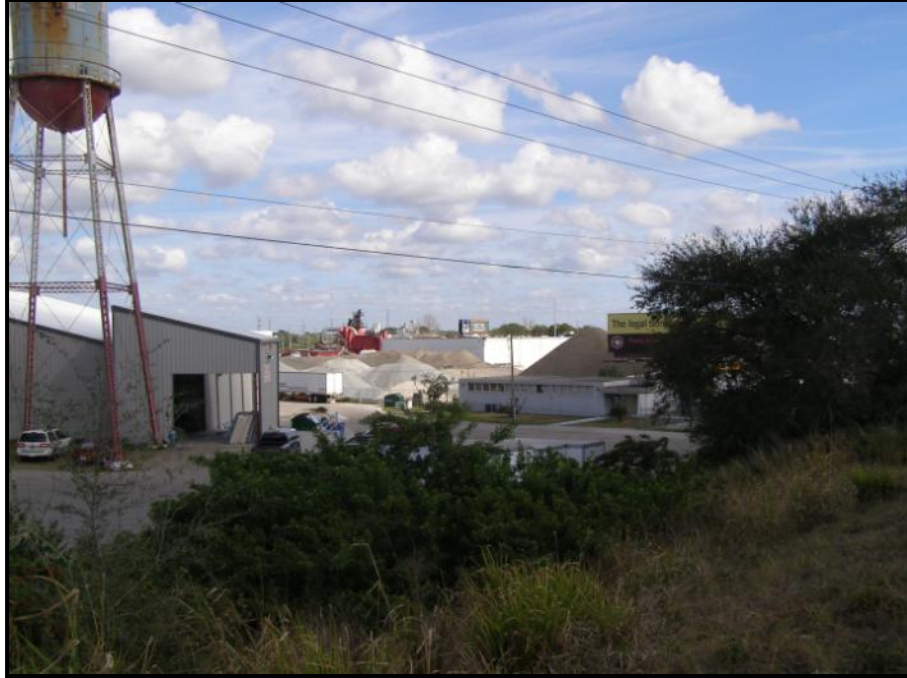
Photo 5.13. General view of the Builders Insulation Inc. Resource Group (8HI11685) at 5226 East Hillsborough Avenue, looking northeast.

8HI11685: The Builders Insulation Inc. Resource Group (**Photo 5.13**) at 5226 East Hillsborough Avenue is comprised of three contributing buildings constructed ca. 1950 in the Industrial Vernacular and Modern styles. Two of the buildings are steel frame and concrete block warehouses, and the third building is a concrete block office. This group of buildings was once used in the manufacture of fertilizer (Naugle 2012a). Builders Insulation Inc. purchased the property ca. 2004. This is a typical example of an industrial complex commonly found throughout Hillsborough County. In addition, none of the buildings within the resource group exhibit any unique features or design, and there are no known significant historical associations. Therefore, 8HI11685 is not considered potentially eligible for listing in the NRHP.

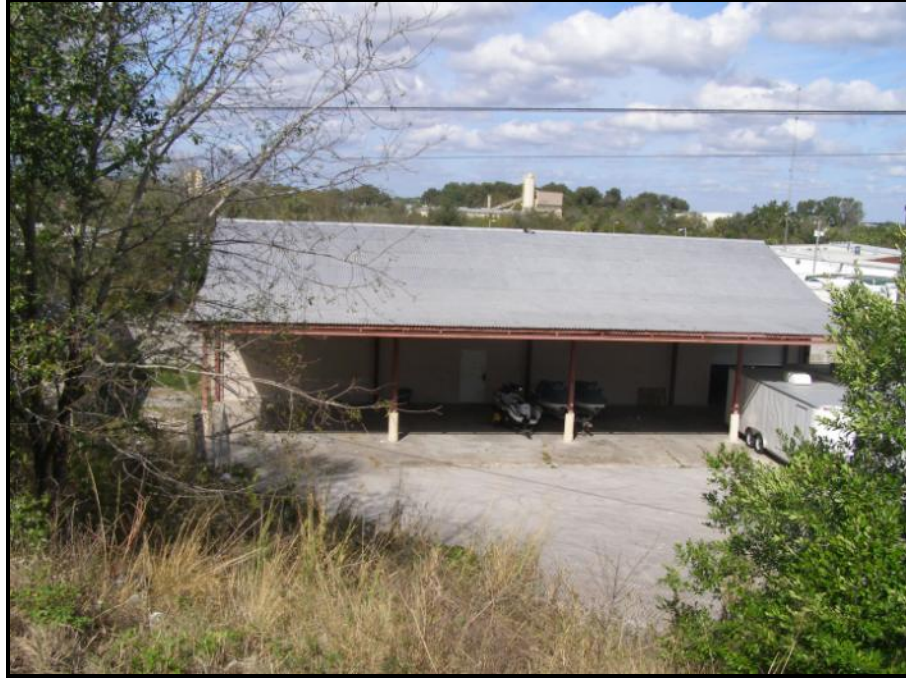
Photo 5.14. East elevation of Building 1 (8HI11674) of the Builders Insulation Inc. Resource Group at 5226 East Hillsborough Avenue.

8HI11674: Building 1 (**Photo 5.14**) of the Builders Insulation Inc. Resource Group (8HI11685) at 5226 East Hillsborough Avenue was constructed ca. 1950 as a Industrial Vernacular style warehouse. The concrete block and steel frame walls are supported by a slab foundation and topped with a gable roof (ca. 1970 replacement) that is covered with corrugated metal and a ridge cap. There are roof vents under the overhang of the roof, corrugated metal in the gables, and a wide canopy on the east elevation. The main entrance, a pair of metal swing doors, is on the east elevation and is accessed via the canopy. A warehouse is to the north (8HI11675) and an office is to the east (8HI11676). This is a typical example of the Industrial Vernacular style found throughout Hillsborough County, and research did not reveal any significant historical associations. Therefore, 8HI11674 is not considered potentially eligible for listing in the NRHP.

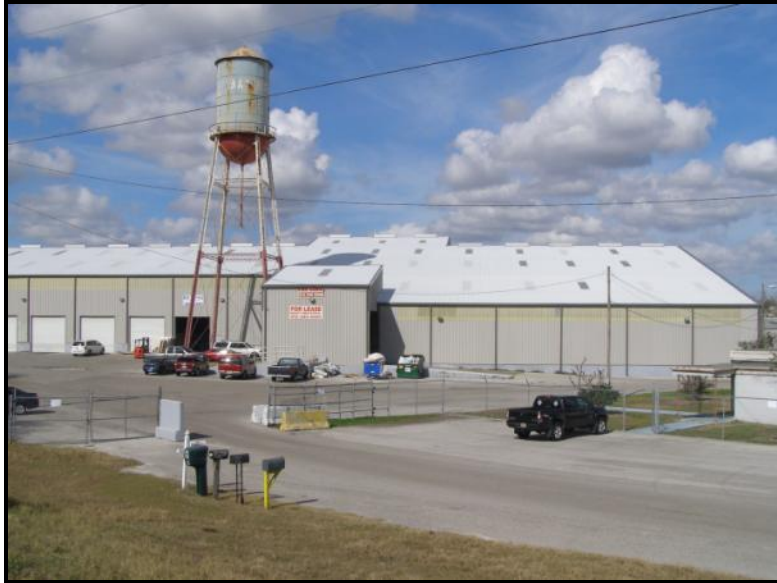
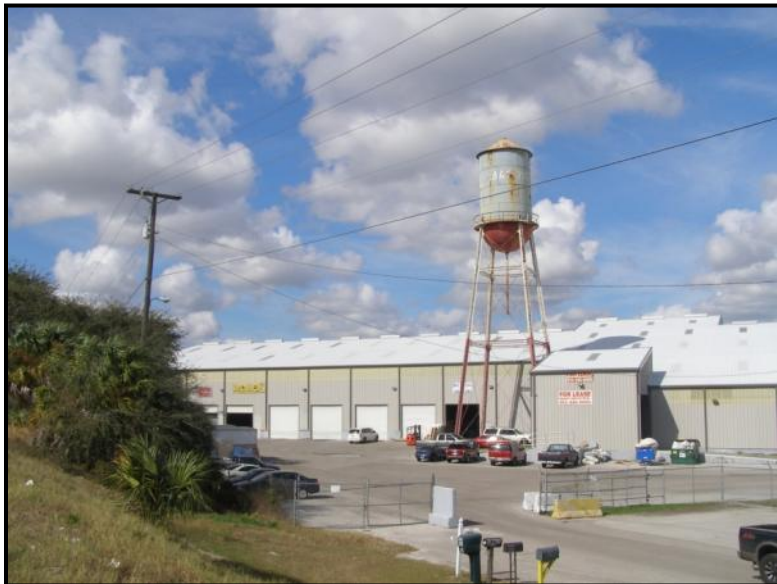
Photo 5.15. North half of the southeast elevation of Building 2 of the Builders Insulation Inc. Resource Group at 5226 East Hillsborough Avenue (8HI11675).

Photo 5.16. South half of the southeast elevation of Building 2 (8HI11675) of the Builders Insulation Inc. Resource Group at 5226 East Hillsborough Avenue.

8HI11675: Building 2 (**Photos 5.15 and 5.16**) of the Builders Insulation Inc. Resource Group (8HI11685) at 5226 East Hillsborough Avenue was constructed ca. 1950 as an Industrial Vernacular style warehouse. Originally two separate buildings, a ca. 1970 annex connects the two. The steel frame walls are clad in corrugated metal and 5-V metal crimp (ca. 2000) and supported by a slab foundation. The gable roof is covered with 5-V metal crimp and there are monitors on the ridge. Other features include multiple skylights throughout the roof and eight garage bays. A water tower that appears to be historic is located to the east. An office is to the east (8HI11676) and a small warehouse is to the south (8HI11674). This is a typical example of the Industrial Vernacular style

found throughout Hillsborough County, and research did not reveal any significant historical associations. Therefore, 8HI11675 is not considered potentially eligible for listing in the NRHP.

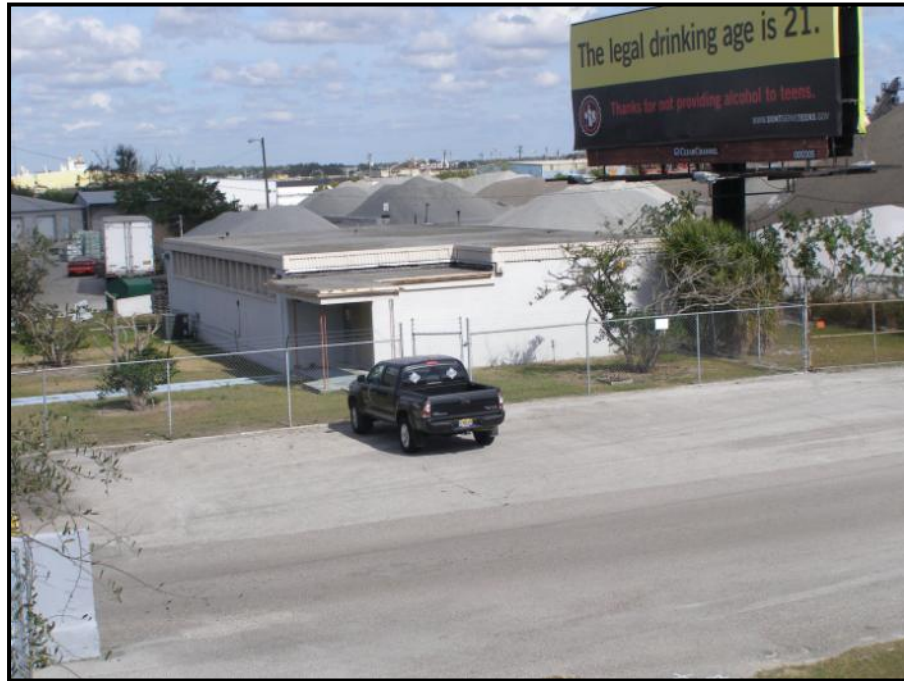
Photo 5.17. South and west elevations of Building 3 (8HI11676) of the Builders Insulation Inc. Resource Group at 5226 East Hillsborough Avenue.

8HI11676: Building 3 (**Photo 5.17**) of the Builders Insulation Inc. Resource Group (8HI11685) at 5226 East Hillsborough Avenue was constructed ca. 1950 in the Modern style. It appears to be an office. The slab foundation supports the concrete block walls that are clad in stucco. The building features a flat roof covered with built-up materials, and a decorative “frieze” located at the roofline. A ribbon of one-light fixed windows is on the west elevation. Two associated warehouse buildings (8HI11674 and 8HI11675) are located to the north and west. This is a typical example of the Industrial Vernacular style found throughout Hillsborough County, and research did not reveal any significant historical associations. Therefore, 8HI11676 is not considered potentially eligible for listing in the NRHP.

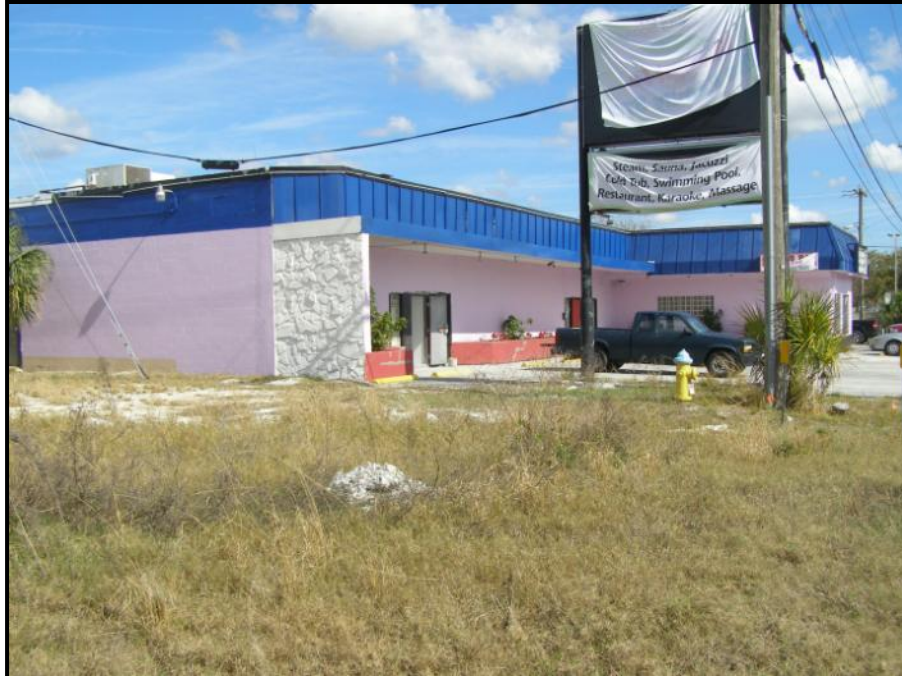
Photo 5.18. South and west elevations of 8HI11677 at 5636 East Hillsborough Avenue.

8HI11677: The Masonry Vernacular style vacant commercial building at 5636 East Hillsborough Avenue was constructed ca. 1957 (**Photo 5.18**). A slab foundation supports the concrete block walls that are partially clad in stucco and fieldstone veneer (ca. 1990). The flat roof, covered in built-up materials, has a ca. 1990 mansard style parapet. Some of the windows are obscured but those that are visible are glass block panels. A pair of one-light metal swing doors is situated on the south elevation. This is a typical example of a Masonry Vernacular style commercial building and alterations diminish its integrity. Furthermore, research did not reveal any significant historical associations. Therefore, 8HI11677 is not considered potentially eligible for listing in the NRHP.

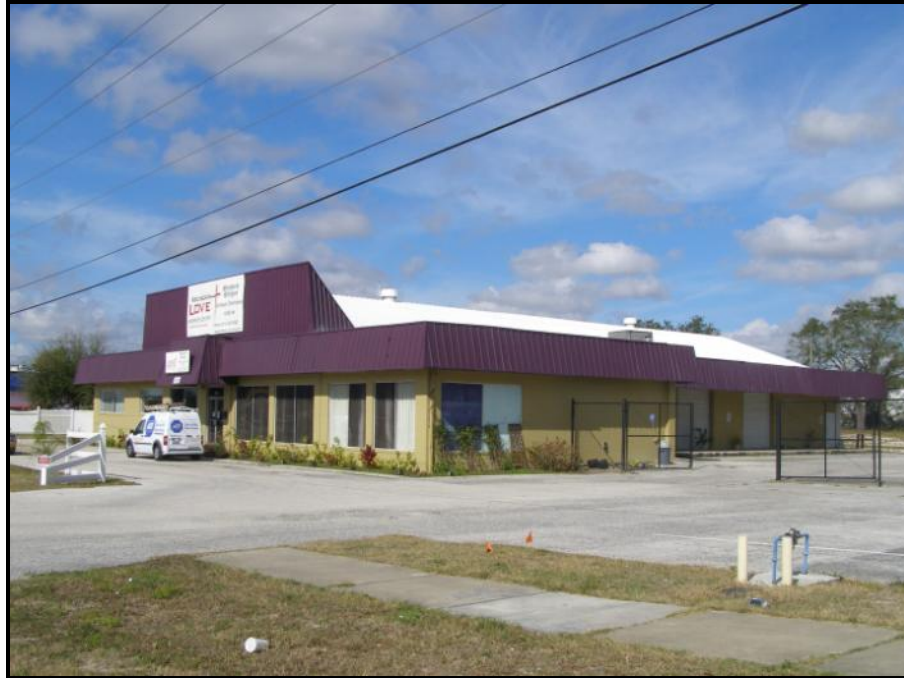
Photo 5.19. South and east elevations of 8HI11678 at 5808 East Hillsborough Avenue.

8HI11678: The Masonry Vernacular style building at 5808 East Hillsborough Avenue was constructed ca. 1956 (**Photo 5.19**). It is currently used as a house of worship. A slab foundation supports the brick walls topped with a gable roof covered with corrugated metal. The building features a mansard style parapet and canopy over the main entrance, and a pair of one-light metal swing doors. The ca. 1990 windows are one-light fixed. This is a typical example of the Masonry Vernacular style found throughout Hillsborough County, and research did not reveal any significant historical associations. Therefore, 8HI11678 is not considered potentially eligible for listing in the NRHP.

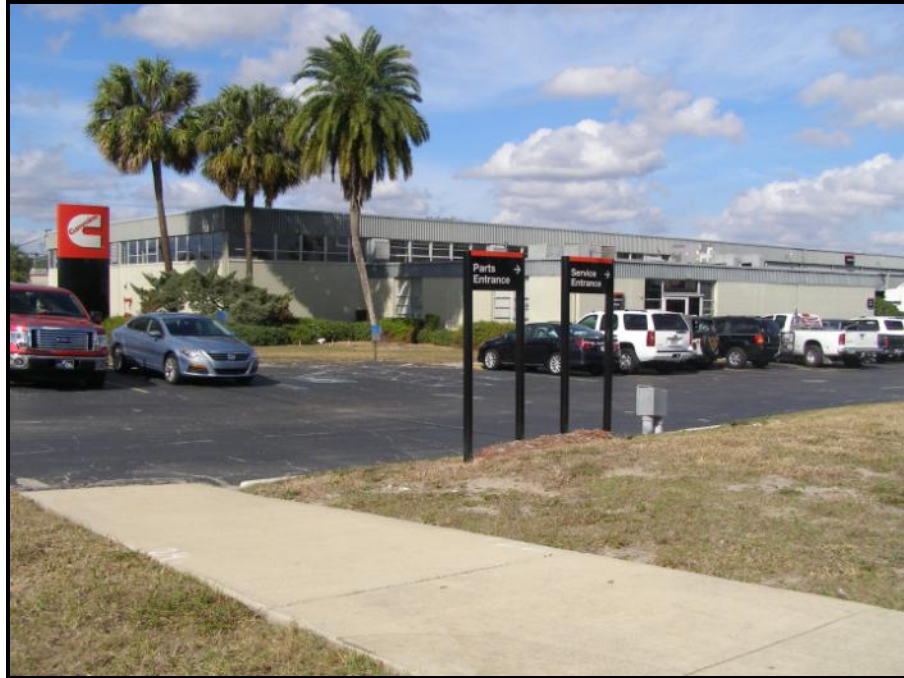
Photo 5.20. South and east elevations of 8HI11679 at 5910 East Hillsborough Avenue.

8HI11679: The Industrial Vernacular style building at 5910 East Hillsborough Avenue, currently used as an auto shop, was constructed ca. 1962 (**Photo 5.20**). The slab foundation supports the concrete block walls that are partially clad in stucco. The building is topped with a flat roof covered with built-up materials and the windows are three-light awning and one-light fixed. Other architectural features include stucco pilasters and a corrugated metal “frieze.” The entrance is a pair of one-light metal swing doors on the east elevation. This is a typical example of the Industrial Vernacular style, and research did not reveal any significant historical associations. Therefore, 8HI11679 is not considered potentially eligible for listing in the NHRP.

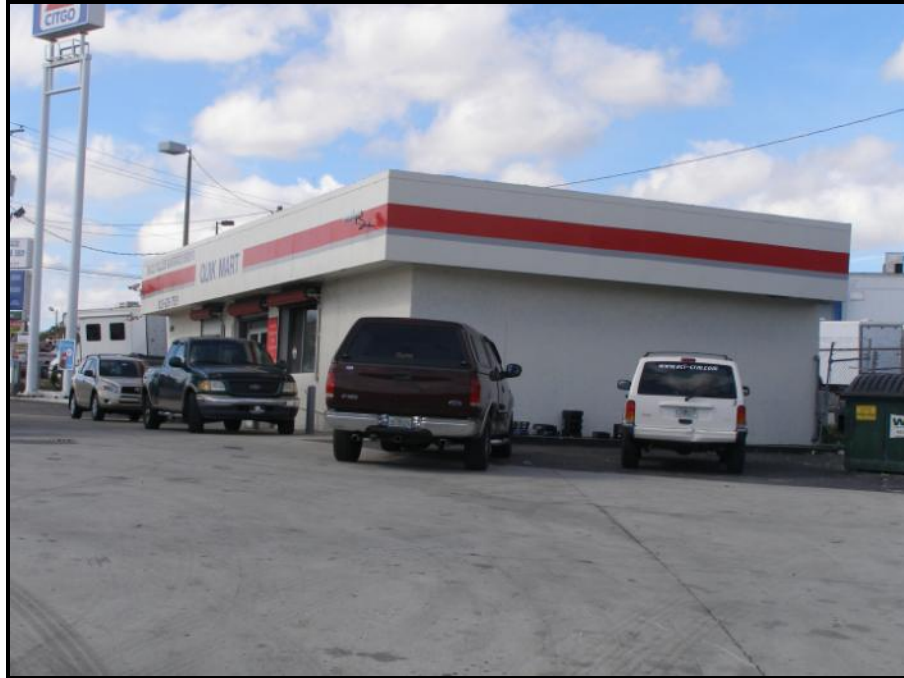
Photo 5.21. North and east elevations of 8HI11680 at 6208 East Hillsborough Avenue.

8HI11680: The Masonry Vernacular style commercial building at 6208 East Hillsborough Avenue was constructed ca. 1960 (**Photo 5.21**). The slab foundation supports the concrete block walls that are clad in stucco (ca. 2000). The building is topped with a flat roof with built-up materials and has a ca. 2000 sign near the roof edge. The windows are ca. 2000 one-light fixed. The main entrance is a pair of one-light metal swing doors on the southeast elevation with a one-light transom. This is a typical example of the Masonry Vernacular style found throughout Hillsborough County, and research did not reveal any significant historical associations. Furthermore, alterations have compromised its integrity. Therefore, 8HI11680 is not considered potentially eligible for listing in the NRHP.

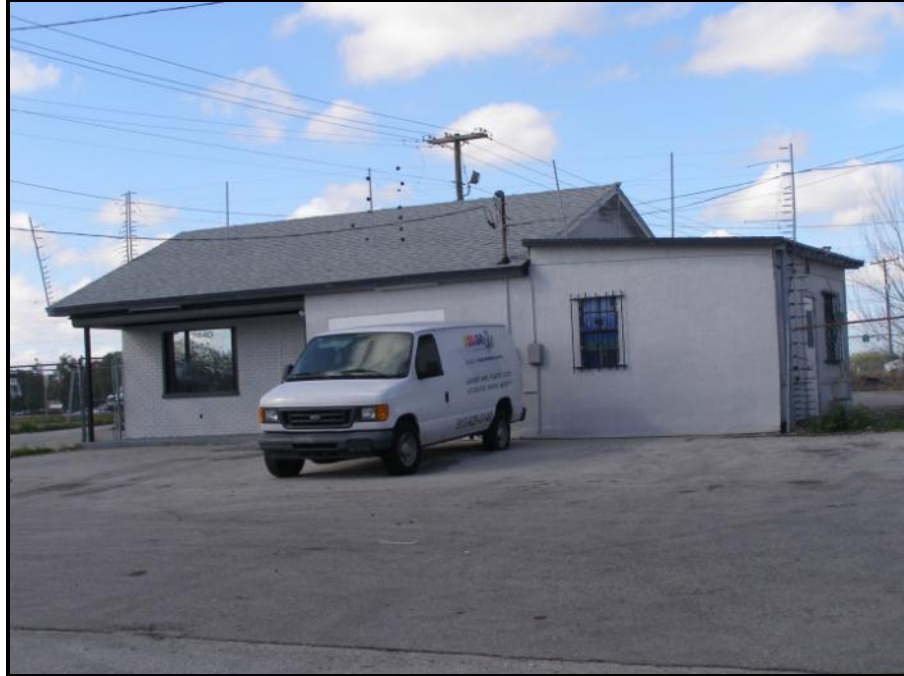
Photo 5.22. North and east elevations of 8HI11681 at 7440 East Hillsborough Avenue.

8HI11681: The Masonry Vernacular style commercial building at 7440 East Hillsborough Avenue was constructed ca. 1959 (**Photo 5.22**). The slab foundation supports the concrete block walls that are clad in stucco and brick veneer (ca. 2000). The gable roof is covered with asphalt shingles and has gable vents. The replacement windows are one-light fixed and 2/2 SHS (ca. 2000) with sills. Some of the windows have security bars. An addition was constructed on the north elevations ca. 1990. An incised porch with an inset roof is on the east elevation and contains the main entrance, a one-light metal swing door. This is a typical example of the Masonry Vernacular style and alterations diminish its integrity. Furthermore, research did not reveal any significant historical associations. Therefore, 8HI11681 is not considered potentially eligible for listing in the NRHP.
