**CULTURAL RESOURCE ASSESSMENT SURVEY
PROPOSED POND SITE ALTERNATIVES AND RE-EVALUATION
TECHNICAL MEMORANDUM**

**Florida Department of Transportation
District 7
I-275 (SR 93) Design Change Re-evaluation
Project Development and Environment Study
from south of 54th Avenue South to north of 4th Street North
Pinellas County, Florida**

Prepared by:
Archaeological Consultants, Inc
Sarasota, Florida

AUGUST 2019

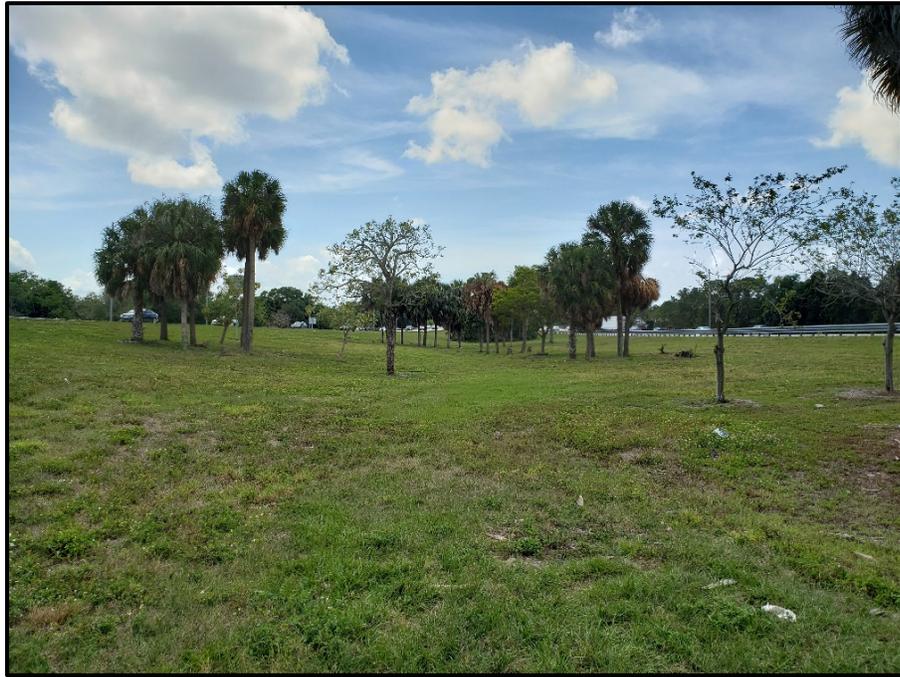
Photo 1. Current conditions of proposed pond 12A.

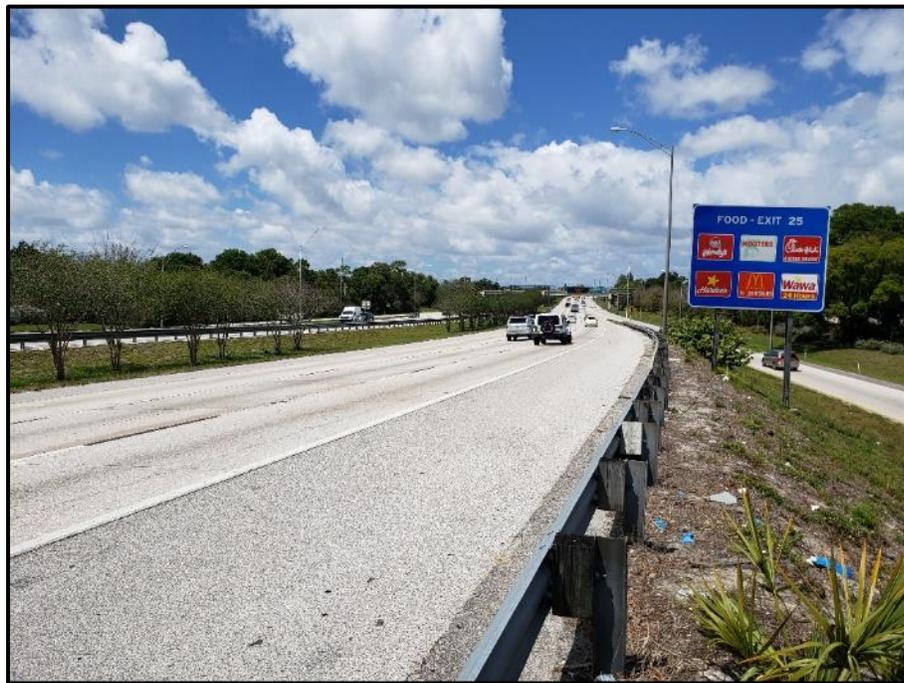
Photo 3. Looking south at current conditions of proposed pond 18B.

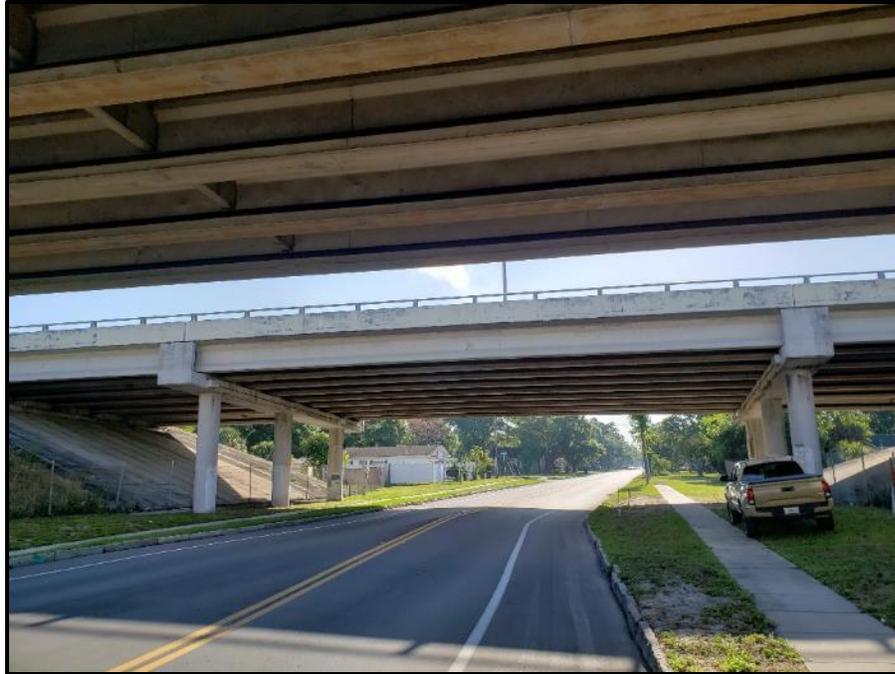
Photo 4. Southbound ROW conditions in the vicinity of 22nd Avenue.
In this area of I-275, pavement widening and bridge widening will occur (see Sheet 12, **Appendix A**).

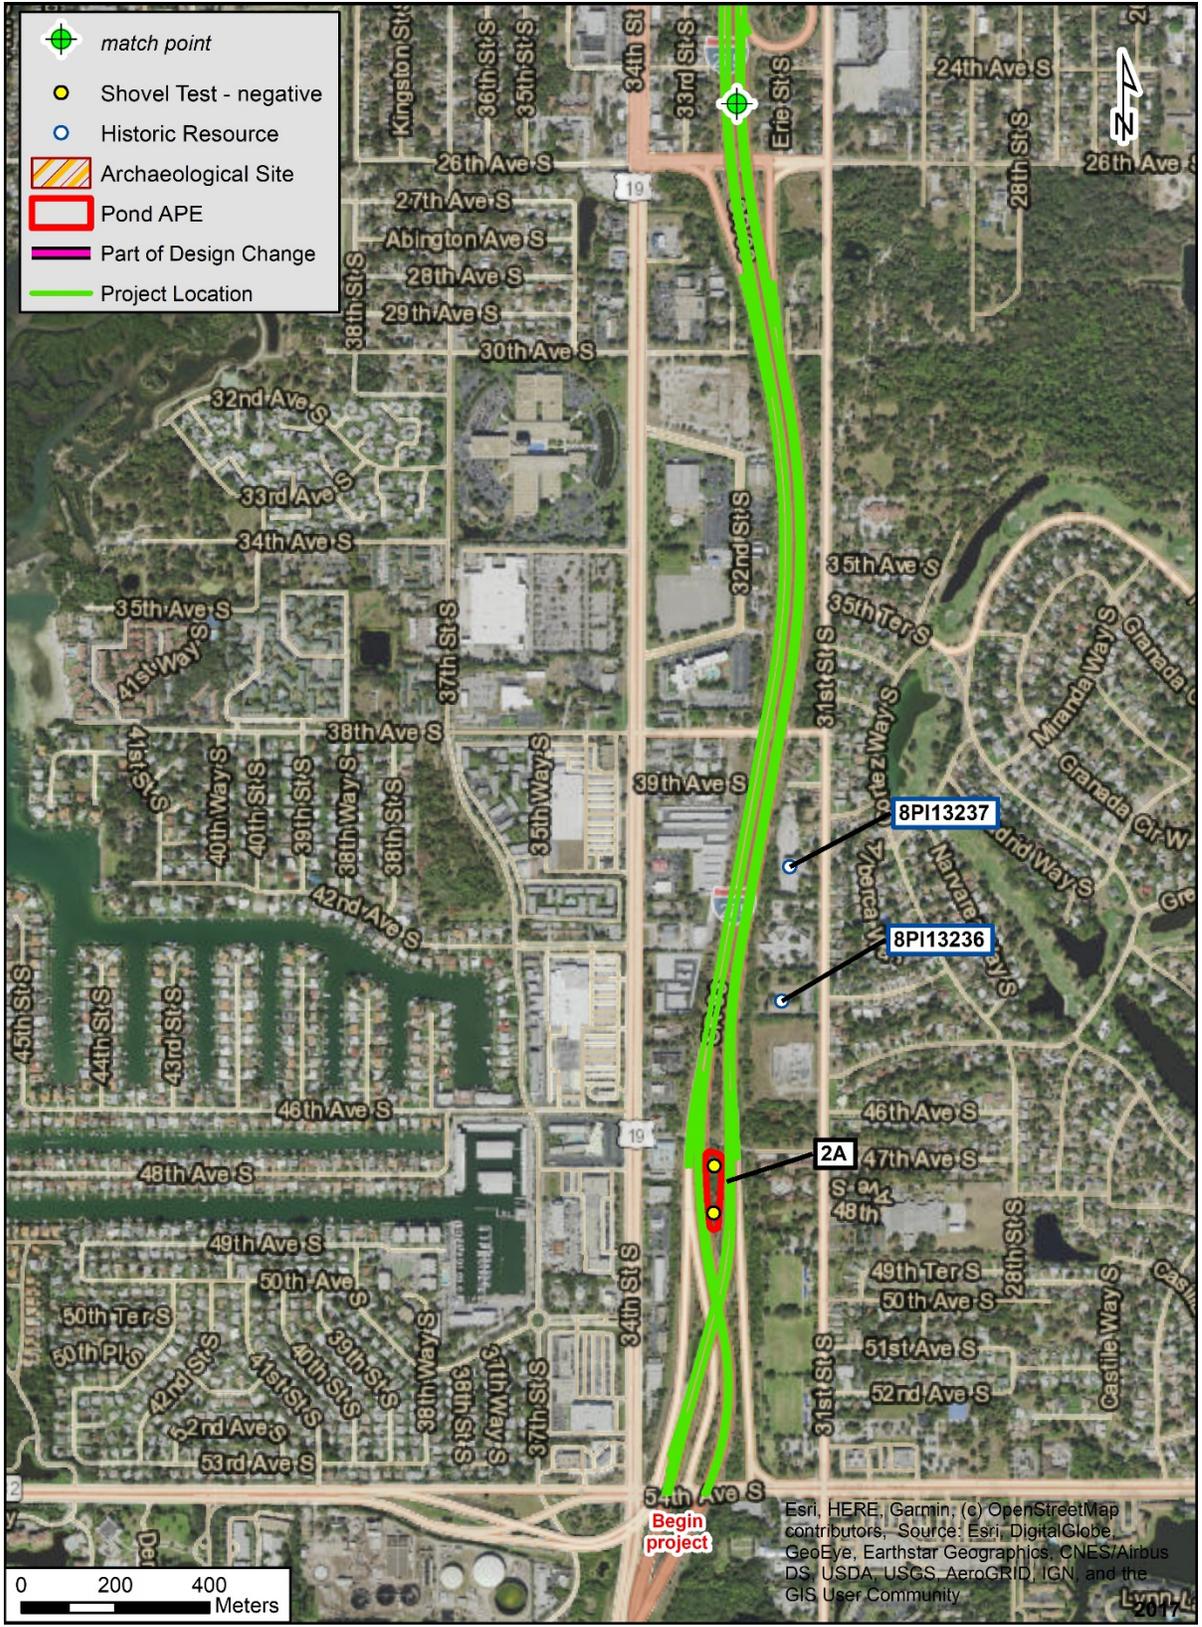
Figure 6. Approximate location of shovel tests within the pond APE and recorded cultural resources. See concept plan sheets 1-4 (**Appendix A**) for proposed design changes.

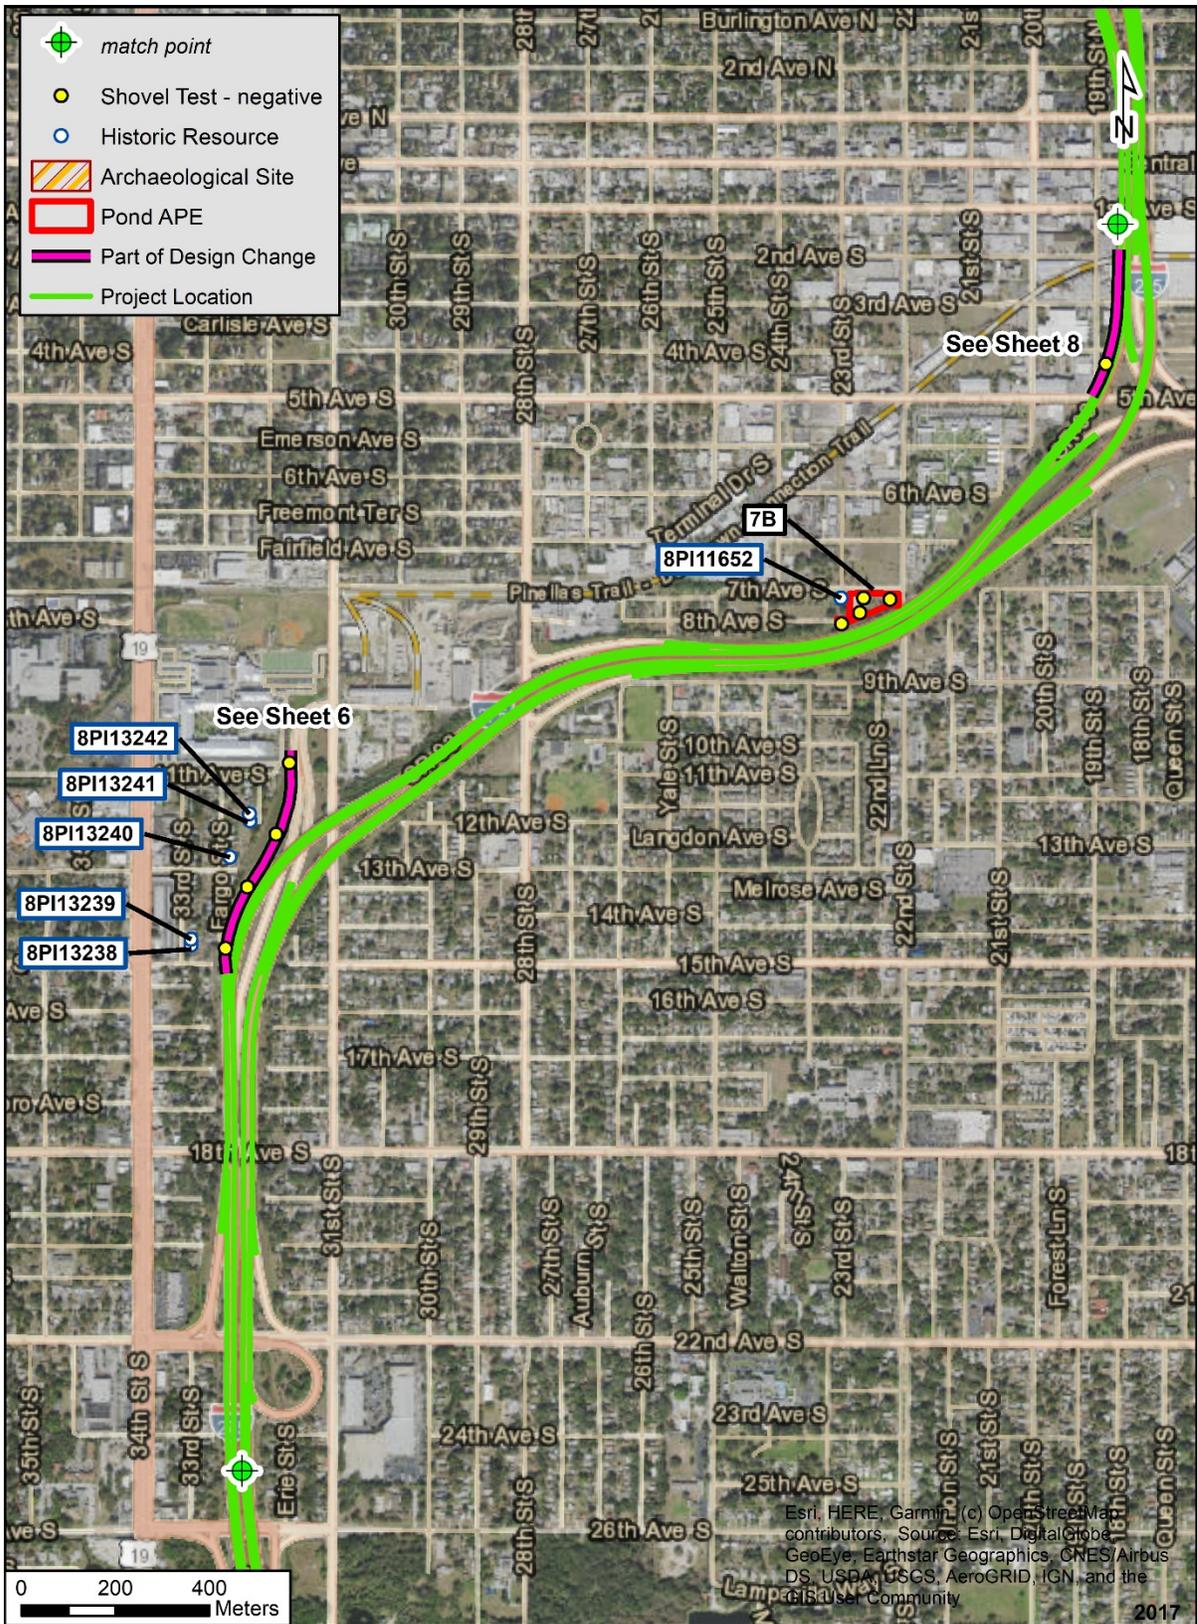
Figure 7. Approximate location of shovel tests within the pond APE and recorded cultural resources. See concept plan sheets 4-9 (Appendix A) for proposed design changes.

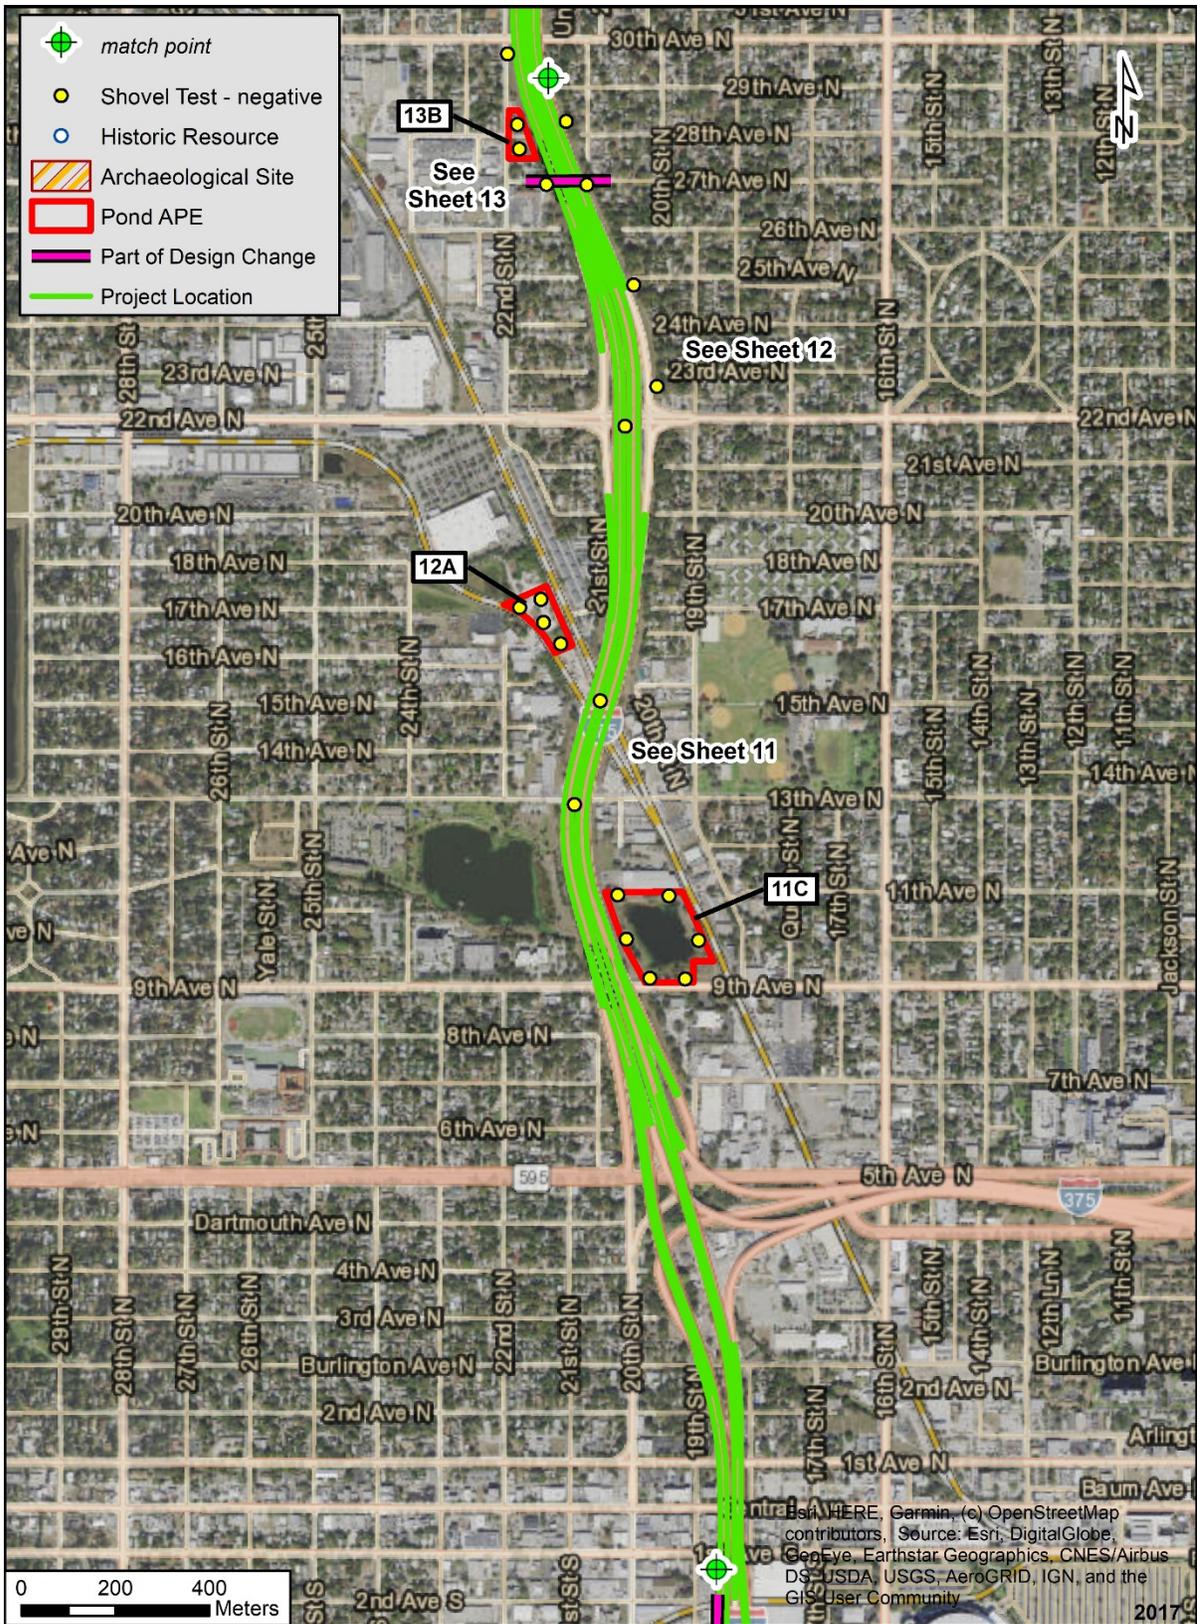
Figure 8. Approximate location of shovel tests within the pond APE and recorded cultural resources. See concept plan sheets 10-13 (**Appendix A**) for proposed design changes.

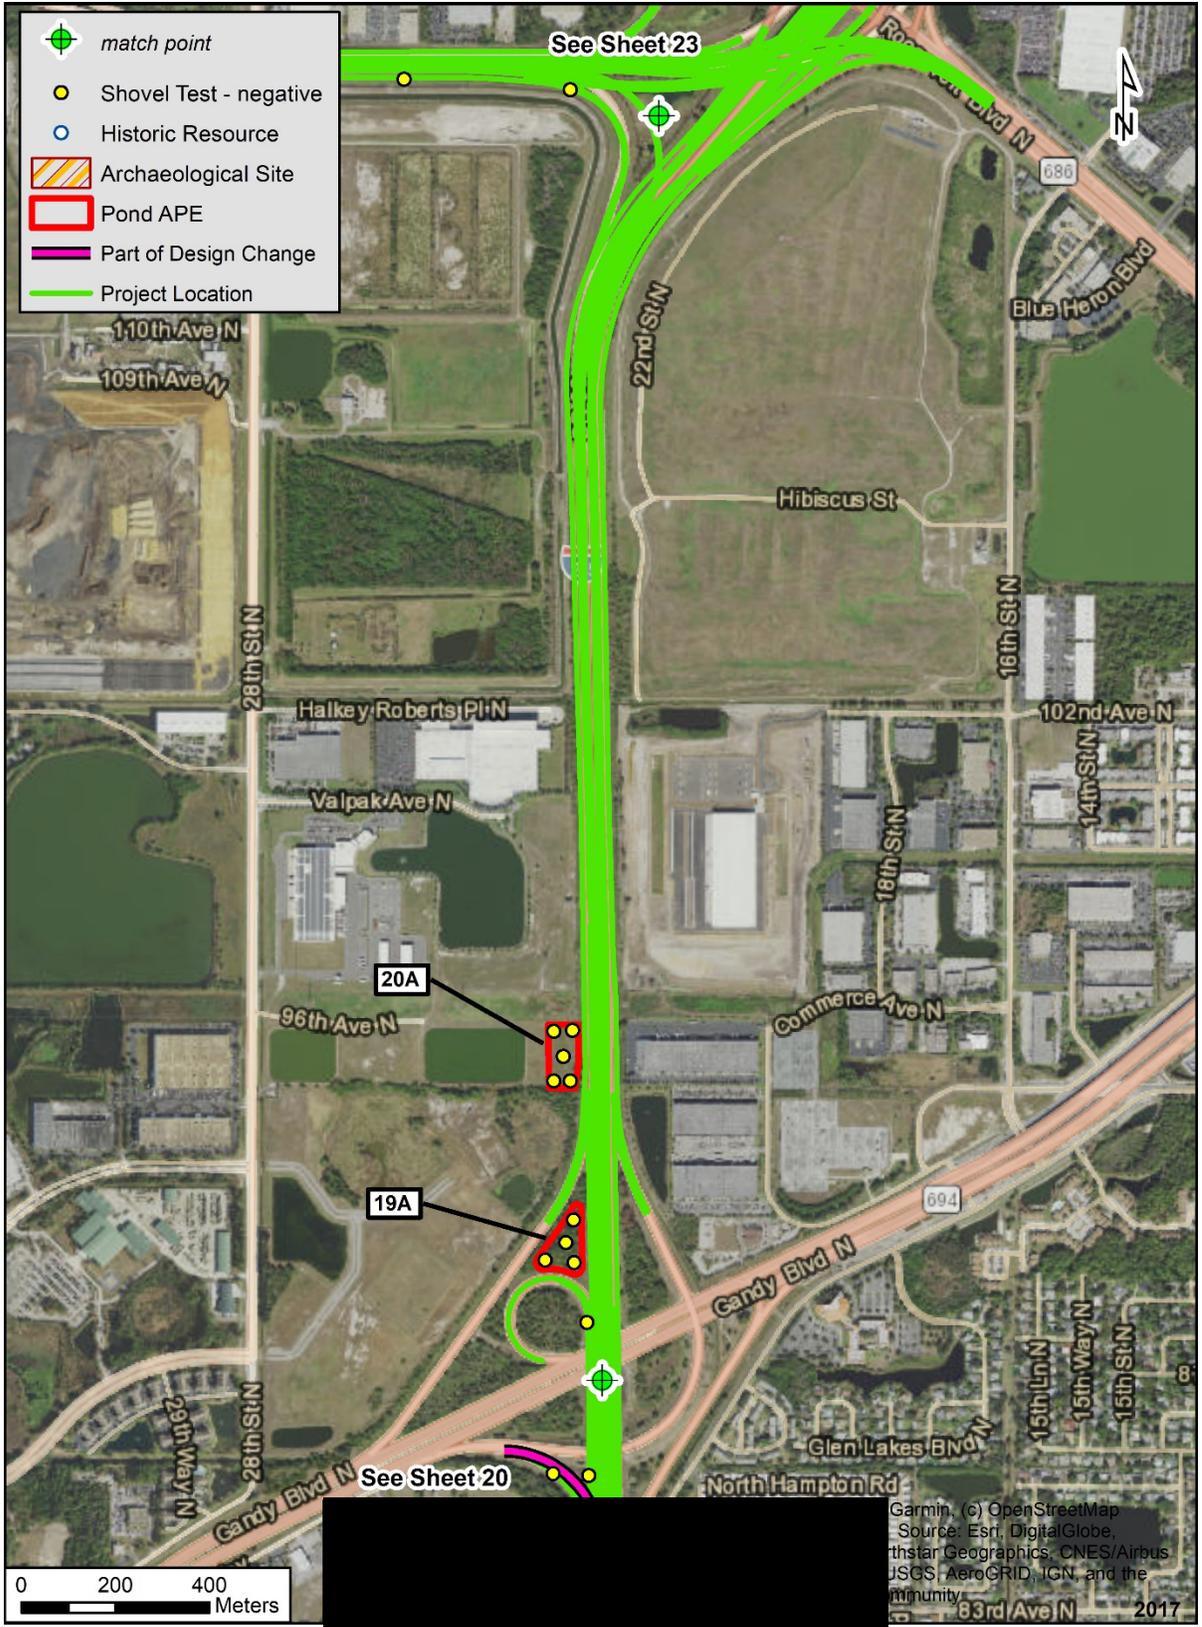
Figure 11. Approximate location of shovel tests within the pond APE and recorded cultural resources. See concept plan sheets 21-23 (**Appendix A**) for proposed design changes.

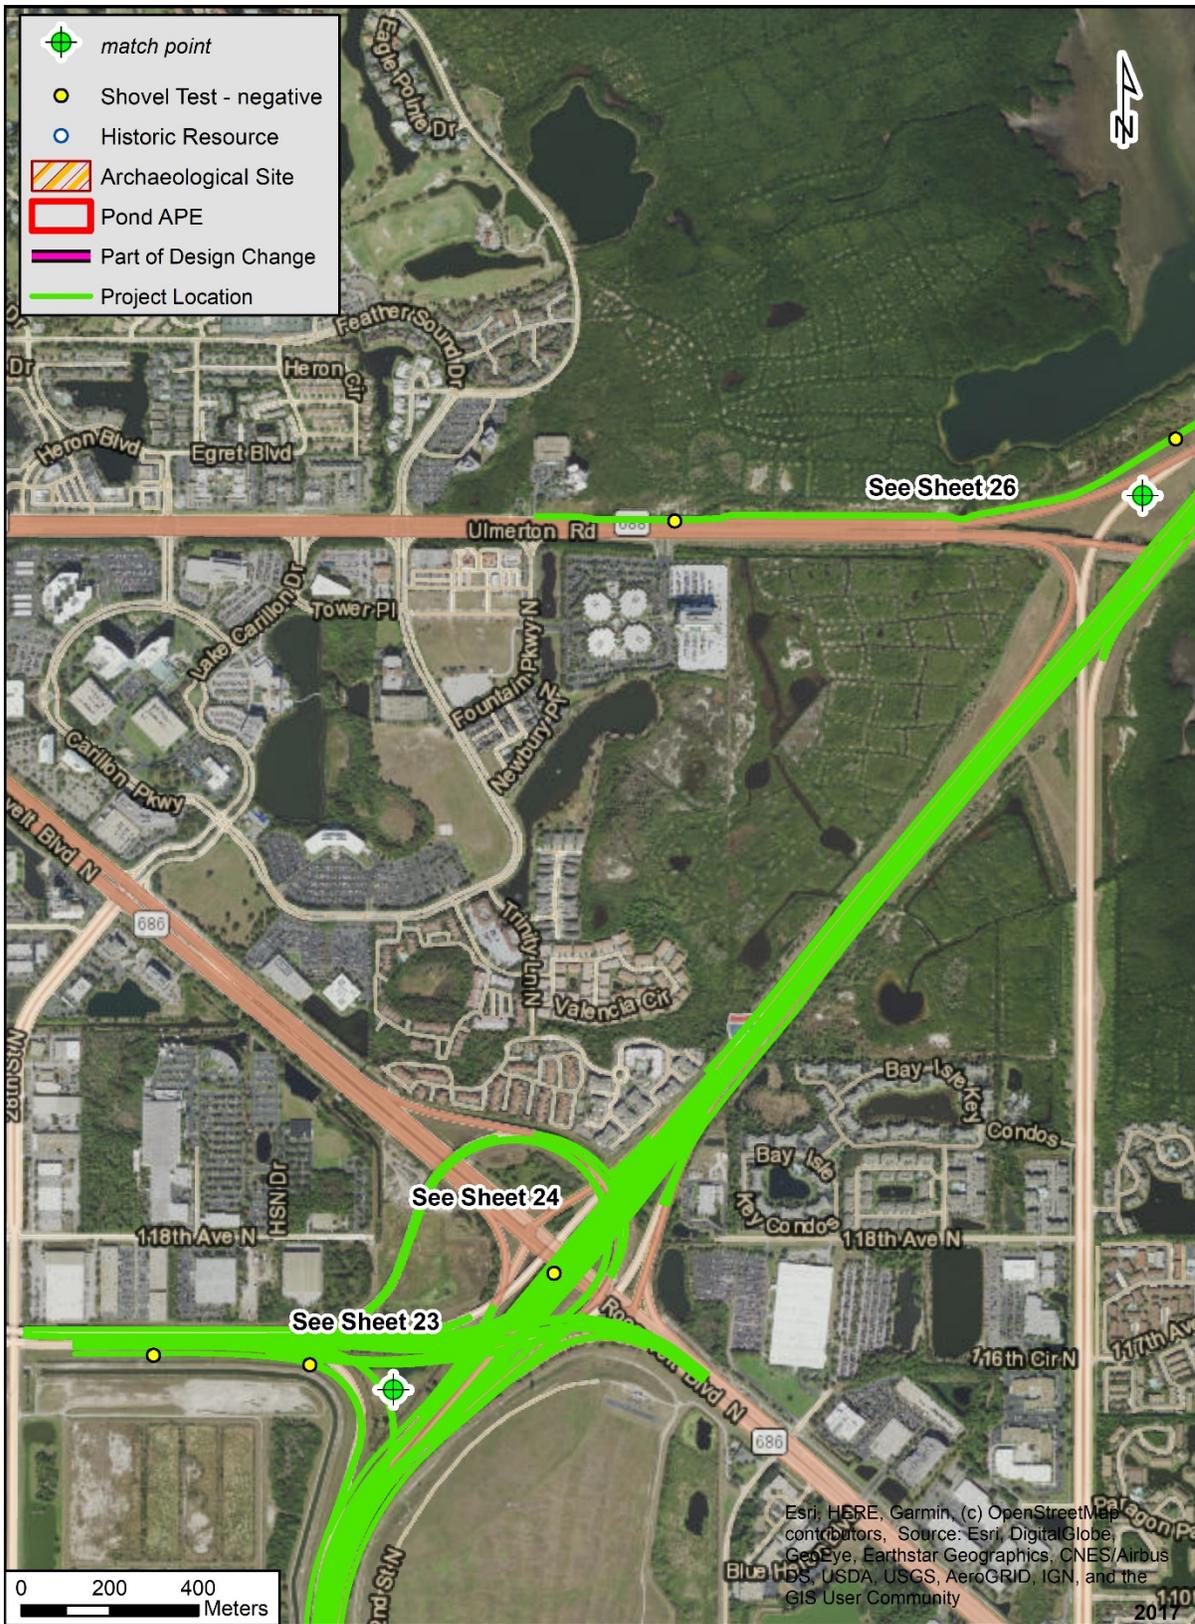
Figure 12. Approximate location of shovel tests within the pond APE and recorded cultural resources. See concept plan sheets 24-26 (**Appendix A**) for proposed design changes.

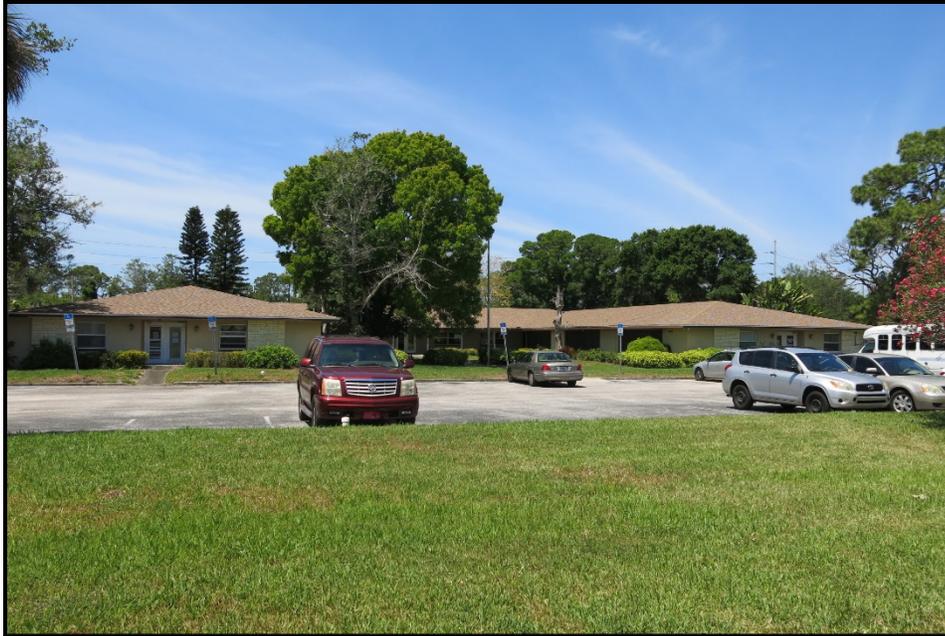
Photo 8. 4301 31st Street S (8PI13236), facing west.

8PI13236: The Masonry Vernacular style building at 4301 31st Street S was constructed circa 1966 and is currently used as an assisted living facility (**Photo 8**). The one-story, H-shaped plan rests on a continuous foundation of concrete block and has a concrete block structural system. The hip roof over the primary mass is covered with composition shingles. There are three entryways on the east elevation through double full-view glass doors beneath the principal roof overhang, facing the parking lot. There is a full-length incised porch that creates an open walkway on the east elevation of the central block and multiple porches with screen enclosures on the north and south elevations of the wing segments. Visible windows include individual and paired, aluminum one-over-one single-hung sash units. Distinguishing architectural features include artstone and overhanging roof with boxed rafters. Building alterations include reroofing and the addition of living space on the north and south elevations beneath a flat roof. There are extended hip roof canopies on the north and south elevations for patient pick-up and drop-off. Overall, the building has been altered, lacks sufficient architectural features, and is not a significant embodiment of a type, period, or method of construction. In addition, background research did not reveal any historic associations with significant persons and/or events. As a result, 8PI13236 does not appear eligible for listing in the NRHP, either individually or as part of a historic district.

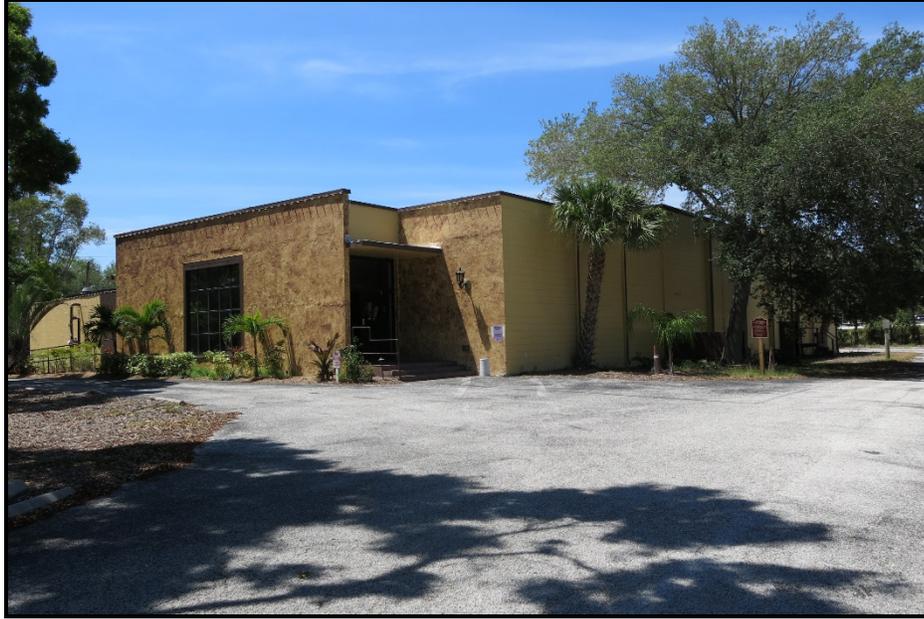
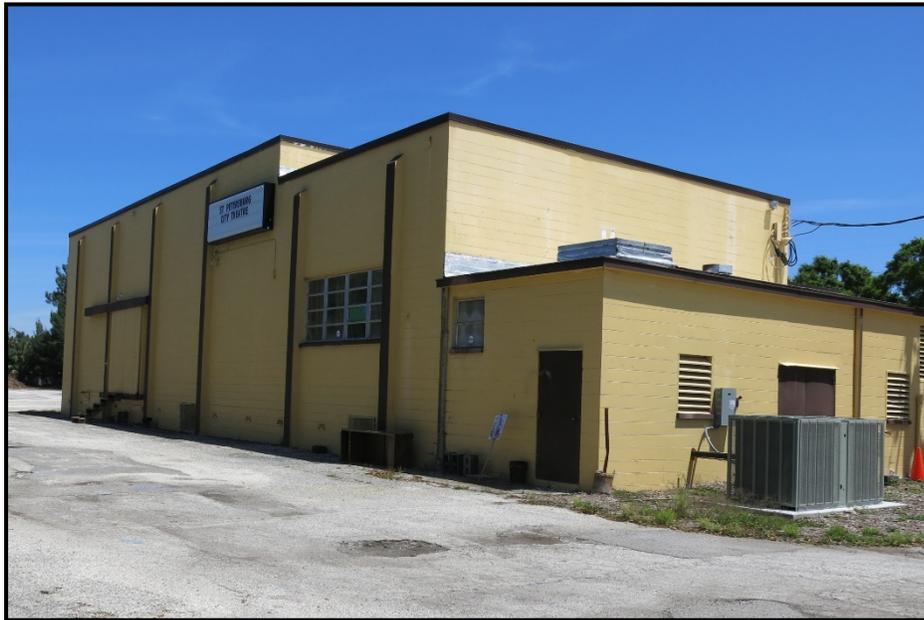
Photo 9. 4025 31st Street S (8PI13237), facing west.

Photo 10. West elevation of the theatre, facing northeast.

8PI13237: The Masonry Vernacular style theatre at 4025 31st Street S was constructed circa 1955 (**Photos 9-10**). The one-story, irregular plan rests on a continuous foundation of concrete block and has a concrete block structural system partially clad in stucco. The flat roof over the primary mass is covered with built-up membrane. The main entrance is on the north and south elevations through double full-view metal frame glass doors with transom and sidelights beneath a flat roof. Windows include individual and paired, metal, two-stacked and grouped (4) four-stacked awning units; and 20-light picture unit. Distinguishing architectural features include buttress, concrete sills, crawl space vents, and wall louvered vents. The building appears to have been reroofed. The building expanded in the 1960s on the south elevation to accommodate for additional rooms and the verandah was enclosed

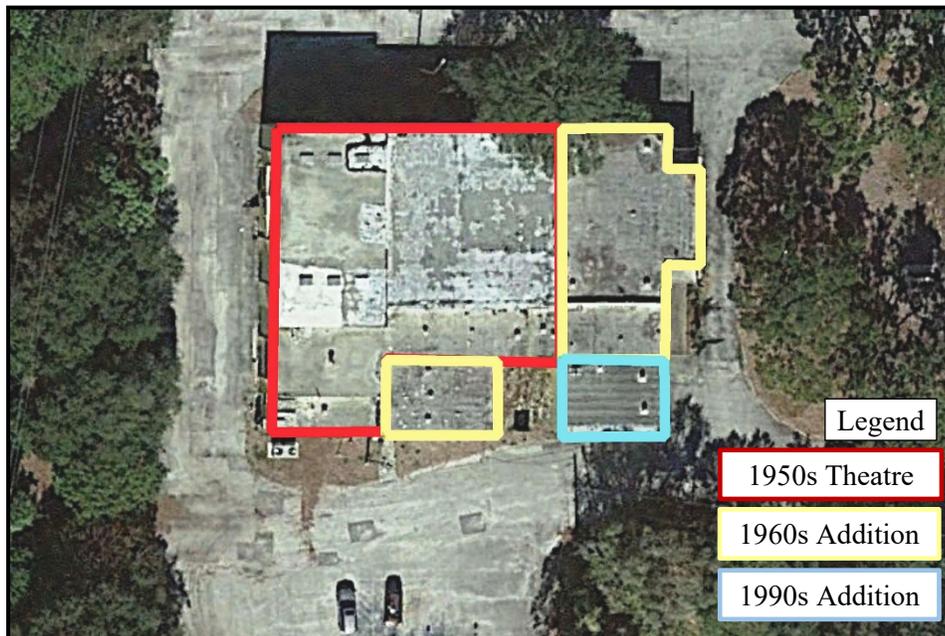
Figure 14. Current aerial of St. Petersburg Theatre showing construction dates for different portions. Google Earth 2019.

Art and culture have played a significant role in the development of St. Petersburg from its inception. The theatre retains significance and integrity as an entertainment and education facility within the community of St. Petersburg. While the property is not the original location affiliated with the establishment of the 1920s theatre, it did become the permanent location of the theatre company that was built in the 1950s. The property continues to play an important role and represents the cultural significance of performing arts within the community. Therefore, the property appears eligible at the local level under Criterion A in the areas of Performing Arts/Theater, Education, and Entertainment. The building, however, does not appear architecturally eligible for listing in the NRHP under Criterion C, either individually or as part of a historic district based on non-historic alterations, lack of sufficient architectural features, and is not a significant embodiment of a type, period, or method of construction.

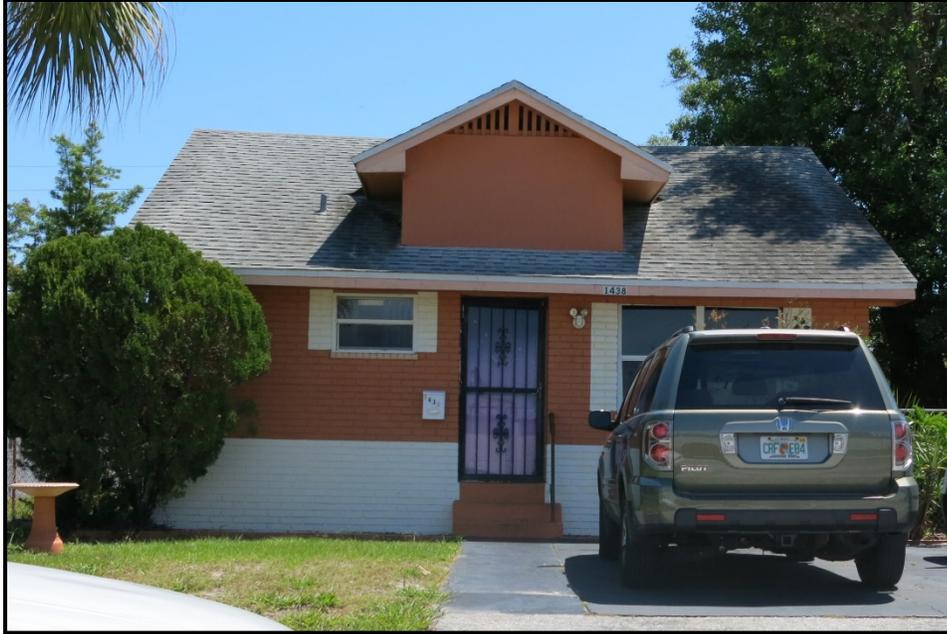
Photo 11. 1438 33rd Street S (8PI13238), facing east.

8PI13238: The Masonry Vernacular style residence at 1438 33rd Street S was constructed circa 1962 (**Photo 11**). The one-story, irregular plan building rests on a continuous foundation of concrete block and has a concrete block structural system clad in stucco and artificial masonry veneer. The cross-gable roof over the principal mass and the gable dormer are clad in composition shingles. The main entrance is on the west elevation through single full-view glass storm door with security grill atop concrete steps with a metal railing. Visible windows include individual and paired, vinyl one-over-one single-hung sash units. Distinguishing features include artificial masonry veneer with painted shutters, minimal roof overhang with boxed eave return, and a gable dormer with vent. The building appears to have been reroofed and has new windows. In addition, the east elevation has a non-historic addition. The building is in good condition and retains some of its original architectural features. Overall, the building has been altered, lacks sufficient architectural features, and is not a significant embodiment of a type, period, or method of construction. In addition, background research did not reveal any historic associations with significant persons and/or events. As a result, 8PI13238 does not appear eligible for listing in the NRHP, either individually or as part of a historic district.

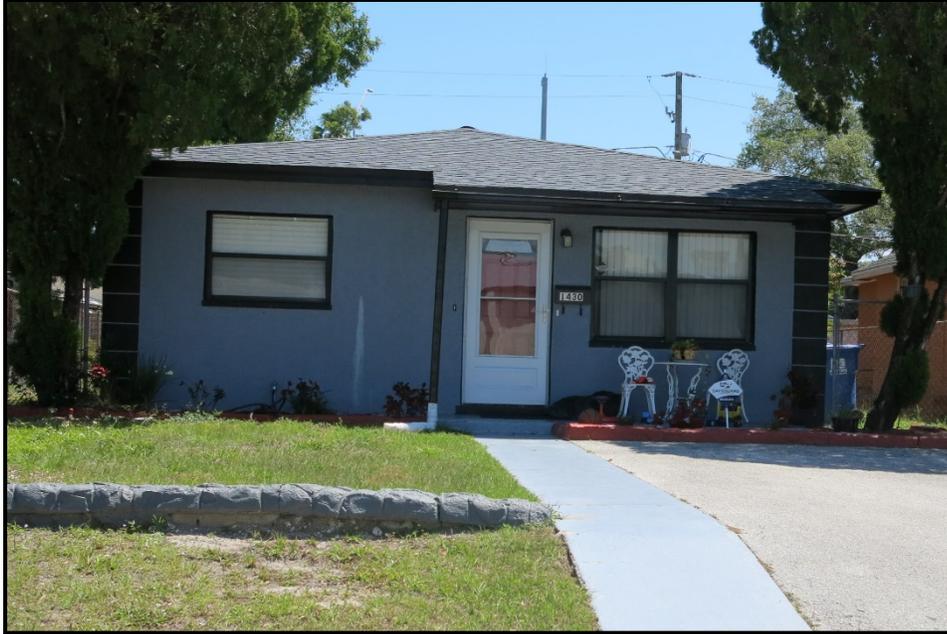
Photo 12. 1430 33rd Street S (8PI13239), facing east.

8PI13239: The Masonry Vernacular style residence at 1430 33rd Street S was constructed circa 1963 (**Photo 12**). The one-story, irregular plan building rests on a continuous foundation of concrete block and has a concrete block structural system clad in stucco. The hip roof over the principal mass is clad in composition shingles. The main entrance is on the west elevation through a single storm door and panel door with a fanlight, within an open, partial-width porch with a concrete stoop beneath the principal roof overhang. Visible windows include individual and paired, vinyl one-over-one single-hung sash units. Distinguishing features include quoining and minimal roof overhang with boxed rafter. The building appears to have been reroofed and has new windows. The building is in good condition and retains some of its original architectural features. Overall, the building has been altered, lacks sufficient architectural features, and is not a significant embodiment of a type, period, or method of construction. In addition, background research did not reveal any historic associations with significant persons and/or events. As a result, 8PI13239 does not appear eligible for listing in the NRHP, either individually or as part of a historic district.

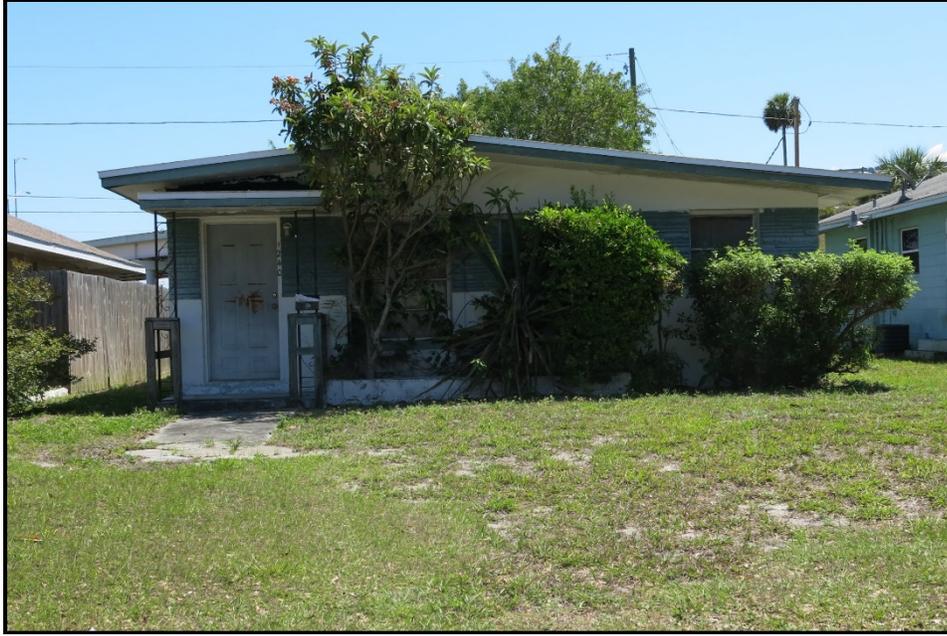
Photo 13. 1240 Fargo Street S (8PI13240), facing east.

8PI13240: The Masonry Vernacular style residence at 1240 Fargo Street S was constructed circa 1959 (**Photo 13**). The one-story, irregular plan building rests on a concrete slab foundation and has a concrete block structural system partially clad in artbrick. The gable roof over the principal mass is clad in built-up membrane. The main entrance is on the west elevation through a single panel door within an open, partial-width porch with a concrete stoop beneath a flat roof and the principal roof overhang. A utility room is attached to the south elevation beneath the principal roof. Visible windows include individual, aluminum, one-over-one single-hung sash; individual, aluminum, four-stacked awning; and individual, aluminum, nine-stacked jalousie units. Distinguishing features include artbrick partially clad on facade, roof overhang with boxed rafters, and concrete sills. The building appears to have been reroofed. The building is in good condition and retains some of its original architectural features. Overall, the building has been altered, lacks sufficient architectural features, and is not a significant embodiment of a type, period, or method of construction. In addition, background research did not reveal any historic associations with significant persons and/or events. As a result, 8PI13240 does not appear eligible for listing in the NRHP, either individually or as part of a historic district.

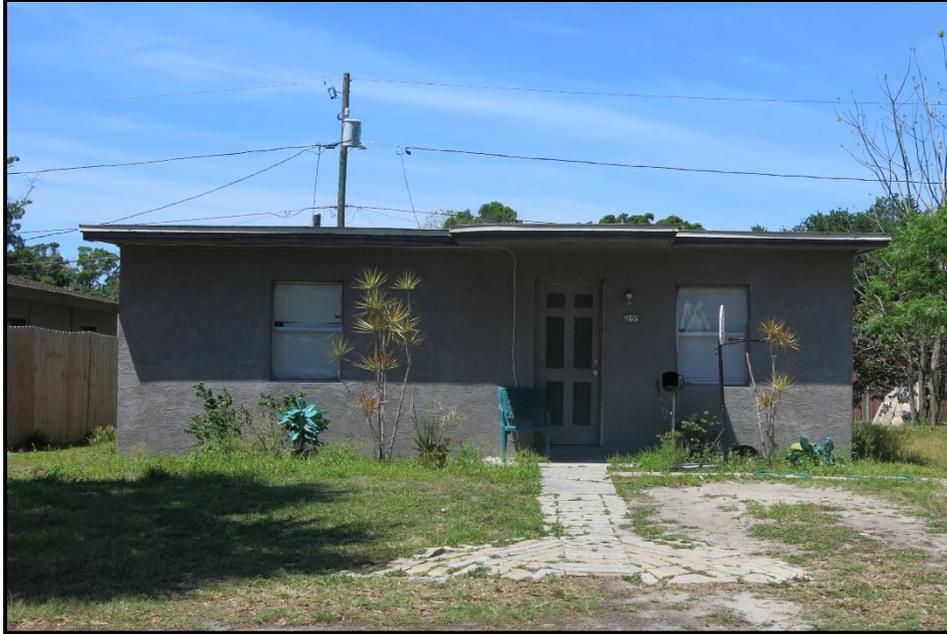
Photo 14. 1155 32nd Street S (8PI13241), facing west.

8PI13241: The Masonry Vernacular style residence at 1155 32nd Street S was constructed circa 1958 (**Photo 14**). The one-story, rectangular plan building rests on a concrete slab foundation and has a concrete block structural system clad in stucco. The flat roof over the principal mass is clad in built-up membrane. The main entrance is on the east elevation through a single panel door beneath a flat roof overhang. Visible windows include individual, one-over-one single-hung sash units. Distinguishing features include roof overhang with boxed rafters. The building appears to have been reroofed. Overall, the building has been altered, lacks sufficient architectural features, and is not a significant embodiment of a type, period, or method of construction. In addition, background research did not reveal any historic associations with significant persons and/or events. As a result, 8PI13241 does not appear eligible for listing in the NRHP, either individually or as part of a historic district.

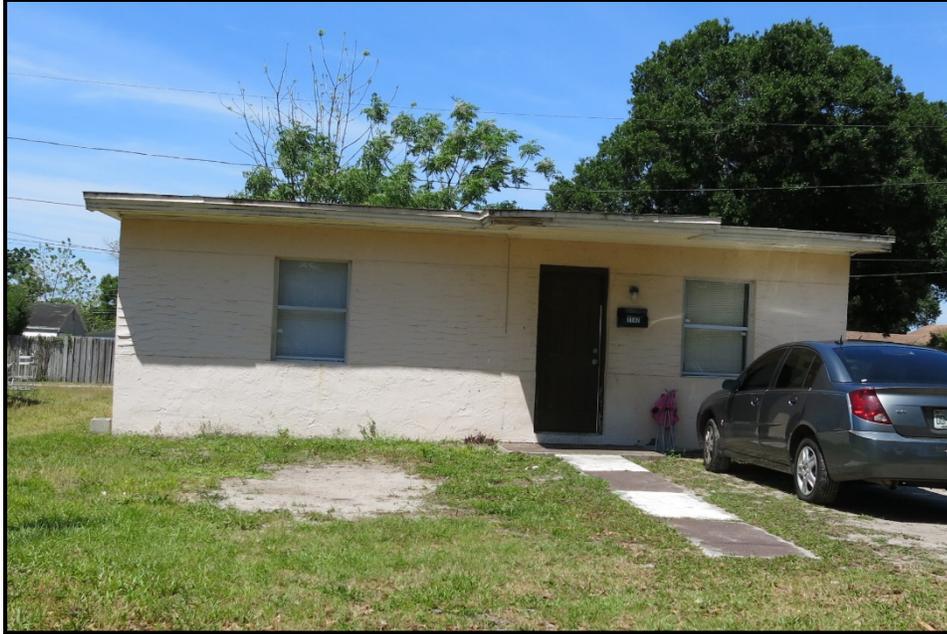
Photo 15. 1147 32nd Street S (8PI13242), facing west.

8PI13242: The Masonry Vernacular style residence at 1147 32nd Street S was constructed circa 1958 (**Photo 15**). The one-story, rectangular plan building rests on a concrete slab foundation and has a concrete block structural system clad in stucco. The flat roof over the principal mass is clad in built-up membrane. The main entrance is on the east elevation through a single panel door beneath a flat roof overhang. Visible windows include individual, one-over-one single-hung sash units. Distinguishing features include roof overhang with boxed rafters. The building appears to have been reroofed. Overall, the building has been altered, lacks sufficient architectural features, and is not a significant embodiment of a type, period, or method of construction. In addition, background research did not reveal any historic associations with significant persons and/or events. As a result, 8PI13242 does not appear eligible for listing in the NRHP, either individually or as part of a historic district.

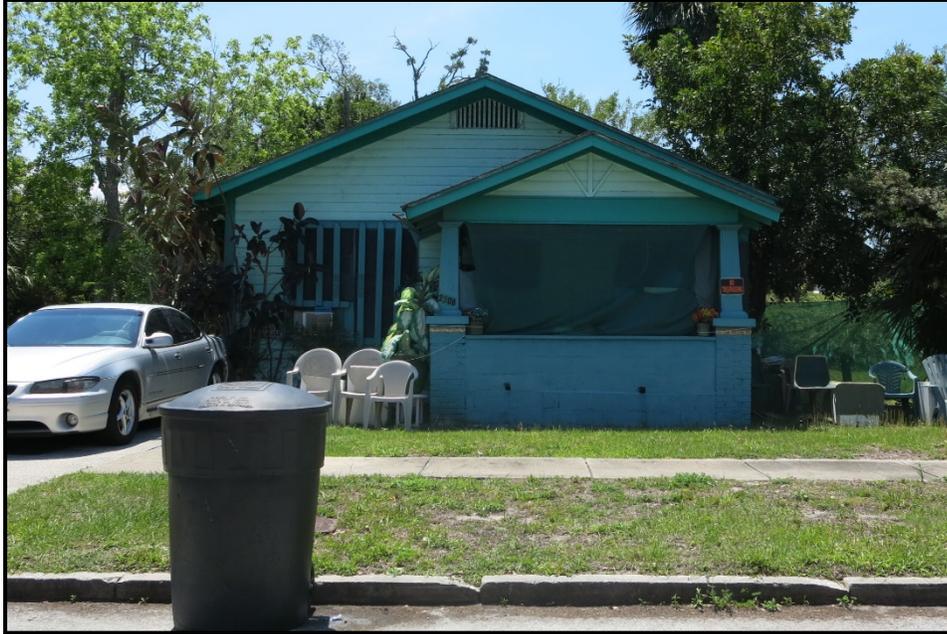
Photo 16. 2308 7th Avenue S (8PI11652), facing south.

8PI11652: The Frame Vernacular style residence at 2308 7th Avenue S was constructed circa 1925 and is adjacent to proposed Pond 7B (**Photo 16**). The one-story, rectangular plan building rests on a pier foundation of concrete block and has a wood-frame structural system clad in wood siding. The front-gabled roof is clad in composition shingles. The main entrance is on the north elevation through single door within an open, partial-width porch with brick piers topped with tapered square columns. An enclosed, partial-width porch beneath the principal roof is located on the south elevation. Visible windows include individual one-over-one single-hung sash units; all windows are covered by wooden planks. Distinguishing features include gable end vents, and porch brick piers topped with tapered square columns. The building appears to have been reroofed and has new siding. Overall, the building has been altered, lacks sufficient architectural features, and is not a significant embodiment of a type, period, or method of construction. In addition, background research did not reveal any historic associations with significant persons and/or events. As a result, 8PI11652 does not appear eligible for listing in the NRHP, either individually or as part of a historic district.

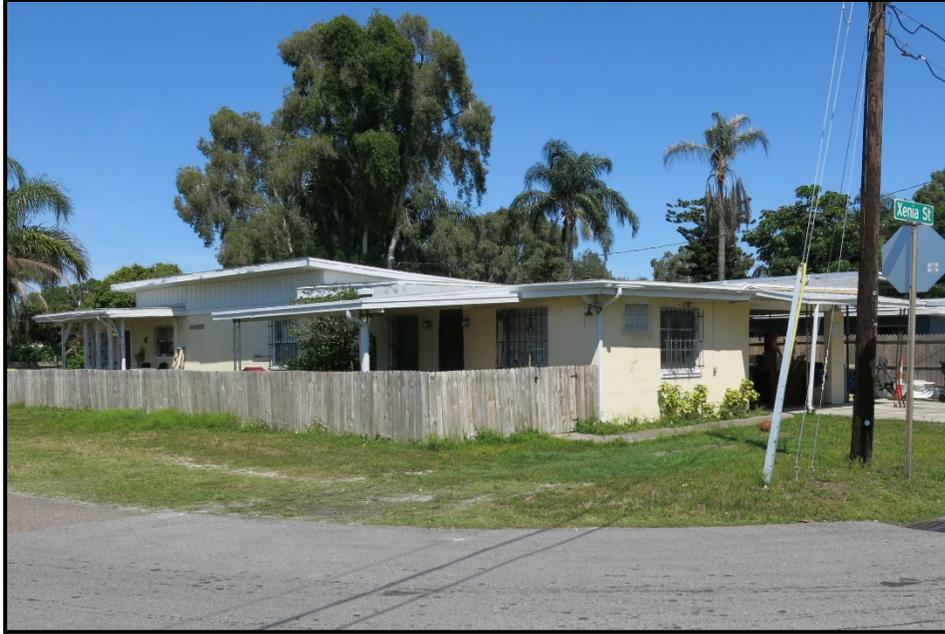
Photo 17. 2435 46th Avenue N (8PI13243), facing west.

8PI13243: The Masonry Vernacular style residence at 2435 46th Avenue N was constructed circa 1952 and is within proposed Pond 16A (**Photo 17**). The one-story, irregular plan building rests on a continuous foundation of concrete block and has a concrete block structural system. The shed and flat roofs over the principal mass are clad in built-up membrane. The main entrance is on the east elevation through single panel door within an attached carport beneath a flat roof with a concrete block square column. Visible windows include individual and paired, aluminum three- and four-stacked awning units, and individual and paired one-over-one and six-over-six single-hung sash units. Distinguishing features include board & batten beneath the shed roof overhang, and security grilles on windows. The building appears to have been reroofed, security grilles added to windows, and one window has been removed and encased with concrete block. Several non-historic additions include, a flat roof metal carport and a metal shed roof on the north elevation; two open porches with flat roofs, one with metal supports and one with wood post supports, on the south elevation; and an enclosed, partial-width porch beneath a flat roof on the west elevation. Overall, the building has been altered, lacks sufficient architectural features, and is not a significant embodiment of a type, period, or method of construction. In addition, background research did not reveal any historic associations with significant persons and/or events. As a result, 8PI13243 does not appear eligible for listing in the NRHP, either individually or as part of a historic district.
