**CULTURAL RESOURCE ASSESSMENT SURVEY
PROPOSED POND SITE ALTERNATIVES AND RE-EVALUATION
TECHNICAL MEMORANDUM**

**Florida Department of Transportation
District 7
I-275 (SR 93) Design Change Re-evaluation
Project Development and Environment Study
from south of 54th Avenue South to north of 4th Street North
Pinellas County, Florida**

Prepared by:
Archaeological Consultants, Inc
Sarasota, Florida

AUGUST 2019

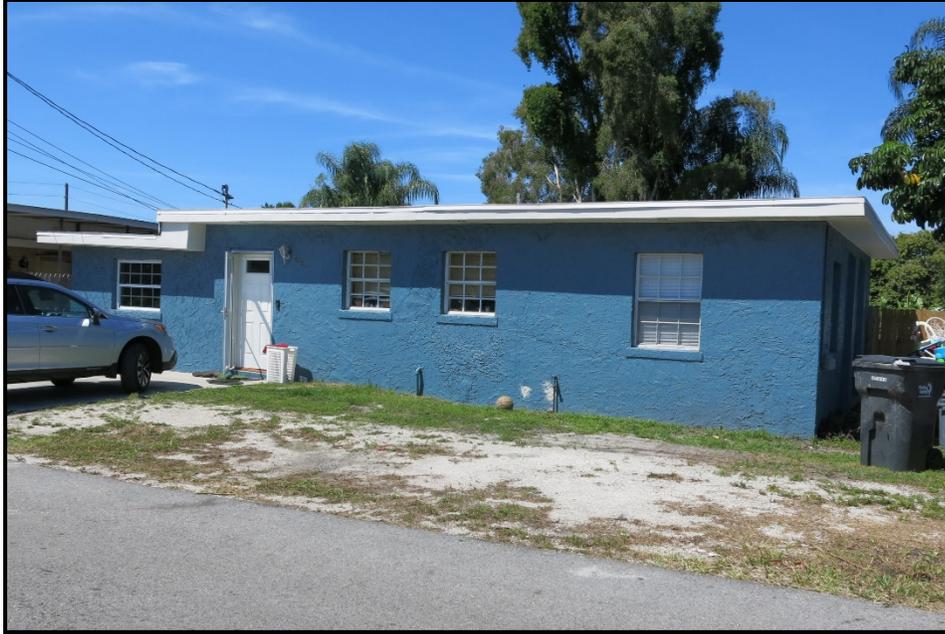
Photo 18. 4600 Xenia Street N (8PI13244), facing southwest.

8PI13244: The Masonry Vernacular style residence at 4600 Xenia Street N was constructed circa 1953 and is within proposed Pond 16A (**Photo 18**). The one-story, irregular plan building rests on a continuous foundation of concrete block and has a concrete block structural system clad in stucco. The flat roof over the principal mass is clad in built-up membrane. The main entrance is on the east elevation through a single panel door with one-light beneath the principal roof overhang. Visible windows include individual six-over-six single-hung sash units. Distinguishing features include broad flat roof overhang. The building alterations include reroofing, new windows, and the attached carport was enclosed. A non-historic addition with a gable roof is located on the west elevation. Overall, the building has been altered, lacks sufficient architectural features, and is not a significant embodiment of a type, period, or method of construction. In addition, background research did not reveal any historic associations with significant persons and/or events. As a result, 8PI13244 does not appear eligible for listing in the NRHP, either individually or as part of a historic district.

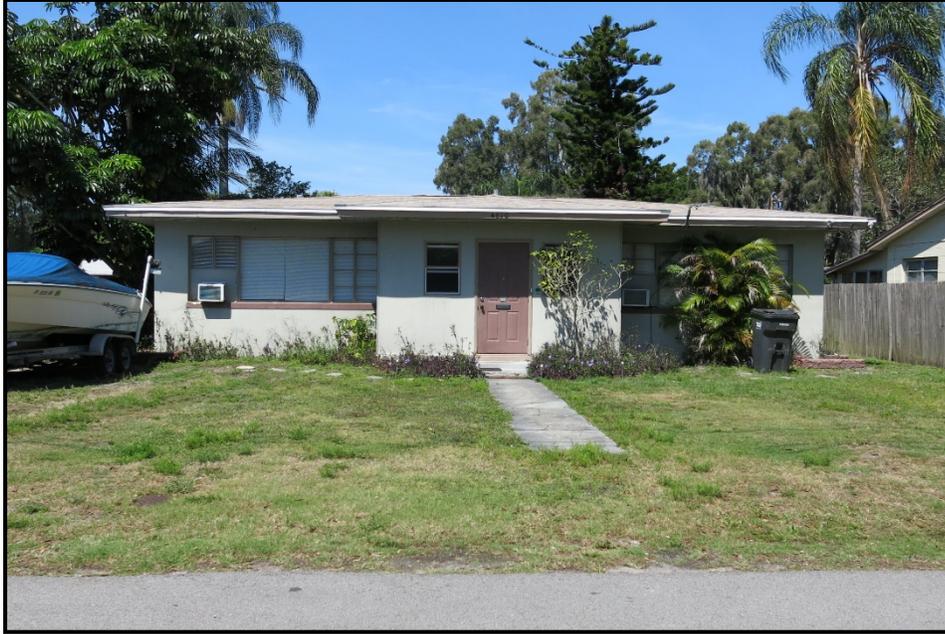
Photo 19. 4610 Xenia Street N (8PI13245), facing west.

8PI13245: The Masonry Vernacular style residence at 4610 Xenia Street N was constructed circa 1953 and is within proposed Pond 16A (**Photo 19**). The one-story, rectangular plan building rests on a concrete slab foundation and has a concrete block structural system clad in stucco and the enclosed porch is clad in wood siding. The hip roof over the principal mass is clad in composition shingles. The main entrance is on the east elevation through a single panel door beneath a hip roof that enters into an enclosed partial-width porch. Visible windows include picture with a central pane flanked by paired four-stacked casement units, and individual one-over-one single-hung sash units. Distinguishing features include roof overhang, concrete sills, and picture window units. Building alterations include reroofing. Overall, the building has been altered, lacks sufficient architectural features, and is not a significant embodiment of a type, period, or method of construction. In addition, background research did not reveal any historic associations with significant persons and/or events. As a result, 8PI13245 does not appear eligible for listing in the NRHP, either individually or as part of a historic district.

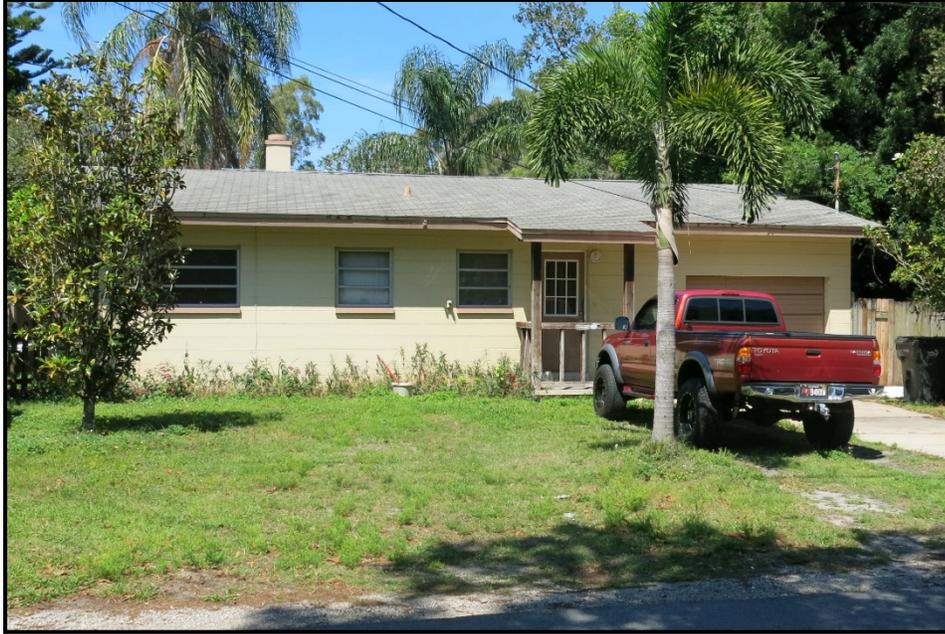
Photo 20. 4614 Xenia Street N (8PI13246), facing west.

8PI13246: The Masonry Vernacular style residence at 4614 Xenia Street N was constructed circa 1959 and is within proposed Pond 16A (**Photo 20**). The one-story, rectangular plan building rests on a concrete slab foundation and has a concrete block structural system. The side-gabled roof over the principal mass is clad in composition shingles. The main entrance is on the east elevation through a single panel door with nine-light beneath a shed roof extension with wood post supports. Visible windows include individual, aluminum three-stacked awning units. Distinguishing features include roof overhang and concrete sills. Building alterations include reroofing. The building has an attached garage beneath the principal roof on the north elevation. Overall, the building has been altered, lacks sufficient architectural features, and is not a significant embodiment of a type, period, or method of construction. In addition, background research did not reveal any historic associations with significant persons and/or events. As a result, 8PI13246 does not appear eligible for listing in the NRHP, either individually or as part of a historic district.

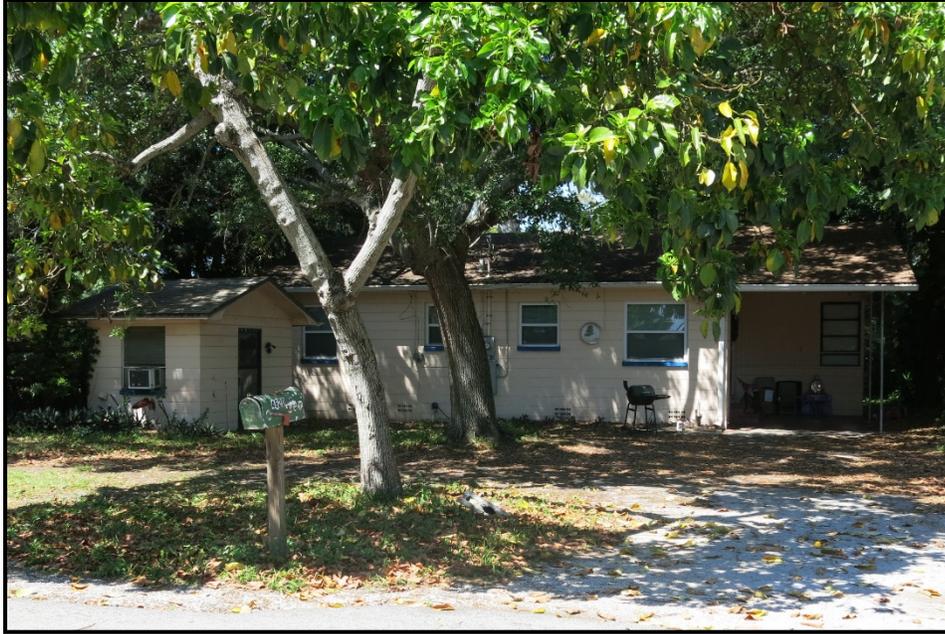
Photo 21. 4620 Xenia Street N (8PI13247), facing west.

8PI13247: The Masonry Vernacular style residence at 4620 Xenia Street N was constructed circa 1957 and is within proposed Pond 16A (**Photo 21**). The one-story, rectangular plan building rests on a continuous foundation of concrete block and has a concrete block structural system. The side-gabled roof over the principal mass is clad in composition shingles. The main entrance is on the north elevation through a single door within an attached carport beneath the principal roof. Visible windows include individual, one-over-one single-hung sash units. Distinguishing features include roof overhang, concrete sills, crawl space vents. Building alterations include reroofing and new windows. A 1975 concrete block shed is located on the east elevation. Overall, the building has been altered, lacks sufficient architectural features, and is not a significant embodiment of a type, period, or method of construction. In addition, background research did not reveal any historic associations with significant persons and/or events. As a result, 8PI13247 does not appear eligible for listing in the NRHP, either individually or as part of a historic district.

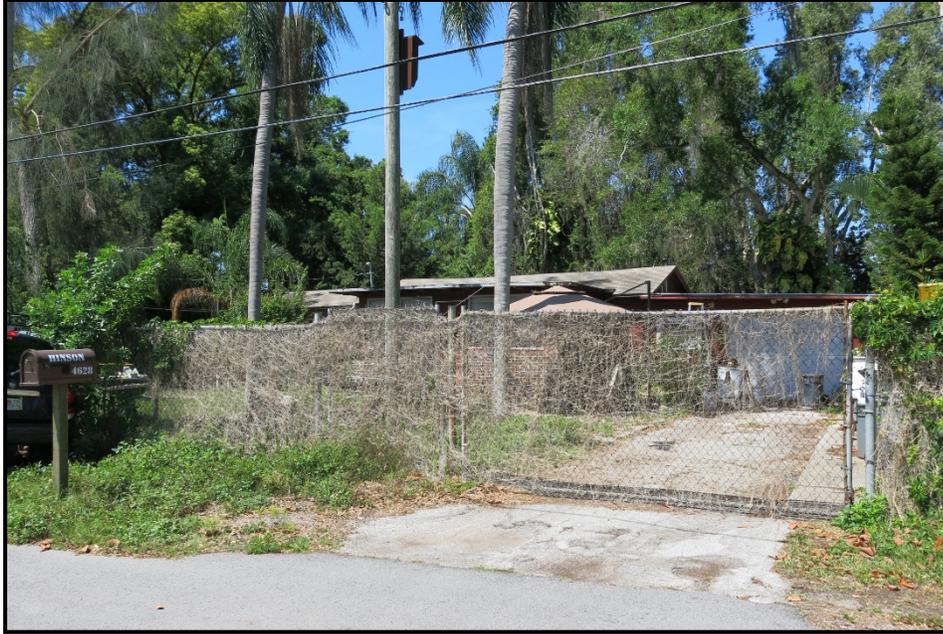
Photo 22. 4628 Xenia Street N (8PI13248), facing west.

8PI13248: The Frame Vernacular style residence at 4628 Xenia Street N was constructed circa 1950 and is within proposed Pond 16A (**Photo 22**). The one-story, irregular plan building rests on a pier foundation of concrete block and has a wood-frame structural system clad in drop siding. The side-gabled roof over the principal mass is clad in composition shingles. The addition on the east elevation is partially clad in artbrick and stucco with a flat roof clad in built-up membrane. The main entrance is on the east elevation through a single panel door beneath the flat roof overhang. Visible windows include individual, one-over-one single-hung sash units, and individual and paired, aluminum, three-stacked awning units. Distinguishing features include gable end vents, artbrick base, and roof overhang with exposed rafters. Building alterations include reroofing. A dilapidated wood-frame shed is located on the north elevation. Overall, the building has been altered, lacks sufficient architectural features, and is not a significant embodiment of a type, period, or method of construction. In addition, background research did not reveal any historic associations with significant persons and/or events. As a result, 8PI13248 does not appear eligible for listing in the NRHP, either individually or as part of a historic district.
