CULTURAL RESOURCE ASSESSMENT SURVEY UPDATE TECHNICAL MEMORANDUM

**I-275 (SR 93) from North of Dr. Martin Luther King, Jr. (MLK)
Boulevard (SR 574) to North of Bearss Avenue (SR 678/ CR 582)
Project Development and Environment (PD&E) Study
Hillsborough County**

**Proposed Stormwater Management Facility (SMF) Sites
SMF 14B and 15B**

**Work Program Item Segment No.: 431821-1
Federal Aid Project No.: TBD**

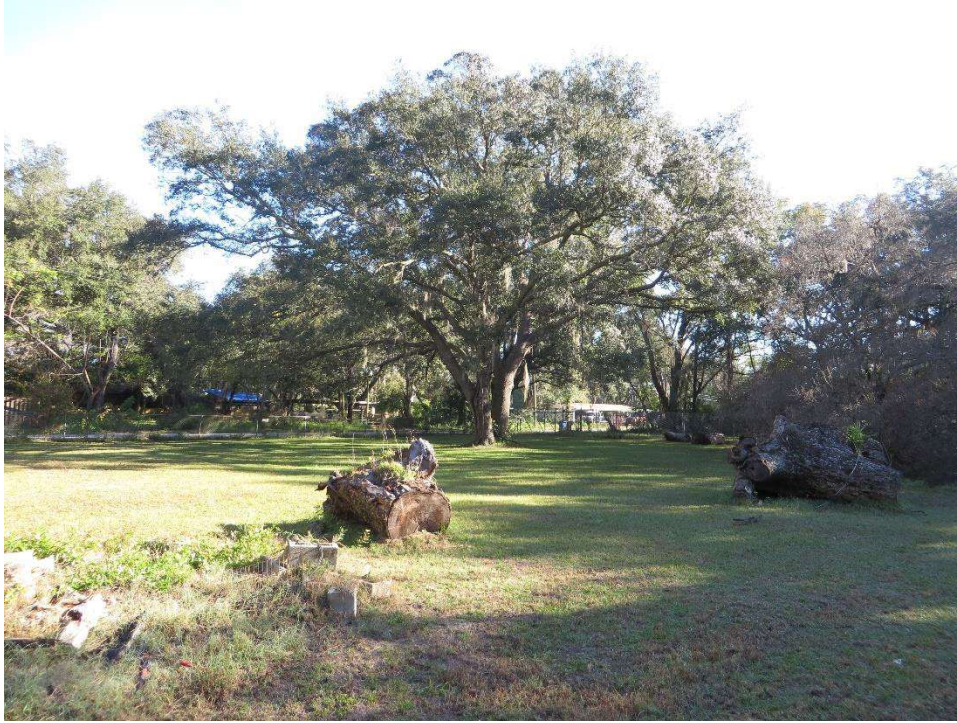
Figure 5: Project Setting for Proposed SMF 14B, Looking North Toward April Lane from Center of Parcel

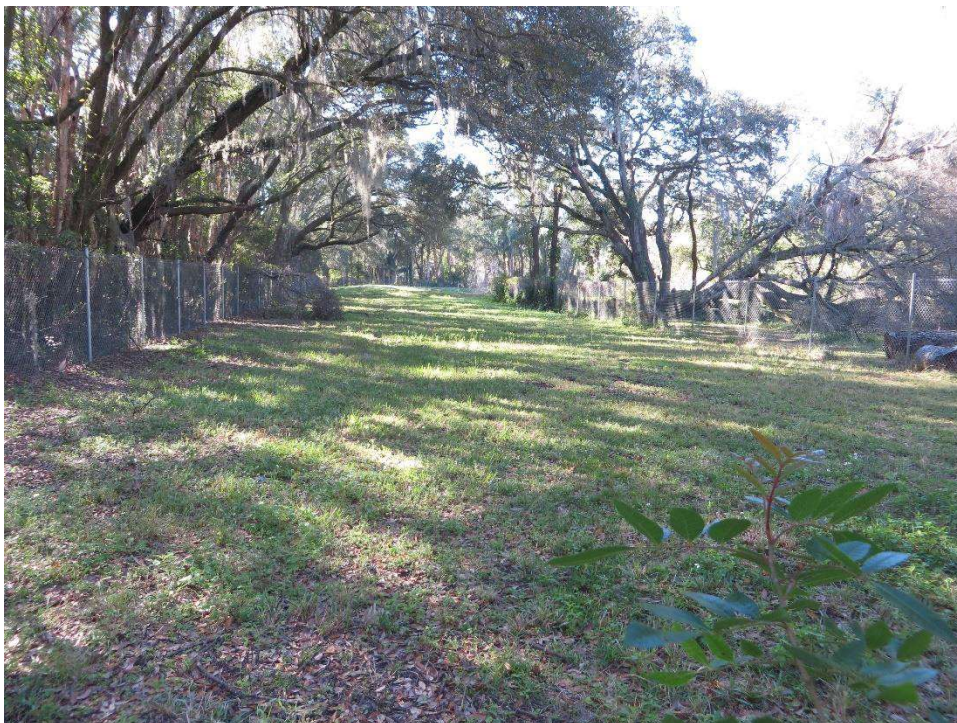
Figure 6: Project Setting for Proposed SMF 14B, Looking South within the Fenced Area at the East Side of the Parcel (Note: This area was not accessible)

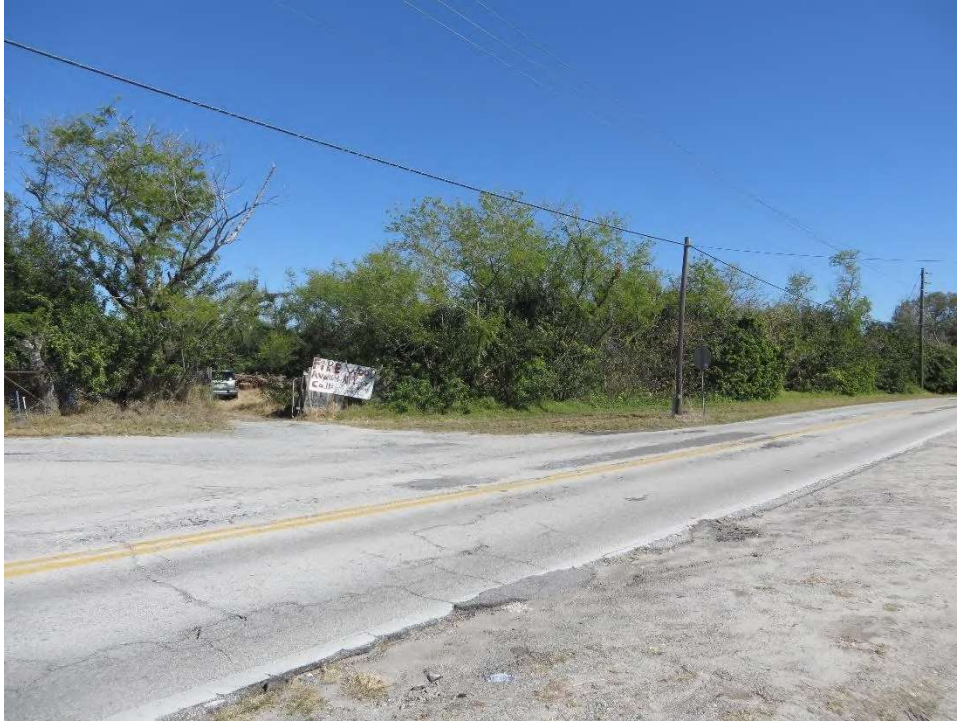
Figure 7: Project Setting for Proposed SMF 15B, Looking Northeast Toward Parcel from Sinclair Hills Road (Note: Heavy vegetation surrounding the parcel)

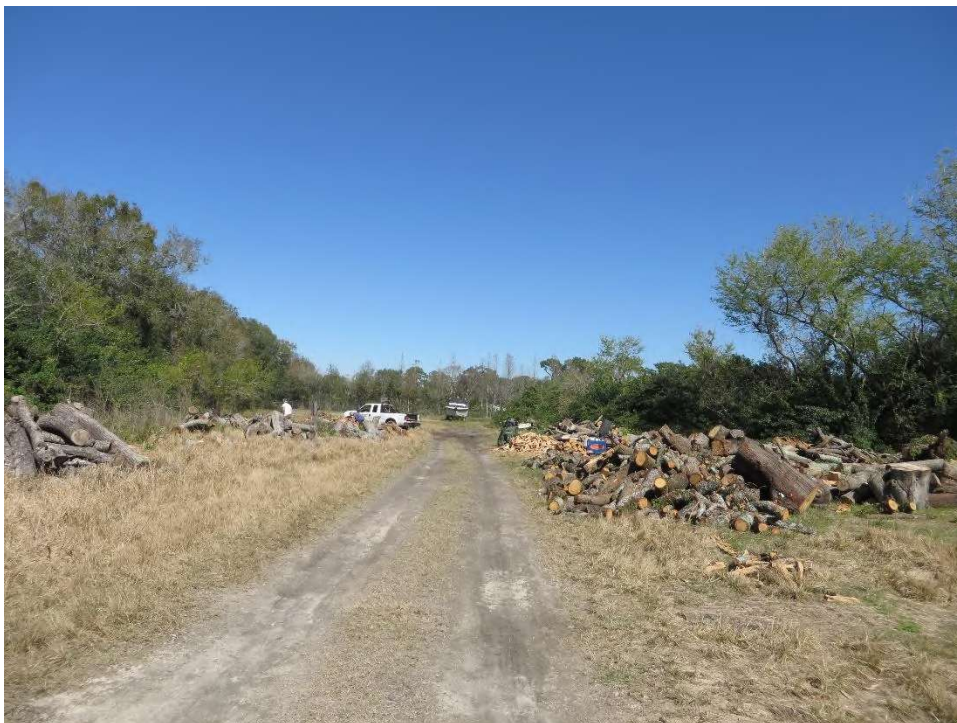
Figure 8: Project Setting for Proposed SMF 15B, Looking North from the South Entrance to the Parcel (Note: Heavy vegetation surrounding the parcel)

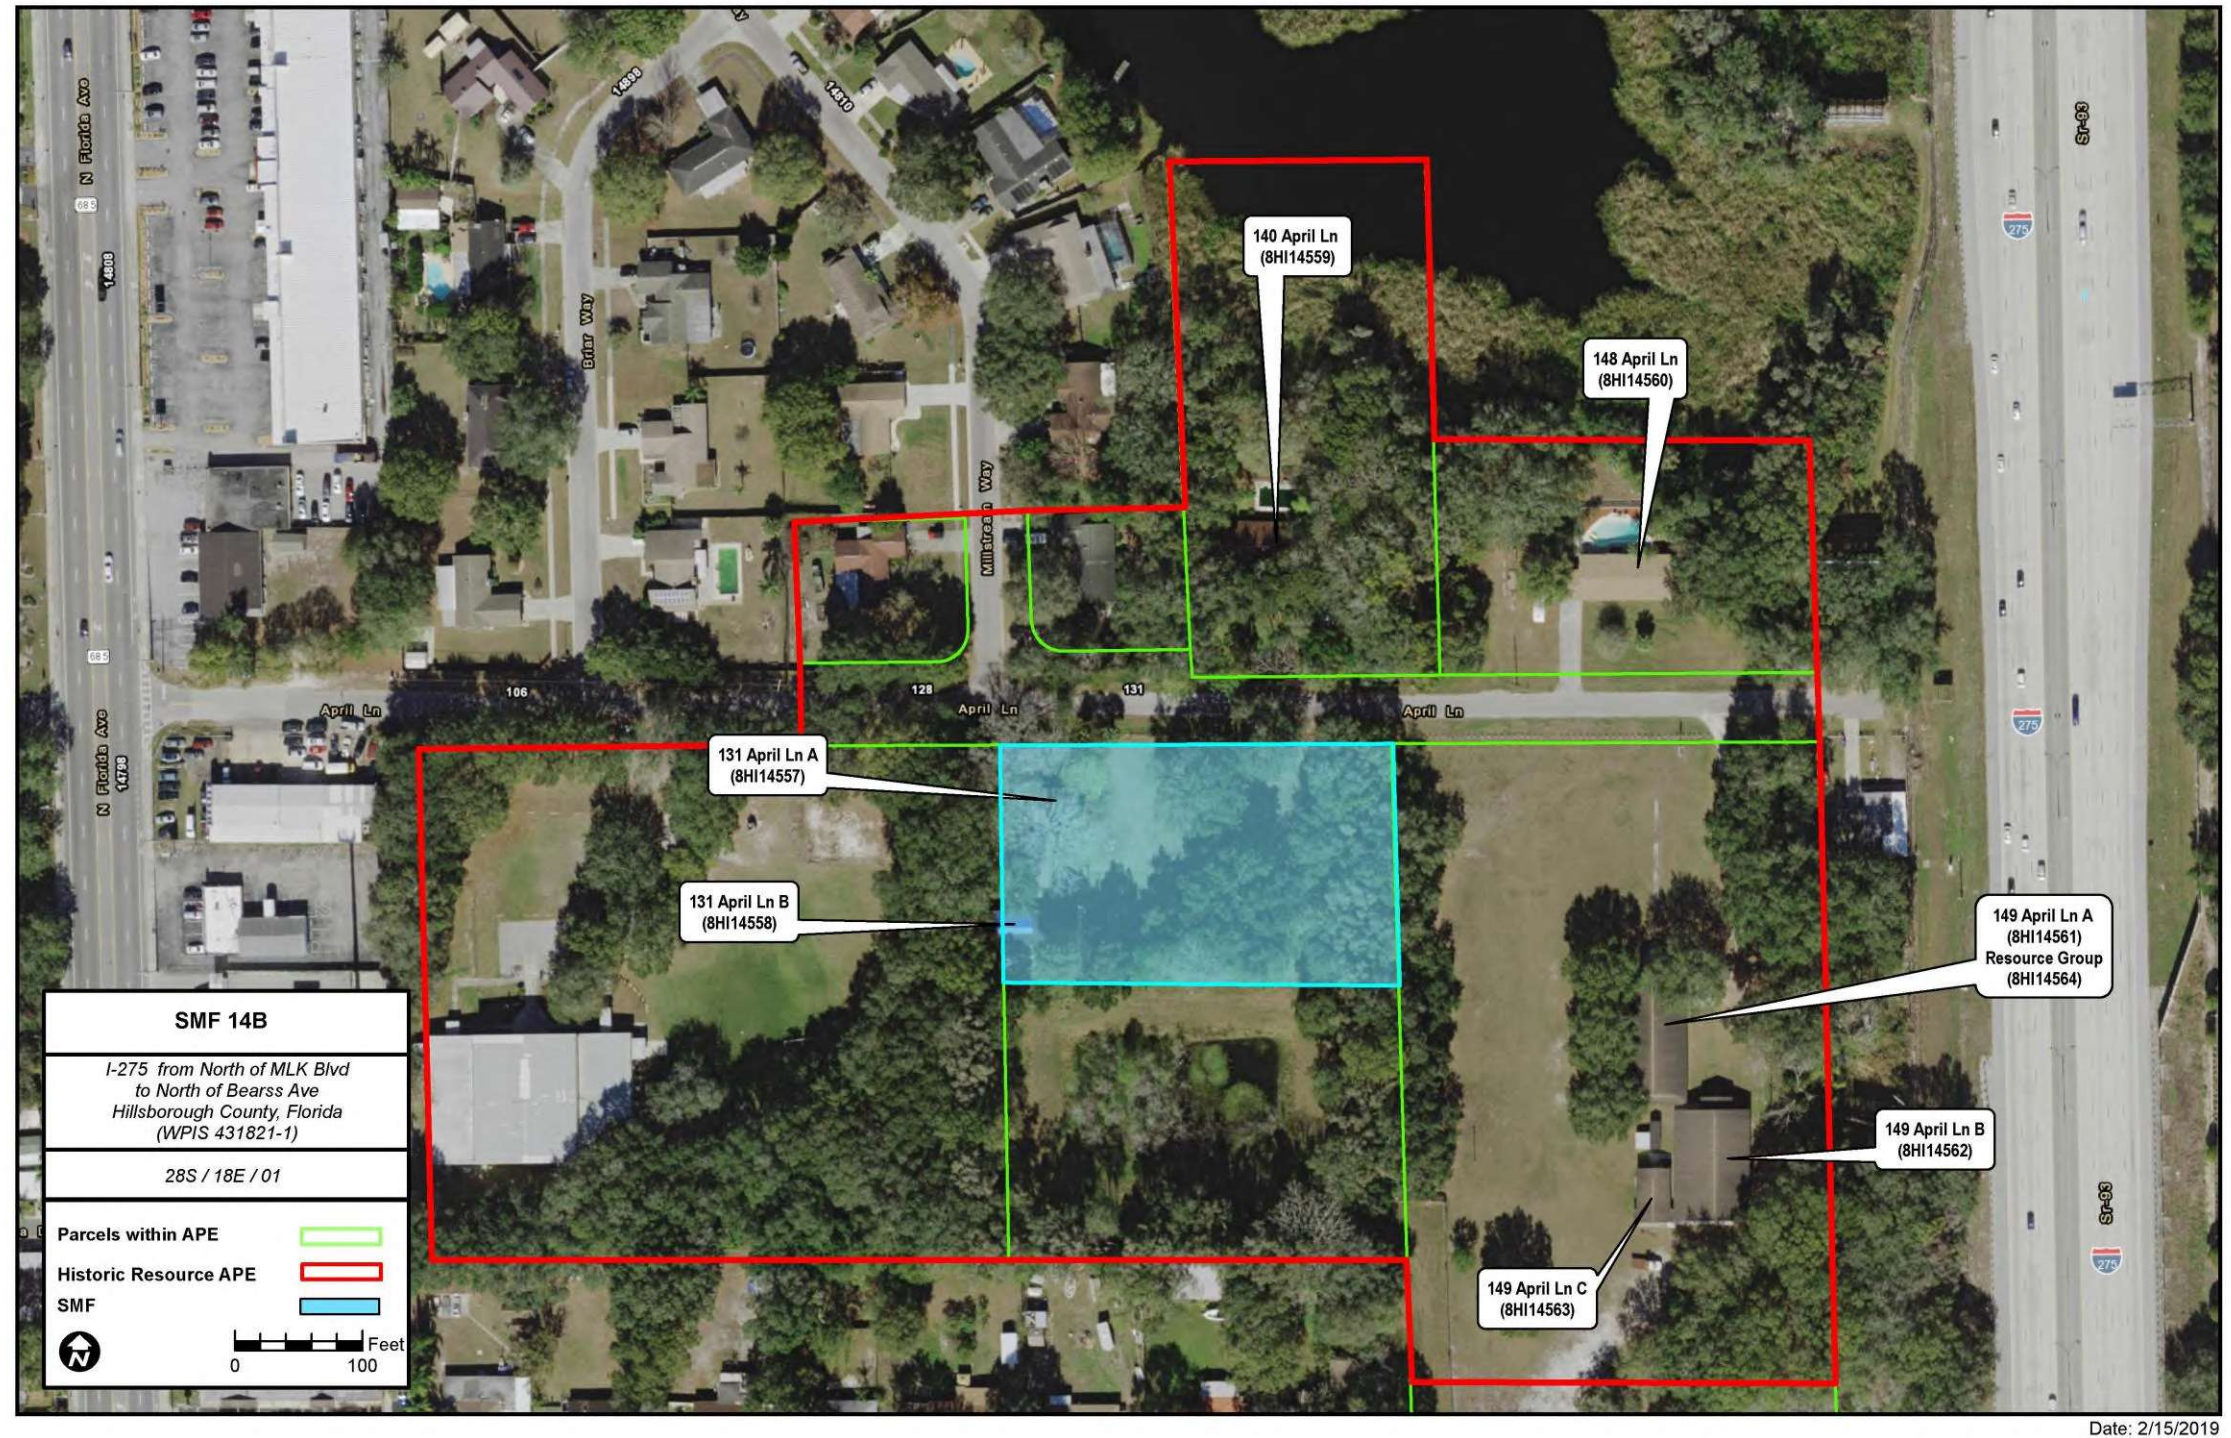
As a result of field survey, eight newly identified historic resources were recorded and evaluated. These include seven historic buildings and one resource group (consisting of three newly recorded historic buildings). See **Table 2 and Figure 10**. Two are located within proposed SMF 14B and the rest are adjacent to proposed SMF 14B but within the historic resources visual APE. No historic resources were identified or recorded within or immediately adjacent to proposed SMF 15B.

Figure 10: Recorded Historic Resources

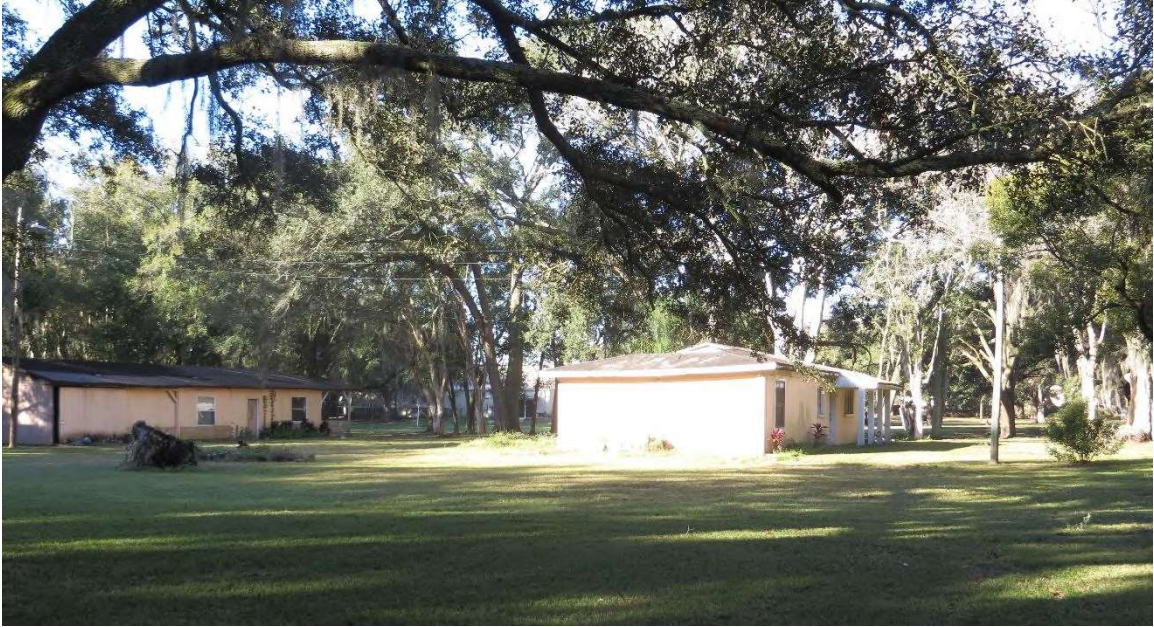
These include two masonry vernacular buildings located at 131 April Lane within proposed SMF 14B that are related to the non-historic church to the west (**Figure 11**). Two masonry vernacular residences are located across the street on the north side of April Lane (**Figures 12 and 13**). The parcel to the east of the proposed SMF 14B contains the Christian Growth Fellowship complex (resource group) consisting of three separate masonry vernacular church related buildings (**Figure 14**). None of these historic resources meet the criteria for listing in the NRHP. FMSF forms are included in **Appendix B**.

Figure 11: 131 April Lane, Looking Southwest

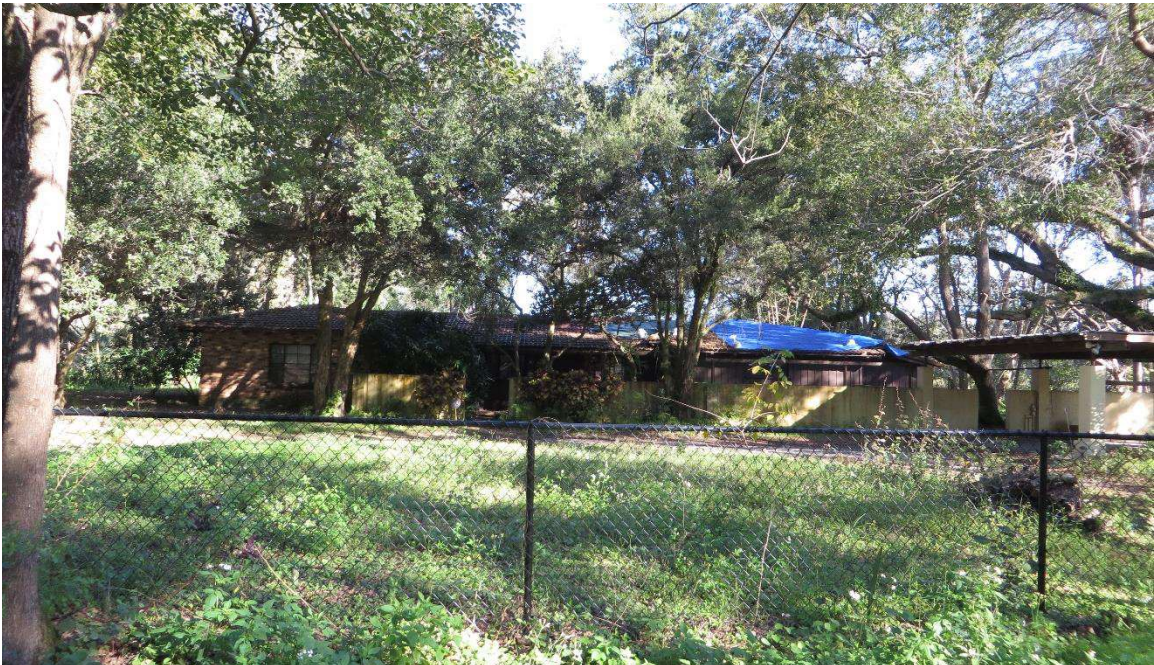
Figure 12: 140 April Lane, Looking North

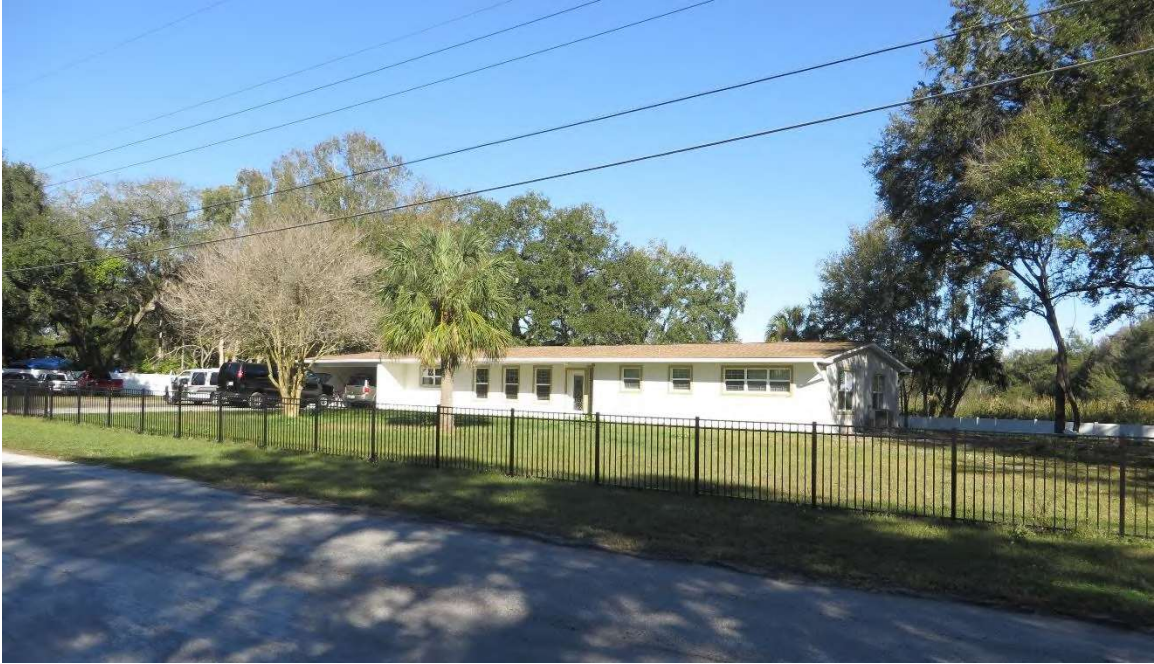
Figure 13: 148 April Lane, Looking Northwest

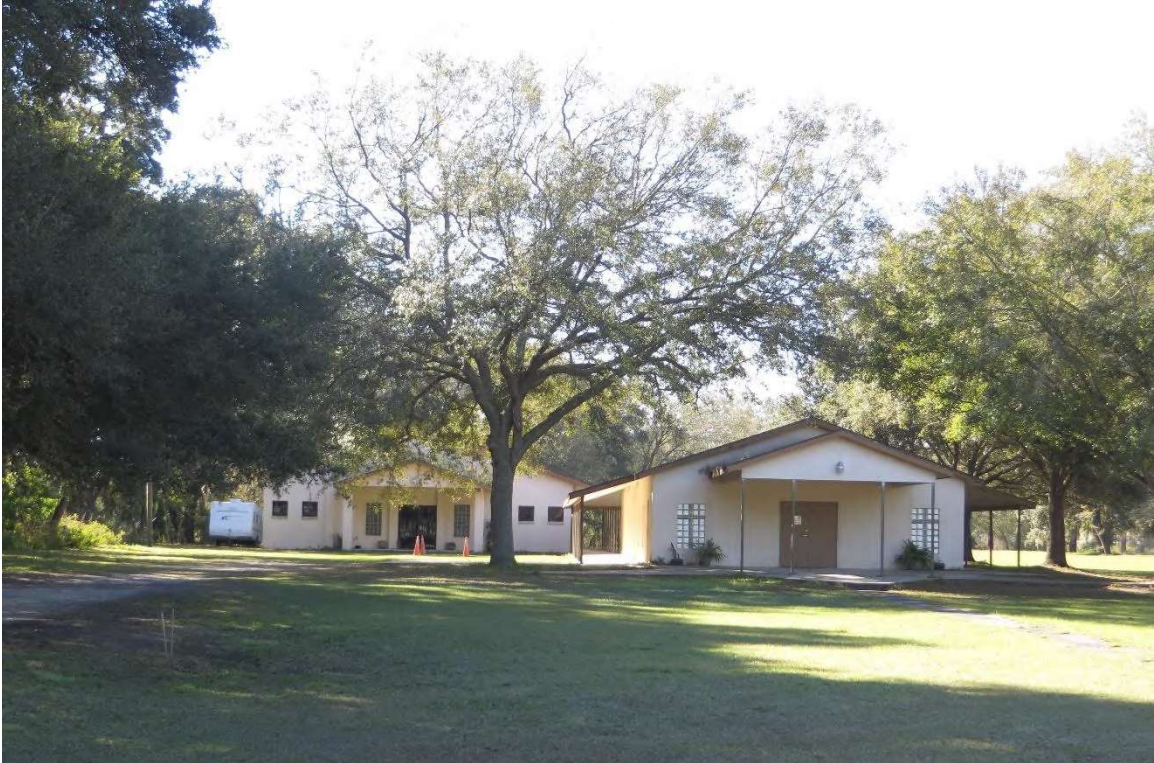
Figure 14: 149 April Lane, Looking South

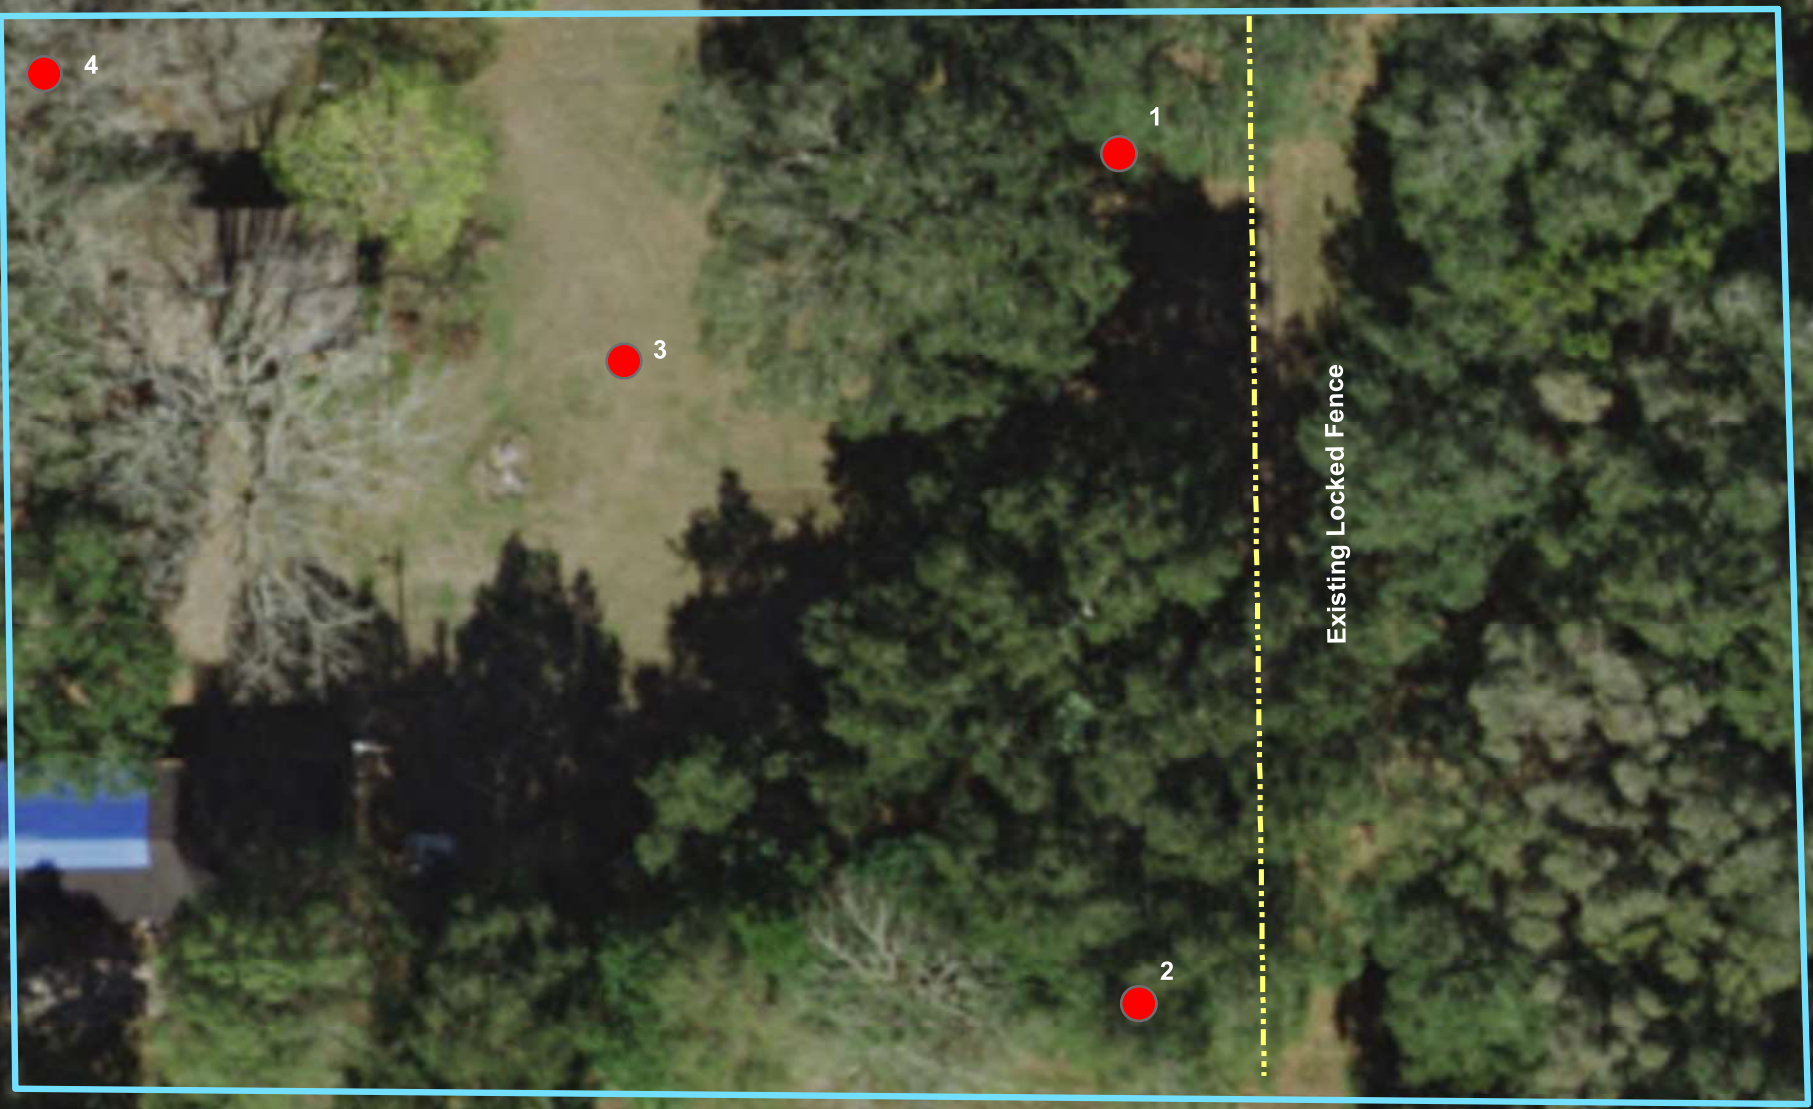
SMF 14B
Shovel Test Map

The southwestern shovel test at SMF 14B is just outside the proposed pond footprint due to existing fill located just south of the structure that is within the southwest corner of the proposed SMF footprint. The eastern portion of the proposed SMF 14B parcel was inaccessible due to a locked fence. The area appeared to be an access road to the existing pond located south of the proposed SMF 14B.

Concentrations of compacted shell and rock fill were observed in three of the four shovel tests excavated at SMF 15B. The shovel tests were terminated several centimeters into the compact fill. The person leasing the parcel had previously noted the heavily compacted fill and mentioned having to use a pickaxe in an attempt to put in post holes. The fourth shovel test in the northwestern corner of the parcel did not display the compact fill and the shovel test was terminated at water.

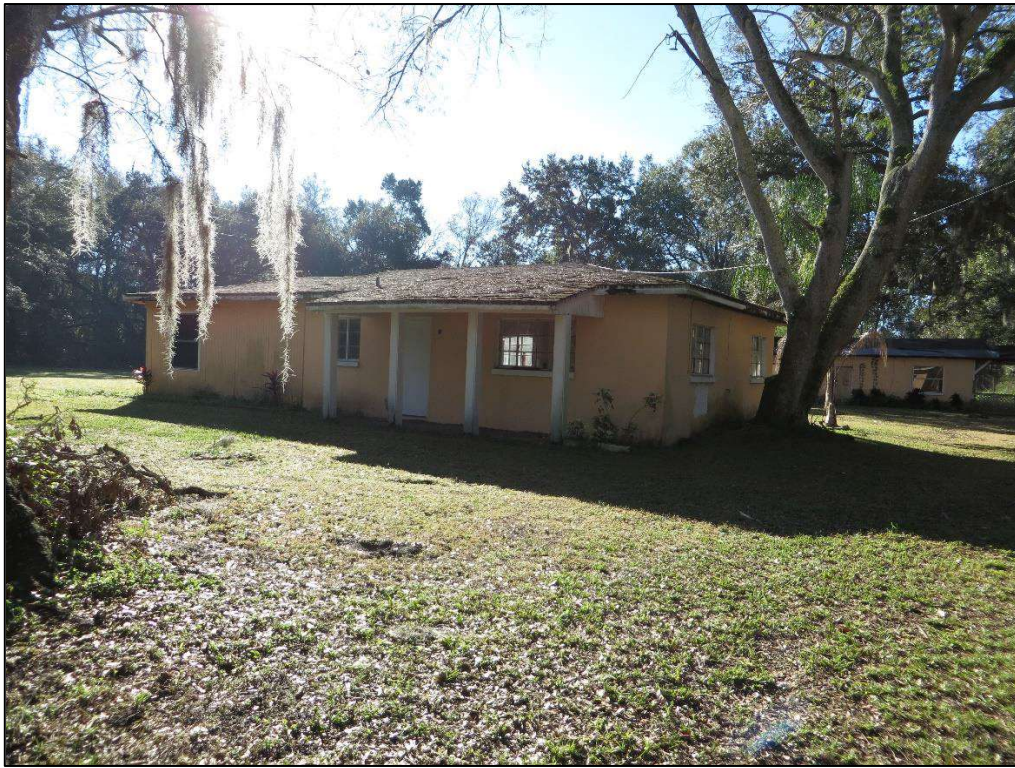
Photograph

Style Masonry Vernacular Exterior Plan Rectangular Number of Stories 1
Exterior Fabric(s) 1. Stucco 2. Wood siding 3. _____
Roof Type(s) 1. Gable 2. Hip 3. _____
Roof Material(s) 1. Composition shingles 2. _____ 3. _____
Roof secondary strucs. (dormers etc.) 1. _____ 2. _____
Windows (types, materials, etc.) Replacement metal 1/1 single-hung sash; metal six-light casement
Distinguishing Architectural Features (exterior or interior ornaments) Concrete sills beneath windows

Chimney: No. 0 Chimney Material(s): 1. 2.
Structural System(s): 1. Concrete block 2. 3.
Foundation Type(s): 1. Slab 2.
Foundation Material(s): 1. Poured Concrete Footing 2.
Main Entrance (stylistic details) Located within north porch extension; replacement wood door

Condition (overall resource condition): [] excellent [] good [x] fair [] deteriorated [] ruinous

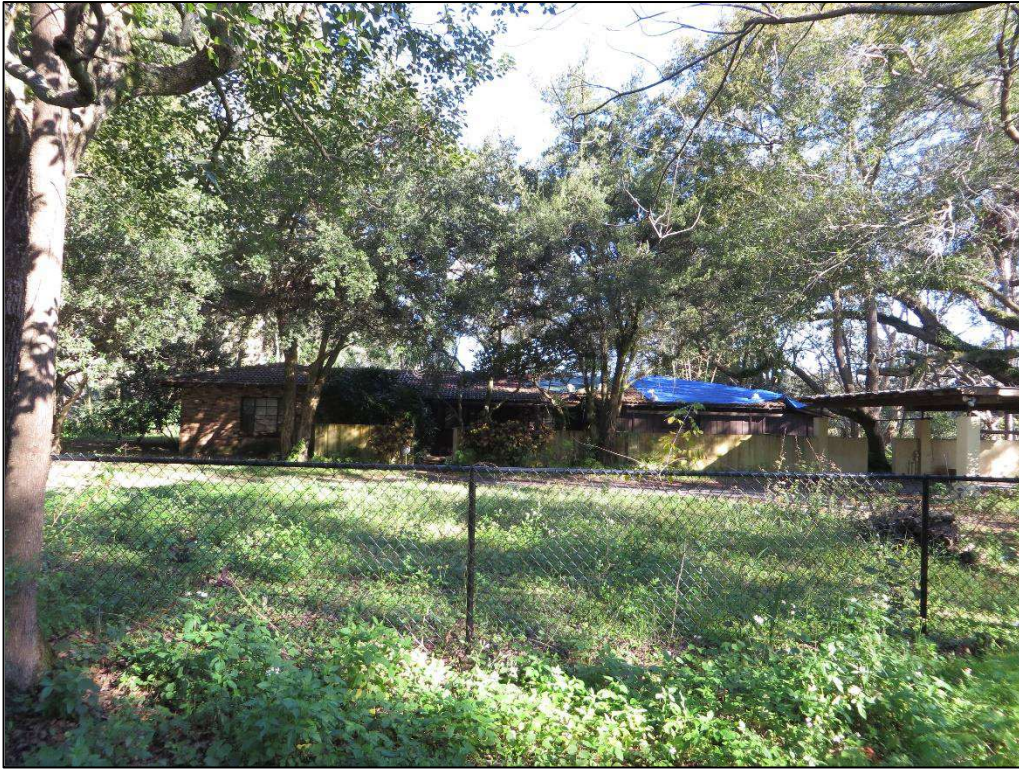
Photograph

Chimney: No. 1 Chimney Material(s): 1. Brick 2.
Structural System(s): 1. Concrete block 2. Wood frame 3.
Foundation Type(s): 1. Unknown 2.
Foundation Material(s): 1. 2.
Main Entrance (stylistic details) Located at south side but not visible from the right-of-way

Condition (overall resource condition): []excellent [x]good []fair []deteriorated []ruinous
Narrative Description of Resource This residence exhibits good integrity but is a typical post-World War II Masonry Vernacular building.

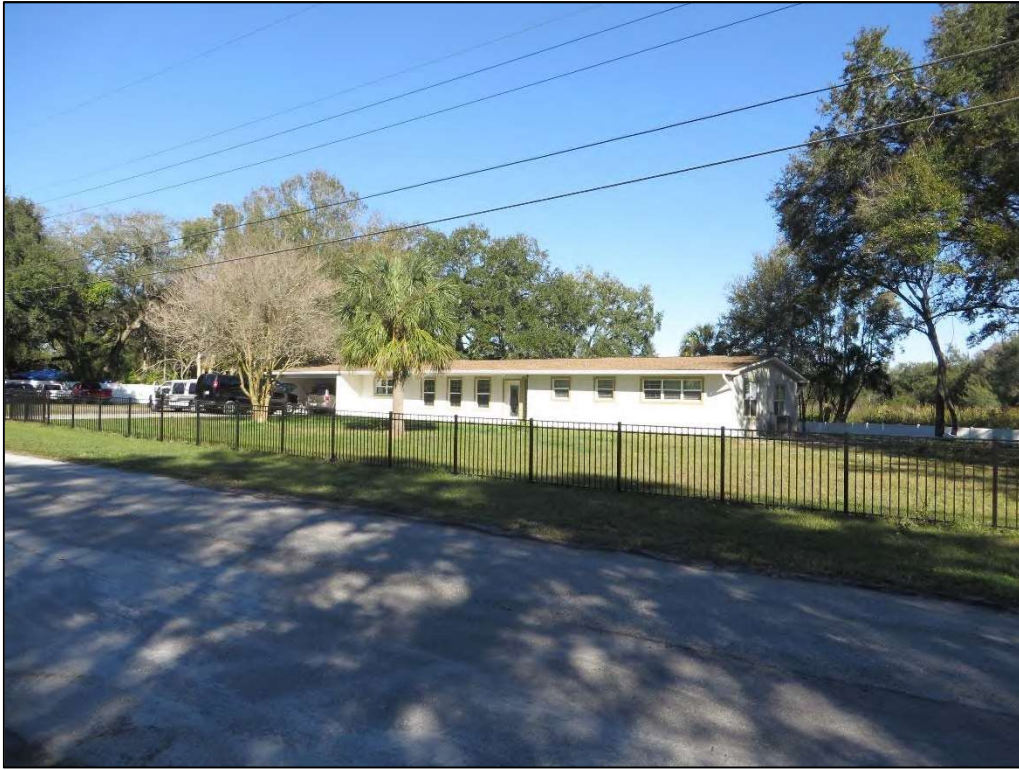
Photograph

Style Masonry Vernacular Exterior Plan Irregular Number of Stories 1
Exterior Fabric(s) 1. Stucco 2. _____ 3. _____
Roof Type(s) 1. Gable 2. _____ 3. _____
Roof Material(s) 1. Composition shingles 2. _____ 3. _____
Roof secondary strucs. (dormers etc.) 1. _____ 2. _____
Windows (types, materials, etc.) Replacement metal 6/6 single-hung sash

Chimney: No. ___ Chimney Material(s): 1. ___ 2. ___
Structural System(s): 1. Concrete block 2. ___ 3. ___
Foundation Type(s): 1. Slab 2. ___
Foundation Material(s): 1. Poured Concrete Footing 2. ___
Main Entrance (stylistic details) New door with leaded glass insert within the south entrance porch

Condition (overall resource condition): [] excellent [x] good [] fair [] deteriorated [] ruinous
