# I-275 (STATE ROAD 93) EXPRESS LANES

## PROJECT DEVELOPMENT & ENVIRONMENT STUDY

## **FINAL CULTURAL RESOURCE ASSESSMENT SURVEY**

### **UPDATED AND NEWLY CREATED FMSF FORMS (8HI12800-8HI12946)**

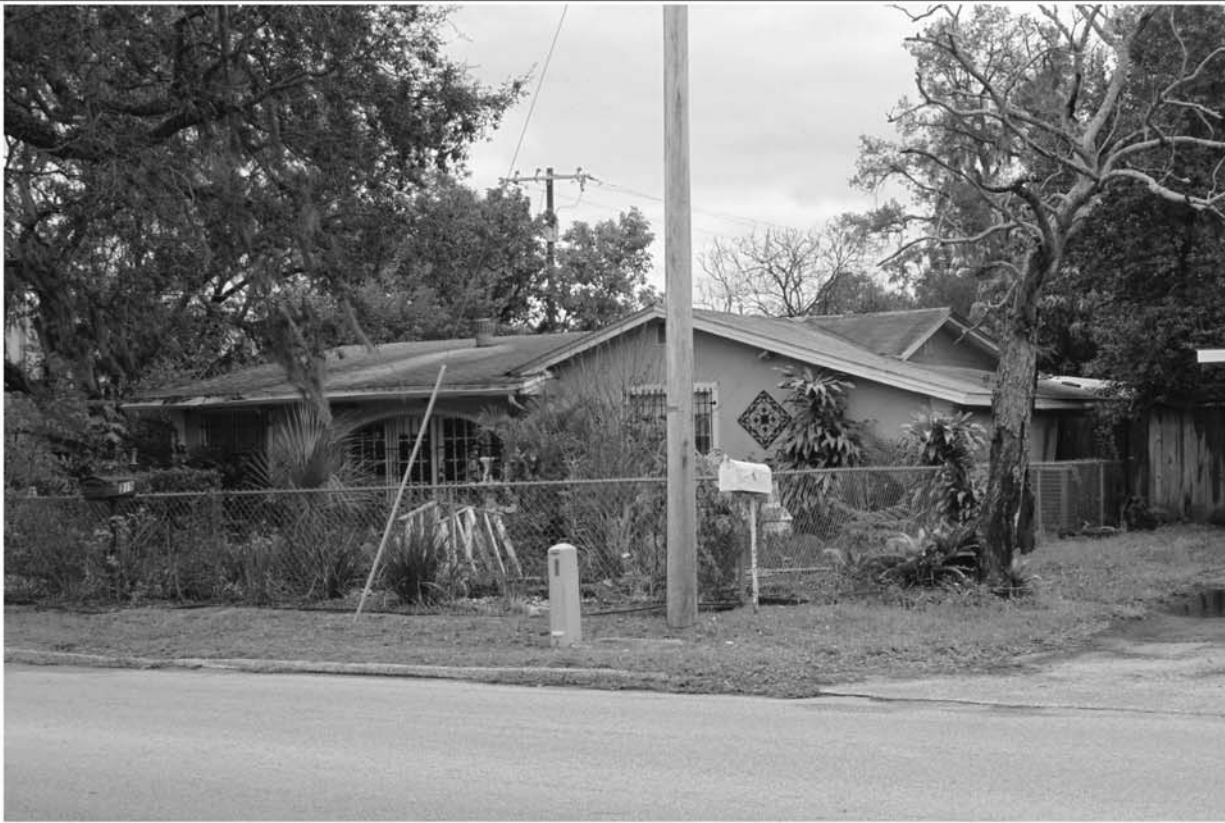
PHOTOGRAPH

Style Frame Vernacular Exterior Plan Irregular Number of Stories 1  
Exterior Fabric(s) 1. Wood siding 2. \_\_\_\_\_ 3. \_\_\_\_\_  
Roof Type(s) 1. Gable 2. Flat 3. \_\_\_\_\_  
Roof Material(s) 1. Composition shingles 2. Built-up 3. \_\_\_\_\_  
Roof secondary strucs. (dormers etc.) 1. \_\_\_\_\_ 2. \_\_\_\_\_  
Windows (types, materials, etc.) Metal replacement 2/2 and 6/6 SHS windows are present, in addition to 3-light awning windows.  
Distinguishing Architectural Features (exterior or interior ornaments) The building features faux shutters, cornerboards, and wood surrounds.

Condition (overall resource condition): [ ]excellent [x]good [ ]fair [ ]deteriorated [ ]ruinous
Narrative Description of Resource This FV style residence is irregular in form with a W original side gable portion and cross-gabled E addition. A 1-bay garage has likely been enclosed at the E front gable fenestration patterns have been altered and there is a N flat roof addition.
Archaeological Remains [ ]Check if Archaeological Form Completed

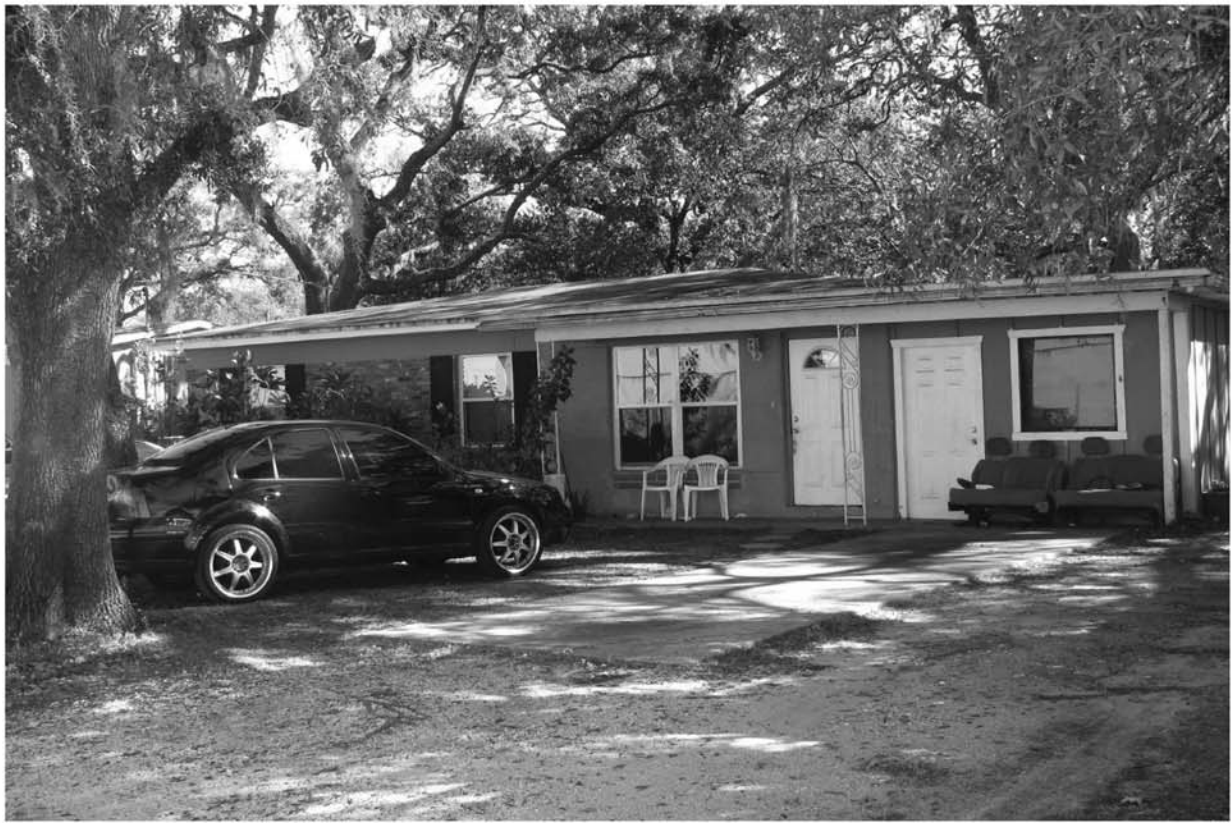
PHOTOGRAPH

Chimney: No. 0 Chimney Material(s): 1. Concrete block 2.
Structural System(s): 1. Concrete block 2. 3.
Foundation Type(s): 1. Continuous 2.
Foundation Material(s): 1. Concrete Block 2.
Main Entrance (stylistic details) At the NE corner integral porch is a 1-light door.

Condition (overall resource condition): [ ]excellent [x]good [ ]fair [ ]deteriorated [ ]ruinous

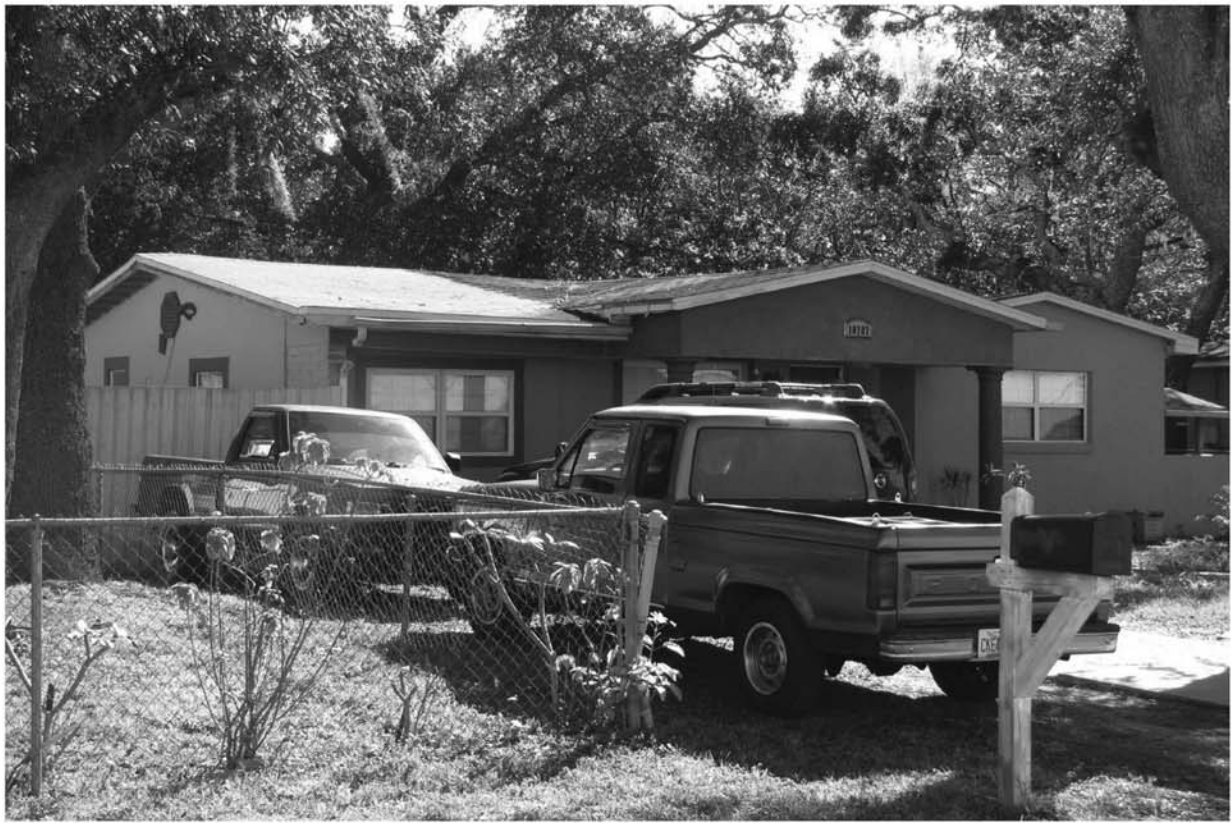
PHOTOGRAPH

Style Masonry Vernacular Exterior Plan Irregular Number of Stories 1  
Exterior Fabric(s) 1. Stucco 2. \_\_\_\_\_ 3. \_\_\_\_\_  
Roof Type(s) 1. Gable 2. Shed 3. \_\_\_\_\_  
Roof Material(s) 1. Composition shingles 2. \_\_\_\_\_ 3. \_\_\_\_\_  
Roof secondary strucs. (dormers etc.) 1. \_\_\_\_\_ 2. \_\_\_\_\_  
Windows (types, materials, etc.) Metal replacement 2/2 SHS windows are present.

Chimney: No. 0 Chimney Material(s): 1. Concrete block 2.
Structural System(s): 1. Concrete block 2. 3.
Foundation Type(s): 1. Continuous 2.
Foundation Material(s): 1. Concrete Block 2.
Main Entrance (stylistic details) At the W facade is a replacement door with metal security door in front.

Condition (overall resource condition): [ ]excellent [x]good [ ]fair [ ]deteriorated [ ]ruinous

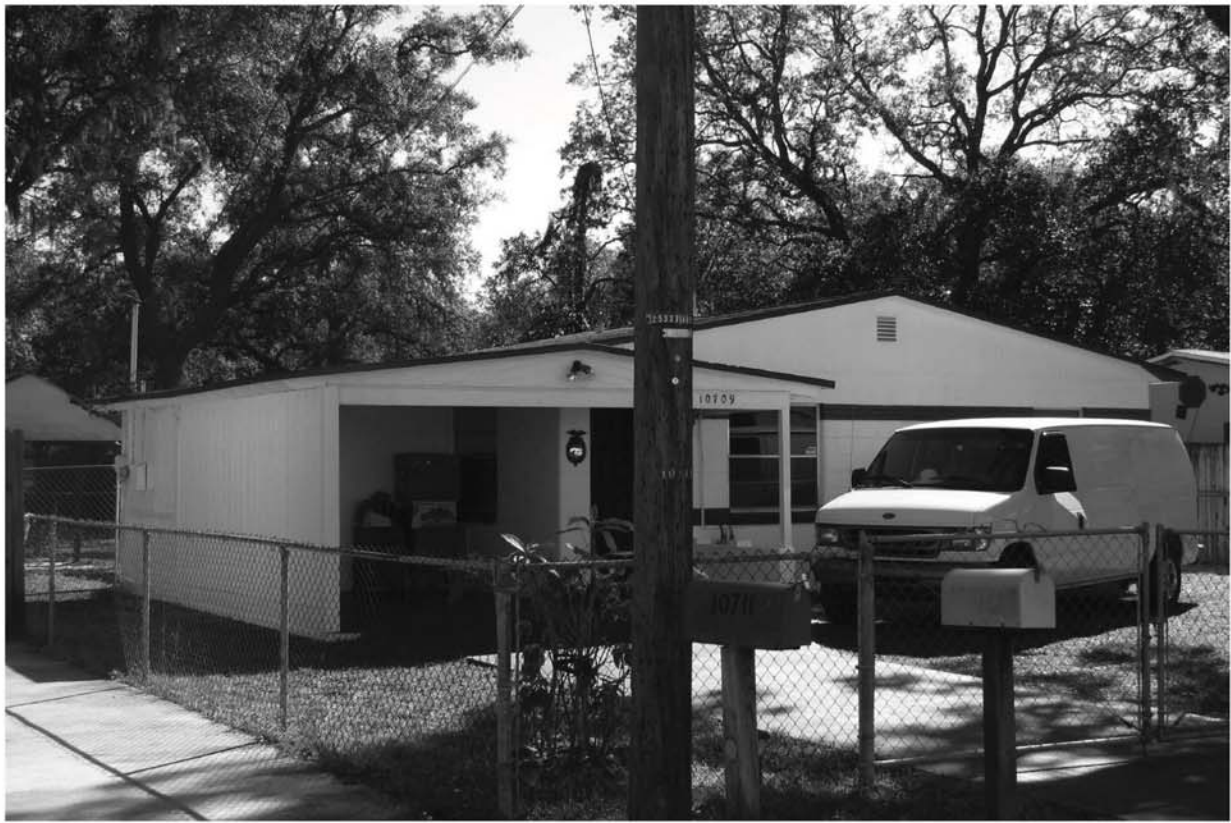
PHOTOGRAPH

Main Entrance (stylistic details) Within the E porch is a replacement wood door with decorative oval inset light and sidelight.

Condition (overall resource condition): [ ] excellent [x] good [ ] fair [ ] deteriorated [ ] ruinous

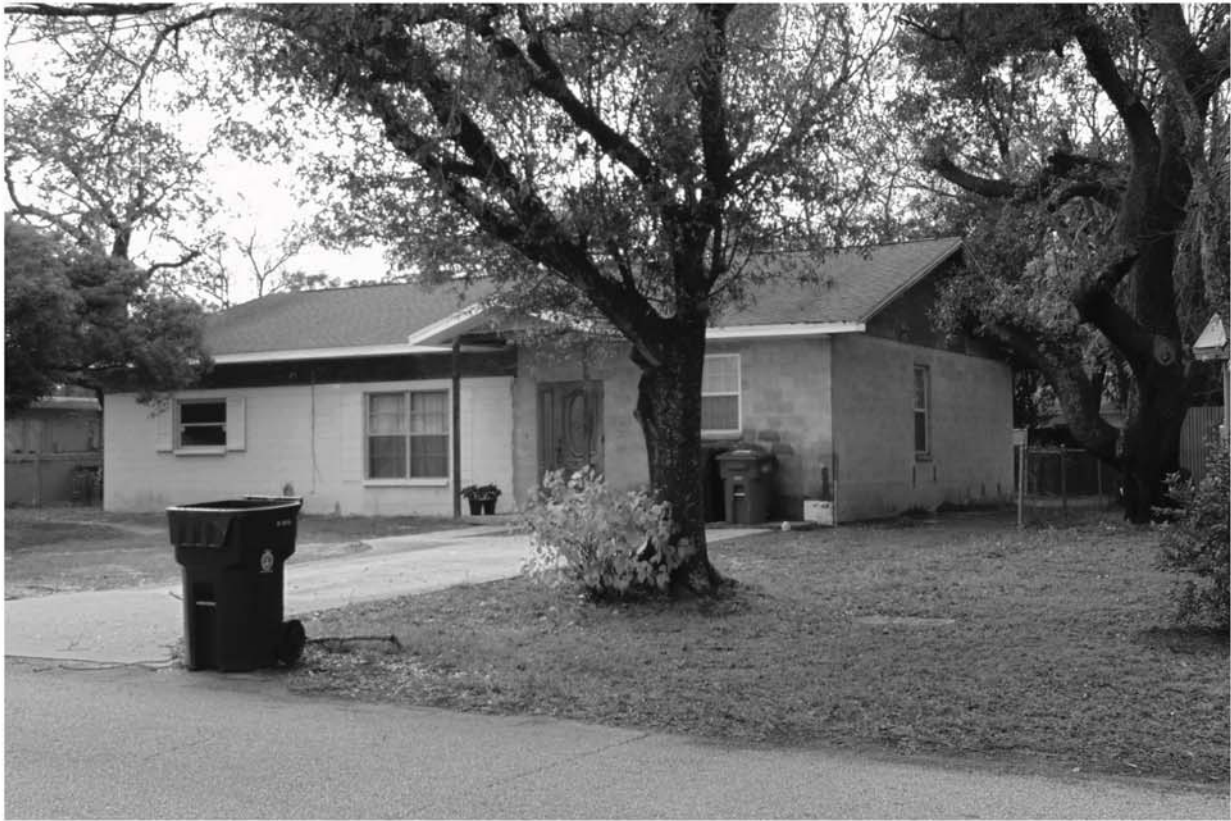
PHOTOGRAPH

Style Masonry Vernacular Exterior Plan Irregular Number of Stories 1  
Exterior Fabric(s) 1. Stucco 2. \_\_\_\_\_ 3. \_\_\_\_\_  
Roof Type(s) 1. Gable 2. Flat 3. \_\_\_\_\_  
Roof Material(s) 1. Composition roll 2. \_\_\_\_\_ 3. \_\_\_\_\_  
Roof secondary strucs. (dormers etc.) 1. \_\_\_\_\_ 2. \_\_\_\_\_  
Windows (types, materials, etc.) Metal replacement 2/2 SHS windows are present.

Chimney: No. 0 Chimney Material(s): 1. Concrete block 2.
Structural System(s): 1. Concrete block 2. 3.
Foundation Type(s): 1. Continuous 2.
Foundation Material(s): 1. Concrete Block 2.
Main Entrance (stylistic details) At the W facade is a replacement panel door within the entrance porch.

Condition (overall resource condition): [ ]excellent [x]good [ ]fair [ ]deteriorated [ ]ruinous

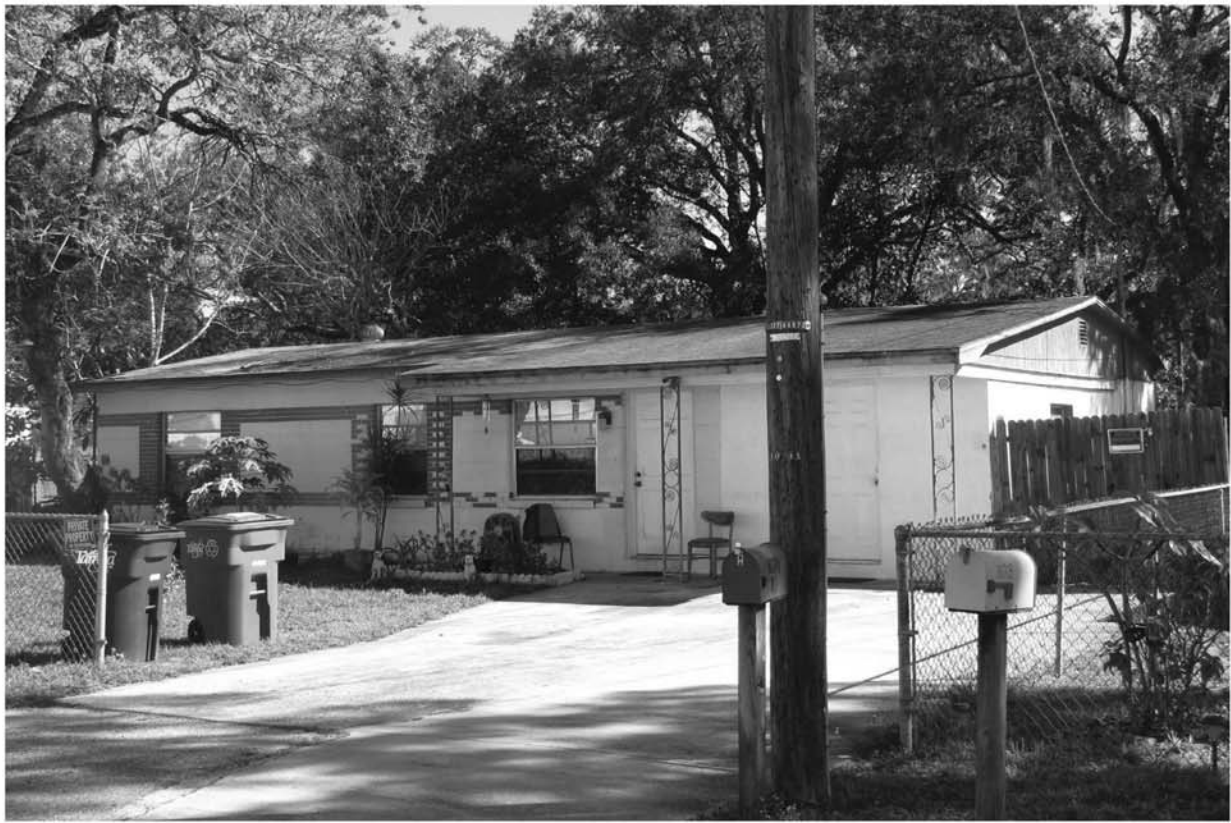
PHOTOGRAPH

Style Minimal Traditional Exterior Plan Irregular Number of Stories 1  
Exterior Fabric(s) 1. Shingles-asbestos 2. \_\_\_\_\_ 3. \_\_\_\_\_  
Roof Type(s) 1. Gable 2. Shed 3. \_\_\_\_\_  
Roof Material(s) 1. Composition shingles 2. \_\_\_\_\_ 3. \_\_\_\_\_  
Roof secondary strucs. (dormers etc.) 1. \_\_\_\_\_ 2. \_\_\_\_\_  
Windows (types, materials, etc.) Metal replacement 1/1 SHS windows are present.

Chimney: No. 1 Chimney Material(s): 1. Stucco 2. \_\_\_\_\_  
 Structural System(s): 1. Wood frame 2. \_\_\_\_\_ 3. \_\_\_\_\_  
 Foundation Type(s): 1. Piers 2. \_\_\_\_\_  
 Foundation Material(s): 1. Concrete Block 2. \_\_\_\_\_  
 Main Entrance (stylistic details) At the W facade is a replacement wood door with glass inset light within the enclosed porch.  
 Porch Descriptions (types, locations, roof types, etc.) None observed

Condition (overall resource condition): excellent good fair deteriorated ruinous

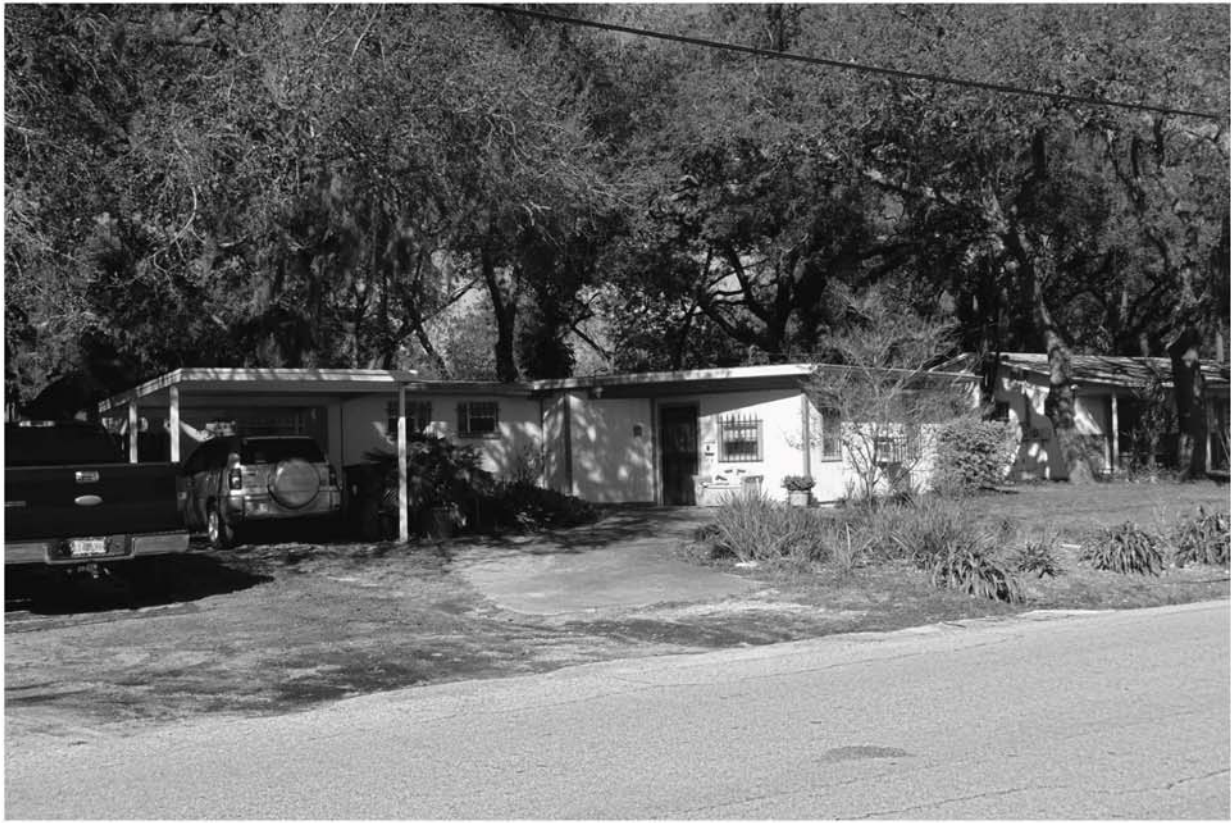
PHOTOGRAPH

Chimney: No. 0 Chimney Material(s): 1. Concrete block 2.
Structural System(s): 1. Concrete block 2. 3.
Foundation Type(s): 1. Continuous 2.
Foundation Material(s): 1. Concrete Block 2.
Main Entrance (stylistic details) The main entrance has been enclosed and relocated to the NE end enclosed carport. It is a panel door with fanlight.
Porch Descriptions (types, locations, roof types, etc.) None observed

Condition (overall resource condition): [ ]excellent [x]good [ ]fair [ ]deteriorated [ ]ruinous
Narrative Description of Resource This MV style residence is irregular in form with a main side gable roof and NE flat roof extension carport. This carport has been enclosed with vertical wood siding and the main entrance is now within the S elevation of the former carport.
Archaeological Remains [ ]Check if Archaeological Form Completed

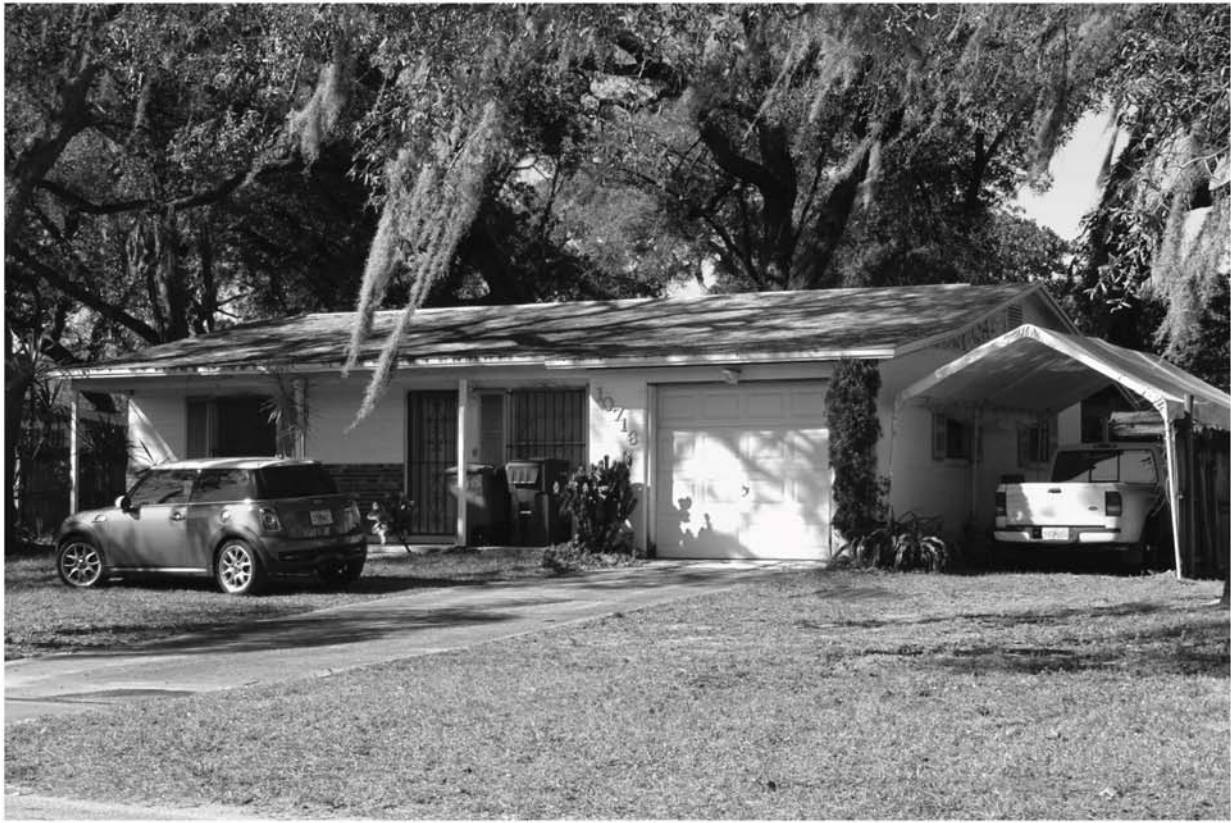
PHOTOGRAPH

Chimney: No. 0 Chimney Material(s): 1. Concrete block 2.
Structural System(s): 1. Concrete block 2. 3.
Foundation Type(s): 1. Continuous 2.
Foundation Material(s): 1. Concrete Block 2.
Main Entrance (stylistic details) Within the E entrance porch is a wood panel door with 9 fixed inset lights.

Condition (overall resource condition): [ ]excellent [x]good [ ]fair [ ]deteriorated [ ]ruinous

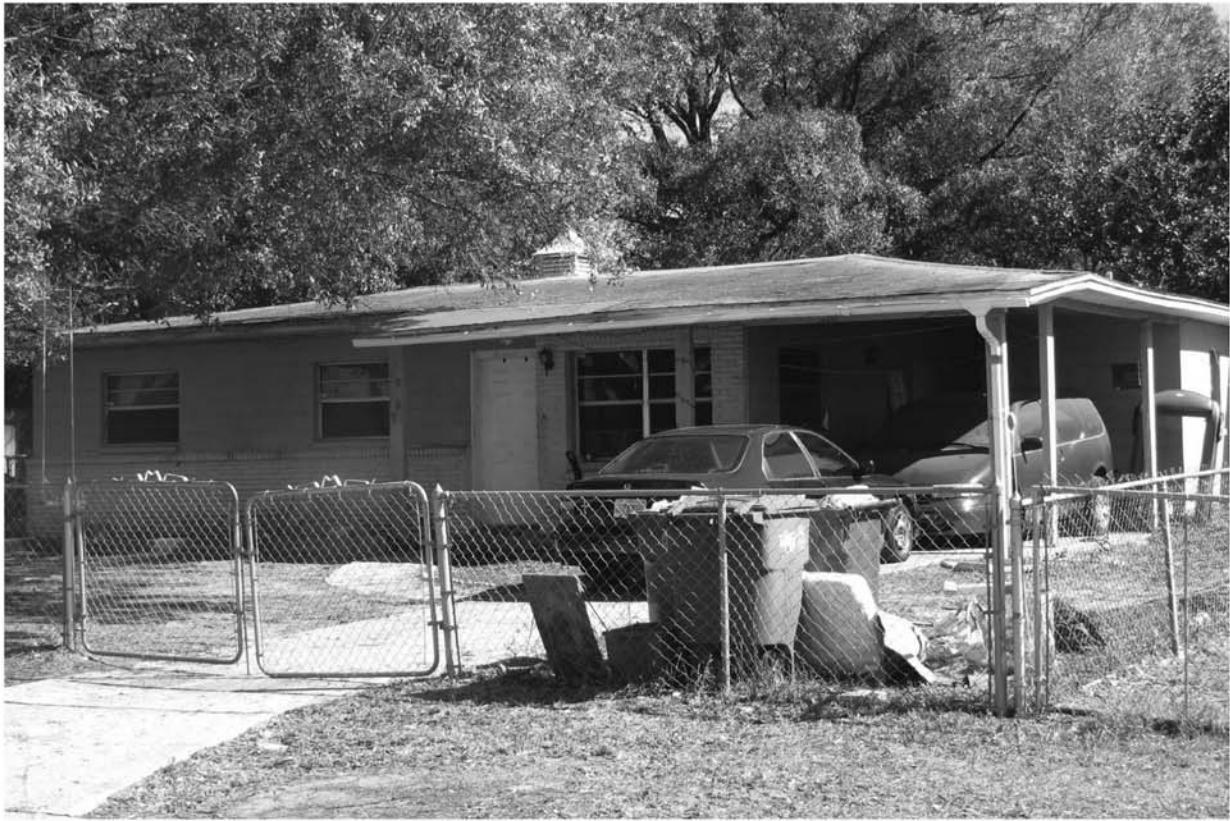
PHOTOGRAPH

Style Masonry Vernacular Exterior Plan Irregular Number of Stories 1  
Exterior Fabric(s) 1. Stucco 2. \_\_\_\_\_ 3. \_\_\_\_\_  
Roof Type(s) 1. Hip 2. Shed 3. \_\_\_\_\_  
Roof Material(s) 1. Composition shingles 2. Built-up 3. \_\_\_\_\_  
Roof secondary strucs. (dormers etc.) 1. \_\_\_\_\_ 2. \_\_\_\_\_  
Windows (types, materials, etc.) Metal replacement 2/2 SHS windows are present.

Chimney: No. 0 Chimney Material(s): 1. Concrete block 2.
Structural System(s): 1. Concrete block 2. 3.
Foundation Type(s): 1. Continuous 2.
Foundation Material(s): 1. Concrete Block 2.
Main Entrance (stylistic details) At the W facade is a replacement panel door.

Condition (overall resource condition): [ ]excellent [x]good [ ]fair [ ]deteriorated [ ]ruinous

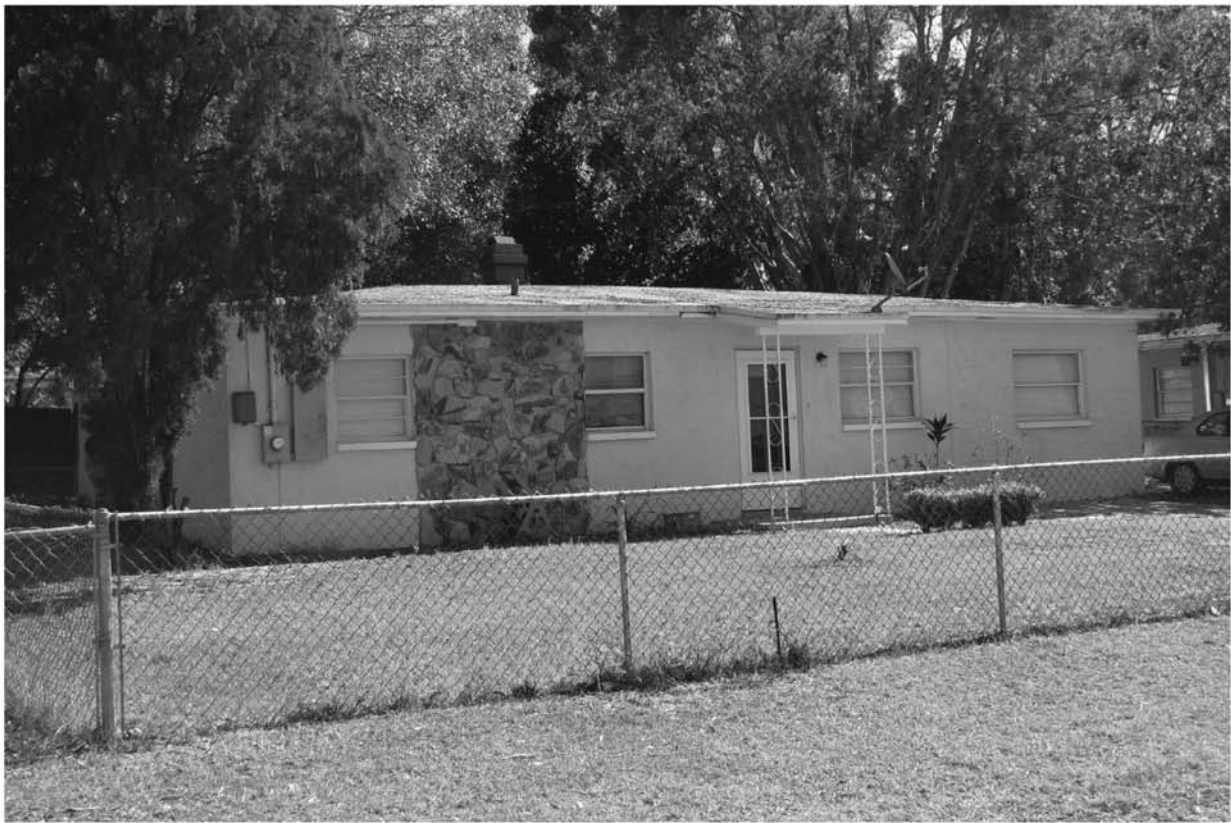
PHOTOGRAPH

Style Masonry Vernacular Exterior Plan Rectangular Number of Stories 1  
Exterior Fabric(s) 1. Stucco 2. \_\_\_\_\_ 3. \_\_\_\_\_  
Roof Type(s) 1. Hip 2. \_\_\_\_\_ 3. \_\_\_\_\_  
Roof Material(s) 1. Built-up 2. \_\_\_\_\_ 3. \_\_\_\_\_  
Roof secondary strucs. (dormers etc.) 1. \_\_\_\_\_ 2. \_\_\_\_\_  
Windows (types, materials, etc.) Metal replacement 1/1 and 2/2 SHS windows are present.

Chimney: No. 0 Chimney Material(s): 1. Concrete block 2.
Structural System(s): 1. Concrete block 2. 3.
Foundation Type(s): 1. Continuous 2.
Foundation Material(s): 1. Concrete Block 2.
Main Entrance (stylistic details) At the W facade is a replacement door with glass door in front.

Condition (overall resource condition): [ ]excellent [x]good [ ]fair [ ]deteriorated [ ]ruinous

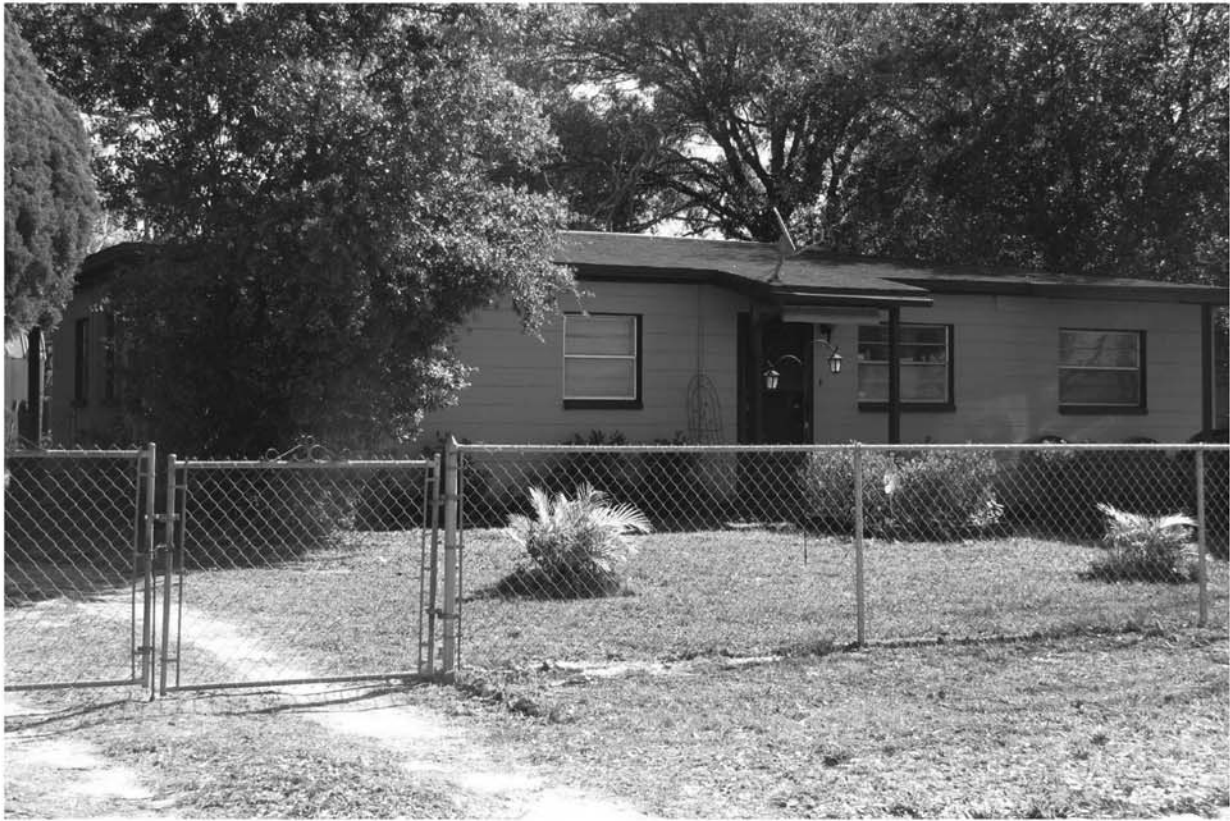
PHOTOGRAPH

Style Masonry Vernacular Exterior Plan Irregular Number of Stories 1  
Exterior Fabric(s) 1. Concrete block 2. \_\_\_\_\_ 3. \_\_\_\_\_  
Roof Type(s) 1. Hip 2. Shed 3. \_\_\_\_\_  
Roof Material(s) 1. Composition shingles 2. Built-up 3. \_\_\_\_\_  
Roof secondary strucs. (dormers etc.) 1. \_\_\_\_\_ 2. \_\_\_\_\_  
Windows (types, materials, etc.) Metal replacement 2/2 SHS windows are present.

Chimney: No. 0 Chimney Material(s): 1. \_\_\_\_\_ 2. \_\_\_\_\_  
 Structural System(s): 1. Concrete block 2. \_\_\_\_\_ 3. \_\_\_\_\_  
 Foundation Type(s): 1. Continuous 2. \_\_\_\_\_  
 Foundation Material(s): 1. Concrete Block 2. \_\_\_\_\_  
 Main Entrance (stylistic details) At the W facade is a replacement door within the porch.

Condition (overall resource condition): excellent good fair deteriorated ruinous

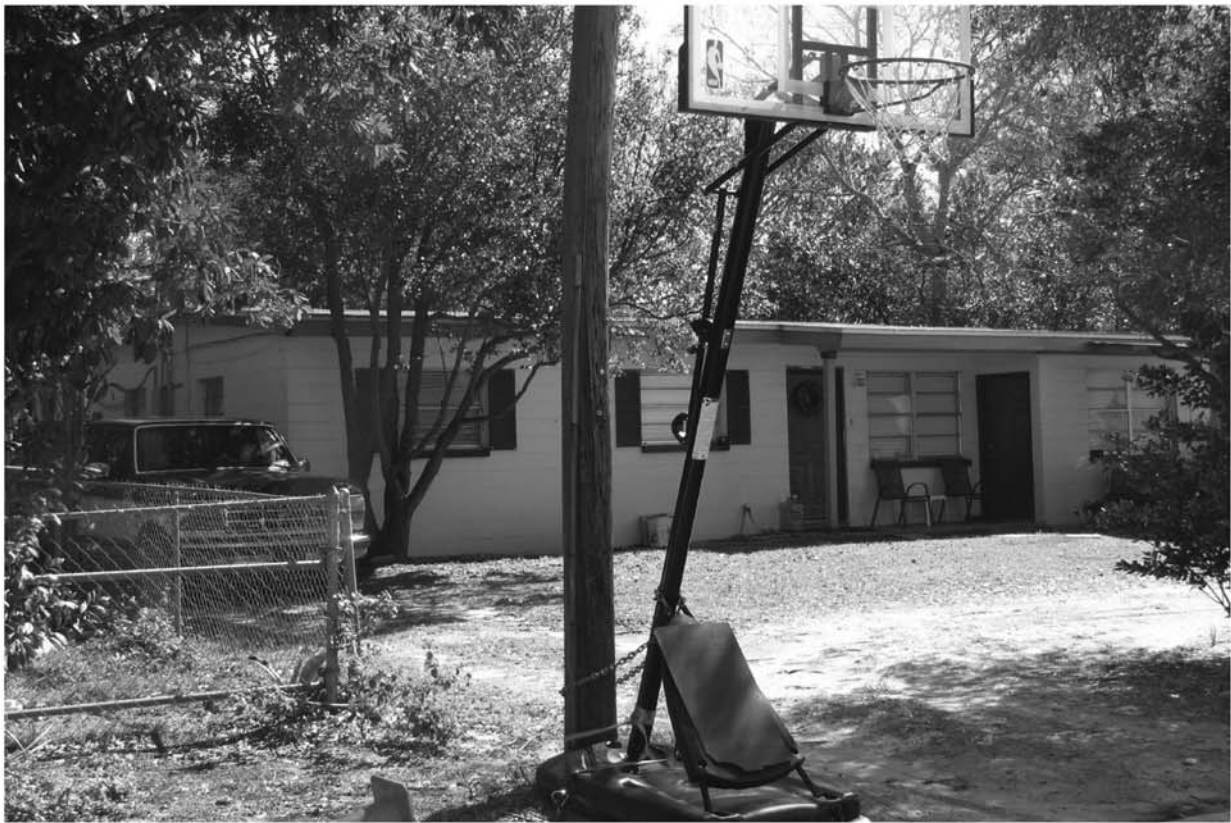
PHOTOGRAPH

Style Masonry Vernacular Exterior Plan Irregular Number of Stories 1  
Exterior Fabric(s) 1. Concrete block 2. \_\_\_\_\_ 3. \_\_\_\_\_  
Roof Type(s) 1. Gable 2. Shed 3. \_\_\_\_\_  
Roof Material(s) 1. Composition shingles 2. Sheet metal: corrugated 3. \_\_\_\_\_  
Roof secondary strucs. (dormers etc.) 1. \_\_\_\_\_ 2. \_\_\_\_\_  
Windows (types, materials, etc.) Metal replacement 2/2 SHS windows are present.

Chimney: No. 0 Chimney Material(s): 1. Concrete block 2.
Structural System(s): 1. Concrete block 2. 3.
Foundation Type(s): 1. Continuous 2.
Foundation Material(s): 1. Concrete Block 2.
Main Entrance (stylistic details) At the W facade is a replacement wood panel door with fanlight.

Condition (overall resource condition): [ ]excellent [x]good [ ]fair [ ]deteriorated [ ]ruinous

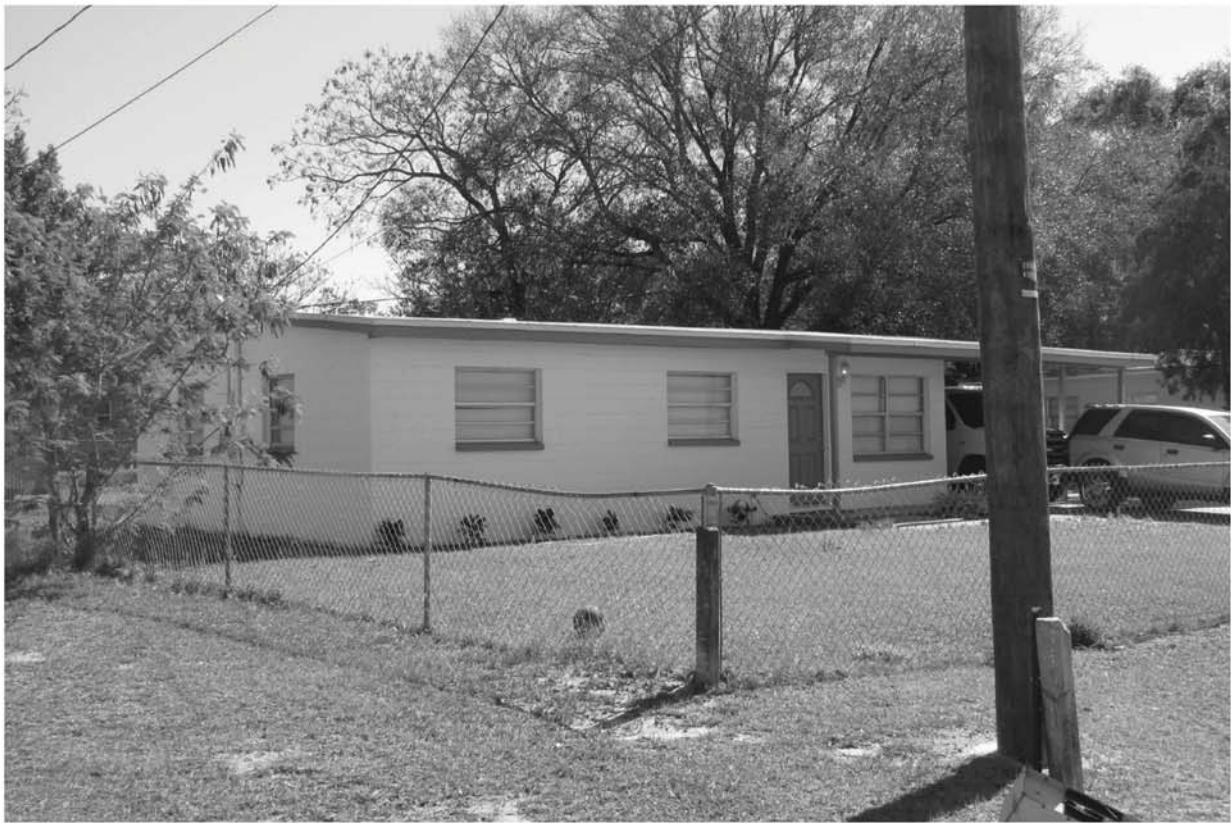
PHOTOGRAPH

Style Masonry Vernacular Exterior Plan Rectangular Number of Stories 1  
Exterior Fabric(s) 1. Concrete block 2. \_\_\_\_\_ 3. \_\_\_\_\_  
Roof Type(s) 1. Gable 2. \_\_\_\_\_ 3. \_\_\_\_\_  
Roof Material(s) 1. Composition roll 2. \_\_\_\_\_ 3. \_\_\_\_\_  
Roof secondary strucs. (dormers etc.) 1. \_\_\_\_\_ 2. \_\_\_\_\_  
Windows (types, materials, etc.) Metal replacement 2/2 SHS windows are present.

Chimney: No. 0 Chimney Material(s): 1. Concrete block 2.
Structural System(s): 1. Concrete block 2. 3.
Foundation Type(s): 1. Continuous 2.
Foundation Material(s): 1. Concrete Block 2.
Main Entrance (stylistic details) At the W facade is a replacement panel door with fanlight.

Condition (overall resource condition): [ ]excellent [x]good [ ]fair [ ]deteriorated [ ]ruinous

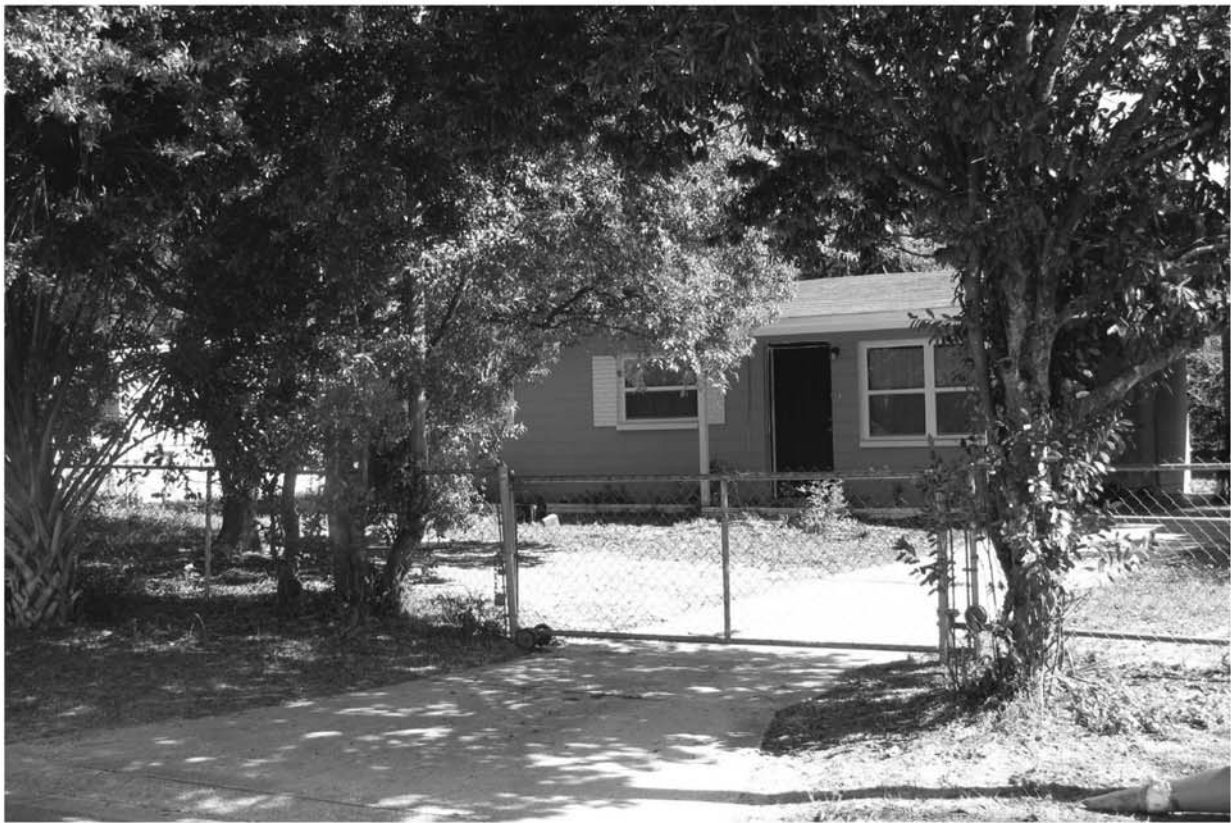
PHOTOGRAPH

Style Masonry Vernacular Exterior Plan Rectangular Number of Stories 1  
Exterior Fabric(s) 1. Concrete block 2. \_\_\_\_\_ 3. \_\_\_\_\_  
Roof Type(s) 1. Gable 2. \_\_\_\_\_ 3. \_\_\_\_\_  
Roof Material(s) 1. Composition shingles 2. \_\_\_\_\_ 3. \_\_\_\_\_  
Roof secondary strucs. (dormers etc.) 1. \_\_\_\_\_ 2. \_\_\_\_\_  
Windows (types, materials, etc.) Metal replacement 1/1 SHS windows are present.

Chimney: No. 0 Chimney Material(s): 1. \_\_\_\_\_ 2. \_\_\_\_\_  
 Structural System(s): 1. Concrete block 2. \_\_\_\_\_ 3. \_\_\_\_\_  
 Foundation Type(s): 1. Continuous 2. \_\_\_\_\_  
 Foundation Material(s): 1. Concrete Block 2. \_\_\_\_\_  
 Main Entrance (stylistic details) At the W facade is a replacement wood panel door within the porch.

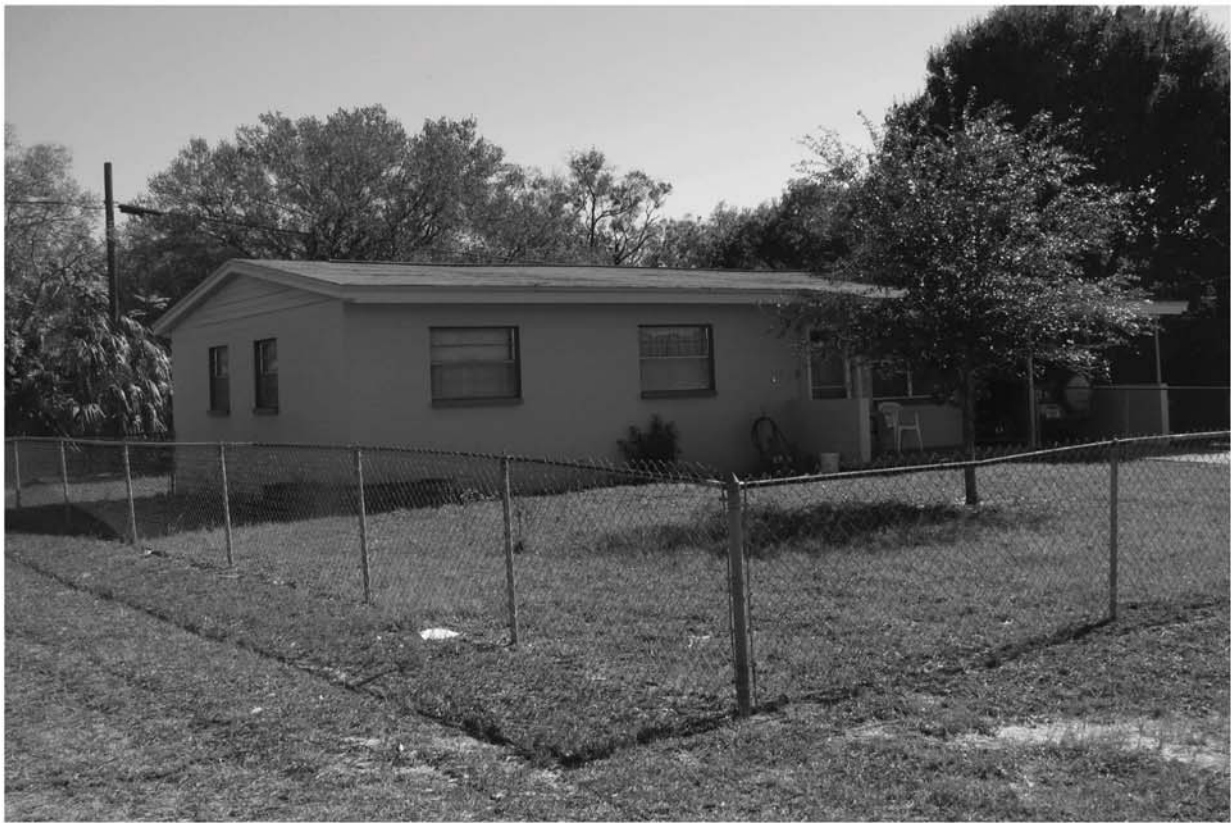
PHOTOGRAPH

Style Masonry Vernacular Exterior Plan Rectangular Number of Stories 1  
Exterior Fabric(s) 1. Concrete block 2. \_\_\_\_\_ 3. \_\_\_\_\_  
Roof Type(s) 1. Gable 2. \_\_\_\_\_ 3. \_\_\_\_\_  
Roof Material(s) 1. Composition shingles 2. \_\_\_\_\_ 3. \_\_\_\_\_  
Roof secondary strucs. (dormers etc.) 1. \_\_\_\_\_ 2. \_\_\_\_\_  
Windows (types, materials, etc.) Metal replacement 2/2 SHS windows are present.

Main Entrance (stylistic details) Within the W entrance porch is a replacement wood panel door with fanlight.

Condition (overall resource condition): [ ]excellent [x]good [ ]fair [ ]deteriorated [ ]ruinous

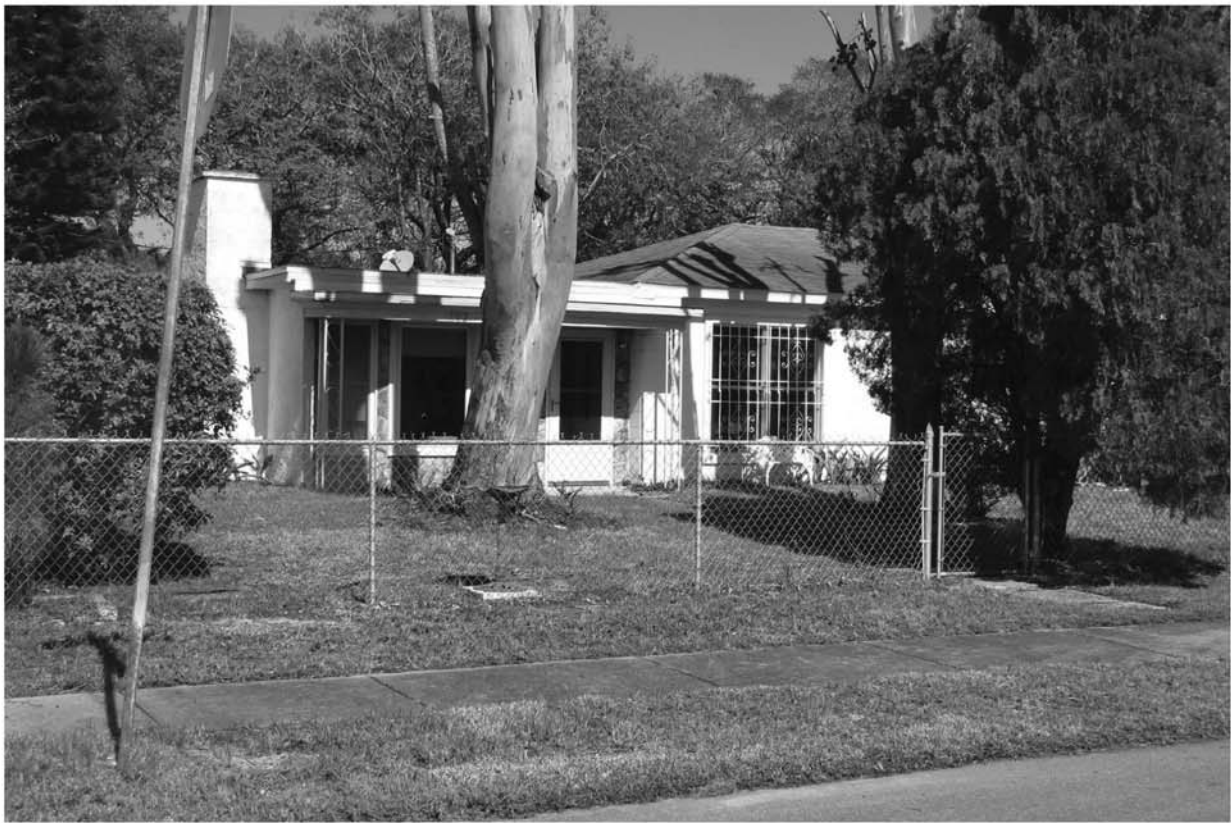
PHOTOGRAPH

Style Log Exterior Plan Irregular Number of Stories 1  
Exterior Fabric(s) 1. Concrete block 2. Stone 3. \_\_\_\_\_  
Roof Type(s) 1. Hip 2. Flat 3. \_\_\_\_\_  
Roof Material(s) 1. Composition shingles 2. Built-up 3. Sheet metal:corrugated  
Roof secondary strucs. (dormers etc.) 1. \_\_\_\_\_ 2. \_\_\_\_\_  
Windows (types, materials, etc.) Metal replacement 1/1 SHS windows are present.

Chimney: No. 0 Chimney Material(s): 1. Concrete block 2.
Structural System(s): 1. Concrete block 2. 3.
Foundation Type(s): 1. Continuous 2.
Foundation Material(s): 1. Concrete Block 2.
Main Entrance (stylistic details) At the S facade is a replacement door with security door in front.

Condition (overall resource condition): [ ]excellent [x]good [ ]fair [ ]deteriorated [ ]ruinous

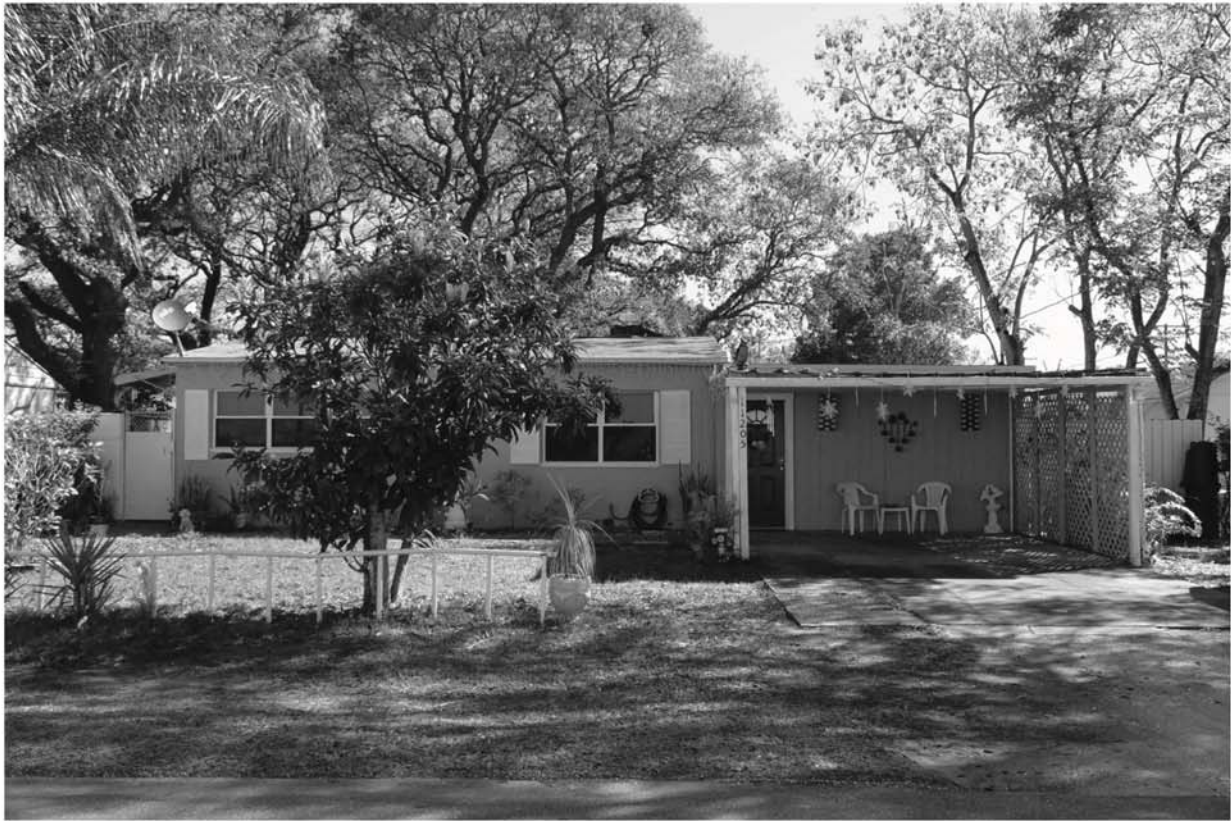
PHOTOGRAPH

Style Masonry Vernacular Exterior Plan Irregular Number of Stories 1  
Exterior Fabric(s) 1. Concrete block 2. Wood/Plywood 3. \_\_\_\_\_  
Roof Type(s) 1. Gable 2. Flat 3. \_\_\_\_\_  
Roof Material(s) 1. Composition shingles 2. Built-up 3. \_\_\_\_\_  
Roof secondary strucs. (dormers etc.) 1. \_\_\_\_\_ 2. \_\_\_\_\_  
Windows (types, materials, etc.) Metal replacement 1/1 SHS windows are present.

Chimney: No. 0 Chimney Material(s): 1. Concrete block 2.
Structural System(s): 1. Concrete block 2. 3.
Foundation Type(s): 1. Continuous 2.
Foundation Material(s): 1. Concrete Block 2.
Main Entrance (stylistic details) There is a replacement wood door with fanlight at W wall of the enclosed garage.

Condition (overall resource condition): [ ]excellent [x]good [ ]fair [ ]deteriorated [ ]ruinous

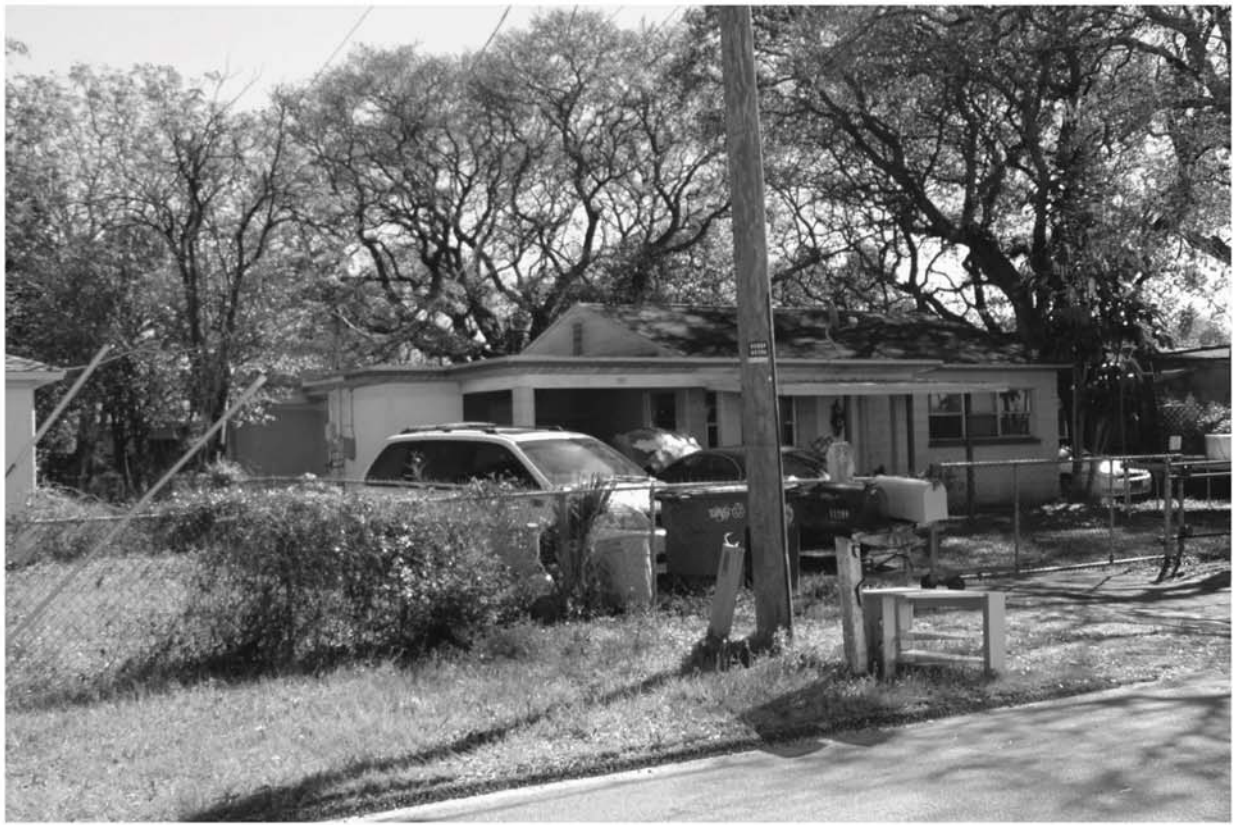
PHOTOGRAPH

Chimney: No. 0 Chimney Material(s): 1. Concrete block 2.
Structural System(s): 1. Concrete block 2. 3.
Foundation Type(s): 1. Continuous 2.
Foundation Material(s): 1. Concrete Block 2.
Main Entrance (stylistic details) At the W facade porch is a wood door with diamond inset light.

Condition (overall resource condition): [ ]excellent [x]good [ ]fair [ ]deteriorated [ ]ruinous

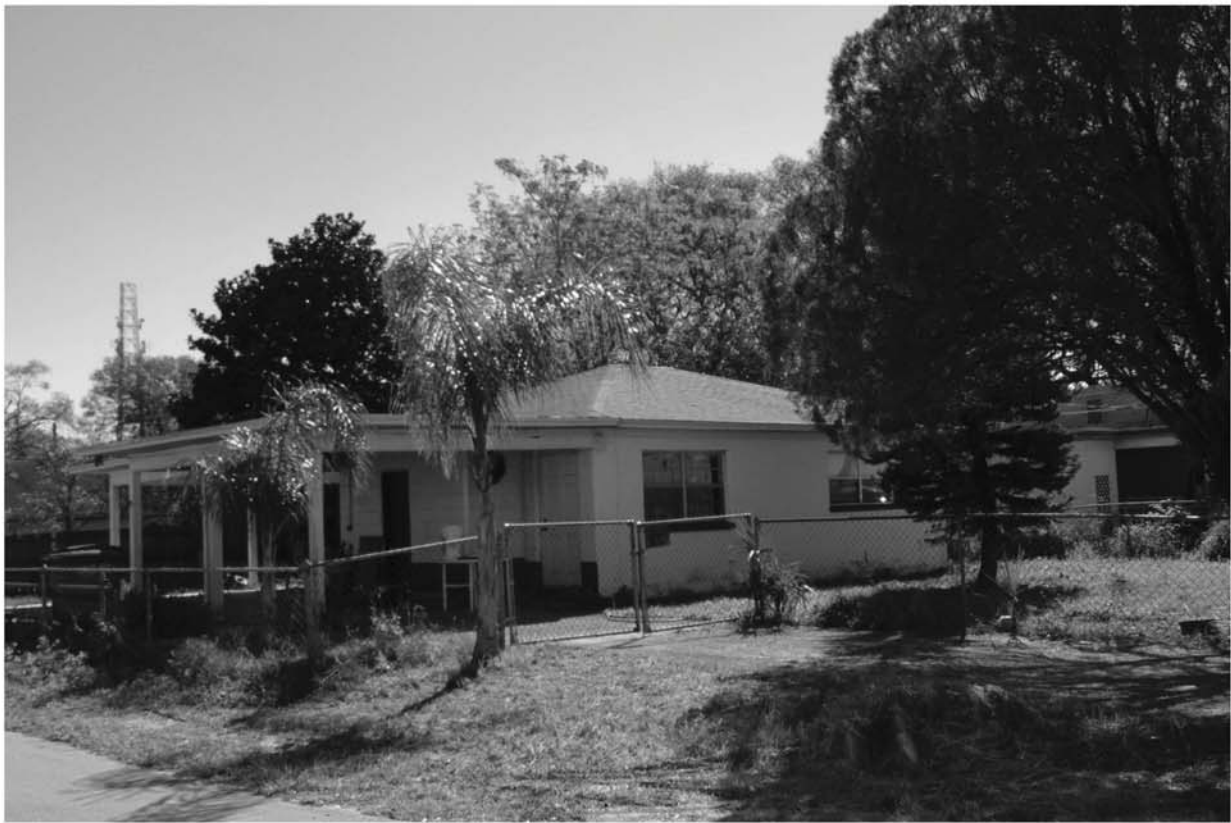
PHOTOGRAPH

Main Entrance (stylistic details) The main entrance is beneath the N flat roof extension and incorporates a replacement door.

Condition (overall resource condition): [ ]excellent [x]good [ ]fair [ ]deteriorated [ ]ruinous
