# I-275 (STATE ROAD 93) EXPRESS LANES

## PROJECT DEVELOPMENT & ENVIRONMENT STUDY

## **FINAL CULTURAL RESOURCE ASSESSMENT SURVEY**

### **UPDATED AND NEWLY CREATED FMSF FORMS (8HI12800-8HI12946)**

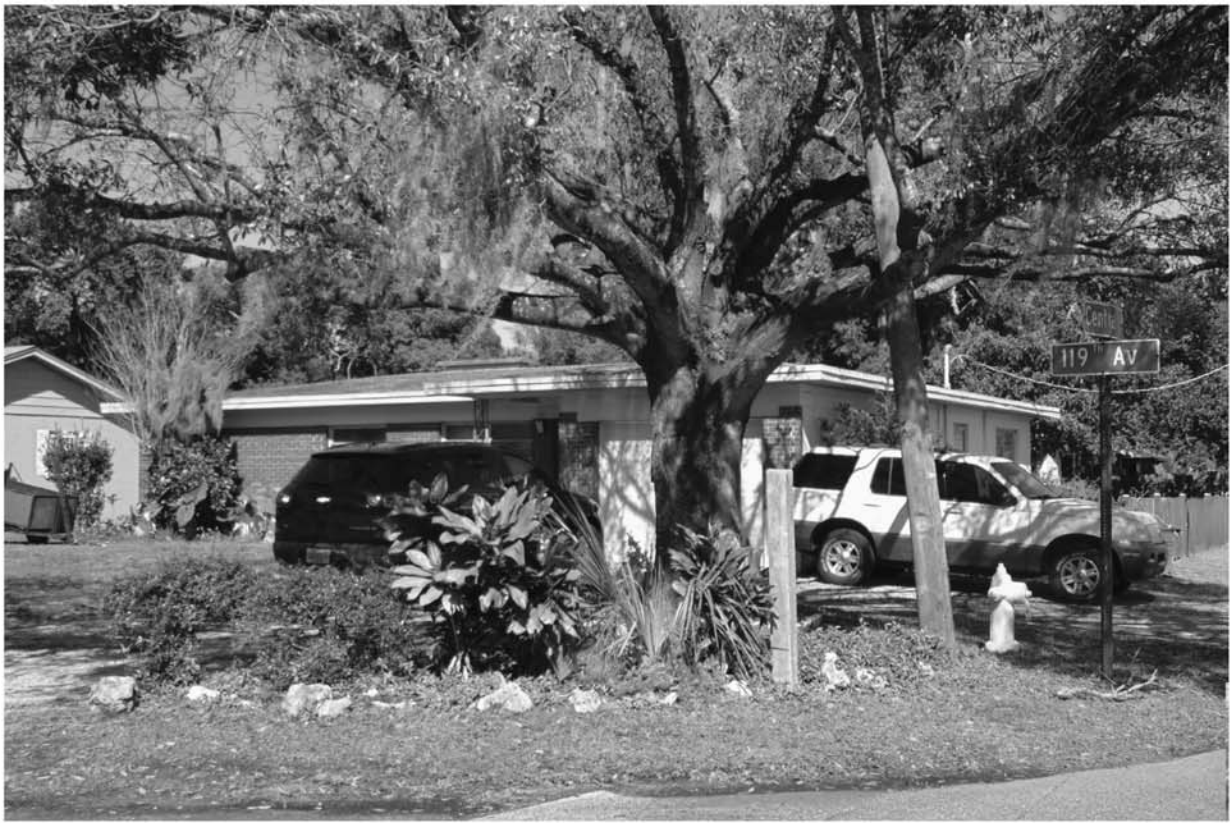
PHOTOGRAPH

Chimney: No. 1 Chimney Material(s): 1. Brick 2.
Structural System(s): 1. Concrete block 2. 3.
Foundation Type(s): 1. Continuous 2.
Foundation Material(s): 1. Concrete Block 2.
Main Entrance (stylistic details) At the S facade is a recessed entrance which incorporates a decorative wrought iron support.
Porch Descriptions (types, locations, roof types, etc.) There appears to be a shed or flat roof porch addition at the N.

Condition (overall resource condition): [ ]excellent [x]good [ ]fair [ ]deteriorated [ ]ruinous
Narrative Description of Resource This MV style residence is irregular in form with an E and W hipped roof portion. At the E end is an integral 1-bay garage and recessed entrance beneath the E hipped roof portion. There appears to be a N shed or flat roof porch addition.
Archaeological Remains [ ]Check if Archaeological Form Completed

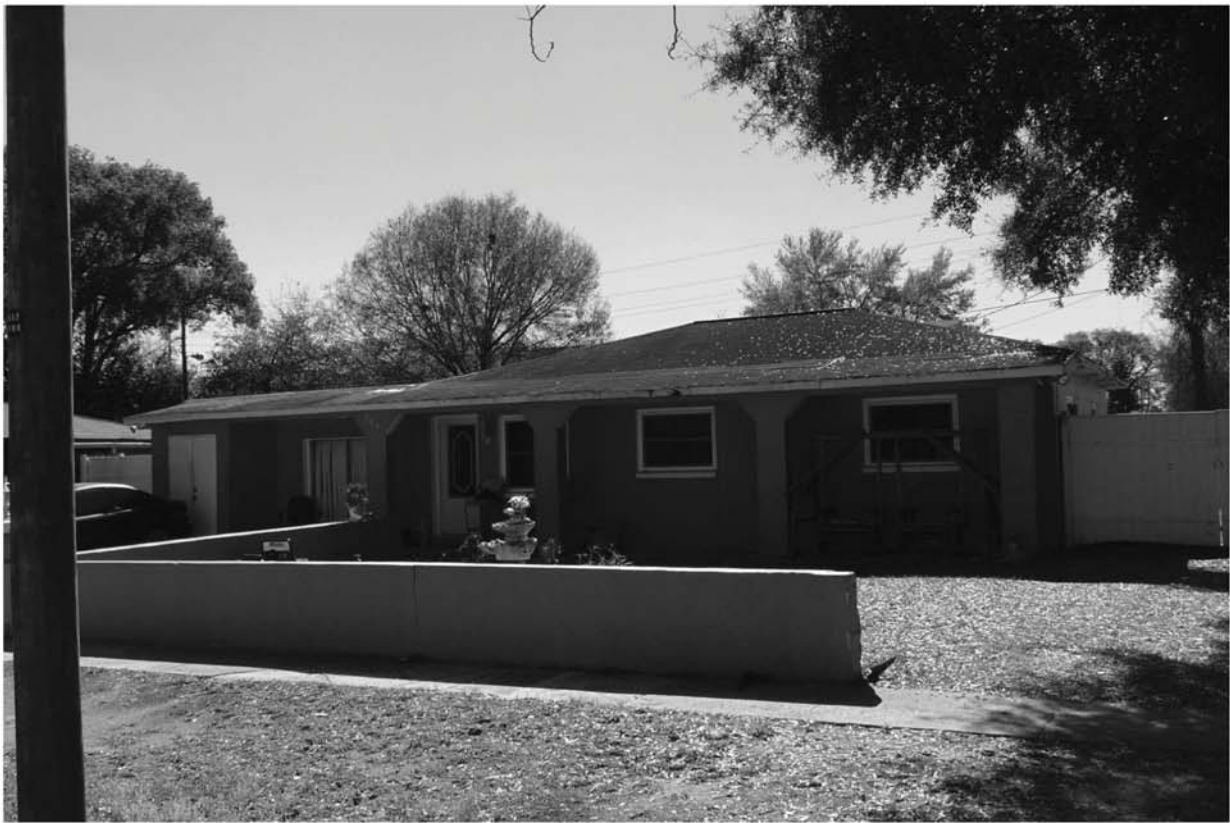
PHOTOGRAPH

Style Masonry Vernacular Exterior Plan Irregular Number of Stories 1  
Exterior Fabric(s) 1. Stucco 2. \_\_\_\_\_ 3. \_\_\_\_\_  
Roof Type(s) 1. Hip 2. Flat 3. Shed  
Roof Material(s) 1. Composition shingles 2. Built-up 3. \_\_\_\_\_  
Roof secondary strucs. (dormers etc.) 1. \_\_\_\_\_ 2. \_\_\_\_\_  
Windows (types, materials, etc.) Metal replacement 1/1 SHS windows are present, in addition to a N sliding glass door at the enclosed garage.  
Distinguishing Architectural Features (exterior or interior ornaments) The building features stuccoed masonry porch supports, concrete sills, stucco surrounds, integral N wall, and textured stucco.  
Ancillary Features / Outbuildings (record outbuildings, major landscape features; use continuation sheet if needed.) There is a S gable roof wood frame shed.

Chimney: No. 0 Chimney Material(s): 1. Concrete block 2.
Structural System(s): 1. Concrete block 2. 3.
Foundation Type(s): 1. Continuous 2.
Foundation Material(s): 1. Concrete Block 2.
Main Entrance (stylistic details) Within the N porch is a replacement door with decorative light inset.

Condition (overall resource condition): [ ] excellent [x] good [ ] fair [ ] deteriorated [ ] ruinous

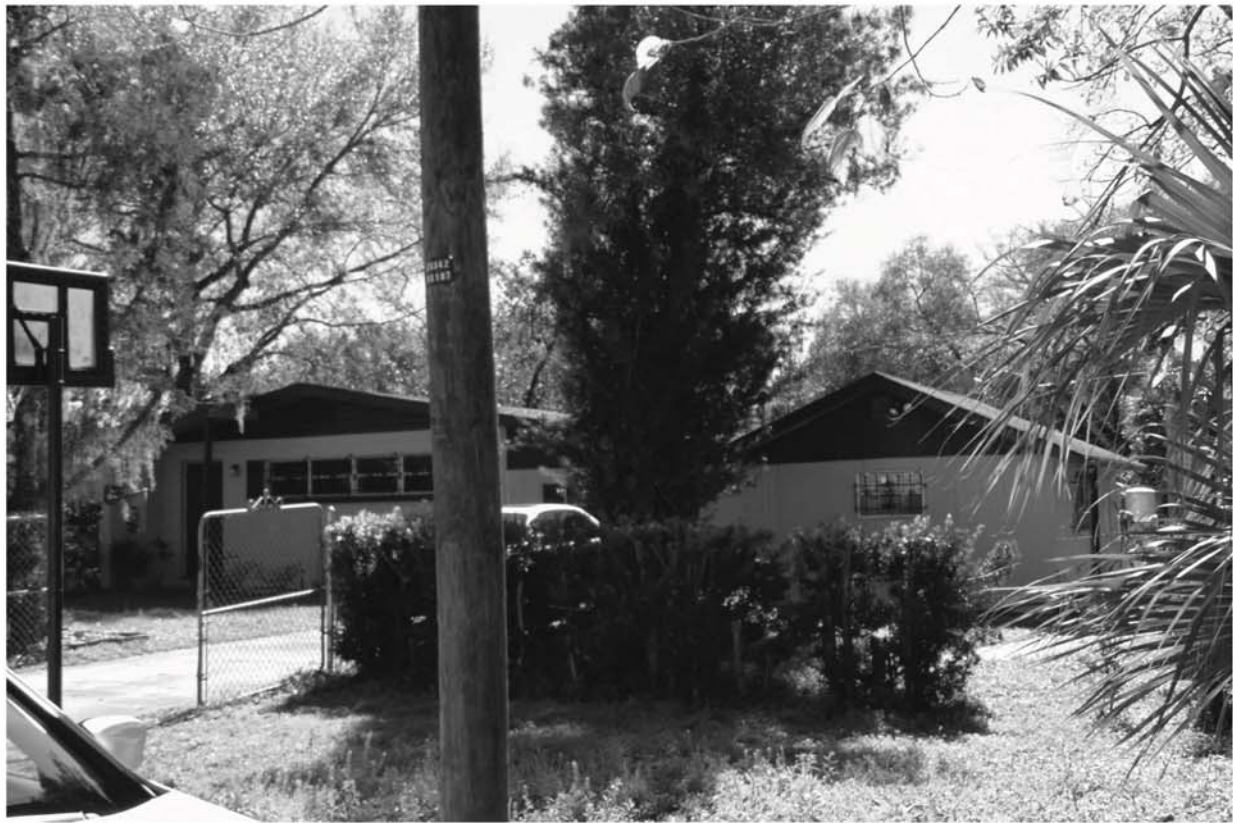
PHOTOGRAPH

Style Masonry Vernacular Exterior Plan Irregular Number of Stories 1  
Exterior Fabric(s) 1. Concrete block 2. Wood/Plywood 3. \_\_\_\_\_  
Roof Type(s) 1. Gable 2. \_\_\_\_\_ 3. \_\_\_\_\_  
Roof Material(s) 1. Composition shingles 2. \_\_\_\_\_ 3. \_\_\_\_\_  
Roof secondary strucs. (dormers etc.) 1. \_\_\_\_\_ 2. \_\_\_\_\_  
Windows (types, materials, etc.) Metal replacement 1/1 SHS windows are present.

Chimney: No. 0 Chimney Material(s): 1. Concrete block 2.
Structural System(s): 1. Concrete block 2. 3.
Foundation Type(s): 1. Continuous 2.
Foundation Material(s): 1. Concrete Block 2.
Main Entrance (stylistic details) At the N facade porch is a replacement wood panel door.

Condition (overall resource condition): [ ]excellent [x]good [ ]fair [ ]deteriorated [ ]ruinous

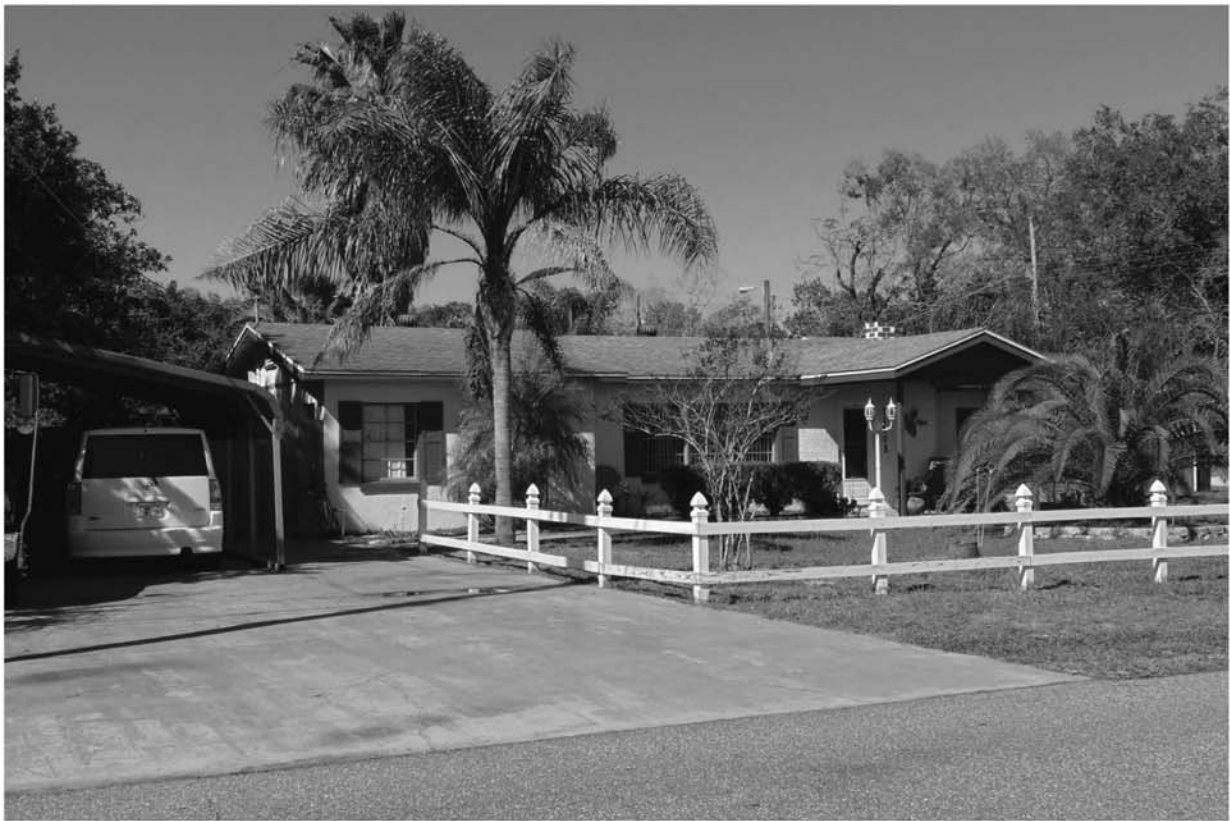
PHOTOGRAPH

Chimney: No. 1 Chimney Material(s): 1. Brick 2.
Structural System(s): 1. Concrete block 2. 3.
Foundation Type(s): 1. Continuous 2.
Foundation Material(s): 1. Concrete Block 2.
Main Entrance (stylistic details) Within the E elevation porch is a replacement door with screen door in front.

Condition (overall resource condition): [ ]excellent [x]good [ ]fair [ ]deteriorated [ ]ruinous

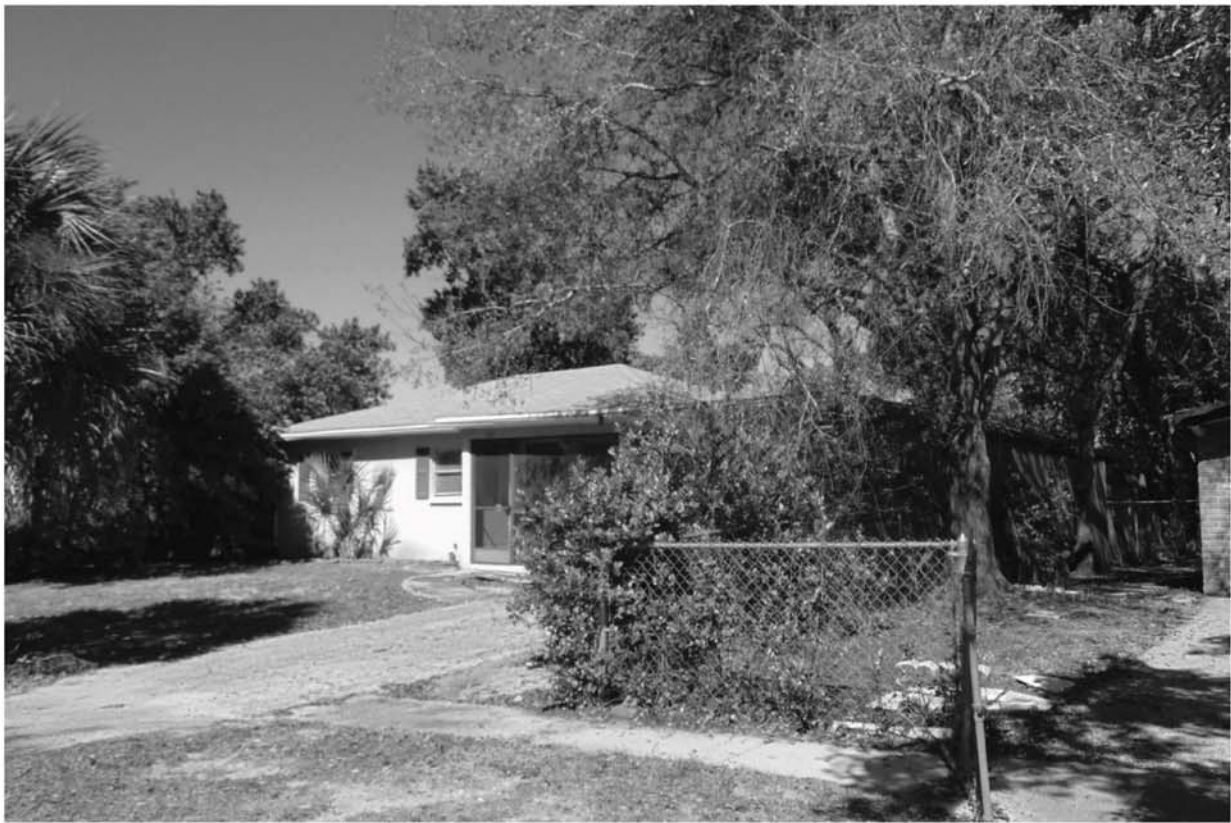
PHOTOGRAPH

Style Masonry Vernacular Exterior Plan Irregular Number of Stories 1  
Exterior Fabric(s) 1. Concrete block 2. \_\_\_\_\_ 3. \_\_\_\_\_  
Roof Type(s) 1. Hip 2. Flat 3. Shed  
Roof Material(s) 1. Composition shingles 2. Built-up 3. \_\_\_\_\_  
Roof secondary strucs. (dormers etc.) 1. \_\_\_\_\_ 2. \_\_\_\_\_  
Windows (types, materials, etc.) Metal replacement 1/1 SHS and 1-light fixed windows are present.

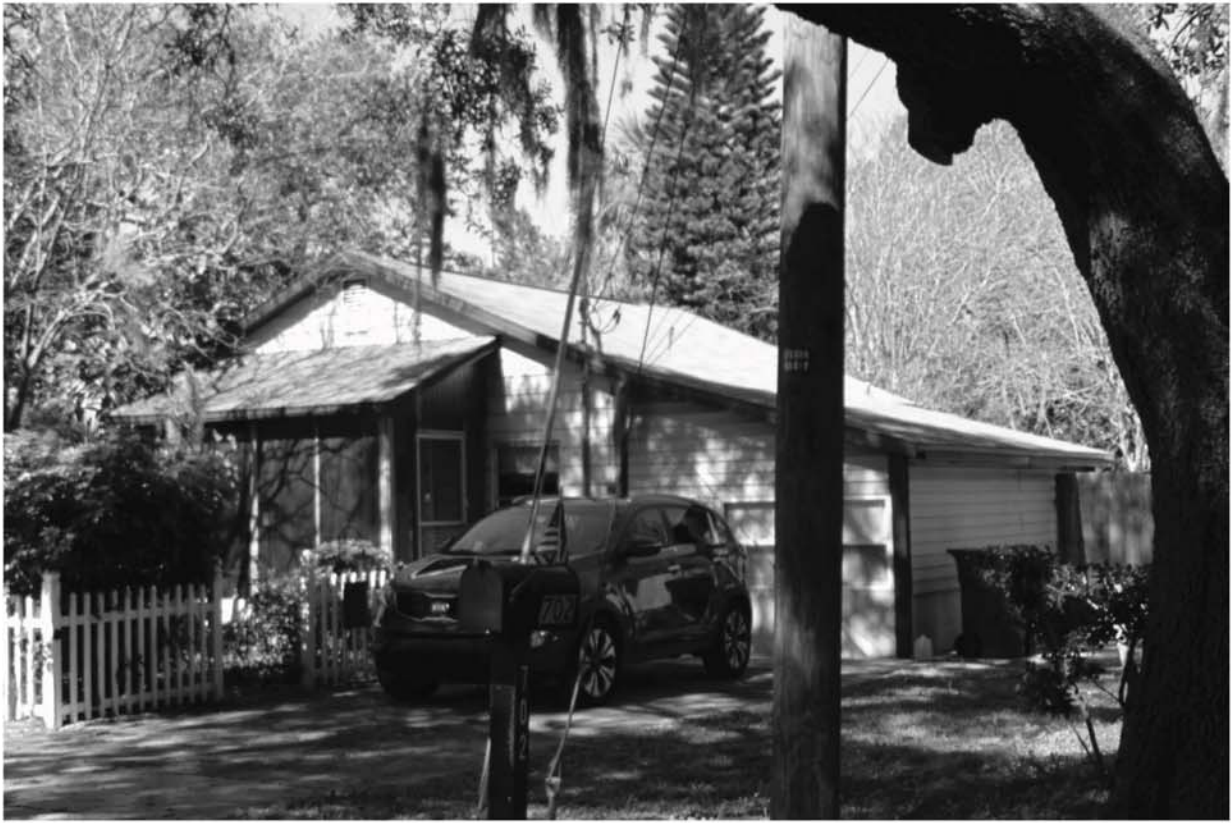
PHOTOGRAPH

Style Frame Vernacular Exterior Plan Irregular Number of Stories 1  
Exterior Fabric(s) 1. Aluminum 2. \_\_\_\_\_ 3. \_\_\_\_\_  
Roof Type(s) 1. Gable 2. Shed 3. \_\_\_\_\_  
Roof Material(s) 1. Composition shingles 2. \_\_\_\_\_ 3. \_\_\_\_\_  
Roof secondary strucs. (dormers etc.) 1. \_\_\_\_\_ 2. \_\_\_\_\_  
Windows (types, materials, etc.) Metal replacement 1/1 SHS windows are present.

Chimney: No. 0 Chimney Material(s): 1. Wood frame 2. Piers
Structural System(s): 1. Wood frame 2. Piers 3.
Foundation Type(s): 1. Piers 2.
Foundation Material(s): 1. 2.
Main Entrance (stylistic details) There is a replacement door in the S porch.

Condition (overall resource condition): [ ]excellent [x]good [ ]fair [ ]deteriorated [ ]ruinous

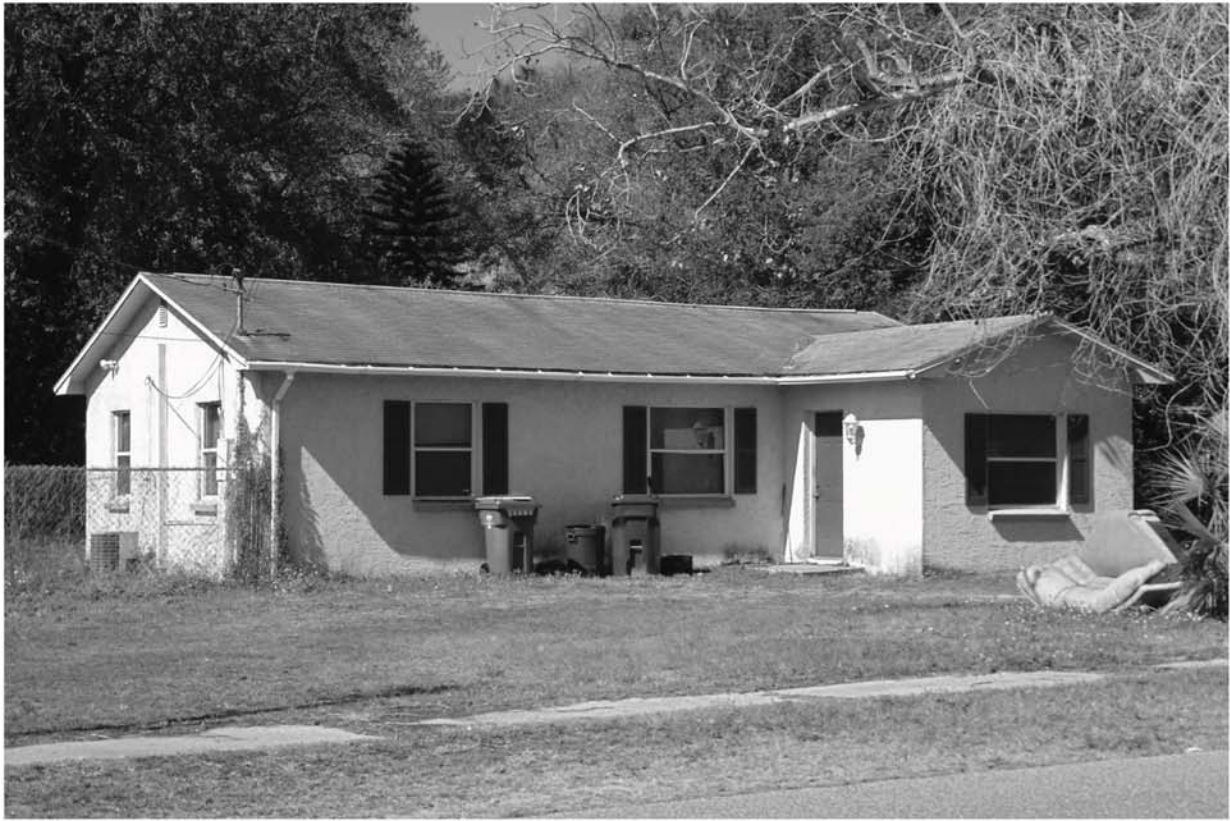
PHOTOGRAPH

Style Masonry Vernacular Exterior Plan Irregular Number of Stories 1  
Exterior Fabric(s) 1. Stucco 2. \_\_\_\_\_ 3. \_\_\_\_\_  
Roof Type(s) 1. Gable 2. \_\_\_\_\_ 3. \_\_\_\_\_  
Roof Material(s) 1. Composition shingles 2. \_\_\_\_\_ 3. \_\_\_\_\_  
Roof secondary strucs. (dormers etc.) 1. \_\_\_\_\_ 2. \_\_\_\_\_  
Windows (types, materials, etc.) Metal replacement 1/1 SHS windows are present.

Chimney: No. 0 Chimney Material(s): 1. Concrete block 2.
Structural System(s): 1. Concrete block 2. 3.
Foundation Type(s): 1. Continuous 2.
Foundation Material(s): 1. Concrete Block 2.
Main Entrance (stylistic details) At the S front gable roof extension is a replacement panel door in the W elevation.
Porch Descriptions (types, locations, roof types, etc.) None observed

Condition (overall resource condition): [ ]excellent [x]good [ ]fair [ ]deteriorated [ ]ruinous
Narrative Description of Resource This MV style residence is irregular in form with a main side gable roof, S front gable extension, and N front gable portion. The building has sustained a NH stucco treatment.

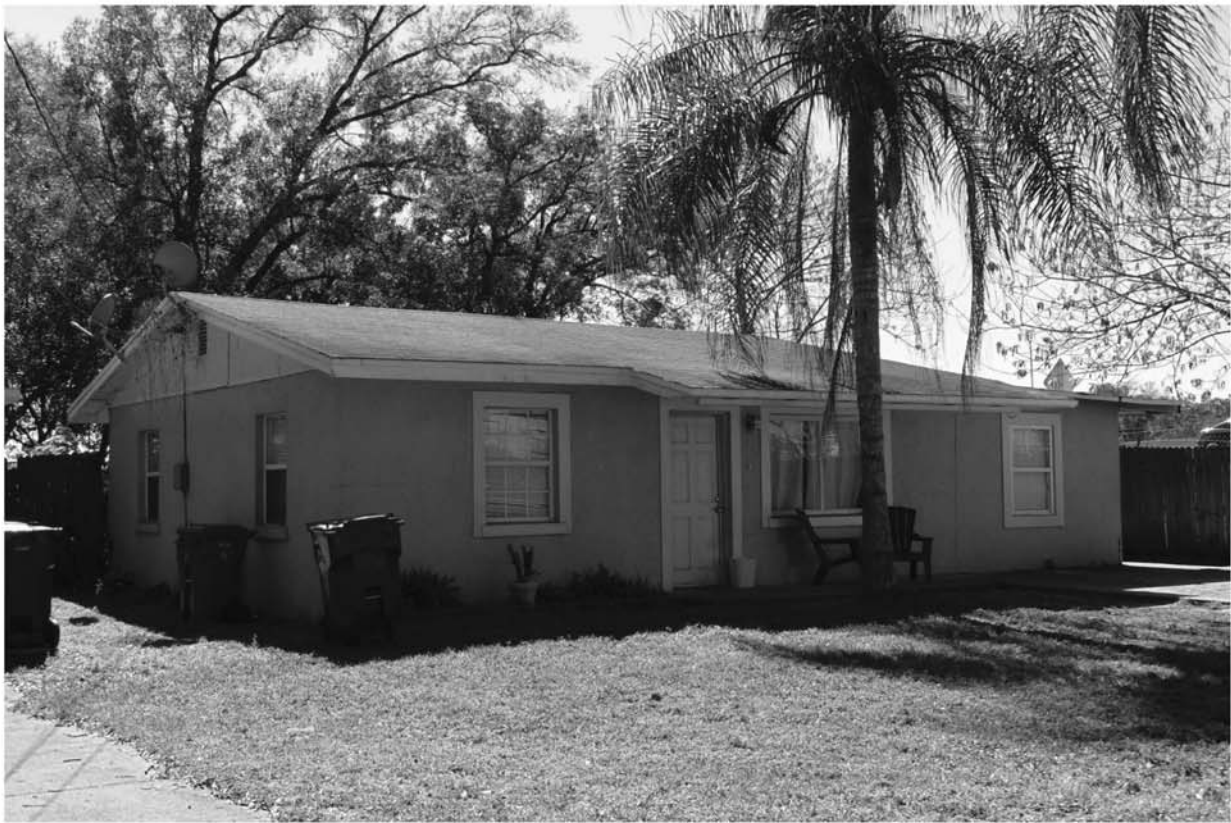
PHOTOGRAPH

Style Masonry Vernacular Exterior Plan Irregular Number of Stories 1  
Exterior Fabric(s) 1. Stucco 2. \_\_\_\_\_ 3. \_\_\_\_\_  
Roof Type(s) 1. Gable 2. Flat 3. \_\_\_\_\_  
Roof Material(s) 1. Composition shingles 2. Built-up 3. \_\_\_\_\_  
Roof secondary strucs. (dormers etc.) 1. \_\_\_\_\_ 2. \_\_\_\_\_  
Windows (types, materials, etc.) Metal replacement 1/1 SHS and 2-light sliding sash windows are present.

Chimney: No. 0 Chimney Material(s): 1. \_\_\_\_\_ 2. \_\_\_\_\_  
 Structural System(s): 1. Concrete 2. \_\_\_\_\_ 3. \_\_\_\_\_  
 Foundation Type(s): 1. Continuous 2. \_\_\_\_\_  
 Foundation Material(s): 1. Concrete Block 2. \_\_\_\_\_  
 Main Entrance (stylistic details) At the N facade is a replacement panel door.

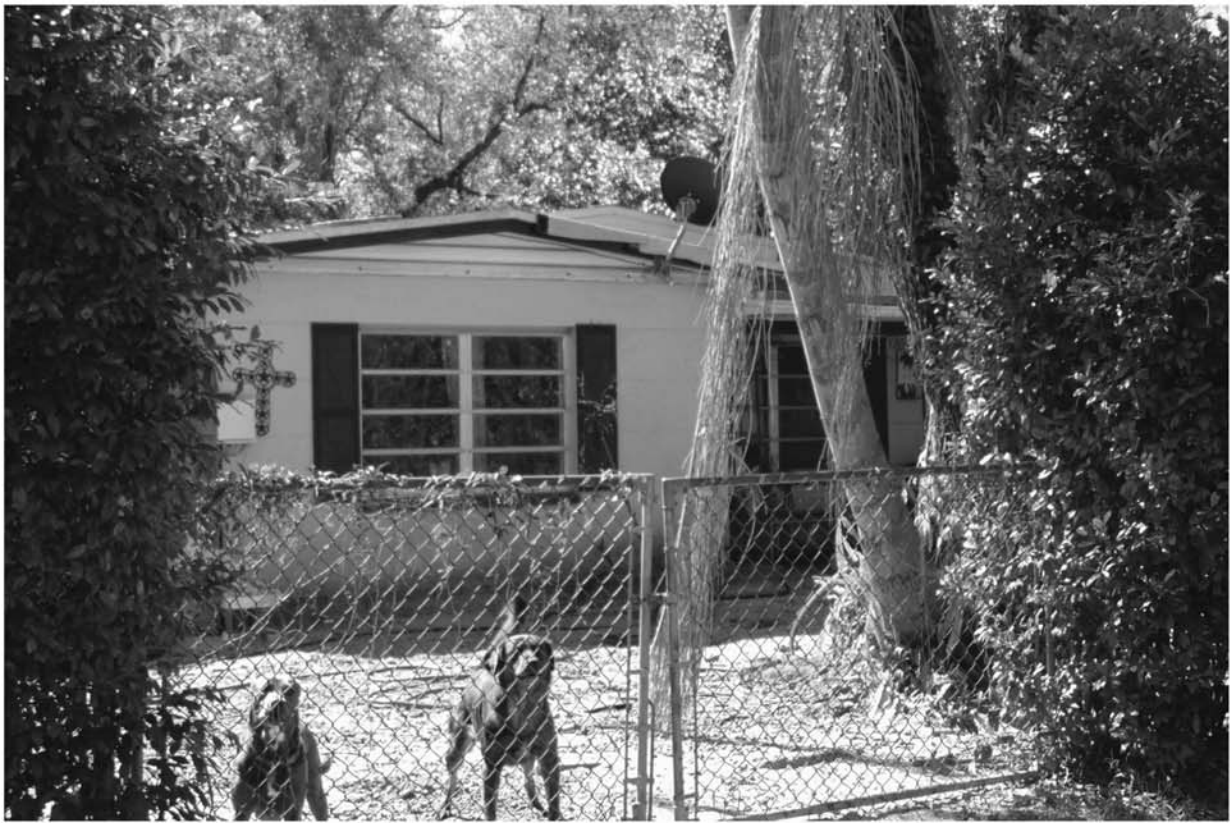
PHOTOGRAPH

Style Masonry Vernacular Exterior Plan Irregular Number of Stories 1  
Exterior Fabric(s) 1. Concrete block 2. \_\_\_\_\_ 3. \_\_\_\_\_  
Roof Type(s) 1. Gable 2. \_\_\_\_\_ 3. \_\_\_\_\_  
Roof Material(s) 1. Composition shingles 2. \_\_\_\_\_ 3. \_\_\_\_\_  
Roof secondary strucs. (dormers etc.) 1. \_\_\_\_\_ 2. \_\_\_\_\_  
Windows (types, materials, etc.) Metal replacement 1/1 SHS and 4-light awning windows are present.

Main Entrance (stylistic details) The entrance is set within the N facade entrance porch but the door could not be observed.

Condition (overall resource condition): [ ]excellent [x]good [ ]fair [ ]deteriorated [ ]ruinous

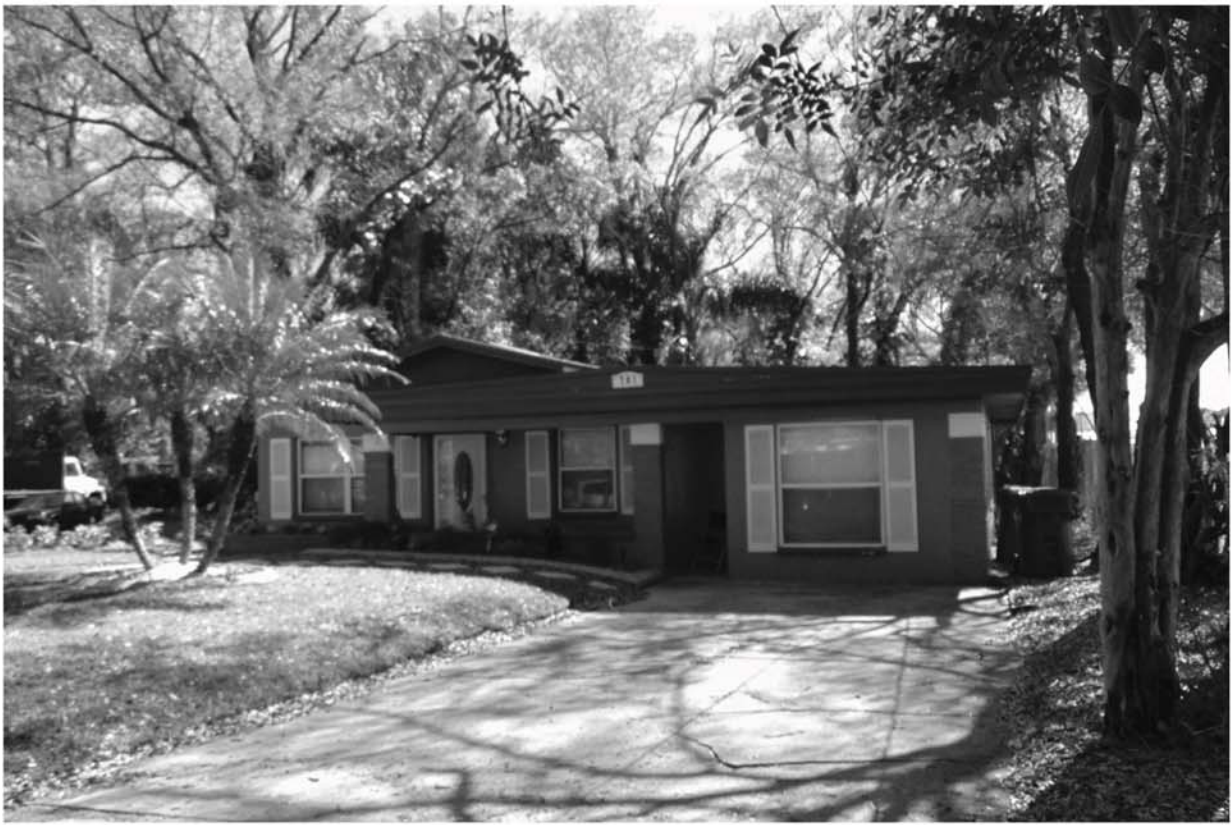
PHOTOGRAPH

Style Masonry Vernacular Exterior Plan Irregular Number of Stories 1  
Exterior Fabric(s) 1. Stucco 2. \_\_\_\_\_ 3. \_\_\_\_\_  
Roof Type(s) 1. Hip 2. \_\_\_\_\_ 3. \_\_\_\_\_  
Roof Material(s) 1. Built-up 2. \_\_\_\_\_ 3. \_\_\_\_\_  
Roof secondary strucs. (dormers etc.) 1. \_\_\_\_\_ 2. \_\_\_\_\_  
Windows (types, materials, etc.) Metal replacement 1/1 SHS windows are present.

Chimney: No. 0 Chimney Material(s): 1. \_\_\_\_\_ 2. \_\_\_\_\_  
 Structural System(s): 1. Concrete block 2. \_\_\_\_\_ 3. \_\_\_\_\_  
 Foundation Type(s): 1. Continuous 2. \_\_\_\_\_  
 Foundation Material(s): 1. Concrete Block 2. \_\_\_\_\_  
 Main Entrance (stylistic details) At the N facade porch is a replacement panel door with decorative oval light inset.

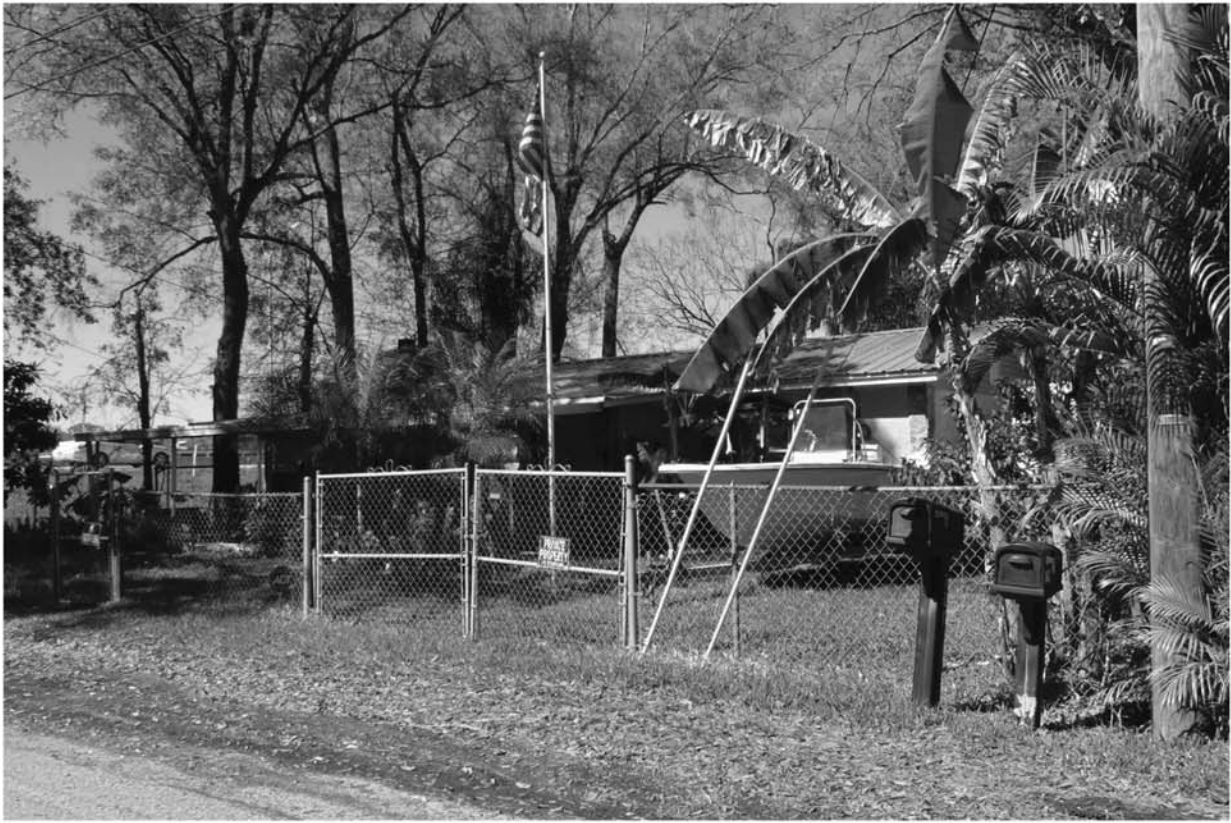
PHOTOGRAPH

Style Masonry Vernacular Exterior Plan Irregular Number of Stories 1  
Exterior Fabric(s) 1. Stucco 2. \_\_\_\_\_ 3. \_\_\_\_\_  
Roof Type(s) 1. Gable 2. Shed 3. \_\_\_\_\_  
Roof Material(s) 1. Sheet metal:standing seam 2. \_\_\_\_\_ 3. \_\_\_\_\_  
Roof secondary strucs. (dormers etc.) 1. \_\_\_\_\_ 2. \_\_\_\_\_  
Windows (types, materials, etc.) Metal replacement 1/1 SHS windows are present, in addition to a S bay window.

Chimney: No. 0 Chimney Material(s): 1. Concrete block 2.
Structural System(s): 1. Concrete block 2. 3.
Foundation Type(s): 1. Continuous 2.
Foundation Material(s): 1. Concrete Block 2.
Main Entrance (stylistic details) At the S facade is a glass door set within the enclosed porch area.

Condition (overall resource condition): [ ]excellent [x]good [ ]fair [ ]deteriorated [ ]ruinous

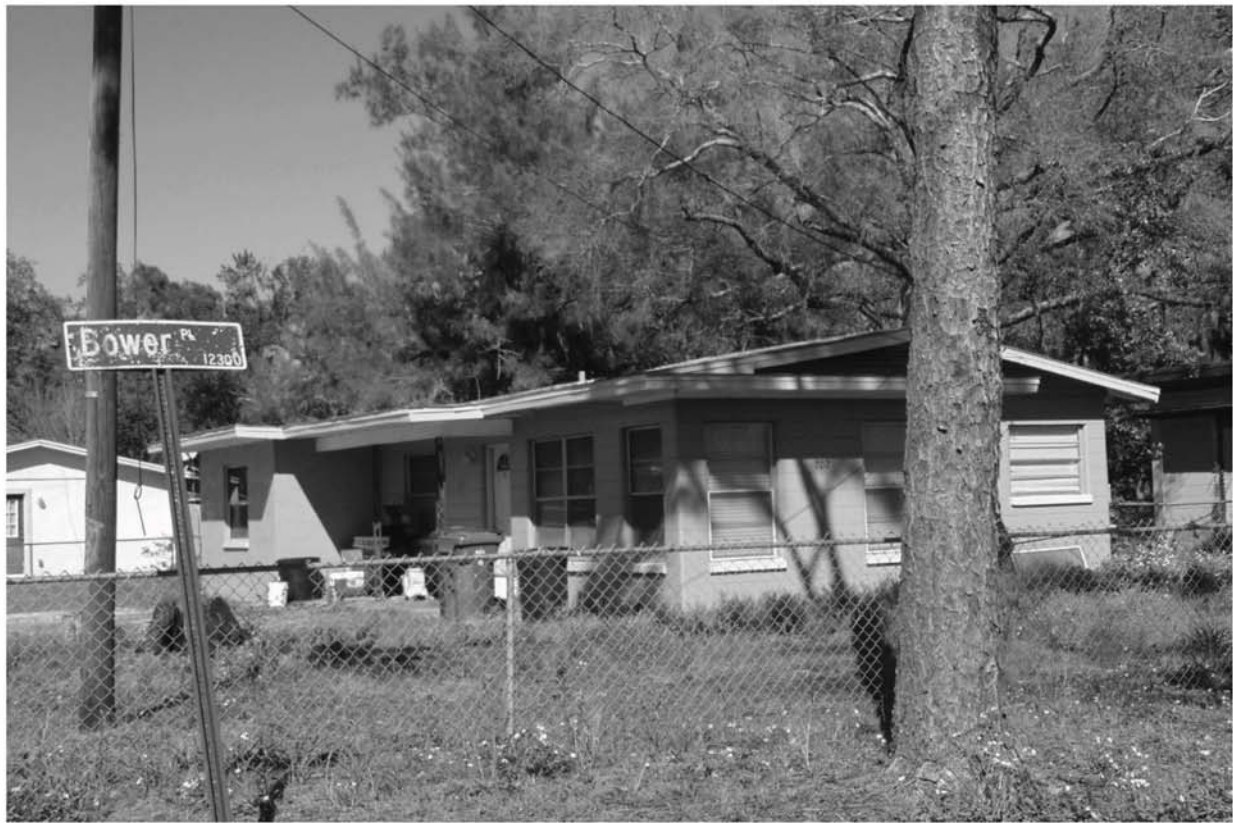
PHOTOGRAPH

Style Masonry Vernacular Exterior Plan Irregular Number of Stories 1  
Exterior Fabric(s) 1. Concrete block 2. Stucco 3. \_\_\_\_\_  
Roof Type(s) 1. Gable 2. Flat 3. \_\_\_\_\_  
Roof Material(s) 1. Built-up 2. \_\_\_\_\_ 3. \_\_\_\_\_  
Roof secondary strucs. (dormers etc.) 1. \_\_\_\_\_ 2. \_\_\_\_\_  
Windows (types, materials, etc.) Metal replacement 2/2 SHS windows are present.

Chimney: No. 0 Chimney Material(s): 1. Concrete block 2.
Structural System(s): 1. Concrete block 2. 3.
Foundation Type(s): 1. Continuous 2.
Foundation Material(s): 1. Concrete Block 2.
Main Entrance (stylistic details) At the W facade is a replacement panel door with fanlight.

Condition (overall resource condition): [ ]excellent [x]good [ ]fair [ ]deteriorated [ ]ruinous

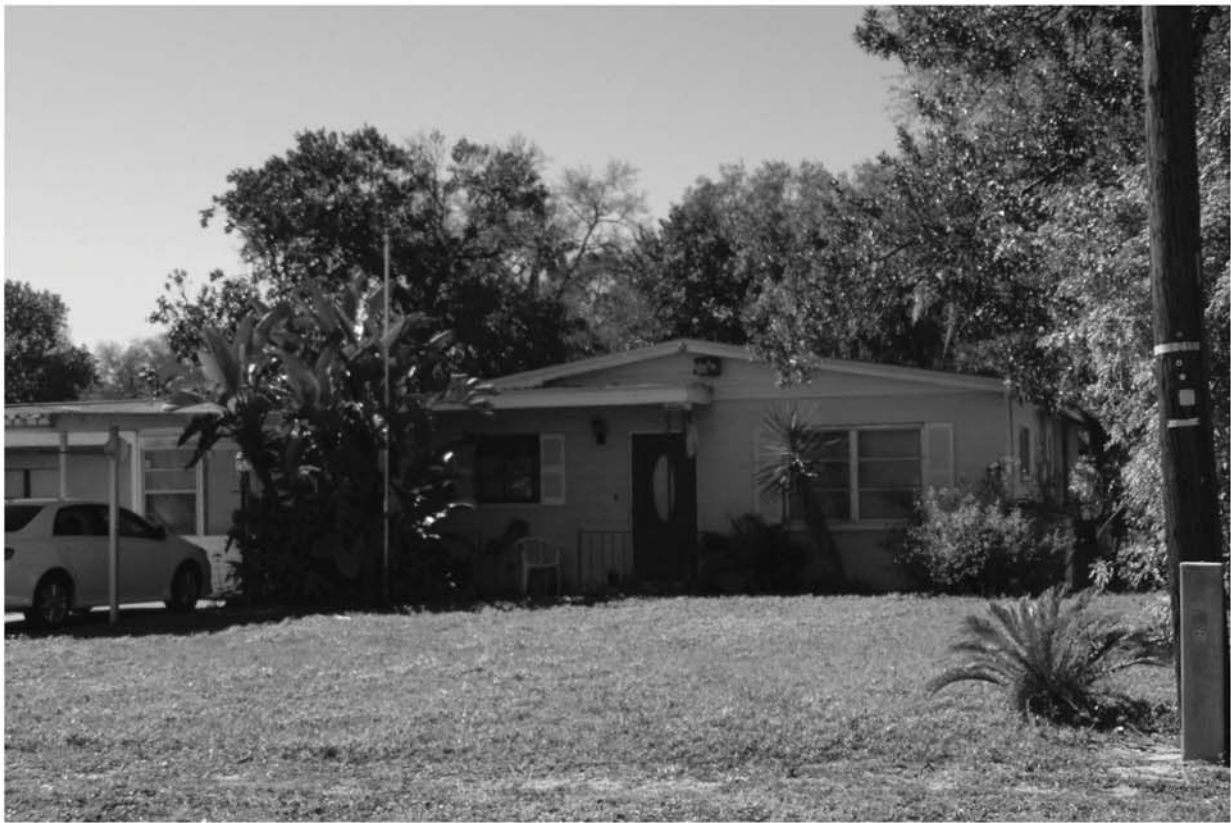
PHOTOGRAPH

Chimney: No. 0 Chimney Material(s): 1. Concrete block 2.
Structural System(s): 1. Concrete block 2. 3.
Foundation Type(s): 1. Continuous 2.
Foundation Material(s): 1. Concrete Block 2.
Main Entrance (stylistic details) There is a replacement wood door with oval inset light within the E porch.

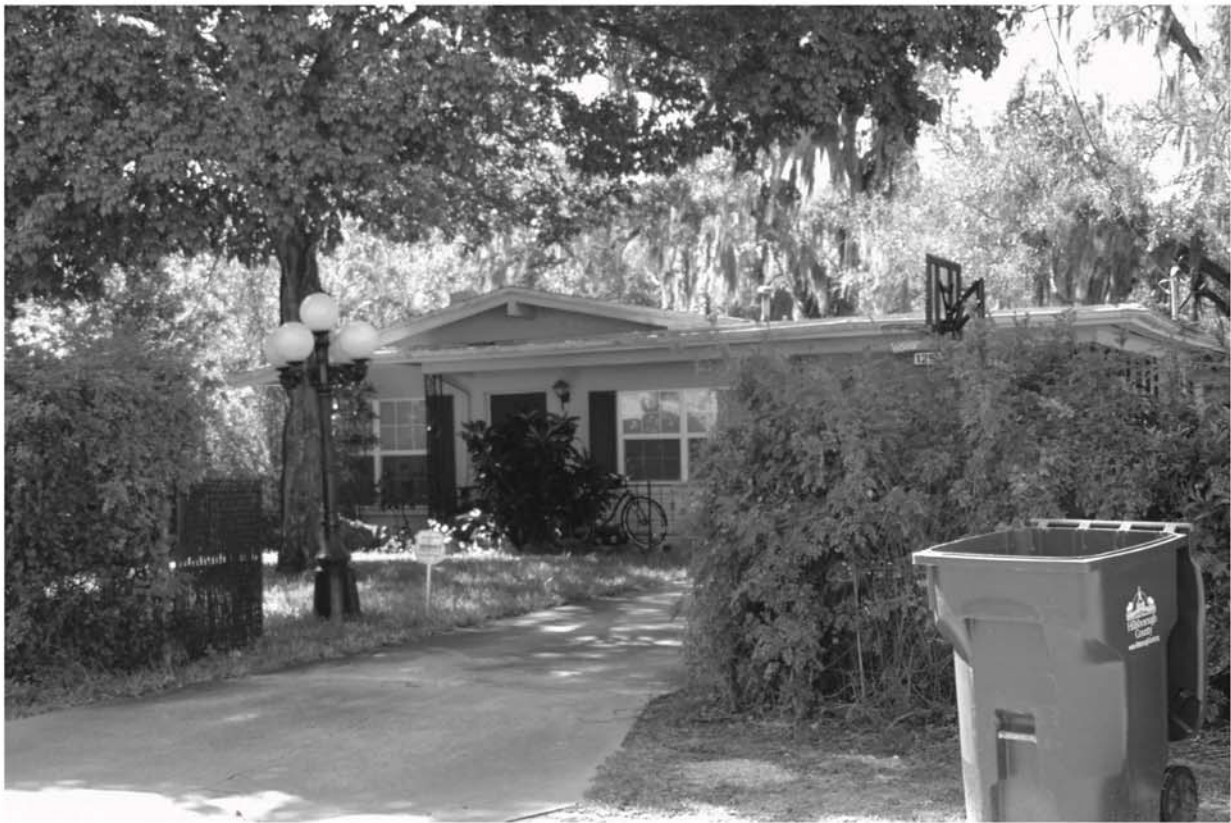
PHOTOGRAPH

Style Frame Vernacular Exterior Plan Rectangular Number of Stories 1  
Exterior Fabric(s) 1. Drop siding 2. \_\_\_\_\_ 3. \_\_\_\_\_  
Roof Type(s) 1. Gable 2. Shed 3. \_\_\_\_\_  
Roof Material(s) 1. Composition shingles 2. Built-up 3. \_\_\_\_\_  
Roof secondary strucs. (dormers etc.) 1. \_\_\_\_\_ 2. \_\_\_\_\_  
Windows (types, materials, etc.) Metal replacement 1/1 and 2/2 SHS windows are present.

Chimney: No. 0 Chimney Material(s): 1. Wood frame 2. Piers 3. Concrete Block
Structural System(s): 1. Wood frame 2. Piers 3. Concrete Block
Foundation Type(s): 1. Piers 2. Concrete Block
Foundation Material(s): 1. Concrete Block 2.
Main Entrance (stylistic details) At the N facade porch is a replacement wood door.

Condition (overall resource condition): [ ] excellent [x] good [ ] fair [ ] deteriorated [ ] ruinous

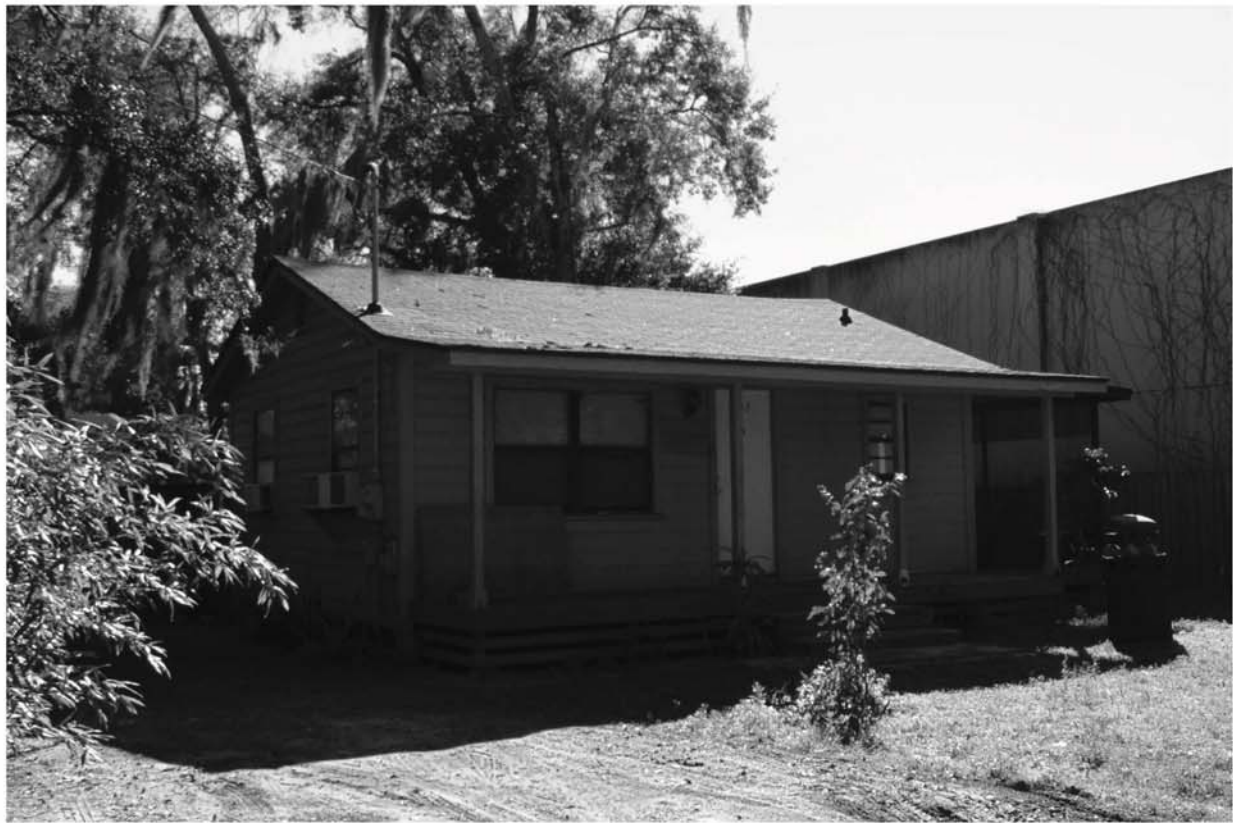
PHOTOGRAPH

Style Masonry Vernacular Exterior Plan Rectangular Number of Stories 1  
Exterior Fabric(s) 1. Stucco 2. \_\_\_\_\_ 3. \_\_\_\_\_  
Roof Type(s) 1. Gable 2. Flat 3. \_\_\_\_\_  
Roof Material(s) 1. Composition shingles 2. \_\_\_\_\_ 3. \_\_\_\_\_  
Roof secondary strucs. (dormers etc.) 1. \_\_\_\_\_ 2. \_\_\_\_\_  
Windows (types, materials, etc.) Metal replacement 1/1 SHS windows are present.

Chimney: No. 0 Chimney Material(s): 1. Concrete block 2.
Structural System(s): 1. Concrete block 2. 3.
Foundation Type(s): 1. Continuous 2.
Foundation Material(s): 1. Concrete Block 2.
Main Entrance (stylistic details) There is a replacement metal door within the E entrance porch.

Condition (overall resource condition): [ ]excellent [x]good [ ]fair [ ]deteriorated [ ]ruinous

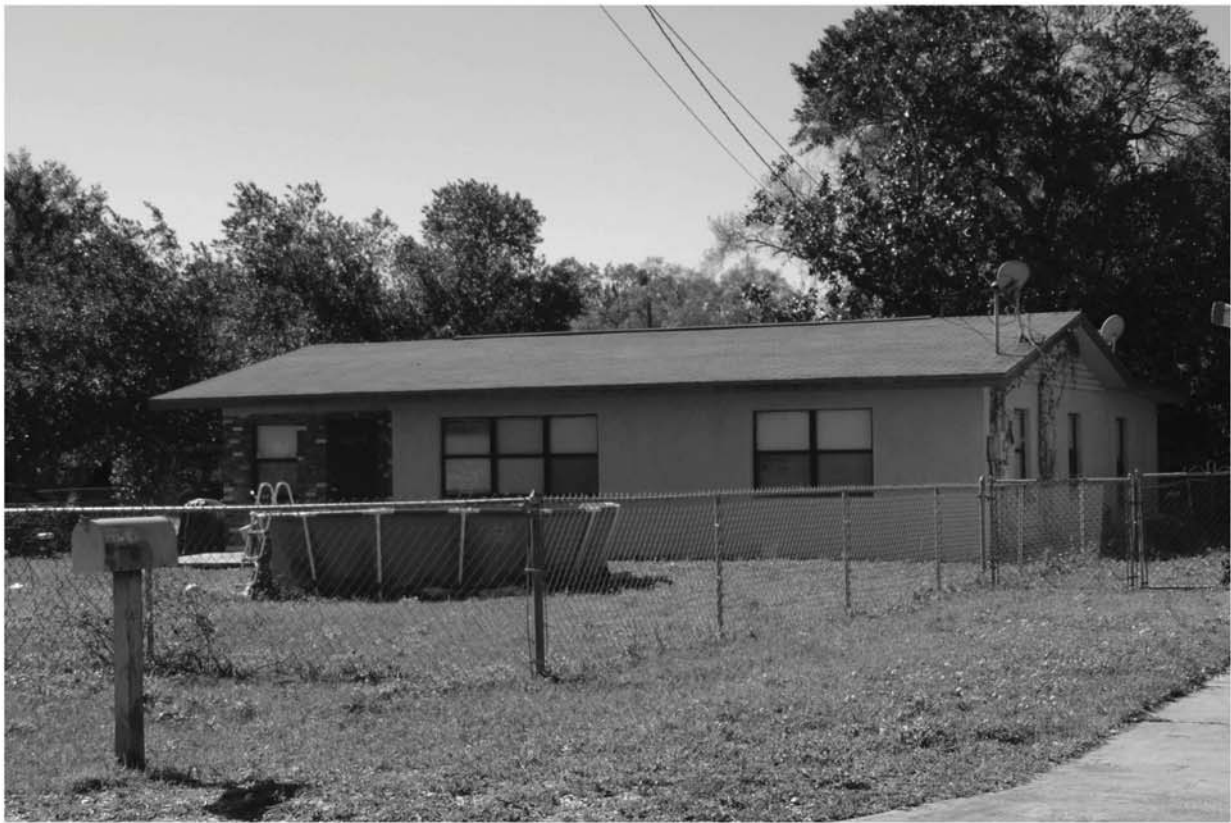
PHOTOGRAPH

Style Frame Vernacular Exterior Plan Irregular Number of Stories 1  
Exterior Fabric(s) 1. Stucco 2. \_\_\_\_\_ 3. \_\_\_\_\_  
Roof Type(s) 1. Gable 2. Flat 3. \_\_\_\_\_  
Roof Material(s) 1. Built-up 2. \_\_\_\_\_ 3. \_\_\_\_\_  
Roof secondary strucs. (dormers etc.) 1. \_\_\_\_\_ 2. \_\_\_\_\_  
Windows (types, materials, etc.) Metal replacement 2/2 SHS and multi-light jalousie windows are present.

Chimney: No. 0 Chimney Material(s): 1. Wood frame 2. Piers 3. Concrete Block
Structural System(s): 1. Wood frame 2. Piers 3. Concrete Block
Foundation Type(s): 1. Piers 2. Concrete Block
Foundation Material(s): 1. Concrete Block 2.
Main Entrance (stylistic details) At the S and E are replacement doors.

Condition (overall resource condition): [ ]excellent [x]good [ ]fair [ ]deteriorated [ ]ruinous

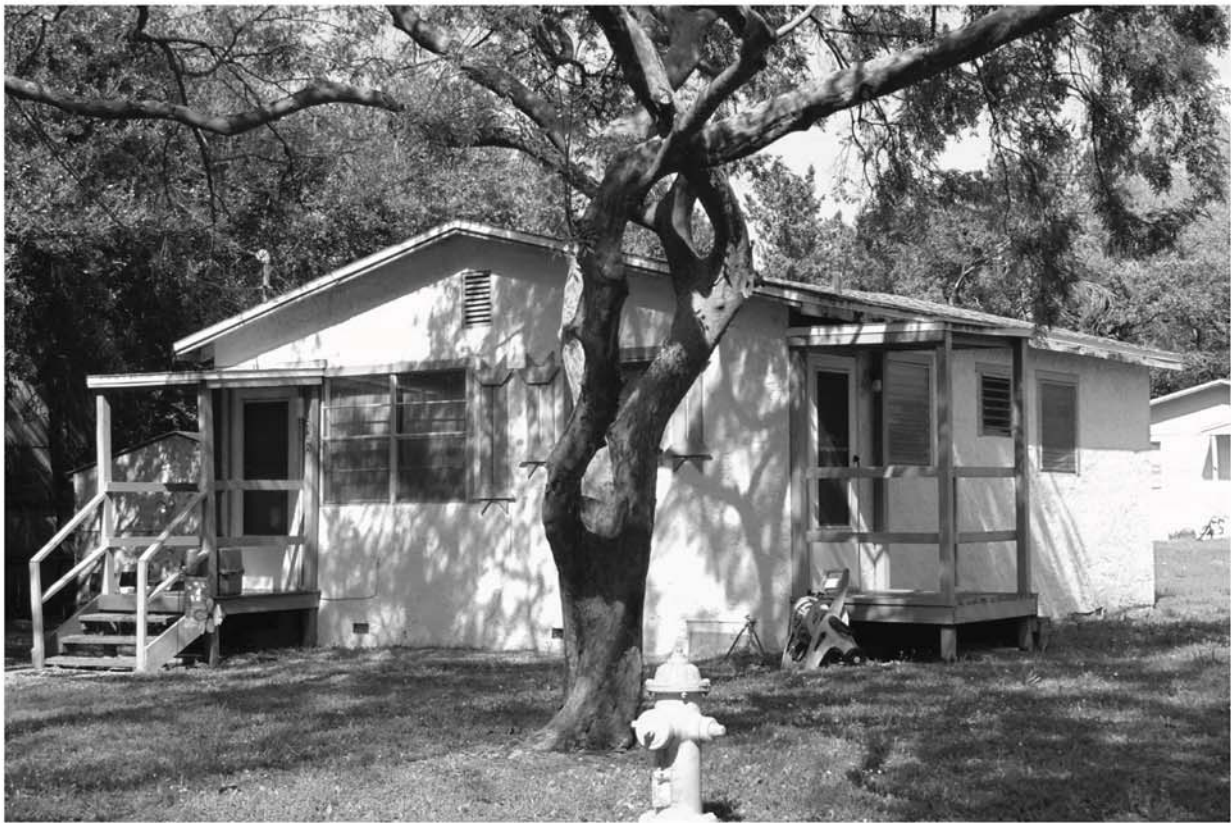
PHOTOGRAPH

Style Frame Vernacular Exterior Plan Rectangular Number of Stories 1  
Exterior Fabric(s) 1. Vinyl 2. \_\_\_\_\_ 3. \_\_\_\_\_  
Roof Type(s) 1. Gable 2. \_\_\_\_\_ 3. \_\_\_\_\_  
Roof Material(s) 1. Composition shingles 2. \_\_\_\_\_ 3. \_\_\_\_\_  
Roof secondary strucs. (dormers etc.) 1. \_\_\_\_\_ 2. \_\_\_\_\_  
Windows (types, materials, etc.) Metal replacement 1/1 and 2/2 SHS windows are present.

Chimney: No. 0 Chimney Material(s): 1. 2.
Structural System(s): 1. Wood frame 2. 3.
Foundation Type(s): 1. Piers 2.
Foundation Material(s): 1. 2.
Main Entrance (stylistic details) The main entrance is at the S elevation of the E enclosed porch and incorporates a replacement door.
Porch Descriptions (types, locations, roof types, etc.) None observed

Condition (overall resource condition): [ ]excellent [x]good [ ]fair [ ]deteriorated [ ]ruinous
Narrative Description of Resource This FV style residence is rectangular in form with a main side gable roof and E roof extension enclosed porch. The building has been re-clad in vinyl siding.

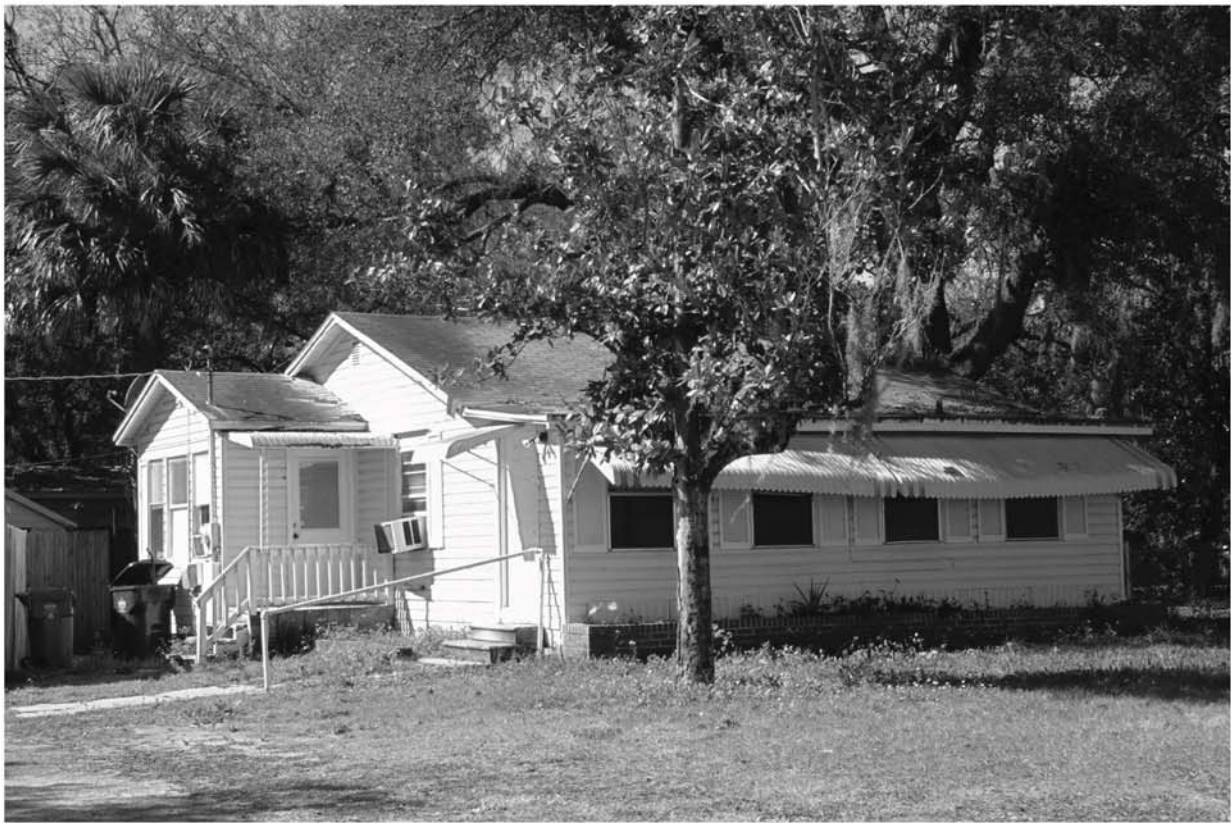
PHOTOGRAPH

Style Frame Vernacular Exterior Plan Irregular Number of Stories 1  
Exterior Fabric(s) 1. Stucco 2. \_\_\_\_\_ 3. \_\_\_\_\_  
Roof Type(s) 1. Gable 2. \_\_\_\_\_ 3. \_\_\_\_\_  
Roof Material(s) 1. Composition shingles 2. \_\_\_\_\_ 3. \_\_\_\_\_  
Roof secondary strucs. (dormers etc.) 1. \_\_\_\_\_ 2. \_\_\_\_\_  
Windows (types, materials, etc.) Metal replacement 6/6 and 8/8 SHS windows are present.

Chimney: No. 0 Chimney Material(s): 1. Wood frame 2. Piers 3. Concrete Block
Structural System(s): 1. Wood frame 2. Piers 3. Concrete Block
Foundation Type(s): 1. Piers 2. Concrete Block
Foundation Material(s): 1. Concrete Block 2.
Main Entrance (stylistic details) There is a replacement door within the altered S porch.

Condition (overall resource condition): [ ] excellent [x] good [ ] fair [ ] deteriorated [ ] ruinous
