# I-275 (STATE ROAD 93) EXPRESS LANES

## PROJECT DEVELOPMENT & ENVIRONMENT STUDY

## **FINAL CULTURAL RESOURCE ASSESSMENT SURVEY**

### **UPDATED AND NEWLY CREATED FMSF FORMS (8HI12800-8HI12946)**

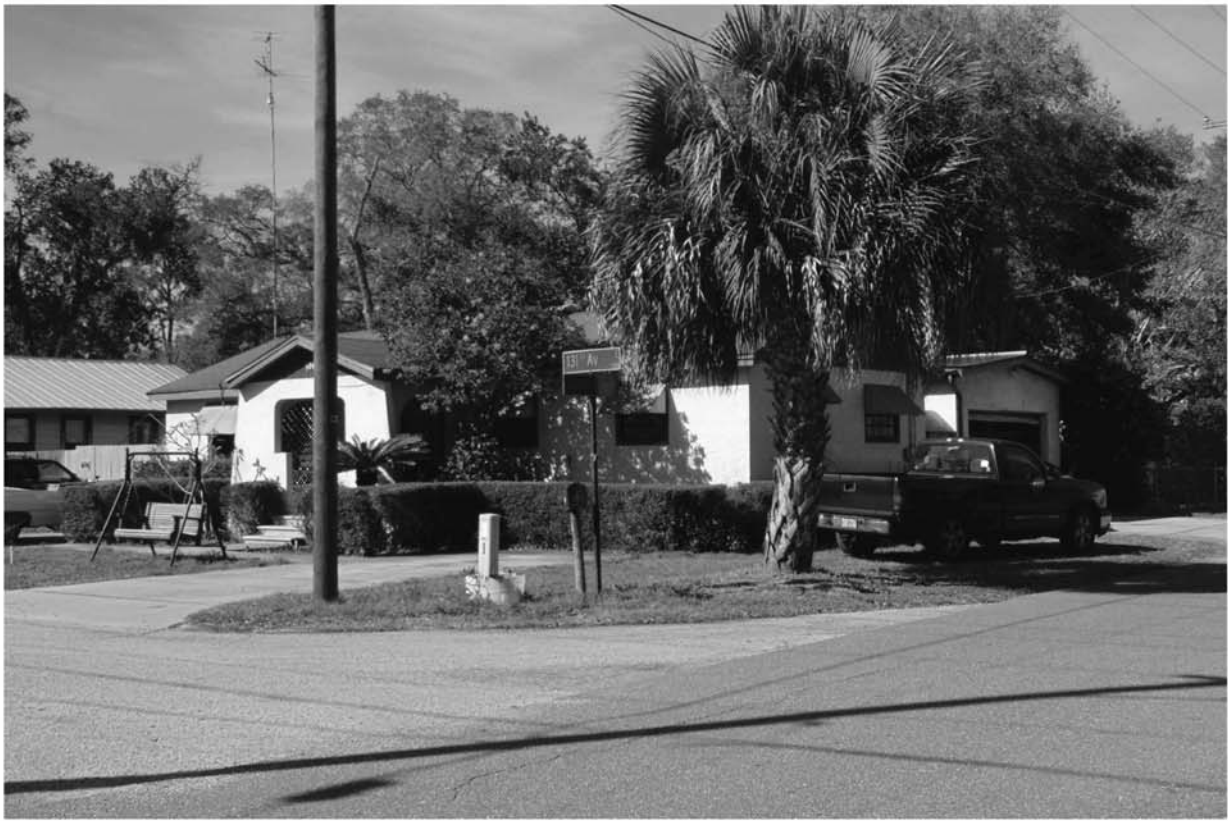
PHOTOGRAPH

Style Masonry Vernacular Exterior Plan Irregular Number of Stories 1  
Exterior Fabric(s) 1. Stucco 2. \_\_\_\_\_ 3. \_\_\_\_\_  
Roof Type(s) 1. Gable 2. \_\_\_\_\_ 3. \_\_\_\_\_  
Roof Material(s) 1. Composition shingles 2. \_\_\_\_\_ 3. \_\_\_\_\_  
Roof secondary strucs. (dormers etc.) 1. \_\_\_\_\_ 2. \_\_\_\_\_  
Windows (types, materials, etc.) Metal replacement 1/1 and 2/2 SHS and 1-light fixed windows are present.

Chimney: No. 1 Chimney Material(s): 1. Concrete block 2. \_\_\_\_\_  
 Structural System(s): 1. Concrete block 2. \_\_\_\_\_ 3. \_\_\_\_\_  
 Foundation Type(s): 1. Continuous 2. \_\_\_\_\_  
 Foundation Material(s): 1. Concrete Block 2. \_\_\_\_\_  
 Main Entrance (stylistic details) At the E facade is a set of replacement double-doors within the porch.

Condition (overall resource condition): excellent good fair deteriorated ruinous

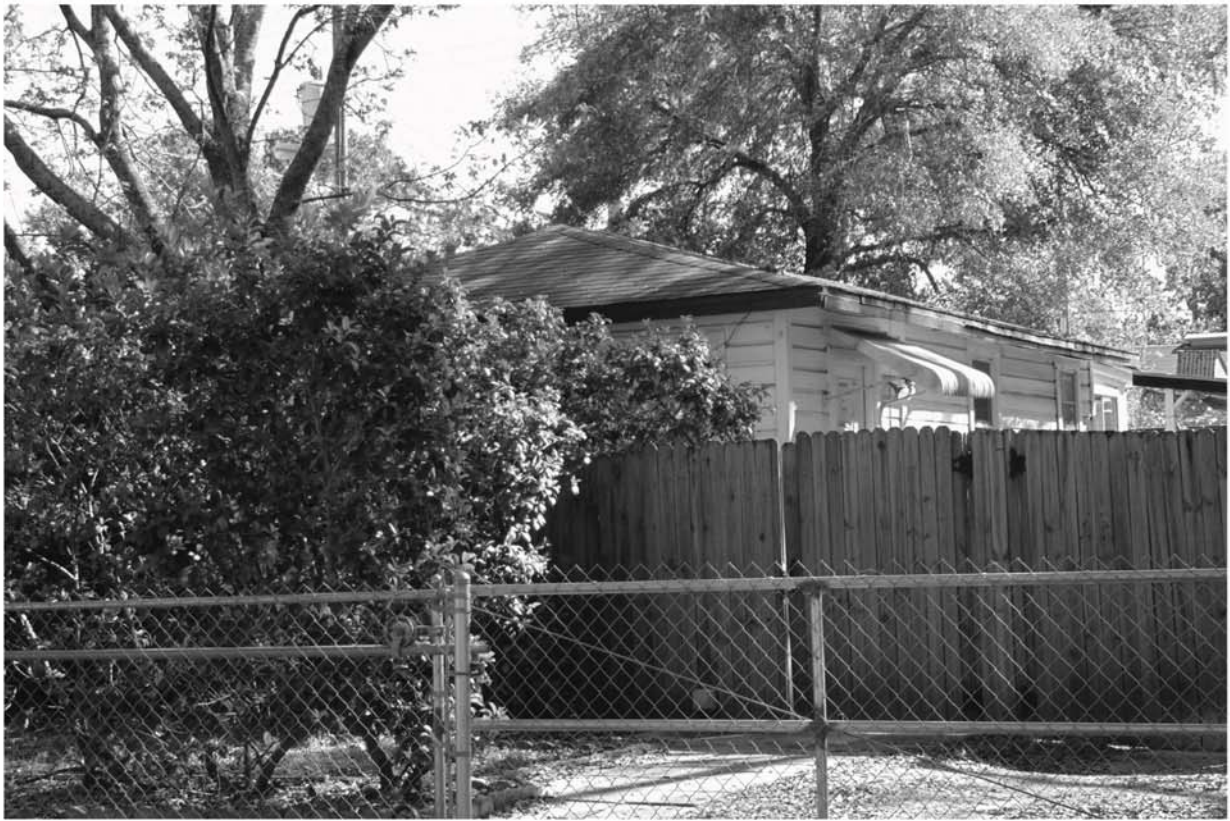
PHOTOGRAPH

Style Frame Vernacular Exterior Plan Irregular Number of Stories 1  
Exterior Fabric(s) 1. Aluminum 2. \_\_\_\_\_ 3. \_\_\_\_\_  
Roof Type(s) 1. Gable 2. \_\_\_\_\_ 3. \_\_\_\_\_  
Roof Material(s) 1. Composition shingles 2. \_\_\_\_\_ 3. \_\_\_\_\_  
Roof secondary strucs. (dormers etc.) 1. \_\_\_\_\_ 2. \_\_\_\_\_  
Windows (types, materials, etc.) Metal replacement 1/1 SHS windows are present.

Chimney: No. 0 Chimney Material(s): 1. Wood frame 2. Piers
Structural System(s): 1. Wood frame 2. Piers 3.
Foundation Type(s): 1. Piers 2.
Foundation Material(s): 1. 2.
Main Entrance (stylistic details) Within the S front gable extension is a replacement door.
Porch Descriptions (types, locations, roof types, etc.) None observed

Condition (overall resource condition): [ ] excellent [x] good [ ] fair [ ] deteriorated [ ] ruinous
Narrative Description of Resource This FV style residence is irregular in form with a man front gable roof and S front gable roof extension where a carport has been enclosed. The building has been re-clad in aluminum siding and there is a S wheelchair ramp addition.
Archaeological Remains [ ] Check if Archaeological Form Completed

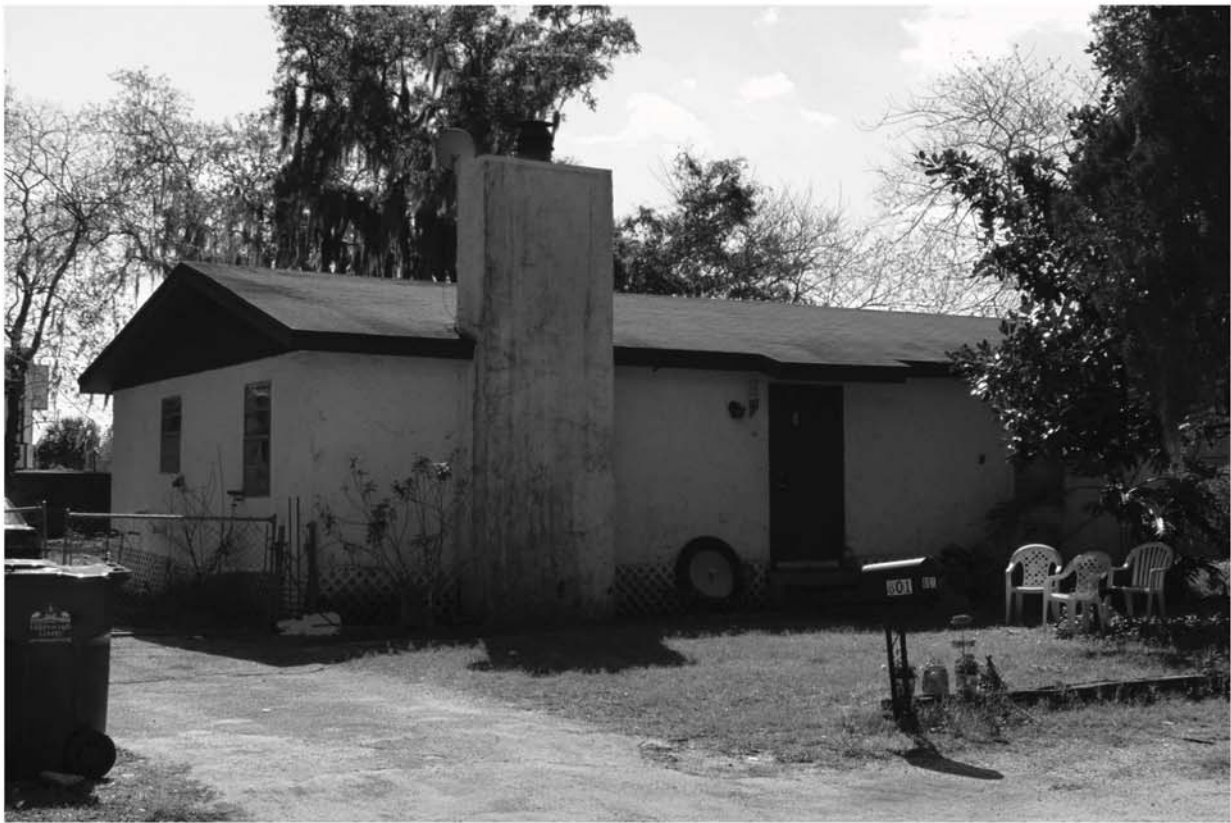
PHOTOGRAPH

Style Frame Vernacular Exterior Plan Rectangular Number of Stories 1  
Exterior Fabric(s) 1. Stucco 2. \_\_\_\_\_ 3. \_\_\_\_\_  
Roof Type(s) 1. Gable 2. \_\_\_\_\_ 3. \_\_\_\_\_  
Roof Material(s) 1. Composition shingles 2. \_\_\_\_\_ 3. \_\_\_\_\_  
Roof secondary strucs. (dormers etc.) 1. \_\_\_\_\_ 2. \_\_\_\_\_  
Windows (types, materials, etc.) Metal replacement 2/2 SHS windows are present.

Chimney: No. 1 Chimney Material(s): 1. Concrete 2.
Structural System(s): 1. Wood frame 2. 3.
Foundation Type(s): 1. Piers 2.
Foundation Material(s): 1. 2.
Main Entrance (stylistic details) At the N facade is a replacement wood door beneath a roof extension.
Porch Descriptions (types, locations, roof types, etc.) None observed

Condition (overall resource condition): [ ]excellent [x]good [ ]fair [ ]deteriorated [ ]ruinous
Narrative Description of Resource This FV style residence is rectangular in form with a side gable roof and N roof extension entrance stoop. The building has been NH stuccoed and some windows openings have been enclosed.

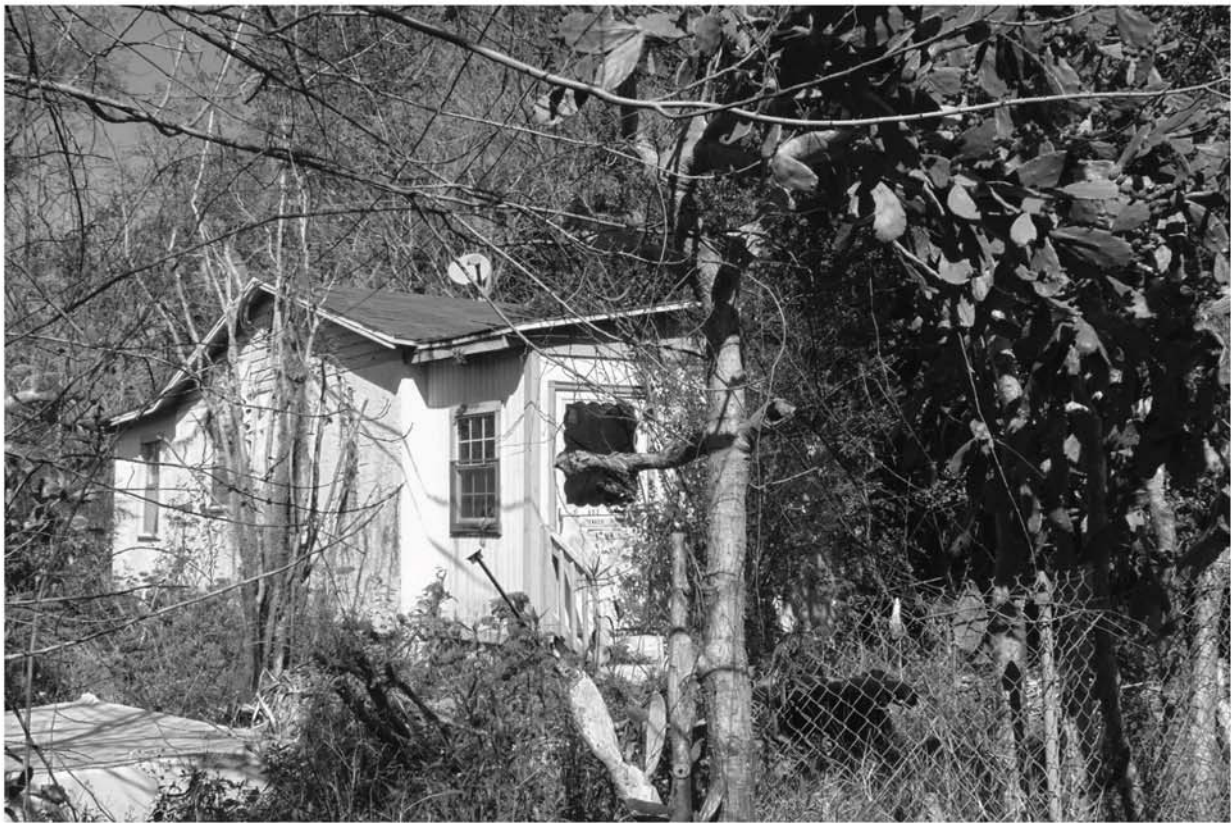
PHOTOGRAPH

Style Frame Vernacular Exterior Plan Irregular Number of Stories 1  
Exterior Fabric(s) 1. Stucco 2. Wood siding 3. \_\_\_\_\_  
Roof Type(s) 1. Gable 2. Shed 3. \_\_\_\_\_  
Roof Material(s) 1. Composition shingles 2. Built-up 3. \_\_\_\_\_  
Roof secondary strucs. (dormers etc.) 1. \_\_\_\_\_ 2. \_\_\_\_\_  
Windows (types, materials, etc.) Metal replacement 2/2 and 6/6 SHS windows are present.

Chimney: No. 0 Chimney Material(s): 1. 2.
Structural System(s): 1. Wood frame 2. 3.
Foundation Type(s): 1. Piers 2.
Foundation Material(s): 1. 2.
Main Entrance (stylistic details) The main entrance could not be observed due to vegetation overgrowth.
Porch Descriptions (types, locations, roof types, etc.) None observed

Condition (overall resource condition): [ ]excellent [ ]good [x]fair [ ]deteriorated [ ]ruinous
Narrative Description of Resource This FV style residence is irregular in form with a central side gable portion, N shed roof addition, and S front gable enclosed porch. The building has been stuccoed. The building was mostly obscured by vegetation.
Archaeological Remains [ ]Check if Archaeological Form Completed

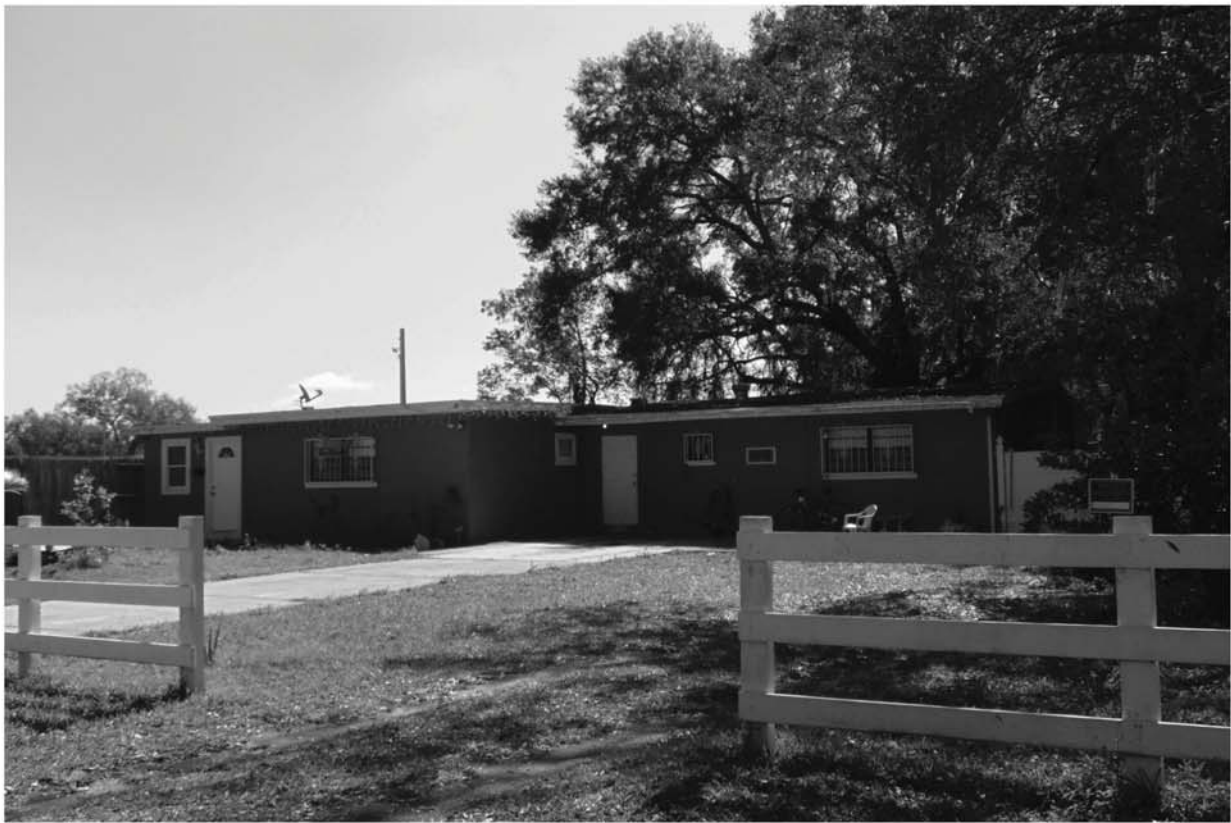
PHOTOGRAPH

Style Masonry Vernacular Exterior Plan Irregular Number of Stories 1  
Exterior Fabric(s) 1. Stucco 2. \_\_\_\_\_ 3. \_\_\_\_\_  
Roof Type(s) 1. Gable 2. Flat 3. \_\_\_\_\_  
Roof Material(s) 1. Composition shingles 2. Built-up 3. \_\_\_\_\_  
Roof secondary strucs. (dormers etc.) 1. \_\_\_\_\_ 2. \_\_\_\_\_  
Windows (types, materials, etc.) Metal replacement 1/1, 2/2, and 6/1 SHS windows are present.

Chimney: No. 0 Chimney Material(s): 1. Concrete block 2.
Structural System(s): 1. Concrete block 2. 3.
Foundation Type(s): 1. Continuous 2.
Foundation Material(s): 1. Concrete Block 2.
Main Entrance (stylistic details) At the N facade are two replacement panel doors with fanlights at the enclosed porch and carport.
Porch Descriptions (types, locations, roof types, etc.) None observed

Condition (overall resource condition): [ ]excellent [x]good [ ]fair [ ]deteriorated [ ]ruinous
Narrative Description of Resource This MV style residence is irregular in form with a W side gable portion and E flat roof portion. The E porch has been enclosed and the W carport enclosed to turn this residence into a duplex.
Archaeological Remains [ ]Check if Archaeological Form Completed

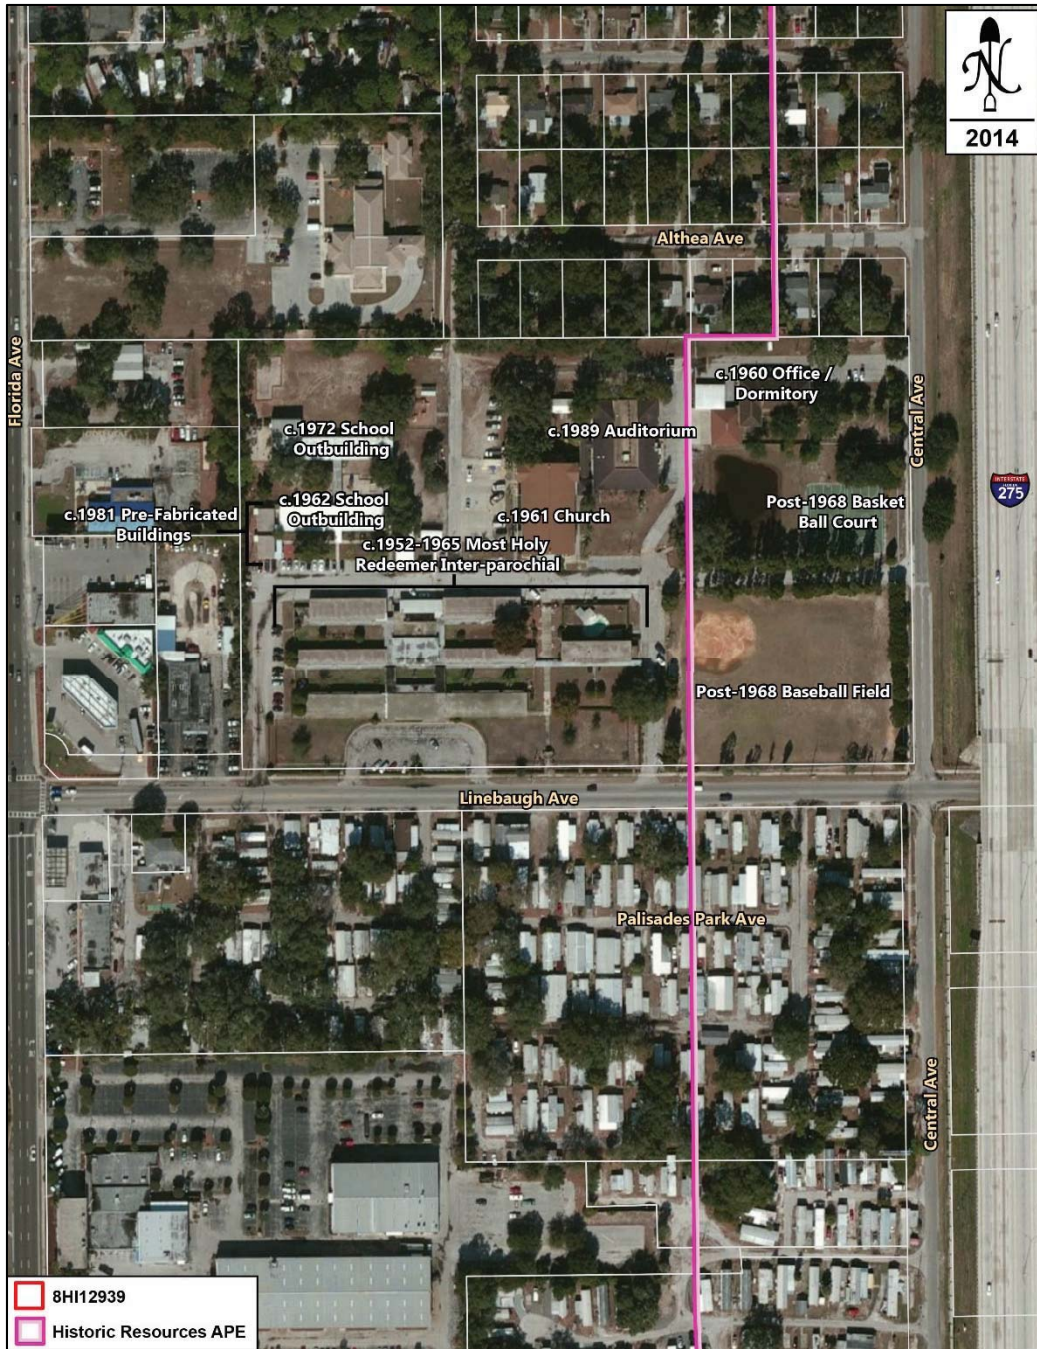
**Figure 1: A Current Aerial Photograph Illustrating the Location and Dates Attributed to Resources within the Most Holy Redeemer School Resource Group (8HI12939)**

One resource with a historic construction date, the circa-1965 Most Holy Redeemer Inter-parochial School outbuilding, could not be observed from the right of way (ROW), and thus could not be evaluated as part of the current study. The circa-1972 Most Holy Redeemer Inter-parochial School outbuilding and circa-1981 prefabricated connected outbuildings could also not be observed from the ROW. In consultation with aerial photographs from 1968, it can be determined that neither are historic; therefore, they can be considered non-contributing resources to the resource group. It should be noted that only the circa-1960 office/dormitory building is located within the current project APE; however, for the purposes of the study, the entire parcel related to Most Holy Redeemer School was surveyed and evaluated as a resource group for National Register significance. Figure 1, a current aerial photograph, illustrates the location and dates of construction attributed to each resource within the resource group. This mapping includes those resources that could not be observed from the ROW. Following Figure 1, are brief narratives for resources which could be observed from the ROW during the survey (Figures 2-8).

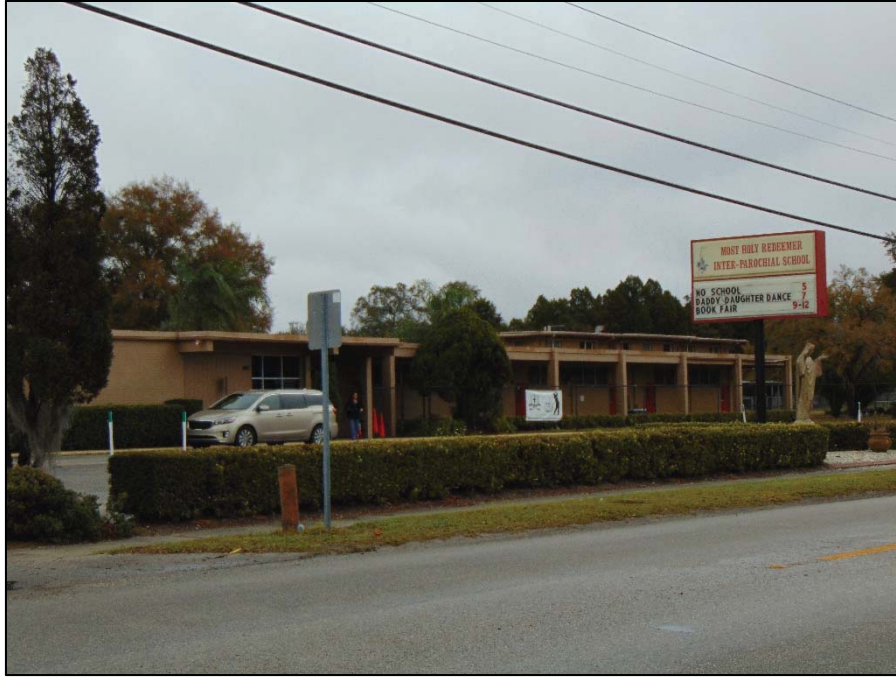
**Figure 2: Most Holy Redeemer Inter-parochial School, constructed between 1952 and 1965, facing Northeast**

In consultation with aerial photographs from 1957 (Figure 3), 1968 (Figure 4), the current aerial photograph (please see Figure 1), and the Hillsborough County Property Appraiser, there are seven buildings related to the Most Holy Redeemer Inter-parochial School which are connected by canopied walkways. These buildings are arranged in three rows, are Masonry Vernacular in style, and were constructed between 1952 and 1965 (please see Figure 1). The one-story buildings north of the circular driveway are constructed of concrete block clad in stucco and feature a flat roof system comprised of built-up materials. It appears that individual classrooms are accessed from the south elevation exterior of the various school complex buildings via concrete walkways covered by overhanging roof eaves. The south walkways incorporate metal supports. Windows are metal replacement fixed light. Classroom doors are simple metal doors with a fixed glass lights inset. It appears that the main entrance/school office is beneath a roof extension to the east of the building immediately north of E Linebaugh Avenue. A passageway is present immediately east of the office which leads into the complex. There are several grassy courtyards between buildings. A two-story Masonry Vernacular style school building is connected to the east by a walkway stemming from the central row of 1-story buildings (Figure 5). This building was constructed circa-1952 and features stucco cladding, a flat roof system comprised of built-up materials, and metal replacement one-over-one single-hung sash windows.

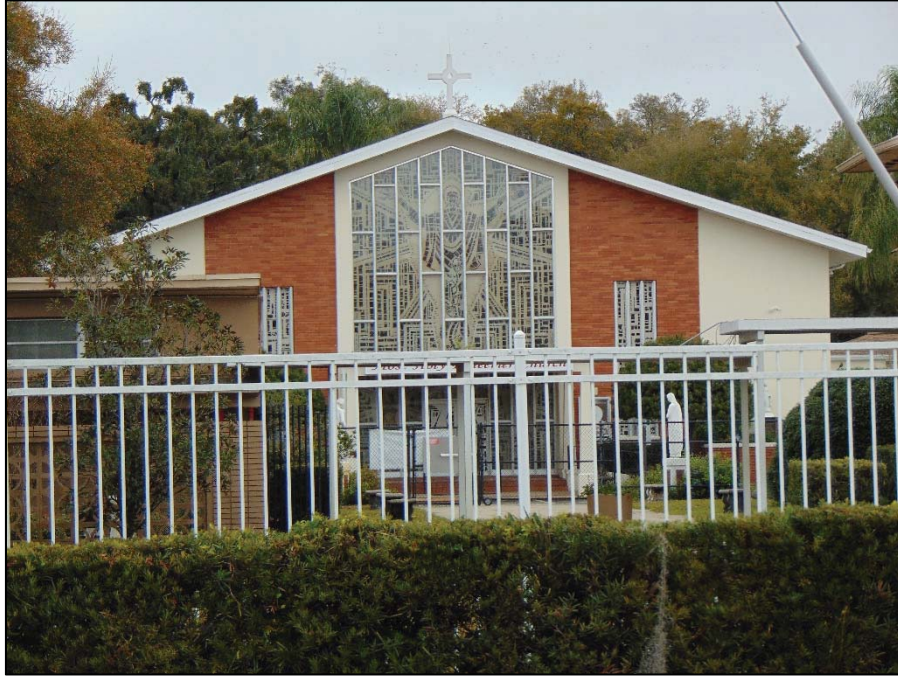
stucco treatment and fenestration consists of metal replacement two-light and three-light sliding sash windows. The building has wide overhanging eaves and concrete sills.

**Figure 6: The Most Holy Redeemer Church Building, facing North**

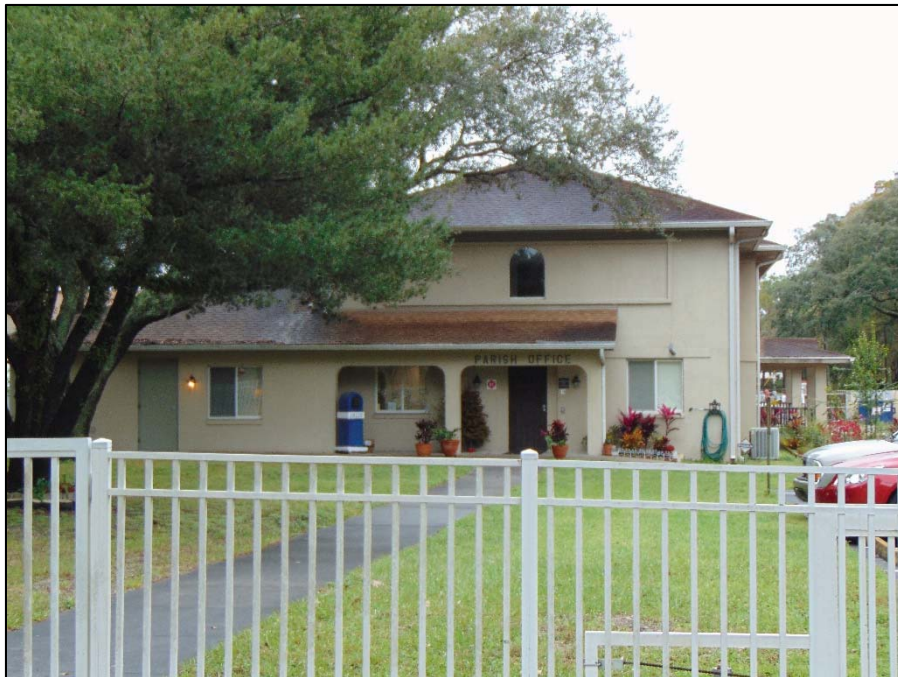
**Figure 7: The Most Holy Redeemer Office/Dormitory Building, facing West**

The circa-1960 constructed non-contributing office/dormitory building is located to the northeast of the parcel and is set on N Central Avenue (Figure 7). As previously mentioned, this is the only structure of Most Holy Redeemer which is within the current project APE. The original building is two stories in height with a main hipped roof system clad in composition shingles. There are two one-story front gable entrances at the north façade to the dormitory housing. A one-story hip roof portion is appended at the south and incorporates a north roof extension at the east entrance. This entrance includes masonry constructed arched openings and a replacement door with metal security bars in front. In consultation with aerial photographs from 1968 (Figure 5), several portions were added to the building after this time period. A two-story hipped roof extension was appended south of the west building end, a one-story hipped roof portion addition was constructed west of the two-story addition, and a flat roof one-story addition was appended at the northwest corner of the one-story hipped roof addition. The entire building is clad in a non-historic

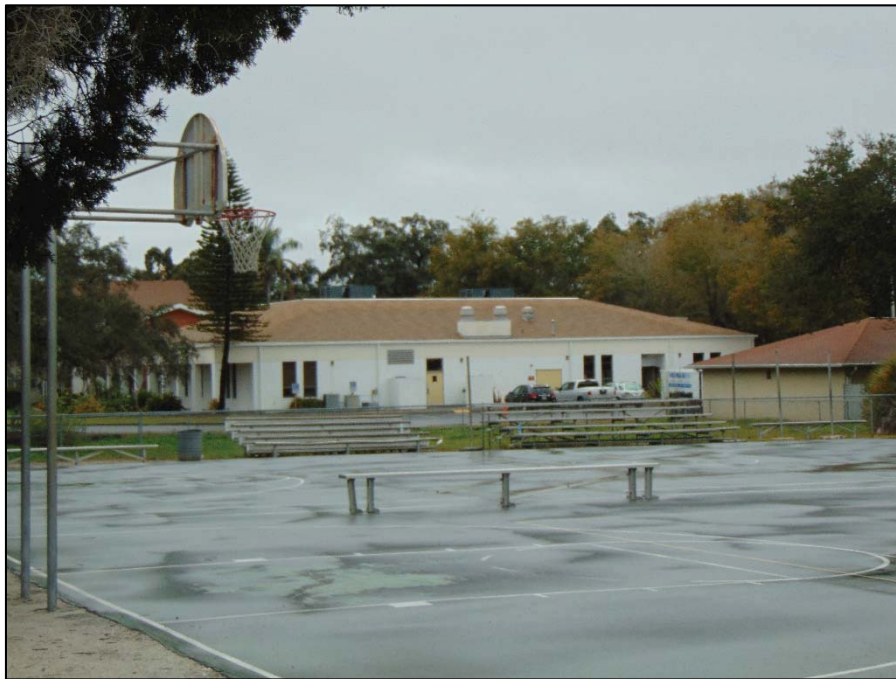
**Figure 8: The circa-1989 Constructed Auditorium Building, facing Northwest**

Figure 8 is a photograph of the circa-1989 constructed auditorium building for Most Holy Redeemer. This structure is located immediately west of the circa-1960 office/dormitory building and is a one-story Masonry Vernacular style building. It features a hipped roof system clad in composition shingles and walls clad in stucco. Fenestration consists of metal doors and fixed-light windows. The non-historic post-1968 constructed baseball field and basketball courts are located to the north and south of the private driveway which leads into the resource group from N Central Avenue (Figure 1).
