PRELIMINARY ENGINEERING REPORT

INTERSTATE 4 IMPROVEMENTS

50TH STREET TO THE  
POLK COUNTY LINE

FLORIDA DEPARTMENT OF TRANSPORTATION

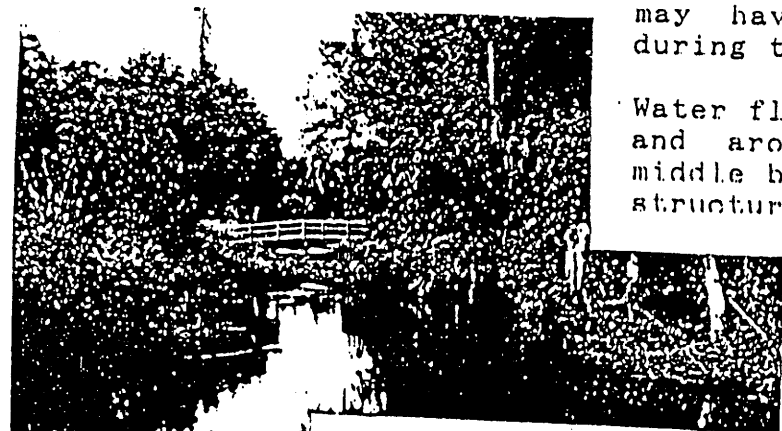
Middle drive bridge looking downstream from the southerly bridge on 9/20/88.
