I-4 (SR 400) Project Development and Environment  
(PD&E) Study from east of 50<sup>th</sup> Street to Polk Parkway

## Cultural Resource Assessment Report (CRAS)

April 2015

431746-1

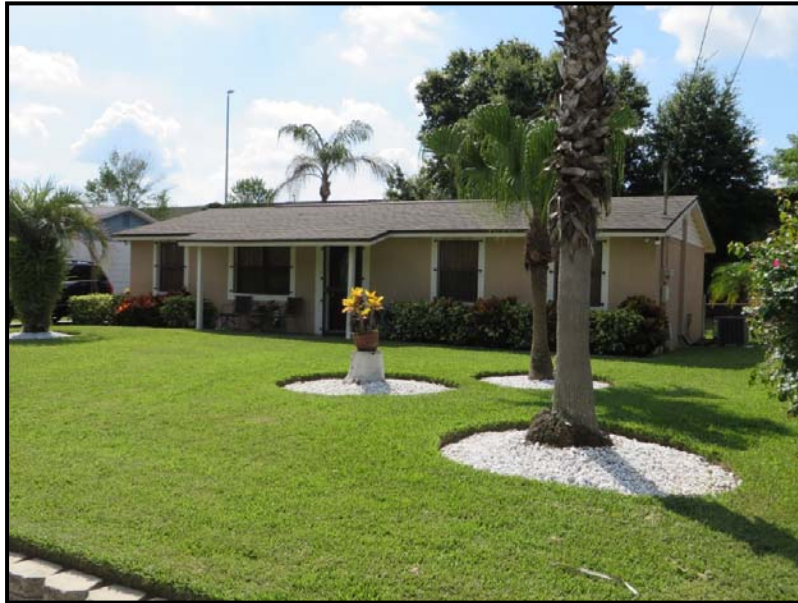
**Photo 5-5** 5617 Terra Ceia Drive (8HI12228), looking northeast, an example of the Masonry Vernacular style.

Within the APE, buildings in this style generally have concrete slab foundations and concrete block walls. Roof types consist of gable and hip, most of which are clad with composition shingles. The exterior cladding often consists of stucco, painted concrete block, or brick, although a few resources are partially clad in wood siding. Windows typically include awning, single-hung-sash (SHS), or casements. Exterior

ornamentation on these structures consists mostly of concrete window sills, gable vents, and porches. The majority of the Masonry Vernacular style resources within the project APE display alterations such as replacement windows, enclosed garages, and additions that have eroded their historic integrity.

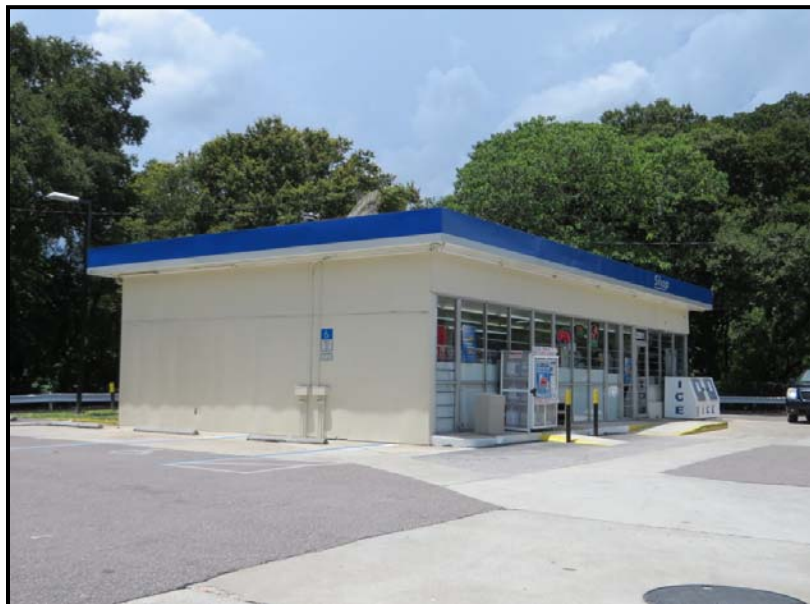
**Photo 5-6** 6026 N. Faulkenburg Road (8HI12245), looking north, an example of a commercial building in the Masonry Vernacular style.

**Masonry Vernacular:** Forty-five structures within the project APE are of the Masonry Vernacular style. These include 11 previously recorded structure built between c. 1910 through c. 1952 (8HI5097, 8HI5107, 8HI8680, 8HI8687, 8HI8689, 8HI8690, 8HI8692, 8HI8693, 8HI8746, 8HI8755, and 8HI8781), and 34 newly recorded structure built between c. 1952 and 1964 (8HI12224 through 8HI12237, 8HI12239 through 8HI12241, 8HI12243, 8HI12244, 8HI12246 through 8HI12254, and 8HI12256 through 8HI12262) (Tables 5-1 and 5-2) (Photos 5-4 through 5-6).

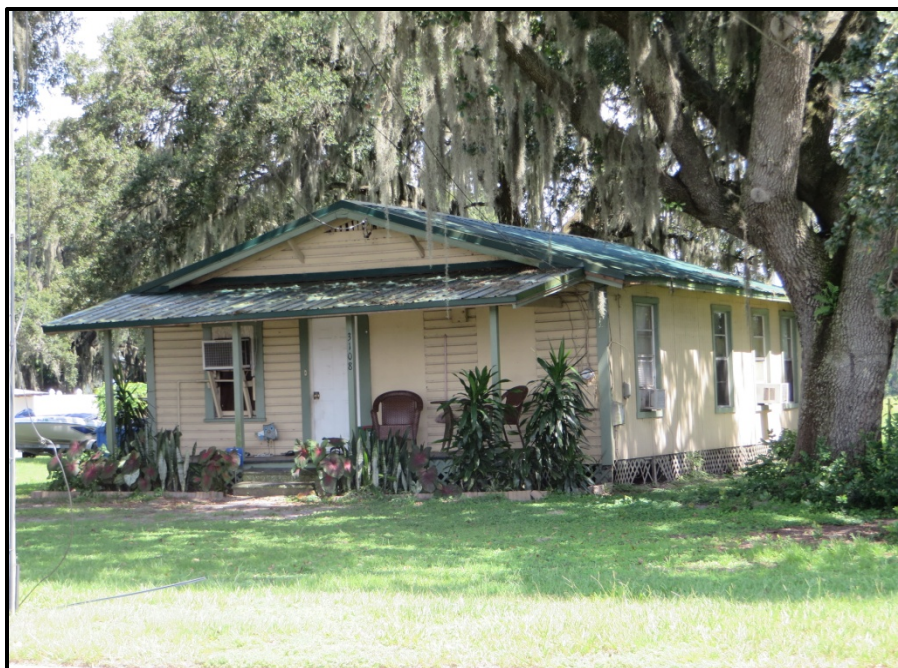
Photo 5-7 3108 N. Frontage Road (8HI5089), looking north, an example of the Frame Vernacular style.

**Frame Vernacular:** Twenty-four structures within the project APE are of the Frame Vernacular style. These include 22 previously recorded structures built between c. 1913 through c. 1953 (8HI5079, 8HI5085, 8HI5086, 8HI5088, 8HI5089, 8HI5090, 8HI5091, 8HI5094, 8HI5109, 8HI8682, 8HI8757, 8HI8758, 8HI8759, 8HI8760, 8HI8763, 8HI8769, 8HI8770, 8HI8771, 8HI8772, 8HI8779, 8HI8780, and 8HI8782), and two newly recorded (8HI12242 and 8HI12245) structure built c. 1955 and c. 1965, respectively (**Tables 5-1 and 5-2**) (**Photos 5-7 through 5-9**).

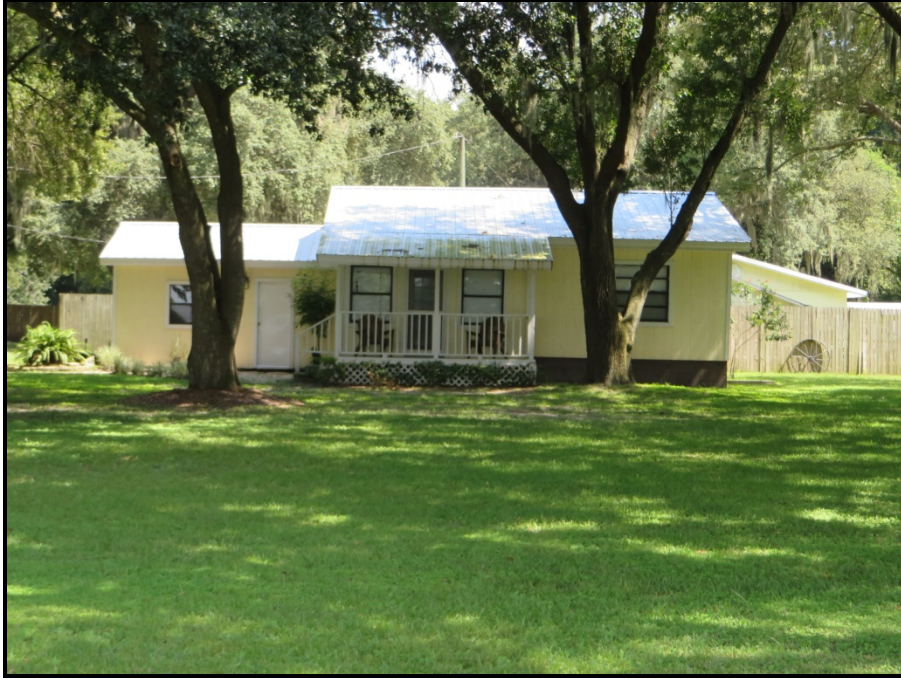
Photo 5-8 3416 N. Frontage Road (8HI8780), looking north, an example of the Frame Vernacular style.

Frame Vernacular style buildings are also simple structures built with available local materials and boasting little ornamentation. Buildings of this style are characterized by the ubiquitous use of wood as the primary building material, and are often clad in wood siding. Within the APE, this building type usually has a concrete pier or slab foundation. The gable is the most represented roof type, but there are also examples with cross-gable and shed roofs. The majority of the roofs are clad with composition shingles or 3-V crimp metal. Windows typically are SHS, but casements, sliders, awning and fixed windows are also present. Exterior ornamentation on these buildings is minimal, and typically consists of wood window surrounds, corner boards, gable vents, and exposed rafter tails. The majority of Frame Vernacular resources within the APE display alterations such as replacement siding, and replacement windows which have diminished their historic integrity.

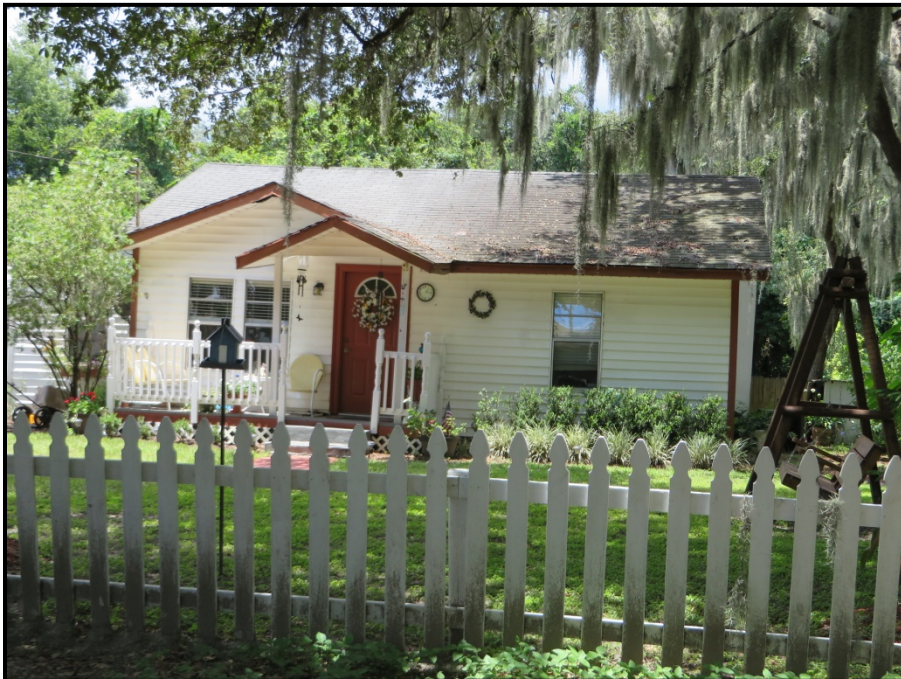
Photo 5-9 1503 Bonnie Road (8HI8757), looking west, an example of the Frame Vernacular style.

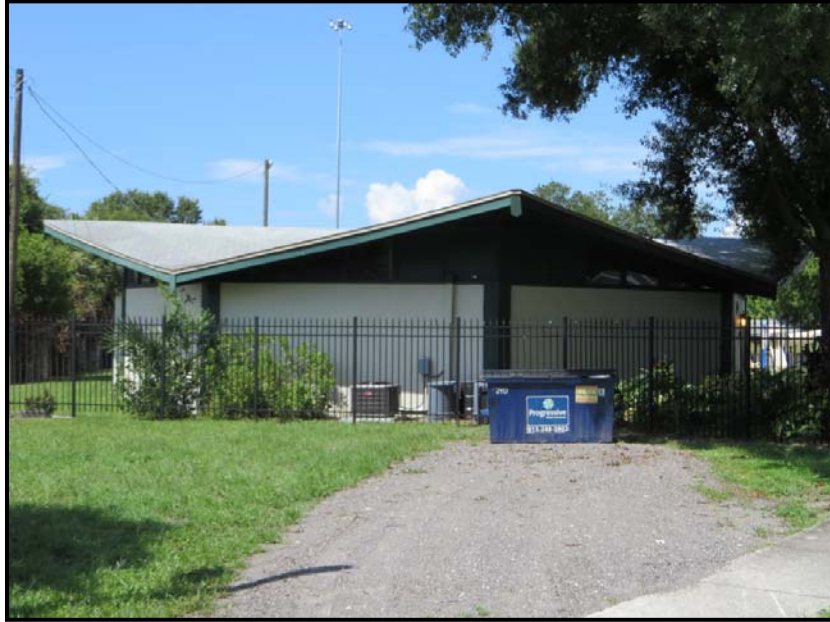
Photo 5-10 7217 Kingsbury Circle (8HI12238), looking southeast, an example of the Mid-Century Modern style.

**Mid-Century Modern:** Two historic resources are of the Mid-Century Modern style. Both were newly identified as part of this project (8HI12255 and 8HI12238) (**Photos 5-10 and 5-11**). They were built c. 1963 and c. 1964, respectively (**Table 5-2**).

The Mid-Century Modern style traces its origins to the International style that emerged in Western Europe, specifically Germany, in the 1920s (Wood 1996). As practiced in America, the Mid-Century Modern was influenced by the space age aesthetics of the early 1960s, and Frank Lloyd Wright's Usonian House principles (McCalester 2013). Buildings of this style were constructed from 1945 to the late 1960s. The style was utilized in both commercial and residential designs. However, many of the residential designs tend to be architect-designed, and are not typically seen in tract housing developments. This style features complex geometry, with triangular features as a common design element. The buildings typically rest on a concrete slab foundation, which supports concrete block walls. The windows are typically metal fixed, awning, or SHS.

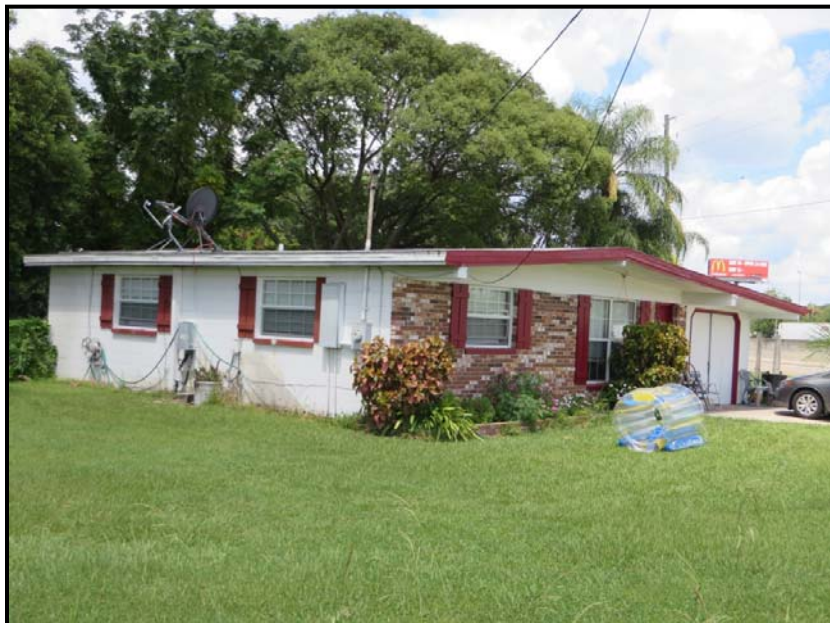
Photo 5-11 2307 N. Gordon Street (8HI12255), looking northwest, an example of the Mid-Century Modern style.

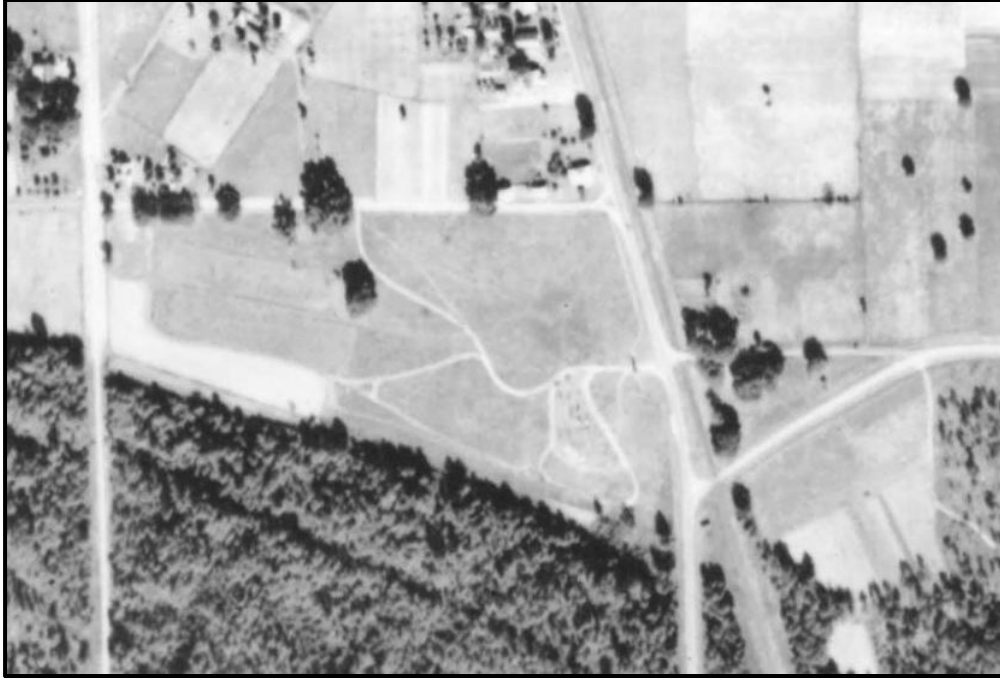
Photo 5-13 1938 aerial photograph depicting the original layout with curvilinear paths set in a rural landscape (PALMM 1938).

This cemetery is representative of a common rural cemetery type found throughout Hillsborough County. It exhibits a common design, which was altered c. 1968 with the introduction of a grid that eliminated the original curvilinear layout. This alteration diminished the historic integrity of the site and landscape. In addition, the cemetery does not contain monuments, mausoleums, or other funerary art of high artistic value. Furthermore, limited research did not reveal any significant historical associations with persons or events. The Memorial Park Cemetery does not meet Criteria Consideration D because it does not derive its primary significance from graves of persons of transcendent importance, from age, from distinctive design features, or from association with historic events. Thus, it is not considered potentially eligible for the NRHP.

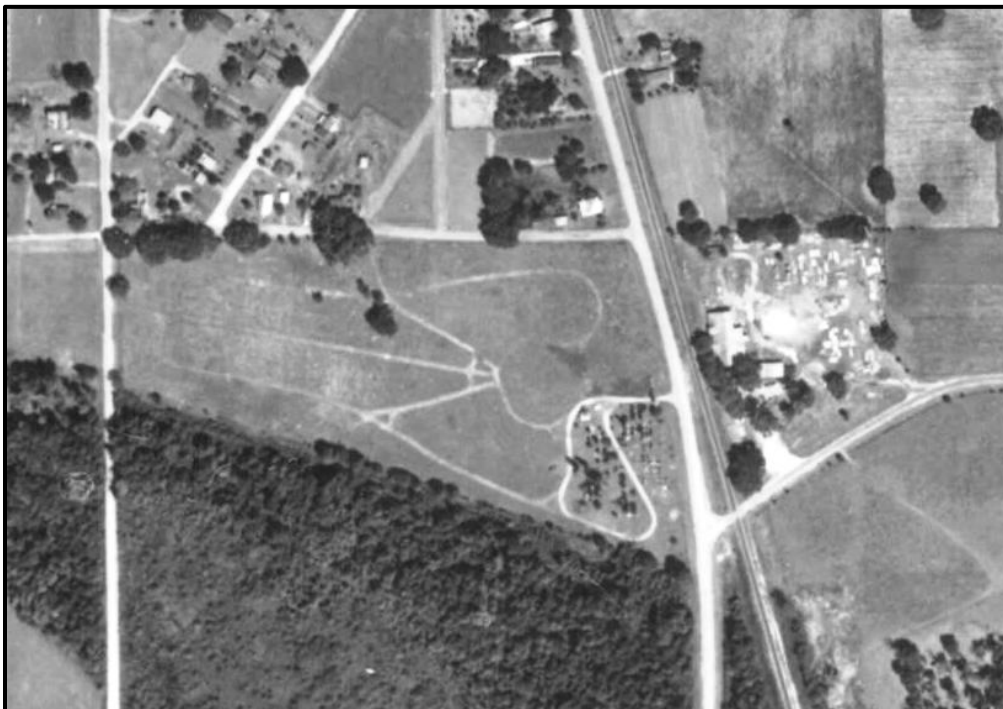
Photo 5-14 1957 aerial photograph depicting the expansion of the original layout with more pathways, still in a curvilinear pattern in keeping with the original layout (PALMM 1957).

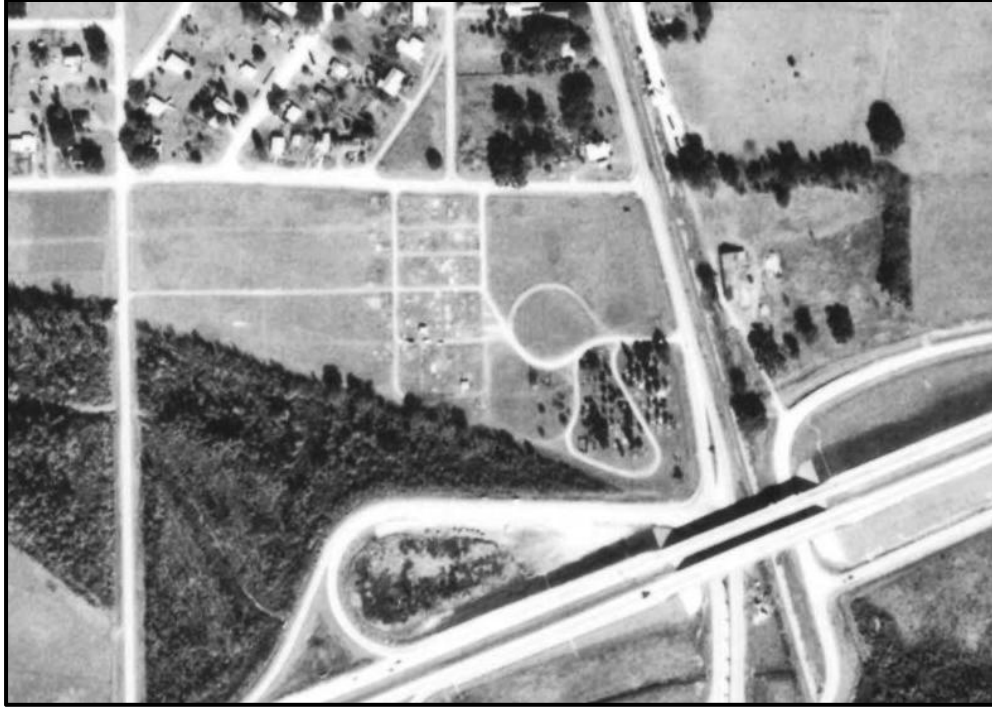
Photo 5-15 1968 aerial photograph depicting the alteration to the original layout with the introduction of a grid pattern with pathways (PALMM 1968).

This cemetery is representative of a common rural cemetery type found throughout Hillsborough County. It exhibits a common design, which was altered c. 1968 with the introduction of a grid that eliminated the original curvilinear layout. This alteration has diminished the historic integrity of the site. In addition, the cemetery does not contain monuments, mausoleums, or other funerary art of high artistic value. Furthermore, limited research did not reveal any significant historical associations. Although significant to the families and descendants of the deceased buried in this cemetery, it does not rise to the significance, nor does it retain the integrity that would qualify this cemetery eligible for the NRHP. Thus, 8HI6730 is not considered potentially eligible for the NRHP.

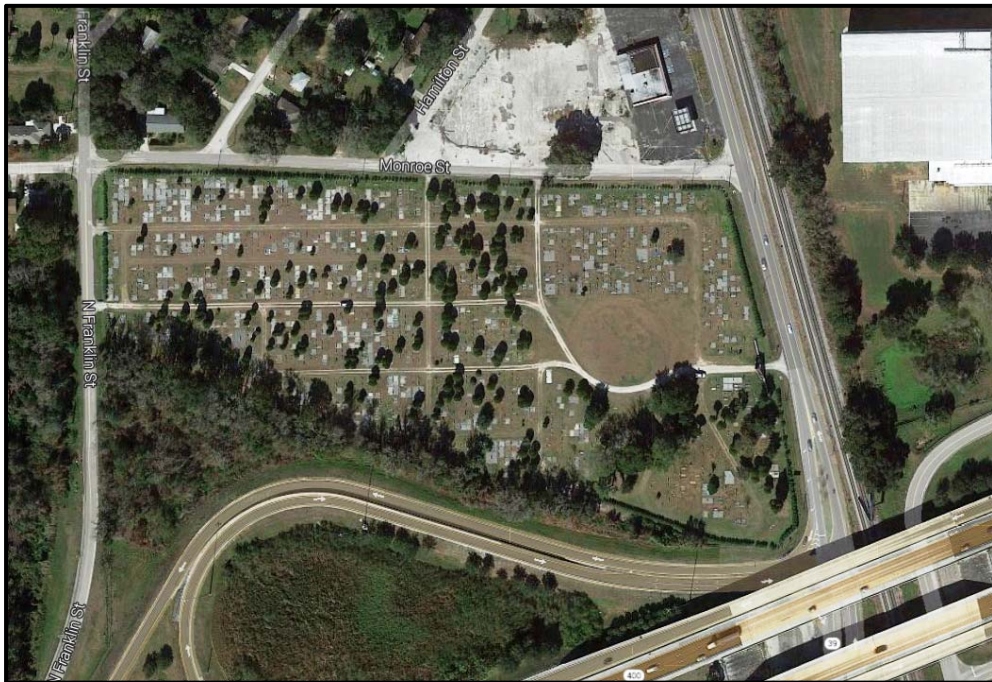
Photo 5-16 2014 Google satellite image depicting the current conditions of the cemetery. Note that the majority of the site is occupied by orderly rows of burials (Google Earth 2014)

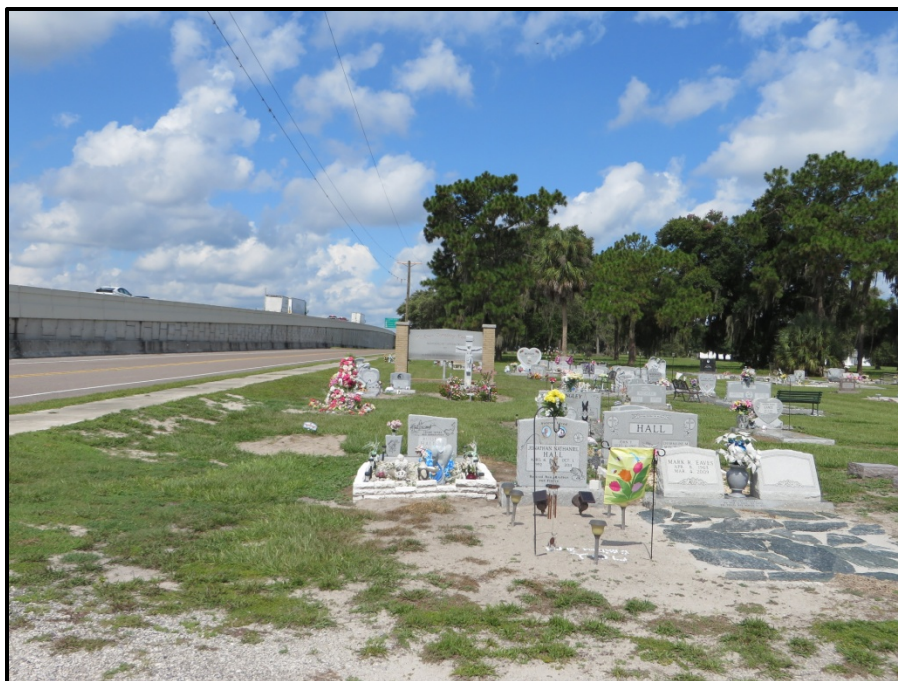
Photo 5-17 Mount Enon Primitive Baptist Cemetery (8HI6737), looking west.

**8HI6737:** Mount Enon Primitive Baptist Cemetery is located on the north side of I-4 (**Photo 5-17**) between County Line Road and Charlie Taylor Road in Section 24 of Township 22 South, Range 22 East (USGS 1975b). The cemetery was previously recorded in 1998; however, it was not evaluated by the SHPO for its NRHP eligibility. Only a small section of the cemetery's southern section, approximately 200 ft, is located within the project's visual APE; no ROW taking is needed at this location.

This cemetery is representative of a typical rural cemetery type found throughout Hillsborough County. It does not display an organized plan or design, but rather an organic accumulation of burial plots in rows loosely oriented north to south, and generally lacks monuments, mausoleums, or other funerary art of high artistic value. Although its establishment dates to the late 19<sup>th</sup> century, only about a dozen burials are associated with this early period. The overwhelming majority of the burials and the current appearance of the site are a result of the late 20<sup>th</sup> century. In addition, limited research did not reveal any significant historical associations to persons or events. Furthermore, the integrity of the site has been diminished greatly by the demolition of the wood-frame church associated with this cemetery. The Mount Enon Primitive Baptist Cemetery does not meet Criteria Consideration D because it does not derive its primary significance from graves of persons of transcendent importance, from age, from distinctive design features, or from association with historic events. Thus, 8H16737 is not considered potentially eligible for the NRHP.

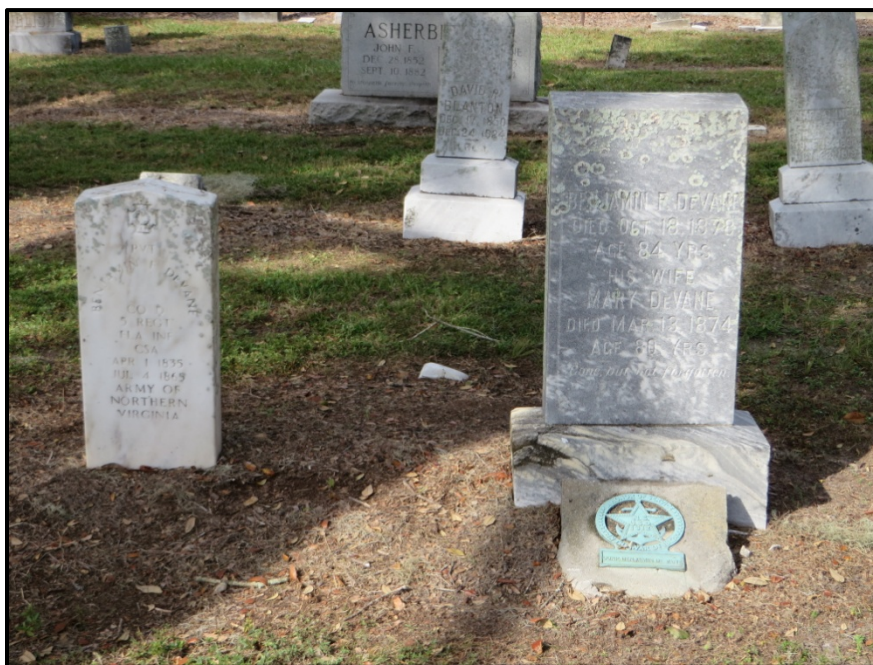
Photo 5-18 White marble tombstone, left, of Civil War veteran.

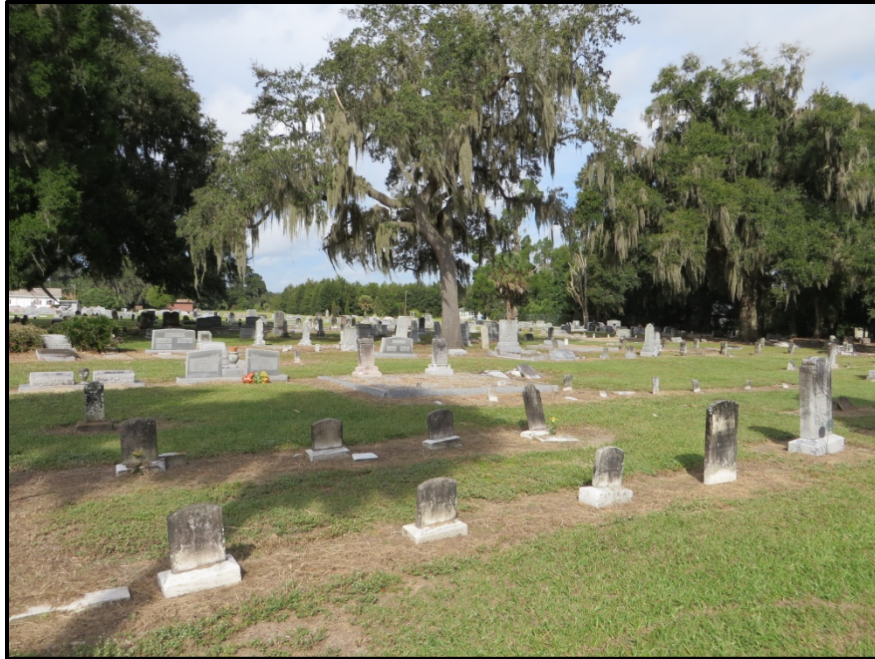
Photo 5-19 Northern section of the cemetery depicting the cluster of late 19<sup>th</sup> century tombstones associated with the earliest burials in the cemetery, looking northwest.

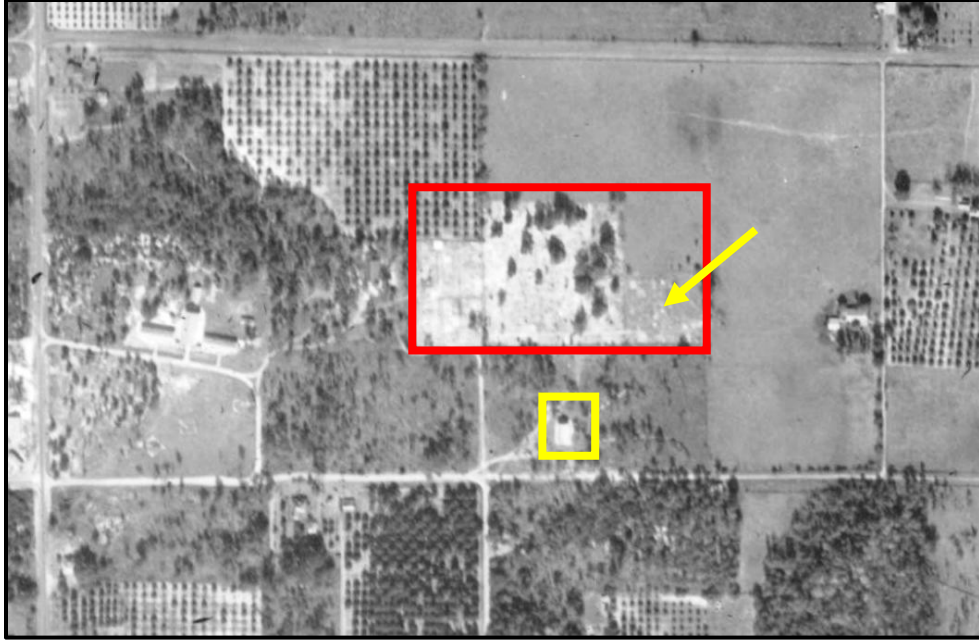
Photo 5-21 1948 aerial photograph depicting the cemetery (red box) and the c. 1930 church (yellow box). Note the appearance of burials east of the original section (yellow arrow) (PALMM 1948a).

(PALMM 1938a) (**Photo 5-20**). The site is also depicted on aerial photographs from 1948 and 1958 (**Photos 5-21 and 5-22**). However, the current size and layout of the cemetery does not appear evident until 1968 (PALMM 1948a, 1958, and 1968a) (**Photo 5-23**). The present appearance of the cemetery (**Photo 5-24**) largely reflects the c. post-1950 period.

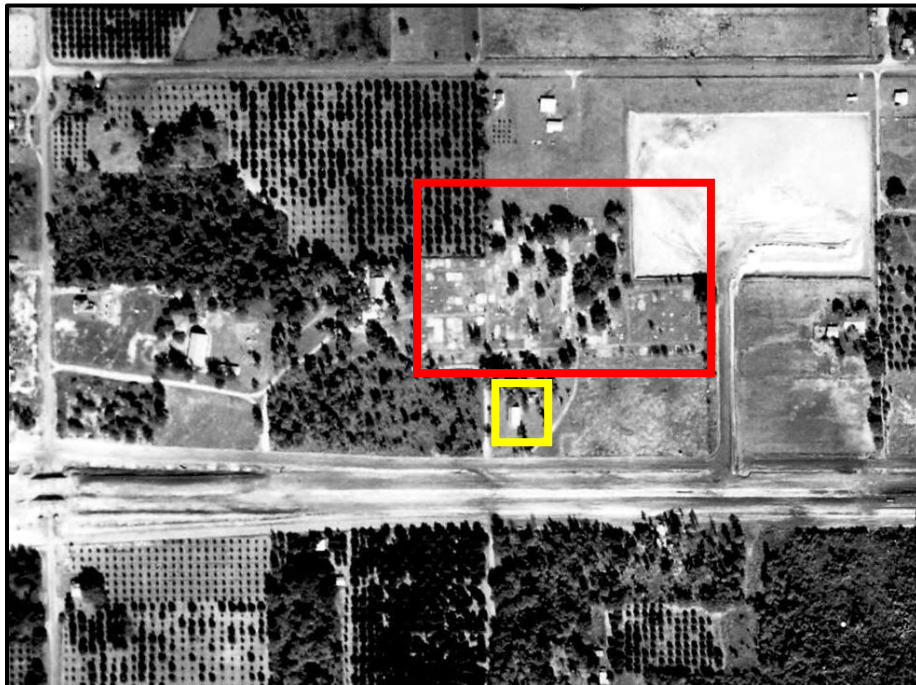
Photo 5-22 1958 aerial photograph depicting the cemetery (red box), and the c. 1930 church (yellow box) (PALMM 1958).

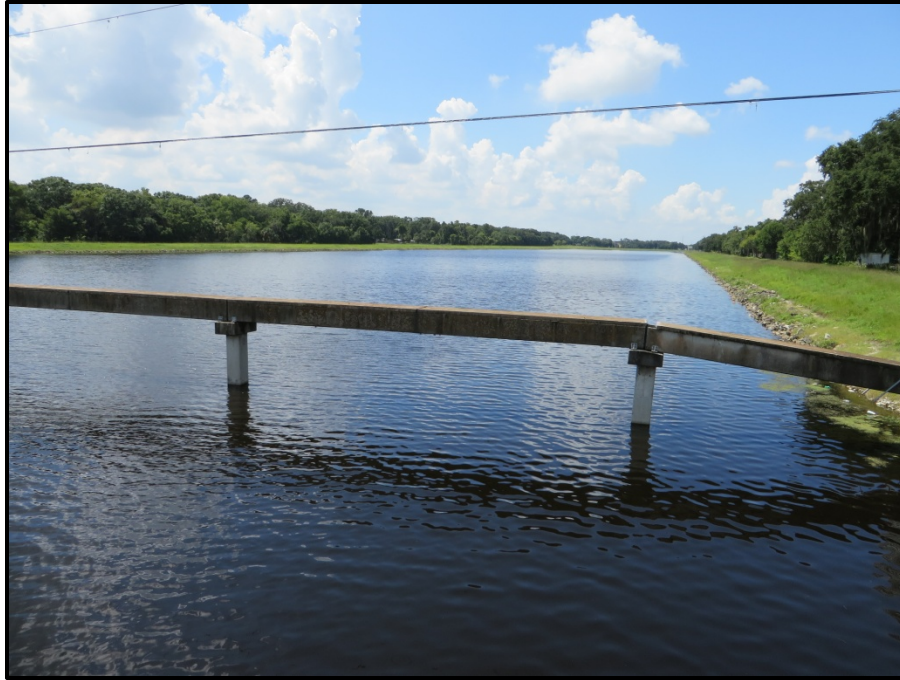
Photo 5-25 Tampa Bypass Canal (8HI12135), looking south.

**8HI12135:** The Tampa Bypass Canal (C-135) (**Photo 5-25**) intersects the project APE and is located in Section 31 of Township 28 South, Range 20 East and Section 6 of Township 29 South, Range 19 East (USGS 1956 and 1974). The 14-mile long flood control canal is managed by the Southwest Florida Water Management District (SWFWMD). It originated as the Six Mile Creek Canal, was likely dredged c. 1925, and is first evident within the I-4 APE on a 1938 aerial (PALMM 1938b) (**Photo 5-26**). However, its current appearance dates from an overhaul of Six Mile Creek began in 1966 and completed in 1981 (Knutilla and Corral 1984) (**Photos 5-27 and 5-28**).

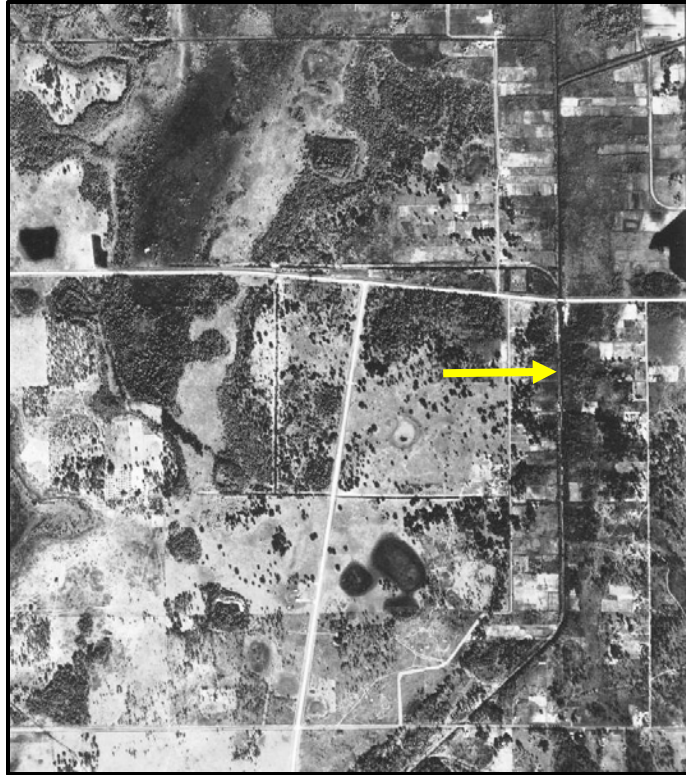
Photo 5-26 1938 aerial photograph depicting the c. 1925 canal in its original condition (PALMM 1938b).

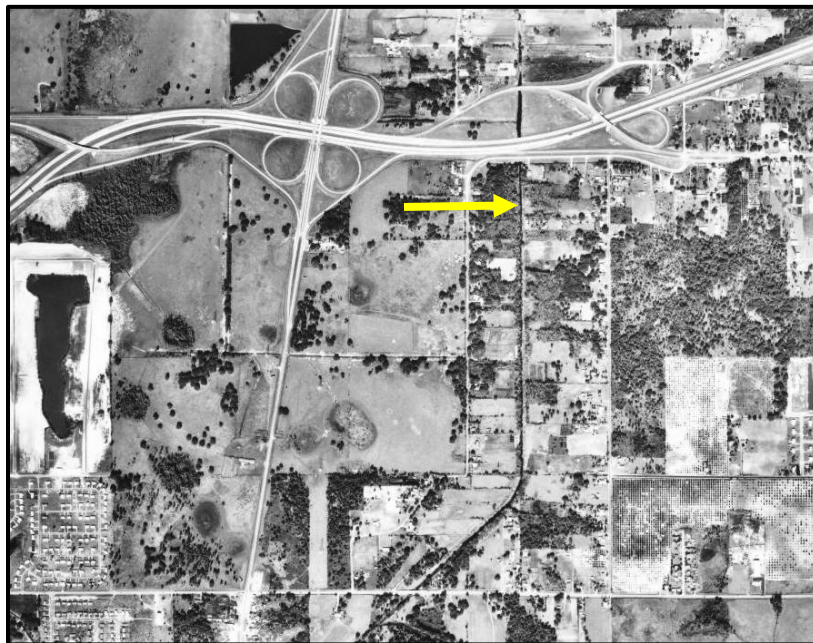
Photo 5-27 1968 aerial photograph depicting the canal after the construction of I-4. Note that the canal retained its original width after the construction of the highway (PALMM 1968b).

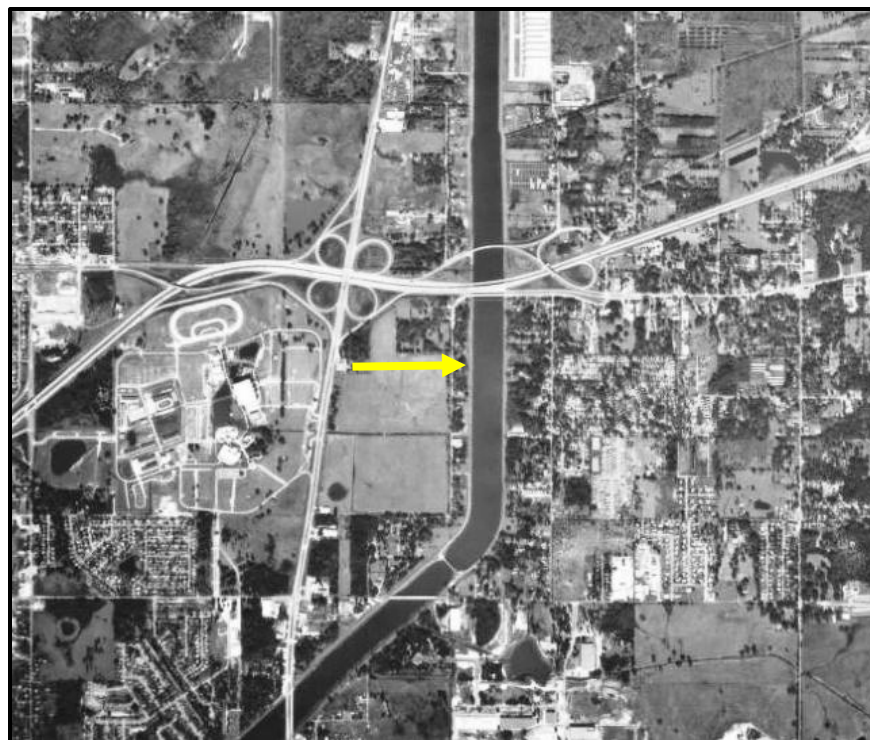
Photo 5-28 1982 aerial photograph depicting the canal after its 1977 widening (PALMM 1982).

An approximately 400-ft segment of the TBC is located within the project APE. This segment is located within section 3B of the canal, which follows the original course of the c. 1925 Six Mile Creek. The expansion and widening of this section of the canal began in 1975 and was completed by June 1977 (Knutilla and Corral 1984). The canal width along this segment is approximately 300 ft, the banks are lined by riprap, bottom widths range from 210 to 365 ft, and water levels are kept at an average of 12 to 15 ft above sea level (Knutilla and Corral 1984).

Only a small segment of the canal is contained within the project APE; it achieved its current configuration in 1977. A survey of the entire 14-mile length of the canal is beyond the scope of this project. As such, there is insufficient information to consider the NRHP eligibility of this linear resource.

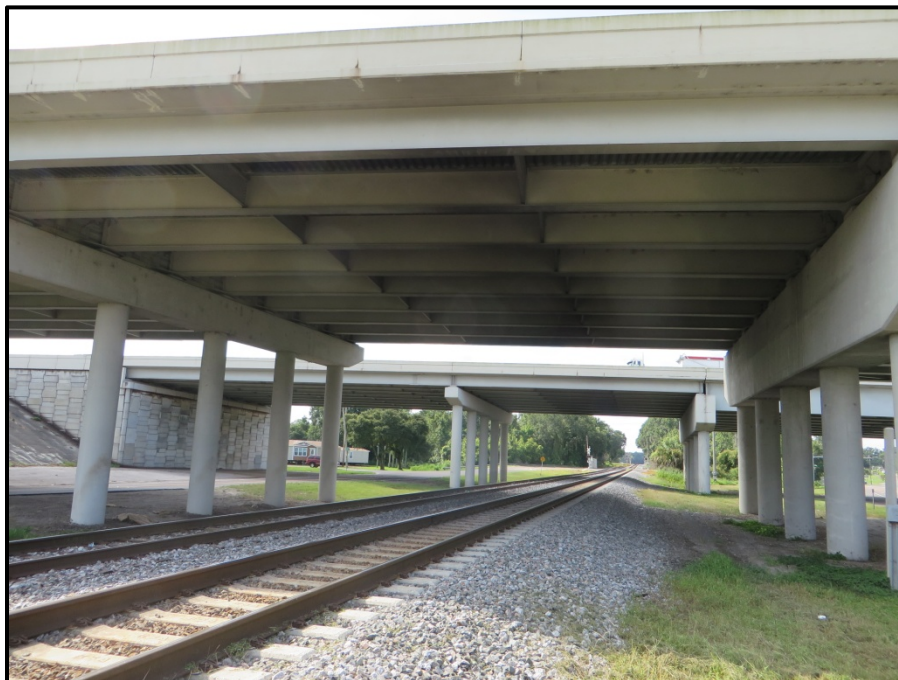
**Photo 5-29** Former Seaboard Air Line Railroad (SAL RR) (8HI10288) within the project APE, looking south.

**The Seaboard Air Line Railroad (8HI10288)** intersects the project area and is located in Section 33 of Township 28 South, Range 22 East (USGS 1975a); there is approximately 400 ft of railway within the APE. This segment of the Seaboard Air Line Railroad (SAL) is a double rail line that passes under the east and west I-4 overpasses (**Photo 5-29**). The line consists of a rail bed set on a berm of crushed rock; a grass shoulder buffers the railroad from N. Frontage Road to the east, and N. Wheeler Street/Paul Buchman Highway to the west.

A segment of the former SAL Railroad, within Hillsborough County, but outside of the project APE, was recorded as part of the CRAS for SR 674 from US 301 to CR 579 (ACI 2007); the SHPO determined that segment to be ineligible for the NRHP in November 2008 (FMSF). Although the segment of the railroad within the project APE may retain its historic materials, the historic setting has been greatly compromised by the construction of the I-4 overpass. In addition, the 400-ft segment recorded as part of this report is a small portion of a trans-state line that extends approximately 11 miles within Hillsborough County alone. An evaluation of the entirety of the rail line within Hillsborough County is beyond the scope of this project. As a result, there is insufficient information to consider the NRHP eligibility of this historic railroad.

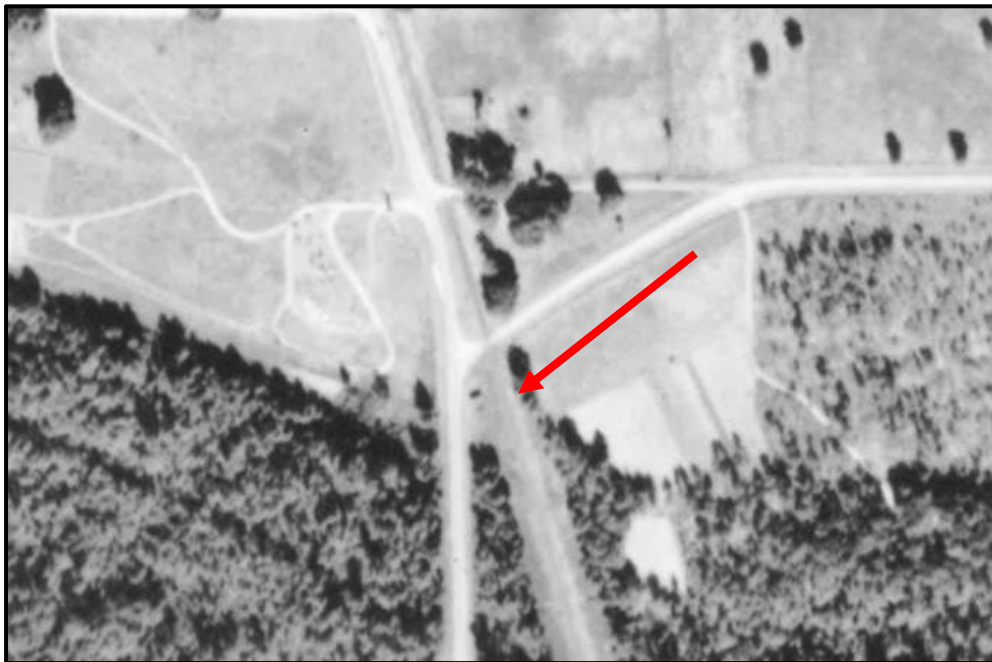
Photo 5-30 1938 aerial depicting the former SAL Railroad in its original setting (red arrow) (PALMM 1938).

the middle of the 20<sup>th</sup> century, connecting Florida to Alabama, Georgia, South Carolina, North Carolina, and Virginia. In 1959, construction of I-4 began, which altered the historic setting of the rail line within the APE by development of two overpasses for the highway. In 1967, the SAL merged with the Atlantic Coast Line Railroad to become the Seaboard Coast Line Railroad; it was merged in 1980 with the Chessie System to form the CSX Corporation, the current owner of the rail line (FMSF). This line is still operational and serves as a local connection to the CSX Railroad. The segment of the railroad within the APE is depicted on 1938, 1948, 1957, and 1968 aerial photographs (PALMM 1938, 1948, 1957 and 1968) **(Photos 5-30 and 5-31).**

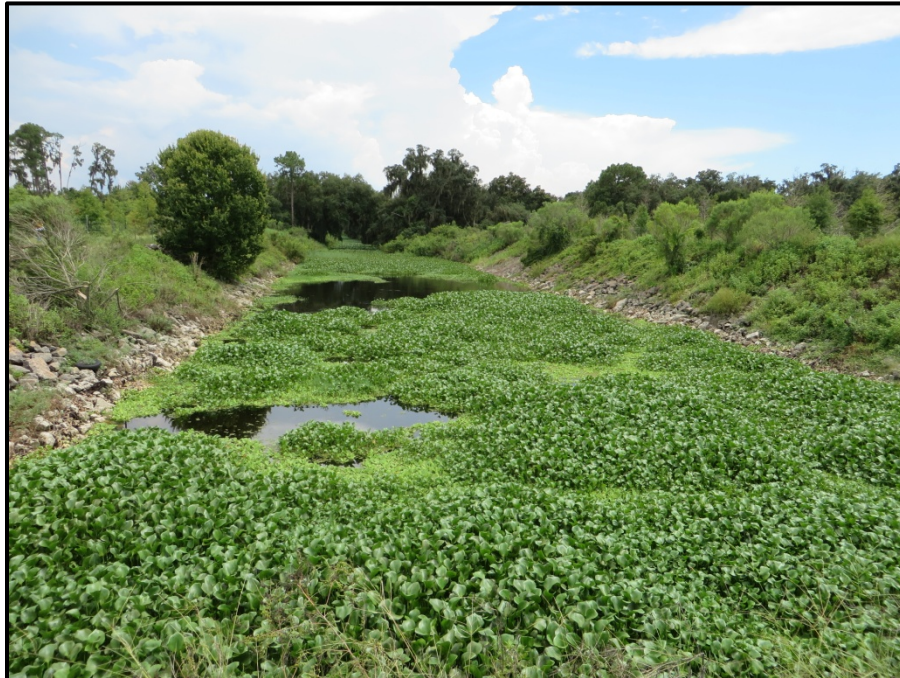
Photo 5-32 Bakers Creek Canal (8HI12281), looking south.

**8HI12281: Bakers Creek Canal (Photo 5-32)** is located in Section 25 of Township 28 South, Range 20 East (USGS 1974). An approximately 400-ft segment of the canal is located within the project APE.

This type of water management canal is a commonly occurring feature in Florida, and the segment within the APE lacks significant attributes and innovative engineering features. Its present appearance dates to the late 1990s. However, most of the canal is located outside the project APE, and a survey of the entire length of the canal is beyond the scope of this project. As a result, there is insufficient information to assess the NRHP eligibility of this linear resource.

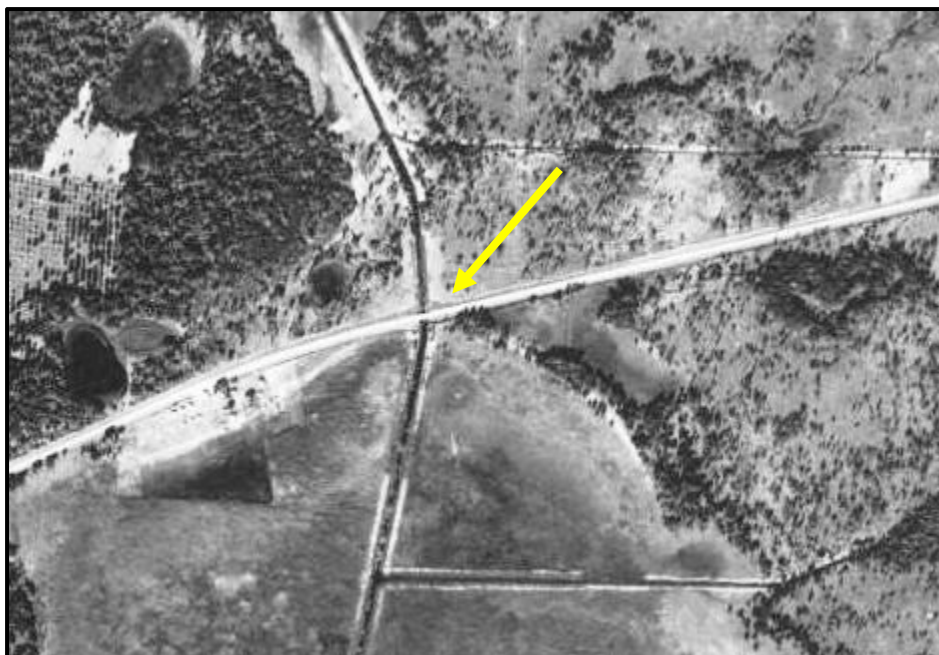
**Photo 5-33** 1938 aerial photograph of the Baker Creek Canal in its original configuration prior to the construction of I-4 (PALMM 1938c).

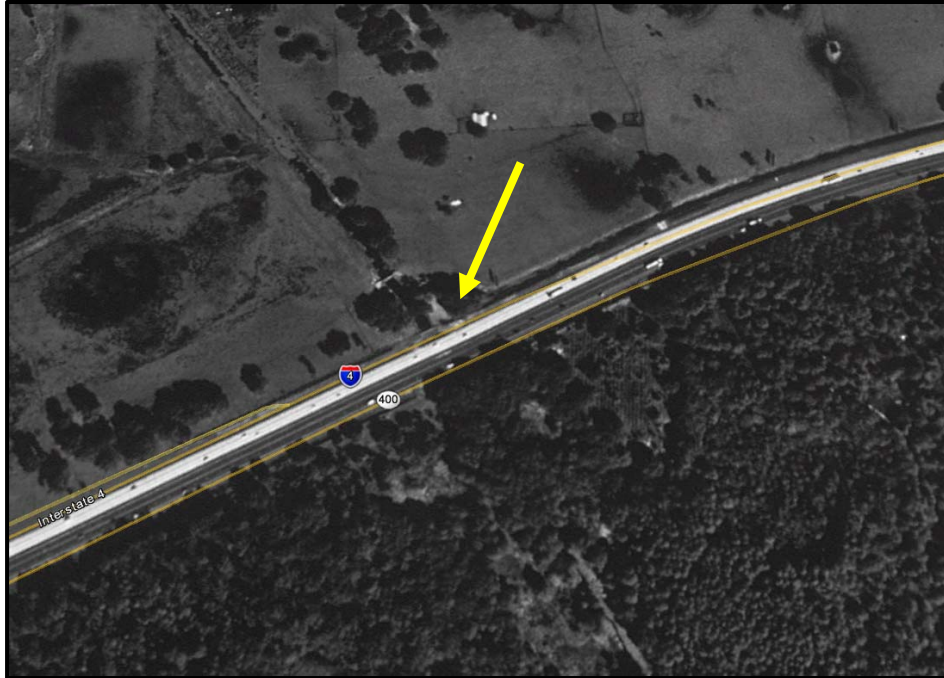
Photo 5-34 1995 Google satellite image of the canal prior to dredging and widening (Google Earth 2014).

The canal is managed by SWFWMD, and is part of the Pemberton Creek/Baker Canal Area (PBA), a pivotal water management area in Hillsborough County (Public Works Department 2002). This canal stretches for approximately six miles following a north to south flow, connecting Lake Thonotosassa in the north, to Lake Valrico in the south. Bakers Creek Canal originally may have been a naturally occurring creek, which was dredged and rerouted c. 1930; it first appears on a 1938 aerial photograph (PALMM 1938c). This image reveals that at that time the canal was not as wide as at present (**Photo 5-33**). Google satellite imagery indicates that the canal was dredged and widened between 1995 and 1999, and retention ponds were created on either side of the canal and south of I-4 at that time (Google 2014) (**Photos 5-34 and 5-35**).

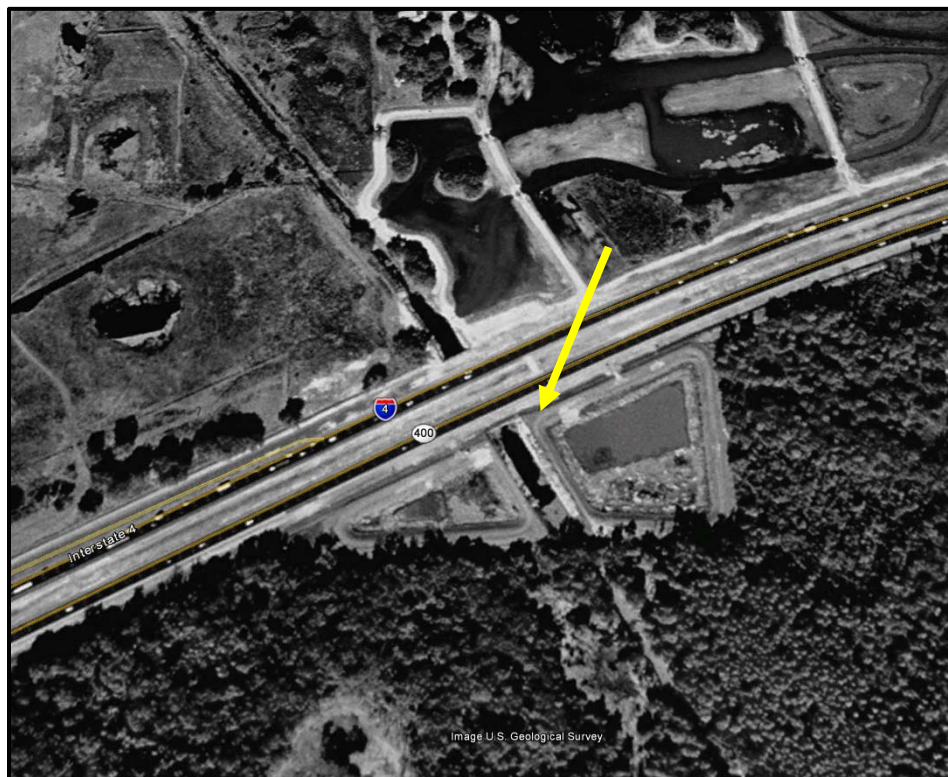
Photo 5-35 2000 Google satellite image of the canal after dredging and the construction of two retention ponds on either side (Google Earth 2014).

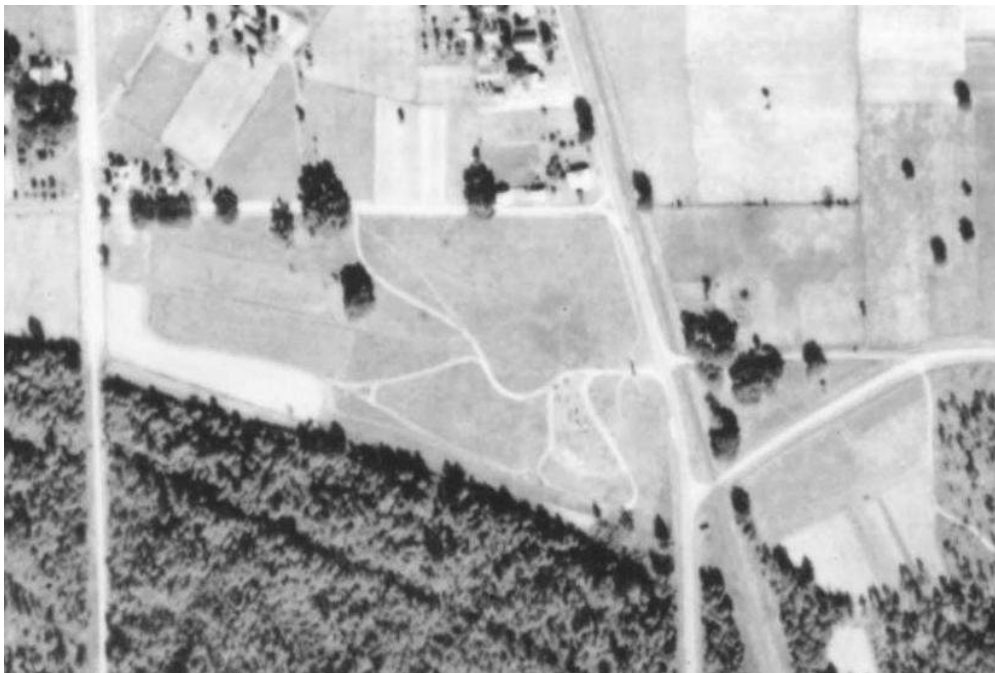
**Photo 5. 10.** 1938 aerial photograph depicting the original layout of the Memorial Park Cemetery (PALMM 1938)

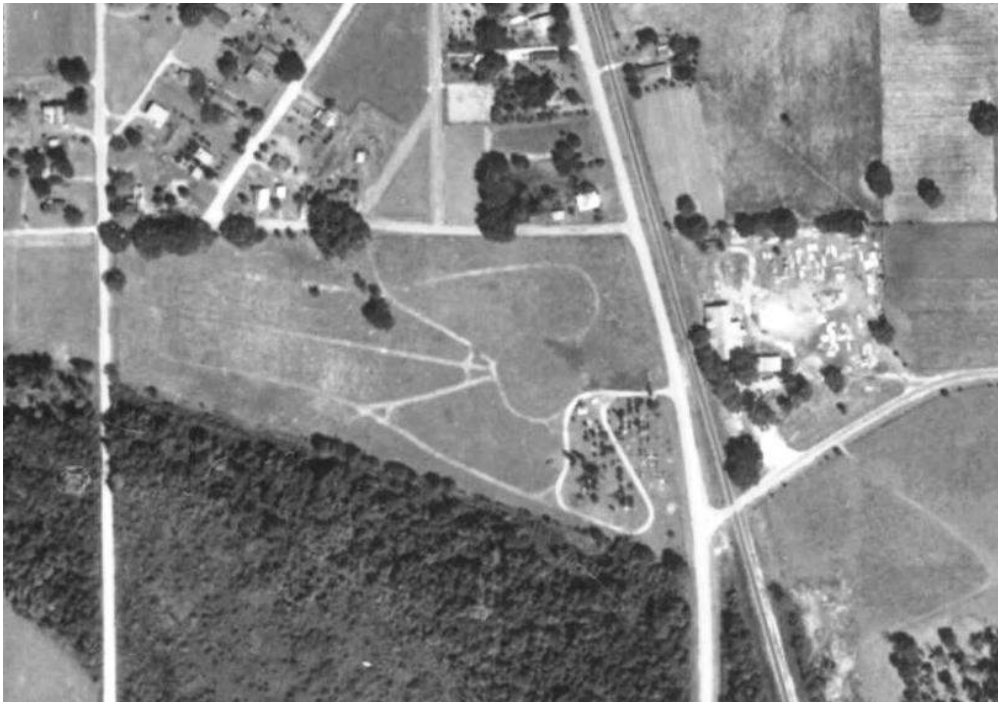
**Photo 5. 21.** 1957 aerial photograph depicting the expansion of the original layout with more pathways, still in a curvilinear pattern in keeping with the original layout (PALMM 1957).

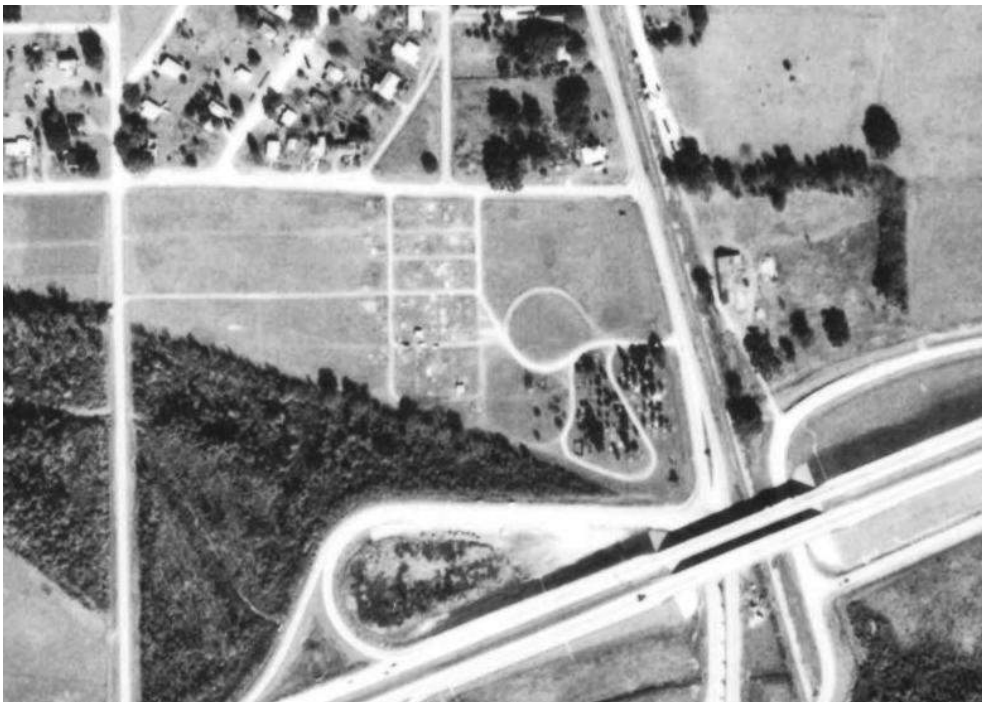
**Photo 5. 32.** 1968 aerial photograph depicting the alteration to the original layout with the introduction of a grid pattern with pathways (PALMM 1968).
