I-4 (SR 400) Project Development and Environment  
(PD&E) Study from east of 50<sup>th</sup> Street to Polk Parkway

## Cultural Resource Assessment Report (CRAS)

April 2015

431746-1

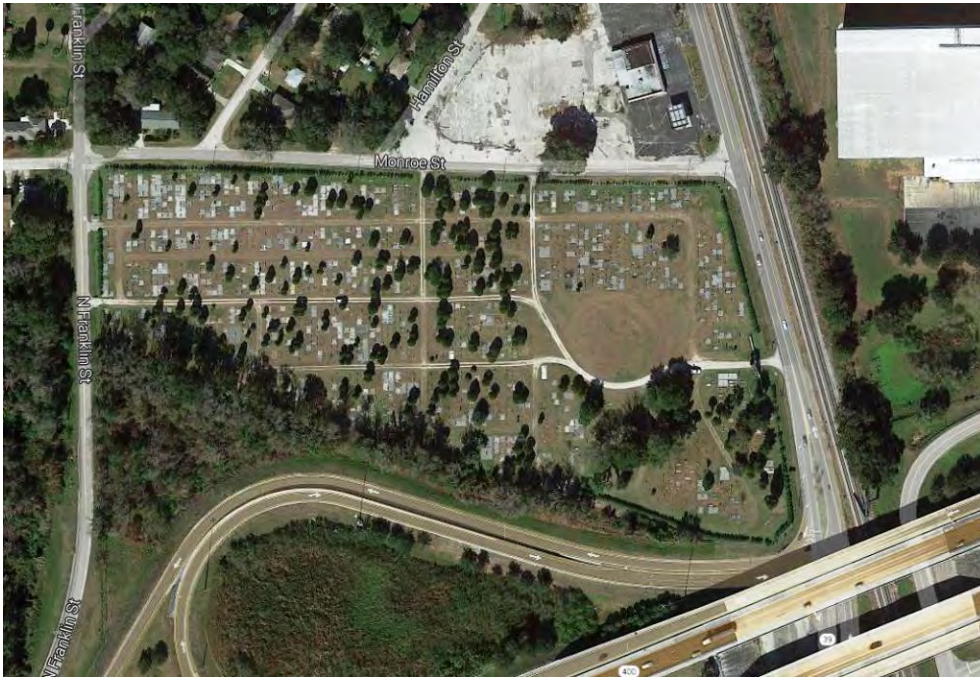
**Photo 5. 43.** 2014 Google satellite image depicting the current conditions of the cemetery (Google Earth 2014)

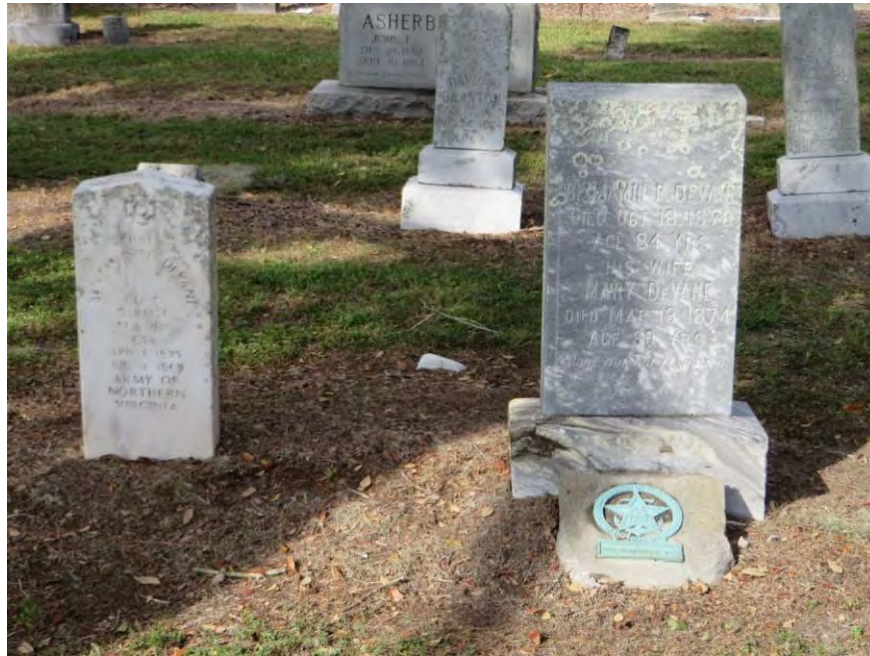
**Photo 5. 15.** White marble tombstone, left, of Civil War veteran.

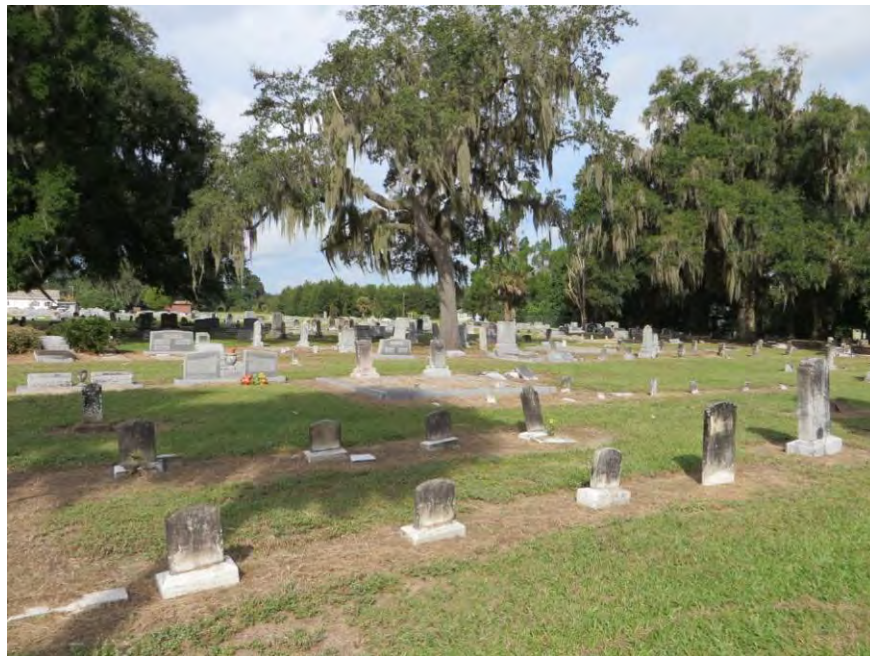
**Photo 5. 16.** Northern section of the cemetery depicting the cluster of late 19<sup>th</sup> century tombstones associated with the earliest burials in the cemetery, looking northwest.

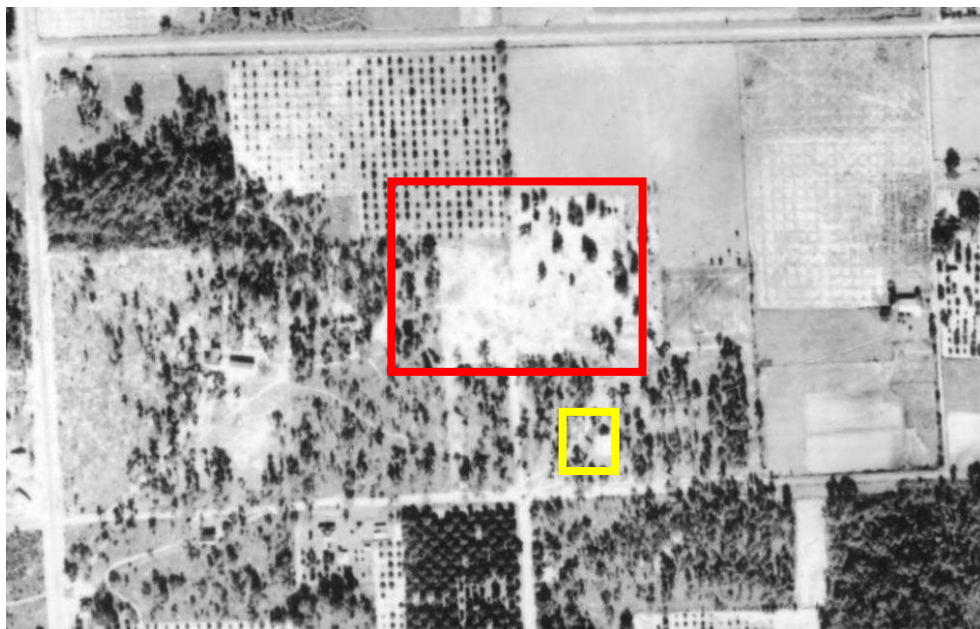
**Photo 5. 17.** 1938 aerial photograph depicting the northern section of the cemetery (red box), and the c. 1930 church (yellow box) (PALMM 1938).

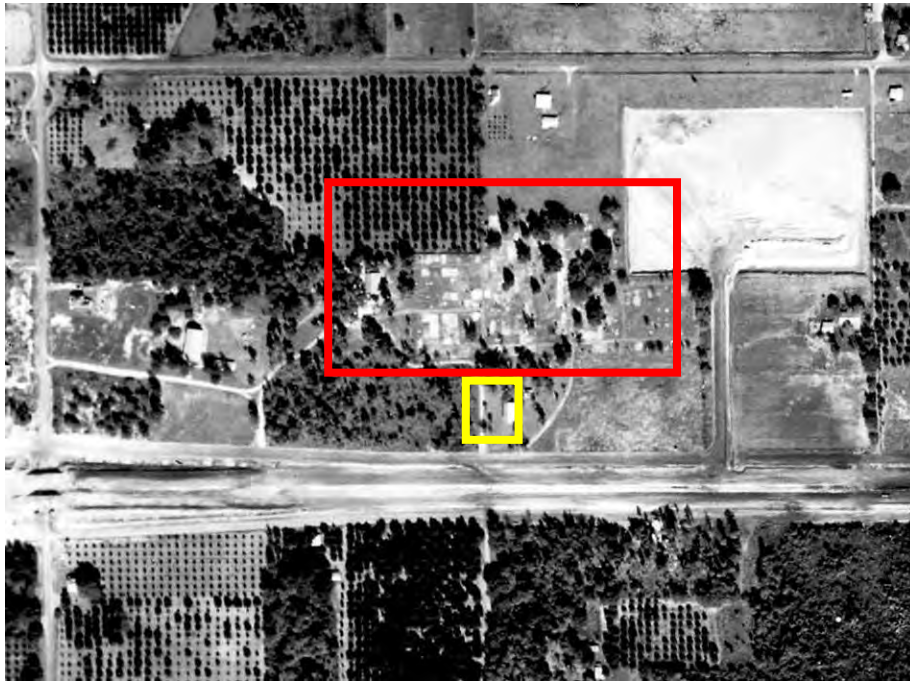
**Photo 5. 19.** 1958 aerial photograph depicting the northern section of the cemetery (red box), and the c. 1930 church (yellow box) (PALMM 1958).

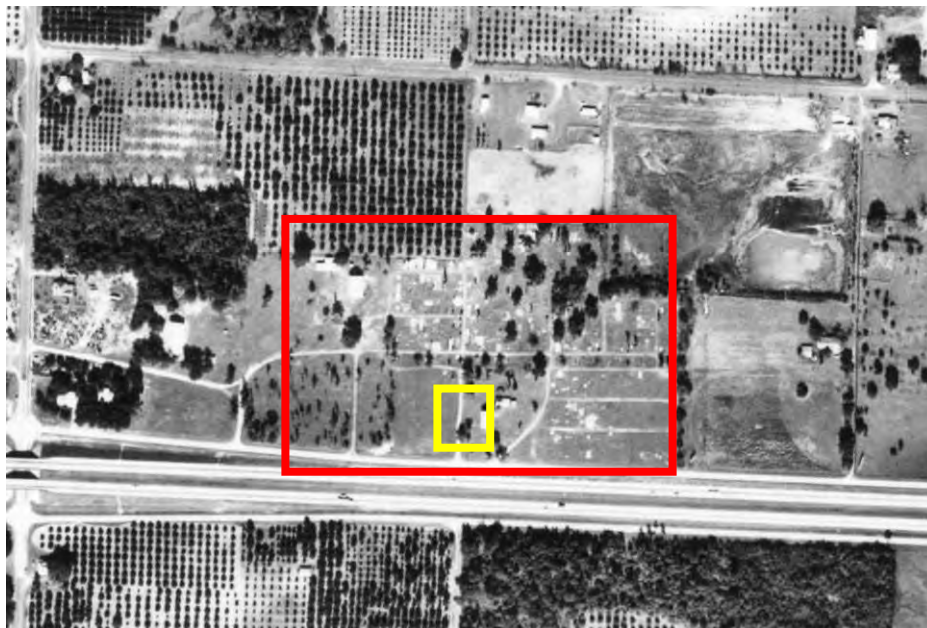
**Photo 5. 20.** 1968 aerial photograph depicting the northern section of the cemetery (red box), and the c. 1930 church (yellow box) (PALMM 1968).

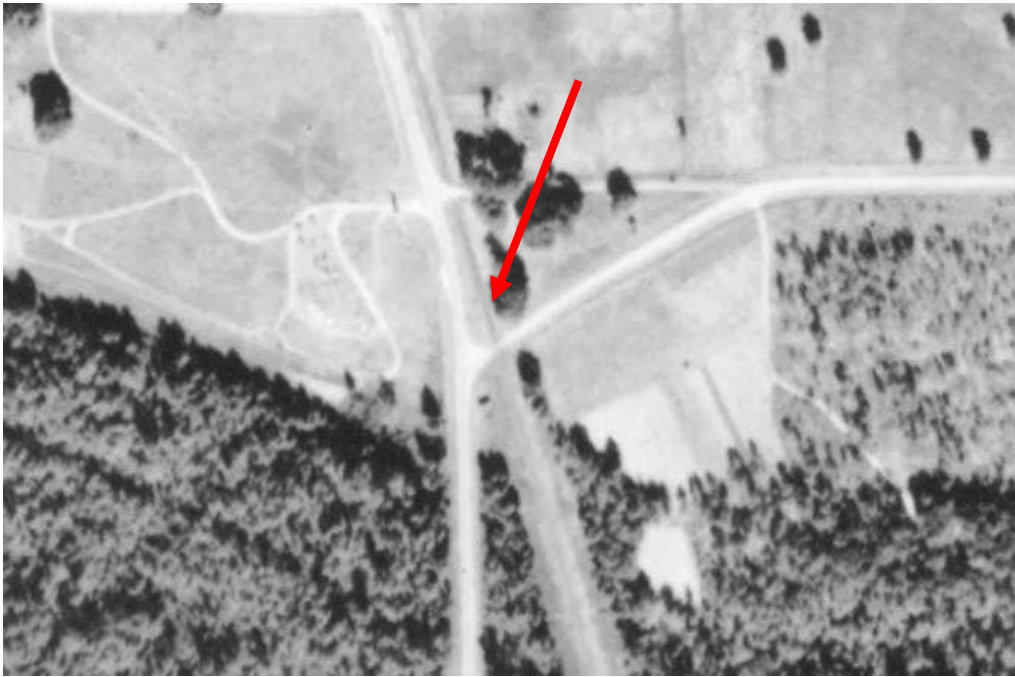
**Photo 1.** 1938 aerial depicting the former SAL Railroad (PALMM 1938)

The SAL Railroad was created in the 1880s by the consolidation of the Seaboard and Roanoke Railroads, and by 1900 the SAL system stretched for over 2,600 miles connecting Virginia to Florida (FMSF). The segment of the SAL Railroad within the project APE is depicted on an 1893 map of Florida railroads; the map indicates that the rail-line within the project APE connected Plant City as its southern terminus to Alachua County in the north, passing through Dade City and Ocala along the way (Mathews-Northrup Co. 1893). A 1909 Sanborn Atlas shows that this line also included both freight and passenger services and served the Plant City SAL Railroad terminal (Sanborn 1909). The railroad had expanded to 4,146 miles by the middle of the 20<sup>th</sup> century connecting Florida to Alabama, Georgia, South Carolina, North Carolina, and Virginia. In 1959 construction of I-4 began, which altered the historic setting of the rail-line within the APE by constructing two overpasses for the highway. In 1967 SAL merged with Atlantic Coast Line Railroad to become the Seaboard Coast Line Railroad; which subsequently merged in 1980 with Chessie System to form CSX Corporation, the current owner of the rail-line (FMSF). The rail-line is still operational and serves as a local connection to the CSX Railroad. The segment of the railroad within the APE is depicted on 1938, 1948, 1957, and 1968 aerial photographs (Publication of Archival, Library, and Museum Materials [PALMM]) (**Photos 1 and 2**).

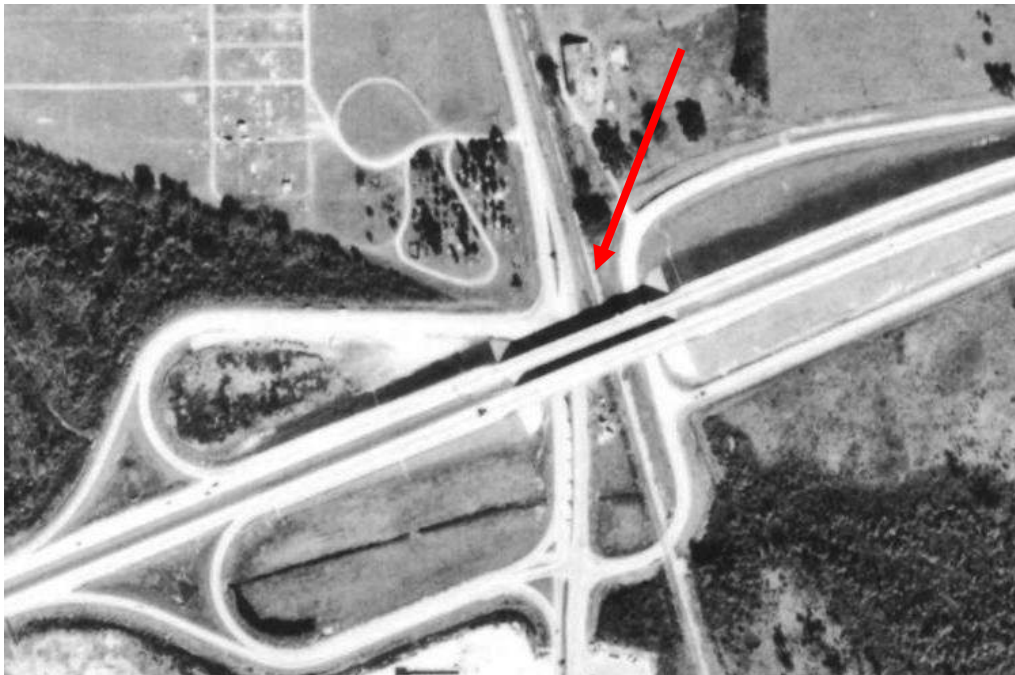
**Photo 2.** 1968 aerial depicting the former SAL Railroad after the construction of I-4 (PALMM 1968)

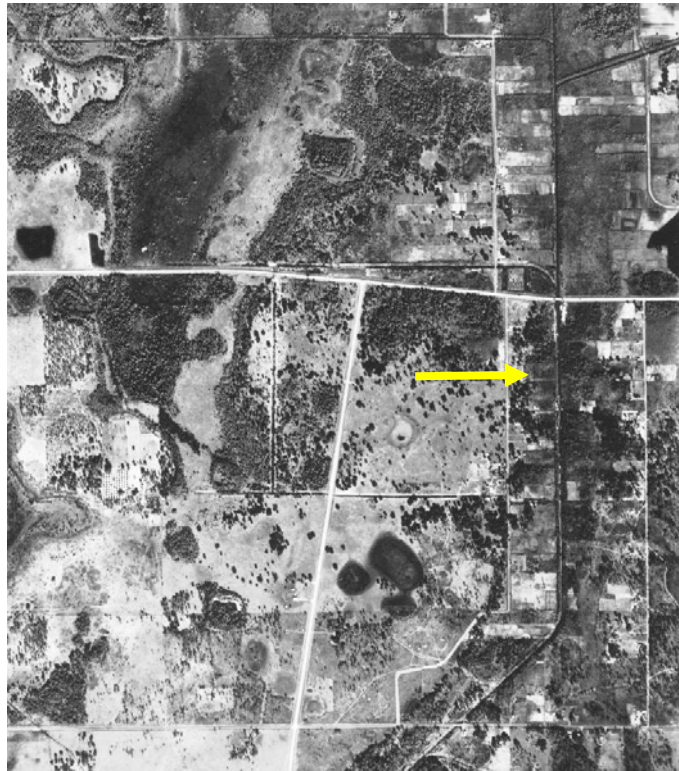
**Photo 1.** 1938 aerial photograph depicting the c. 1925 canal in its original condition (PALMM 1938)

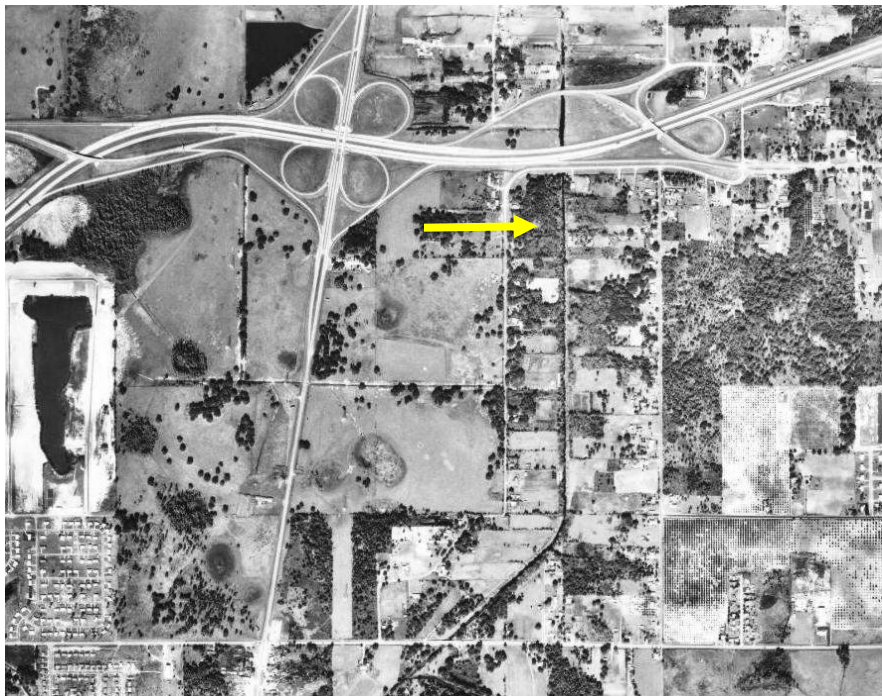
**Photo 2.** 1968 aerial photograph depicting the canal after the construction of I-4, notice that the canal still retained its c. 1925 layout and dimensions then (PALMM 1968).

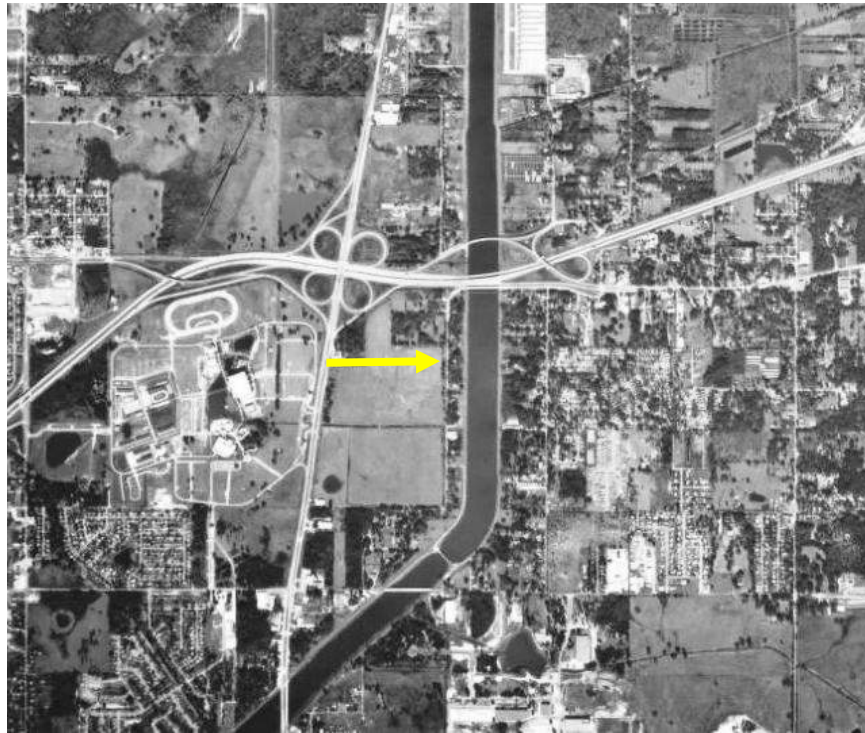
**Photo 3.** 1982 aerial photograph depicting the canal after its widening (PALMM 1982)

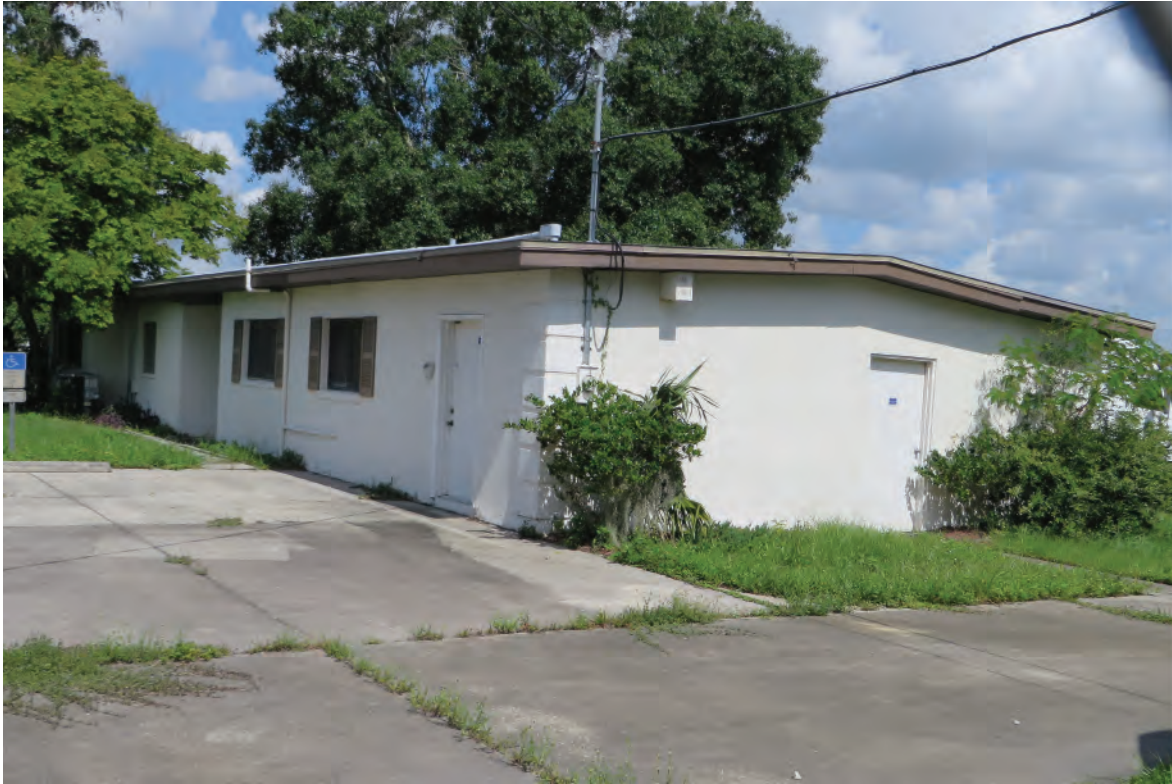
**PHOTOGRAPH**

Condition (overall resource condition): ☐ excellent ☒ good ☐ fair ☐ deteriorated ☐ ruinous

Narrative Description of Resource One-story commercial building in the Masonry Vernacular style exhibiting circa 1990 alterations, such as new stucco parging, replacement windows, and replacement doors.

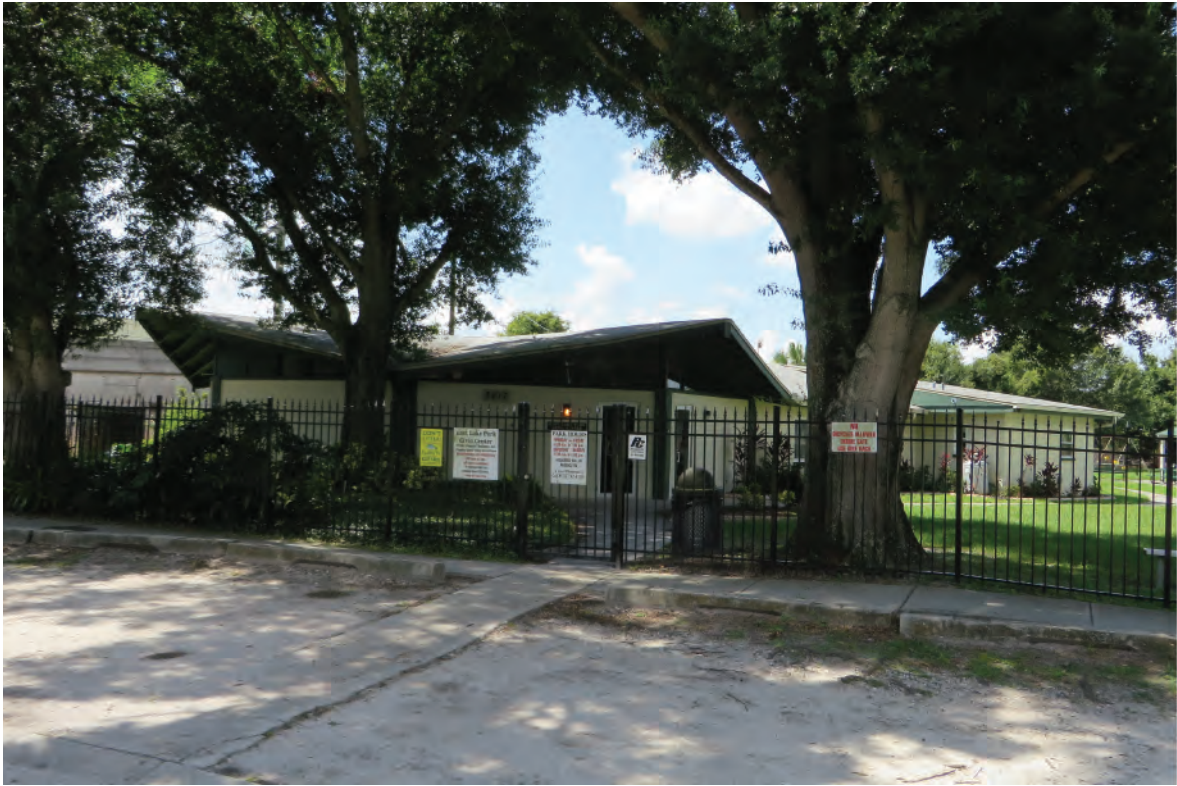
## PHOTOGRAPH

Condition (overall resource condition): ☐ excellent ☒ good ☐ fair ☐ deteriorated ☐ ruinous

Narrative Description of Resource One-story Mid-Century Modern community center building with a distinctive hyperbolic paraboloid roof. The structure exhibits a circa 1990 addition, and some alterations, such as replacement windows, and stucco parging.

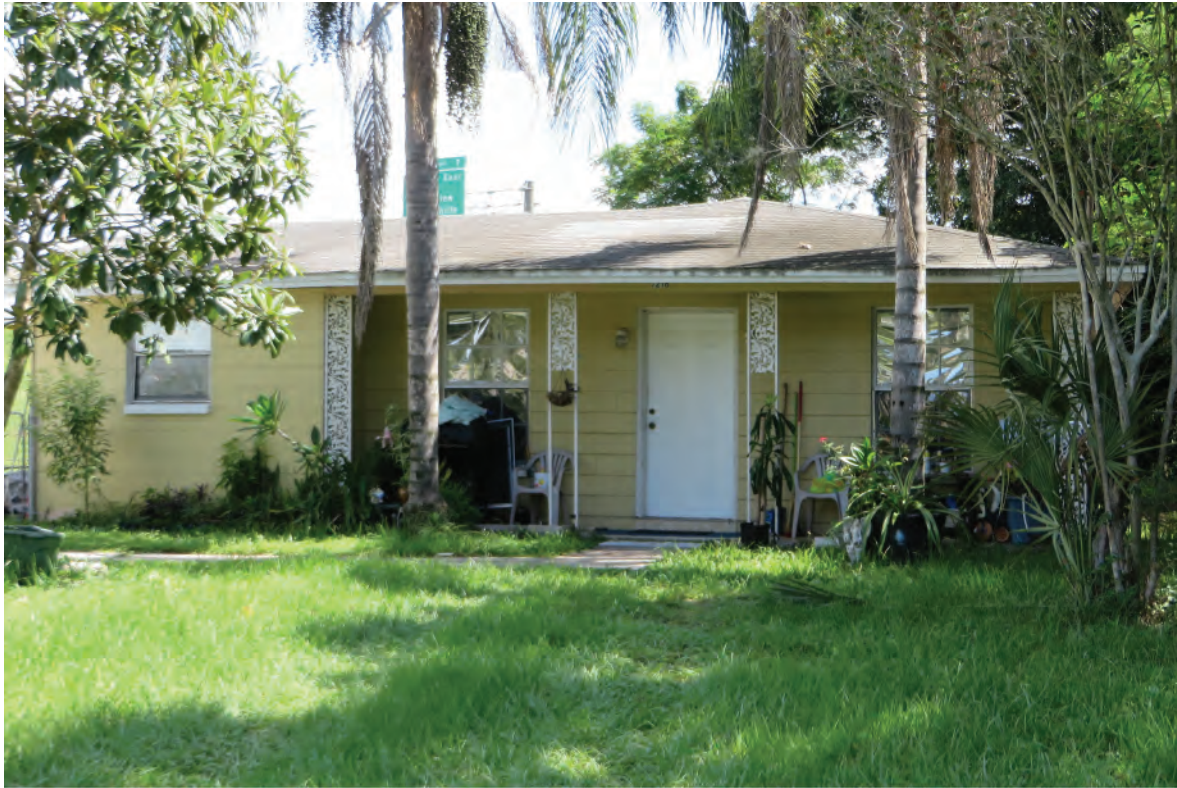
**PHOTOGRAPH**

Condition (overall resource condition): ☐ excellent ☒ good ☐ fair ☐ deteriorated ☐ ruinous

Explanation of Evaluation (required, whether significant or not; use separate sheet if needed) This is a typical example of the Masonry Vernacular style found throughout Hillsborough County. Furthermore, limited research revealed no significant historical associations. Therefore, 8HI12239 does not appear eligible for listing in the NRHP.

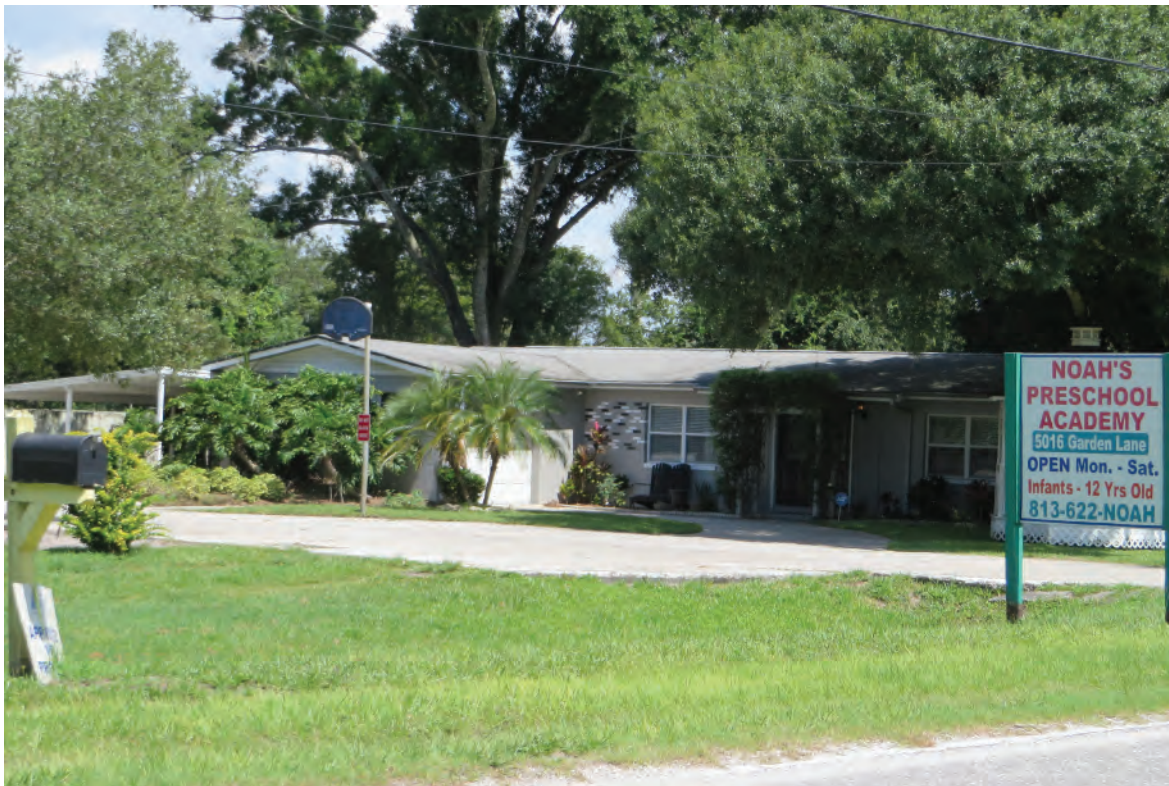
## PHOTOGRAPH

Condition (overall resource condition): ☐ excellent ☒ good ☐ fair ☐ deteriorated ☐ ruinous

Explanation of Evaluation (required, whether significant or not; use separate sheet if needed) This is a typical example of the Masonry Vernacular style found throughout Hillsborough County. Furthermore, limited research revealed no significant historical associations. Therefore, 8HI12240 does not appear eligible for listing in the NRHP.

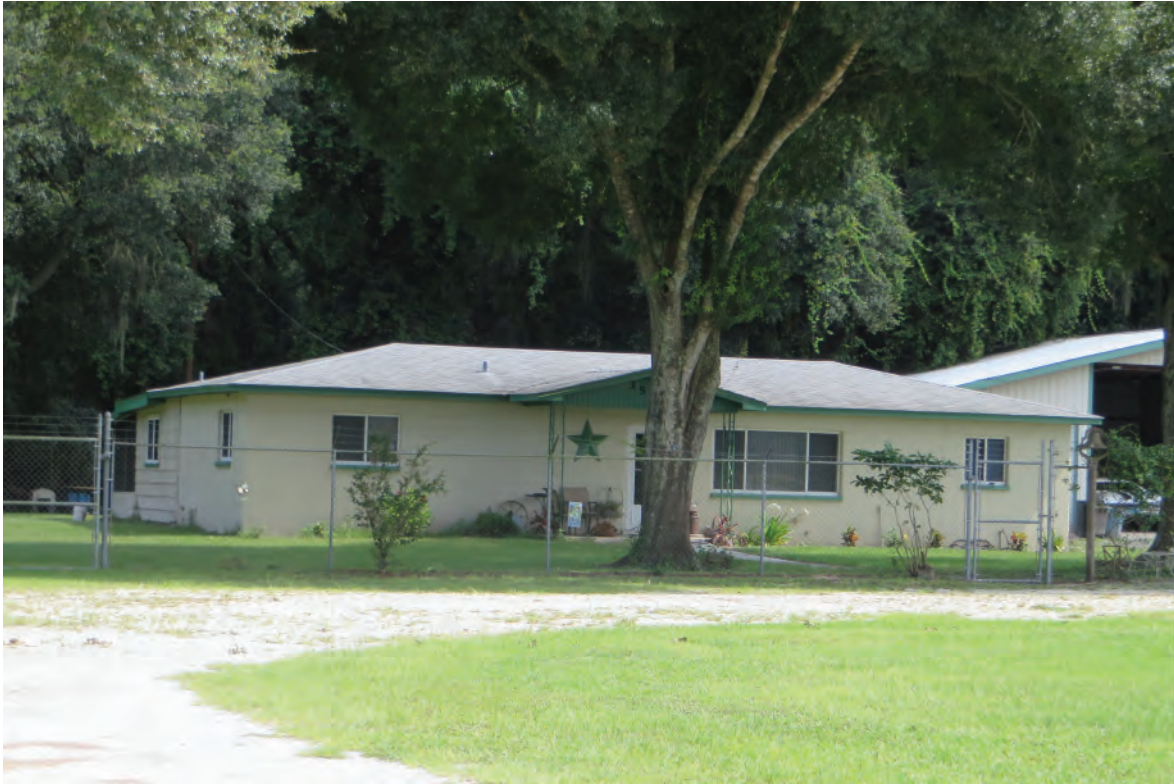
**PHOTOGRAPH**

Condition (overall resource condition): ☐ excellent ☐ good ☒ fair ☐ deteriorated ☐ ruinous

Narrative Description of Resource One-story Masonry Vernacular style residence with circa 1990 replacement vinyl windows. Two sheds are present on the lot, one directly north of the house, and a large garage northeast of the house.

Explanation of Evaluation (required, whether significant or not; use separate sheet if needed) This is a typical example of the Masonry Vernacular style found throughout Hillsborough County. Furthermore, limited research revealed no significant historical associations. Therefore, 8HI12258 does not appear eligible for listing in the NRHP.

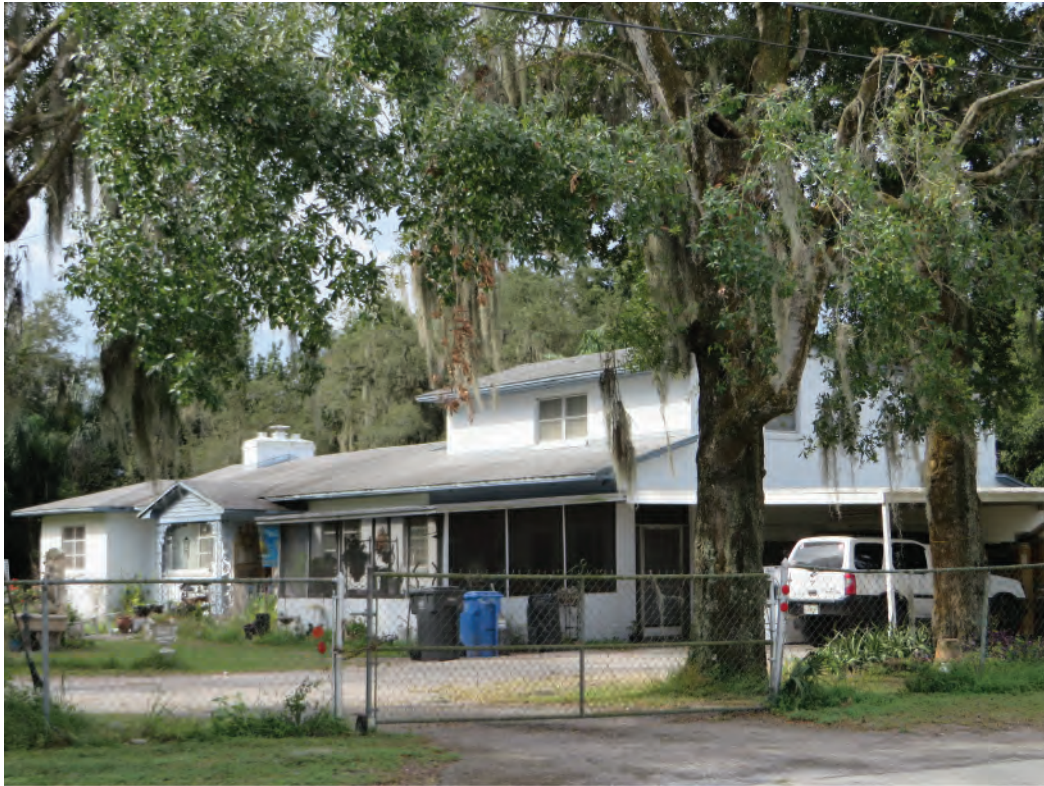
**PHOTOGRAPH**

Condition (overall resource condition): ☐ excellent ☒ good ☐ fair ☐ deteriorated ☐ ruinous

Narrative Description of Resource One-story Masonry Vernacular style residence with circa 1990 replacement vinyl windows and iron window grills.

Explanation of Evaluation (required, whether significant or not; use separate sheet if needed) This is a typical example of the Masonry Vernacular style found throughout Hillsborough County. Furthermore, limited research revealed no significant historical associations. Therefore, 8HI12259 does not appear eligible for listing in the NRHP.

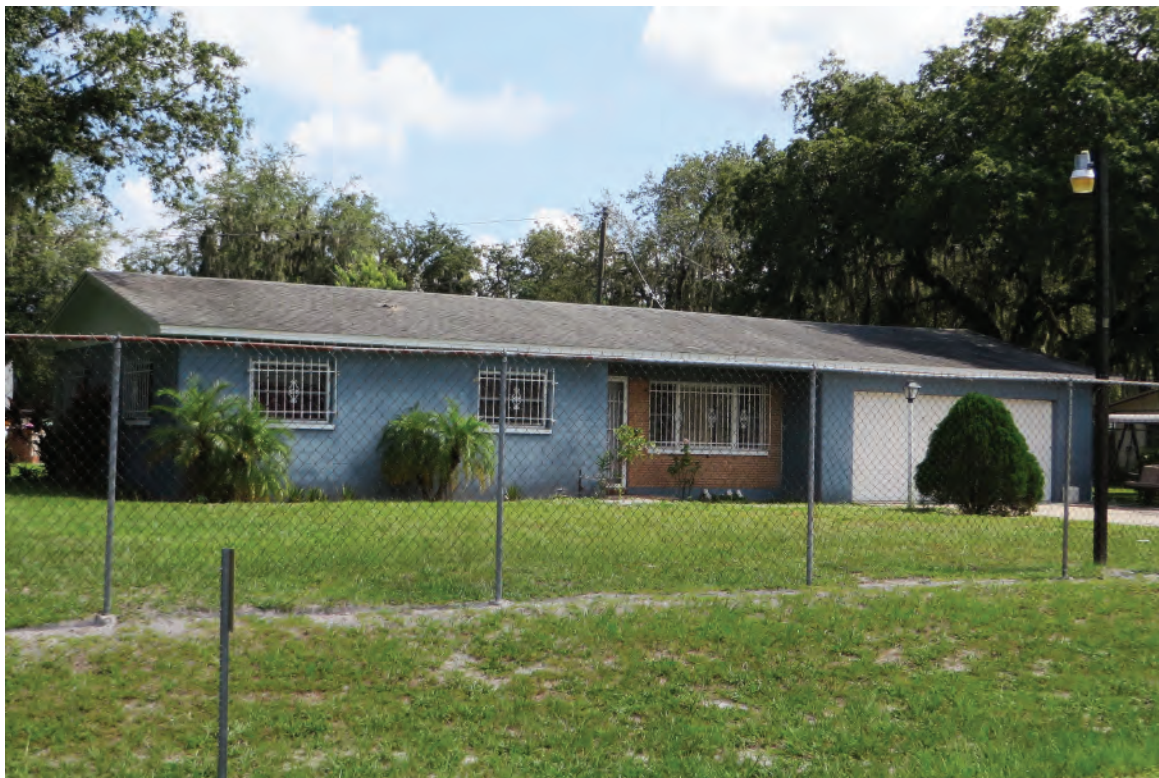
## PHOTOGRAPH

Chimney: No. 1 Chimney Material(s): 1. Brick 2. \_\_\_\_\_  
 Structural System(s): 1. Concrete block 2. \_\_\_\_\_ 3. \_\_\_\_\_  
 Foundation Type(s): 1. Slab 2. \_\_\_\_\_  
 Foundation Material(s): 1. Concrete, Generic 2. \_\_\_\_\_  
 Main Entrance (stylistic details) S elevation, square opening, single door

Condition (overall resource condition): ☐ excellent ☒ good ☐ fair ☐ deteriorated ☐ ruinous

Appears to meet the criteria for National Register listing individually? ☐ yes ☒ no ☐ insufficient information  
 Appears to meet the criteria for National Register listing as part of a district? ☐ yes ☒ no ☐ insufficient information  
 Explanation of Evaluation (required, whether significant or not; use separate sheet if needed) This is a typical example of the Masonry Vernacular style found throughout Hillsborough County. Furthermore, limited research revealed no significant historical associations. Therefore, 8HI12260 does not appear eligible for listing in the NRHP.

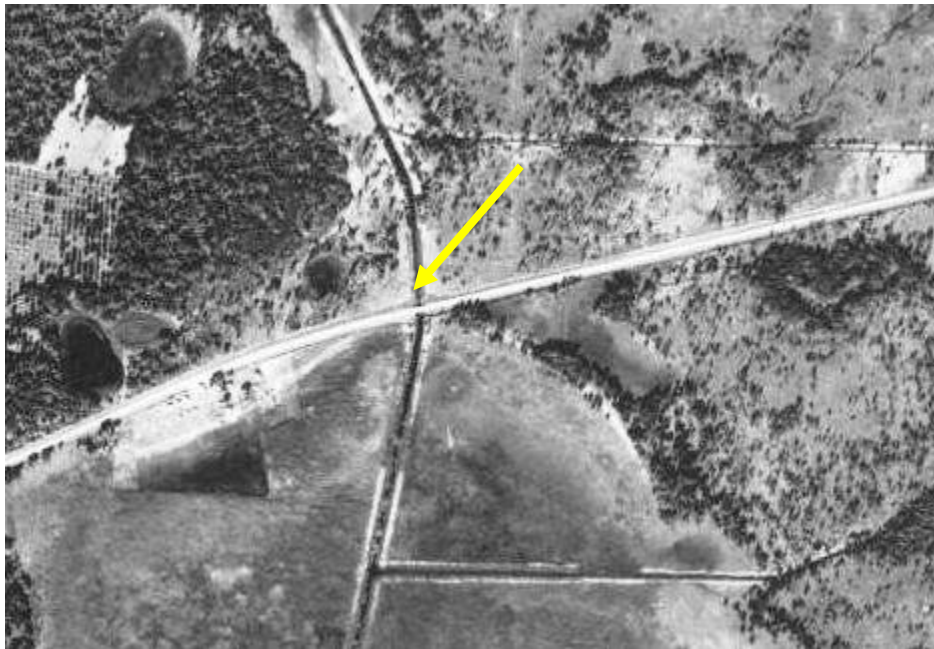
**8HI12281:** Bakers Canal intersects the project area and is located in Section 25 of Township 28 South Range 20 East (USGS 1974); an approximately 400-foot segment of the canal is located within the project APE. The canal is managed by the Southwest Florida Water Management District (SWFWMD), and is part of the Pemberton Creek/Baker Canal Area (PBA), a pivotal water management area in Hillsborough County (Hillsborough County Public Works Department 2002). This canal stretches for approximately six miles on a north to south flow, connecting Lake Thonotosassa in the north, to Lake Valrico in the south. Bakers Canal may have been originally a naturally occurring creek, which was dredged and rerouted c. 1930; it first appears on a 1938 aerial photograph, which reveals that at that time the canal was not as wide as presently (**Photo 1**). A 1999 satellite image indicates that the canal was dredged again and widened between 1995 and 1999; in addition, retention ponds were created on either side of the canal and south of I-4 at that time (**Photos 2 and 3**).

**Photo 1.** 1938 aerial photograph of the canal in its original configuration (PALMM 1938)

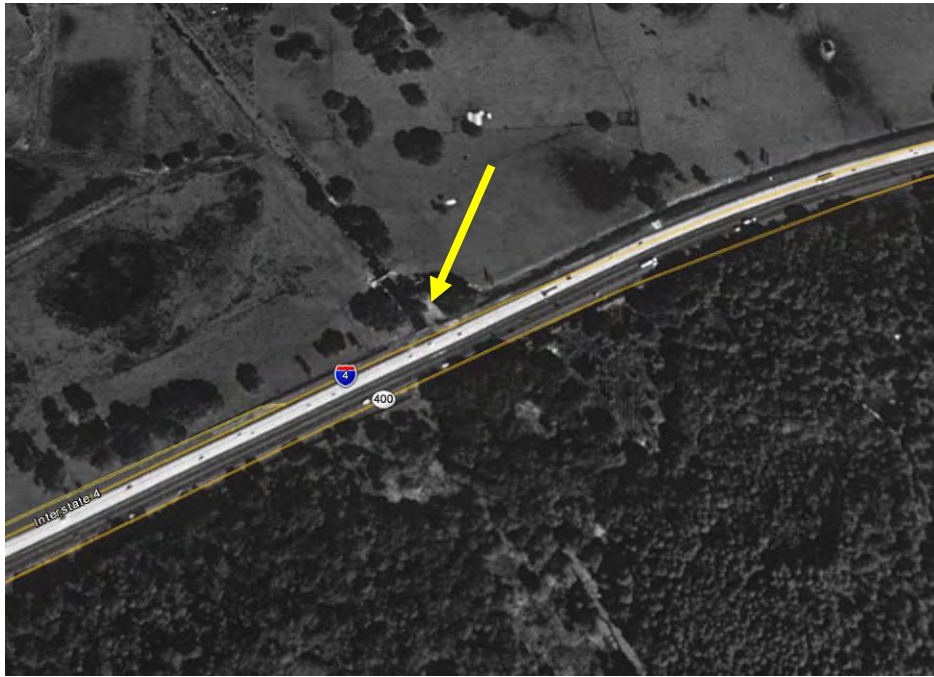
**Photo 2.** 1995 Google satellite image of the canal prior to dredging (Google Earth 1995)

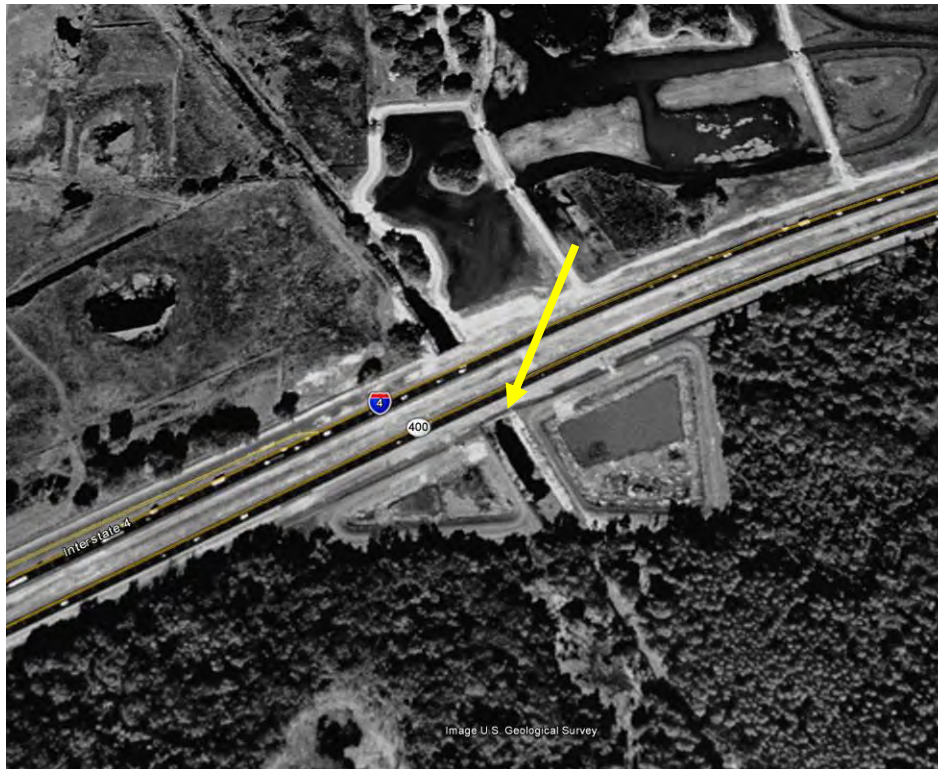
This type of water management canal is a common feature in the state, the segment within the APE lacks significant attributes and innovative engineering features, and its present appearance dates to the late 1990s. Furthermore, most of the canal's trajectory is located outside the project APE. A survey of the entire length of the canal is beyond the scope of this project, as such only the 400-foot segment within the project APE was evaluated. As such, there is insufficient information to determine the NRHP eligibility of this linear resource.

**Photo 3.** 2000 Google satellite image of the canal after dredging and the construction of two retention ponds on either side (Google Earth 2000)
