**HISTORIC RESOURCES SURVEY UPDATE
TECHNICAL MEMORANDUM**

**I-75 (SR 93A) FROM MOCCASIN WALLOW ROAD
TO SOUTH OF US 301
HILLSBOROUGH AND MANATEE COUNTIES, FLORIDA**

Work Program Item Segment No.: 419235-2-22-01

May 2020

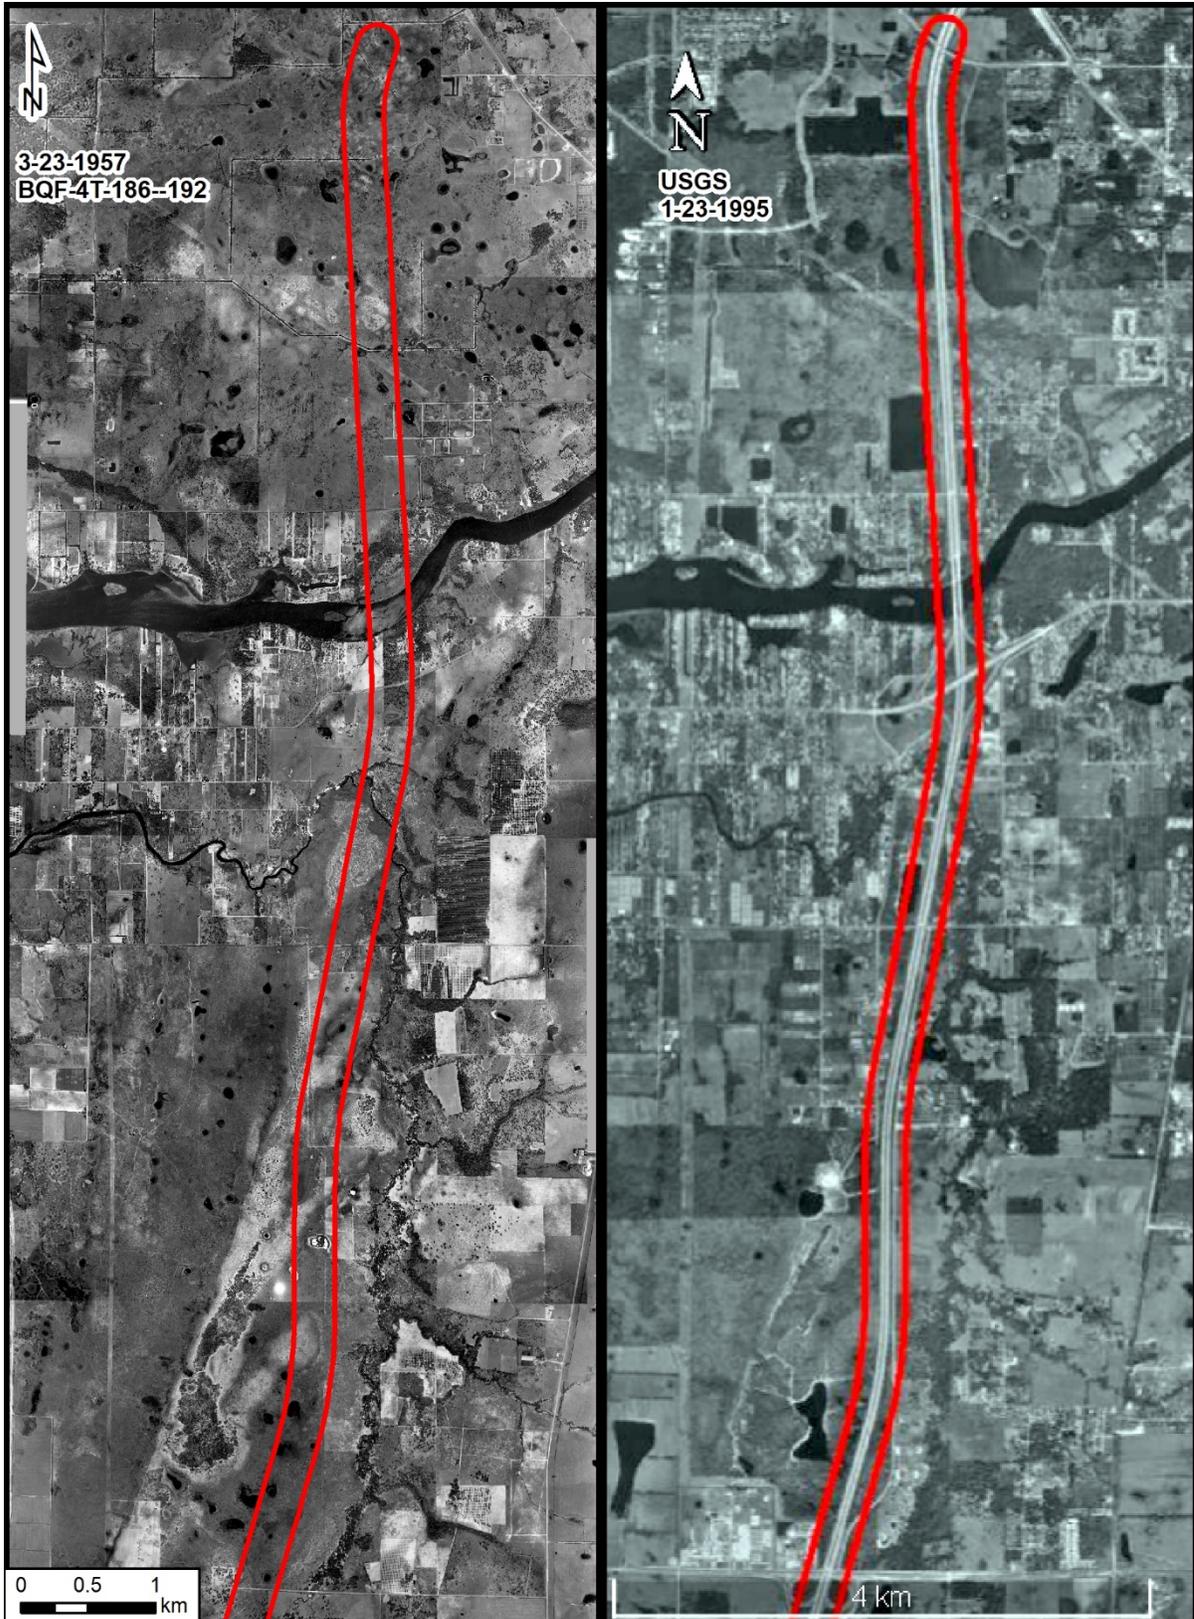
Figure 2. 1957 and 1995 aerial photographs showing development of the I-75 (SR 93A) corridor between Big Bend Road and Progress Boulevard/Bloomington Avenue.

A review of relevant historic United States Geographical Survey (USGS) quadrangle maps (Brandon 1956a, Gibsonton 1956b, Riverview 1956c, Ruskin 1956d, Palmetto 1964, Parrish 1973), historic aerial photographs, and the Manatee and Hillsborough County Property Appraiser’s data revealed the potential for six new historic resources 50 years of age or older (constructed in or prior to 1969) within the APE (Hackney 2019; Henriquez 2019).

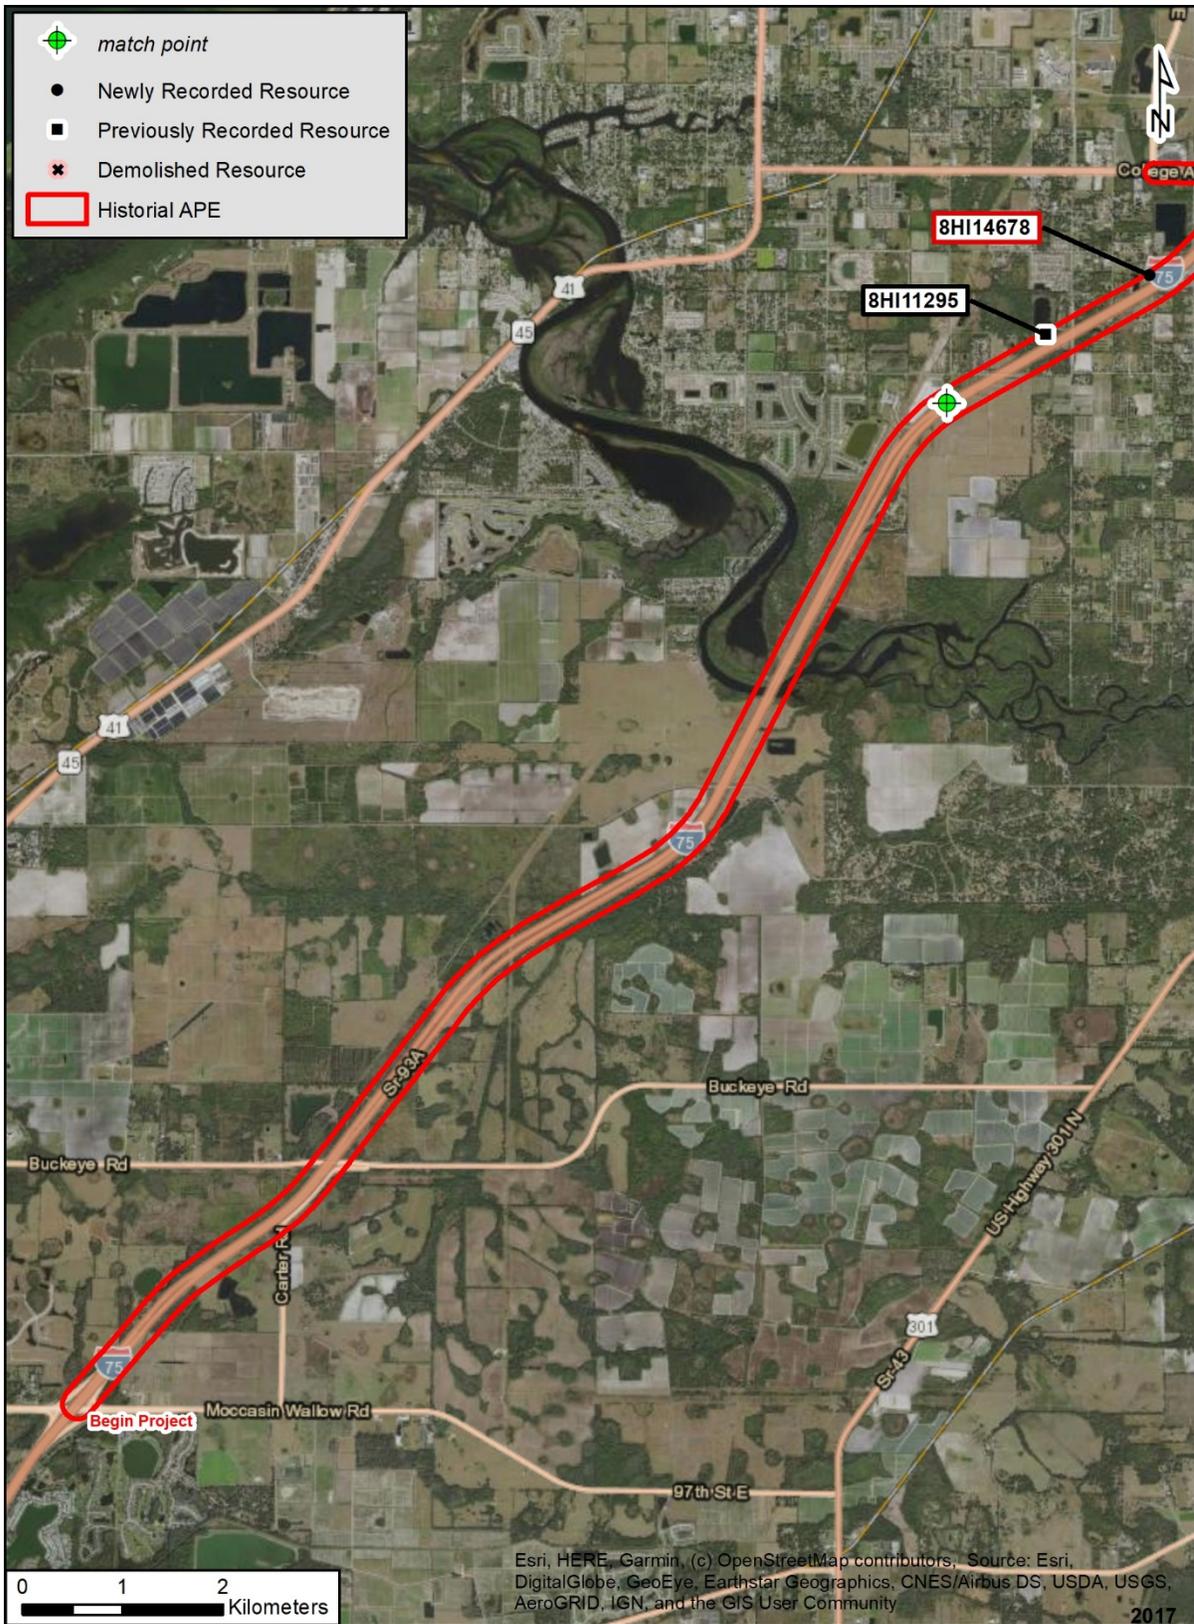
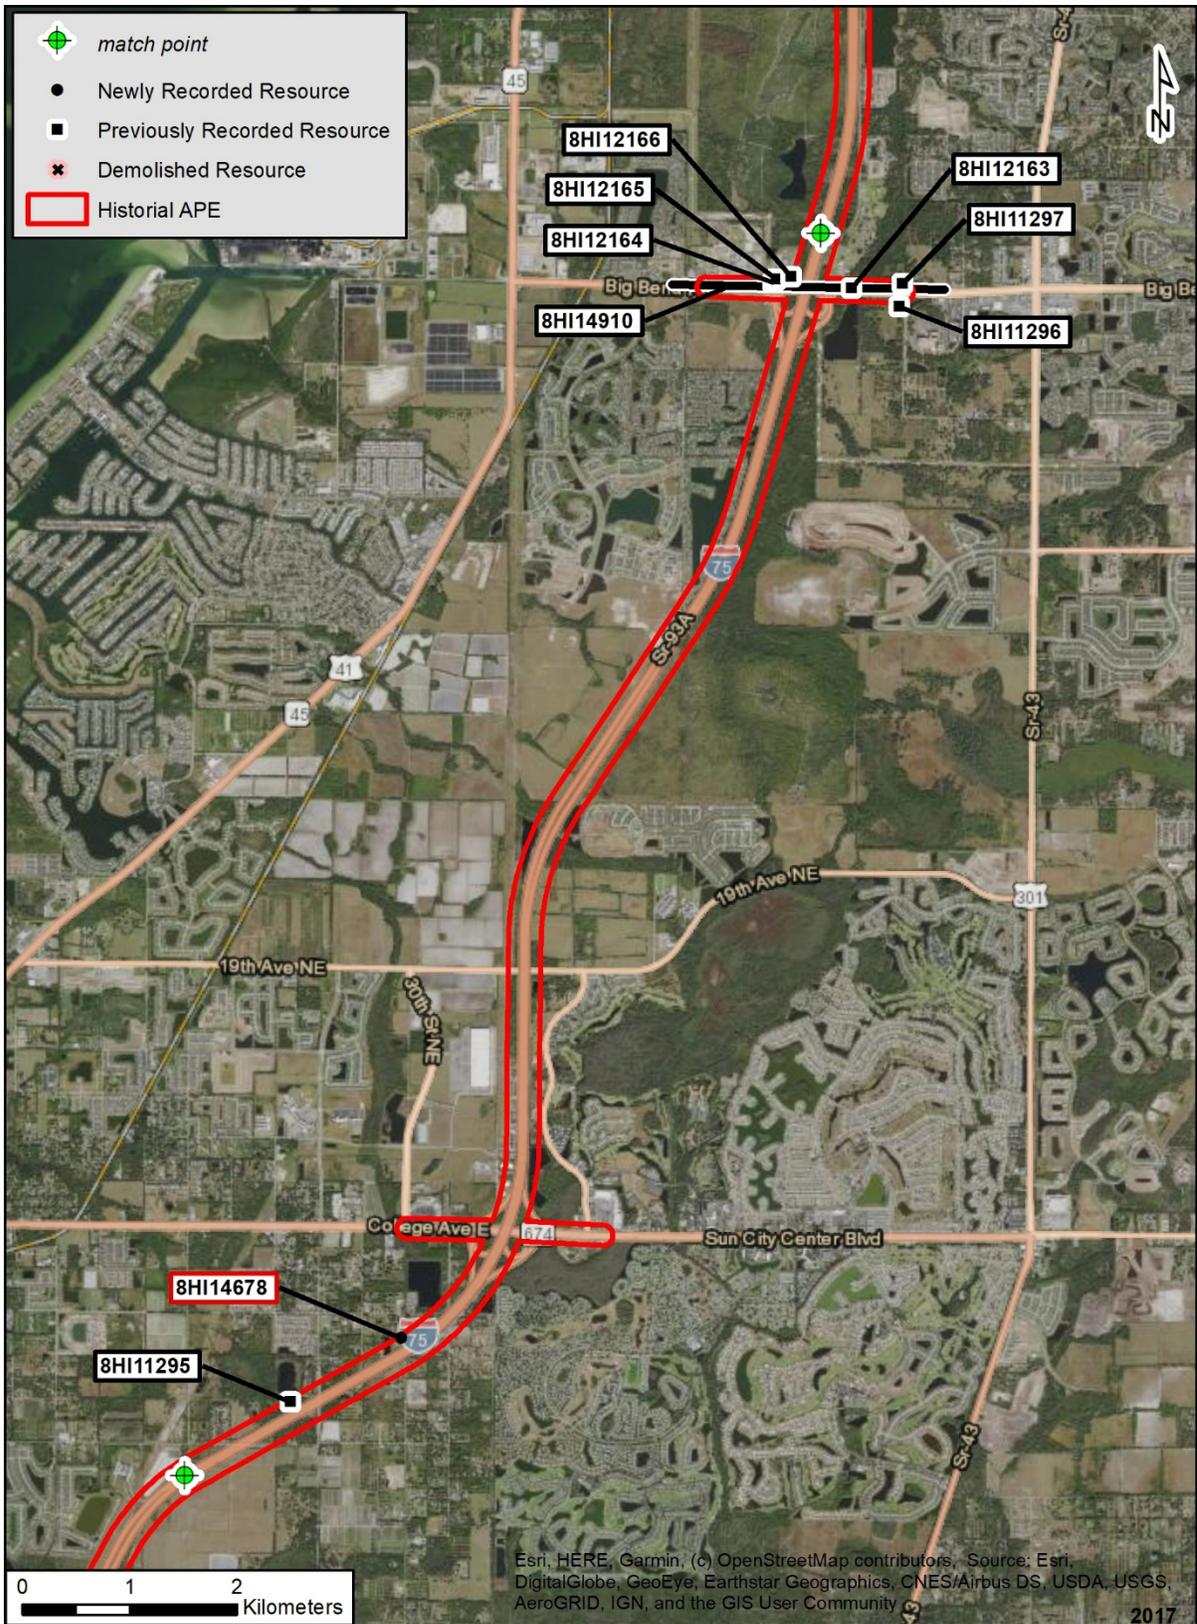
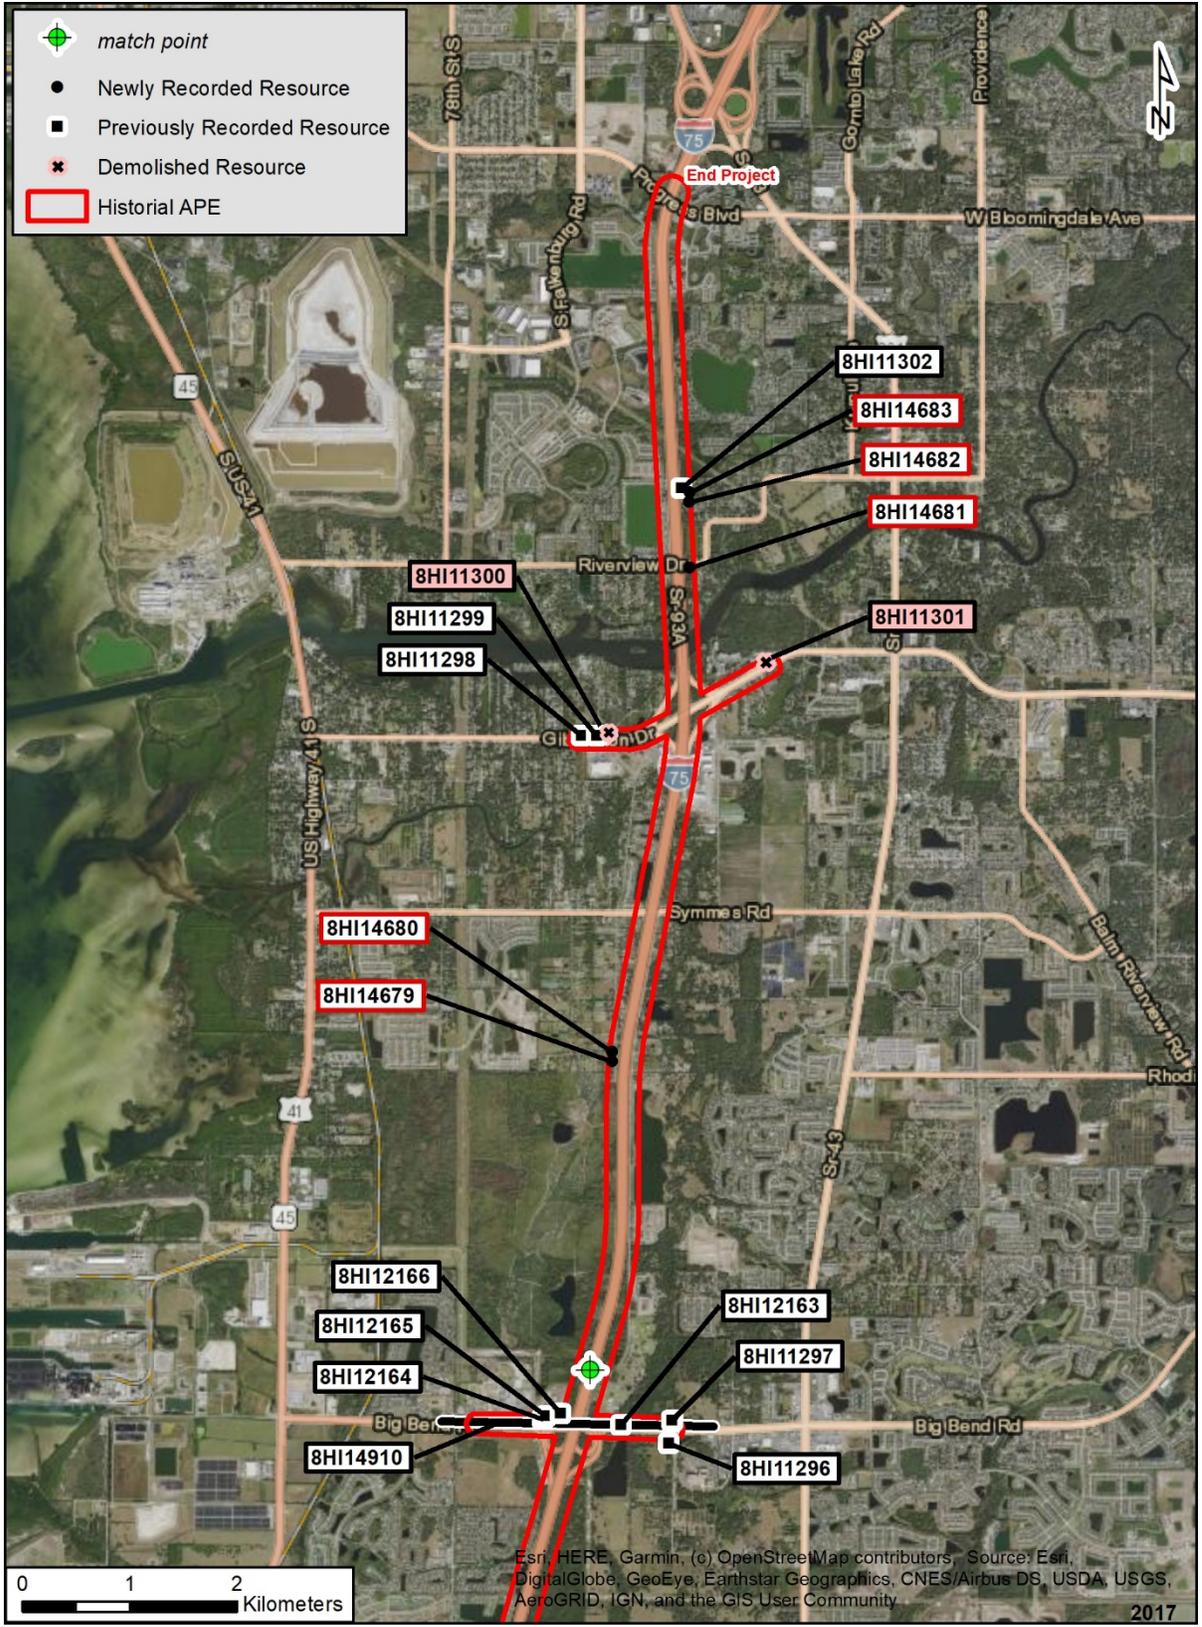
Figure 3. Location newly recorded (red text box) and previously recorded (black text box) historic resources within the I-75 (SR 93A) corridor APE.

Figure 4. Location newly recorded (red text box) and previously recorded (black text box) historic resources within the I-75 (SR 93A) corridor APE.

Figure 5. Location newly recorded (red text box) and previously recorded (black text box) historic resources within the I-75 (SR 93A) corridor APE.

As a result of historic field survey, six historic resources (8HI14678-HI14683) were identified, recorded, and evaluated within APE (**Table 2; Figures 3-5**). These include four Frame Vernacular (8HI14678; 8HI14681-8HI14683) and two Masonry Vernacular (8HI14679 & 8HI14680) style buildings constructed between circa (c.) 1957 and 1969. These resources are common examples of their respective architectural styles without significant historical associations; therefore, none appears eligible for listing in the NRHP, either individually or as part of a historic district. Descriptions of the resources follow, and FMSF forms are contained in **Appendix B**. Field survey also revealed that two previously recorded historic resources (8HI11300 & 8HI11301) are no longer extant. A letter to the FMSF noting their changed status is contained in **Appendix C**.

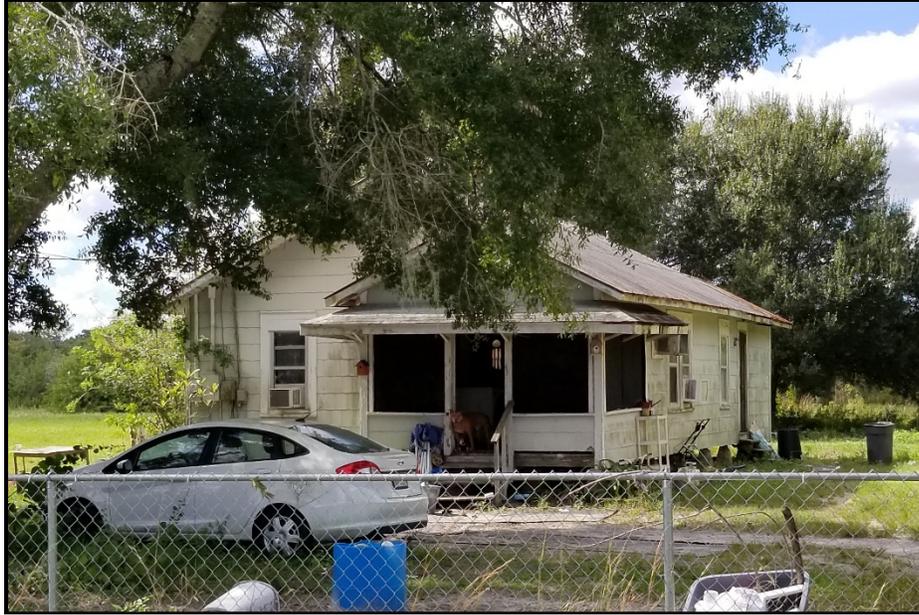
Photo 1. 1515 SE 30th Street (8HI14678), looking west-southwest.

8HI14678: The Frame Vernacular style building at 1515 SE 30th Street was constructed in c. 1960 per property appraiser's data; however, the building appears to have been constructed at an earlier date (**Photo 1**). A review of historic aerial photography revealed that the building was moved to the property between c. 1980 and c. 1984 (FDOT 1980, 1984). The one-story, irregular plan building rests on a pre-cast tapered concrete pier foundation and has a wood-frame structural system clad in asbestos siding. The front gable roof and gable extension are covered with 3v crimp sheet metal, while the half hip pent roof is covered in composition shingles. A brick chimney is located on the ridge of the main roof. The main entryway is on the east elevation within a partial width open porch beneath a gable extension with screening, half walls, and wooden brackets. Visible windows include individual and paired, one-over-one wood single-hung-sash units. Distinguishing architectural features include overhanging eaves, wooden window casings, gable vent, wooden brackets, brick chimney, tapered concrete piers, and corner boards. Alterations include replacement roofing, windows, and siding. A non-historic utility shed is located to the northwest. Overall, the building has been altered, lacks sufficient architectural features, and is not a significant embodiment of a type, period, or method of construction. In addition, background research did not reveal any historic associations with significant persons and/or events. As a result, 8HI14678 does not appear eligible for listing in the NRHP, either individually or as part of a historic district.

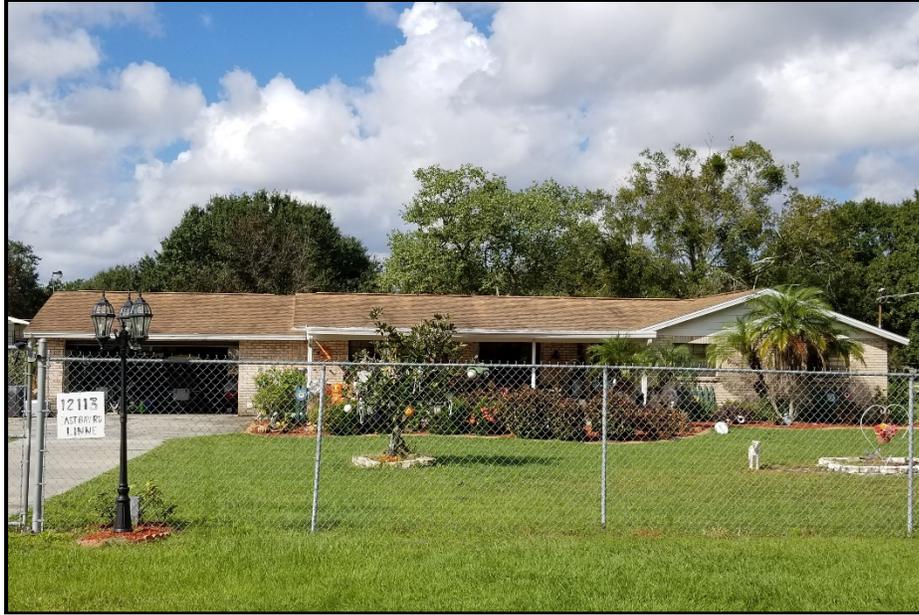
Photo 2. 12113 East Bay Road (8HI14679), looking west.

8HI14679: The Masonry Vernacular style building at 12113 East Bay Road was constructed in c. 1966 (**Photo 2**). The one-story, irregular plan building rests on a concrete slab foundation and has a concrete block structural system clad in brick veneer, stucco, and clapboard siding. The cross-gabled roof with side gable extension are covered in composition shingles, while the flat roof is covered in composition roll. The main entryway is on the east elevation through a single door within a partial width open porch beneath a flat roof supported by metal porch supports. Visible windows include a mixture of individual, one-over-one and eight-over-eight metal single-hung-sash units. Distinguishing architectural features include clapboard siding in the gable ends, brick windowsills, and boxed rafters. Alterations include replacement roofing and siding. Additions include an attached garage on the south elevation, a flat roof porch on the east elevation, and two additions to the west elevation. A non-historic detached garage, detached carport, and utility shed are located to the south of the building. Overall, the building has been altered, lacks sufficient architectural features, and is not a significant embodiment of a type, period, or method of construction. In addition, background research did not reveal any historic associations with significant persons and/or events. As a result, 8HI14679 does not appear eligible for listing in the NRHP, either individually or as part of a historic district.

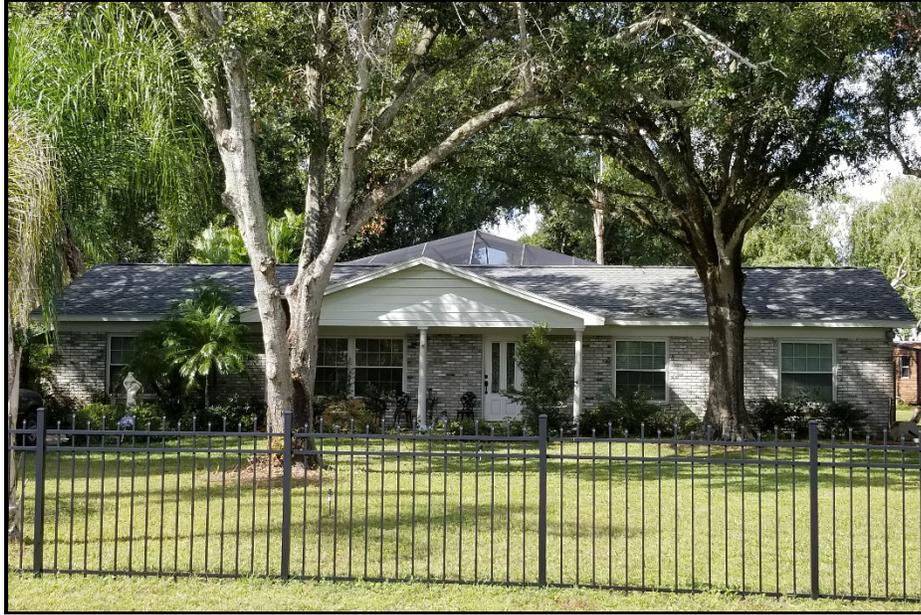
Photo 3. 12039 East Bay Road (8HI14680), looking west.

8HI14680: The Masonry Vernacular style building at 12039 East Bay Road was constructed in c. 1966 (**Photo 3**). The one-story, irregular plan building rests on a concrete slab foundation and has a concrete block structural system partially clad in brick veneer and clapboard siding. The side gable roof with gable extension are covered in composition shingles. The main entryway is on the east elevation through a single door with two rectangular leaded lights within a partial width open porch beneath a gable extension supported by column porch supports. Visible windows include a mixture of individual and paired, eight-over-eight vinyl single-hung-sash units and individual, two-over-two vinyl single-hung-sash units. Distinguishing architectural features include clapboard siding in the gable ends, boxed rafters, canvas awnings, and column porch supports. The property is surrounded by metal fence with four square masonry piers with lion caps at the front entrance. Alterations include replacement roofing and windows. A non-historic detached garage and swimming pool with screened enclosure are located to the west of the building. Overall, the building has been altered, lacks sufficient architectural features, and is not a significant embodiment of a type, period, or method of construction. In addition, background research did not reveal any historic associations with significant persons and/or events. As a result, 8HI14680 does not appear eligible for listing in the NRHP, either individually or as part of a historic district.

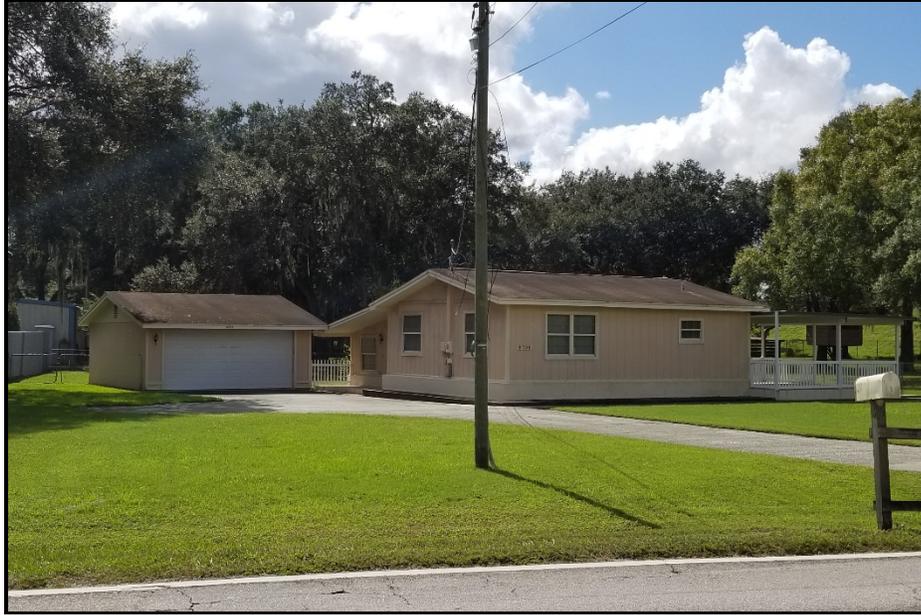
Photo 4. 9709 Riverview Drive (8HI14681), looking south.

8HI14681: The Frame Vernacular style building at 9709 Riverview Drive was constructed in c. 1969 (**Photo 4**). The one-story, irregular plan building rests on a concrete slab foundation and has a wood-frame structural system clad in plywood. The side gable roof and shed roof are covered with composition shingles, while the flat roof is sheathed in built up membrane. The main entryway is on the northeast elevation through a single panel door with fanlight within a partial-width open porch beneath the shed roof overhang. An open, partial-width porch beneath a flat roof with vinyl porch supports is located on the southwest elevation. Visible windows include a mixture of individual and paired, one-over-one and three-over-three vinyl single-hung-sash units and paired, six-over-six vinyl single-hung-sash units. Distinguishing architectural features include wide base molding, wood window frames and door surrounds, and overhanging eaves. Alterations include replacement roofing, siding, and windows. An addition is located on the south elevation beneath a shed roof and two porches on the southwest elevation beneath a flat roof. A non-historic detached garage is located immediately adjacent to the east of the building. Overall, the building has been altered, lacks sufficient architectural features, and is not a significant embodiment of a type, period, or method of construction. In addition, background research did not reveal any historic associations with significant persons and/or events. As a result, 8HI14681 does not appear eligible for listing in the NRHP, either individually or as part of a historic district.

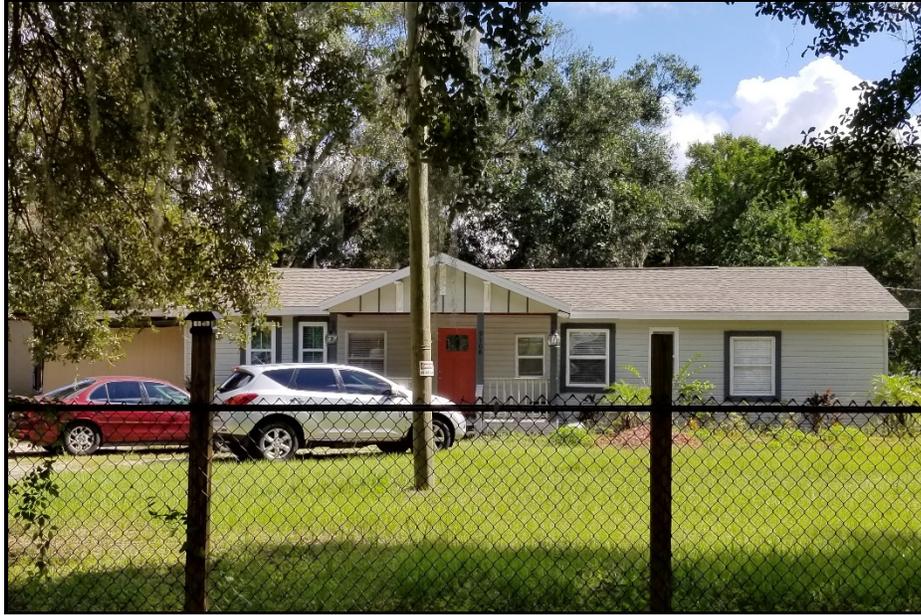
Photo 5. 9708 Lorraine Road (8HI14682), looking east.

8HI14682: The Frame Vernacular style building at 9708 Lorraine Road was constructed in c. 1957 (**Photo 5**). The one-story, irregular plan building rests on a concrete slab foundation and has a wood-frame structural system clad in vinyl siding. The side gable roof and gable extension are covered with composition shingles, while the shed extension is covered with 3v crimp sheet metal. The main entryway is on the west elevation through a single panel door with a rectangular light. Preceding the entryway is a partial width open porch beneath a gable extension supported by wooden porch supports with railings accessed by two wooden steps with a wooden railing. Visible windows include a mixture of individual, one-over-one, two-over-one, two-over-two, and one-over-four vinyl single-hung-sash units. Distinguishing architectural features include faux knee braces, decorative trim in the gable ends, and wood window frames. Alterations include replacement roofing, siding, and windows. Additions include gable roof extensions on the south and west elevation completed during a c. 2018 renovation and a carport on the north elevation. A non-historic utility shed is located to the north of the building. Overall, the building has been altered, lacks sufficient architectural features, and is not a significant embodiment of a type, period, or method of construction. In addition, background research did not reveal any historic associations with significant persons and/or events. As a result, 8HI14682 does not appear eligible for listing in the NRHP, either individually or as part of a historic district.

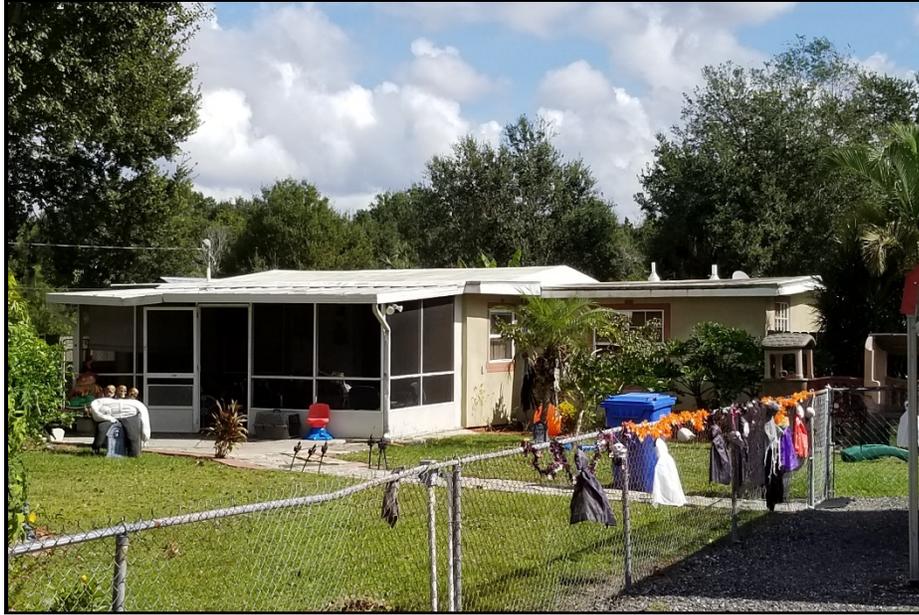
Photo 6. 8012 Formby Street (8HI14683), looking northeast.

8HI14683: The Frame Vernacular style building at 8012 Formby Street was constructed in c. 1964 (**Photo 6**). The one-story, irregular plan building rests on a concrete slab foundation and has a wood-frame structural system clad in stucco. The side gable roof is covered with composition shingles, while the shed roof is covered with 5V crimp sheet metal. The main entryway is on the west elevation through within a partial-width open screened-in porch beneath a shed roof supported by metal porch supports. Visible windows include a mixture of individual, one-over-one and eight-over-eight vinyl single-hung-sash units. Distinguishing architectural features include contrasting trim with keystones around windows and overhanging eaves. Alterations include replacement roofing, siding, and windows. Additions include porch with shed roof on the west and east elevations. A non-historic detached carport is located to the west of the building and a non-historic utility shed is located to the north. Overall, the building has been altered, lacks sufficient architectural features, and is not a significant embodiment of a type, period, or method of construction. In addition, background research did not reveal any historic associations with significant persons and/or events. As a result, 8HI14683 does not appear eligible for listing in the NRHP, either individually or as part of a historic district.
