**CULTURAL RESOURCE ASSESSMENT SURVEY  
ADDENDUM TECHNICAL MEMORANDUM**

**Interstate 75 / SR 93A**

**From south of US 301/SR 43 to North of Bruce B. Downs Boulevard**

**Project Development and Environment Study**

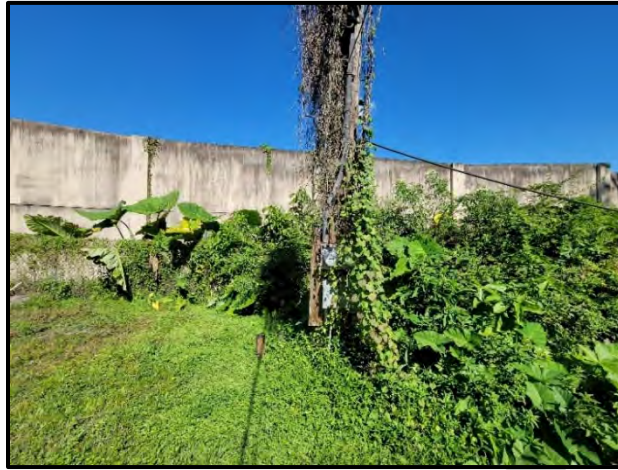
**Photo 1. Looking north towards I-4 (east of Falkenburg Road), sound barrier wall, and utilities.**

The APE is located in Sections 31 and 32 of Township 28 South, Range 19 East and Section 6 of Township 29 South, Range 19 East (USGS 1956, 1974) (**Figure 7** in **Section 5**). Extensive Environmental Overviews are found in the I-75 CRAS (ACI 2009) and the I-4 CRAS reports (ACI 2014; Estabrook and Fuhrmeister 1992) and not repeated here. Currently, although the soils within the APE range from very poorly drained to moderately well-drained (**Figure 5**; United States Department of Agriculture [USDA] 1989), the environment of the APE has been extremely altered as a result of the construction, maintenance, and improvements to I-75 and I-4, residential, industrial, and commercial development, above ground and subsurface utilities, culverts and ditching. Vegetation includes weeds, various oaks and pines, and ornamentals. **Photos 1-3** show some of the disturbance observed within the APE.

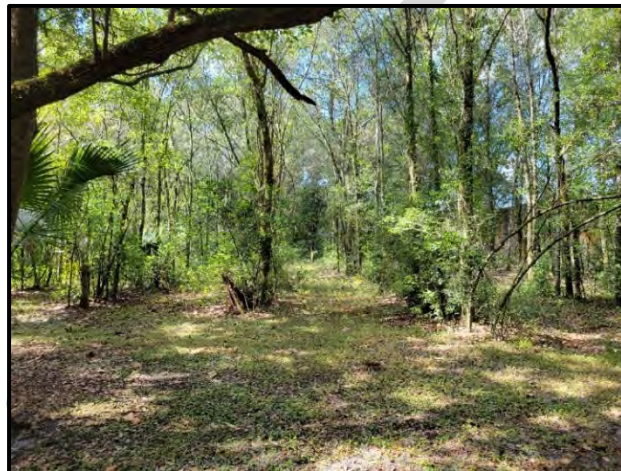
**Photo 2. Looking west at sample vegetation within the APE, west of Falkenburg Road.**

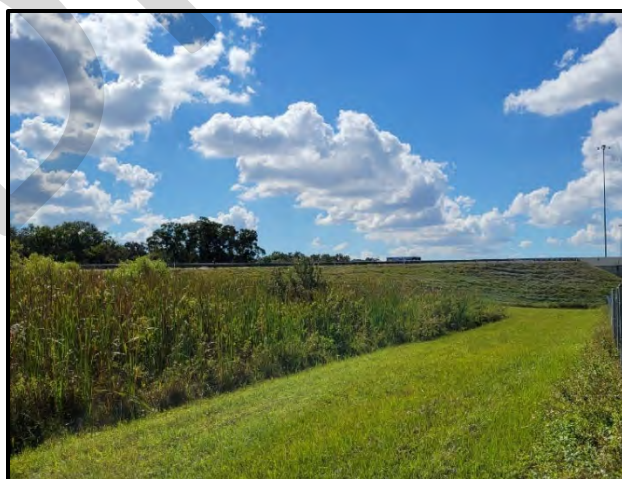
**Photo 3. Looking west at easement along I-4 at on ramp from US 92, west part of APE.**

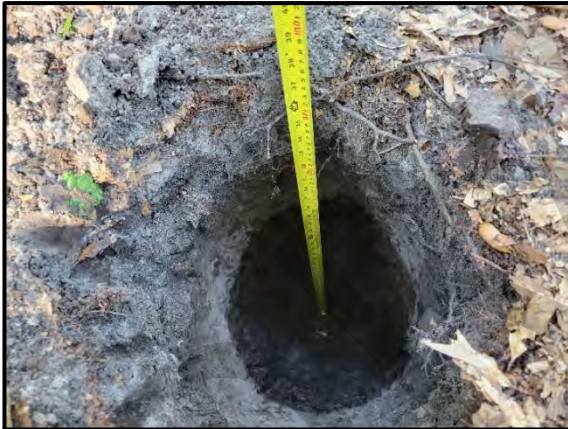
- 0-40 cm of gray sand, 40-60 cm of dark brown sand, 60-100 cm of light brown sand
- 0-30 cm of gray/brown sand, 30-100 cm of light, brown sand.
- 0-20 cm of dark gray/brown, gravelly sand with compact gravel fill at 20 cm.

Photo 4. Sample stratigraphy showing hard pan at the bottom.

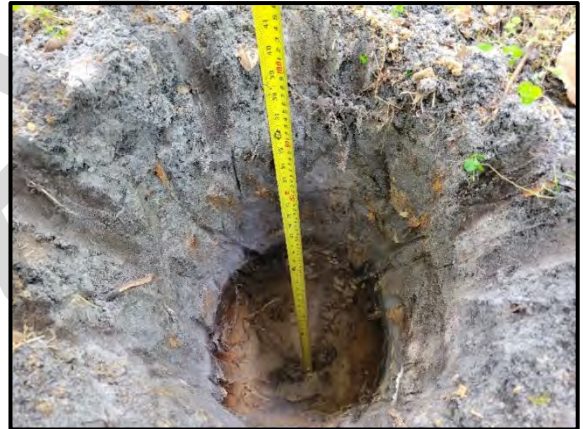
Photo 5. Sample stratigraphy showing mottling of soil.

**Archaeological Survey Results:** Archaeological field survey included both ground surface reconnaissance and the systematic and judgmental excavation of a total 55 shovel tests within the APE (**Figures 8 and 9**). The archaeological APE had a variable archaeological potential - low to high. Systematic shovel tests were placed at 25, 50, and 100 m intervals. Each shovel test measured 0.5 m in diameter and was dug to a depth of 1 m unless impeded by hardpan, road asphalt, compact gravel, and/or utilities. Sample stratigraphy is noted below and in **Photos 4 and 5**.

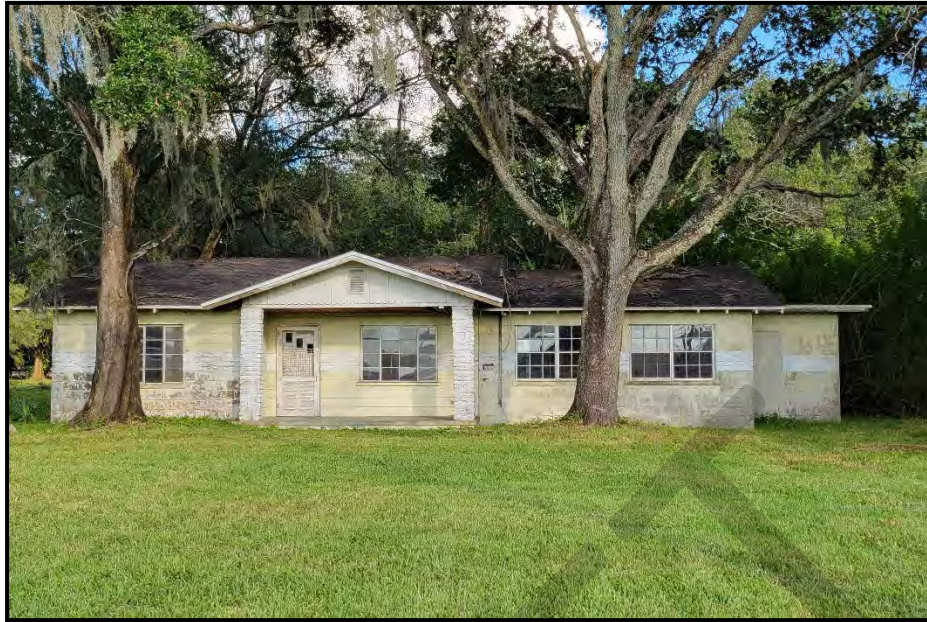
**Photo 8. 5219 Eureka Springs Road (8HI08706), looking east.**

**8HI08706:** The Ranch style building at 5219 Eureka Springs Road was constructed in ca. 1953 (**Photo 8**). The one-story, irregular plan building rests on a continuous concrete block foundation and has a concrete block structural system with an exposed concrete block exterior and sections of art brick and vertical plank siding on the gable ends. The side gable roof is covered with composition shingles and the flat roof is covered in built-up membrane. The main entrance is located on the west elevation through a single door with three-lights diagonally arranged. Visible windows include a mixture of individual, paired, and grouped (3) metal four-light casement and fixed units, paired metal six-over-six single-hung-sash, and individual and paired metal jalousie units. Distinguishing architectural features include exposed rafter ends, concrete windowsills, vents in gable ends, and porch supports clad in art brick. Alterations include replacement windows and roofing materials. A flat roof addition has been added to the south elevation. Overall, the building has been altered, lacks sufficient architectural features, and is not a significant embodiment of the Ranch style, mid-century period, or method of construction. In addition, background research did not reveal any historic associations with significant persons and/or events. As a result, 8HI08706 does not appear eligible for listing in the NRHP, either individually or as part of a historic district.

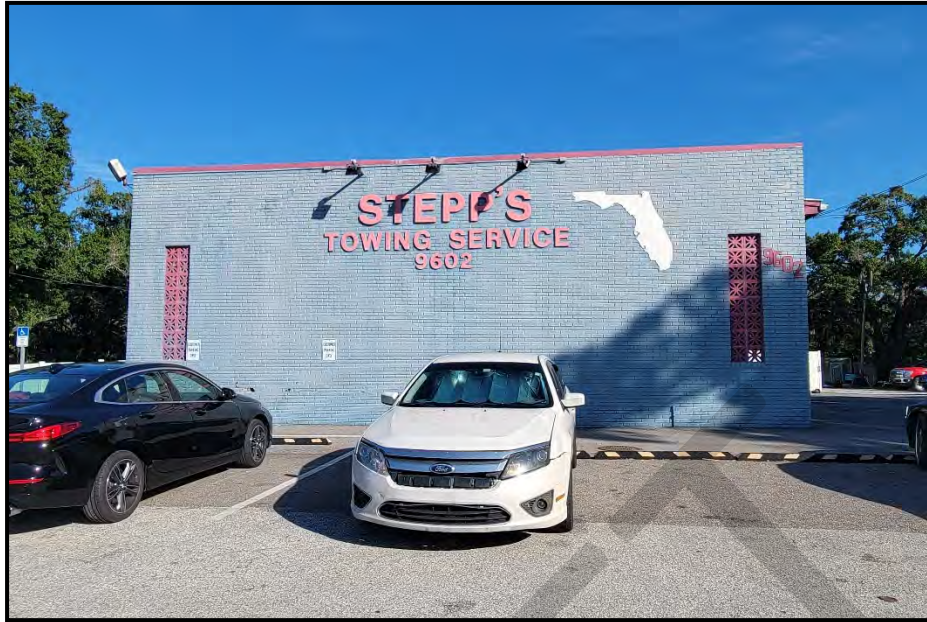
**Photo 9. 9602 E US 92 Highway, Stepp's Towing (8HI15186), looking north.**

**8HI15186:** The Masonry Vernacular style building at 9602 E US 92 Highway, Stepp's Towing, was constructed in ca. 1970 (**Photo 9**). The one-story, irregular plan building rests on a continuous concrete block foundation and has a concrete block structural system with a faux brick façade. The gable and shed roofs are covered with 5V crimp sheet metal. The main entrance is located on the east elevation through a single metal frame glass door with a sidelight window within a recessed entry way. Visible windows include a mixture of individual vinyl slider, one-over-one vinyl single-hung-sash, and fixed units with metal security bars. Distinguishing architectural features include concrete windowsills, cinder block pilasters, brick façade with parapet, decorative cinder blocks, garage doors, and louvered vents. Alterations include replacement windows, doors, and roofing materials. Two metal frame extensions have been added to the north elevation, one with a gable roof and garage doors, and the other with a shed roof. A non-historic open bay garage is located northeast of the building. Overall, the building has been altered, lacks sufficient architectural features, and is not a significant embodiment of a type, period, or method of construction. In addition, background research did not reveal any historic associations with significant persons and/or events. As a result, 8HI15186 does not appear eligible for listing in the NRHP, either individually or as part of a historic district.

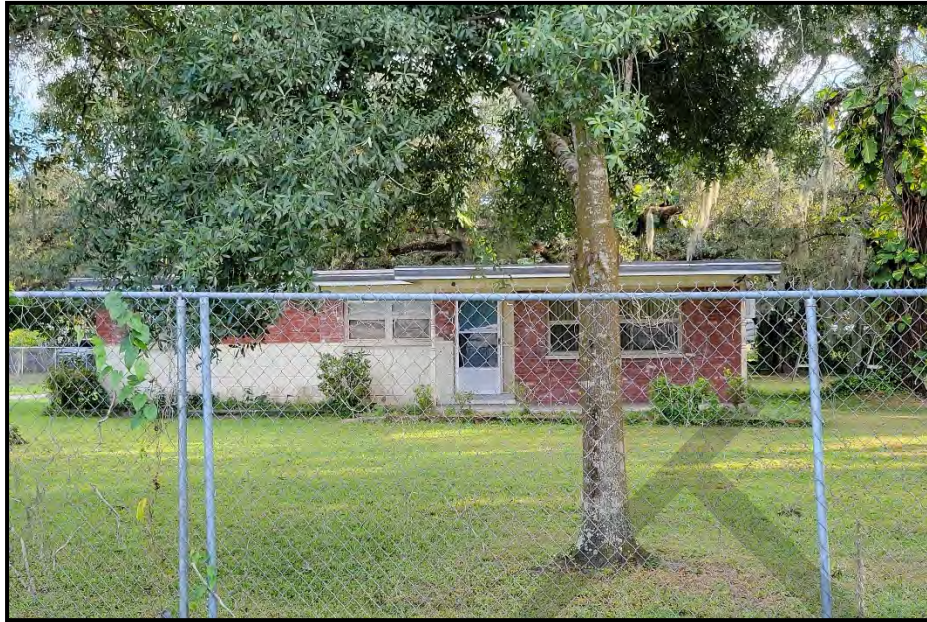
**Photo 10. 5279 Eureka Springs Road (8HI15187), looking south.**

**8HI15187:** The Masonry Vernacular style residence at 5279 Eureka Springs Road was constructed in ca. 1962 (**Photo 10**). The one-story, irregular plan building rests on a continuous concrete block foundation and has a concrete block structural system with a partially clad art brick façade and vertical plank siding on the gable ends. The gable and shed roofs are covered with composition roll roofing material. The main entrance is located on the north elevation through a single door beneath a flat roof extension. This building has two open, partial width porches. The north elevation porch is beneath a flat roof extension with decorative wood support columns preceding the entrance. The south elevation porch is screened beneath a flat roof extension. Visible windows include a mixture of individual and paired one-over-one vinyl single-hung-sash units. Distinguishing architectural features include concrete windowsills, partially clad art brick façade, decorative wood porch support columns, and a low pitch gable roof. Alterations include replacement windows and roofing materials and an addition to the south elevation. A non-historic garage and shed are located to the south of the building. Overall, the building has been altered, lacks sufficient architectural features, and is not a significant embodiment of a type, period, or method of construction. In addition, background research did not reveal any historic associations with significant persons and/or events. As a result, 8HI15187 does not appear eligible for listing in the NRHP, either individually or as part of a historic district.

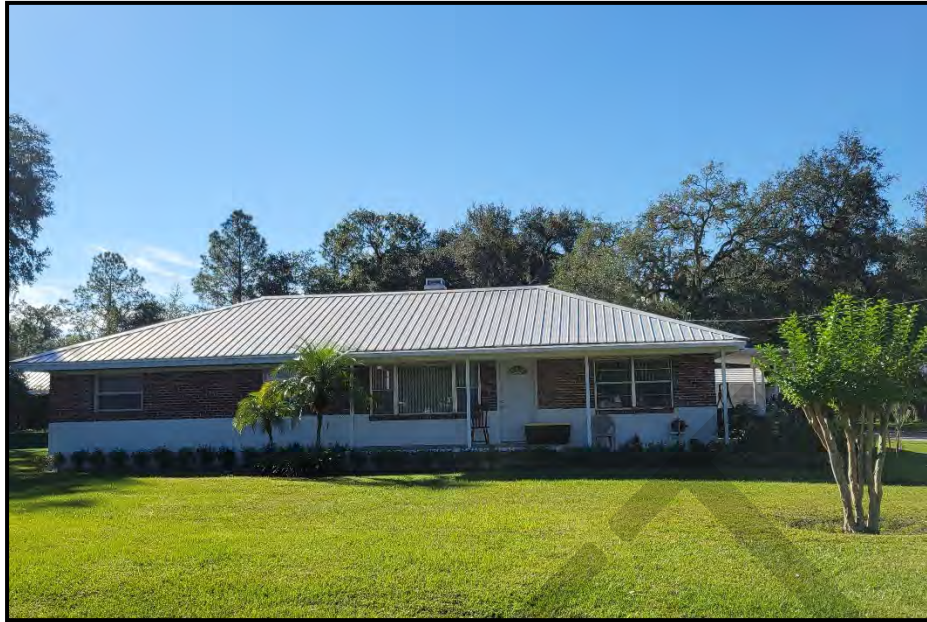
**Photo 11. 5287 Eureka Springs Road (8HI15188), looking south.**

**8HI15188:** The Masonry Vernacular style residence at 5287 Eureka Springs Road was constructed in ca. 1964 (**Photo 11**). The one-story, irregular plan building rests on a continuous concrete block foundation and has a concrete block structural system partially clad in art brick. The hip roof and shed roof extension are covered with 5V crimp sheet metal. A brick chimney is located on the roof slope of the south elevation. The main entrance is located on the north elevation through a paneled door with a fan window beneath a shed roof extension. This building has two open, partial width porches. The north elevation porch is beneath a shed roof extension with wood support columns and the west elevation porch is beneath a shed roof extension with wood support columns. Visible windows include a mixture of individual and paired one-over-one and two-over-two vinyl single-hung-sash units and a picture unit flanked by four-over-four single-hung-sash units. Distinguishing architectural features include brick windowsills and a partially clad art brick facade. Alterations include replacement roofing materials, and a porch was added to the west elevation. One ca. 1964 shed and two non-historic detached garages are located to the south of the building. Overall, the building has been altered, lacks sufficient architectural features, and is not a significant embodiment of a type, period, or method of construction. In addition, background research did not reveal any historic associations with significant persons and/or events. As a result, 8HI15188 does not appear eligible for listing in the NRHP, either individually or as part of a historic district.

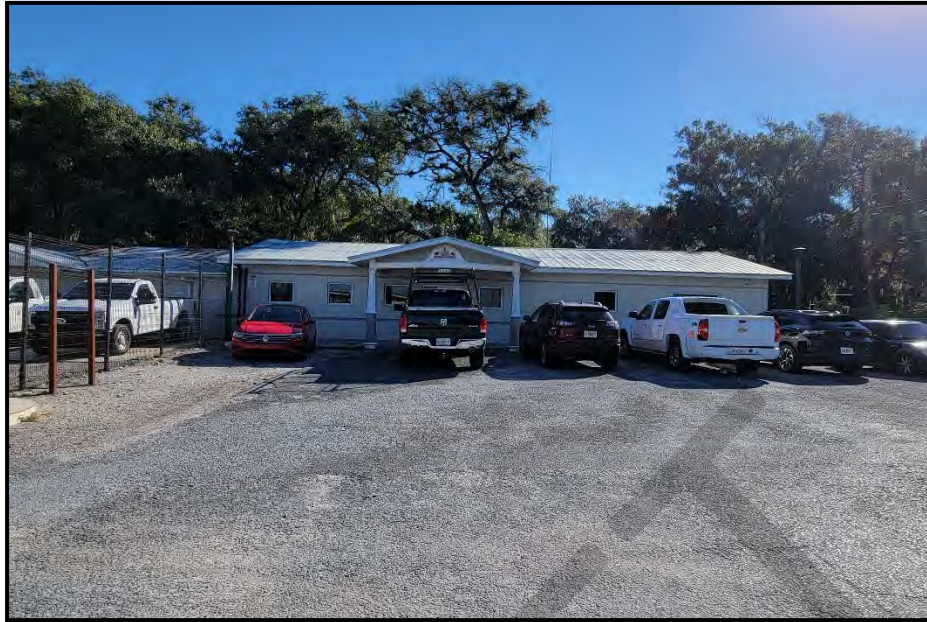
**Photo 12. 5288 Eureka Springs Road (8HI15189), looking east.**

**8HI15189:** The Masonry Vernacular style building at 5288 Eureka Springs Road was constructed in ca. 1957 (**Photo 12**). The one-story, irregular plan building rests on a continuous concrete block foundation and has a concrete block structural system in stucco. The gable roof is covered with 5V crimp sheet metal. The main entrance is located on the west elevation through single glass door with vertical sidelight window beneath a gable roof extension with decorative support columns. Visible windows include individual vinyl fixed units. Distinguishing architectural features include bands of stucco trim and decorative support columns. Alterations include replacement windows, door, and roofing materials. A second building (non-historic) and a four-bay garage were added to the north elevation of the main building. Two non-historic buildings are located to the west of the building. Overall, the building has been altered, lacks sufficient architectural features, and is not a significant embodiment of a type, period, or method of construction. In addition, background research did not reveal any considerable historic associations with significant persons and/or events. As a result, 8HI15189 does not appear eligible for listing in the NRHP, either individually or as part of a historic district.

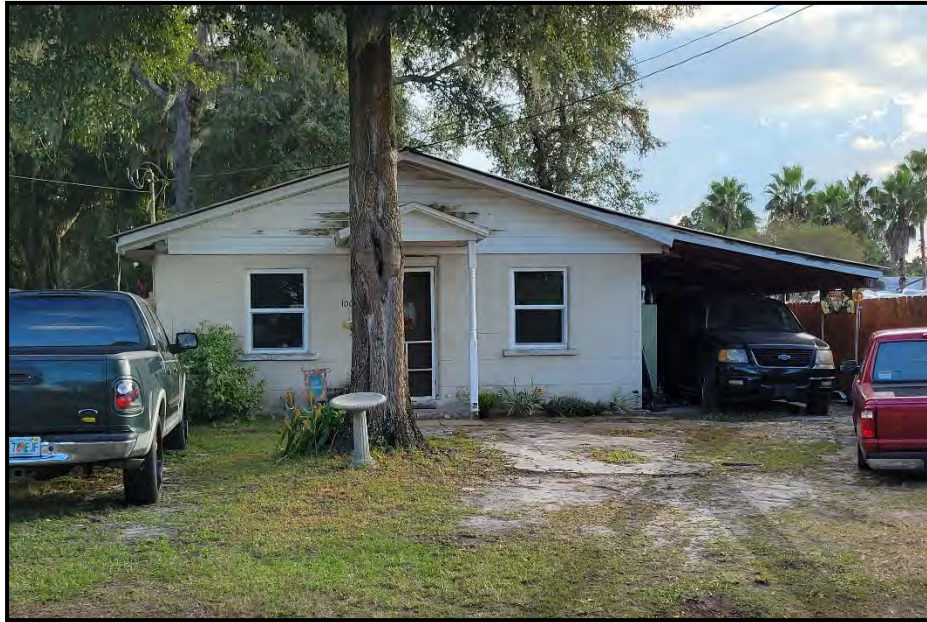
**Photo 13. 10002 Hines Road (8HI15190), looking south.**

**8HI15190:** The Masonry Vernacular style residence at 10002 Hines Road was constructed in ca. 1959 (**Photo 13**). The one-story, irregular plan building rests on a continuous concrete block foundation and has a concrete block structural system clad in stucco and the gable ends are clad in vinyl siding. The gable and shed roofs are covered with 5V crimp sheet metal and the gable extension is covered in composite roll. The main entrance is located on the north elevation through a single paneled wood door behind a screen door beneath a gable roof extension with decorative wood supports. There is a partial width open screened porch beneath a shed roof on the south elevation. Visible windows include a mixture of individual one-over-one vinyl single-hung-sash and grouped (3) metal jalousie units. Distinguishing architectural features include concrete windowsills and overhanging boxed eaves. Alterations include replacement windows and roofing materials. Additions include an attached carport on the west elevation and an open, shed roof screened porch on the south elevation. Overall, the building has been altered, lacks sufficient architectural features, and is not a significant embodiment of a type, period, or method of construction. In addition, background research did not reveal any historic associations with significant persons and/or events. As a result, 8HI15190 does not appear eligible for listing in the NRHP, either individually or as part of a historic district.

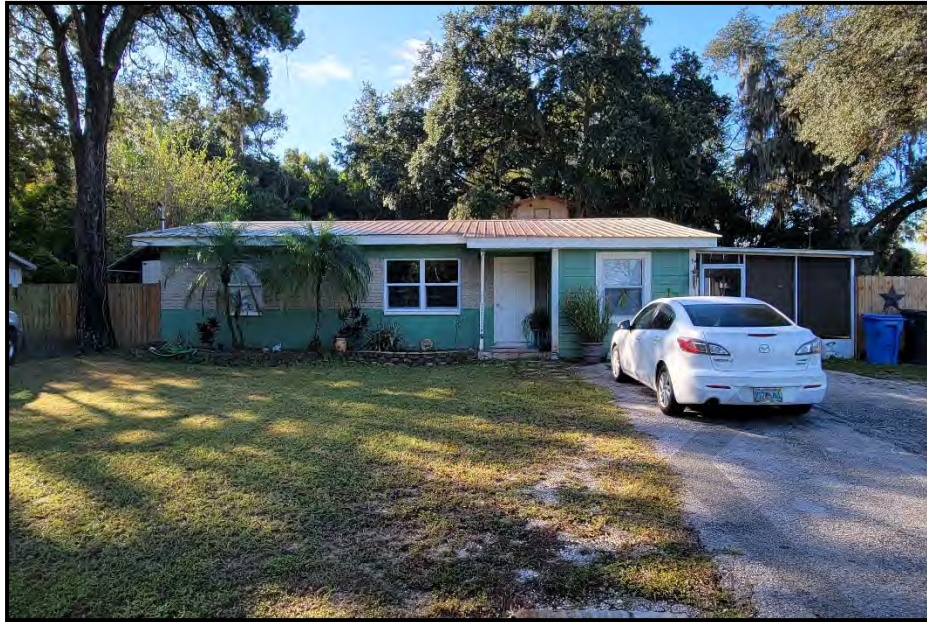
**Photo 14. 10004 Hines Road (8HI15191), looking south.**

**8HI15191:** The Masonry Vernacular style residence at 10004 Hines Road was constructed in ca. 1960 (**Photo 14**). The one-story, irregular plan building rests on a continuous concrete block foundation and has a concrete block structural system partially clad in stucco and art brick. The gable roof is covered with 5V crimp sheet metal and the flat roof is covered in standing seam sheet metal. The main entrance is located on the north elevation through a single paneled door beneath the principal roof extension. There is an open, full-width porch beneath a shed roof on the west elevation. Visible windows include a mixture of individual and paired one-over-one vinyl single-hung-sash units. Distinguishing architectural features include concrete windowsills, art brick, and overhanging boxed eaves. Alterations include replacement windows and roofing materials and enclosing the carport. Additions include an open porch beneath a shed roof on the west elevation. A shed is located to the south of the building. Overall, the building has been altered, lacks sufficient architectural features, and is not a significant embodiment of a type, period, or method of construction. In addition, background research did not reveal any historic associations with significant persons and/or events. As a result, 8HI15191 does not appear eligible for listing in the NRHP, either individually or as part of a historic district.

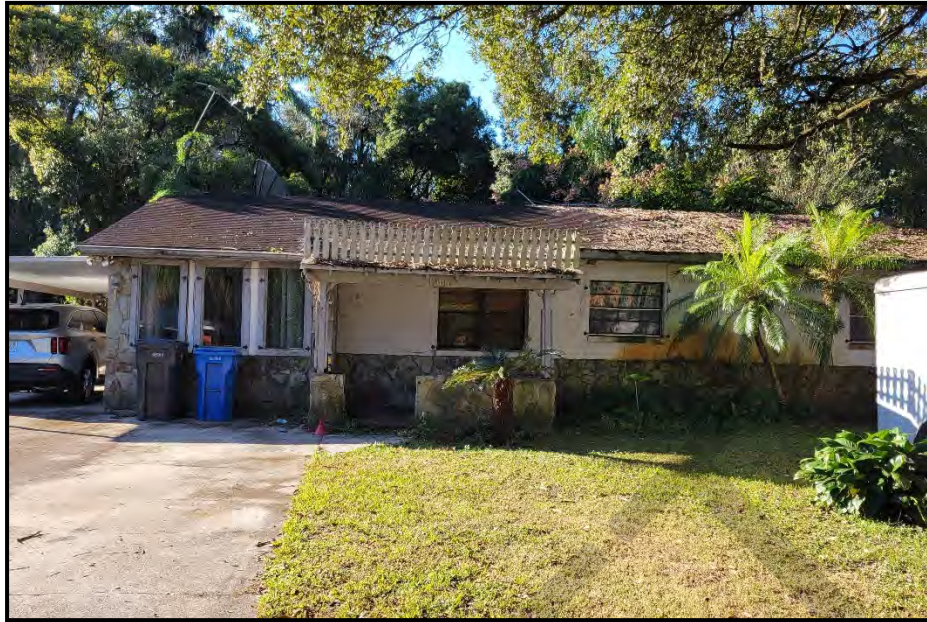
**Photo 15. 10006 Hines Road (8HI15192), looking south.**

**8HI15192:** The Masonry Vernacular style residence at 10006 Hines Road was constructed in ca. 1959 (**Photo 15**). The one-story, irregular plan building rests on a continuous concrete block foundation and has a concrete block structural system partially clad in stucco and art stone. The gable roof is covered with asphalt shingles and the flat roof above the carport is covered with standing seam sheet metal. The main entrance is located on the east elevation through an obscured door beneath the flat roof of the attached carport. There is a partial-width, open porch beneath a shed roof with decorative wood supports sitting on stone base piers on the north elevation. Visible windows include a mixture of grouped (3) wood single light fixed units, and individual two-over-two wood and metal single-hung-sash units. Distinguishing architectural features include concrete windowsills, decorative porch supports, and partially clad art stone facade. Alterations include replacement roofing materials, enclosing the carport, and fenestration changes. Additions include an attached carport on the east elevation and a shed roof on the south elevation. Overall, the building has been altered, lacks sufficient architectural features, and is not a significant embodiment of a type, period, or method of construction. In addition, background research did not reveal any historic associations with significant persons and/or events. As a result, 8HI15192 does not appear eligible for listing in the NRHP, either individually or as part of a historic district.

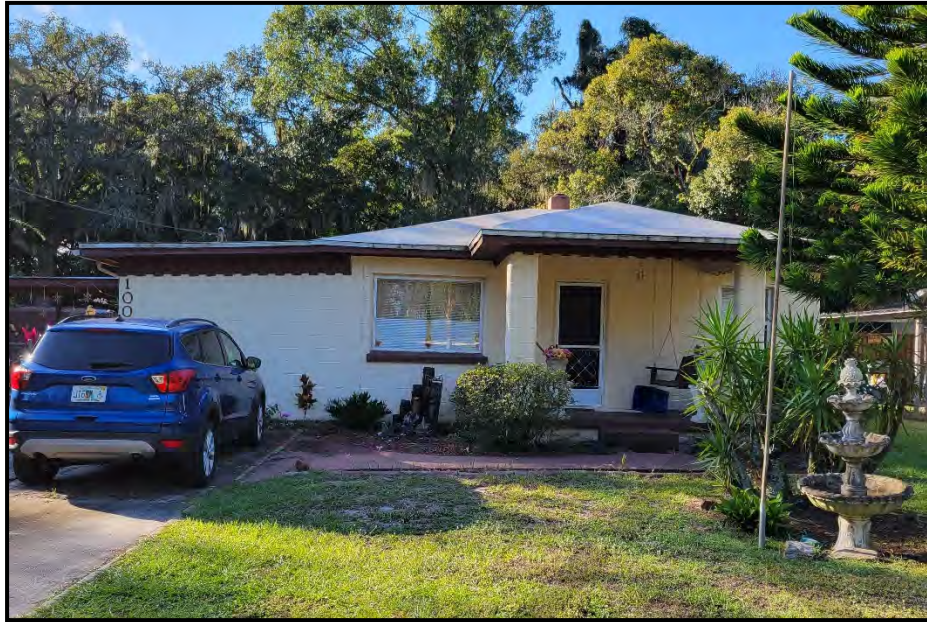
**Photo 16. 10008 Hines Road (8HI15193), looking south.**

**8HI15193:** The Masonry Vernacular style residence at 10008 Hines Road was constructed in ca. 1955 (**Photo 16**). The one-story, irregular plan building rests on a continuous concrete block foundation and has a concrete block structural system clad in stucco. The hip and flat roofs are covered with composition roll and 5V crimp sheet metal. A concrete chimney is located on the slope of the south. The main entrance is located on the north elevation through a single door behind a metal frame screen door beneath a hip roof extension with concrete block support columns. The building has two visible partial width open porches. The entry porch is raised and sits beneath a hip roof with concrete block support columns and decorative fascia preceding the main entrance. The second porch is beneath a flat roof with wood support columns on the east elevation. Visible windows include a mixture of individual vinyl one-over-one and two-over-two single-hung-sash units and a picture unit. Distinguishing architectural features include decorative frieze, concrete windowsills, and concrete block support columns. Alterations include replacement windows and roofing materials. A shed roof porch was added to the east elevation and structural extensions were made to the east elevation. One shed is located to the southwest of the building. Overall, the building has been altered, lacks sufficient architectural features, and is not a significant embodiment of a type, period, or method of construction. In addition, background research did not reveal any historic associations with significant persons and/or events. As a result, 8HI15193 does not appear eligible for listing in the NRHP, either individually or as part of a historic district.

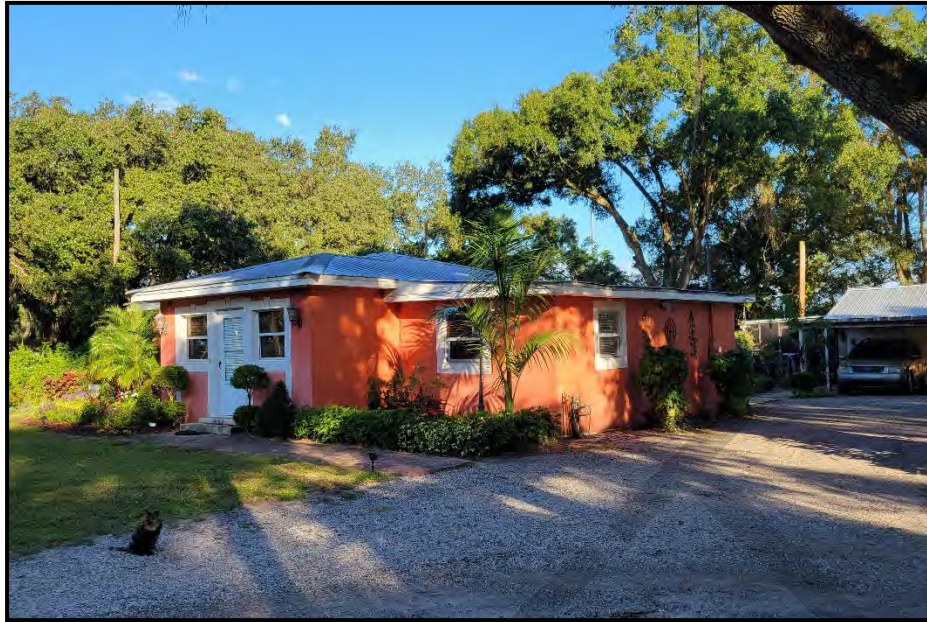
**Photo 17. 10005 Hines Road (8HI15194), looking northwest.**

**8HI15194:** The Masonry Vernacular style residence at 10005 Hines Road was constructed in ca. 1955 (**Photo 17**). The one-story, irregular plan building rests on a concrete slab foundation and has a concrete block structural system clad in stucco. The hip and flat roofs are covered with 5V crimp sheet metal. The main entrance is located on the south elevation through a single storm door with two-light. Visible windows include a mixture of individual one-over-one vinyl single-hung-sash units. Distinguishing architectural features include stucco window and door frames with keystone. Alterations include replacement doors, windows, and roofing materials as well as enclosure of the carport. A non-historic detached garage and a shed are located north of the building. Overall, the building has been altered, lacks sufficient architectural features, and is not a significant embodiment of a type, period, or method of construction. In addition, background research did not reveal any historic associations with significant persons and/or events. As a result, 8HI15194 does not appear eligible for listing in the NRHP, either individually or as part of a historic district.

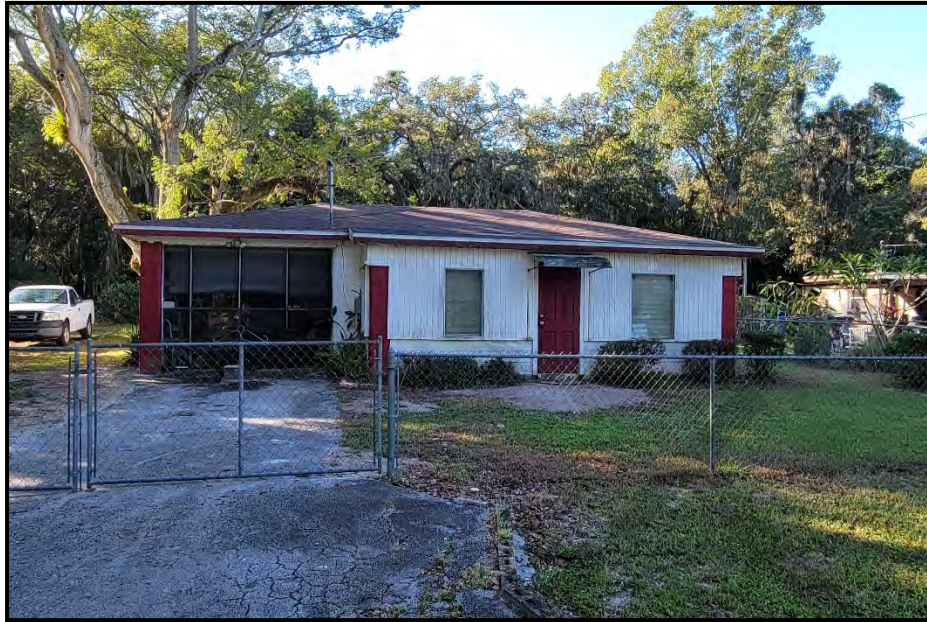
**Photo 18. 10010 Hines Road (8HI15195), looking south.**

**8HI15195:** The Masonry Vernacular style residence at 10010 Hines Road was constructed in ca. 1954 (**Photo 18**). The one-story, irregular plan building rests on a continuous concrete block foundation and has a concrete block structural system clad in stucco and partially clad in vertical plank siding. The hip roof is covered with asphalt shingles. This building has a screened porch beneath the principal hip roof in the east elevation. The main entrance is located on the north elevation through a single panel door beneath a metal awning. Visible windows include a mixture of individual metal jalousies units and two-over-two single-hung-sash units. Distinguishing architectural features include partially clad vertical plank siding. Alterations include replacement roofing materials and an enclosed carport. The north elevation porch was enclosed and expanded. A shed is located south of the building. Overall, the building has been altered, lacks sufficient architectural features, and is not a significant embodiment of a type, period, or method of construction. In addition, background research did not reveal any historic associations with significant persons and/or events. As a result, 8HI15195 does not appear eligible for listing in the NRHP, either individually or as part of a historic district.

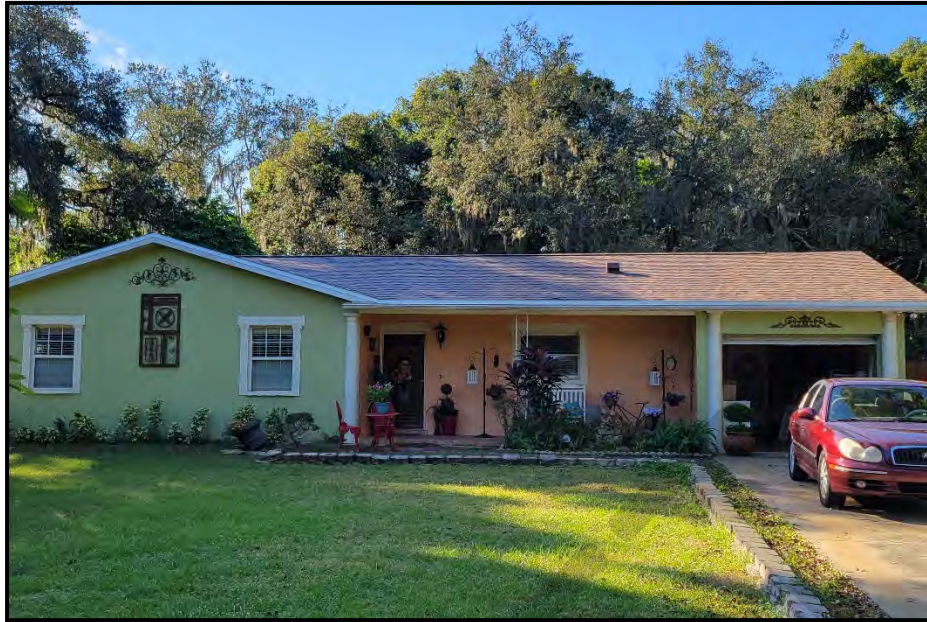
**Photo 19. 10012 Hines Road (8HI15196), looking south.**

**8HI15196:** The Masonry Vernacular style residence at 10012 Hines Road was constructed in ca. 1963 (**Photo 19**). The one-story, irregular plan building rests on a continuous concrete block foundation and has a concrete block structural system clad in stucco. The gable roof is covered with asphalt shingles. The main entrance is located on the north elevation through a single panel door within an open recessed porch beneath the principal roof with a metal porch support. Visible windows include individual six-over-six and one-over-one vinyl single-hung-sash units. Distinguishing architectural features include engaged columns, stucco windowsills, metal porch support, and metal window security grates. Alterations include replacement windows, doors, and roofing materials as well as replacement porch supports and addition of engaged columns. Two non-historic sheds are located southeast of the building. Overall, the building has been altered, lacks sufficient architectural features, and is not a significant embodiment of a type, period, or method of construction. In addition, background research did not reveal any historic associations with significant persons and/or events. As a result, 8HI15196 does not appear eligible for listing in the NRHP, either individually or as part of a historic district.

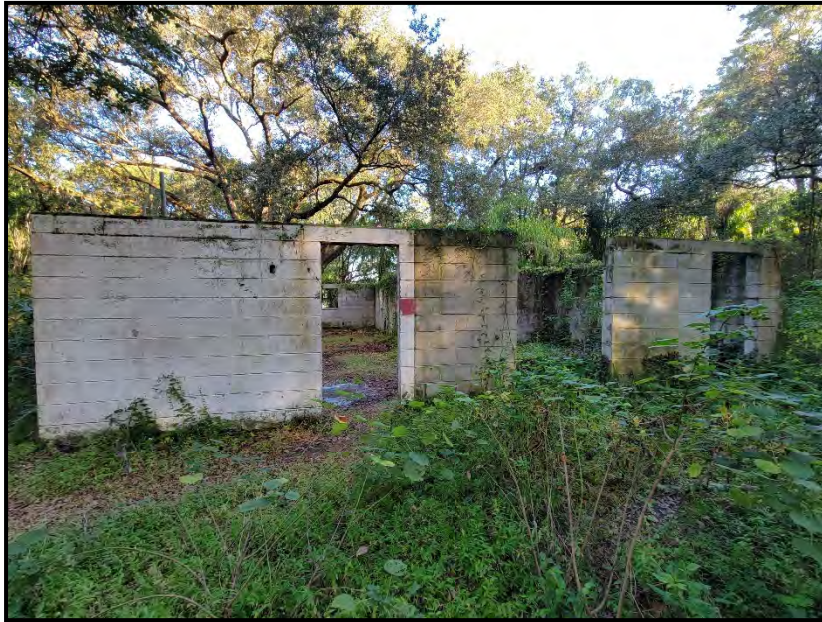
**Photo 20. 5515 N Falkenburg Road (8HI15197), looking south.**

**8HI15197:** The Masonry Vernacular style former residence at 5515 N Falkenburg Road was constructed in ca. 1961 (**Photo 20**). The one-story, irregular plan building rests on a continuous concrete block and brick foundation and has a concrete block and brick structural system and exterior. No roof, windows, doors, or interior finishing's are present. Distinguishing architectural features include a single brick elevation and concrete windowsills. A structural extension was added to the south elevation. Overall, the building is in a state of ruin and is not a significant embodiment of a type, period, or method of construction. In addition, background research did not reveal any historic associations with significant persons and/or events. As a result, 8HI15197 does not appear eligible for listing in the NRHP, either individually or as part of a historic district.
