Interstate 75/SR 93A

**Project Development & Environment (PD&E)
Study**

**From South of US 301/SR 43
To North of Bruce B. Downs Boulevard**

**Draft Contamination Screening Evaluation
Report Addendum**

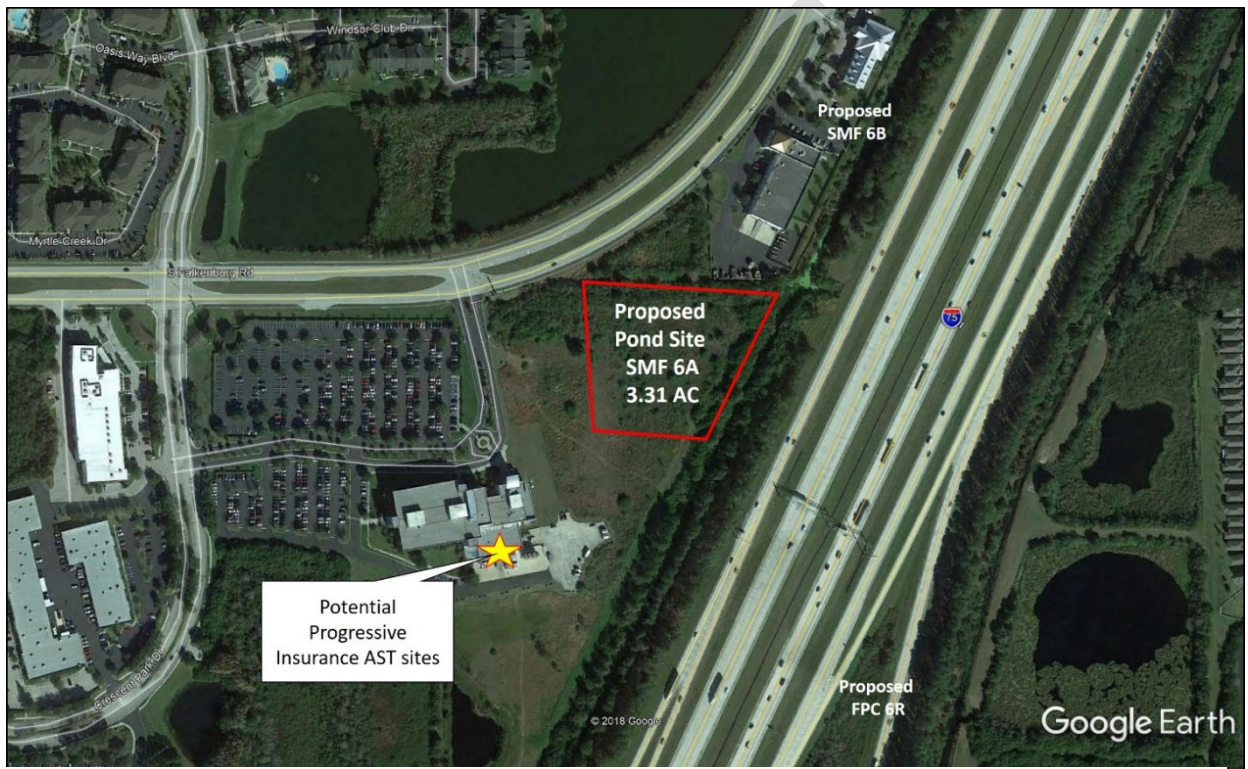
Figure 9. Proposed SMF 6A

Proposed SMF 6A is a vacant 3.31-acre site located at 3302 Crescent Park Drive west of and immediately adjacent to I-75 right-of-way. The Hillsborough County Property Assessor website shows the site is part of an 80-acre tract owned by Progressive Casualty Insurance Company. This site is identified in the 2010 CSER as Site 6. The 2010 CSER states, the facility at 3302 Crescent Park Drive maintained a National Pollutant Discharge Elimination System (NPDES) permit. This permit was issued on November 21, 2003 and expired on November 20, 2008. No information for inspections, outfalls/pipe schedules, limits report,

measurements and violations, compliance schedules and violations, evidentiary hearings, pretreatment inspections/audits, and pretreatment performance summary information was included in the Water Discharge Permits Detailed Report for this site. According to the FDEP TANKS report, two 3,000-gallon above ground storage tanks (AST) containing diesel fuel are in service at the address for emergency generators. These ASTs were installed in July 2004. The ASTs were not found during the field review and their locations could not be verified. The 2010 CSER gave Site 6 a LOW ranking. After a review of current FDEP and EPA information, the risk rating of LOW was found to still apply. Proposed SMF 6A is a preferred pond site. The locations of SMF 6A and Progressive Insurance are depicted in Figure 9.

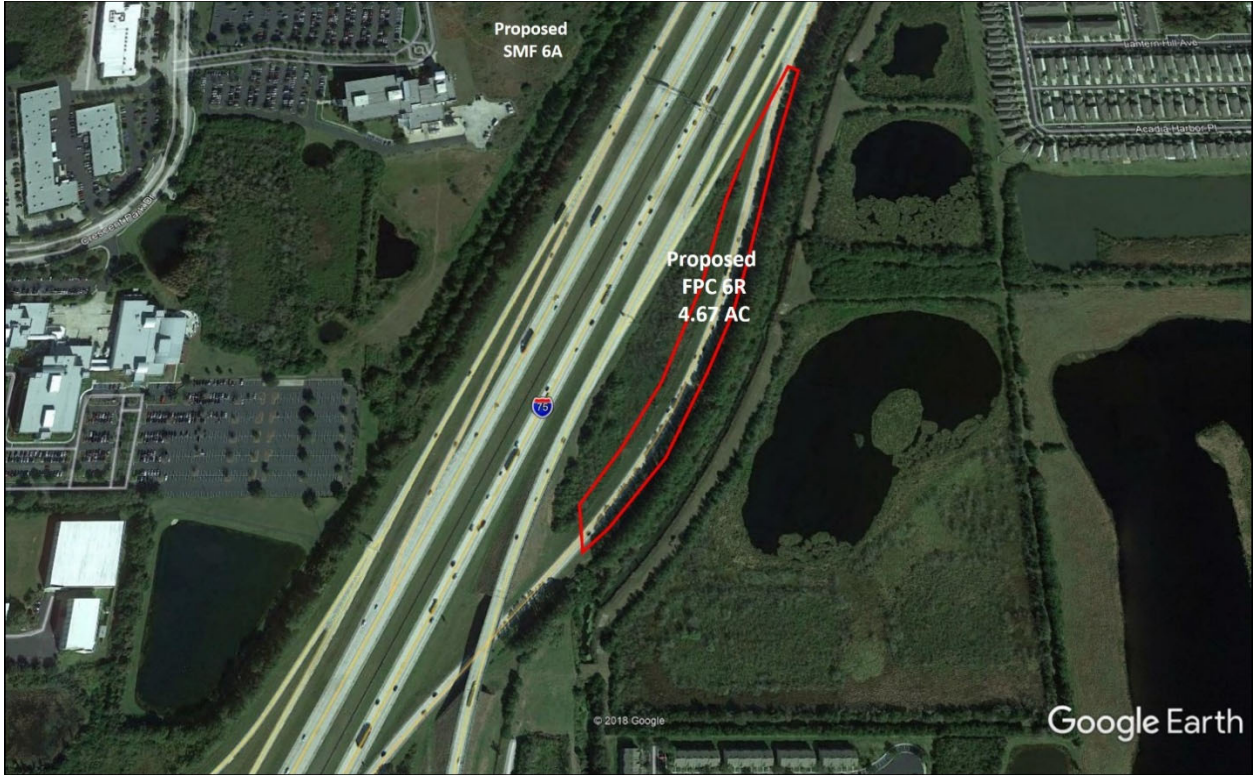
Figure 11. Proposed FPC 6R

Proposed FPC 6R is a 4.67-acre site located within FDOT right-of-way east of I-75 that currently is the Selmon Expressway exit ramp from I-75 northbound. The site was not identified in the 2010 CSER. Based on this Level I contamination evaluation, there do not appear to be contamination issues associated with this site. There are no identified issued based on the current FDEP database or the Environmental Protection Agency (EPA) Echo database. After a review of current FDEP and EPA information, FPC Site 6R received a risk rating of NO. Proposed FPC 6R is a preferred FPC site. The location of FPC 6R is depicted in Figure 11.

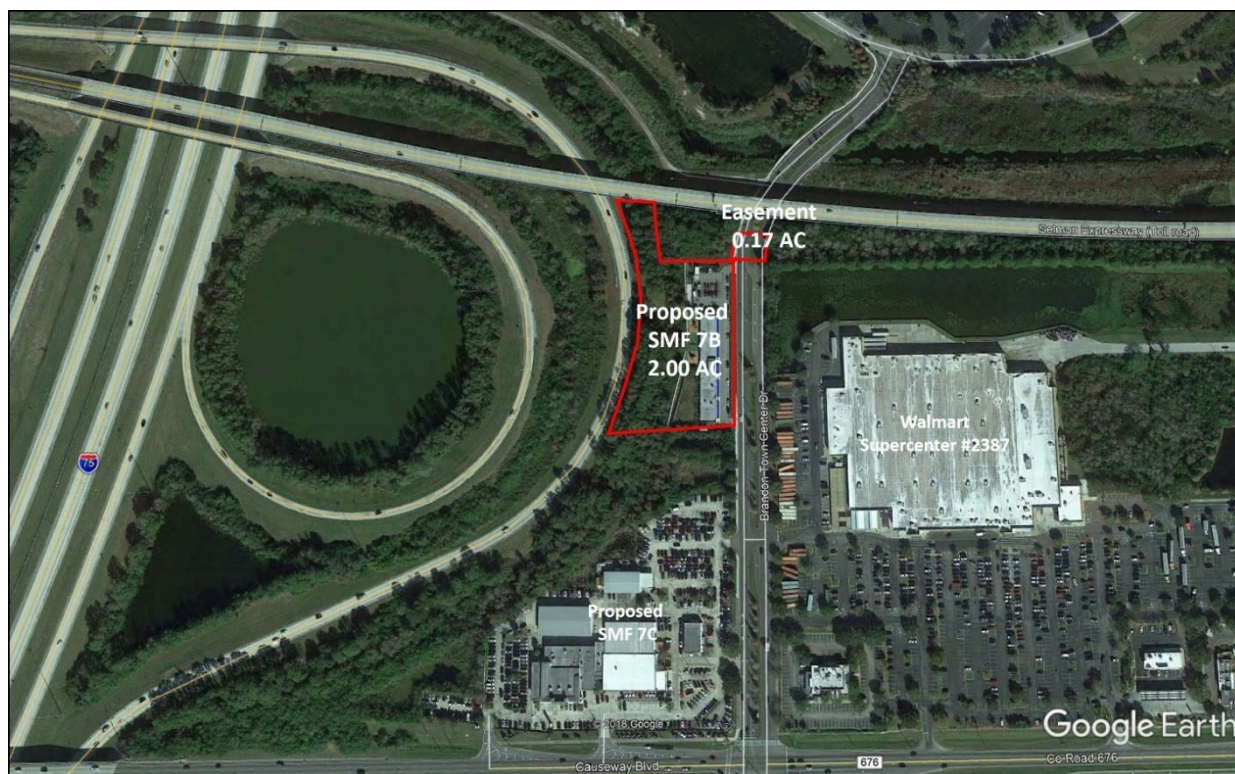
Figure 14. Proposed SMF 7B

Proposed SMF 7B is a 2.00-acre site located west of Brandon Town Center Drive, east of the I-75 northbound entrance ramp to the Selmon Expressway and south of the Selmon Expressway. The Hillsborough County Property Assessor website shows a portion of the site is a day care center owned by Hyperion Education, LLC located at 730 Brandon Town Center Drive. The site is found on the FDEP database as a Managed Entity. An NPDES permit (FLR 100B40) was issued for site construction. The permit was issued May 16, 2014 and expired May 15, 2019. No additional information was identified for the property. After a review of current FDEP and EPA information, SMF Site 7B received risk ratings of NO. The location of SMF 7B is depicted in Figure 14.

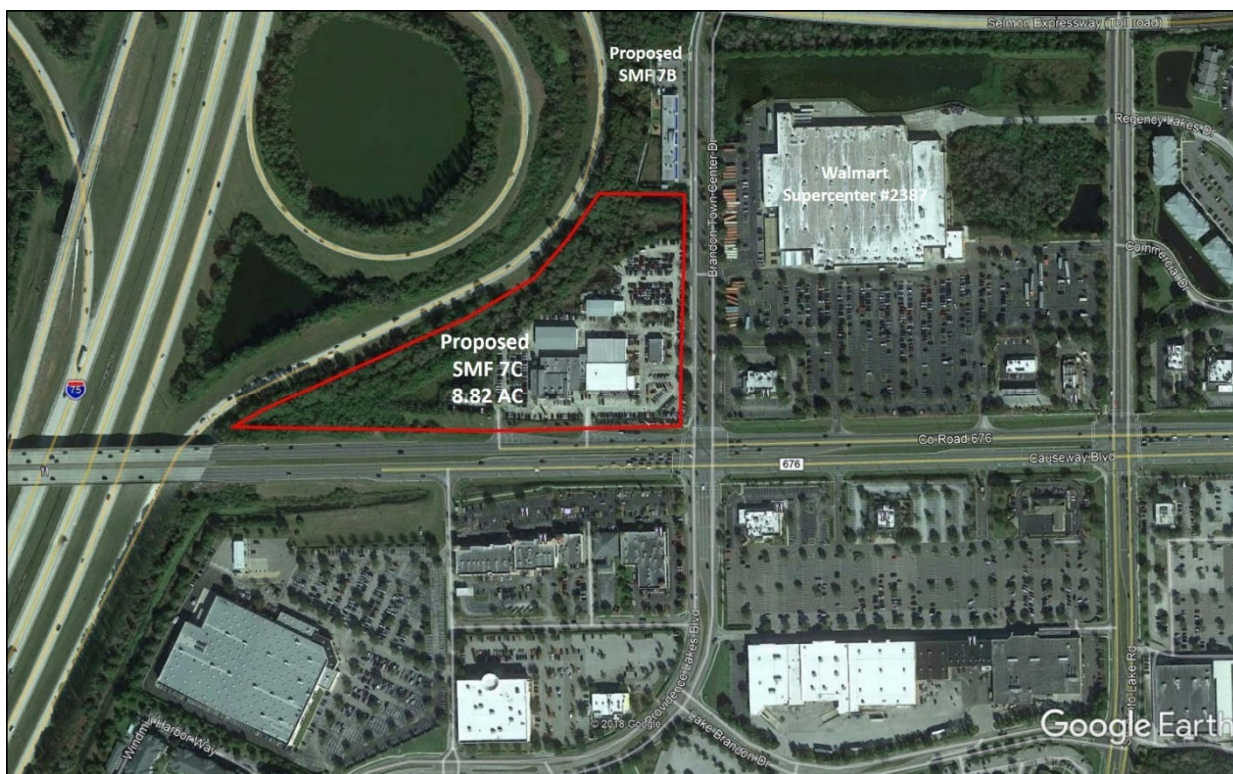
Figure 15. Proposed SMF 7C

Proposed SMF 7C is an 8.82-acre site located west of Brandon Town Center Drive, north of Causeway Boulevard and east and adjacent to the I-75 northbound to westbound Selmon Expressway entrance ramp. The Hillsborough County Property Assessor website identified the property as an auto dealership located at 11020 Causeway Boulevard, owned by Morse Operations, Inc. The property is identified in the 2010 CSER as Site 10. The 2010 CSER states the facility maintained an NPDES permit. The permit was state-issued on April 6, 2007 and expired on April 5, 2012. No information for inspections, outfalls/pipe schedules, limits report, measurements and violations, compliance schedules and violations, evidentiary hearings, pretreatment inspections/audits, or pretreatment performance summary information was included in the Water Discharge Permits Detailed Report for this site. This facility is registered as a conditionally-exempt small quantity generator of hazardous wastes. No formal enforcement actions have been taken against the facility within the last five years. The FDEP TANKS report identified one 300-gallon AST containing unleaded gasoline is in service. The AST was installed in July 1994. The current FDEP database shows all tanks are in compliance. Inspection comments stated the AST is located on a concrete slab and is equipped with normal and emergency venting. The spill containment box and dispenser liner appeared to be intact. Due to current information, SMF 7C received a risk rating of LOW. The location of SMF 7C and its easement are depicted in Figure 15.

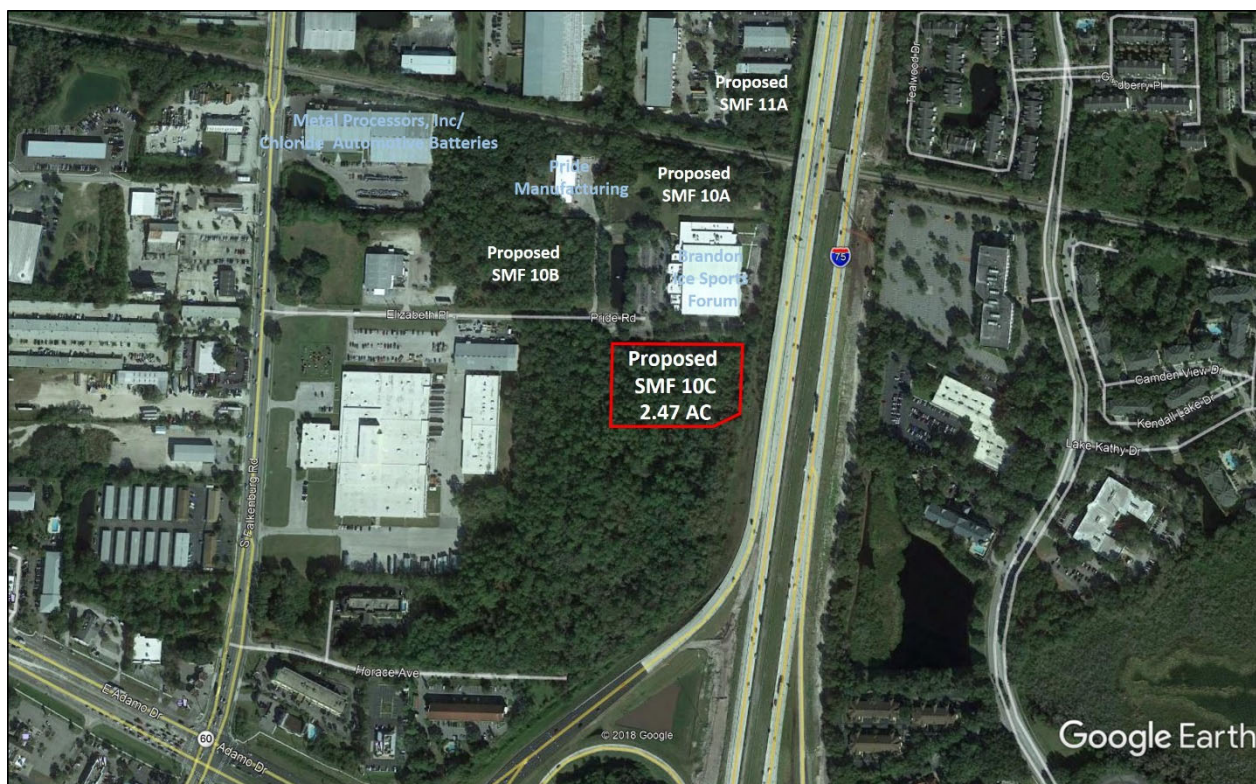
Figure 22. Proposed SMF 10C

Proposed SMF 10C is a 2.47-acre site located immediately adjacent west of I-75 on Pride Road south of the Ice Sports Forum discussed in SMF 10B. No physical address was listed for the property. The Hillsborough County Property Assessor website shows the property is vacant industrial owned by Elizabeth Place Properties, LLC in Pinellas Park, Florida. The total acreage of the site parcel is 6.77 acres. The site is not identified in the 2010 CSER. The site was field reviewed in 2019 and found to be a fenced, wooded, wetland area. There was no debris or waste noted on site; however, the site is adjacent to and south of the Brandon Ice Forum (outlined in proposed SMF 10A); and located in an area of industrial land uses. Site SMF 10C was assigned a risk rating of LOW. Proposed SMF 10C is a preferred pond site. The location of SMF 10C is depicted in Figure 22.

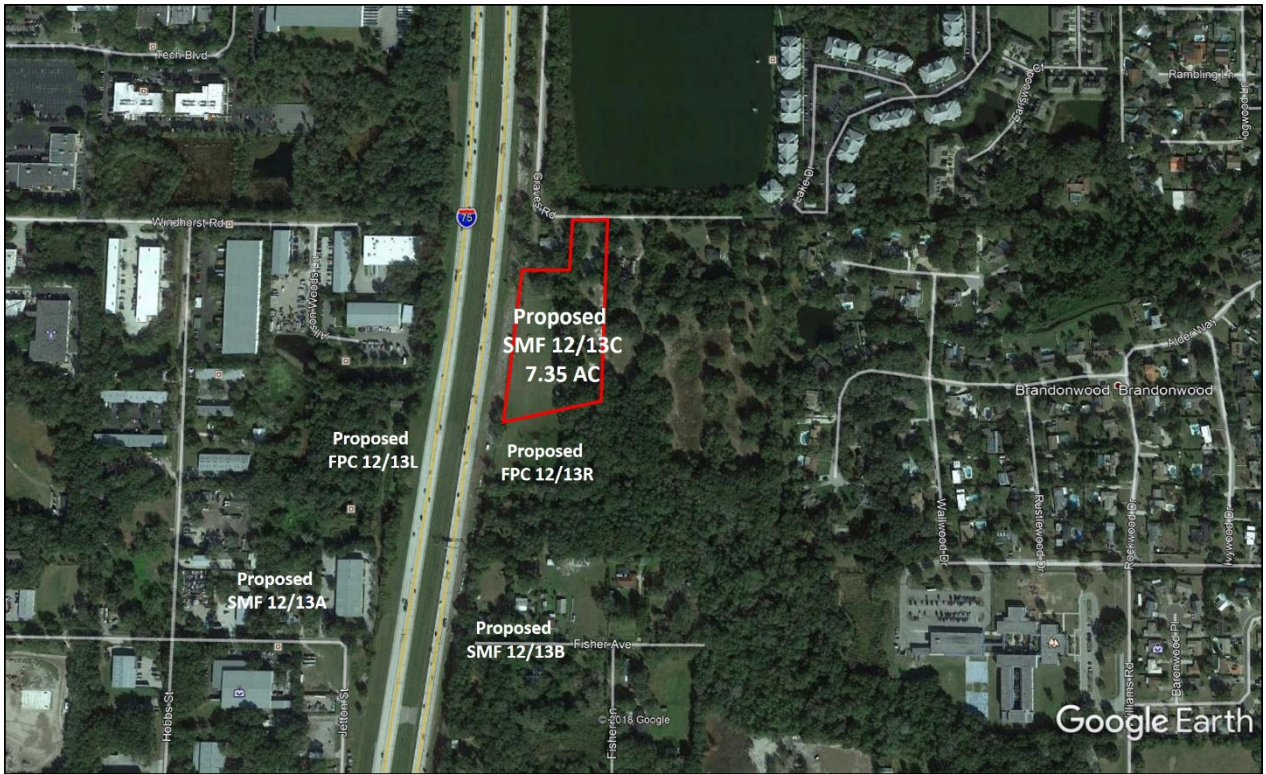
Figure 27. Proposed SMF 12/13C

and Louise Springer Trustees, Brandon, FL. The property is identified as vacant residential. The 2010 CSER did not identify either property and no information was found in the FDEP or EPA databases. SMF 12/13C received a risk rating of NO. Proposed SMF 12/13C is a preferred pond site. The location of SMF 12/13C is depicted in Figure 27.

SMF 12/13C	1550+00, RT	2	7.35	Pasture Vacant Residential	NO	No issues identified.
SMF 14A	1575+00, RT	1	5.72	Vacant Commercial	LOW	FDEP Managed Entity and a current NPDES permit is associated with this site. Field visit found one metal barrel on the ground.
SMF 14B	1572+00, RT	3	4.96	Single Family Residential Vacant Residential	LOW	FDEP Managed Entity for the site and several NPDES permits adjacent to the site.
SMF 15/16	1615+00, RT	0	6.27	FDOT ROW	NO	Site shown as FDEP Managed Entity. No issues identified.
SMF 17A	1665+00, LT	2	3.93	Pasture	LOW	Site shown as FDEP Managed Entity. No issues identified.
SMF 17B	1664+00, RT	2	4.09	Pasture Utility	NO	No issues identified.

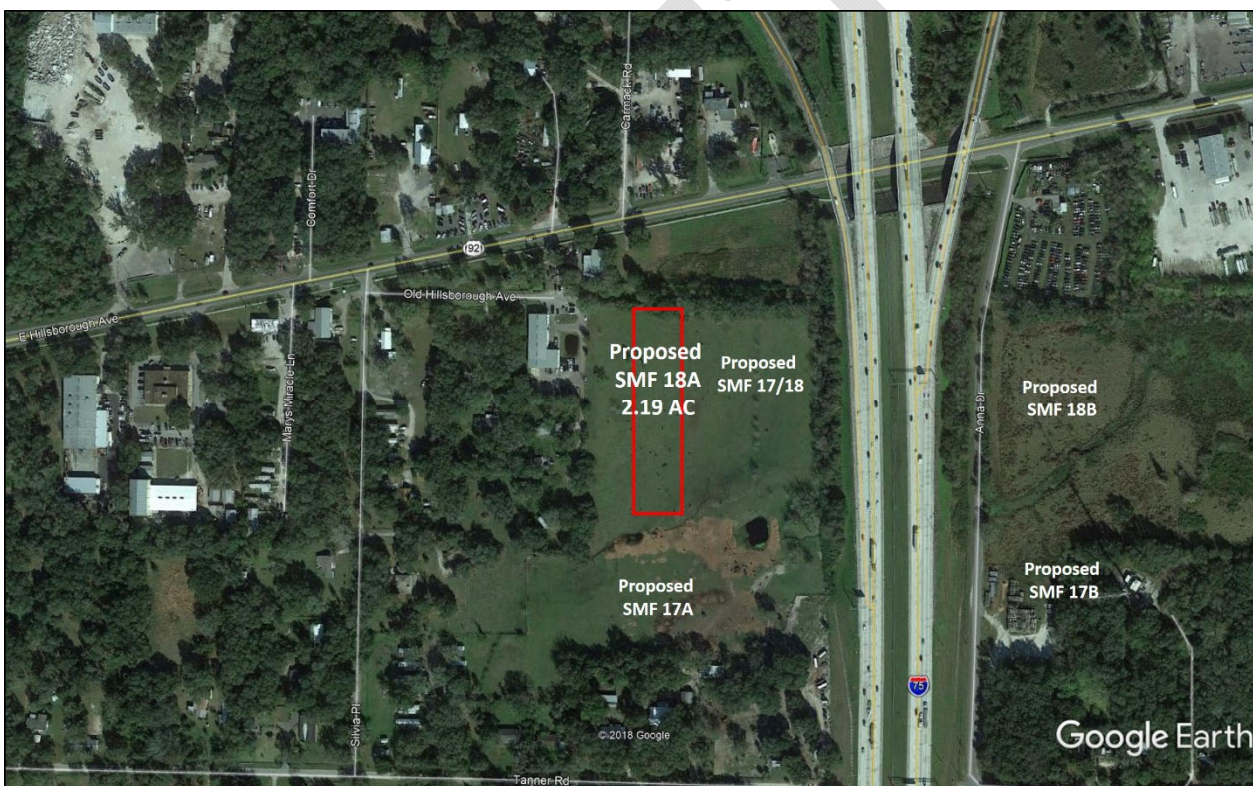
Figure 37. Proposed SMF 18A

Proposed SMF 18A is a 2.19-acre site located adjacent and west of site FPC 17/18, approximately 550 feet west of I-75 right-of-way and approximately 200 feet south of Hillsborough Avenue. The property is the same parcel identified in FPC 17/18 located at 10404 Tanner Road. The property is classified as pasture and owned by Frederick Laverne Patrick. The 2010 CSER does not identify this site. The site was field reviewed. No signs of contamination were observed. The property is agricultural with livestock present. The FDEP database and EPA ECHO show the property as a Managed Entity. A Compliance and Enforcement Tracking for HAZardous Facilities permit is located on the property adjacent and west of the site, associated with Gulf Coast Signs. The business has since closed. The building is now Classic Soft Trim an auto restyling center. After a current FDEP and EPA databases there do not appear to be contamination issues associated with this site. SMF 18A received a risk rating of NO. Proposed site SMF 18A is a preferred pond site. The location of SMF 18A is depicted in Figure 37.

SMF 18A	1670+00, LT	1	2.19	Pasture	NO	Site shown as an FDEP Managed Entity, but no issues identified. Approximately 200 feet west of the site, is a Compliance and Enforcement Tracking for HAZardous Facilities site (Gulf Coast Signs) that is also listed as a County Small Quantity Generator. This business has closed
SMF 18B	1670+00, RT	1	2.05	Pasture	LOW	Current FDEP and EPA databases do not identify issues with the site; however, it should be noted that Steins Auto Graveyard is located adjacent north of the property. The facility is a junkyard/automobile salvage storage area located in the southeast quadrant of I-75 and US 92 East.
SMF 19A	1699+00, RT	0	1.57	FDOT ROW	NO	No issues identified. NPDES permit found for adjacent property.
SMF 19B	1699+00, RT	0	2.05	FDOT ROW	NO	No issues identified. NPDES permit found for adjacent property.
SMF 19C	1700+00, LT	0	2.80	FDOT ROW	NO	No issues identified.

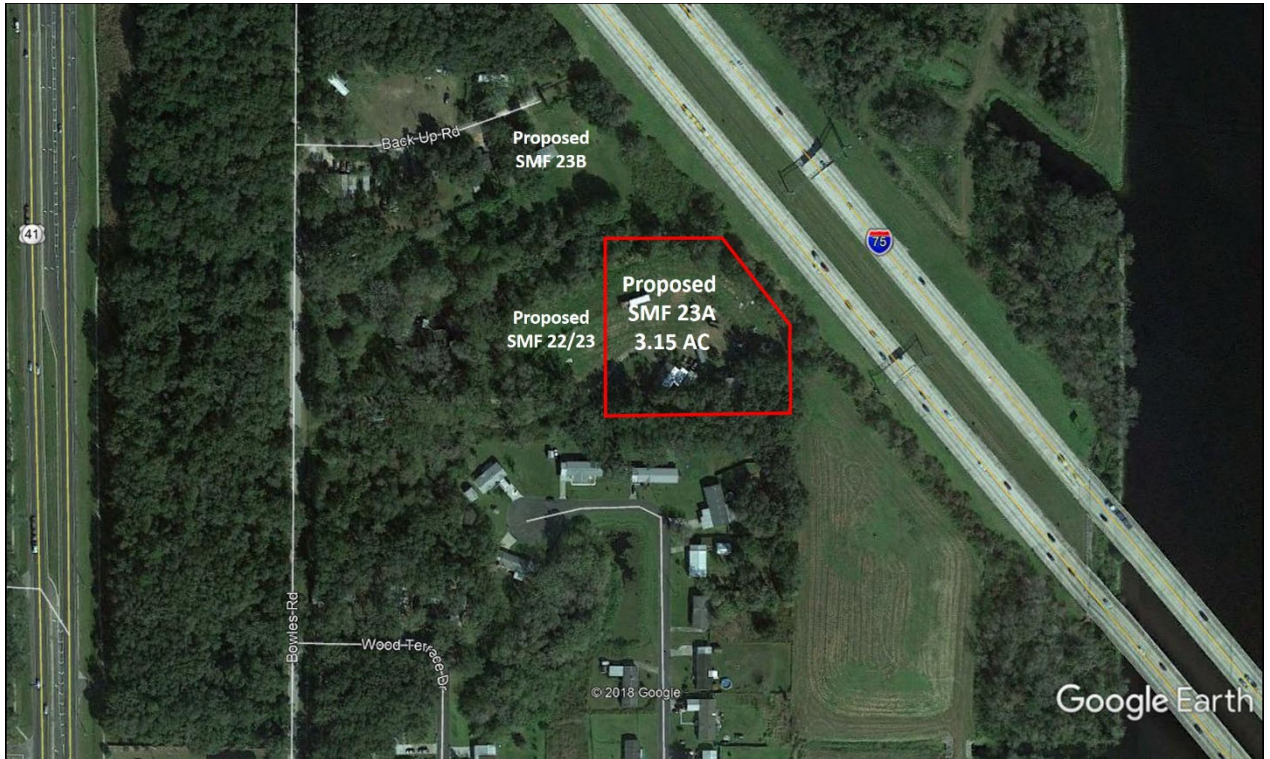
Figure 54. Proposed SMF 23A

All three properties are owned by Travis M. and Jaime F. Malloy, Lockmoor Avenue, Tampa, FL. The properties were not identified in the 2010 CSER. The current FDEP database shows the site with a County Small Quantity Generator associated with Slates Nursery (Facility ID 123687) located at 8913 Bowles Road. Current FDEP documentation shows the nursery is not a hazardous waste generator and is out of business. There is no information for the properties on the EPA database. For this reason, SMF 23A has been given a risk rating of LOW. The location of SMF 23A is depicted in Figure 54.

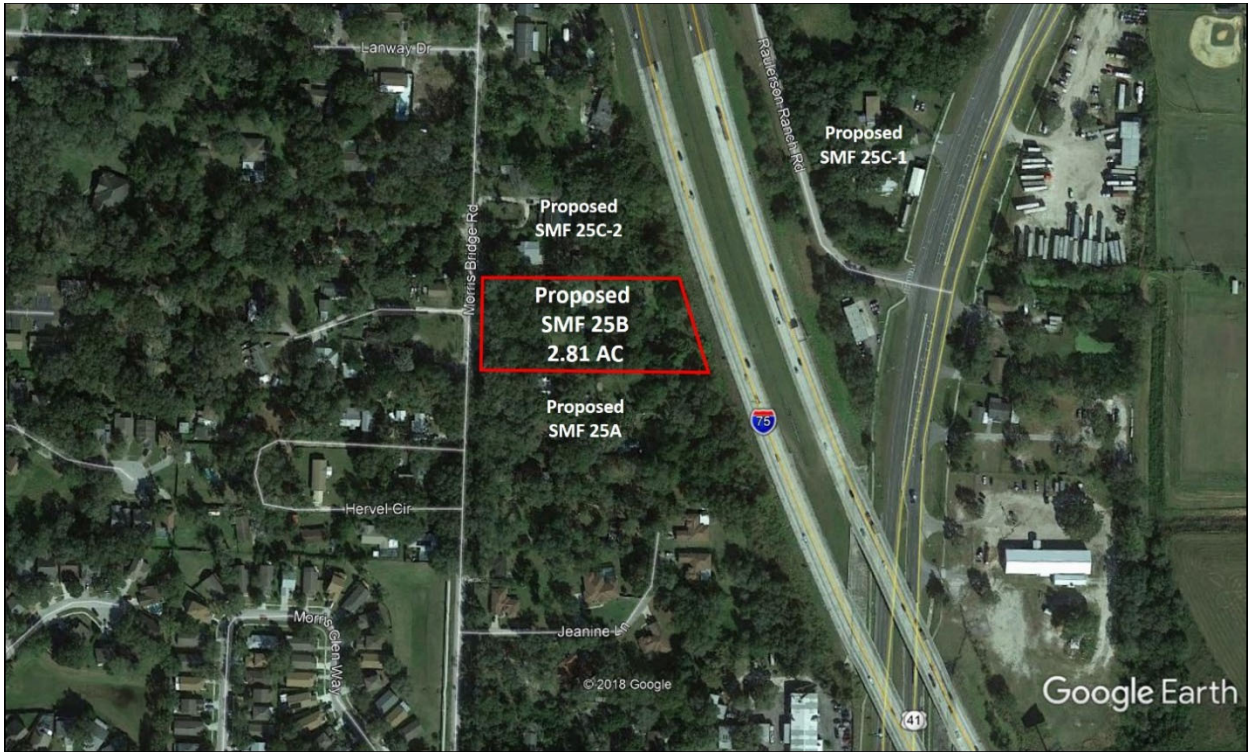
Figure 59. Proposed SMF 25B

as single family residential. The second of the four properties consist of a 0.90-acre property located at 9925 Morris Bridge Road, Tampa, owned by Robert D. Boughner and Robert D. Boughner, Jr. of the same address. The property is classified as single family residential. The third property consists of a 0.58-acre parcel located on both the east and west sides of I-75. The properties physical address is 9930 N. 301 Highway, Tampa, owned by Raymond A. Halin, 10401 Skewlee Road, Thonosassa. The property is classified as Auto Repair D. Aerial images show the auto repair business (Terrace Auto Repair) is located on the east side of I-75. The portion of the property located on the west side of I-75 is vacant wooded. This site was identified in the 2010 CSER (Site 64) and given a risk ranking of LOW. Current FDEP information does not show contamination issues associated with any parcel associated with SMF 25B. A County Small Quantity Generators (Aunt Gracie and Kids) permit is identified approximately 100-feet west of the southern end of the site; however, documentation states unverified generator status with no corresponding waste information. The status of the facility is out of business. FDEP markers for County Small Quantity Generators (Bass Bill Barry – Facility ID No. 145176 and Ronald Smith M/DBA Home Tec Ro – Facility ID No. 42407) were also identified approximately 250-feet west of the northern end of the site. FDEP documentation states unverified generator status with no corresponding waste information for both properties. The status of both facilities is out of business. Based on current FDEP and EPA databases, SMF 25B has been given a risk rating of NO. The location of SMF 25B is depicted in Figure 59.

SMF 24A	1838+00, LT	1	2.04	Vacant Commercial	NO	No issues identified.
SMF 24B	1838+00, RT	3	1.83	Vacant Commercial FDOT ROW	LOW	Compliance and Enforcement Tracking for HAZardous Facility associated with Carter Century South.
SMF 25A	1854+00, LT	4	1.86	Single Family Residential FDOT ROW	NO	No issues identified.
SMF 25B	1857+00, LT	4	2.81	Single Family Residential Vacant	NO	No issues identified.
