HISTORIC RESOURCES SURVEY UPDATE

Interstate 75 (State Road 93A) Project Development and Environment Study

**From south of US 301/State Road 43 to north of Bruce B. Downs
Boulevard/County Road 581**

Hillsborough County, Florida

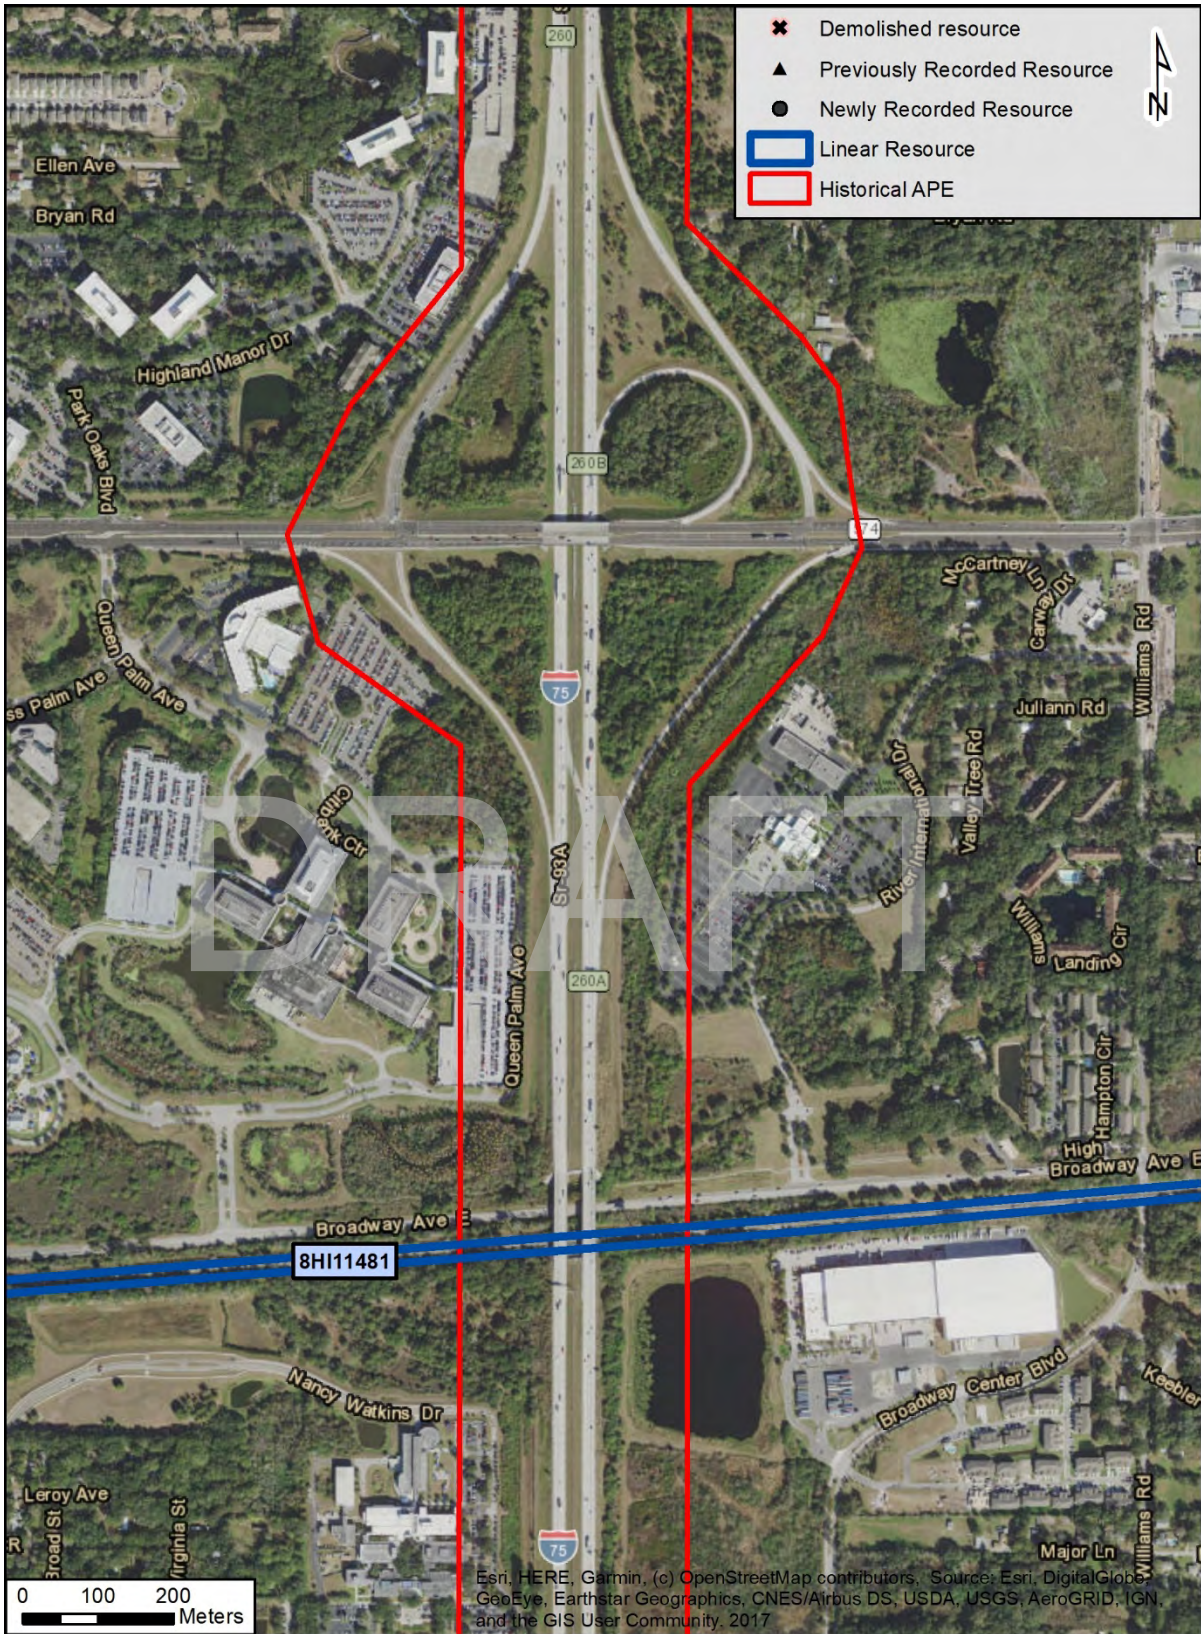
Figure 3. Location newly recorded and previously recorded historic resources within the I-75 (SR 93A) corridor APE.

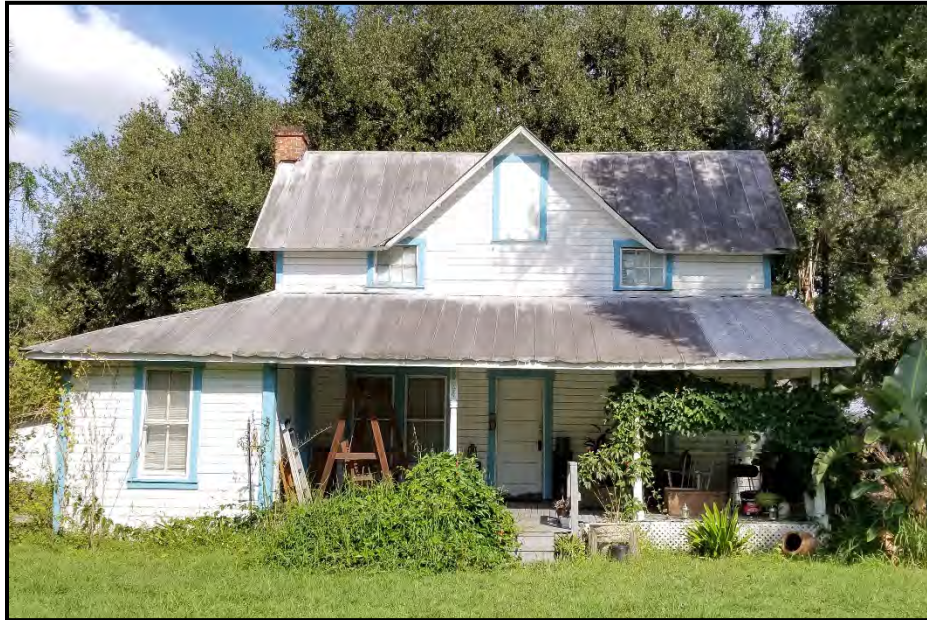
Photo 1. 10426 Tanner Road (8HI08742), looking south.

8HI08742: The Frame Vernacular style building at 10426 Tanner Road was constructed in ca. 1891 (**Photo 1**). The two-story I-house has an irregular plan that rests on a pier foundation (obscured by wooden lattice) and has a wood frame structural system clad in drop siding. The centered gable principal roof and half-hip roof of the first story are covered with 5V crimp sheet metal. A brick chimney is located on the gable wall of the west elevation. The main entryway is on the south elevation through a single wooden door with rectangular paneling within a partial width open porch beneath a half-hip roof supported by turned wooden porch supports and accessed by two wooden steps. Visible windows include a mixture of individual and paired, two-over-two wood double-hung-sash units; individual six-light wood fixed units; and individual, one-over-one metal single-hung-sash units. Distinguishing architectural features include overhanging eaves with boxed rafter tails, centered gable roof, exposed beams in the front gable, wooden trim around windows and doors, turned wooden porch supports, brick chimney, and corner boards. Alterations include patched roofing and replacement windows. Additions include the partial enclosure of the porch on the north elevation, completed in ca. 1920, and a ca. 1960 shed roof addition to the north elevation. A non-historic utility shed is located to the west of the building.

However, the historic property maintains most of its character-defining architectural features and appears to remain significant or NRHP eligible under Criterion C in the area of Architecture. Minor alterations have taken place since the Frame Vernacular style building was updated in 2009, including the patching of a section of the first-story half-hip roof with like materials, the replacement of three visible historic windows, and the boarding up of a centrally located window in the front gable. In-kind materials were used when patching the roof and the majority of visible historic wood windows have been maintained. Despite these alterations, the exterior alterations could easily be changed to return the building to its original historic appearance.

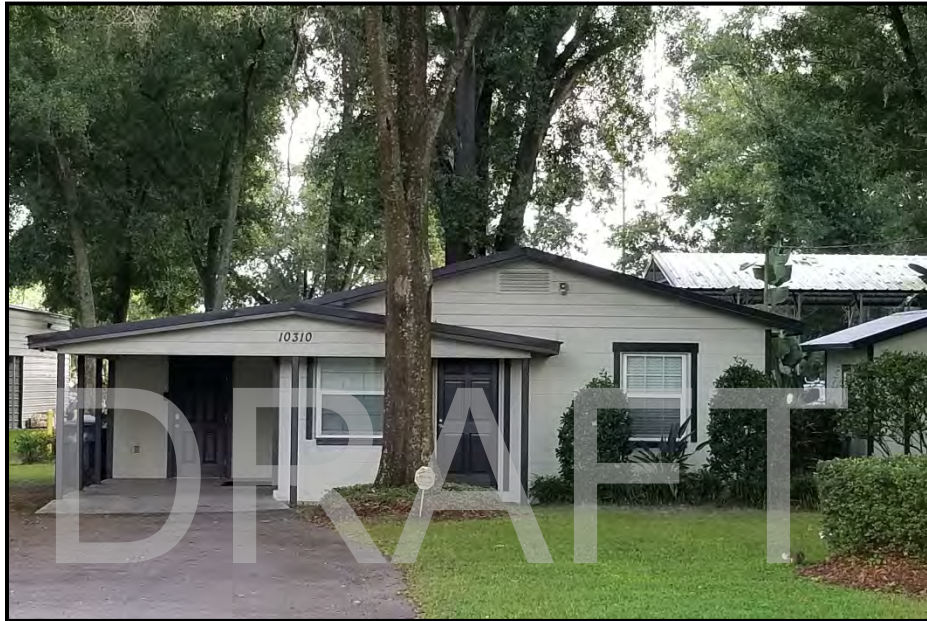
Photo 2. 10310 Woodberry Road (8HI14684), looking north.

8HI14684: The Masonry Vernacular style building at 10310 Woodberry Road was constructed in ca. 1960 (**Photo 2**). The one-story, irregular plan building rests on a concrete slab foundation and has a concrete block structural system with horizontal plank siding in the gable ends. The front gable roof is covered with standing seam sheet metal. The main entryway is on the south elevation through a single wood panel door within a partial width open porch beneath a gable roof with metal porch supports. Visible windows include a mixture of individual one-over-one, six-over-six, and eight-over-eight vinyl single-hung-sash units. Distinguishing architectural features include a vent in the gable end. Alterations include replacement roofing and windows. An attached one-car carport with rear utility room is located on the west elevation. A utility shed and non-historic detached carport are located on the property. Overall, the building has been altered, lacks sufficient architectural features, and is not a significant embodiment of a type, period, or method of construction. In addition, background research did not reveal any historic associations with significant persons and/or events. As a result, 8HI14684 does not appear eligible for listing in the NRHP, either individually or as part of a historic district.

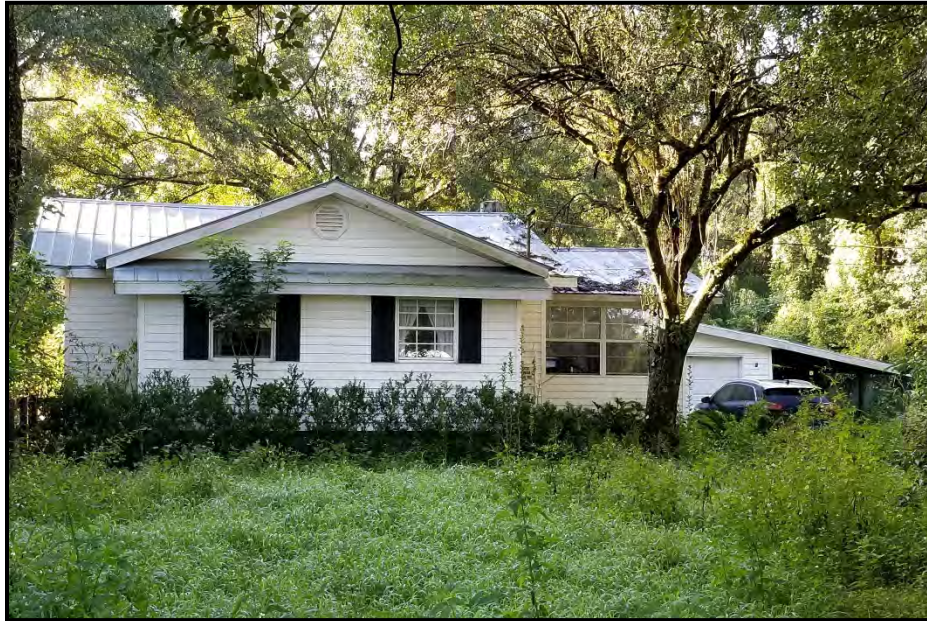
Photo 3. 2307 Fisher Avenue (8HI14685), looking south.

8HI14685: The Frame Vernacular style building at 2307 Fisher Avenue was constructed in ca. 1930 (**Photo 3**). The one-story, irregular plan building rests on a pier foundation and has a wood frame structural system clad in vinyl siding. The cross-gabled roof is covered with 5V crimp sheet metal. A stucco chimney is located on the west elevation slope. The main entryway is on the east elevation through a single door beneath an overhanging eave. Visible windows include a mixture of individual and paired six-over-six and eight-over-eight vinyl single-hung-sash units. Distinguishing architectural features include overhanging eaves, window shutters, octagonal gable vent, and corner boards. Alterations include replacement roofing, siding, and windows. A detached garage is located to the south of the building. Overall, the building has been altered, lacks sufficient architectural features, and is not a significant embodiment of a type, period, or method of construction. In addition, background research did not reveal any historic associations with significant persons and/or events. As a result, 8HI14685 does not appear eligible for listing in the NRHP, either individually or as part of a historic district.

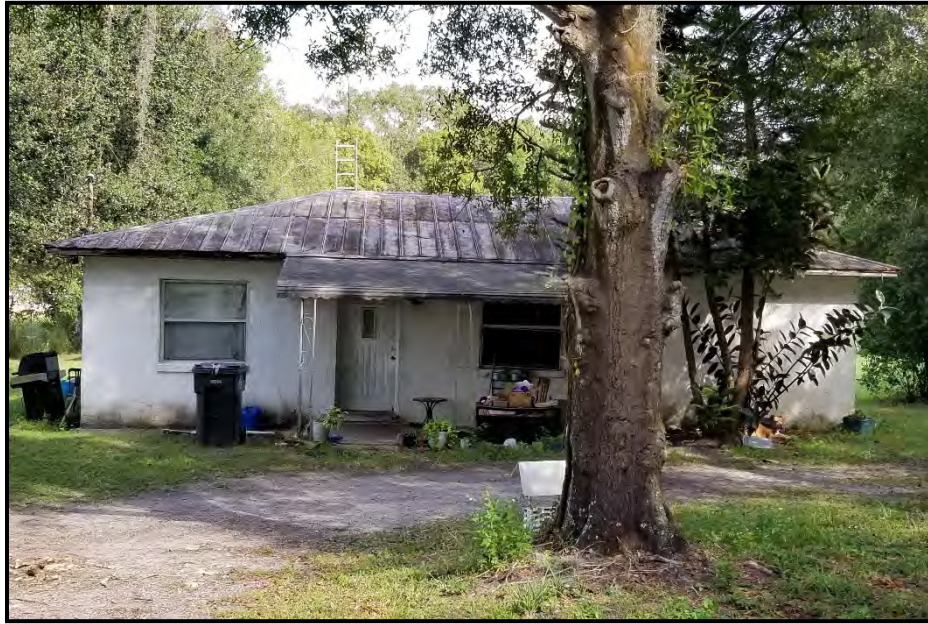
Photo 4. 2320 Fisher Avenue (8HI14686), looking north.

8HI14686: The Masonry Vernacular style building at 2320 Fisher Avenue was constructed in ca. 1957 (**Photo 4**). The one-story, irregular plan building rests on a concrete slab foundation and has a concrete block structural system clad in stucco. The hip roof is covered with 5V crimp sheet metal. The main entryway is on the south elevation through a single door with a rectangular light within a partial width open porch beneath shed metal roof with a scalloped edging supported by metal porch supports with a decorative scroll pattern. Visible windows include a mixture of individual, one-over-one and four-over-four vinyl single-hung-sash units. Distinguishing architectural features include stucco windowsills and metal porch supports. Alterations include replacement roofing and windows. A non-historic utility shed is located to the northwest of the building. Overall, the building has been altered, lacks sufficient architectural features, and is not a significant embodiment of a type, period, or method of construction. In addition, background research did not reveal any historic associations with significant persons and/or events. As a result, 8HI14686 does not appear eligible for listing in the NRHP, either individually or as part of a historic district.

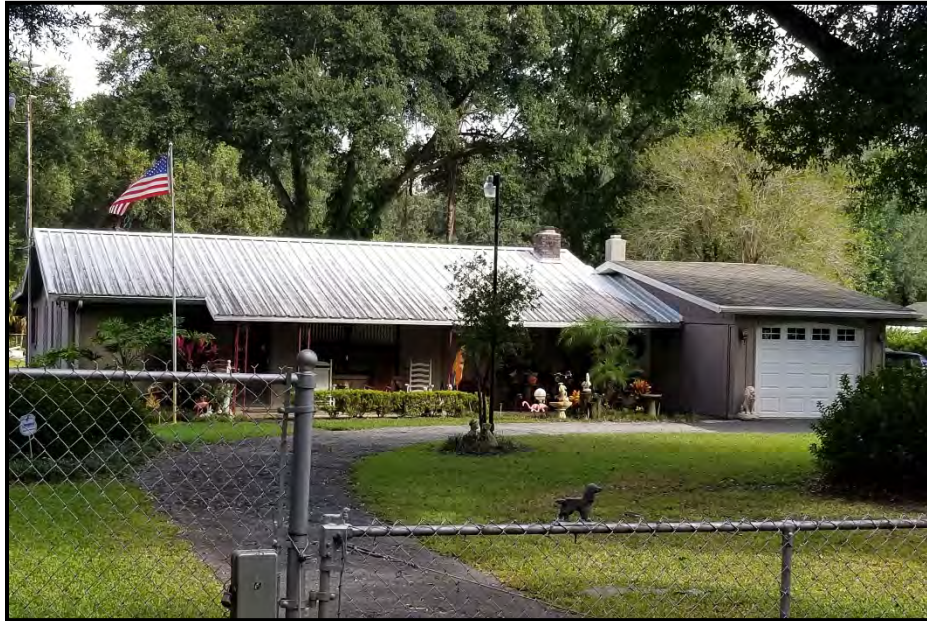
Photo 5. 2314 Fisher Avenue (8HI14687), looking north-northeast.

8HI14687: The Masonry Vernacular style building at 2314 Fisher Avenue was constructed in ca. 1960 (**Photo 5**). The one-story, irregular plan building rests on a concrete slab foundation and has a concrete block structural system clad in stucco. The side gable roof is covered with ribbed sheet metal, while the garage addition has a composition shingle gable roof. A brick chimney is located on the east elevation slope of the principal roof and a concrete block chimney is located on the slope of the garage addition. The main entryway is on the south elevation through a single door with a metal frame screen door within a partial width open porch beneath the principal roof supported by metal porch supports with a decorative scroll pattern. Visible windows include individual, one-over-one metal single-hung-sash units. Distinguishing architectural features include stucco windowsills, shutters, and metal porch supports. Alterations include replacement roofing and windows and additions include an attached wood-frame one-car garage and an attached one-car carport on the east elevation. A gazebo and two utility sheds are located to the north of the building. Overall, the building has been altered, lacks sufficient architectural features, and is not a significant embodiment of a type, period, or method of construction. In addition, background research did not reveal any historic associations with significant persons and/or events. As a result, 8HI14687 does not appear eligible for listing in the NRHP, either individually or as part of a historic district.

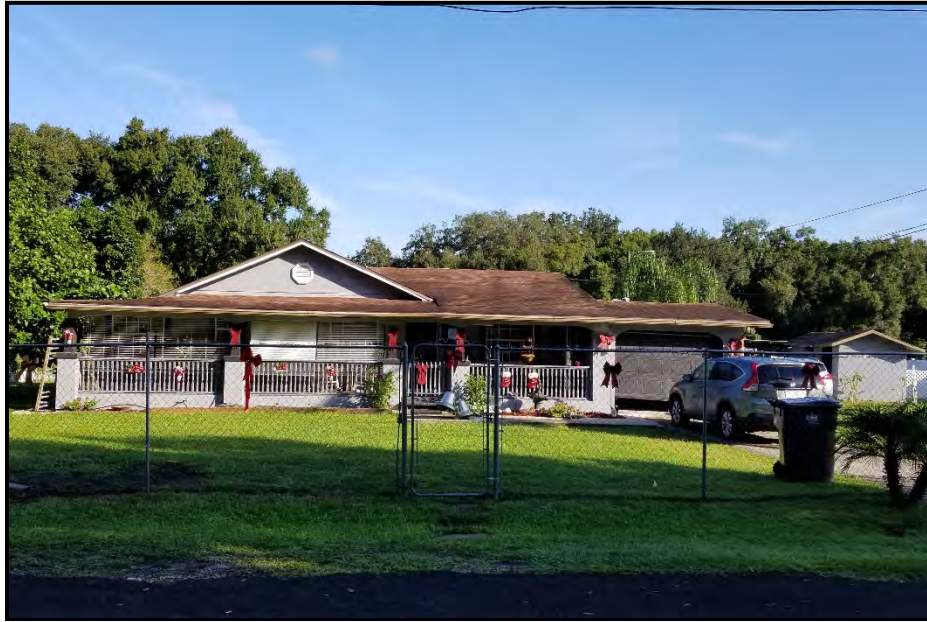
Photo 6. 2308 Fisher Avenue (8HI14688), looking north.

8HI14688: The Frame Vernacular style building at 2308 Fisher Avenue was constructed in ca. 1932 (**Photo 6**). The one-story, irregular plan building rests on a continuous foundation and has a wood frame structural system clad in stucco with plywood siding in the gable ends. The cross-gabled roof is covered with composition shingles. The main entryway is on the south elevation through a single door within a full width open porch beneath a half hip roof supported by tapered wooden porch supports on squared stucco piers with a wooden railing. Visible windows include individual, eight-over-eight vinyl single-hung-sash units. Distinguishing architectural features include tapered wooden porch supports on squared stucco piers, overhanging eaves, and stucco trim around the windows. Alterations include replacement roofing, siding, and windows and additions include the south porch and attached one-car garage. A non-historic guest house with attached carport and utility sheds are located to the north of the building. Overall, the building has been altered, lacks sufficient architectural features, and is not a significant embodiment of a type, period, or method of construction. In addition, background research did not reveal any historic associations with significant persons and/or events. As a result, 8HI14688 does not appear eligible for listing in the NRHP, either individually or as part of a historic district.

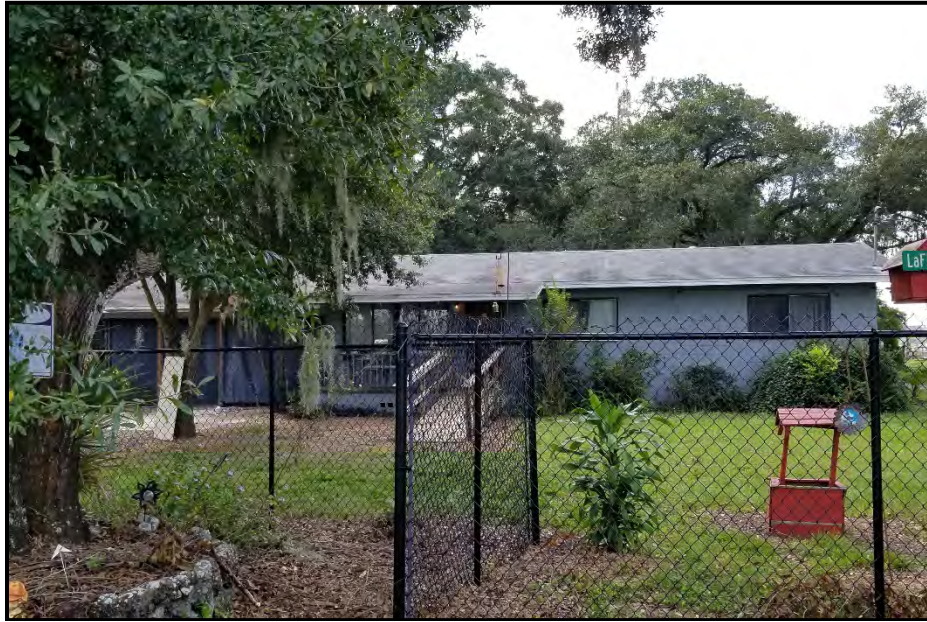
Photo 7. 2408 Graves Road (8HI14689), looking south.

8HI14689: The Masonry Vernacular style building at 2408 Graves Road was constructed in ca. 1961 (**Photo 7**). The one-story, irregular plan building rests on a continuous concrete block foundation and has a concrete block structural system. The side gable roof over the principal mass and the shed extension are covered with composition shingles. The main entryway is on the north elevation through a single door with a metal frame screen door within a partial width open porch beneath the shed extension supported by metal porch supports with a decorative scroll pattern and matching railing. A wooden ramp extends to the front porch. Visible windows include a mixture of individual, one-over-one metal sliding units and individual three-light metal fixed units. Distinguishing architectural features include stucco windowsills, metal porch supports, and overhanging eaves with boxed rafters. Alterations include replacement roofing and windows; and additions include an attached carport on the east elevation. A ca. 1961 utility shed, a non-historic utility shed, and a non-historic detached carport are located to the south of the building. Overall, the building has been altered, lacks sufficient architectural features, and is not a significant embodiment of a type, period, or method of construction. In addition, background research did not reveal any historic associations with significant persons and/or events. As a result, 8HI14689 does not appear eligible for listing in the NRHP, either individually or as part of a historic district.

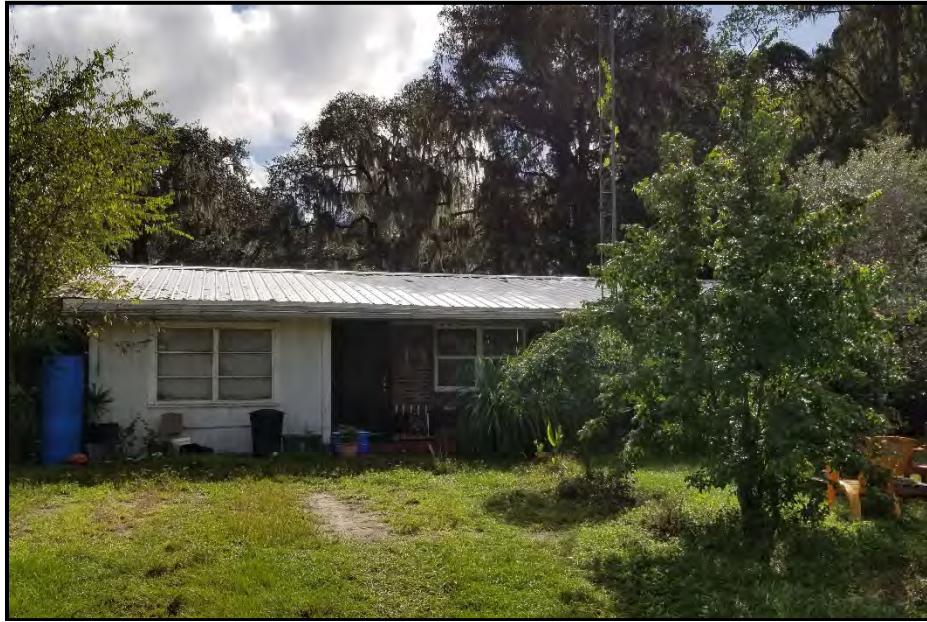
Photo 8. 8913 Bowles Road (8HI14872), looking southeast.

8HI14872: The Masonry Vernacular style building at 8913 Bowles Road was constructed in ca. 1963 (**Photo 8**). The one-story, irregular plan building rests on a concrete slab foundation and has a concrete block structural system clad in brick veneer. The side gable roof is covered with ribbed sheet metal. The main entryway is on the west elevation through a single door within a partial width incised porch beneath the principal roof. Visible windows include a mixture of individual one-over-one vinyl single-hung-sash units and paired three-stacked metal awning units. Distinguishing architectural features include overhanging eaves with boxed rafter tails and brick windowsills. Alterations include replacement roofing and windows. Additions include an enclosed carport with plywood siding on the north elevation and a finished utility shed on the east elevation. A non-historic Quonset hut and detached carport are located to the east of the building. Overall, the building has been altered, lacks sufficient architectural features, and is not a significant embodiment of a type, period, or method of construction. In addition, background research did not reveal any historic associations with significant persons and/or events. As a result, 8HI14872 does not appear eligible for listing in the NRHP, either individually or as part of a historic district.

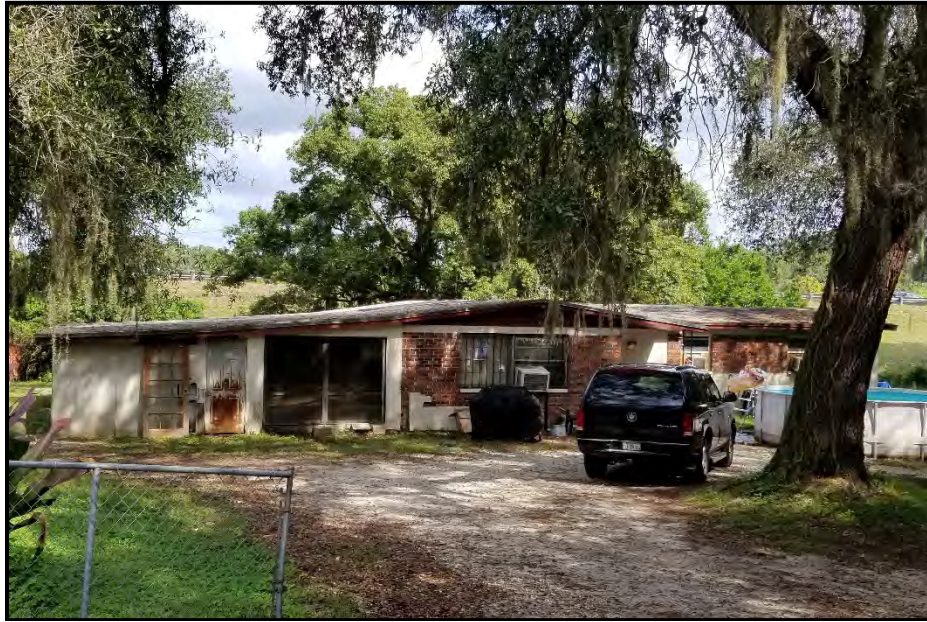
Photo 9. 9119 Bowles Road (8HI14690), looking northeast.

8HI14690: The Masonry Vernacular style building at 9119 Bowles Road was constructed in ca. 1962 (**Photo 9**). The one-story, irregular plan building rests on a concrete slab foundation and has a concrete block structural system partially clad in brick veneer with plywood siding in the gable ends. The low-pitched cross-gabled roof and shed extension are covered in built-up membrane. The main entryway is on the southwest elevation through an obscured door within a partial width open porch beneath the principal roof supported by metal porch supports with a decorative scroll pattern set into a brick planter. Visible windows include a mixture of individual and paired, one-over-one and two-over-two metal single-hung-sash units; individual, one-over-one vinyl single-hung-sash units; and paired, two-light metal picture units. Distinguishing architectural features include masonry windowsills, brick veneer cladding, metal porch supports, low-pitched roof, and a brick planter wall. Alterations include replacement roofing and windows, and installed window security bars; as well as a large north elevation addition beneath a shed extension. A brick entry planter is located beneath the southwest porch and a non-historic above-ground swimming pool is located to the southwest of the building. Overall, the building has been altered, lacks sufficient architectural features, and is not a significant embodiment of a type, period, or method of construction. In addition, background research did not reveal any historic associations with significant persons and/or events. As a result, 8HI14690 does not appear eligible for listing in the NRHP, either individually or as part of a historic district.

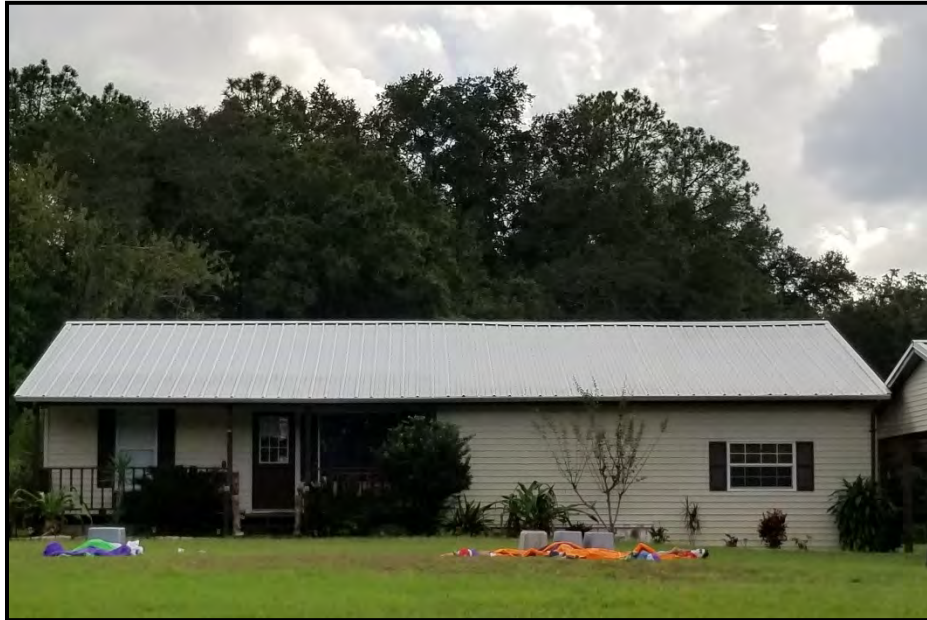
Photo 10. 9203 Harney Road (Building #1) (8HI14691), looking southeast.

8HI14691: The Frame Vernacular style building at 9203 Harney Road was constructed in ca. 1966 (**Photo 10**). The one-story, rectangular plan building rests on a concrete slab foundation and has a wood frame structural system clad in vinyl siding. The side gable roof is covered with ribbed sheet metal. The main entryway is on the north elevation through a single door with an inset six-light fixed window within a partial width incised porch beneath the principal roof overhang supported by squared wooden porch supports and accessed by wooden steps with a wooden railing. Visible windows include a mixture of individual, one-over-one, two-over-two, and eight-over-eight vinyl single-hung-sash units; and an individual one-light vinyl picture unit. Distinguishing architectural features include overhanging eaves with boxed rafters, window shutters, and corner boards. Alterations include replacement roofing, siding, and windows. A non-historic detached carport with a covered walkway which connects to a ca.

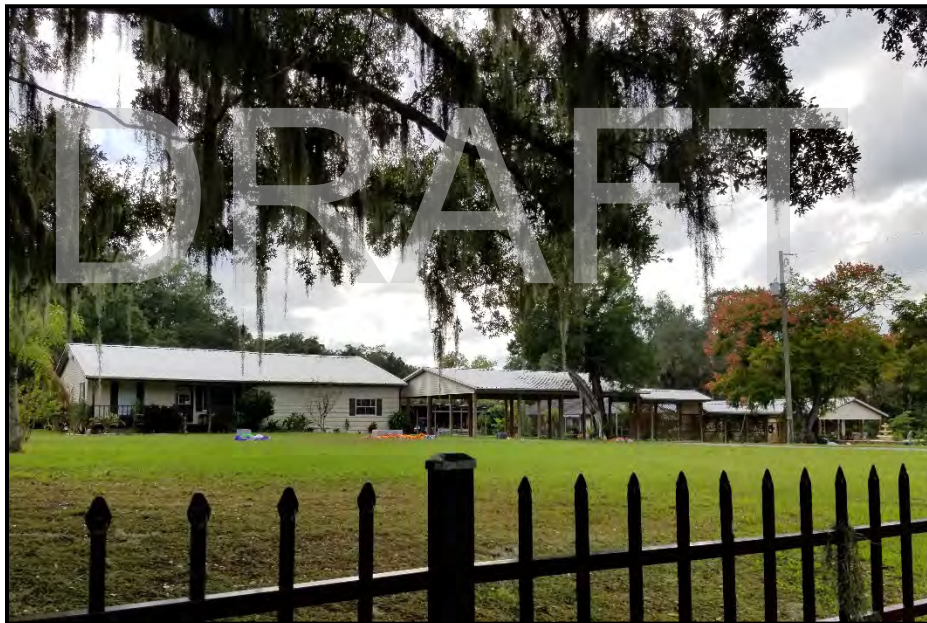
Photo 11. 9203 Harney Road, looking south. Building #1 (8HI14691) is depicted on the left and Building #2 (8HI14692) is depicted on the far right.

1968 Frame Vernacular style building (8HI14692). Other features located on the property include two utility sheds, a swimming pool, and a pole barn (**Photo 11**). Overall, the building has been altered, lacks sufficient architectural features, and is not a significant embodiment of a type, period, or method of construction. In addition, background research did not reveal any historic associations with significant persons and/or events. As a result, 8HI14691 does not appear eligible for listing in the NRHP, either individually or as part of a historic district.

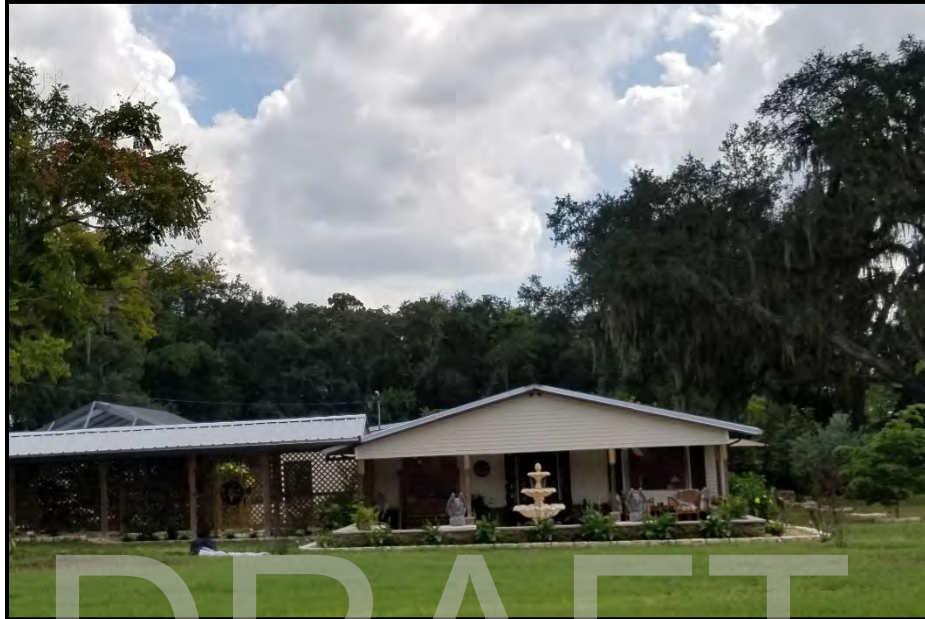
Photo 12. 9203 Harney Road (Building #2) (8HI14692), looking southeast.

8HI14692: The Frame Vernacular style building at 9203 Harney Road was constructed in ca. 1955 per property appraiser's data; however, the building first appears on historic aerial photographs in 1968 (Henriquez 2019; USDA 1968) (**Photo 12**). The one-story, irregular plan building rests on a concrete slab foundation and has a wood frame structural system clad in vinyl siding and artificial masonry veneer along the foundation. The front gable roof is covered with ribbed sheet metal, as well as the shed and gable extensions. The main entryway is on the north elevation through a single door with an oval light and sidelights within a full width open porch beneath the principal roof supported by wooden porch supports. Visible windows include a mixture of paired, six-over-six metal single-hung-sash units; and an individual one-light vinyl picture unit. Distinguishing architectural features include overhanging eaves with boxed rafters, window shutters, and corner boards. Alterations include replacement roofing, siding, and windows. Additions include a shed extension on the east elevation and a gable extension on the south elevation. A ca. 1966 Frame Vernacular style building (8HI14691) and a non-historic covered walkway, detached carport, utility sheds, swimming pool, and pole barn are located northeast of the building. Overall, the building has been altered, lacks sufficient architectural features, and is not a significant embodiment of a type, period, or method of construction. In addition, background research did not reveal any historic associations with significant persons and/or events. As a result, 8HI14692 does not appear eligible for listing in the NRHP, either individually or as part of a historic district.

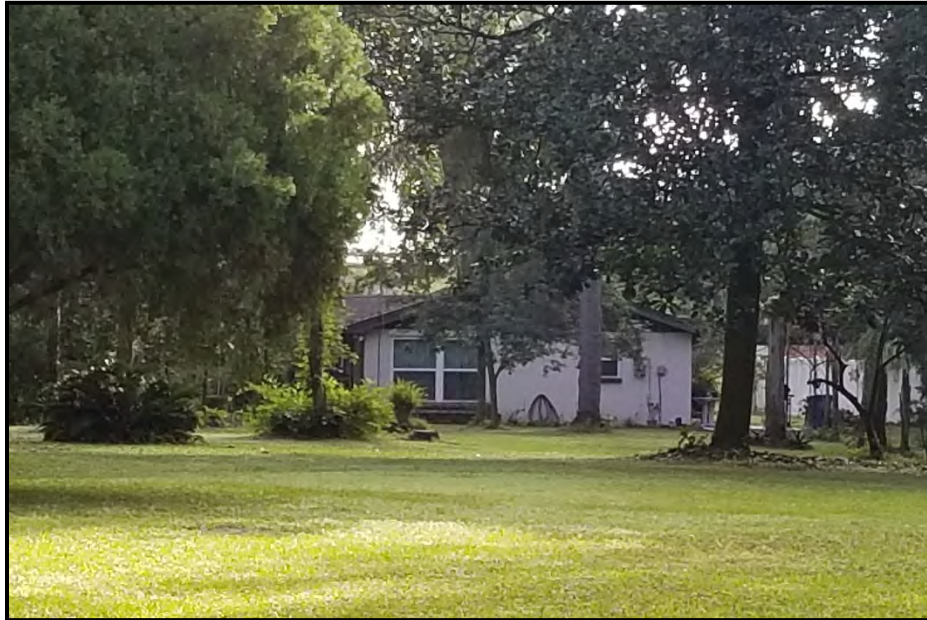
Photo 13. 9913 Morris Bridge Road (8HI14693), looking east-southeast.

8HI14693: The Masonry Vernacular style building at 9913 Morris Bridge Road was constructed in ca. 1960 (**Photo 13**). The one-story, irregular plan building rests on a concrete slab foundation and has a concrete block structural system clad in stucco with plywood siding in the gable ends. The cross-gabled roof is covered with composition shingles. The main entryway is on the north elevation and obscured. Visible windows include a mixture of individual and paired, one-over-one vinyl single-hung-sash units. Distinguishing architectural features include stucco windowsills. Alterations include replacement roofing and windows. Overall, the building has been altered, lacks sufficient architectural features, and is not a significant embodiment of a type, period, or method of construction. In addition, background research did not reveal any historic associations with significant persons and/or events. As a result, 8HI14693 does not appear eligible for listing in the NRHP, either individually or as part of a historic district.

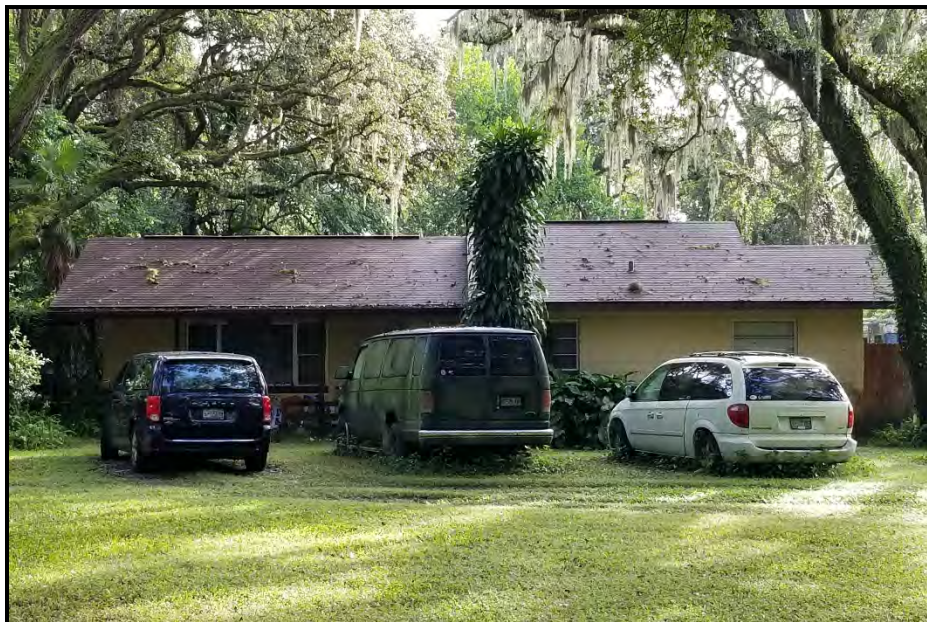
Photo 14. 9919 Morris Bridge Road (8HI14694), looking east.

8HI14694: The Masonry Vernacular style building at 9919 Morris Bridge Road was constructed in ca. 1965 (**Photo 14**). The one-story, irregular plan building rests on a concrete slab foundation and has a concrete block structural system. The side gable roof is covered with composition shingles. The main entryway is on the west elevation within a partial width open porch beneath the principal roof supported by squared wooden porch supports. Visible windows include a mixture of individual, three-stacked metal awning units and an individual, vinyl picture unit with a central light flanked by four-over-four single-hung-sash units. Distinguishing architectural features include stucco windowsills. Alterations include replacement roofing and windows. A ca. 1965 utility shed, and detached garage are located to the east of the building. Overall, the building has been altered, lacks sufficient architectural features, and is not a significant embodiment of a type, period, or method of construction. In addition, background research did not reveal any historic associations with significant persons and/or events. As a result, 8HI14694 does not appear eligible for listing in the NRHP, either individually or as part of a historic district.

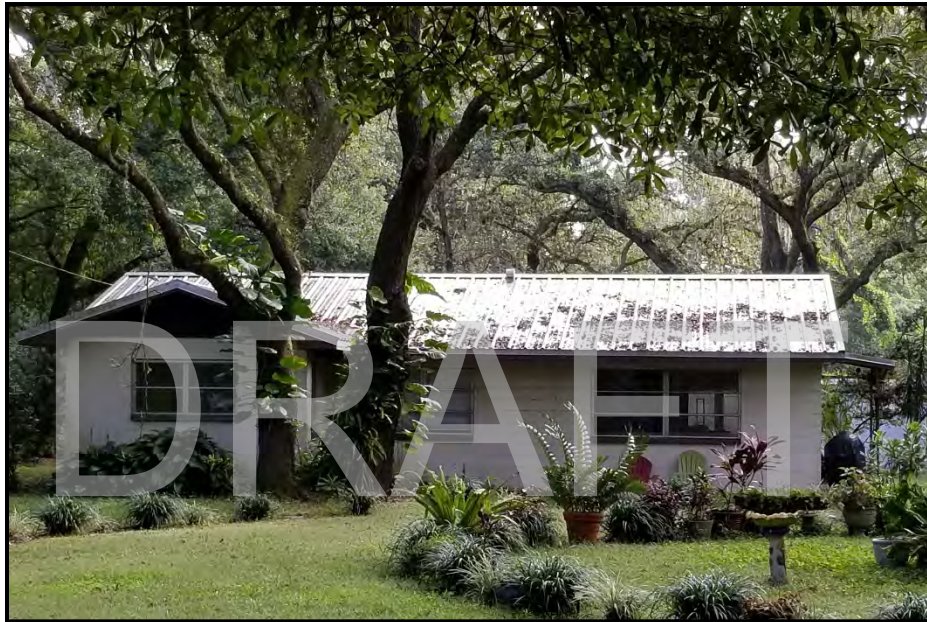
Photo 15. 9921 Morris Bridge Road (8HI14695), looking east.

8HI14695: The Masonry Vernacular style building at 9921 Morris Bridge Road was constructed in ca. 1961 (**Photo 15**). The one-story, irregular plan building rests on a concrete slab foundation and has a concrete block structural system with clapboard siding in the gable ends. The cross-gabled roof is covered with ribbed sheet metal. The main entryway is on the south elevation through a single door within a partial width open porch beneath a shed roof supported by metal pole porch supports. Visible windows include a mixture of paired, two-stacked and three-stacked metal awning units. Distinguishing architectural features include stucco windowsills and overhanging eaves with boxed rafter tails. Alterations include replacement roofing. A ca. 1963 detached garage is located to the east of the building. Overall, the building has been altered, lacks sufficient architectural features, and is not a significant embodiment of a type, period, or method of construction. In addition, background research did not reveal any historic associations with significant persons and/or events. As a result, 8HI14695 does not appear eligible for listing in the NRHP, either individually or as part of a historic district.

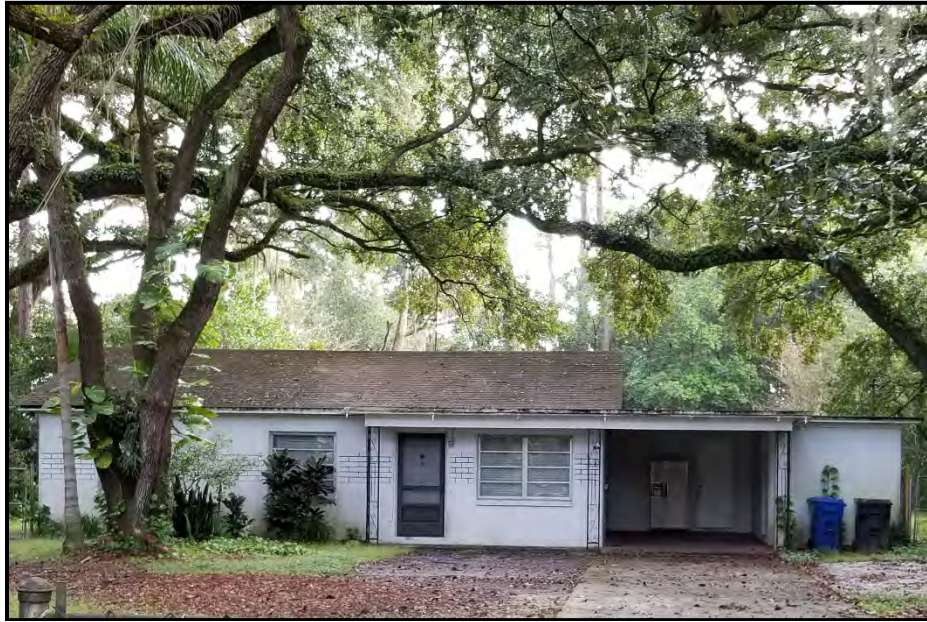
Photo 16. 9923 Morris Bridge Road (8HI14696), looking east.

8HI14696: The Masonry Vernacular style building at 9923 Morris Bridge Road was constructed in ca. 1960 (**Photo 16**). The one-story, irregular plan building rests on a concrete slab foundation and has a concrete block structural system clad in stucco and brick veneer with clapboard siding in the gable ends. The side gable roof is covered with composition shingles, while the flat roof extension is covered with built-up membrane. The main entryway is on the west elevation through a single wood panel door with a metal frame screen door within a partial width open porch beneath a flat roof extension supported by metal porch supports with a decorative scroll pattern. Visible windows include a mixture of individual and paired, four-stacked metal awning units. Distinguishing architectural features include stucco windowsills and brick veneer paneling. Alterations include replacement roofing and additions include a utility room on the south elevation of the attached carport. Overall, the building has been altered, lacks sufficient architectural features, and is not a significant embodiment of a type, period, or method of construction. In addition, background research did not reveal any historic associations with significant persons and/or events. As a result, 8HI14696 does not appear eligible for listing in the NRHP, either individually or as part of a historic district.

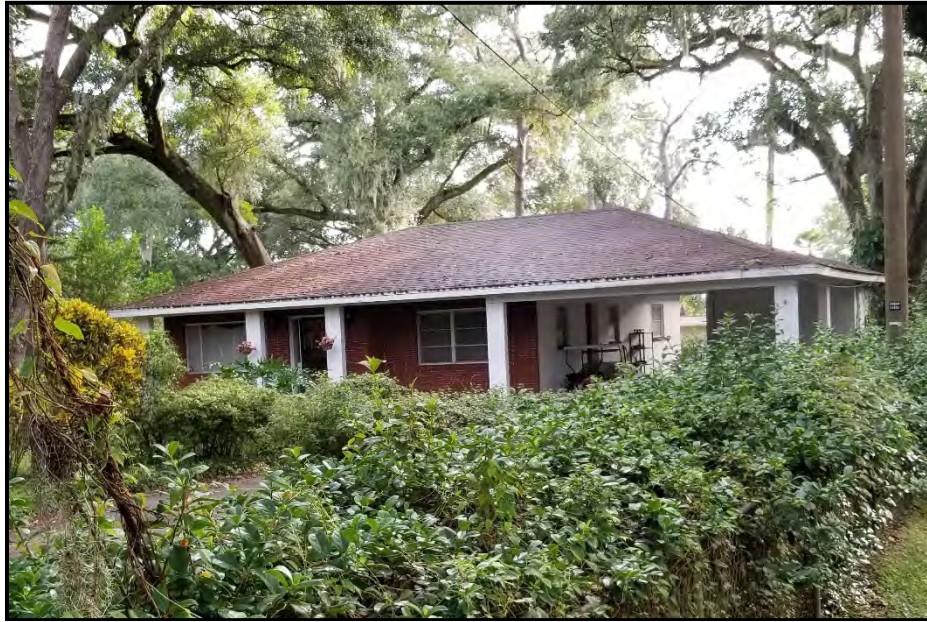
Photo 17. 9925 Morris Bridge Road (8HI14697), looking northeast.

8HI14697: The Masonry Vernacular style building at 9925 Morris Bridge Road was constructed in ca. 1962 (**Photo 17**). The one-story, irregular plan building rests on a concrete slab foundation and has a concrete block structural system partially clad in brick veneer. The hip roof is covered with composition shingles. The main entryway is on the west elevation through a single door with metal security bar door and sidelights within a partial width open porch beneath the principal roof with concrete block porch supports. Visible windows include a mixture of individual and paired, two-stacked and three-stacked metal awning units and an individual metal picture unit with a central pane flanked by three-stacked lights. Distinguishing architectural features include overhanging eaves, brick planter box, and brick windowsills. Alterations include replacement roofing. An attached two-car carport with rear utility room is located on the south elevation. Overall, the building has been altered, lacks sufficient architectural features, and is not a significant embodiment of a type, period, or method of construction. In addition, background research did not reveal any historic associations with significant persons and/or events. As a result, 8HI14697 does not appear eligible for listing in the NRHP, either individually or as part of a historic district.

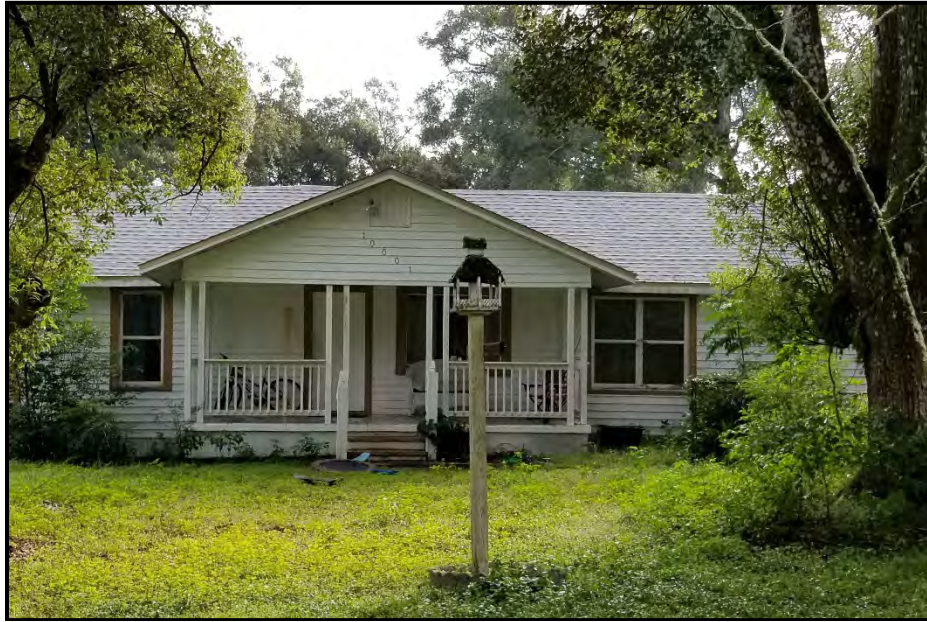
Photo 18. 10001 Morris Bridge Road (8HI14698), looking east.

8HI14698: The Frame Vernacular style building at 10001 Morris Bridge Road was constructed in ca. 1947 per property appraiser's data; however, the building first appears on historic aerial photographs in 1968 (Henriquez 2019; USDA 1968) (**Photo 18**). The one-story, irregular plan building rests on a pier foundation that is obscured by vinyl skirting. The building has a wood frame structural system clad in vinyl siding; and the open porch rests on a continuous concrete block foundation. The cross-gabled roof is covered with composition shingles. The main entryway is on the west elevation through a single door within a partial width open porch beneath a gable roof with square wooden porch supports and accessed by three steps with a wooden railing. Visible windows include a mixture of individual and paired, one-over-one vinyl single-hung-sash units and an individual single-light vinyl picture unit. Distinguishing architectural features include overhanging eaves and wood trim around the windows and doors. Alterations include replacement roofing, siding, and windows. A non-historic utility shed is located immediately adjacent to the south elevation. Overall, the building has been altered, lacks sufficient architectural features, and is not a significant embodiment of a type, period, or method of construction. In addition, background research did not reveal any historic associations with significant persons and/or events. As a result, 8HI14698 does not appear eligible for listing in the NRHP, either individually or as part of a historic district.

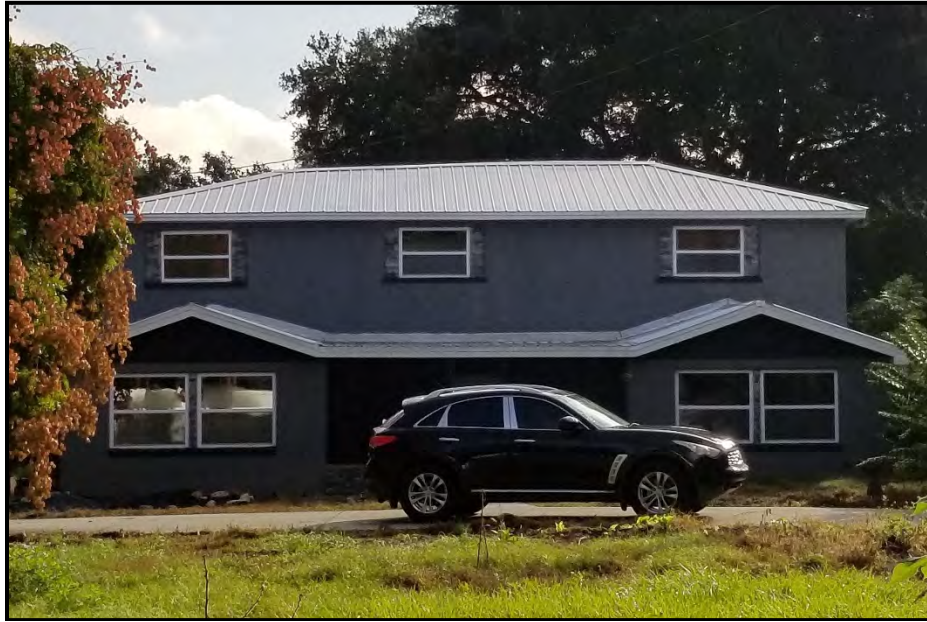
Photo 19. 10003 Morris Bridge Road (8HI14699), looking east.

8HI14699: The Masonry Vernacular style building at 10003 Morris Bridge Road was constructed in ca. 1947 (**Photo 19**). The two-story, irregular plan building rests on a concrete slab foundation and has a concrete block structural system clad in stucco with plywood siding in the gable ends. The hip roof, gable extensions, and shed roof extension are covered with ribbed sheet metal. The main entryway is on the west elevation through a single door with oval light within a partial width open porch beneath a shed roof extension with screening and a stone half wall. Visible windows include individual and paired, one-over-one vinyl single-hung-sash units. Distinguishing architectural features include stucco windowsills, stone veneer shutters, and artificial masonry veneer trim around the windows. Alterations include replacement roofing, windows, and trim; and additions include two front gable extensions connected by a shed extension on the west elevation and an addition along the east elevation. A non-historic swimming pool is located to the east of the building. Overall, the building has been altered, lacks sufficient architectural features, and is not a significant embodiment of a type, period, or method of construction. In addition, background research did not reveal any historic associations with significant persons and/or events. As a result, 8HI14699 does not appear eligible for listing in the NRHP, either individually or as part of a historic district.

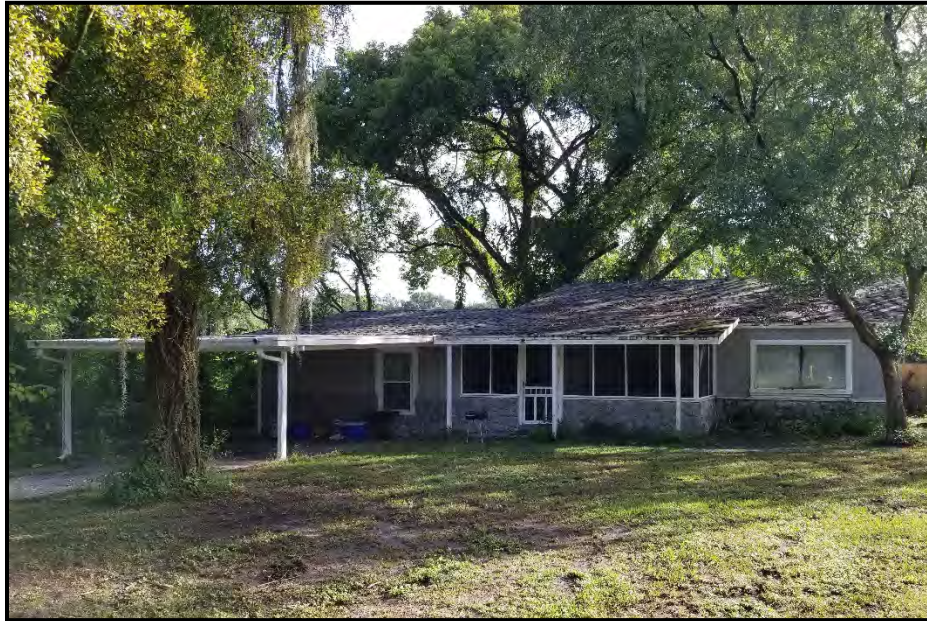
Photo 20. 10009 Morris Bridge Road (8HI14700), looking east-northeast.

8HI14700: The Frame Vernacular style building at 10009 Morris Bridge Road was constructed in ca. 1968 (**Photo 20**). The one-story, irregular plan building rests on a concrete slab foundation and has a wood frame structural system clad in stucco and artificial masonry veneer along the base. The side gable roof is covered with composition shingles, while the carport addition has a standing seam metal shed roof. The main entryway is on the west elevation through a single door with arched light within a partial width incised porch beneath the principal roof with screening and an artificial masonry veneer half wall. Visible windows include a mixture of individual, one-over-one vinyl single-hung-sash units and an individual one-light vinyl picture unit. Distinguishing architectural features include wooden trim around the windows, artificial masonry veneer, and overhanging eaves with boxed rafter tails. Alterations include replacement roofing, windows, and siding and additions include an attached two-car carport on the west elevation. Overall, the building has been altered, lacks sufficient architectural features, and is not a significant embodiment of a type, period, or method of construction. In addition, background research did not reveal any historic associations with significant persons and/or events. As a result, 8HI14700 does not appear eligible for listing in the NRHP, either individually or as part of a historic district.
