HISTORIC RESOURCES SURVEY UPDATE

Interstate 75 (State Road 93A) Project Development and Environment Study

**From south of US 301/State Road 43 to north of Bruce B. Downs
Boulevard/County Road 581**

Hillsborough County, Florida

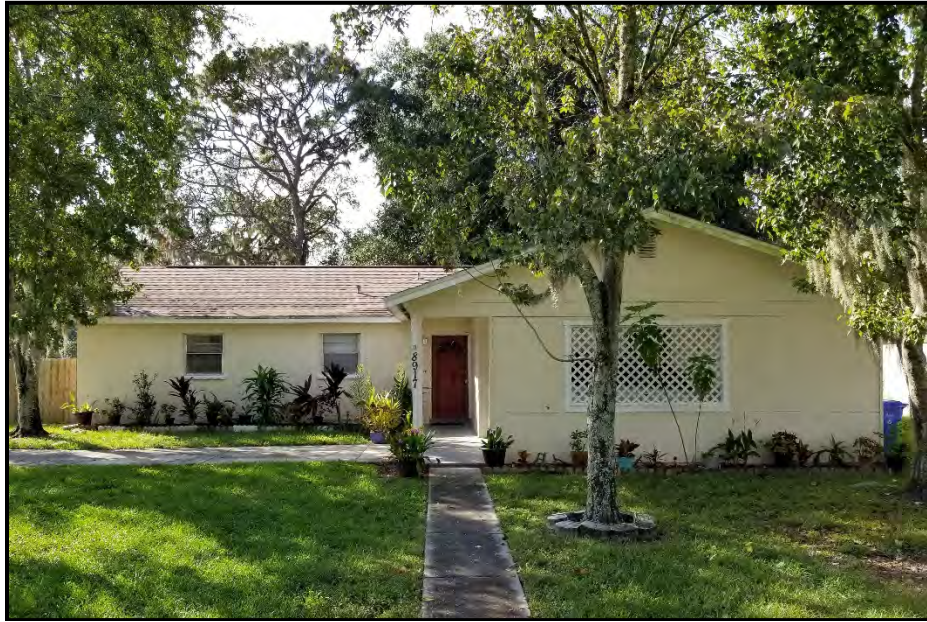
Photo 21. 8917 Navajo Avenue (8HI14701), looking south.

8HI14701: The Masonry Vernacular style building at 8917 Navajo Avenue was constructed in ca. 1964 (**Photo 21**). The one-story, L-shaped plan building rests on a concrete slab foundation and has a concrete block structural system with plywood siding in the gable ends. The cross-gabled roof is covered with composition shingles. The main entryway is on the north elevation through a single wood panel door with a fanlight within a partial width incised porch beneath the principal roof with square wooden porch supports. Visible windows include a mixture of individual and paired, two-over-two metal single-hung-sash units. Distinguishing architectural features include overhanging eaves with boxed rafter tails and rusticated stucco windowsills. Alterations include replacement roofing and the partial enclosure of the carport. An attached carport with plywood siding and a wooden lattice inset is located on the north elevation. Overall, the building has been altered, lacks sufficient architectural features, and is not a significant embodiment of a type, period, or method of construction. In addition, background research did not reveal any historic associations with significant persons and/or events. As a result, 8HI14701 does not appear eligible for listing in the NRHP, either individually or as part of a historic district.

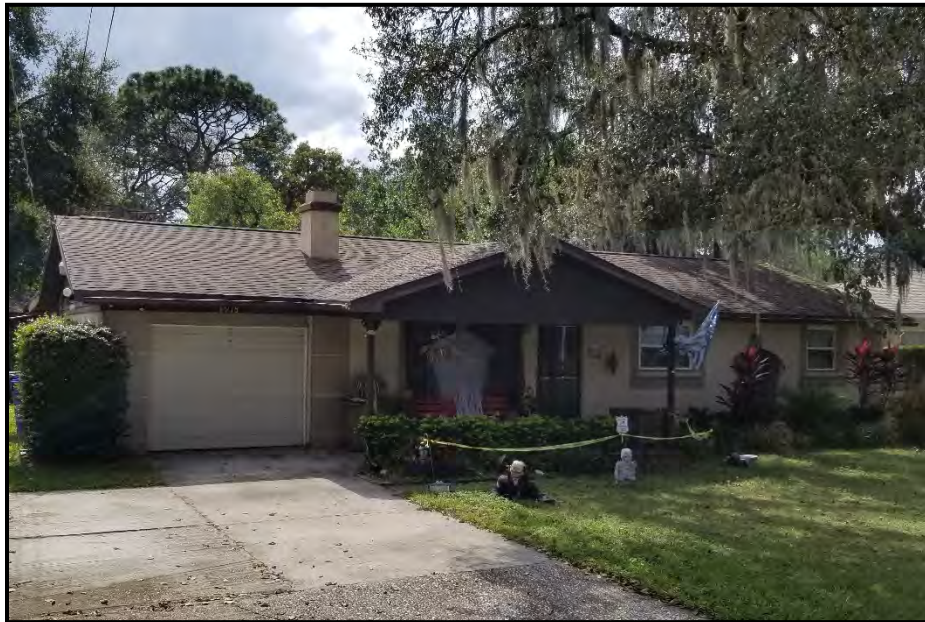
Photo 22. 8915 Navajo Avenue (8HI14702), looking southwest.

8HI14702: The Masonry Vernacular style building at 8915 Navajo Avenue was constructed in ca. 1964 (**Photo 22**). The one-story, irregular plan building rests on a concrete slab foundation and has a concrete block structural system clad in stucco with plywood siding in the gable ends. The cross-gabled roof is covered with composition shingles. The main entryway is on the north elevation through a single door with a full-light storm door within a partial width open porch beneath a gable roof supported by squared wooden porch supports. Visible windows include a mixture of individual, one-over-one vinyl single-hung-sash units and an individual one-over-one vinyl sliding unit. Distinguishing architectural features include overhanging eaves with boxed rafter tails, stucco windowsills, stucco trim around the windows, and stucco quoins. Alterations include replacement roofing, windows, and the application of stucco quoins. Additions include a ca. 1993 stucco chimney located on the slope of the north elevation and an addition on the south elevation. A one-car garage with segmental garage door is located on the north elevation. A non-historic utility shed is located to the south of the building. Overall, the building has been altered, lacks sufficient architectural features, and is not a significant embodiment of a type, period, or method of construction. In addition, background research did not reveal any historic associations with significant persons and/or events. As a result, 8HI14702 does not appear eligible for listing in the NRHP, either individually or as part of a historic district.

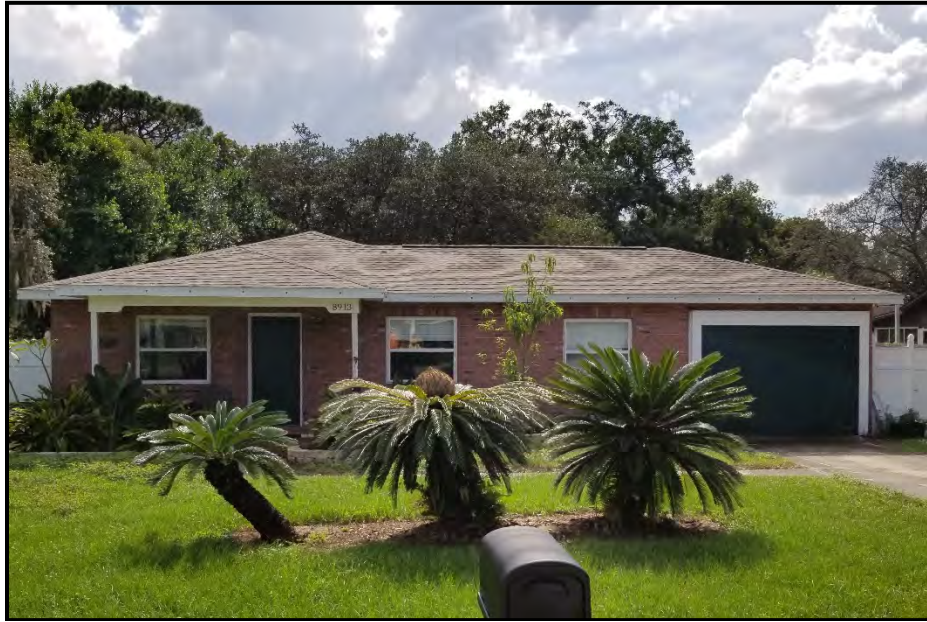
Photo 23. 8913 Navajo Avenue (8HI14703), looking south.

8HI14703: The Masonry Vernacular style building at 8913 Navajo Avenue was constructed in ca. 1962 (**Photo 23**). The one-story, irregular plan building rests on a concrete slab foundation and has a concrete block structural system clad in brick veneer and stucco. The hip roof is covered with composition shingles. The main entryway is on the north elevation through a single door within a partial width open porch beneath a hip roof supported by squared wooden porch supports. Visible windows include a mixture of individual and paired, one-over-one vinyl single-hung-sash units. Distinguishing architectural features include overhanging boxed eaves and brick windowsills. Alterations include replacement roofing and windows. An attached one-car garage with segmental garage door is located on the north elevation. A non-historic utility shed is located immediately adjacent to the south elevation. Overall, the building has been altered, lacks sufficient architectural features, and is not a significant embodiment of a type, period, or method of construction. In addition, background research did not reveal any historic associations with significant persons and/or events. As a result, 8HI14703 does not appear eligible for listing in the NRHP, either individually or as part of a historic district.

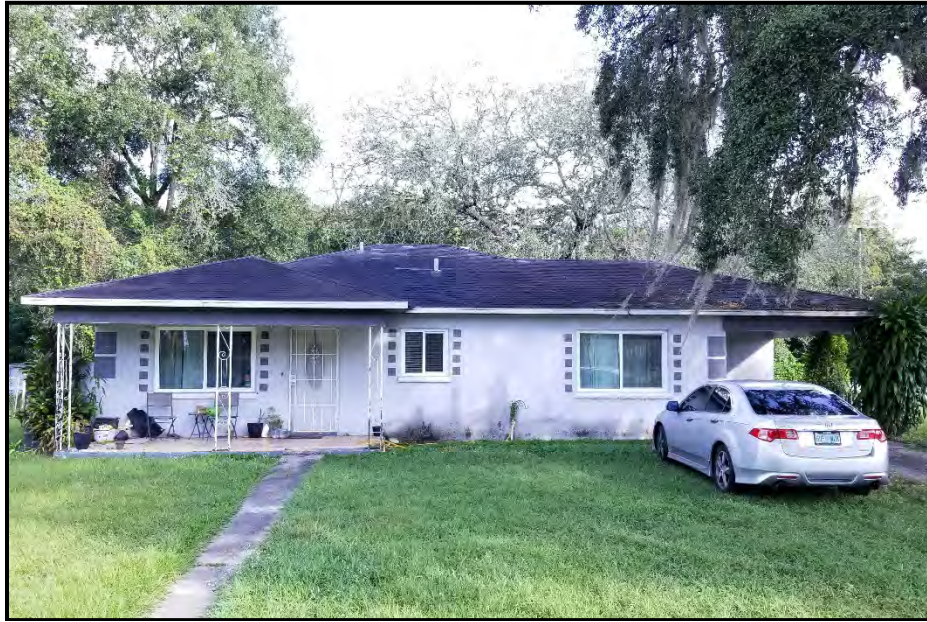
Photo 24. 8918 Navajo Avenue (8HI14704), looking north.

8HI14704: The Masonry Vernacular style building at 8918 Navajo Avenue was constructed in ca. 1963 (**Photo 24**). The one-story, irregular plan building rests on a concrete slab foundation and has a concrete block structural system clad in stucco. The hip roof is covered with composition shingles. A stucco chimney is located on the slope of the north elevation. The main entryway is on the south elevation through a single door with an oval light and metal security bar screen door within a partial width open porch beneath a hip roof supported by metal porch supports with a decorative scroll pattern. Visible windows include individual, one-over-one vinyl sliding units. Distinguishing architectural features include overhanging boxed eaves, stucco windowsills, and stucco quoins. Alterations include replacement roofing, windows, and the application of stucco quoins. An attached one-car carport with rear utility room and decorative scroll pattern metal supports and railing is located on the south elevation. A non-historic utility shed is located to the north of the building. Overall, the building has been altered, lacks sufficient architectural features, and is not a significant embodiment of a type, period, or method of construction. In addition, background research did not reveal any historic associations with significant persons and/or events. As a result, 8HI14704 does not appear eligible for listing in the NRHP, either individually or as part of a historic district.

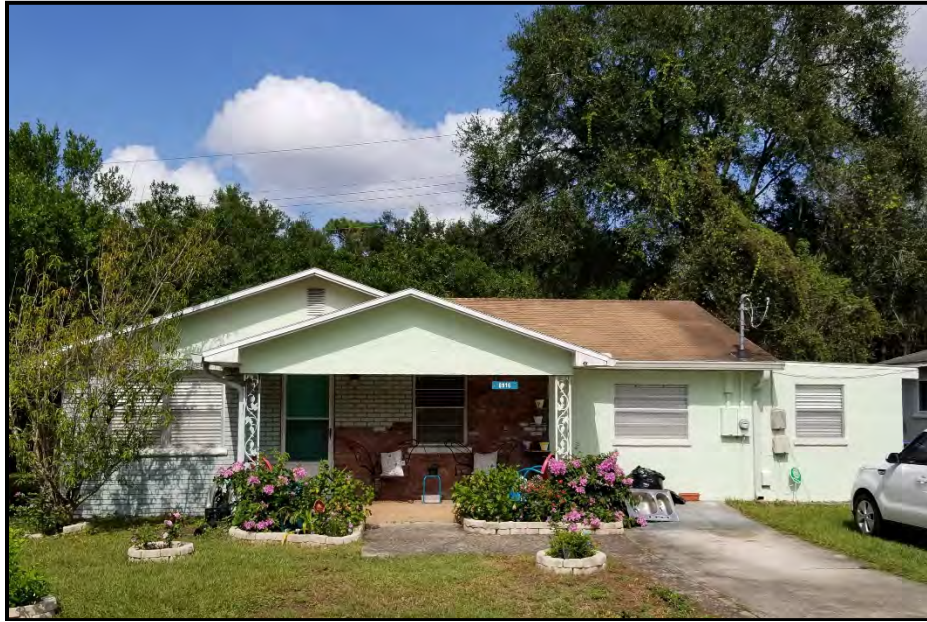
Photo 25. 8916 Navajo Avenue (8HI14705), looking northeast.

8HI14705: The Masonry Vernacular style building at 8916 Navajo Avenue was constructed in ca. 1964 (**Photo 25**). The one-story, irregular plan building rests on a concrete slab foundation and has a concrete block structural system clad in stucco, brick veneer, and plywood siding in the side gable ends. The cross-gabled roof is covered with composition shingles, while the shed extension is covered with 3V crimp sheet metal. The main entryway is on the south elevation through a single door with a $\frac{3}{4}$ -light storm door within a partial width open porch beneath a gable roof supported by metal porch supports with a decorative floral pattern. Visible windows include a mixture of individual and paired, two-over-two metal single-hung-sash units. Distinguishing architectural features include metal porch supports, overhanging eaves with boxed rafter tails, and stucco windowsills. Alterations include replacement roofing and additions include a shed roof extension on the east elevation. A non-historic utility shed, and above-ground swimming pool are located to the north of the building. Overall, the building has been altered, lacks sufficient architectural features, and is not a significant embodiment of a type, period, or method of construction. In addition, background research did not reveal any historic associations with significant persons and/or events. As a result, 8HI14705 does not appear eligible for listing in the NRHP, either individually or as part of a historic district.

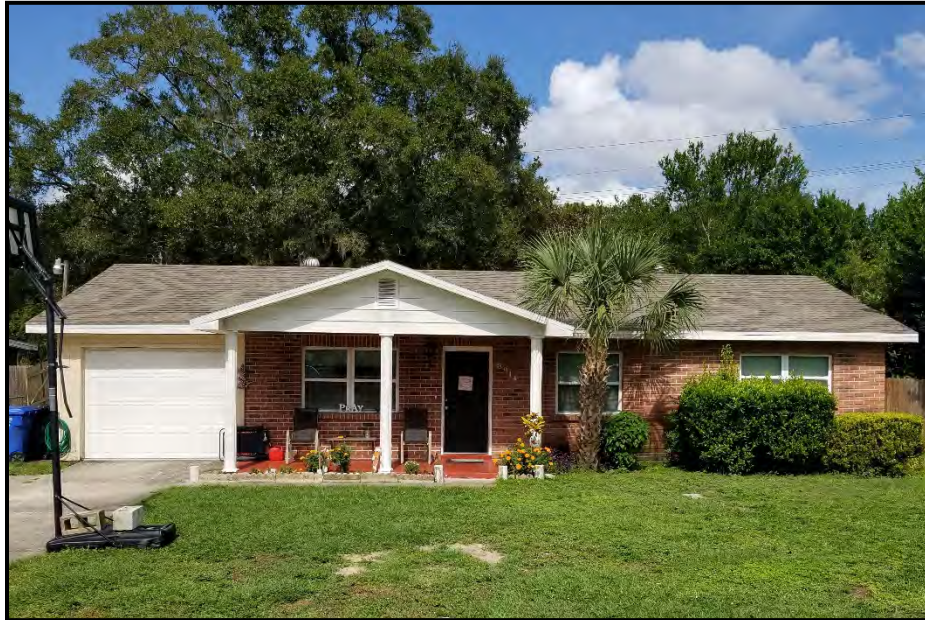
Photo 26. 8914 Navajo Avenue (8HI14706), looking north.

8HI14706: The Masonry Vernacular style building at 8914 Navajo Avenue was constructed in ca. 1963 (**Photo 26**). The one-story, irregular plan building rests on a concrete slab foundation and has a concrete block structural system clad in brick veneer, stucco, and vinyl siding in the gable ends. The cross-gabled roof is covered with composition shingles. The main entryway is on the south elevation through a single door within a partial width open porch beneath a gable roof supported by fluted column porch supports. Visible windows include a mixture of individual and paired, one-over-one vinyl single-hung-sash units. Distinguishing architectural features include fluted columns, overhanging eaves with boxed rafter tails, and brick windowsills. Alterations include replacement roofing, windows, and enclosing the carport with plywood siding to form a one-car garage; and an addition was placed on the north elevation. A non-historic swimming pool and utility sheds are located to the north of the building. Overall, the building has been altered, lacks sufficient architectural features, and is not a significant embodiment of a type, period, or method of construction. In addition, background research did not reveal any historic associations with significant persons and/or events. As a result, 8HI14706 does not appear eligible for listing in the NRHP, either individually or as part of a historic district.

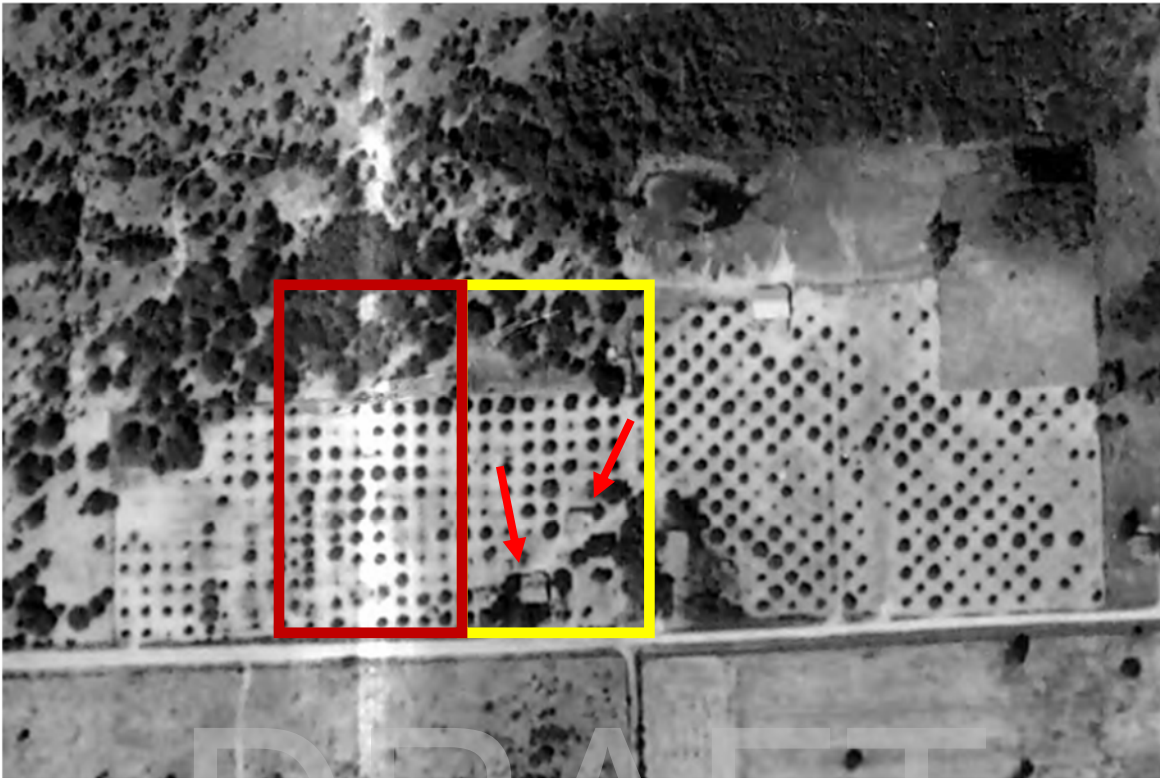
Photo 1. 1957 aerial photograph depicting the 8HI08742 property. Included in the yellow boundary line is the Frame Vernacular style building (left), the historic barn (right); and the red boundary line includes the historic orange grove (USDA 1957).

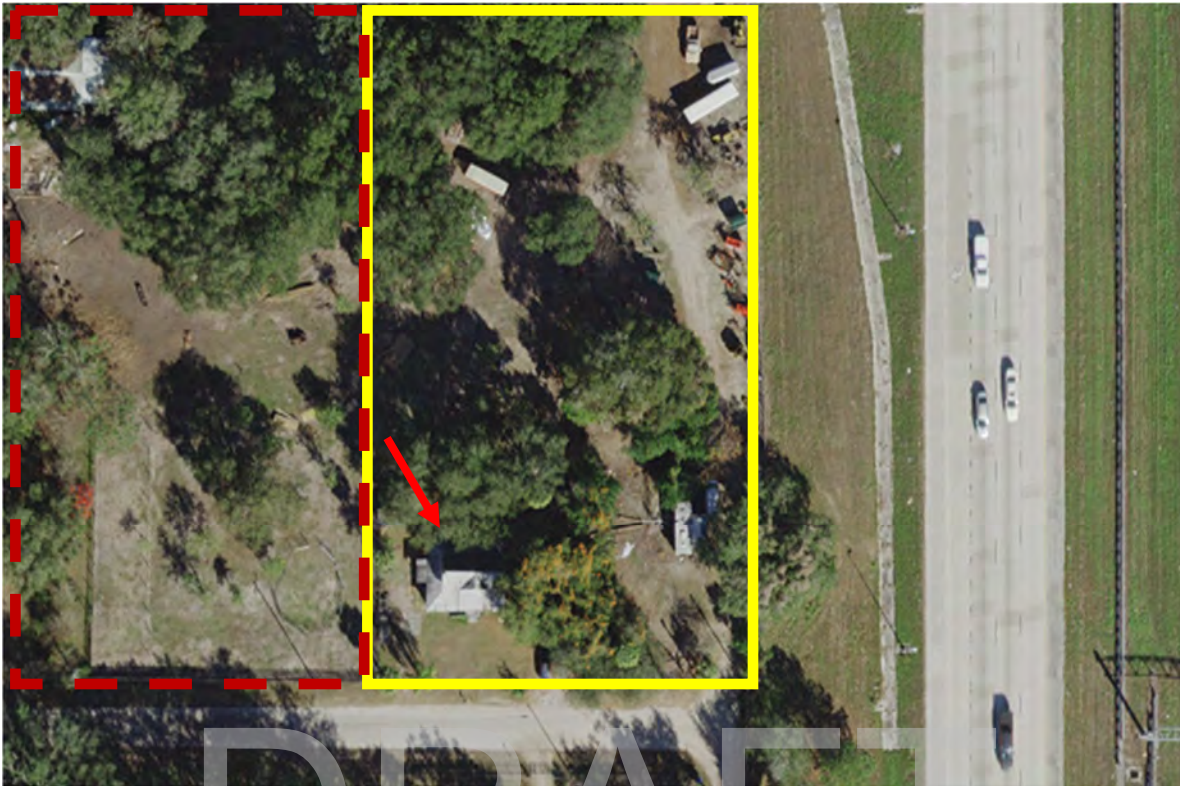
Photo 3. 2017 aerial photograph depicting the 8HI08742 property, including the Frame Vernacular style building. The remaining historic orange grove to the left of the building has been removed and the historic barn has been demolished (FDOT 2017). Yellow line denotes the remaining 1.28-acre boundary; dashed red line represents the 1.42-acre parcel that contained the orange grove and is no longer included as part of the NRHP boundary.

The property at 10426 Tanner Road (8HI08742) was previously recorded in 2003 and 2008 (ACI/Janus Research 2003; ACI 2009). As a result of the *Cultural Resource Assessment Survey Project Development and Environment (PD&E) Study from South of US 301 to North of Fletcher Avenue Hillsborough County, Florida*, the resource was determined eligible for listing in the NRHP by the SHPO in 2010 (ACI 2009). The property was determined eligible at the local level under Criterion A for its association with early settlement and agricultural practice in Hillsborough County and under Criterion C as a fine example of late 19th to early 20th century rural vernacular architecture. In the previous survey, the proposed NRHP boundary for this historic resource included the surrounding 1.28-acre parcel and the adjacent 1.42-acre property, totaling 2.7 acres. Associated with the 1.42-acre parcel was the historic orange grove, and the 1.28-acre parcel contained the residence and barn. Since the 2009 update, the associated historic barn and orange grove that contributed to the resource's significance under Criterion A have been demolished and removed (**Photos 1 – 3**). With the removal of the citrus grove and barn, the Tanner Residence no longer retains the significant physical features that contributed to its historical associations with the broad trends and patterns of the farming and citrus industries that once characterized late 19th and early 20th century Florida. Therefore, the Tanner Residence no longer appears eligible for listing in the NRHP under Criterion A.
