# Project Development & Environment Study

## I-75 (SR 93A)

From South of US 301 (SR 43) to North of Fletcher Avenue (CR 482A), Hillsborough County

## DRAFT Wetlands Evaluation and Biological Assessment Report

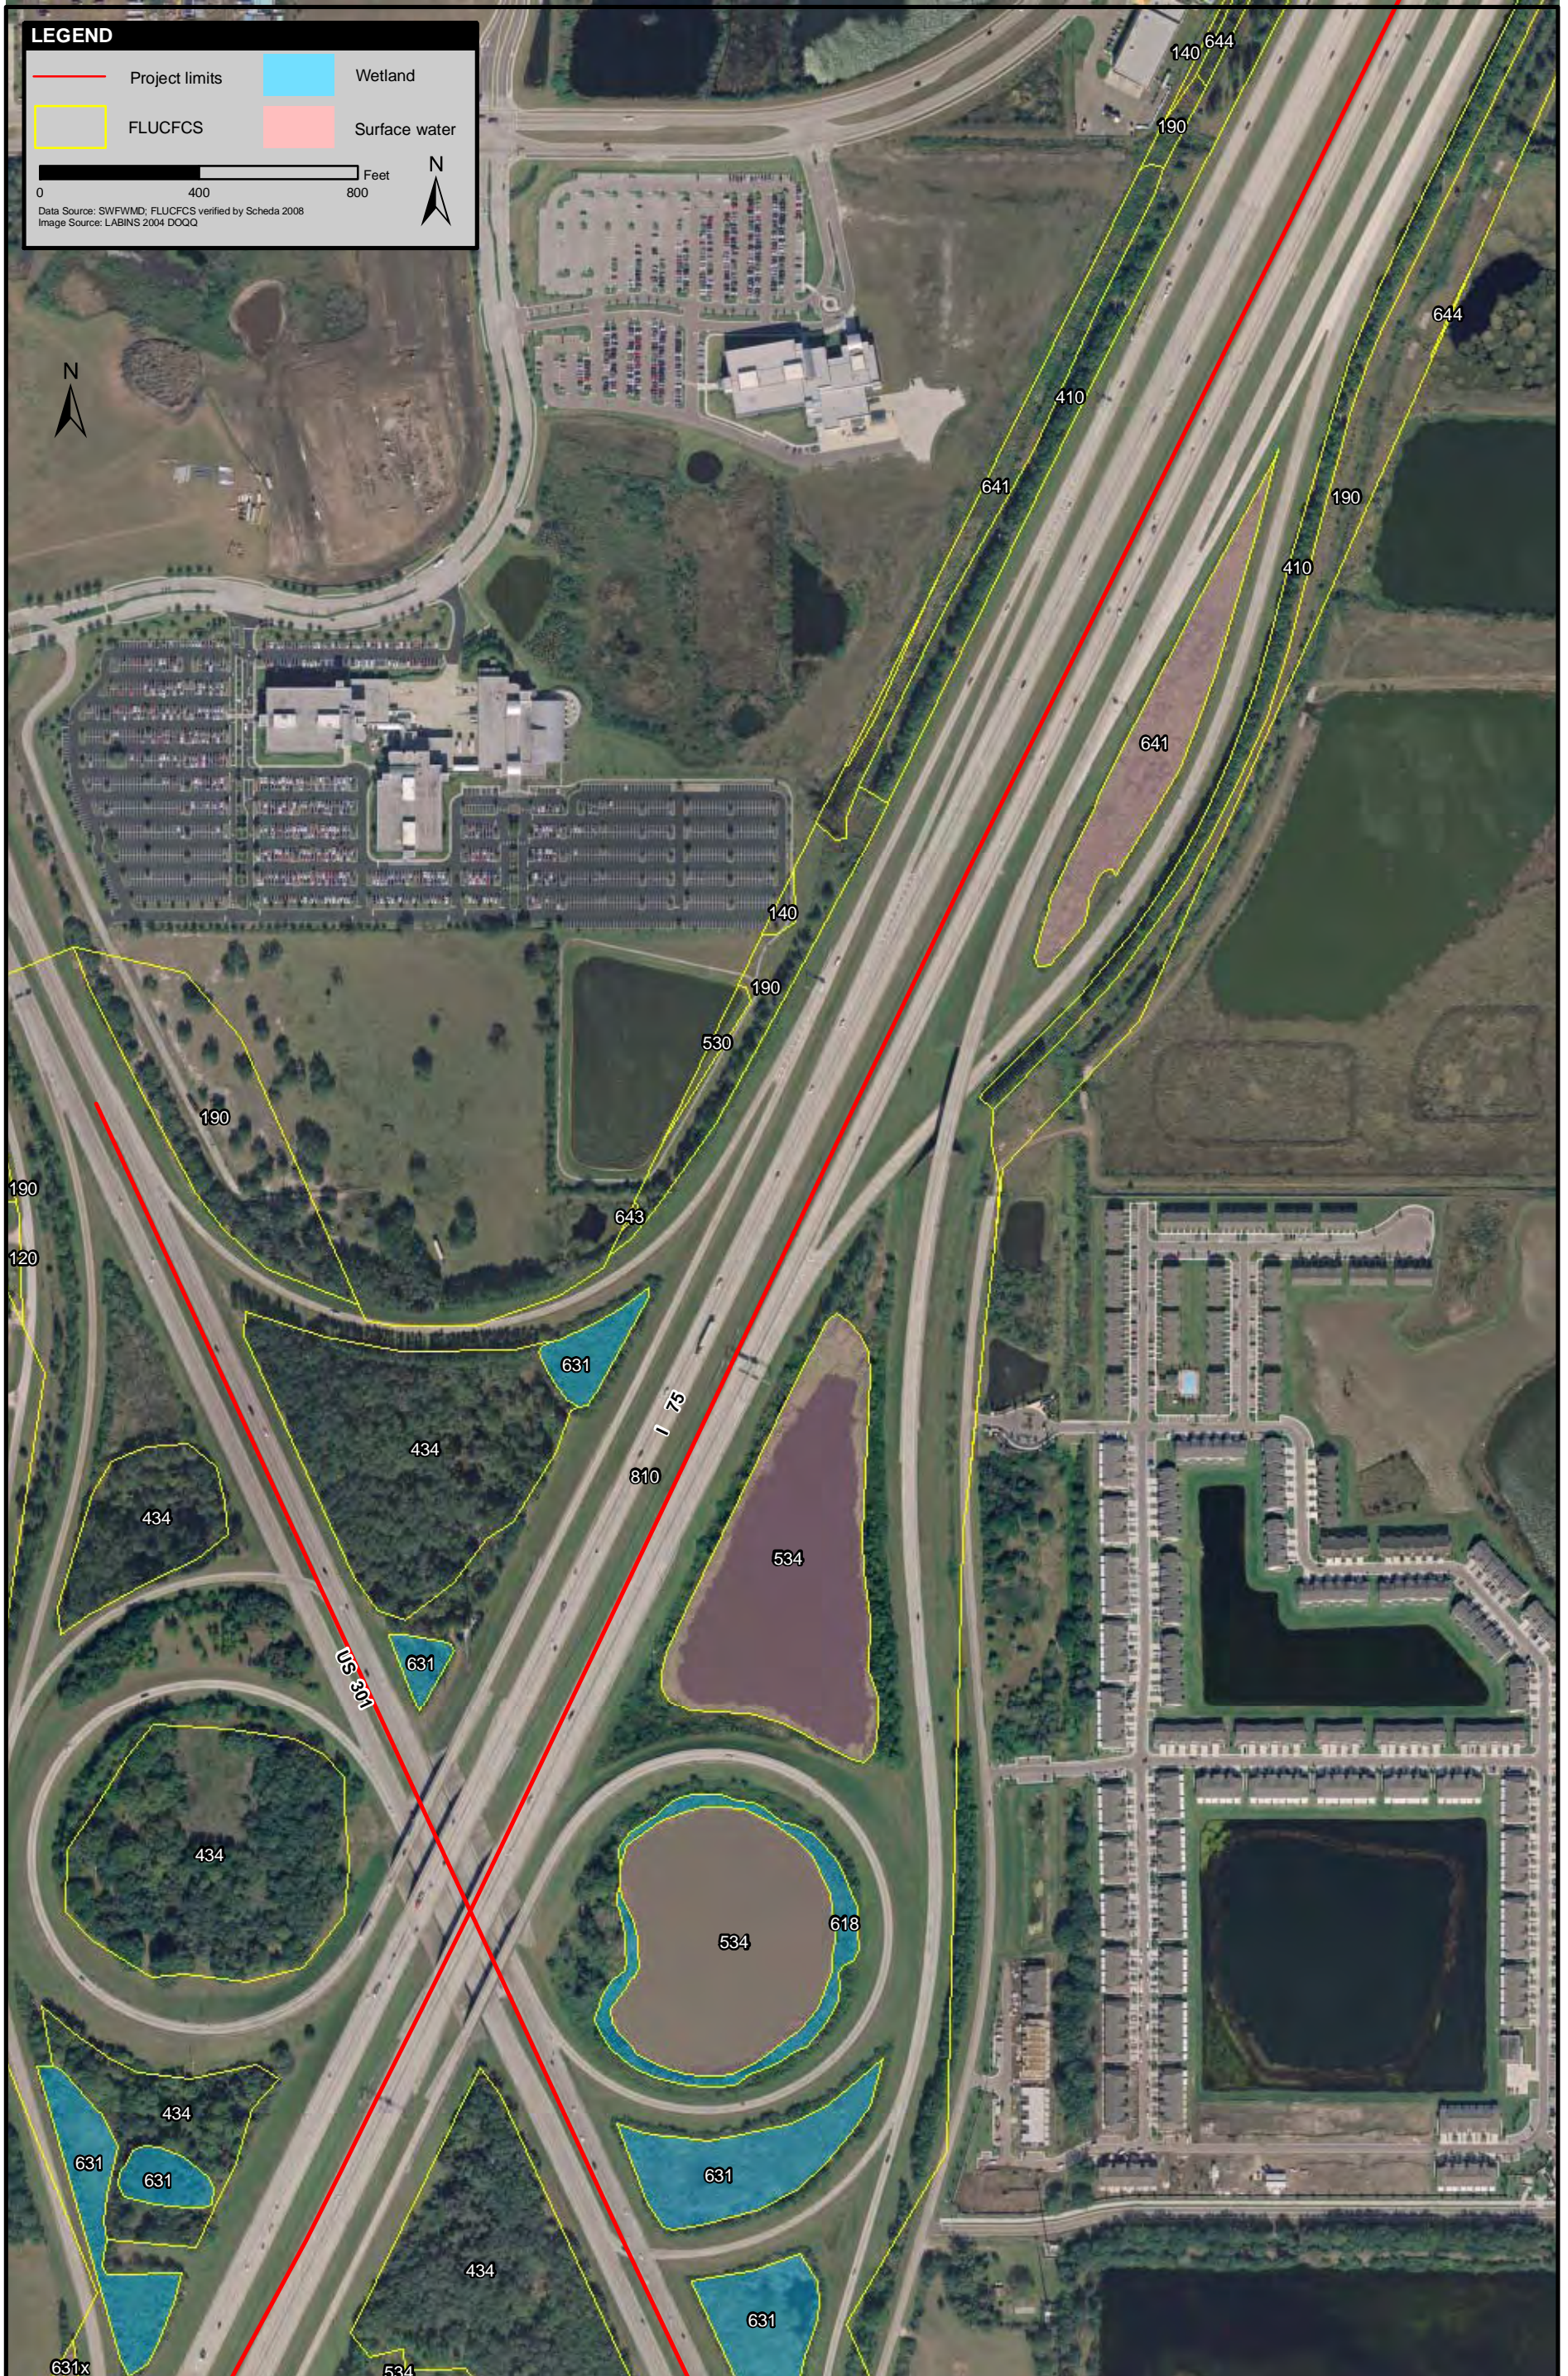
Figure 3-1  
Sheet 3 of 16

### EXISTING FLUCFCS, WETLANDS, AND SURFACE WATERS WITHIN PROJECT AREA

Wetlands were numbered and assigned a location code as per the side of the alignment (L=left or north, C=center, and R=right or south). The systems were classified according to USFWS methodology (Cowardin *et al.* 1979) and FLUCFCS (FDOT, 1999) for NWI and FLUCFCS codes, respectively. Table 3-2 lists all wetlands that are within the limits of proposed right-of-way design, along with the proposed impact acreages. Photos of the wetlands can be found in Appendix F.

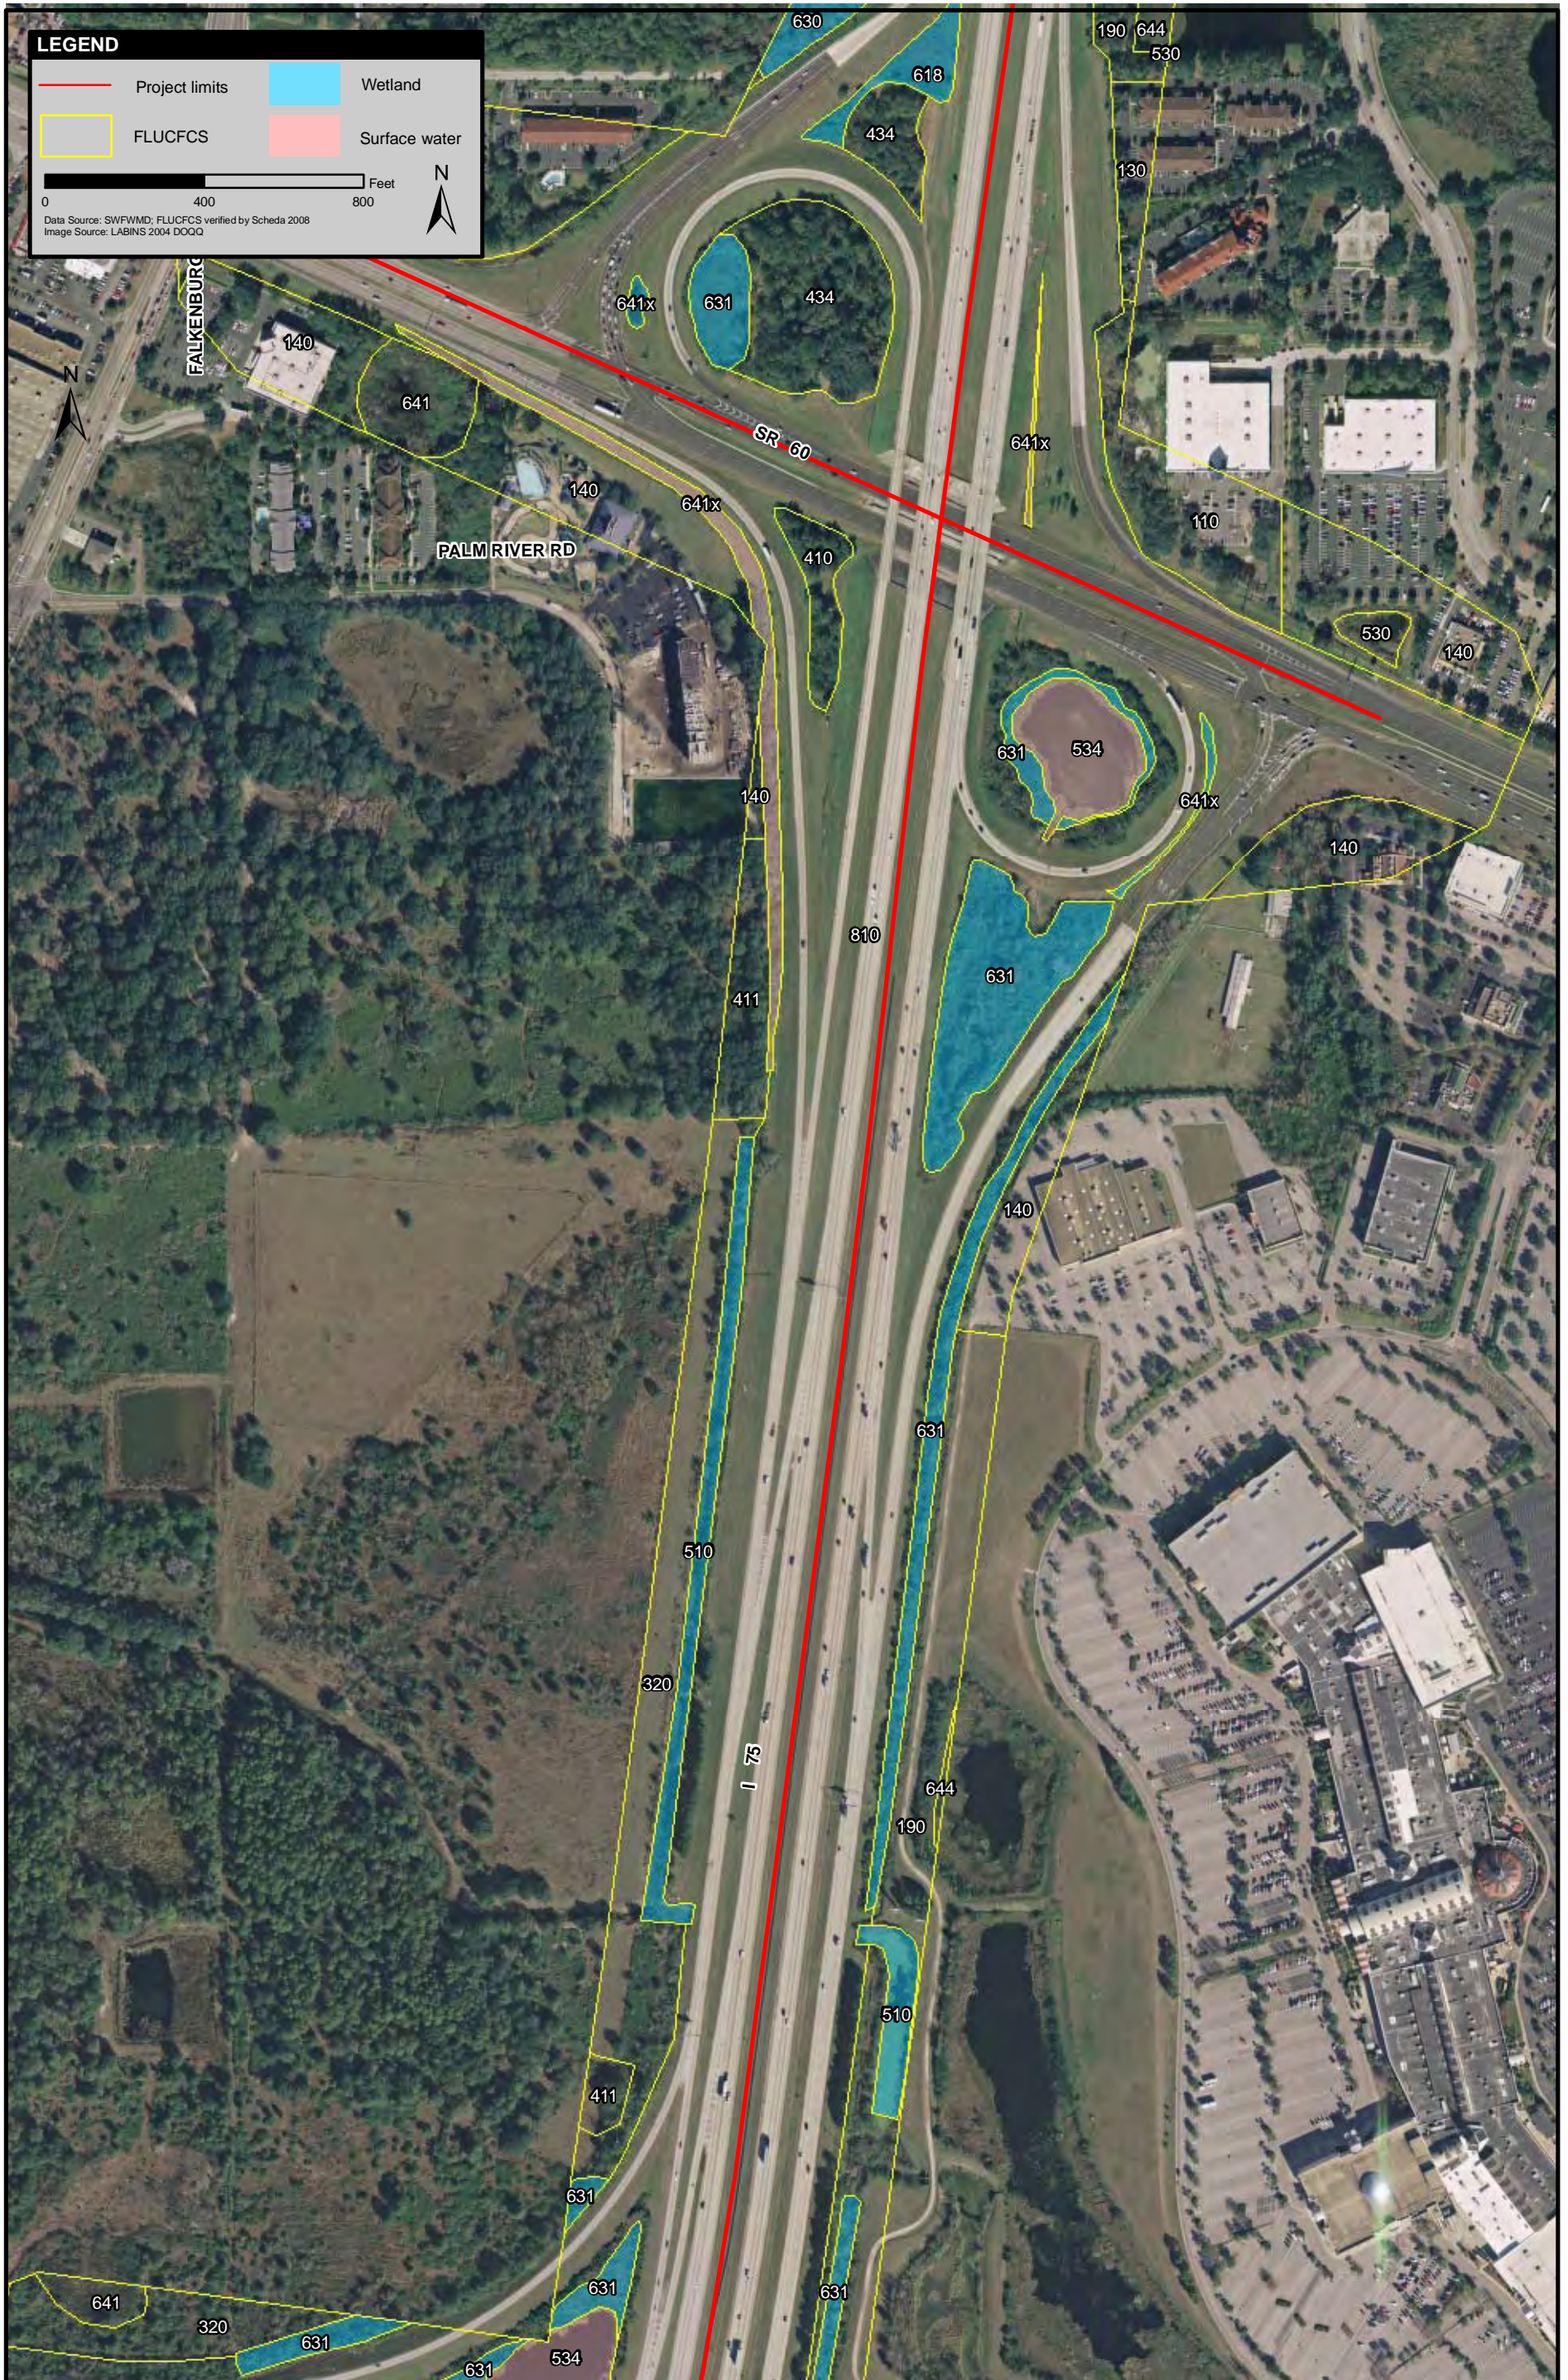
Figure 3-1  
Sheet 5 of 16

### EXISTING FLUCFCS, WETLANDS, AND SURFACE WATERS WITHIN PROJECT AREA

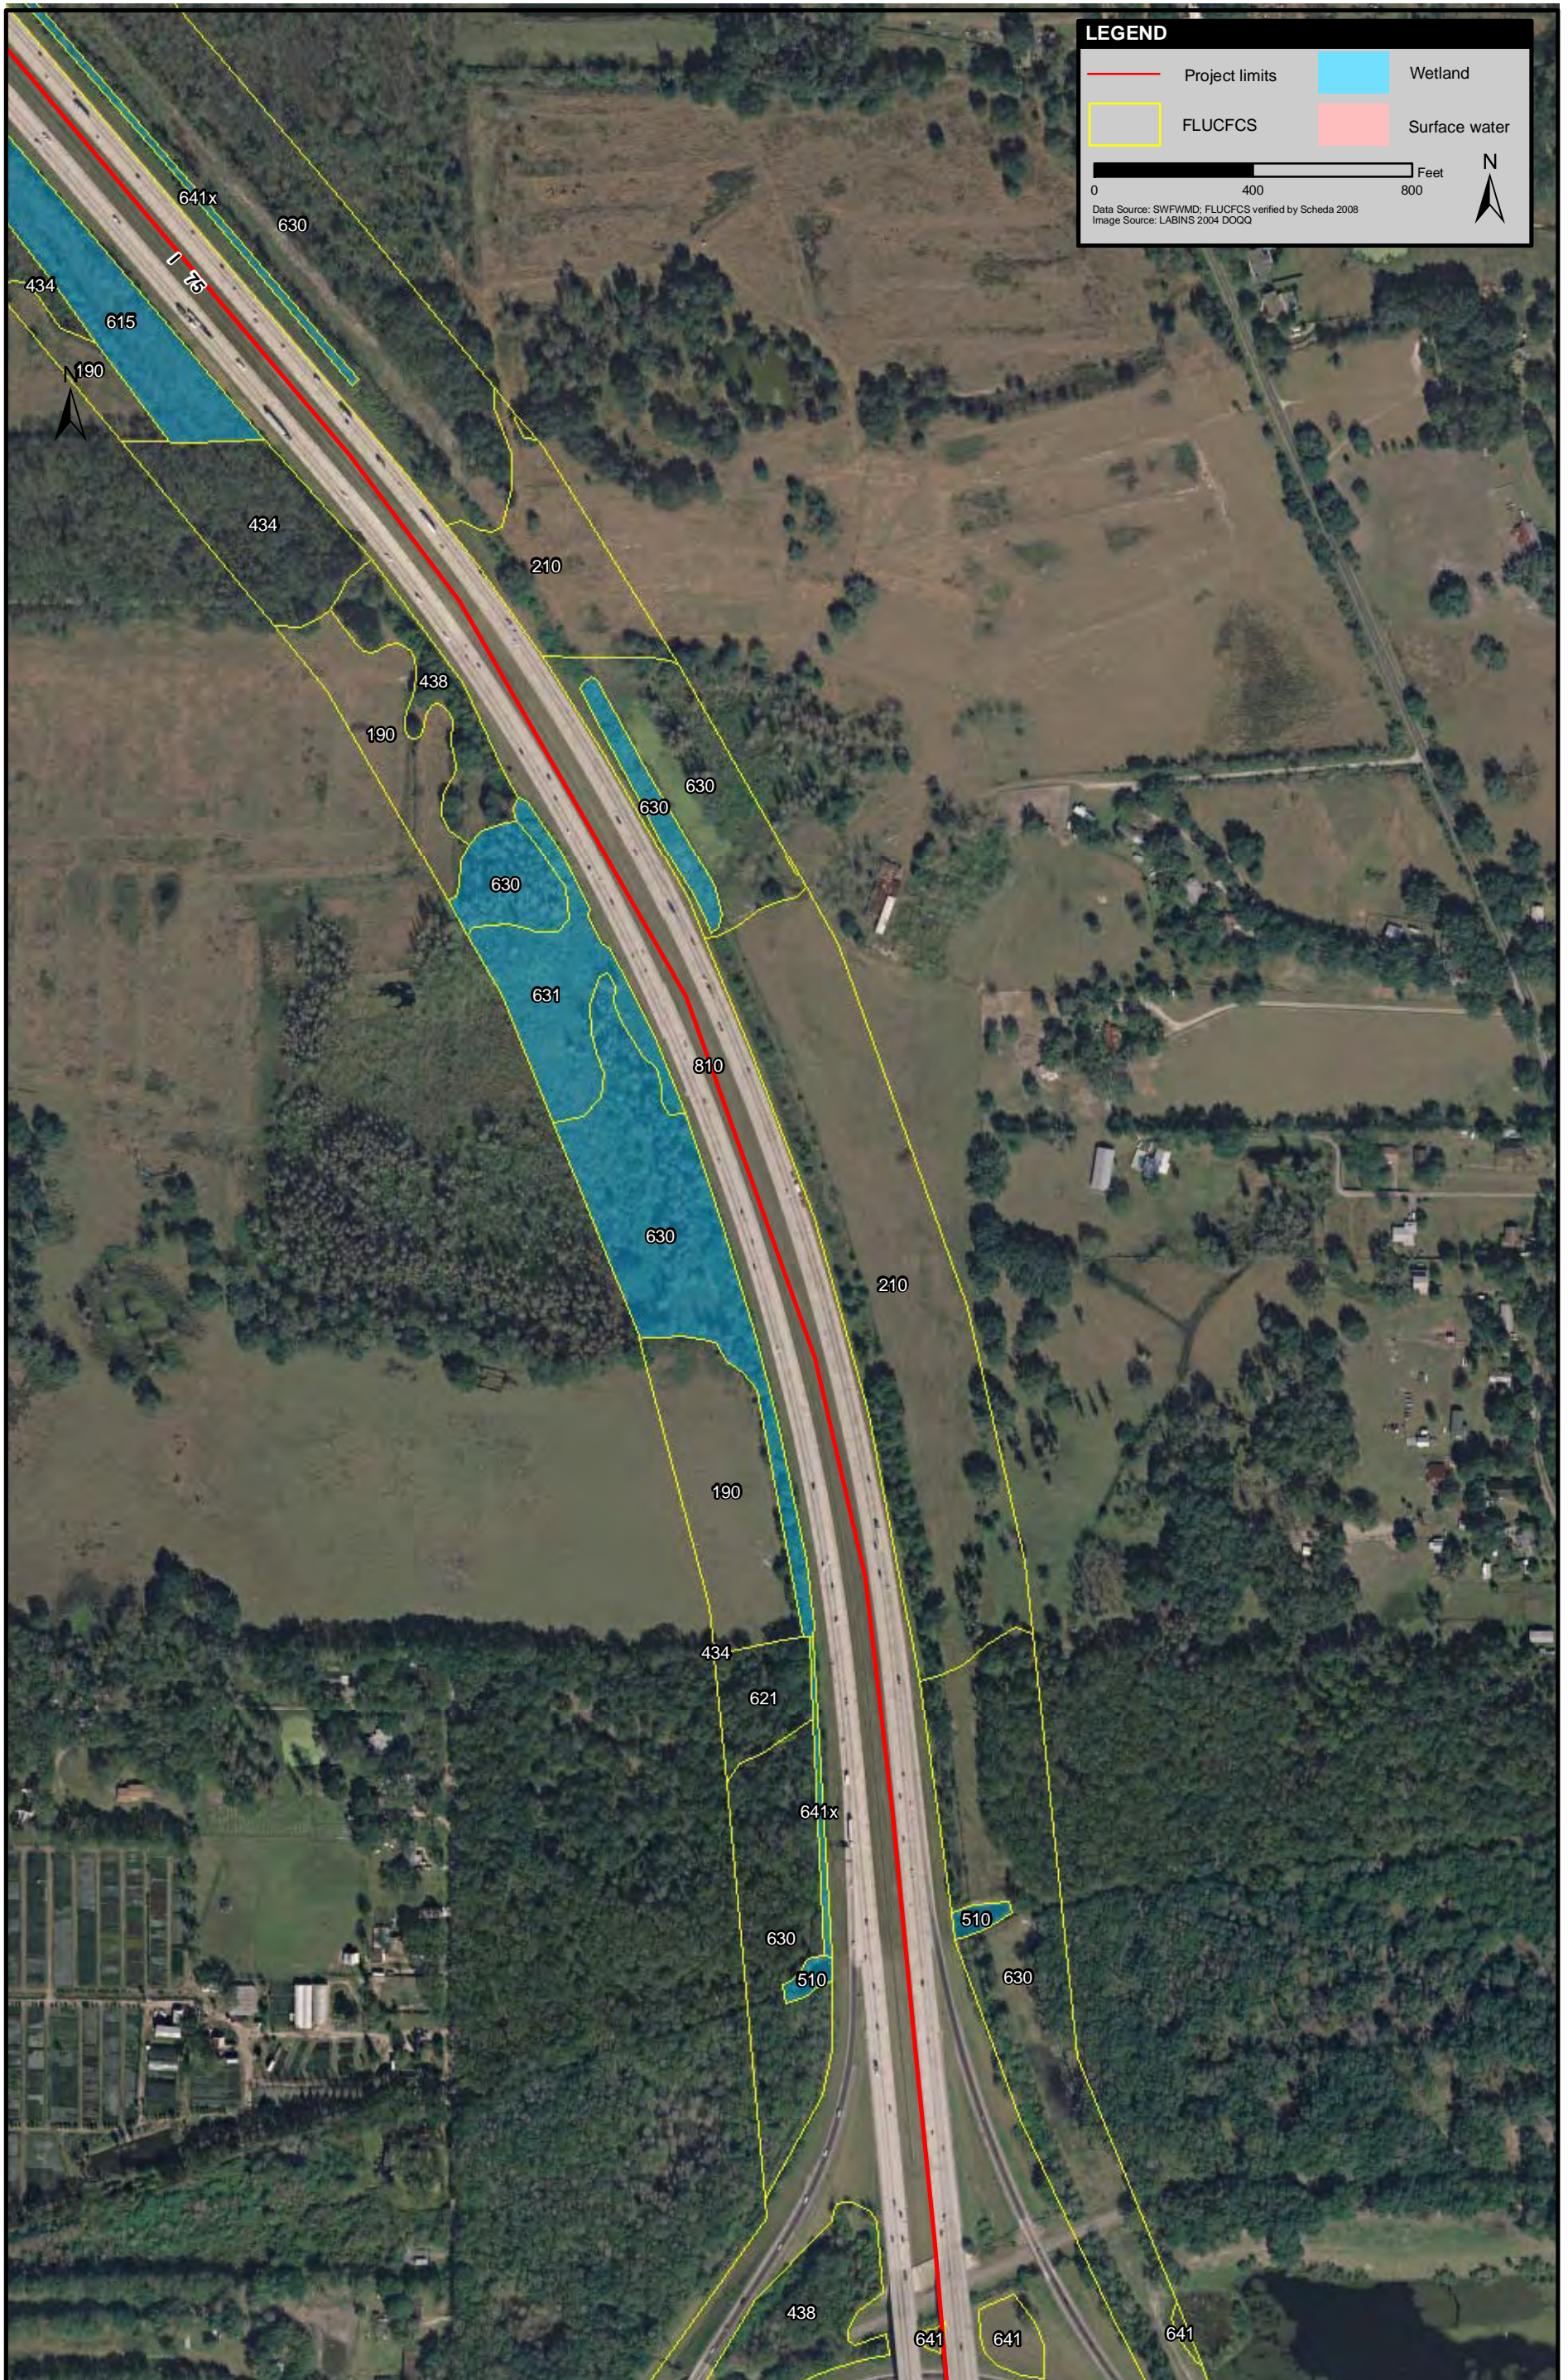
Figure 3-1  
Sheet 10 of 16

### EXISTING FLUCFCS, WETLANDS, AND SURFACE WATERS WITHIN PROJECT AREA

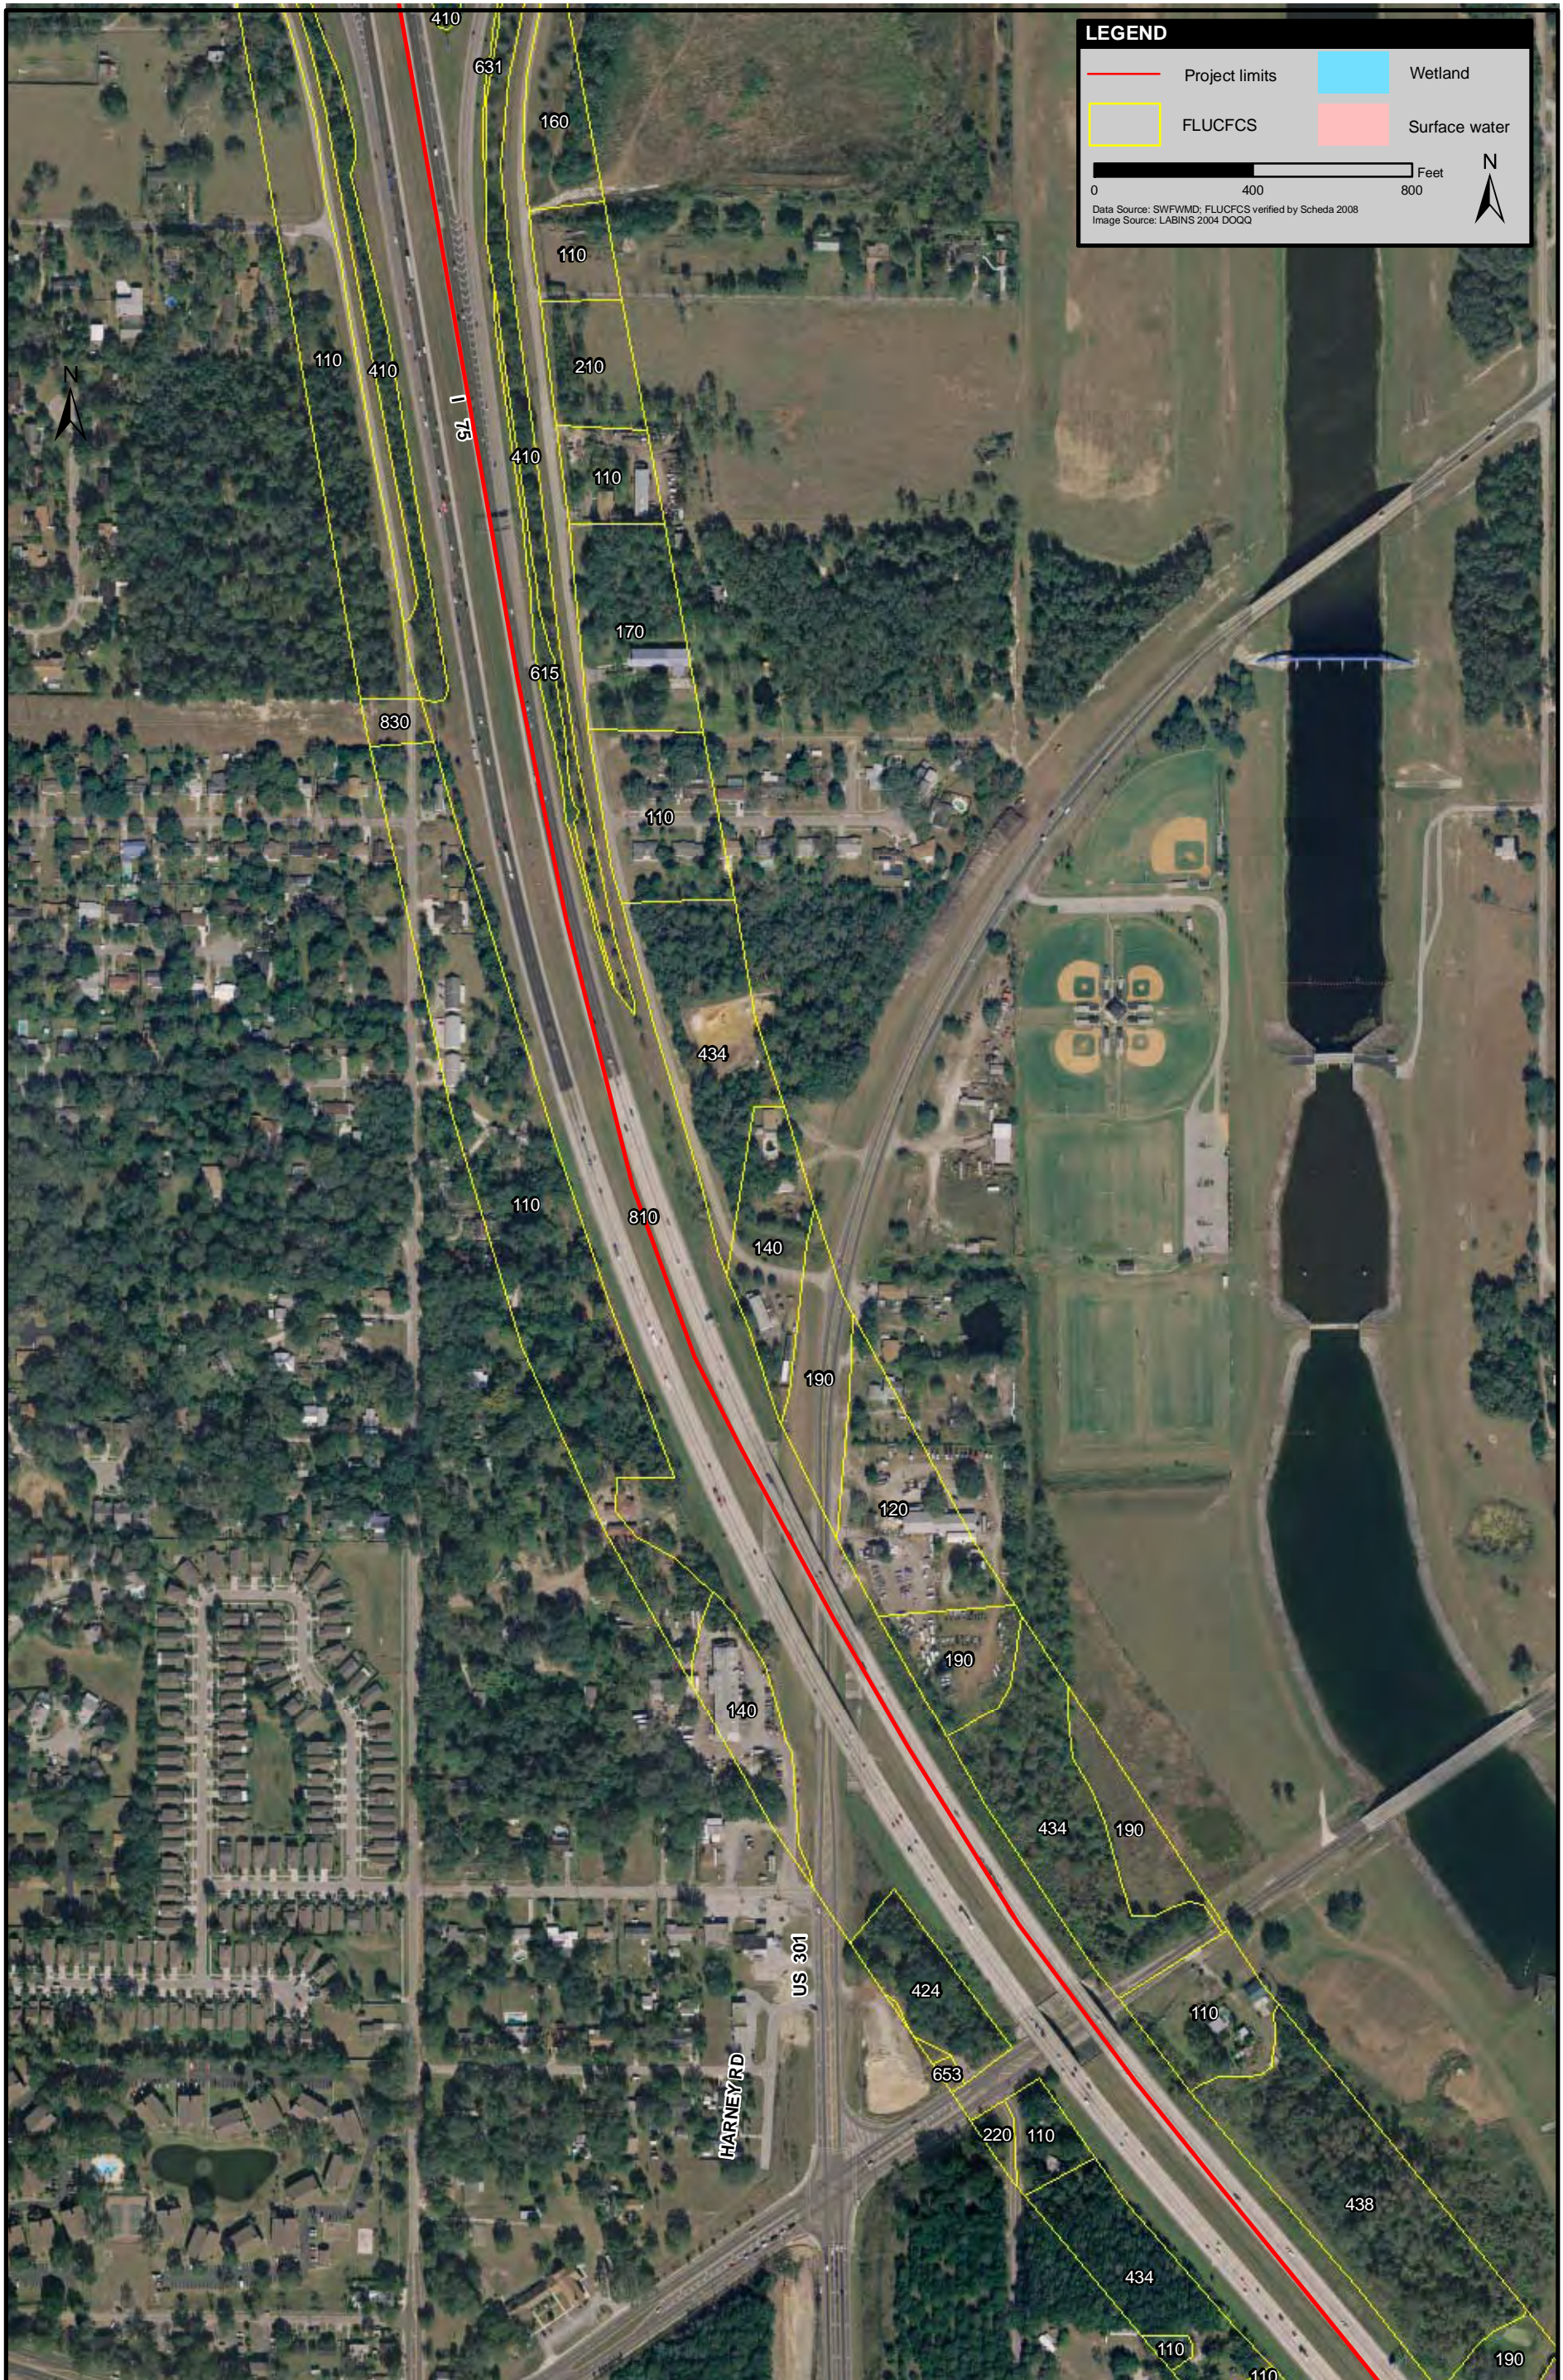
Figure 3-1  
 Sheet 12 of 16

**EXISTING FLUCFCS, WETLANDS, AND  
 SURFACE WATERS WITHIN PROJECT AREA**

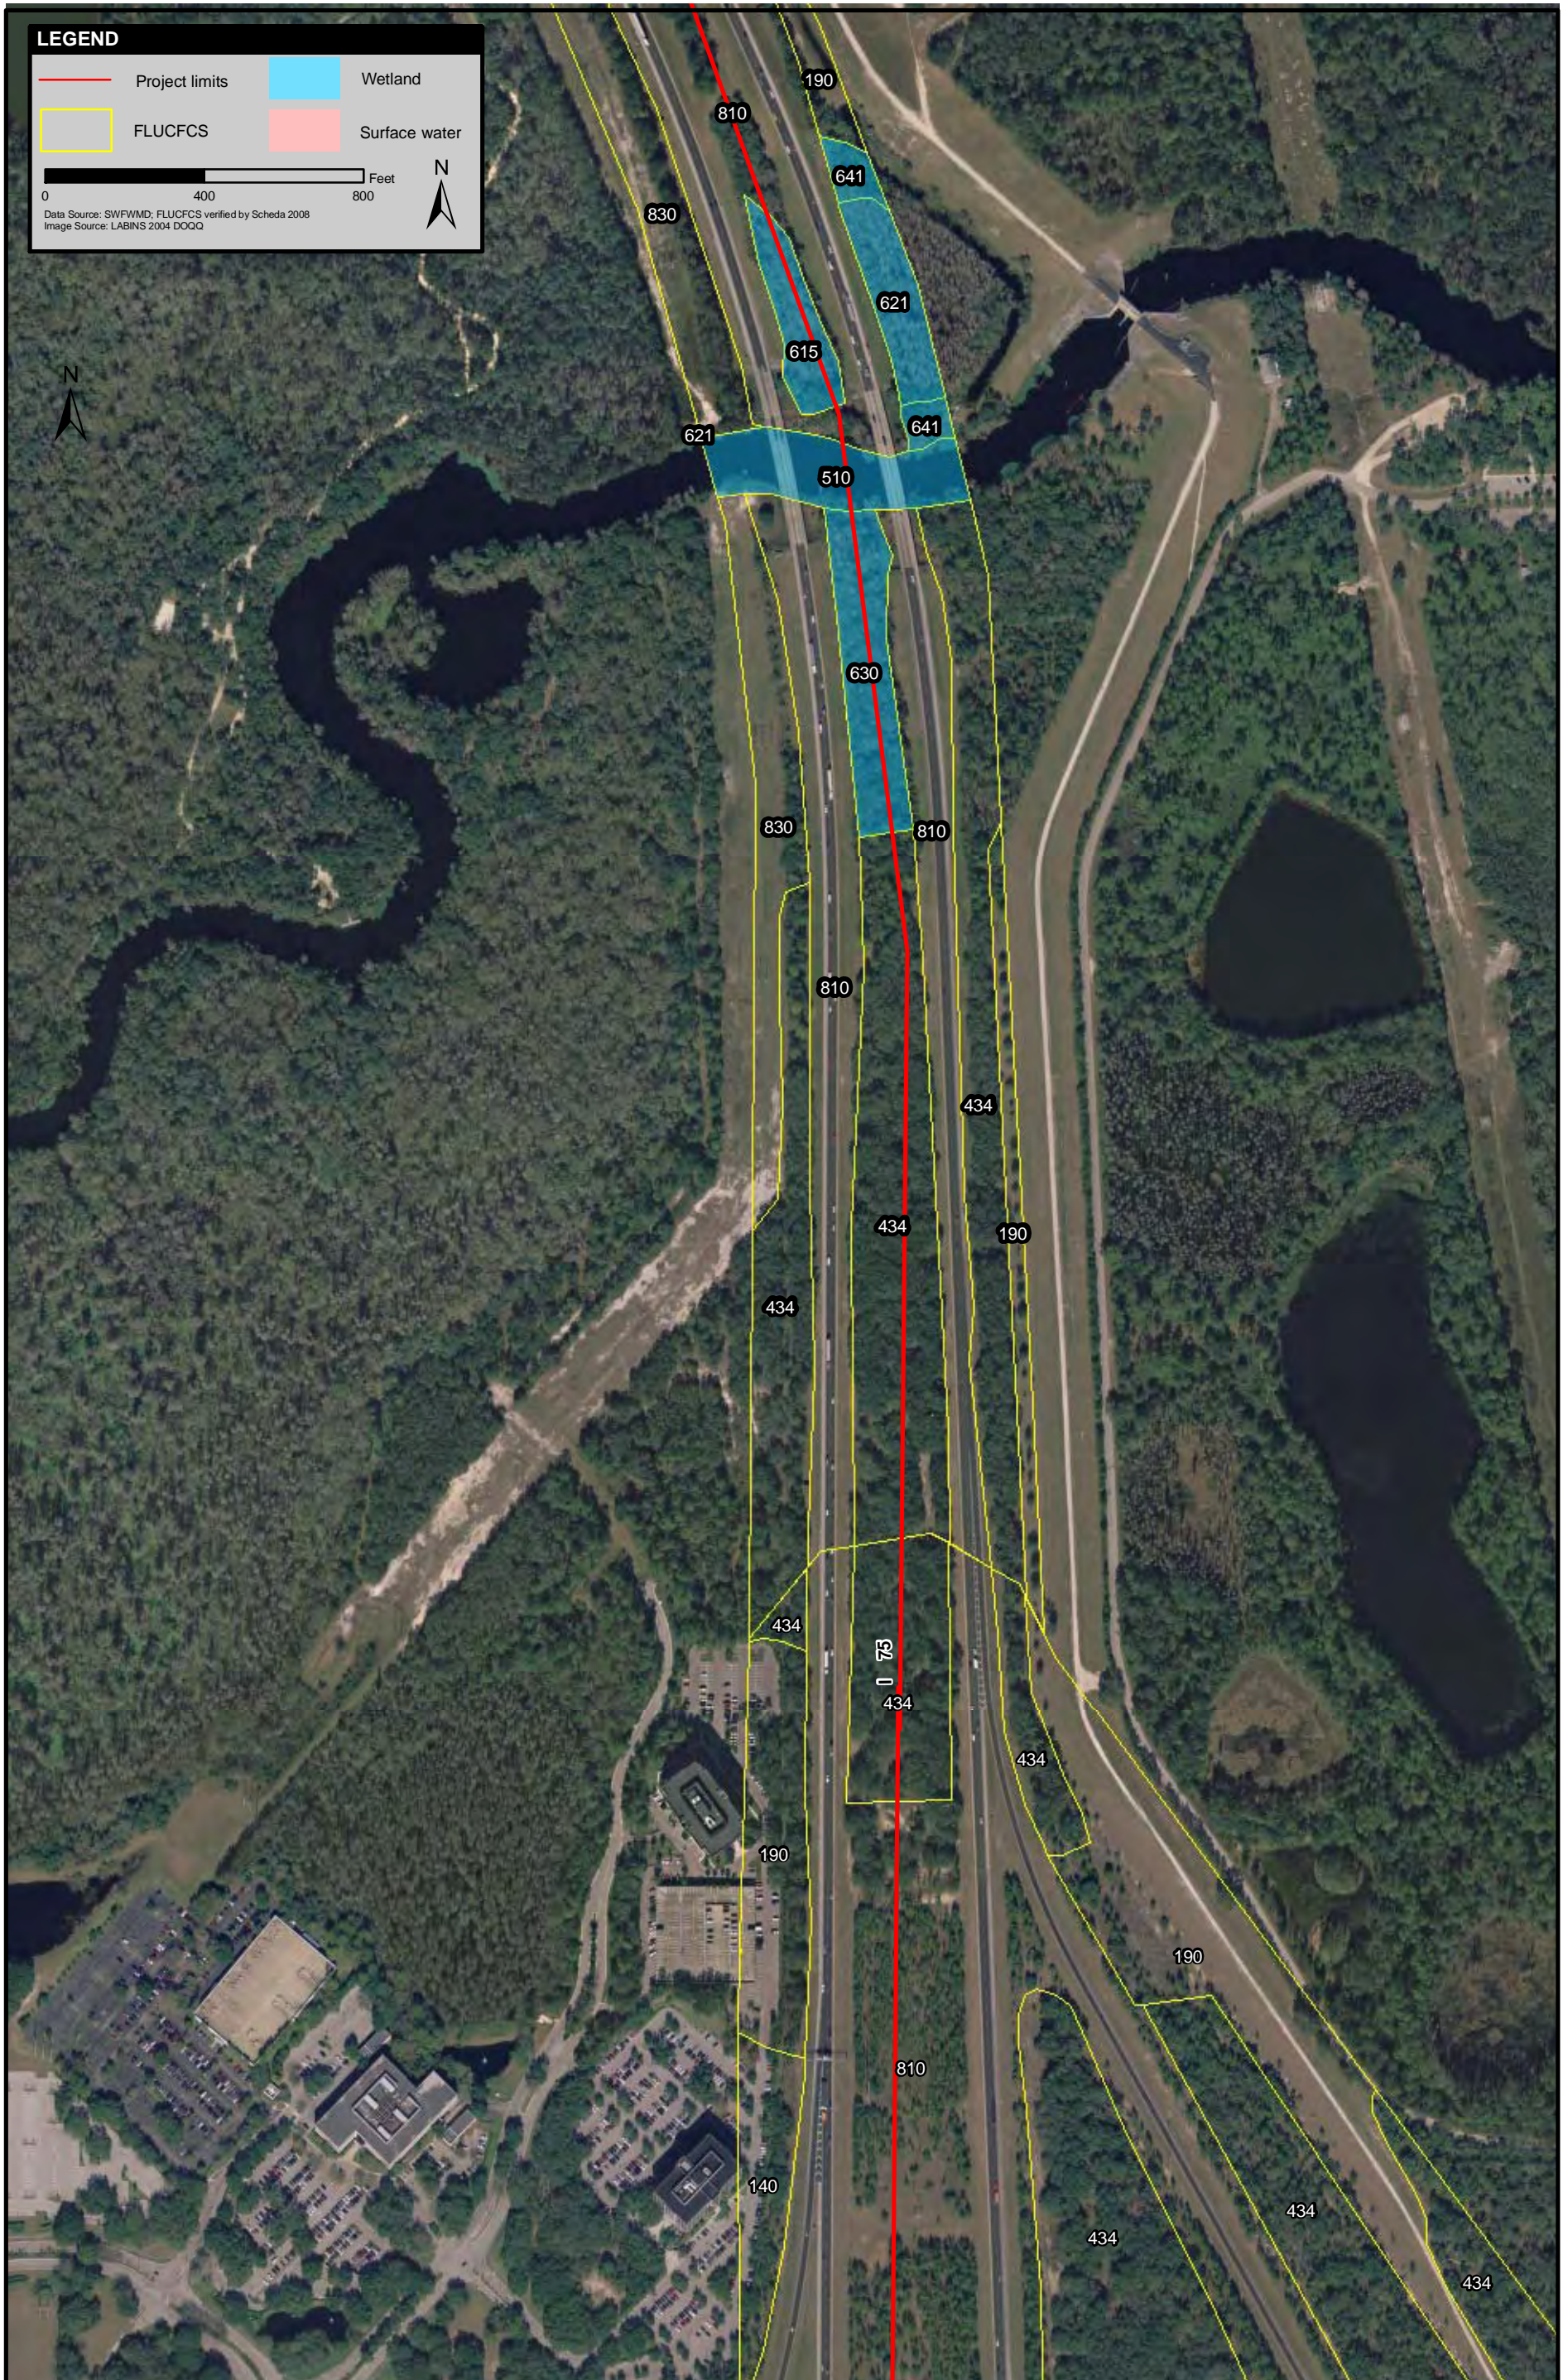
Figure 3-1  
Sheet 15 of 16

### EXISTING FLUCFCS, WETLANDS, AND SURFACE WATERS WITHIN PROJECT AREA
