# **McIntosh Road**

## **From South of US 92 to North of I-4**

#### ***Cultural Resource Assessment Technical Memorandum Preferred Stormwater Management Facilities (SMF) and Floodplain Compensation (FPC) Sites***

July 2024

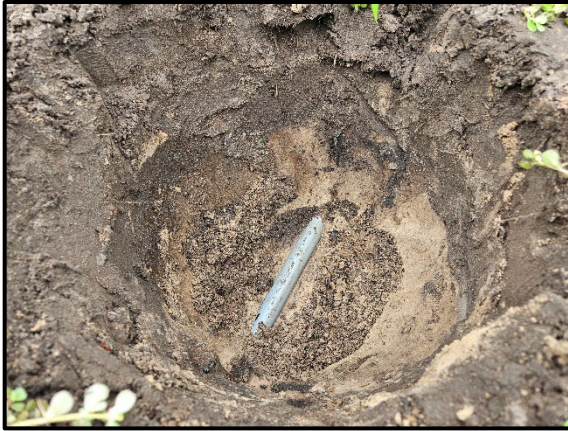
**Photo 14.** Stratigraphy in SMF 1 and 7-1, facing north. Note PVC utility pipe at bottom which prevented further digging.

Pond (acreage)	No. ST	Stratigraphy
SMF 1 and 7-1 (2.58)	6	0-20 cmbs dark brown sand, 20-60 cmbs brown sand, irrigation pipe at 60 cmbs ( <b>Photo 14</b> ) which prevented further digging; pond is in an existing agricultural field.
FPC 1-1 (3.21)	7	0-15 cmbs dark gray sand, 15-40 cmbs gray sand, 40-60 cmbs brown sand, 60-100 light brown sand ( <b>Photo 15</b> ) very compact which prevented uniformity in the shovel test; pond is in a mixed hammock adjacent to a recreational boardwalk path.
FPC 2-1 (5.46)	10	0-20 cmbs dark brown sand, 20-30 cmbs gray sand, 30-50 cmbs very dark brown sand, 50-100 light brown sand ( <b>Photo 16</b> ); pond is within an existing agricultural field surrounded by mixed hammock.
SMF 2-2 (2.51)	6	0-30 cmbs gray sand, 30-50 cmbs light gray sand, 50-70 cmbs dark brown sand, 70-100 cmbs light brown sand ( <b>Photo 17</b> ), very compact; pond is in an open pasture enclosure.

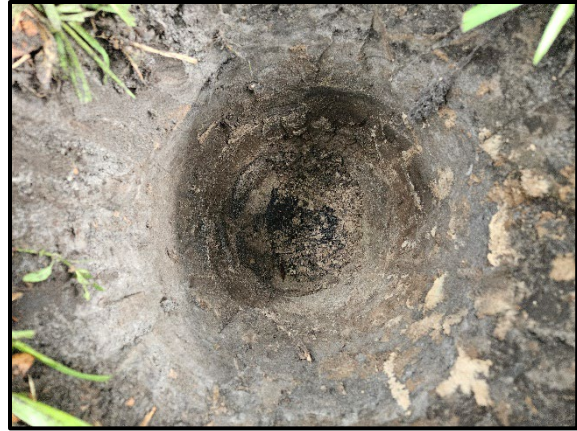
**Photo 15.** Stratigraphy in FPC 1-1, facing north; soil is very compact which prevented a uniform shovel test.

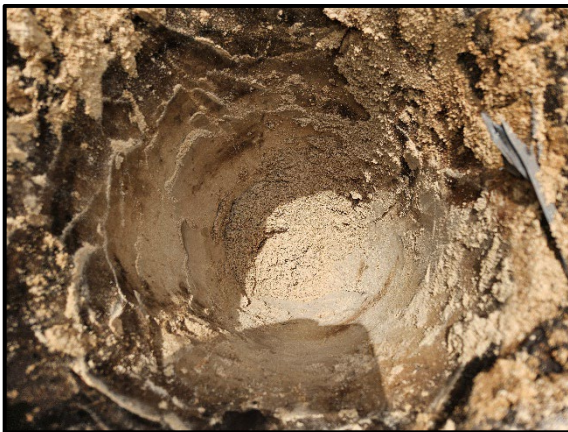
**Photo 16.** Stratigraphy in FPC 2-1, facing east.

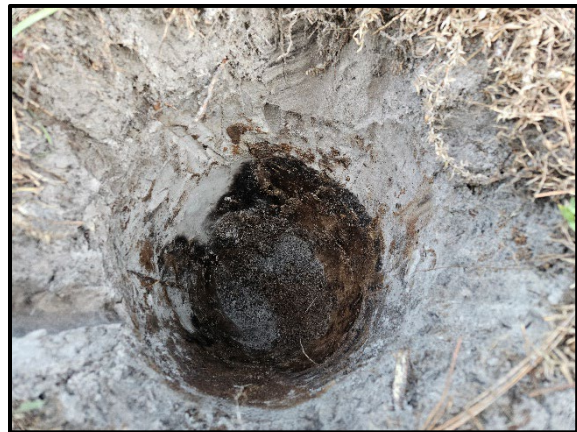
**Photo 17.** Stratigraphy in SMF 2-2, facing west; very compact at bottom.

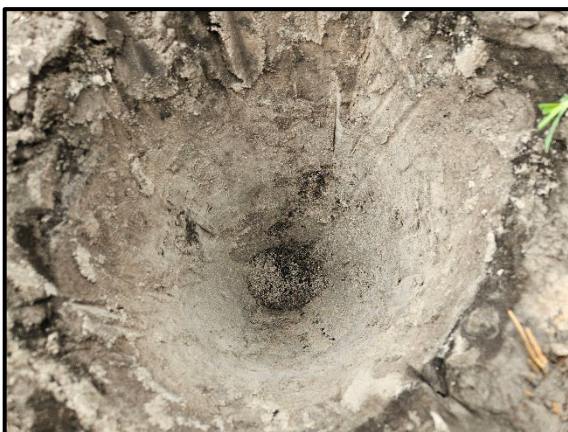
**Photo 18.** Stratigraphy in FPC 3-2, facing north; sandy soil kept collapsing the test unit preventing uniformity near the bottom.

FPC 3-2 (6.87)	10	0-10 cmbs gray sand, 10-60 cmbs light gray sand, 60-100 cmbs dark gray sand ( <b>Photo 18</b> ); soil kept collapsing near bottom preventing a uniform shovel test; Easement was not tested as it was along a roadway; pond is an existing agriculture field.
SMF 3-1 (3.35)	8	0-25 cmbs gray sand, 25-60 light gray sand, 60-70 cmbs very dark brown sand, 70-100 brown sand; pond is in a mixed hammock within a pasture enclosure.
FPC 4-1 (10.94)	15	0-20 cmbs brown sand, 20-35 cmbs light gray sand, 35-60 dark gray sand, 60-100 light brown damp sand ( <b>Photo 19</b> ); pond is within an open pasture enclosure.
SMF 5-2 (2.19)	5	0-20 cmbs gray sand, 20-50 cmbs dark gray sand, 50-60 light gray sand, 60-100 dark brown sand ( <b>Photo 20</b> ); pond is within an open pasture enclosure.
FPC 5-1 (1.64)	4	0-40 centimeters below surface (cmbs) dark brown sand, 40-70 cmbs gray sand, 70-100 brown sand, water intrusion at bottom; pond is within a residential lot with maintained grass.

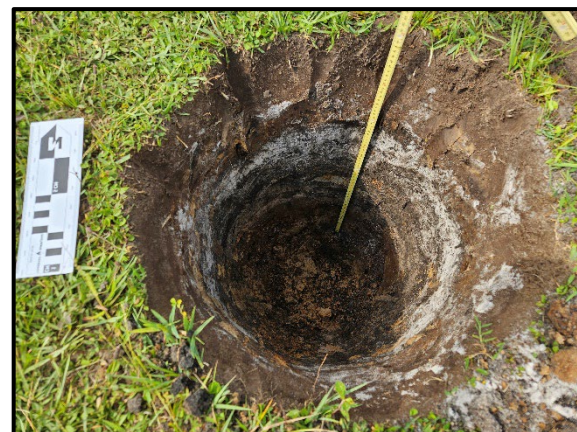
**Photo 19.** Stratigraphy in FPC 4-1, facing north.

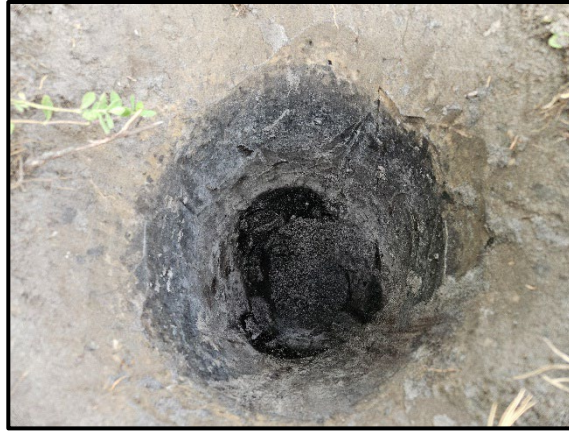
**Photo 20.** Stratigraphy in SMF 5-2, facing west.

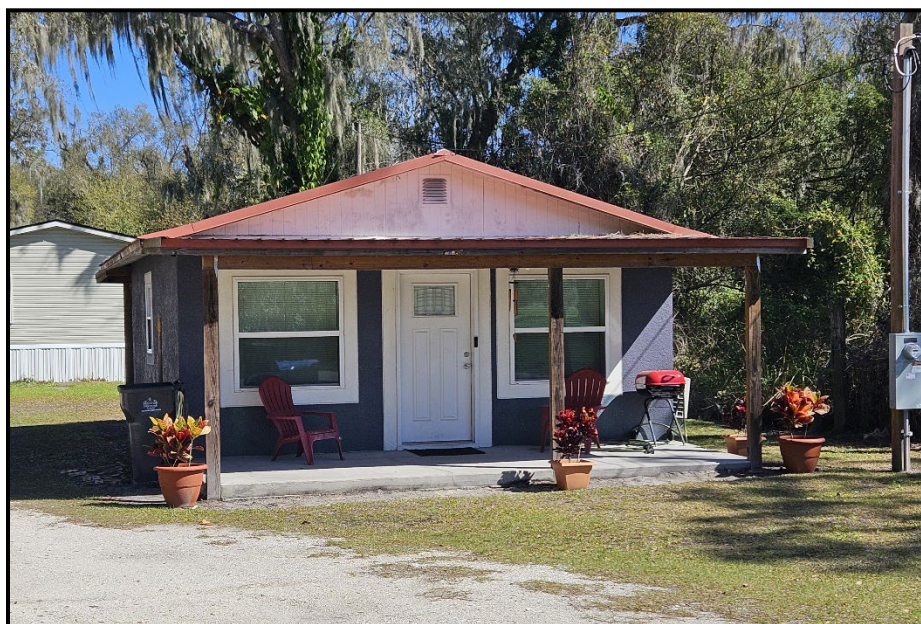
**Photo 21.** 4303 McIntosh Road (8HI15618), looking east.

**8HI15618:** The Frame Vernacular style building at 4303 McIntosh Road was constructed in ca. 1960 and is located adjacent to FPC 2-1 (**Photo 21**). The one-story, rectangular plan building rests on a concrete slab foundation and has a wood frame structural system clad in stucco with wood siding in the gable end. The front gable roof and shed roofs are covered with ribbed sheet metal. The main entryway is on the west elevation through a single door with paneling and inset leaded light within a full width open porch beneath a shed roof with squared wooden porch supports. Visible windows include individual one-over-one vinyl single-hung sash units. Distinguishing architectural features include overhanging eaves with boxed rafter tails, rectangular gable vents, and stucco trim around the windows and door. Alterations include replacement roofing, siding, and windows. A non-historic mobile home is located to the east of the building. Overall, the building has been altered, lacks sufficient architectural features, and is not a significant embodiment of a type, period, or method of construction. In addition, background research did not reveal any historic associations with significant persons and/or events. As a result, 8HI15618 does not appear eligible for listing in the NRHP, either individually or as part of a historic district.

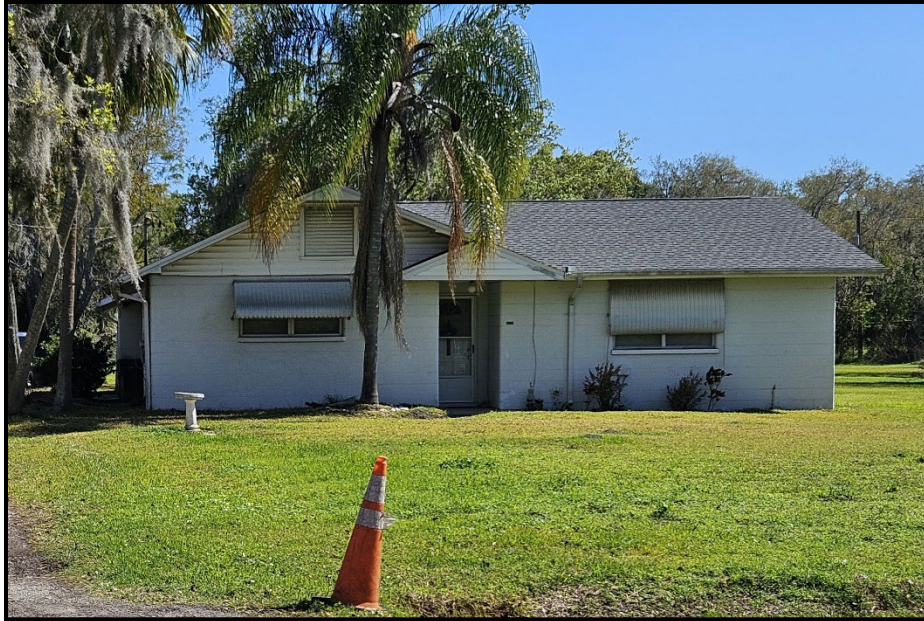
**Photo 22.** 9239 McIntosh Road (8HI15621), looking east.

**8HI15621:** The Masonry Vernacular style building at 9239 McIntosh Road was constructed in ca. 1968 and is located within FPC 5-1 (**Photo 22**). The one-story, irregular plan building rests on a concrete slab foundation and has a concrete block structural system clad in stucco and vinyl siding. The intersecting gable and gable roof addition are covered with composition shingles. The main entryway is on the west elevation through a single door with paneling, inset fanlight, and metal frame screen door recessed beneath the principal roof. Visible windows include a mixture of individual and paired, one-over-one metal single-hung sash units; paired four-stacked metal awning units; individual 10-stacked metal jalousie units. Distinguishing architectural features include overhanging eaves with boxed rafter tails, concrete windowsills, metal clamshell awning, a large rectangular gable vent, and stucco siding scored with horizontal lines. Alterations include replacement roofing and siding. A large-scale gable roof addition is located on the east elevation. Overall, the building has been altered, lacks sufficient architectural features, and is not a significant embodiment of a type, period, or method of construction. In addition, background research did not reveal any historic associations with significant persons and/or events. As a result, 8HI15621 does not appear eligible for listing in the NRHP, either individually or as part of a historic district.

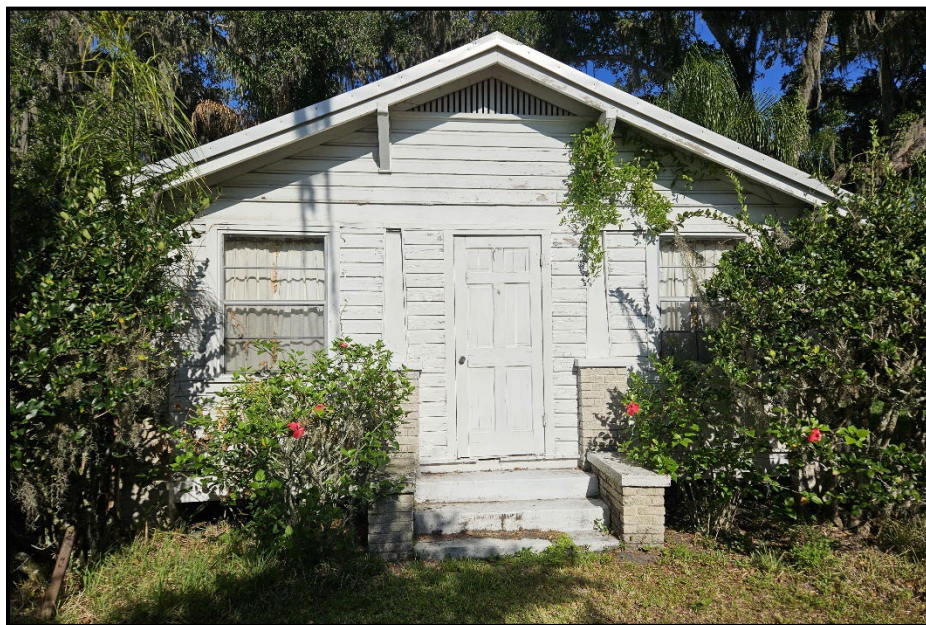
**Photo 23.** Dukes Farm (House) (8HI15640), looking west.

**8HI15640:** The Frame Vernacular style building at 12837 US 92 was constructed in ca. 1935 and is located approximately 130-feet north of SMF 1 & 7-1 (**Photo 23**). The one-story, T-shaped building rests on brick piers with a wood frame structural system with novelty siding. The roof is comprised of two intersecting gables covered with ribbed sheet metal. A brick chimney is located on the eave end of the south elevation but the stack above the roof line has been removed and roofed over. The main entryway is on the east elevation through an individual wooden door with paneling accessed by three concrete steps flanked by brick piers. The entryway is flanked by two tapered wooden posts resting on brick piers which are remnants of the incised, full width porch that has been enclosed on the east elevation. Visible windows include a mixture of individual and paired one-over-one wood single-hung sash units, and individual and paired two-over-two metal single-hung sash units. Distinguishing architectural features also include

overhanging eaves with exposed rafter tails, diamond-shaped gable vents, wooden knee braces, corner boards, and wood trim around the windows and doors. Alterations include replacement roofing, windows, and siding, as well as the enclosure of the east elevation porch. This building is a contributing resource within the Dukes Farm (8HI15639) building complex resource group and is located northeast of the Dukes Farm outbuilding (8HI15642) and north of the Dukes Farm barn (8HI15641). Overall, the building has been altered, lacks sufficient architectural features, and is not a significant embodiment of a type, period, or method of construction. In addition, background research did not reveal any historic associations with significant persons and/or events. As a result, 8HI15640 does not appear eligible for listing in the NRHP, either individually or as part of a historic district.

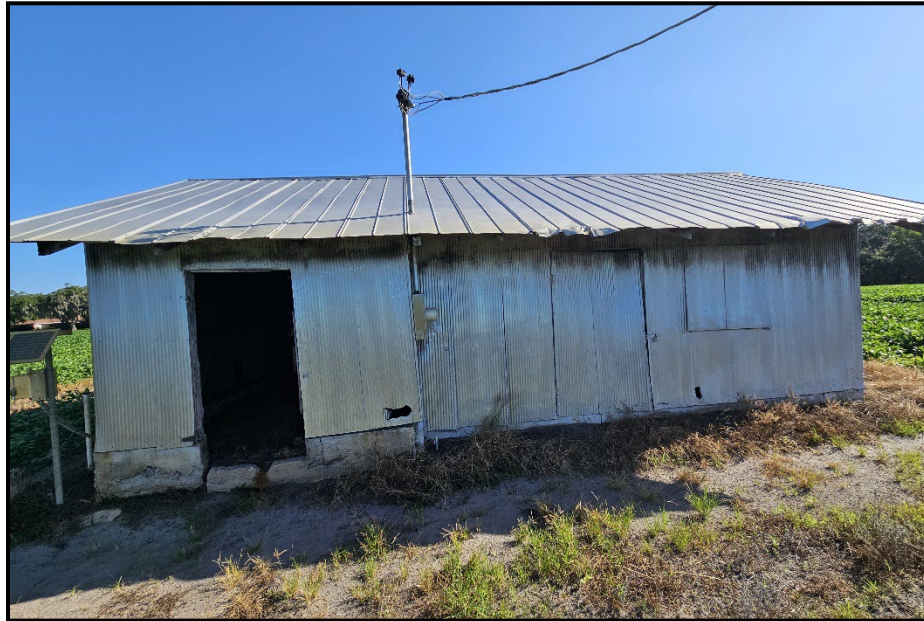
**Photo 24.** Dukes Farm (Barn) (8HI15641), looking north.

**8HI15641:** The Frame Vernacular style building at 12837 US 92 was constructed between ca. 1915 and 1935 and is located 15-ft south of SMF 1 & 7-1 (**Photo 24**). The one-story rectangular building rests on a concrete continuous foundation with a wood frame structural system with sheet metal exterior walls. The side gable roof is covered with 3V crimp sheet metal. The main entryway is located on the south elevation and is comprised of an individual rectangular opening – a door is not visible. Visible windows include an individual six pane wood fixed unit. Several other windows are covered with plywood or metal siding. Distinguishing architectural features also include overhanging eaves with exposed rafter tails. Alterations include replacement roofing and siding, and the enclosure of several windows. This building is a contributing resource within the Dukes Farm (8HI15639) building complex resource group and is located south of the Dukes Farm house (8HI15640) and southeast of the Dukes Farm outbuilding (8HI15642). Overall, the building has been altered, lacks sufficient architectural features, and is not a significant embodiment of a type, period, or method of construction. In addition, background research did not reveal any historic associations with significant persons and/or events. As a result, 8HI15641 does not appear eligible for listing in the NRHP, either individually or as part of a historic district.

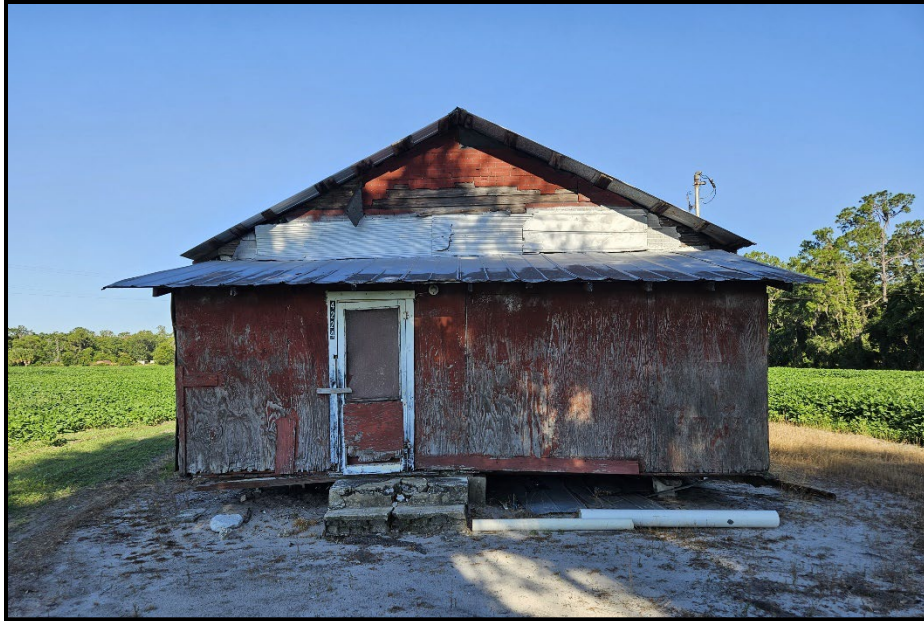
**Photo 25.** Dukes Farm (Outbuilding) (8HI15642), looking west.

**8HI15642:** The Frame Vernacular style building at 12837 US 92 was constructed in ca. 1915 and is located 135-ft southeast of FPC 1-1 (**Photo 25**). The one-story rectangular building rests on a concrete block pier foundation and has a wood frame structural system covered with wood siding and plywood. Sheet metal has been used to repair the building where the shed roof meets the gable ends. The gable roof and shed roofs are covered with 3V crimp sheet metal. The main entryway is located on the east elevation through a single door with a metal frame storm door and is accessed by two concrete steps. The entryway is located on the exterior wall of a full width open porch beneath a shed roof that has been enclosed with plywood siding. A partial width open porch beneath a shed roof with wooden porch supports is located on the west elevation. The porch appears to have originally been full width but has been partially enclosed. Visible windows include individual four-stacked metal awning units; individual one-over-one wood single-hung sash units; individual one-over-one metal single-hung sash units. One window is boarded with plywood. Distinguishing architectural features include overhanging eaves with exposed rafter tails. Alterations include replacement roofing, windows, and siding, and enclosed porches. At least one shed roof addition is located on the west elevation. This building is a contributing resource within the Dukes Farm (8HI15639) building complex resource group and is located southwest of the Dukes Farm house (8HI15640) and north-west of the Dukes Farm barn (8HI15641). Overall, the building has been altered, lacks sufficient architectural features, and is not a significant embodiment of a type, period, or method of construction. In addition, background research did not reveal any historic associations with significant persons and/or events. As a result, 8HI15642 does not appear eligible for listing in the NRHP, either individually or as part of a historic district.
