McIntosh Road

Project Development & Environment (PD&E) Study

Cultural Resource Assessment Technical Memorandum

Additional Preferred Stormwater Management Facilities (SMF) and Floodplain Compensation (FPC) Sites

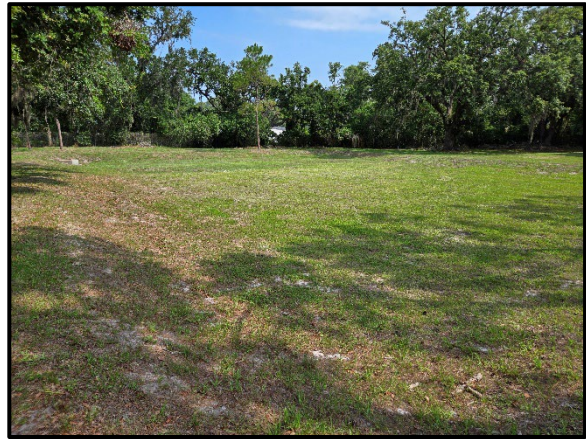
Photo 6. General environment with drainage ditch behind metal warehouse within FPC 3-3, facing north.

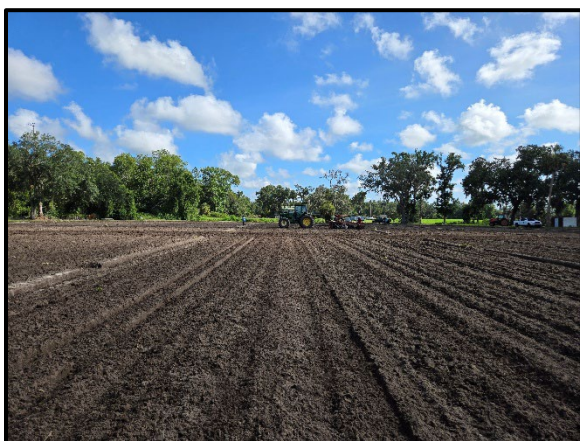
Photo 11. Agricultural row in the west half of FPC 3-2A undergoing active tilling, facing north.

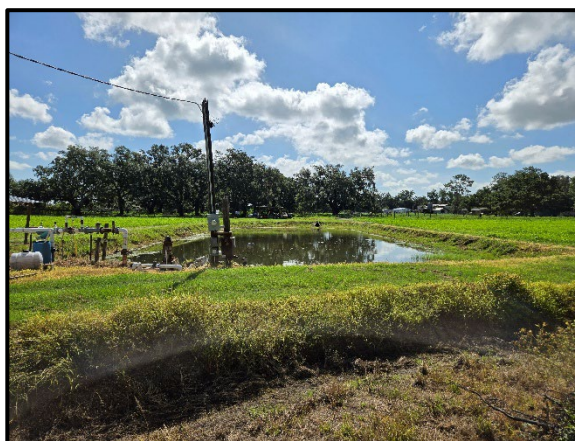
Photo 12. Example of retention pond within northeast corner of FPC 3-2A, facing east.

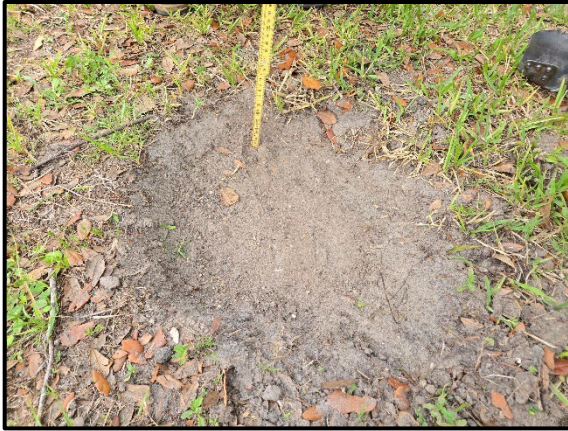
Photo 13. Stratigraphy within SMF 1 & 7-3, facing southwest. Note early termination due to near surficial compact fill.

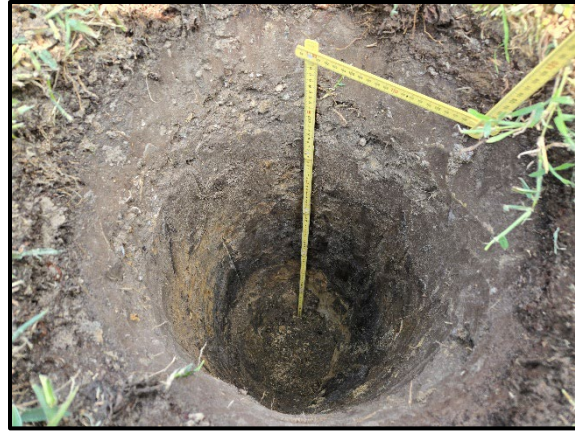
Photo 14. Stratigraphy within SMF 2-3, facing west.

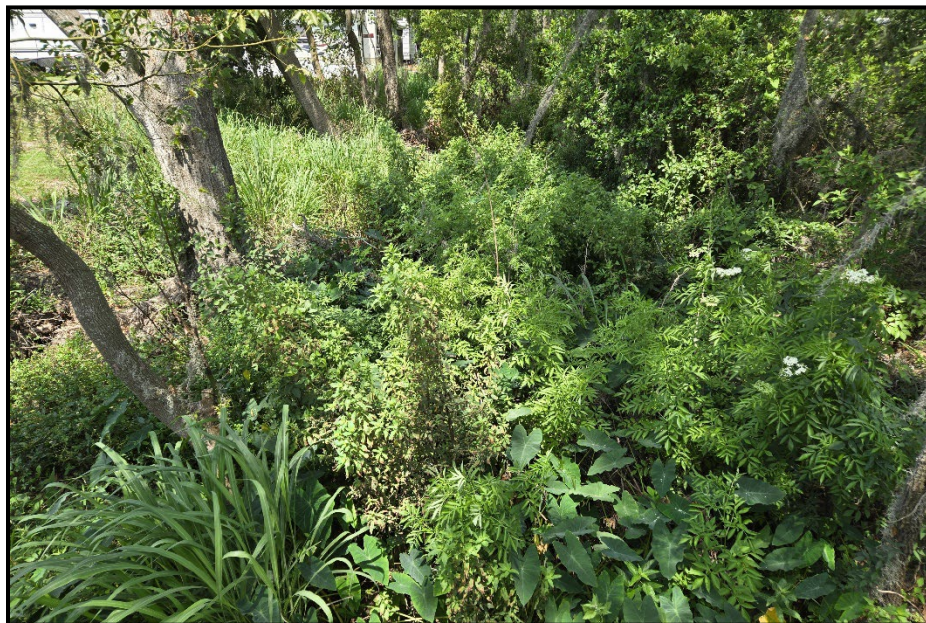
Photo 15. Baker Creek Canal (8HI15616), looking west.

8HI15616: The segments of the Baker Creek Canal within the APE are located in Section 30 of Township 28 South, Range 21 East (USGS 1975). The canal flows through FPC 3-3, SMF 1 & 7-3, and FPC 3-2A. The canal was dredged ca. 1938 or earlier and spans from Baker Creek in the west to south of US 92 in the east—a distance of roughly 1.5 miles in its entirety (USDA 1938). The segments within the APE are located to the east and west of McIntosh Road and approximately 0.76 miles long in total and 15 ft wide with steep earthen banking. The main segment within the APE runs through agricultural fields in the east, then east-west before turning northwest-southeast and the secondary segment runs northeast-southwest. The canal within the APE is heavily overgrown with surrounding vegetation (**Photo 15**). A portion of the canal with the APE was recorded during the 2024 mainline CRAS and was evaluated by the surveyor as ineligible for listing in the NRHP but was determined to have insufficient information for evaluating NRHP eligibility by the SHPO (Survey No. 29426) (ACI 2024). Overall, the segments of the

linear resource are common examples of a drainage canal found throughout Florida and Hillsborough County, lack unique design and engineering features, and background research did not reveal any historic associations with significant persons and/or events. As a result, 8HI15616 within the APE does not appear eligible for listing in the NRHP, either individually or as part of a historic district; however, there is insufficient information to evaluate the linear resource as whole.

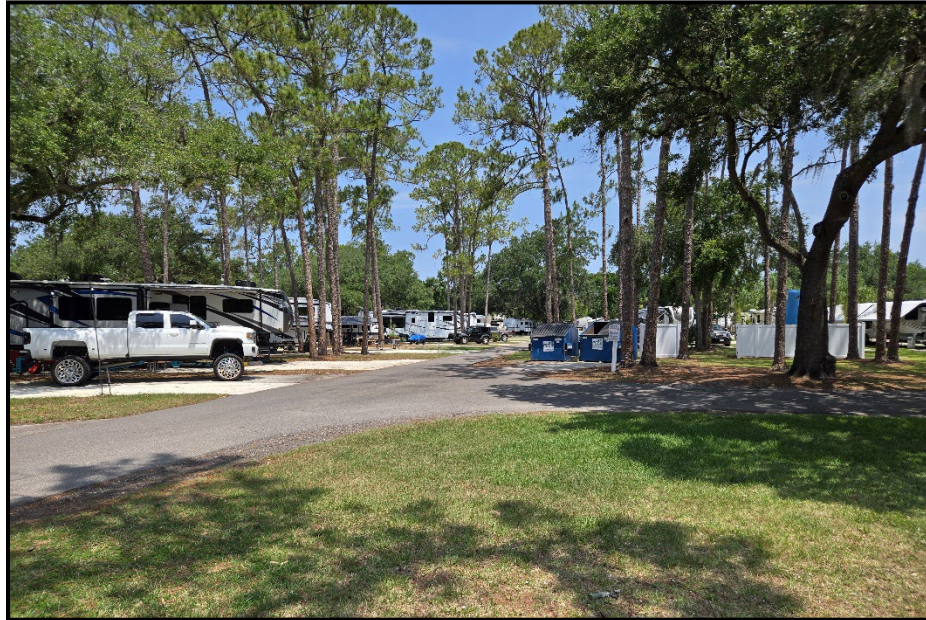
Photo 16. Tampa East RV Resort (8HI16268), looking north.

8HI16268: The Tampa East RV Resort is a building complex resource group located at 12870 US 92 in Section 30 of Township 28 South, Range 21 East (USGS 1975) (**Photo 16**). The resource is located adjacent to FPC 3-3 and SMF 1 & 7-3. The building complex resource group was established ca. 1980 and is comprised of a ca. 1980 community center building and numerous concrete pads for RV parking. Amenities include a swimming pool, shuffleboard court, and tennis courts. The only historic permanent building on the property is the community center which is located outside of the APE. The RV resort is contained within Hillsborough County parcel No. U-30-28-21-ZZZ-000003-78880.0 to the north of US 92 and west of McIntosh Road. The parcel boundary includes additional properties to the west and north, but the resource boundary only includes the historic boundary of the RV park (**Figure 7**). The Tampa East RV Resort is comprised of one main loop, Air Stream Avenue, with approximately eight north-south streets within the loop and two east-west streets. The concrete pads for RV parking are angled with the short end of the pad facing the roadway and as such, most are situated northeast-southwest. The Tampa East RV Resort first appears on historic aerial photographs ca. 1980, at which time the majority of the street plan had been established and the community center, swimming pool, and shuffleboard court had been constructed (FDOT 1980) (**Figure 7**). The RV parking spots were not paved with concrete pads until the 2000s and the tennis court was not constructed until ca. 2015 (Google Earth 2025). The RV resort appears to have connected with the adjacent RV/mobile home park during the 1990s when Air Stream Avenue was extended to the west. Overall, Tampa East RV Resort is a common example of an RV park found throughout Florida and is not a significant embodiment of a type, period, or method of construction. Background research did not reveal any historic associations with significant persons and/or events. As a result, 8HI16268 does not appear eligible for listing in the NRHP, either individually or as part of a historic district.

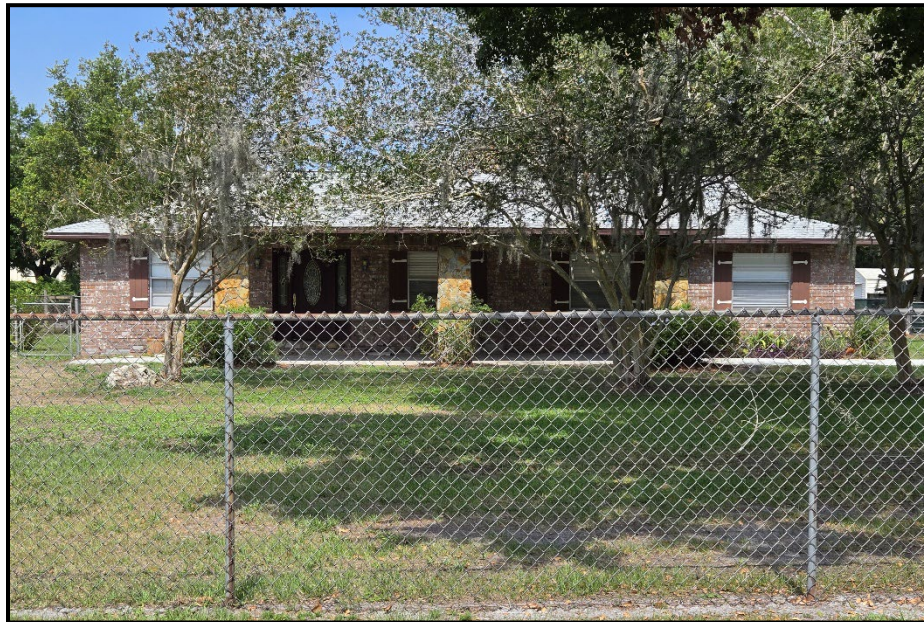
Photo 17. 4540 McIntosh Road (Residence) (8HI16269), looking west.

8HI16269: The Masonry Vernacular style residence at 4540 McIntosh Road was constructed ca. 1980 (**Photo 17**). The resource is located adjacent to FPC 3-3. The one-story, irregular plan building rests on a continuous concrete block foundation and has a concrete block structural system clad in brick veneer. The gable on hip roof and standard hip roofs are covered with composition shingles. A masonry chimney is located within the ridge of the principal roofline. The main entryway is on the east elevation through a single door with paneling, inset oval light, and sidelights. The entryway is within a partial width open porch

beneath a hip roof with squared porch supports covered with brick veneer. The porch was originally a carport. Visible windows include individual two-over-two metal single-hung sash units. Distinguishing architectural features include overhanging eaves with boxed rafter tails, brick windowsills, and faux shutters. Alterations include replacement roofing. A ca. 1980 outbuilding (8HI16270) is located to the north of the residence and a non-historic prefabricated metal outbuilding is located to the west. Overall, the building has been altered, lacks sufficient architectural features, and is not a significant embodiment of a type, period, or method of construction. In addition, background research did not reveal any historic associations with significant persons and/or events. As a result, 8HI16269 does not appear eligible for listing in the NRHP, either individually or as part of a historic district.

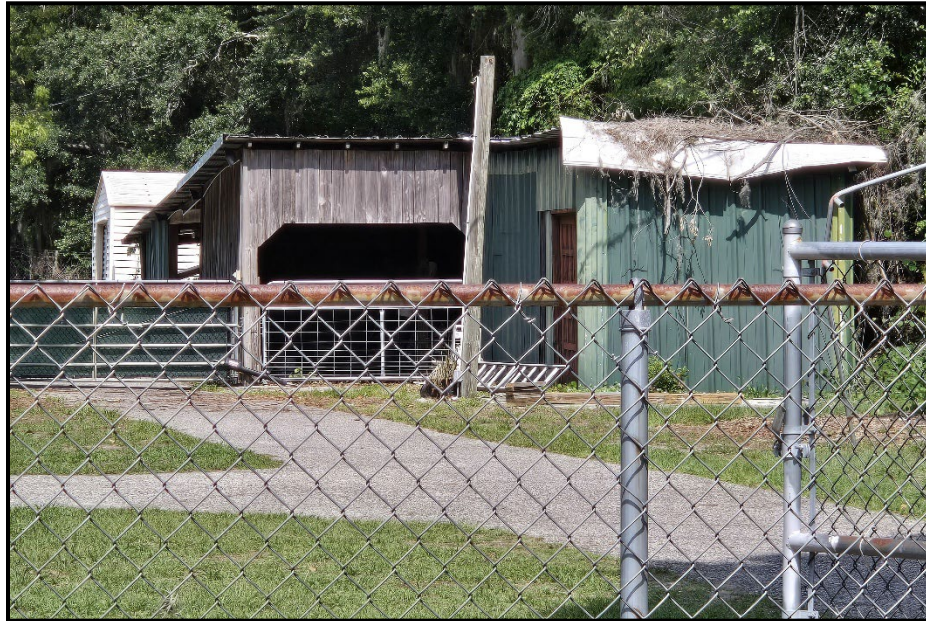
Photo 18. 4540 McIntosh Road (Outbuilding) (8HI16270), looking west.

8HI16270: The outbuilding with no style at 4540 McIntosh Road was constructed ca. 1980 (**Photo 18**). The resource is located adjacent to FPC 3-3. The one-story, irregular plan building rests on a concrete slab foundation and has a wood frame structural system clad in various metal sidings and wood. The shed roofs are covered with 3V crimp sheet metal. The main entryway is on the south elevation through a single door with rectangular paneling. No windows are visible on the outbuilding. Distinguishing architectural features include exposed rafter tails and an open-air bay. The bay opening is equipped with a metal gate. Alterations include replacement roofing and siding. Additions include the shed roof segment on the west elevation. A ca. 1980 Masonry Vernacular style residence (8HI16269) is located to the south of the outbuilding and a non-historic prefabricated metal outbuilding is located to the southwest. Overall, the building has been altered, lacks sufficient architectural features, and is not a significant embodiment of a type, period, or method of construction. In addition, background research did not reveal any historic associations with significant persons and/or events. As a result, 8HI16270 does not appear eligible for listing in the NRHP, either individually or as part of a historic district.

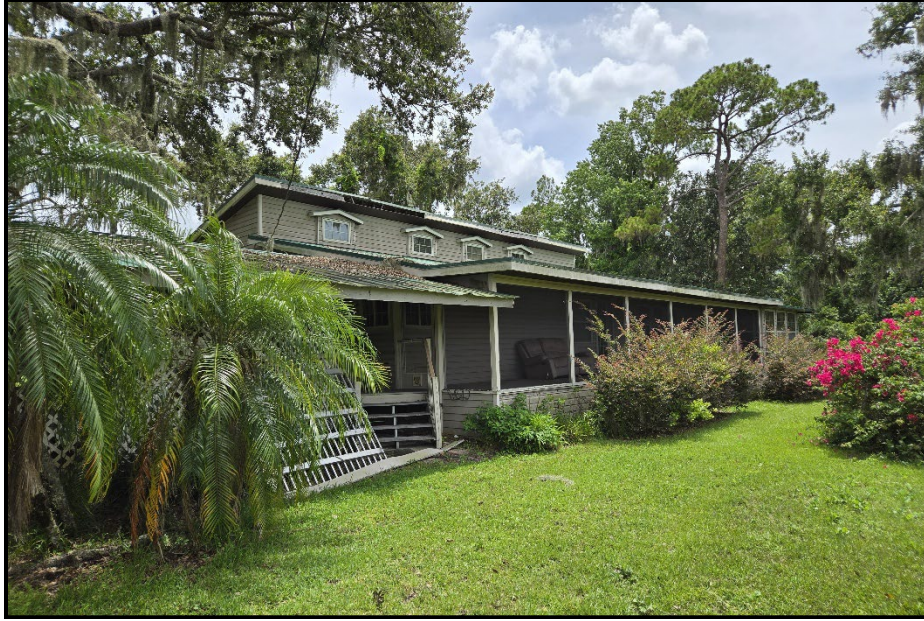
Photo 19. 13045 Newsome Road (8HI16291), looking southwest.

8HI16291: The Frame Vernacular style residence at 13045 Newsome Road was constructed ca. 1980 (**Photo 19**). The resource is located adjacent to FPC 3-2A. The two-story, irregular plan building rests on a concrete slab foundation and has a wood frame structural system clad in vinyl siding. The double shed roof is covered with 3V crimp sheet metal, as are the shed roof porch and gable roof carport. The main entryway is on the north elevation through a single door with a 15-pane inset light. The entryway is within a partial width open porch beneath a shed roof with squared porch supports and screening. Visible windows include individual, paired, and grouped (3) one-over-one, six-over-six, and eight-over-eight vinyl single-hung sash units; individual six-pane vinyl fixed units; individual six-by-six vinyl sliding units. Distinguishing architectural features include overhanging eaves with boxed rafter tails, an angular shed roof line, and faux gable dormers. Alterations include replacement roofing, siding, and windows. A large gable roof carport addition is located on the east elevation. Overall, the building has been altered, lacks sufficient architectural features, and is not a significant embodiment of a type, period, or method of construction. In addition, background research did not reveal any historic associations with significant persons and/or events. As a result, 8HI16291 does not appear eligible for listing in the NRHP, either individually or as part of a historic district.
