RE: SR 50 (US 98/Cortez Boulevard) PD&E Study
From the Brooksville Bypass/SR 50A/East Jefferson Street to I-75
Work Program Item Segment No.: 430051-1
FAP No.: TBD
Hernando County, Florida

Cultural Resource Assessment Survey

April 2015

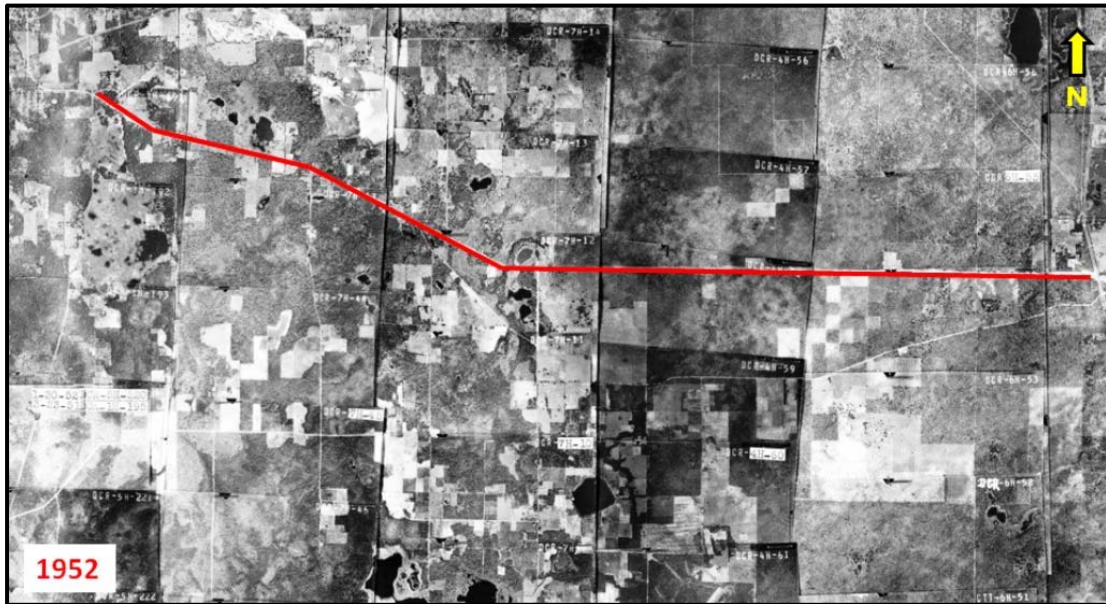
Figure 3-3 1952 PALMM aerial of the project area
The red line follows the realigned SR 50

The aerial photographs of the project area from 1944, 1952, 1969, and 1984, available from the Publication of Archival Library & Museum Materials (PALMM), as well as 1995 and 1999 Google Earth satellite images provided an overview history of development along the project corridor (PALMM 1944, 1952, 1969, and 1984; Google Earth 1995, and 1999). These images indicate that the project area remained mostly undeveloped and predominantly rural throughout the first half of the 20th century, even after the original SR 50 was constructed circa 1920 (**Figures 3-2 and 3-3**).

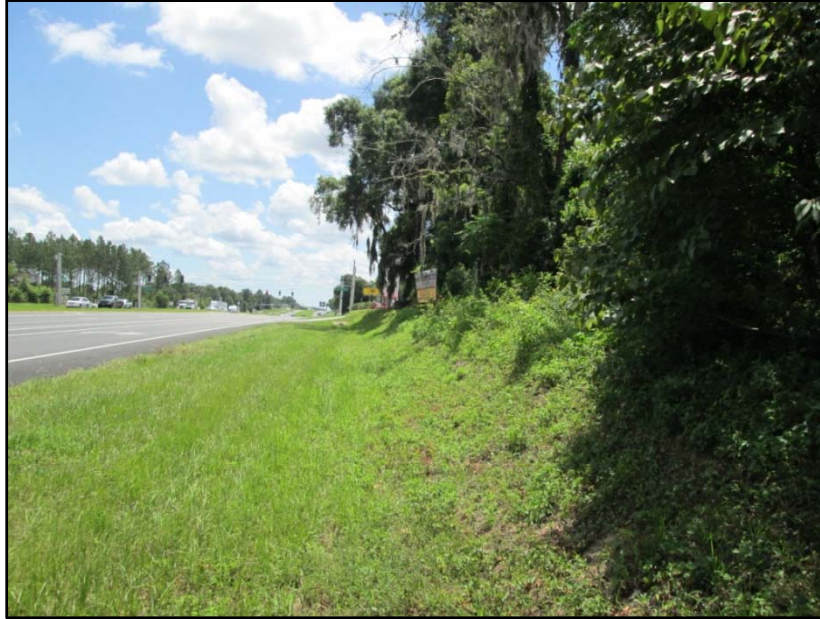
Photo 5-1 General view of 8HE230 site area, looking east

ACI conducted surface reconnaissance and excavated five shovel tests at 25 m (82 ft) intervals in the site area and vicinity (**Figure 5-4; Photo 5-1**). All were negative, and thus, no evidence of 8HE230 was discovered within the project APE. The generalized stratigraphic profile is 0-10 cm (0-4 in) of gray sand underlain by light brown sand at 10-100 cm (4-40 in). The current condition of the site area has been disturbed by road construction, drainage improvements, and construction of a Hess Station.

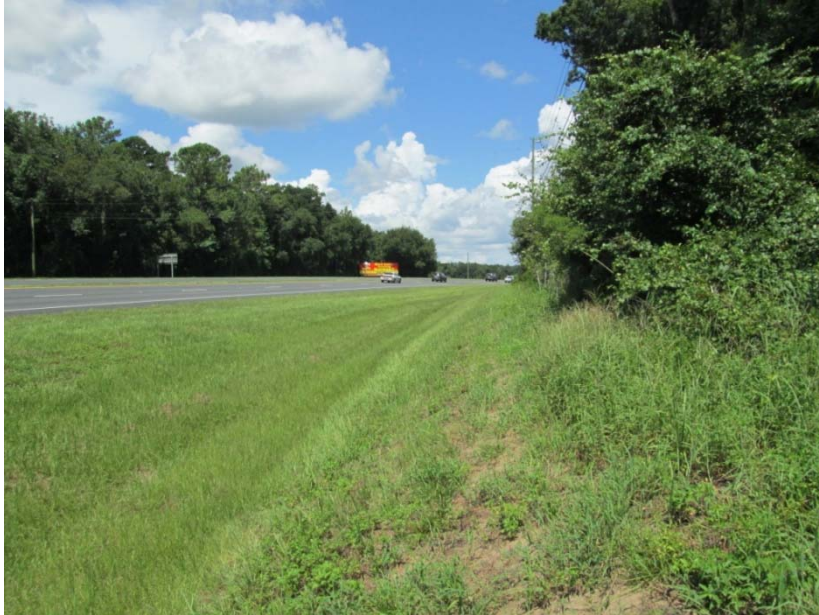
Photo 5-2 General view of 8HE231 site area, looking west

ACI conducted surface reconnaissance and excavated four shovel tests at 25 m (82 ft) intervals in the site area and vicinity (**Figure 5-4; Photo 5-2**). All were negative, and thus, no evidence of 8HE231 was discovered within the project APE. The generalized stratigraphic profile is 0-100 cm (0-40 in) of light brown sand. The current condition of the site area is disturbed, as noted by Ballo.

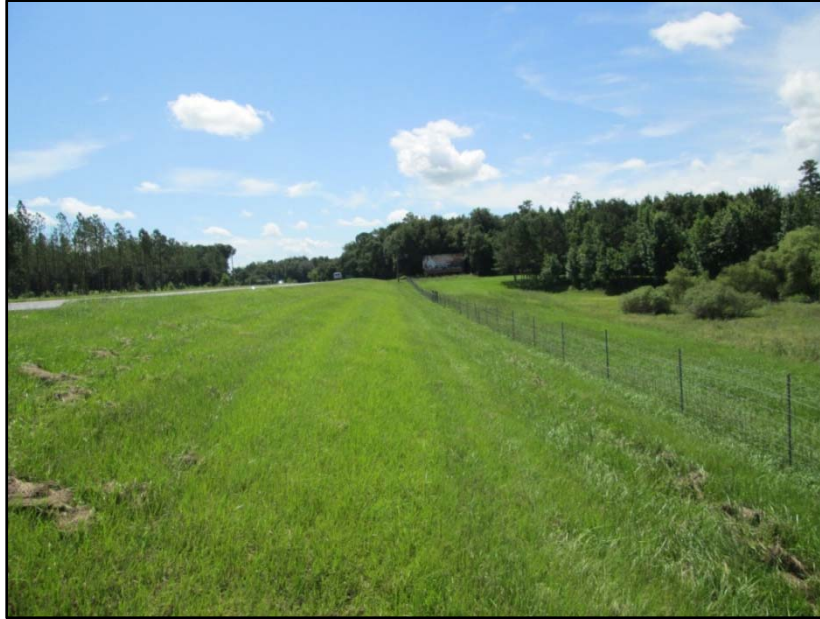
Photo 5-3 General view of 8HE232 site area, looking east

ACI conducted surface reconnaissance and excavated four shovel tests at 25 m (82 ft) intervals in the site area and vicinity (**Figure 5-4; Photo 5-3**). All were negative, and thus, no evidence of 8HE232 was discovered within the project APE. The generalized stratigraphic profile is 0-30 cm (0-12 in) of dark gray sand underlain by brown sand at 30-100 cm (12-40 in). The current condition of the site area is disturbed, as noted by Ballo.

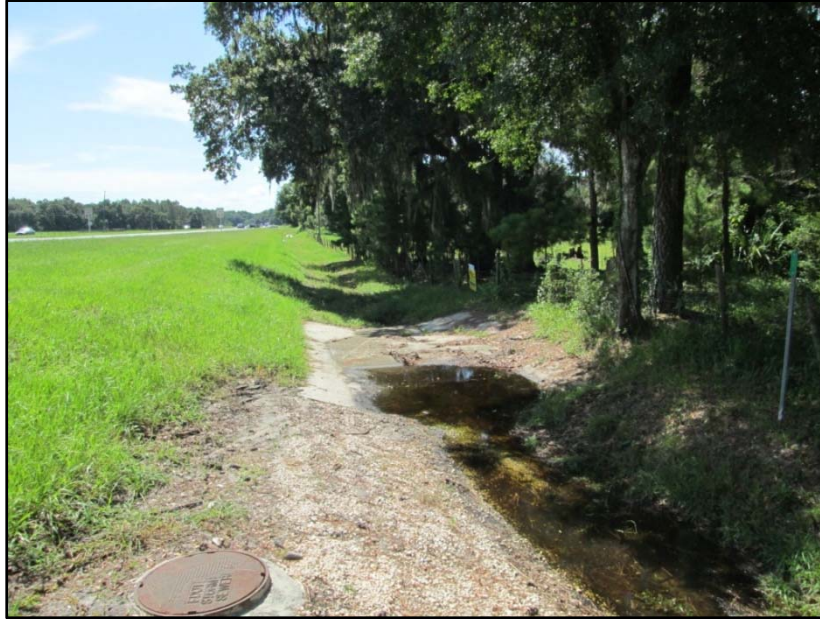
Photo 5-4 General view of 8HE233 site area, looking east

ACI conducted surface reconnaissance and excavated five shovel tests at 25 m (82 ft) intervals in the site area and vicinity (**Figure 5-3; Photo 5-4**). All were negative, and thus, no evidence of 8HE233 was discovered within the project APE. The generalized stratigraphic profile is 0-100 cm (0-40 in) of grayish brown sand. The current condition of the site area is disturbed, as noted by Ballo.

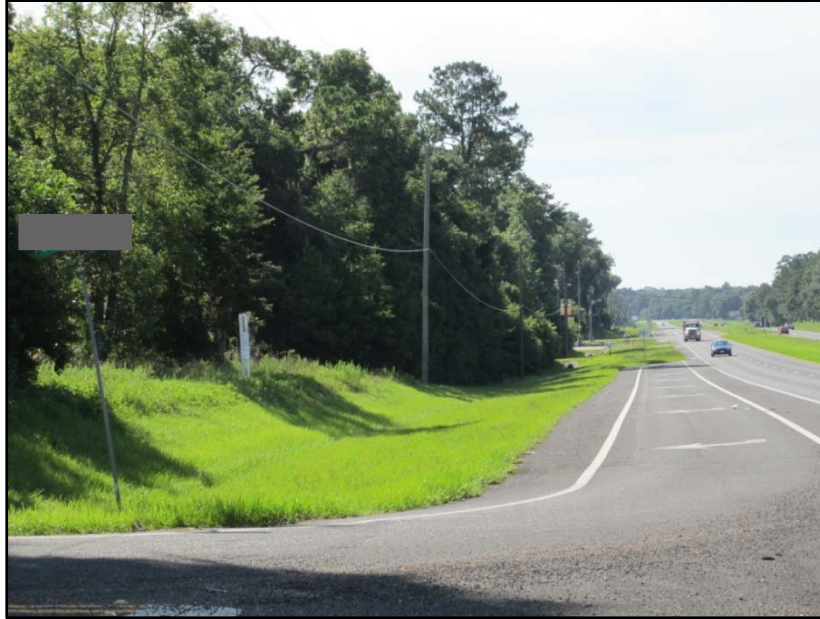
Photo 5-5 General view of 8HE234 site area, looking east

ACI conducted surface reconnaissance and excavated 10 shovel tests at 25 m (82 ft) intervals in the site area and vicinity (**Figure 5-3; Photo 5-5**). All were negative, and thus, no evidence of 8HE234 was discovered within the project APE. The generalized stratigraphic profile is 0-40 cm (0-16 in) of gray sand underlain by light brown sand at 40-100 cm (16-40 in). The current condition of the site area is disturbed, as noted by Ballo.

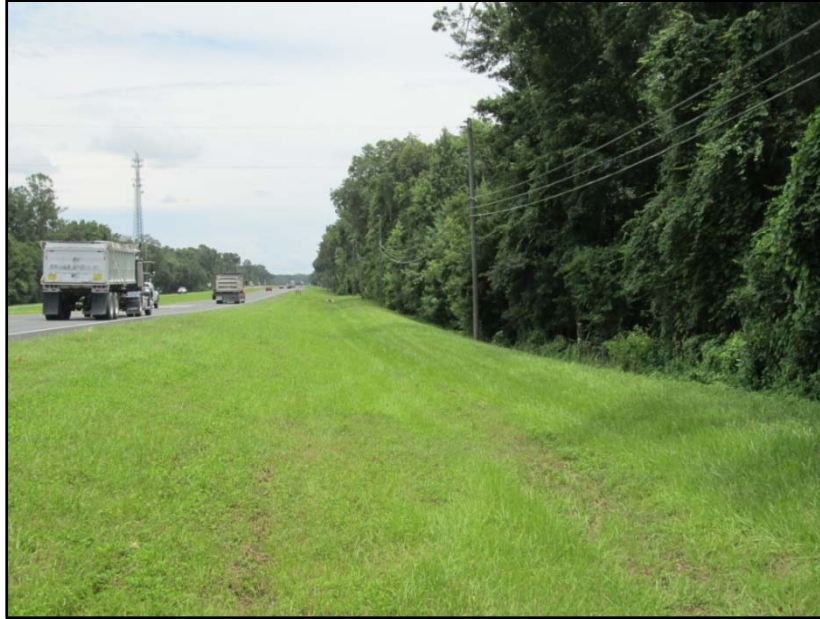
Photo 5-6 General view of 8HE235 site area, looking east

ACI conducted surface reconnaissance and excavated five shovel tests at 25 m (82 ft) intervals in the site area and vicinity (**Figure 5-2; Photo 5-6**). All were negative, and thus, no evidence of 8HE235 was discovered within the project APE. The generalized stratigraphic profile is 0-20 cm (0-8 in) of gray sand underlain by light brown sand at 20-100 cm (8-40 in). The current condition of the site area is disturbed, as noted by Ballo.

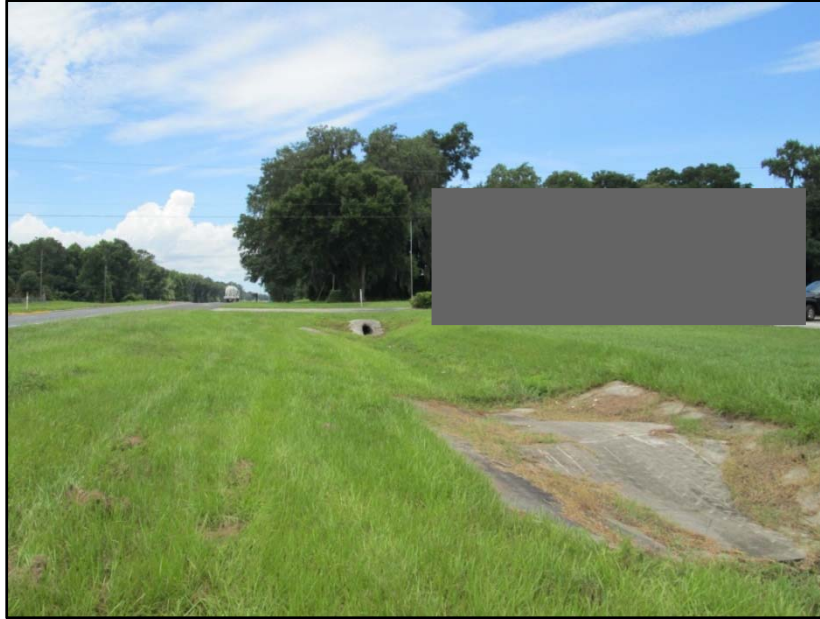
Photo 5-7 General view of 8HE236 site area, looking west

ACI conducted surface reconnaissance and excavated ten shovel tests at 25 m (82 ft) and two shovel tests at 50 m (164 ft) intervals in the site area and vicinity (**Figure 5-2; Photo 5-7**). All were negative, and thus, no evidence of 8HE236 was discovered within the project APE. The generalized stratigraphic profile is 0-20 cm (0-8 in) of gray sand underlain by light brown sand at 20-100 cm (8-40 in). The current condition of the site area is disturbed, as noted by Ballo.

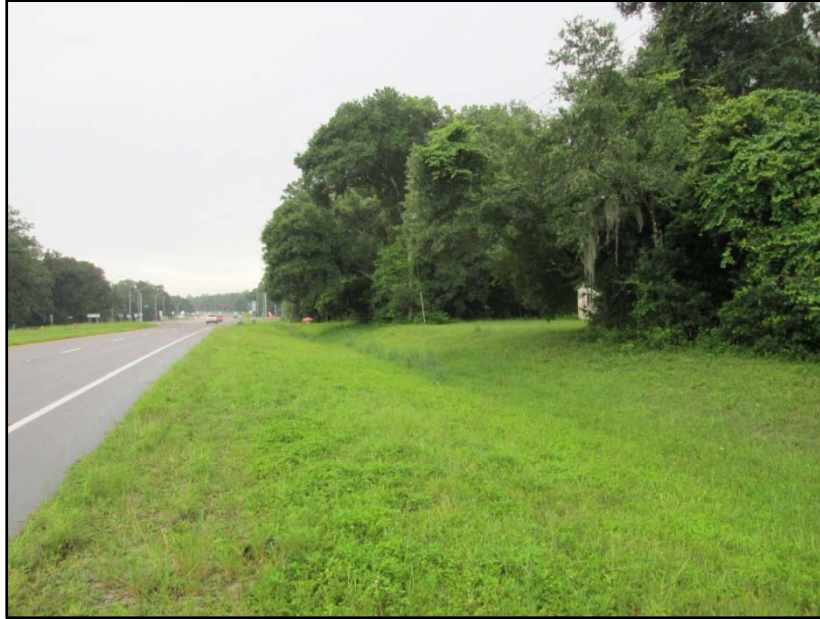
Photo 5-8 General view of 8HE240 site area, looking east

ACI conducted surface reconnaissance and excavated five shovel tests at 25 m (82 ft) intervals in the site vicinity (**Figure 5-1; Photo 5-8**). None yielded cultural materials. The generalized stratigraphic profile is 0-80 cm (0-31 in) of gray sand underlain by 80-100 cm (31-40 in) of brown sand. Thus, no evidence of 8HE240 was discovered within the project APE.

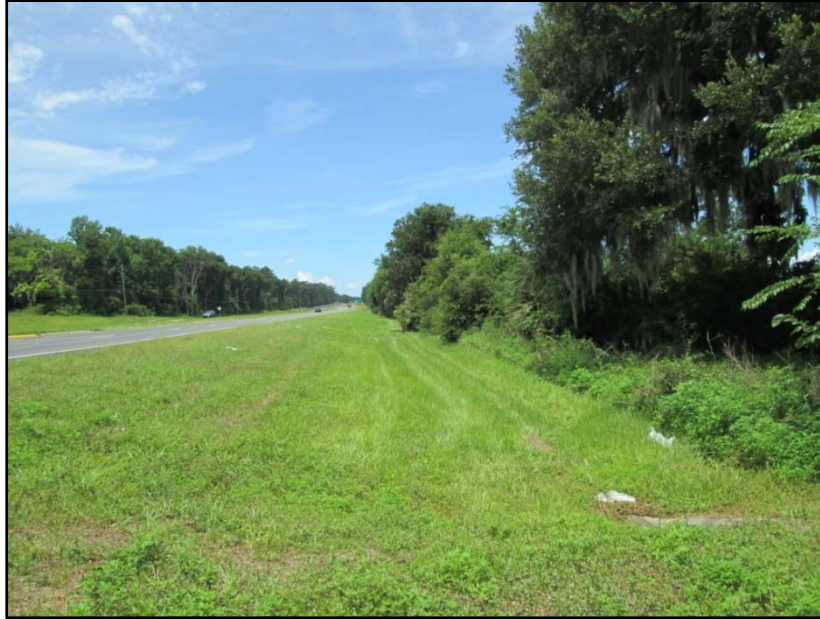
Photo 5-9 General view of 8HE272 site area, looking west

ACI conducted surface reconnaissance and excavated 15 shovel tests at 25 m (82 ft) and eight shovel tests at 50 m (164 ft) intervals in the site area and vicinity (**Figure 5-2; Photo 5-9**). All were negative, and thus, no evidence of 8HE272 was discovered within the project APE. The generalized stratigraphic profile is 0-20 cm (0-8 in) of gray sand underlain by grayish brown gravelly sand at 20-100 cm (8-40 in) and 0-30 cm (0-12 in) of dark gray sand followed by 30-100 cm (12-40 in) of gray sand. The current condition of the area is disturbed as a result of road construction, drainage improvements, and buried cables.

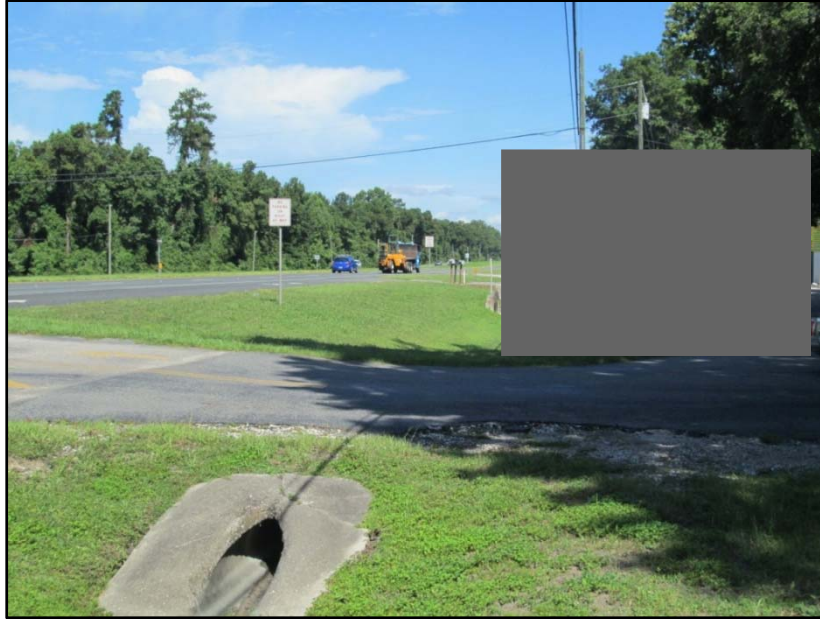
Photo 5-10 General view of 8HE280 site area, looking west

ACI conducted surface reconnaissance and excavated 14 shovel tests at 50 m (164 ft) intervals in the site area and vicinity (**Figure 5-3; Photo 5-10**). All were negative, and thus, no evidence of 8HE280 was discovered within the project APE. The generalized stratigraphic profile is 0-100 cm (0-40 in) of gray sand. The current condition of the area is disturbed as a result of road construction, drainage improvements, and buried cables.

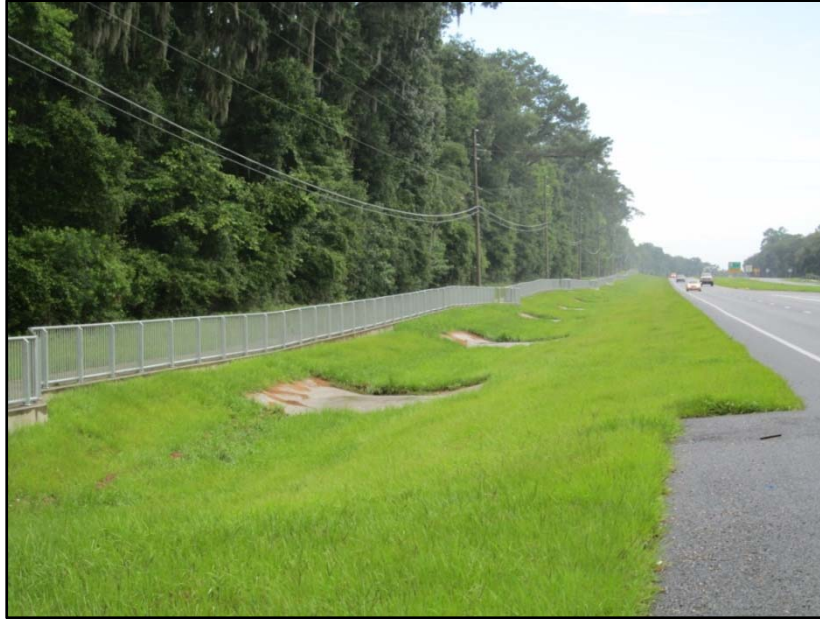
Photo 5-11 General view of the 8HE630 site area, looking west

8HE630: The Desolation Row Site is located in Section 25 of Township 22 South, Range 19 East, on the south side of SR 50. The artifact scatter was recorded in 2007 (Dickinson et al. 2007). Of 14 shovel tests placed in the area by SouthArc, four pieces of lithic debitage and two unidentified metal fragments were recovered from four shovel tests (Dickinson et al. 2007). Because it was possible that the site extended outside the tested boundaries, it was evaluated by SHPO as having insufficient information for a determination of NRHP eligibility.

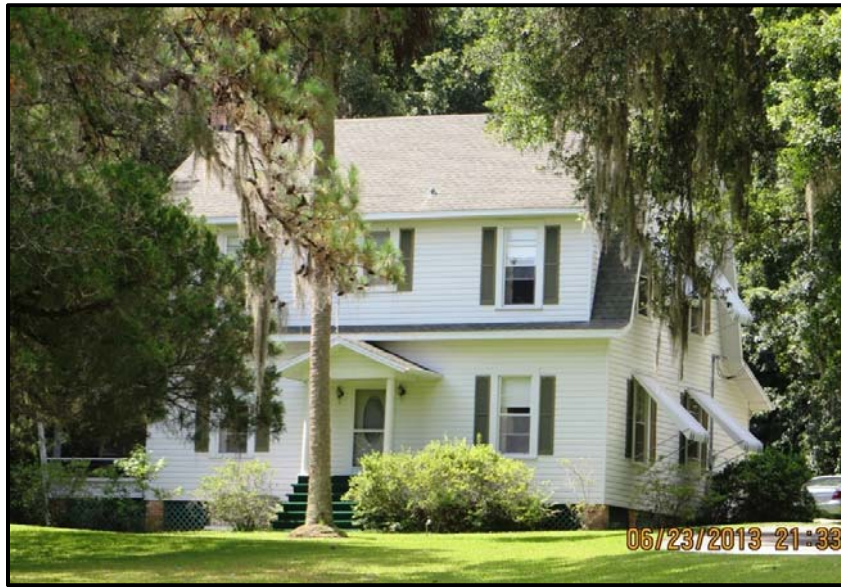
Photo 5-12 7378 Griffin Rd (8HE712), looking south

8HE712: This single-family residence in the Dutch Colonial style is located at 7378 Griffin Road, in Section 25 of Township 22 South, Range 19 East (USGS 1954) (**Photo 5-12**). The house is two-stories tall and three-bays wide along its main elevation (north elevation). The structure rests on brick piers that support a wood frame clad in vinyl siding. The gambrel roof is covered with asphalt shingles. The windows throughout the house are 1/1 wood single-hung-sash (SHS). The house boasts a partial porch centered on the main elevation. The porch has a gable roof supported by two wood columns. Other decorative elements include faux vinyl shutters, and ca. 1960 metal awnings on some windows. The house embodies the distinct characteristics of the Dutch Colonial style, which is a rare architectural style in Hernando County.

In conclusion, the house located at 7378 Griffin Road retains a high degree of integrity, despite some modifications, and embodies the distinct characteristics of the Dutch Colonial style. This architectural style is rare in Hernando County, where no examples have been previously recorded. As such, 8HE712 is considered individually eligible for the NRHP under Criterion C for Architecture.

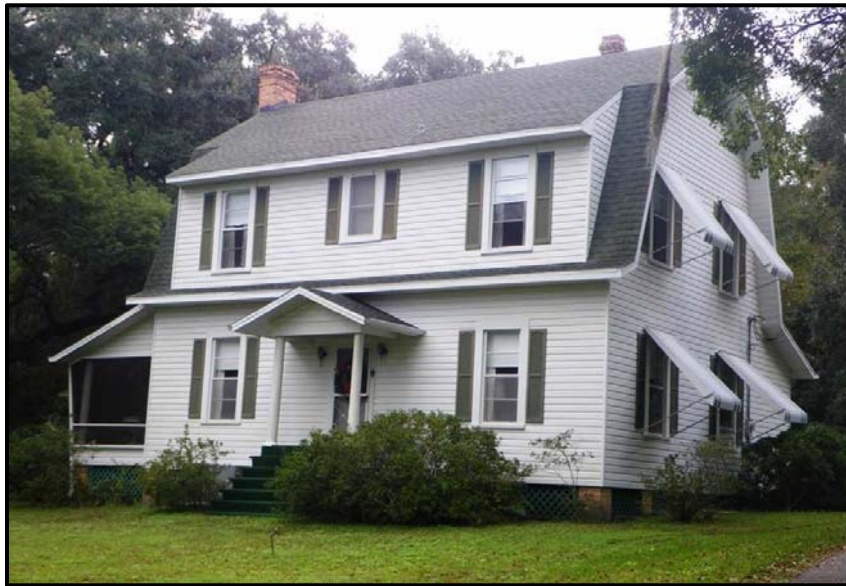
**Photo 5-13 Main elevation of 7378 Griffin Rd (8HE712), looking southeast
(Hernando County Property Appraiser 2014).**

The house at 7378 Griffin Road embodies the distinct characteristics of the Dutch Colonial style. The house exhibits two key design elements that differentiate the Dutch Colonial subcategory from other Colonial Revival designs based on Georgian or Federal vocabularies; these two elements are the gambrel roof and a long shed dormer along its principal elevation (**Photo 5-14**). The design of this house retains a high degree of integrity despite some alterations. The original wood siding has been replaced with vinyl siding, and some windows display decorative faux shutters and metal awnings. However, these alterations are reversible changes that have not adversely affected the massing, proportions, and spatial relationship of this building. Furthermore, this house is an example of an uncommon architectural style in Hernando County. A review of the FMSF database revealed that no examples of this style had been previously recorded in the county, and only 233 have been recorded throughout the state to date.

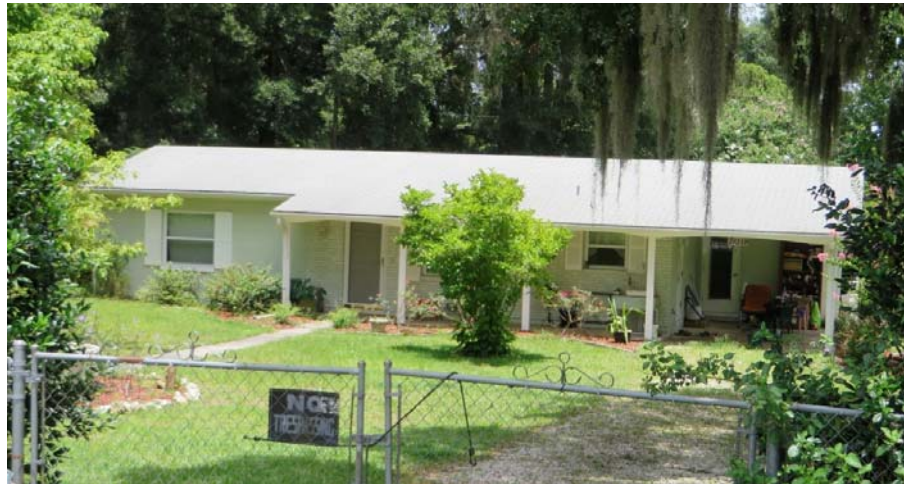
Photo 5-15 2739 Frampton Road (8HE729), looking north

Masonry Vernacular: Twelve historic resources within the project APE are of the Masonry Vernacular style (8HE680, 8HE717, 8HE721, 8HE726, 8HE727-33, and 8HE735) (**Photos 5-15 through 5-17**). The majority of these resources are residential buildings with construction dates that range from 1956 to 1963 (**see Table 5-2**). A “Vernacular” style is a misnomer, since vernacular buildings reflect the local customs, environment, and building materials, and do not rely on academic architectural vocabulary for their design and ornament (Wood 1996). Vernacular buildings are rarely architect-designed, and are often built by developers, contractors, master carpenters, or the building’s occupants. These buildings are decidedly practical structures.

Within the APE, this building type generally has concrete slab foundations and concrete block walls. Roof types consist of gable, and hip, most of which are clad with composition shingles. The exterior cladding often consists of stucco, painted concrete block, brick, or wood siding. Windows typically include awning, SHS, or casements. Exterior ornamentation on these structures consists mostly of concrete window sills, gable vents, and porches. The majority display alterations or additions, such as replacement sidings, replacement windows, and garage additions, which have eroded the historic integrity of the resources.

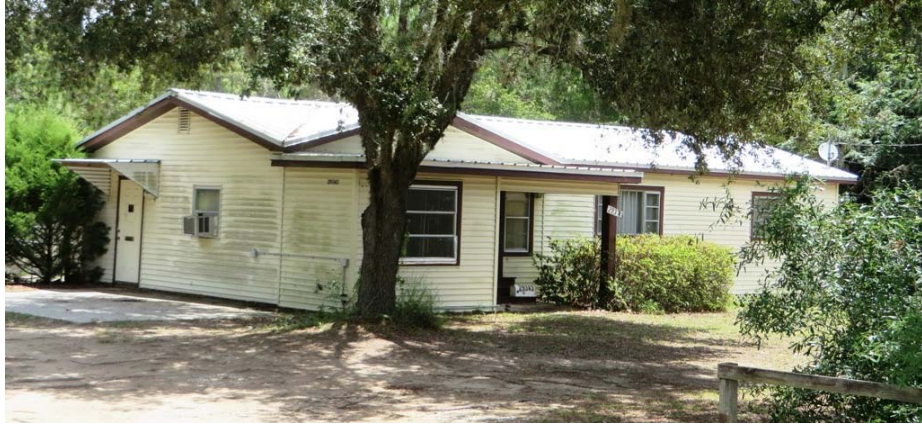
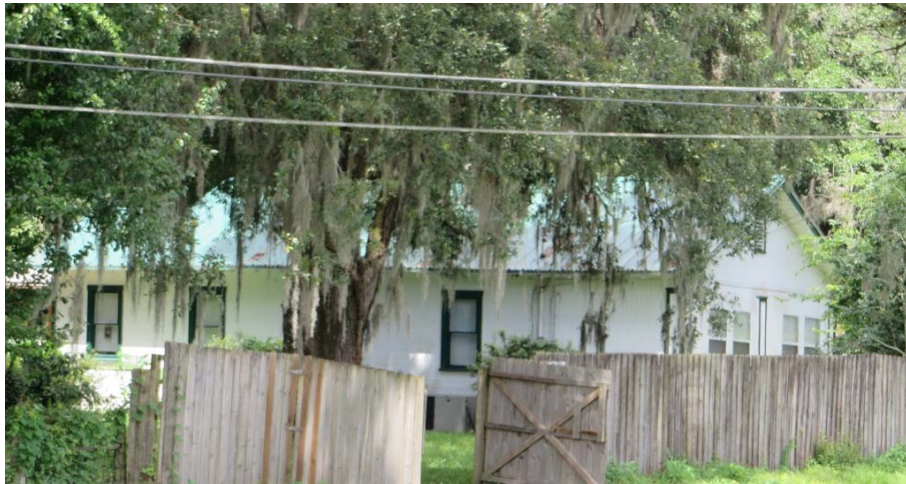
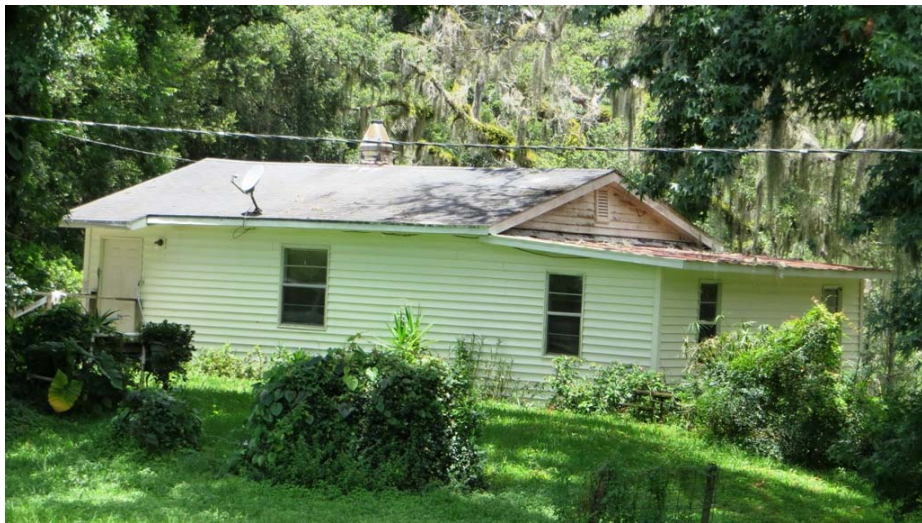
Frame Vernacular: Fourteen historic resources within the project APE are of the Frame Vernacular style (8HE679, 8HE711, 8HE714, 8HE715, 8HE716, 8HE718, 8HE719, 8HE720, 8HE722, 8HE723, 8HE724, 8HE725, 8HE736, and 8HE737) (**Photos 5-18 through 5-20**), and have construction dates that range from 1890 to 1962 (**see Table 5-2**). The majority of these resources are residential buildings. Similar to Masonry Vernacular style buildings, Frame Vernacular structures are also simple structures built with available local materials and boasting little ornamentation. Within the APE, this building type usually has concrete pier or slab foundations. The gable is the most represented roof type, but there are also examples with cross-gable and shed roofs. Most of the roofs are clad with composition shingles or 3-V crimp metal. The majority of these buildings are clad in wood siding. Fenestration typically includes SHS windows, but casements, sliders, awning and fixed windows are also present. Exterior ornamentation is minimal, and typically consists of wood window and door surrounds, corner boards, gable vents, and exposed rafter tails. The majority display alterations or additions, such as replacement sidings, replacement windows, and living-space additions, which have contributed to an erosion of the resource's historic integrity.

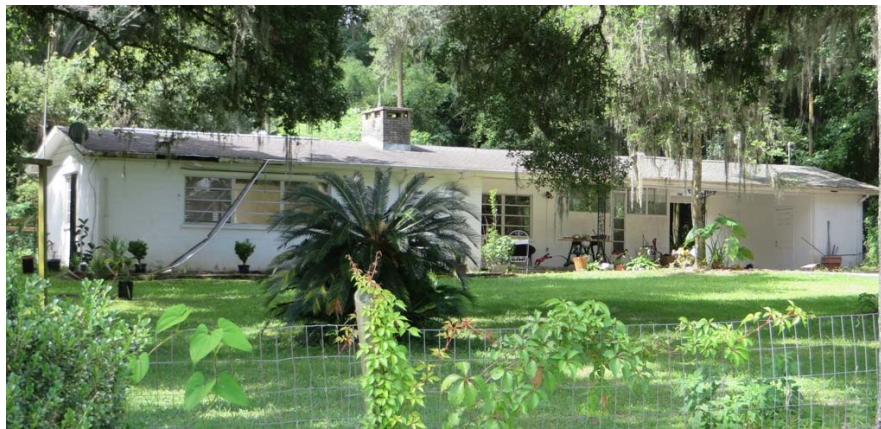
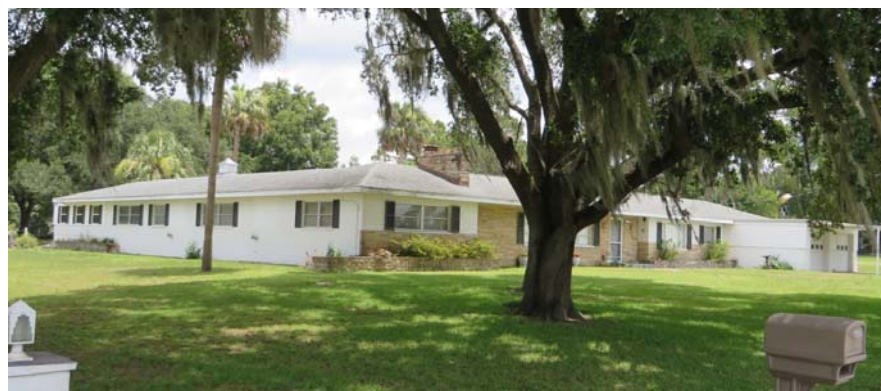
Ranch: Two historic resources, 8HE713 and 8HE734, are of the Ranch style (**Photo 5-21 and 5-22**). They were built ca. 1955 and ca. 1961, respectively (**see Table 5-2**). The Ranch style originated in California in the mid-1930s, and gained widespread popularity after World War II (McAlester 2013). Buildings of this style are almost exclusively single-family residences, and are ubiquitous in post-World War II suburbs throughout the country, particularly in the south and southwest. The style features low-slung buildings and a low-pitched roof with large windows. The buildings typically rest on a concrete slab foundation, which supports concrete block walls. The windows are typically metal awning, or SHS.

The two Ranch style resources are typical examples of their type in Hernando County. Neither displays unique design features that would differentiate them from hundreds of other examples in the county. In addition, one resource (8HE734) exhibits a ca. 1980 garage addition, which has affected its historic integrity.

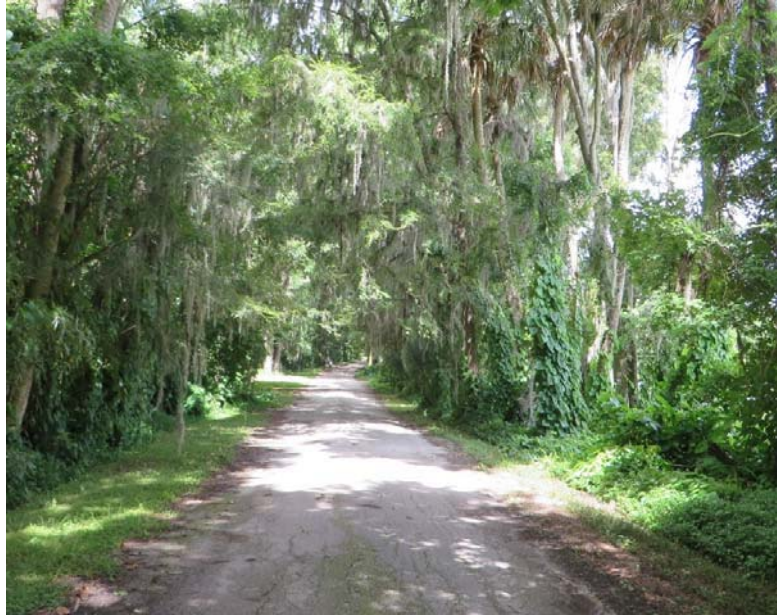
Photo 5-23 Singer Lane (8HE741), looking west

8HE741: This road, known as Singer Lane, is located adjacent to the project APE in Section 30 of Township 22 South, Range 20 East (USGS 1954) (**Photo 5-23**). It extends for approximately 0.22 miles parallel to and south of SR 50, and consists of a narrow single-lane roadway covered with asphalt and gravel. Trees and shrubbery line both sides of the roadway, and buffer the road from SR 50 to the north.

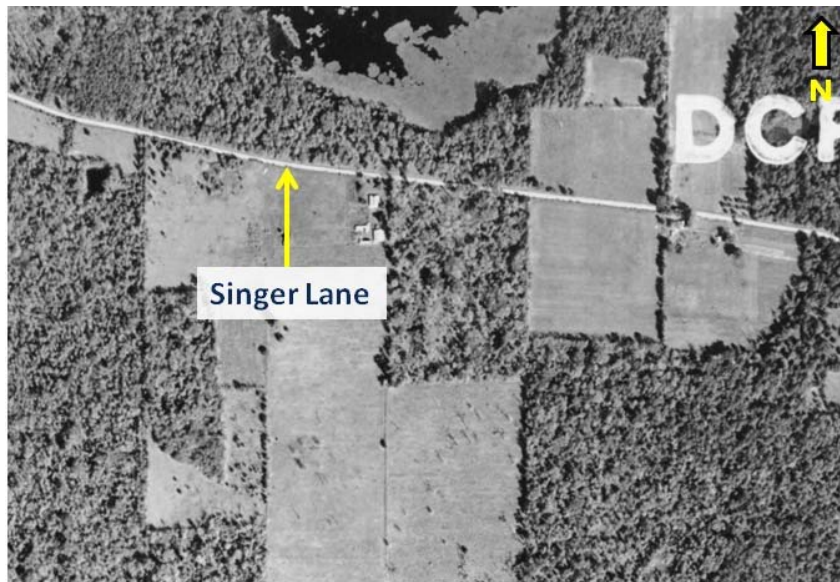
Figure 5-7. 1944 PALMM aerial showing the original condition of the roadway, built ca. 1920

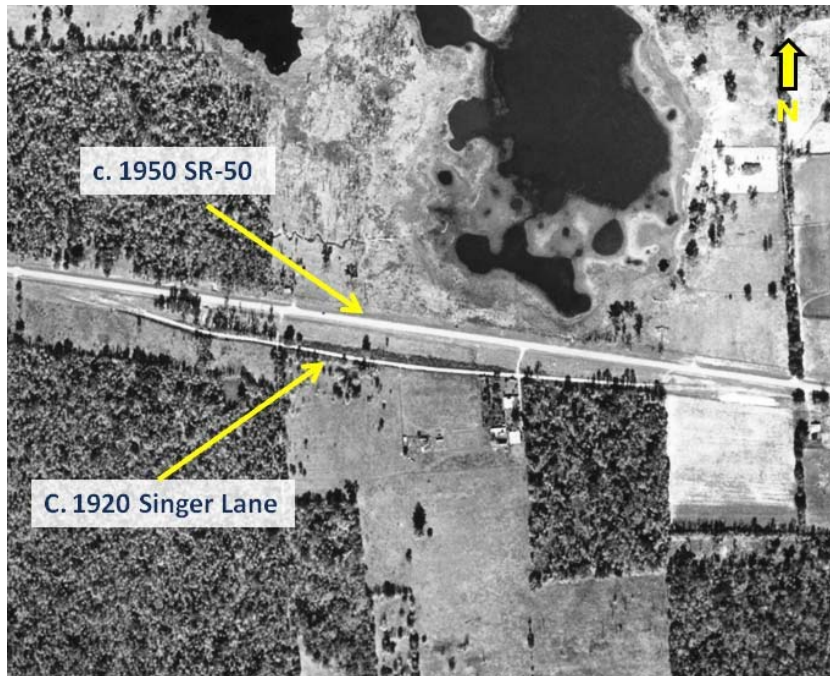
Figure 5-8 1952 PALMM aerial depicting the construction of SR 50 around 1950 and the remaining section of the 1920s roadway, renamed Singer Lane

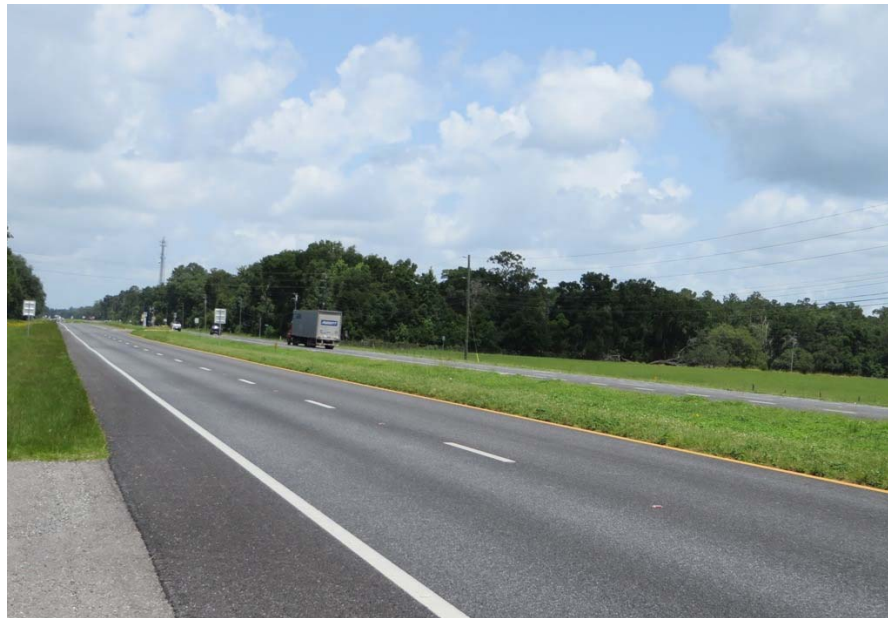
Photo 5-24 SR 50 (8HE742), looking west

8HE742: SR 50 within the entirety of the project APE is located in Section 25 of Township 22 South, Range 19 East, and Sections 1 through 4, and 30 through 33 of Township 22 South, Range 20 East (USGS 1954) (**Photo 5-24**). SR 50 is a cross-peninsula highway spanning from US 19 at Weeki Wachee on the west to US 1 at Titusville on the east, a total length of approximately 115 miles. However, only 8.2 miles are located within the project APE. This constitutes less than seven percent of the

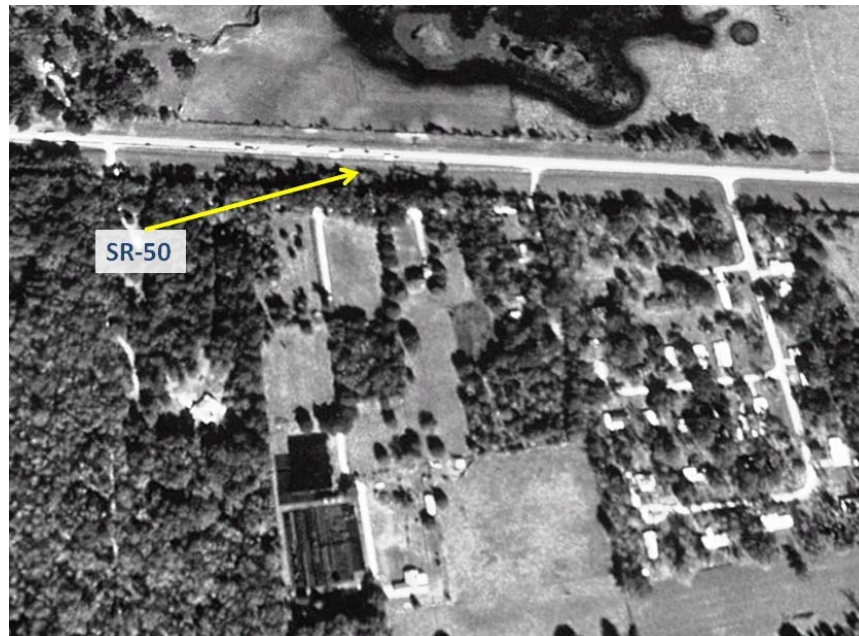
**Figure 5-9 1995 satellite image depicting SR 50 as a two-lane highway
(Google Earth 1995)**

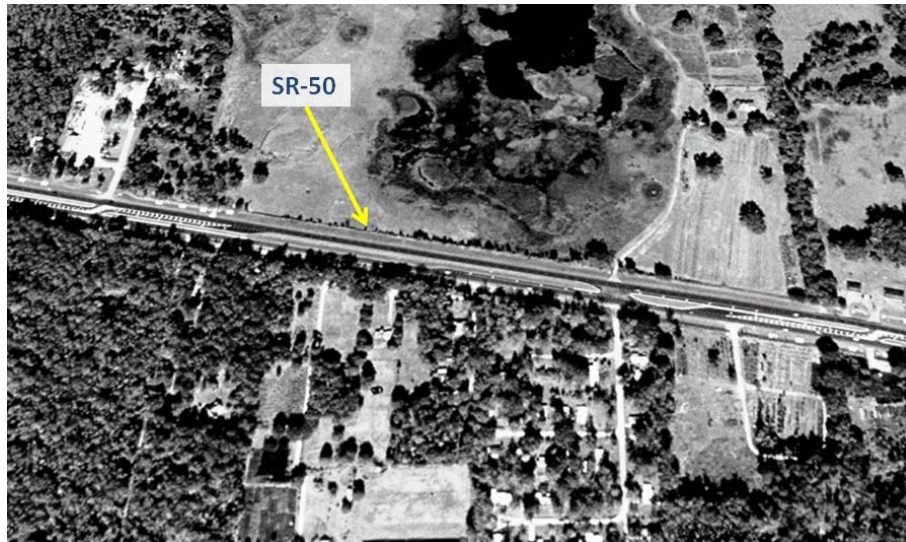
Figure 5-10 1999 satellite image depicting an enlarged SR 50 featuring four lanes and a median (Google Earth 1999)

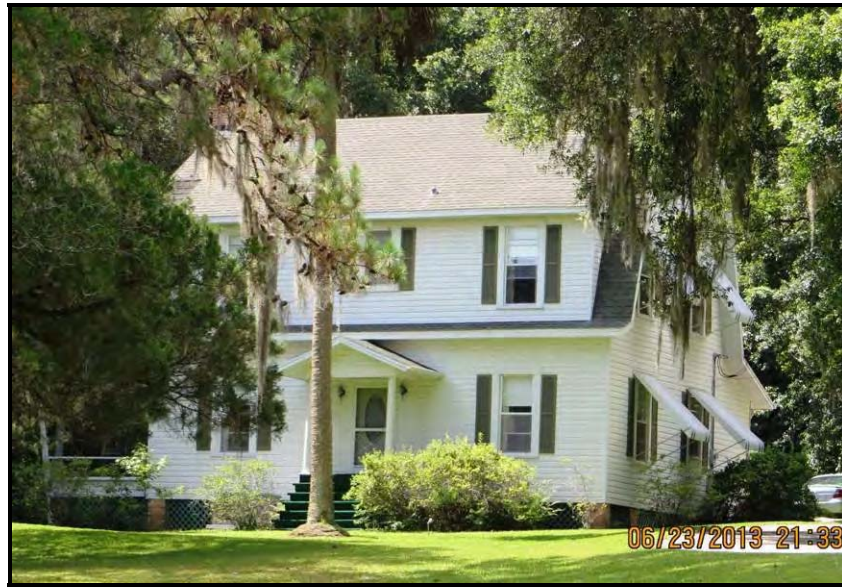
Photo 1. 7378 Griffin Rd (8HE712), looking south

8HE712: This single-family residence in the Dutch Colonial style is located at 7378 Griffin Road, in Section 25 of Township 22 South Range 19 East (USGS 1954) (**Photo 1**). The house is two-stories tall and three-bays wide along its main elevation (north elevation). The structure rests on brick piers that support a wood frame clad in vinyl siding. The gambrel roof is covered with asphalt shingles. The windows throughout the house are 1/1 wood single-hung-sash. The house boasts a partial porch centered on the main elevation. The porch has a gable roof supported by two wood columns. Other decorative elements include faux vinyl shutters, and circa 1960 metal awnings on some windows. The house embodies the distinct characteristics of the Dutch Colonial style, which is a rare architectural style in Hernando County. As such, it is the opinion of ACI's architectural historian that 8HE712 is considered eligible for the NRHP under Criterion C for architecture.

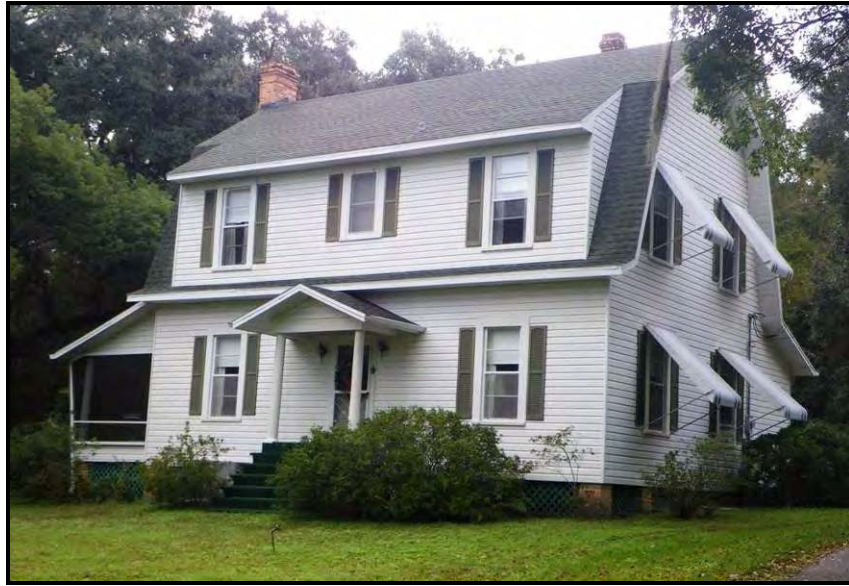
Photo 2. Main elevation of 7378 Griffin Rd, looking southeast (Emerson 2014)

The house at 7378 Griffin Road embodies the distinct characteristics of the Dutch Colonial style. The house exhibits two key design elements that differentiate the Dutch Colonial subcategory from other Colonial Revival designs based on Georgian or Federal vocabularies; these two elements are the gambrel roof and a long shed dormer along its principal elevation (**Photo 3**). The design of this house retains a high degree of integrity despite some alterations. The original wood siding has been replaced with vinyl siding, and some windows display decorative faux shutters and metal awnings. However, these alterations are reversible changes that have not adversely affected the massing, proportions, and spatial relationship of this building. Furthermore, this house is an example of an uncommon architectural style in Hernando County. A review of the FMSF database revealed that no examples of this style had been previously recorded in the county, and only 233 have been recorded throughout the state to date.

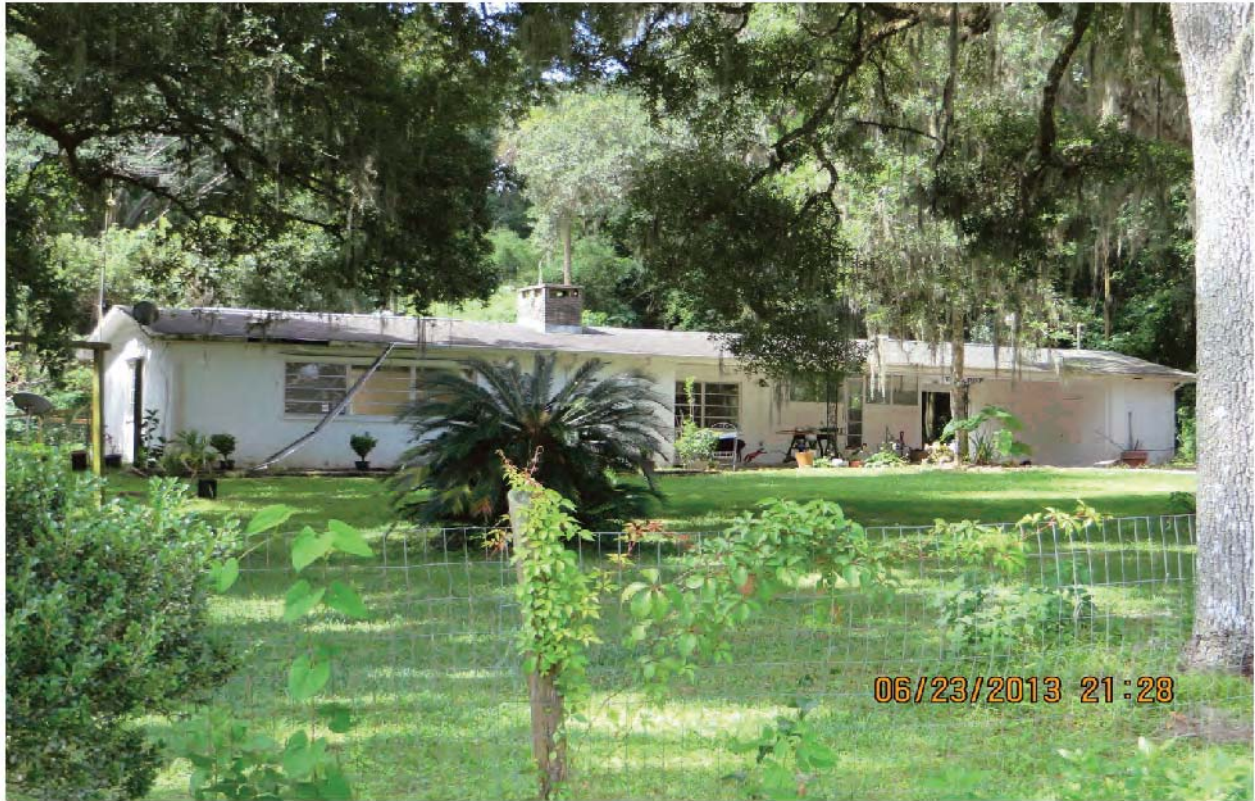
PHOTOGRAPH

Chimney: No. 1 Chimney Material(s): 1. Brick 2.
Structural System(s): 1. Concrete block 2. 3.
Foundation Type(s): 1. Slab 2.
Foundation Material(s): 1. Concrete, Generic 2.
Main Entrance (stylistic details) NW elevation, squared opening, single-door

Condition (overall resource condition): []excellent [x]good []fair []deteriorated []ruinous
Narrative Description of Resource One-story Ranch style residence constructed circa 1955.

Explanation of Evaluation (required, whether significant or not; use separate sheet if needed) This is a typical example of a Ranch style residence found throughout Hernando County. Furthermore, limited research revealed no significant historical associations. Therefore, 8HE00713 does not appear eligible for listing in the NRHP.

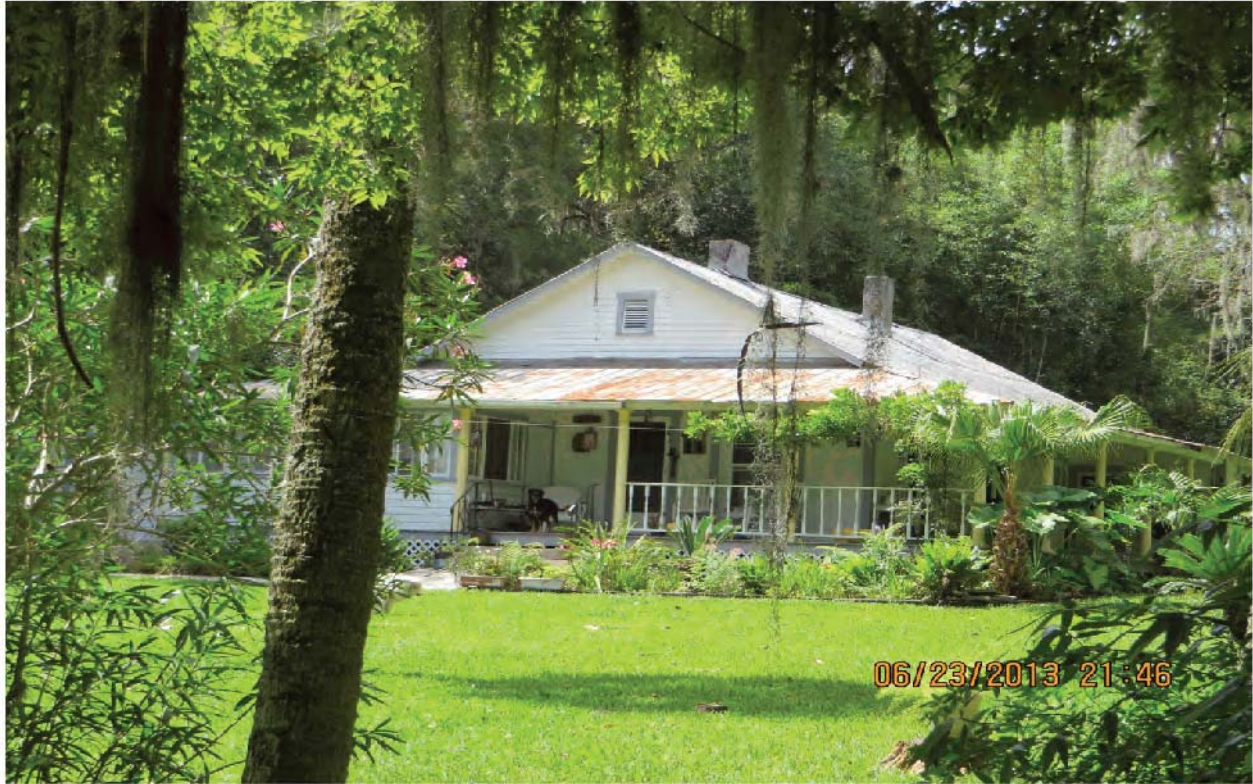
PHOTOGRAPH

Chimney: No. 2 Chimney Material(s): 1. Stucco 2.
Structural System(s): 1. Wood frame 2. 3.
Foundation Type(s): 1. Piers 2.
Foundation Material(s): 1. Brick 2.
Main Entrance (stylistic details) N elevation, squared opening, single-door

Condition (overall resource condition): []excellent [x]good []fair []deteriorated []ruinous

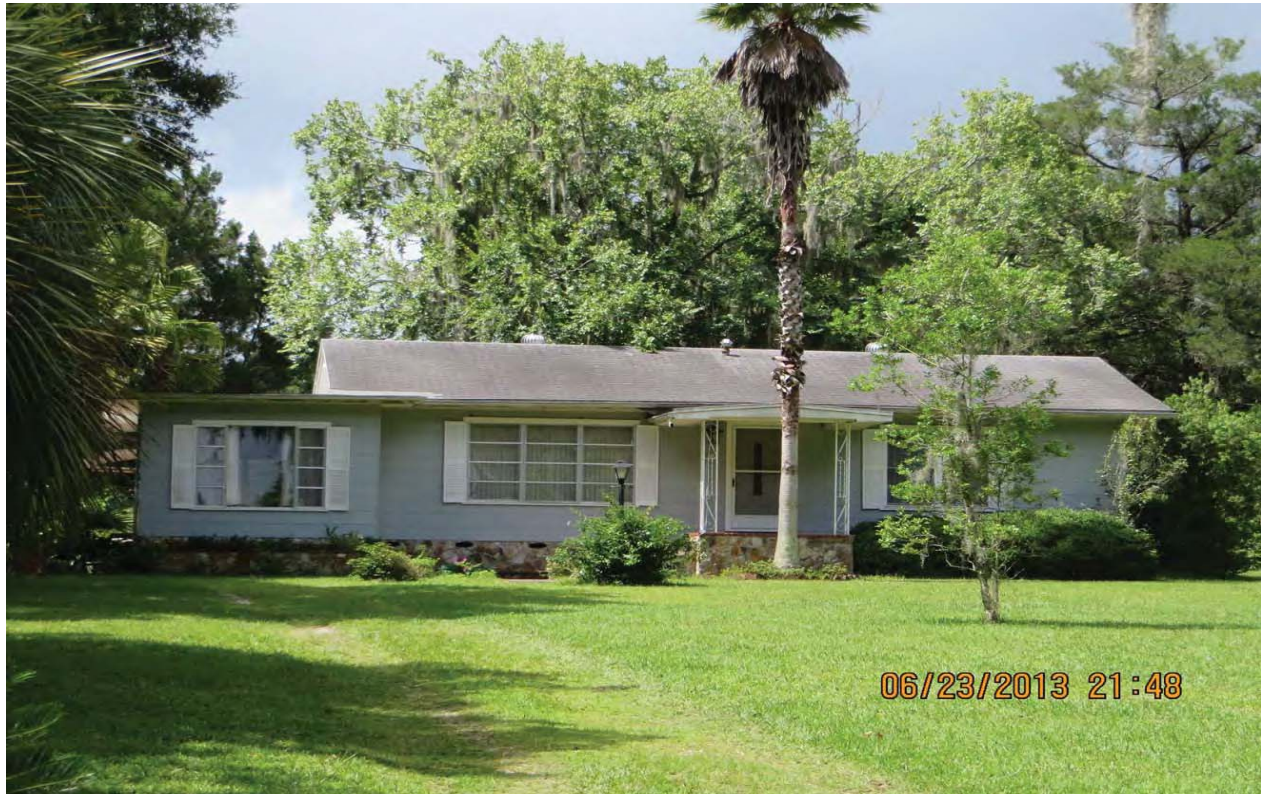
PHOTOGRAPH

Style Frame Vernacular Exterior Plan Rectangular Number of Stories 1
Exterior Fabric(s) 1. Wood siding 2. _____ 3. _____
Roof Type(s) 1. Gable 2. _____ 3. _____
Roof Material(s) 1. Asphalt shingles 2. _____ 3. _____
Roof secondary strucs. (dormers etc.) 1. _____ 2. _____
Windows (types, materials, etc.) Four-light metal awning, grouped; One-light metal fixed flanked by 4-light metal awning, independent; 1/1 metal SHS, individual
Distinguishing Architectural Features (exterior or interior ornaments) Metal porch columns; stone foundation; ridge vents

Chimney: No. ___ Chimney Material(s): 1. ___ 2. ___
Structural System(s): 1. Wood frame 2. ___ 3. ___
Foundation Type(s): 1. Continuous 2. ___
Foundation Material(s): 1. Stone 2. ___
Main Entrance (stylistic details) N elevation, squared opening, single-door

Condition (overall resource condition): [] excellent [x] good [] fair [] deteriorated [] ruinous
Narrative Description of Resource One-story Frame Vernacular residence constructed circa 1955
