RE: SR 50 (US 98/Cortez Boulevard) PD&E Study
From the Brooksville Bypass/SR 50A/East Jefferson Street to I-75
Work Program Item Segment No.: 430051-1
FAP No.: TBD
Hernando County, Florida

Cultural Resource Assessment Survey

April 2015

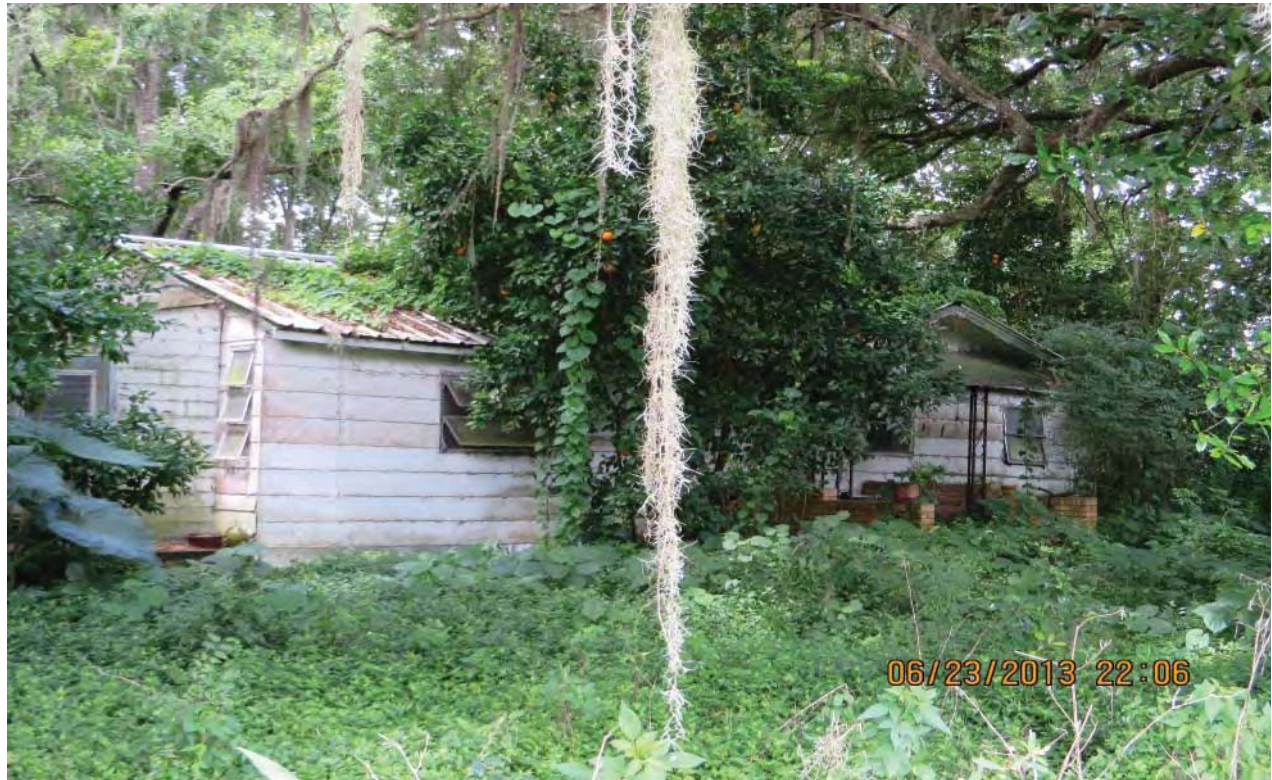
PHOTOGRAPH

Chimney: No. ___ Chimney Material(s): 1. ___ 2. ___
Structural System(s): 1. Wood frame 2. ___ 3. ___
Foundation Type(s): 1. Piers 2. ___
Foundation Material(s): 1. Concrete Block 2. ___
Main Entrance (stylistic details) N elevation, squared opening, single-door

Condition (overall resource condition): []excellent [x]good []fair []deteriorated []ruinous
Narrative Description of Resource One-story Frame Vernacular residence constructed circa 1945

Explanation of Evaluation (required, whether significant or not; use separate sheet if needed) This is a typical example of a Frame Vernacular style residence found throughout Hernando County. Furthermore, limited research revealed no significant historical associations. Therefore, 8HE00716 does not appear eligible for listing in the NRHP.

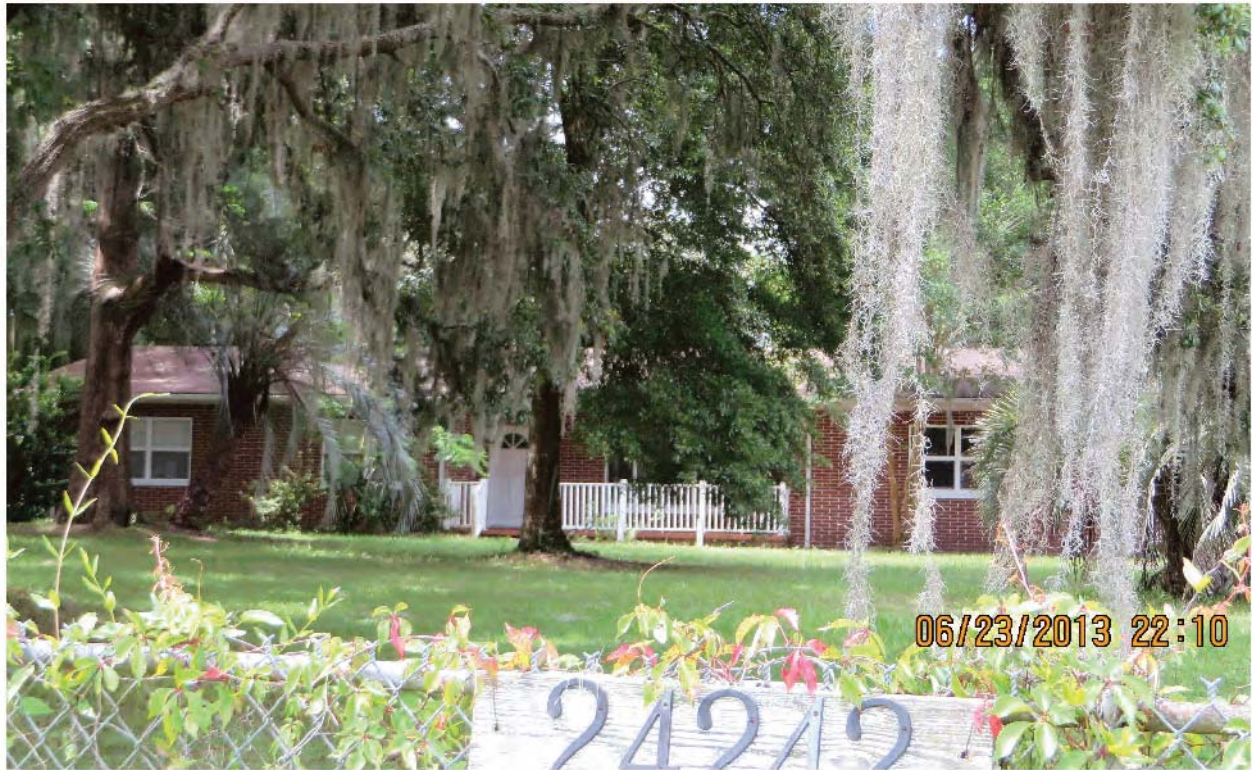
PHOTOGRAPH

Construction Year: 1958 approximately year listed or earlier year listed or later
Original Use Private Residence (House/Cottage/Cabin) From (year): 1958 To (year): cur
Current Use _____ From (year): _____ To (year): _____
Other Use _____ From (year): _____ To (year): _____
Moves: yes no unknown Date: _____ Original address _____
Alterations: yes no unknown Date: c. 2000 Nature Replacement windows
Additions: yes no unknown Date: _____ Nature _____
Architect (last name first): Unknown Builder (last name first): Unknown
Ownership History (especially original owner, dates, profession, etc.) _____

Chimney: No. 0 Chimney Material(s): 1. _____ 2. _____
 Structural System(s): 1. Unknown 2. _____ 3. _____
 Foundation Type(s): 1. Continuous 2. _____
 Foundation Material(s): 1. Brick 2. _____
 Main Entrance (stylistic details) N elevation, squared opening, single-door

Explanation of Evaluation (required, whether significant or not; use separate sheet if needed) This is a typical example of a Masonry Vernacular style residence found throughout Hernando County. Furthermore, limited research revealed no significant historical associations. Therefore, 8HE00717 does not appear eligible for listing in the NRHP.

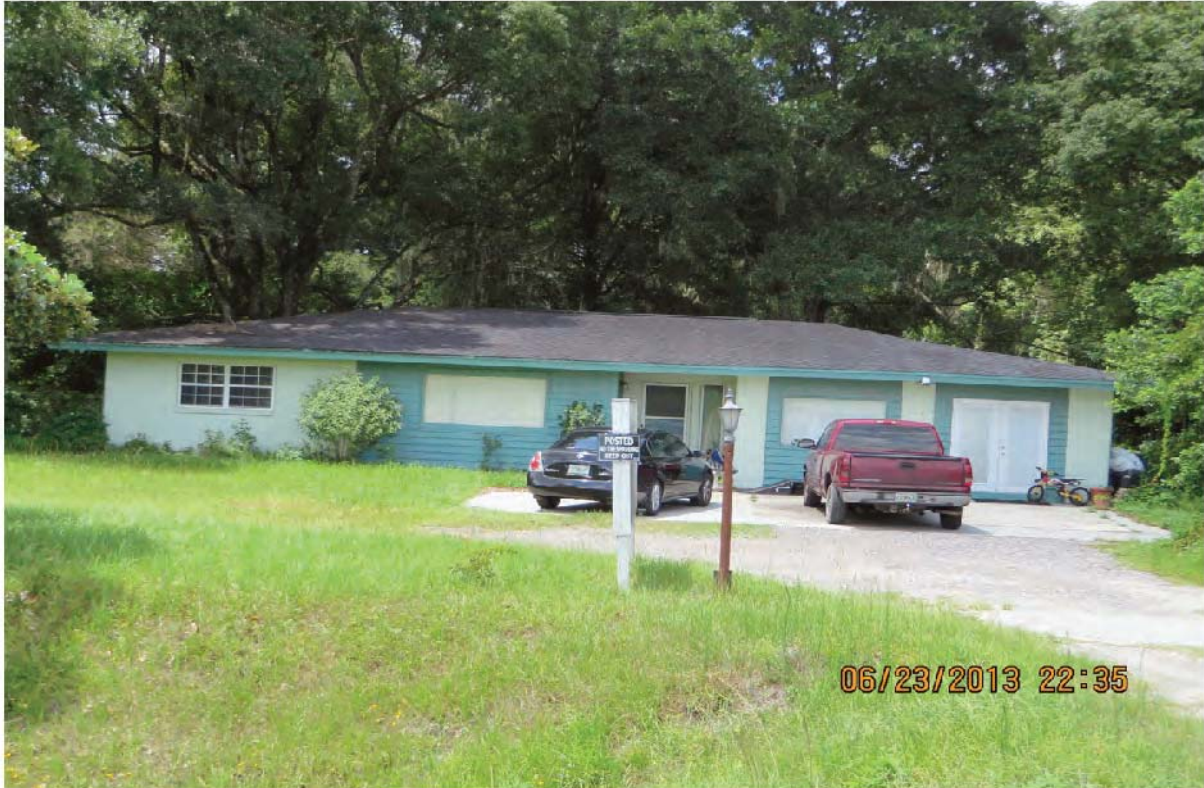
PHOTOGRAPH

Chimney: No. 0 Chimney Material(s): 1. Concrete block 2. Wood frame
Structural System(s): 1. Concrete block 2. Wood frame 3.
Foundation Type(s): 1. Slab 2.
Foundation Material(s): 1. Concrete, Generic 2.
Main Entrance (stylistic details) Multiple

Condition (overall resource condition): []excellent [x]good []fair []deteriorated []ruinous

Explanation of Evaluation (required, whether significant or not; use separate sheet if needed) This is a typical example of a Masonry Vernacular style building found throughout Hernando County. Furthermore, limited research revealed no significant historical associations. Therefore, 8HE00727 does not appear eligible for listing in the NRHP.

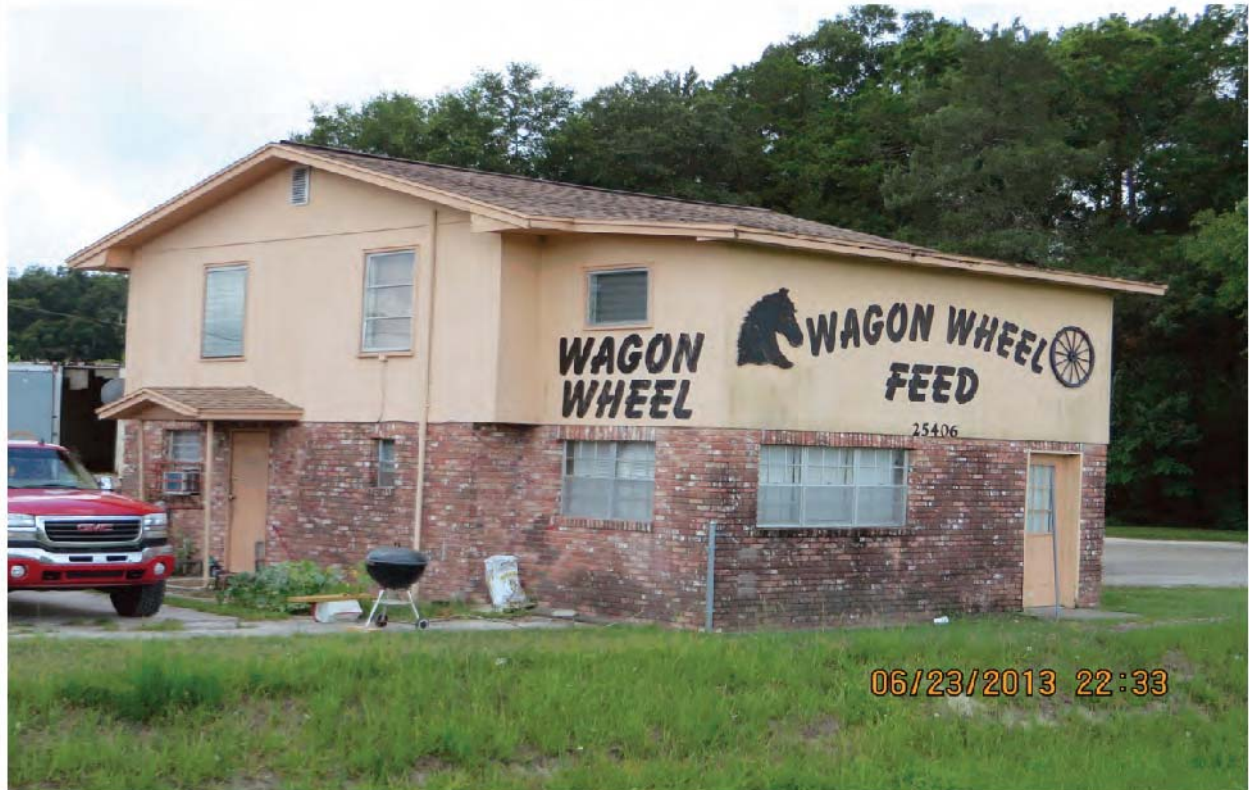
PHOTOGRAPH

Chimney: No. 0 Chimney Material(s): 1. Concrete block 2. Wood frame
Structural System(s): 1. Concrete block 2. Wood frame 3.
Foundation Type(s): 1. Slab 2.
Foundation Material(s): 1. Concrete, Generic 2.
Main Entrance (stylistic details) S elevation, square opening, single-door

Condition (overall resource condition): [] excellent [x] good [] fair [] deteriorated [] ruinous

Explanation of Evaluation (required, whether significant or not; use separate sheet if needed) This is a typical example of a Masonry Vernacular style residence found throughout Hernando County. Furthermore, limited research revealed no significant historical associations. Therefore, 8HE00728 does not appear eligible for listing in the NRHP.

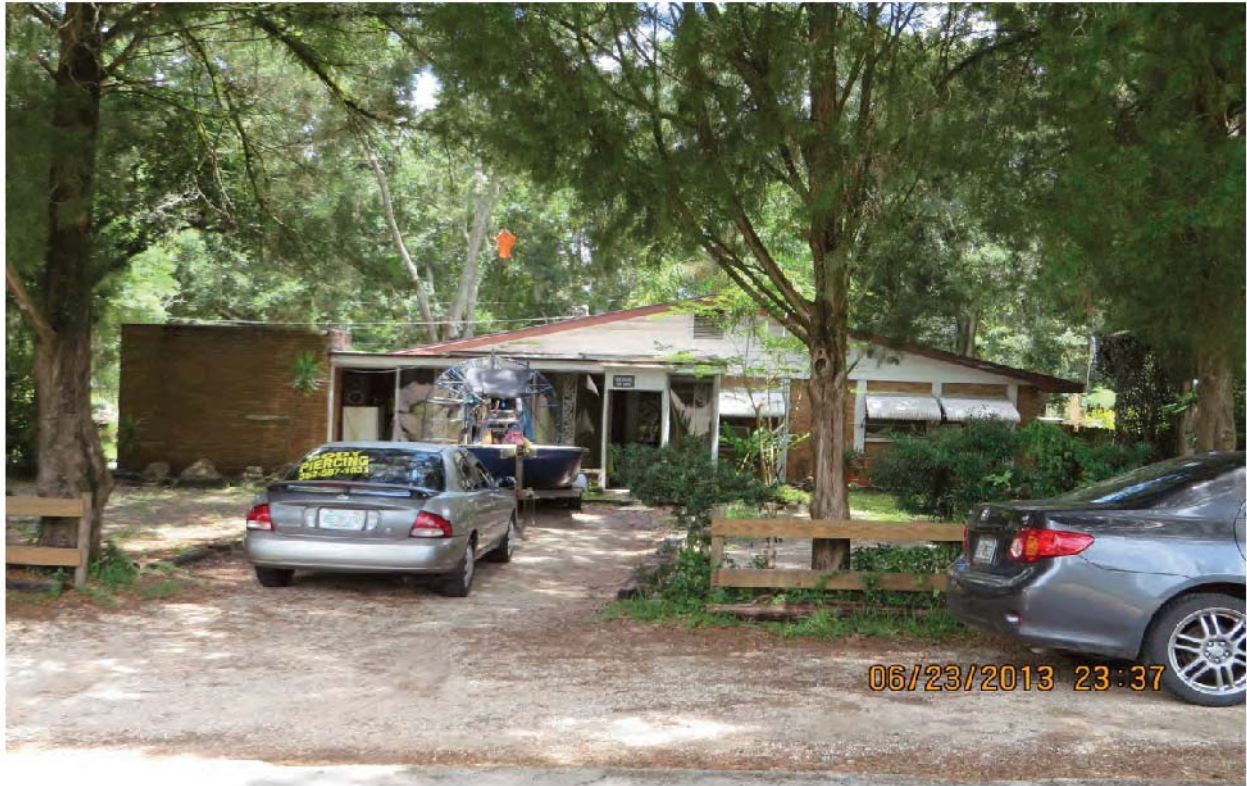
PHOTOGRAPH

Construction Year: 1959 approximately year listed or earlier year listed or later
Original Use Private Residence (House/Cottage/Cabin) From (year): 1959 To (year): cur
Current Use _____ From (year): _____ To (year): _____
Other Use _____ From (year): _____ To (year): _____
Moves: yes no unknown Date: _____ Original address _____
Alterations: yes no unknown Date: c. 1990 Nature Replacement windows
Additions: yes no unknown Date: _____ Nature _____
Architect (last name first): Unknown Builder (last name first): Unknown
Ownership History (especially original owner, dates, profession, etc.) _____

Chimney: No. 0 Chimney Material(s): 1. Concrete block 2.
Structural System(s): 1. Concrete block 2. 3.
Foundation Type(s): 1. Slab 2.
Foundation Material(s): 1. Concrete, Generic 2.
Main Entrance (stylistic details) S elevation, square opening, single-door with storm door

Condition (overall resource condition): [] excellent [x] good [] fair [] deteriorated [] ruinous

Explanation of Evaluation (required, whether significant or not; use separate sheet if needed) This is a typical example of a Masonry Vernacular style residence found throughout Hernando County. Furthermore, limited research revealed no significant historical associations. Therefore, 8HE00729 does not appear eligible for listing in the NRHP.

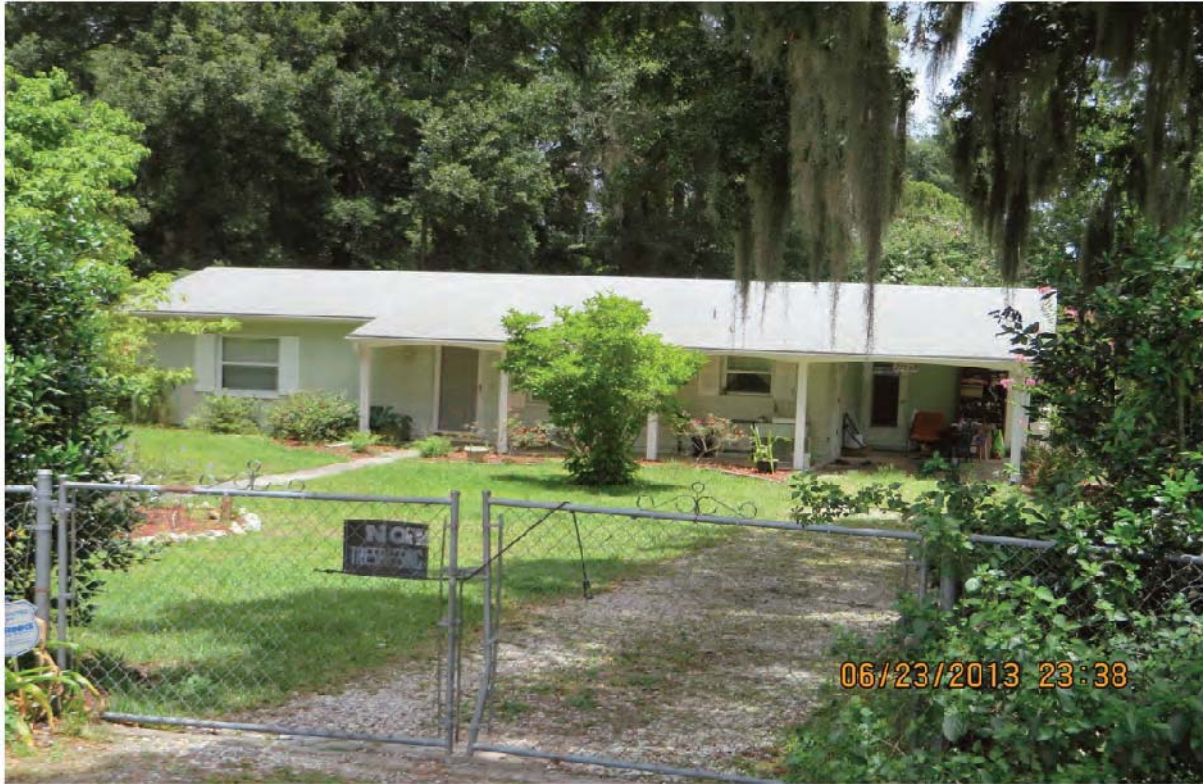
PHOTOGRAPH

Construction Year: 1963 approximately year listed or earlier year listed or later
Original Use Private Residence (House/Cottage/Cabin) From (year): 1963 To (year): cur
Current Use _____ From (year): _____ To (year): _____
Other Use _____ From (year): _____ To (year): _____
Moves: yes no unknown Date: _____ Original address _____
Alterations: yes no unknown Date: c. 1990 Nature Replacement garage door
Additions: yes no unknown Date: _____ Nature _____
Architect (last name first): Unknown Builder (last name first): Unknown
Ownership History (especially original owner, dates, profession, etc.) _____

Condition (overall resource condition): excellent good fair deteriorated ruinous

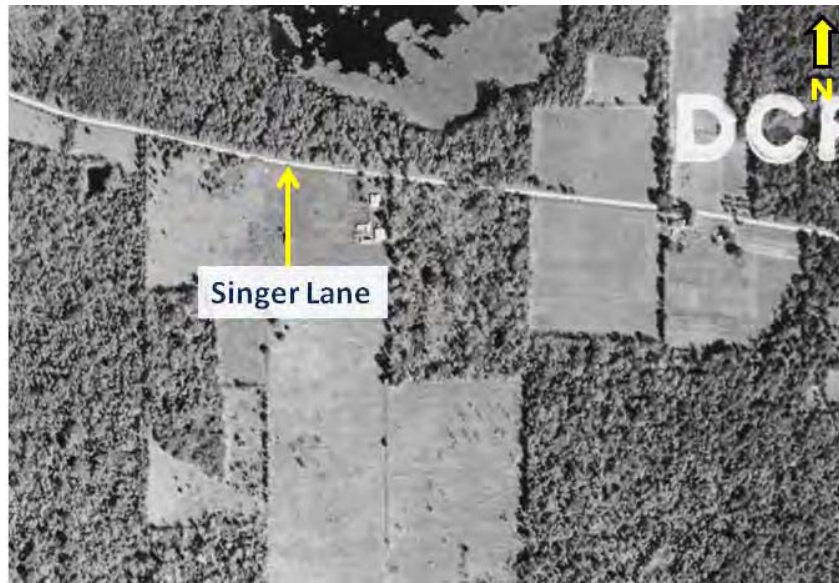
Singer Lane is a remnant of the original SR 50 constructed circa 1920 as a two-lane roadway (PALMM 1944). The roadway is depicted in a Rand McNally Auto Trails Map from 1922, and an aerial photograph from 1944 illustrates the original condition of this roadway prior to the construction of present-day SR 50 around 1950 (**Photo 1**). The aerial photograph also indicates that the original path of SR 50, within this area of Hernando County, was very different from its current course. Based on the information gathered from the County Property Appraiser and historic aerial photographs, it appears that upon the construction of present-day SR 50, the original road from the 1920s was vacated and the land consolidated with adjacent privately owned parcels; thus, this remaining segment became a private access road for properties to the south. During field survey, Richard Whatley, an adjacent property owner, spoke to the survey architectural historian. Mr. Whatley confirmed that the road had once been SR 50, and noted that the road was now privately owned, and its maintenance was the responsibility of the property owners, not the county.

Photo 1. 1944 aerial photograph depicting the original condition of the roadway built circa 1920 (PALMM 1944).

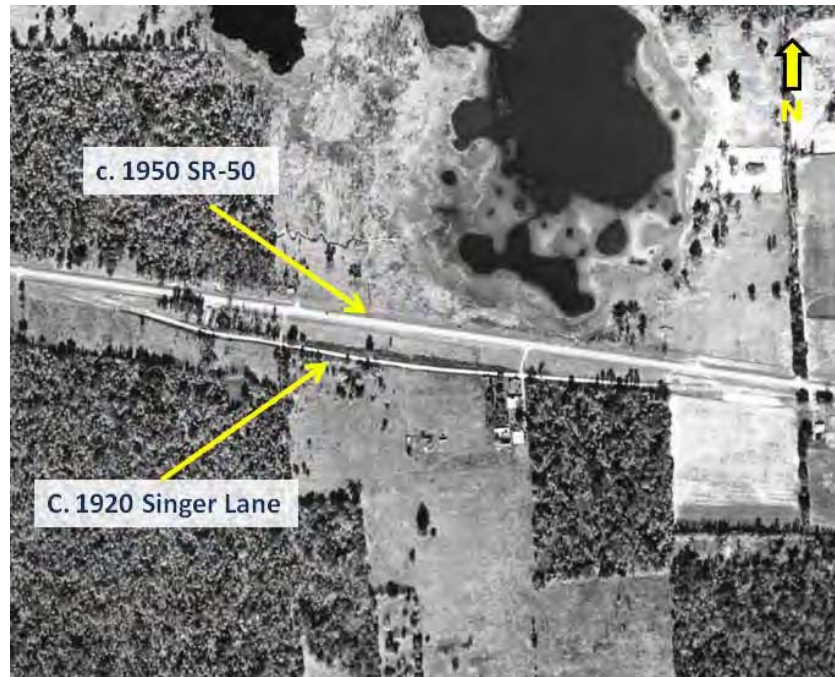
An aerial photograph from 1952 illustrates the condition soon after the new SR 50 was constructed (**Photo 2**). The trees and shrubs currently present on either side of this road are absent from this image, and arguably were planted sometime after this date to buffer this private road from SR 50. The trees and shrubs do not constitute a designed landscape and are merely utilitarian alterations, which do not reflect the original use and design of the roadway as built circa 1920. Furthermore, the roadway has suffered significant alterations. Singer Lane is a small segment of a former highway once part of the state highway system. The width of the roadway appears to have been reduced from an original two-lane highway to a single lane. In addition, the road retains little, if any, of its original pavement. It currently exhibits a combination of asphalt and gravel. These significant alterations have eroded the historic integrity of the roadway. It neither retains its historic fabric, nor conveys its original design and setting. As such, 8HE741 is not considered eligible for the NRHP, either individually or as part of a resource group.

Photo 2. 1952 aerial photograph depicting the construction of SR 50 around 1950 and the remaining section of the 1920s roadway, renamed Singer Lane (PALMM 1952).

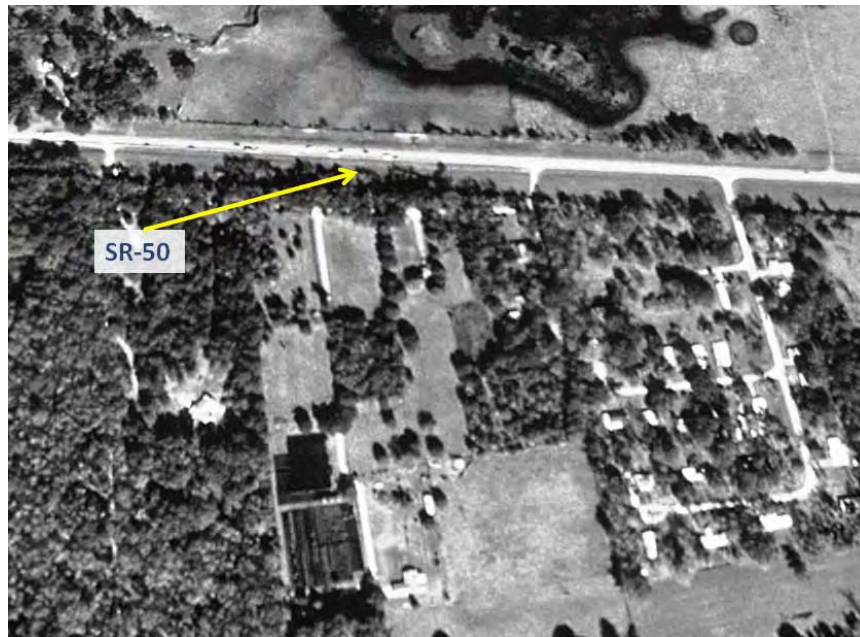
Present-day SR 50 was constructed circa 1950 and replaced a previous road built circa 1920, a segment of which remains and was recorded during this survey (8HE741). The highway is depicted soon after its construction on a 1952 historic aerial, and also appears on aerial photographs from 1969 and 1984 (PALMM 1952, 1969 and 1984). The road was originally designed and constructed as a two-lane highway and was expanded between 1995 and 1999 into a four-lane highway with median (**Photos 1 and 2**). This alteration has caused the segment of the roadway within the APE to lose its historic integrity. An evaluation of the entirety of the roadway within Charlotte County is beyond the scope of this project.

Photo 1. 1995 satellite image depicting SR 50 as a two-lane highway (Google Earth 1995).

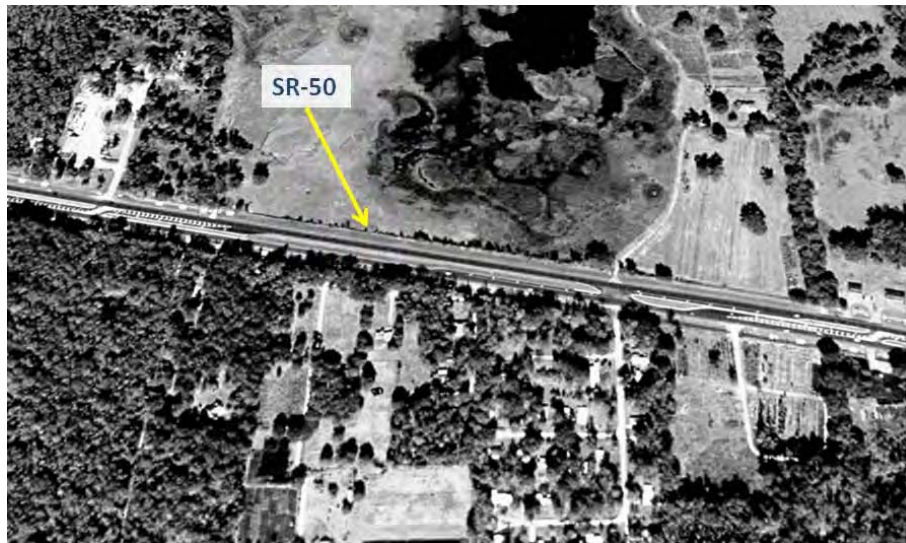
In conclusion, the stretch of SR 50 within the project APE is a small segment of a 115-mile cross-peninsula highway. Furthermore, the segment of the roadway within the project APE has lost its historic integrity owing to widening, and repavement campaigns, which have completely altered its original design, and setting. As such, 8HE742 within the project APE is not considered eligible for the NRHP.

Photo 2. 1999 satellite image depicting an enlarged SR 50 featuring four lanes and a median (Google Earth 1999).
