FINAL ENVIRONMENTAL TECHNICAL COMPENDIUM

SR 50 (CORTEZ BOULEVARD) PROJECT DEVELOPMENT AND ENVIRONMENT STUDY

**SR 50 (Cortez Boulevard)
from West of I-75 to US 301 (SR 35/Treiman Boulevard)
Hernando County, Florida**

**Atkins North America, Inc.
4030 West Boy Scout Boulevard, Suite 700
Tampa, Florida 33607**

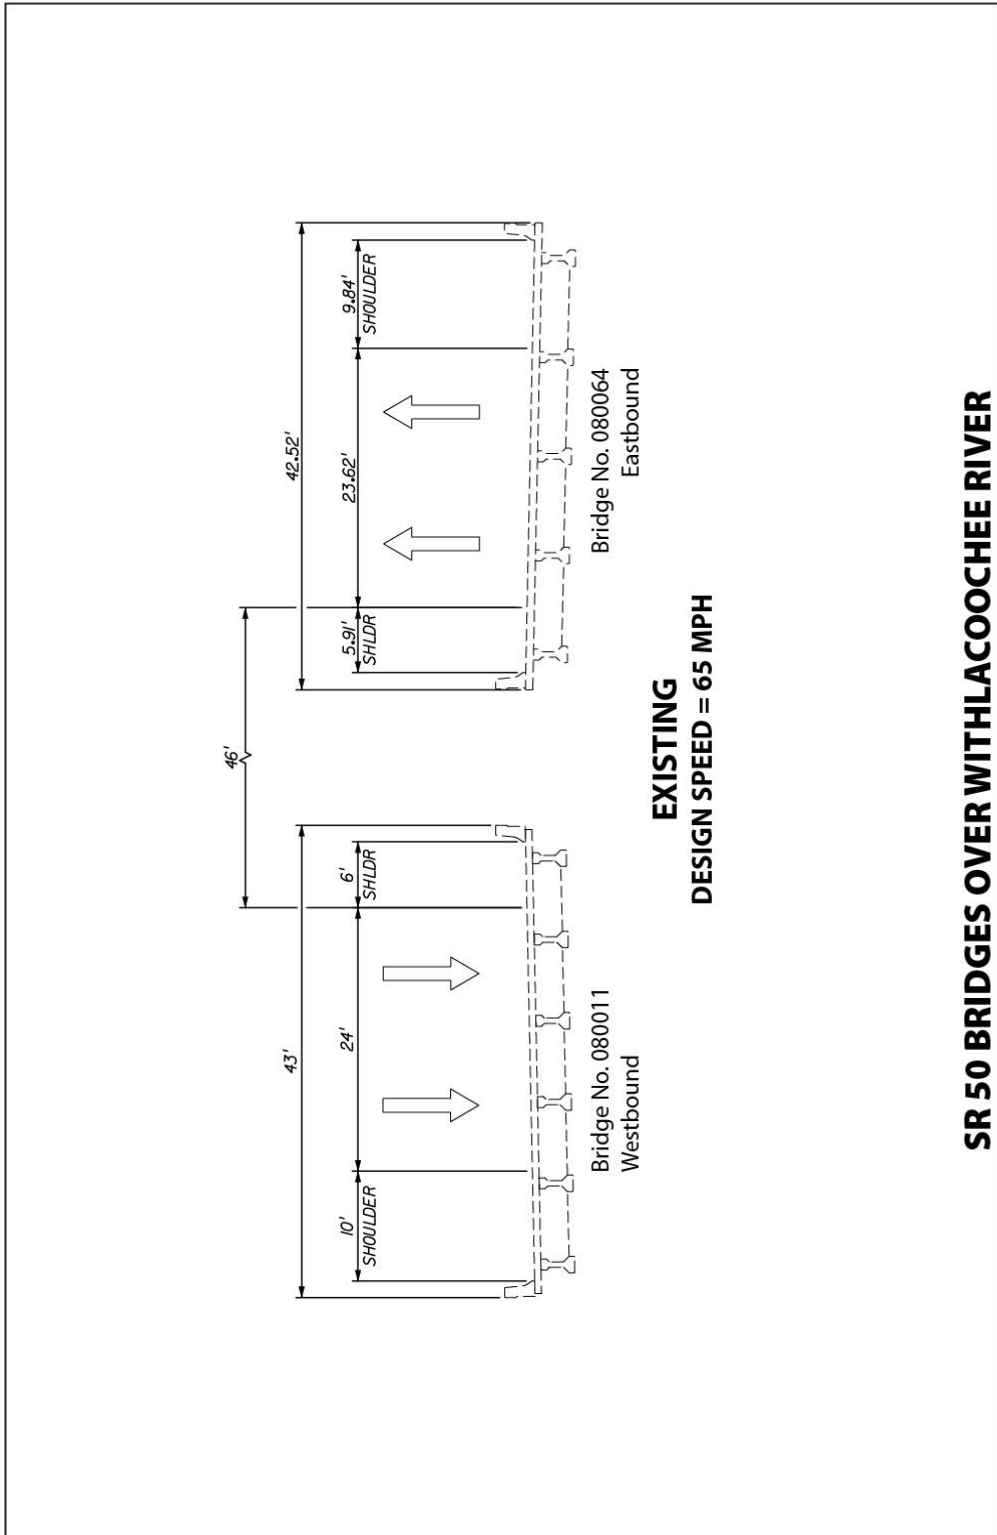
Figure 3: Existing Bridge Typical Section

SR 50 BRIDGES OVER WITHLACOOCHEE RIVER

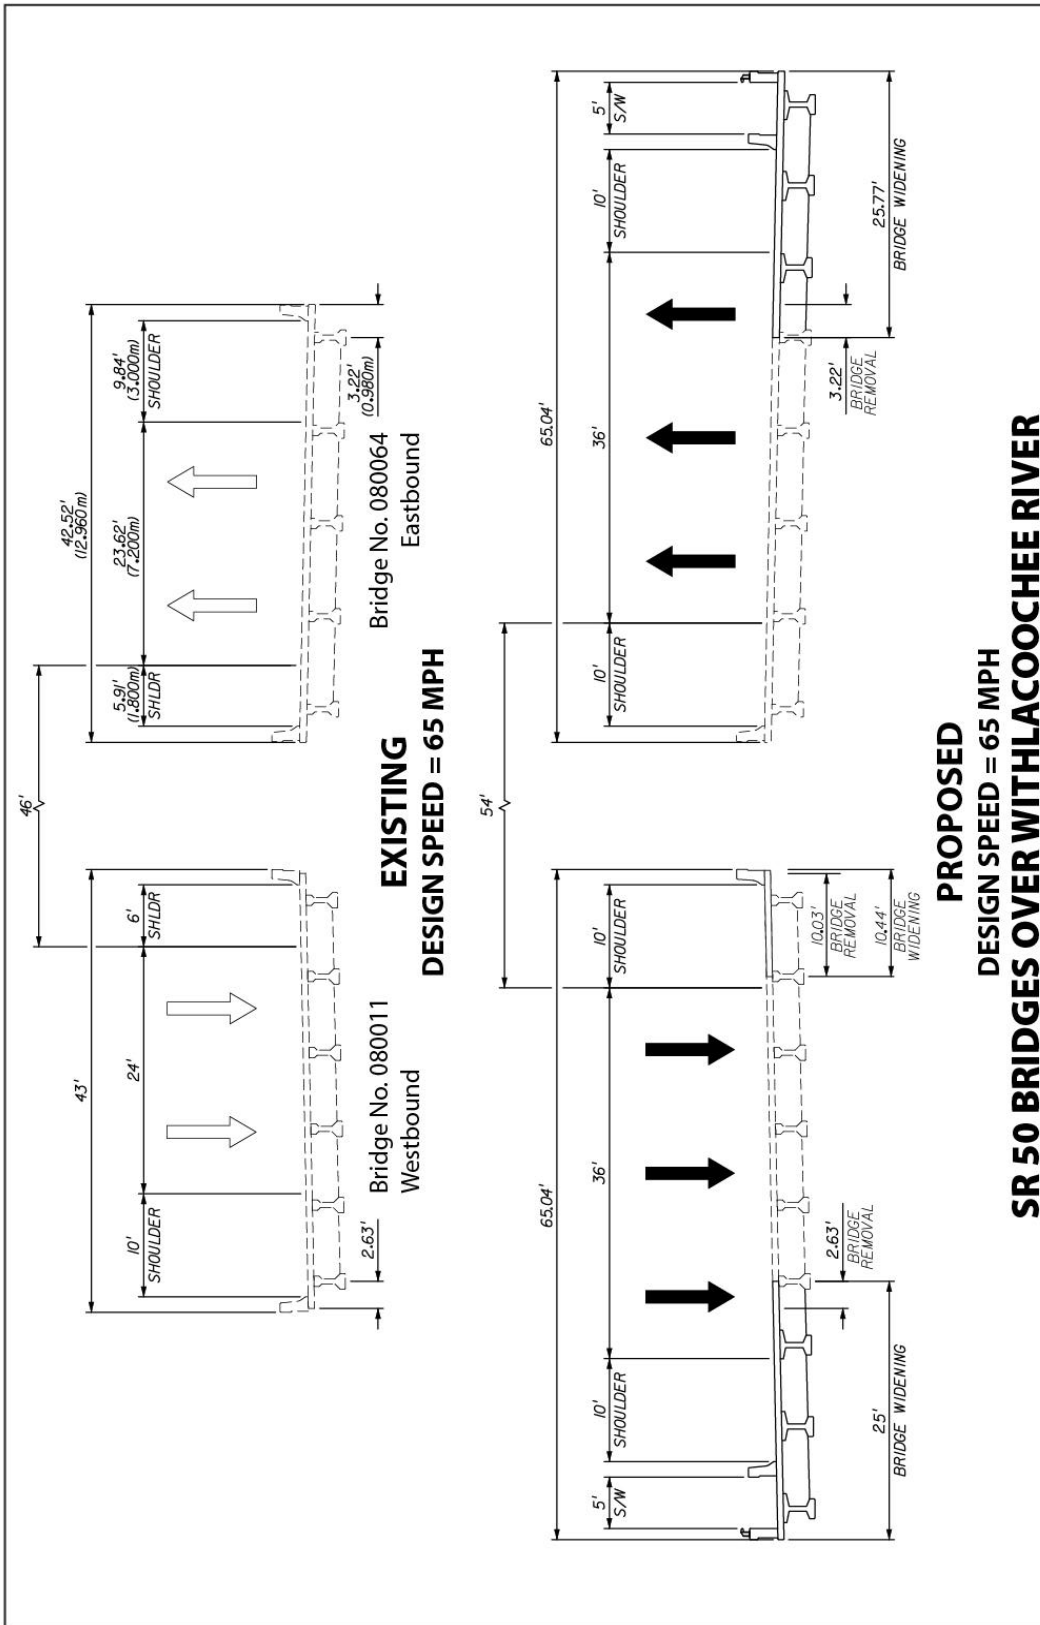
Figure 6: Proposed Bridge Typical Section

**PROPOSED
DESIGN SPEED = 65 MPH
SR 50 BRIDGES OVER WITHLACOOCHEE RIVER**

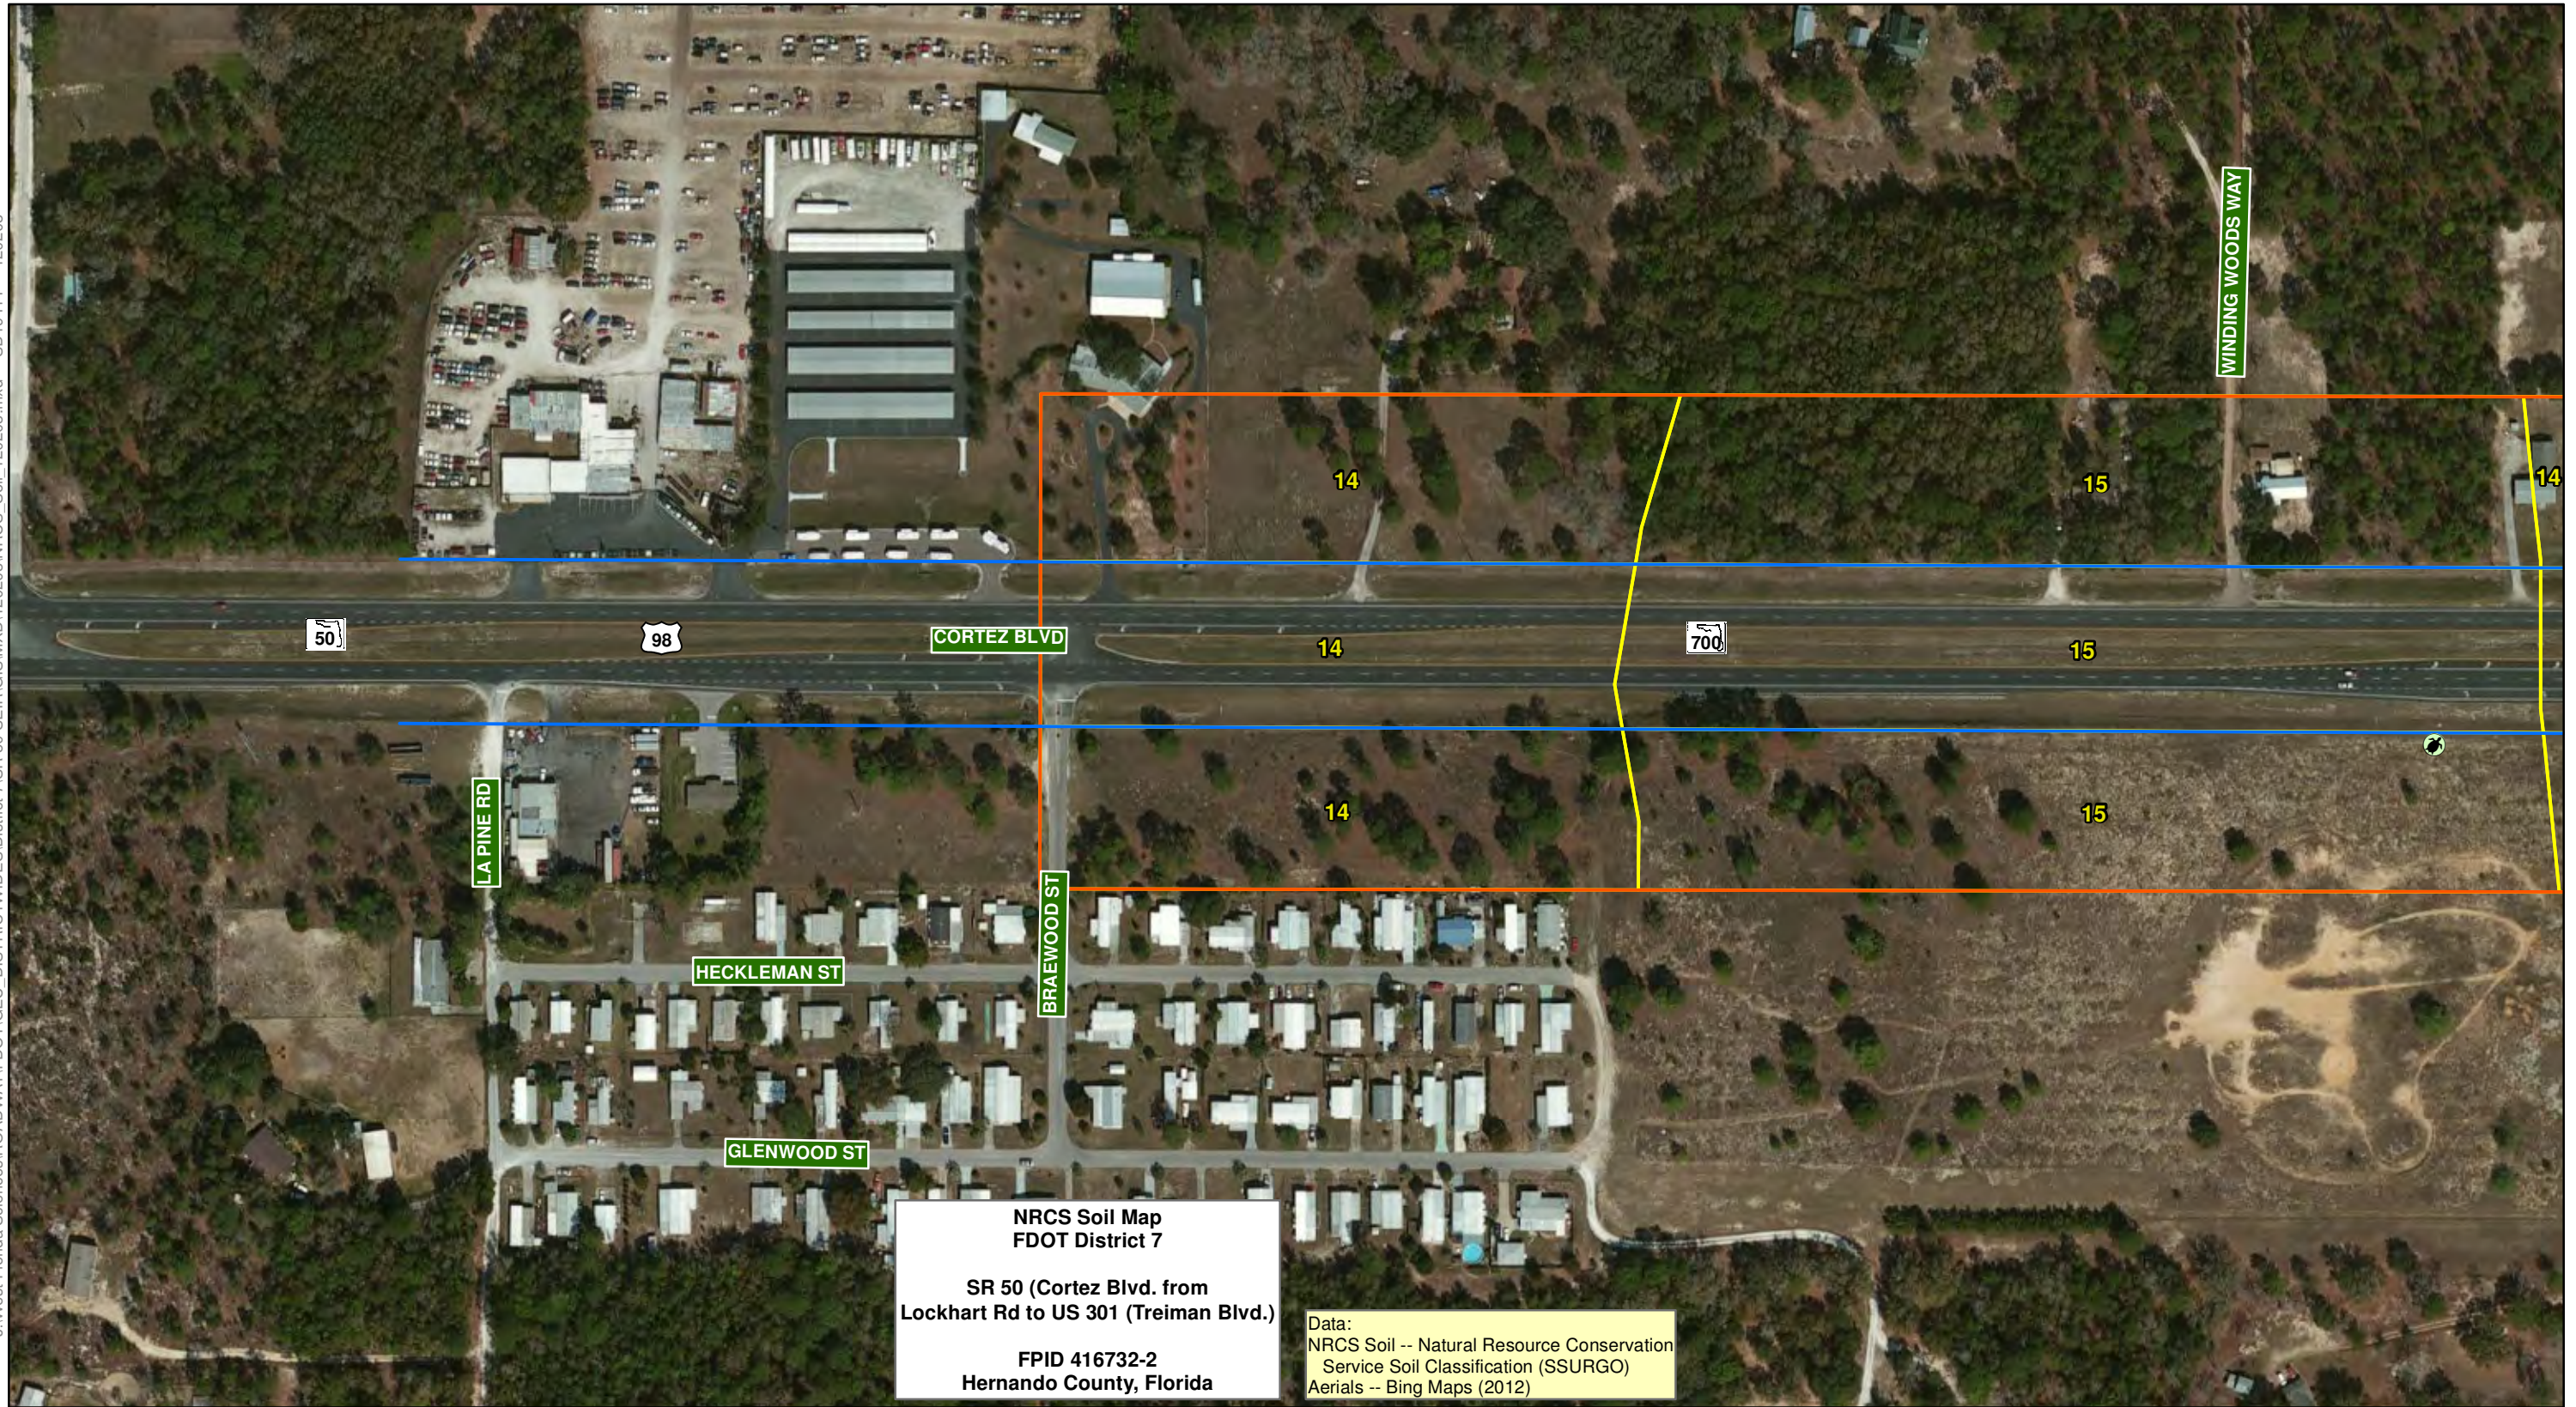
SOIL TYPES PRESENT ALONG PROJECT CORRIDOR

Anclote Fine Sand consists of low, nearly level, very poorly drained soils that formed in sandy, marine sediments. They are typically found in low depressional areas. Under natural conditions, the water table is above the surface for 3 to 6 months during the wet season. This soil series is classified as hydric.

The Astatula soils series consists of well drained, sandy soils typically with water table below 80 inches. This soil is typically found in uplands and is classified as non-hydric.

Basinger Fine Sand consists of nearly level, poorly drained soils typically found in poorly defined drainage ways, wet depressions, and sloughs in flatwoods. The water table is at a depth of less than 10 inches for two to six months and at a depth of 10 inches to 30 inches for the remainder of the year. This soil series is classified as hydric.

The Candler Series are excessively drained, sandy soils found typically in uplands. The water table is below a depth of 80 inches for much of the year. This soil type was identified in the areas classified by FLUCFCS as 653 (Intermittent Ponds). These areas were excavated to utilize for storm water management. This soil series is classified as non-hydric.

Pomello soils are nearly level to sloping, moderately drained sandy soils. This series is typically found in low ridges in flatwoods with the water table at 24 to 40 inches for one to four months of the year and at 40 to 60 inches the remainder of the year. This soil type is classified as hydric.

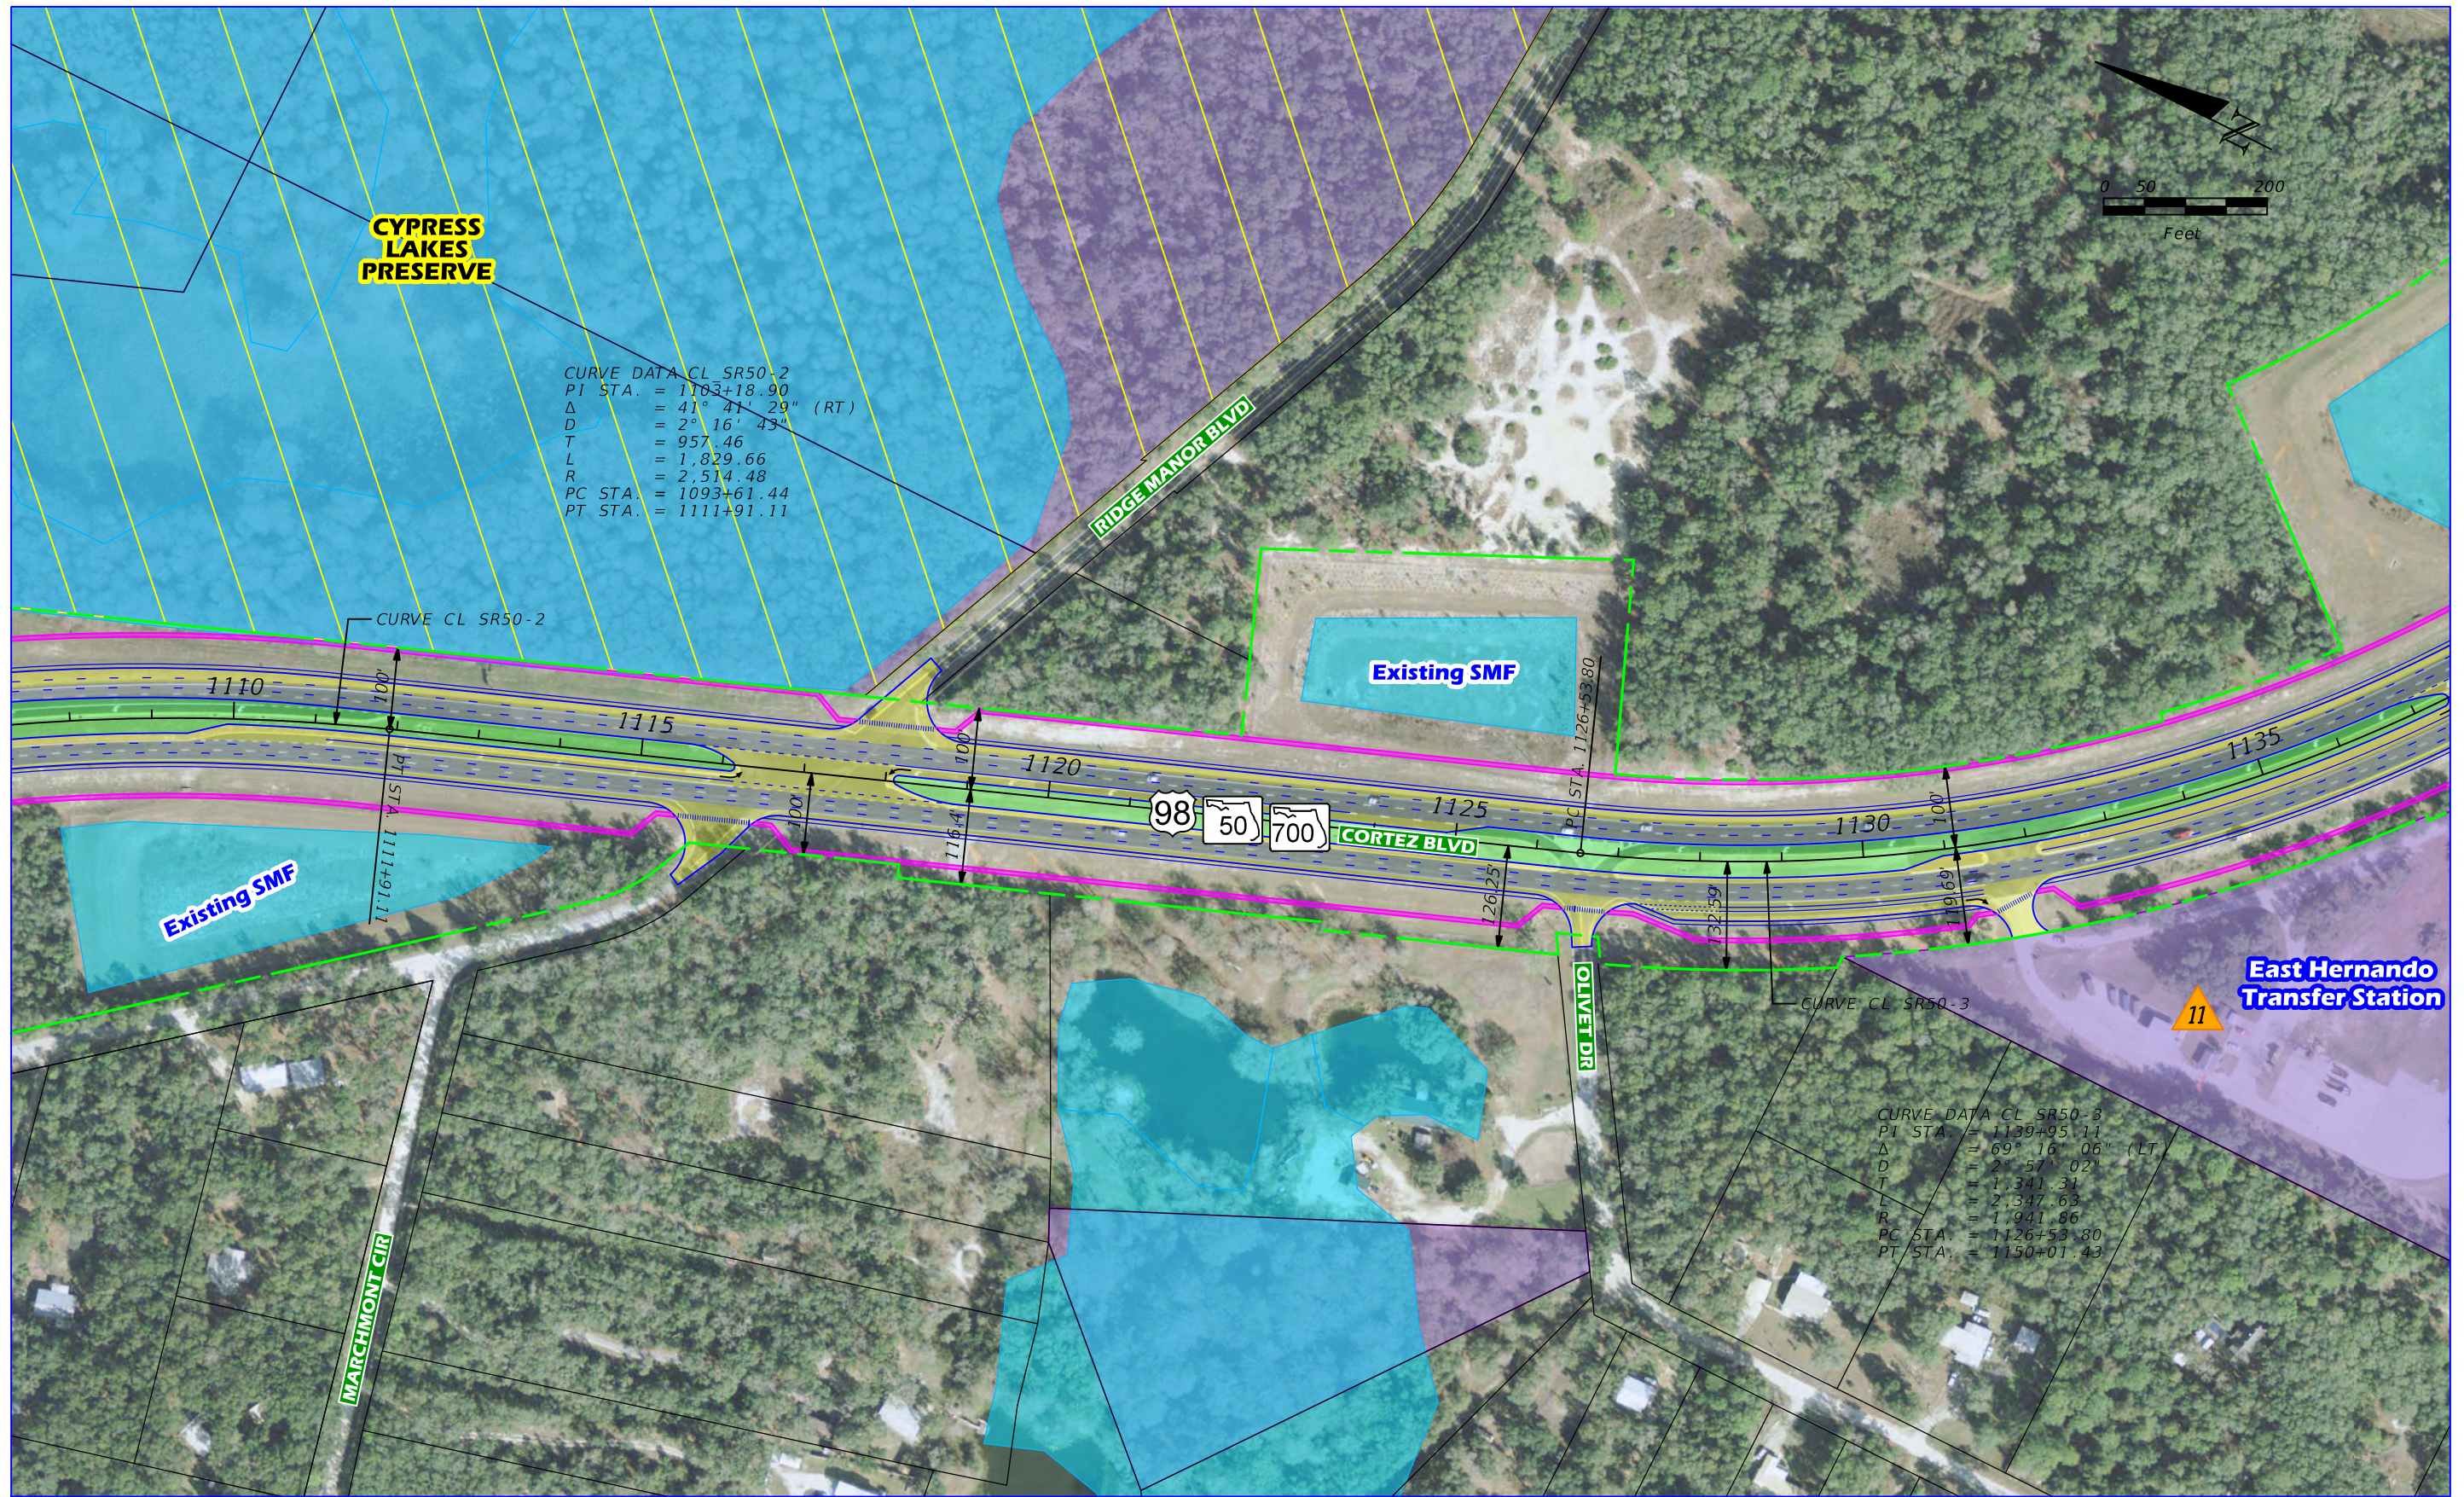
SHEET NO.
5

CURVE DATA CL SR50-2
 PI STA. = 1103+18.90
 Δ = 41° 41' 29" (RT)
 D = 2° 16' 43"
 T = 957.46
 L = 1,829.66
 R = 2,514.48
 PC STA. = 1093+61.44
 PT STA. = 1111+91.11

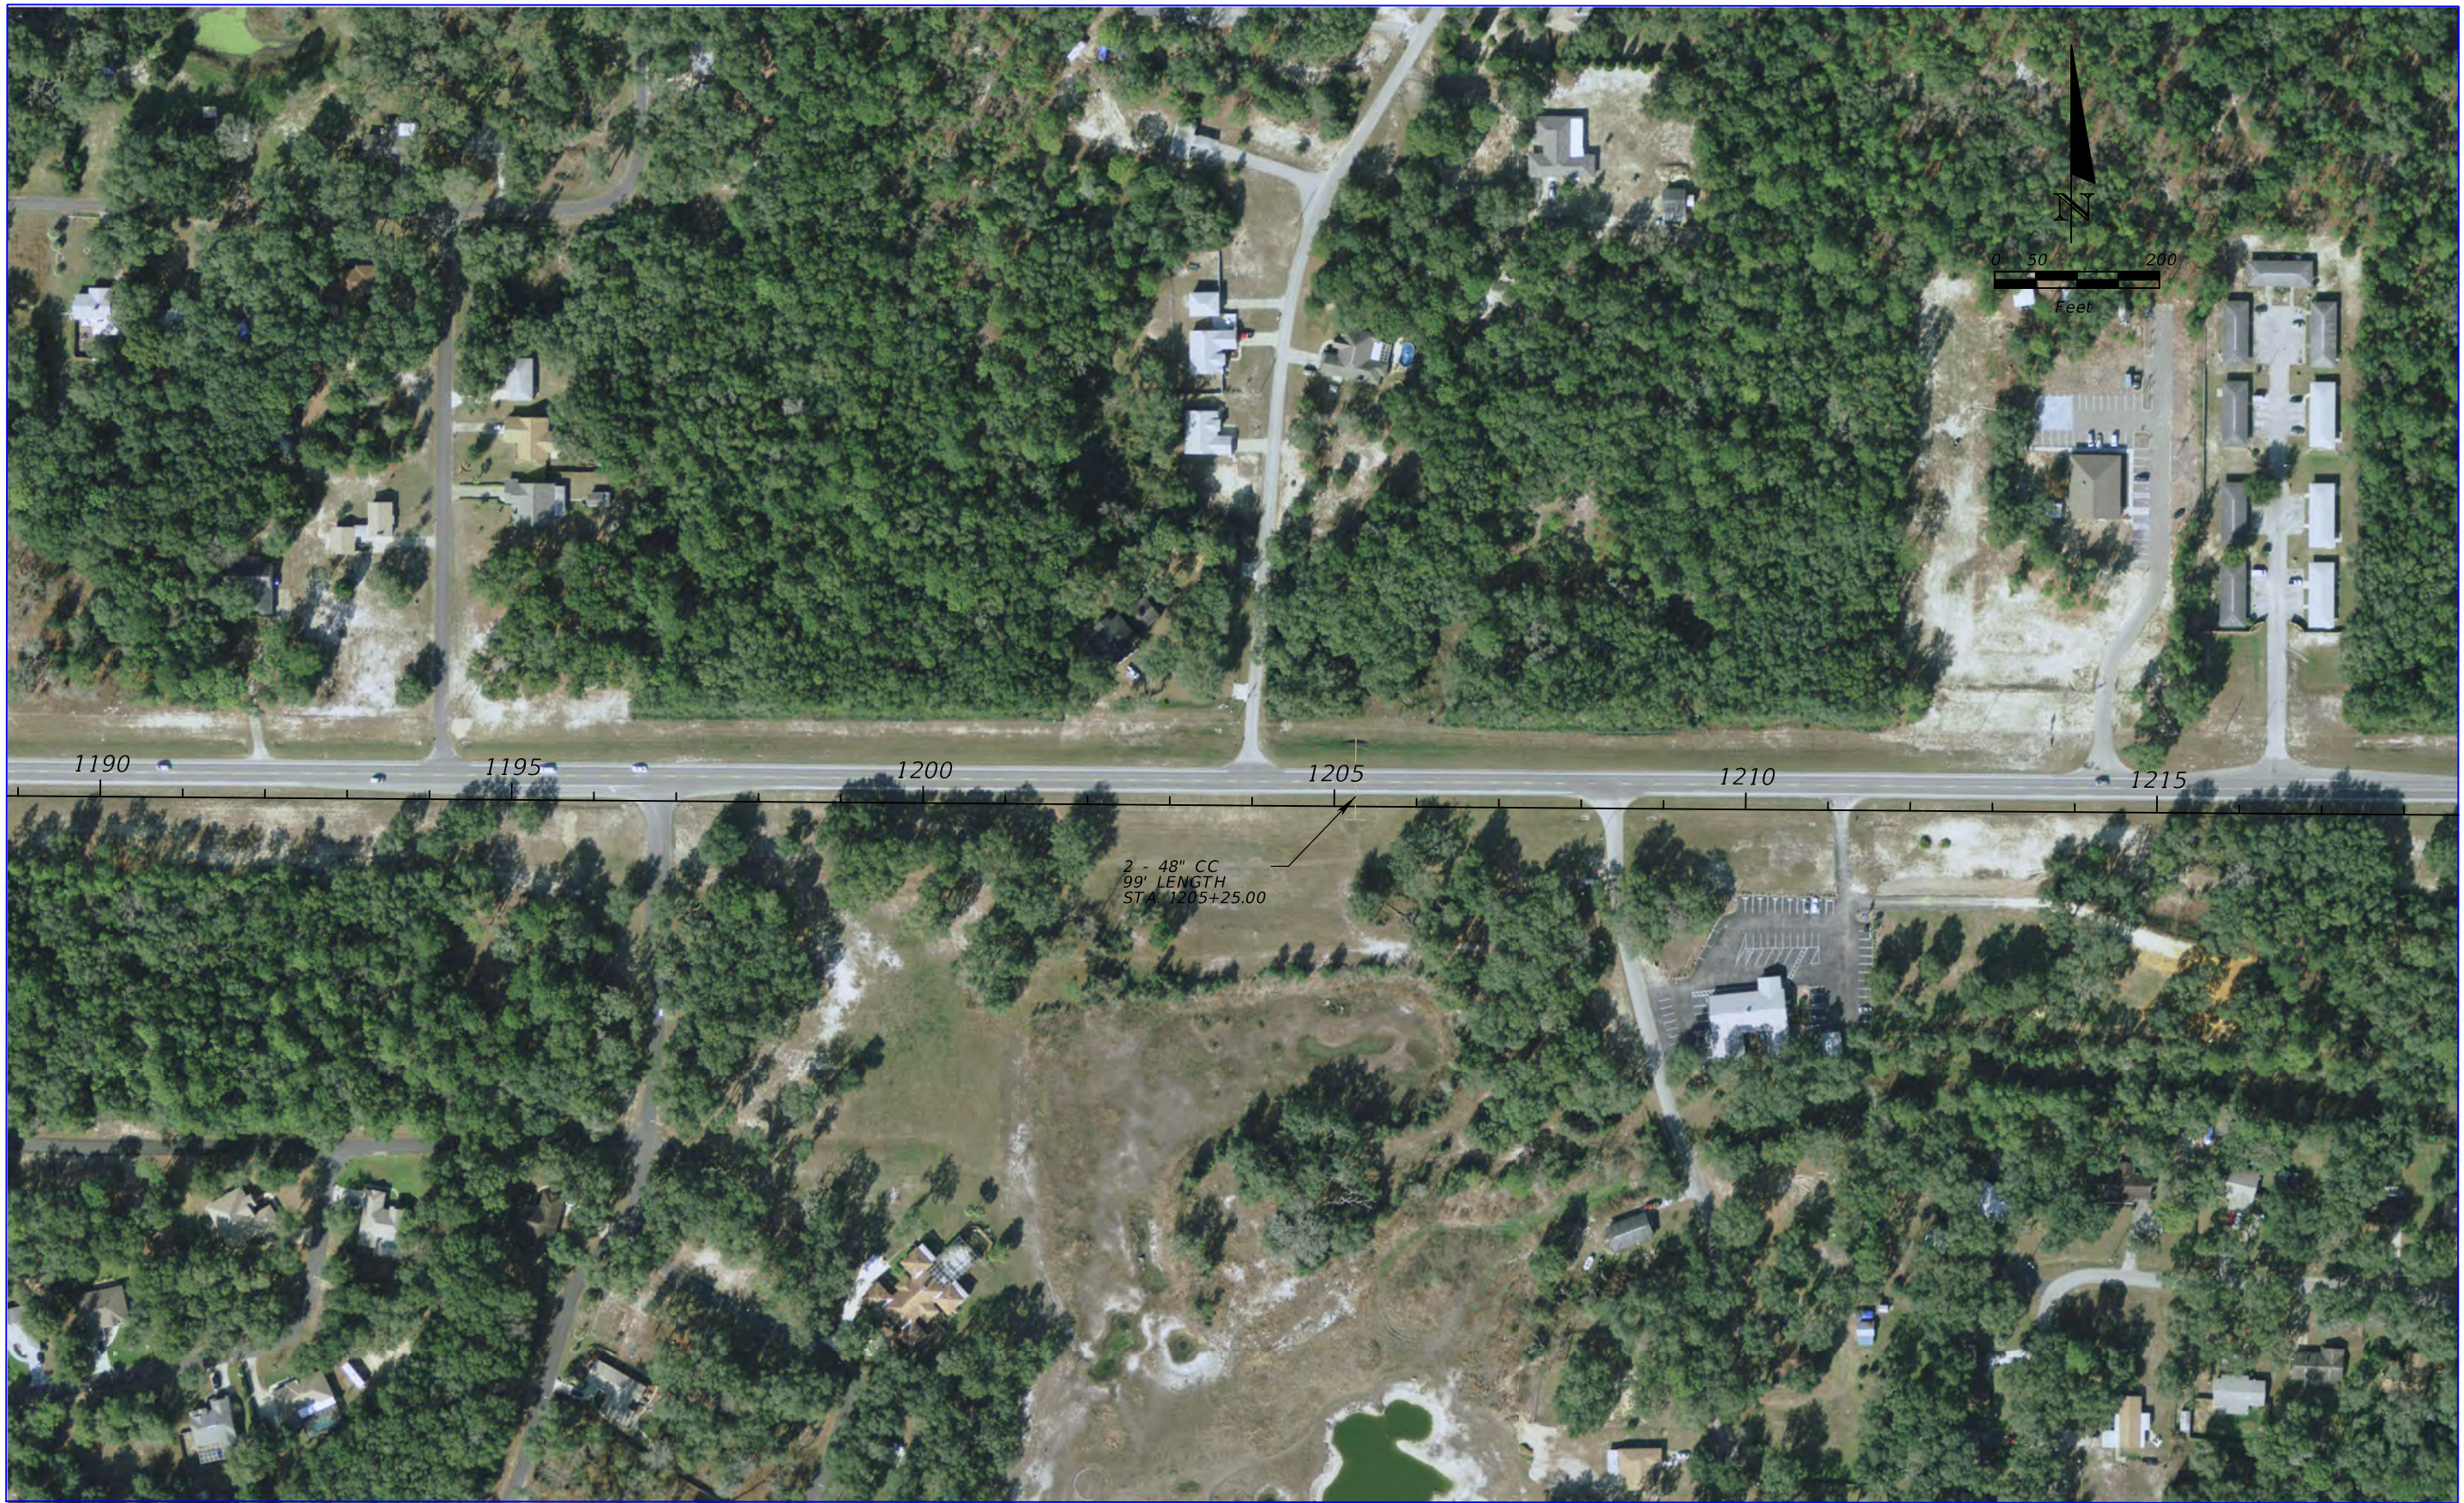
2 - 48" CC
99' LENGTH
STA. 1205+25.00
