**HISTORIC RESOURCES UPDATE SURVEY
TECHNICAL MEMORANDUM**

**STATE ROAD 50 (SR 50) [CORTEZ BOULEVARD] FROM
LOCKHART ROAD TO US 301 (SR 35/TREIMAN BOULEVARD),
HERNANDO COUNTY, FLORIDA**

Work Program Item Segment Number: 416732-2

February 2012

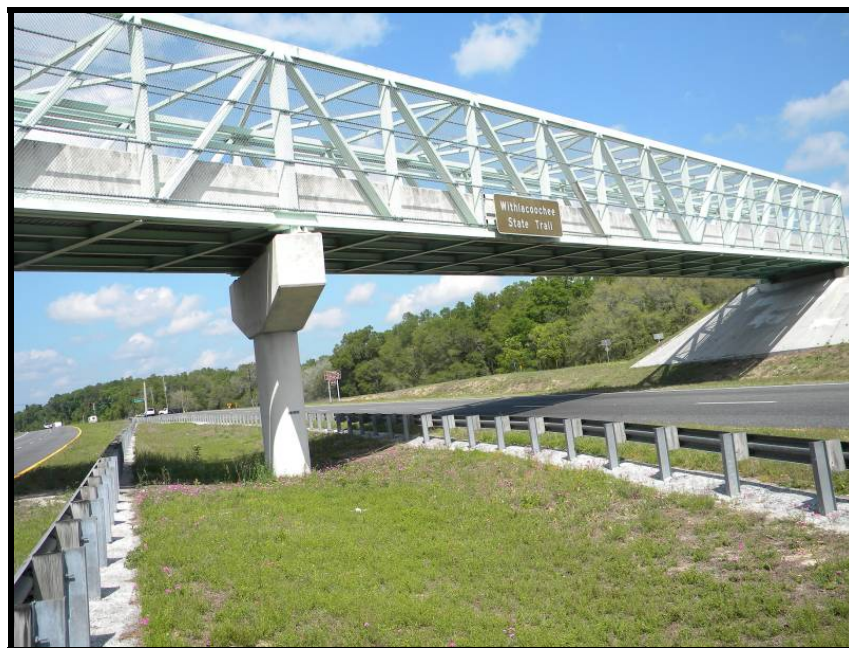
Photo 1. Looking west from SR 50 (Cortez Boulevard) at CSX Railroad segment.

Crossing the SR 50 (Cortez Boulevard) project APE is the Withlacoochee State Trail, a 46-mile paved hiking/biking trail between Trilby at the south and Dunellon to the north. The trail was constructed in 1989 as part of the rails-to-trails program of the Florida Department of Environmental Protection, Division of Recreation and Parks. The recreational trail follows the former Atlantic Coast Line Railroad (CSX RR) corridor, but the railroad bed is no longer visible (**Photo 1**). The trail is located approximately 400 feet east of the intersection of Kettering Road and SR 50 (Cortez Boulevard). As contained within the project APE, it is an elevated truss bridge that carries the path over SR 50 (Cortez Boulevard).

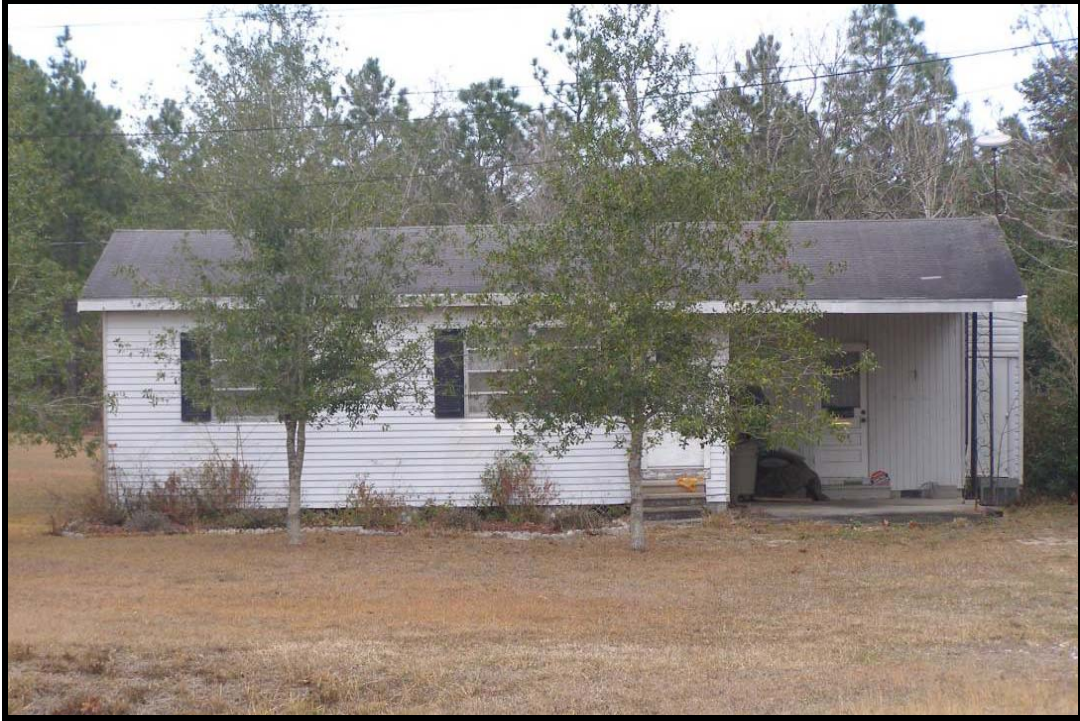
Photo 2. South elevation of 29367 Cortez Boulevard, 8HE679.

8HE679: The Frame Vernacular style residence at 29367 Cortez Boulevard was constructed ca. 1962 (**Photo 2**). The wood frame walls are supported by a continuous concrete block foundation and clad in vinyl siding (ca. 1990). The gable roof is covered in asphalt shingles and the windows are three- and four-light awning. Other architectural features include fixed window shutters and scroll posts. This is a typical example of the Frame Vernacular style commonly found throughout Hernando County. Furthermore, the building does not exhibit any unique design features and research did not reveal any significant historical associations. Therefore, 8HE679 is not considered potentially eligible for listing in the NRHP.

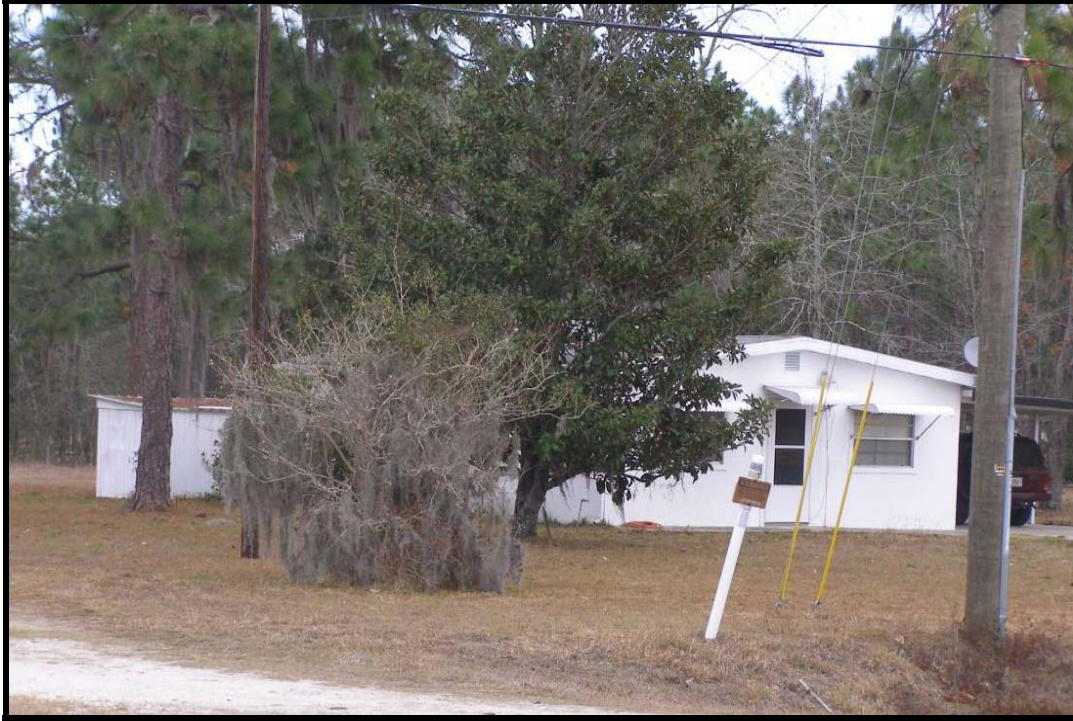
Photo 3. South and west elevations of 29373 Cortez Boulevard, 8HE680.

8HE680: The Masonry Vernacular style residence at 29373 Cortez Boulevard was constructed ca. 1957 (**Photo 3**). The slab foundation supports the concrete block walls that are clad in stucco and topped with a gable roof covered with asphalt shingles. The windows are 2/2 SHS with storm windows and awnings. The building features a gable vent, awnings over the main entrance, a wood swing door on the south elevation with a two-light storm door, and a ca. 1980 carport addition. A utility shed is to the northwest. This is a typical example of the Masonry Vernacular style commonly found throughout Hernando County. Furthermore, the building did not exhibit any unique design features and research did not reveal any significant historical associations. Therefore, 8HE680 is not considered potentially eligible for listing in the NRHP.

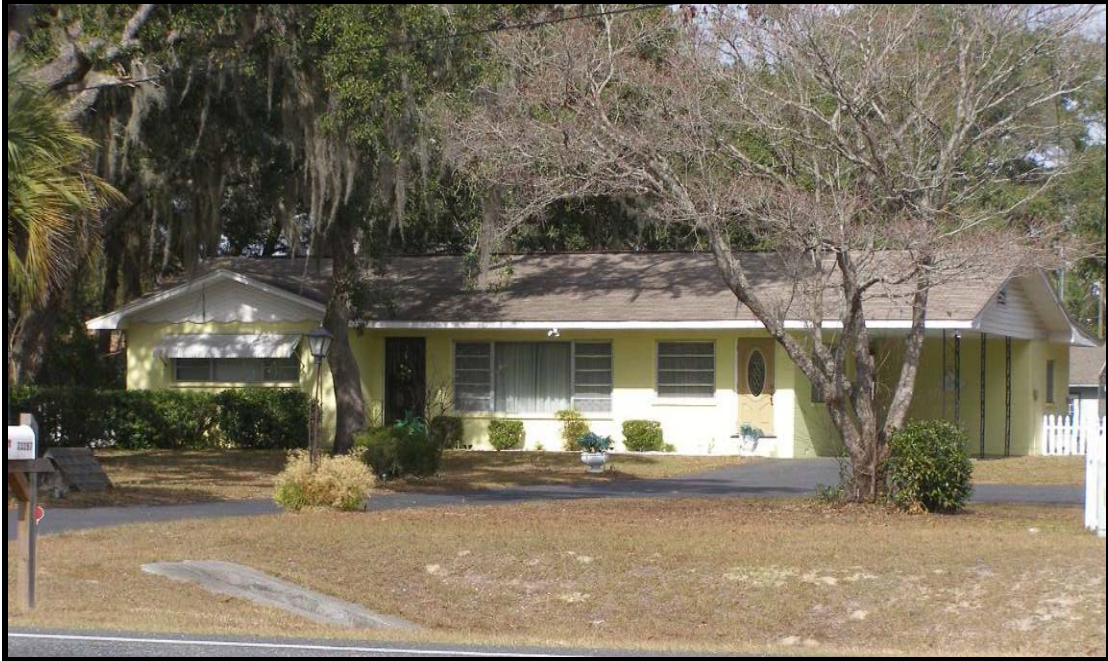
Photo 4. South and east elevations of 33297 Cortez Boulevard, 8HE681.

8HE681: The Masonry Vernacular style residence at 33297 Cortez Boulevard was constructed ca. 1960 (**Photo 4**). The concrete block walls are supported by a slab and continuous concrete block foundation and the gable roof is covered with asphalt shingles. The windows include four- and five-light awning, and one-light fixed with four- or five-light awning. Other features include window sills, gable vents, foundation vents, wood siding in the gables, awnings over the windows, and scroll posts. This is a typical example of a Masonry Vernacular style residence found throughout Hernando County. Furthermore, alterations diminish its integrity and research did not reveal any significant historical associations. Therefore, 8HE681 is not considered potentially eligible for listing in the NRHP.

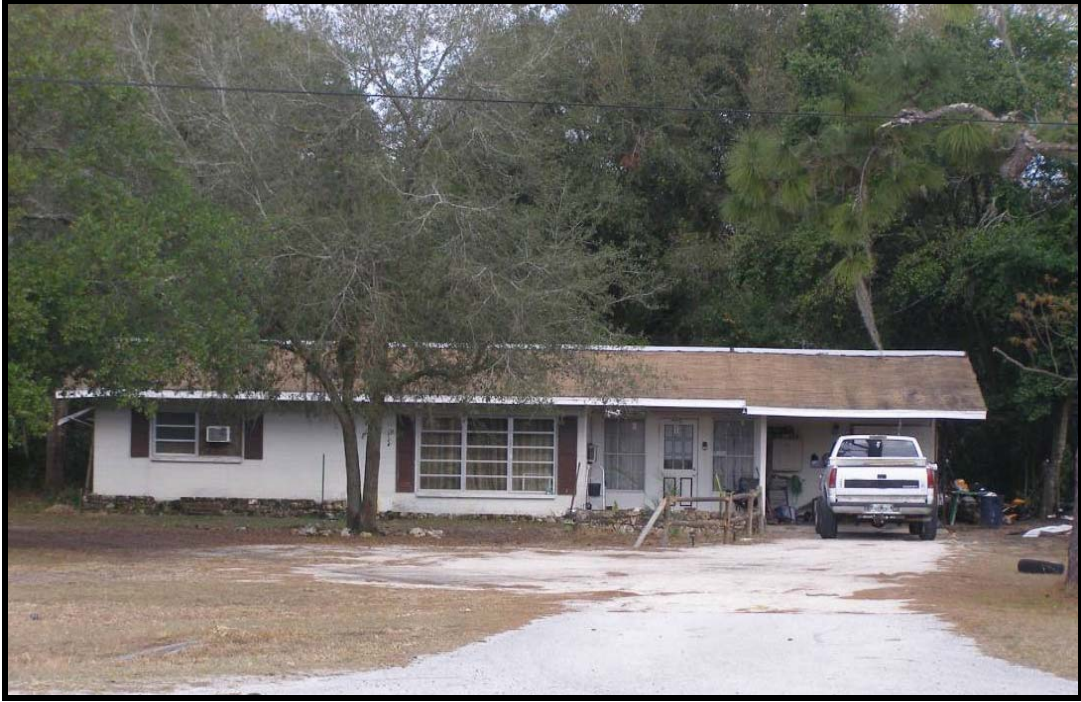
Photo 5. South elevation of 33325 Cortez Boulevard, 8HE682.

8HE682: The Masonry Vernacular style residence at 33325 Cortez Boulevard was constructed ca. 1958 (**Photo 5**). The slab foundation supports the concrete block walls that are topped with a gable roof covered with asphalt shingles. The carport was enclosed ca. 1990 and an addition was built on the east elevation. The replacement windows (ca. 1970; 1990) include three- and five-light awning, and 1/1 SHS which are 6/6 simulated-divided-light. Other window features include fixed window shutters and awnings. The main entrance is a nine-light, two-panel wood swing door on the south elevation. This is a typical example of a Masonry Vernacular style residence found throughout Hernando County. Furthermore, alterations diminish its integrity and research did not reveal any significant historical associations. Therefore, 8HE682 is not considered potentially eligible for listing in the NRHP.

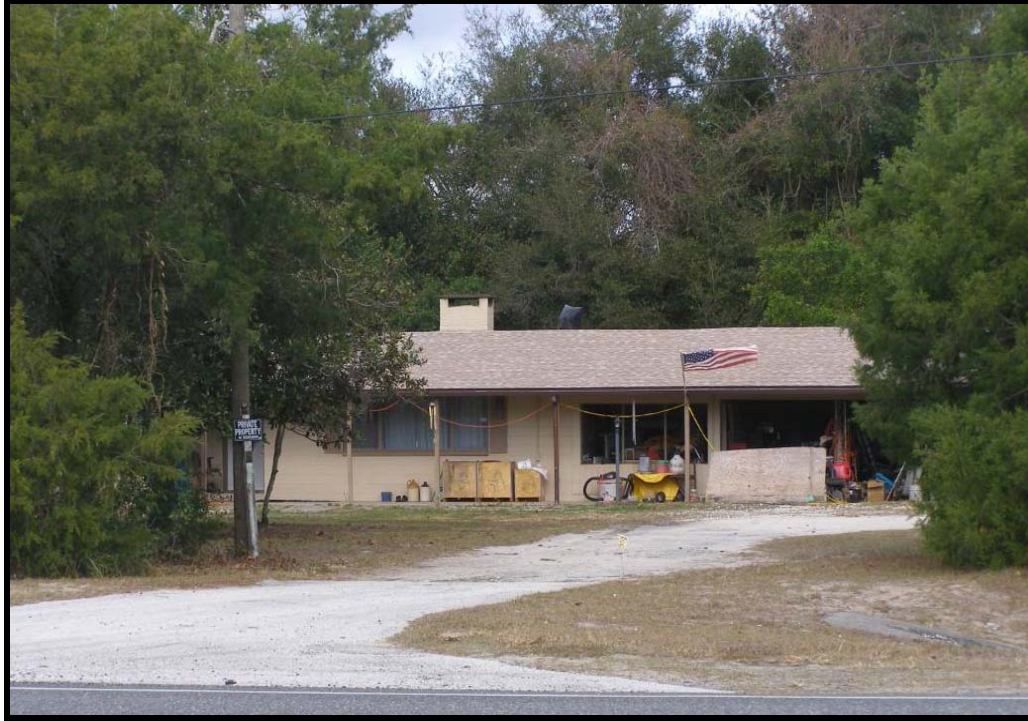
Photo 6. South elevation of 33345 Cortez Boulevard, 8HE683.

8HE683: The Masonry Vernacular style residence at 33345 Cortez Boulevard was constructed ca. 1956 (**Photo 6**). The concrete block walls rest on a slab foundation. The residence is topped with a gable roof covered with asphalt shingles (ca. 2000) and contains a brick chimney near the ridge. The windows include jalousie and one-light fixed (ca. 1980) with window sills and fixed window shutters. An incised porch is on the south elevation and contains the main entrance, a four-light, four-panel vinyl swing door (ca. 2000). Other alterations include an enclosed carport (ca. 1980). Given the alterations, the lack of historical significance in the available data, and that this is an example of a residential house common throughout Hernando County, it appears that 8HE683 is not considered potentially eligible for listing in the NRHP.

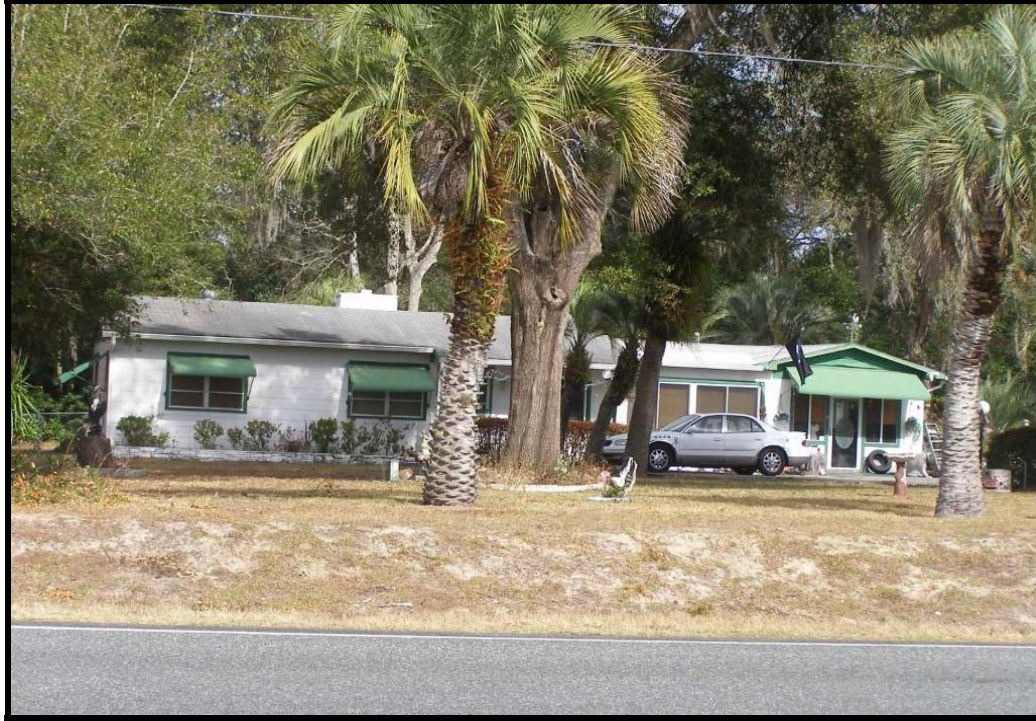
Photo 7. South elevation of 33359 Cortez Boulevard, 8HE684.

8HE684: The Masonry Vernacular style residence at 33359 Cortez Boulevard was constructed ca. 1959 (**Photo 7**). The slab foundation supports the concrete block walls. The residence is topped by a gable roof covered with asphalt shingles and a brick chimney near the ridge. The windows are three-light awning and two-light sliding (ca. 1990). A one-light vinyl swing door is on the main entrance. The carport was enclosed ca. 1980 and an addition was constructed on the east elevation. Other features include lattice posts and awnings over the windows. Given the extent of alterations to this residence, its similarity to others in Hernando County, and the lack of historical significance in the available data, it appears that 8HE684 does not appear eligible for listing in the NRHP.

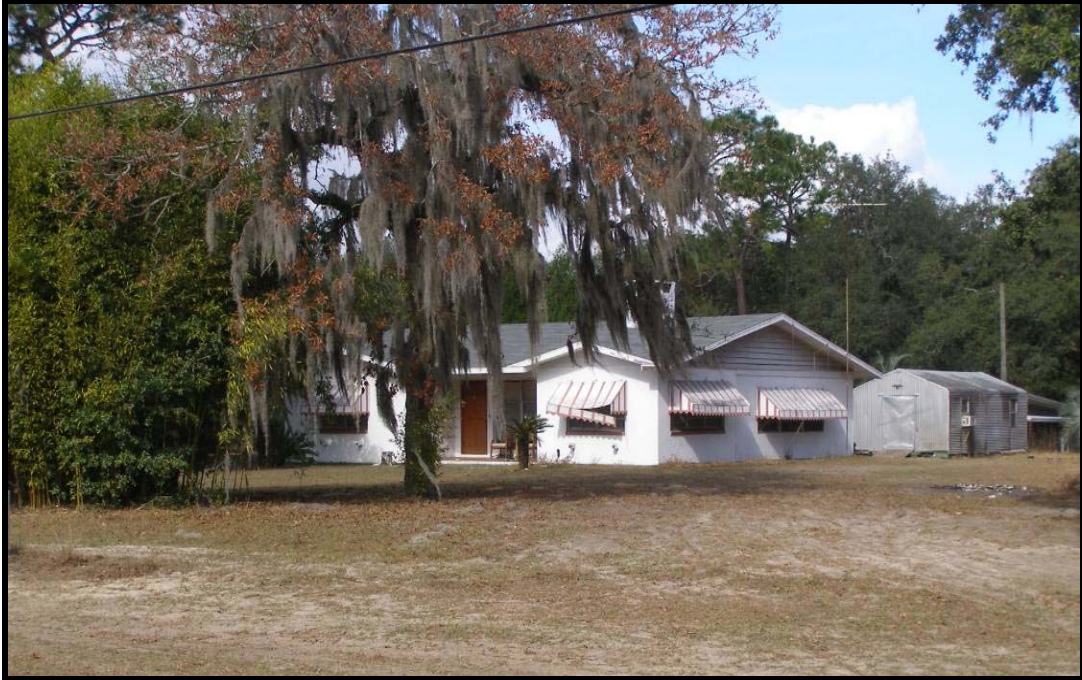
Photo 8. South and east elevations of 33555 Westwood Drive, 8HE685.

8HE685: The Masonry Vernacular style residence at 33555 Westwood Drive was constructed ca. 1957 (**Photo 8**). The slab foundation supports the concrete block walls clad in stucco. The replacement gable roof (ca. 1990) is covered in asphalt shingles and features a brick chimney at the ridge. There is wood siding in the gables. The windows are three- and four-light awning with awnings and sills. The main entrance, a six-panel wood swing door, is on the south elevation. The carport was enclosed ca. 1980. A non-historic shed is to the north. The available data does not indicate any historically significant associations. It is a common example of a residential building common in Hernando County, and thus, does not appear potentially eligible for listing in the NRHP.

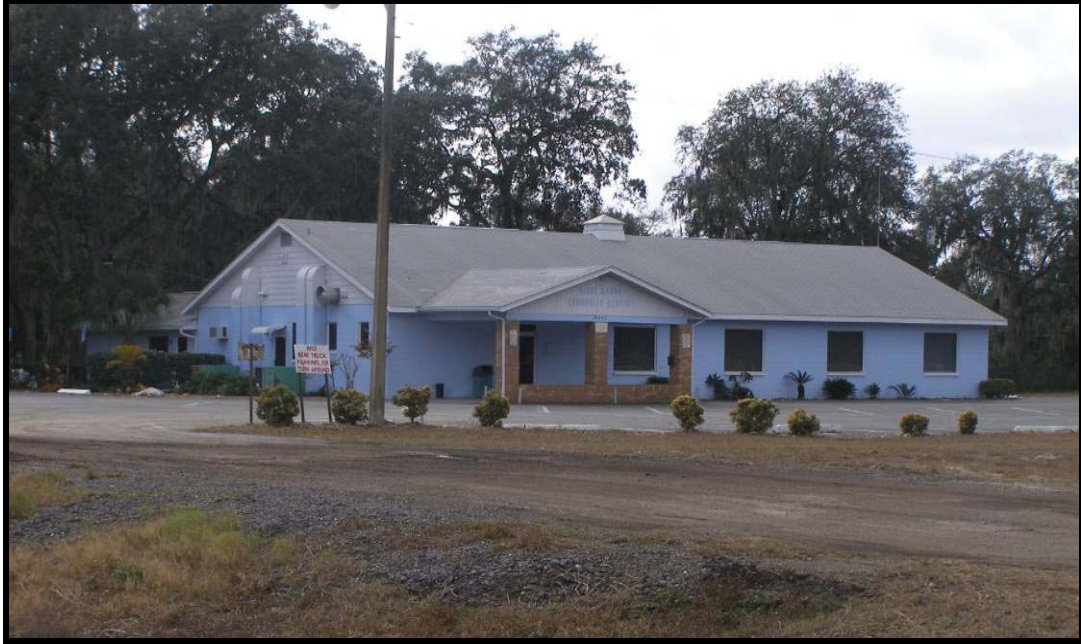
Photo 9. North and east elevations of 34240 Cortez Boulevard, 8HE686.

8HE686: The Masonry Vernacular style community center at 34240 Cortez Boulevard was constructed ca. 1962 (**Photo 9**). The slab foundation supports the concrete block walls that are topped with a gable roof covered with asphalt shingles. The windows are one-light fixed with window sills. Other features include gable vents, wood siding in the gables, an awning over the side entrance, and a port-cochere. A south addition was built ca. 1980. A non-historic detached garage/storage building is to the east. This is a typical example of a Masonry Vernacular style building found throughout Hernando County, and research did not reveal any significant historical associations. Therefore, 8HE686 is not considered potentially eligible for listing in the NRHP.

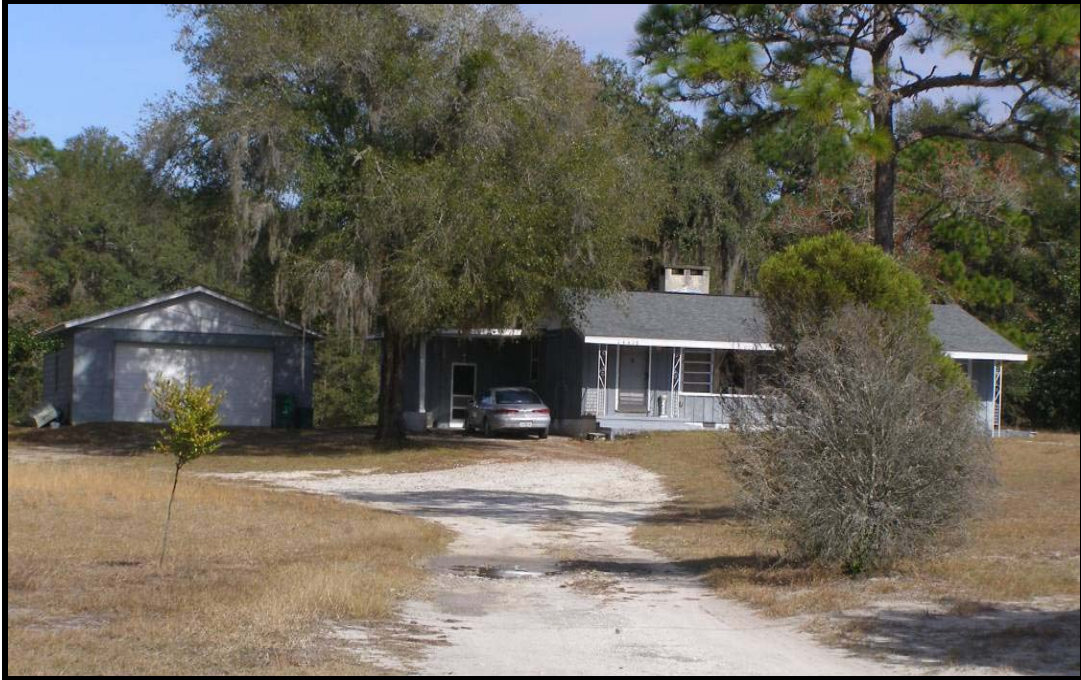
Photo 10. South elevation of 34415 Cortez Boulevard, 8HE687.

8HE687: The Frame Vernacular style residence at 34415 Cortez Boulevard was constructed ca. 1956 (**Photo 10**). The continuous concrete block foundation supports the wood frame walls that are clad in vertical plank (ca. 1980). The gable roof is covered with asphalt shingles and a concrete block chimney is near the ridge. The wide overhang provides a canopy that spans the length of the residence. A west addition was constructed ca. 1980. The windows, some of which were replaced ca. 1980, include three- and four-light awning, one-light fixed with five-light awning sidelights, and 1/1 SHS. Other features include foundation vents and scroll posts. A non-historic detached garage is to the west. This is a typical example of a Frame Vernacular style residence found throughout Hernando County, and research did not reveal any significant historical associations. Therefore, 8HE687 is not considered potentially eligible for listing in the NRHP.

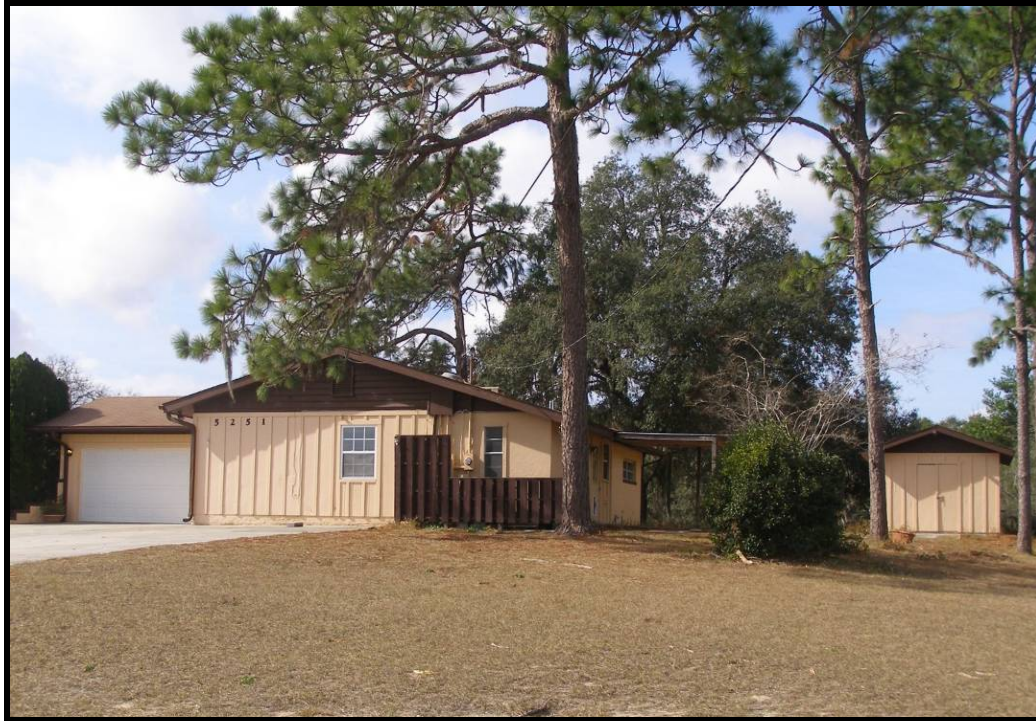
Photo 11. East elevation of 5251 Tree Lane, 8HE688.

8HE688: The Masonry Vernacular style residence at 5251 Tree Lane was constructed ca. 1957 (**Photo 11**). The concrete block walls rest on a slab foundation and are clad in stucco or vertical plank (ca. 1980). The gable roof is covered in asphalt shingles. The replacement windows (ca. 1980) are 1/1 and 2/2 SHS, and two-light awning. The carport was enclosed ca. 1980 and a garage was added to the south elevation. Other features include gable vents, window sills, and a shed to the north. This is a typical example of the Frame Vernacular style commonly found throughout Hernando County. Furthermore, the building did not exhibit any unique design features and research did not reveal any significant historical associations. Therefore, 8HE688 is not considered potentially eligible for listing in the NRHP.

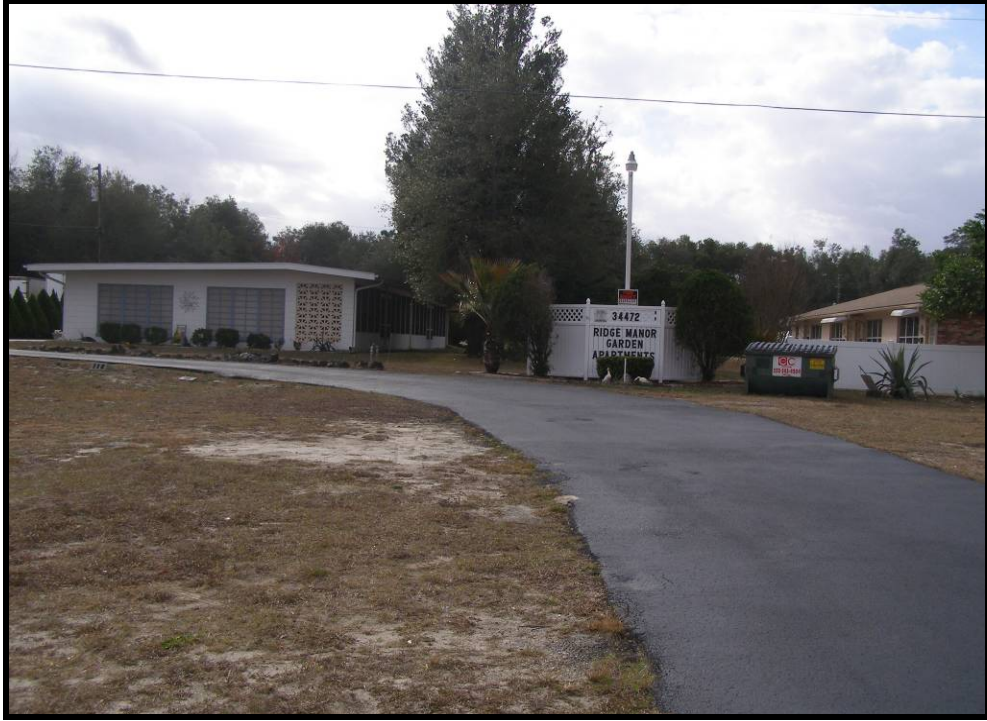
Photo 12. General view of the Ridge Manor Garden Apartments, 8HE678.

8HE678: The Ridge Manor Garden Apartments Resource Group at 34472 Cortez Boulevard (**Photo 12**) consists of two ca. 1959 buildings constructed in the Masonry Vernacular style, 8HE689 and 8HE690. Each building contains four apartment units, each with its own screened porch. Both buildings lack unique design features or significant historical association, and one of the building's integrity is diminished due to modern alterations. Therefore, 8HE678 is not potentially eligible for listing in the NRHP. A description of each building follows.

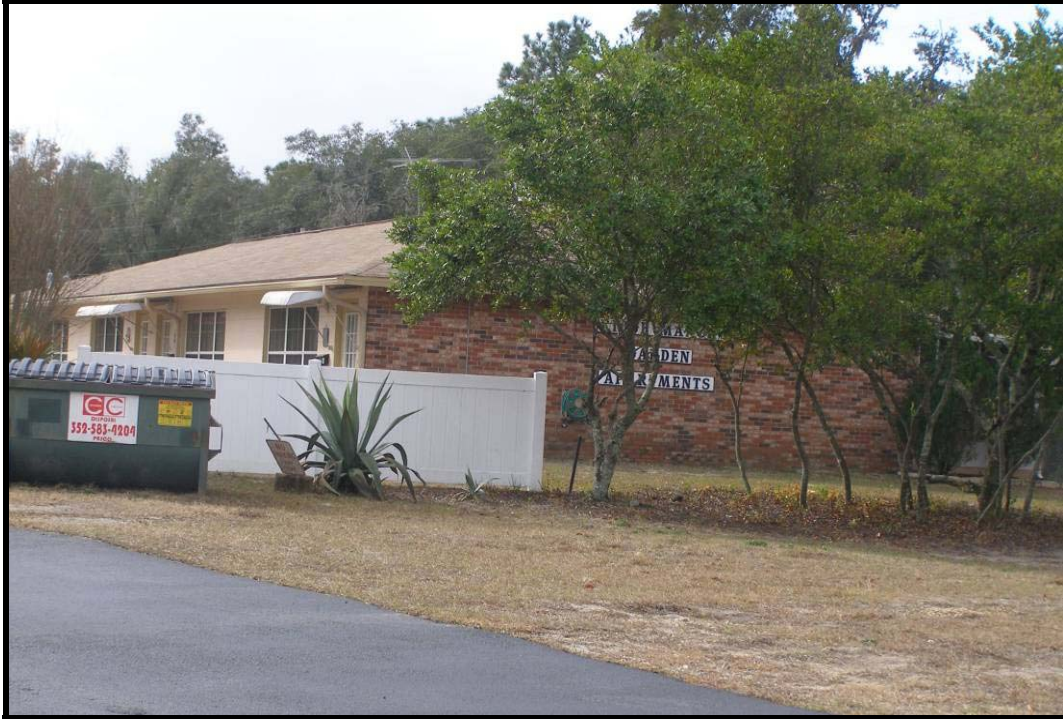
Photo 13. North and east elevations of 34472 Cortez Boulevard, Building 1, 8HE689.

8HE689: The Masonry Vernacular style apartment building (Building 1) at 34472 Cortez Boulevard was constructed ca. 1959 (**Photo 13**). The building features four apartments. The slab foundation supports the concrete block walls that are partially clad in brick (ca. 1990). The replacement hip roof (ca. 1990) is covered with asphalt shingles. The windows are 1/1 SHS (6/6 simulated-divided-light) with screens and awnings. Each of the four units has a screened porch. This is a typical example of a Masonry Vernacular style apartment building found throughout Hernando County and research did not reveal any significant historical associations. Therefore, 8HE689 is not potentially eligible for listing in the NRHP either individually or collectively as part of the Ridge Manor Garden Apartments Resource Group, 8HE678.

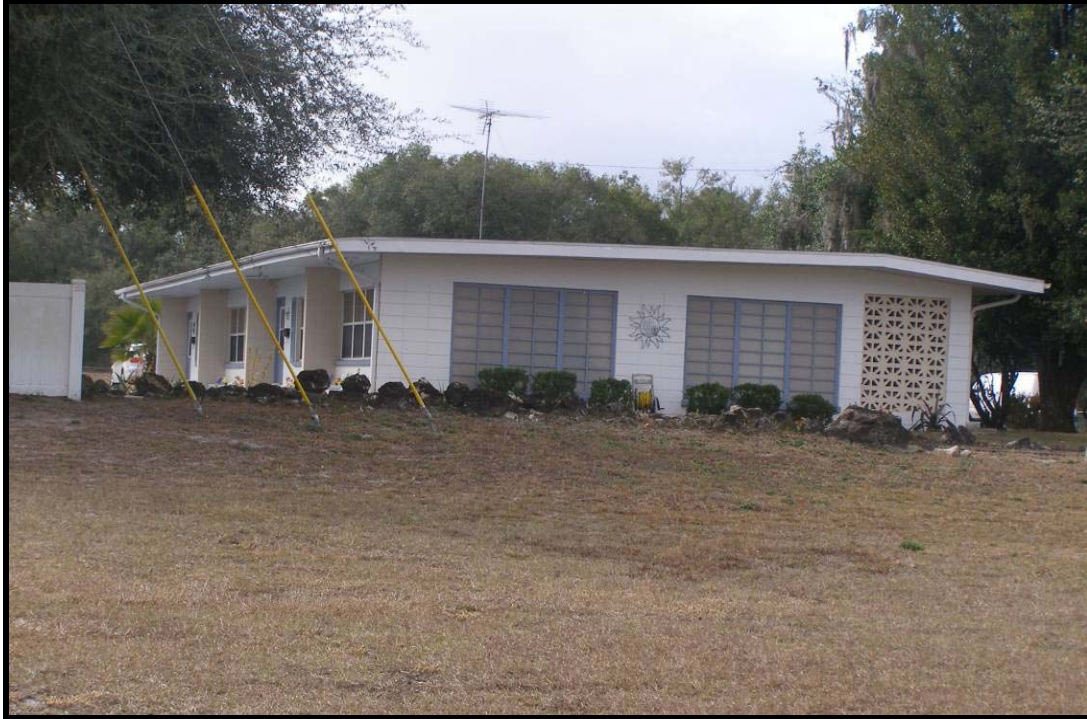
Photo 14. South and east elevations of 34472 Cortez Boulevard, Building 2, 8HE690.

8HE690: The Masonry Vernacular style apartment building (Building 2) at 34472 Cortez Boulevard was constructed ca. 1959 (**Photo 14**). The building features four apartments. The slab foundation supports the concrete block walls that are topped with a salt box roof covered with asphalt shingles. The ca. 1990 windows are 1/1 SHS. Each of the four units has a screened porch. A punched concrete block wall is on the north elevation and 48-light panels are also on the north elevation. This is a typical example of a Masonry Vernacular style apartment building found throughout Hernando County and research did not reveal any significant historical associations. Therefore, 8HE690 is not potentially eligible for listing in the NRHP either individually or collectively as part of the Ridge Manor Garden Apartments Resource Group, 8HE678.

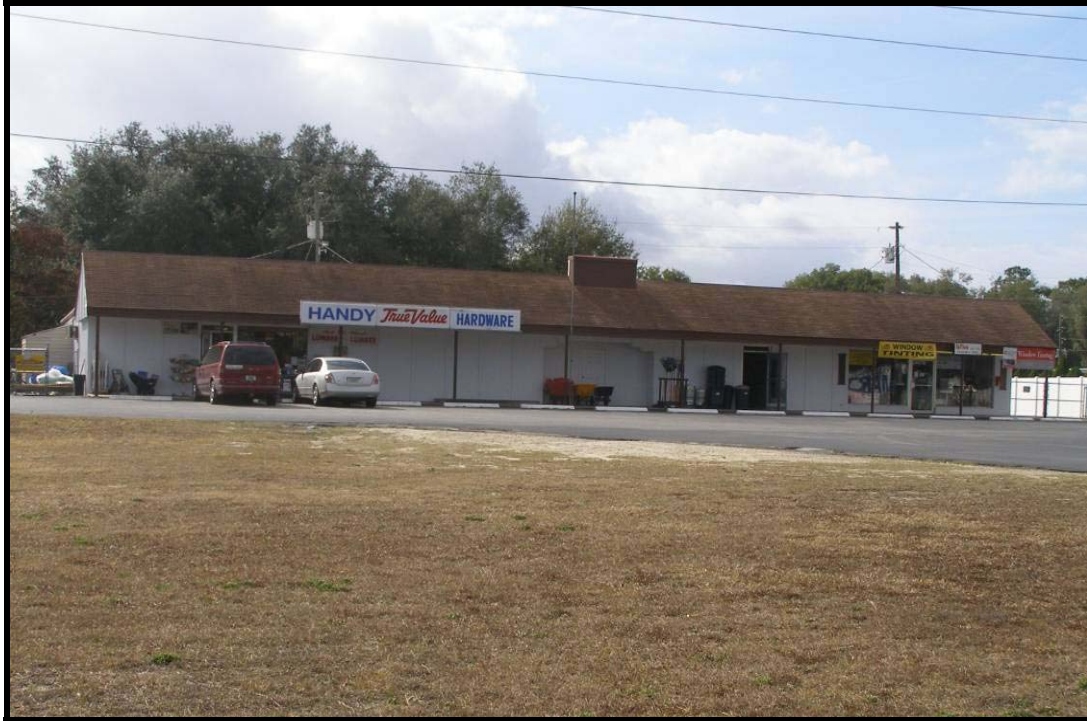
Photo 15. North elevation of 34486 Cortez Boulevard, 8HE691.

8HE691: The Masonry Vernacular style commercial building at 34486 Cortez Boulevard was constructed ca. 1960 (**Photo 15**). The building features three commercial units with a fourth unit that appears to have been closed ca. 1970. The slab foundation supports the concrete block walls that are partially clad with plywood sheeting (ca. 1970). The gable roof is covered with asphalt shingles and a canopy runs the length of the building. An addition was constructed on the east elevation ca. 1970. The replacement windows (ca. 1970) are one-light fixed. This is a typical example of a commercial Masonry Vernacular style building found throughout Hernando County. Furthermore, alterations diminish its integrity and research did not reveal any significant historical associations. Therefore, 8HE691 is not considered potentially eligible for listing in the NRHP.

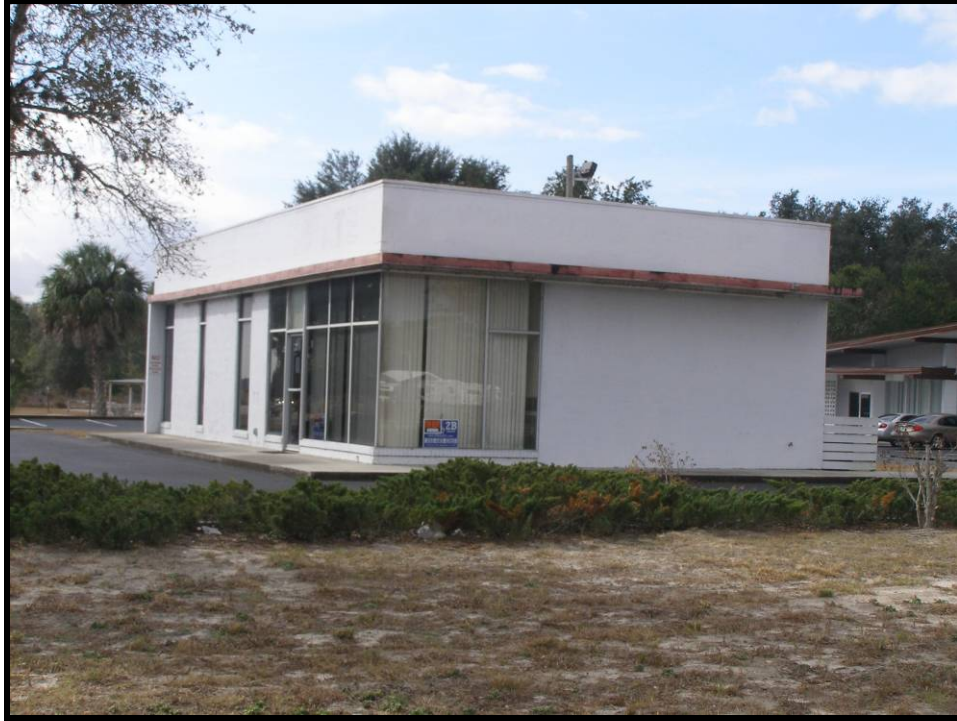
Photo 16. North and east elevations of 34508 Cortez Boulevard, 8HE692.

8HE692: The Modern style commercial building at 34508 Cortez Boulevard was constructed ca. 1960 (**Photo 16**). The now vacant building features a slab foundation, a flat roof with built-up roofing, a stucco exterior, and one-light fixed windows with sills, primarily on the northeast corner. A wider overhang on the north and east elevations provides a narrow canopy. This is a typical example of a Modern style building found throughout Hernando County with no unique design features and research did not reveal any significant historical associations. Therefore, 8HE692 is not considered potentially eligible for listing in the NRHP.

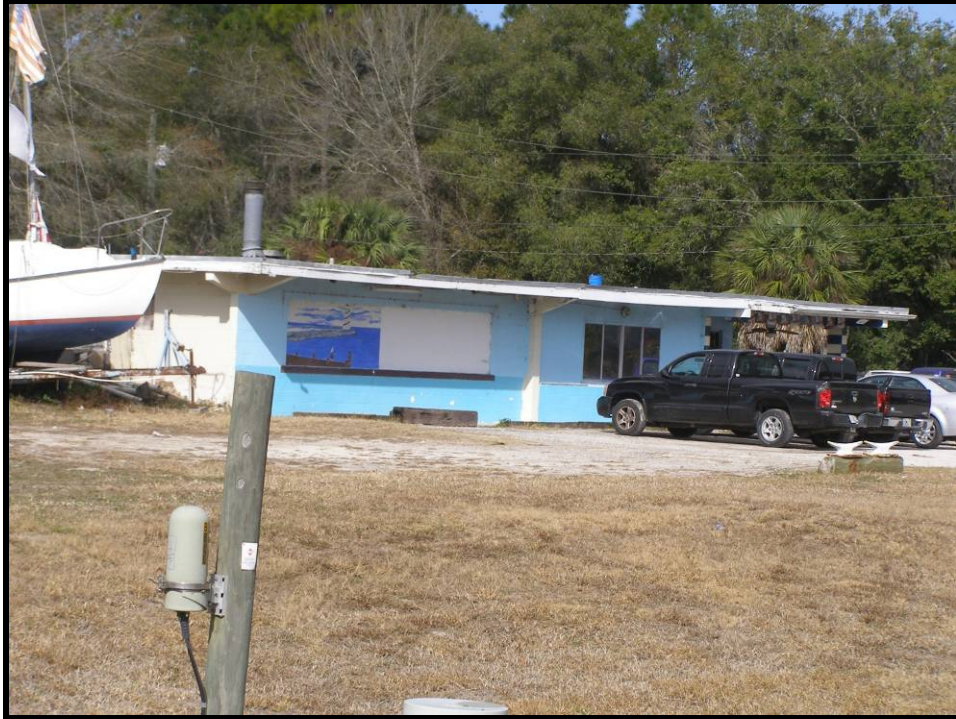
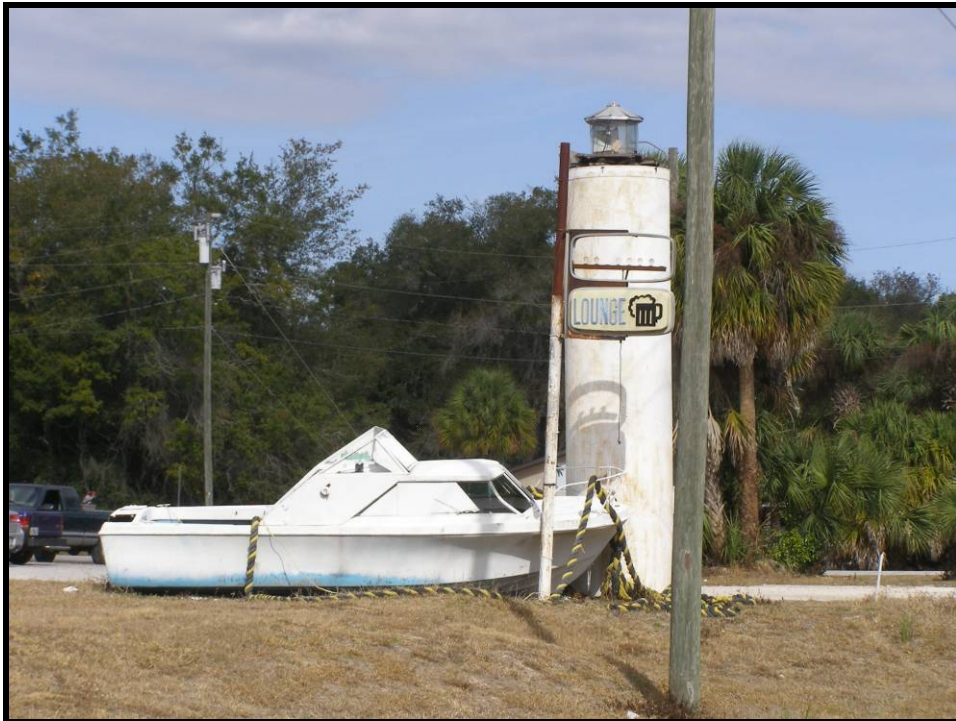
Photo 17. East elevation of Miller Lighthouse Lounge, at 5025 Treiman Boulevard, 8HE693.

Photo 18. Ancillary features to Miller Lighthouse Lounge, at 5025 Treiman Boulevard, 8HE693.

8HE693: The Miller Lighthouse Lounge, at 5025 Treiman Boulevard, was constructed ca. 1960 in the Masonry Vernacular style (**Photos 17 and 18**). The slab foundation supports the concrete block walls that are clad in stucco. The shed roof is covered with built-up roofing and has concrete brackets and a wide canopy overhang. Some of the windows have been covered but those that remain are ca. 1970 two-light sliding with sills. A decorative lighthouse and boats are located to the east and the south. This is a typical example of a Masonry Vernacular commercial building found throughout Hernando County and research did not reveal any significant historical associations. Therefore, 8HE693 is not considered eligible for listing in the NRHP.
