**FINAL  
CONTAMINATION SCREENING EVALUATION  
REPORT**

**STATE ROAD 52 PD&E STUDY  
FROM I-75 (SR 93) to E. of EMMAUS CEMETERY ROAD**

Pasco Work Order Number: C 3623.00  
WPI Segment Number: 408827 1

**June 2005**

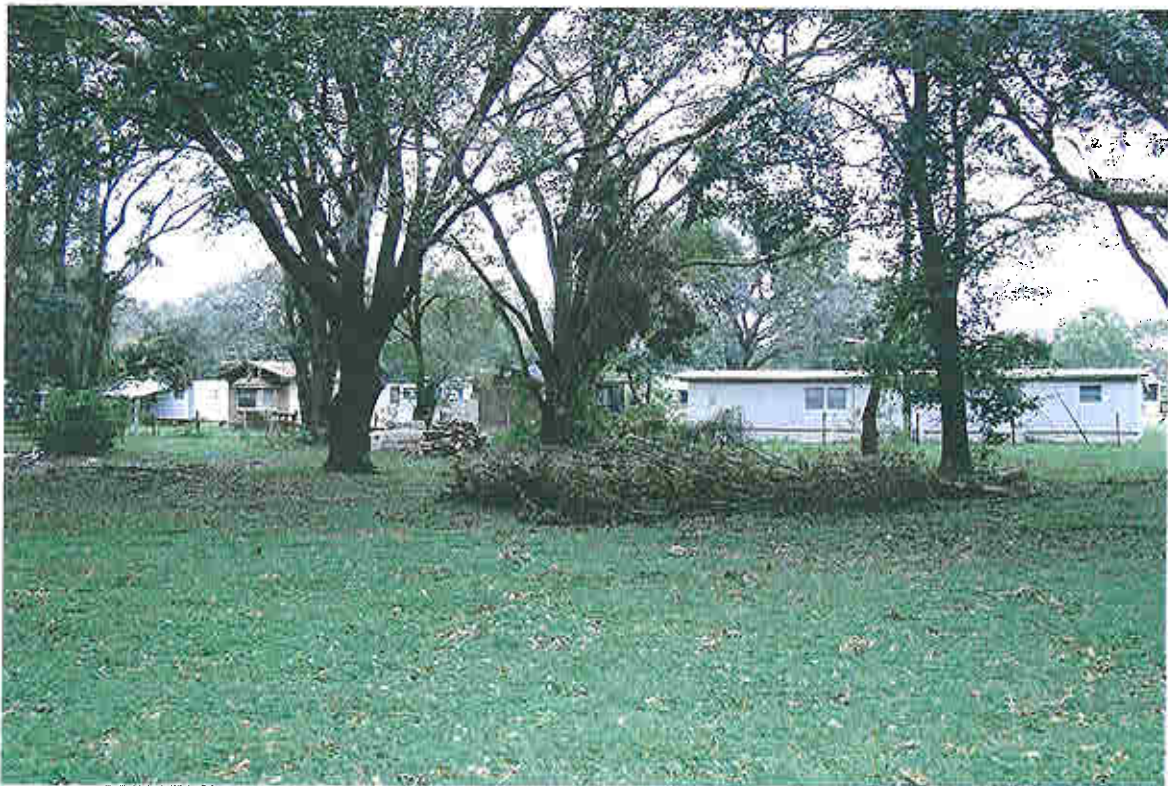
**Photo 2:** View of mobile home community located to the north of State Road 52 near the east end of the project area.

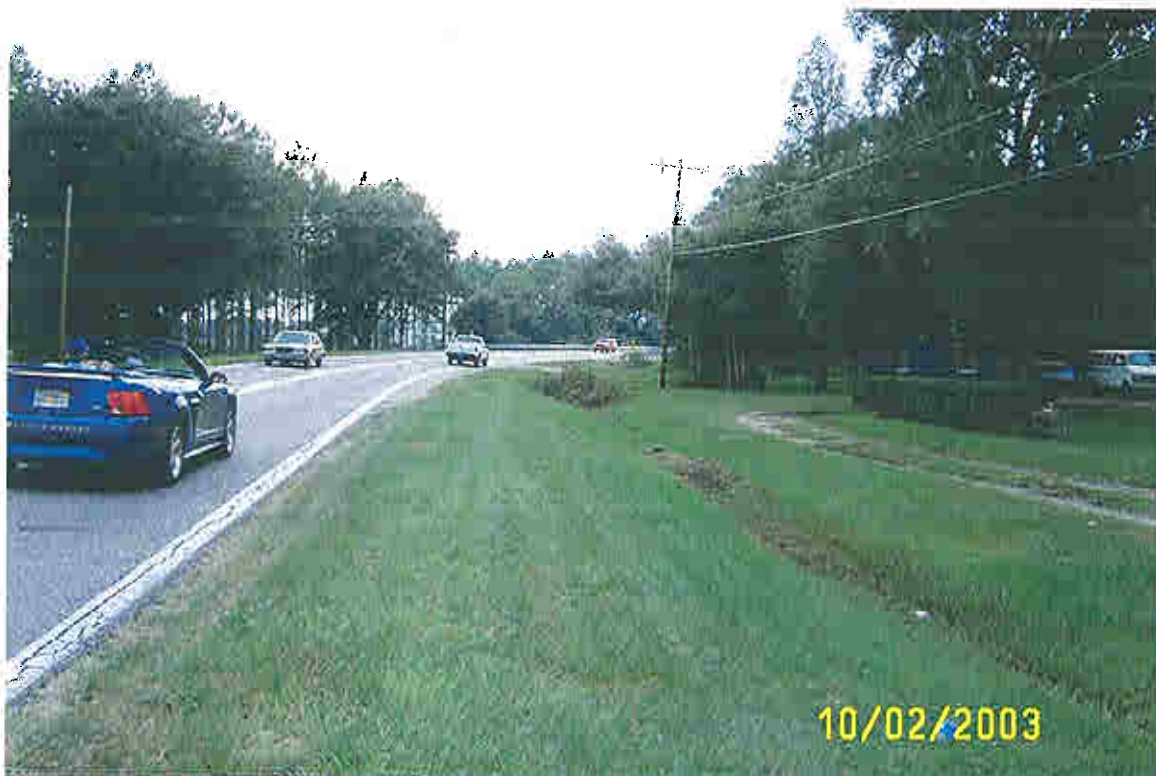
**Photo 3:** View from northeast of Bayou Branch looking southwest along State Road 52. The small bridge over Bayou Branch can be seen in the background of the photo.

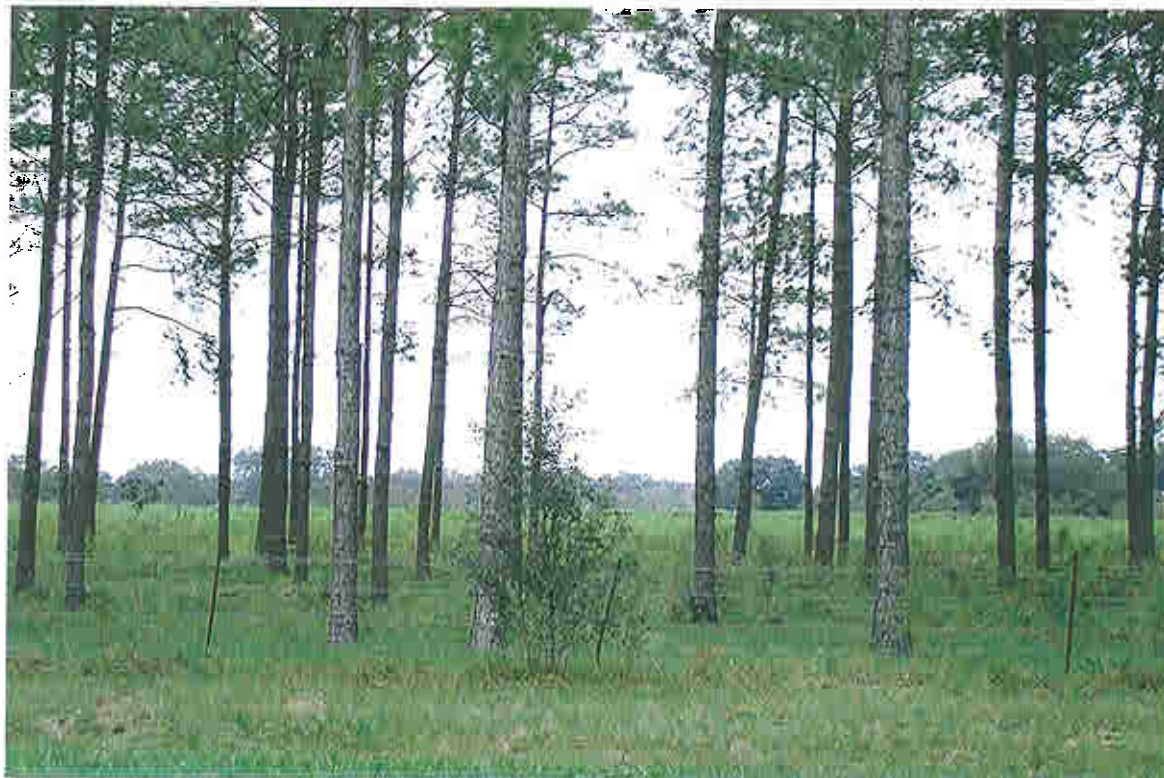
The eastern end of the project area is bounded to the north by primarily residential properties and two church properties. The San Antonio Community Church is located at 31251 State Road 52 and the Piney Grove Church is located at 31027 State Road 52. A small mobile home community located to the north of State Road 52 near the eastern end is shown in **Photo 2 in Appendix F**. A culvert for Bayou Branch creek runs beneath the roadway near the central portion of the project area. A view looking west at this portion of the roadway is included as **Photo 3 in Appendix F**. The eastern portion of the project area is bounded to the south by partially wooded land and pastureland. **Photo 4 in Appendix F** provides a typical view of the area south of State Road 52 and shows the location of proposed stormwater pond C-1.

**Photo 4:** View looking south from State Road 52 at proposed location of Pond C-1

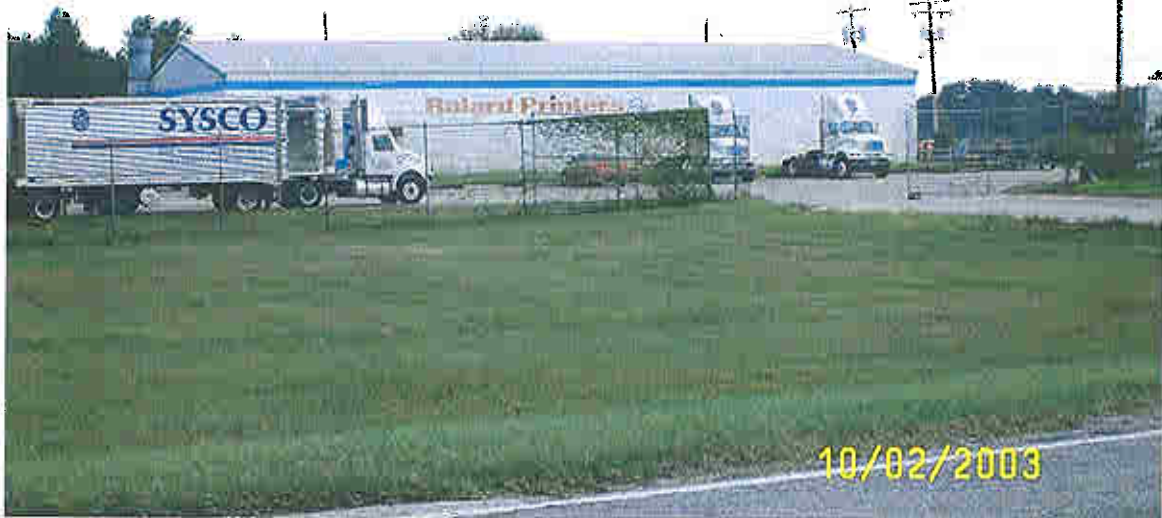
Rack-It Truck Racks, Inc., is located at 30904 State Road 52. This facility manufactures truck rack systems. According to the company owner, Mr. David Graham, the property was formerly occupied by Ralard Printers, Inc. During that time, there was an underground storage tank that was removed by the previous property owner. Prior to Ralard, the site was occupied by a chicken hatchery. A view of the former Ralard Printers facility is shown in **Photo 5 in Appendix F**.

**Photo 5:** View looking south at the Ralard Printers facility located south of State Road 52, near the eastern end of the project area.

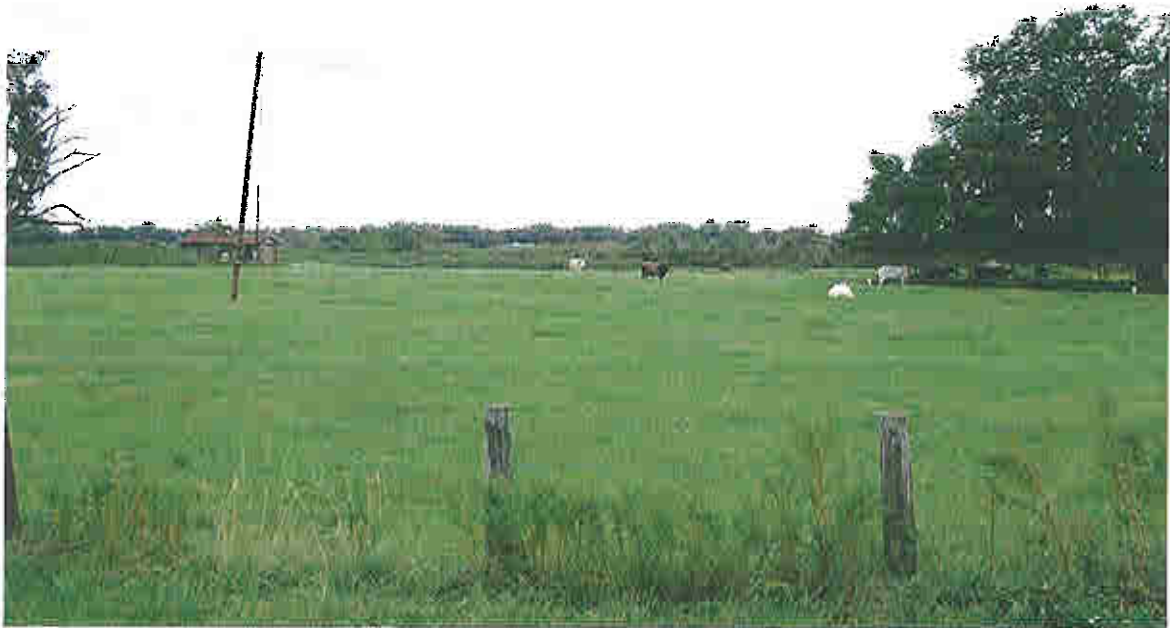
Cattle pastureland is present to the north and south sides of State Road 52, west of the Rack-It facility. A view of the pastureland located to the north of State Road 52 is provided as **Photo 6 in Appendix F**. A view of a pastureland located south of State Road 52 can be seen in **Photo 7 in Appendix F**. A view looking east, along State Road 52, near the central portion of the project area is shown in **Photo 8 in Appendix F**. A view of the proposed stormwater pond B-1 is included as **Photo 9 in Appendix F**.

**Photo 9:** View looking north at proposed location of stormwater pond B-1.

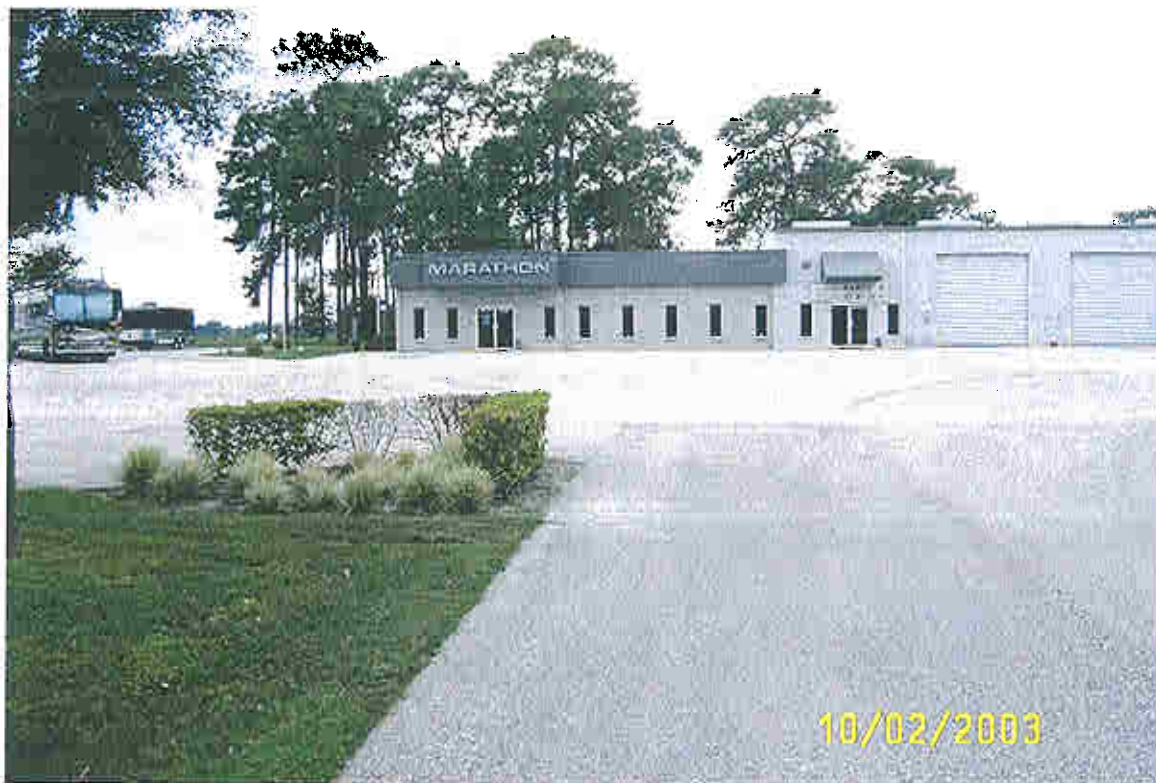
Marathon Coach, Inc. is located at 11623 Corporate Lake Boulevard, just north of State Road 52 near the central portion of the project area. According to the facility's Director of Operations, Mr. Matthew Matlach, this facility customizes buses, vans, and recreational vehicles. The facility does store new and used oil and antifreeze for routine vehicle servicing. These chemicals are stored at the far north end of the facility on a concrete floor. A view of the Marathon Coach facility can be seen in **Photo 11 in Appendix F**.

**Photo 11:** View of the Marathon Coach facility located at 11623 Corporate Lake Boulevard, north of the central portion of the project area.

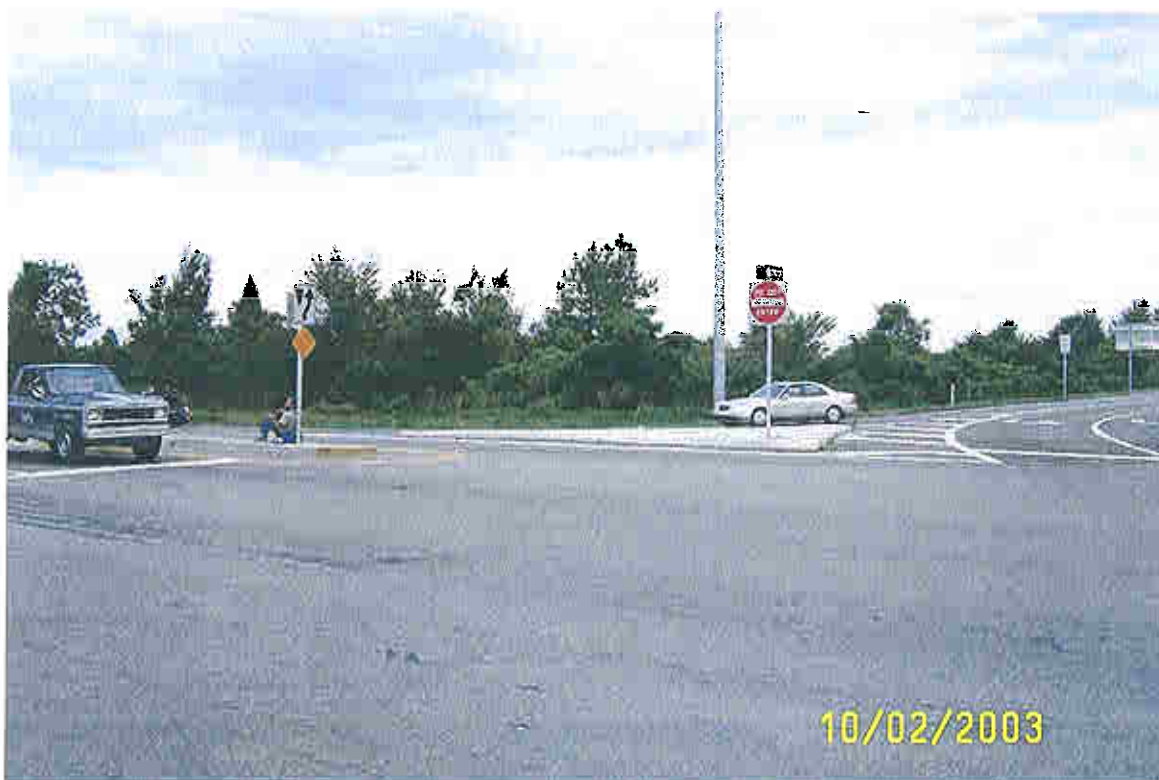
Undeveloped, partially wooded land is present on the south side of State Road 52 at the western end of the project area. A view of this land is provided as **Photo 16 in Appendix F**. A view looking south at the proposed location of stormwater pond A-1 is shown in **Photo 17 in Appendix F**. A view looking east along the northern side of State Road 52, from the western end of the project area is provided as **Photo 18 in Appendix F**.

**Photo 16:** View looking southeast at the partially wooded property located south of State Road 52 at the western end of the project area.

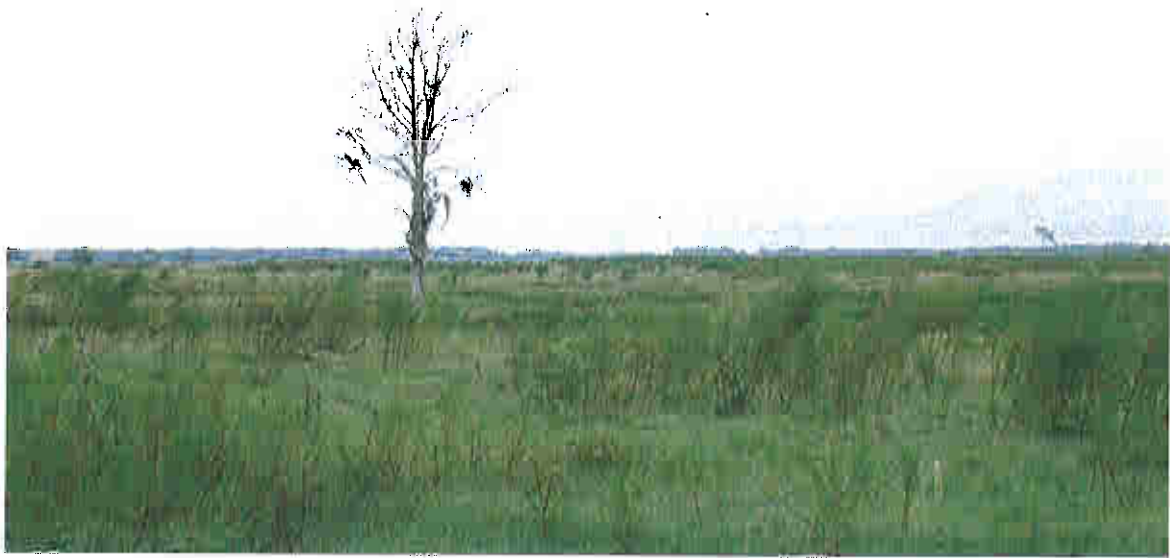
**Photo 17:** View looking south at the proposed location of proposed stormwater pond A-1.
