## FINAL GEOTECHNICAL REPORT

## PROJECT DEVELOPMENT AND ENVIRONMENT STUDY US 19 (SR 55) FROM SOUTH OF US 98 TO CR 488 CITRUS COUNTY, FLORIDA

Work Program Item Segment No: 405822 1 Federal-Aid Program No: 1852 007 P

Florida Department of Transportation District Seven 11201 North McKinley Drive Tampa, Florida 33612-6456

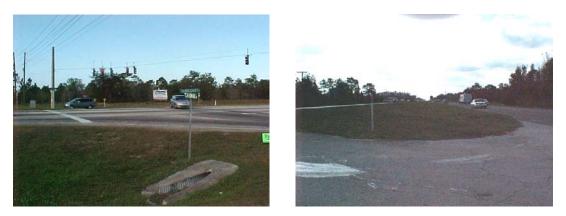
#### Photo 1 & 2

West Cardinal Street and US 19 intersection. Photo 1 is Station 261+90, 120 RT. looking northwest across the intersection. Photo 2 is Station 261+90, 50 RT. looking north. The North Bound lanes are approximately  $1\frac{1}{2}$  to 2 feet higher in elevation.

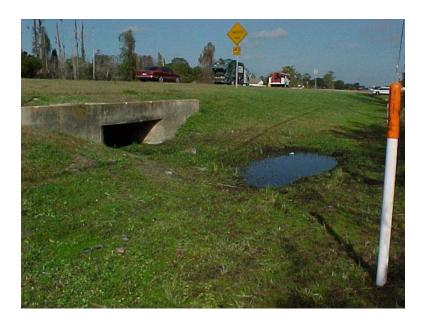
#### Photo 3

Approximate Station 272+00, 120 RT. A culvert crosses under US 19. Head walls may need to be extended based on final roadway geometry.

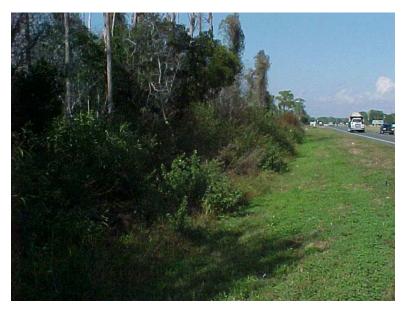
#### Photo 4

Approximate Station 273+00, 30 LT facing north. The area was tested for the presence of soil considered detrimental to the roadway corridor. Muck and plastic materials were encountered.

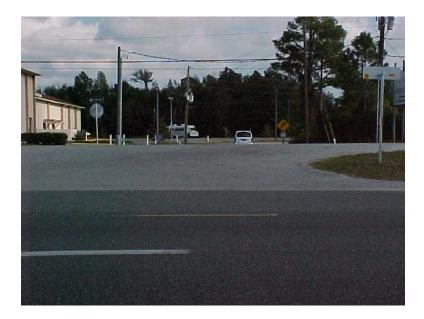
Photo 5

Station 369+50, 20 LT. US 19 and West Green Acres Street intersection looking northeast across the intersection. The North Bound lanes are still 2 to  $2\frac{1}{2}$  feet higher in elevation.

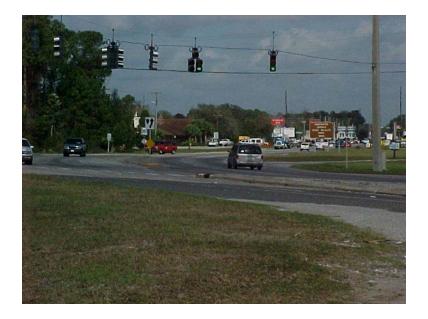
#### Photos 6

Station 413+00, 20 LT is near the W Yulee Drive and US 19 intersection. Raised concrete median looking north on US 19.

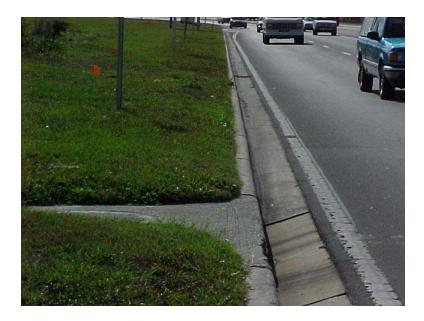
Photo 7

Station 424+40, 60 RT. Curb and gutter looking south on US 19. Curb and gutter starts at West Yulee Drive (CR490) and extends north.

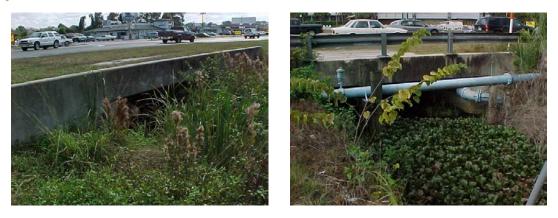
#### Photo 8 & 9

A culvert crossing under US 19. Photo 8 is Station 430+10, 80 LT.; a culvert on the South Bound of US 19 looking southeast. Photo 9 is Station 430+10, 50RT.; a culvert on the North Bound of US 19 looking west. The culverts are just north of Homosassa Springs Park. A headwall is located approximately 25 feet west of the South Bound lanes and  $23\frac{1}{2}$  feet east of the North Bound lanes. A 12-inch diameter potable water supply runs through the culvert under US 19 and an 8-inch diameter water supply was noted on the east side of the alignment.

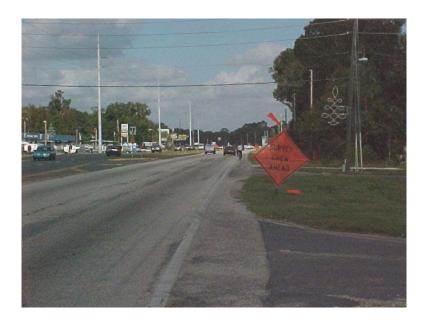
#### Photo 10

Station 443+10, 30 RT. US 19 looking north. Curb and gutters have stopped north of Homosassa Springs. Curb and gutters stop at approximate Station 442+00.

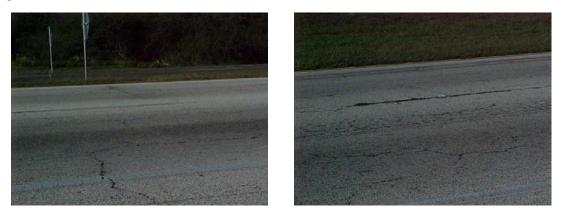
#### Photo 11 & 12

Photo 11 is Station 271+00, 80 RT and Photo 12 is Station 467+00, 20 RT. These photos depict road oxidation on North Bound lanes. Stress cracks are more prevalent for the North Bound lanes.

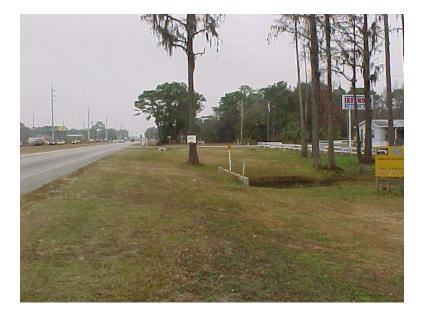
#### Photo 13

Approximate Station 606+85. Photo 13 depicts the east side of US 19 looking north. The area was tested for the presence of soil considered detrimental to the roadway corridor. Muck was encountered within the limits of the relic cypress head.

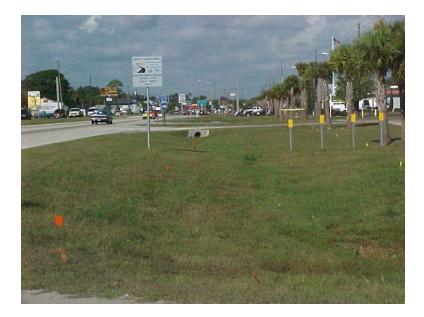
## Photo 14

Station 658+00, 20 LT. Looking east across North Bound US 19 at the Crystal River Airport main runways.

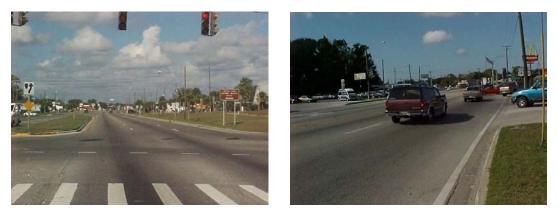
#### Photo 16 & 17

Photo 16 depicts Station 714+00 (Fort Island Trail and US 19 Intersection) and Photo 17 depicts Station 38+80, 100 RT. In Photo 16 North Bound US 19 goes to three (3) lanes, while South Bound drops to two (2) lanes. In Photo 17 North Bound US 19 drops to two (2) lanes, while South Bound goes to three (3) lanes.

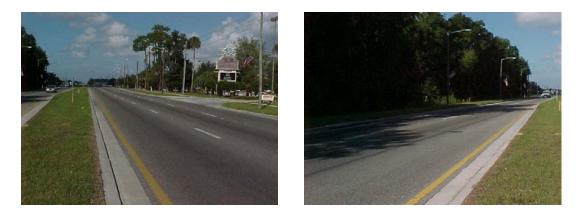
Station 858+50, standing in the median, facing north. Photo 18 depicts an extra North Bound right turn lane at Crystal River Mall. Photo 19 at Station 858+50 in the median facing north, depicts two (2) lanes on US 19 South Bound.

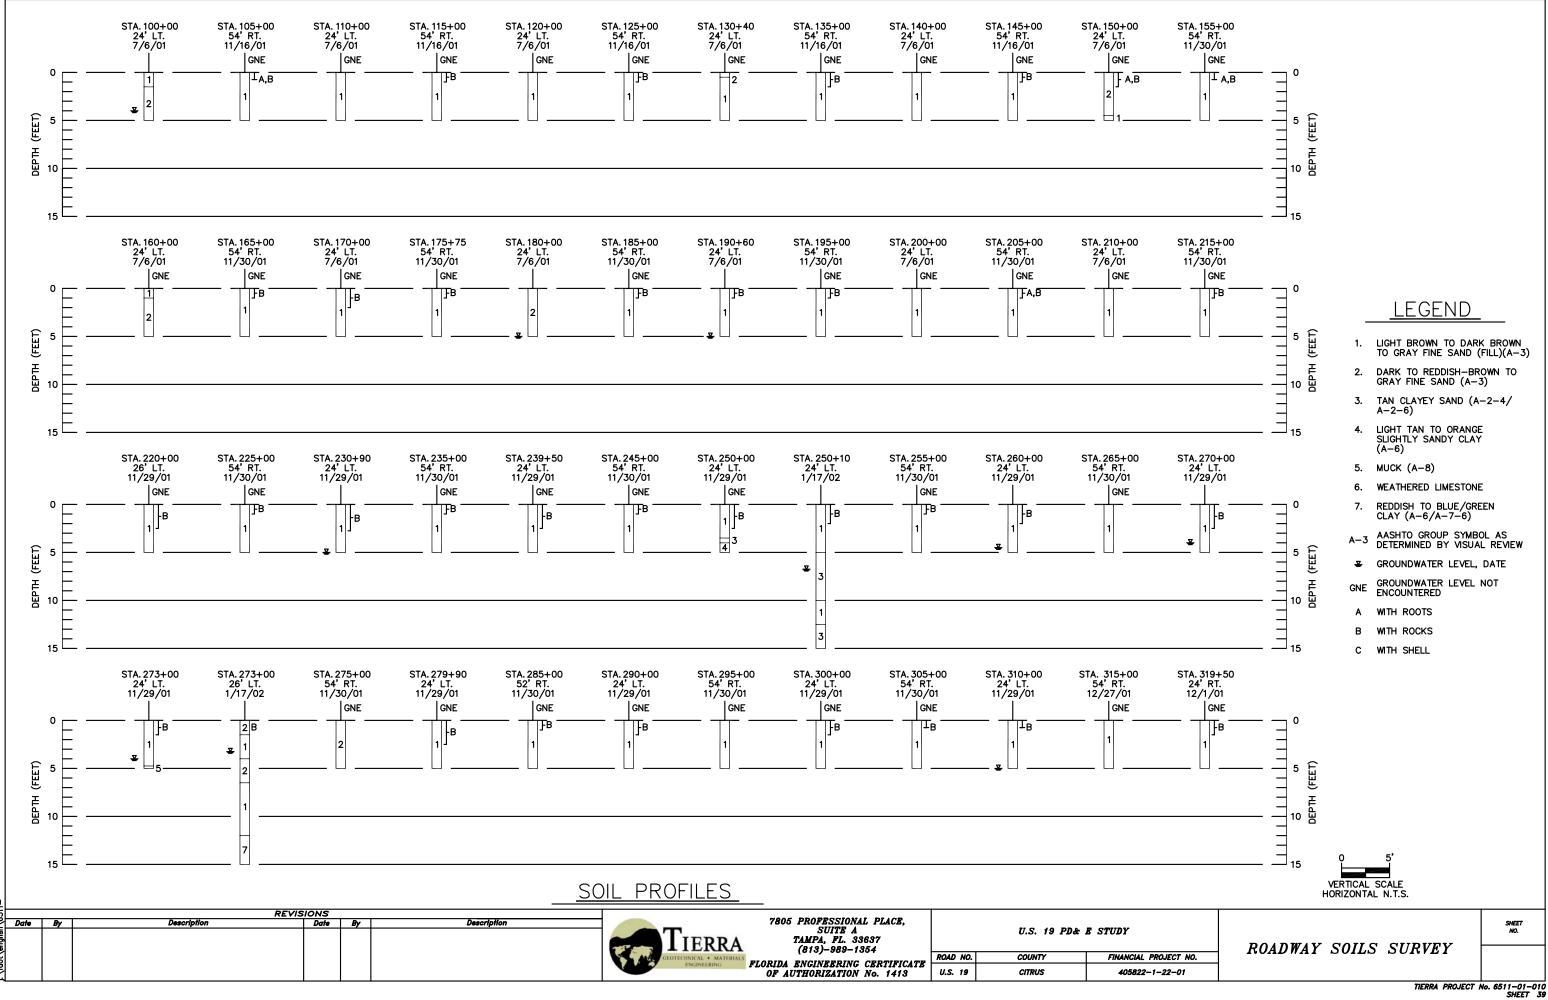
PROJECT NO.	ROADWAY SOILS SURVEY	Sheet NO.
RUJECI NU.	4	
1-22-01		
	TIERRA PROJECT No.	6511-01-010 SHEET 38

SURVEY BEGINS STA. 100+00									SURVEY ENDS <u>STA. 1105+00</u>												
		ORGANIC CONTENT		MOISTURE CONTENT		SIEVE ANALYSIS RESULTS % PASS					ATTERBERG LIMITS (%			IITS (%)			CORROSION TEST RESULTS					
s	TRATUM NO.	No. OF TESTS	% ORGANIC	No. OF TESTS	MOISTURE CONTENT	No. OF TESTS	10 MESH	40 MESH	60 MESH	100 MESH	200 MESH	NO. OF TESTS	LIQUID LIMIT	PLASTIC INDEX	AASHTO GROUP	DESCRIPTION	NO. OF TESTS	RESISTIVITY OHM-CM	CHLORIDES PPM	SULFATE PPM	рН

1. THE MATERIAL FROM STRATA NUMBERS 1 AND 2 APPEAR SATISFACTORY FOR USE IN THE EMBANKMENT WHEN UTILIZED IN ACCORDANCE WITH INDEX 505. 2. THE MATERIAL FROM STRATUM NUMBER 3 (A-2-4) APPEARS SATISFACTORY FOR USE IN THE EMBANKMENT WHEN UTILIZED IN ACCORDANCE WITH INDEX 505. HOWEVER, THIS MATERIAL IS LIKELY TO RETAIN EXCESS MOISTURE AND MAY BE DIFFICULT TO DRY AND COMPACT. IT SHOULD BE USED IN THE EMBANKMENT ABOVE WATER LEVEL EXISTING AT THE TIME OF CONSTRUCTION. 5. THE MATERIAL FROM STRATUM OF (WEATHERED LIMESTONE) WAS ENCOUNTERED BETWEEN STATIONS 845+00 AND 1080+00. THE LIMESTONE STRATUM WAS 1. THE MATERIAL FROM STRATUM NUMBER 3 (A-2-4) APPEARS SATISFACTORY FOR USE IN THE EMBANKMENT WHEN UTILIZED IN ACCORDANCE WITH INDEX 505. HOWEVER, THIS MATERIAL IS LIKELY TO RETAIN EXCESS MOISTURE AND MAY BE DIFFICULT TO DRY AND COMPACT. IT SHOULD BE USED IN THE EMBANKMENT ABOVE WATER LEVEL EXISTING AT THE TIME OF CONSTRUCTION.

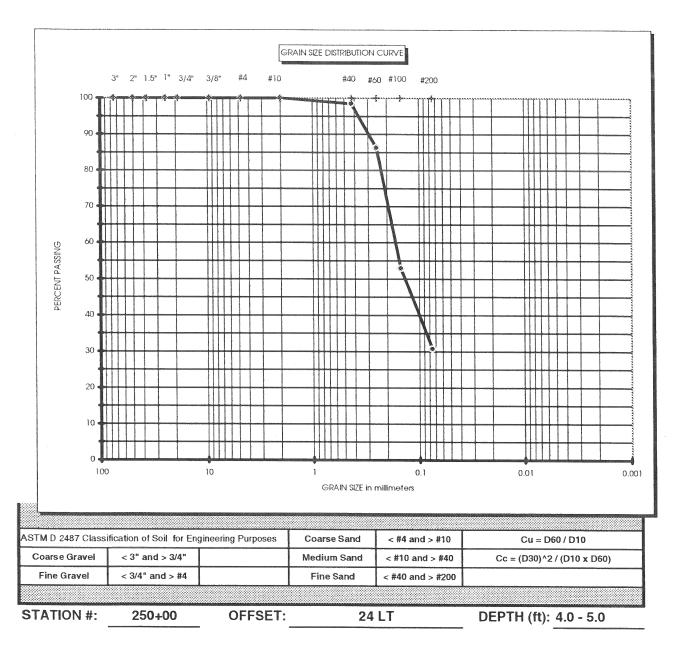
SOIL DESCRIPTION: A-2-6

ATTERBERG LIMIT (-#	40 Material )
LIQUID LIMIT	33
PLASTIC LIMIT	14
PLASTIC INDEX	19

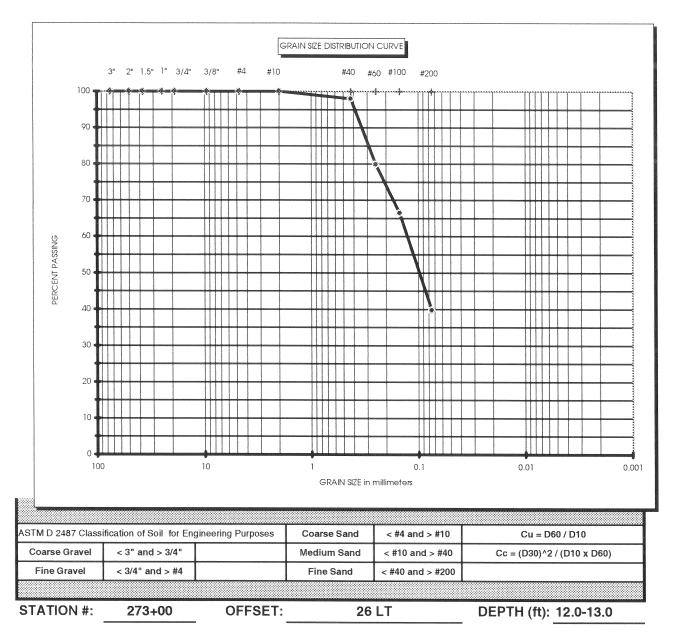
SOIL DESCRIPTION: A-7-6

ATTERBERG LIMIT (-#	40 Material)
LIQUID LIMIT	48
PLASTIC LIMIT	18
PLASTIC INDEX	30

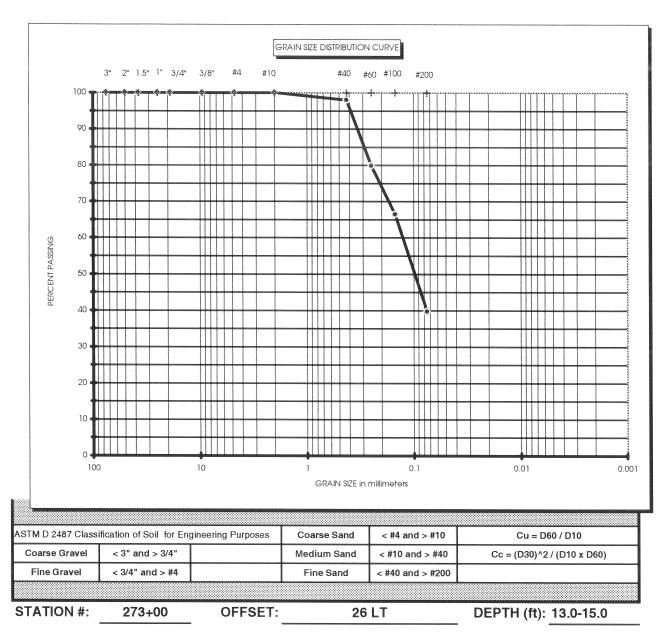
SOIL DESCRIPTION: A-6

ATTERBERG LIMIT (-#	40 Material )
LIQUID LIMIT	31
PLASTIC LIMIT	13
PLASTIC INDEX	18
