***Project
Development
and
Environment
(PD&E) Study***

***Final Contamination Screening
Evaluation Report***

***S.R. 574 (Martin Luther King Jr. Boulevard)
from C.R. 579 to McIntosh Road
Hillsborough County, Florida***

**WPI Segment No. 255893 1
FAP No. 2081-018P**

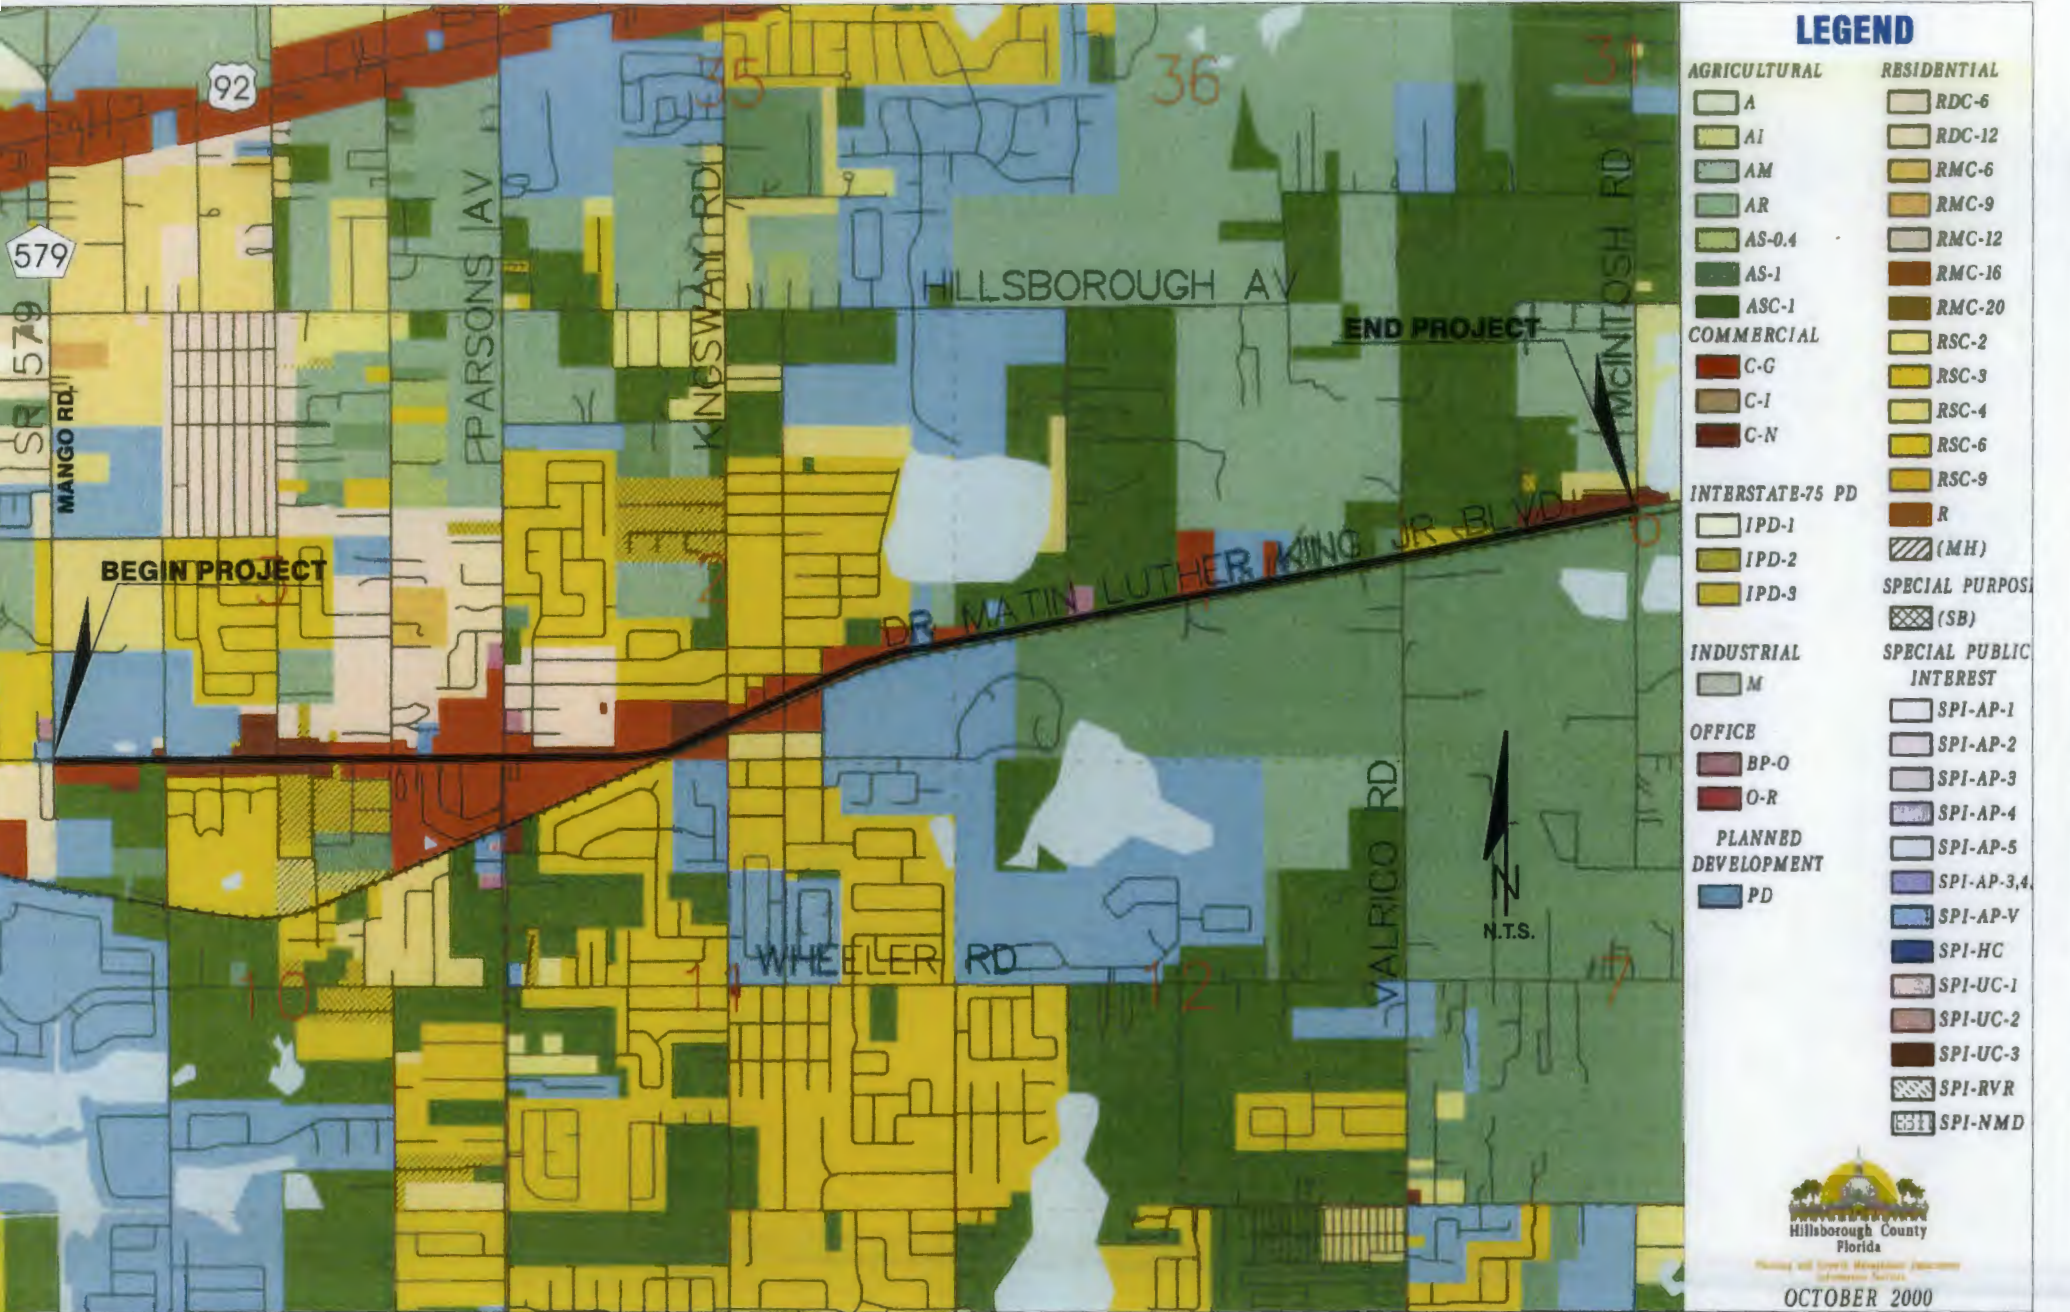
EXISTING LAND USE

Commercial facilities are present along the length of the corridor. The highest concentration of commercial facilities is located in the western half of the corridor between Mango Road and Kingsway Road. Examples of commercial establishments observed include:

- Restaurants
- Gasoline Stations
- Automobile Repair Shops
- Banks
- Medical Clinics
- Day Care
- Convenience Stores
- Grocery Stores
- Beauty Shops
- Dry Cleaning Facilities
- Television Repair Facilities
- Taverns
- Miscellaneous Retail Stores

Industrial land use is confined to the eastern portion of the S.R. 574 corridor. These properties tend to be large facilities involved in light manufacturing and trucking. The industrial facilities noted during the field inspection include W & W Trucking Co., Old Oak Truss Co., and Quality Precast.
