# **WETLAND EVALUATION AND BIOLOGICAL ASSESSMENT REPORT**

**Florida Department of Transportation  
District Seven**

## **SR 600 (US 92) Project Development & Environment Study Re-evaluation**

From East of I-4 to East of County Line Road  
Hillsborough County, Florida

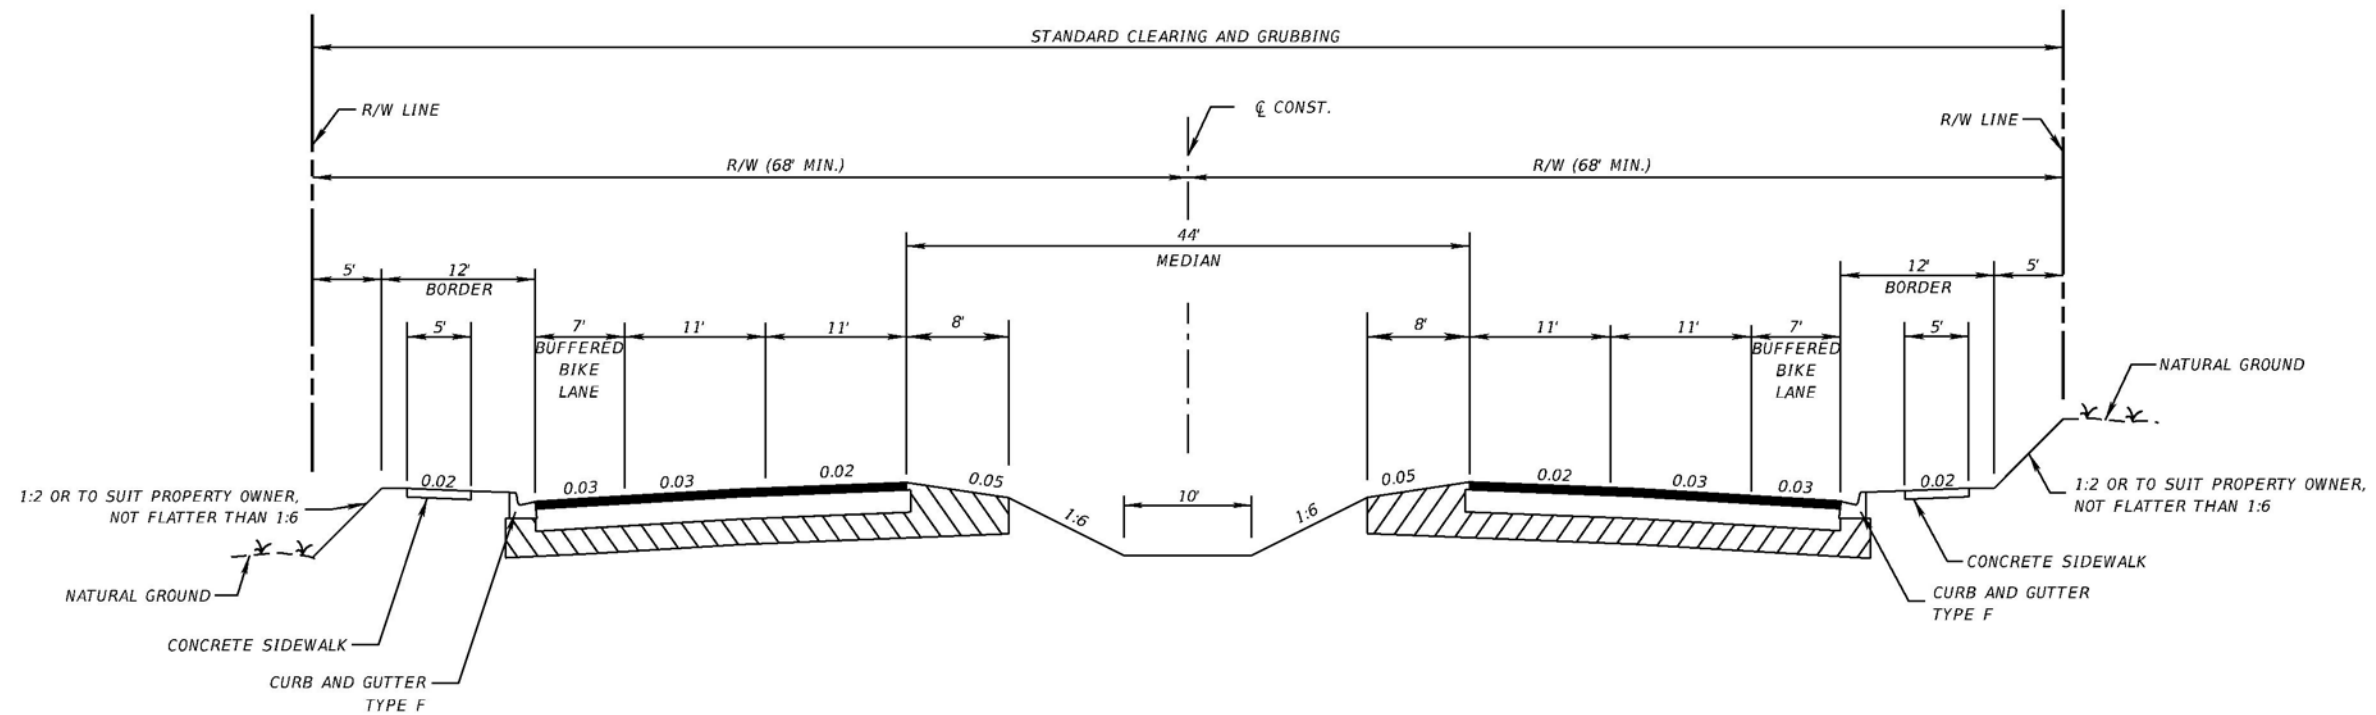
Figure  
**2A**

FROM EAST OF I-4 TO WEST OF I-75  
 AND FROM EAST OF I-75 TO WEST OF CR 579 - SEGMENT 1  
 FROM WEST OF CR 579 TO EAST OF CR 579 - SEGMENT 2  
 FROM EAST OF CR 579 TO NORTH PARSONS AVENUE - SEGMENT 3  
 FROM NORTH PARSONS AVENUE TO EAST OF CROW WING DRIVE - SEGMENT 4  
 DESIGN SPEED = 45 MPH

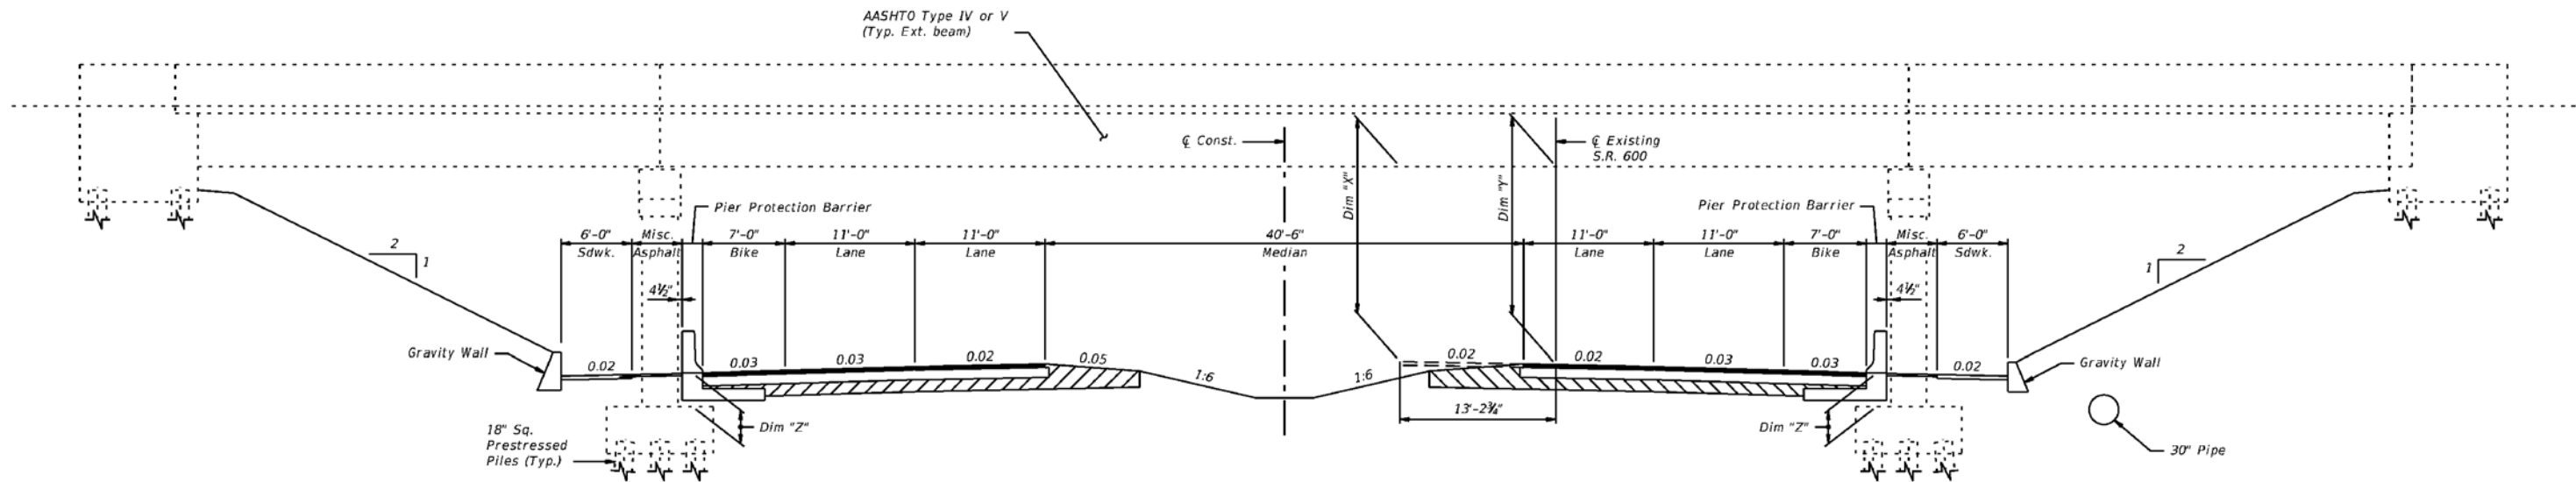
Figure  
**2B**

UNDER I-75 BRIDGE  
 FROM WEST OF I-75 TO EAST OF I-75 - SEGMENT 1  
 DESIGN SPEED = 45 MPH

BRIDGE NO.	DIM "X" (ft.)	DIM "Y" (ft.)	DIM "Z" (ft.)	
			PIER 2	PIER 3
100414	18.235	18.500	4.135	3.135
100415	19.069	19.333	2.552	2.552
100422	17.673	17.938	2.745	2.245
100424	16.038	16.302	3.438	3.438

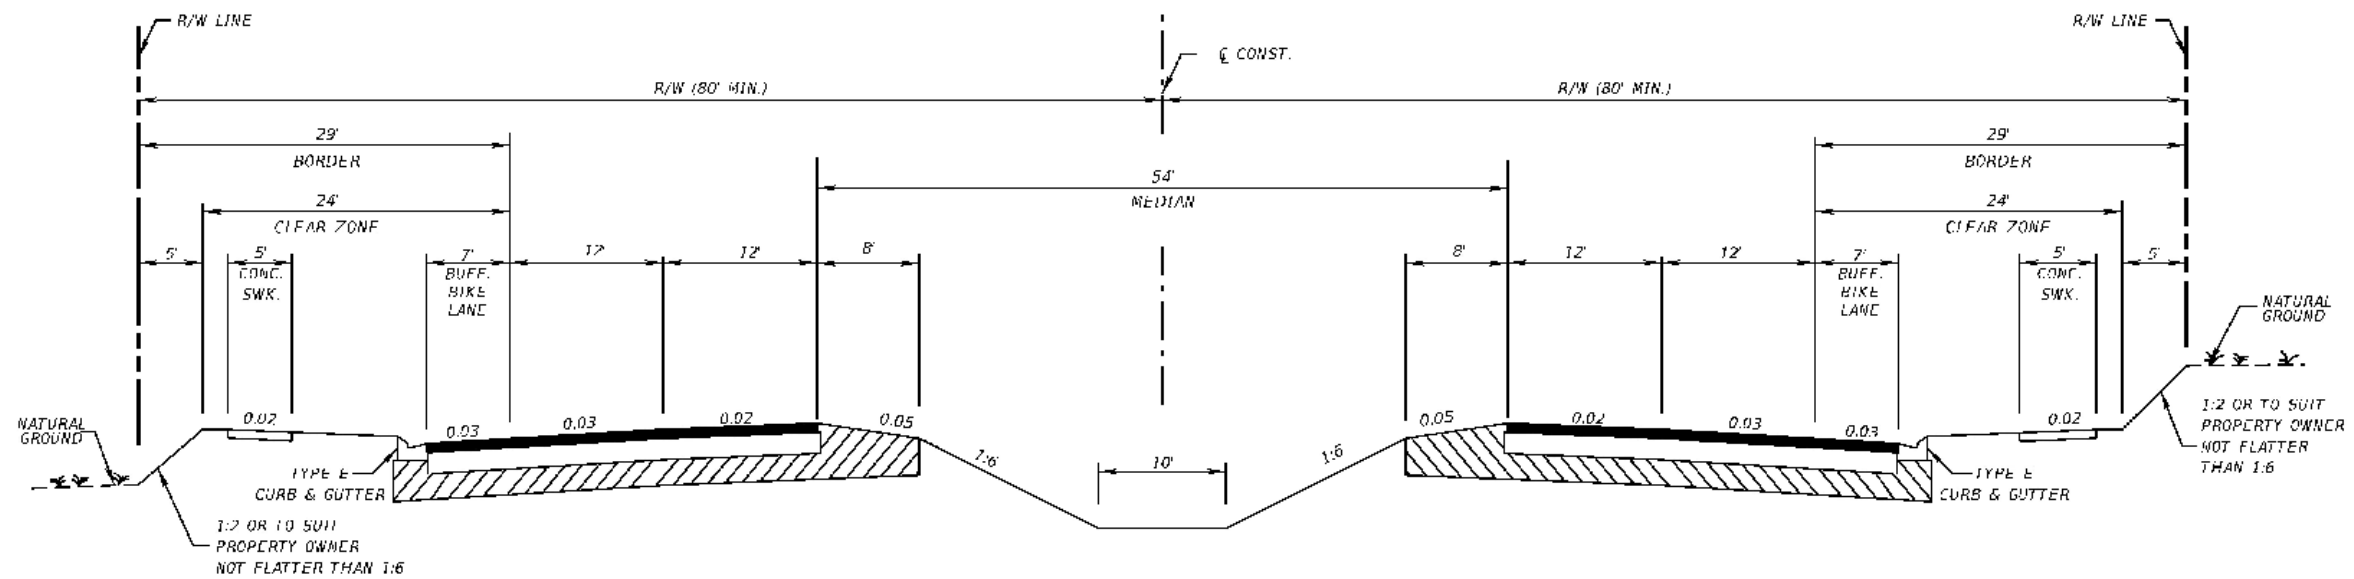
Figure  
 2C

FROM EAST OF CROW WING DRIVE TO CASTLEWOOD ROAD - SEGMENT 5  
 FROM CASTLEWOOD ROAD TO WEST OF GALLAGHER ROAD - SEGMENT 6  
 FROM WEST OF GALLAGHER ROAD TO LYNN OAKS CIRCLE - SEGMENT 7  
 FROM LYNN OAKS CIRCLE TO EAST OF BETHLEHEM ROAD - SEGMENT 8  
 FROM EAST OF BETHLEHEM ROAD TO EDWARDS STREET - SEGMENT 9  
 DESIGN SPEED = 50 MPH

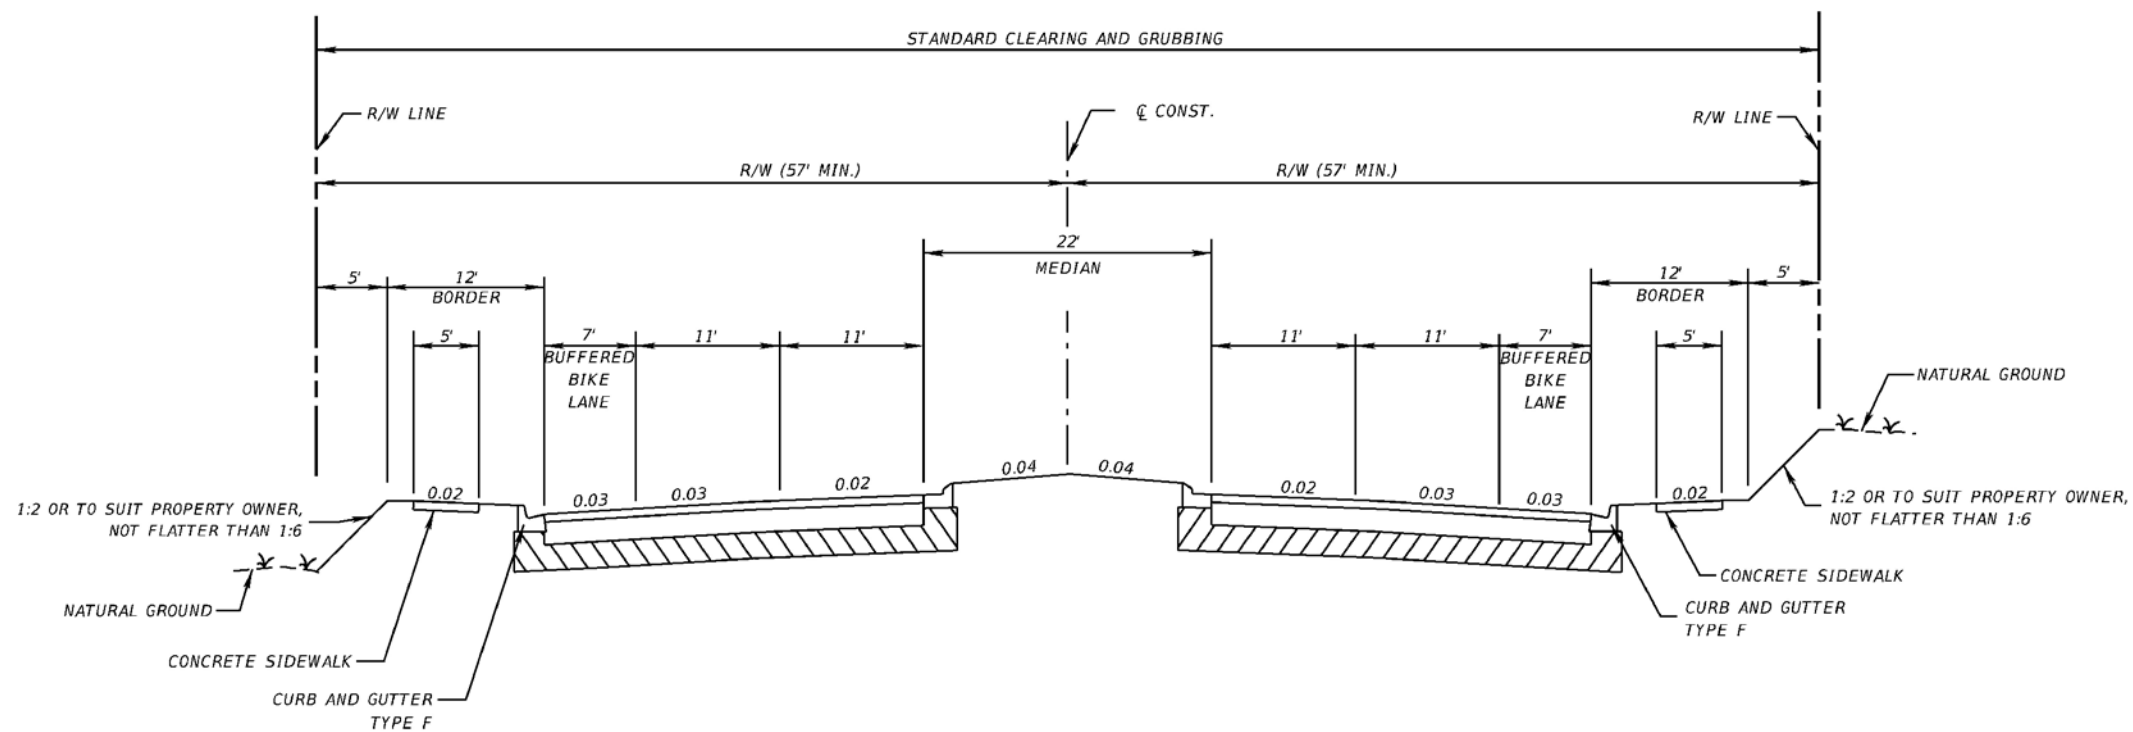
Figure  
 2D

FROM EDWARDS STREET TO MOBLEY STREET - SEGMENT 9  
 DESIGN SPEED = 45 MPH

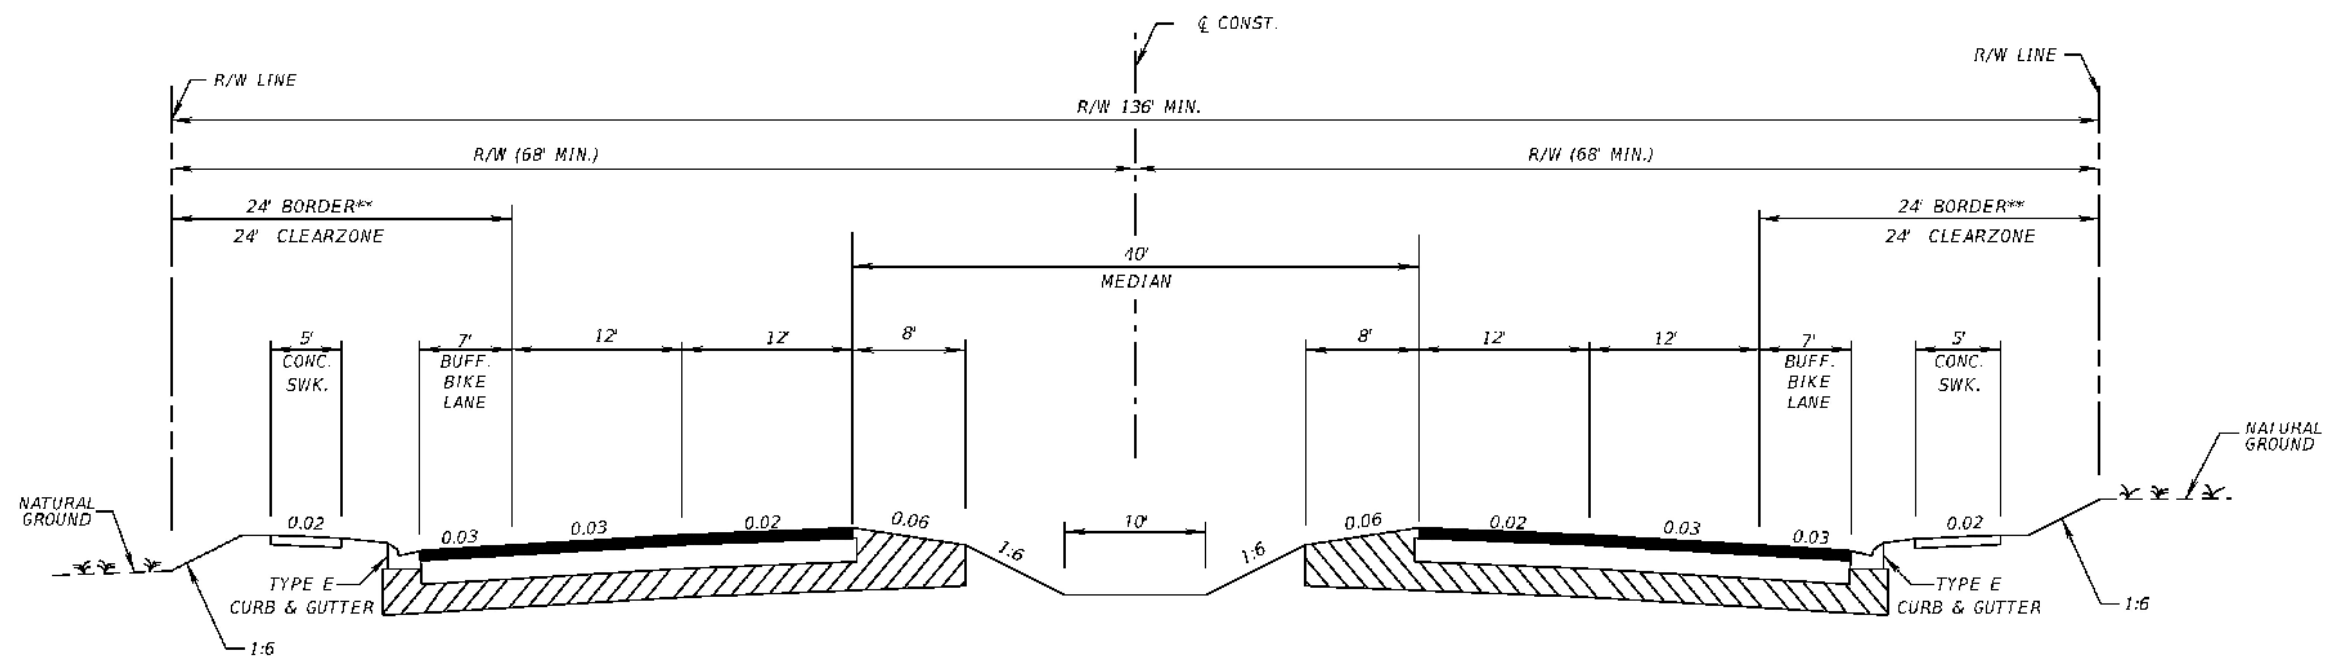
Figure  
**2E**

FROM PARK ROAD TO COUNTY LINE ROAD - SEGMENT 11  
 DESIGN SPEED = 50 MPH

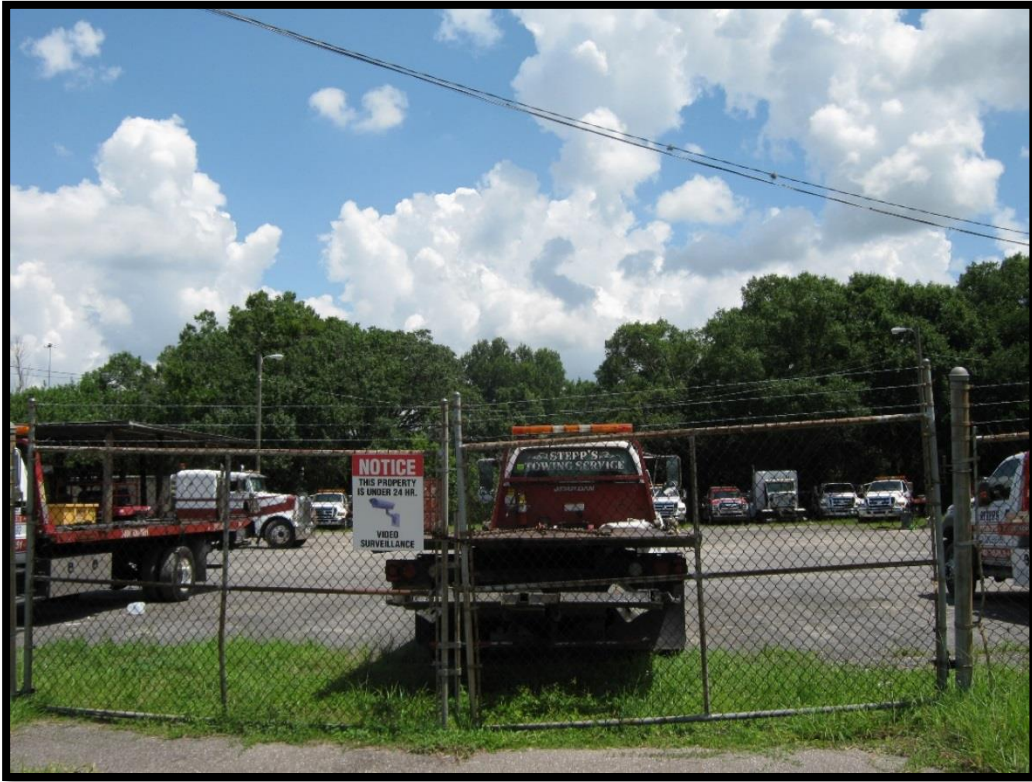
*Photo 9: SMF 1, commercial property adjacent to U.S. 92*

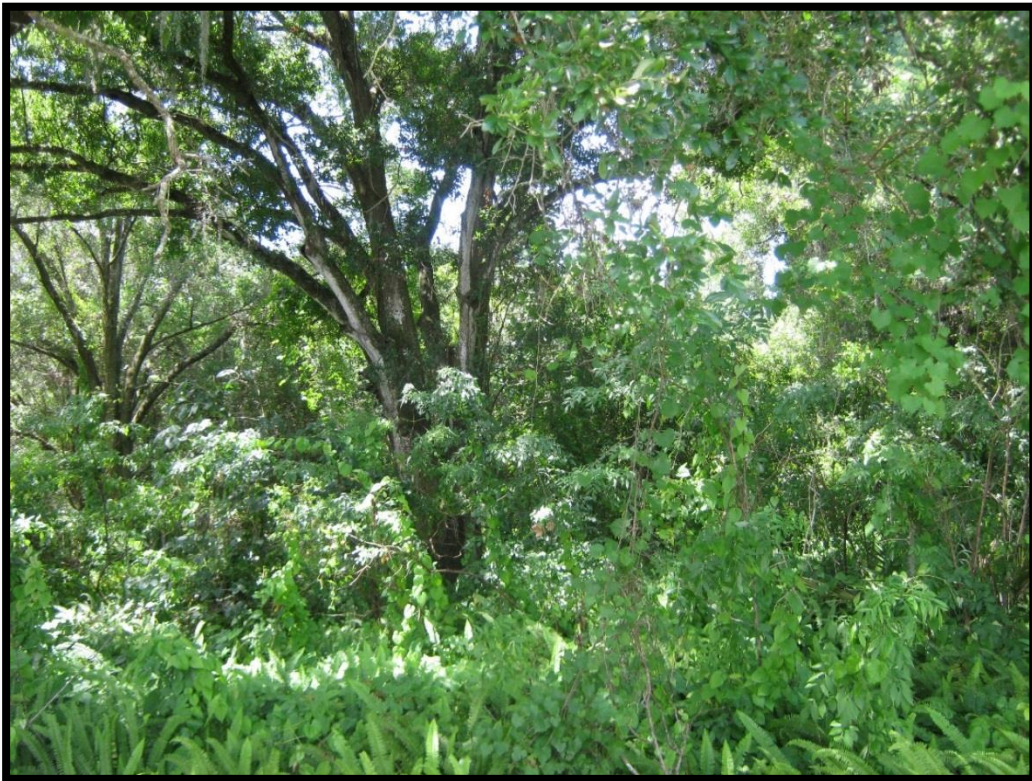
*Photo 10: SMF 1, representative vegetation along the northern boundary*

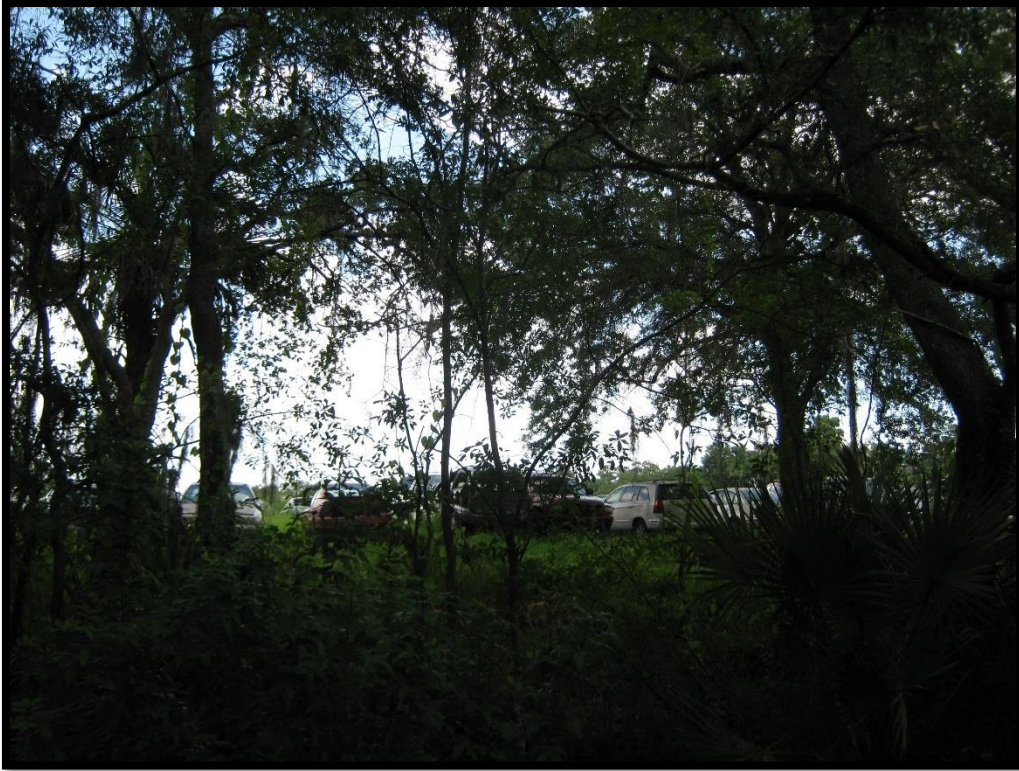
*Photo 11: SFM 2, southern boundary of site*

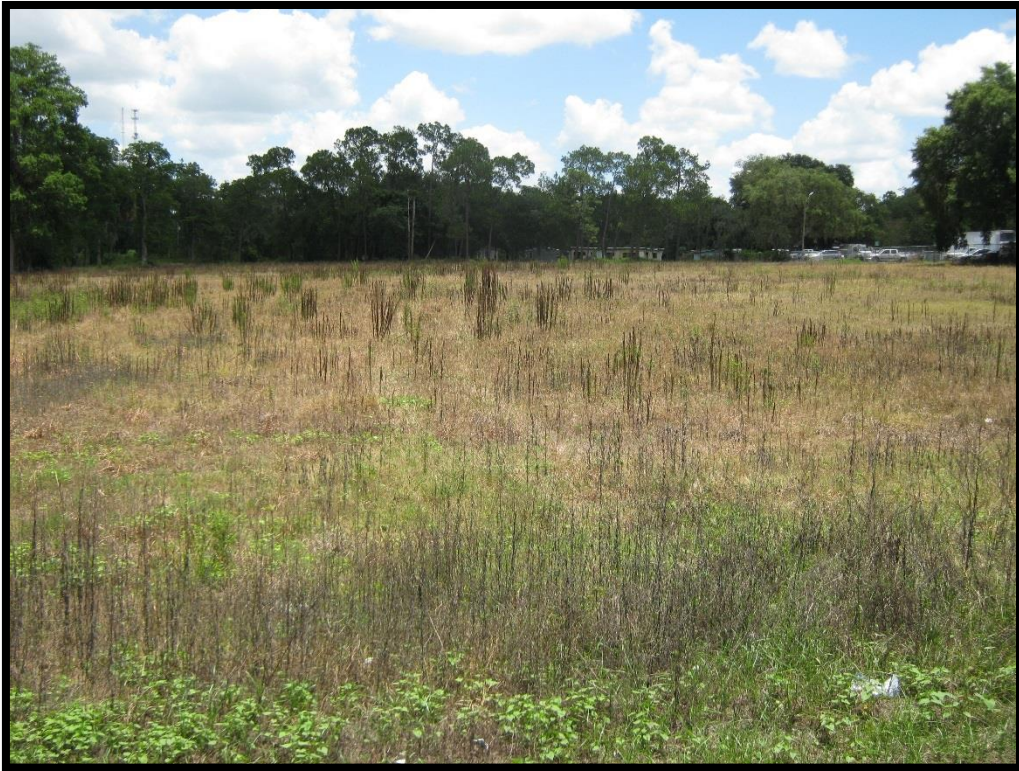
*Photo 30: SMF 15, site has been cleared with construction in progress*

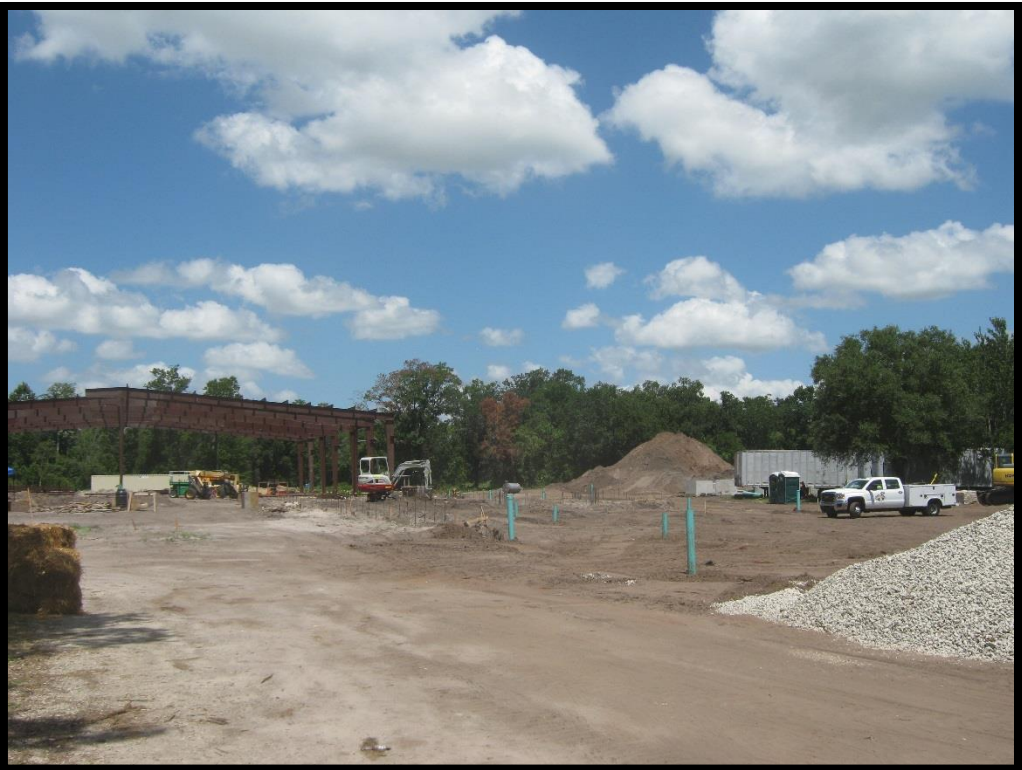
*Photo 58: FPC-12, construction in progress, facing west toward SMF 15*
