**REVISED**  
**CULTURAL RESOURCE ASSESSMENT SURVEY**

**STATE ROAD (SR) 674**  
**FROM US 301 (SR 43) TO CR 579**  
**PROJECT DEVELOPMENT AND ENVIRONMENT (PD&E) STUDY,**  
**HILLSBOROUGH COUNTY, FLORIDA**

**Financial Project ID No.: 422762 1 21 01**

**August 2007**  
**Revised March 2008**

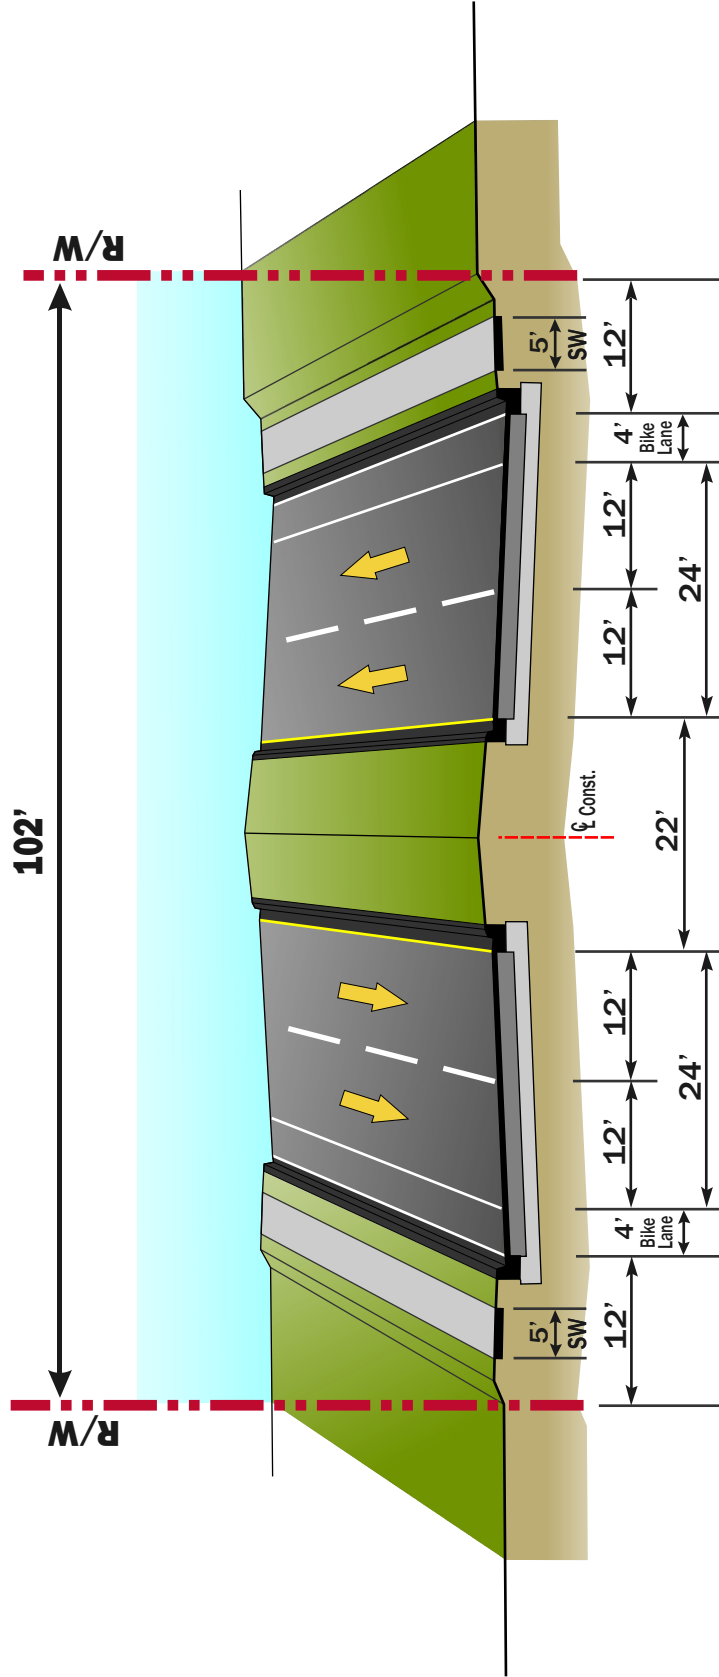
## **Proposed Four-Lane Urban Typical Section for SR 674 102 Feet of Right-of-Way**

- Segment 2 - From West Lake Drive to 7<sup>th</sup> Street: The right of way along this segment is limited to 80 feet. However, most buildings along this segment are set back allowing adequate space for widening with minimal potential relocations. This segment would be widened to provide a four-lane urban typical section (two travel lanes in each direction). This typical section includes bicycle lanes and sidewalks on both sides and requires, at a minimum, 102 feet of right of way. Figure 1.4 depicts the proposed typical section for this segment. To accommodate this typical section, an additional 22 feet of right of way would be needed along SR 674.

- Segment 4 – from Edina Street to east of CR 579: The right of way along this segment is 100 feet. This segment would be widened to provide a four-lane urban typical section (two travel lanes in each direction). This typical section includes bicycle lanes and sidewalks on both sides and requires, at a minimum, 102 feet of right of way. Figure 1.4 depicts the proposed typical section for this segment. To accommodate this typical section, an additional 2 feet of right of way would be needed along SR 674.

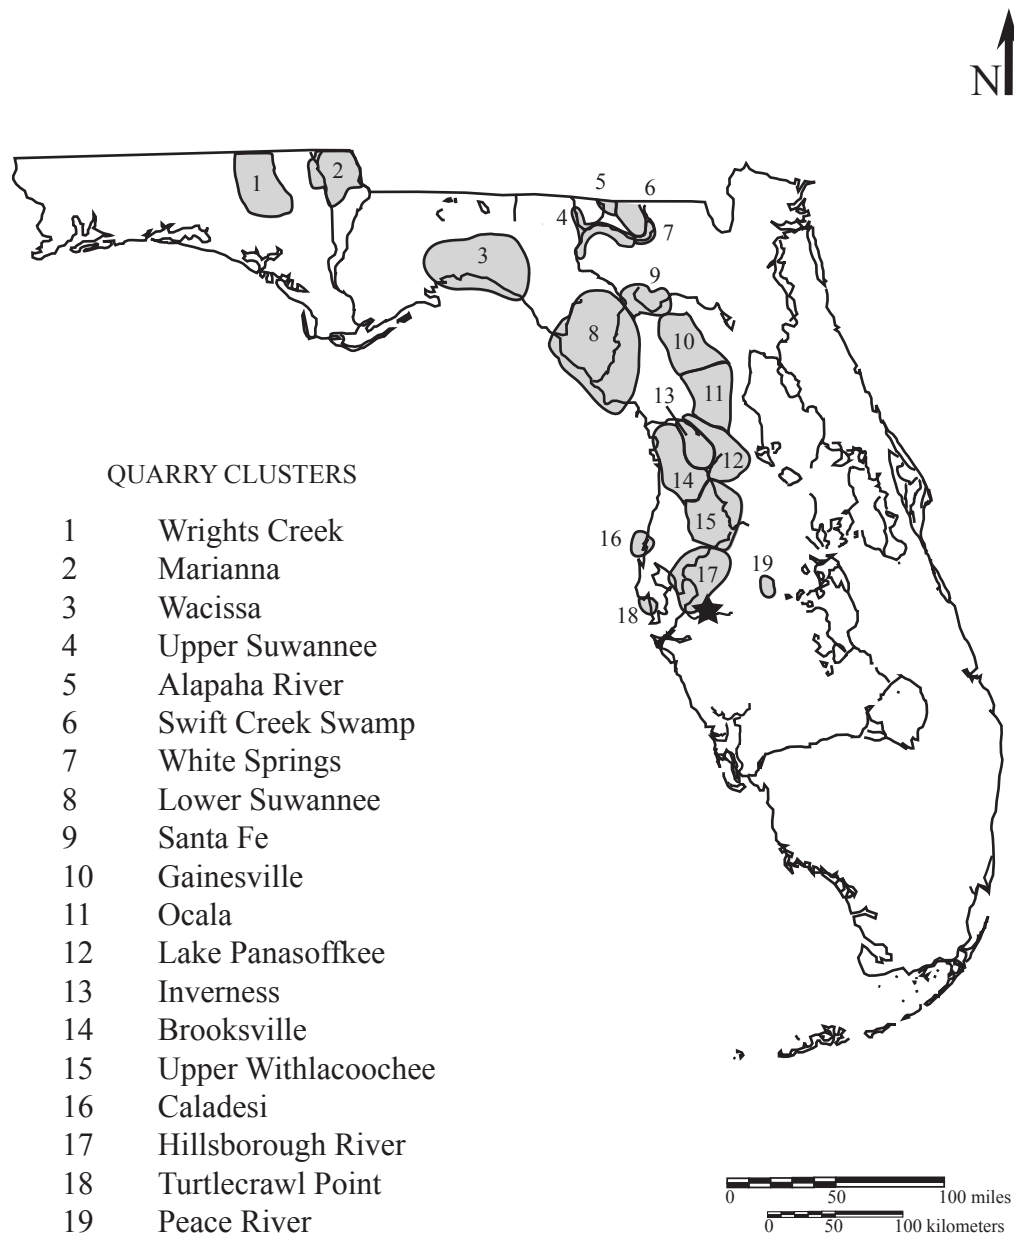
**Figure 2.2.** Location of the SR 674 project relative to the quarry clusters.

The SR 674 project is located just east of the Hillsborough River Quarry Cluster, which extends along the Hillsborough River and its tributaries to Hillsborough Bay (Figure 2.2). The Hillsborough River Quarry Cluster provided a significant source of Tampa Formation silicified limestone. Cherts from this cluster vary widely in color and fabric and contain few diagnostic fossils, though several subareas within this cluster have been identified, based primarily on fossil content and rock fabric (Goodyear et al. 1983; Upchurch et al. 1982).

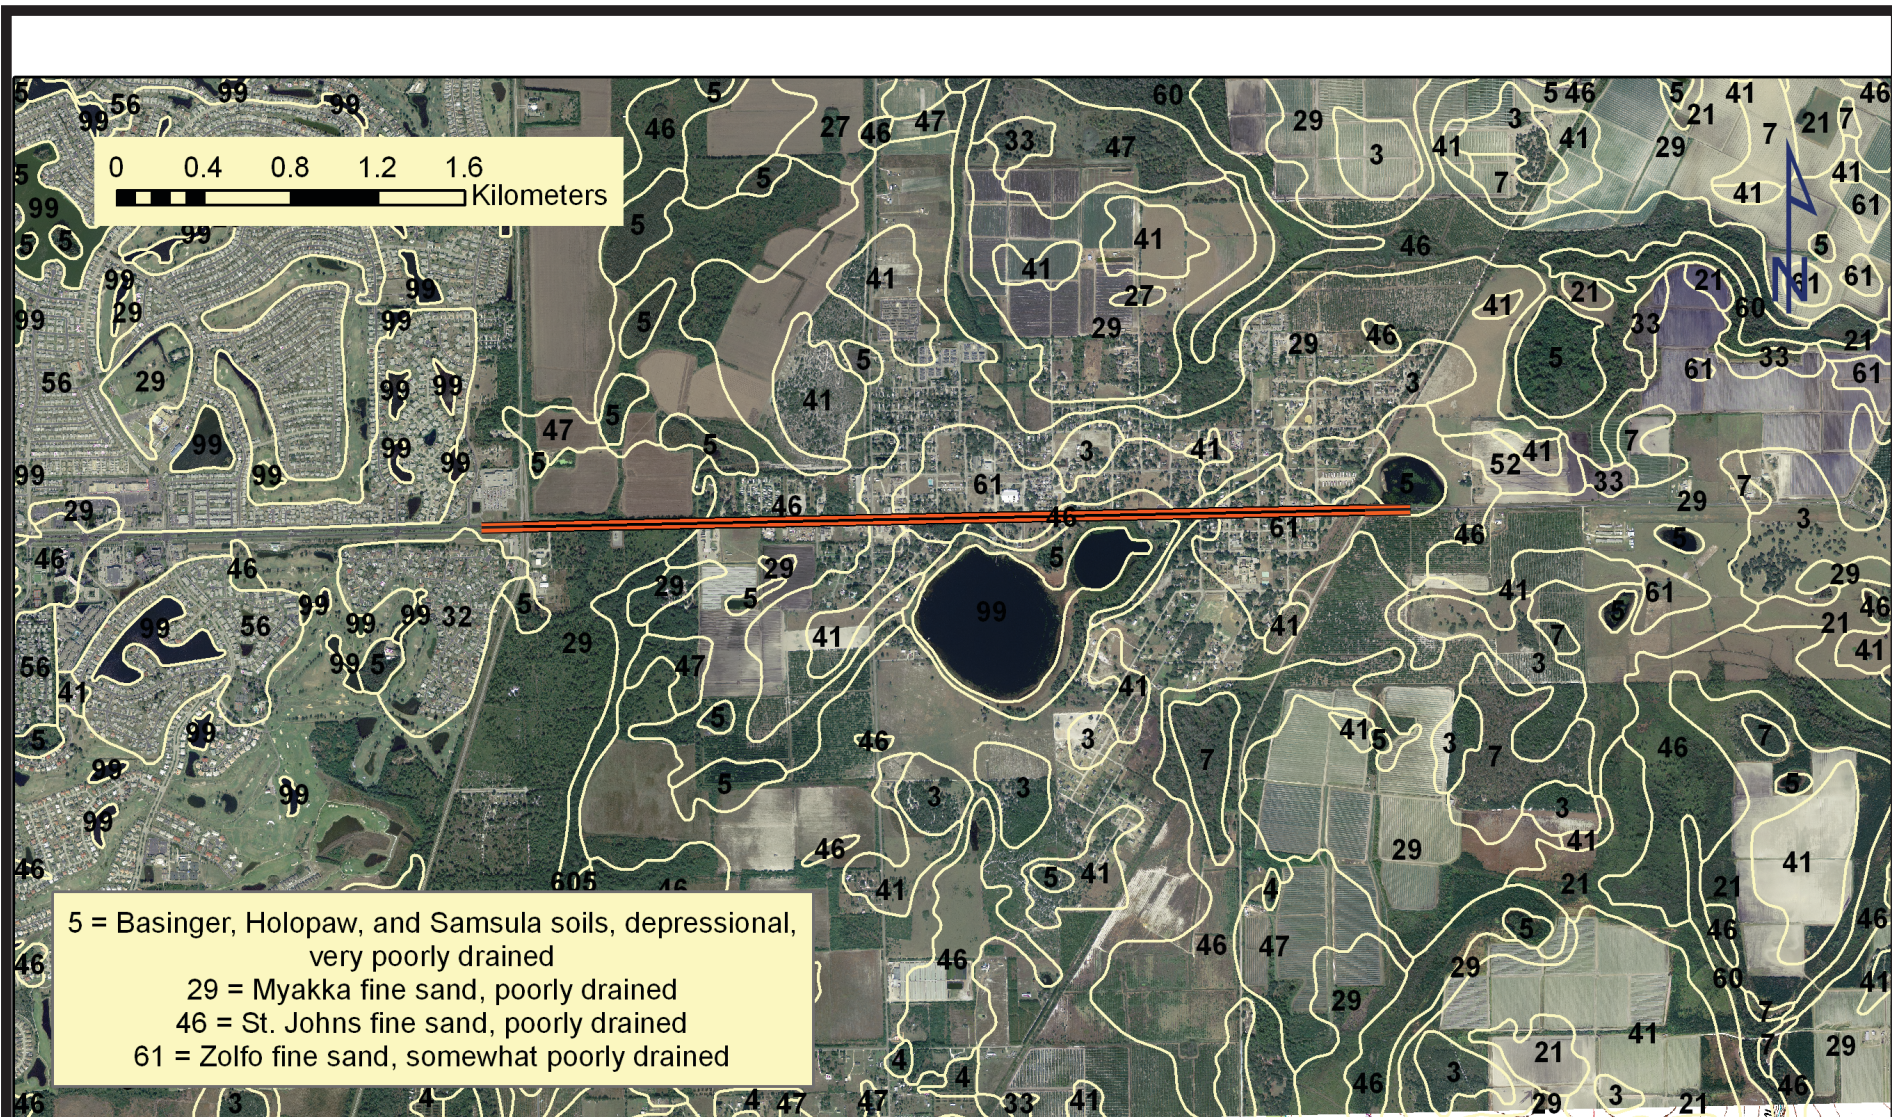
Figure 2.3. Soil types along the SR 674 project corridor (USDA 2005).

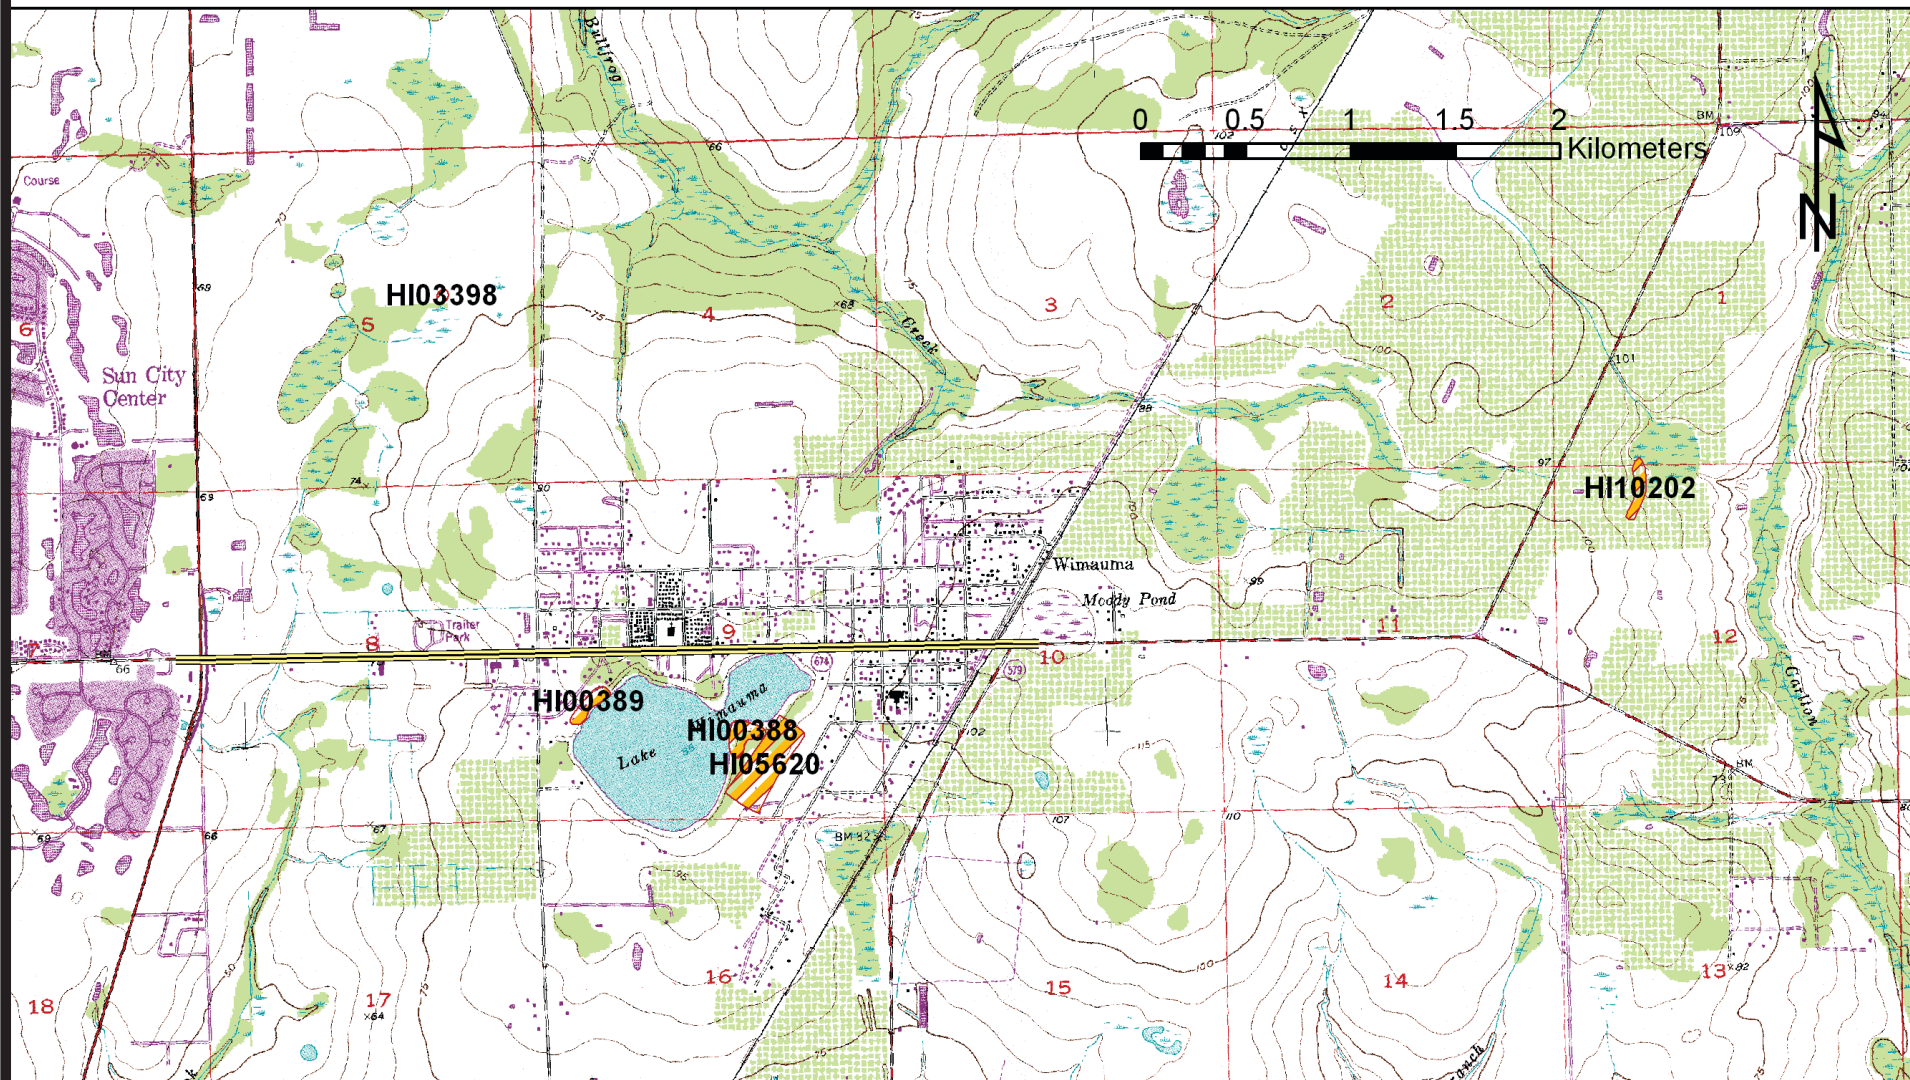
**Figure 5.1.** Location of the previously recorded archaeological sites within two miles of the SR 674 project APE.

A review of the FMSF revealed that no archaeological sites have been recorded within the project APE. However, five previously recorded archaeological sites are located within approximately two miles, of which three are located around the shore of Lake Wimauma (Figure 5.1, Table 5.1). Two of these sites, 8HI388 (Kaymen) and 8HI389 (Simmons) were recorded by University of South Florida students based on local informant reports (FMSF). The Kaymen Site consists of a scattering of projectile points along the southeast shore of Lake Wimauma. The Simmons Site consists of lithic debitage as well as projectile points recovered from the northwest side of Lake Wimauma. Neither site has been professionally examined nor has the significance of the sites been defined. The Lake Wimauma Site (8HI5620), a light scatter of lithic debitage recorded during survey of the Wimauma Lakes Subdivision (Grammer et al. 1994), is located just upslope of 8HI388. Given their proximity, they may be part of the same site.

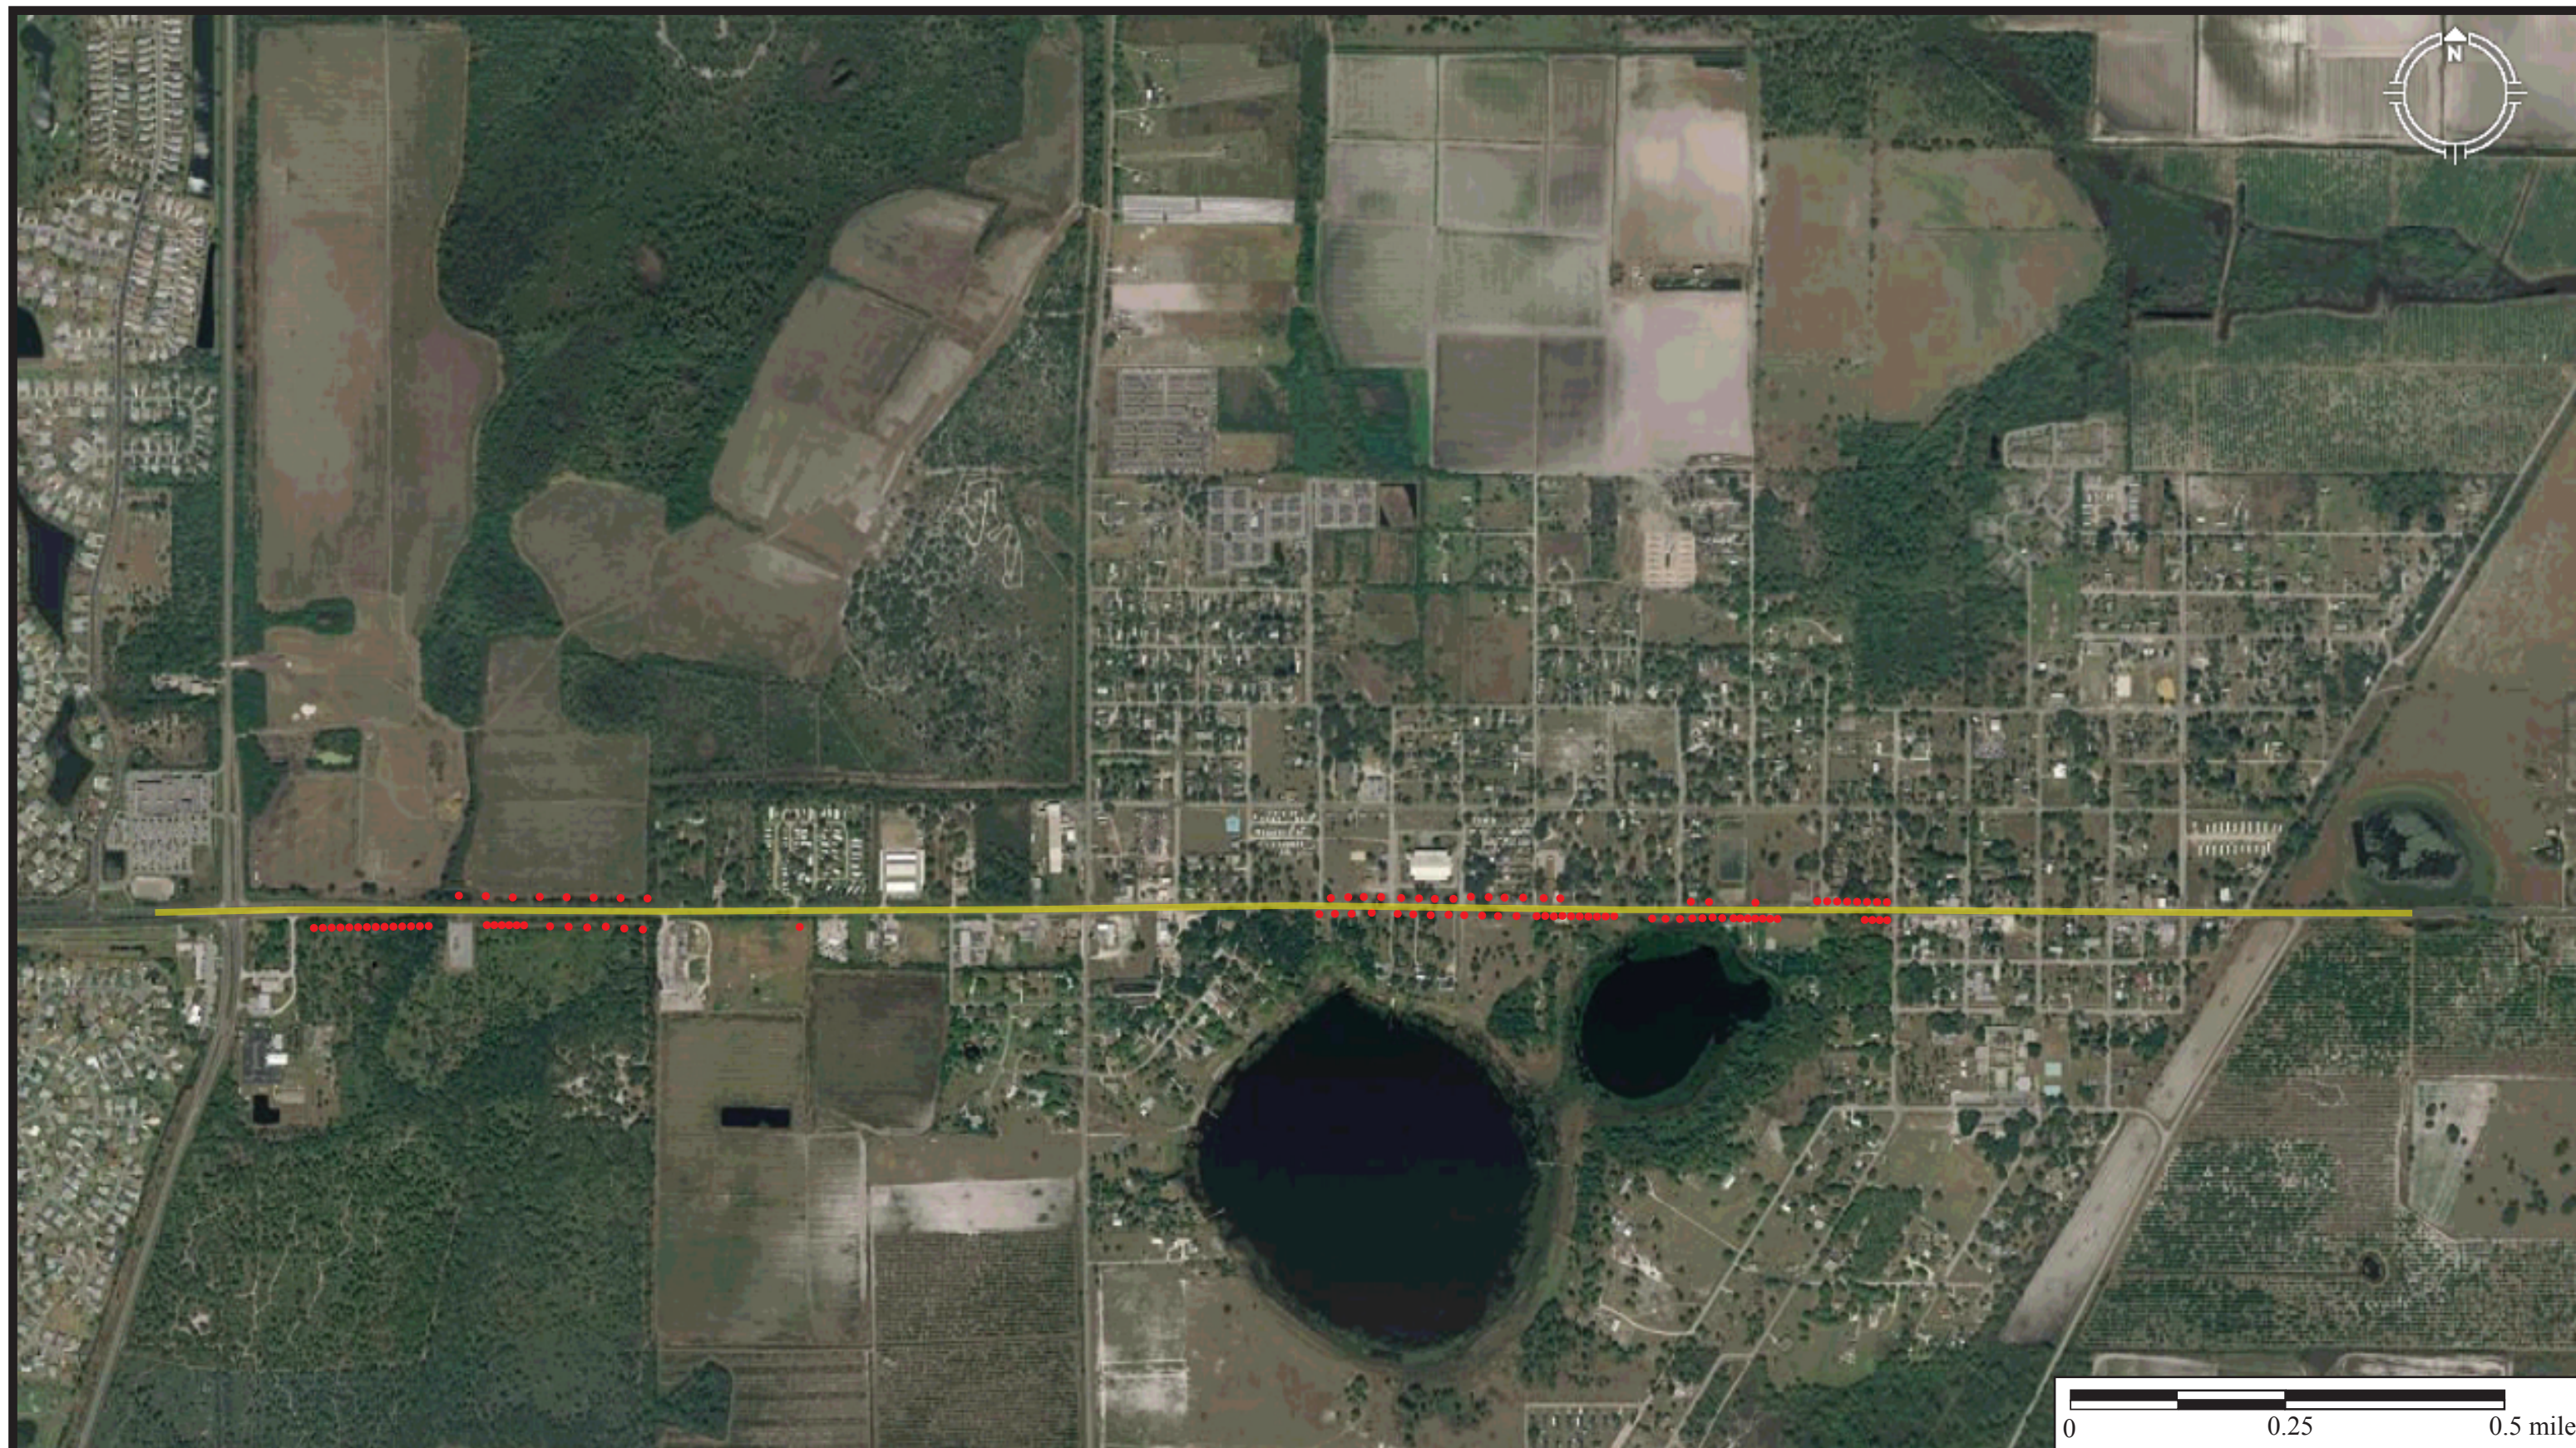
**Figure 6.1.** Approximate location of shovel tests within the SR 674 project APE.

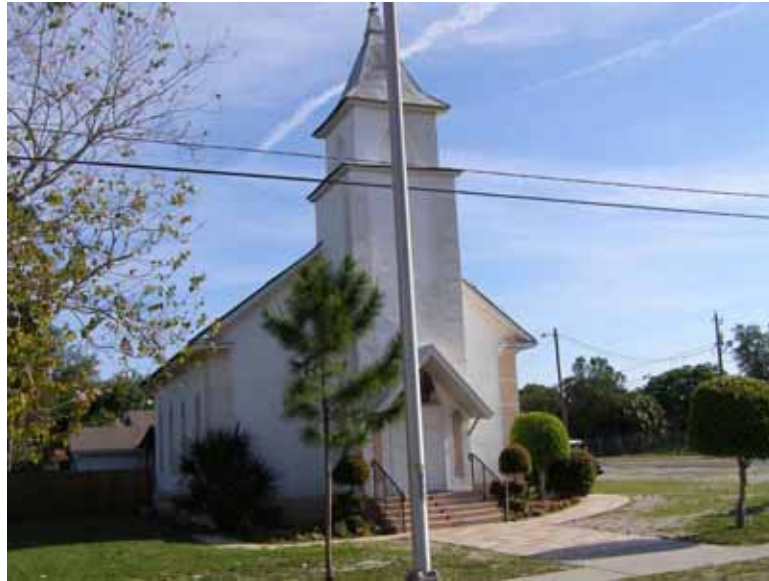
**Photo 6.1.** Former Wimauma Church of the Nazarene (8HI1002), south and west elevations.

When last recorded in 1998 by the HCPGM, the wood frame walls of the church were clad in clapboard with wood cornerboards. Today, the walls of the church (now Templo Filadelfia Pentecostal) are covered in stucco with applied stucco quoins. A steeple is located on the south elevation and has a lancet belfry with a pyramidal roof. Originally, the steeple terminated in a spiked finial but the finial has been removed. Lancet windows with applied stucco window surrounds are located along the west and east elevations. A lancet window is also located over the main entrance, which consists of a pair of 15-panel wood swing doors on the south elevation. A non-historic addition was constructed on the north elevation during the 1970s. Two outbuildings, a Fellowship Hall, and an office building/parsonage, are located to the north of the church. Both of these ancillary buildings are of the Masonry Vernacular style. The church is an example of early 20<sup>th</sup> century religious architecture, but due to alterations such as the change in exterior fabric, the removal of the spiked finial, and the north addition, the architectural integrity of this building has been compromised. Therefore, 8HI1002 is not considered potentially eligible for listing in the NRHP.

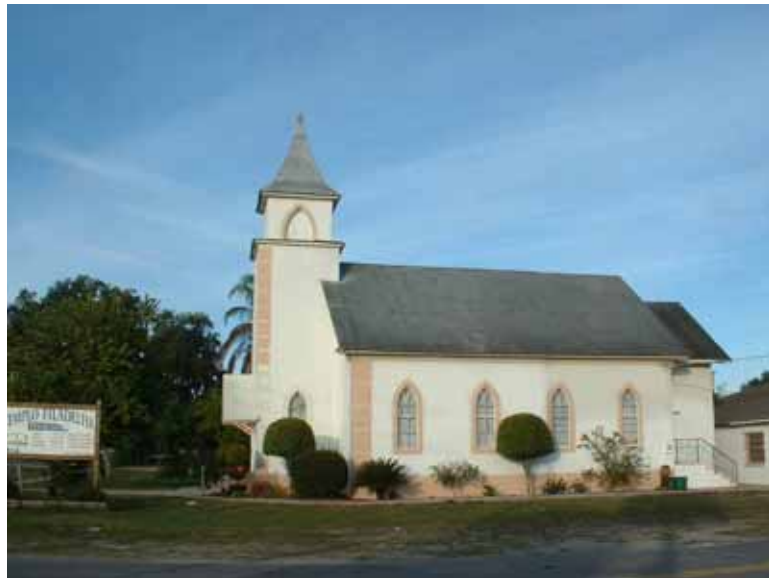
**Photo 6.2.** Former Wimauma Church of the Nazarene (8HI1002), east elevation.

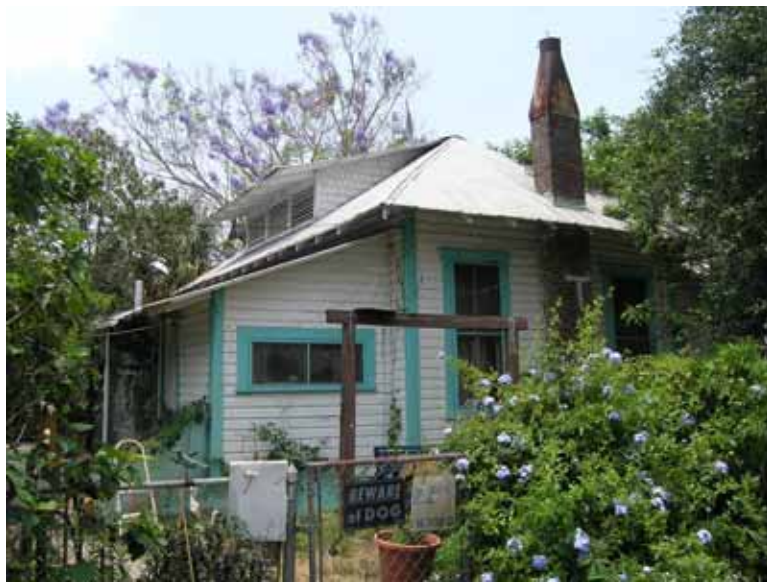
**Photo 6.5.** The former West Farms Office (8HI6562), north and west elevations.

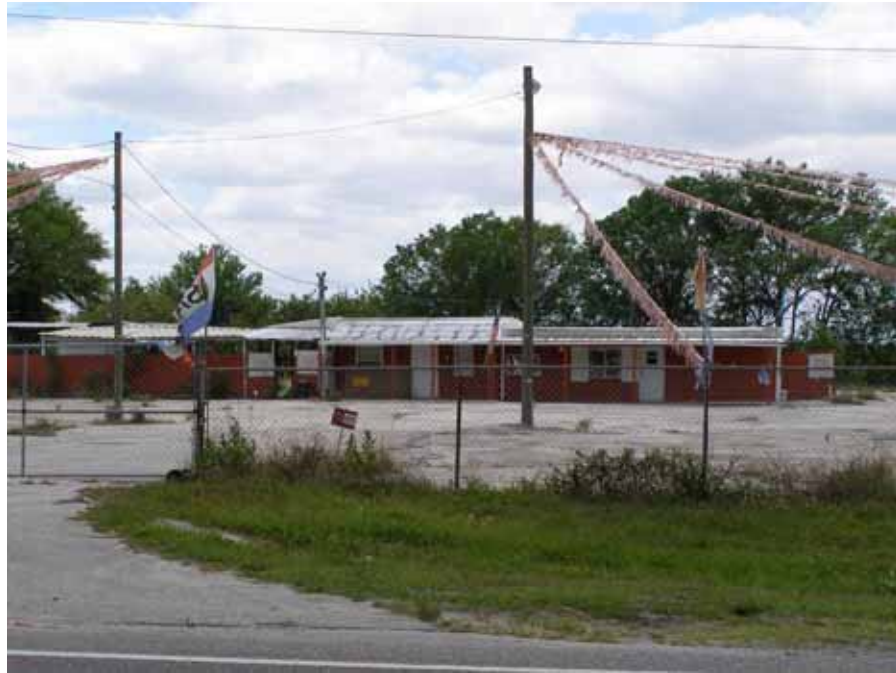
**Photo 6.6.** Commercial building at 5117 SR 674 (8HI10255), south elevation.

**8HI10255:** The commercial building at 5117 SR 674 was built in the Frame Vernacular style ca. 1957. The walls are clad in wood siding and are topped with a gable and shed roof covered in 5-V crimp metal sheeting. The windows consist of one-light over one-light single hung sash and paired one-light sliding. An open porch is located on the north elevation and has a shed roof. Ancillary features include an attached shed to the west, and a detached shed to the southwest. This is a typical example of a Frame Vernacular style building found throughout Hillsborough County, and research revealed no significant historical associations with this building. Therefore, 8HI10255 is not considered potentially eligible for listing in the NRHP.

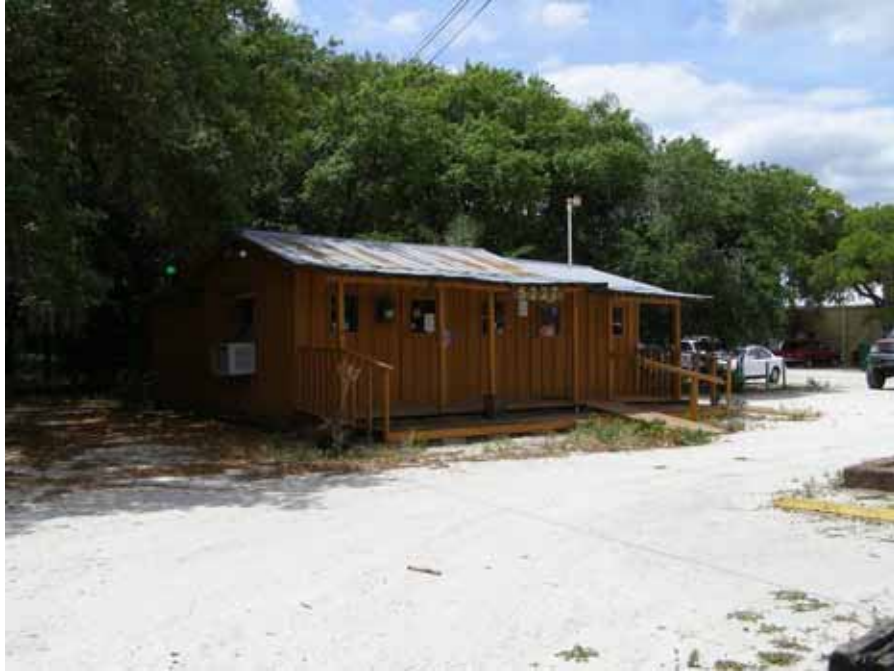
**Photo 6.7.** Commercial building at 5227 SR 674 (8HI10256), north and west elevations.

**8HI10256:** The commercial building at 5227 SR 674 was built ca. 1957 in the Frame Vernacular style. The wood frame walls are covered in board and batten siding and are topped with a gable roof covered in 5-V crimp metal sheeting. Windows are one-light fixed and have a shed roof covered in composition shingle. Exterior ornament includes cornerboards. Ancillary features include a barn structure to the south with a gambrel roof covered in composition shingle. This is a typical example of a Frame Vernacular style building found throughout Hillsborough County and research revealed no significant historical associations. Therefore, 8HI10256 is not considered potentially eligible for listing in the NRHP.

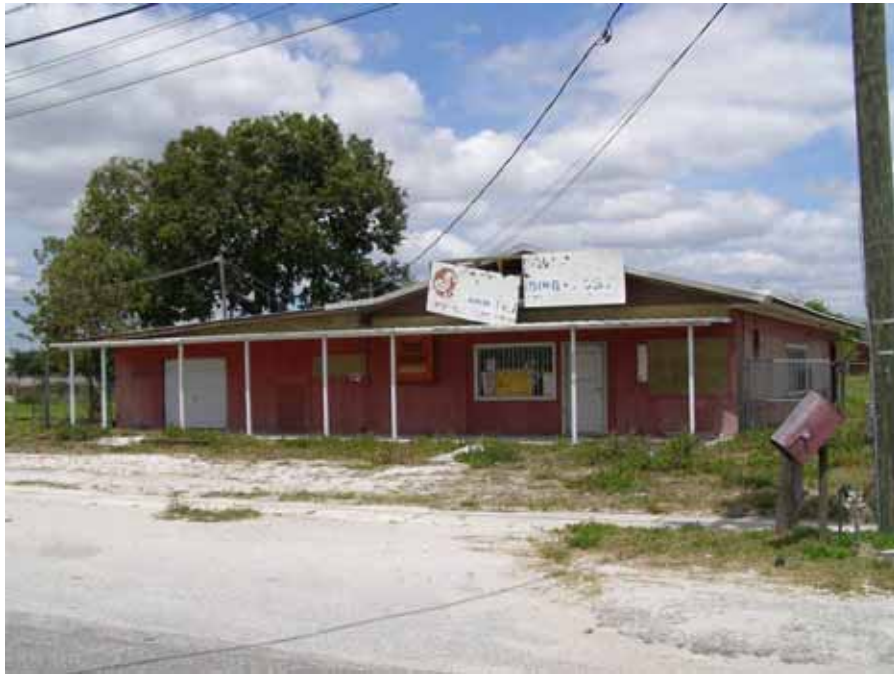
**Photo 6.8.** Commercial building at 5206 SR 674 (8HI10257), south and west elevations.

**8HI10257:** 5206 SR 674 is a building constructed ca. 1957 in the Frame Vernacular style. A poured concrete slab foundation supports the wood frame walls that are covered in weatherboard and corrugated metal. The gable roof is covered in 5-V crimp metal sheeting, and the windows consist of one-light fixed and one-light over one-light single hung sash. Other windows are obscured with plywood. There are two open porches on the structure, one on the south elevation and another on the west elevation. Both feature a shed roof. This is a typical example of an Agricultural/Commercial style building found throughout Hillsborough County and research revealed no significant historical associations. Therefore, 8HI10257 is not considered potentially eligible for listing in the NRHP.

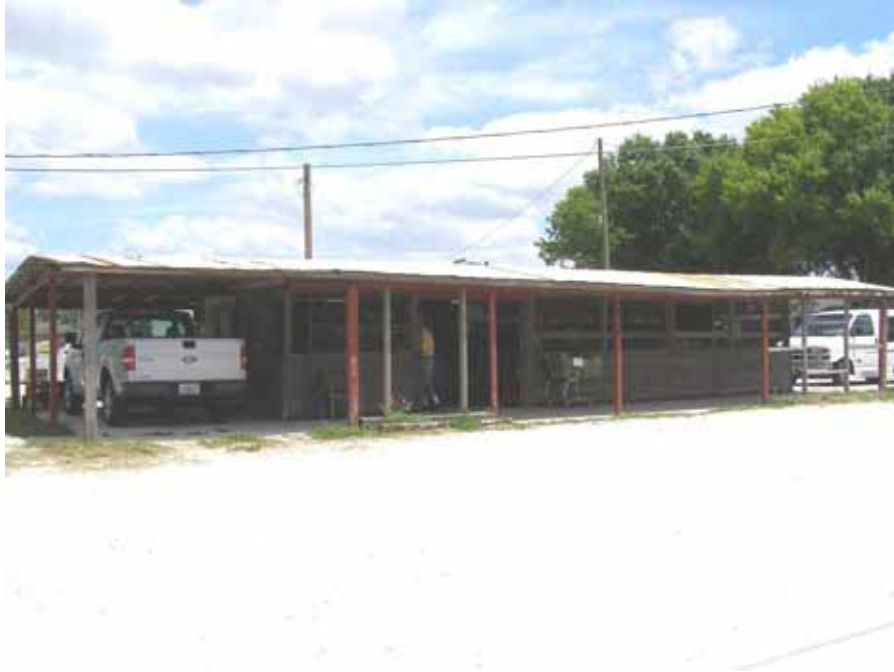
**Photo 6.9.** Commercial building at 5214 SR 674 (8HI10258), south and east elevations.

**8HI10258:** The fruit stand at 5214 SR 674 was built ca. 1957 in the Frame Vernacular style. A slab foundation supports the wood frame walls which are covered in wood logs and weatherboard. The gable roof is faced with 5-V crimp metal sheeting. There are two open porches on this building, one on the north elevation and one on the south. An attached carport is located on the west elevation. An addition for a cooling unit was added to the north elevation during the 1980s. This is a typical example of an Agricultural/Commercial style building found throughout Hillsborough County. Research revealed no significant historical associations. Therefore, 8HI10258 is not considered potentially eligible for listing in the NRHP.

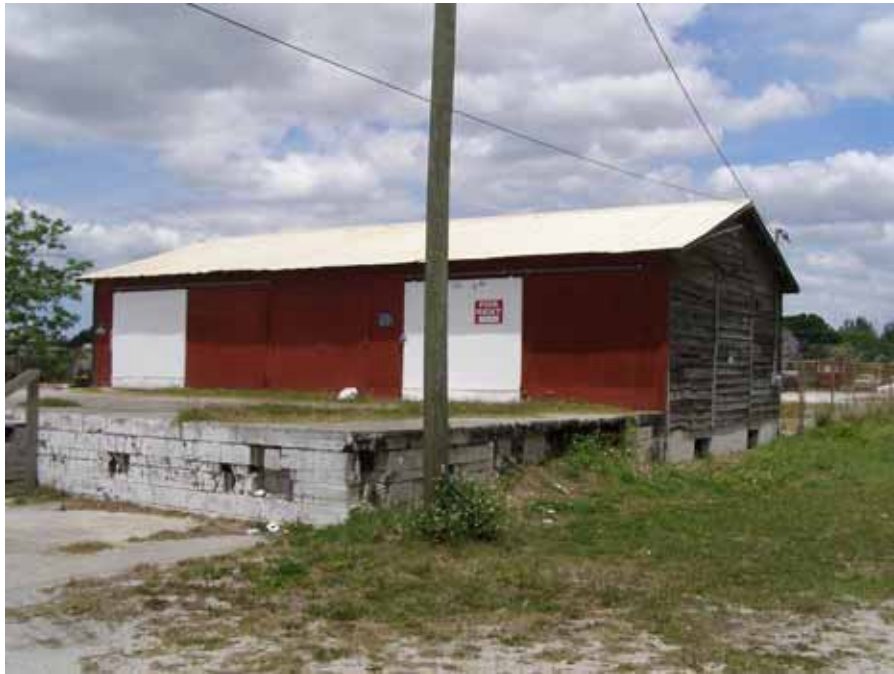
**Photo 6.10.** Agricultural building at 725 14<sup>th</sup> Street (8HI10259), south and east elevations.

**8HI10259:** The building at 725 14<sup>th</sup> Street was constructed ca. 1940 in the Frame Vernacular style. The wood frame walls are covered in wood siding and are supported by a continuous concrete block foundation. It is topped with a gable roof that is covered in 5-V crimp metal sheeting. The main entrance is located on the east elevation and is a one-panel sliding door. An open porch is located on the south elevation. Exterior ornament includes gable vents. This is a typical example of a Barn, common agricultural style building found throughout Hillsborough County. Furthermore, research revealed no significant historical associations. Therefore, 8HI10259 is not considered potentially eligible for listing in the NRHP.

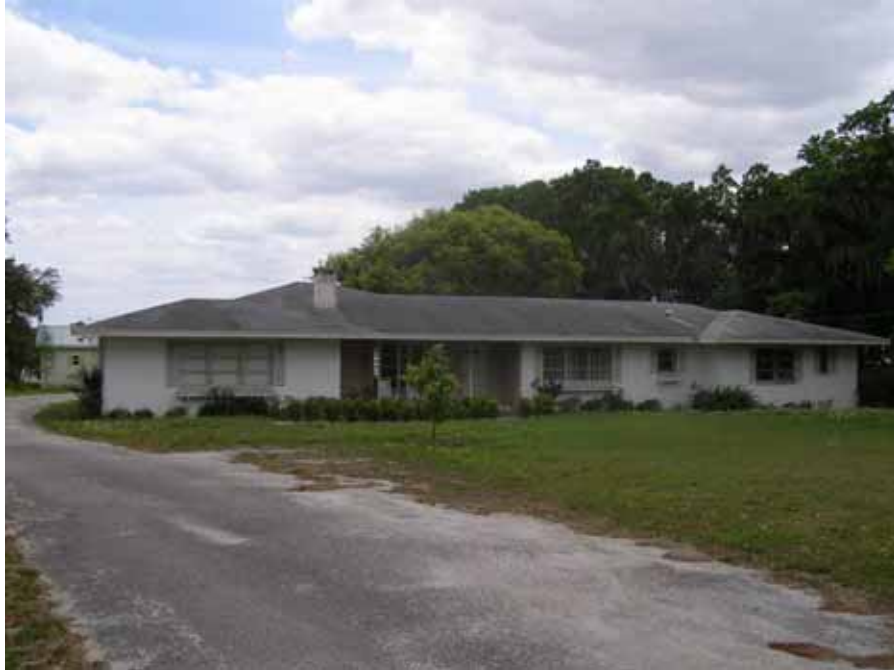
**Photo 6.11.** Residence at 5313 SR 674 (8HI10260), north elevation.

**8HI10260:** The residence at 5313 SR 674 was constructed ca. 1952 in the Masonry Vernacular style. The concrete block walls are supported by a slab foundation and covered in brick veneer. The hip on hip roof is faced with composition shingles. One masonry chimney is located on the north elevation. Windows consist of three-light awning, two-light awning, and four-light awning. The north elevation has one incised porch that contains the main entrance, a wood swing door with a five-light fanlight. Another porch is located on the south elevation and is closed with a flat roof. Architectural features include fixed window shutters and brick window sills. Ancillary features include a detached shed to the southwest and a garage to the west. This is a typical example of a Masonry Vernacular style building found throughout Hillsborough County, and research revealed no significant historical associations. Therefore, 8HI10260 is not considered potentially eligible for listing in the NRHP.

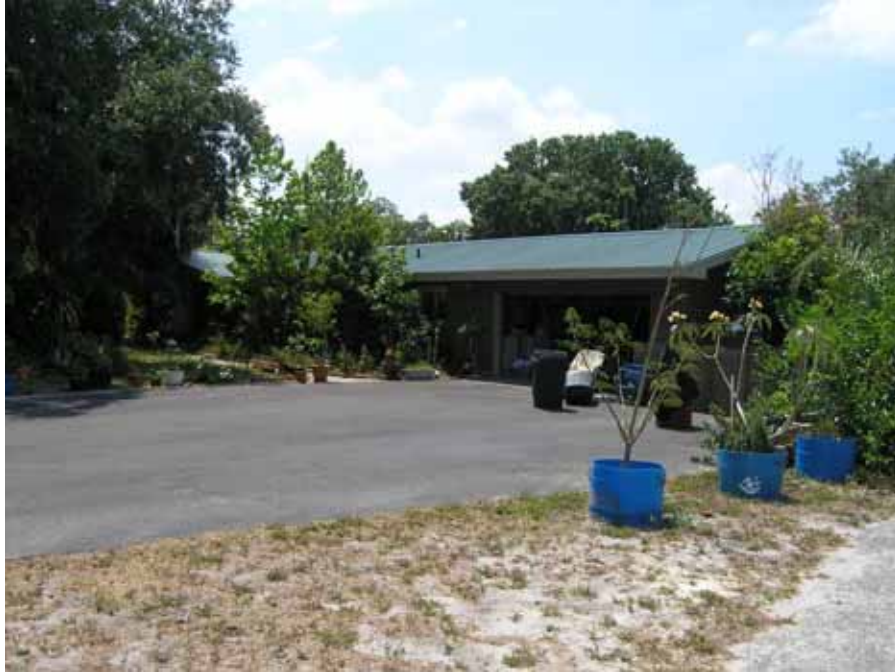
**Photo 6.12.** Residence at 5401 SR 674 (8HI10261), north elevation.

**8HI10261:** The Masonry Vernacular residence at 5401 SR 674 was built ca. 1957. The concrete block walls rest on a slab foundation and are covered in vinyl siding. The gable roof is covered in 3-V crimp metal sheeting. There is also a brick chimney located on the south slope. The windows consist of one-light sliding, two-light awning, and four-light awning. Exterior ornament includes an octagonal gable vent. An incised porch is located on the north elevation. This is a typical example of a Masonry Vernacular style building found throughout Hillsborough County and research revealed no significant historical associations. Therefore, 8HI10261 is not considered potentially eligible for listing in the NRHP.

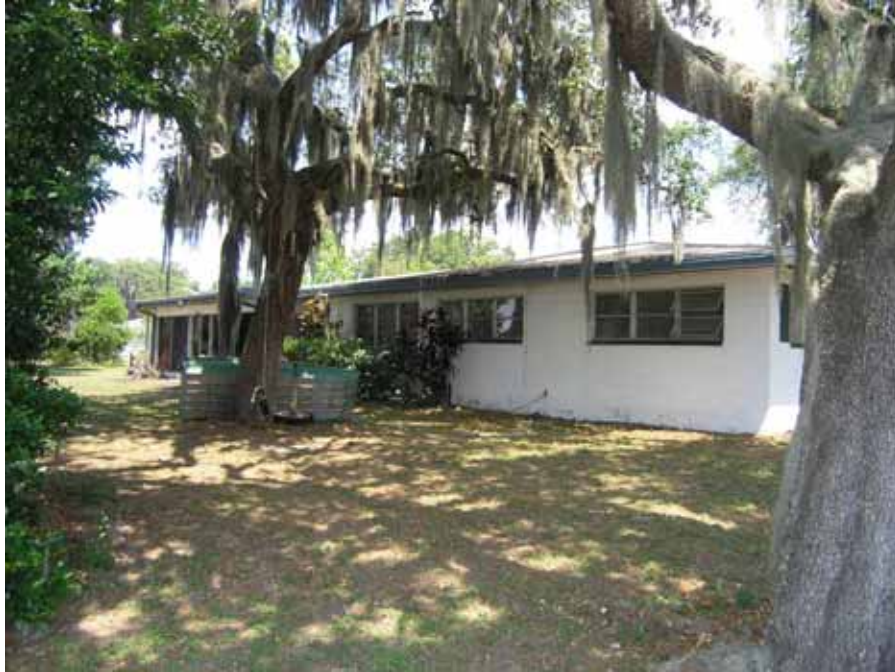
**Photo 6.13.** Residence at 5411 SR 674 (8HI10262), north and west elevations.

**8HI10262:** 5411 SR 674 is a Masonry Vernacular style residence constructed ca. 1957. A slab foundation supports the concrete block walls that are decorated with a brick veneer. A gable roof tops the building and is covered with composition shingles. Windows are two-light awning. An incised porch is located on the north elevation and contains the main entrance. Ancillary features include a shed to the south and a carport to the west. This is a typical example of a Masonry Vernacular style building found throughout Hillsborough County. Furthermore, research revealed no significant historical associations. Therefore, 8HI10262 is not considered potentially eligible for listing in the NRHP.

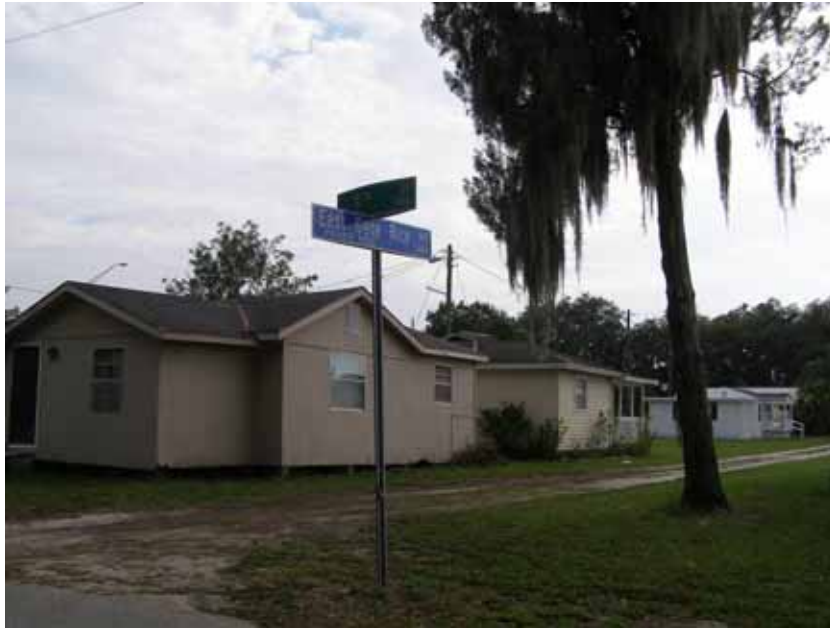
**Photo 6.14.** Wimauma Church of God Campground Resource Group (8HI10284), general view looking southwest.

Landmark. The 11 historic properties located within the project APE represent only a small part of the remaining community of church member-owned cottages, originally estimated at 250 buildings. While few residences remain to the west of the John D. Nichols Worship Center, those portions of the original Church of God campground situated to the east and north of the church have largely survived and should be evaluated in their totality. Such an assessment was beyond the scope of this transportation project.

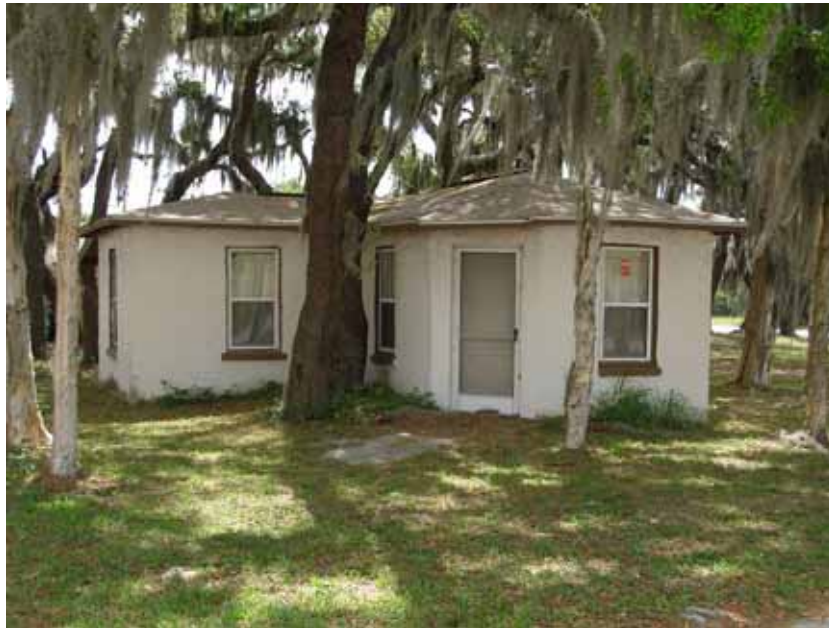
**Photo 6.15.** Church of God Campground residence (8HI10263), west elevation.

**8HI10263:** The residence at the northeast corner of East Gene Rice Avenue and 10<sup>th</sup> Street was built in the Masonry Vernacular style ca. 1950 and is part of the Wimauma Church of God Campground Resource Group. A slab foundation supports the concrete block walls which are topped with a gable roof covered in composition shingle. Windows are jalousie and located on the east elevation, and one over one single hung sash on the other elevations. On the south elevation is a bay addition clad in stucco (ca. 1970s). This is a typical example of a Masonry Vernacular style building found throughout Hillsborough County. Furthermore, the south addition compromises its architectural integrity. Therefore, 8HI10263 is not considered potentially eligible for listing in the NRHP.

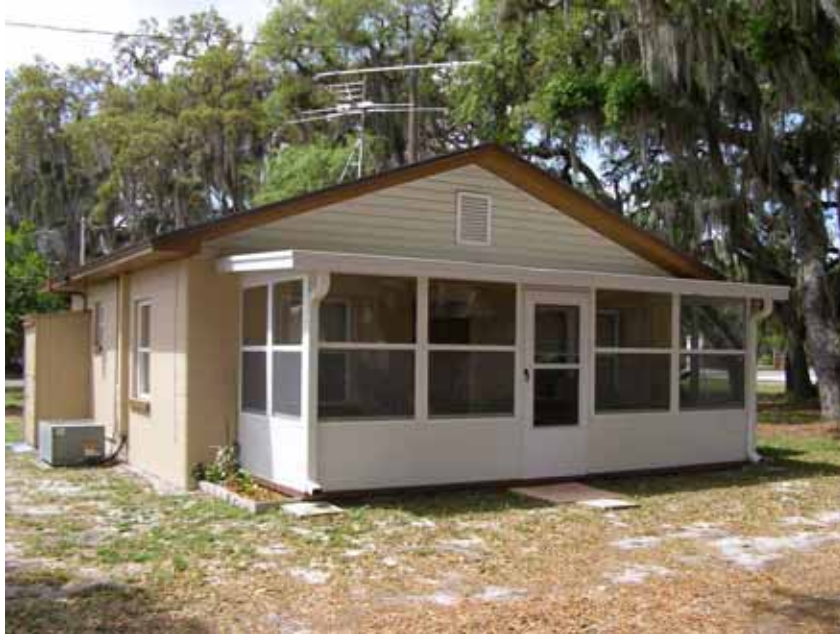
**Photo 6.16.** Church of God Campground residence (8HI10264), north elevation.

**8HI10264:** The residence at 5425 East Gene Rice Avenue is of the Masonry Vernacular style, and was constructed ca. 1950. It is part of the Wimauma Church of God Campground Resource Group. The concrete block walls are supported by a slab foundation and topped with a gable roof covered in composition shingles. Windows are one-light over one-light single hung sash. An open porch with a shed roof is located on the north elevation and contains the main entrance. Other architectural features include an awning over the back door and rounded corners. This is a typical example of a Masonry Vernacular style building found throughout Hillsborough County. Therefore, 8HI10264 is not considered potentially eligible for listing in the NRHP.

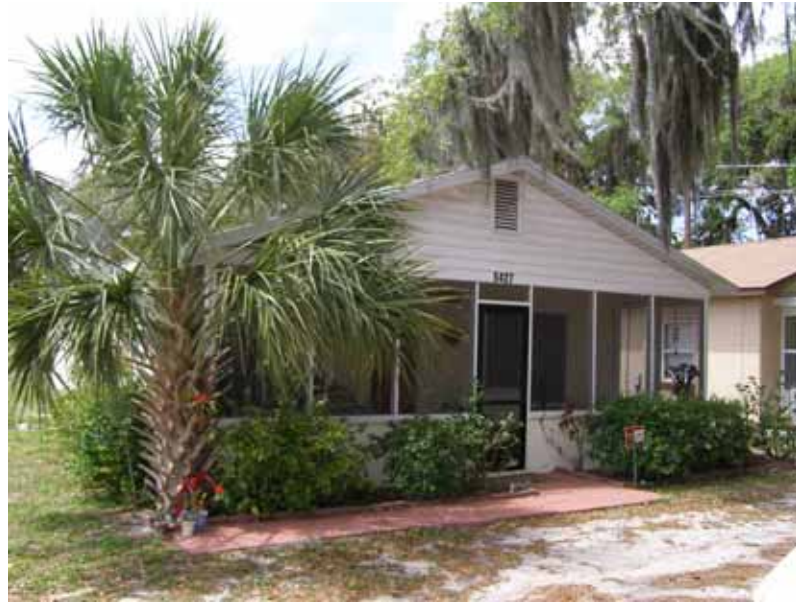
**Photo 6.17.** Church of God Campground residence (8HI10265), north and west elevations.

**8HI10265:** The building at 5427 East Gene Rice Avenue is a Frame/Masonry Vernacular residence built ca. 1950. It is part of the Wimauma Church of God Campground Resource Group. The concrete block walls, covered in wood siding, are supported by a slab foundation and topped with a gable roof covered in composition shingle. The windows consist of one-light over one-light single hung sash, some with four-over-four simulated divided lights. There is one open porch located on the north elevation with a gable roof. Exterior ornament includes gable vents. This is a typical example of a Frame/Masonry Vernacular style building built throughout Hillsborough County. Therefore, 8HI10265 is not considered potentially eligible for listing in the NRHP.
