**REVISED**  
**CULTURAL RESOURCE ASSESSMENT SURVEY**

**STATE ROAD (SR) 674**  
**FROM US 301 (SR 43) TO CR 579**  
**PROJECT DEVELOPMENT AND ENVIRONMENT (PD&E) STUDY,**  
**HILLSBOROUGH COUNTY, FLORIDA**

**Financial Project ID No.: 422762 1 21 01**

**August 2007**  
**Revised March 2008**

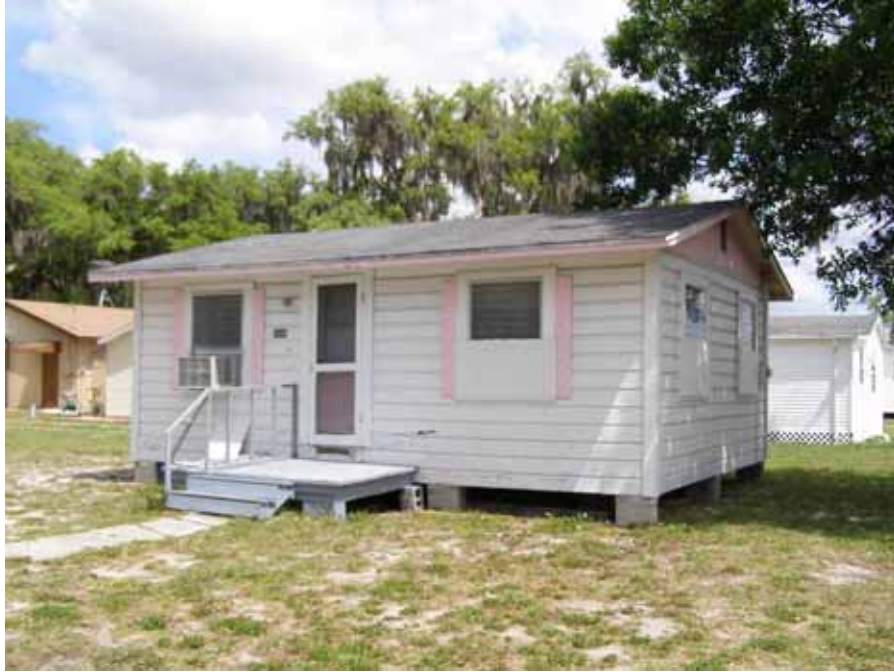
**Photo 6.18.** Church of God Campground residence (8HI10266), south and east elevations.

**8HI10266:** 5430 SR 674 was constructed ca. 1950 in the Frame Vernacular style and is part of the Wimauma Church of God Campground Resource Group. The wood frame walls are supported by a concrete block pier foundation and are clad in wood drop siding. The gable roof is covered in composition shingles and the windows consist of jalousie. The main entrance is accessed via an open porch on the south elevation. Other architectural features include wood window surrounds, fixed window shutters, wood door surrounds, and gable vents. This is a typical example of a Frame Vernacular style building found throughout Hillsborough County. Therefore, 8HI10266 is not considered potentially eligible for listing in the NRHP.

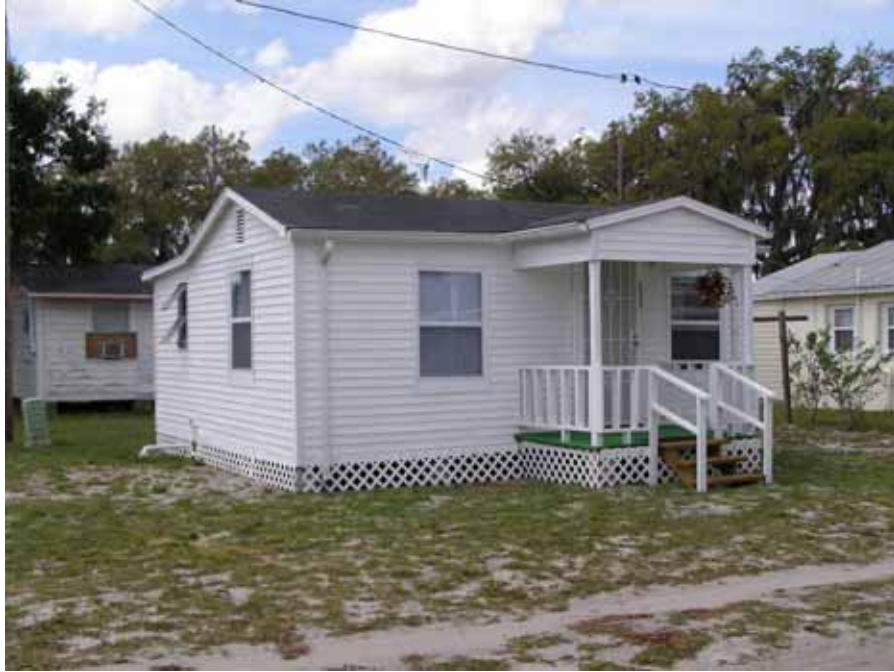
**Photo 6.19.** Church of God Campground residence (8HI10267), north and east elevations.

**8HI10267:** The Frame Vernacular residence at 5429 East Gene Rice Avenue was constructed ca. 1950 and is part of the Wimauma Church of God Campground Resource Group. A pyramidal pier foundation supports the wood frame walls clad in wood siding. The gable roof is faced in composition shingles. Windows include two-light awning and one-light over one-light single hung sash. One open porch with a gable roof is located on the north elevation and contains the main entrance, a wood swing door with a metal screen. A closed porch with a shed roof is located on the south elevation. Exterior ornament includes lattice work around the foundation. Ancillary features include a shed to the south. This is a typical example of a Frame Vernacular style building found throughout Hillsborough County. Therefore, 8HI10267 is not considered potentially eligible for listing in the NRHP.

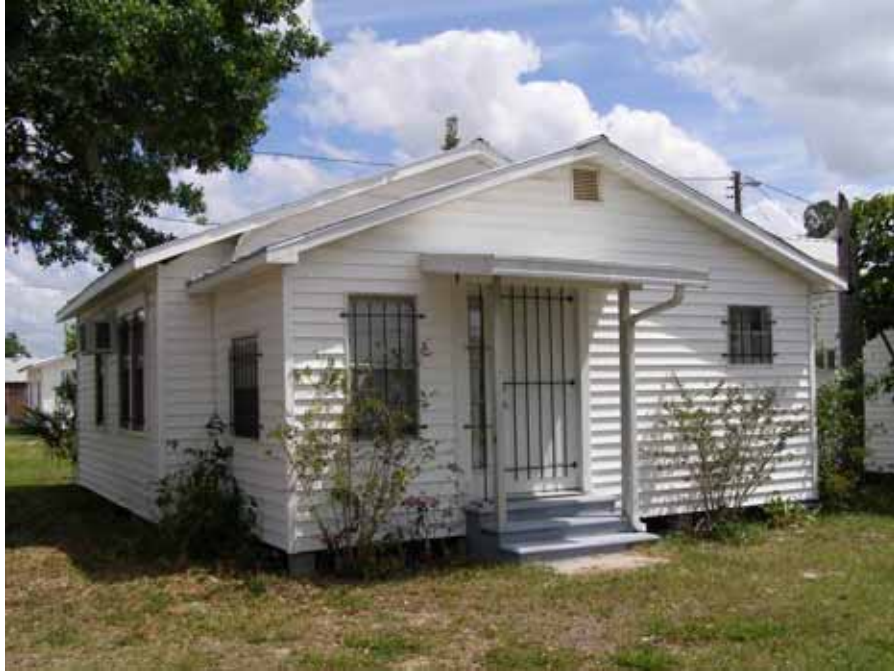
**Photo 6.20.** Church of God Campground residence (8HI10268), south and west elevations.

**8HI10268:** The residence at 5432 SR 674 was constructed ca. 1950 in the Frame Vernacular style and is part of the Wimauma Church of God Campground Resource Group. A concrete block pier foundation supports the wood frame walls faced with clapboard. The residence is topped by a gable roof covered in composition shingle. Windows are one-light over one-light single hung sash. The main entrance is a wood swing door with a five-light sidelight. It is accessed via an open porch on the south elevation with a shed roof. Exterior ornament includes iron grills on the doors and windows, and gable vents. This is a typical example of a Frame Vernacular style building found throughout Hillsborough County. Therefore, 8HI10268 is not considered potentially eligible for listing in the NRHP.

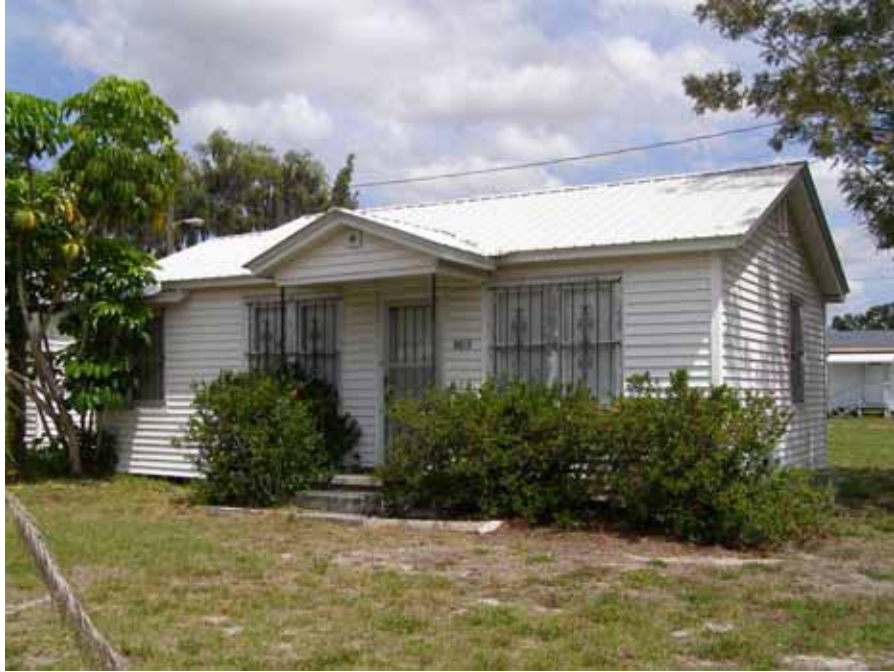
**Photo 6.21.** Church of God Campground residence (8HI10269), south and east elevations.

**8HI10269:** The Frame Vernacular style residence at 5434 SR 674 was constructed ca. 1950 and is part of the Wimauma Church of God Campground Resource Group. The clapboard covered wood frame walls are supported by a concrete block pier foundation. They are topped with a gable roof covered in 3-V crimp. There are two porches on this residence, one incised on the north elevation, and an open porch on the south elevation with a gable roof. The south porch also contains the main entrance, a wood swing door. Windows are one-light over one-light single hung sash with window grills. An addition was built on the west elevation during the 1970s. This is a typical example of a Frame Vernacular style building found throughout Hillsborough County. In addition, the west addition has compromised its architectural integrity. Therefore, 8HI10269 is not considered potentially eligible for listing in the NRHP.

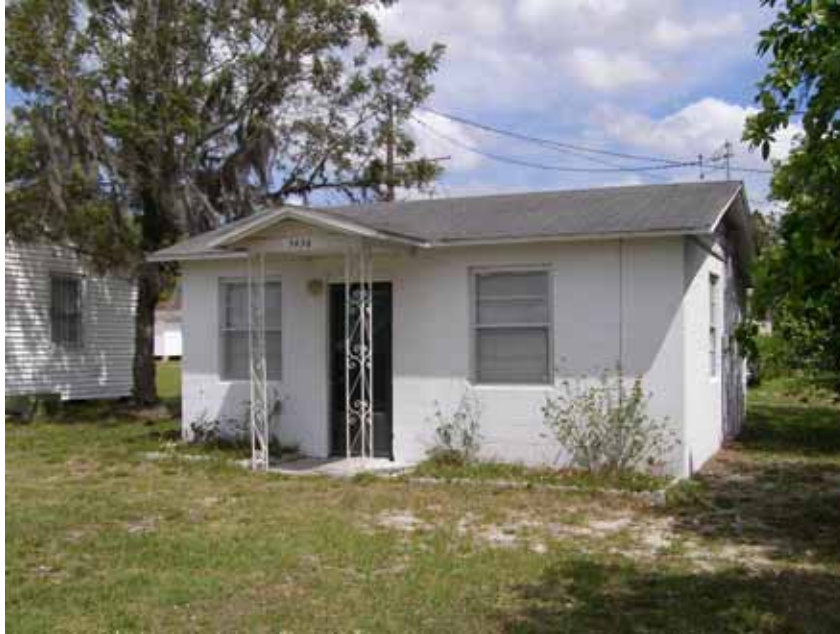
**Photo 6.22.** Church of God Campground residence (8HI10270), north and east elevations.

**8HI10270:** 5436 SR 674 is a residence built in the Masonry Vernacular style ca. 1950 and is part of the Wimauma Church of God Campground Resource Group. The concrete block walls rest on a poured concrete slab foundation. The gable roof is covered in composition shingles. Windows are two-light over two-light single hung sash. An open porch is located on the south elevation, and contains the main entrance, a three-panel wood swing door. Decorative features include scroll porch posts. This is a typical example of a Masonry Vernacular style building found throughout Hillsborough County. Therefore, 8HI10270 is not considered potentially eligible for listing in the NRHP.

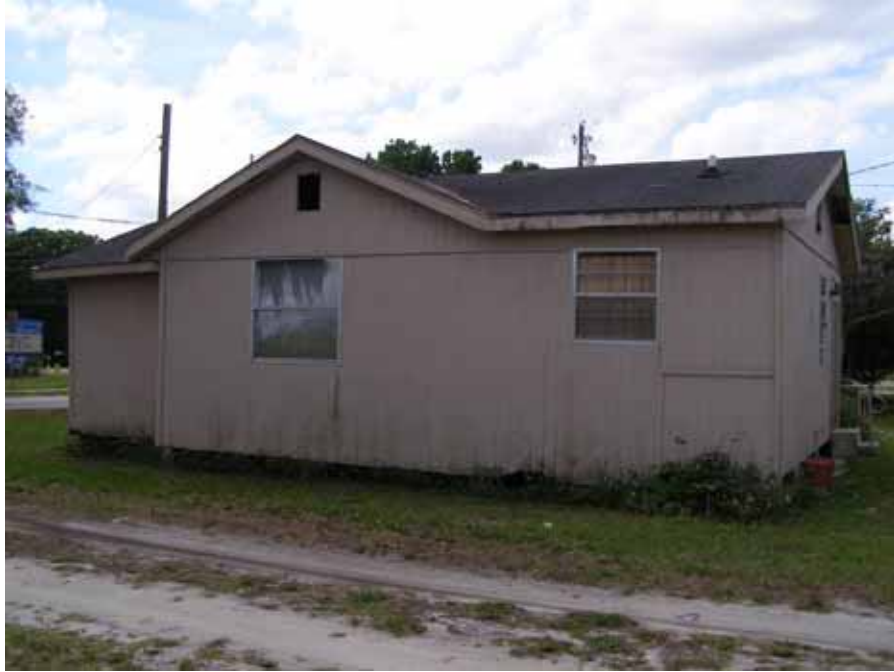
**Photo 6.23.** Church of God Campground residence (8HI10271), north and west elevations.

**8HI10271:** The residence at 5433 East Gene Rice Avenue was built ca. 1950 in the Frame Vernacular style and is part of the Wimauma Church of God Campground Resource Group. Its wood frame walls are clad in weatherboard and are topped with an intersecting gable roof faced in composition shingle. The windows consist of two-light over two-light single hung sash and one-light over one-light single hung sash. An open porch sits on the west elevation and contains the main entrance, a wood swing door. Other architectural features include gable vents. This is a typical example of a Frame Vernacular style building found throughout Hillsborough County. Therefore, 8HI10271 is not considered potentially eligible for listing in the NRHP.

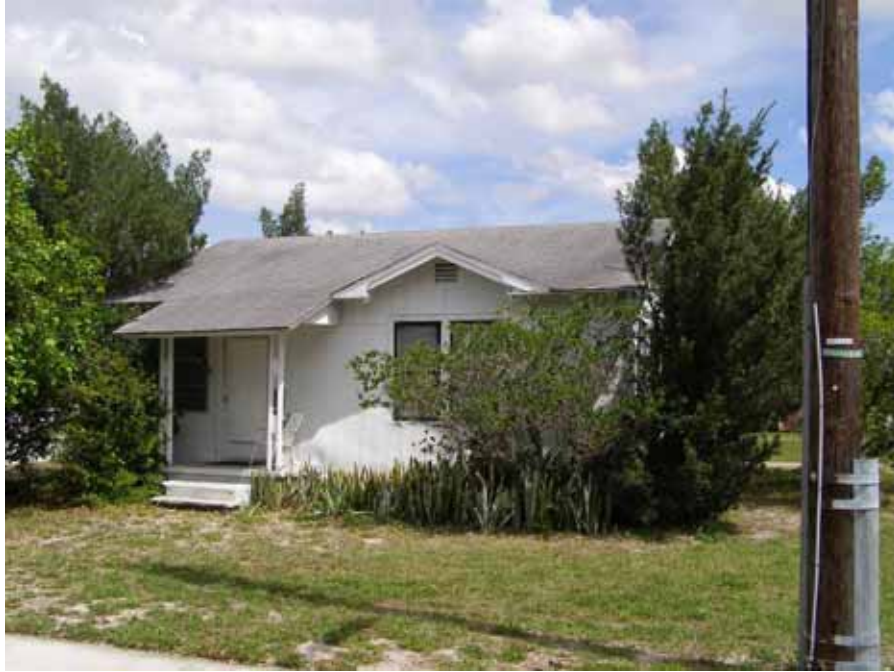
**Photo 6.24.** Church of God Campground residence (8HI10272), south elevation.

**8HI10272:** The Frame Vernacular style residence at 5438 SR 674 was constructed ca. 1950 and is part of the Wimauma Church of God Campground Resource Group. The concrete block pier foundation supports the wood frame walls that are clad in weatherboard. The gable and shed roof is covered in composition shingles. Windows are either three-light awning or one-light over one-light single hung sash. A wood swing door comprises the main entrance and is located on the south elevation via an open porch with a shed roof. Exterior ornament includes decorative porch posts and gable vents. This is a typical example of a Frame Vernacular style building found throughout Hillsborough County. Therefore, 8HI10272 is not considered potentially eligible for listing in the NRHP.

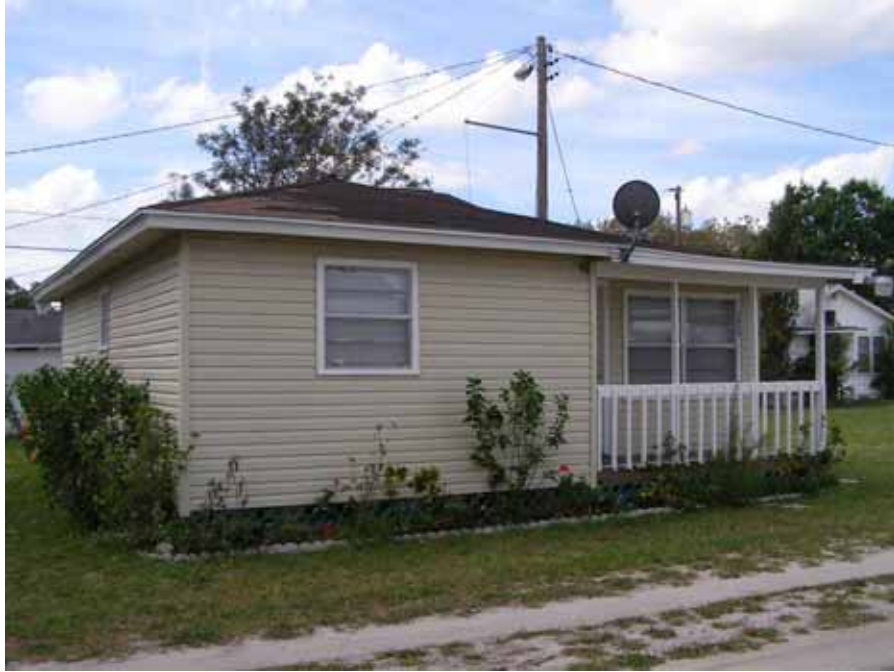
**Photo 6.25.** Church of God Campground residence (8HI10273), north and east elevations.

**8HI10273:** The Frame Vernacular style residence at 5435 East Gene Rice Avenue was built ca. 1950 and is part of the Wimauma Church of God Campground Resource Group. A concrete block pier foundation supports the wood frame walls that are clad in replacement vinyl siding. The clipped gable roof is covered in composition shingle. The windows consist of one-light over one-light single hung sash and two-light over two-light single hung sash. There are two wraparound open porches on this building, one around the southwest corner and one around the northwest corner, both with shed roofs. Other architectural features include wood railings and lattice work around the foundation. This is a typical example of a Frame Vernacular style building found throughout Hillsborough County. Therefore, 8HI10273 is not considered potentially eligible for listing in the NRHP.

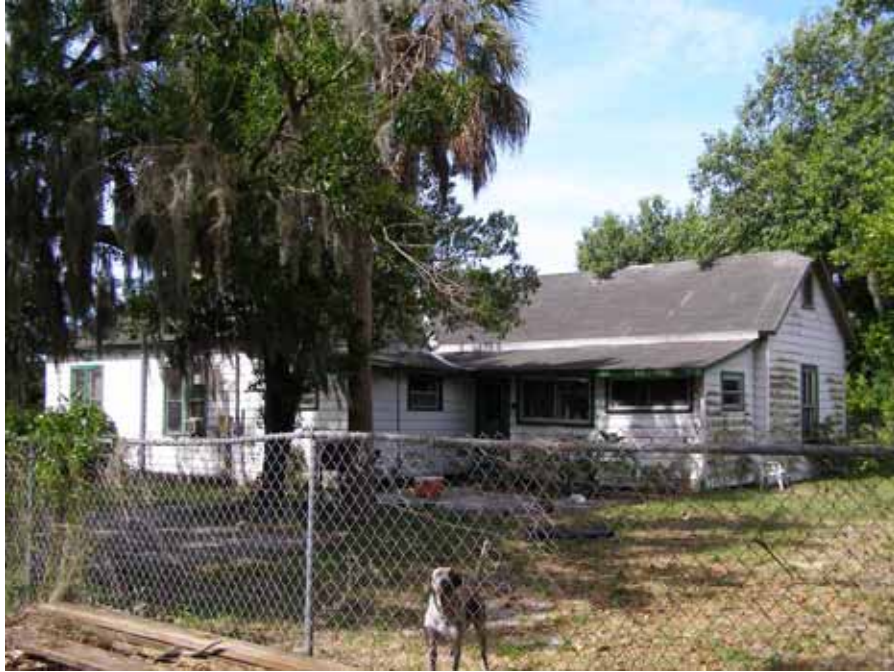
**Photo 6.26.** Residence at 5534 SR 674 (8HI10274), south and east elevation.

**8HI10274:** The Frame Vernacular style residence at 5534 SR 674 was constructed ca. 1930. Its wood frame walls are supported by a concrete block pier foundation and are clad in wood siding. The hip and gable roof is covered in composition shingle and has a masonry chimney on the east elevation. The windows are one-light over one-light single hung sash and jalousie. The main entrance, a nine-light wood swing door, is accessed via an open porch on the south elevation. Other architecture features include turned porch columns, fixed window shutters, wood window surrounds, gable vents, and a lattice wall on the porch. Ancillary features include a detached garage to the north. This is a typical example of a Frame Vernacular style building found throughout Hillsborough County and research revealed no significant historical associations. Therefore, 8HI10274 is not considered potentially eligible for listing in the NRHP.

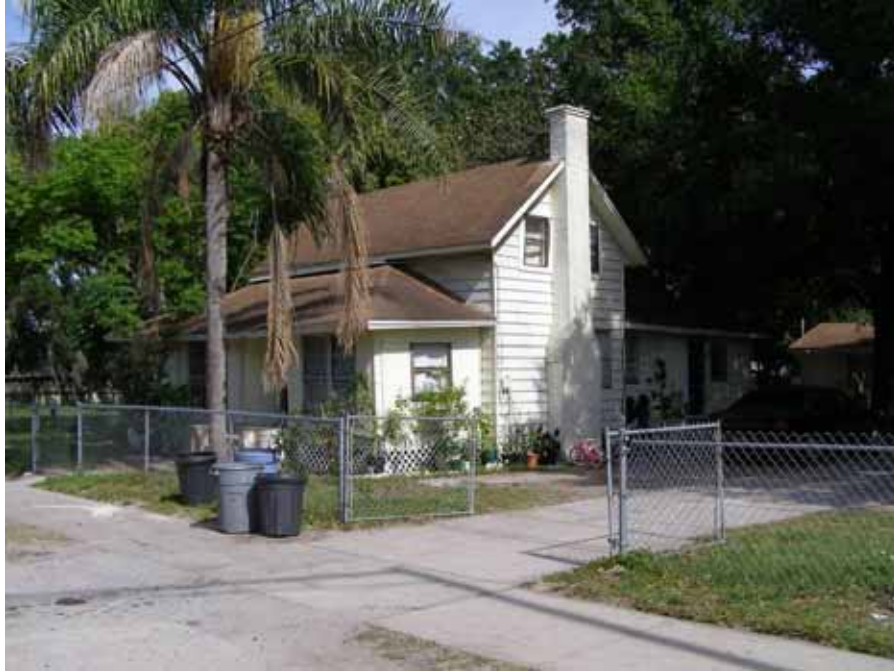
**Photo 6.27.** Residence at 5624 SR 674 (8HI10275), south and east elevations.

**8HI10275:** The residence at 5624 SR 674 was built ca. 1940 in the Frame Vernacular style. The wood frame walls, clad in wood siding, are supported by a concrete block pier foundation. The gable and shed roof is covered in composition shingles. On the south elevation is an enclosed porch with a hip roof that contains the main entrance, a 15-light wood swing door. Also on this porch are engaged classical style columns. One masonry chimney is located on the east elevation. Windows consist of eight-light casement, two-light over one-light double hung sash, and six-light over six-light double hung sash. Other architectural features include wood window surrounds. Ancillary features include a detached garage/studio to the north. This is a typical example of a Frame Vernacular style building found throughout Hillsborough County, and research revealed no significant historical associations. Therefore, 8HI10275 is not considered potentially eligible for listing in the NRHP.

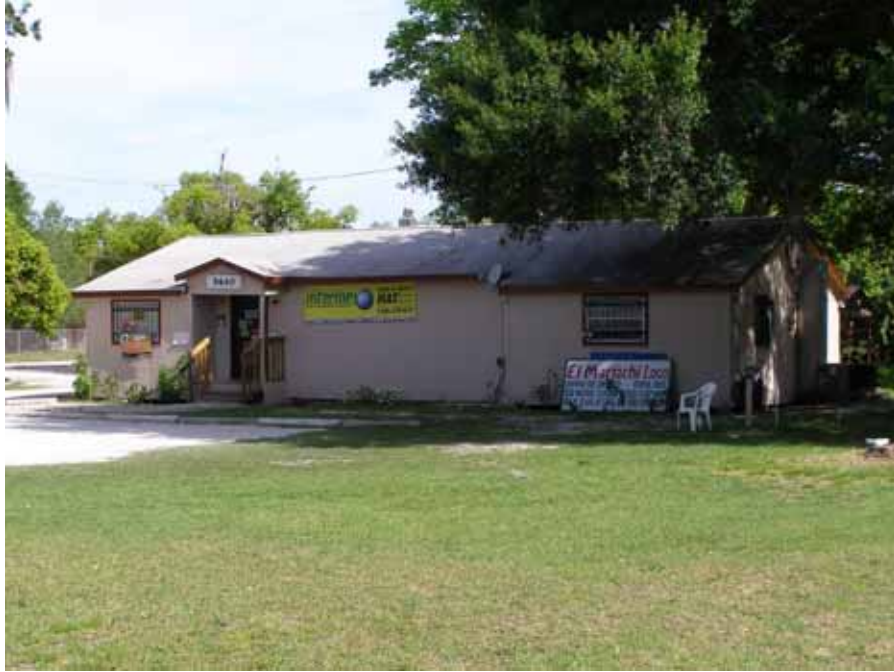
**Photo 6.28.** Residence at 5640 SR 674 (8HI10276), south and west elevation.

**8HI10276:** The residence at 5640 SR 674 is a Frame Vernacular style building constructed ca. 1951. The concrete block pier foundation supports the wood frame walls that are covered in stucco. Its gable roof is covered in composition shingles. The windows are one-light over one-light single hung sash with or without one-light over one-light single hung sash sidelights. One masonry chimney is located on the ridge. The main entrance, located on the south elevation, consists of a wood swing door and is accessed via an open porch with a gable roof. Other architectural features include wood window surrounds and window grills. Ancillary features include a shed to the east. This is a typical example of a Masonry Vernacular style building found throughout Hillsborough County, and research revealed no significant historical associations. Therefore, 8HI10276 is not considered potentially eligible for listing in the NRHP.

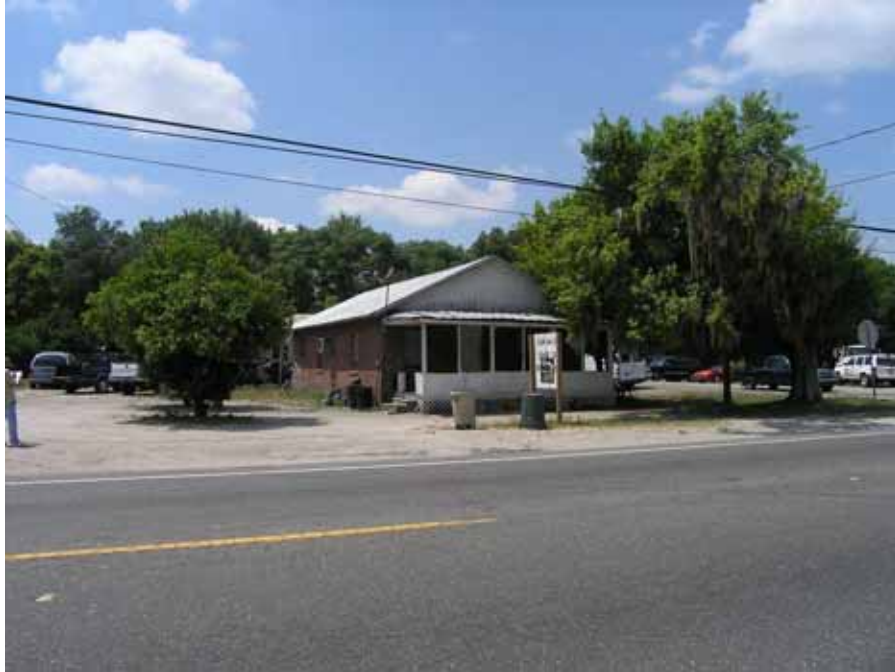
**Photo 6.29.** Residence at 5641 SR 674 (8HI10277), north and east elevation.

**8HI10277:** The residence at 5641 SR 674 was constructed ca. 1950 in the Masonry Vernacular style. The brick walls rest on a slab foundation and are topped with a gable roof covered in 3-V crimp metal sheeting. There are two porches on this building, one open porch on the north elevation with a shed roof, and a closed porch on the south elevation with a shed roof. Windows consist of two-light over two-light single hung sash and have brick window sills. This is a typical example of a Masonry Vernacular style building found throughout Hillsborough County and research revealed no significant historical associations. Therefore, 8HI10277 is not considered potentially eligible for listing in the NRHP.

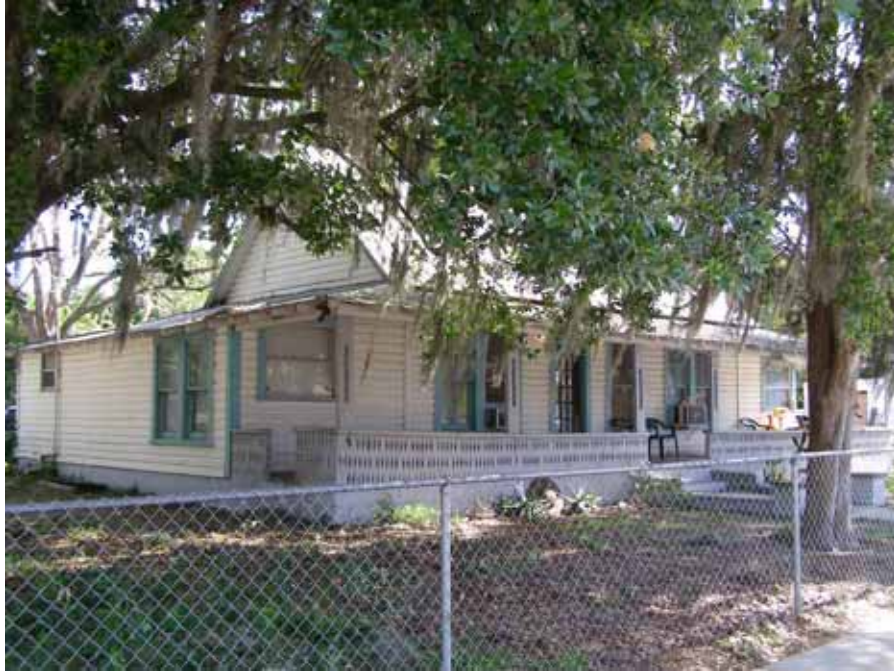
**Photo 6.30.** Residence at 5702 SR 674 (8HI10278), south and west elevations.

**8HI10278:** The residence at 5702 SR 674 was constructed in the Frame Vernacular style ca. 1915. A pier and continuous concrete block foundation support the wood frame walls that are clad in wood siding. The gable roof is covered in 5-V crimp metal sheeting. Replacement windows include one-light over one-light single hung sash and two-light over two-light single hung sash. The main entrance is located on the south elevation and consists of a fifteen-light wood swing door. It is accessed via a wraparound porch on the south and east elevations with pierced porch posts and a low pierced concrete block railing. Another enclosed wraparound porch with a shed roof is located on the north and east elevations. Other architectural features include gable vents, wood window surrounds, and wood door surrounds. Ancillary buildings include a smokehouse to the west, a coop or stable to the north, and a shed to the northeast. This is a typical example of a Frame Vernacular style building constructed in the early twentieth century in Hillsborough County. Alterations including a replacement roof, replacement windows, and the enclosed porch compromise its architectural integrity, and research revealed no significant historical associations. Therefore, 8HI10278 is not considered potentially eligible for listing in the NRHP.

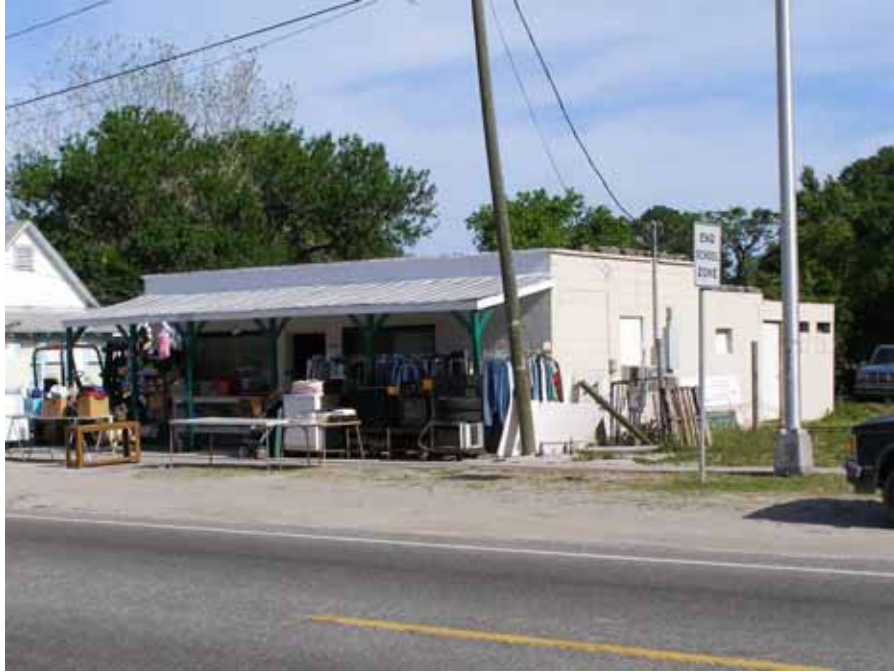
**Photo 6.31.** Commercial building at 5704 SR 674 (8HI10279), south and east elevations.

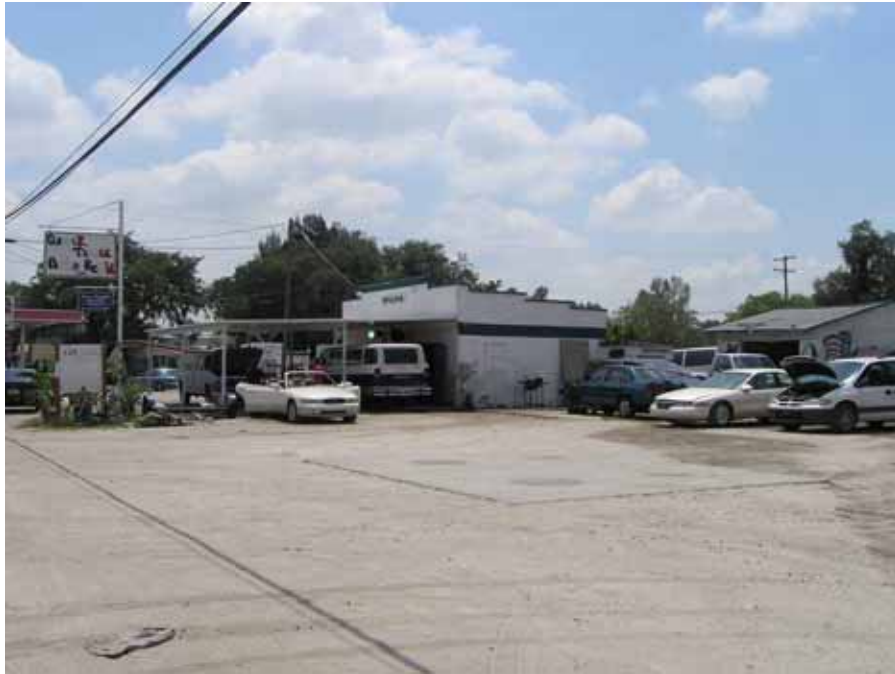
**Photo 6.32.** Commercial building at 5749 SR 674 (8HI10280), north and west elevations.

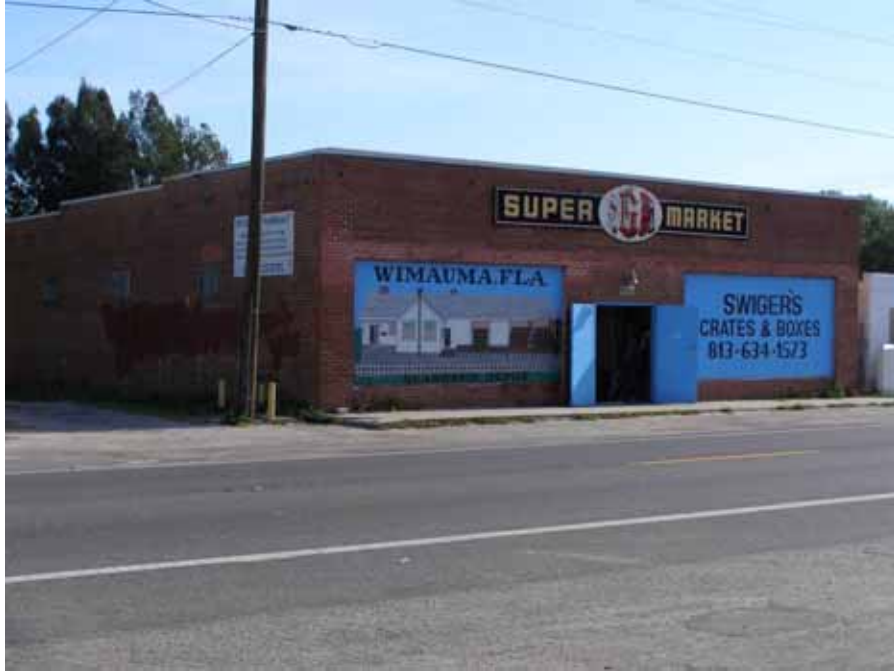
**Photo 6.33.** Commercial building at 5816 SR 674 (8HI10281), south and west elevations.

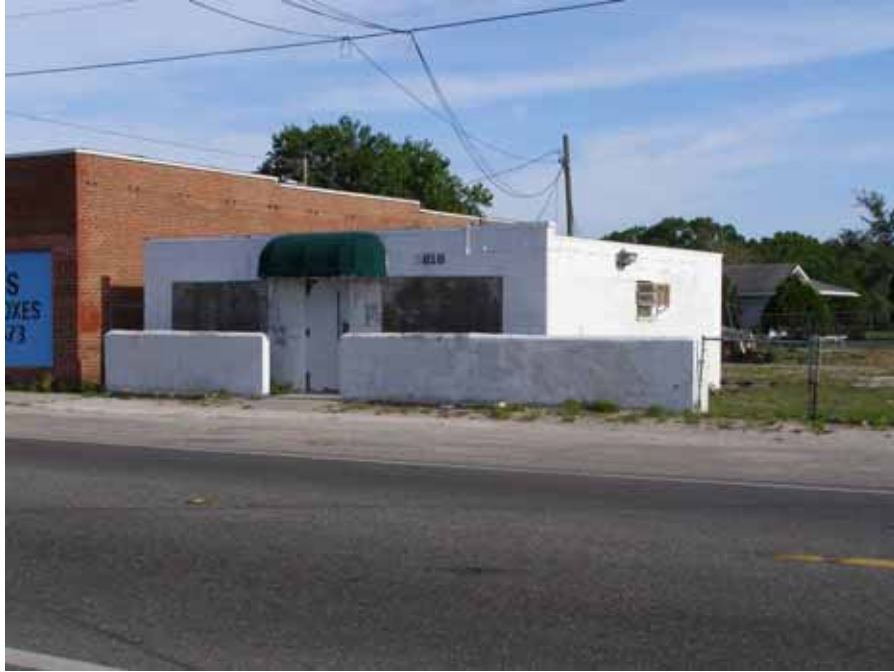
**Photo 6.34.** Commercial building at 5818 SR 674 (8HI10282), south and east elevations.

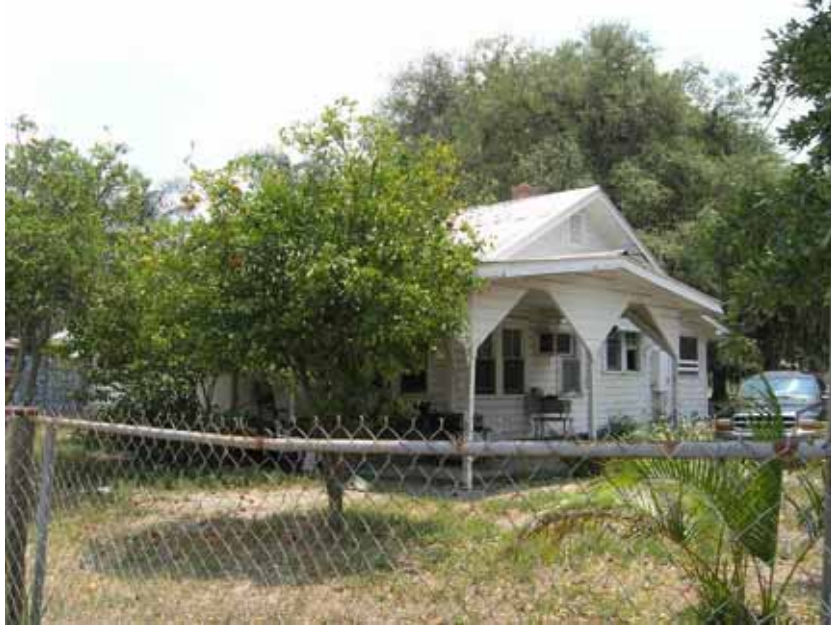
**Photo 6.35.** Residence at 5911 SR 674 (8HI10283), north and west elevations.

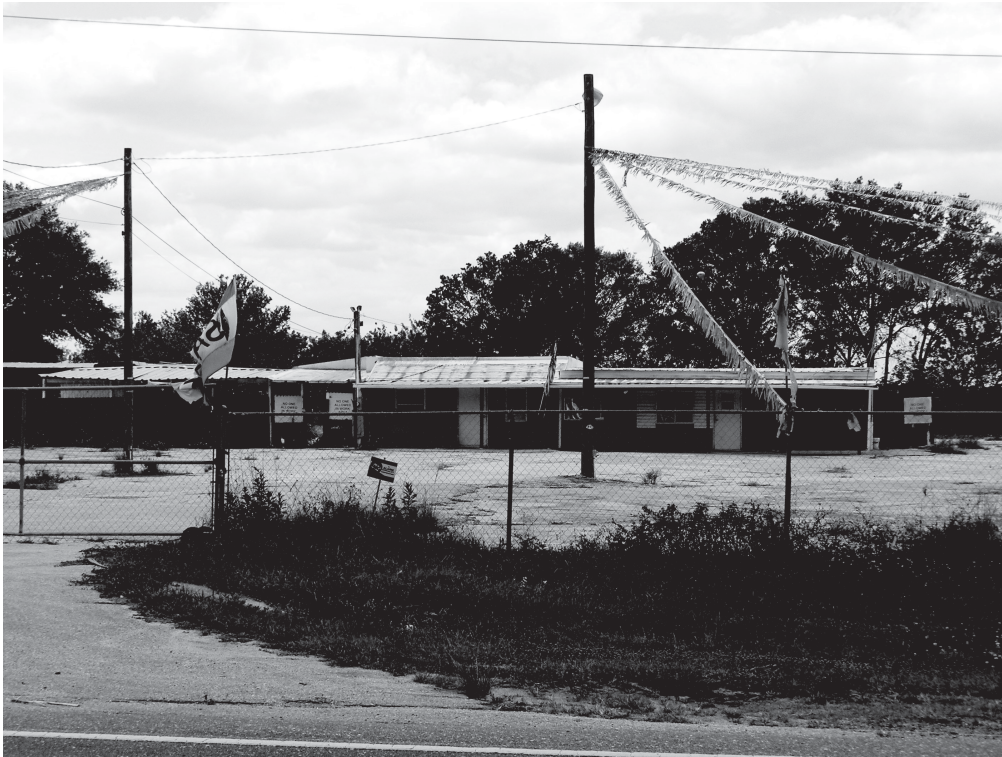
**PHOTOGRAPH**

Style Frame Vernacular Other Style \_\_\_\_\_  
Exterior Plan Irregular Other Exterior Plan \_\_\_\_\_  
Number of Stories 1  
Structural System(s) \_\_\_\_\_ >> Wood frame  
Other Structural System(s) \_\_\_\_\_  
Foundation Type(s) \_\_\_\_\_ >> Unknown  
Other Foundation Types \_\_\_\_\_  
Foundation Material(s) \_\_\_\_\_ >> Unspecified  
Other Foundation Material(s) \_\_\_\_\_  
Exterior Fabric(s) \_\_\_\_\_ >> Wood siding  
Other Exterior Fabric(s) \_\_\_\_\_  
Roof Type(s) \_\_\_\_\_ >> Gable  
Other Roof Type(s) \_\_\_\_\_  
Roof Material(s) \_\_\_\_\_ >> Sheet metal:5V crimp  
Other Roof Material(s) \_\_\_\_\_  
Roof Secondary Structure(s) (dormers etc) \_\_\_\_\_ >> \_\_\_\_\_  
Other Roof Secondary Structure(s) \_\_\_\_\_  
Number of Chimneys \_\_\_\_\_  
Chimney Material \_\_\_\_\_  
Other Chimney Material(s) \_\_\_\_\_  
Chimney Location(s) \_\_\_\_\_

Window Descriptions 1/1 SHS, metal, independent; 2-light slidingMain Entrance Description (stylistic details) wood swingPorches: #open 1 #closed        #incised        Location(s) NPorch Roof Types(s) shedExterior Ornament       Interior Plan UnknownOther Interior Plan       Condition Fair

- > **Foundation types:**  
Unknown
- > **Foundation materials:**  
Unspecified
- > **Exterior fabrics:**  
Wood siding
- > **Roof types:**  
Gable  
Shed
- > **Roof materials:**

Sheet metal:5V crimp
- > **Roof secondary structures (dormers etc):**
- > **Change status/year changed/date noted/nature:**
- > **Original, intermediate, present uses/year started/year ended:**  
Commercial unspecified;;

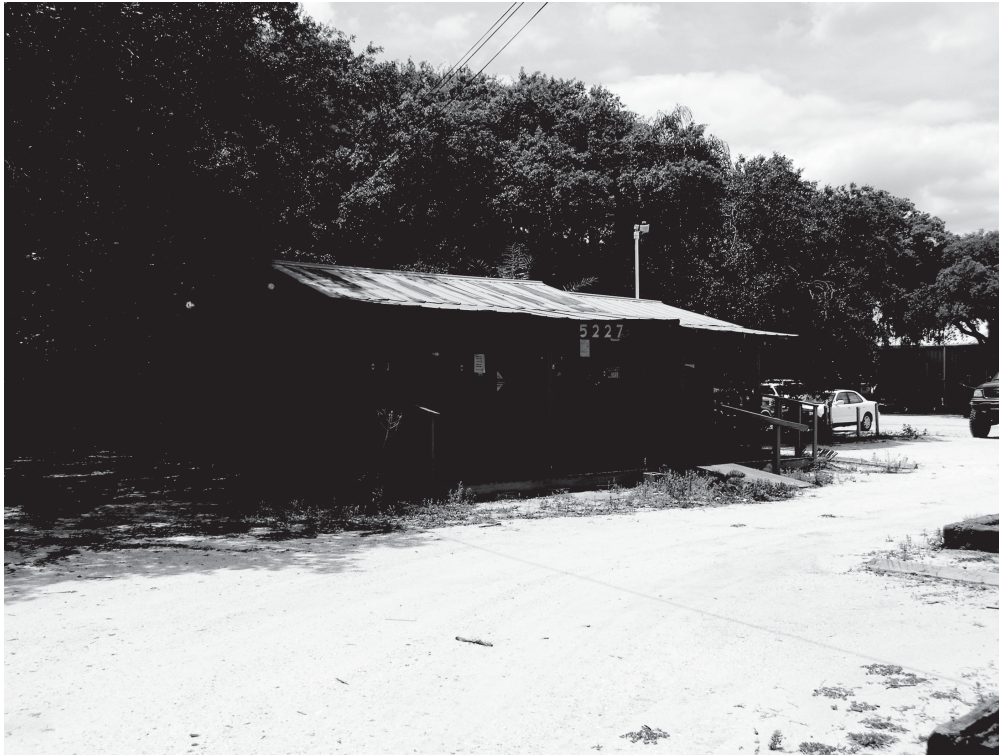
**PHOTOGRAPH**

Style Frame Vernacular Other Style \_\_\_\_\_  
Exterior Plan Irregular Other Exterior Plan \_\_\_\_\_  
Number of Stories 1  
Structural System(s) \_\_\_\_\_ >> Wood frame  
Other Structural System(s) \_\_\_\_\_  
Foundation Type(s) \_\_\_\_\_ >> Piers  
Other Foundation Types \_\_\_\_\_  
Foundation Material(s) \_\_\_\_\_ >> Concrete Block  
Other Foundation Material(s) \_\_\_\_\_  
Exterior Fabric(s) \_\_\_\_\_ >> Board and batten  
Other Exterior Fabric(s) \_\_\_\_\_  
Roof Type(s) \_\_\_\_\_ >> Gable  
Other Roof Type(s) \_\_\_\_\_  
Roof Material(s) \_\_\_\_\_ >> Sheet metal:5V crimp  
Other Roof Material(s) \_\_\_\_\_  
Roof Secondary Structure(s) (dormers etc) \_\_\_\_\_ >> \_\_\_\_\_  
Other Roof Secondary Structure(s) shed roofs over windows  
Number of Chimneys \_\_\_\_\_  
Chimney Material \_\_\_\_\_  
Other Chimney Material(s) \_\_\_\_\_  
Chimney Location(s) \_\_\_\_\_

Condition Fair

- > **Foundation types:**  
Piers
- > **Foundation materials:**  
Concrete Block
- > **Exterior fabrics:**  
Board and batten
- > **Roof types:**  
Gable
- > **Roof materials:**

Sheet metal:5V crimp
- > **Roof secondary structures (dormers etc):**
- > **Change status/year changed/date noted/nature:**
- > **Original, intermediate, present uses/year started/year ended:**  
Unknown;orig;  
Commercial unspecified;curr;

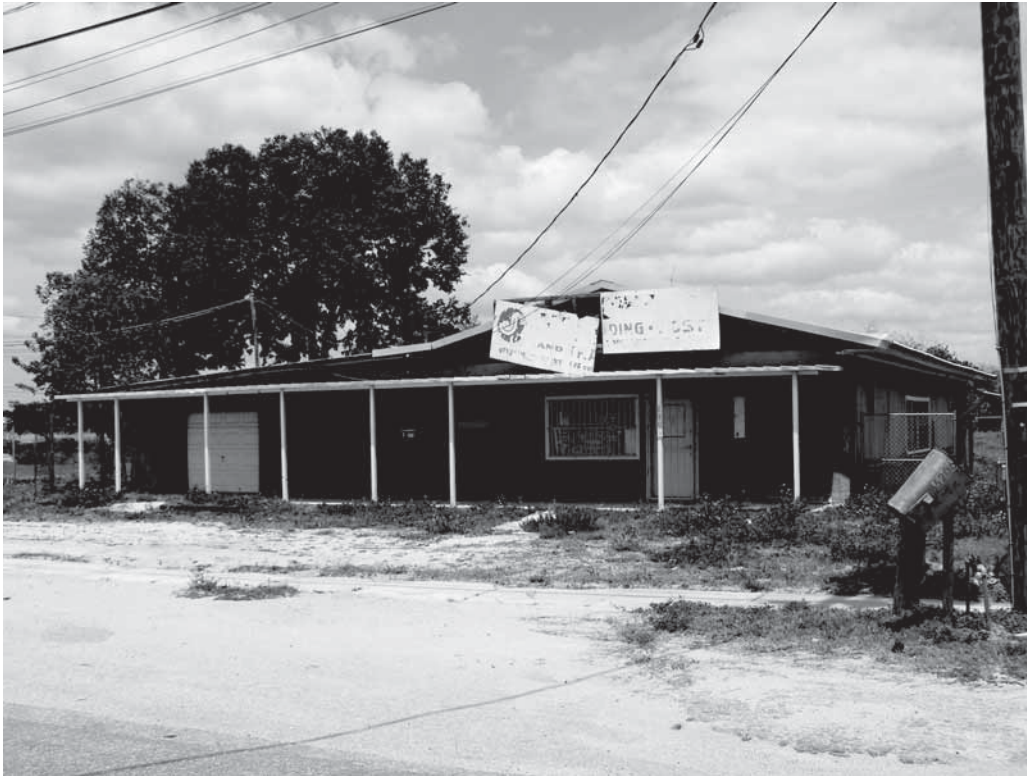
**PHOTOGRAPH**

Style \_\_\_\_\_ Other Style Frame Vernacular  
Exterior Plan Irregular Other Exterior Plan \_\_\_\_\_  
Number of Stories 1  
Structural System(s) \_\_\_\_\_ >> Wood frame  
Other Structural System(s) \_\_\_\_\_  
Foundation Type(s) \_\_\_\_\_ >> Slab  
Other Foundation Types \_\_\_\_\_  
Foundation Material(s) \_\_\_\_\_ >> \_\_\_\_\_  
Other Foundation Material(s) poured concrete  
Exterior Fabric(s) \_\_\_\_\_ >> Weatherboard  
Other Exterior Fabric(s) \_\_\_\_\_  
Roof Type(s) \_\_\_\_\_ >> Gable  
Other Roof Type(s) \_\_\_\_\_  
Roof Material(s) \_\_\_\_\_ >> Sheet metal: 5V crimp  
Other Roof Material(s) \_\_\_\_\_  
Roof Secondary Structure(s) (dormers etc) \_\_\_\_\_ >> \_\_\_\_\_  
Other Roof Secondary Structure(s) \_\_\_\_\_  
Number of Chimneys \_\_\_\_\_  
Chimney Material \_\_\_\_\_  
Other Chimney Material(s) \_\_\_\_\_  
Chimney Location(s) \_\_\_\_\_

- > **Foundation types:**  
Slab
- > **Foundation materials:**
- > **Exterior fabrics:**  
Weatherboard  
Metal
- > **Roof types:**  
Gable
- > **Roof materials:**

Sheet metal;5V crimp
- > **Roof secondary structures (dormers etc):**
- > **Change status/year changed/date noted/nature:**  
Addition;unk;;N add
- > **Original, intermediate, present uses/year started/year ended:**  
Unknown;orig;  
Vacant;curr;

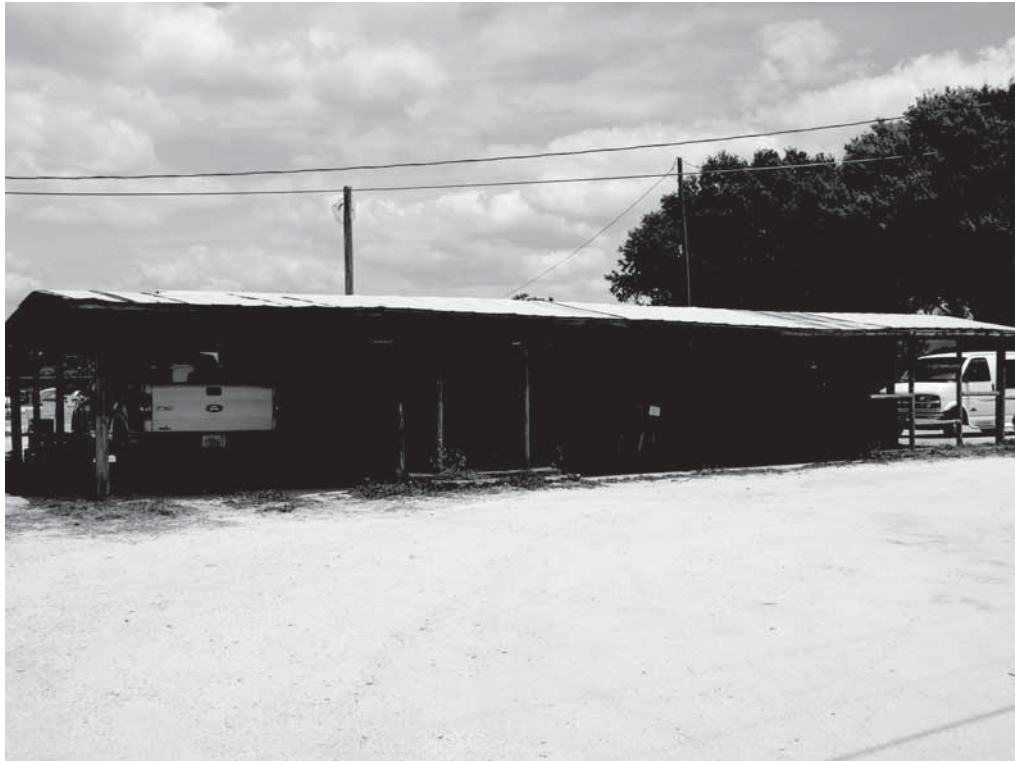
**PHOTOGRAPH**

- > **Foundation types:**  
Slab  
Piers
- > **Foundation materials:**  
Poured Concrete Footing  
Wood Blocks
- > **Exterior fabrics:**  
Weatherboard
- > **Roof types:**  
Gable

- > **Roof materials:**  
Sheet metal:5V crimp
- > **Roof secondary structures (dormers etc):**
- > **Change status/year changed/date noted/nature:**  
Addition;c1980;;north addition

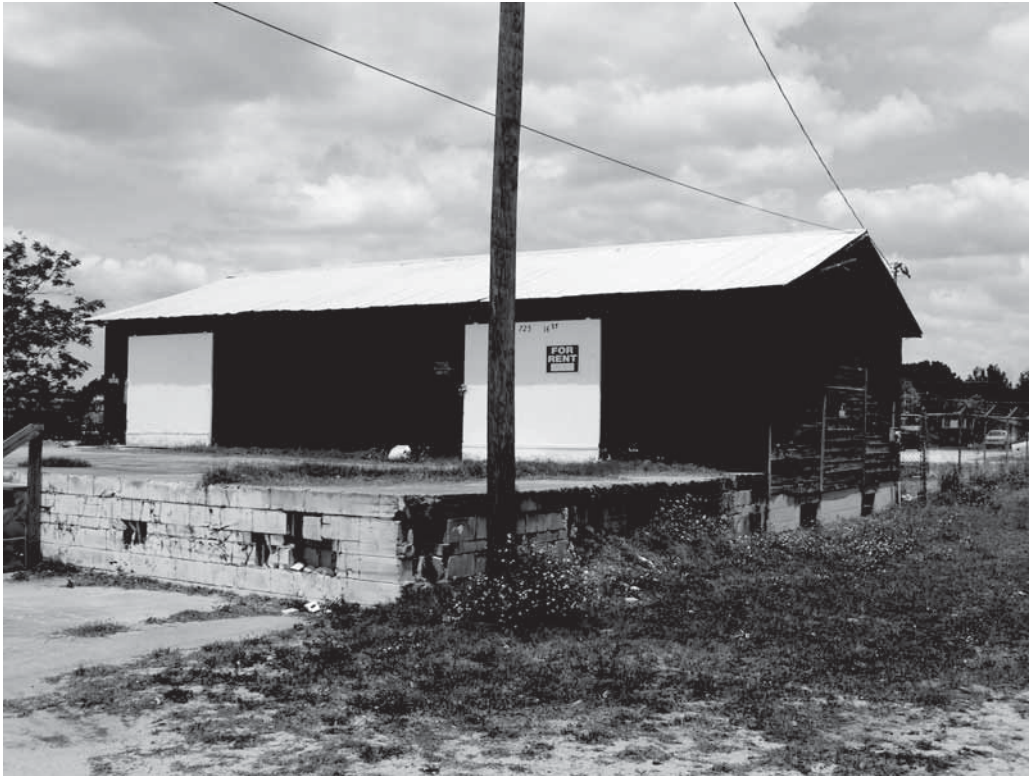
**PHOTOGRAPH**

- > **Foundation types:**  
Continuous
- > **Foundation materials:**  
Concrete Block
- > **Exterior fabrics:**  
Wood siding
- > **Roof types:**  
Gable
- > **Roof materials:**

Sheet metal:5V crimp
- > **Roof secondary structures (dormers etc):**
- > **Change status/year changed/date noted/nature:**
- > **Original, intermediate, present uses/year started/year ended:**  
Unknown;orig;  
Vacant;curr;

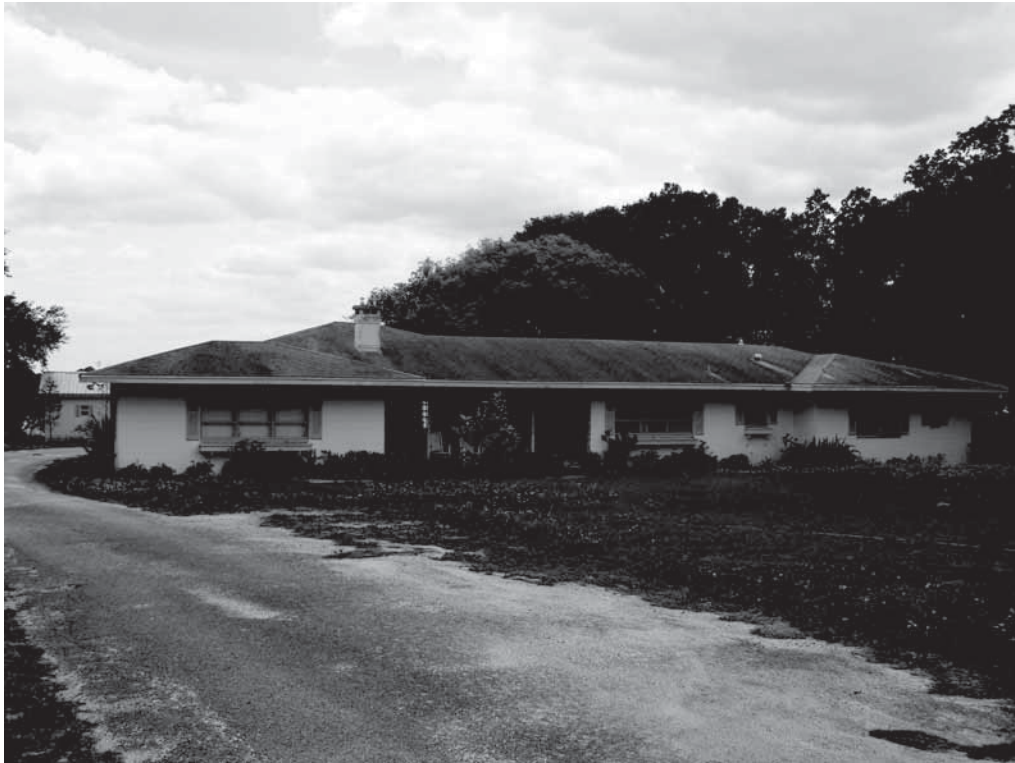
**PHOTOGRAPH**

Condition Good

- > **Foundation types:**  
Slab
- > **Foundation materials:**
- > **Exterior fabrics:**  
Block-concrete  
Artif masonry veneer
- > **Roof types:**  
Hip on hip

- > **Roof materials:**  
Composition shingles
- > **Roof secondary structures (dormers etc):**
- > **Change status/year changed/date noted/nature:**
- > **Original, intermediate, present uses/year started/year ended:**  
Residence--private;orig;  
Residence--private;curr;
