**CULTURAL RESOURCES ASSESSMENT SURVEY  
UPDATE**

**TECHNICAL MEMORANDUM**

**FOR SR 679 (PINELLAS BAYWAY STRUCTURE E)  
AT INTRACOASTAL WATERWAY  
(BRIDGE NO. 150049)  
PINELLAS COUNTY, FLORIDA**

**FPID NO.: 410755-2-52-01  
FEDERAL AID PROJECT NO.: TBD**

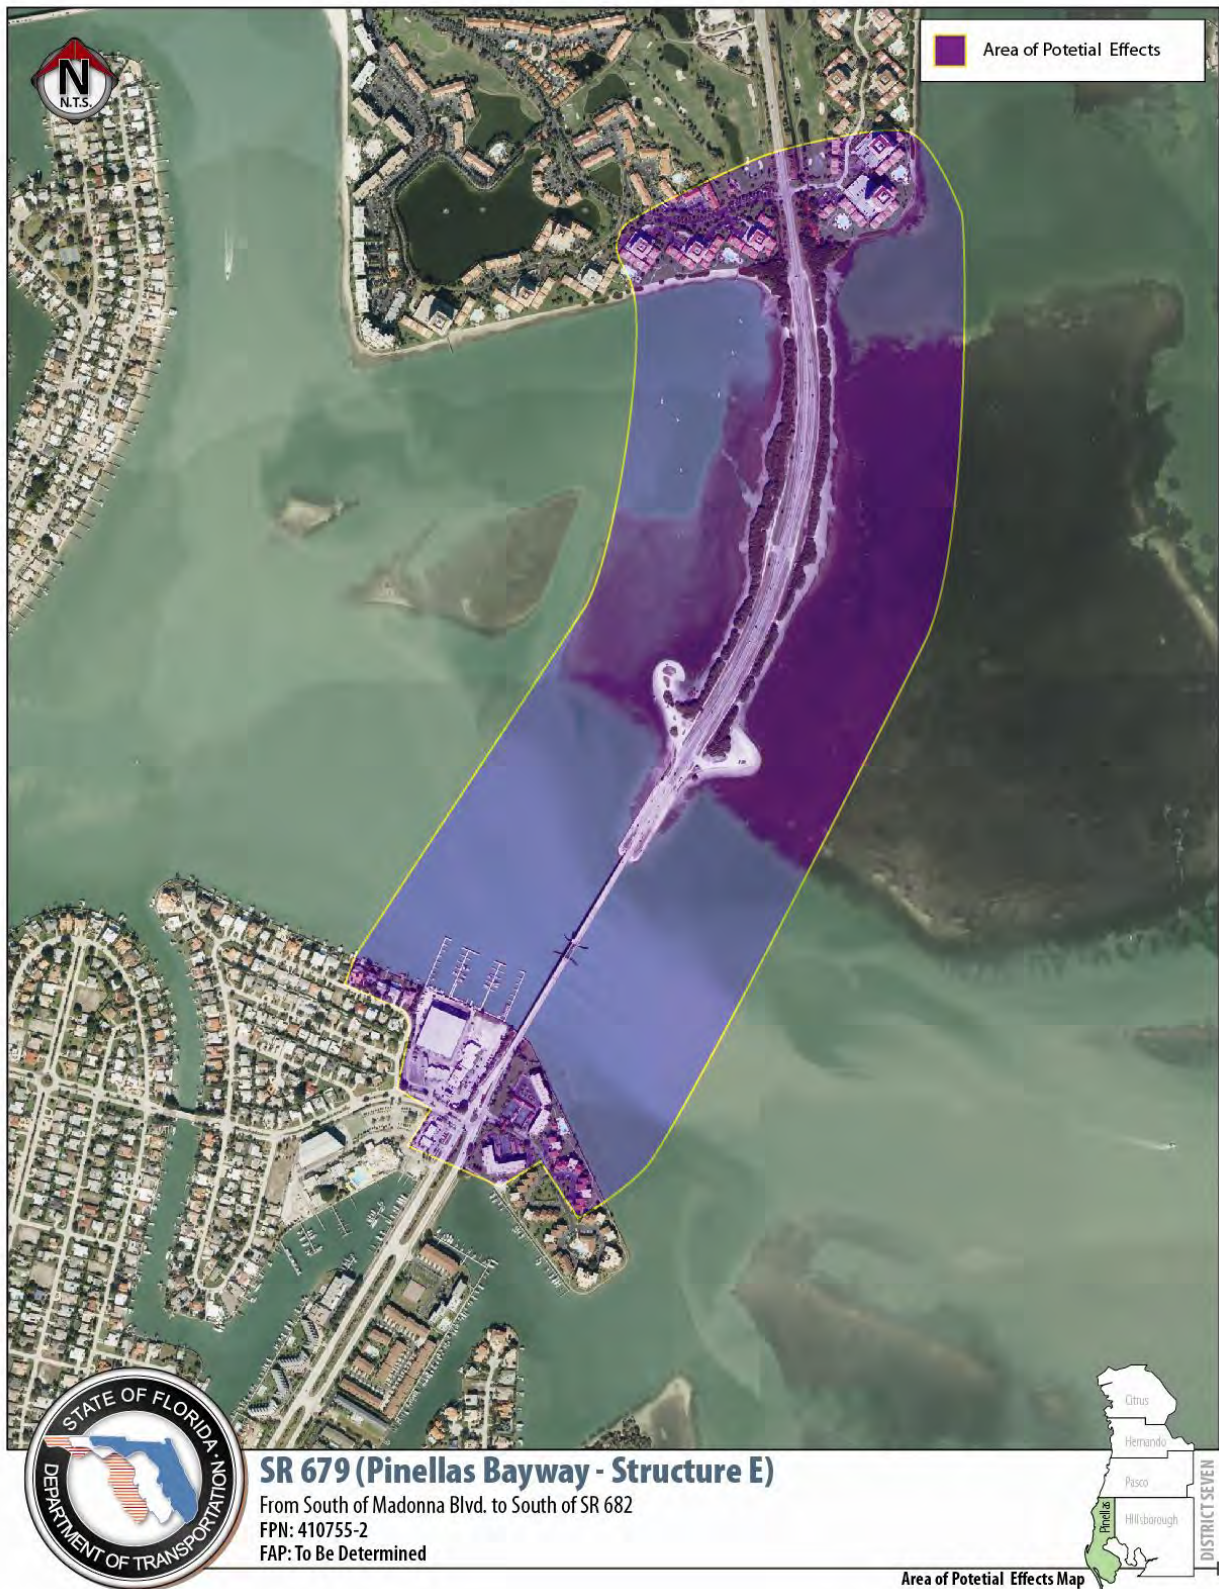
**Figure 1-3: Project Area of Potential Effect (APE)**

As a result of the PD&E Study, the recommended alternative was the high-level fixed bridge over the existing channel. The 400 ft wide APE for the historical/architectural survey still appears to be adequate to include potential visual effects; however, to be conservative, the current CRAS Update included a review of the Pinellas County property appraiser's website database to check for historic structures within a 1,000 ft wide APE from the center line of the existing bridge as shown in **Figure 1-3**.

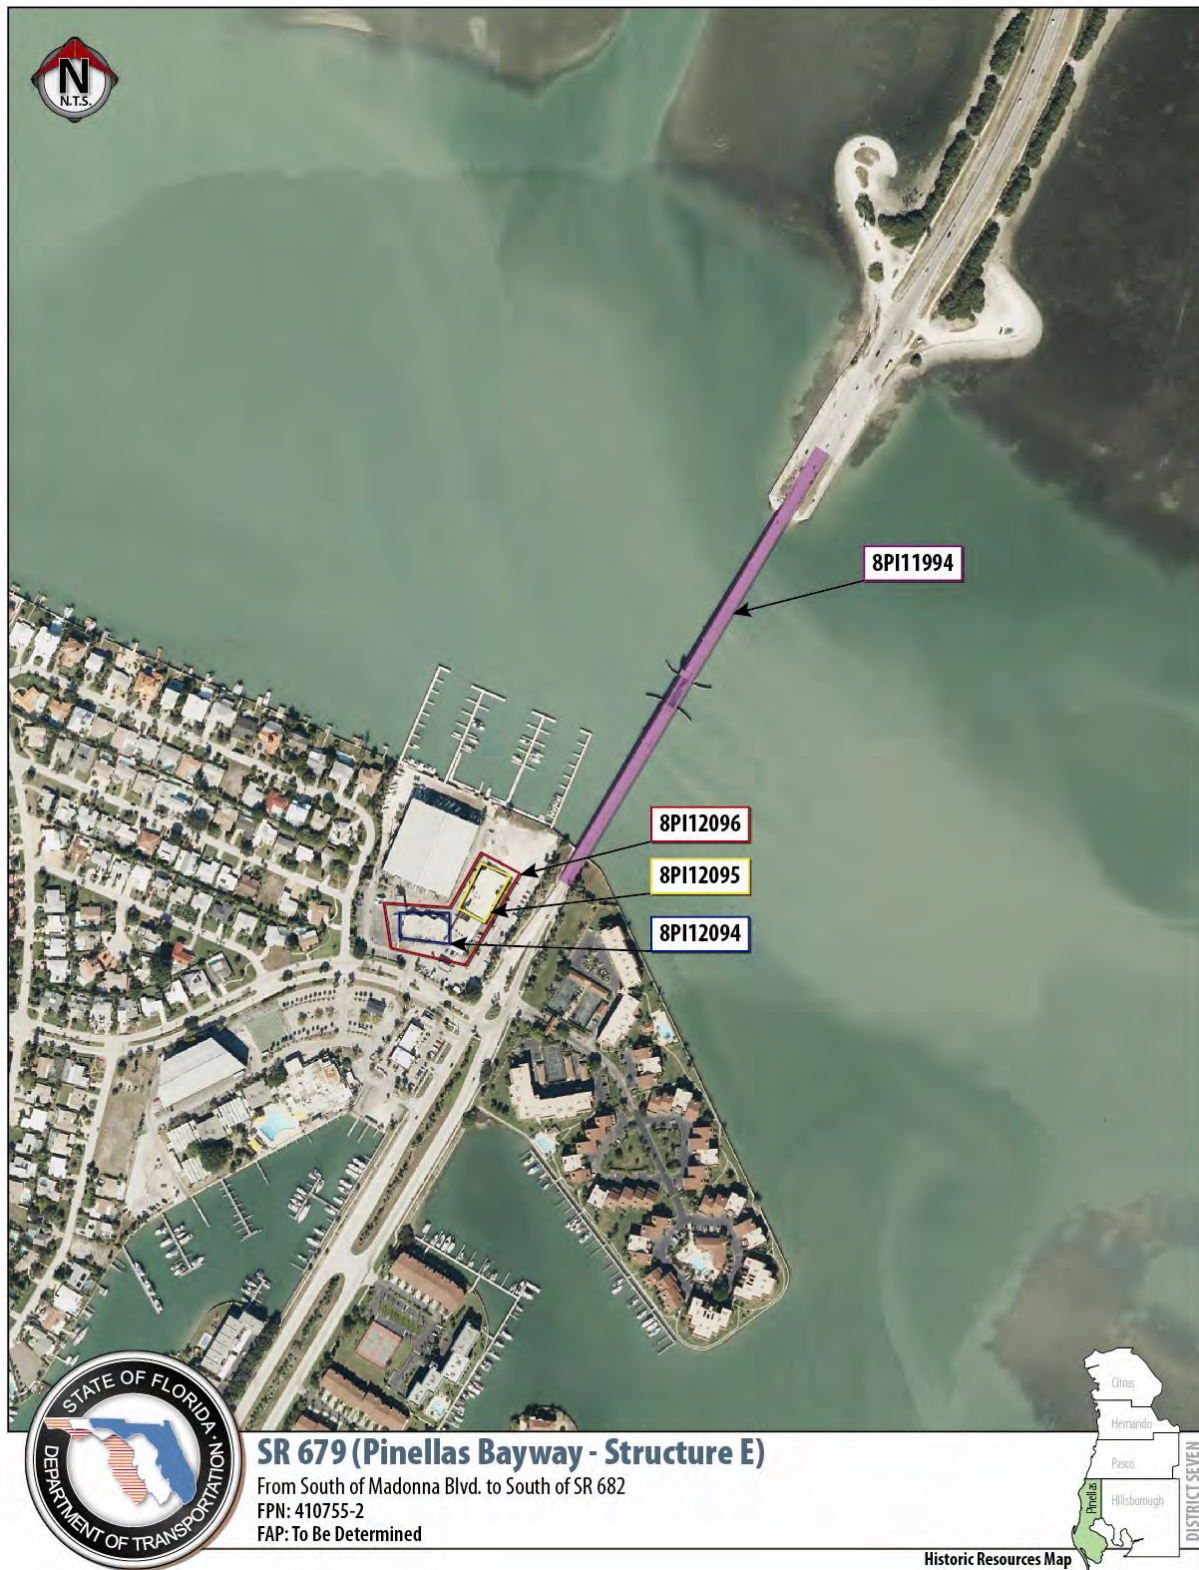
**Figure 5-1: Historic Resources Map**

Four historic resources were located and evaluated as a result of this assessment (**Table 5-1**). **Figure 5-1** shows the locations of the historic resources. The construction dates for the buildings were obtained from the Pinellas County Property Appraiser's website. Based on the results, the newly recorded resources, 1960s commercial buildings, do not appear to represent significant resources and the previously recorded bridge has been determined not NRHP-eligible by the SHPO. FMSF forms are included in **Appendix D**.

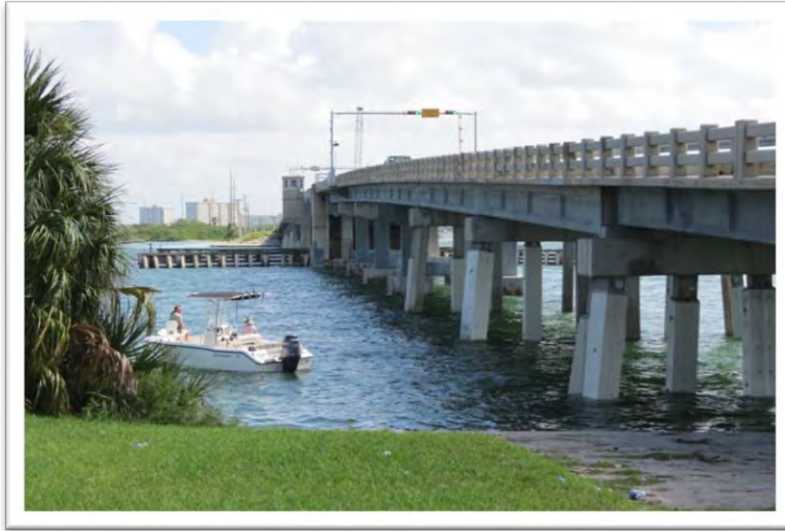
SR 679 (Bayway Structure E), also known as the Tierra Verde Bridge, was built in 1961 to connect the islands of Tierra Verde and Fort DeSoto to the mainland (Photo 5-1). This is a two-lane low-level double-leaf bascule structure that provides a 90- ft horizontal clearance between fenders and a 21.5 ft vertical navigational clearance (when closed) over the Intracoastal Waterway. It is a standard bascule bridge constructed of materials commonly associated with this bridge type. There does not appear to be any unique architectural or engineering features and research did not reveal any significant historic associations. It was not considered eligible for NRHP-listing by the SHPO in September 2011 (See letter in **Appendix B**). This bridge has also recently been evaluated as not NRHP-eligible as part of the FDOT Historic Highway Bridges of Florida Survey (ACI 2012). The original FMSF form prepared in 2011 is included in **Appendix D**. Although the bridge was repaired in 2012, there are no noticeable changes that would require a FMSF Update form.

Photo 5-1: – SR 679 (Bayway Structure E)/Tierra Verde Bridge/Bridge No. 150049 (PI11994), looking north from Tierra Verde along west side of bridge

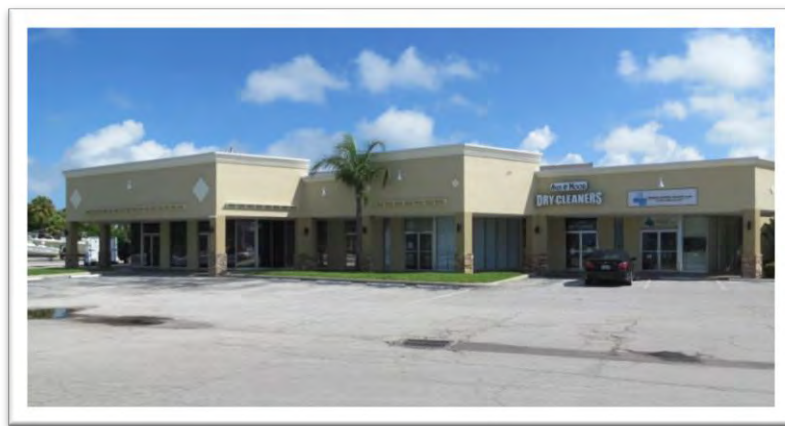
This shopping center building (Photo 5-2) was constructed in 1963 and features concrete slab foundation, concrete walls covered in stucco and a flat roof beyond the concrete parapet. The doors and windows are fixed glass in metal storefront frames. Current details include stone veneer at the columns supporting the covered walkway and decorative elements at the parapet. A 1970 aerial (PALMM 1970) depicts a building at this location but the shape appears to have been different. The original layout for the shopping center complex appears to have been a collection of hexagonal or octagonal shapes joined together. Based on the property appraiser's record and a review of other aerials, this building has been altered through the years (in shape and exterior materials), most recently within the past few years. The alterations have been so great that it does not retain its historic integrity. Due to the alterations and the typical commercial shopping center design and construction, this building does not appear to be NRHP-eligible.

Photo 5-2: – 128 Pinellas Bayway (Building A) (PI12094), looking northwest

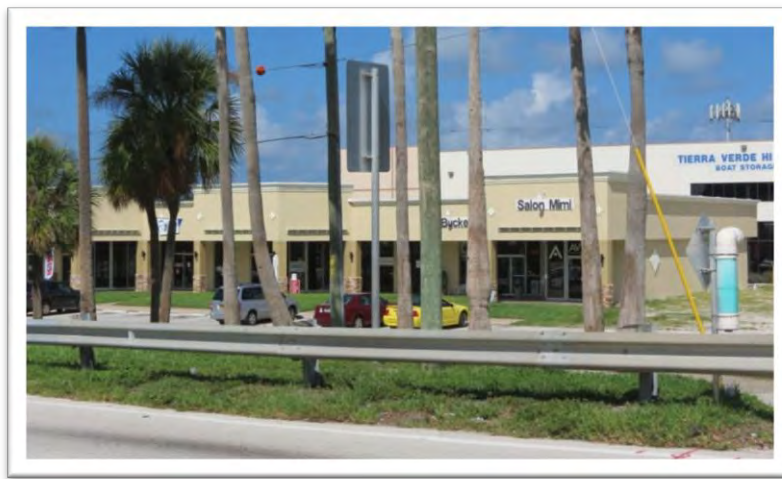
This shopping center building (Photo 5-3) was constructed in 1963 and features concrete slab foundation, concrete walls covered in stucco and a flat roof beyond the concrete parapet. The doors and windows are fixed glass in metal storefront frames. Current details include stone veneer at the columns supporting the covered walkway and decorative elements at the parapet. A 1970 aerial (PALMM 1970) depicts a building at this location but the shape appears to have been different. The original layout for the shopping center complex appears to have been a collection of hexagonal or octagonal shapes joined together. Based on the property appraiser's record and a review of other aerials, this building has been altered through the years (in shape and exterior materials), most recently within the past few years. The alterations have been so great that it does not retain its historic integrity. Due to the alterations and the typical commercial shopping center design and construction, this building does not appear to be NRHP-eligible.

Photo 5-3: – 128 Pinellas Bayway (Building B) (PI12095), looking southwest

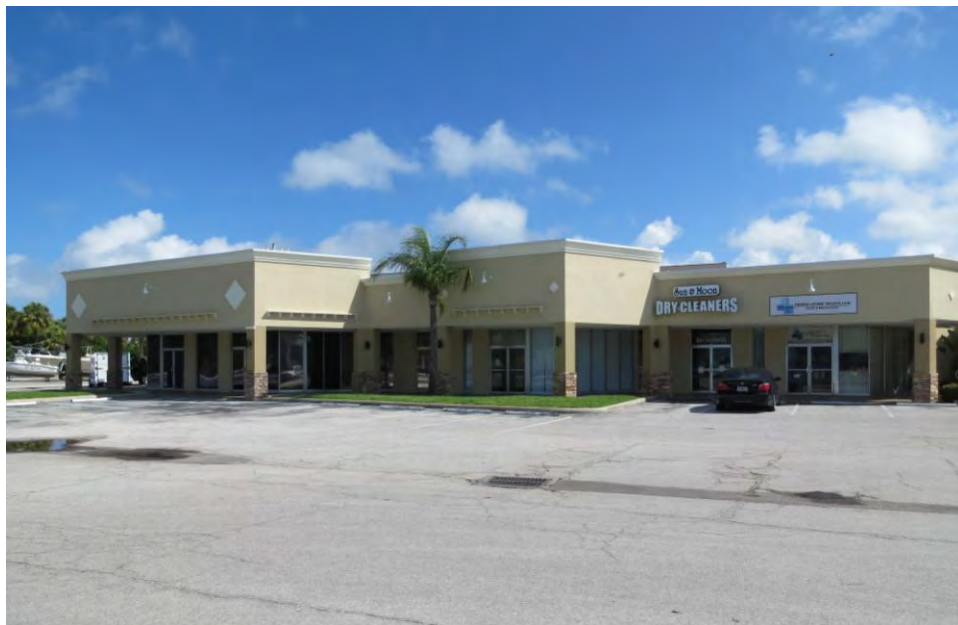
**128 Pinellas Bayway – Building A**

Looking North

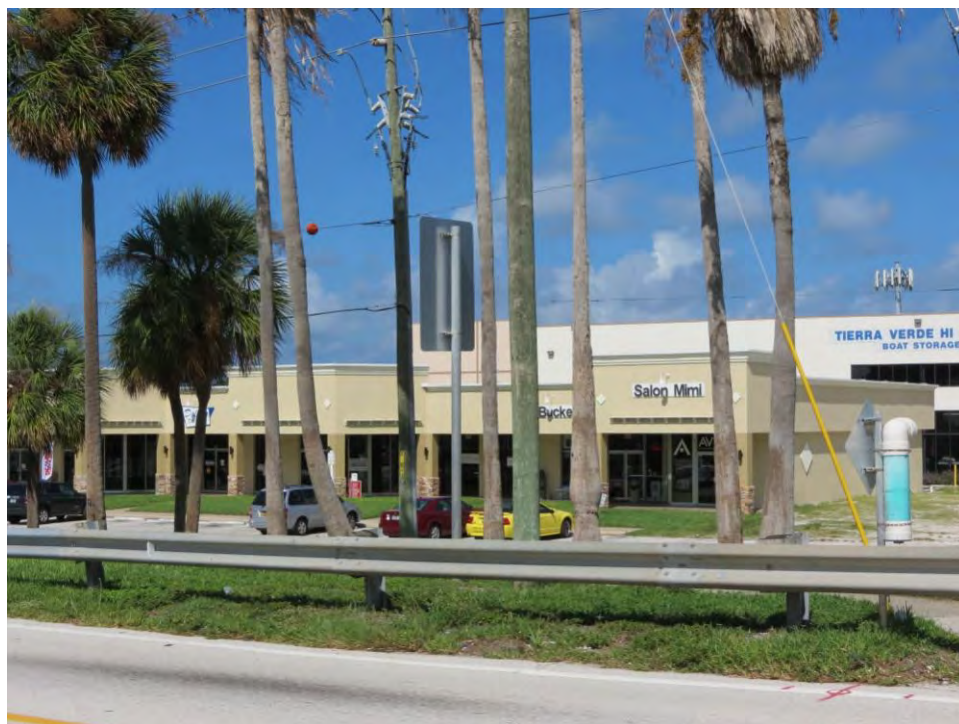
**128 Pinellas Bayway – Building B**

Looking Southwest
