**UPDATED LEVEL I HAZARDOUS MATERIAL AND
CONTAMINATION INVESTIGATION**
*for State Road 679 (Pinellas Bayway) Over Boca Ciega Bay,
from Yacht Club Lane to Bahia Del Mar Boulevard,
Pinellas County, Florida*

Financial Project Number: 410755-1-C2-01

August 19, 2009

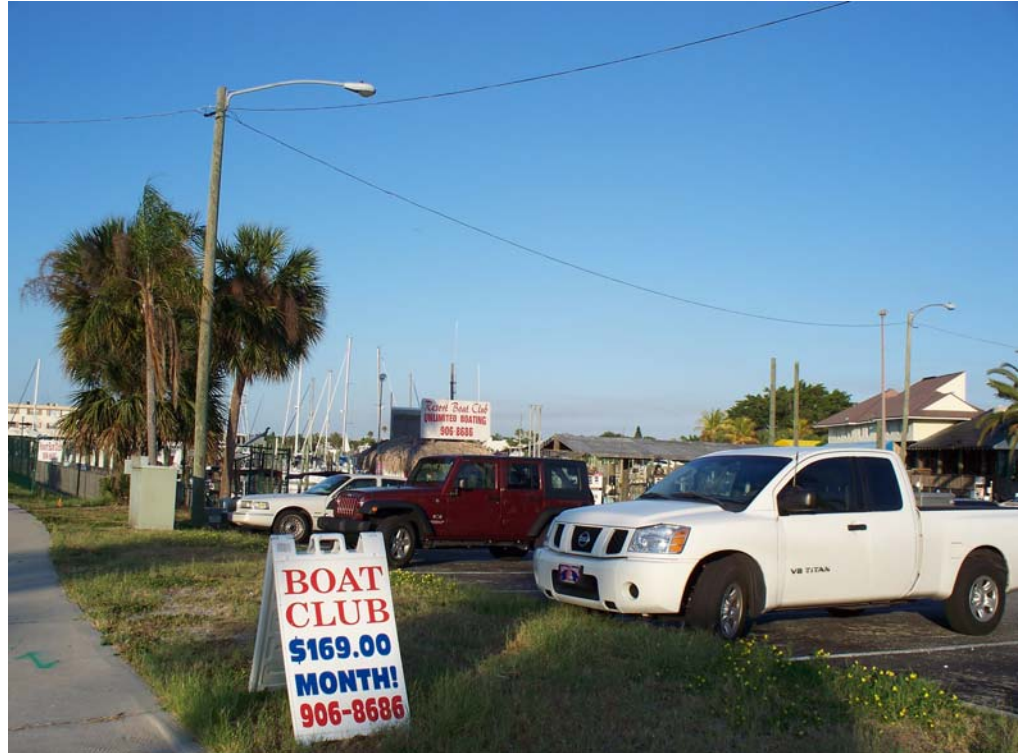
1

Site 1: A and S Tierra Verde Ventures, LLC, Tierra Verde Resort & Marina, 200 Madonna Blvd.

View of site and portion of western SR 679 ROW.

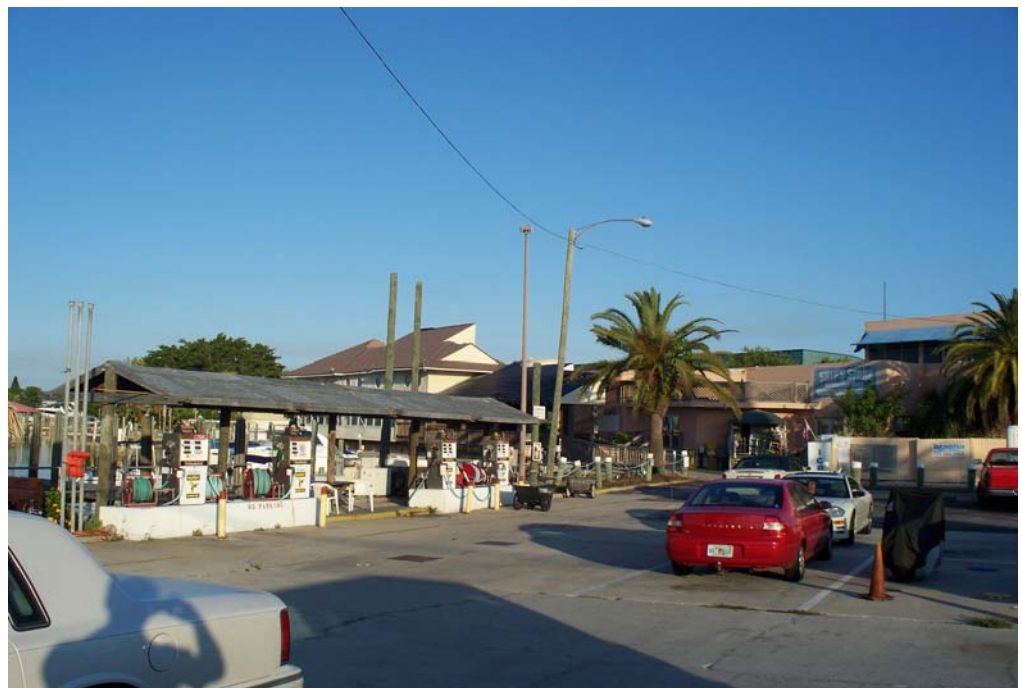
2

Site 1: A and S Tierra Verde Ventures, LLC, Tierra Verde Resort & Marina, 200 Madonna Blvd.

View of UST area and marina fueling facility from western SR 679 ROW.

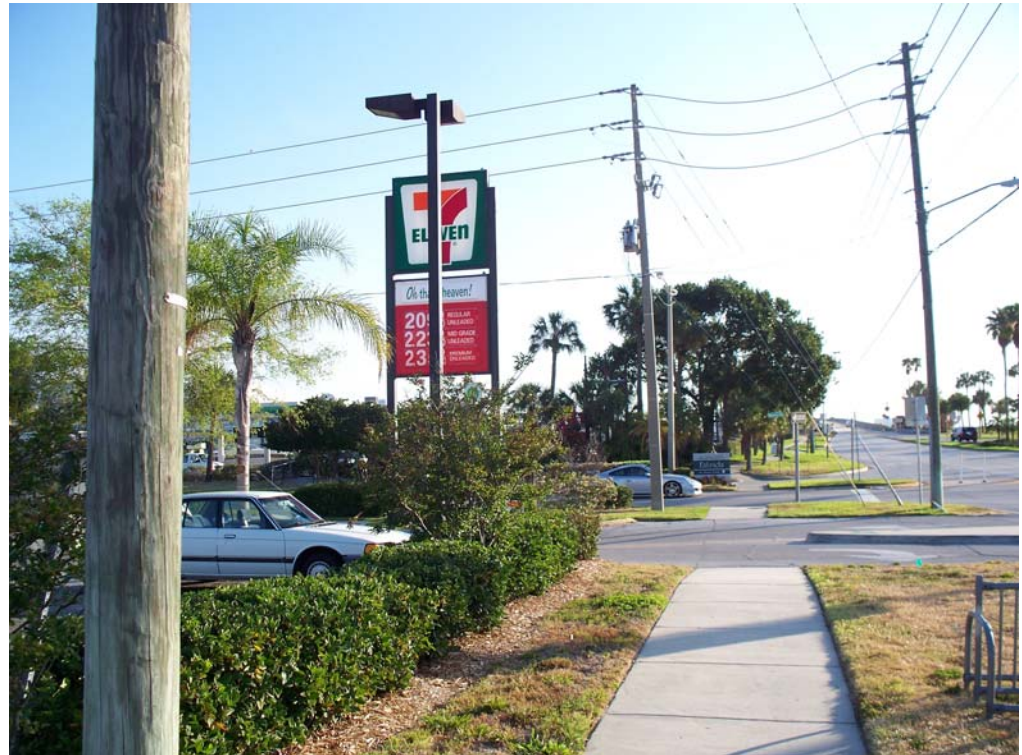
Site 2: 7-Eleven Food Store # 29301, 150 Pinellas Bayway.

View of western SR 679 ROW, in front of 7-Eleven.

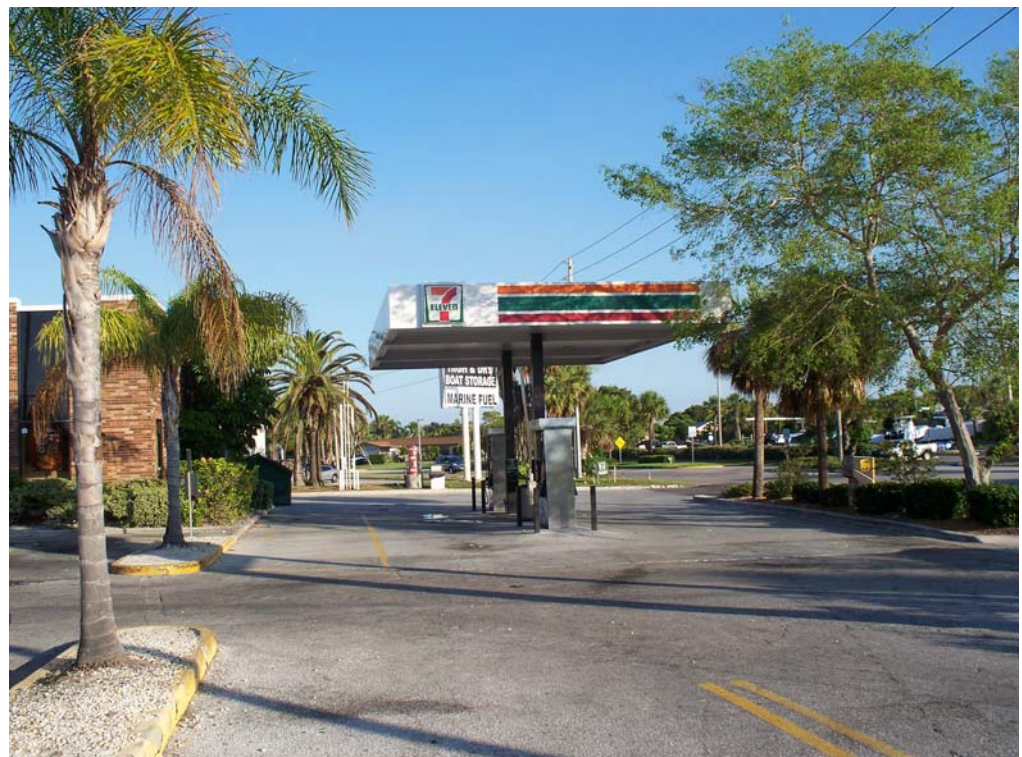
4

Site 2: 7-Eleven Food Store # 29301, 150 Pinellas Bayway.

View of dispenser area, with UST area located behind dispensers, from western SR 679 ROW.

With two open releases recorded for the site and the magnitude and distribution of impacts not determined, a risk rating of **Medium** has been assigned to this site. The dispenser area is located approximately 85 feet west of SR 679. Shaw recommends performing soil and groundwater assessment activities in front of the site, in the SR 679 right-of-way (ROW), and in the Madonna Boulevard ROW adjacent to the SR 679 intersection.

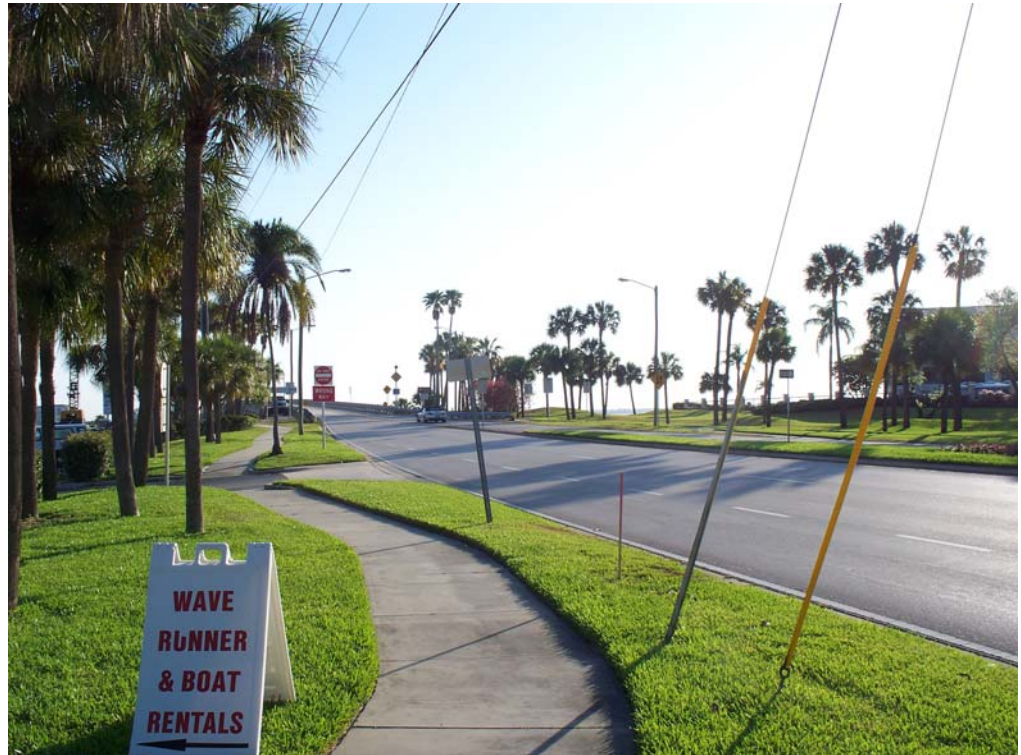
Site 4: Tierra Verde-BP,
128 Pinellas Bayway.

Western SR 679 ROW, in
front of southern portion
of Site 5.

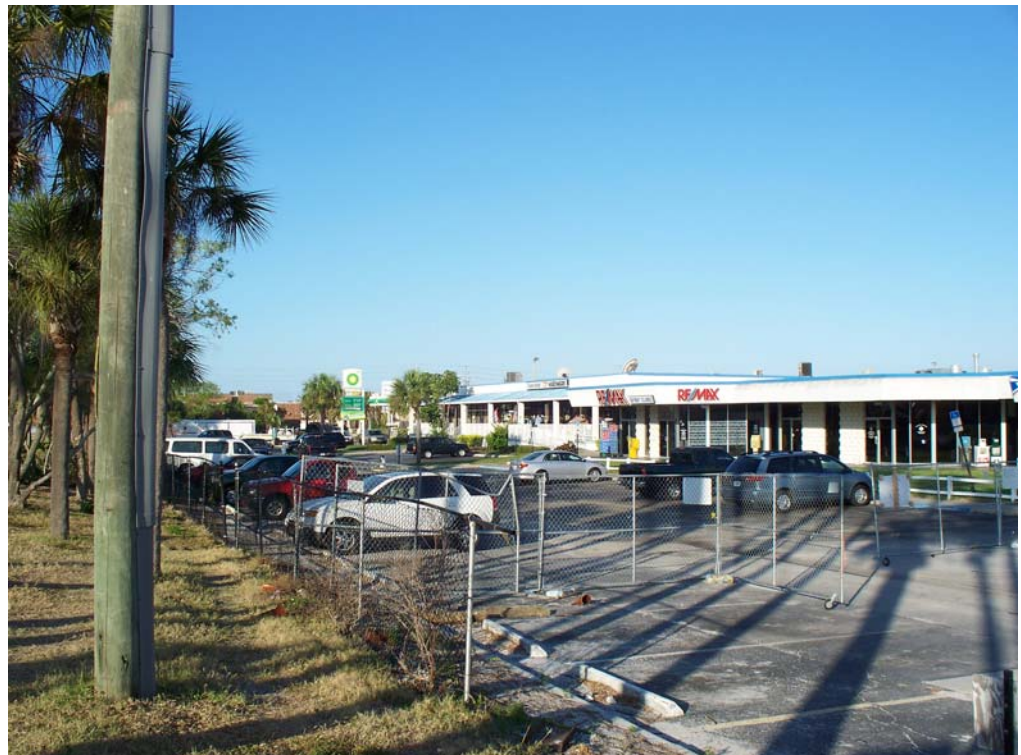
6

Site 4: Tierra Verde-BP,
128 Pinellas Bayway.

Western SR 679 ROW, in
front of northern portion
of Site 5. Portion of
northern UST area
located in lower right of
photograph.

With two prior releases recorded for the marine (northern) storage tank area, a risk rating of **Medium** has been assigned to this site. This northern storage tank area is located approximately 52 feet west of SR 679, while the southern UST area is located approximately 125 feet west of SR 679. Shaw recommends performing soil and groundwater assessment activities in the SR 679 ROW, adjacent to the northern UST area. Additionally, Shaw recommends assessing the soil and groundwater in the SR 679 ROW in the area of the southern UST/dispenser area.

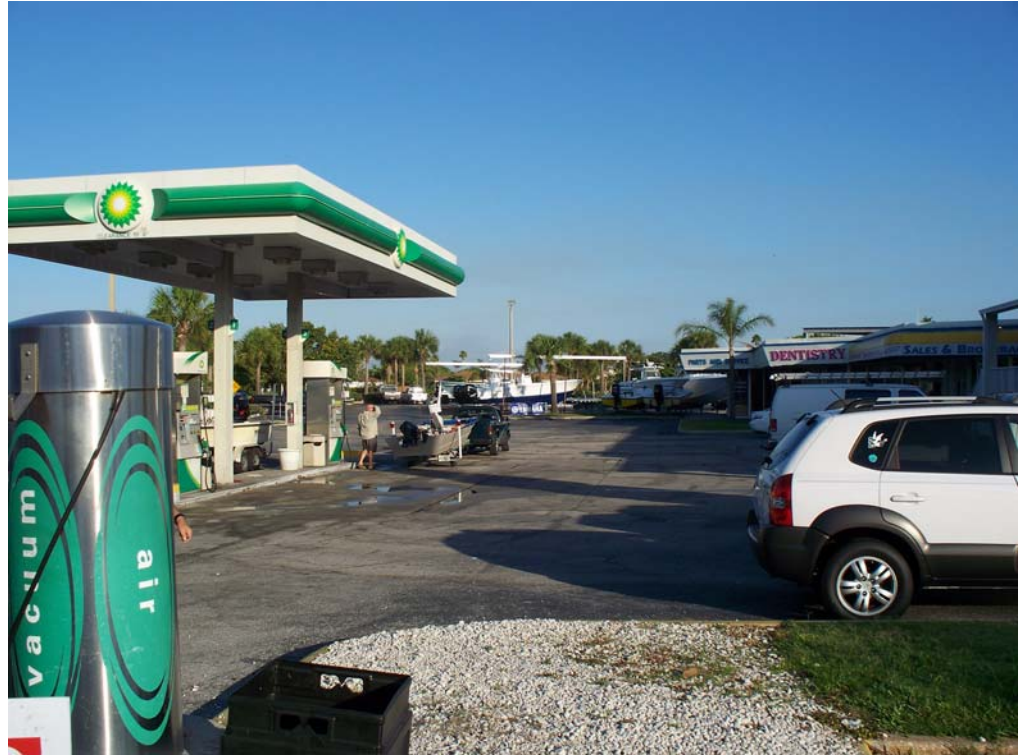
Site 4: Tierra Verde-BP,
128 Pinellas Bayway.

View of southern
dispenser and UST area.
Single UST is located
beneath dispensers.

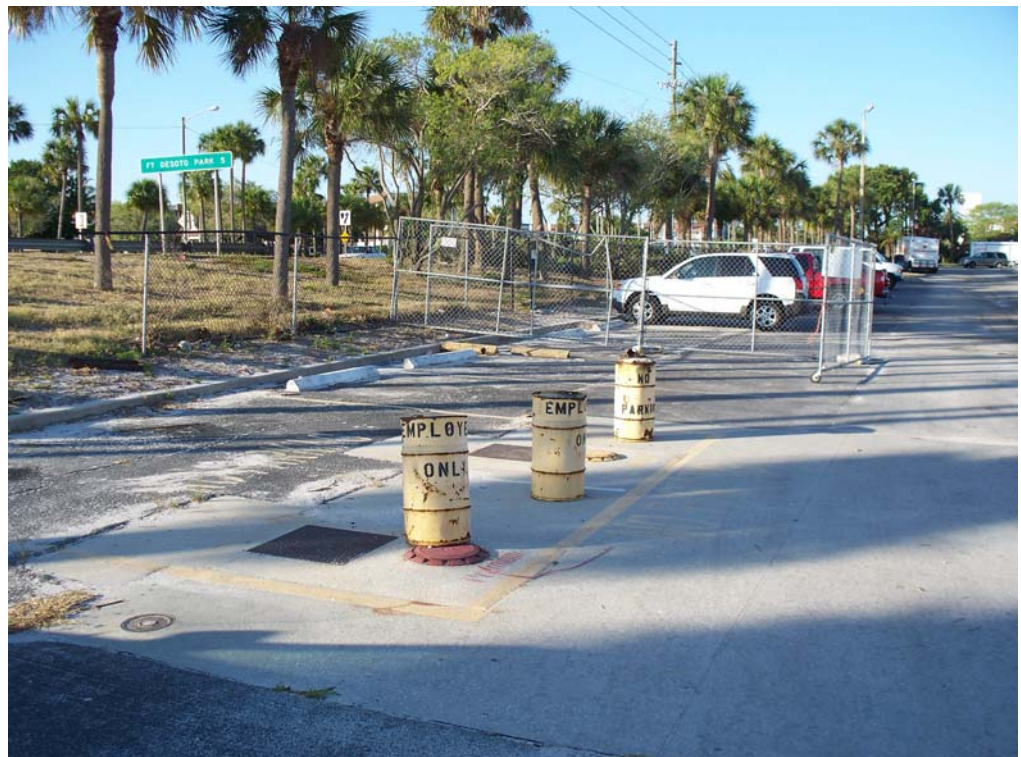
8

View of northern out-of-
service UST area.

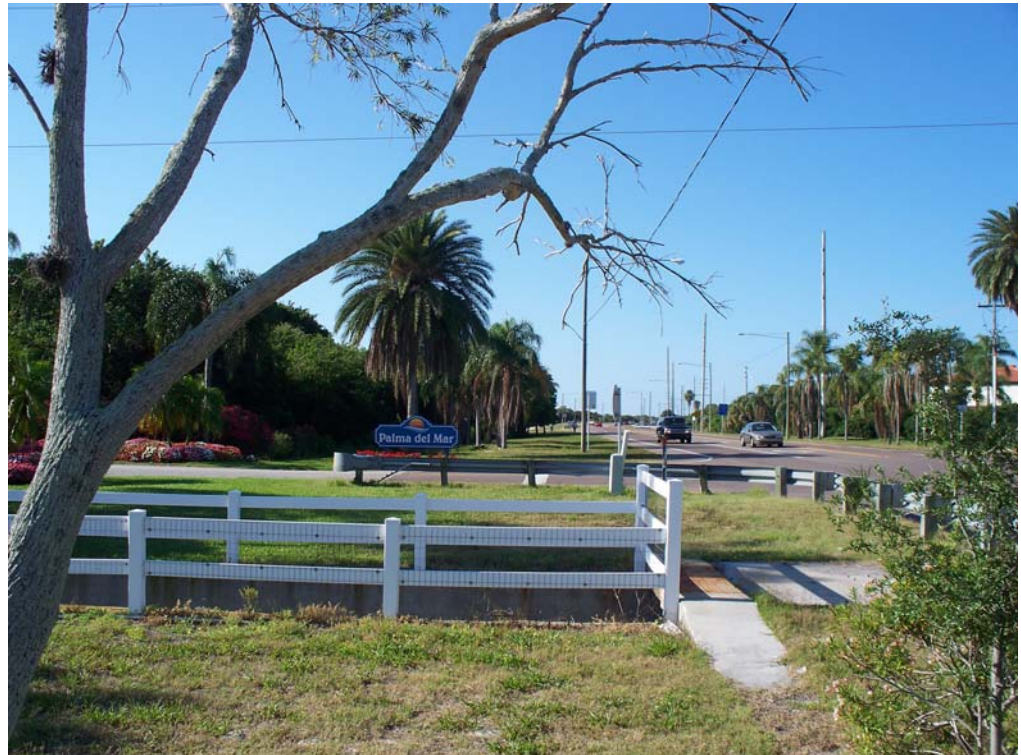
View of intersection of Palma Del Mar Blvd and SR 679, and eastern ROW of SR 679 from north of intersection.

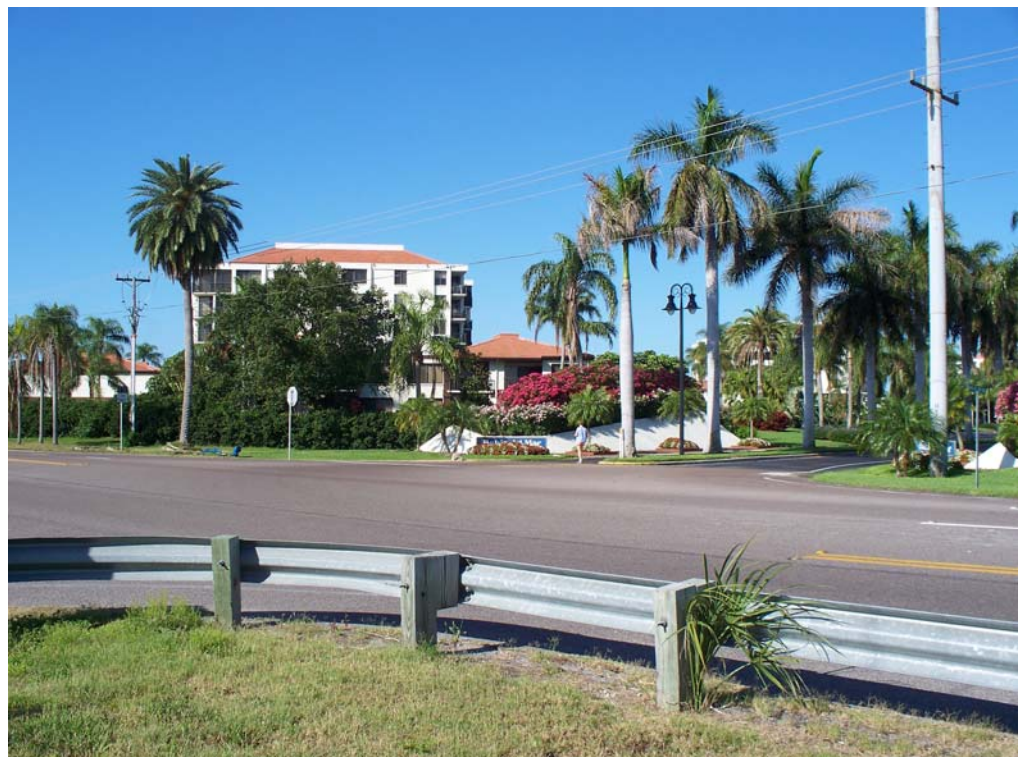
10

View of intersection of Bahia Del Mar Blvd and SR 679 from eastern SR 679 ROW, just north of intersection.

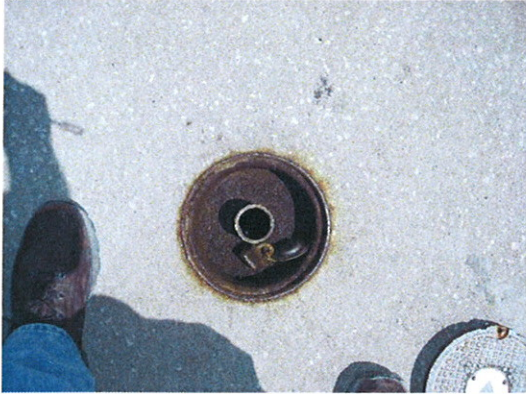
01. 2007_mar_22_rhs SW
monitoring well cap broken, well not
sealed; covers faded, need re-
marked

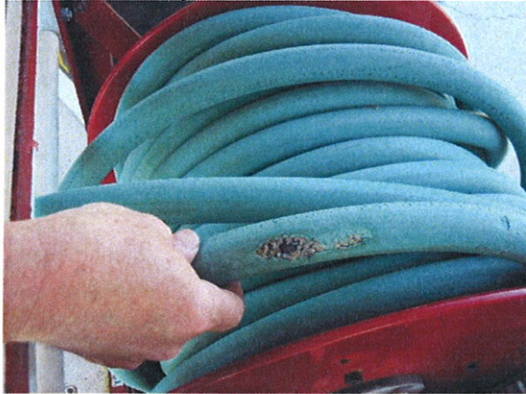
02. 2007_mar_22_rhs Dispenser 1B
reel hose excessively worn
