FINAL POND SITING REPORT

**US 301 (SR 43) Project Development and Environment (PD&E) Study
From Falkenburg Road to Causeway Boulevard
WPI SEG. NO.: 421140-6
Hillsborough County**

August 2008

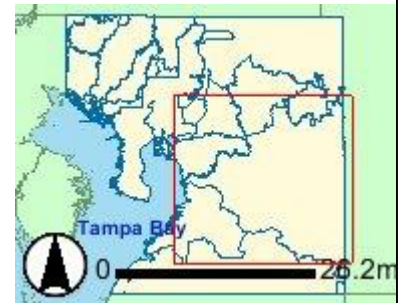
Figure 4-1
 SWFWMD Alafia River Basin
 US 301 Falkenburg Road to Causeway Blvd.
 WPI Seg. No. 421140-6
 Hillsborough County, FL

The US Highway 301 project lies entirely within the Alafia River Basin (see *Figure 4-1*). The project corridor lies entirely within the Delaney Creek Basin according to Hillsborough County and Florida Department of Environmental Protection (FDEP) (see *Figure 4-2*).

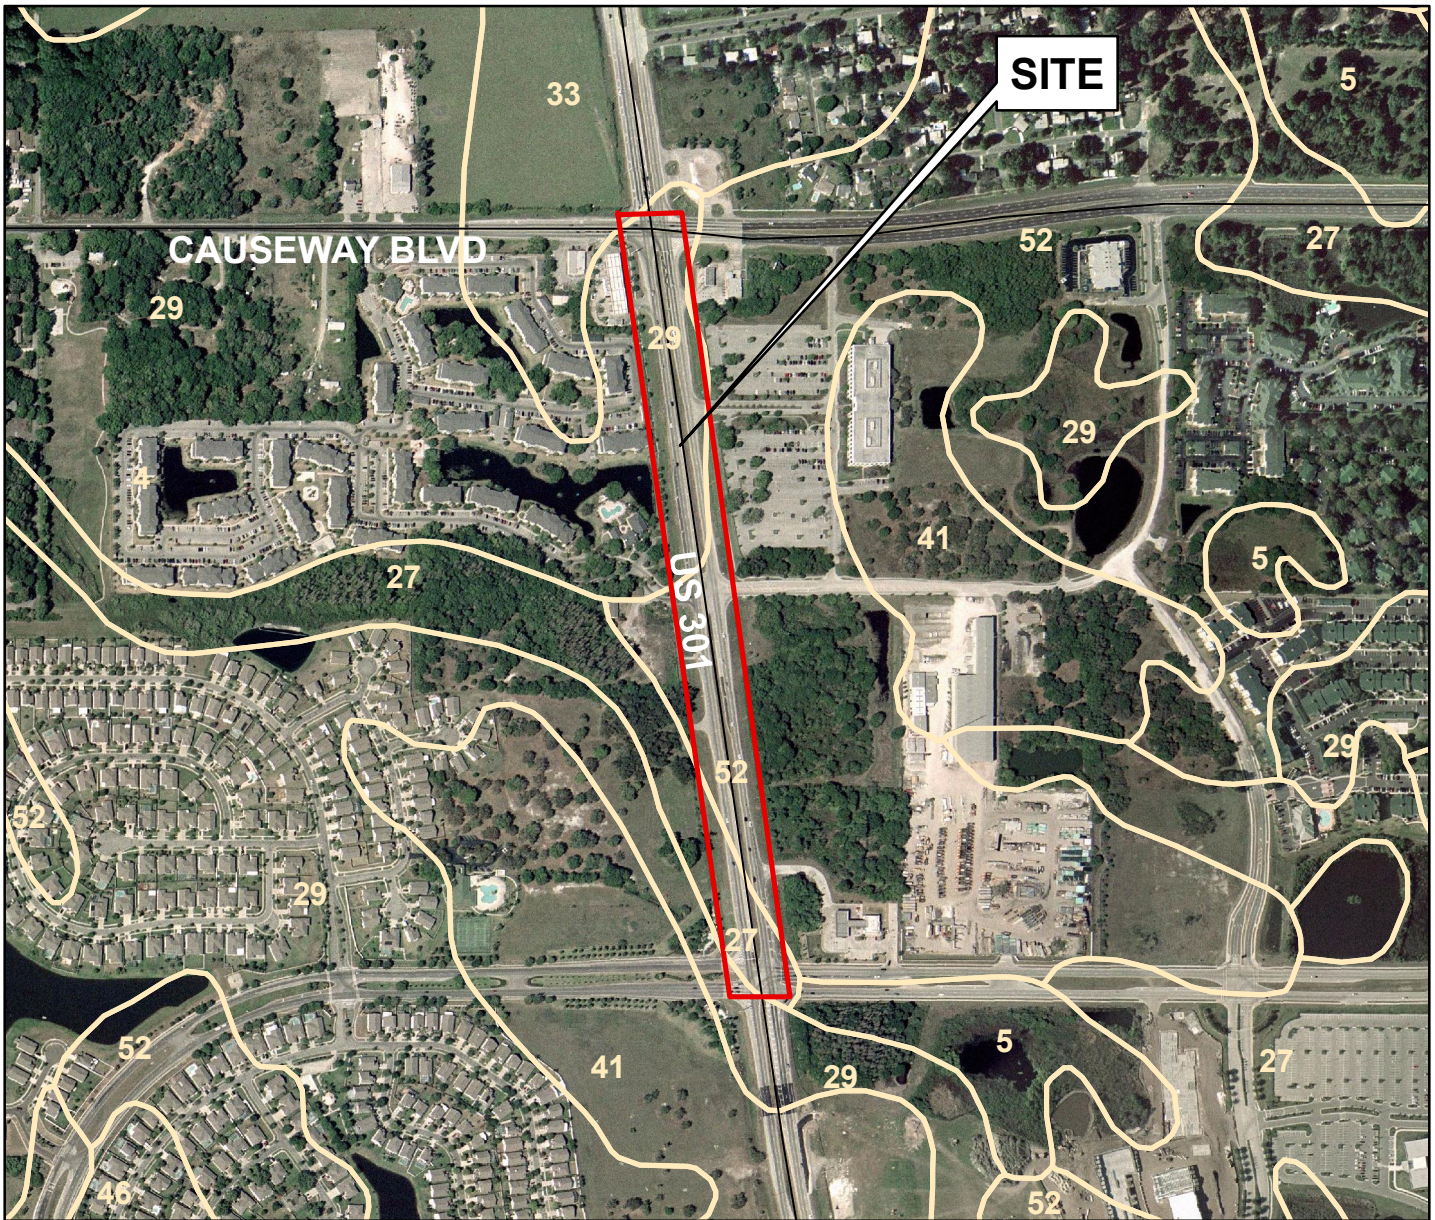
- Ona fine sand (33) – This soil is nearly level and poorly drained. It is on broad plains on the flatwoods. The slope is 0 to 2 percent. Typically, this soil has a surface layer of very dark gray fine sand about 4 inches thick. The upper part of the subsoil, to a depth of about 8 inches, is black fine sand. The lower part, to a depth of about 22 inches, is a very dark brown fine sand. In most years, a seasonal high water table fluctuates from the soil surface to a depth of 10 inches for more than 2 months and recedes to a depth of 10 to 40 inches for 6 months or more. Permeability is rapid in the surface layer, moderate or moderately rapid in the subsoil, and rapid in the substratum. The available water capacity is low or moderate. The HSG for this soil is B/D.
