FINAL ENVIRONMENTAL TECHNICAL COMPENDIUM

**US 301 (SR 43) Project Development and Environment (PD&E) Study
From Falkenburg Road to Causeway Boulevard
WPI SEG. NO.: 421140-6
Hillsborough County**

August 2008

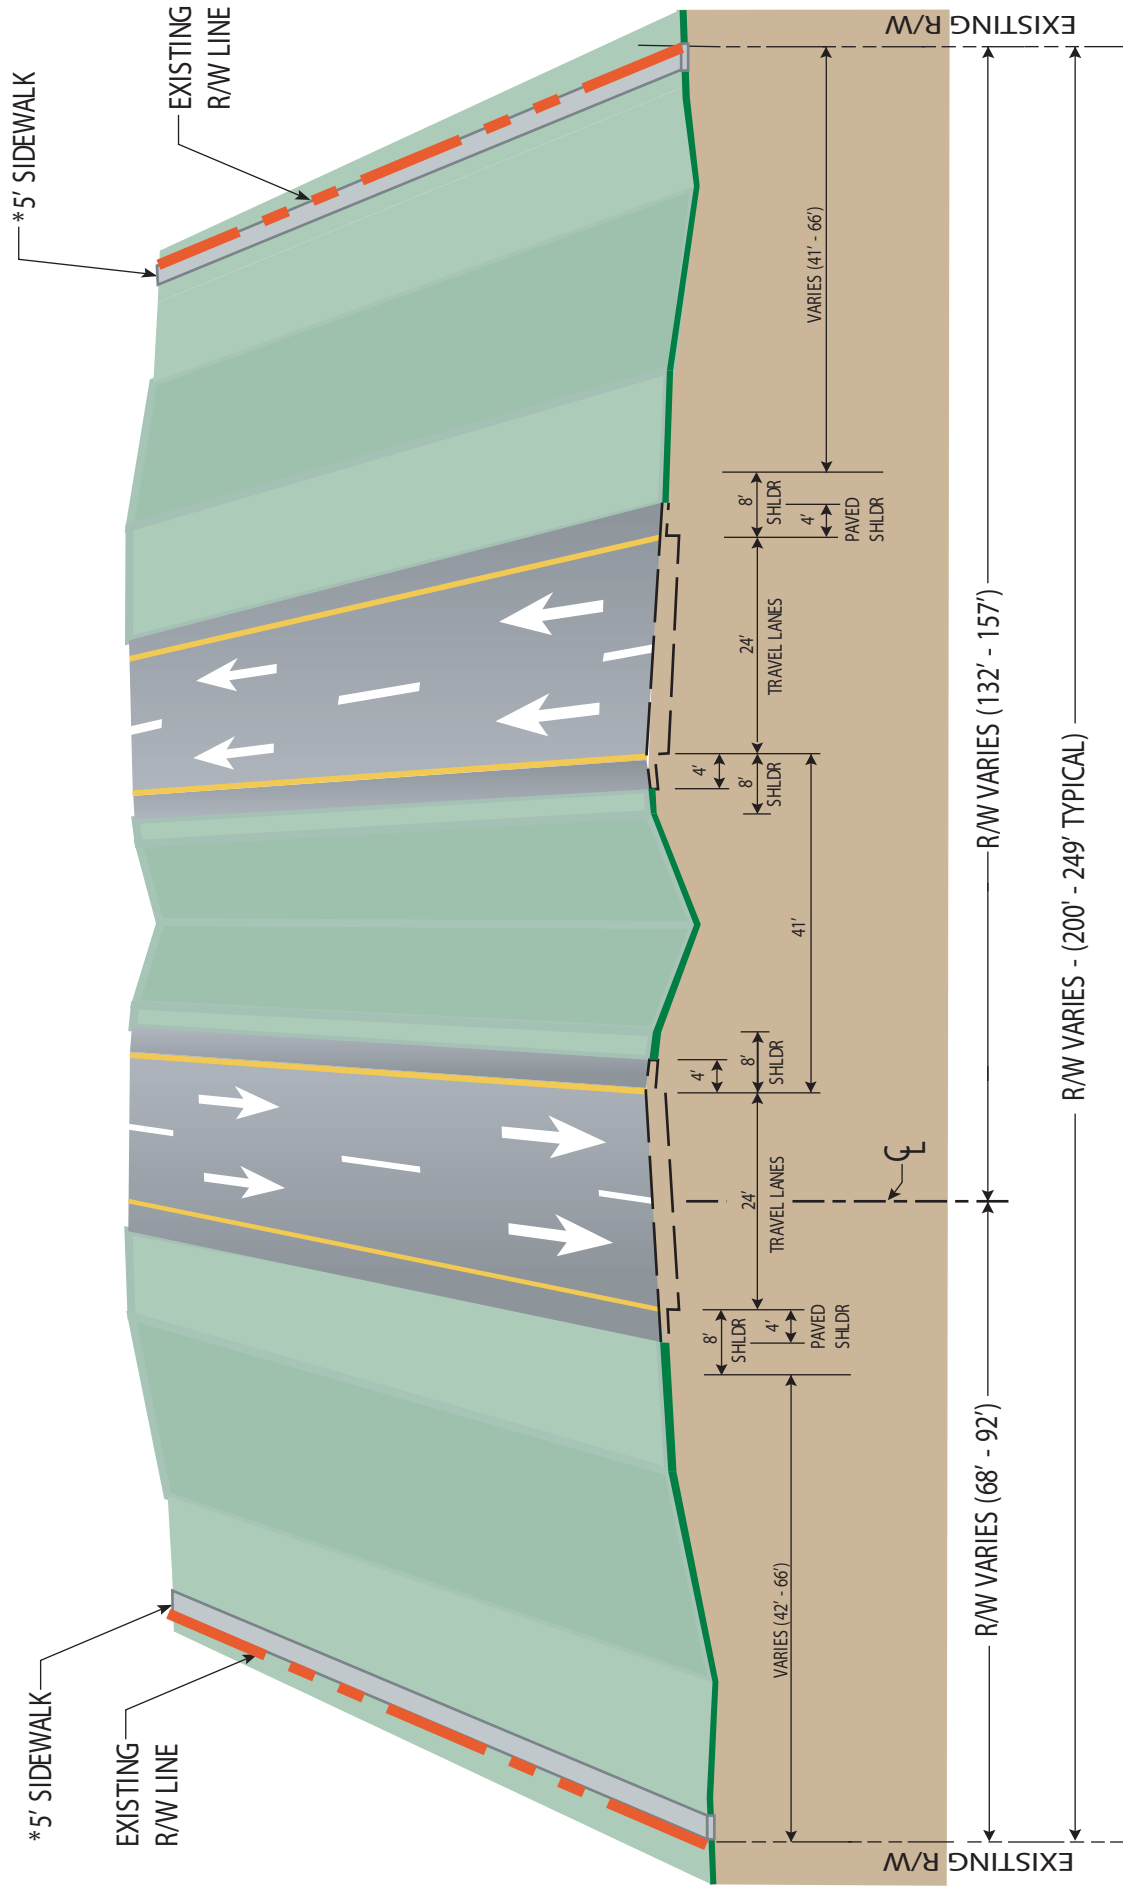
FIGURE 2

* Existing sidewalk is from
Wes Kearney Way to Causeway Blvd.

**EXISTING TYPICAL SECTION (4 TO 6 LANES)
US 301 (SR 43)
FROM FALKENBURG RD TO CAUSEWAY BLVD
WPI Seg. No. 421140-6**

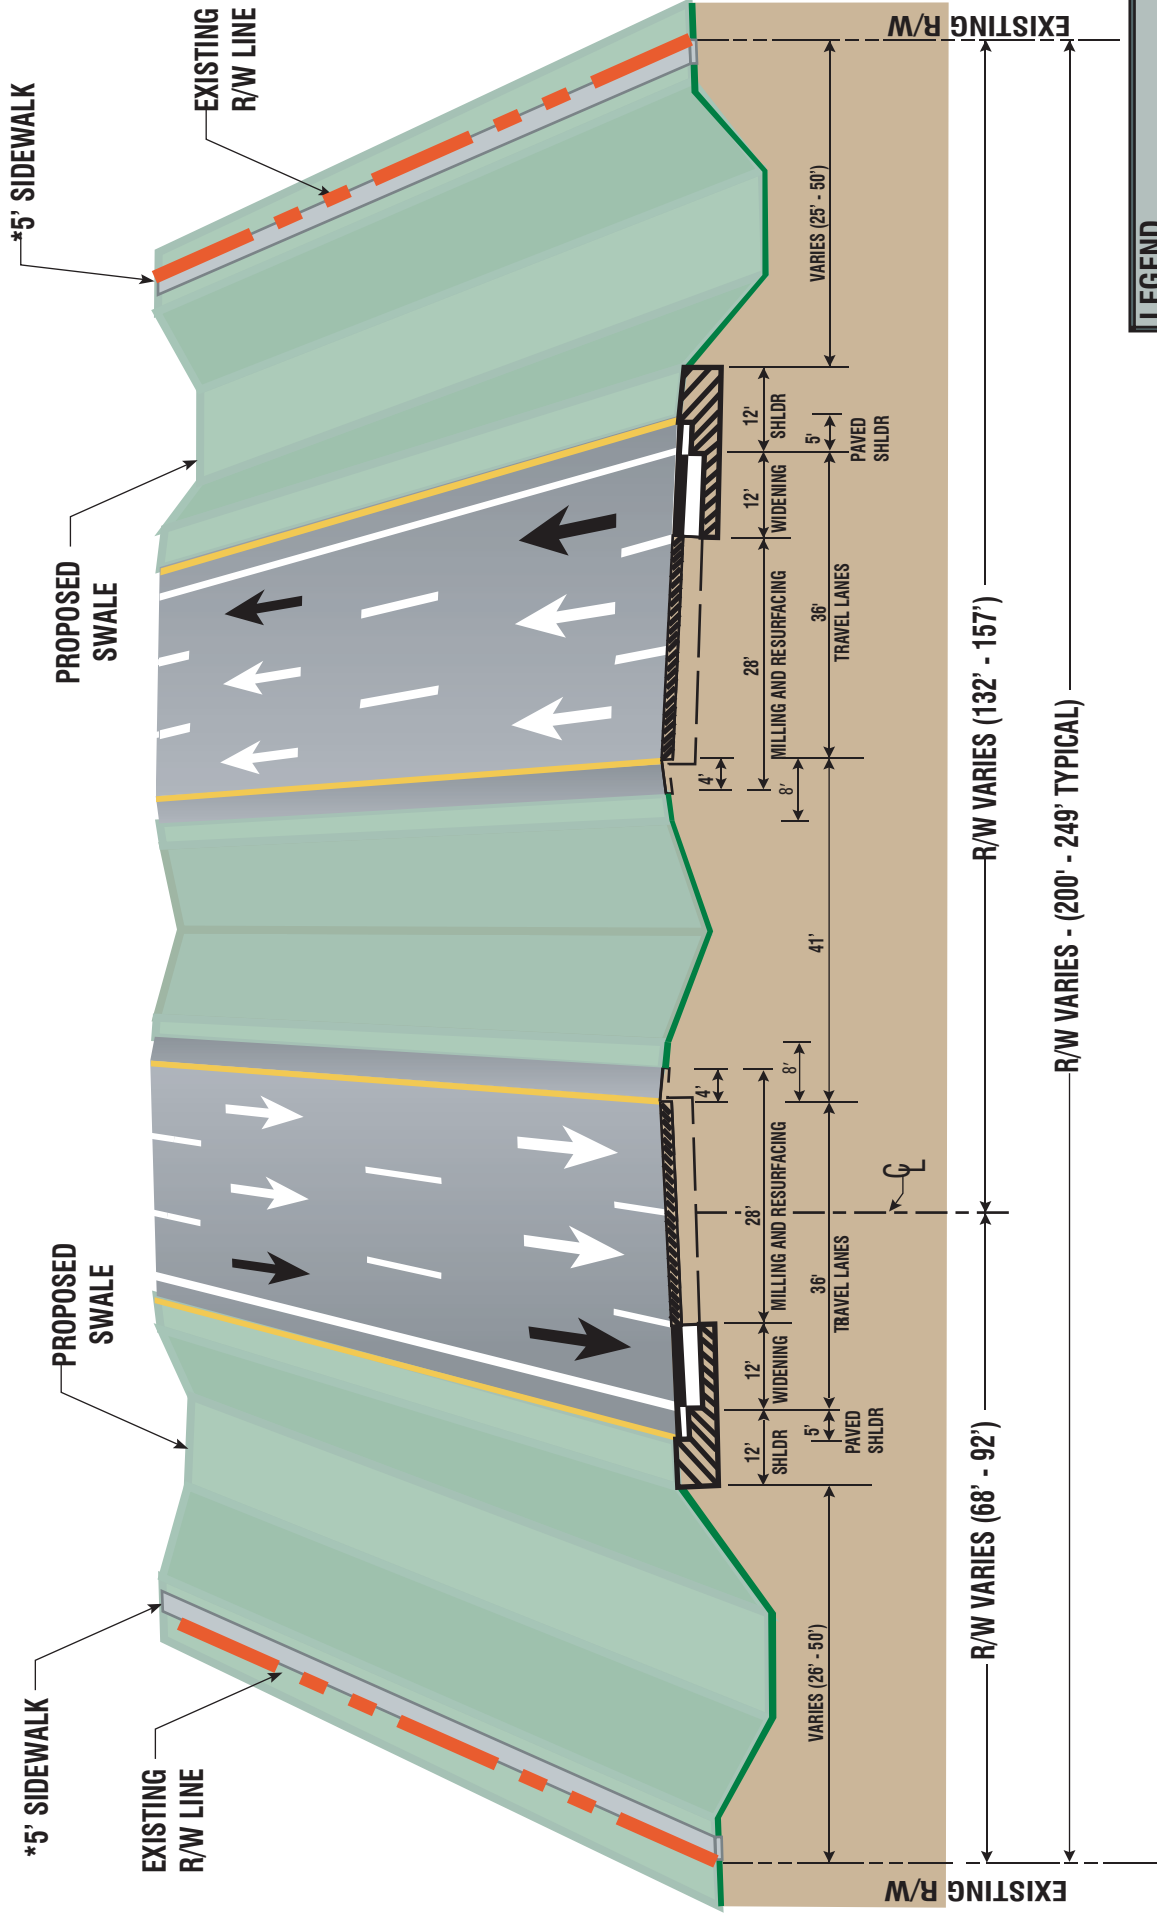
Figure 3

* Proposed sidewalk from Falkenburg Rd. to Wes Kearney Way

**PROPOSED TYPICAL SECTION (4 TO 6 LANES)
US 301 (SR 43)**

The Build Alternative involves increasing the roadway from four lanes to six lanes by adding lanes to the outside of the existing lanes (see *Figure 3*). This PD&E Study evaluated the need and feasibility to widen US Highway 301 to 6 lanes from Falkenburg Road to Causeway Boulevard. Other improvements will include 12 foot shoulders, 5 feet of which is paved, that can accommodate bicycles, access management, and modifications to the existing stormwater management system to provide water quality and quantity treatment. The roadway improvements will not require acquisition of additional R/W. The existing intersection with Wes Kearney Way will be maintained. Five-foot sidewalks will be added near the existing R/W from Falkenburg Road to Wes Kearney Way.

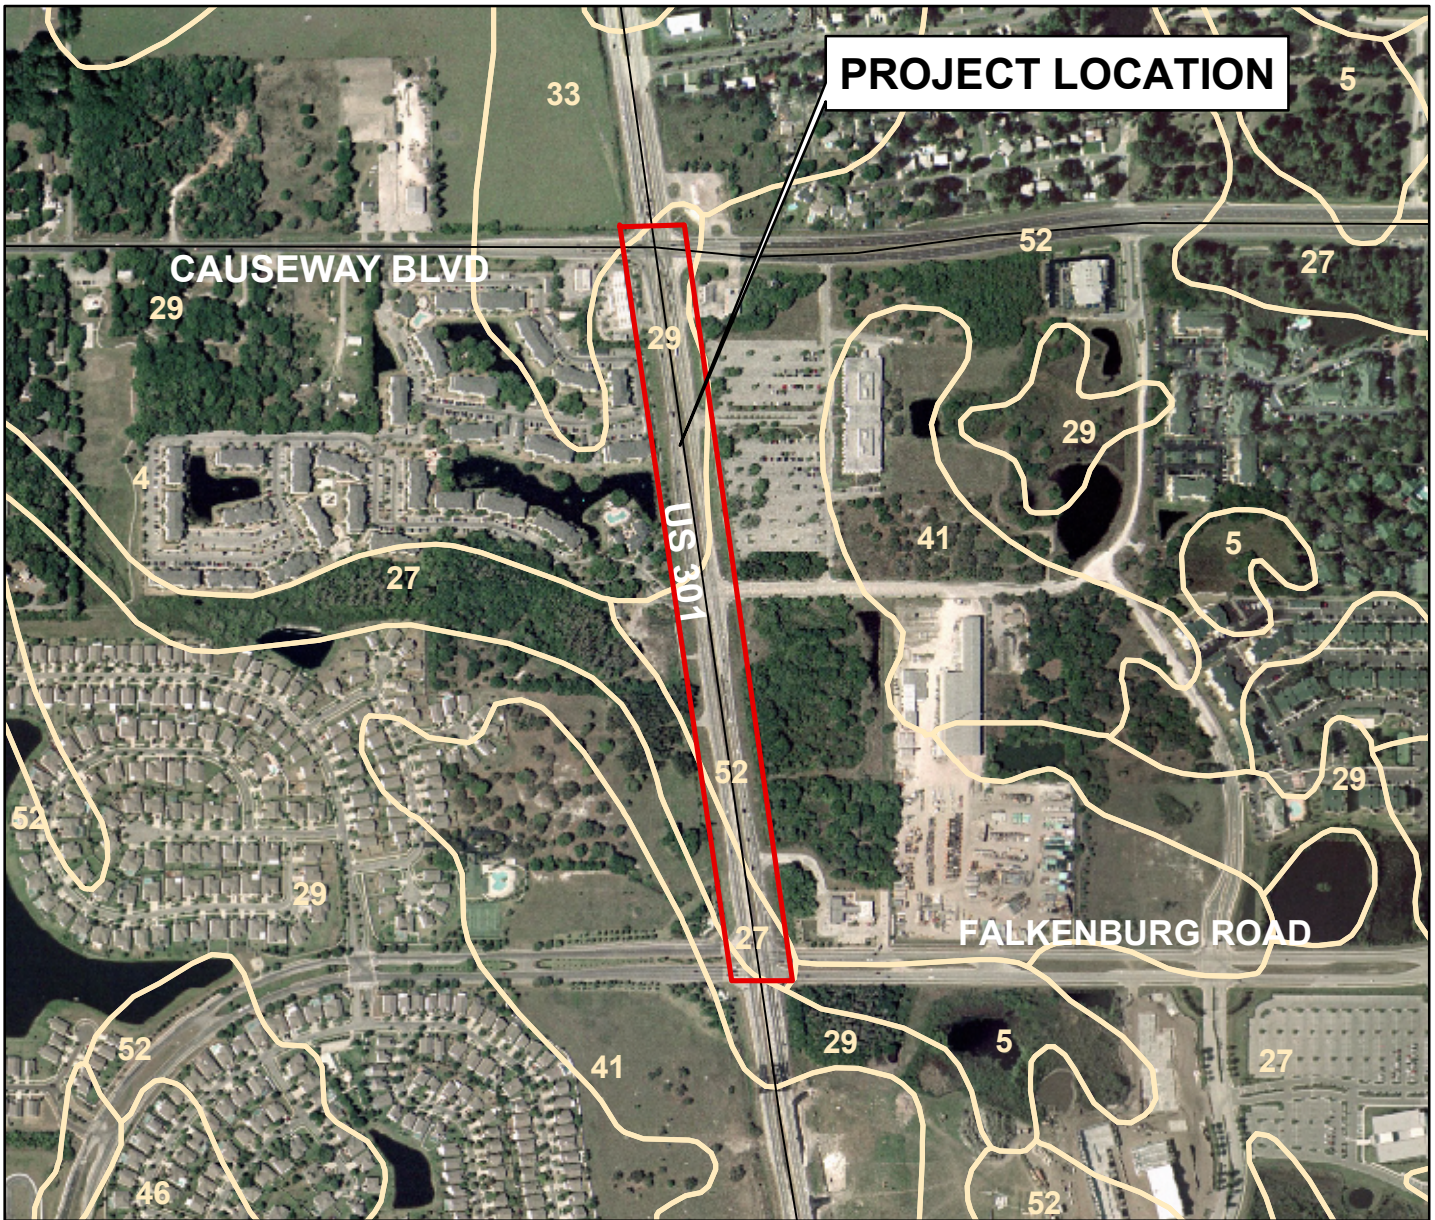
FIGURE: 5

- 27 = Malabar fine sand, 0 to 2 percent slope
- 29 = Myakka fine sand, 0 to 2 percent slope
- 33 = Ona fine sand, 0 to 2 percent slope
- 52 = Smyrna fine sand, 0 to 2 percent slope

USDA/SCS SOILS MAP

According to the United States Department of Agriculture/Natural Resource Conservation Service (USDA/NRCS) Soil Survey of Hillsborough County Area, Florida (1989), three soil types exist within the proposed project area. A list of these soils and a copy of the USDA/NRCS Soil Map are provided in *Figure 5*. Only Malabar fine sand is generally considered to be hydric by the Hydric Soils of Florida Handbook (2000).

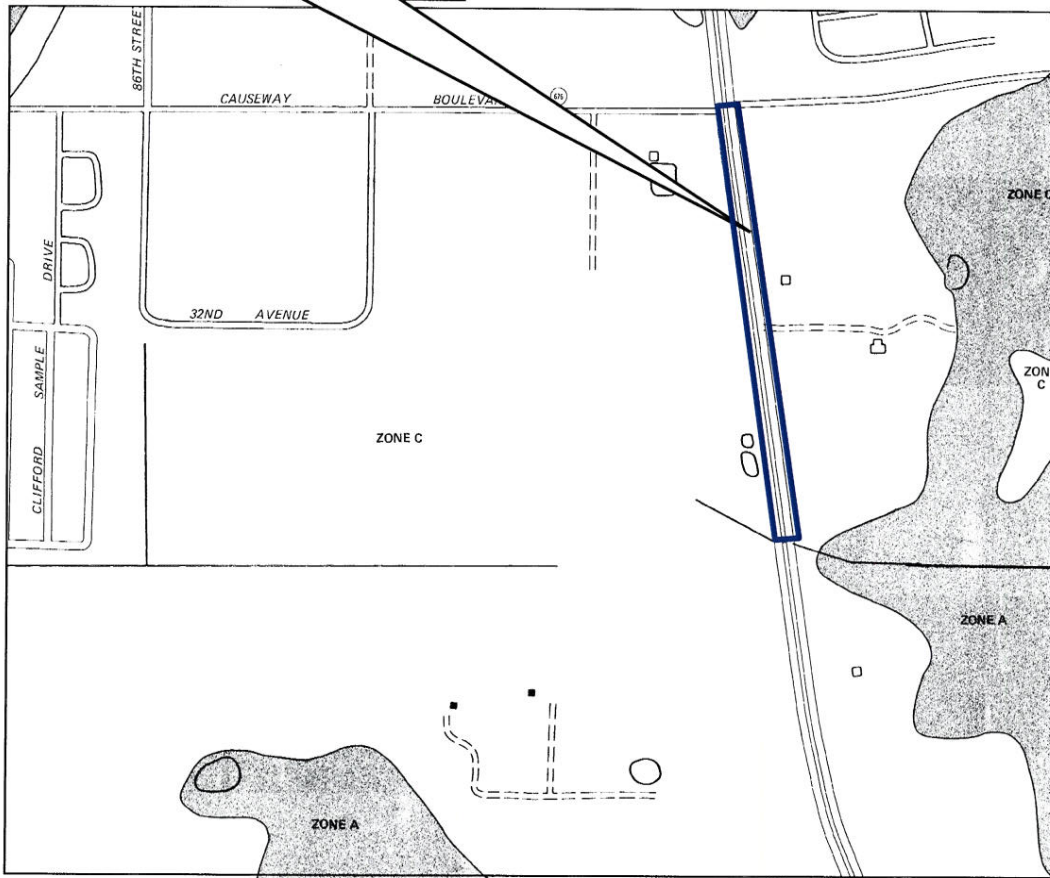
SCALE: As Shown	WPI SEG. NO.: 421140-6	DATE: January 2007	FIGURE: 6
--------------------	---------------------------	-----------------------	--------------

Zone C – Areas of Minimal Flooding.

FEMA FLOOD INSURANCE RATE MAPS

The Flood Insurance Rate Maps (FIRM) for Hillsborough County (Community Panel Number 120112 038E, dated August 15, 1989) was reviewed to evaluate impacts to floodplains. A FEMA Firmette (FIRM) Map for the project corridor has been included as *Figure 6*.

The entire project corridor is within FEMA designated Flood Zone C. Flood Zone C denotes areas of minimal flooding. Therefore, the project will not result in impacts to the FEMA designated 100-year floodplain.

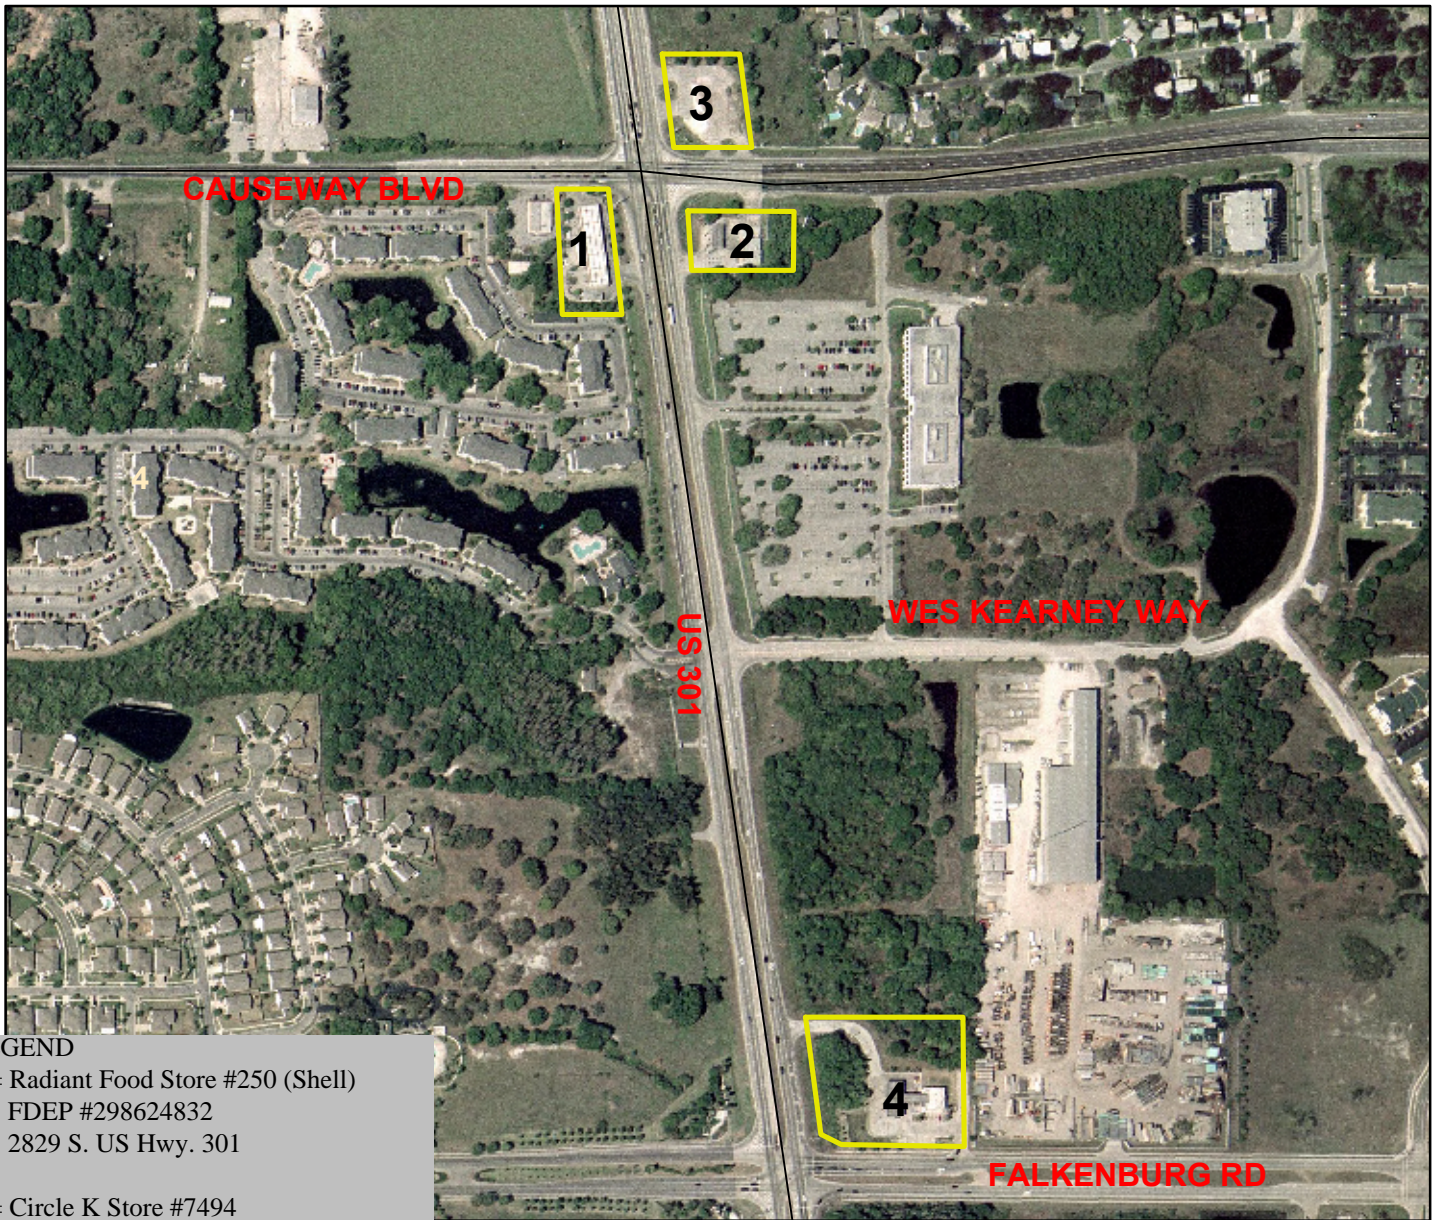
- 1 = Radiant Food Store #250 (Shell)
FDEP #298624832
2829 S. US Hwy. 301
- 2 = Circle K Store #7494
FDEP #298840559
2802 S. US Hwy. 301
- 3 = Shell Station (likely)
FDEP #298625032
2620 S. US Hwy. 301
- 4 = 7 Eleven Gas Station
FDEP #298625032
3603 S. US Hwy. 301
- 5 = Pavillions (location unknown)
FDEP #299200283

Table 3 Potential Contamination Sites					
Facility	Address/Location	FDEP ID	Approx. Distance from Roadway	Status	Risk
Radiant Food Store # 250	2829 South US 301	298624832	Adjacent	In Service	Medium
Circle K # 7494	2820 South US 301	298840559	Adjacent	In Service	Medium
Pavilions	Location Unknown	299200283	Adjacent	Closed	Low
Shell	Formerly located at 2620 US 301	298625032	Adjacent	Closed	Low
7-Eleven	3603 South US 301	299803172	Adjacent	In Service	Medium

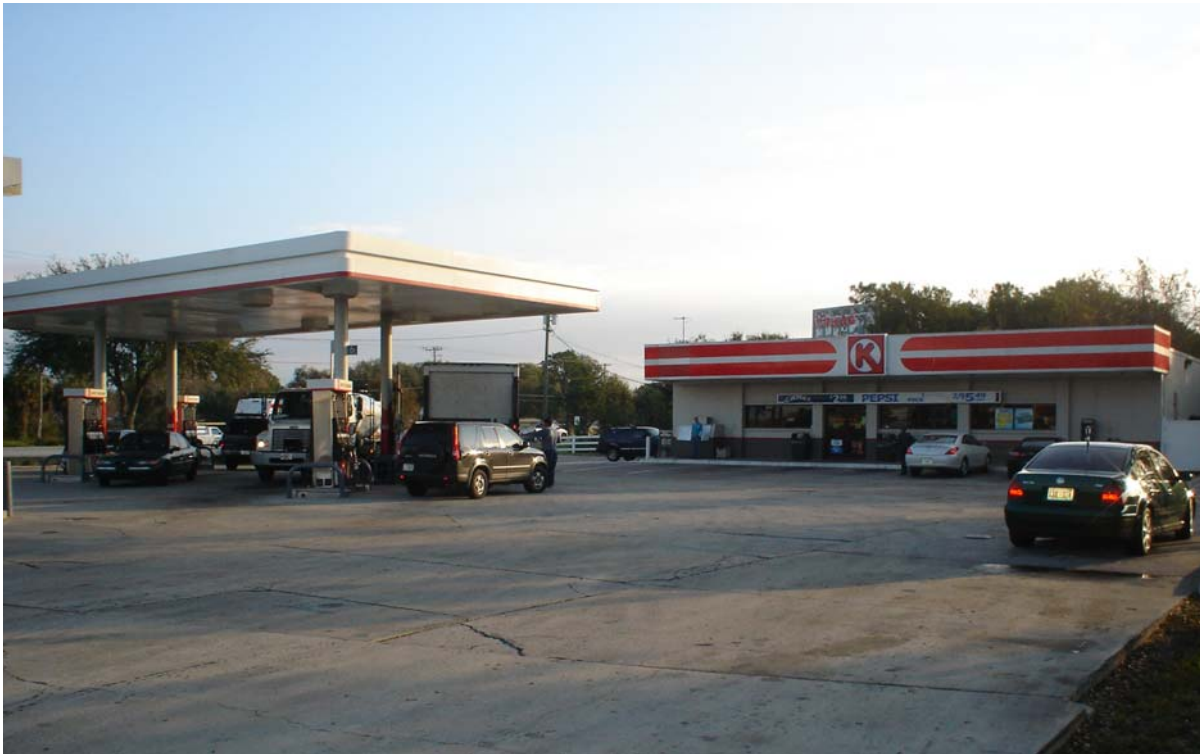
Photo 1: Circle K- Southeast corner of US 301 and Causeway Boulevard

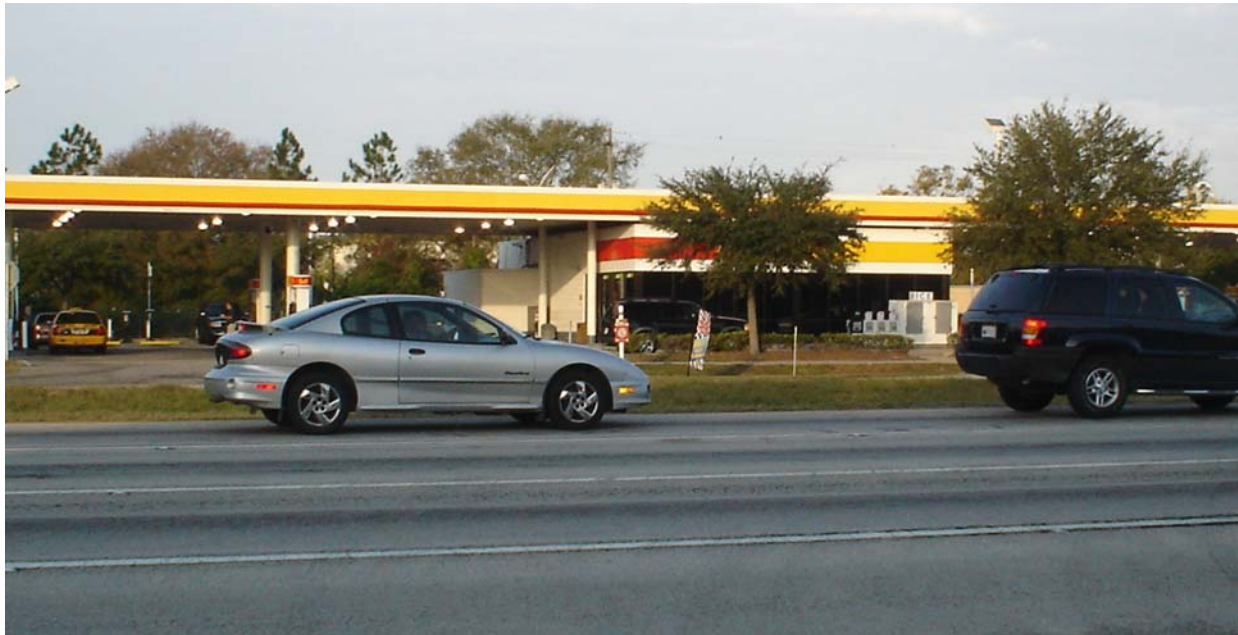
Photo 2: Shell Station-Southwest corner of US 301 and Causeway Boulevard

This facility was observed on the 1985 aerial photograph but not the 1979 aerial photograph. A review of the records indicated that this currently operational gas station had two discharges, one in 1990 and one in 1994. This facility has a score of 11. Although the site is considered contaminated, neither the FDEP nor the EPC are requiring remediation at this time. Based on the fact that known or potential contamination exists, this site is considered a **medium** risk.

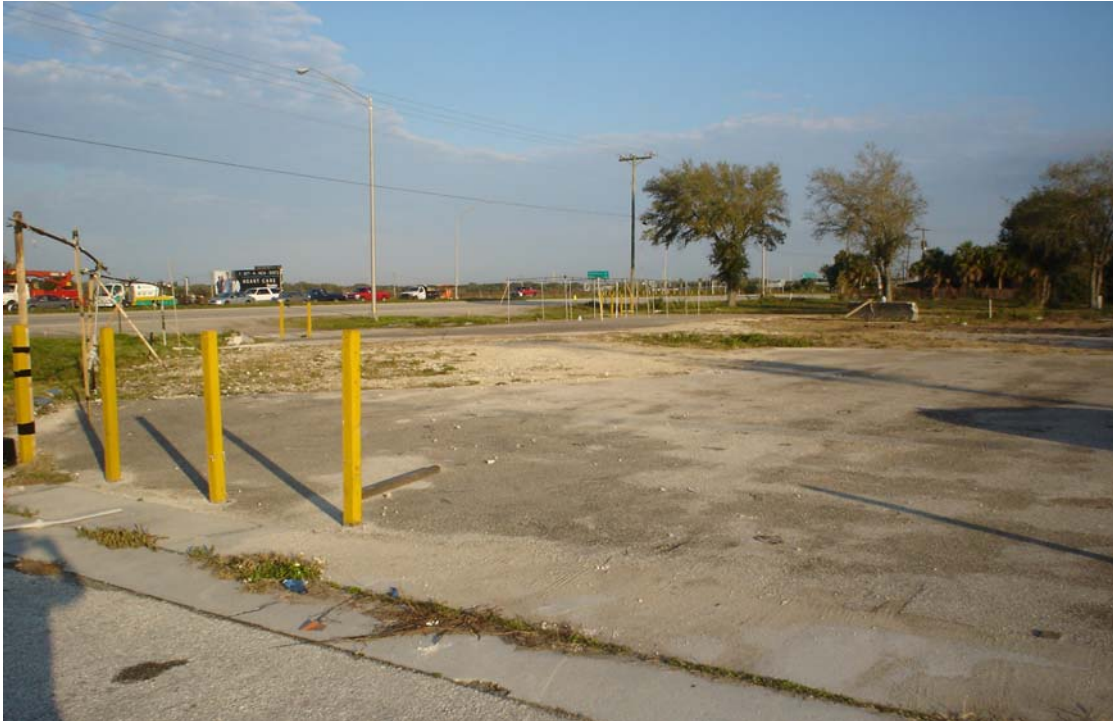
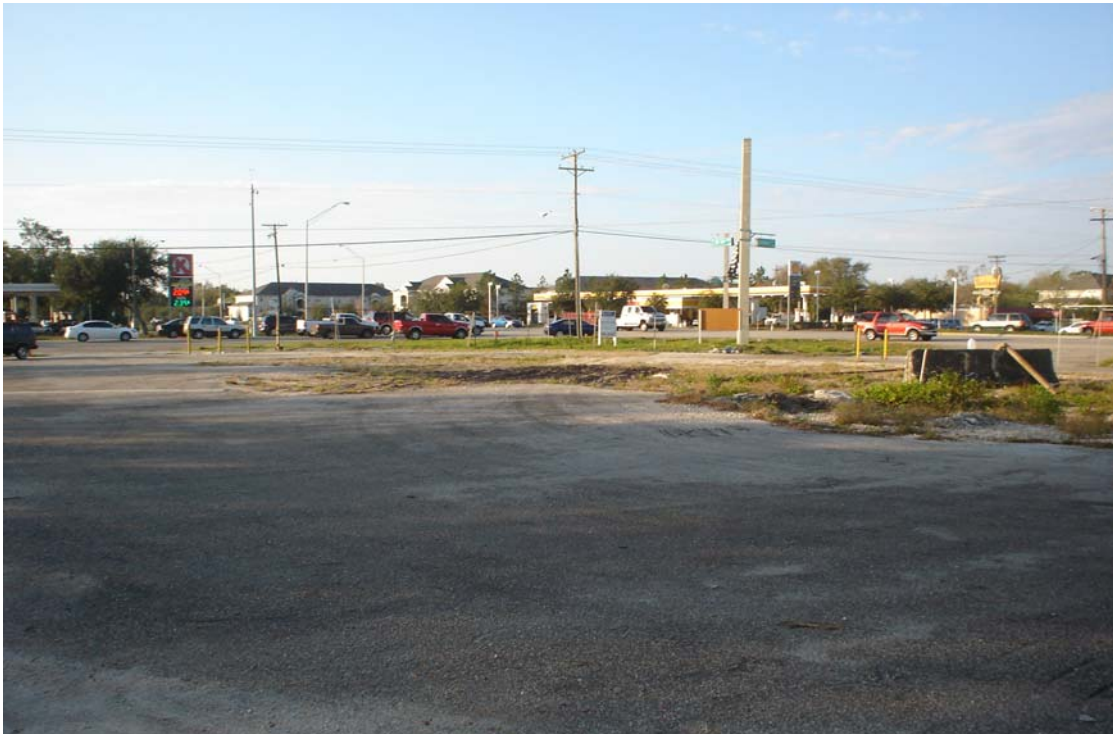
Photo 3: Former (possibly gas station) site-Northeast corner of US 301 and Causeway Boulevard

According to the FirstSearch report, this facility was located at 2620 US Highway 301. It appears that this facility may have been located at the northeast corner of US Highway 301 and Causeway Boulevard from approximately 1991 to 2004. A facility was not in this location on the 1985 aerial photograph. A review of the EPC files indicates that there were three tanks on site that are now closed. These files included:

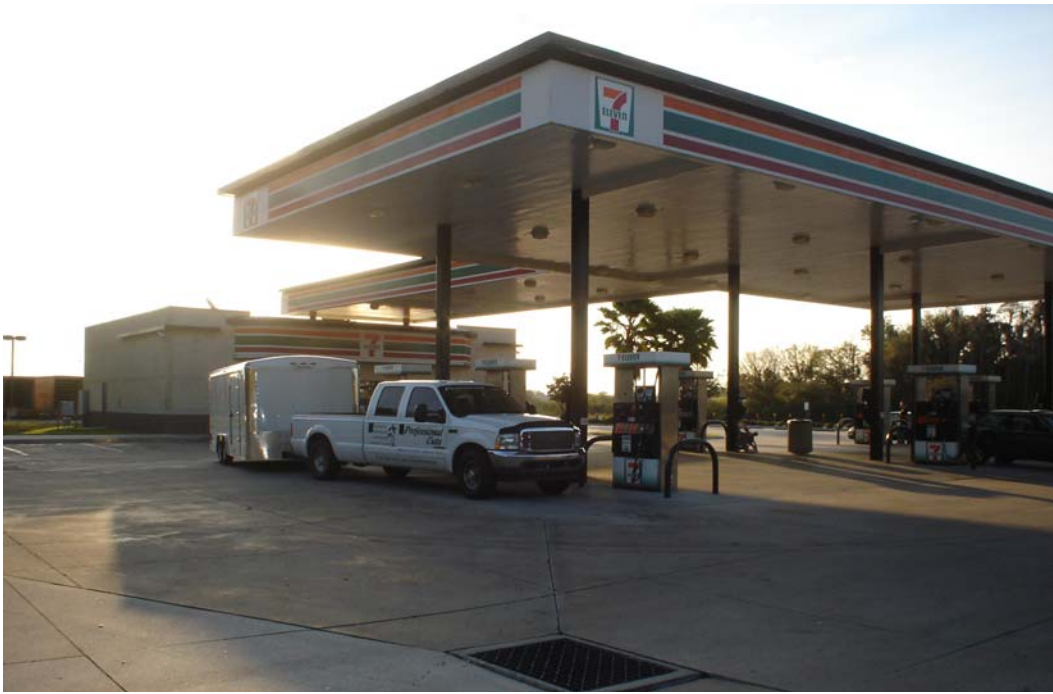
Photo 4: 7-Eleven-Northeast corner of US 301 and Falkenburg Road

This facility was observed on the 2002 aerial photograph, but not 2000 aerial photograph. A review of the EPC files indicated that a discharge of petroleum occurred on May 5, 2006. Free product was identified in at least one of the monitoring wells. EPC scored this discharge 10 on August 8, 2006. Although the site is considered contaminated, neither the FDEP nor the EPC are currently requiring remediation. Based on the fact that known or potential contamination exists, this site is considered a **medium** risk.

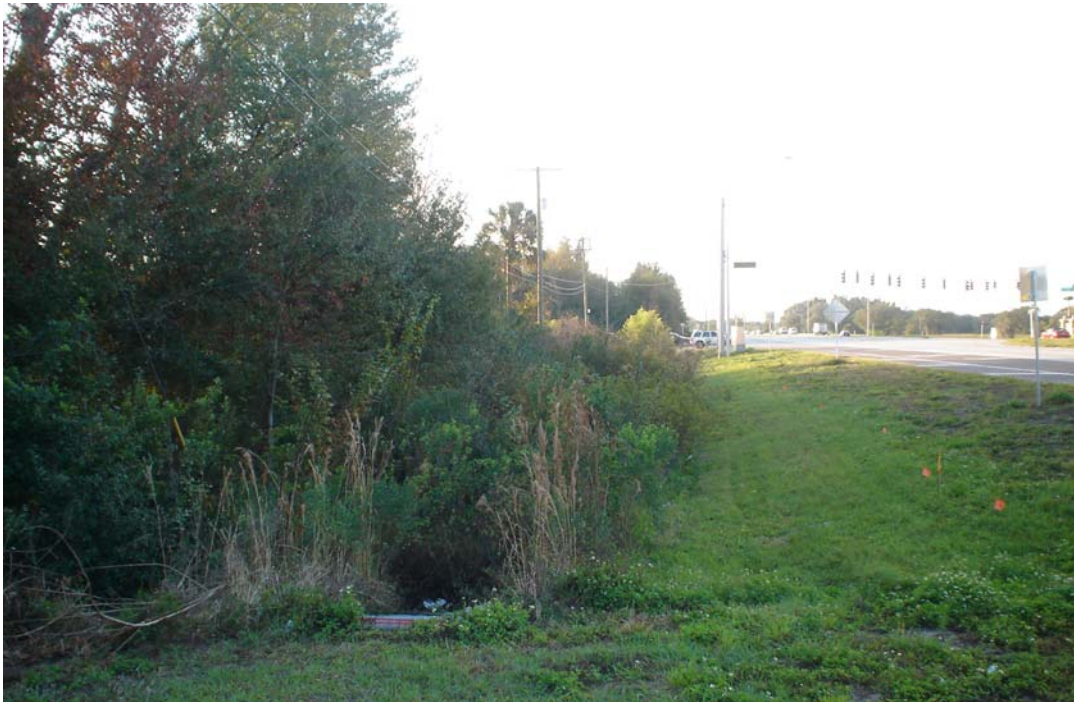
Photo 5: Swale in front of 7-Eleven, facing south

Roadside swales were observed during site reconnaissance. These swales were directly adjacent to both wetlands “E” and “O” referenced above. It appears that these swales were excavated through wetlands “E” and “O” and are hydrologically connected. Therefore, it is likely that the Southwest Florida Water Management District (SWFWMD), EPC, and the United States Army Corps of Engineers (USACE) will claim these swales as jurisdictional wetlands and will likely require compensatory mitigation if impacts are proposed. It appears that approximately 0.1 acres of impacts to these swales will occur. A summary of these features is provided in *Table 1*.

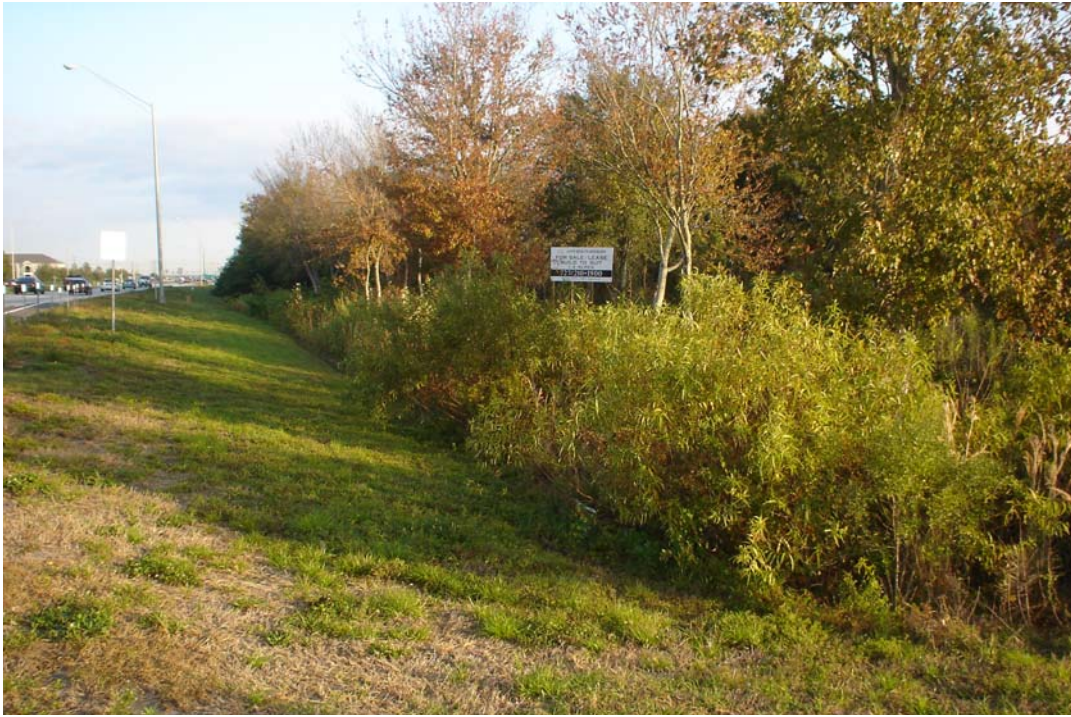
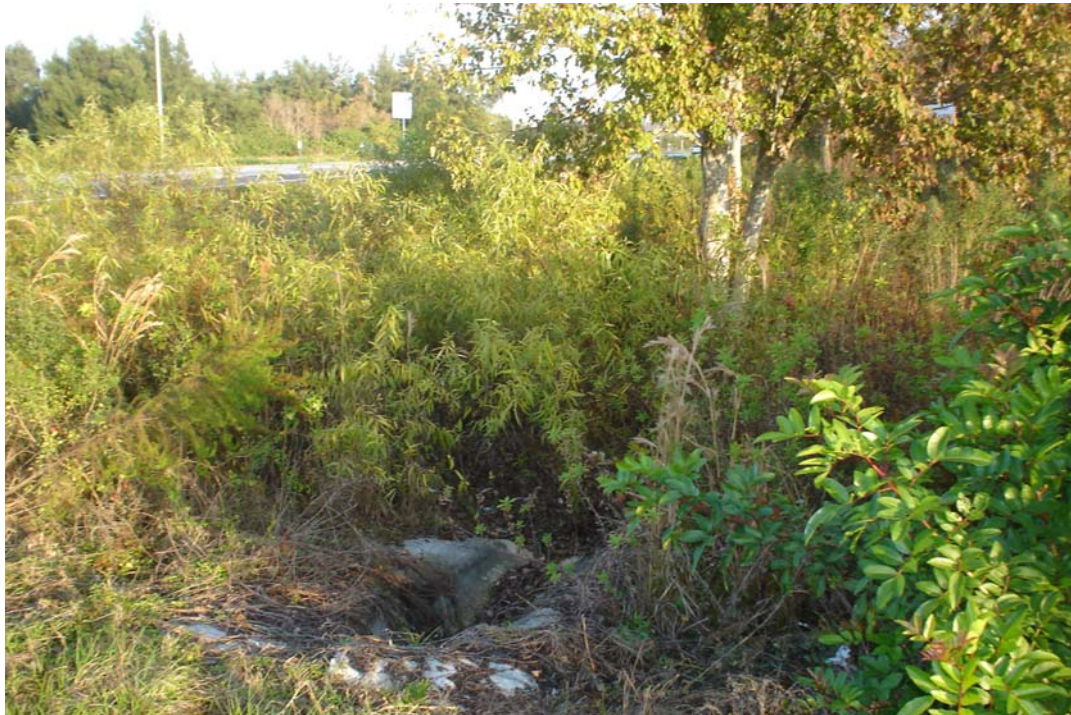
Photo 6: Wetland and swales north of 7-Eleven, facing north

Two wetlands were observed adjacent to the east of project. They are located south of Wes Kearney Boulevard and north of Falkenburg Road. One wetland is located on an undeveloped parcel; the other is located in front of a 7- 11 gas station. As discussed below, these wetlands were claimed by EPC and were identified as “E” and “O” (see *Figure 6*). Vegetation in this area consists of primrose willow (*Ludwigia peruviana*), cattail (*Typha sp.*), Carolina willow (*Salix sp.*), red maple (*Acer rubrum*) and dollar weed (*Hydrocotyle umbellata*). According to the USDA/NRCS Soil Survey of Hillsborough County Area, Florida (1989), the soil type in this area is Smyrna fine sand, 0 to 2 percent slope. This soil is generally not considered hydric.
