**A CULTURAL RESOURCE ASSESSMENT SURVEY  
OF THE U.S. 301/ZEPHYRHILLS  
PROJECT DEVELOPMENT AND ENVIRONMENT (PD&E) STUDY  
FROM S.R. 39 TO C.R. 54  
PASCO COUNTY, FLORIDA**

**APPENDIX D: Cultural Resource Assessment Survey Technical Memorandum for  
Proposed Pond Site Alternatives for the Recommended Build Alternative**

**CULTURAL RESOURCE ASSESSMENT SURVEY  
TECHNICAL MEMORANDUM  
FOR PROPOSED POND SITE ALTERNATIVES FOR THE  
RECOMMENDED BUILD ALTERNATIVE**

**U.S. 301  
PROJECT DEVELOPMENT AND ENVIRONMENT (PD&E) STUDY  
FROM S.R. 39 TO C.R. 54  
PASCO COUNTY, FLORIDA**

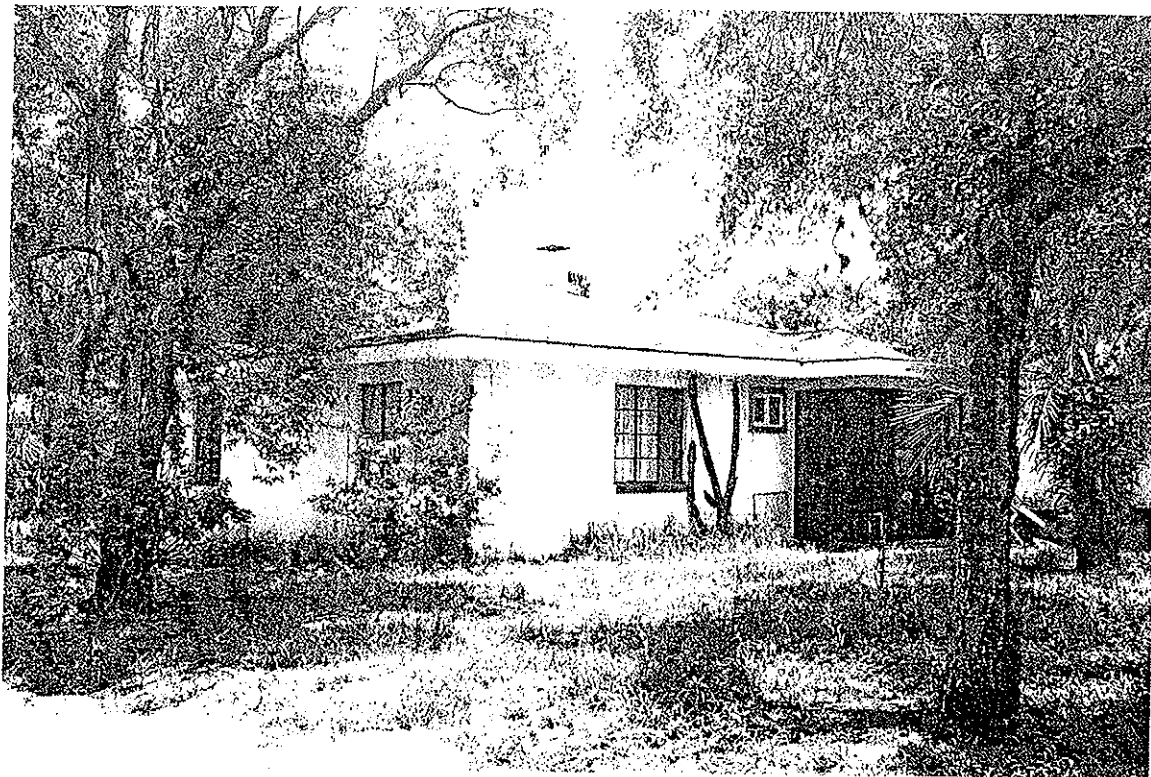
PHOTOGRAPH

Style\* Ranch Exterior Plan\* rectangular Number of Stories 1  
 Structural System(s)\* concrete block  
 Foundation: Type(s)\* continuous Material(s)\* concrete block  
 Exterior Fabric(s)\* concrete block  
 Roof: Type(s)\* hip Material(s)\* composition shingle  
 Roof secondary strucs. (dormers etc.)\* \_\_\_\_\_  
 Chimney: No 1 Material(s)\* brick Location(s)\* int E slope  
 Windows (types, materials, etc.)\* 12 and 8 light casement, metal, independent  
 Main Entrance (stylistic details) \_\_\_\_\_  
 Porches: #open 1 #closed \_\_\_\_\_ #incised \_\_\_\_\_ Location(s) S  
 Porch roof type(s) hip  
 Exterior Ornament rounded corners  
 Interior Plan\* unknown  
 Condition (Please check one):  excellent  good  fair  deteriorated  ruinous  
 Surroundings (N=None, S=Some, M=Most, A=All/nearly all): commercial M residential S institutional \_\_\_\_\_ undeveloped  
 Ancillary Features (No., type of outbuildings, major landscape features. Use continuation sheet for descriptions of interior, landscaping, etc)

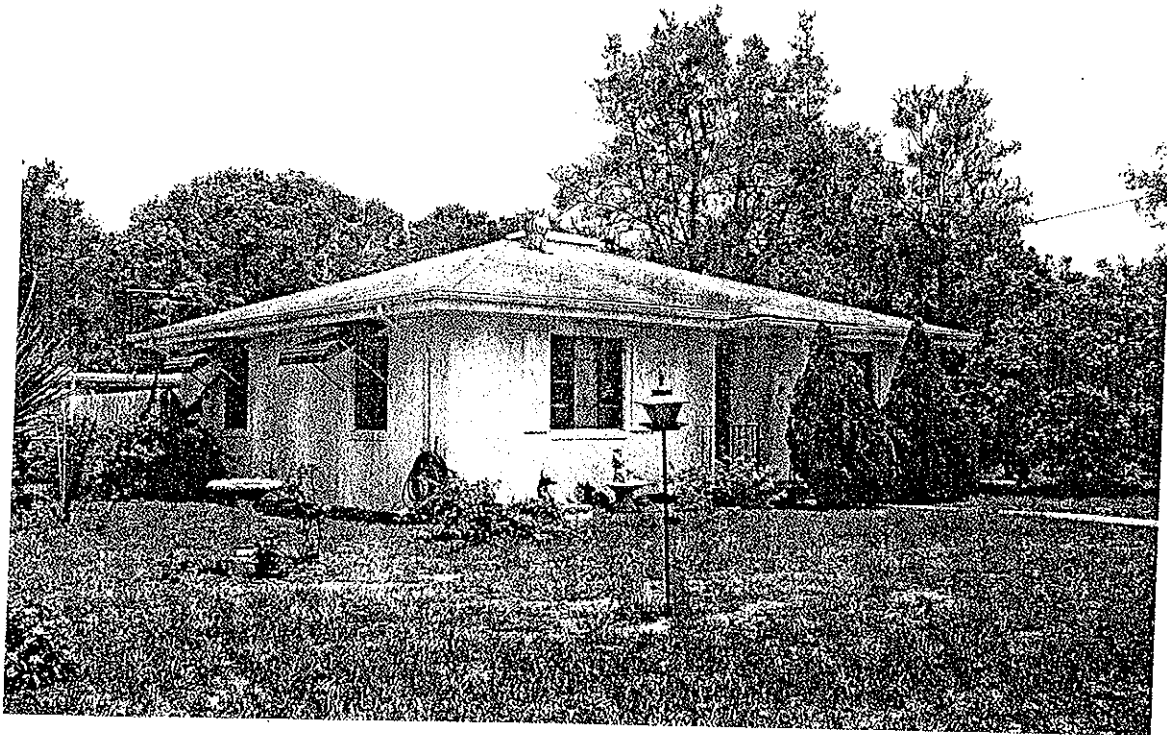
PHOTOGRAPH

Style\* Ranch Exterior Plan\* irregular Number of Stories 1  
Structural System(s)\* concrete block  
Foundation: Type(s)\* continuous Material(s)\* concrete block  
Exterior Fabric(s)\* stucco  
Roof: Type(s)\* hip Material(s)\* composition shingle  
Roof secondary strucs. (dormers etc.)\* \_\_\_\_\_  
Chimney: No 1 Material(s)\* brick Location(s)\* int N slope  
Windows (types, materials, etc.)\* 12 and 8 light casement, metal, independent; 2 light awning, metal, independent; 2/2 SHS, metal, independent  
Main Entrance (stylistic details) \_\_\_\_\_  
Porches: #open 1 #closed \_\_\_\_\_ #incised \_\_\_\_\_ Location(s) S  
Porch roof type(s) hip  
Exterior Ornament metal awnings  
Interior Plan\* unknown  
Condition (Please check one):  excellent  good  fair  deteriorated  ruinous  
Surroundings (N=None, S=Some, M=Most, A=All/nearly all): commercial M residential S institutional \_\_\_\_\_ undeveloped

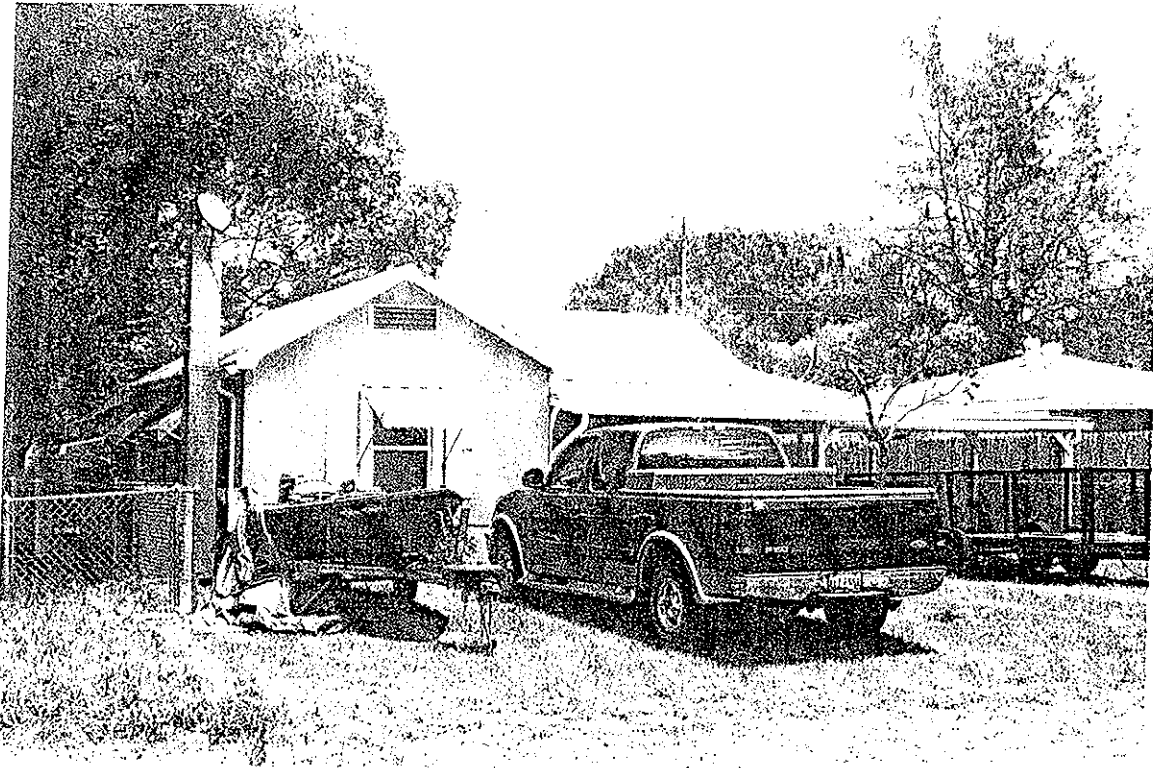
PHOTOGRAPH

Explanation of Evaluation (required, whether positive or not; limit to three lines; attach longer statement, if needed, on separate sheet)  
Limited research did not reveal any historical significance. This building is typical of Frame Vernacular buildings found throughout Zephyrhills and Pasco County. Therefore, it does not appear NRHP eligible.

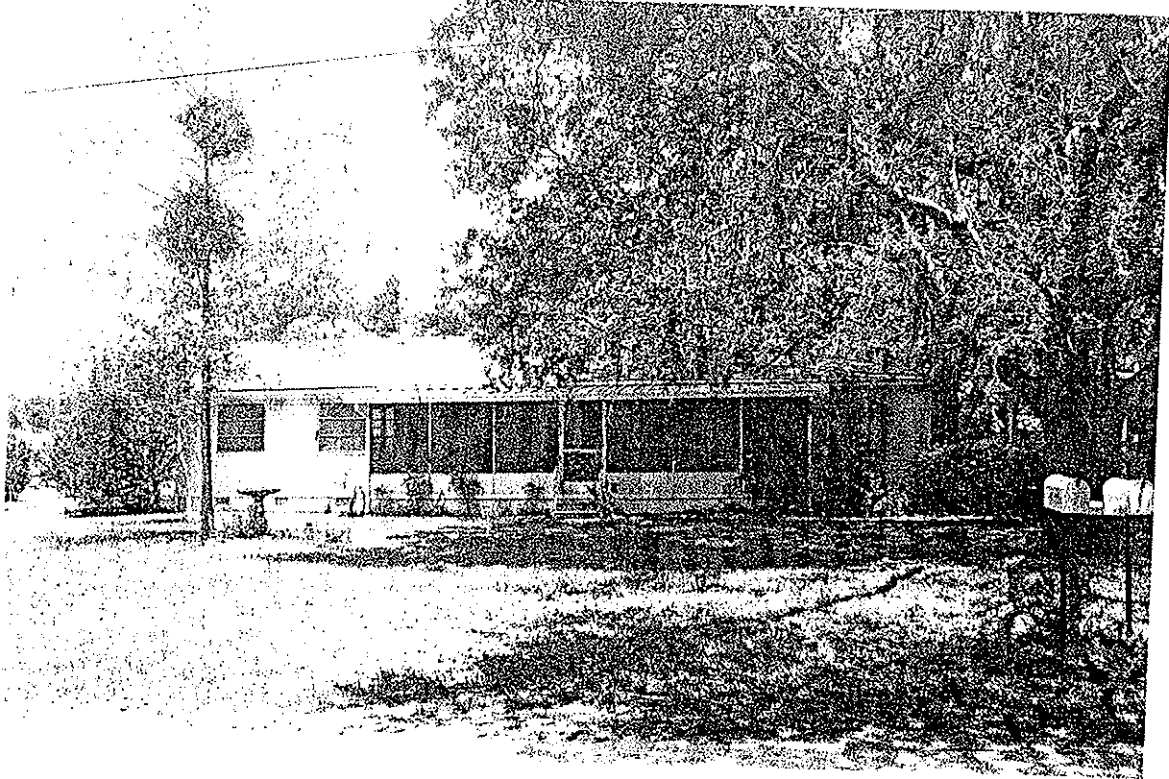
PHOTOGRAPH

Style\* Frame Vernacular Exterior Plan\* rectangular Number of Stories 1  
Structural System(s)\* wood frame  
Foundation: Type(s)\* continuous Material(s)\* concrete block  
Exterior Fabric(s)\* vinyl siding  
Roof: Type(s)\* gable, shed Material(s)\* composition shingle, corrugated metal  
Roof secondary strucs. (dormers etc.)\* \_\_\_\_\_  
Chimney: No 0 Material(s)\* \_\_\_\_\_ Location(s)\* \_\_\_\_\_  
Windows (types, materials, etc.)\* 1/1 DHS, wood, independent; 3 light awning, metal, independent and paired;  
2 light awning, metal, independent  
Main Entrance (stylistic details) \_\_\_\_\_  
Porches: #open 1 #closed \_\_\_\_\_ #incised \_\_\_\_\_ Location(s) S  
Porch roof type(s) shed  
Exterior Ornament \_\_\_\_\_  
Interior Plan\* unknown  
Condition (Please check one):  excellent  good  fair  deteriorated  ruinous  
Surroundings (N=None, S=Some, M=Most, A=All/nearly all): commercial M residential S institutional \_\_\_\_\_ undeveloped

**8PA1286:** The duplex located within proposed Pond 2-21 at 38025-31 13th Avenue was constructed in a largely residential area ca. 1950. Built in the Frame Vernacular style, the rectangular one-story duplex has a continuous concrete block foundation, vinyl siding, a gable roof, and 1/1 double-hung sash and three-light awning windows. A porch with a shed roof is located on the south facade. Alterations include the ca. 1970 replacement of some original windows, and the ca. 1985 application of vinyl siding over the original siding. A ca. 1950 shed is east of the residence, and a ca. 1995 carport is southeast of the duplex. Alterations to this typical Frame Vernacular duplex have diminished its architectural integrity. In addition, limited research did not reveal any historical significance. Therefore, 8PA1286 does not appear NRHP eligible.

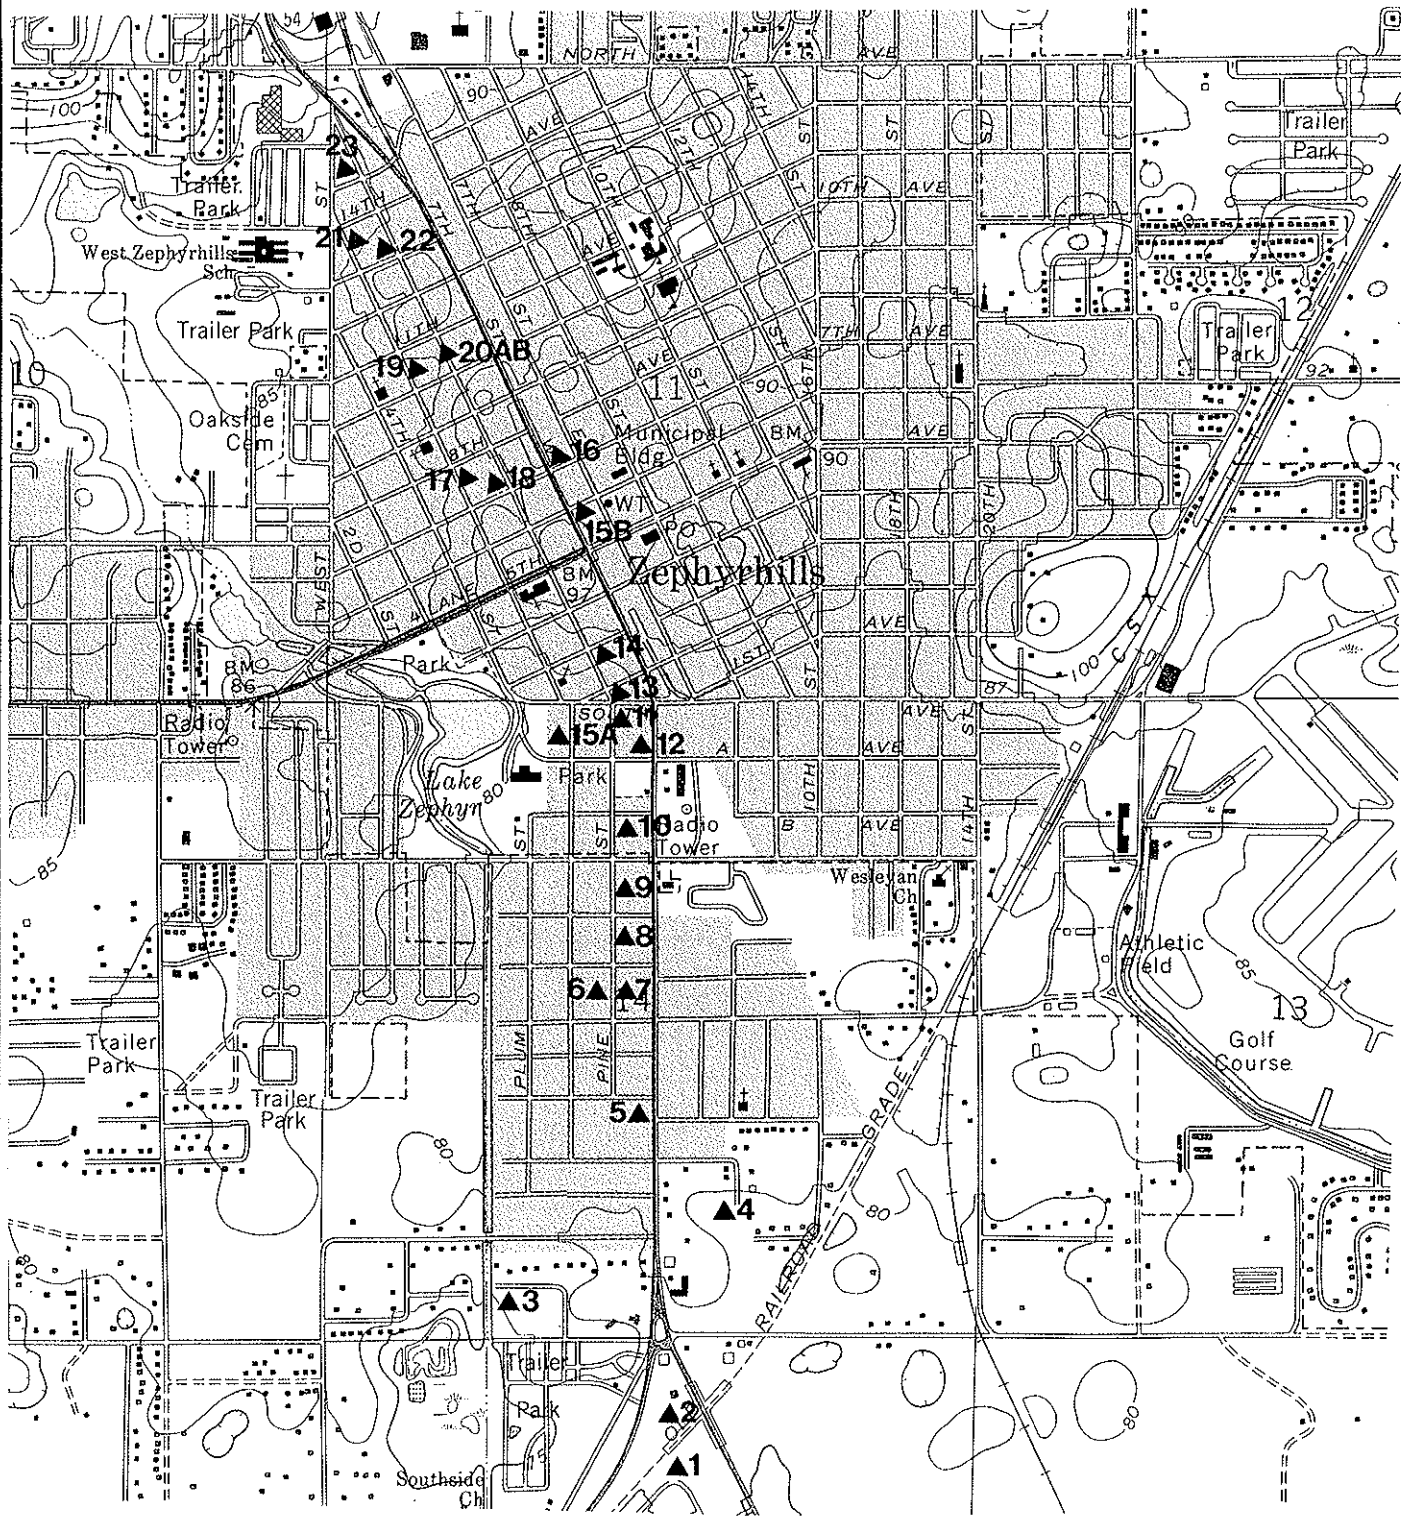
**ATTACH PLOT OF SURVEY AREA ON PHOTOCOPIES OF USGS 1:24,000 MAP(S)**

**U.S. 301/ZEPHYRHILLS  
PROPOSED POND SITE ALTERNATIVES**  
(Triangles denote approximate locations)  
(USGS Zephyrhills, Fla. 1975 PR 1987  
Scale 1:24,000
