US 41 (SR 45)

Project Development and Environment (PD&E) Study

Final Cultural Resource Assessment Survey

WPI Segment No: 421140 8
Hillsborough County

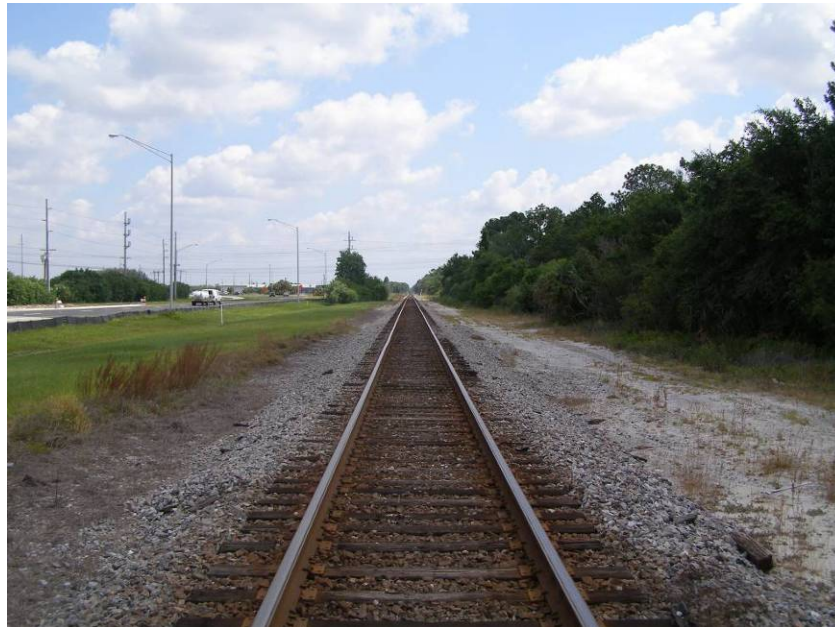
Photo 6-1 Looking north at the recorded segment of CSX Railroad, 8HI10237, adjacent to US 41.

8HI10237: A segment of the CSX Railroad (Photo 6-1), measuring approximately 1.35 miles in length, is located adjacent to the US 41 project APE. It is located in Township 31 South, Range 19 East, Sections 15 and 22 (Figure 6-3). Based on examination of modern aerials, the entire resource within Hillsborough County measures approximately 25 miles and runs from a CSX service station north of Adamo Drive, south to the Hillsborough/Manatee County Line. This segment consists of a single standard gauge track constructed on a stone ballast. It is currently in use and appears to be maintained. A modern spur line has been constructed north of the segment and crosses US 41. There are two crossing signals within the recorded segment. One is located at the intersection of Apollo Beach Boulevard, and the other is located approximately 0.2 miles south of the northern terminus of this recorded segment (Photo 6-2). In addition, this segment crosses over the Newman Branch waterway via a bridge (Photo 6-3) located approximately 0.48 miles north of the intersection of Apollo Beach Boulevard. No railroad-related structures were observed in relation to this segment of 8HI10237.

The railway was historically important to the promotion of development of the region, and appears to retain its historic function and association. However, this small segment is typical of railroad construction and function in the region. In addition, background research revealed no associations with any significant historical event or person. Although the system retains significance for its role in the development of the area, the segment evaluated within this project represents a small portion of the system. Thus, there is insufficient information to assess the significance of 8HI10237 based on the small segment recorded (cf., ACI 2008; Janus Research 2006; Johnston and Mattick 2001). Evaluation of the entire line through Hillsborough County was outside the scope of this project.

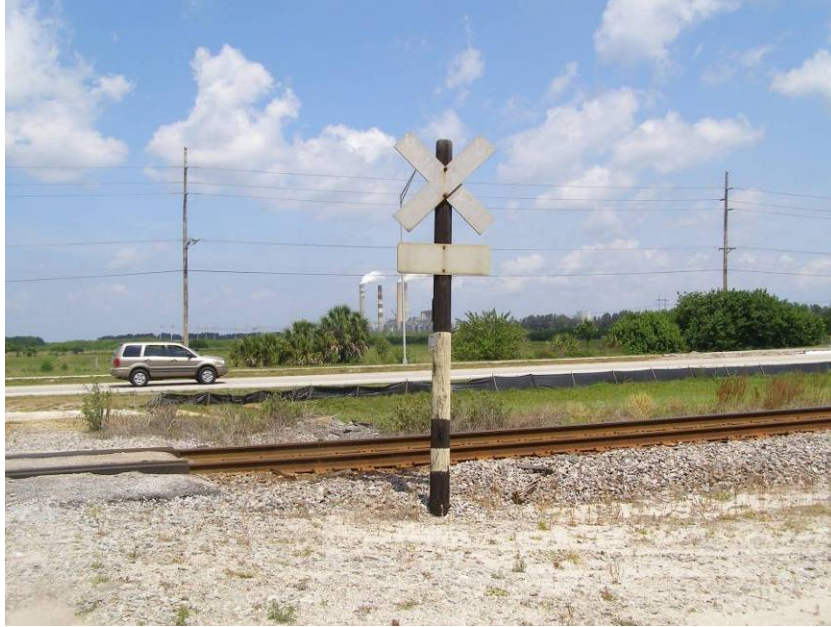
Photo 6-2 Detail of the northern railroad crossing within the recorded segment.

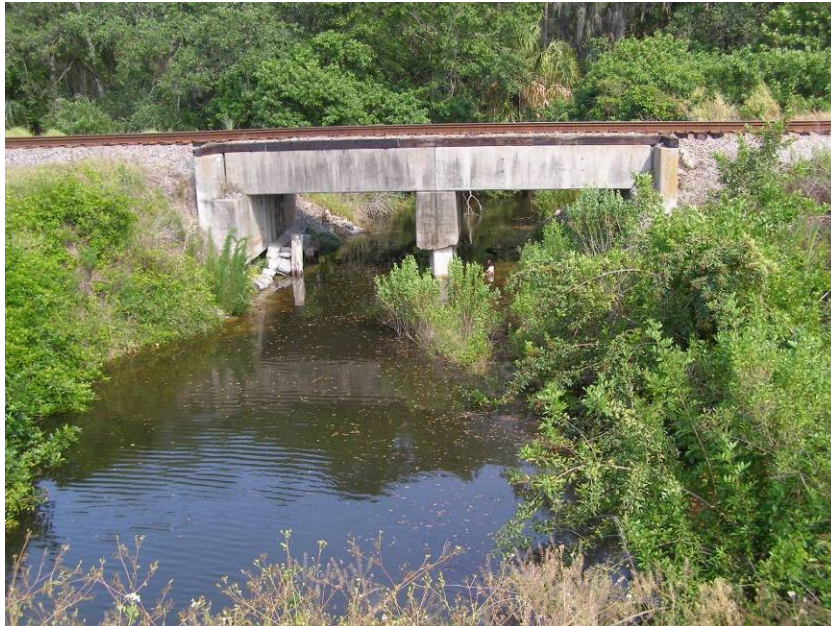
Photo 6-3 Bridge over Newman Branch waterway.

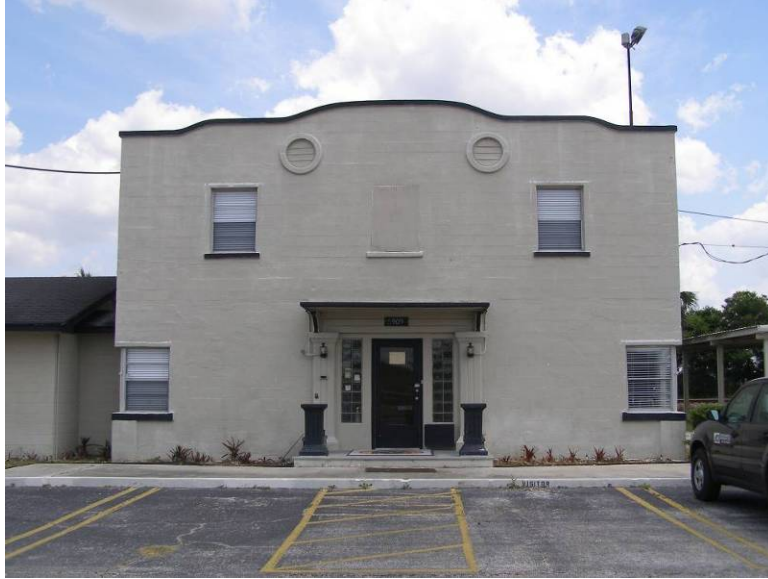
Photo 6-4 West elevation of the Ruskin Vegetable Corporation Office, 8HI1010.

8HI11317: The vacant Ruskin Vegetable Corporation Resource Group (Photos 6-4 and 6-5) at 5909 South US Highway 41 was built during the period of ca. 1941 and 1945. This resource group consists of two contributing resources, an office building (8HI1010) constructed ca. 1941, and the packing warehouse building (8HI11362), constructed ca. 1945. The Ruskin Vegetable Corporation began as the Manatee Growers Association est. 1918. It later became the Ruskin Vegetable Corporation under the leadership of one of Ruskin's founders, Paul Dickman. The corporation was eventually sold and managed through a number of people before it finally closed down in the early 2000s. These two

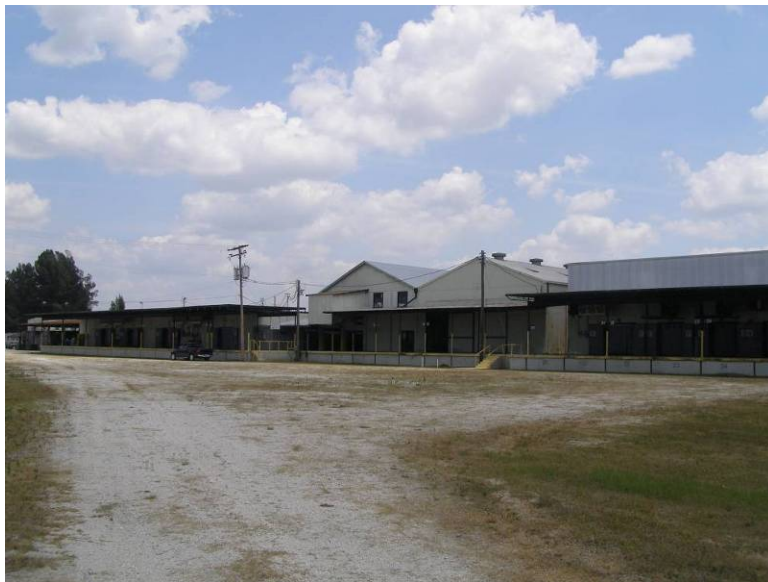
Photo 6-5 Looking northeast at the Ruskin Vegetable Corporation Resource Group, 8HI11317.

agricultural buildings feature a unique architectural style to the area and represent an important local industry. Therefore, 8HI11317 appears to be potentially eligible for listing in the NRHP under Criterion A for its contribution to the early development of Ruskin and its role as one of the leading tomato packinghouses in the area, and under Criterion C as unique examples of the Mission style associated with an agricultural commercial use.

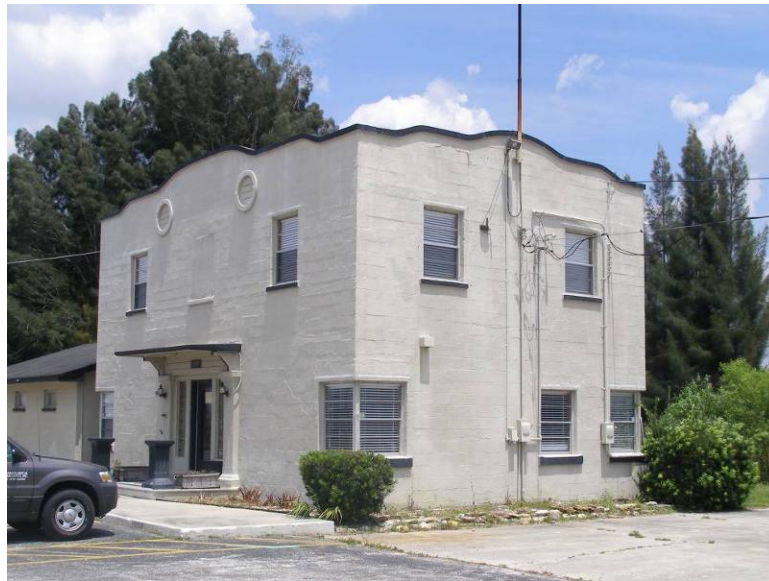
Photo 6-6 South and west elevations of the Ruskin Vegetable Corporation Office, 8HI1010.

8HI1010: The Ruskin Vegetable Corporation Office building (Photo 6-6), located at 5909 South US 41, was constructed ca. 1941 in the Mission style. The building has a slab foundation which supports the concrete block walls that are clad in stucco. The flat roof has a Mission style parapet, and the windows are replacement two-over-two single hung sash (ca. 1970). The main entrance, on the west elevation, is a one-light wood swing door flanked by glass block sidelights. It is accessed via an open porch with a flat roof supported by engaged pilasters and decorative brackets. Other architectural features include projecting window sills and ocular roof vents. An addition was constructed on the north elevation ca. 1970. This is a good example of the Mission style used as a commercial building in Hillsborough County. It was previously recorded as part of the Cultural Resources of the Unincorporated Portions of Hillsborough County survey and is locally listed as a Hillsborough County Historic Landmark (HT/HCPB 1980). The office building has undergone minimal alterations, and the addition does not detract from its overall character; thus, it maintains a high level of integrity. In addition, it remains as an example of the once thriving tomato industry in the Ruskin area. Thus, 8HI1010 appears to be potentially eligible for individual listing in the NRHP under Criterion A for its contribution to the early agricultural development of Ruskin and its role as one of the leading tomato packinghouses in the area, and under Criterion C as a unique example of the Mission style associated with the agricultural industry.

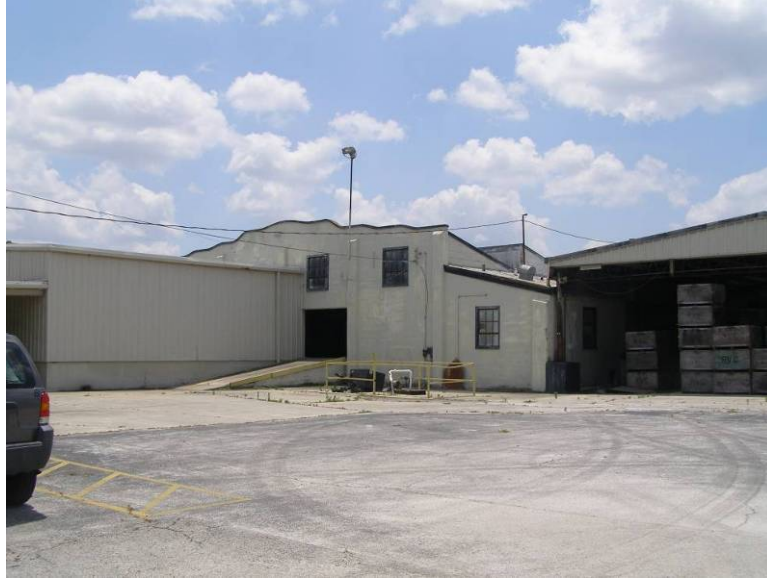
Photo 6-7 North elevation of the Ruskin Vegetable Corporation Warehouse, 8HI11362.

8HI11362: The Ruskin Vegetable Corporation Warehouse building (Photos 6-7 and 6-8), located at 5909 South US 41, was constructed ca. 1945 in the Mission style. The slab foundation supports the concrete block walls that are clad in stucco. The sawtooth and shed roof has a Mission style parapet and the windows are six-over-three awning with projecting window sills. There are garage-style openings on the east and north elevations. Three additions have been added to the south and west elevations ca. 1970 and 2000, which feature gable and shed roofs, and concrete block walls clad in corrugated metal and asbestos shingles. This resource was originally recorded as an ancillary feature of the Ruskin Vegetable Corporation Office, 8HI1010. This is a unique example of the Mission

style used as an agricultural warehouse in Hillsborough County, and it remains as an example of the once thriving tomato industry in the Ruskin area. However, the additions to the south and west compromise its integrity. Thus, 8HI11362 contributes to the Ruskin Vegetable Corporation Resource Group, 8HI11317; however, it does not appear to be potentially individually eligible for listing in the NRHP.

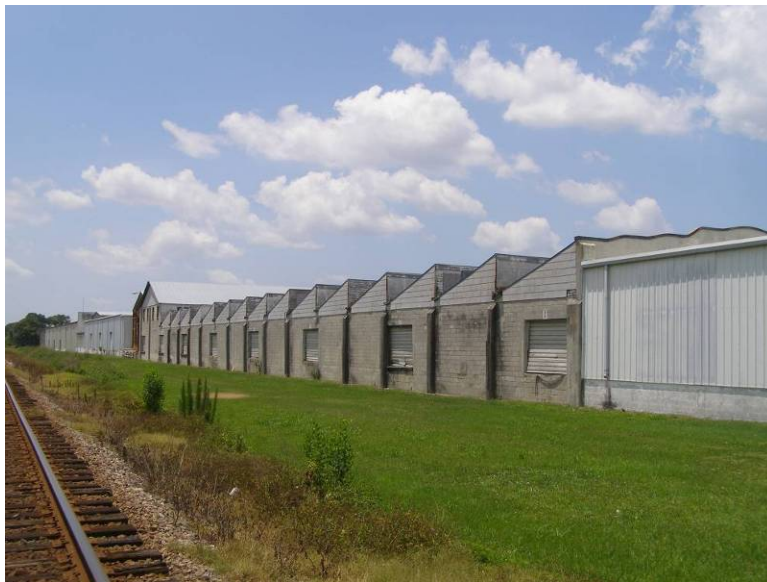
Photo 6-8 East elevation of the Ruskin Vegetable Corporation Warehouse, 8HI11362.

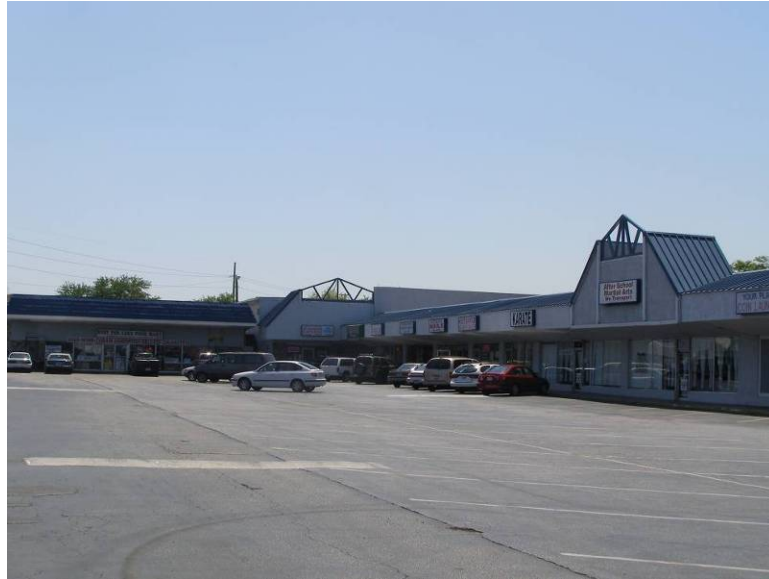
Photo 6-9 North and east elevations of 6018 South US Highway 41, 8HI11363.

first of its kind in Apollo Beach (Conlan 2008). The concrete block walls, supported by a slab foundation, are clad in ca. 1970 stucco, decorative wood siding panels and stone veneer. The flat and shed roof is faced in built-up material and corrugated metal. The replacement windows are one-light fixed with metal window surrounds (ca. 1970). The building contains 12 businesses, all of which are accessed via the wide canopy created by the false parapet that was added ca. 1970. An addition was constructed at the southeast corner ca. 1970. Although this is the earliest example of a shopping center in Apollo Beach, it is a typical example of the Commercial style found throughout Hillsborough County. Furthermore, the replacement stucco, stone veneer, and windows, false parapet, and the additions diminish its architectural integrity. Therefore, 8HI11363 is not considered potentially eligible for listing in the NRHP.

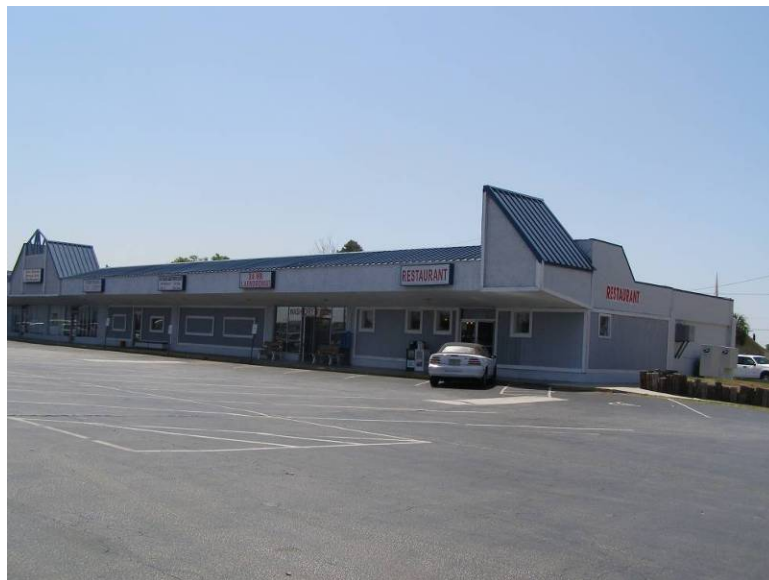
Photo 6-10 North and east elevations of 6018 South US Highway 41, 8HI11363.

8HI11363: The Apollo Beach Shopping Center (Photos 6-9 and 6-10), a ca. 1959 Commercial style building, is located at 6018 South US Highway 41. According to Kevin Conlan, member of the Apollo Beach Board of Directors, the shopping center was the

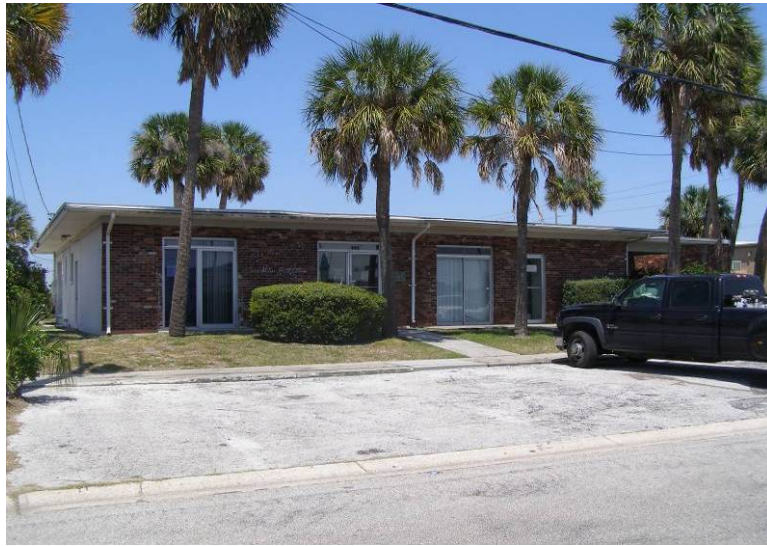
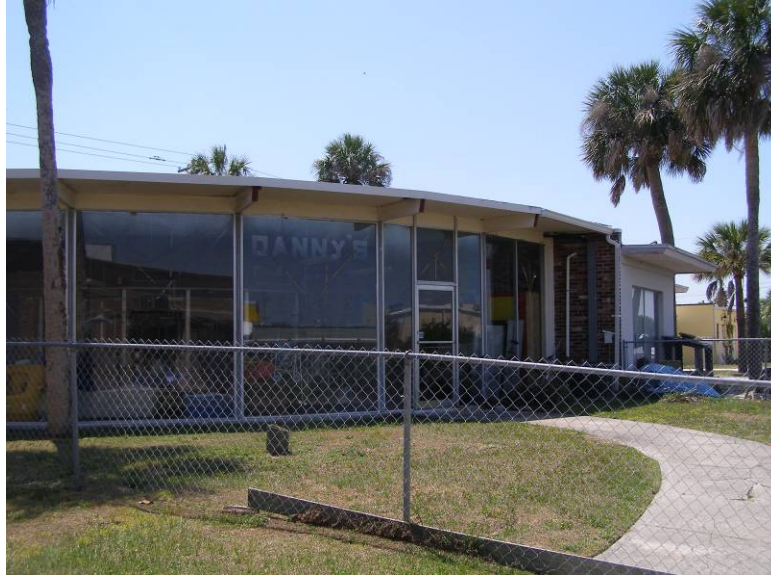
Photo 6-11 South elevation of 111 Flamingo Drive, 8HI11364.

Photo 6-12 South elevation of 111 Flamingo Drive, 8HI11364.

Photo 6-13 North elevation of 111 Flamingo Drive, 8HI11364.

8HI11364: The Modern commercial building located at 111 Flamingo Drive (Photos 6-11, 6-12 and 6-13) was constructed ca. 1958. The slab foundation supports the brick and concrete block walls that are partially clad in stucco. The building is topped by a flat roof with wide overhanging eaves. The windows are one-over-one single hung sash, one-light sliding, and one-light fixed. Some of these one-light fixed windows form a semi-circular curtain wall on the northeast elevation. An open porch is on the southeast elevation. Attempts were made to contact the original property owner to inquire about this building's designer, but with no response. This is an early example of the Modern style in the Apollo Beach area. 8HI11364 exhibits typical Modern features including a flat roof with wide eaves, the contrasting use of solid material (brick) and light material (glass), exposed beams, and the unique shape of the curtain wall. It remains largely unaltered, thus, maintaining a high degree of integrity. Research of historic resources, including a review of the FMSF, the NRHP, and Historic Resources of Hillsborough County surveys (HT/HCPB 1980; Maio and Mohlman 1998; HPCGM 2004), indicate that a small number of mid-century buildings in the Modernistic style with a high level of integrity remain throughout the county. Therefore, 8HI11364 is considered potentially eligible for listing in the NRHP at the local level under Criterion C.

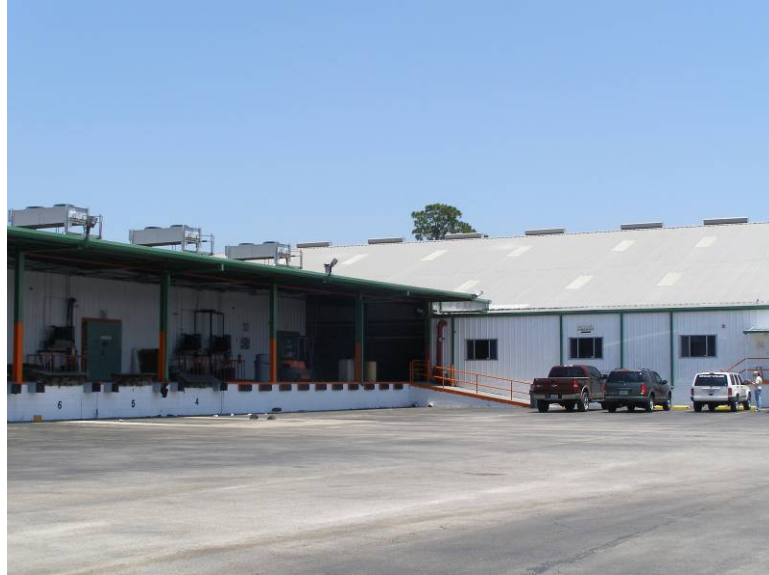
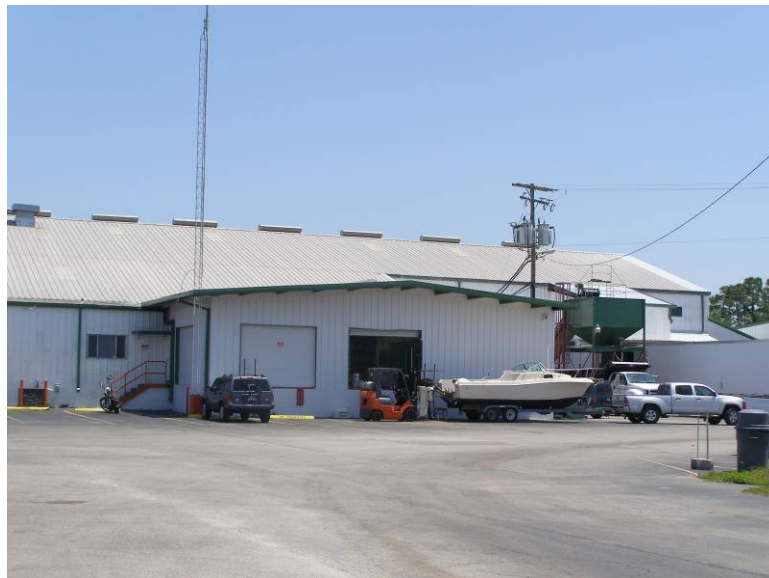
Photo 6-14 View of the Pacific Tomato Growers Ltd. Resource Group, looking northwest.

Photo 6-15 View of the Pacific Tomato Growers Ltd. Resource Group, looking southwest.

8HI11318: Pacific Tomato Growers Ltd. Resource Group (Photos 6-14 and 6-15), located at 6855 North US Highway 41, was constructed ca. 1954 as an extension of the Ruskin Tomato Growers (Burns 2008). It consists of four contributing buildings (8HI11365 - 8HI11368), two in the Industrial Vernacular style, and two in the Frame Vernacular style, used as the main packinghouse, a storage building, an office, and a scale building. Although these buildings represent the once thriving local tomato industry, these are typical examples of the Industrial and Frame Vernacular styles used as

an agricultural commercial complex in the area. Furthermore, additions and alterations have diminished the collective architectural integrity. Therefore, 8HI11318 is not considered eligible for listing in the NRHP.

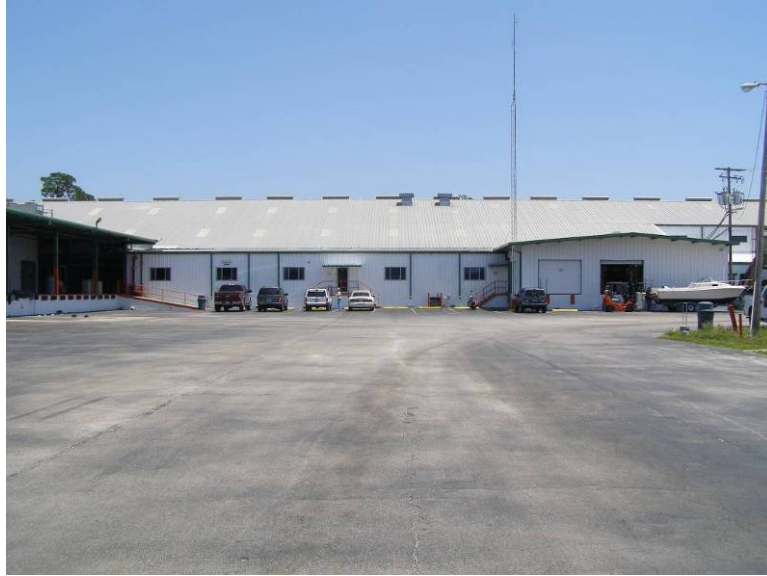
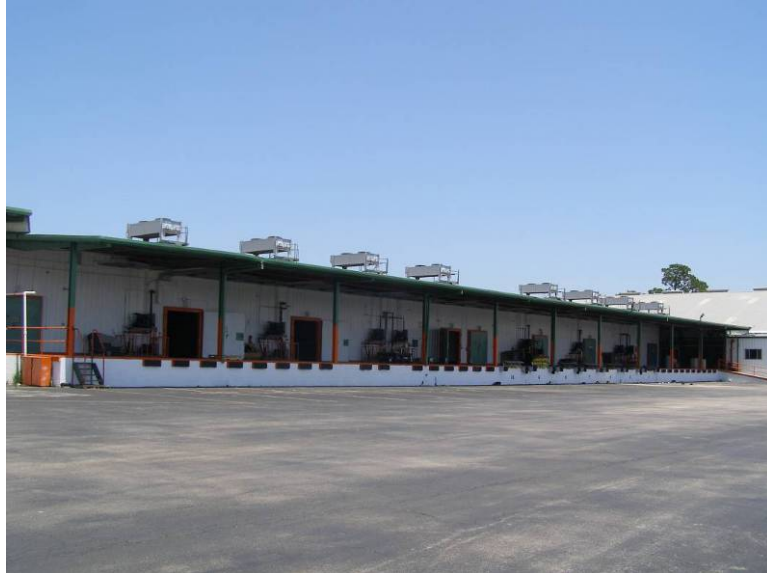
Photo 6-16 West elevation of the Pacific Tomato Growers Ltd. Packinghouse at 6855 North US Highway 41, 8HI11365.

Photo 6-17 Circa 1970 addition to the Pacific Tomato Growers Ltd. Packinghouse at 6855 North US Highway 41, 8HI11365.

8HI11365: The Packinghouse (Photos 6-16 and 6-17) of the Pacific Tomato Growers, Ltd. Complex, located at 6855 North US Highway 41, was constructed in the Industrial Vernacular style ca. 1954. The building rests on a continuous concrete block foundation

and the concrete block and steel frame walls are partially clad in aluminum sheeting. The building is topped with a gable roof covered with 3-V crimp metal sheeting and the windows are one-light fixed flanked by one-light sliding. The main entrance is within an open porch with a shed roof on the west elevation and is accessed via a set of concrete steps. Other architectural features include roof vents and exposed rafters. An addition, used as a filling station for loading and unloading trucks, was constructed on the west elevation ca. 1970. Although part of a complex that represents the once thriving local tomato industry, this is a typical example of the Industrial Vernacular style found throughout Hillsborough County. Therefore, 8HI11366 does not appear to be potentially eligible for listing in the NRHP.

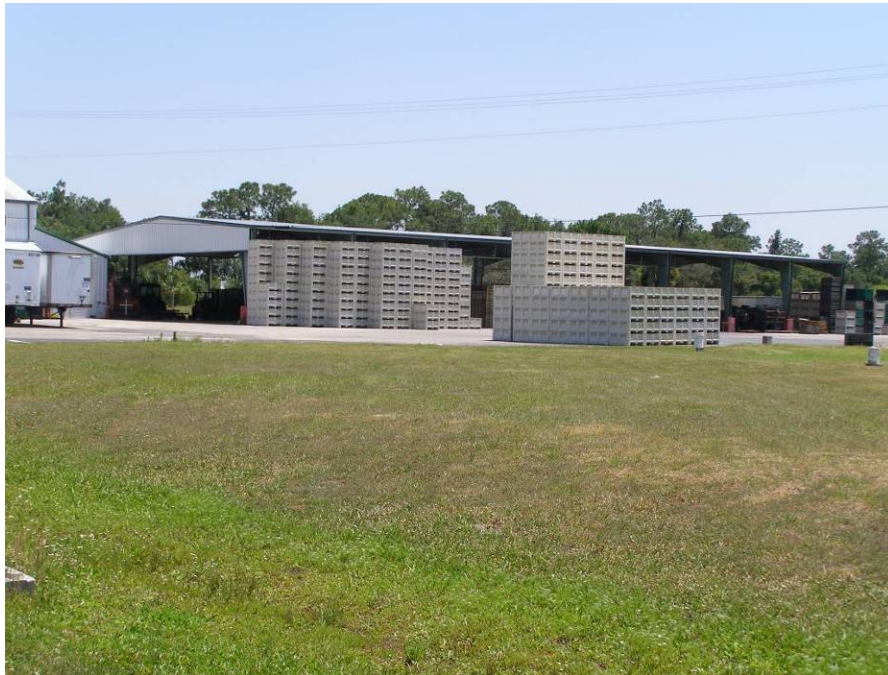
Photo 6-18 North and west elevations of the Storage Building at 6855 North US Highway 41, 8HI11366.

8HI11366: The Storage Building (Photo 6-18) of the Pacific Tomato Growers, Ltd. Complex, located at 6855 North US Highway 41, was constructed as a warehouse ca. 1954 in the Industrial Vernacular style. The slab foundation supports the steel frame structure. The gable roof is covered with 3-V crimp metal sheeting. Although part of a complex that represents the once thriving local tomato industry, this is a typical example of the Industrial Vernacular style found throughout Hillsborough County. Therefore, 8HI11366 does not appear to be potentially eligible for listing in the NRHP.

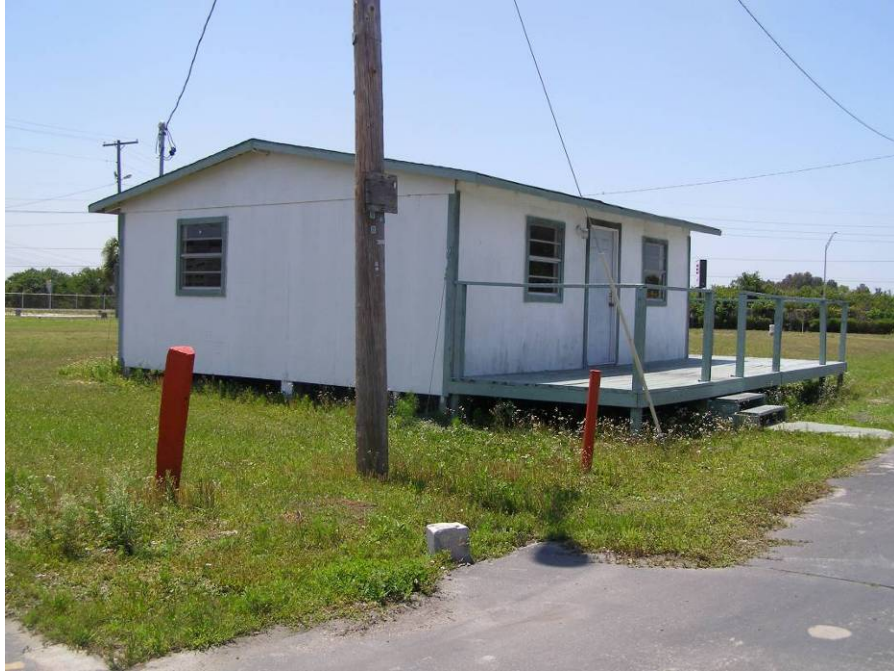
Photo 6-19 North and east elevations of the old Office Building at 6855 North US Highway 41, 8HI11367.

8HI11367: The old Office Building (Photo 6-19) of the Pacific Tomato Growers, Ltd complex, 6855 North US Highway 41, was constructed in the Frame Vernacular style ca. 1954. The concrete block pier foundation supports the wood frame walls clad in plywood sheeting. The gable roof is faced with composition shingles and the windows are two-over-two single hung sash. An open porch with no roof is located on the north elevation and provides access to the main entrance. Although part of a complex that represents the once thriving local tomato industry, this is a typical example of the Frame Vernacular style found throughout Hillsborough County. Therefore, 8HI11367 does not appear to be potentially eligible for listing in the NRHP.

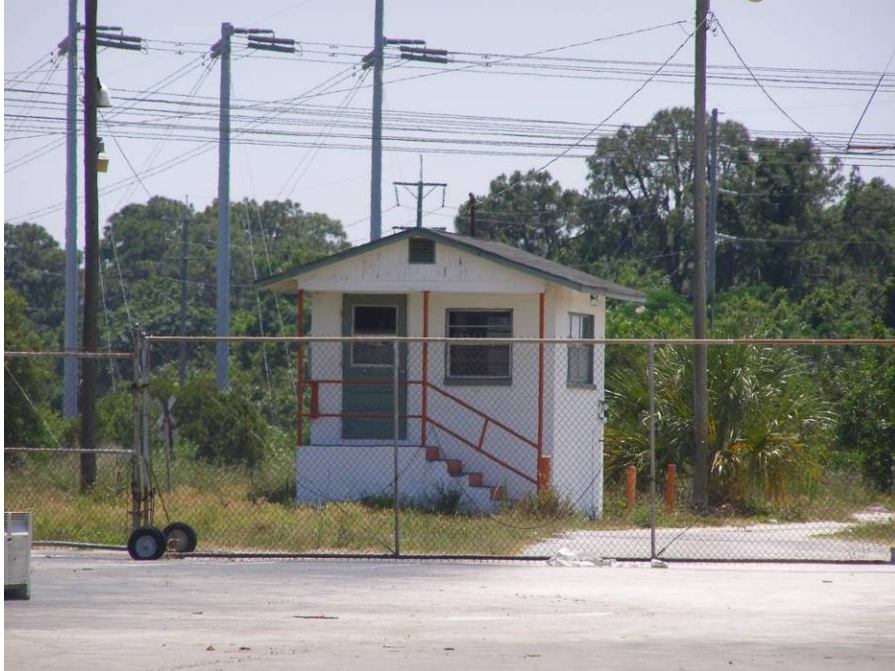
Photo 6-20 North and west elevations of the Scale Building at 6855 North US Highway 41, 8HI11368.

8HI11368: The Scale Building (Photo 6-20) at the Pacific Tomato Growers, Ltd complex, 6855 North US Highway 41, was constructed in the Frame Vernacular style ca. 1954. It was used to weigh the trucks as they were loaded from the warehouses prior to transport. The concrete block pier foundation supports the wood frame walls clad in plywood sheathing. The gable roof is faced with composition shingles, and the windows are two-over-two single hung sash. An incised porch with concrete steps is located on the north elevation and provides access to the main entrance. This building is part of a complex that represents the once thriving local tomato industry; however, it is uncharacterized by its design. Therefore, 8HI11368 is not considered potentially eligible for listing in the NRHP.

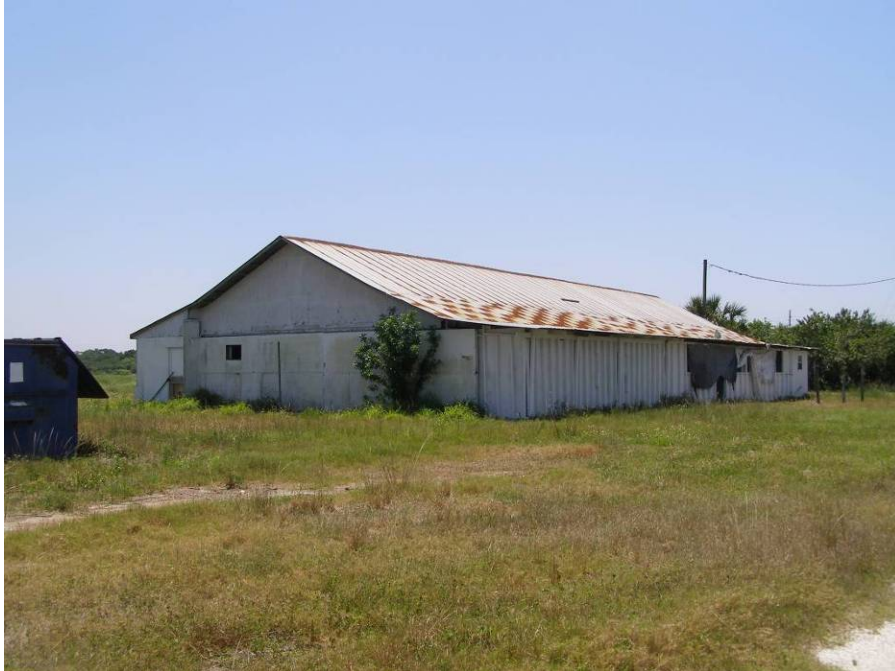
Photo 6-21 North and west elevations of 13124 South US Highway 41 (8HI11360), looking southeast.

8HI11360: This ca. 1945 Frame Vernacular style structure (Photo 6-21), formerly used as a warehouse, is located at 13124 South US Highway 41. It is currently vacant. This resource features a slab foundation, wood frame walls faced with plywood sheeting and corrugated metal, a gable and shed roof faced with 5-V metal crimp, and one-over-one single hung sash windows. Additions (ca. 1980 and ca. 1990) are on the east and west with barn-style openings. This resource was recently recorded as part of the Cultural Resource Assessment Survey of the Big Bend Distribution Center property, during which it was evaluated as ineligible for listing in the NRHP (ACI 2008). It has not yet been evaluated by the SHPO. Given the recent evaluation by ACI, the FMSF form was not updated as part of the US 41 project.

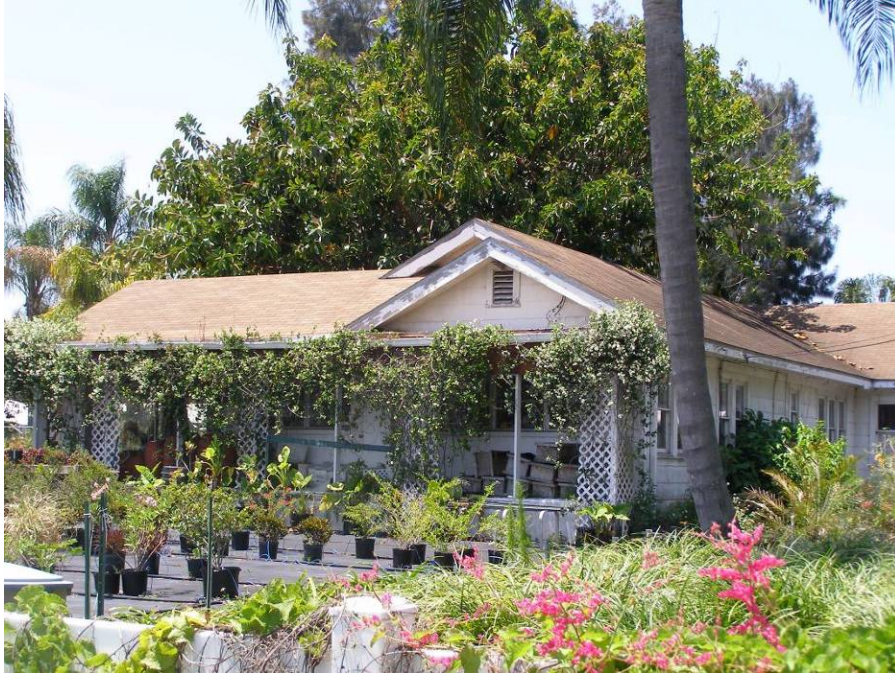
Photo 6-22 North and east elevations 101 Big Bend Road, 8HI11369.

8HI11369: The Frame/Masonry Vernacular style building (Photo 6-22) located at 101 Big Bend Road was constructed ca. 1935. Originally a residence, it is currently used as a garden center. The original portions of this building feature a continuous brick and slab foundation that supports the wood frame and concrete block walls clad in asbestos shingles. It is topped with a cross gable and hip roof that is faced in composition shingles. The windows are original one-over-one double hung sash. Other architectural features include some window surrounds, gable vents, and eave vents. In ca. 1960, the east porch was enclosed. Concrete block additions with stucco and two-light awning and one-light fixed windows were also built on the east and south elevations ca. 1960. A carport with a flat roof was constructed on the south elevation ca. 1965. The original portions of this structure are typical of the Frame Vernacular style throughout Hillsborough County, but numerous additions have compromised its architectural integrity. In addition, research revealed no significant historical associations. Therefore, 8HI11369 is not considered potentially eligible for listing in the NRHP.

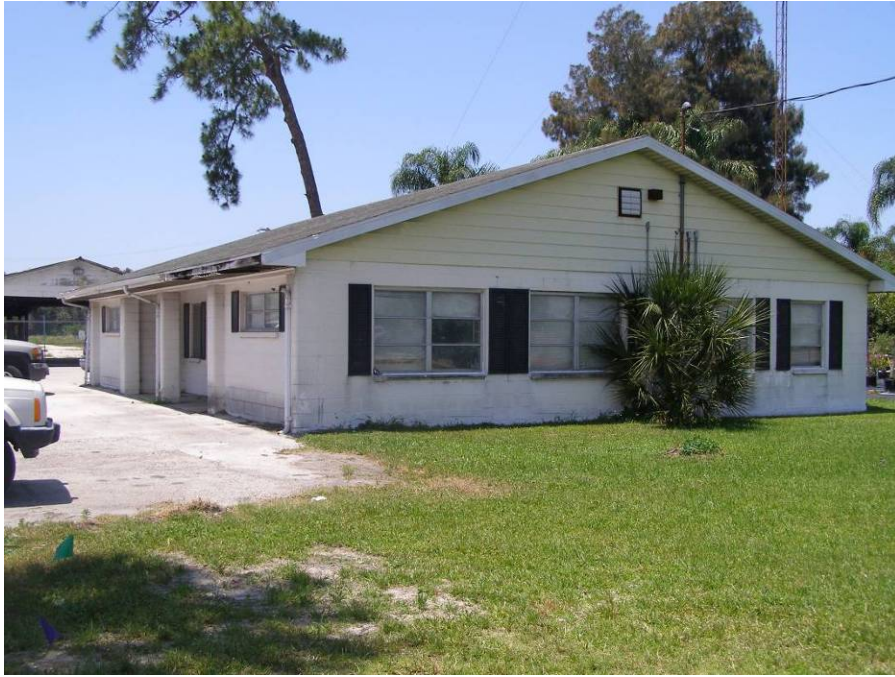
Photo 6-23 South and east elevations of 103 Big Bend Road, 8HI11370.

8HI11370: The Masonry Vernacular style farm office (Photo 6-23) located at 103 Big Bend Road was constructed ca. 1950. The continuous concrete block foundation supports the concrete block walls that are clad in aluminum siding in the gables. The building is topped by a gable roof faced in composition shingles. The main entrance is located on the south elevation and is accessed via an incised porch with engaged pilasters. The windows are two-light awning and three-light fixed, all with fixed window shutters. Decorative features included rounded corners on the building and pilasters, and projecting window sills. This is a typical example of the Masonry Vernacular and is not distinguished by its architectural features. In addition, research did not reveal any associations to significant historic events or persons. Therefore, 8HI11370 does not appear to be potentially eligible for listing in the NRHP.

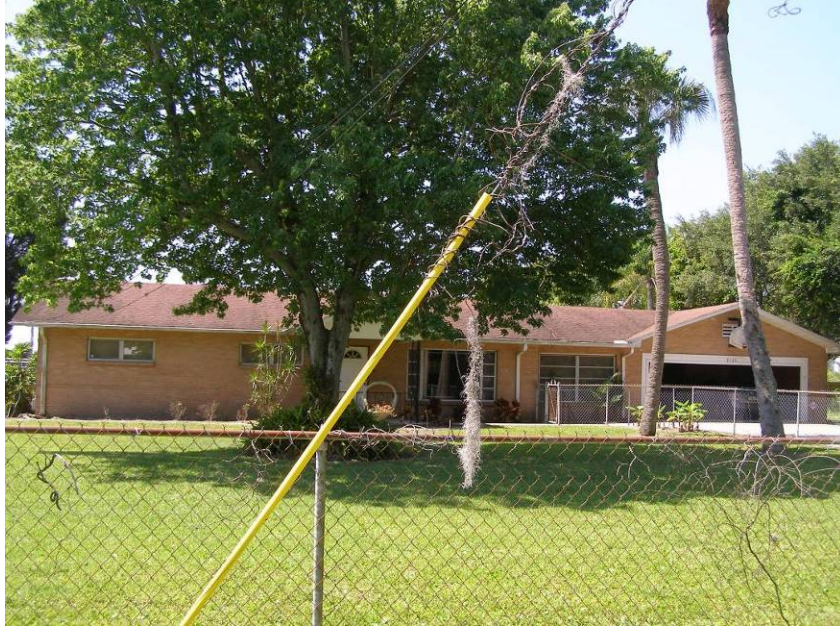
Photo 6-24 North elevation of 6125 Adamsville Road, 8HI11371.

and brick chimney, and an outhouse to the southeast. This is a typical example of the Ranch style found throughout Hillsborough County with no distinct features. In addition, research revealed no significant historical associations. Therefore, 8HI11371 is not considered potentially eligible for listing in the NRHP

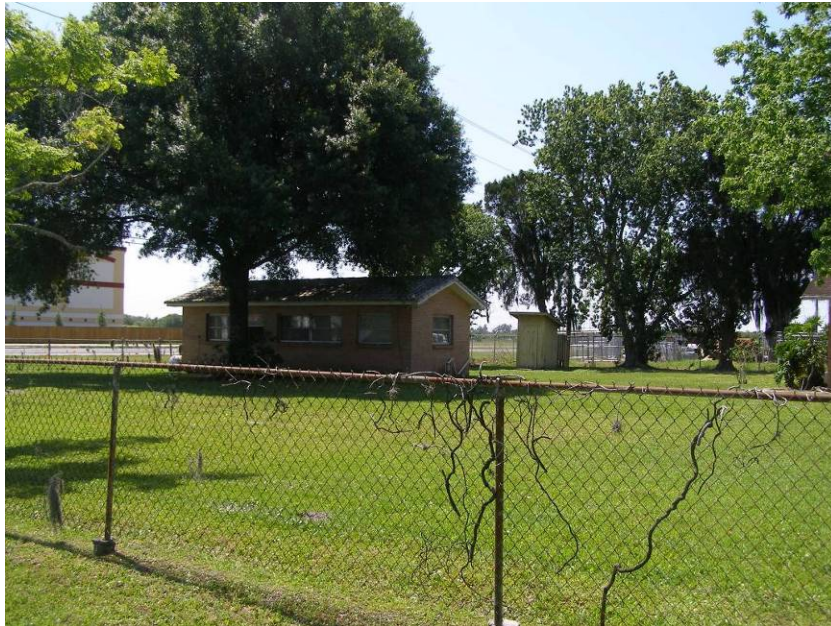
Photo 6-25 Ancillary structure to 6125 Adamsville Road, 8HI11371.

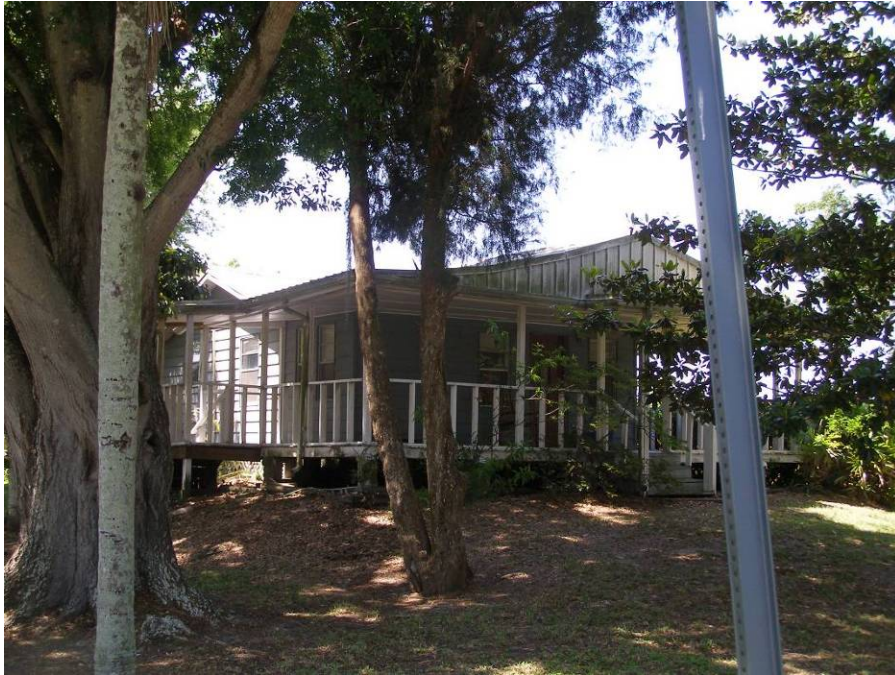
Photo 6-26 North and east elevations of 6123 Adamsville Road, 8HI11372.

8HI11372: The Frame Vernacular style residence (Photo 6-26) located at 6123 Adamsville Road was built ca. 1935. The pier foundation of poured concrete supports the wood frame walls that are clad in aluminum siding. The cross-gable roof is faced in 3-V crimp and the windows are replacement two-over-two single hung sash (ca. 1970). A wraparound porch with shed and gable roof is located on the south elevation and partially on the east and west elevations. The porch has a wooden rail and steps, and an access ramp was added on the west elevation ca. 1980. The porch provides access to the main entrance, a one-light, eight-panel wood swing door. A non-historic shed/carport is to the southwest. This is a typical example of the Frame Vernacular style found throughout Hillsborough County with no distinct features, and the replacement siding and windows diminish its integrity. In addition, research revealed no significant historical associations. Therefore, 8HI11372 does not appear to be potentially eligible for listing in the NRHP.

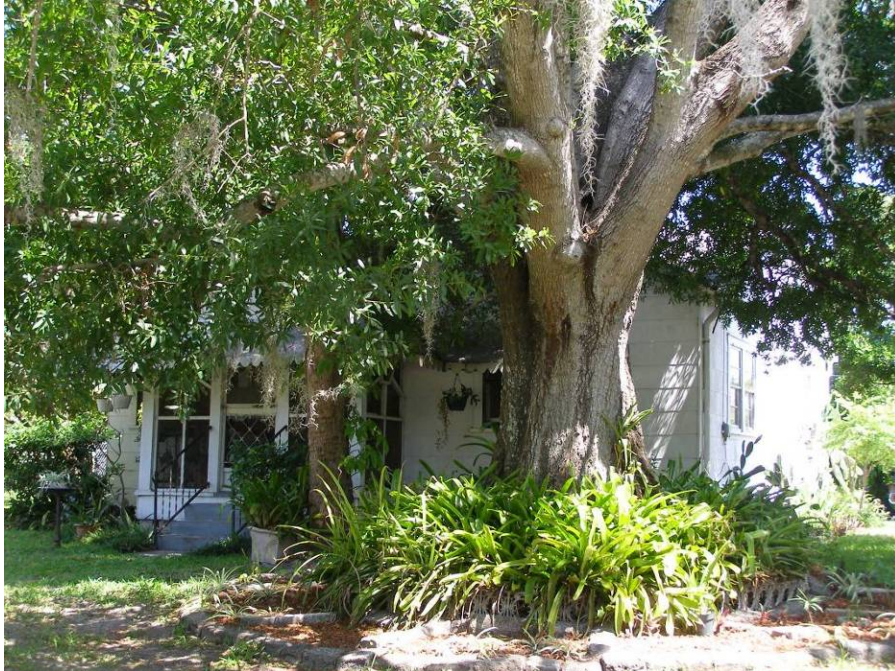
Photo 6-27 South and east elevations of 6124 Adamsville Road, 8HI11373.

8HI11373: The residence at 6124 Adamsville Road (Photo 6-27) was built in the Frame Vernacular style ca. 1935 (Spivey 2008). The continuous and pier foundation of concrete block and pierced concrete block supports the wood frame walls clad in asbestos shingles. A cross gable roof tops the house and is faced with composition shingles. The windows are one-over-one single hung sash with ca. 1960 storm windows. An open porch with a gable roof is located on the south elevation. It has decorative screen muntins and contains the main entrance. Other architectural features include wood window surrounds, awnings around the porch and over the windows, gable vents, and projecting window sills. An ancillary shed is to the northwest and a garage is to the northeast. This is an example of the Frame Vernacular style commonly found throughout Hillsborough County. Furthermore, research did not reveal any significant historical associations. Therefore, 8HI11373 does not appear to be potentially eligible for listing in the NRHP.

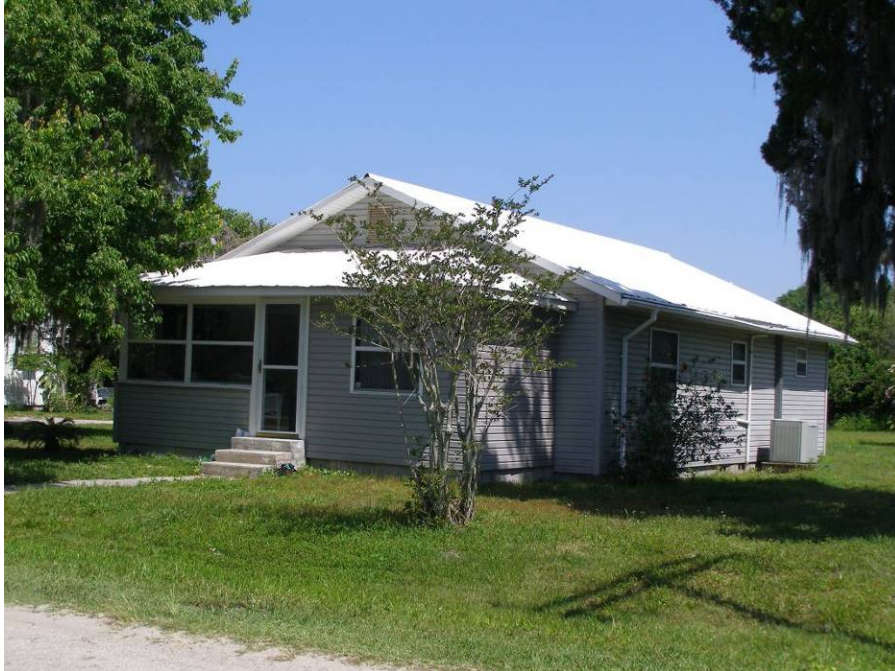
Photo 6-28 South and east elevations of 6126 Adamsville Road, 8HI11374.

8HI11374: The Frame Vernacular style residence (Photo 6-28) located at 6126 Adamsville Road was built ca. 1925. A concrete block pier and slab foundation supports the wood frame walls that are clad in vinyl siding (ca. 2000). The gable roof is faced with 5-V crimp (ca. 2000) and the windows were replaced ca. 2000 with one-over-one single hung sash, some of which have eight-over-eight simulated divided light. The main entrance is accessed via an enclosed porch (ca. 2000) on the south elevation. Other architectural features include gable vents and vinyl corner boards. Ancillary features include a non-historic garage to the northwest. This is a typical example of the Frame Vernacular style found throughout Hillsborough County. The replacement siding, roof, windows, and enclosed porch compromise its architectural integrity. Furthermore, research did not reveal any significant historical associations. Therefore, 8HI11374 does not appear to be potentially eligible for listing in the NRHP.

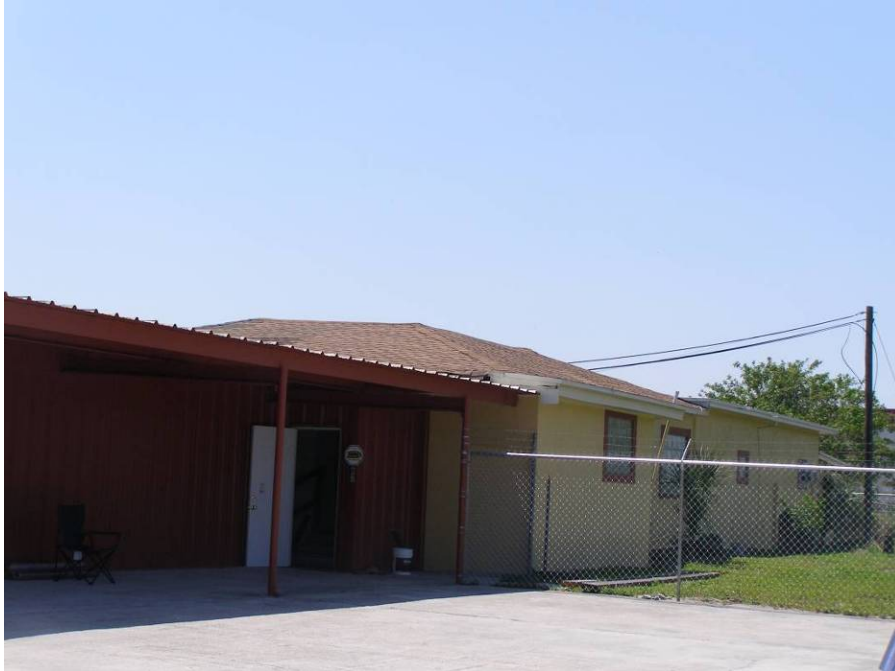
Photo 6-29 North and west elevations of 12623 South US Highway 41, 8HI11375.

8HI11375: The Frame/Masonry Vernacular style commercial building (Photo 6-29) located at 12623 South US Highway 41 was constructed ca. 1955. The poured concrete pier and slab foundation supports the wood frame and concrete block walls that are clad in stucco. The building is topped with a hip and flat roof covered in composition shingles and built-up material. The windows are glass block and some have wood window surrounds. A canopy is on the northwest elevation and two concrete block additions are on the south elevation. Although this Frame/Masonry Vernacular style structure is not typical of those found in Hillsborough County, numerous additions have compromised its architectural integrity. In addition, research revealed no significant historical associations. Therefore, 8HI11375 is not considered potentially eligible for the NRHP.

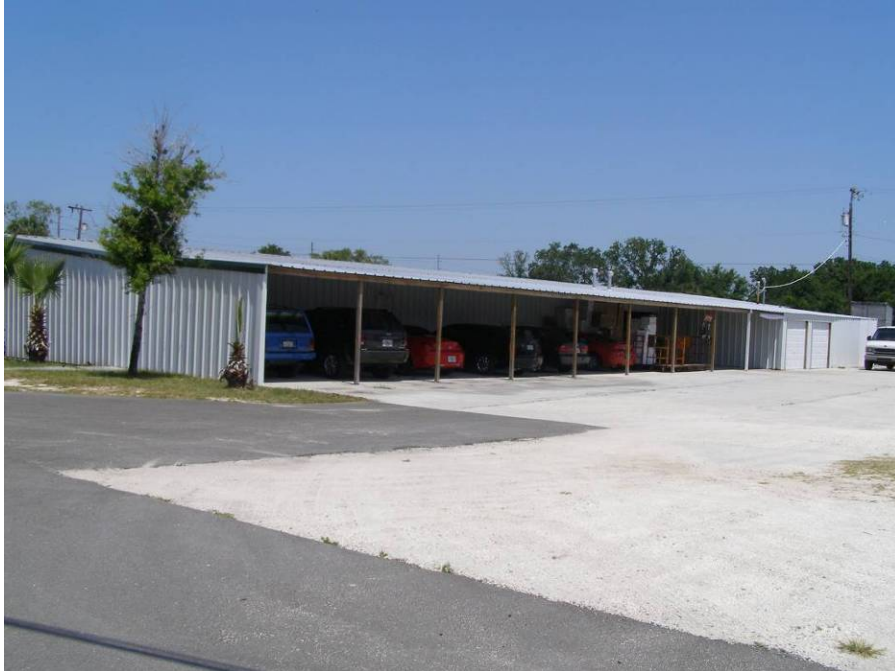
Photo 6-30 South and west elevations of 12608 South US Highway 41, 8HI11376.

8HI11376: The Masonry Vernacular style commercial building (Photo 6-30) located at 12608 South Highway 41 was constructed ca. 1953. A slab foundation supports the concrete block walls that are entirely encased in corrugated metal (ca. 1990). The building is topped with a gable roof also covered in corrugated metal (ca. 1990). An open porch (added ca. 1990) is located on the east elevation and contains the main entrance. The windows are two-light casement and have folding shutters. There are three ca. 1990 additions on the east elevation, including an area for covered parking. This is a typical example of the Masonry Vernacular style found throughout Hillsborough County, and the replacement siding and numerous additions compromise its integrity. In addition, research revealed no significant historical associations. Therefore, 8HI11376 is not considered potentially eligible for listing in the NRHP.

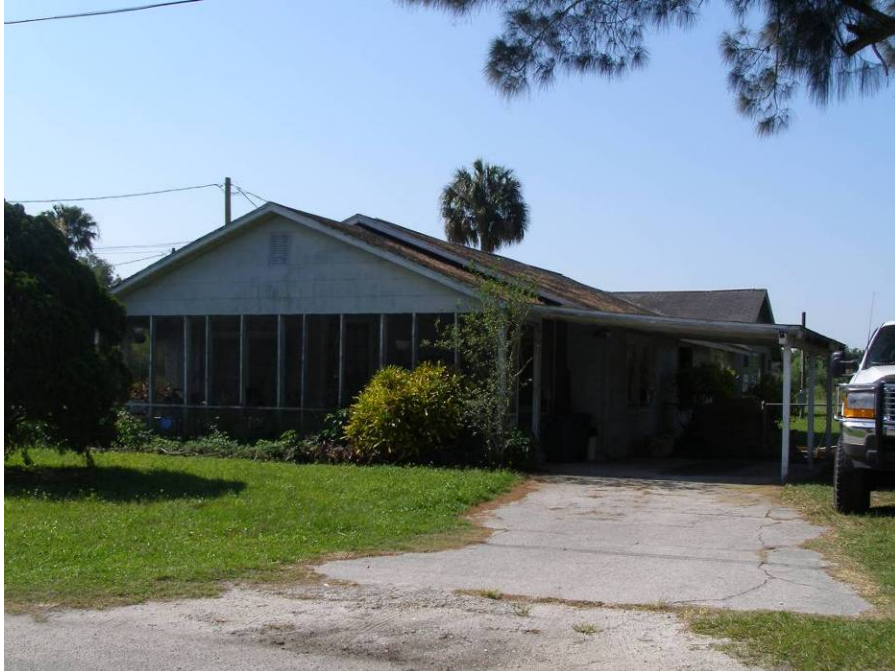
Photo 6-31 North and west elevation of 6115 Kracker Avenue, 8HI11377.

8HI11377: The Frame Vernacular style residence (Photo 6-31) located at 6115 Kracker Avenue was constructed ca. 1940. The wood frame walls rest on a concrete block and pre-cast concrete pier foundation and are clad in asbestos shingles, vertical wood siding, and weatherboard. The house is topped with a cross-gable roof that is faced in composition shingles. There is an open porch on the north elevation that contains the main entrance. The windows are one-over-one double hung sash, jalousie (ca. 1960), and awning (ca. 1960). Other architectural features include wood window and door surrounds, corner boards, projecting window sills, gable vents, and an exposed ridge beam. In ca. 1970, an addition was constructed on the south elevation and a carport with a shed roof was attached to the west elevation. Ancillary features include two sheds to the south. This is a typical example of the Frame Vernacular style found throughout Hillsborough County and the replacement windows, south addition and carport diminish its architectural integrity. Furthermore, research did not reveal any significant historical associations. Therefore, 8HI11377 does not appear to be potentially eligible for listing in the NRHP.
