US 41 (SR 45)

Project Development and Environment (PD&E) Study

Final Cultural Resource Assessment Survey

WPI Segment No: 421140 8
Hillsborough County

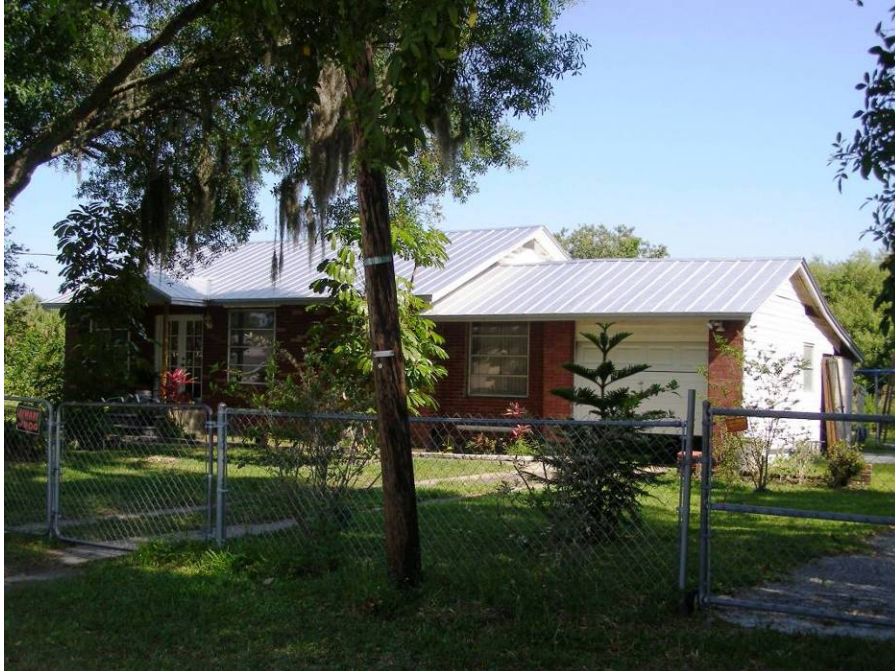
Photo 6-32 South and east elevations of 6118 Kracker Avenue, 8HI11378.

8HI11378: The residence at 6118 Kracker Avenue (Photo 6-32) was built in the Frame Vernacular style ca. 1935. The pier foundation supports the wood frame walls that are clad in face brick and aluminum siding (placed ca. 1970). The gable roof is faced in 5-V crimp metal sheeting and the windows are replacement two- and four-light awning (ca. 1960) and one-over-one single hung sash (ca. 1970). The main entrance, a pair of ten-light wood swing doors, is accessed via an open porch with a gable roof on the south elevation. Other architectural features include gable vents. A ca. 1960 addition connects the house to the one-car garage to the east. This is a typical example of the Frame Vernacular style found throughout Hillsborough County with no distinct features. Also, it does not retain its original windows or siding, causing a loss in integrity. In addition, research revealed no significant historical associations. Therefore, 8HI11378 is not considered potentially eligible for the NRHP.

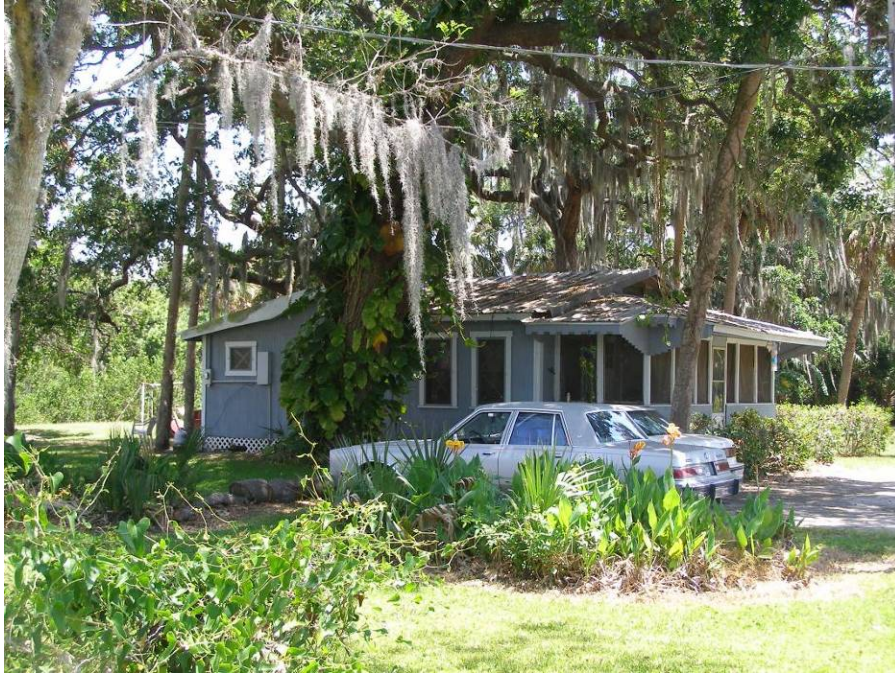
Photo 6-33 South and west elevations of 6214 Kracker Avenue, 8HI11379.

8HI11379: The Frame Vernacular style residence (Photo 6-33) located at 6214 Kracker Avenue was constructed ca. 1945. Its wood frame walls, clad in vertical board, are supported by a pier foundation with lattice infill. The cross gable roof is faced in 3-V crimp and corrugated metal sheeting (replaced ca. 1970). A screened-in open porch (ca. 1980) with a hip roof is on the south elevation and contains the main entrance. The windows have wood surrounds and projecting sills and are one-over-one single hung sash and one-light awning. Other architectural features include decorative corner eaves and gable vents. This is an example of the Frame Vernacular style commonly found throughout Hillsborough County. In addition, research revealed no significant historical associations. Therefore, 8HI11379 is not considered potentially eligible for listing in the NRHP.

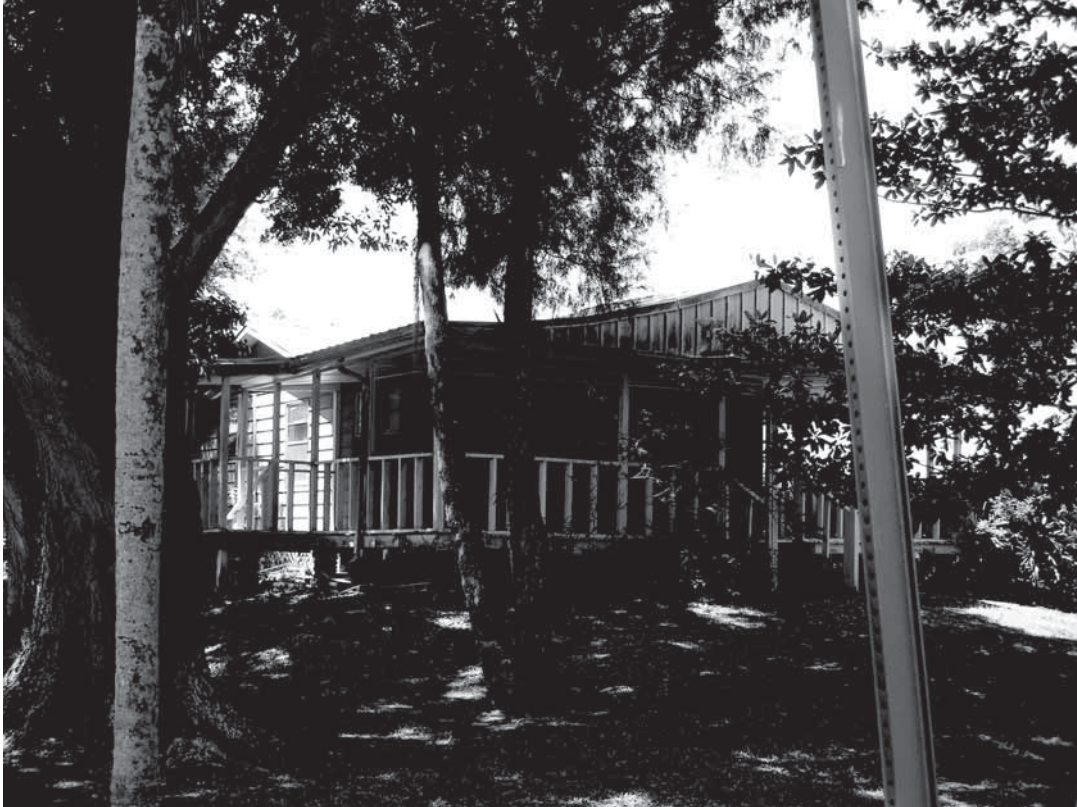
PHOTOGRAPH

Chimney: No. 0 Material(s) * _____
 Structural System(s) * wood frame
 Foundation: Type(s) * continuous; pier Material(s) * concrete block, pierced concrete block
 Main Entrance (stylistic details) screen door on south (porch)
 Porch Descriptions (types, locations, roof types, etc.) open, south, gable (entry)

Condition (overall resource condition): excellent good fair deteriorated ruinous
 Narrative Description of Resource This is a Frame Vernacular residence built ca. 1935. It has a continuous and pier foundation of concrete block. The wood frame walls are clad in asbestos shingles and the gable roof is covered in composition shingle. An open porch is on the south, a shed is to the northwest, and a garage is to the northeast.
 Archaeological Remains _____ Check if Archaeological Form Completed

Appears to meet the criteria for National Register listing individually? yes no insufficient information
 Appears to meet the criteria for National Register listing as part of a district? yes no insufficient information
 Explanation of Evaluation (required, whether significant or not; use separate sheet if needed) This is an example of the Frame Vernacular style commonly found throughout Hillsborough County. Furthermore, research did not reveal any significant historical associations. Therefore, 8HI11373 does not appear to be potentially eligible for listing in the NRHP.

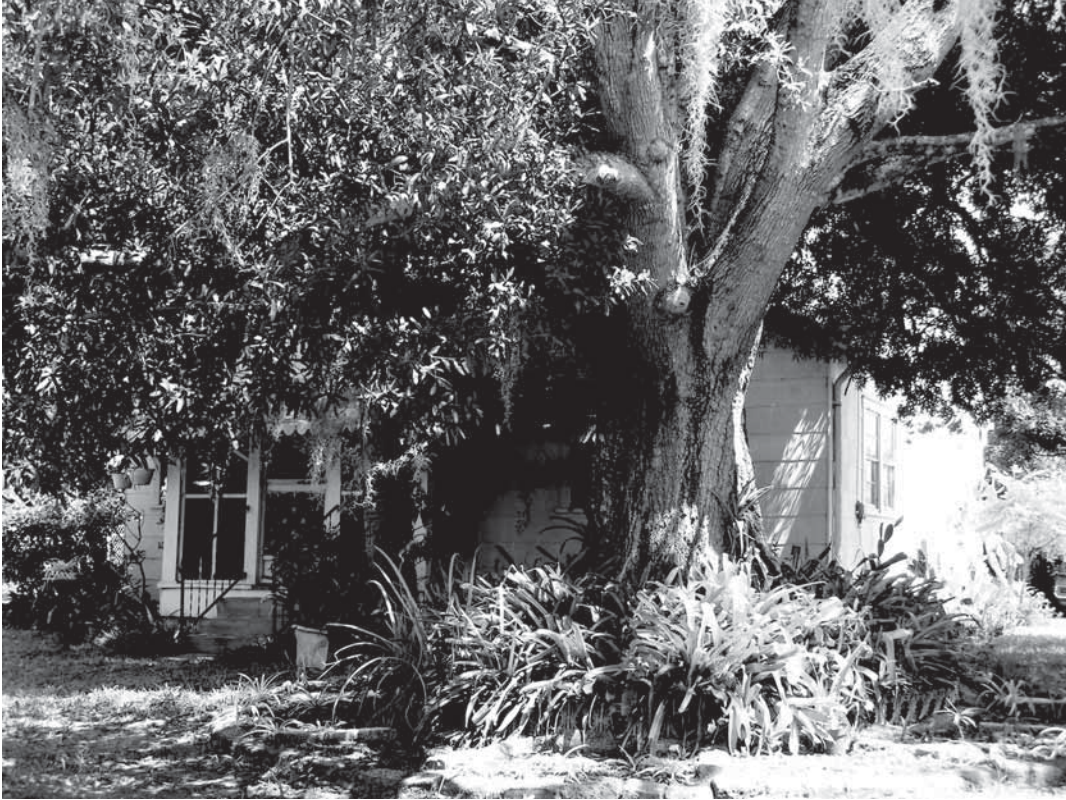
PHOTOGRAPH

Chimney: No. 0 Material(s) * _____
 Structural System(s) * wood frame
 Foundation: Type(s) * pier; slab Material(s) * concrete block, pierced concrete block; poured concrete
 Main Entrance (stylistic details) storm door on south (porch)
 Porch Descriptions (types, locations, roof types, etc.) enclosed, south, hip (entry)

Narrative Description of Resource This is a Frame Vernacular style residence constructed ca. 1925. It has a concrete block pier and slab foundation and wood frame walls clad in vinyl siding. The gable roof is faced in 5-V crimp. A ca. 2000 enclosed porch is on the south elevation. The windows are 1/1 SHS, some are 8/8 SDL. A garage is to the northwest.

Explanation of Evaluation (required, whether significant or not; use separate sheet if needed) This is typical example of the Frame Vernacular style found throughout Hillsborough County. The replacement windows, siding, and enclosed porch compromise its architectural integrity. In addition, research revealed no significant historical associations. Therefore, 8HI11374 is not considered eligible for the NRHP.

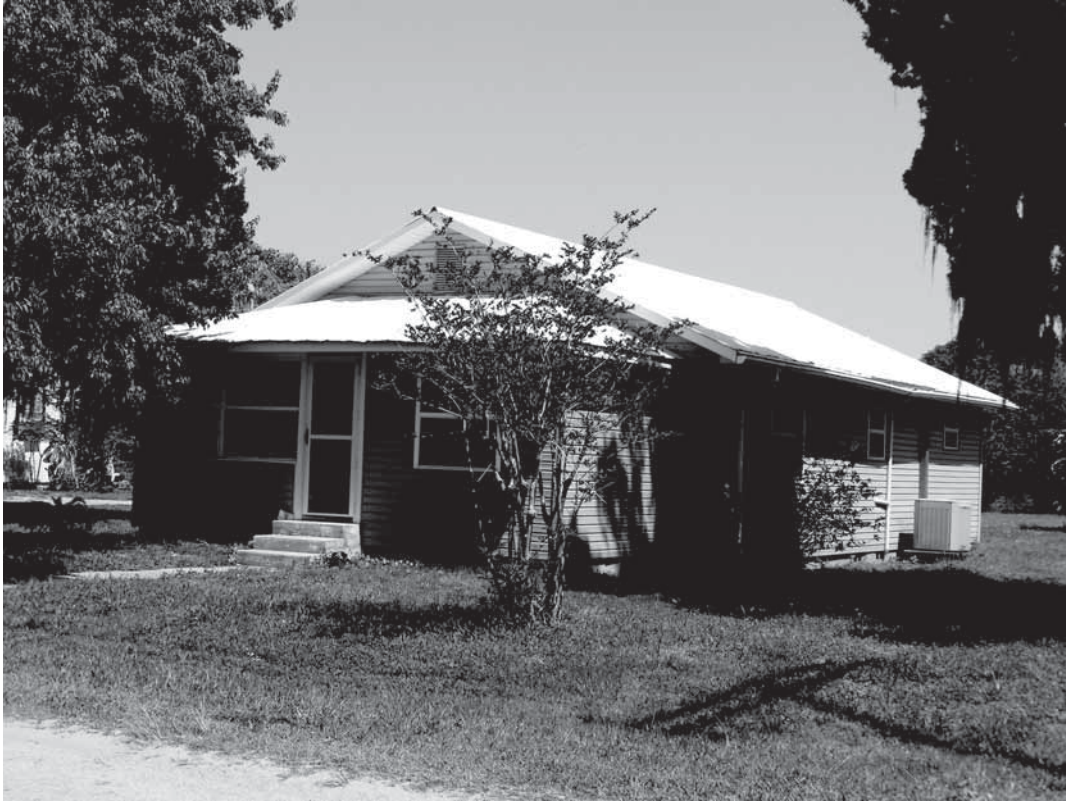
PHOTOGRAPH

Chimney: No. 0 Material(s) * _____
 Structural System(s) * wood frame; concrete block
 Foundation: Type(s) * pier; slab Material(s) * poured concrete
 Main Entrance (stylistic details) 8-panel wood swing door on the north elevation, accessed by porch
 Porch Descriptions (types, locations, roof types, etc.) canopy area at northwest corner

Condition (overall resource condition): excellent good fair deteriorated ruinous
 Narrative Description of Resource This is a Frame/Masonry Vernacular commercial building originally constructed ca. 1955 with a pier foundation. Since then, it has had two concrete block additions built on the south and a metal addition built on the north. It is currently faced with stucco and has glass block windows.
 Archaeological Remains _____ Check if Archaeological Form Completed

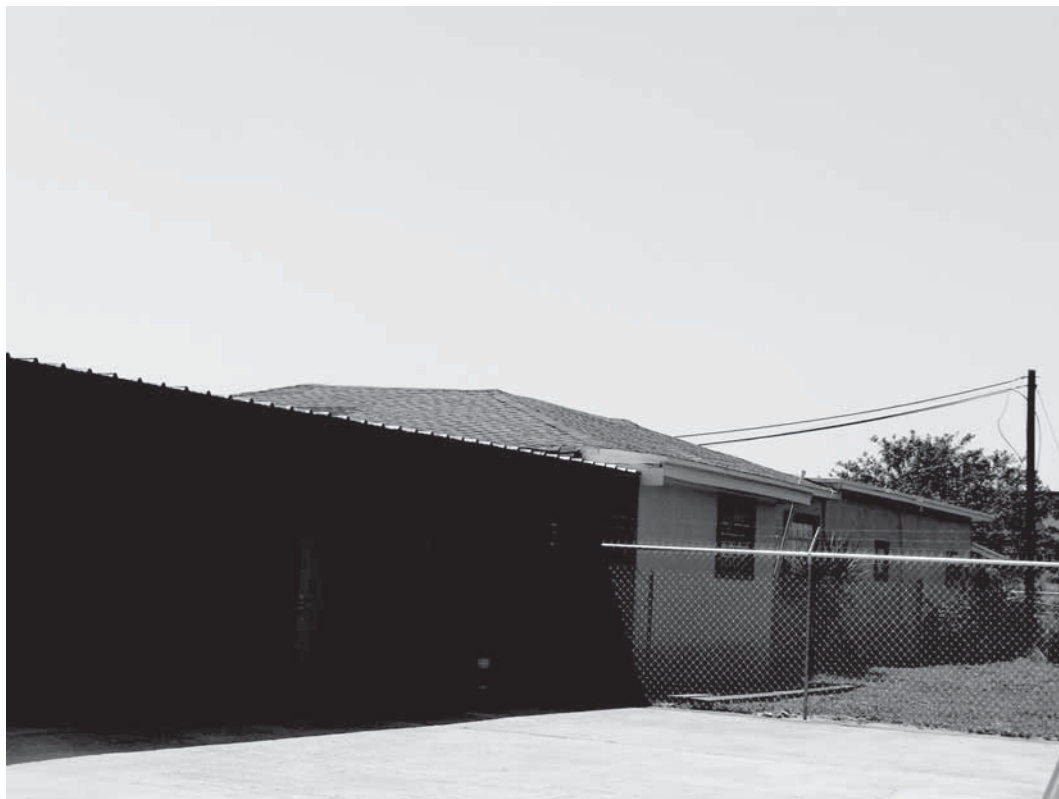
PHOTOGRAPH

Chimney: No. 0 Material(s) * _____
 Structural System(s) * concrete block
 Foundation: Type(s) * slab Material(s) * poured concrete
 Main Entrance (stylistic details) wood swing on east (porch)
 Porch Descriptions (types, locations, roof types, etc.) open, east, shed (entry)

Narrative Description of Resource This is a Masonry Vernacular commercial building constructed ca. 1953. A slab foundation supports concrete block walls, which are entirely covered in corrugated metal. The gable roof is also covered in corrugated metal. Three ca. 1990 additions and a porch are on the east elevation. The windows are 2-light casement with shutters. Covered parking is on the east elevation.
