US 41 (SR 45)

Project Development and Environment (PD&E) Study

From 12th Street to Kracker Avenue

Final Wetland Evaluation and Biological Assessment Report

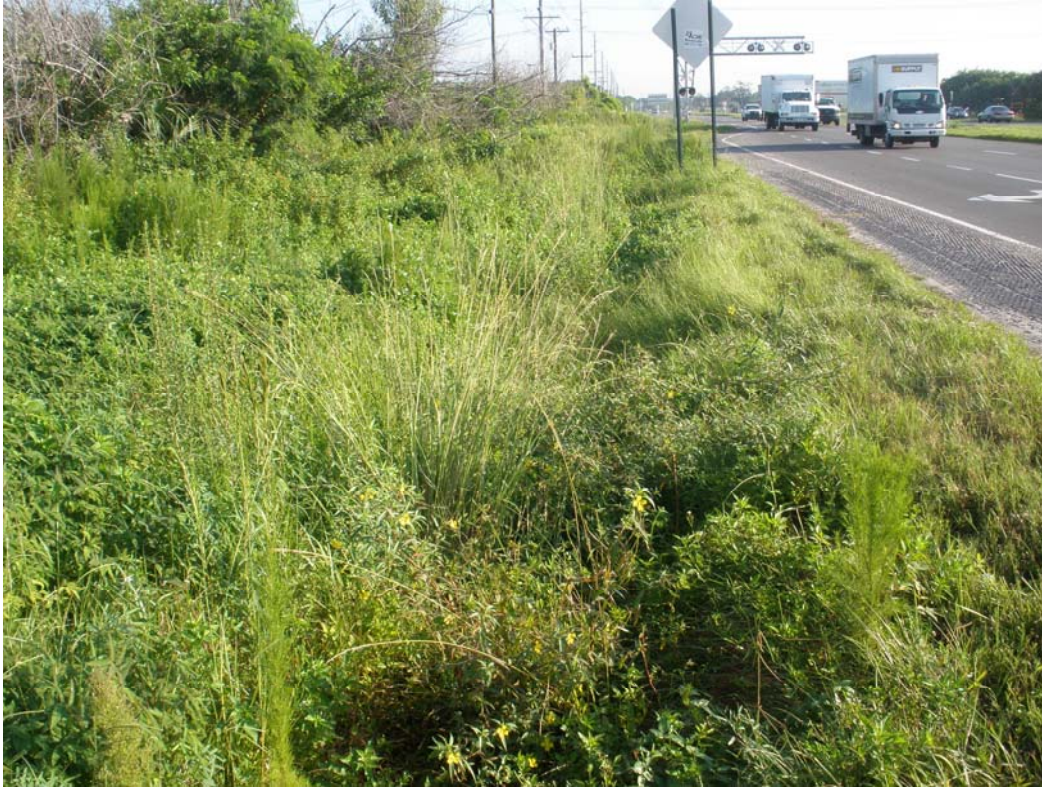
Representative roadside ditch – 8/7/2008

There are thirty-three (33) ditches (W-5, W-7, W-11, W-14 – W-22, W-25 – W-29, W-31 – W-36, W-38, W-39 and W-41 - W-48) located within or near the project corridor. Most, if not all, of the ditches appear to be manmade and are used for either agricultural purposes for the surrounding lands or are used as a source of stormwater runoff/treatment for the existing roadway. Common wetland plant species found within the ditches are cattails, ludwigia, Brazilian pepper, and Carolina willow. A few of the ditches are open

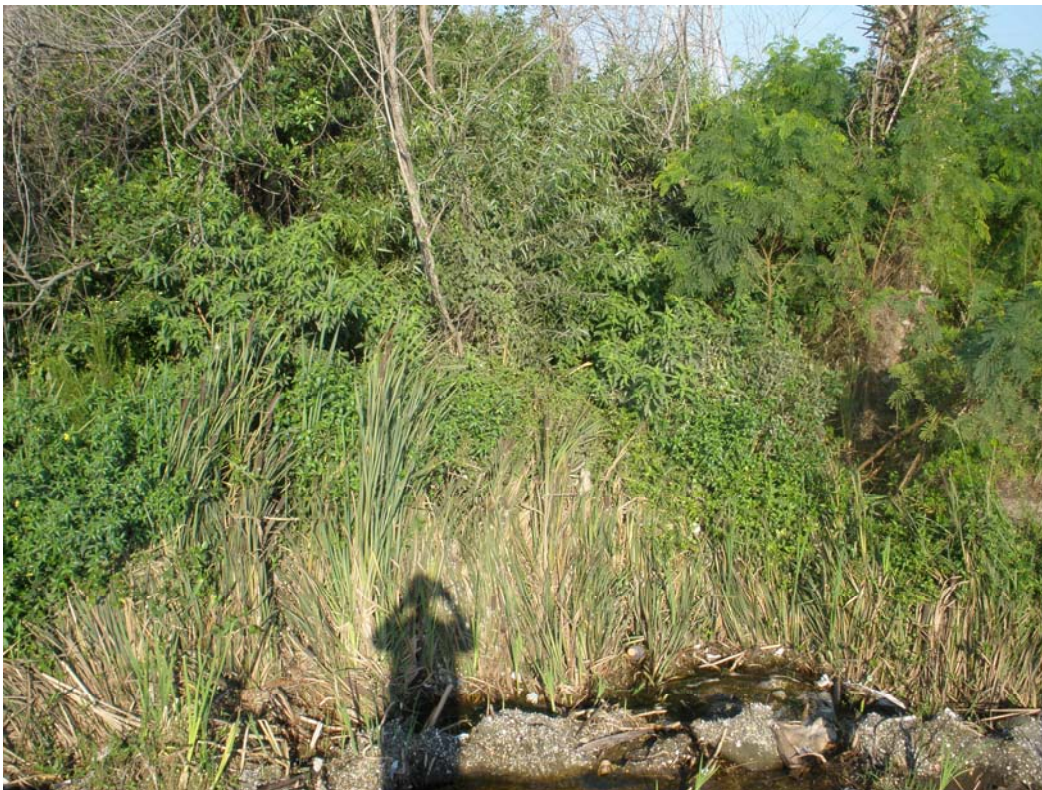
Representative shrub/scrub non-forested wetland – 8/7/2008

There are three (3) wetlands (W-8, W-12, and W-23) classified as Palustrine scrub-shrub wetlands that are located within or near the project corridor. Typical vegetation found

within these wetlands consists of Carolina willow, ludwigia, cattails, Brazilian pepper, salt bush and some pickerelweed. These sites have been altered by the surrounding development and are located along the roadway, allowing less-desirable plant species to invade. Standing water was observed in the wetlands during field reviews indicating some hydrologic function.

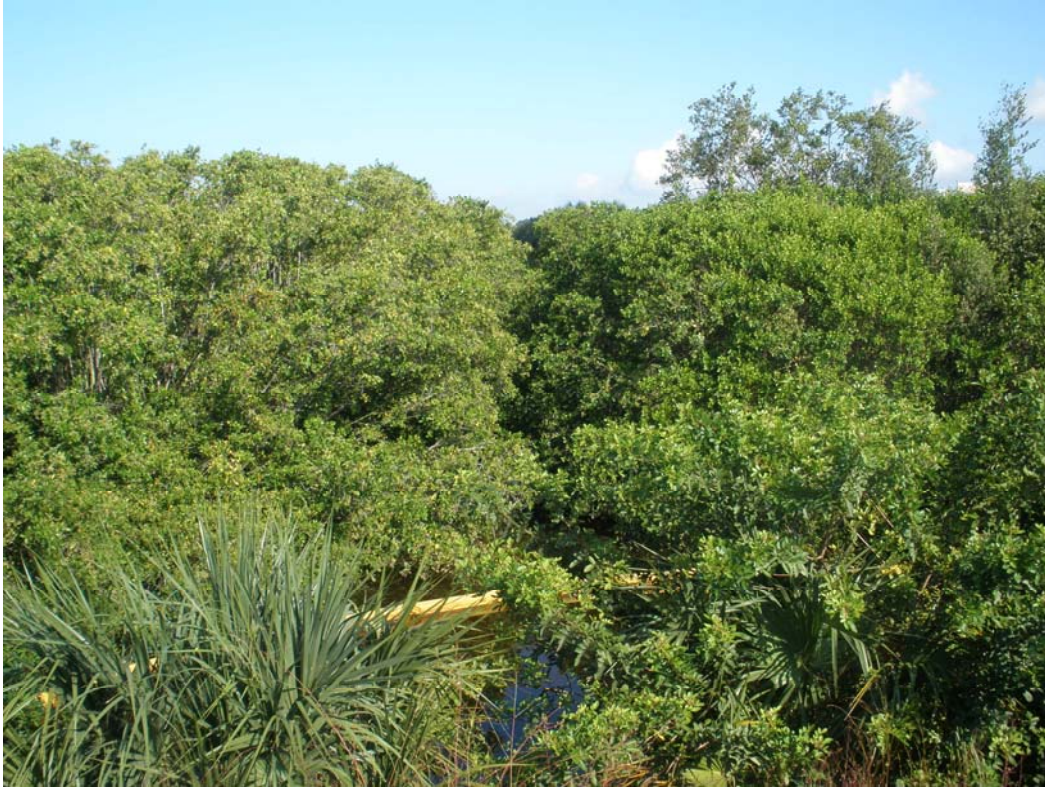
Mangrove wetland connected to Bay – 8/7/2008

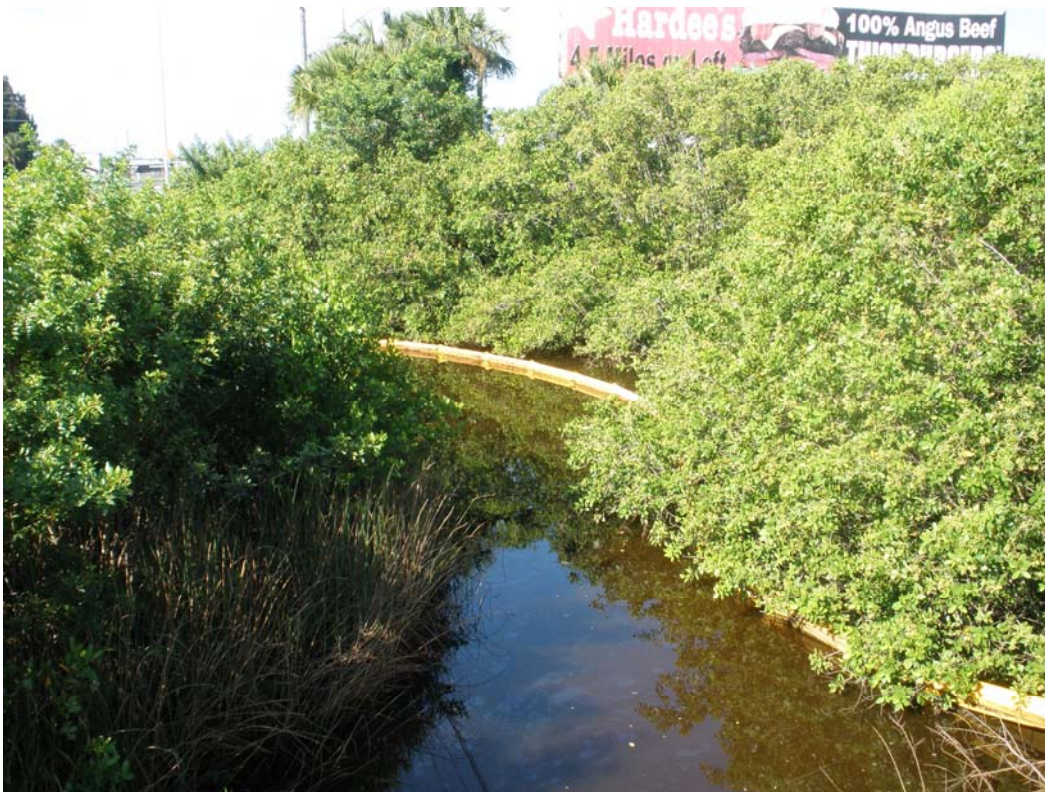
Mangrove wetland connected to Bay – 8/7/2008

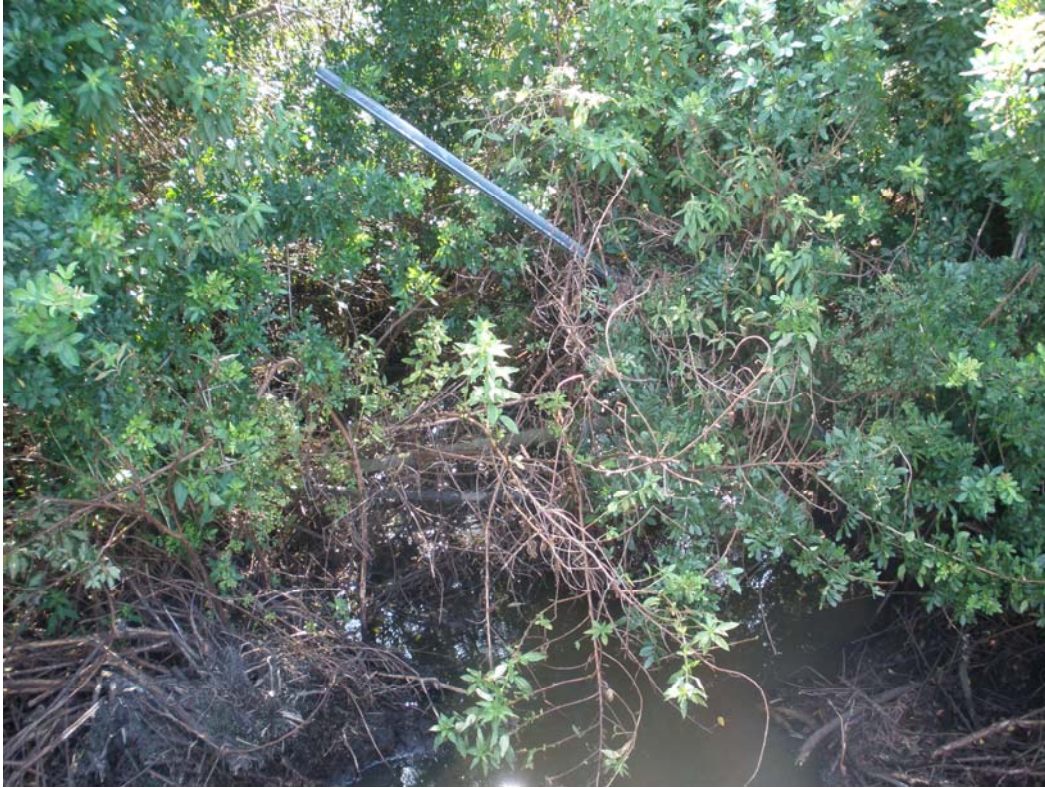
Overgrown ditch running perpendicular to roadway – 8/7/2008
