### CULTURAL RESOURCE ASSESSMENT SURVEY UPDATE TECHNICAL MEMORANDUM

### STORMWATER MANAGEMENT FACILITY (SMF) SITES AND HISTORIC RESOURCES SURVEY UPDATE (HRSU)

## US 98 FROM US 301 SOUTH TO US 301 NORTH (US 98 BYPASS) PASCO COUNTY, FLORIDA

Federal Aid Project No.: D721 039 B Work Program Item Segment (WPIS) No.: 256423-3

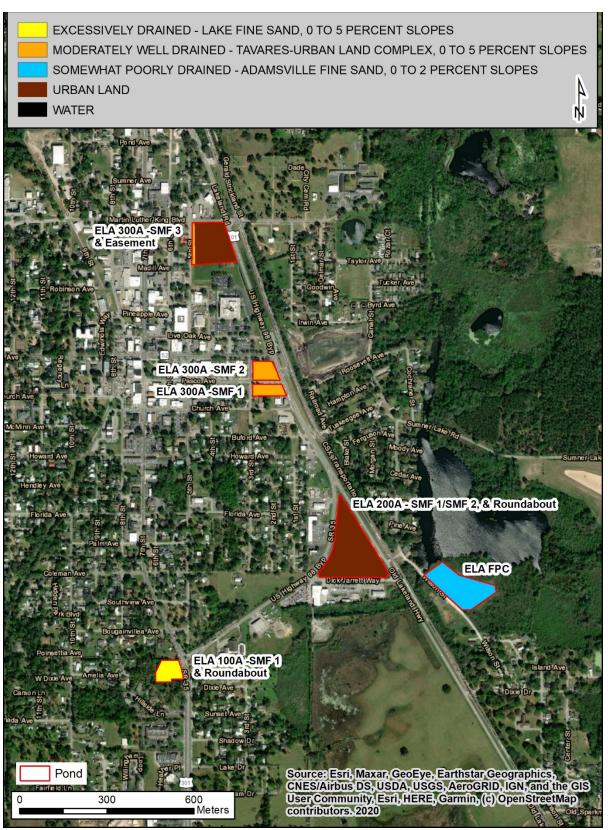
Figure 2. Soil types within the APE.

The archaeological APE is located in Sections 26, 27, 34, and 35 of Township 24 South, Range 21 East (USGS Dade City 1960). The APE is situated on the Lake-Candler soil association which is characterized by nearly level to gently sloping terrain with excessively drained soils (United States Department of Agriculture [USDA] 1982). Specific soils found within the APE are denoted on **Figure 2**. Typical vegetation includes bluejack, turkey, and blackjack oaks, and scattered longleaf pine and slash pine with an understory of pineland threeawn, chalky bluestem, sweetgum, waxmyrtle, broomsedge, inkberry, saw palmetto, and various grasses. Freshwater in the general vicinity consists of swamps. The elevation, ranging from 75 to 100 ft, can be seen on the USGS quad map in Section 5.0 (**Figure 4**). Existing land use within the APE includes recreational, residential, commercial, and industrial areas along with some vacant parcels. Associated disturbances consists of above ground and underground utilities and impervious surfaces (asphalt, concrete) (**Photos 1-10**).

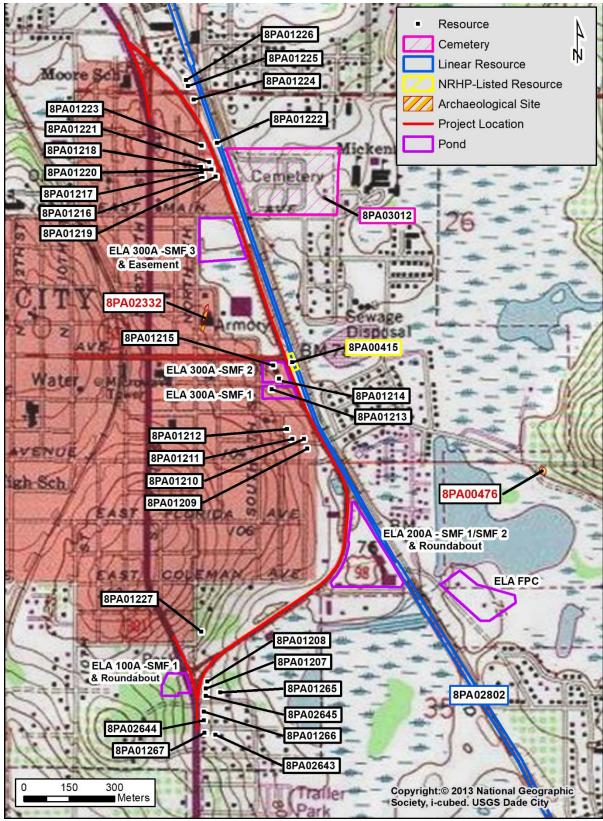
**Figure 4.** Environmental setting of the APE and previously recorded cultural resources within and immediately adjacent to the APE.

As a result of the archaeological background research, no previously recorded historic or prehistoric archaeological sites are located within the APE; however, one is recorded within one-fourth mile. This site, 8PA02332 (**Figure 4**), is a lithic scatter site found during a survey of the Dade City National Guard Armory (Stokes 2005). The SHPO determined the site not eligible for listing in the NRHP. In 2000, a CRAS was prepared by ACI for the PD&E Study (Survey No. 06210). The CRAS resulted in no prehistoric or historic archaeological sites but one isolated artifact (a ceramic sherd, categorized as an Archaeological Occurrence) was found. A few other surveys conducted in the general vicinity, for cell towers, private developers, and the FDOT (ACI 2019; FAC 2006, 2007; Knowles 2005; Sueiro-Vazquez 2018) yielded negative archaeological results.

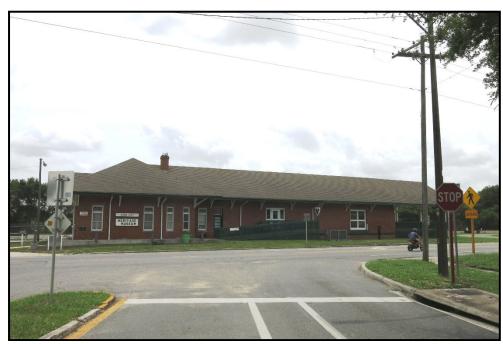
Photo 15. NRHP-Listed Dade City ACL Railroad Depot (8PA00415), looking east.

8PA00415: The Dade City Atlantic Coast Line (ACL) Railroad Depot at 14206 US 98 Bypass in Dade City, Florida is a ca. 1912 Masonry Vernacular style railroad (Photos 15 & 16). The onestory, rectangular plan rests on a continuous foundation of brick and has a brick structural system with a common bond pattern and alternating header-stretcher bond every sixth row. The historically segregated main entryway is on the north elevation through two single doors with rectangular paneling and inset rectangular lights; however, a single metal door with two inset lights and sidelights accessed by a wooden ADA ramp on the west elevation now serves as the main entrance. Visible windows include a mixture of individual, one-over-one and one-over-two wooden double-hung-sash units topped with leaded stained glass transom lights; individual, three-light wooden fixed dormer unit; individual, four-light metal fixed unit. A brick chimney is located within the slope of the west elevation of the gable roof. A restoration of the depot following Secretary of the Interior's Standards for the Treatment of Historic Properties began in 1996. Alterations conducted during the renovation after listing in the NRHP include replacement roofing, the uncovering and restoration of the original windows, the openair freight platform was restored and brought to modern building codes with the installation of wooden railings, the construction of two wooden ADA compliant accessibility ramps, and the replacement of three wooden loading doors with metal frame doors accessed by the ADA ramps.

The ca. 1912 Dade City Atlantic Coast Line Railroad Depot (8PA00415) was listed in the NRHP on July 15, 1994, under Criteria A and C in the areas of Transportation, Community Planning and Development, and Architecture. In 1996, the property underwent a restoration following Secretary of the Interior's Standards for the Treatment of Historic Properties. No alterations that significantly detract from the historic integrity of the building have been completed since listing. Overall, the renovations were necessary for continued use and maintenance of the building. Therefore, the Dade City Atlantic Coast Line Railroad Depot appears to retain integrity as a NRHP-listed resource under Criteria A and C in the areas of Transportation, Community Planning and Development, and Architecture. In addition, the railroad depot is a contributing resource to the existing Florida's Historic Railroad Resources Multiple Property Listing under property type F.1 (Survey No. 06289).

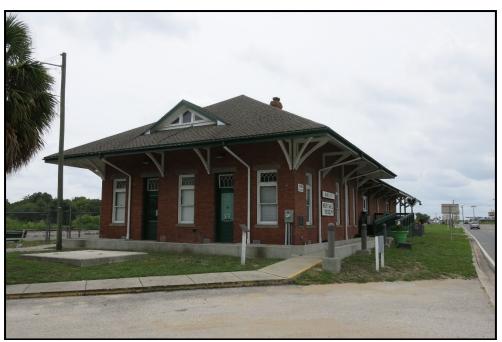
Photo 16. NRHP-Listed Dade City ACL Railroad Depot (8PA00415), looking southeast.

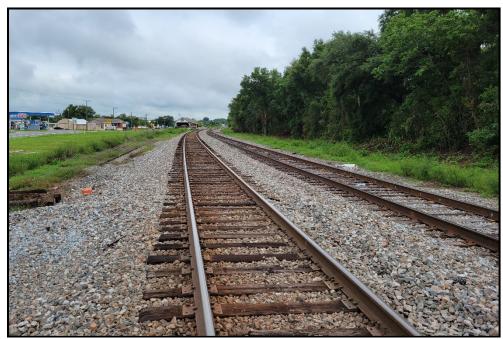
**Photo 17**. South Florida Railroad – Pemberton Ferry Branch/Richloam Railroad (8PA02802), looking northwest.

**8PA02802:** The segment of the South Florida Railroad – Pemberton Ferry Branch/Richloam Railroad within the APE is located in Sections 26, 27, and 35 of Township 24 South, Range 21 East (USGS Dade City 1960). This segment is approximately 1.2 miles long, running parallel to Old Lakeland Highway and US 98 Bypass from south of Dick Jarrett Way to north of River Road. The rail line consists of two sets of standard gauge tracks affixed to timber railroad ties with single and double

shoulder tie plates and hook head track spikes laid over gravel track ballast (**Photo 17**). The resource has been modified to modern standards, no longer reflecting ca. 1885 materials, and railroad crossings located within the APE have been paved with asphalt. Crossings are equipped with modern flashing lights with gates.

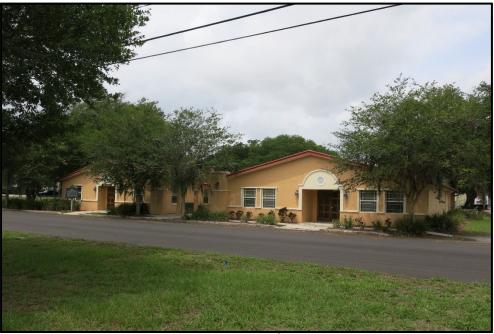
**Photo 18.** Former Jones Nursing Home at 14433 5<sup>th</sup> Street (8PA03331), looking southwest.

**8PA03331:** The former Jones Nursing Home is a ca. 1965 Masonry Vernacular style building located at 14433 5th Street in Dade City, Florida (Photo 18). The Jones Nursing Home, established in ca. 1965 by Otis and Naomi Jones, is believed to be the first nursing home in Dade City and Pasco County. The facility was also the first in Dade City to accept both black and white residents – an uncommon feature during the era of the Civil Rights Movement (Squires 2002). The property was formerly the location of the Jones family residence and later a family-owned barbeque restaurant; however, the Jones' constructed a nursing home in ca. 1965 to tend to the elderly and sick of Dade City (Squires 2004). Naomi and Otis Jones regularly cooked for and visited members of the community who could not care for themselves, leading the couple to construct the original one-wing facility on the site. This was followed by an additional wing in ca. 1971 to accommodate the growing number of residents (Hedman 2005). The nursing home was managed by the Joneses until the mid-1970s, after which it was sold several times and officially closed in 2001 (Squires 2002; Moorehead 2004). In 2003, the vacant building was purchased by St. Leo University in order to establish offices in Dade City and large-scale renovations began in 2004 (Moorehead 2004). The building was renovated to match the Mediterranean Revival style of St. Leo University's campus in St. Leo, Florida. Following the dedication of the university's new building, a historical marker was erected on 5th Street to commemorate the significance of the nursing home in Dade City and the role the Jones family played in improving the lives of the community's senior citizens (Hedman 2005).

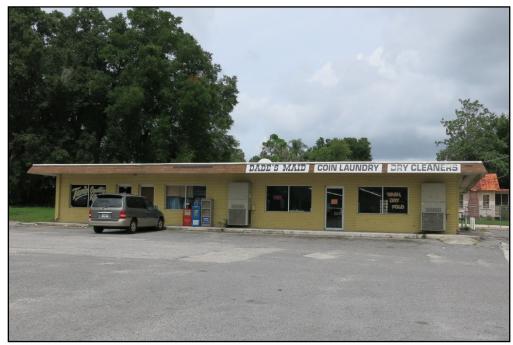
**Photo 19**. Typical example of a Commercial style building. The historic resource is located at 14131 US 98 Bypass (8PA03326), looking west.

**Commercial:** Four historic resources within the APE are of the Commercial style (8PA03319, 8PA03325, 8PA03326, 8PA03339) (**Photo 19**), and have construction dates between 1969 to 1974 (see Table 3). Within the APE, this building type usually consists of multiple units beneath a flat roof and parapet. Most entrances are through metal doors with full-view glass panels, fronted by a full-width open, entryway. Most of the building exteriors are clad with stucco. Full-length, fixed pane windows with metal frames are most common, and exterior ornamentation is minimal. The majority display fenestration alterations as well as new roofing and siding.

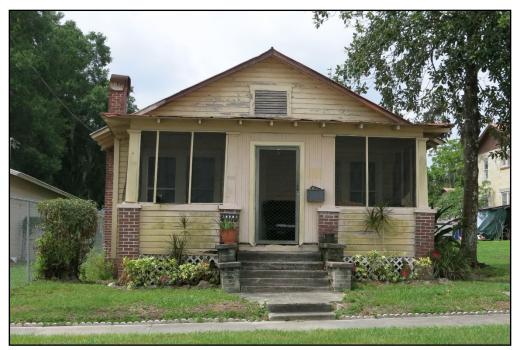
**Photo 20**. Typical example of a Craftsman style building. The historic resource is located at 38132 Pasco Avenue (8PA01213), looking south.

**Craftsman**: One historic resource within the APE is of the Craftsman style (8PA01213) (**Photo 20**). The resource was constructed in ca. 1922. The style is limited to residential buildings within the APE. The Craftsman style gained popularity in the first three decades of the 20<sup>th</sup> century and was inspired by both the English Arts and Craft Movement and Asian architecture (McAlester 2013). It features low pitched roofs, prominent porches, and wood ornamentation. Within the APE, this building type has a pier foundation. The gable roof is most common and is clad with 3v crimp sheet metal. The building is clad in wood siding and exterior ornamentation feature exposed rafter tails, corner boards, and brick porch supports. The building displays alterations such as replacement doors and windows, enclosed porches, and living-space additions.

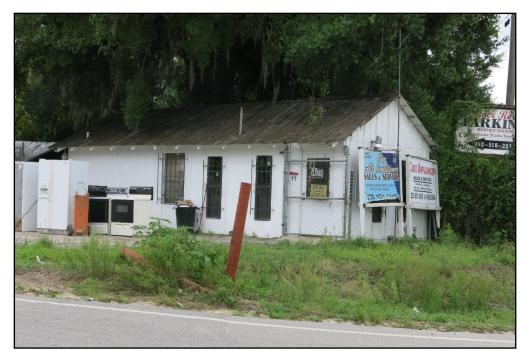
**Photo 21.** Frame Vernacular style building (8PA01224) located at 14721 5th Street, looking southeast.

**Frame Vernacular**: A total of 11 historic resources (8PA01216, 8PA01218, 8PA01219, 8PA01222, 8PA01224, 8PA01227, 8PA01266, 8PA01267, 8PA03311, 8PA03316, 8PA03335) within the APE are of the Frame Vernacular style (**Photos 21 and 22**) and have construction dates that range from 1913 to 1972. The majority of these resources are residential with a few commercial buildings represented in this style. Frame Vernacular style buildings are simple structures built with available

local materials and boasting little ornamentation (McAlester 2013). They are often built by developers, contractors, master carpenters, or the building's occupants. These buildings are decidedly practical structures. Within the APE, this building type has pier, continuous, or slab foundations. Gable roofs are most common, and the majority of the roofs are clad with composition shingles. The majority of these buildings are clad in wood siding, vinyl, or stucco. Fenestration typically includes single-hung sash windows, but awning and fixed windows are also present. Exterior ornamentation is minimal, and typically consists of wood window and door surrounds, corner boards, gable vents, and exposed rafter tails. The majority display alterations or additions, such as replacement siding and windows and living-space additions.

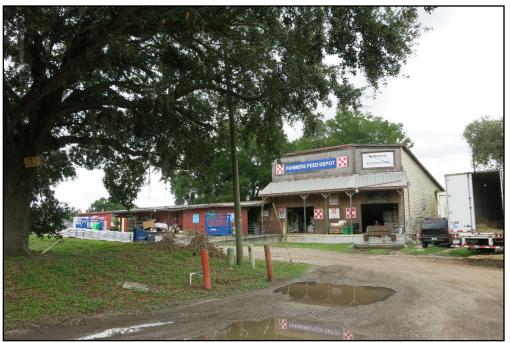
**Photo 22.** Frame Vernacular style building (8PA03335) located at 14648 7th Street, looking northwest.

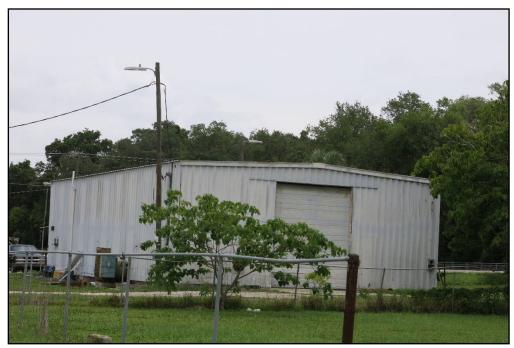
**Photo 23.** Industrial Vernacular style building (8PA03334) located at 14618 6th Street, looking northeast.

**Industrial Vernacular**: One historic resource (8PA03334) within the APE is of the Industrial Vernacular style (**Photo 23**). Similar to Masonry Vernacular and Frame Vernacular style buildings, Industrial Vernacular style structures are simply built with available local materials and display little ornamentation. Within the APE, this building type has a continuous concrete block foundation, and gable roof. The building exterior, as well as the roof, are clad with metal.

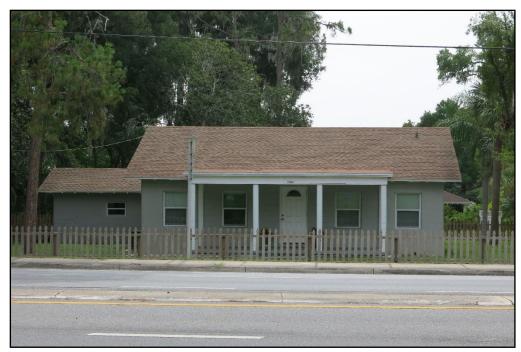
Photo 24. Masonry Vernacular style building (8PA02644) located at 13440 US 301, looking east.

Masonry Vernacular: A total of 25 historic resources (8PA01214, 8PA02642, 8PA02644, 8PA02645, 8PA03312-8PA03315; 8PA03317, 8PA03318, 8PA03320-8PA03324; 8PA03327-8PA03330; 8PA03332, 8PA03333, 8PA03337, 8PA03338, 8PA03340, 8PA03342) within the APE are of the Masonry Vernacular style (Photo's 24 & 25). The majority of these resources are for commercial use; however, several resources are single-family residences. These resources have construction dates that range from ca. 1920 to ca. 1973. Masonry Vernacular style buildings reflect the local customs, environment, and building materials, and do not rely on academic architectural vocabulary for their

design and ornament. Within the APE, the commercial buildings have full-length, fixed pane windows with metal frames are most common, and exterior ornamentation is minimal. The buildings used as single-family residences generally have a concrete slab or continuous concrete block foundations and concrete block walls and the windows typically are awning or single-hung sash. Roof types commonly consist of gable, most of which are clad with composition shingles. Most of the buildings used for commercial purposes have a flat roof covered with built-up membrane. The exterior cladding often consists of painted concrete block, stucco, and artificial masonry or brick veneer. Most display replacement windows and roofs, fenestration changes, and additions.

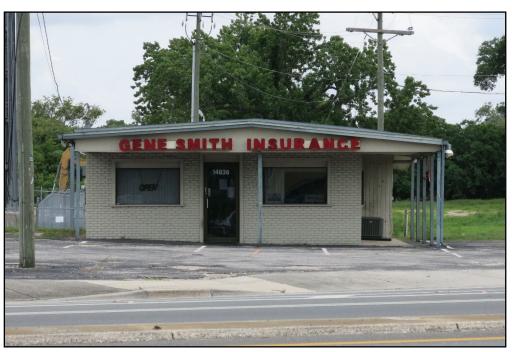
Photo 25. Masonry Vernacular style building (8PA03340) located at 14836 US 301, looking east.

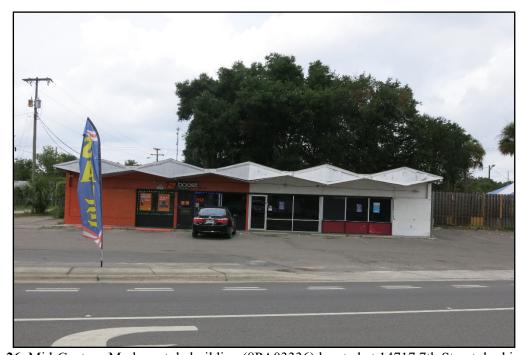
Photo 26. Mid-Century Modern style building (8PA03336) located at 14717 7th Street, looking west.

**Mid-Century Modern**: Two historic resources (8PA03336 & 8PA03341) within the project APE is of the Mid-Century Modern style (**Photo 26**). These resources have construction dates of ca. 1957 and ca. 1964. Mid-Century Modern buildings are inspired by the International style and feature flat roofs, multiple large windows (typically fixed windowpanes), and minimal ornamentation (McAlester 2013). Within the APE, the building features a slab foundation, flat roof covered with built-up membrane and a zigzag roof line with enclosed diamond-shaped parapet overhang, exterior masonry cladding, and large fixed windowpanes. The buildings display alterations, such as replacement siding and windows and the zigzag roof was replaced in 2012. Overall, these resources do not display a high level of architectural integrity or character-defining architectural and decorative features. In addition, background research did not reveal any historic associations with significant persons and/or events.

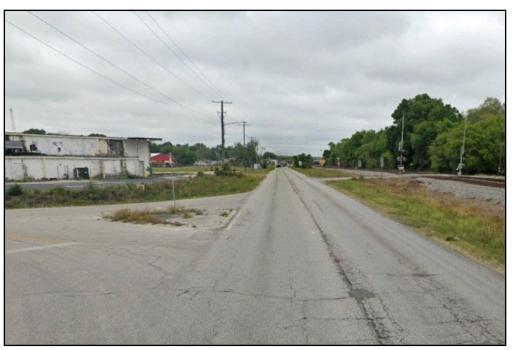
Photo 27. Linear resource, Old Lakeland Highway (8PA03343), looking northwest.

Linear Resource: The segment of Old Lakeland Highway within the APE is comprised of two 12 ft wide travel lanes and turning lanes paved with asphalt and lined with modern roadway signage and signals (Photo 27). The road extends approximately 0.6 miles from the intersection of Meridian Avenue in the north – the original northern terminus of the route – to approximately 254 ft south of Dick Jarrett Way. The segment of the Old Lakeland Highway within the APE was originally known as the Lakeland-Dade City Highway which was constructed between Dade City beginning at the intersection with Meridian Avenue at the north (adjacent to the Dade City ACL Railroad Depot) and extending southward through Pasco County to Polk County and Lakeland (Tampa Times 1925). The segment was highly altered in ca. 1963 with the construction of the US 301 truck route – now known as the US 98 bypass. The overwhelming majority of the Old Lakeland Highway is located outside the project APE. Surveying and recording the entire highway are beyond the scope of this report, as such only the segment within the project APE was surveyed and recorded. The surveyed segment is a common two-lane roadway found throughout Pasco County, without historic paving or markers and lacks unique design features or characteristics.

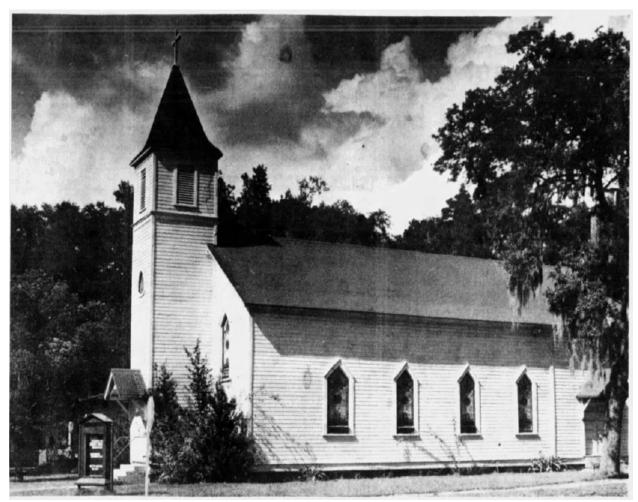
**Explanation of Evaluation:** Overall, the historic integrity of the Old St. Rita's Catholic Church has been destroyed through the removal of the church from its original setting and several large-scale material changes, including the removal of multiple character defining features such as the historic bell tower and stained glass windows. As a result, the building is not significant under Criterion C as it is not a significant embodiment of a type, period, or method of construction. In addition, the resource is not significant under Criterion A or Criterion Consideration A as background research did not reveal any historic associations with significant persons and/or events. As a result, 8PA01227 does not appear eligible for listing in the NRHP, either individually or as part of a historic district.

**Photo 1.** St. Rita's Catholic Church prior to relocation and several large scale alterations (Tampa Bay Times 1974b).
