FINAL PRELIMINARY ENGINEERING REPORT

WITHLACOCHEE RIVER BRIDGE REPLACEMENT

ON S.R. 700 IN PASCO COUNTY, FLORIDA

WPI No.: 7115954
State Project No.: 14080-3506
Bridge No.: 140026

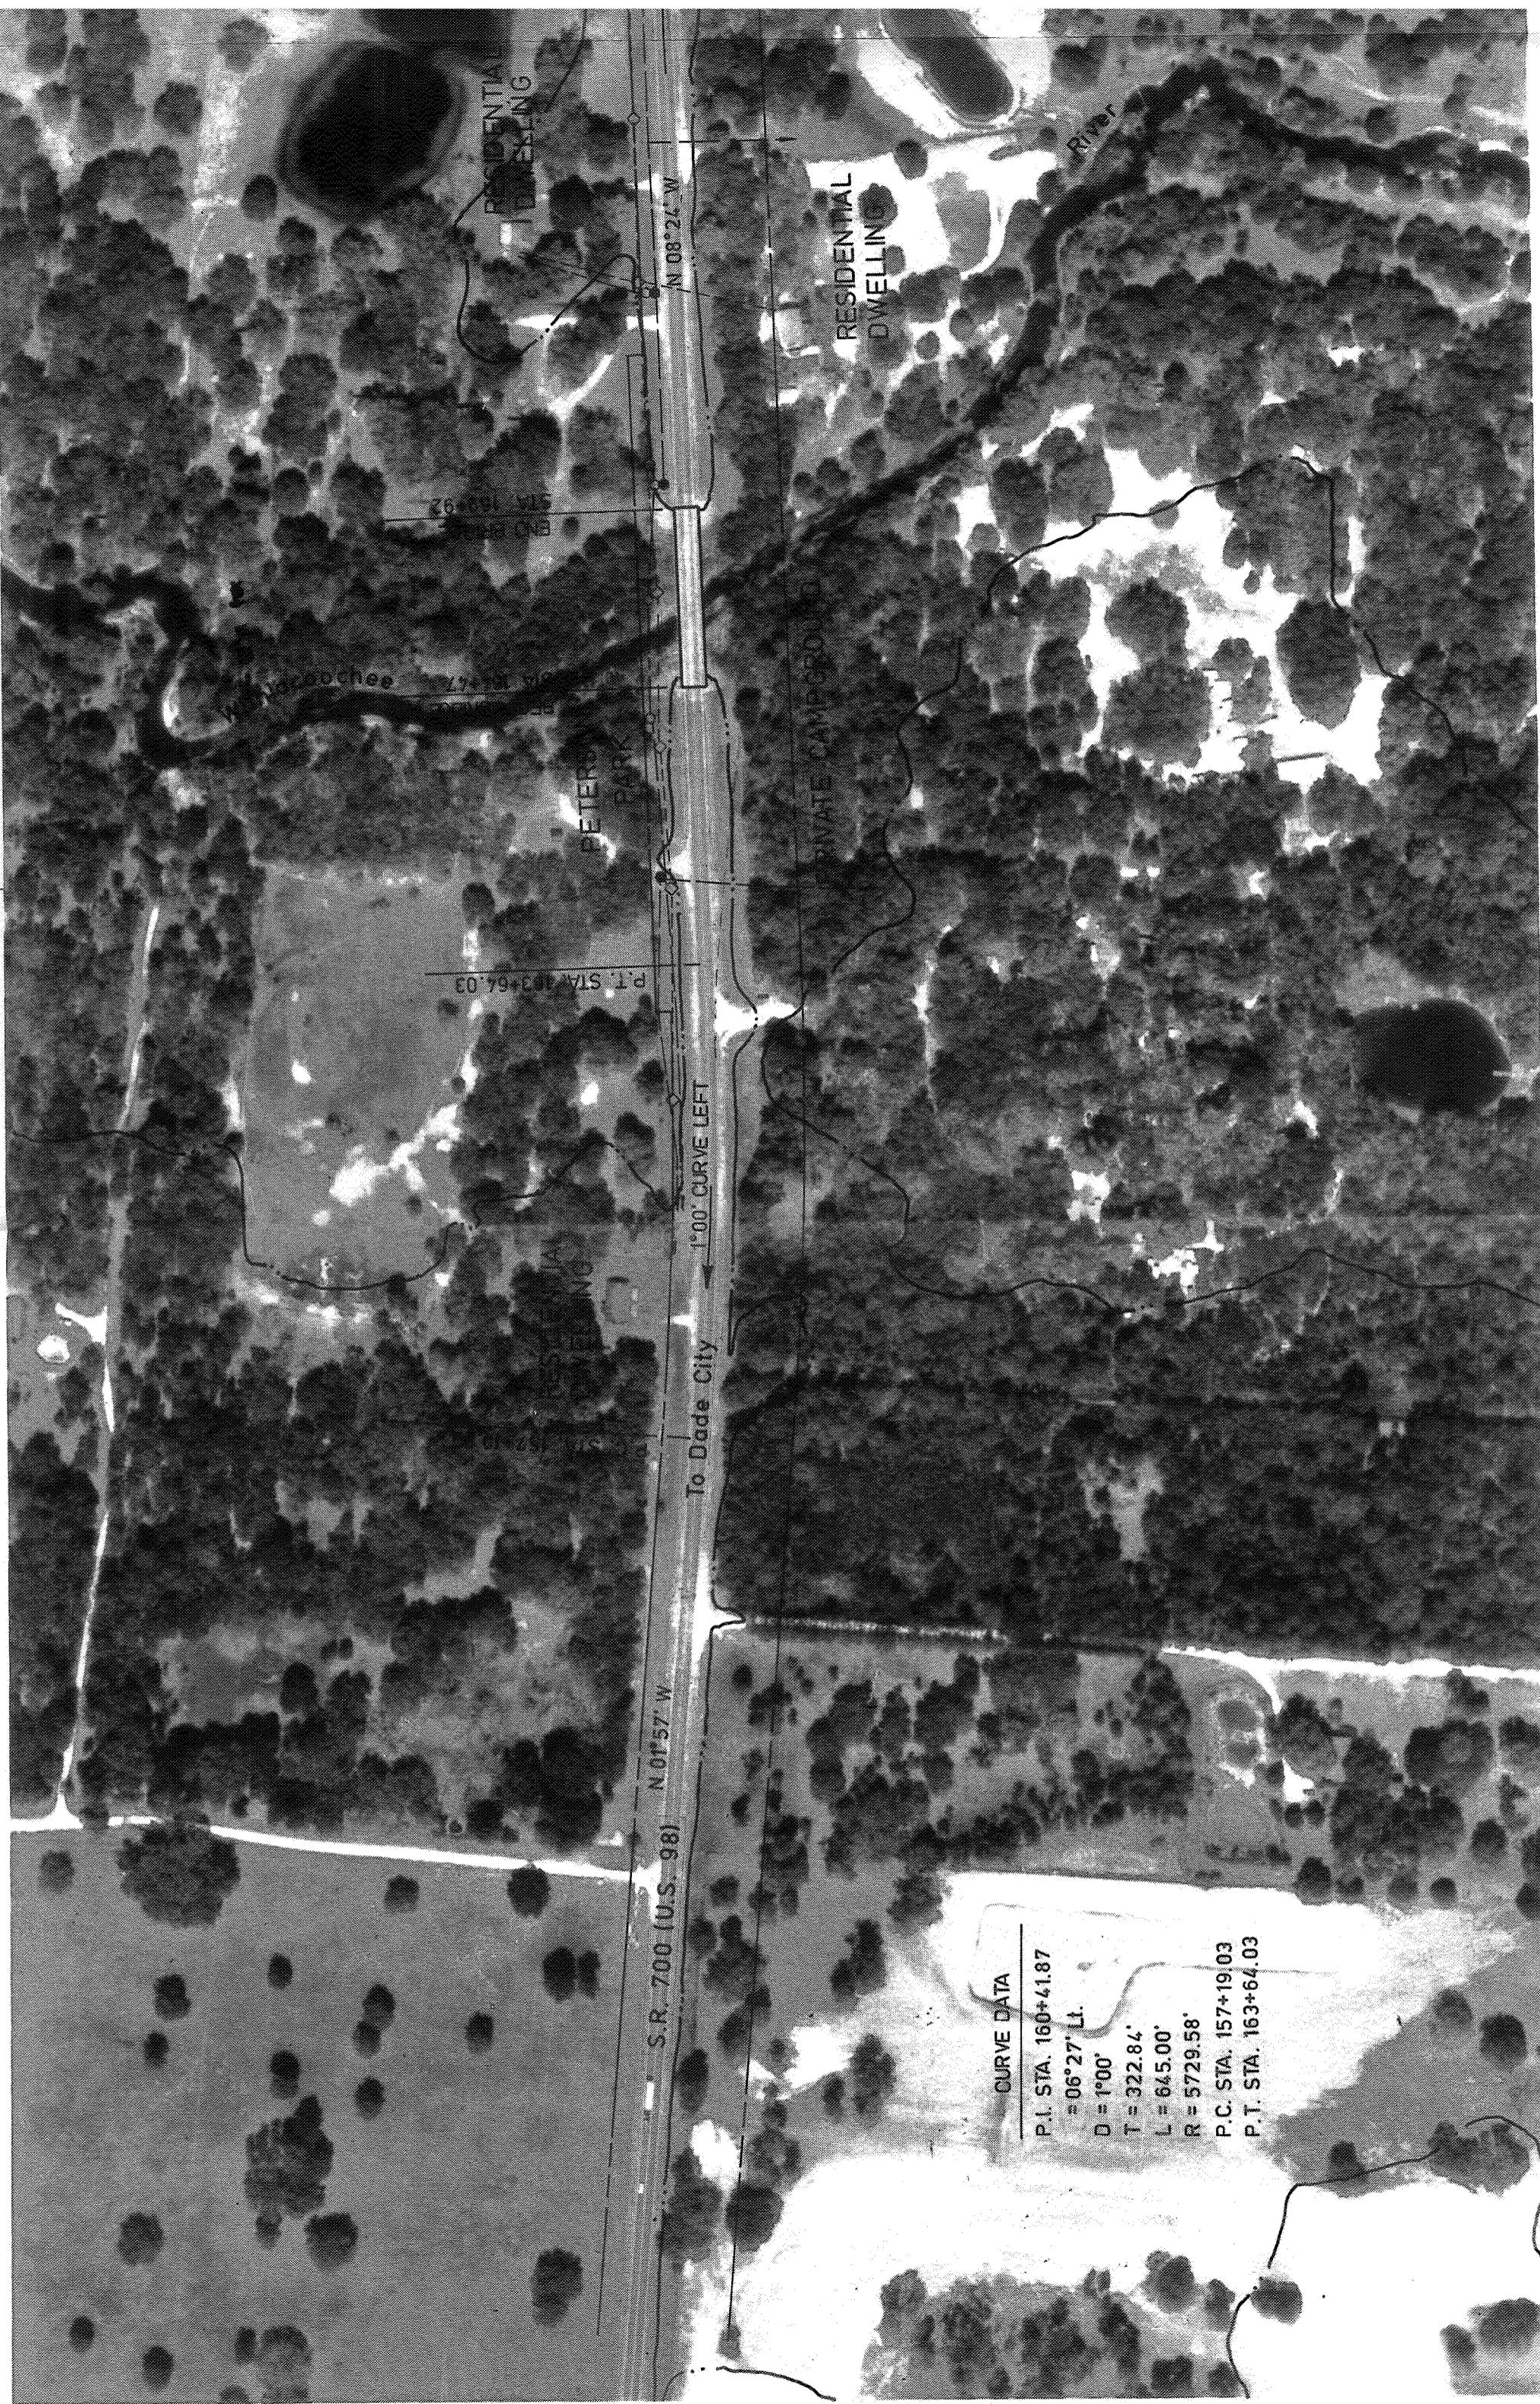
FIGURE 2-2

EXISTING CONDITIONS

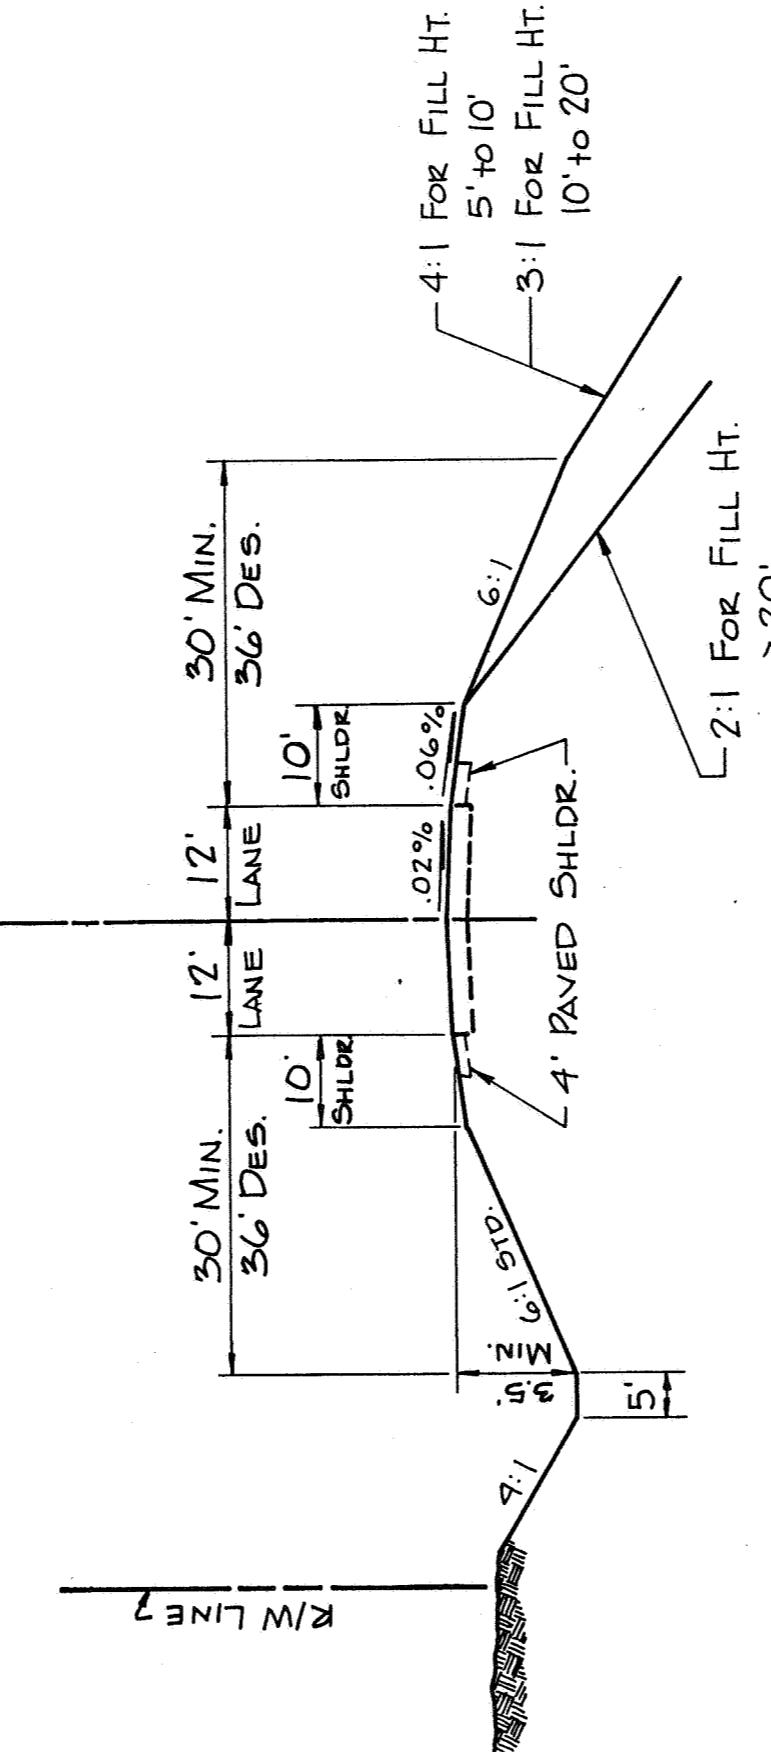
PROPOSED
TYPICAL ROADWAY SECTION
N.T.S.

S.R. 700 (U.S. 98)

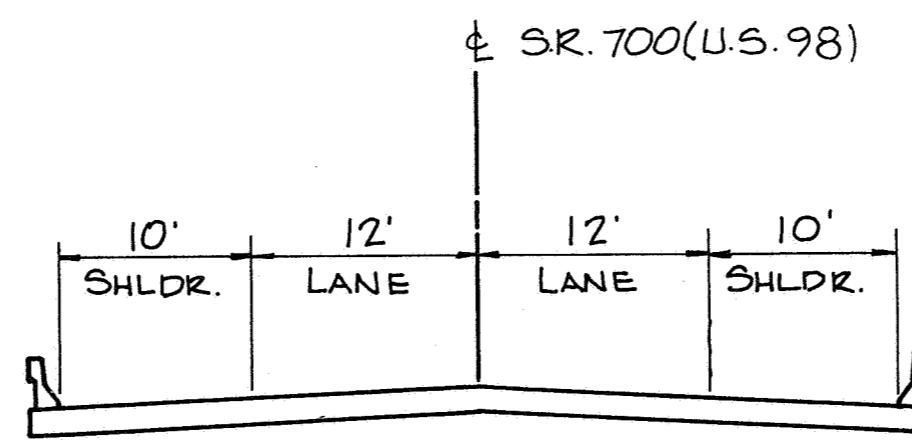
TYPICAL BRIDGE SECTION

Typical Section: The typical section consists of two 12-foot travel lanes with 10-foot shoulders and standard 1'-6 1/2" barrier rails (see Figure 4-2). According to the FDOT Structures Design Guidelines bridge shoulders should match the approach roadway shoulders. Ten foot shoulders are desirable for a two lane rural highway, (FDOT Greenbook, Table III-8), and are recommended for this project. The typical section will have an overall width of 47'-1". The Pasco County Comprehensive Plan does not recommend pedestrian or bicycle facilities on SR 700 at this location. No provisions are proposed for bicycles or pedestrians at this structure.

Superstructure types considered viable for this project include cast in place concrete decks composite with precast concrete AASHTO Type II or Type III beams or rolled steel beams, cast in place concrete flat slabs, or prestressed concrete planks post-tensioned transversely. Superstructure depths vary from approximately 2 to 5 feet.

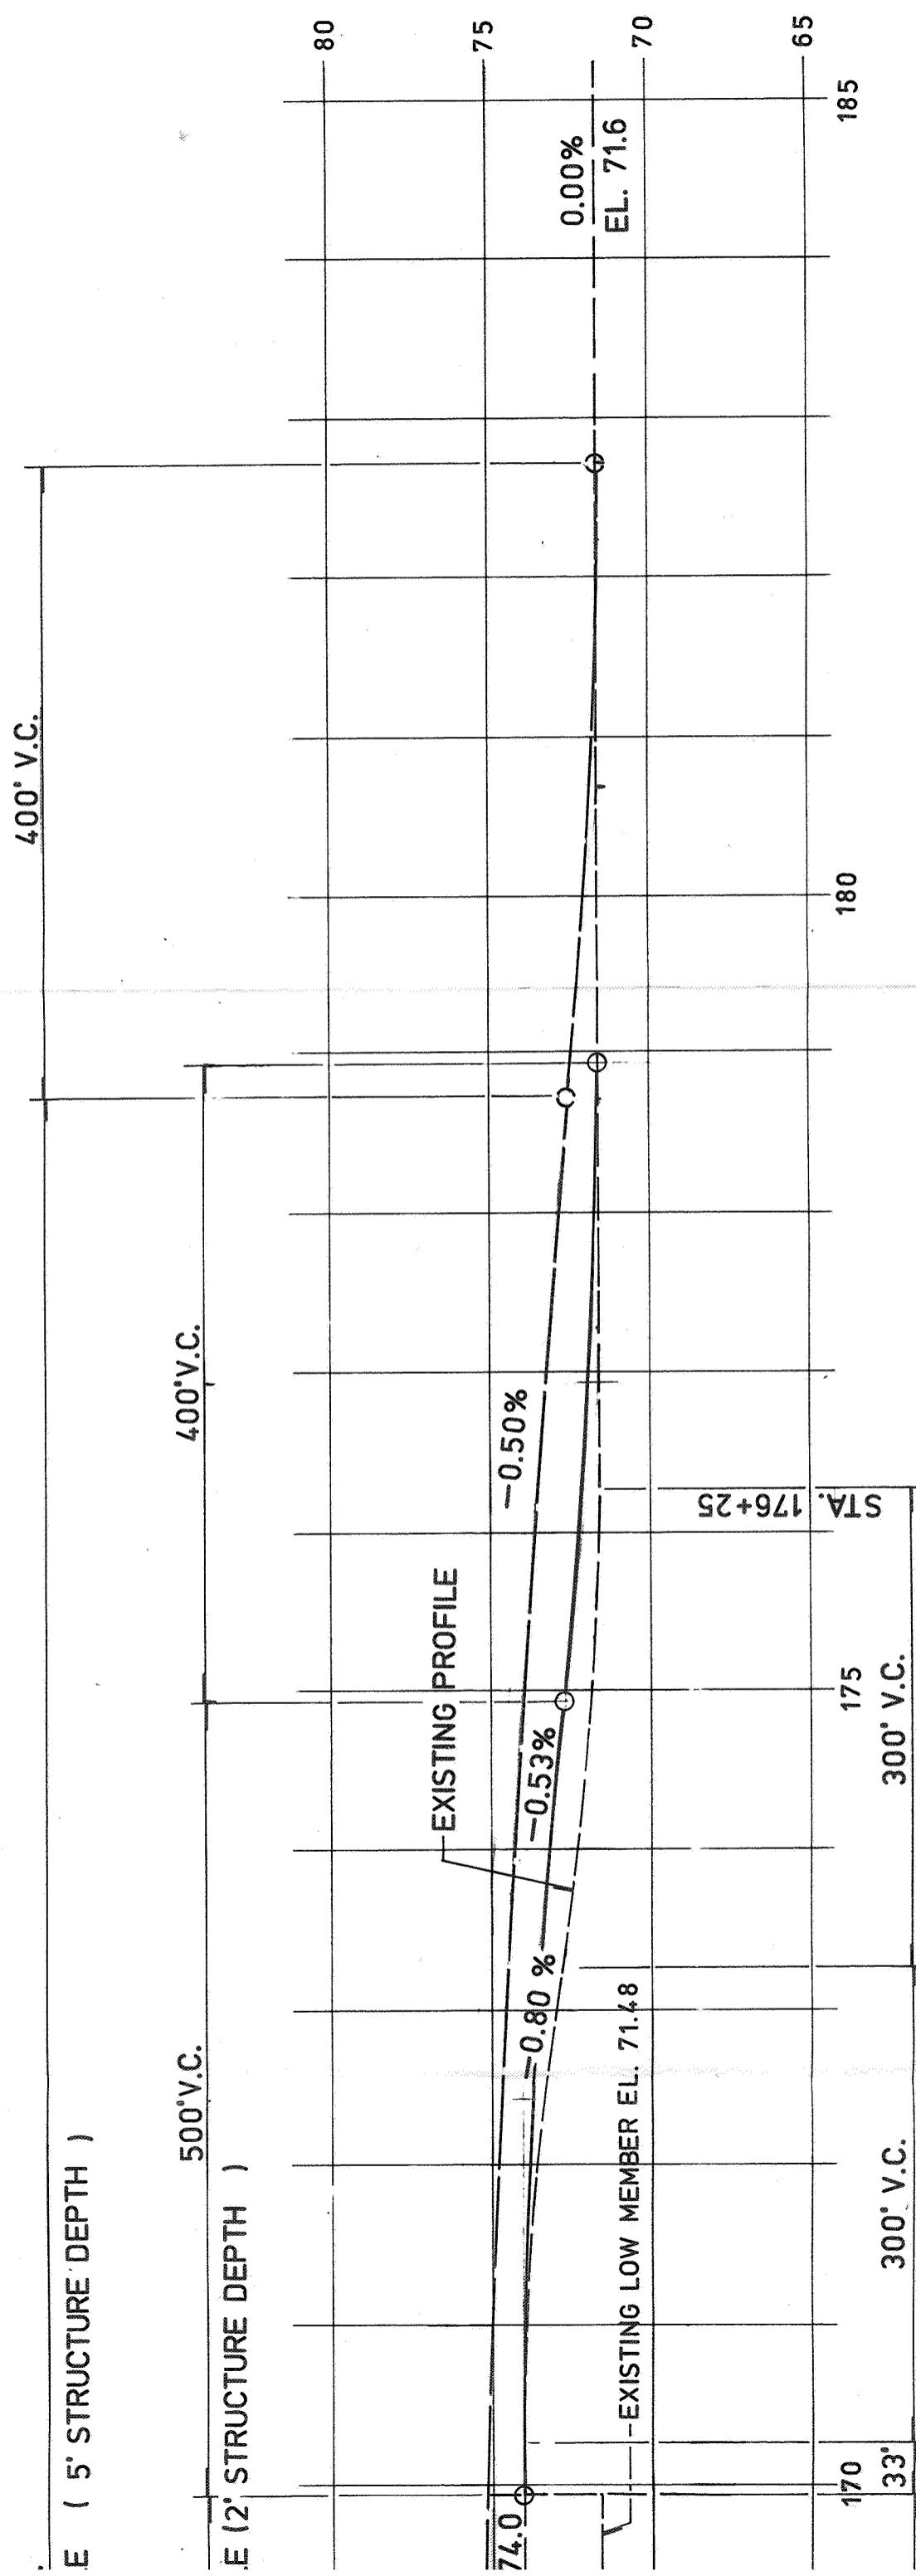
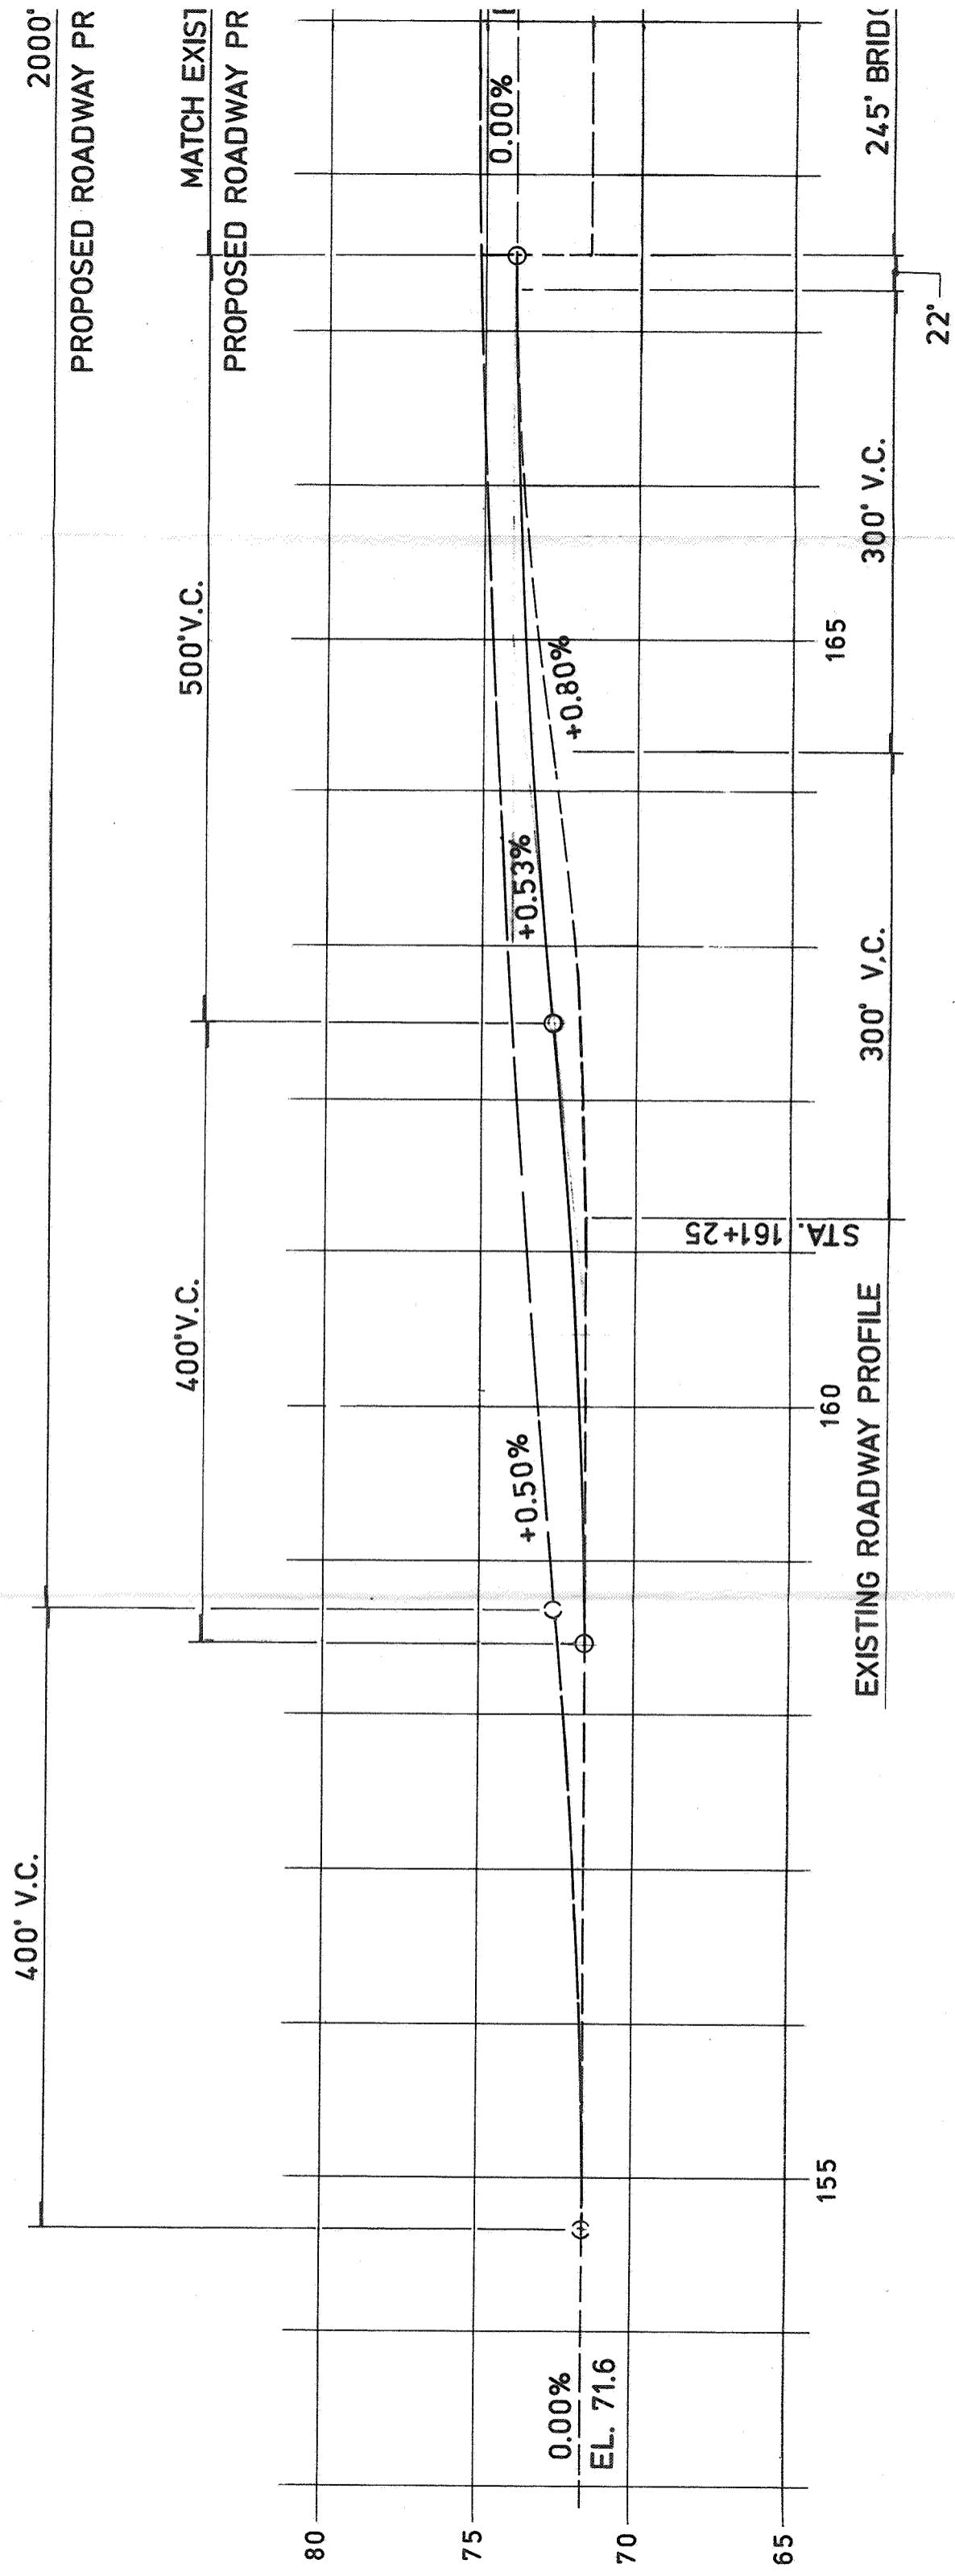
FIGURE 4-3

PROPOSED VERTI
S.R. 700 OVER THE W

The proposed vertical alignments at the replacement structure are shown in Figure 4-3. These vertical alignments will accommodate the superstructure types identified in Section 4.4.4.

bridge depending on the depth of structure. Using the two foot structure depth would allow the existing approach roadways to remain. Necessary changes in vertical alignment due to the substandard 300-foot long crest and sag vertical curves at the approaches could be accomplished by using overbuild during resurfacing of the approach roadways. The existing one degree horizontal curve south of the existing structure utilizes no superelevation. Based on current AASHTO criteria this corresponds with a design speed of 40 m.p.h. Necessary changes to the superelevation in this curve could also be accomplished with overbuild during resurfacing. The proposed range of vertical alignments are shown in Figure 4-3.

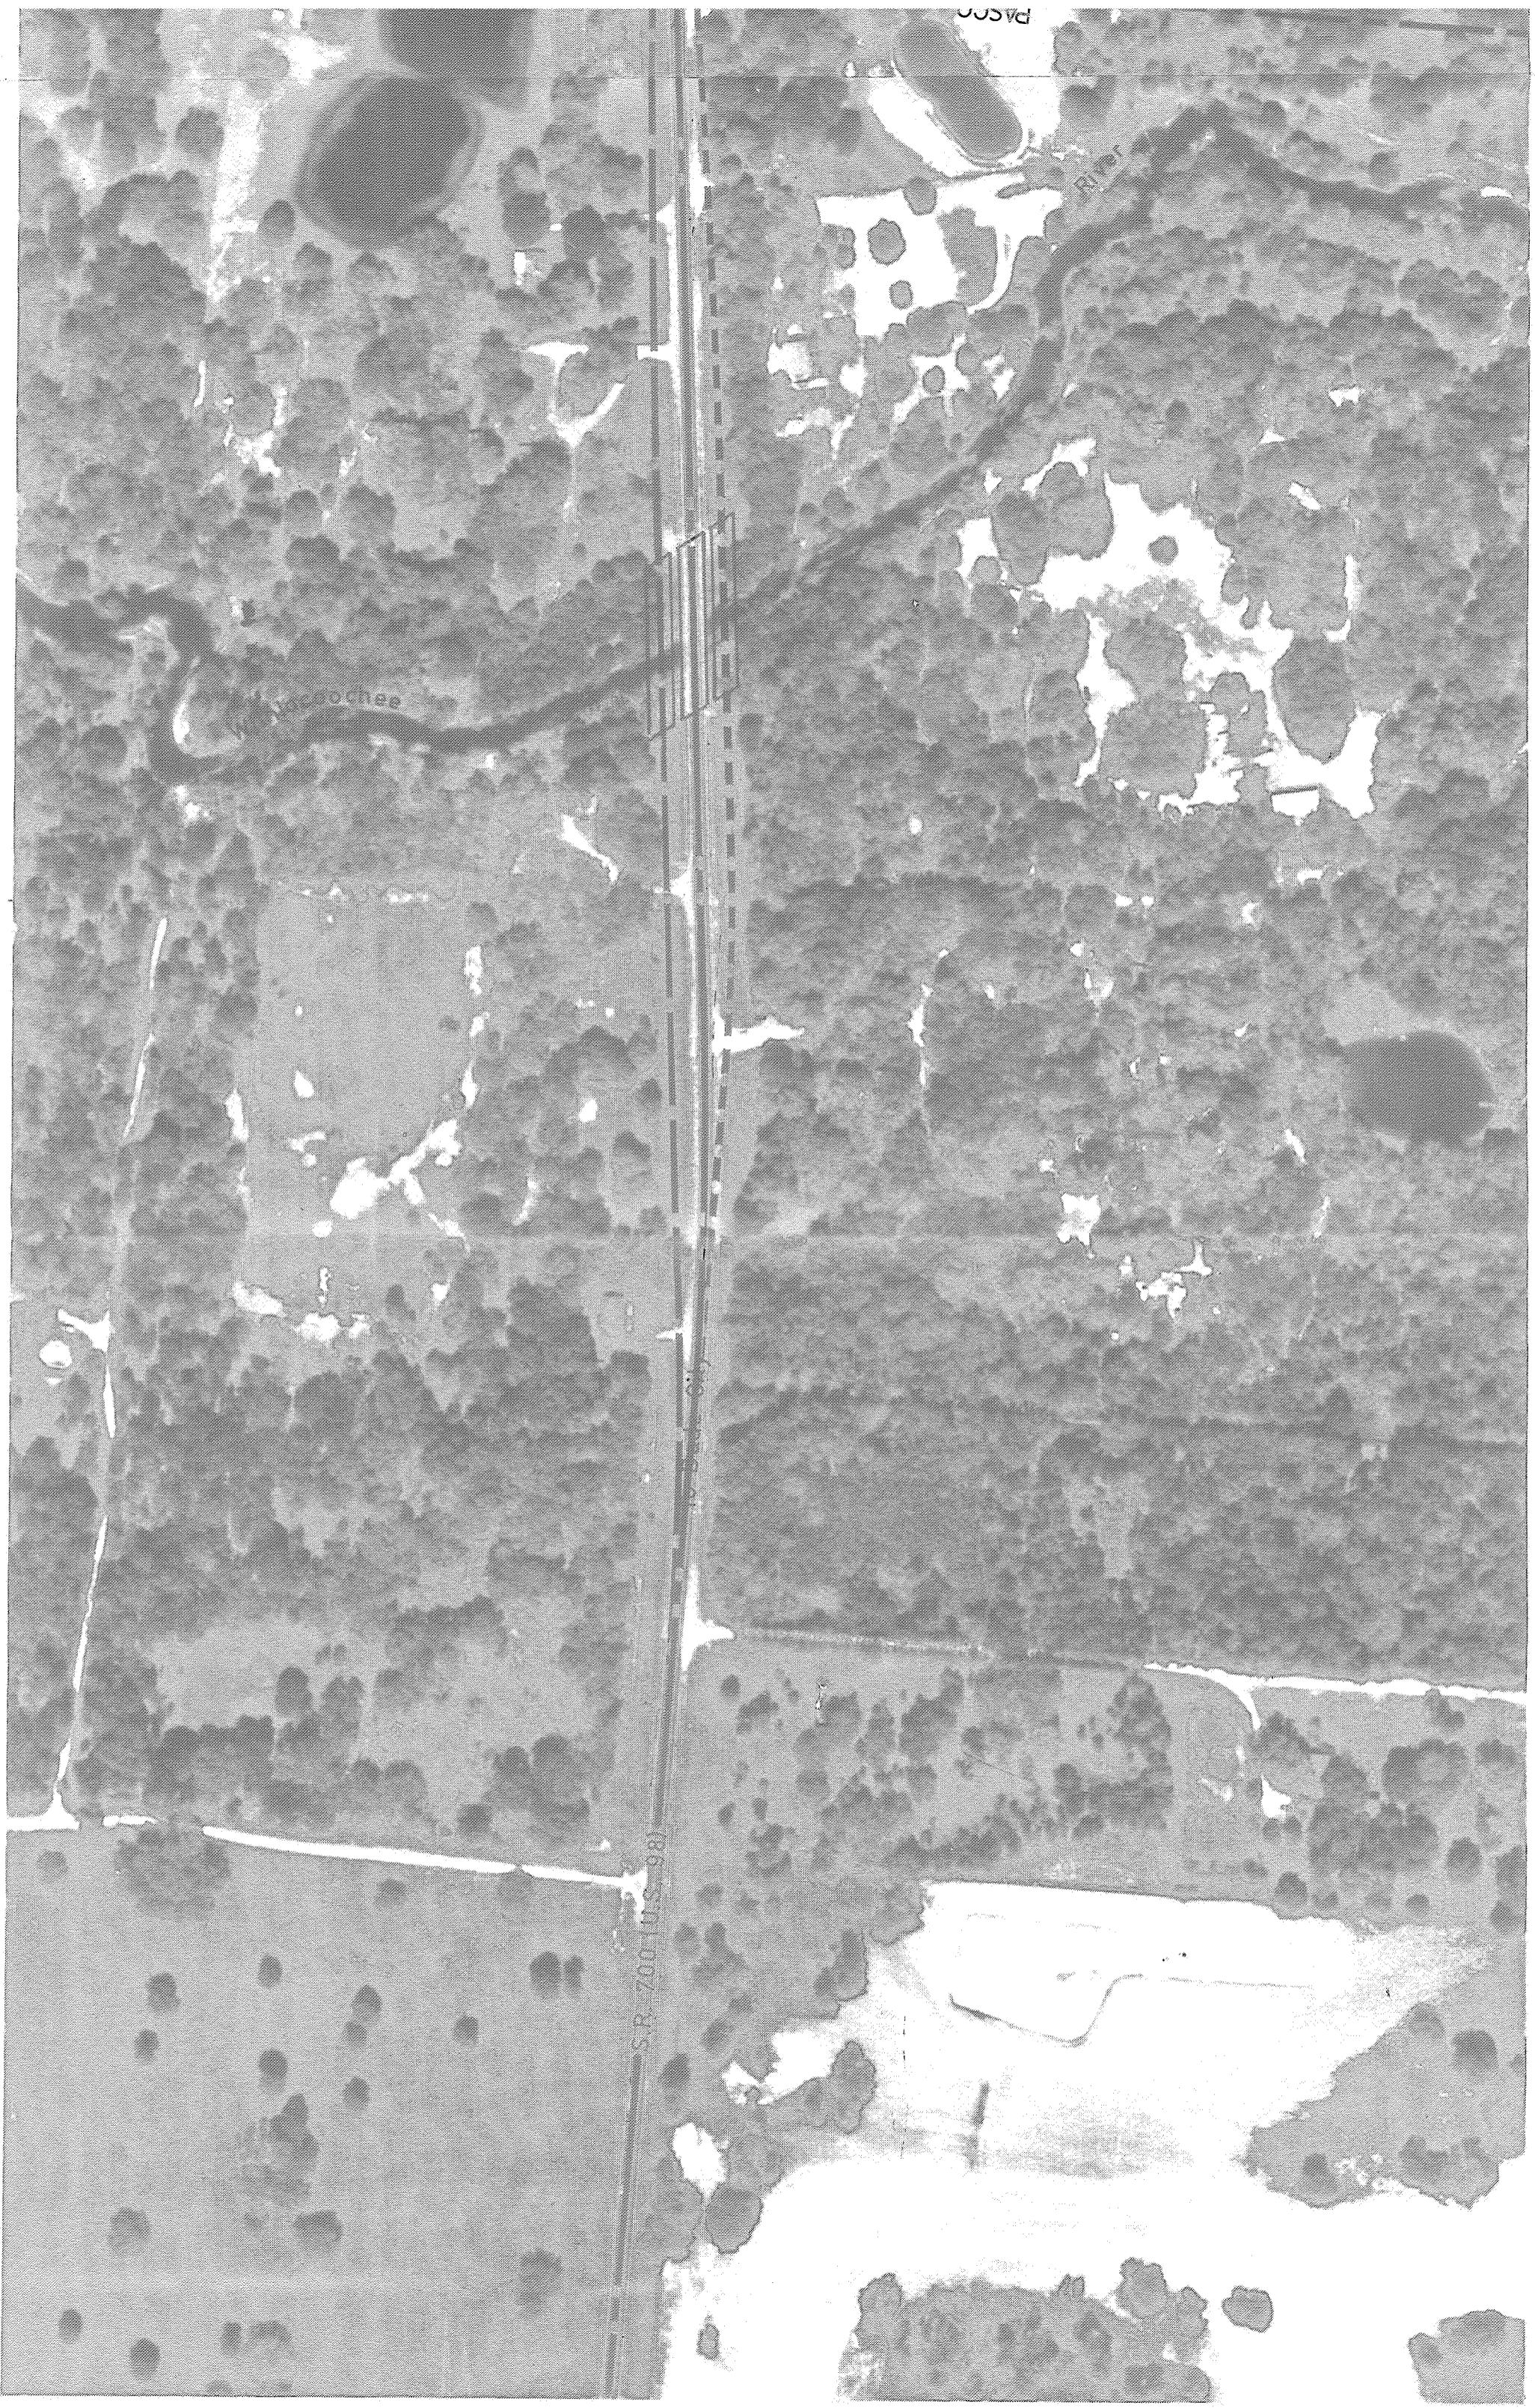
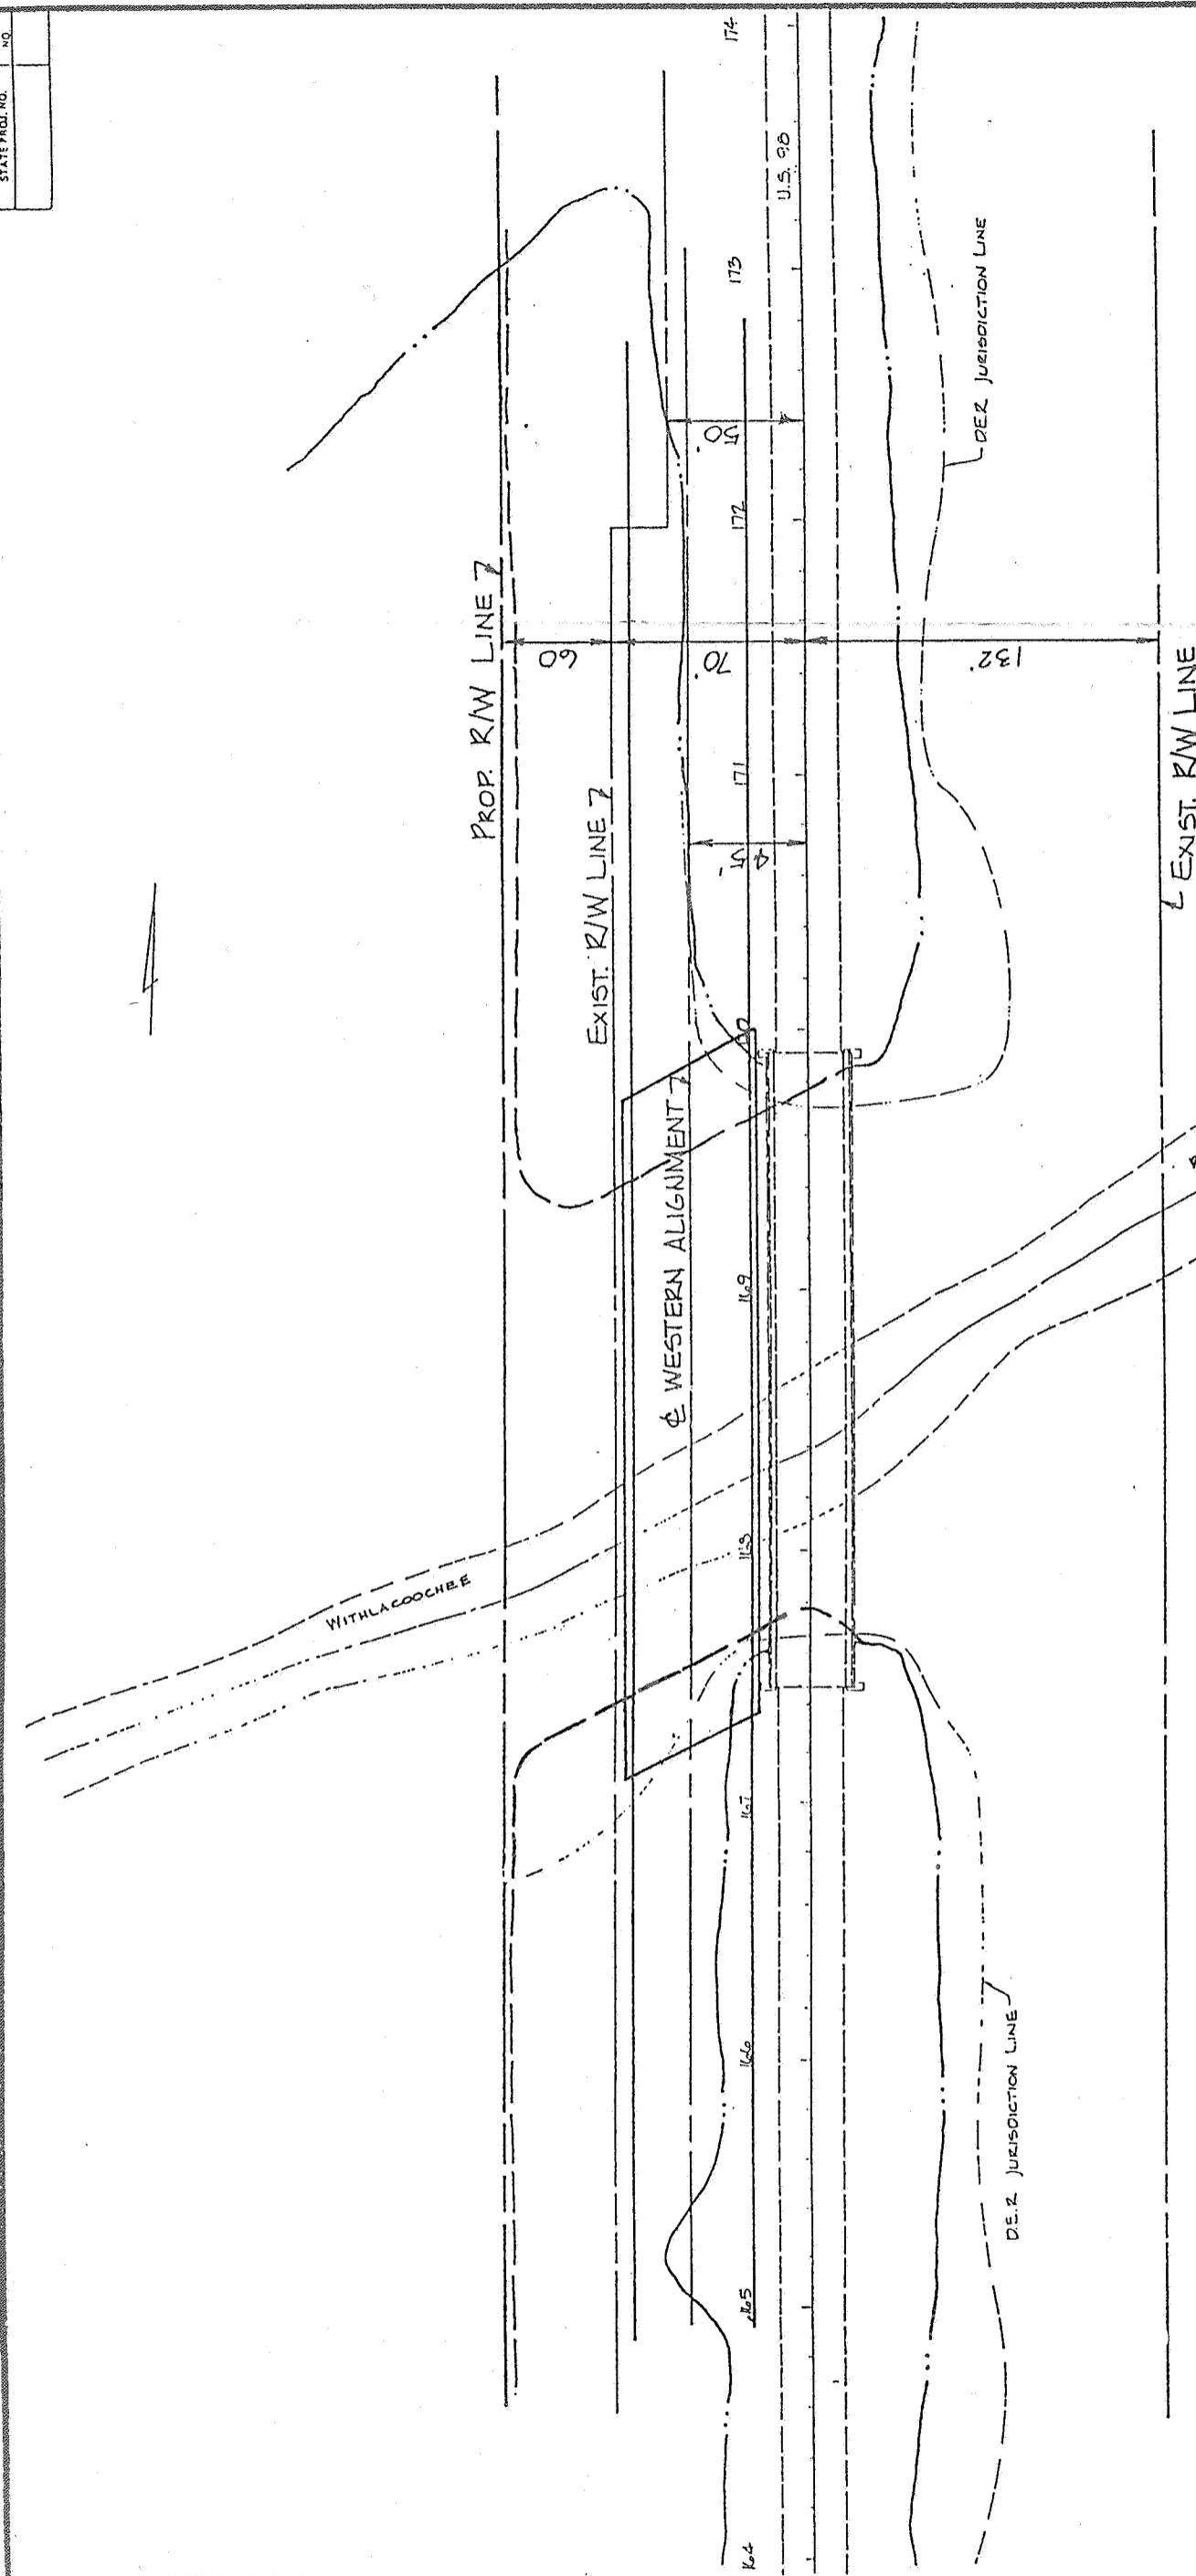
This alternative consists of a replacement bridge approximately 245 feet long located west of the existing bridge (see Figure 5-2). The centerline of the new bridge would be approximately 45 feet from the centerline of the existing bridge. The proposed alignment would tie into the existing roadway approximately 2000 feet north and 1800 feet south of the center of the existing bridge. The north connection would be accomplished through the use of fifteen minute reverse curves. These curves would require no superelevation for the seventy mile per hour design speed. The south connection would be accomplished through the use of a one degree curve.

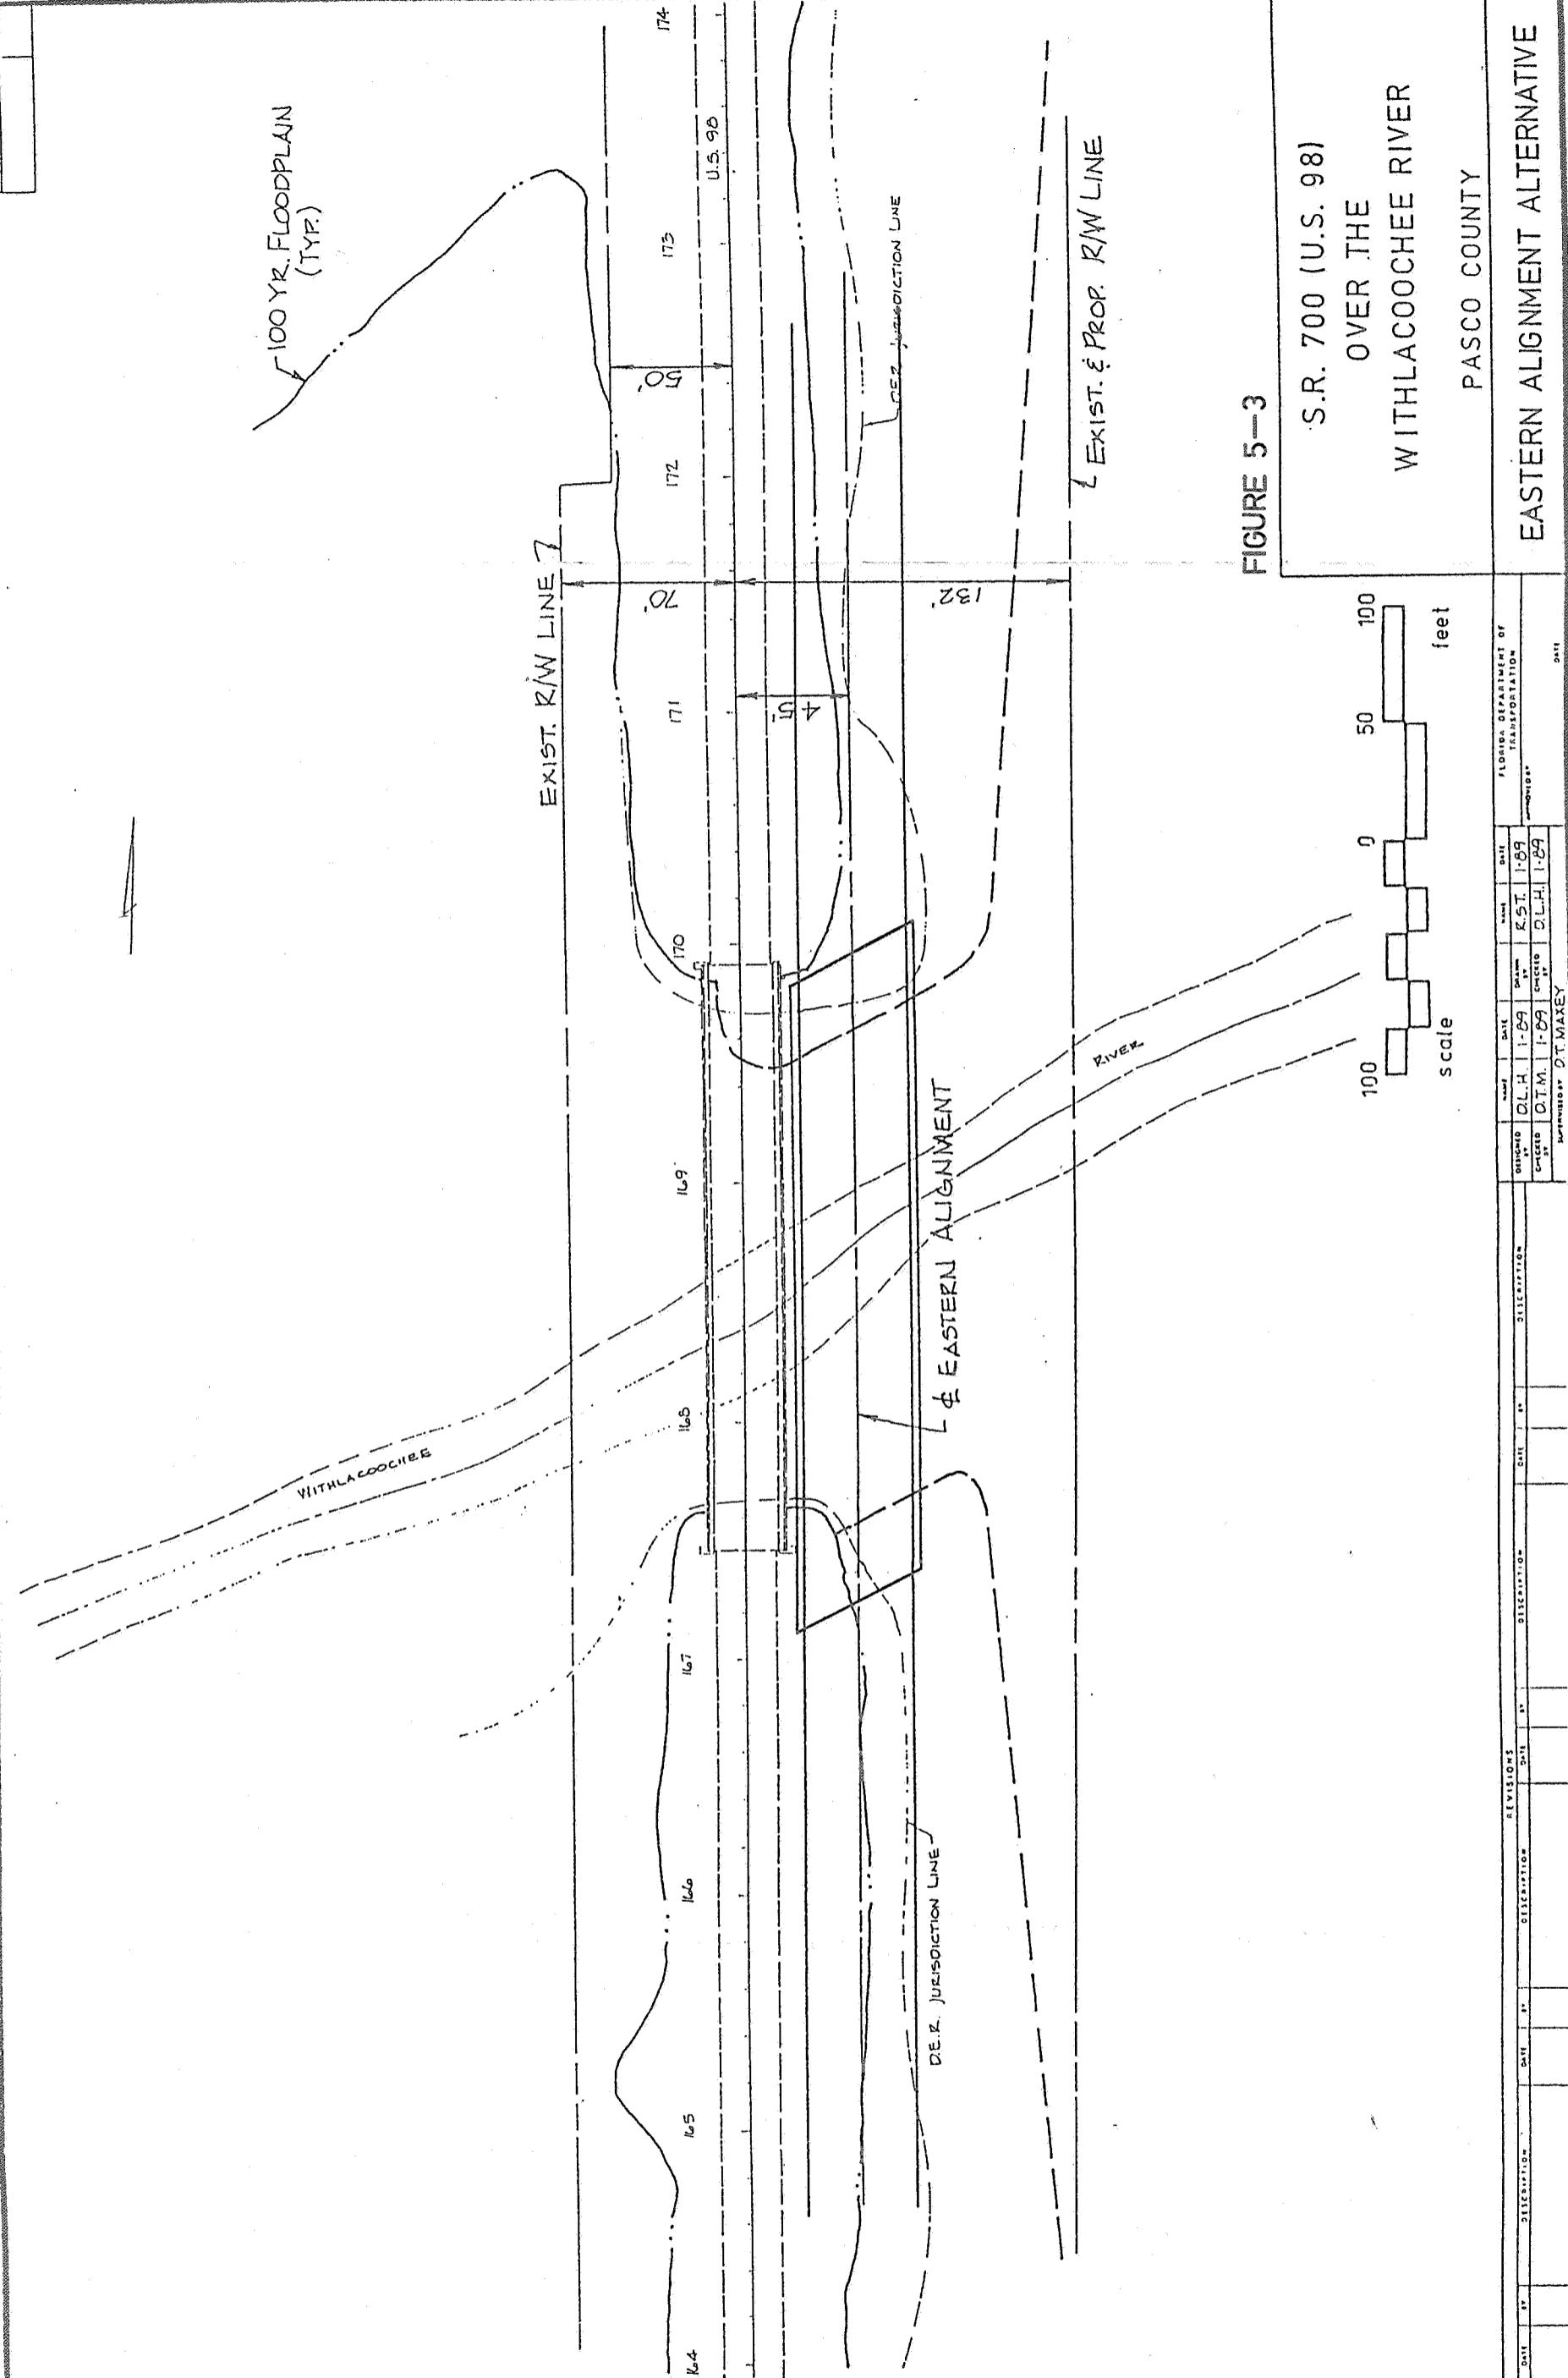
This alternative consists of a replacement bridge approximately 245 feet long located east of the existing bridge (see Figure 5-3). The centerline of the new bridge would be approximately 45 feet from the centerline of the existing bridge. The proposed alignment would tie into the existing roadway approximately 2000 feet north and 1800 feet south of the center of the existing bridge. The north connection would be accomplished through the use of fifteen minute

S.R. 700 (U.S. 98)
OVER THE
WITHLACOOCHEE RIVER
