FINAL PRELIMINARY ENGINEERING REPORT

WITHLACOCHEE RIVER BRIDGE REPLACEMENT

ON S.R. 700 IN PASCO COUNTY, FLORIDA

WPI No.: 7115954
State Project No.: 14080-3506
Bridge No.: 140026

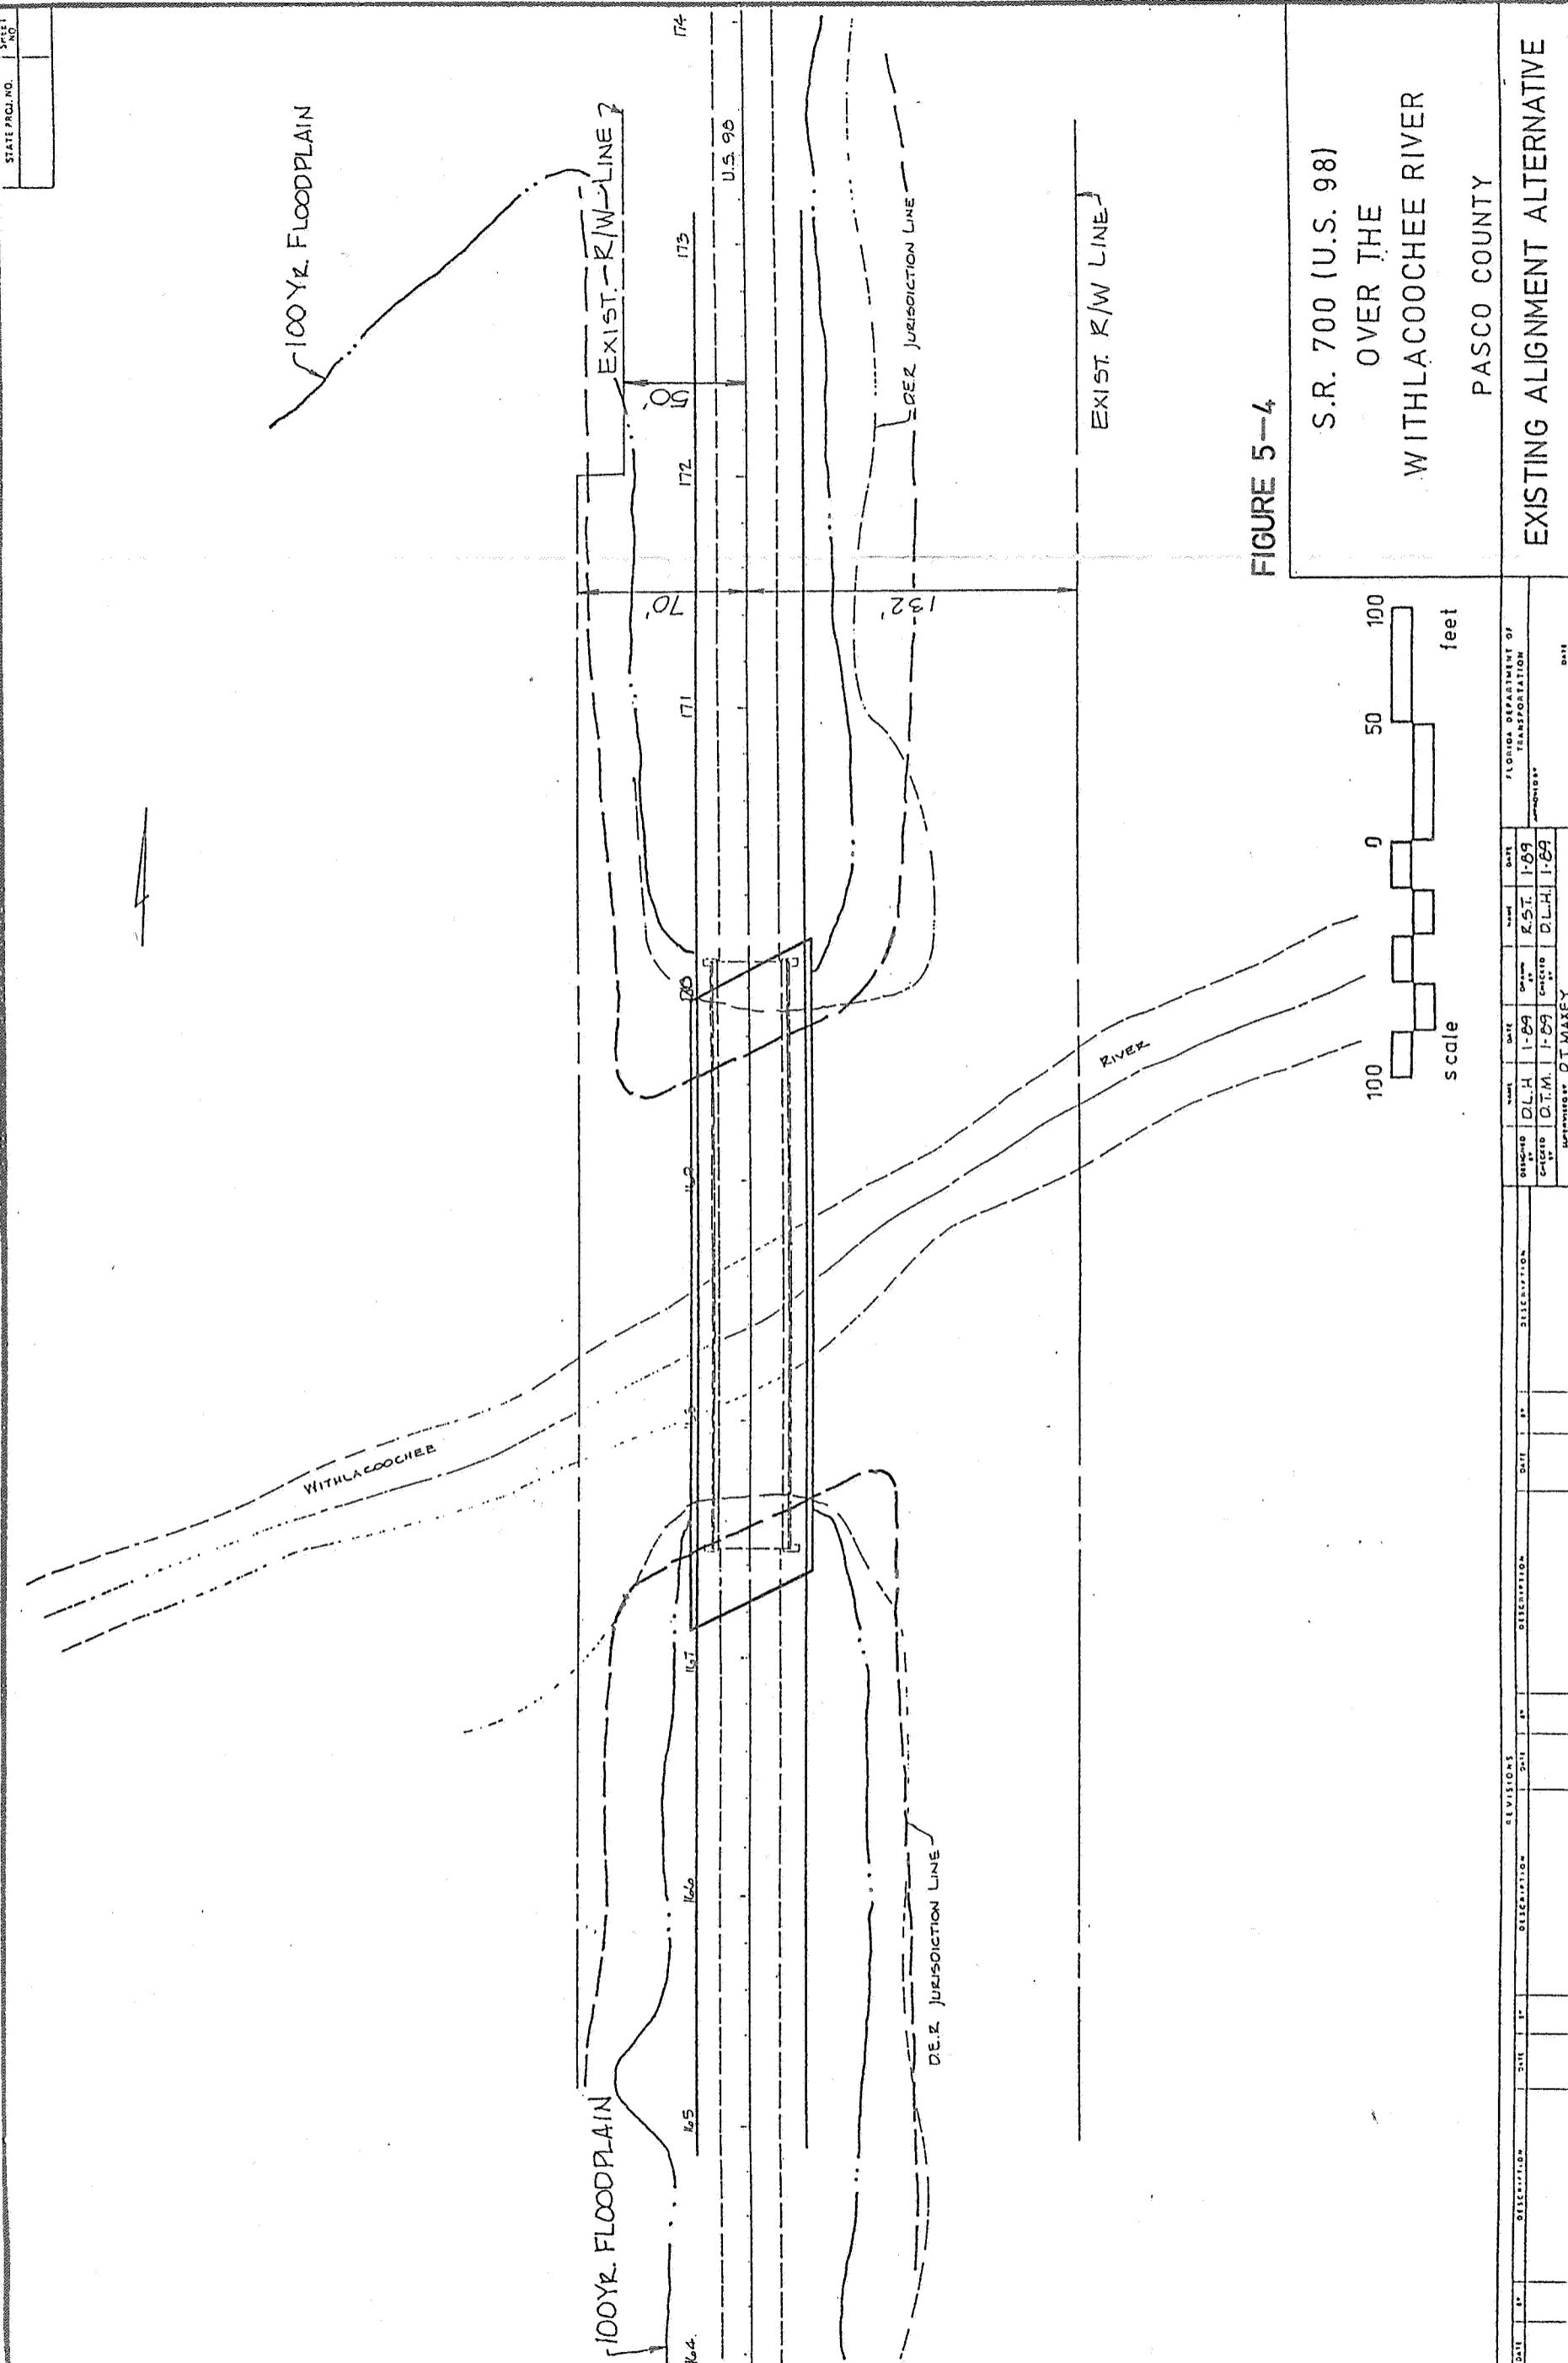
This alternative consists of a replacement bridge approximately 245 feet long located on the existing bridge alignment (see Figure 5-4). This alignment would tie into the existing roadway between 1000 and 1400 feet north and south of the center of the existing

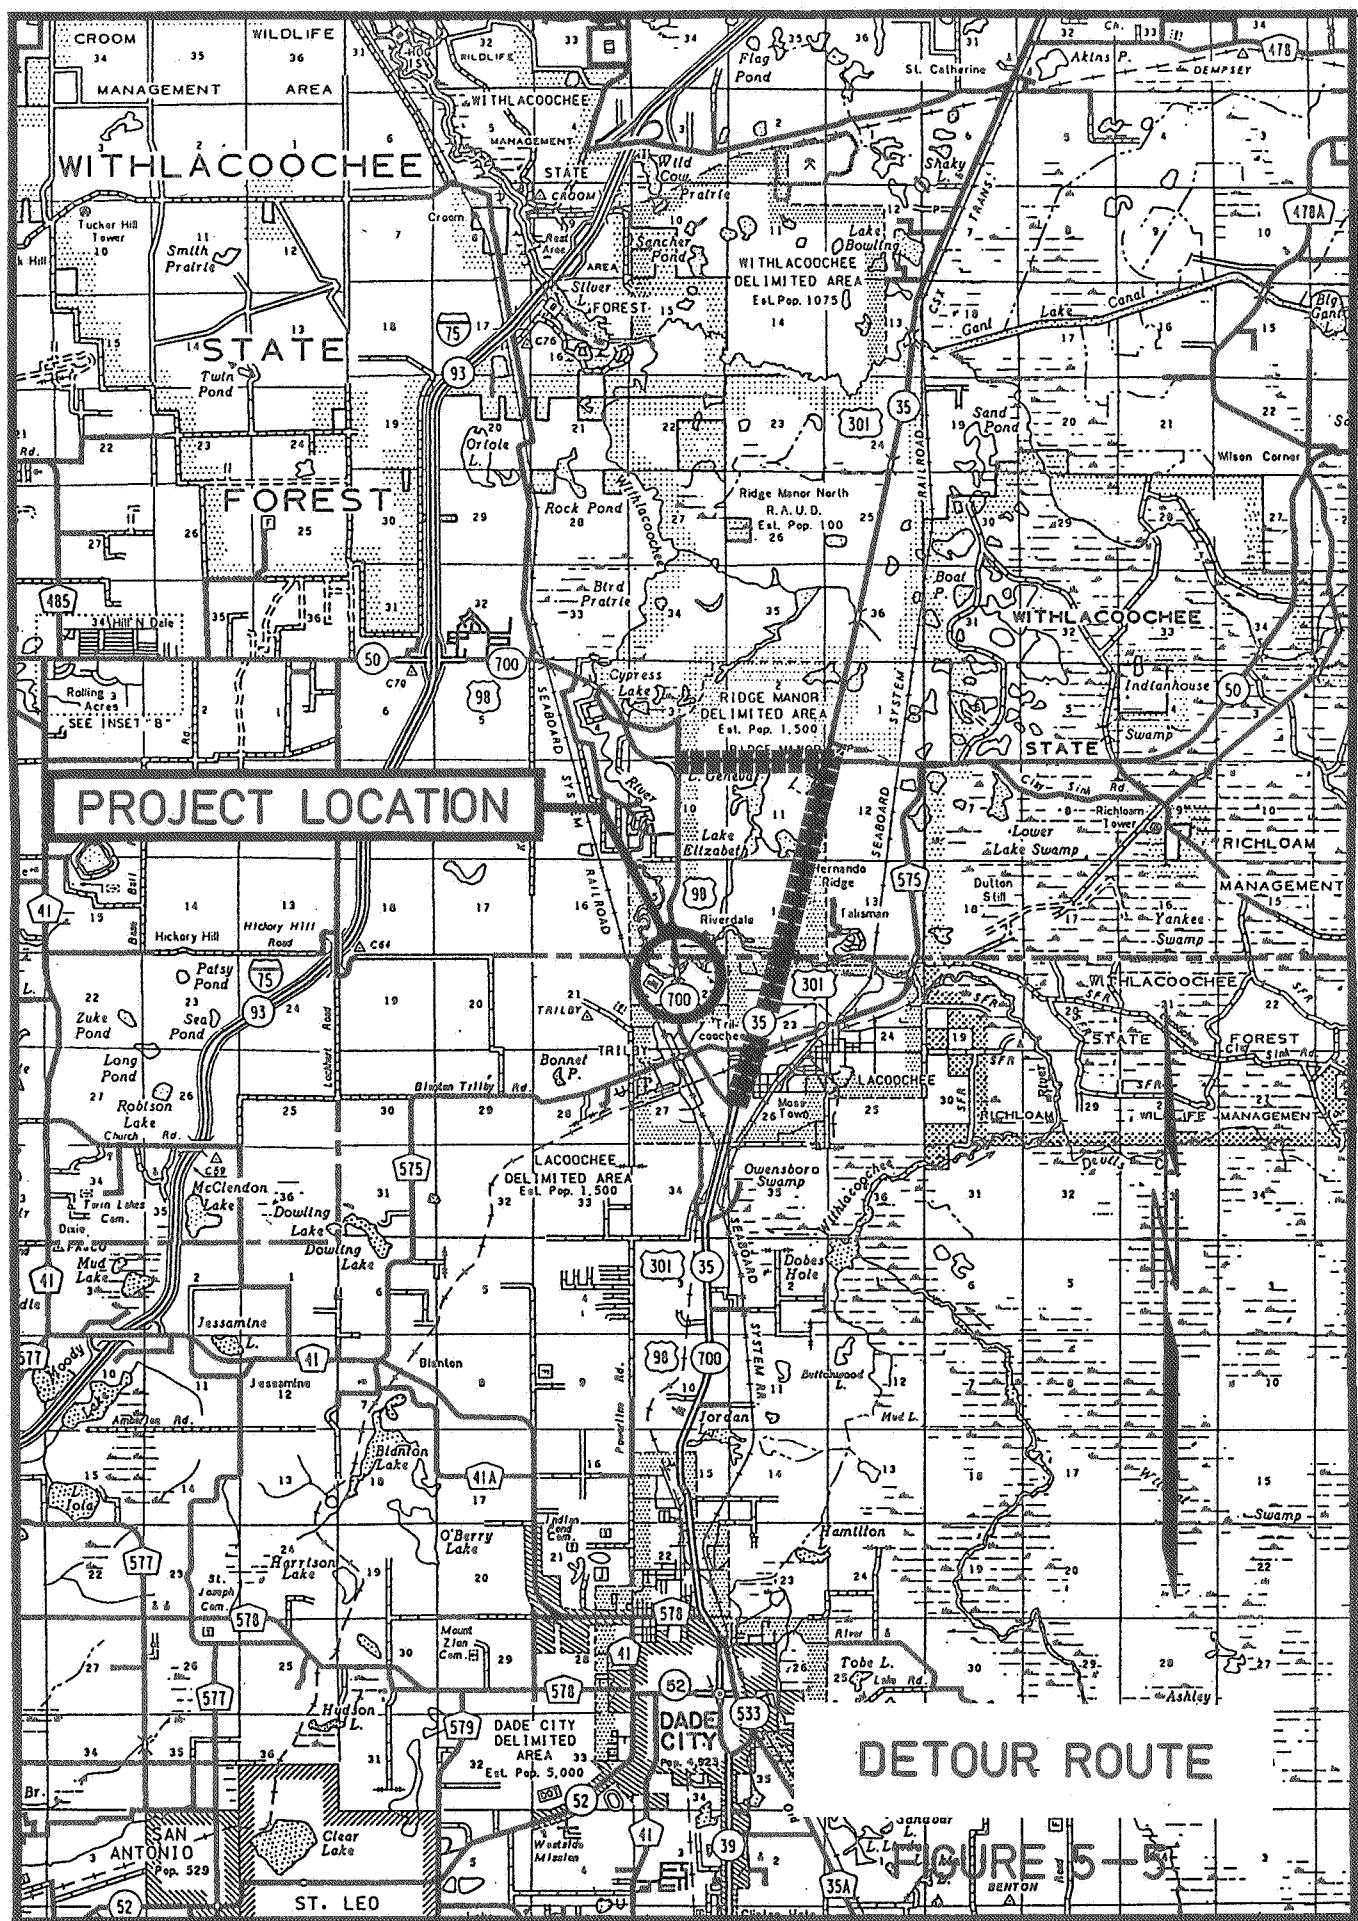
5.4.1 Detour Utilizing Existing State Roads (MOT 1): The proposed detour would begin approximately 2.1 miles north of the bridge at the intersection of SR 700 and SR 50 (see Figure 5-5). From this intersection, the route would follow SR 50 east for 1.5 miles to SR 35, and SR 35 south 3.7 miles to the merger with SR 700 resulting in an increase of

approximately 1.5 miles for through traffic on SR 700. The total detour length for local traffic travelling from one side of the bridge to the other is 8.9 miles. The design speed of the detour will be the posted speed limits along the proposed route.

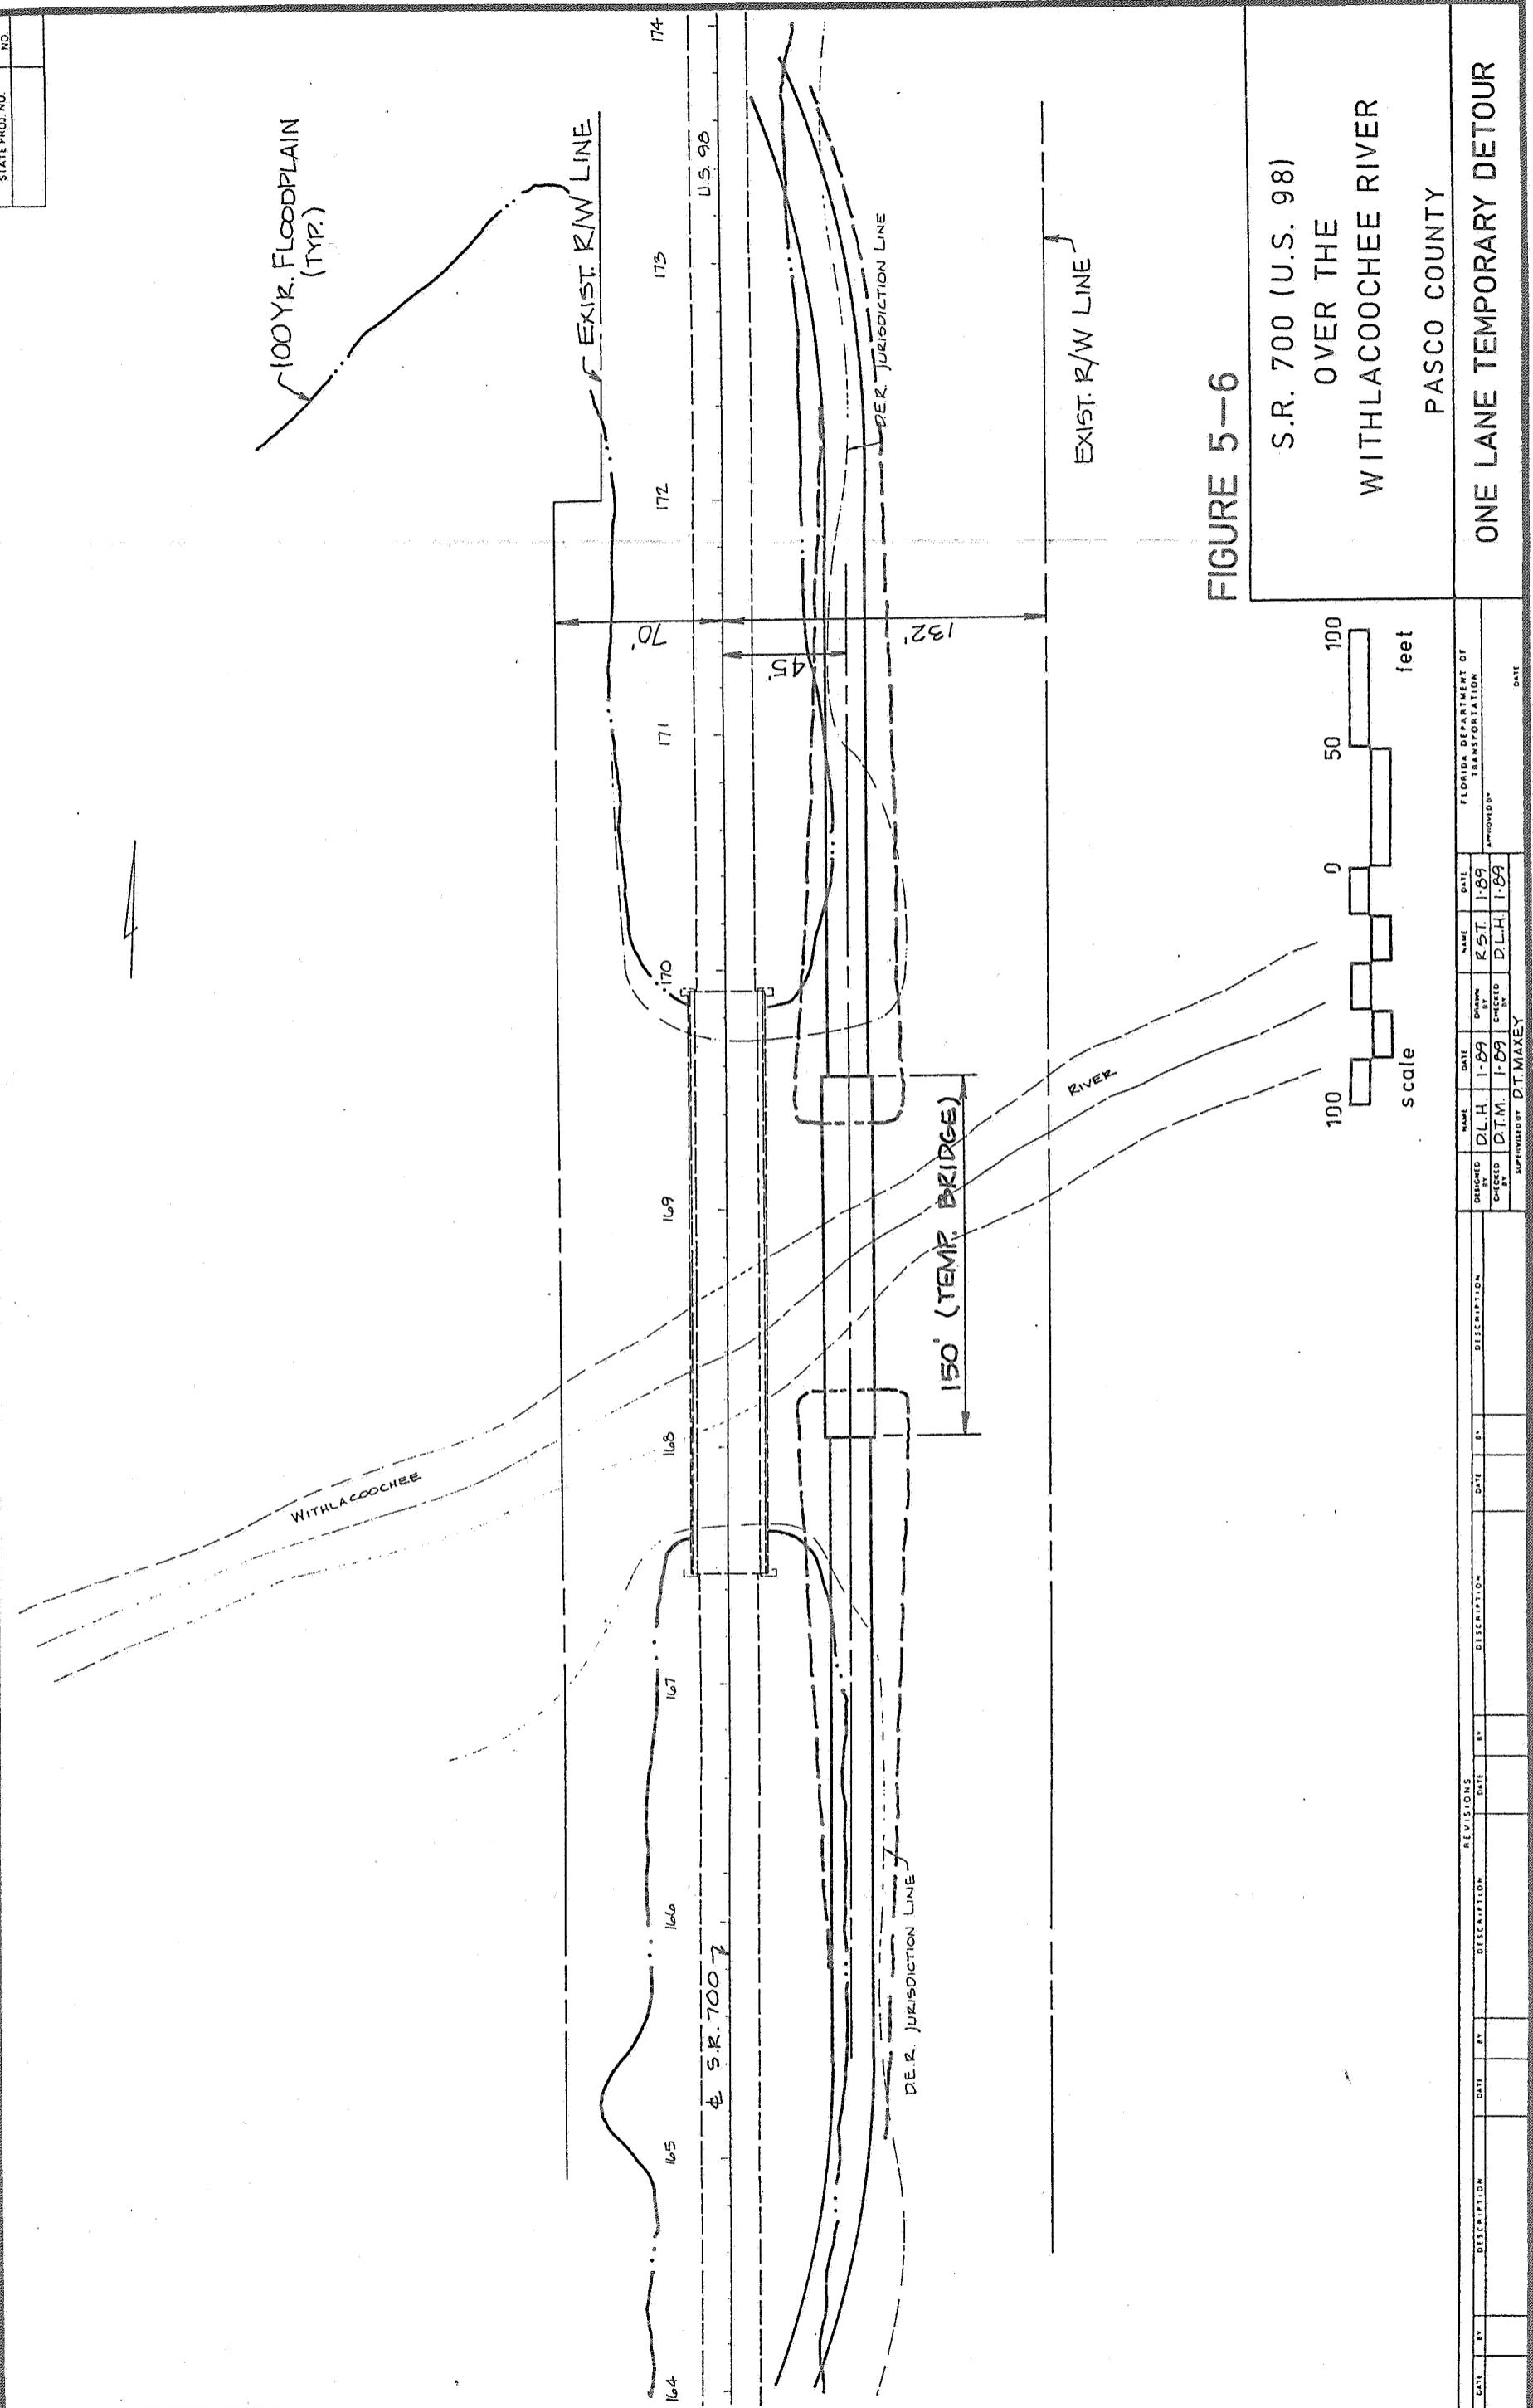
Detour Utilizing One Lane Temporary Detour Structure (MOT 2): The temporary bridge structure alternative would utilize a prefabricated superstructure (stockpiled by FDOT in Orlando approximately 60 miles to the east) on temporary timber bents adjacent to the existing bridge (see Figure 5-6). The existing bridge is offset in the 202-foot right-of-way (see Figure 2-1) which indicates a temporary construction easement would not be required for the proposed eastern detour alignment. A one lane temporary structure would require signalization. The approximate length of the temporary detour structure is 150 feet. This length was established by providing a structure that would span the main channel of the river. A design speed 10 m.p.h. below the posted speed limit of 55 m.p.h. would be anticipated for the temporary detour structure and approaches.

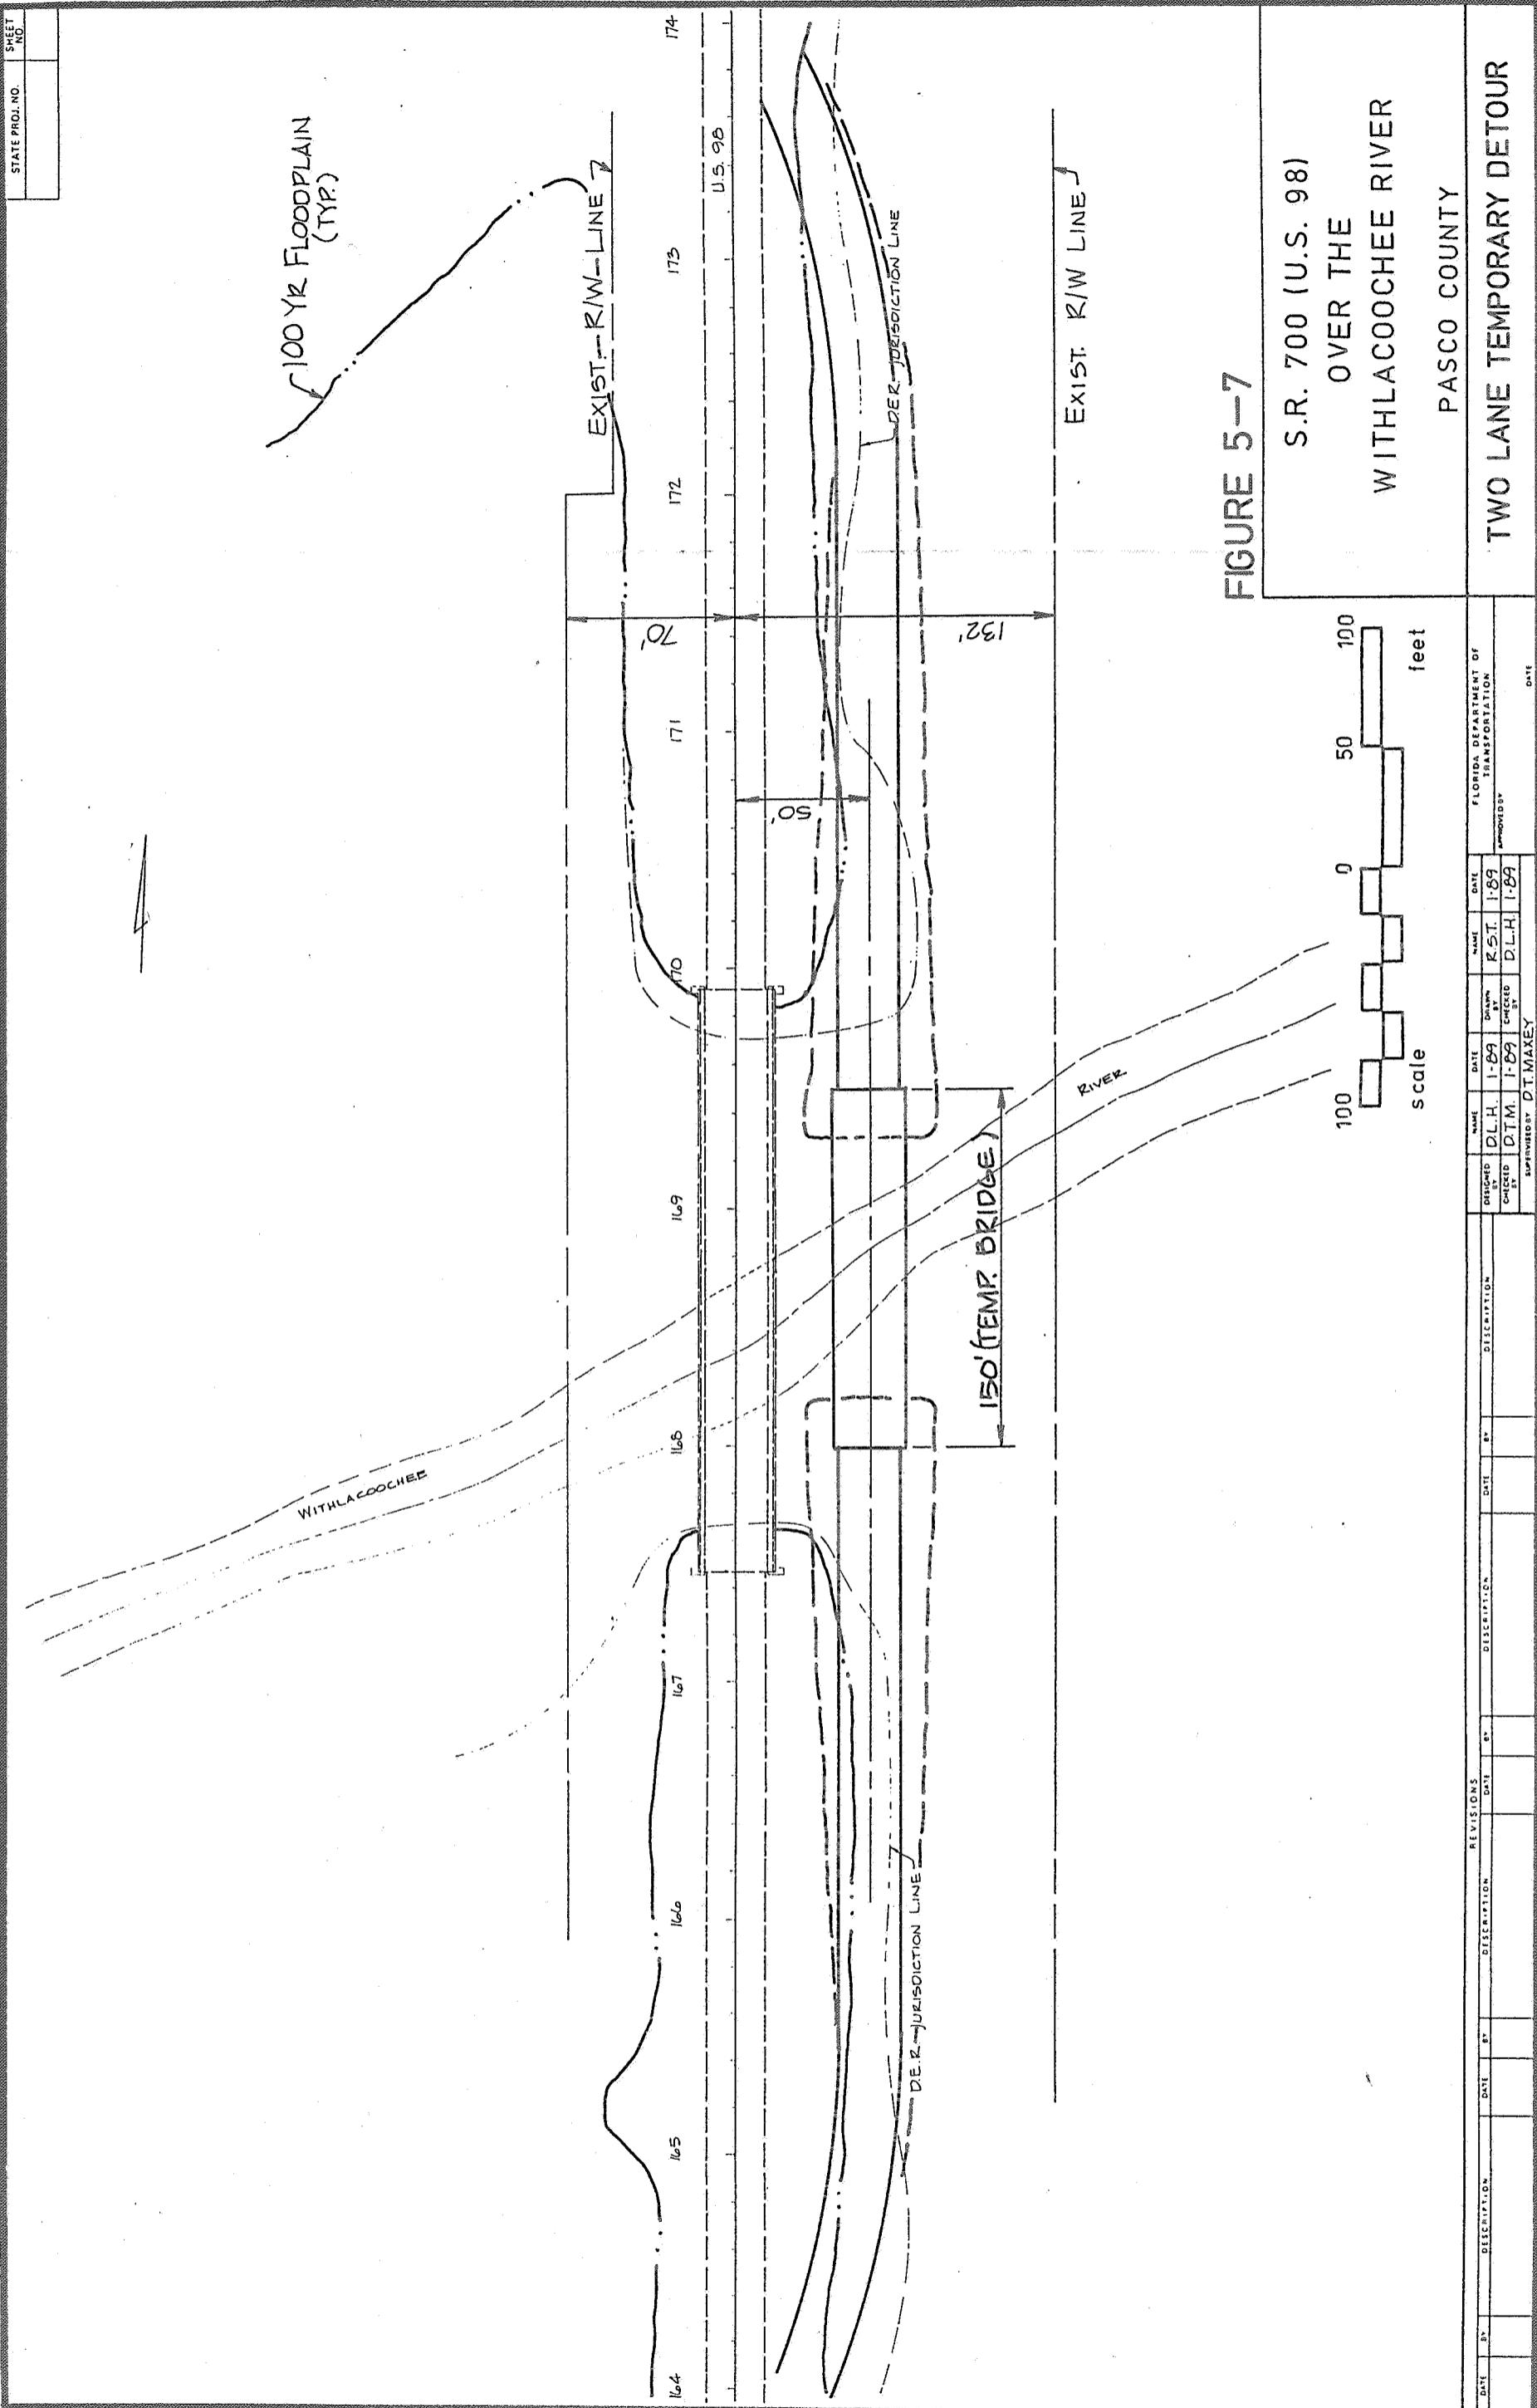
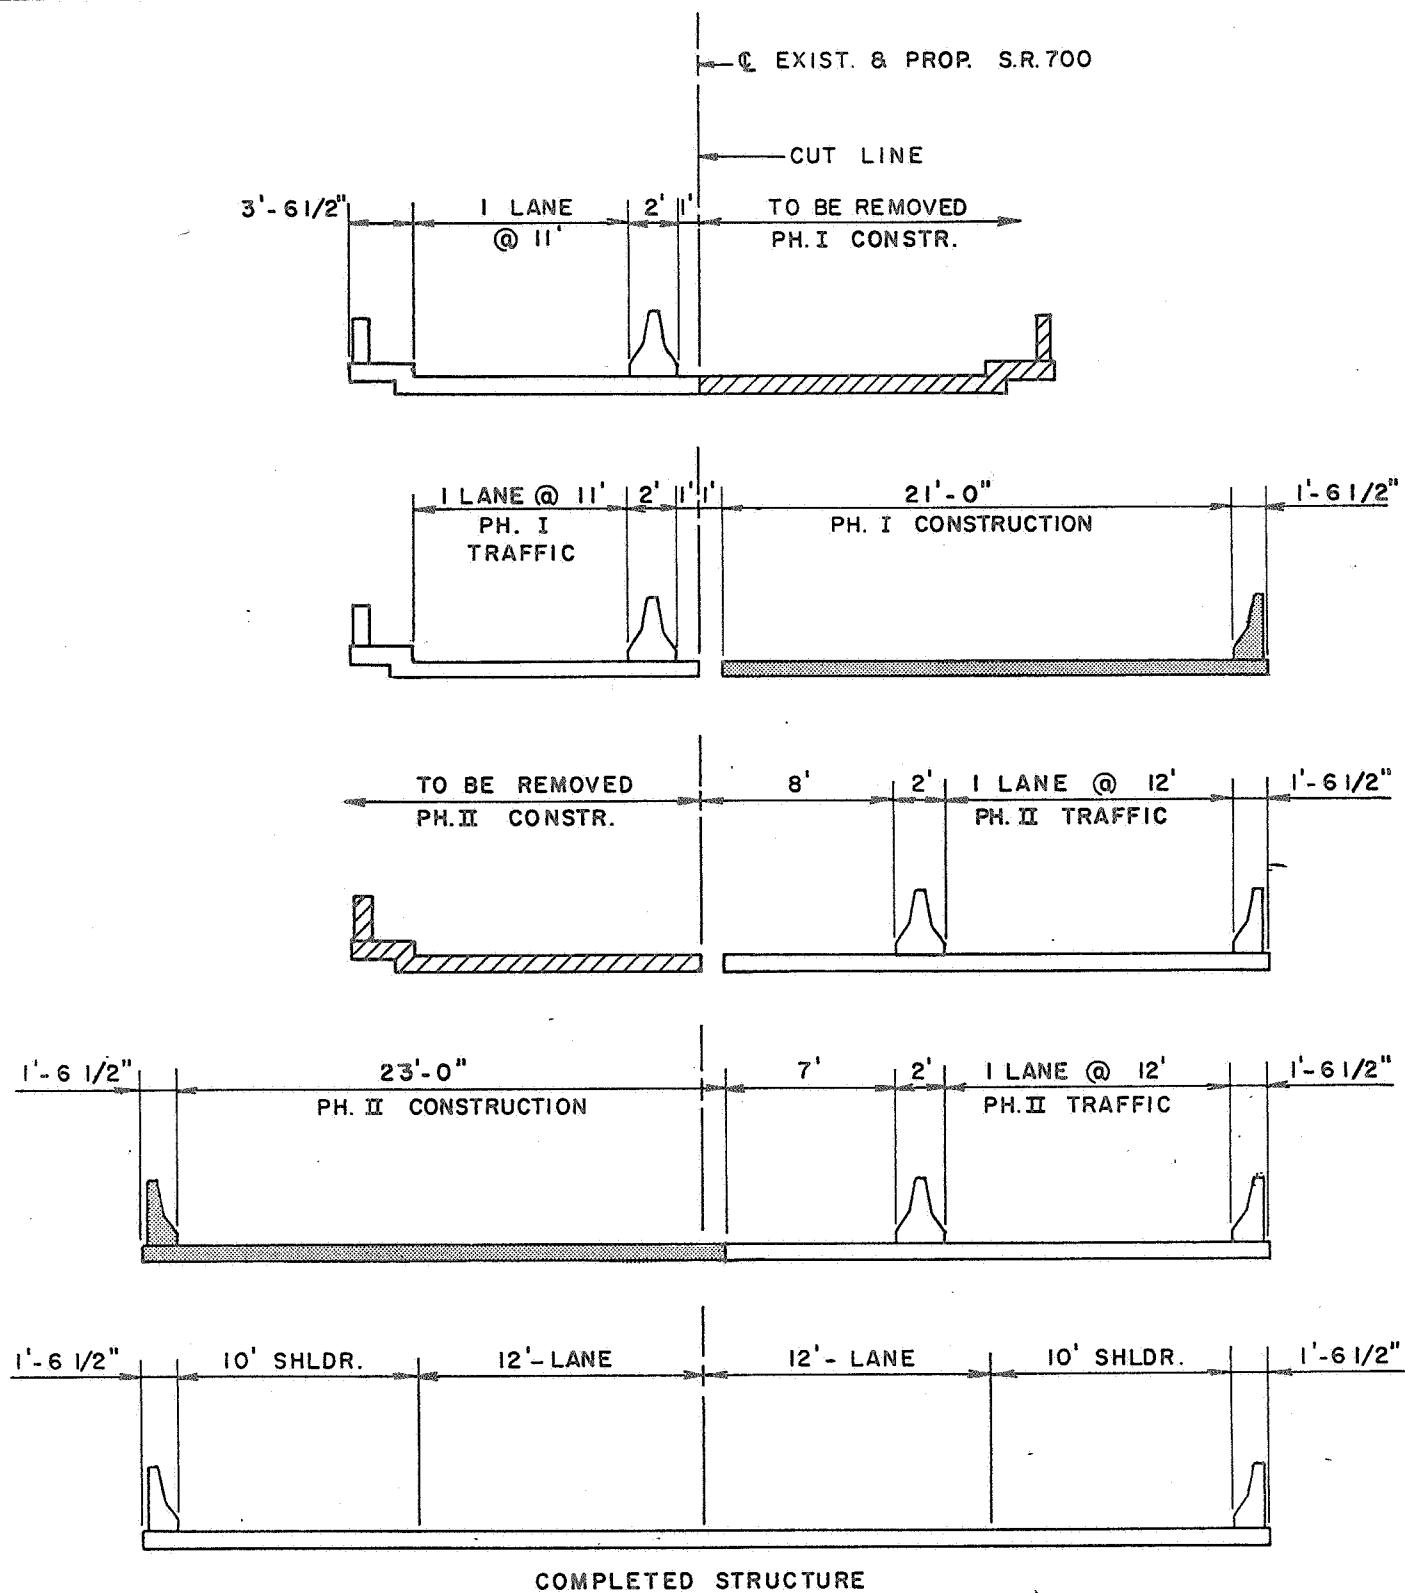
FIGURE 5-8

One Lane Phased Construction (MOT 4): This alternative would have one lane of traffic on approximately one half of the existing bridge while the other half is being removed and replaced. Traffic would be switched to the new portion upon completion and the remaining part of the existing structure would be removed and replaced. Signalization would be required to regulate two-way traffic on one lane. A typical section depicting each phase of construction is shown in Figure 5-8.

S.R. 700 (U.S. 98) over the WITHLACOOCHEE RIVER
PASCO COUNTY

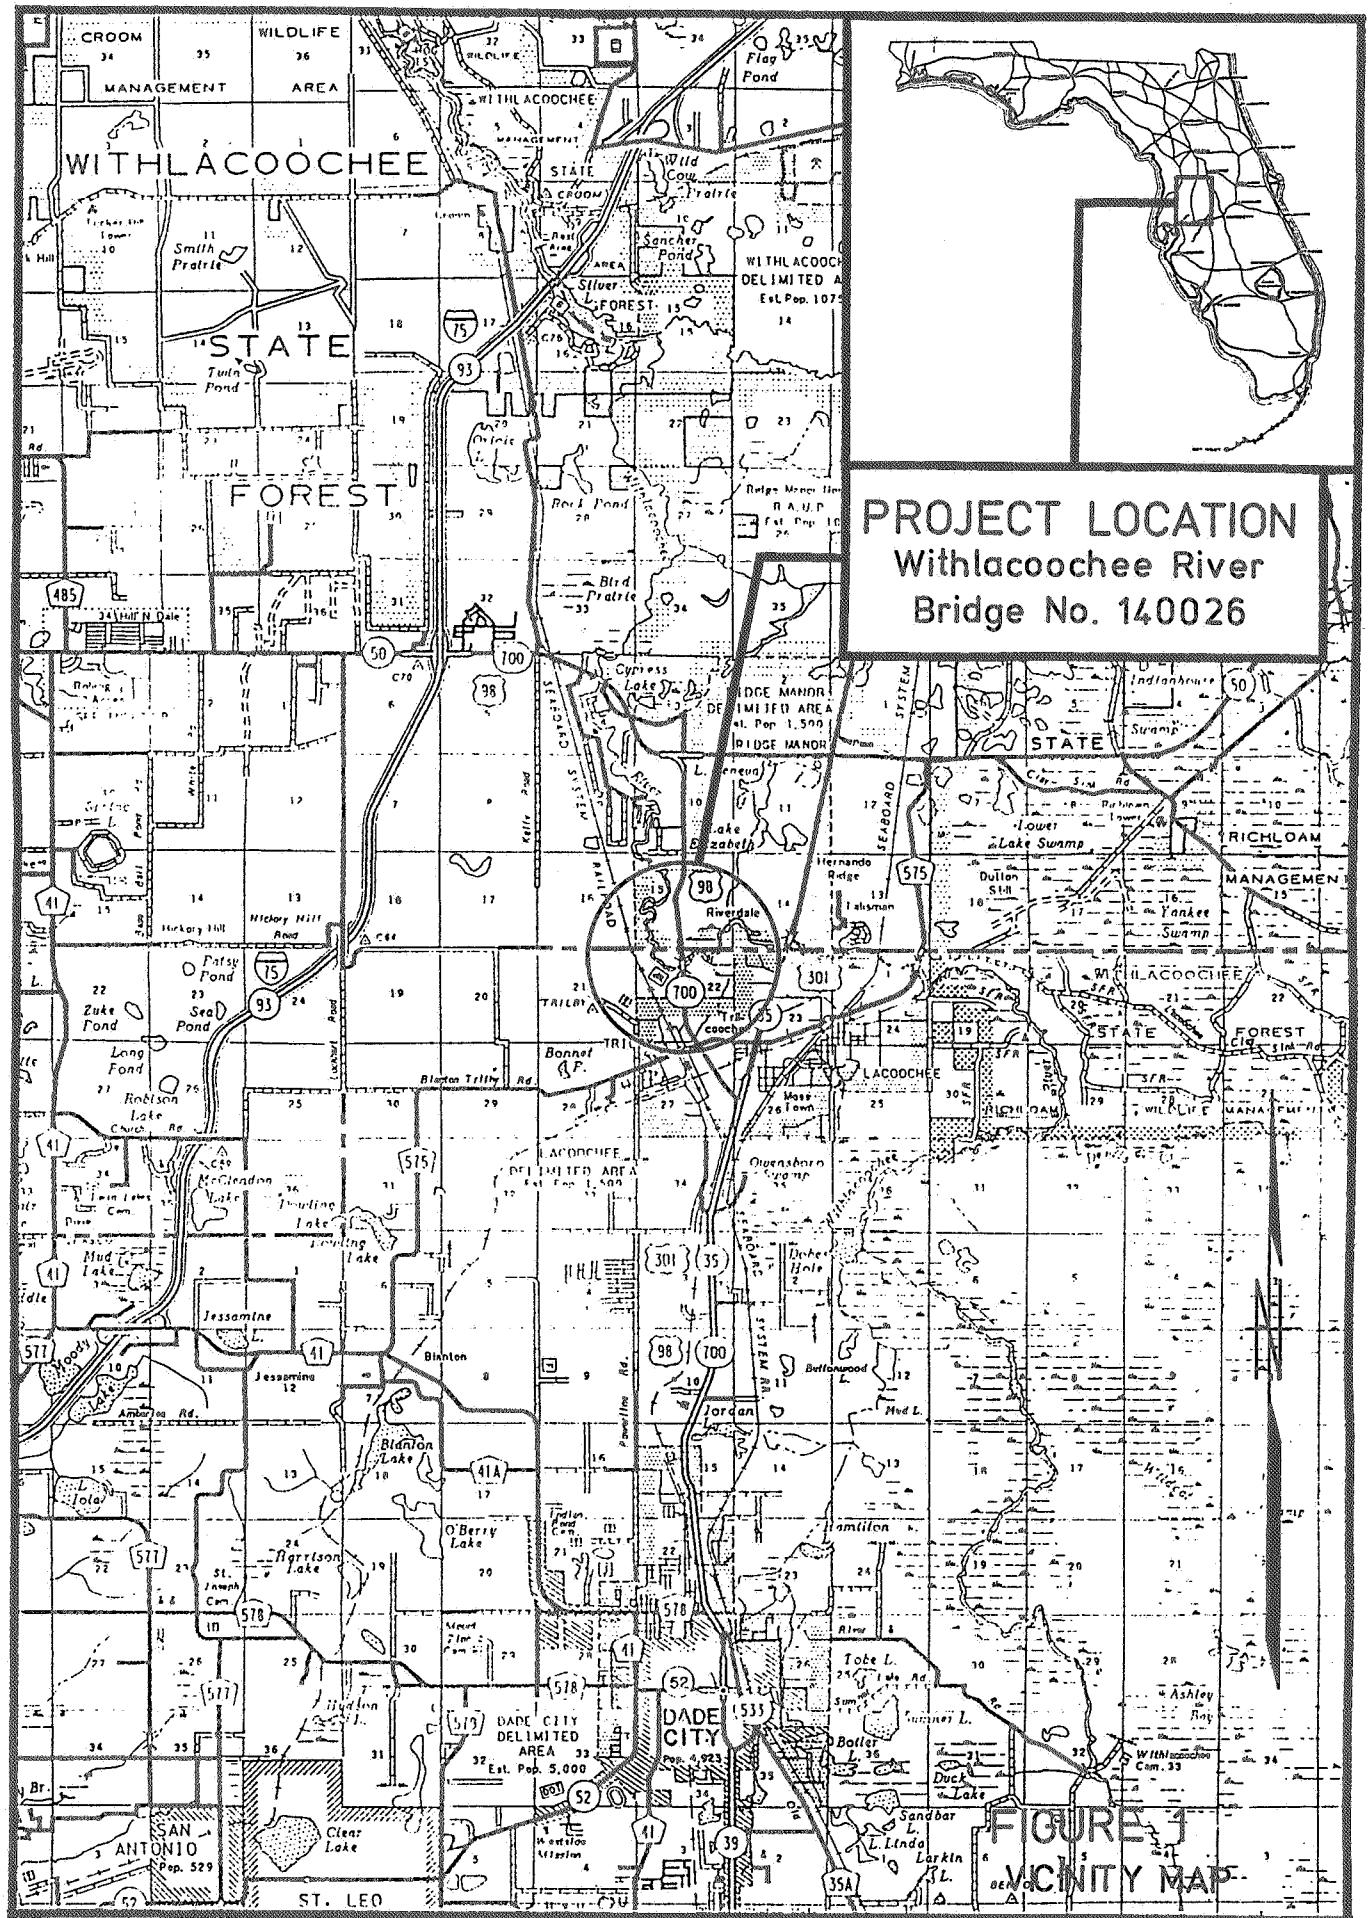
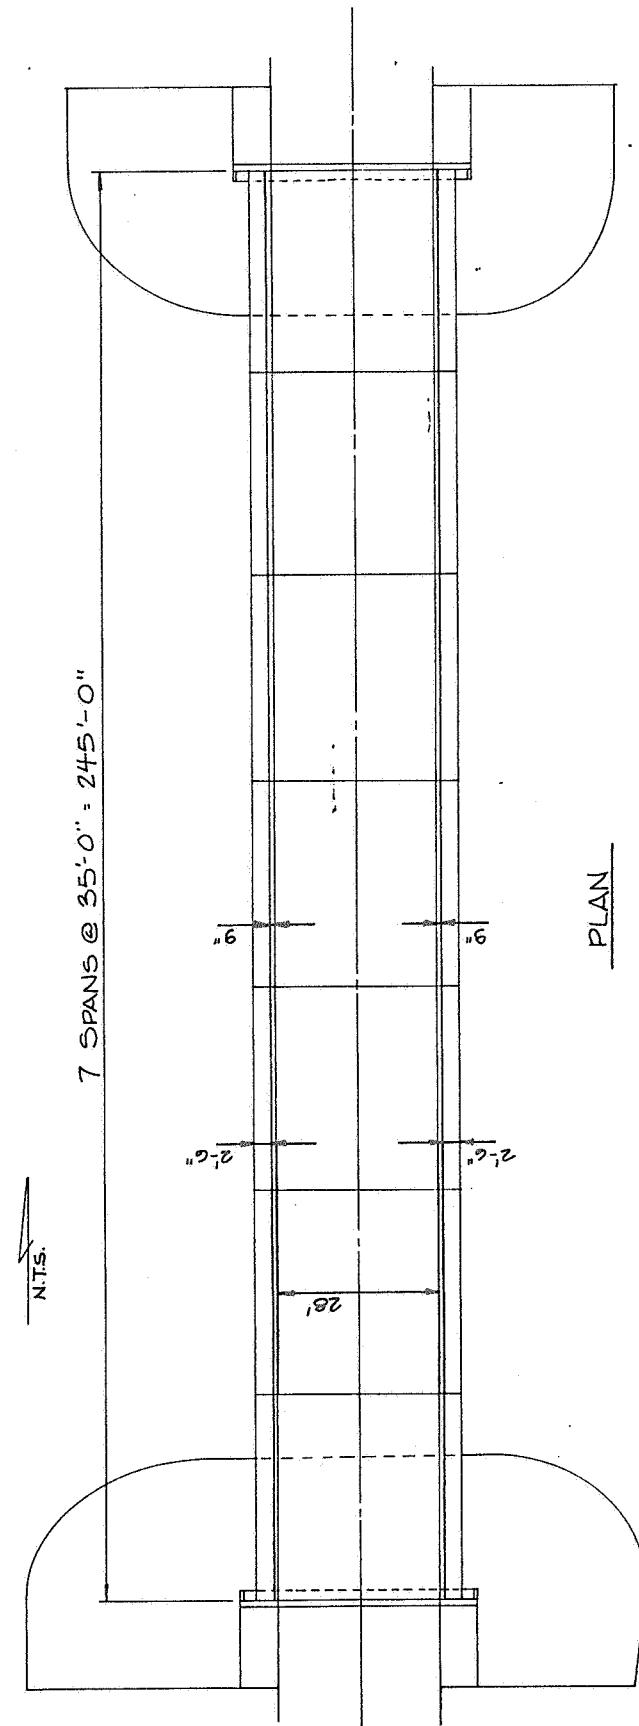
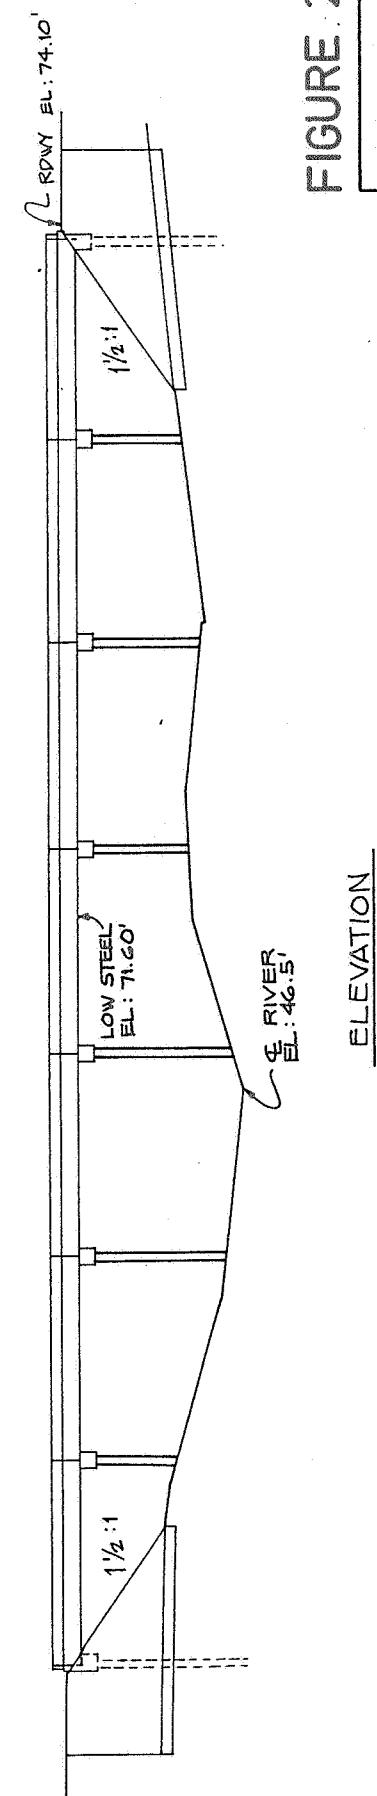
FIGURE 2

The existing bridge was constructed in 1951 and consists of seven 35 foot simply supported spans comprising a total length of 245 feet. (See Figure-2). The bridge is supported by pile bents consisting of prestressed concrete piles and cast in place concrete pile caps. The existing bridge cross section consists of a 28 foot clear roadway with 9" curbs (2'-6" wide) separating the roadway from the concrete handrail. The approach roadway cross section consists of two 12 foot travel lanes with 8 foot grass shoulders on an approximately 15 foot high embankment. Both the roadway and bridge are offset 31 feet from the centerline of the 202 foot wide right-of-way.

EXISTING CONDITIONS
S.R. 700 OVER THE WILACOOCHEE RIVER PASCO CO.
