FINAL PRELIMINARY ENGINEERING REPORT

WITHLACOCHEE RIVER BRIDGE REPLACEMENT

ON S.R. 700 IN PASCO COUNTY, FLORIDA

WPI No.: 7115954
State Project No.: 14080-3506
Bridge No.: 140026

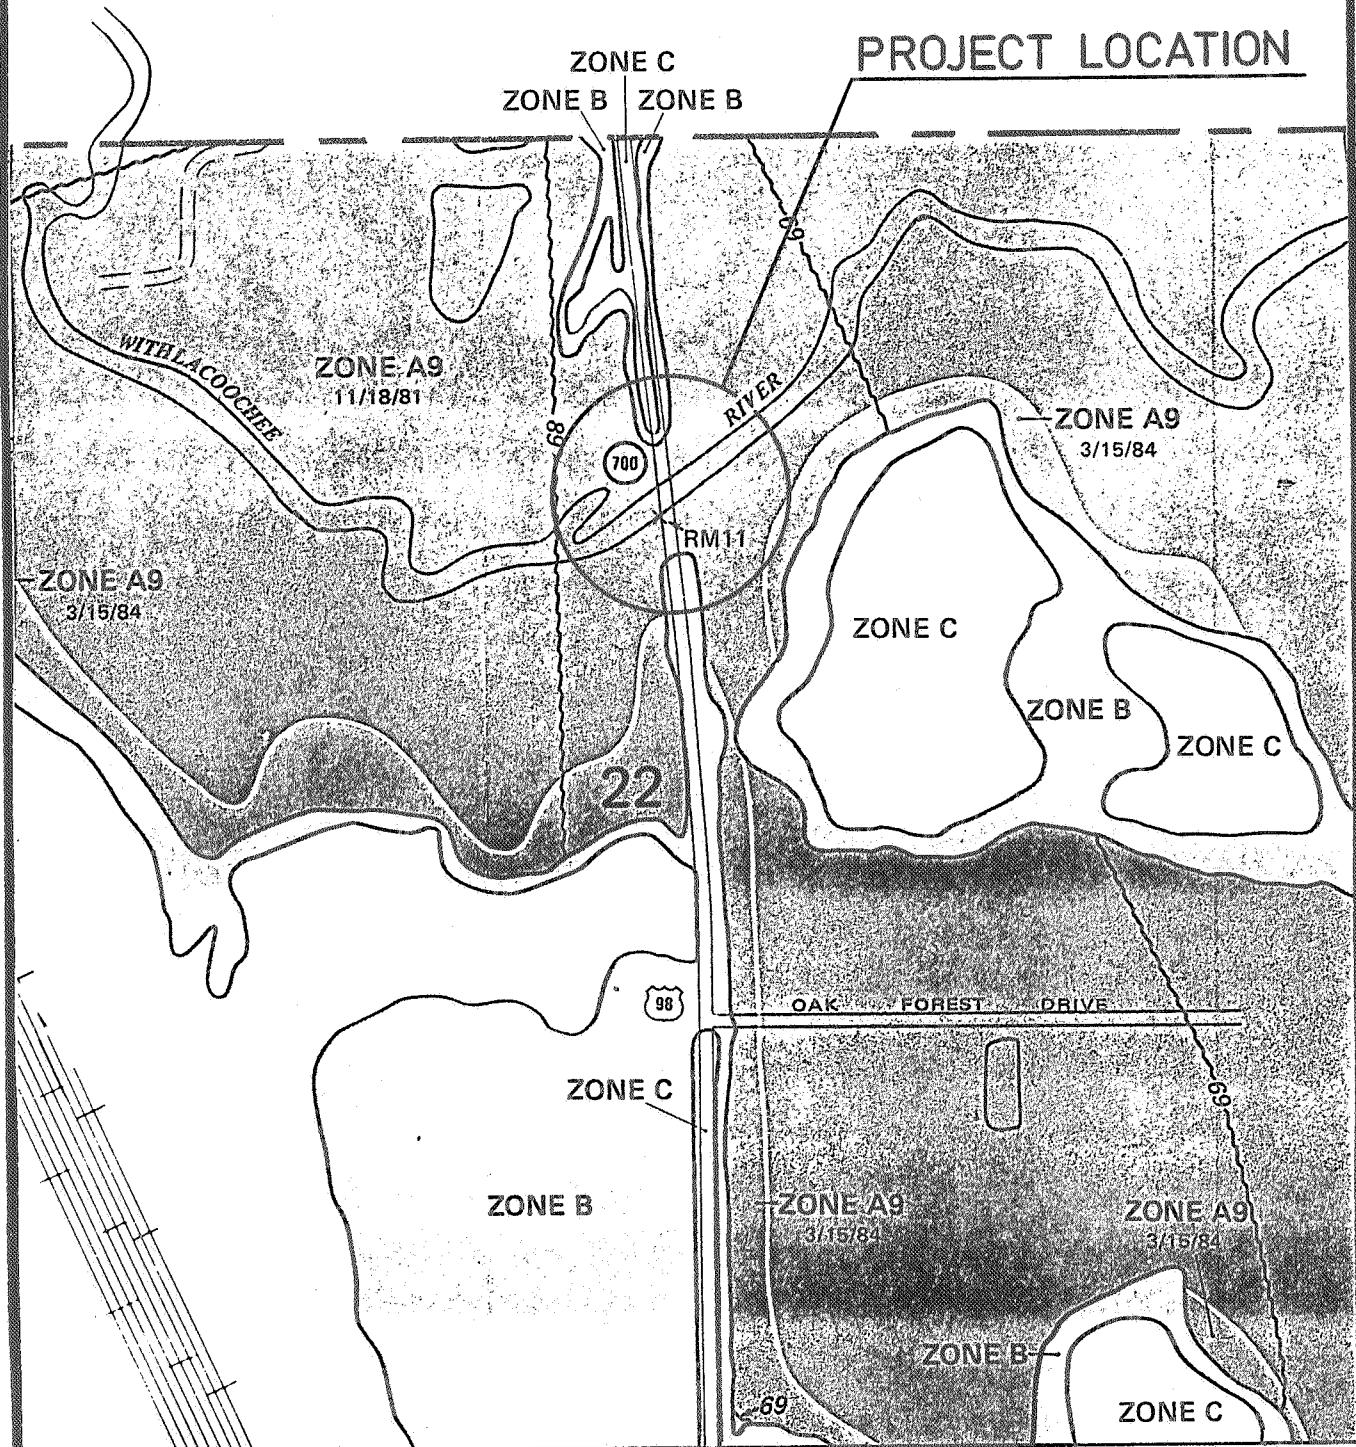
FLOOD INSURANCE RATE MAP
PASCO COUNTY, FLORIDA
PANEL 102 OF 500

The Withlacoochee River bridge is located in Flood Zone A9 according to Federal Emergency Management Agency's (FEMA) Flood Insurance Rate Map (FIRM) for Pasco County, panel number 102 of 500, dated March 15, 1984. (See Figure-3). Flood Zone A9 is defined as the area of the 100-year flood with base flood elevations and flood hazard factors determined. The associated

FLOOD ZONE DELINEATION

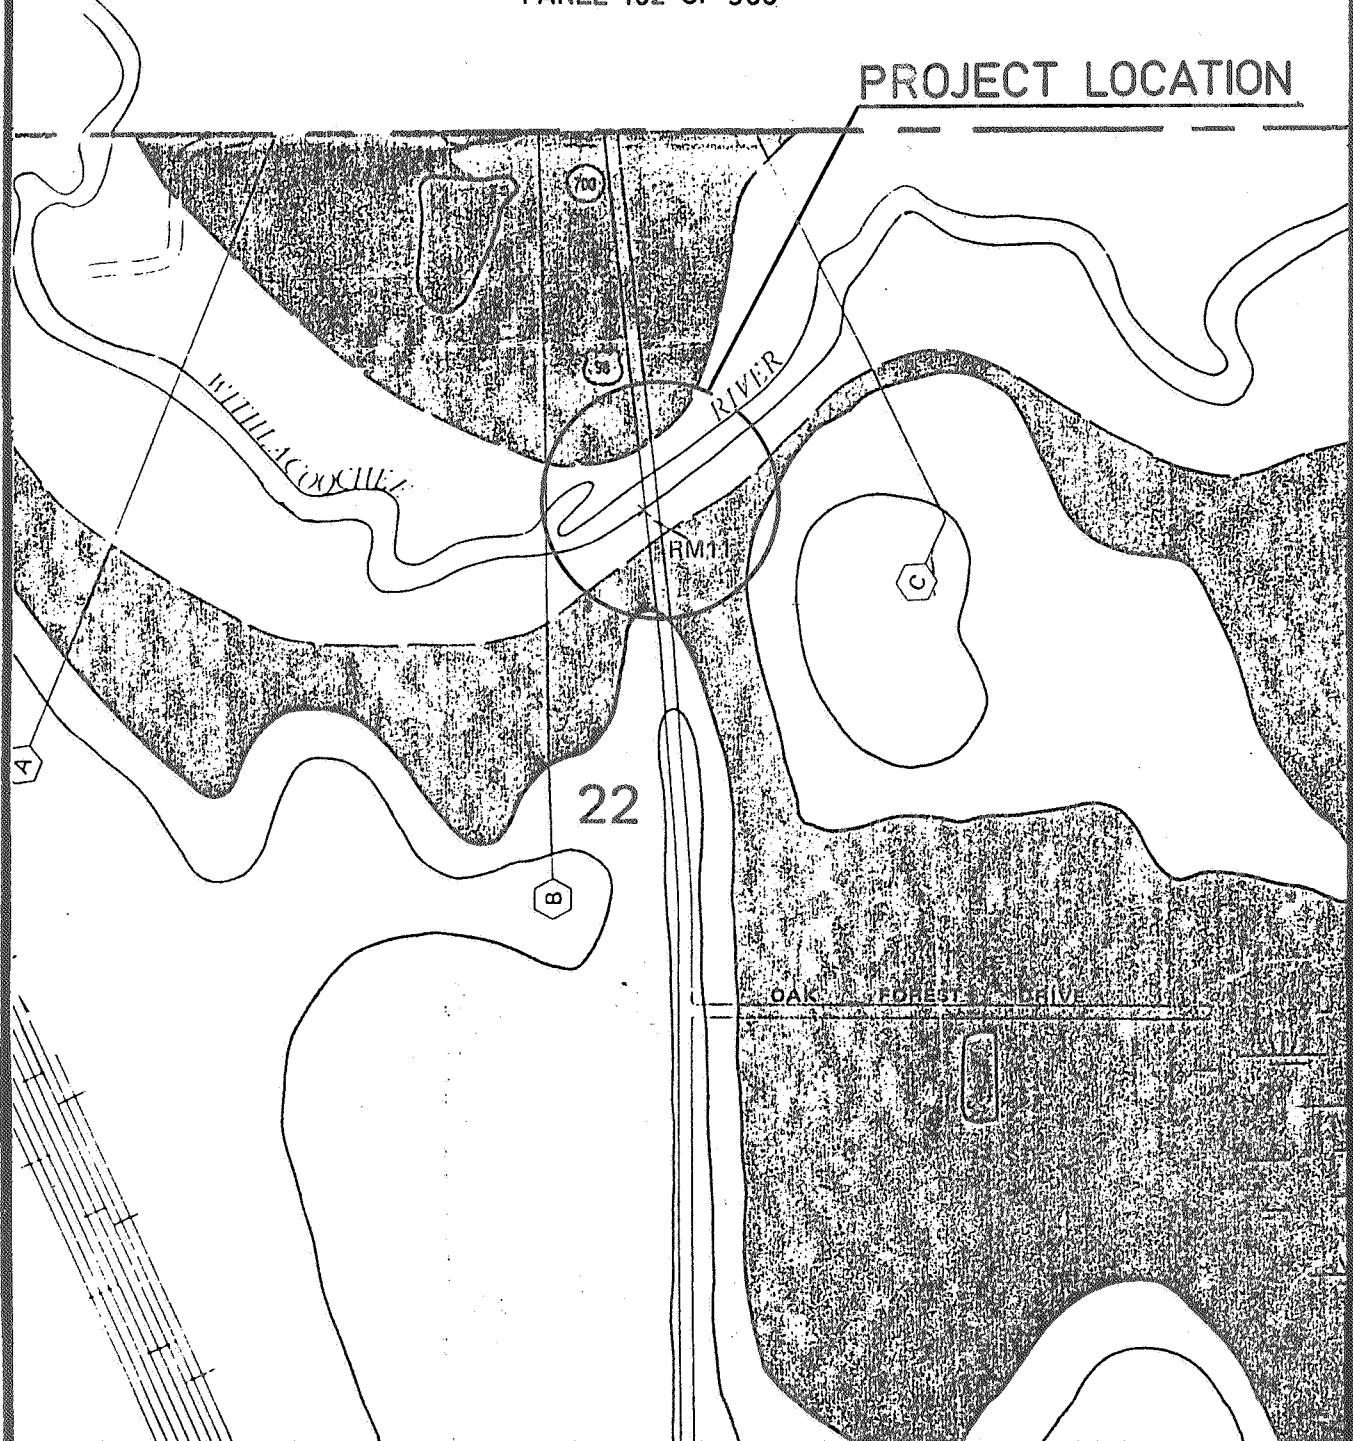
FIGURE 4

Encroachment on flood plains, such as fill, reduces the floodcarrying capacity, increases the flood heights of streams and increases flood hazards in areas beyond the encroachment itself. One aspect of flood-plain management involves balancing the economic gain from flood-plain development against the resulting increase in flood hazard. For purposes of the National Flood Insurance Program, the concept of a floodway is used as a tool to assist local communities in this aspect of flood-plain management. Under this concept the 100-year flood is divided into a floodway and floodway fringe. The floodway is the channel of a stream plus any adjacent flood-plain areas that must be kept free of encroachment in order that the 100-year flood may be carried without substantial increases in flood heights. Minimum standards of FEMA limit such increases in flood heights to 1.0 foot, provided that hazardous velocities are not produced. From the FEMA Floodway Map for Pasco County, Florida (See Figure-4), the limits of the 100-year floodway at the SR 700 (US 98) bridge were located at the existing bridge abutments.

FLOOD BOUNDARY AND FLOODWAY MAP
PASCO COUNTY, FLORIDA
PANEL 102 OF 500

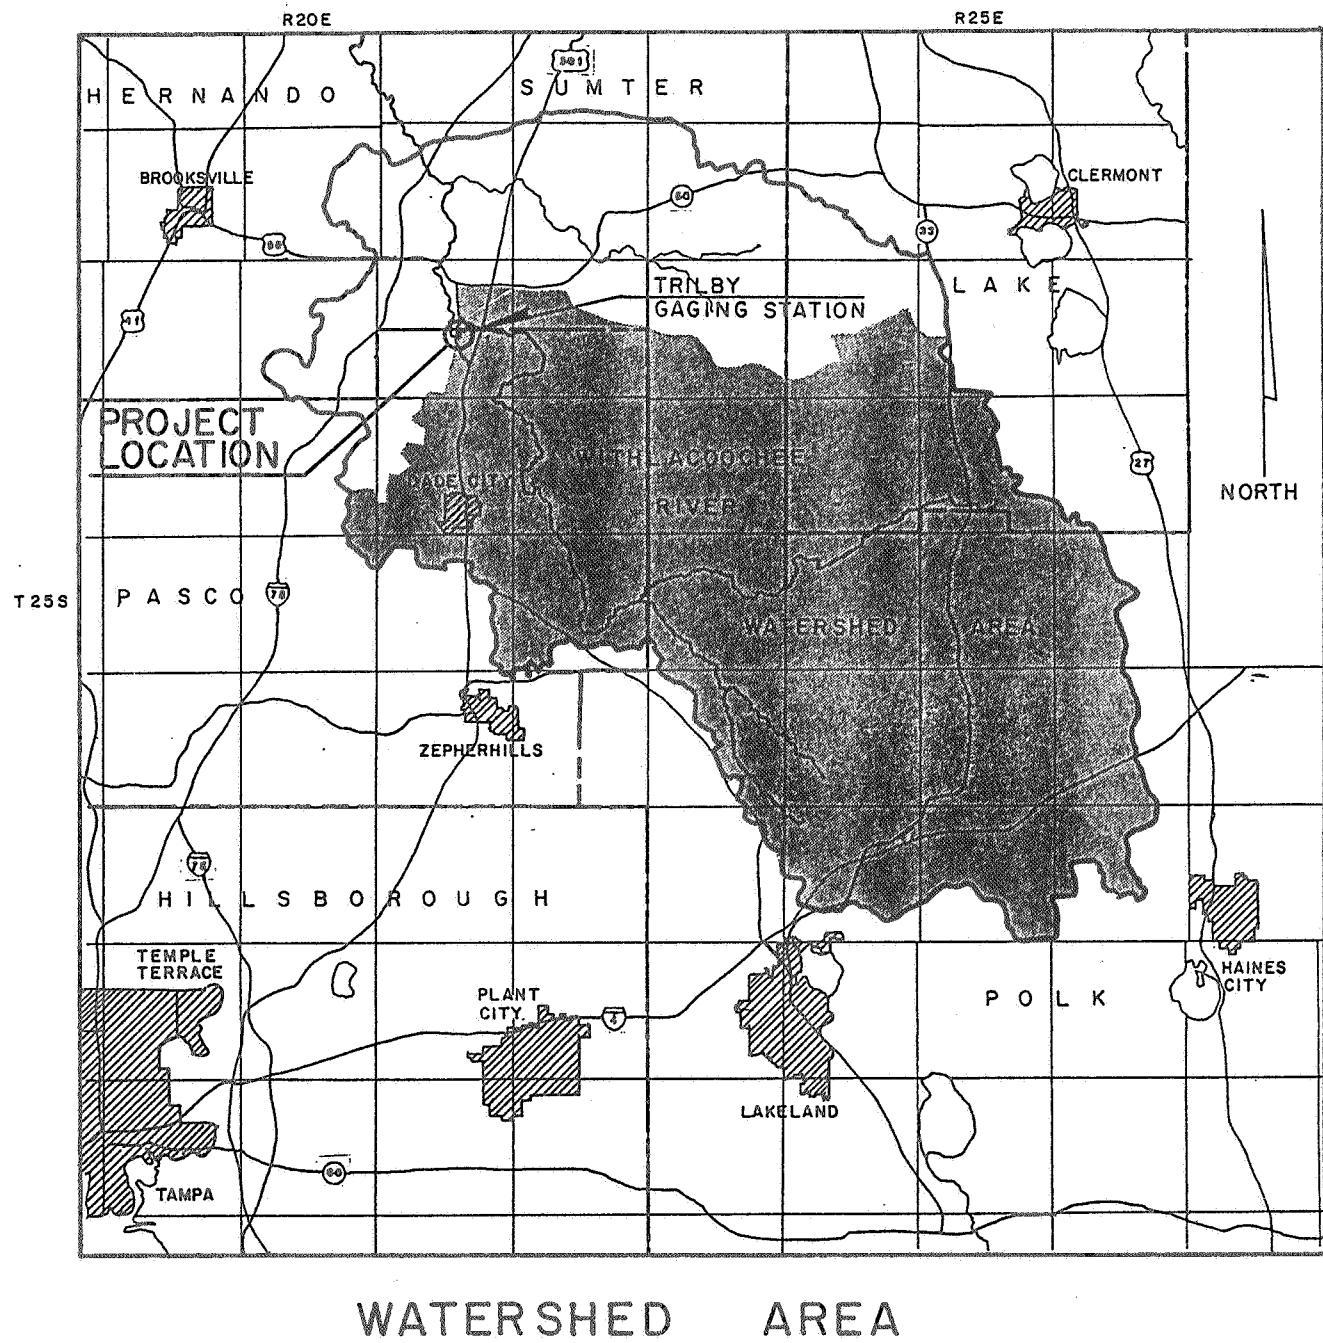
FIGURE 6

A USGS stream gage is located at the SR 35 (US 301) bridge in Trilby, Florida (Gage No. 02312000). This gage is located 1.53 miles upstream of the SR 700 (US 98) crossing. According to the "Water Resources Data, Florida, Water Year 1987", the drainage area associated with the Trilby stream gage is 570 square miles. This stream gage has been in place since 1928. An additional 4 square mile drainage area has been estimated between the gage at Trilby and the SR 700 (US 98) crossing. Therefore, the drainage area of the watershed at the SR 700 (US 98) bridge is approximately 574 square miles. (See Figure-6).

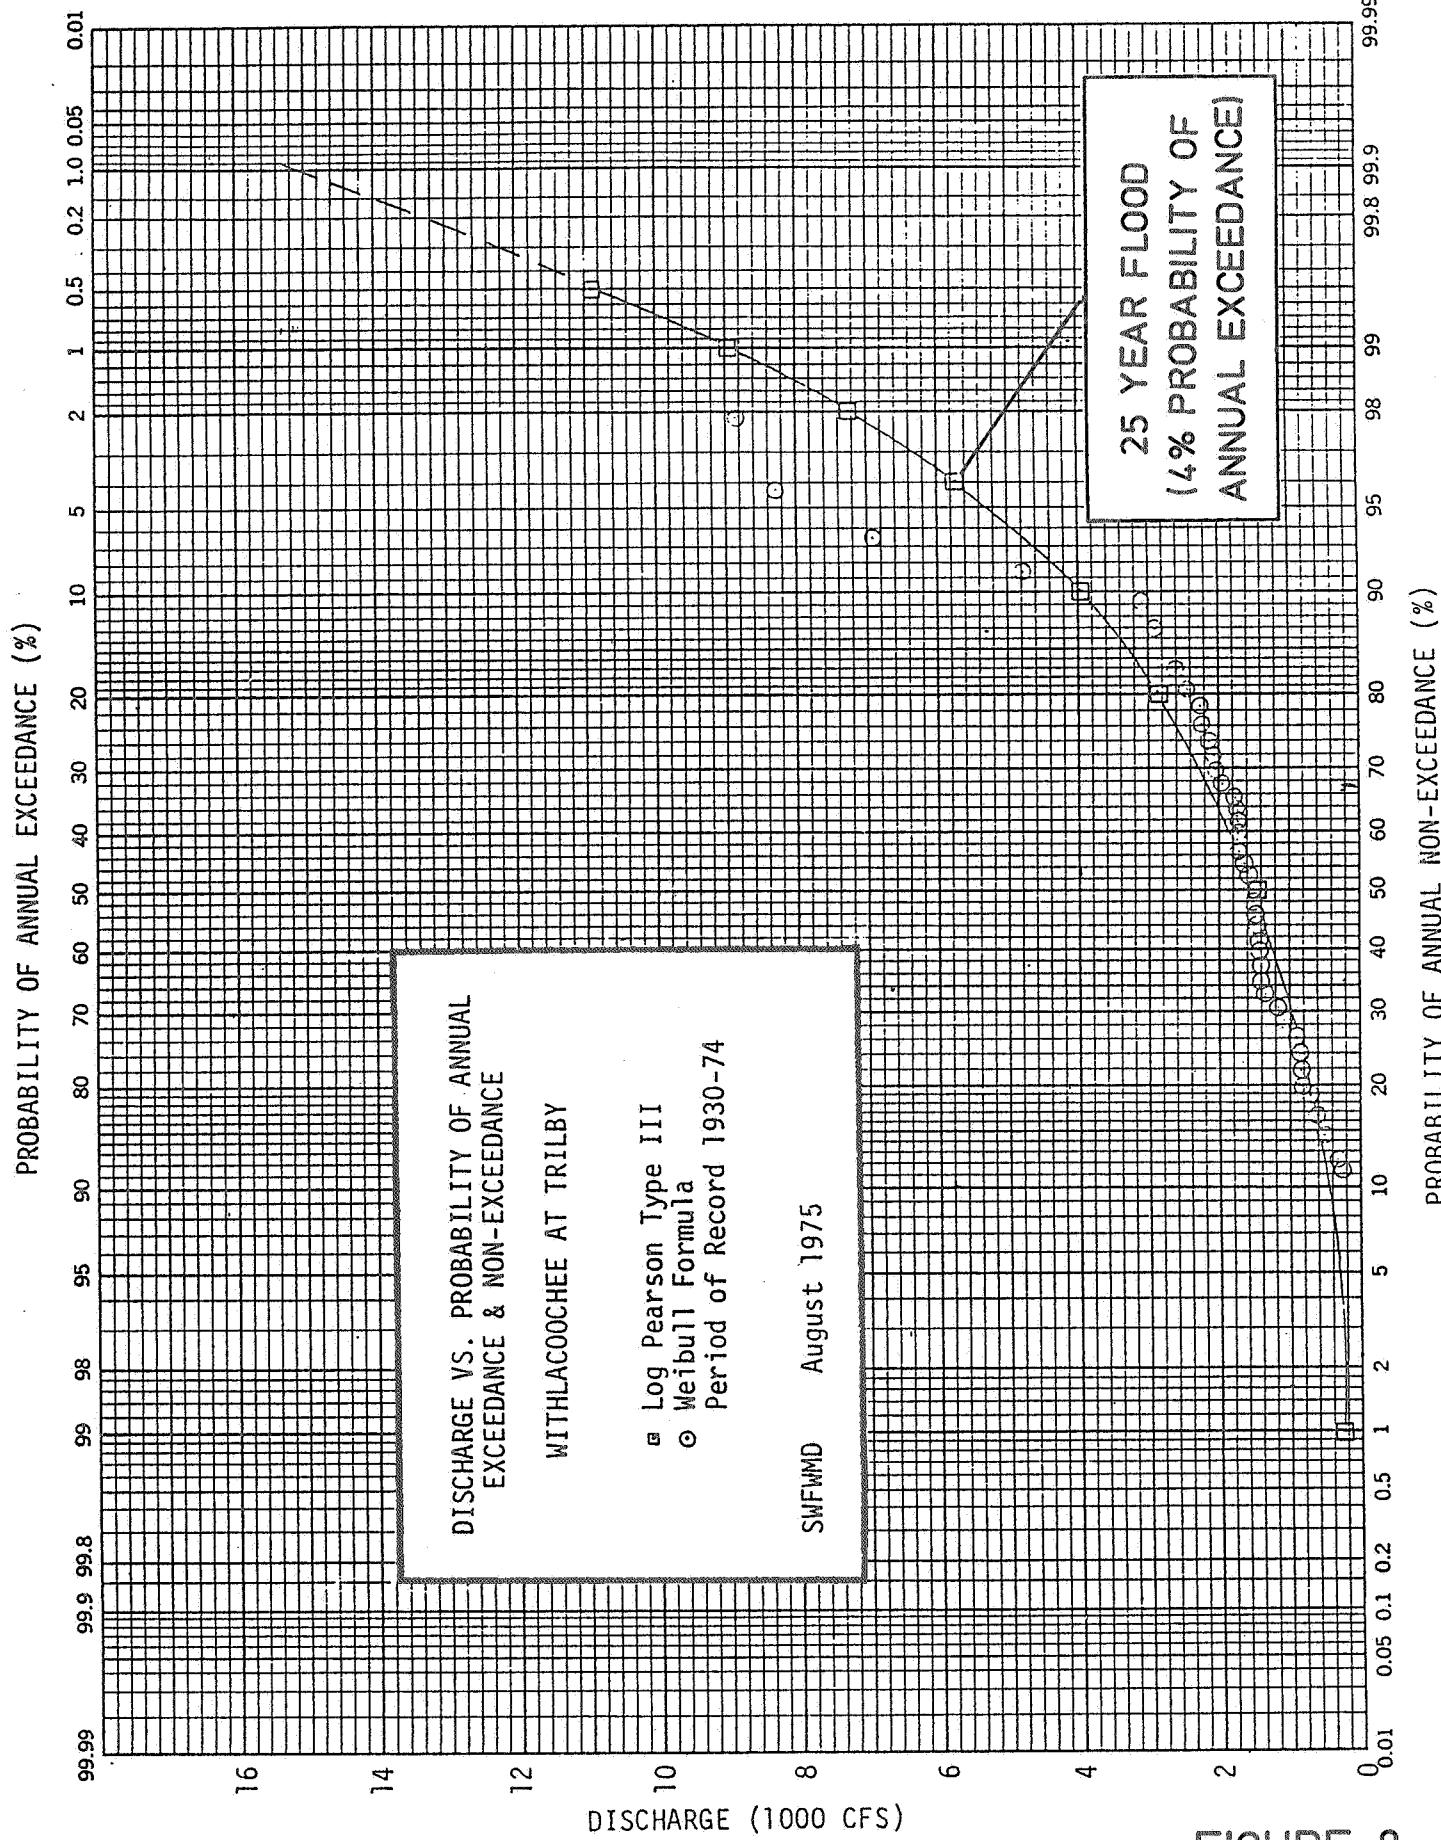
FIGURE 8

* The discharge values for the 25-year flood was taken from the DISCHARGE vs. PROBABILITY OF ANNUAL EXCEEDANCE graph for the Withlacoochee River at Trilby. (See Figure-8).

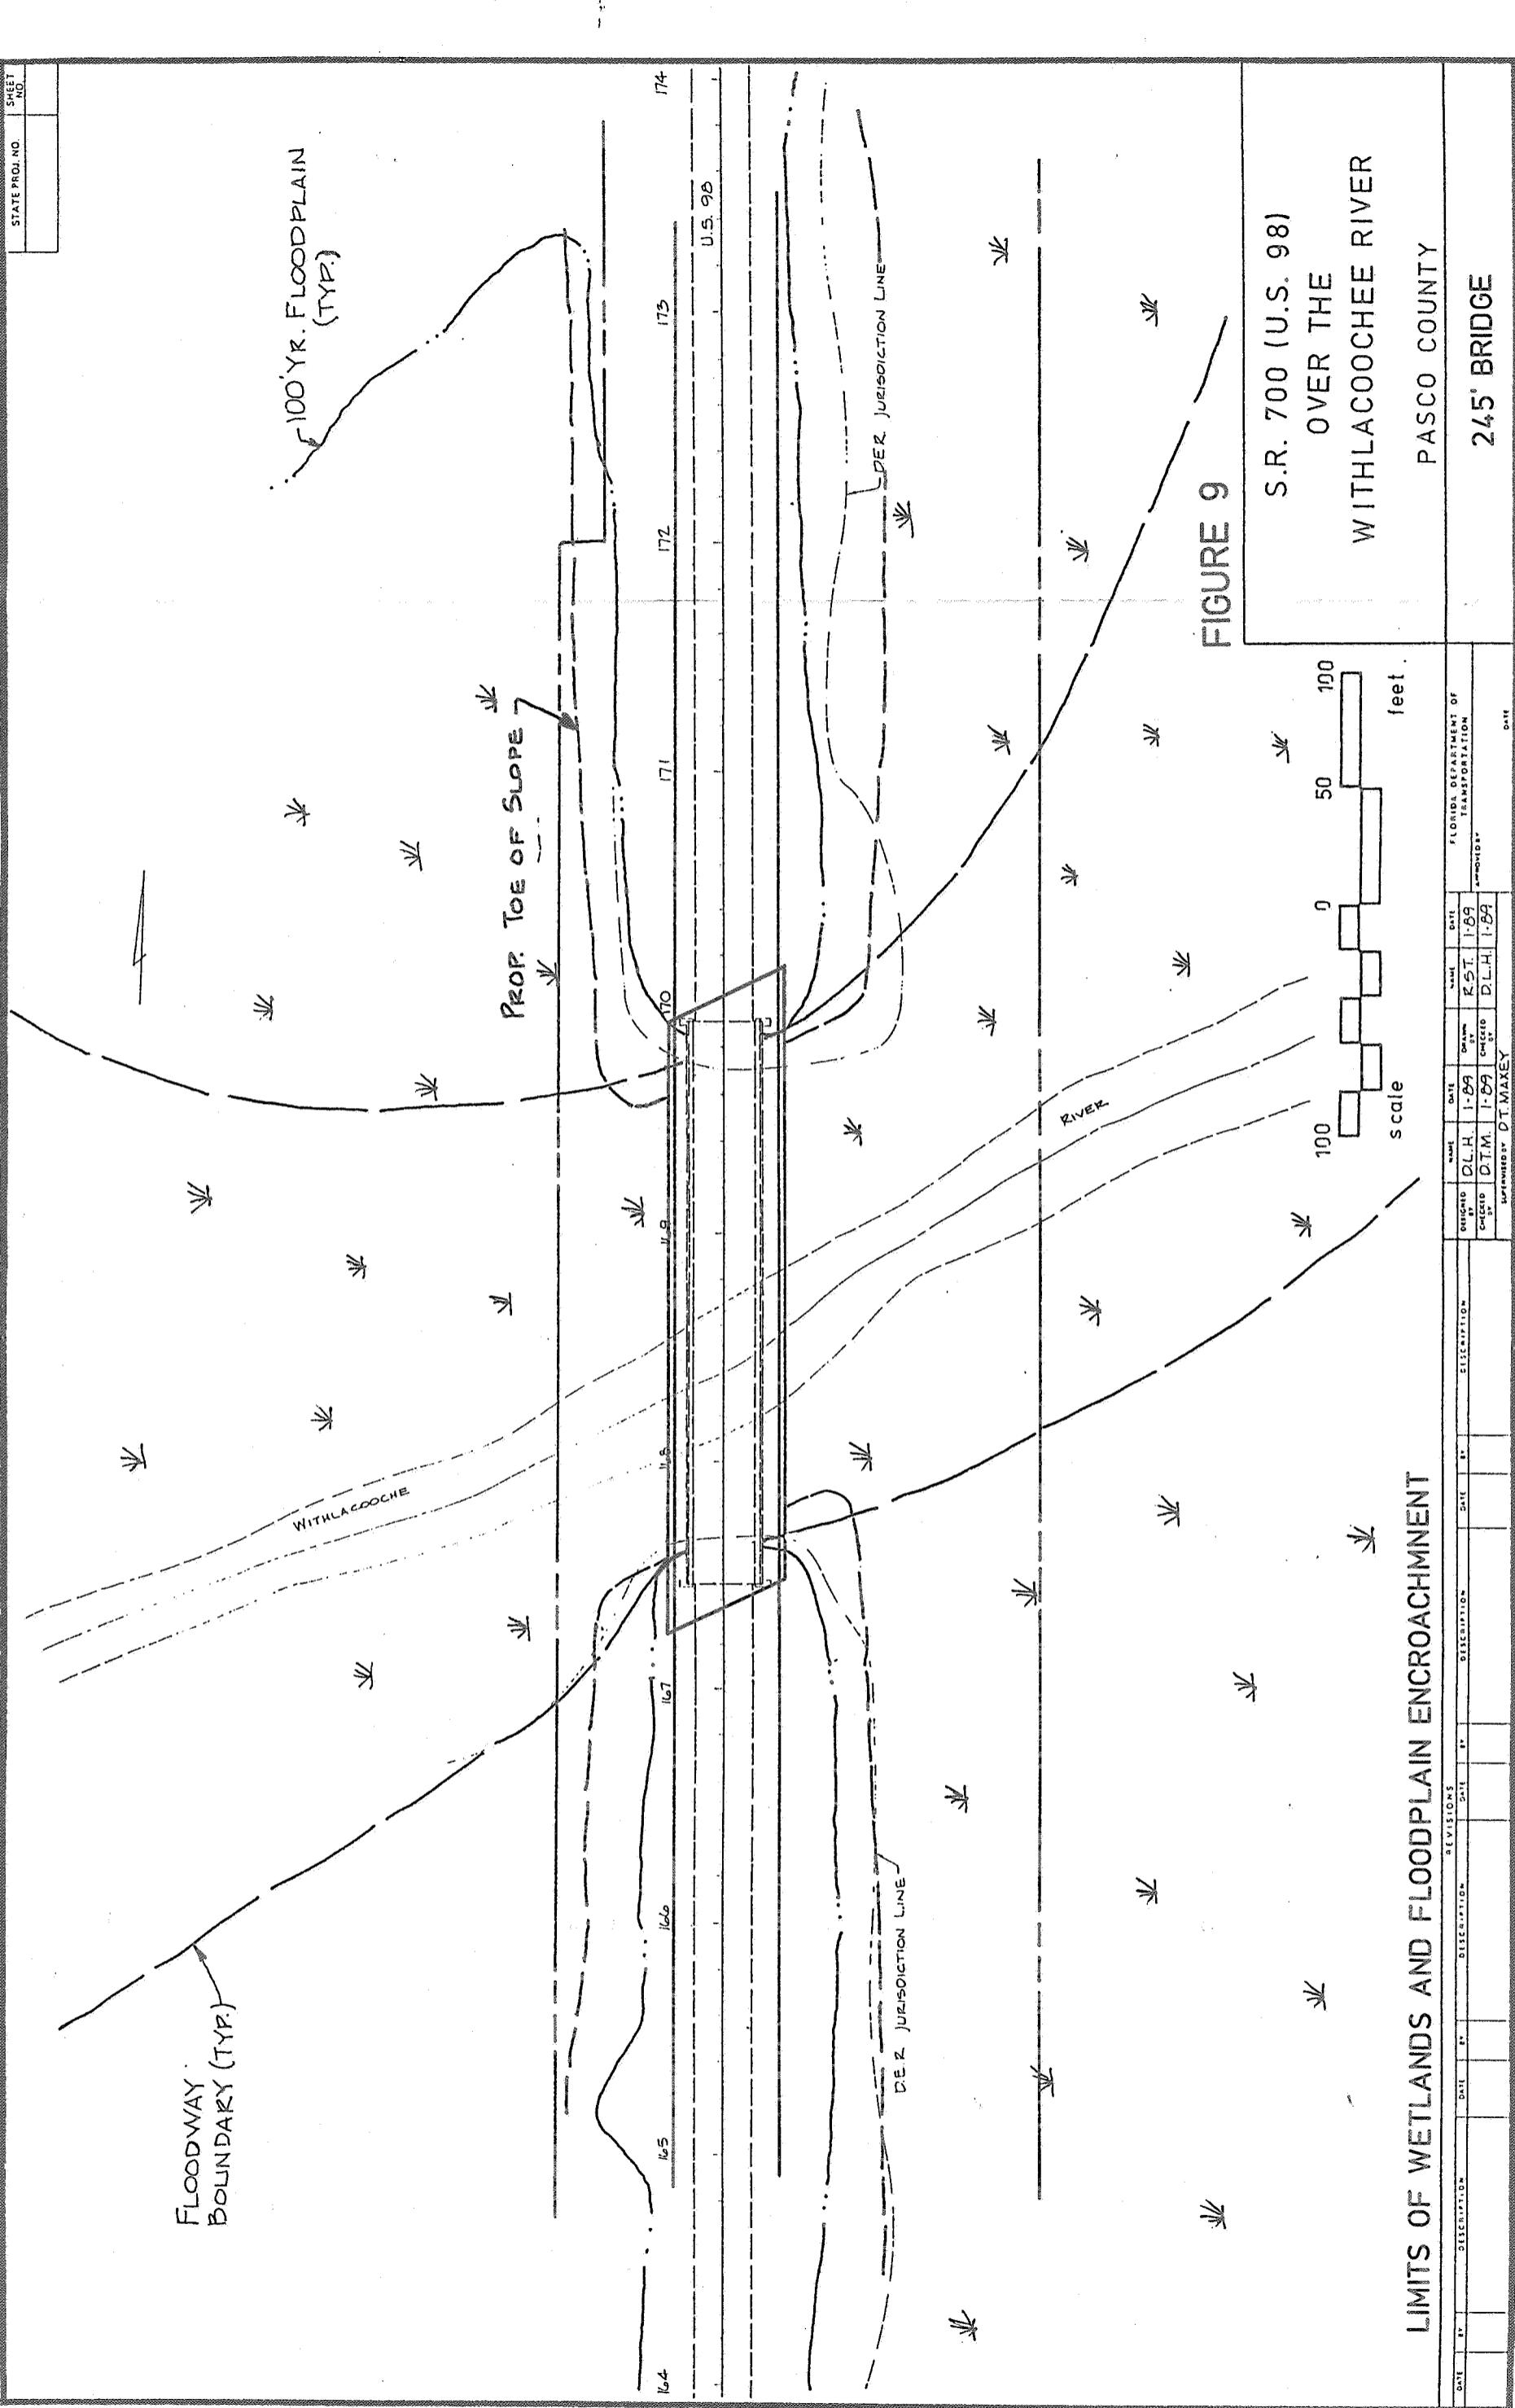
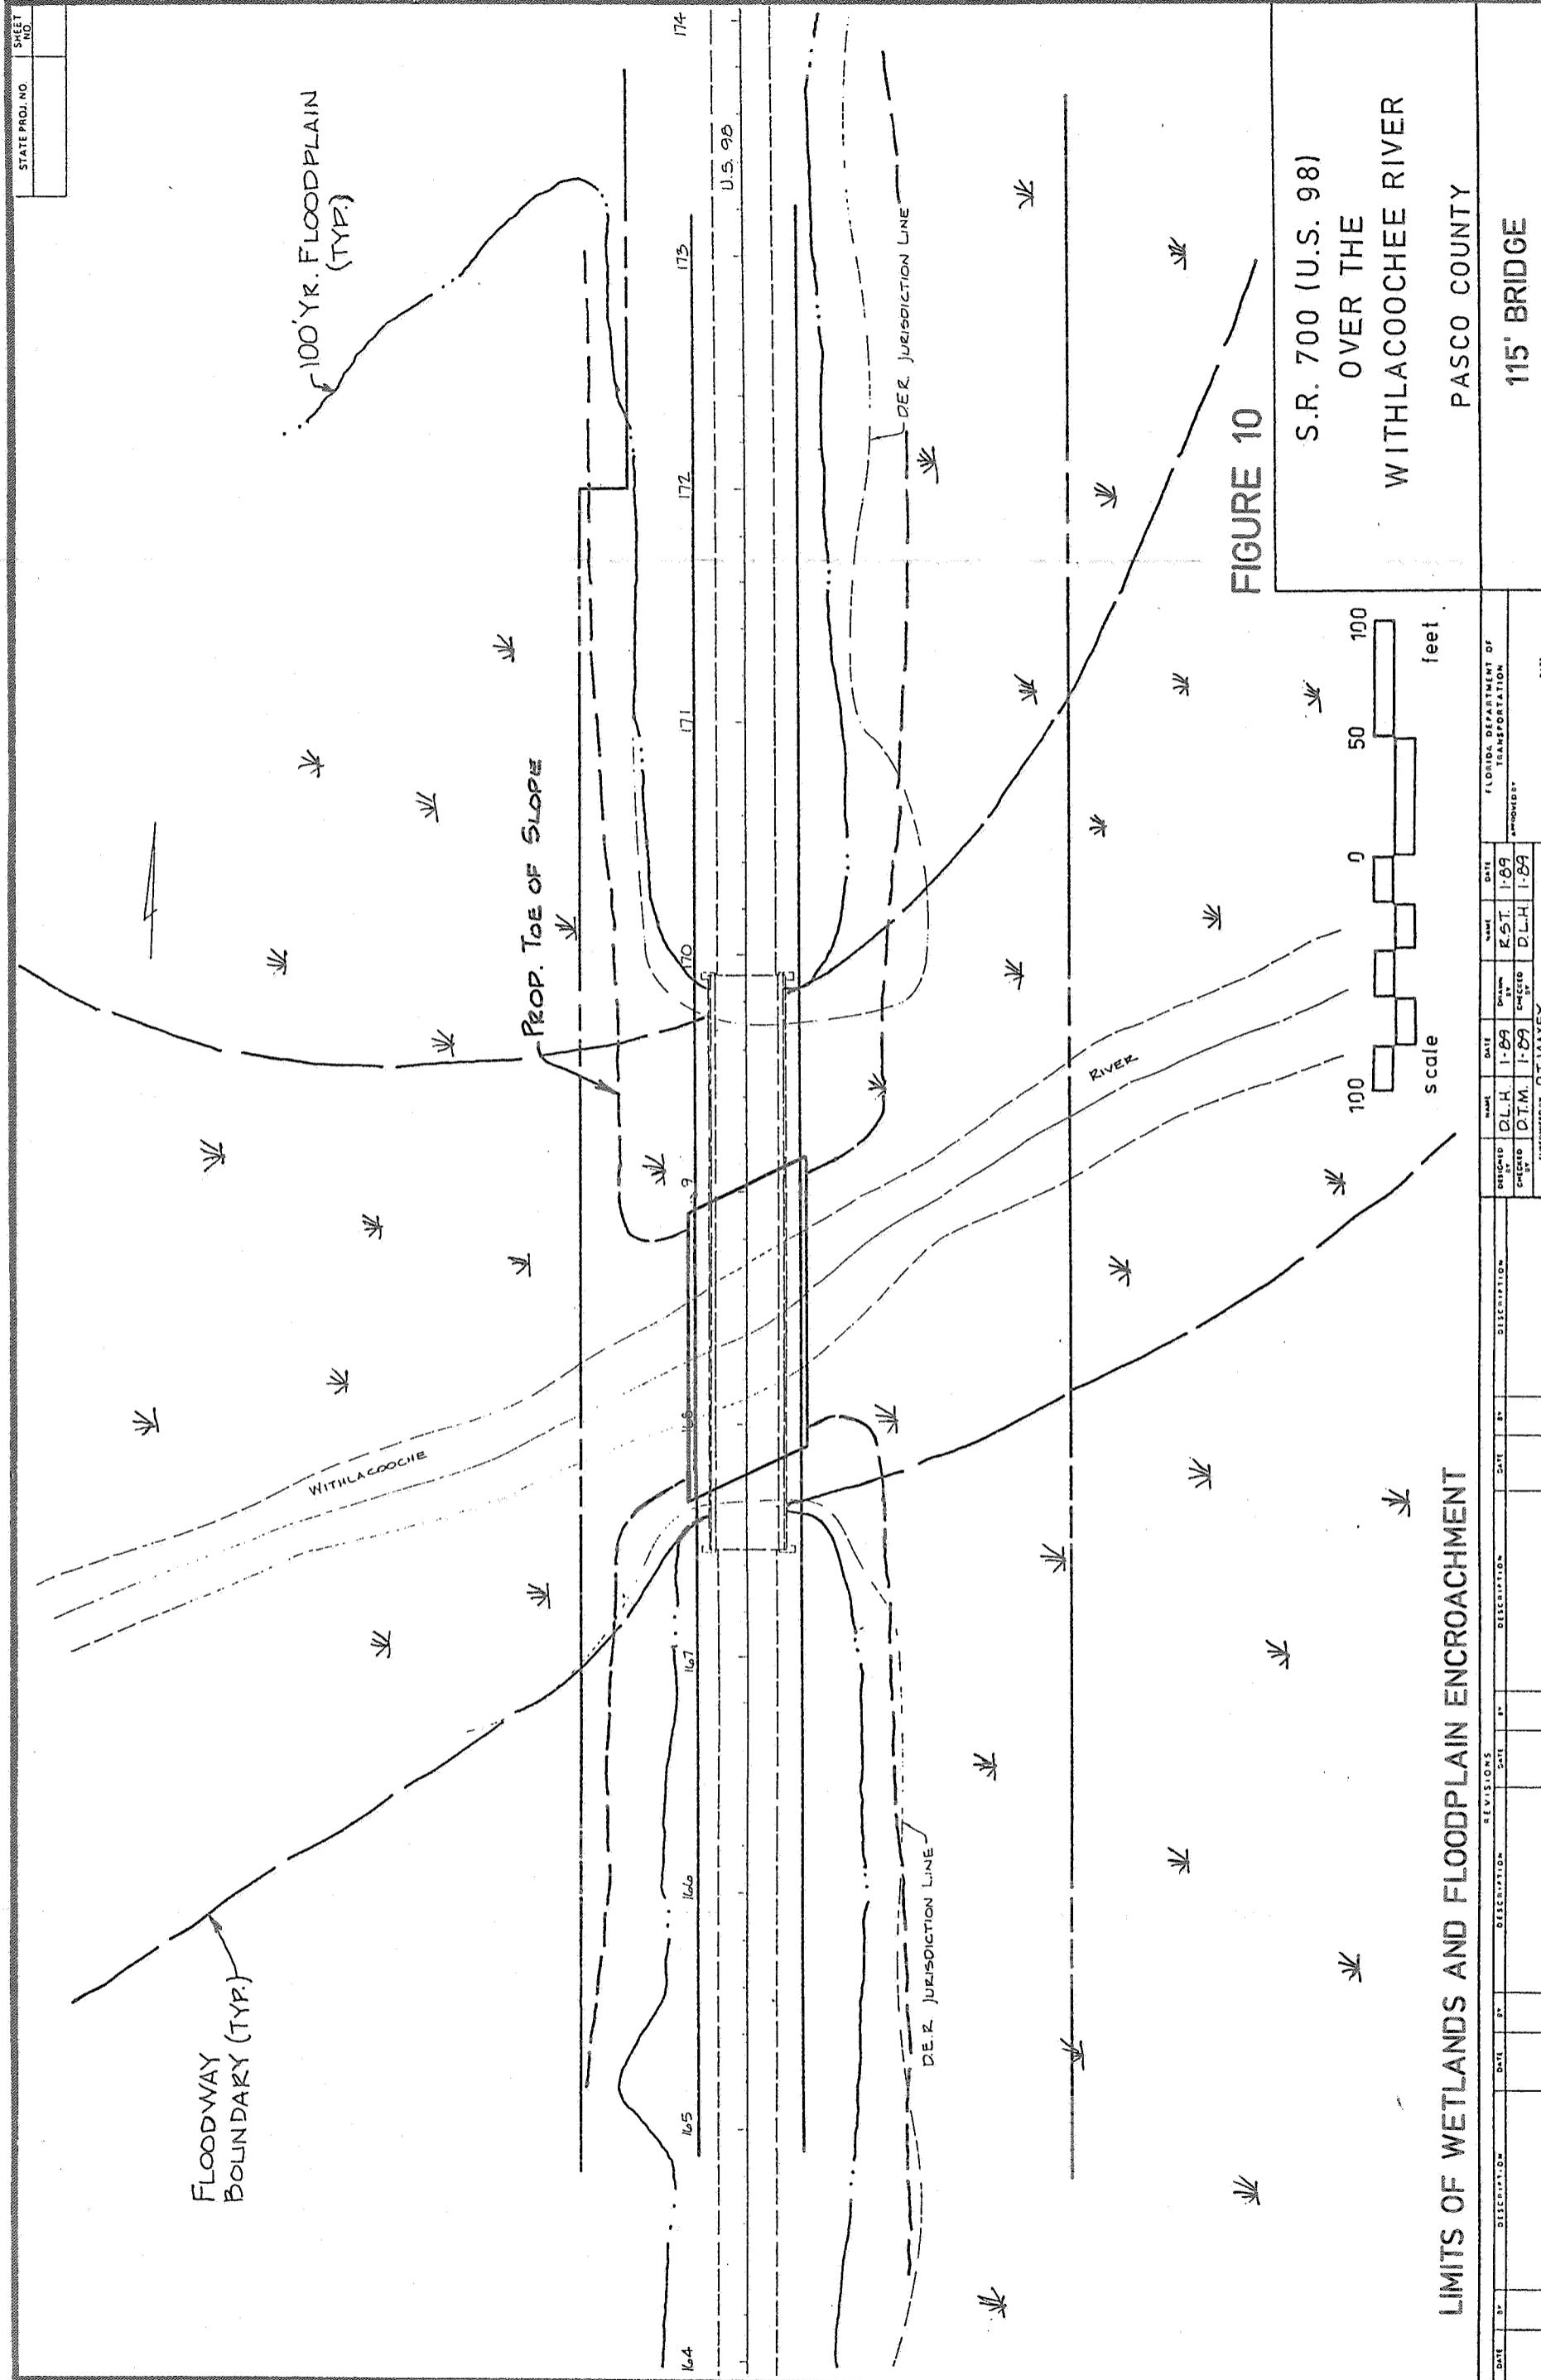
The 115 foot structure requires the placement of fill on approximately 0.5 acres of wetland area. This fill is the result of conformance with current FDOT slope criteria and lengthening of the roadway embankments.

LIMITS OF WETLANDS AND FLOODPLAIN ENROACHMENT

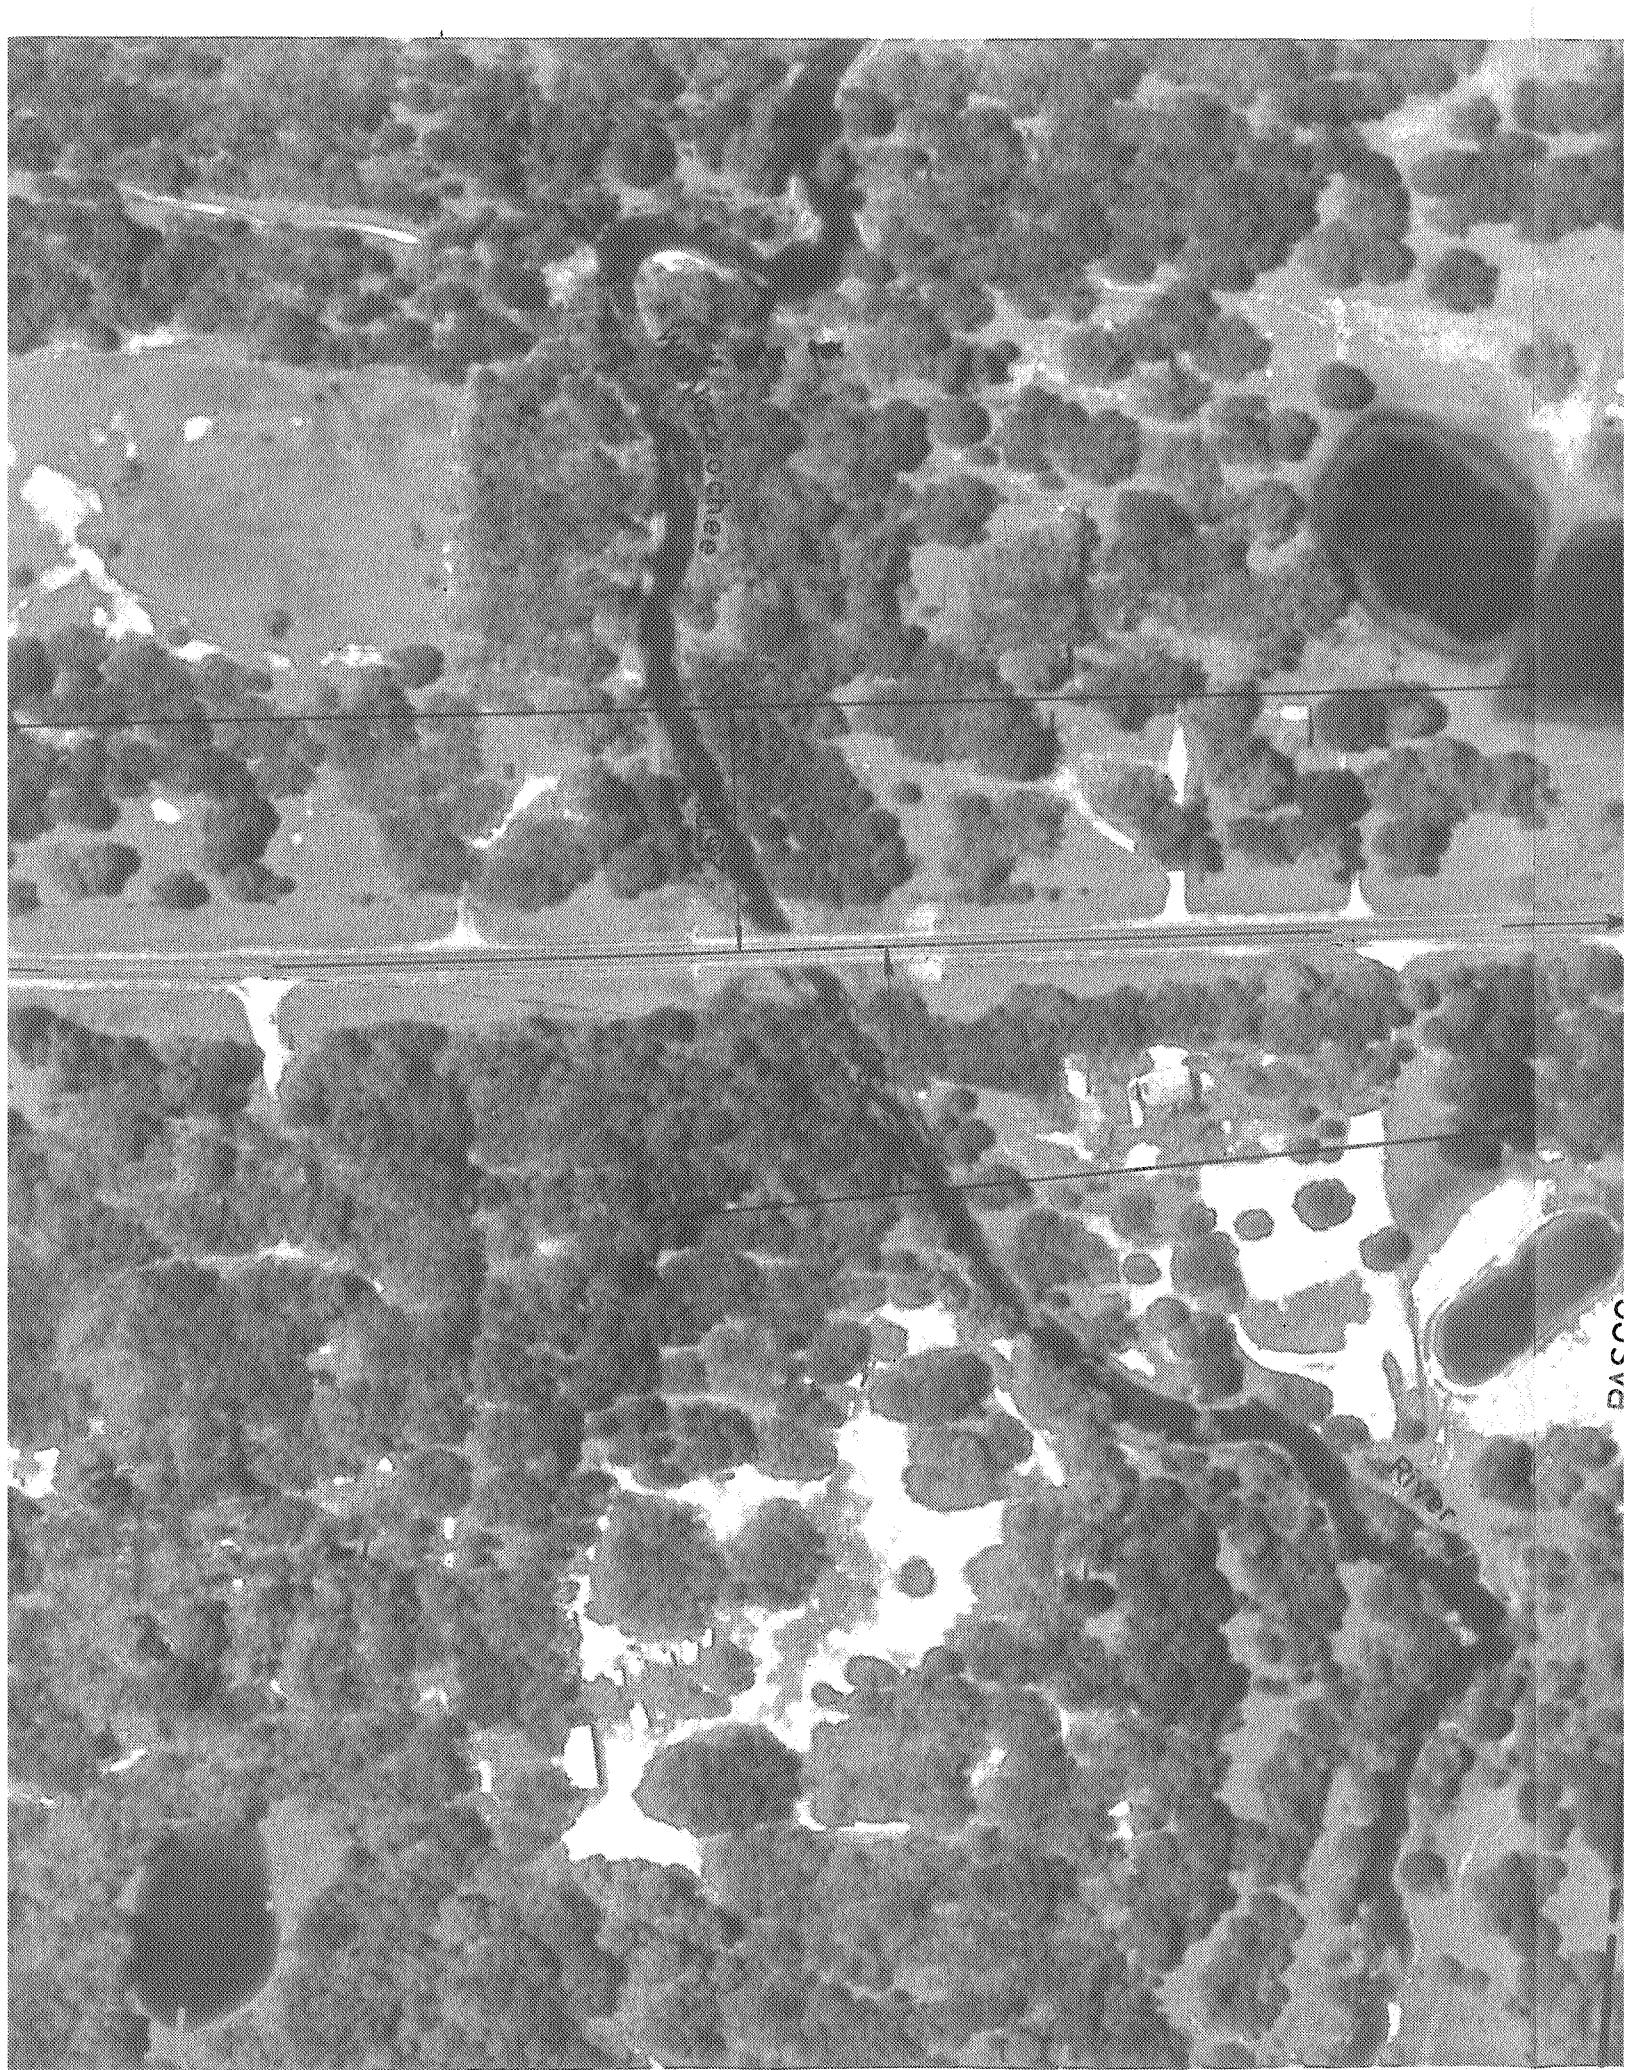
CROSS SECTION @ STRUCTURE

LOOKING UPSTREAM

SCALE: 1" = 300 HORIZ.
1" = 5 VERT.
